historic structure report  
appomattox manor

october 1982

HISTORIC STRUCTURE REPORT  
PHYSICAL HISTORY AND ANALYSIS SECTION  
APPOMATTOX MANOR  
CITY POINT UNIT  
PETERSBURG NATIONAL BATTLEFIELD  
VIRGINIA

By  
Richard G. Turk  
and  
G. Frank Williss

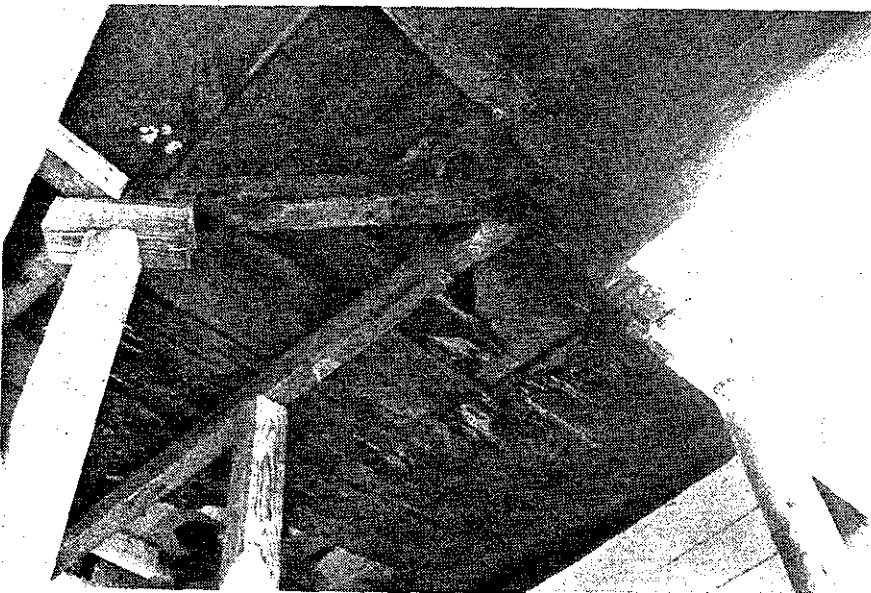
Illustration 54  
Manor House  
Detail, framing of east wing  
Bathroom

Note: Water damage repaired  
1981

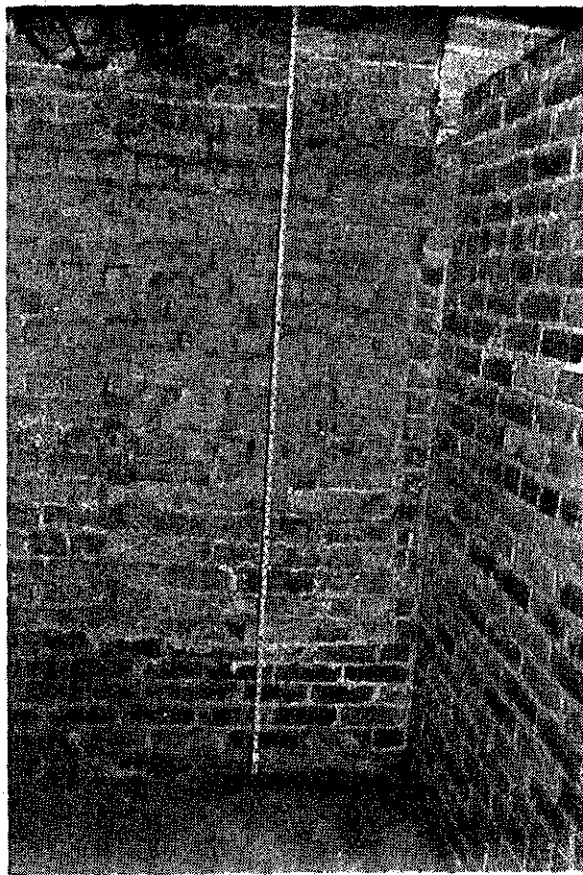
Illustration 66  
Manor House, basement  
Interior, Room B-12  
Detail south wall

Note: Brick change at base  
of wall.

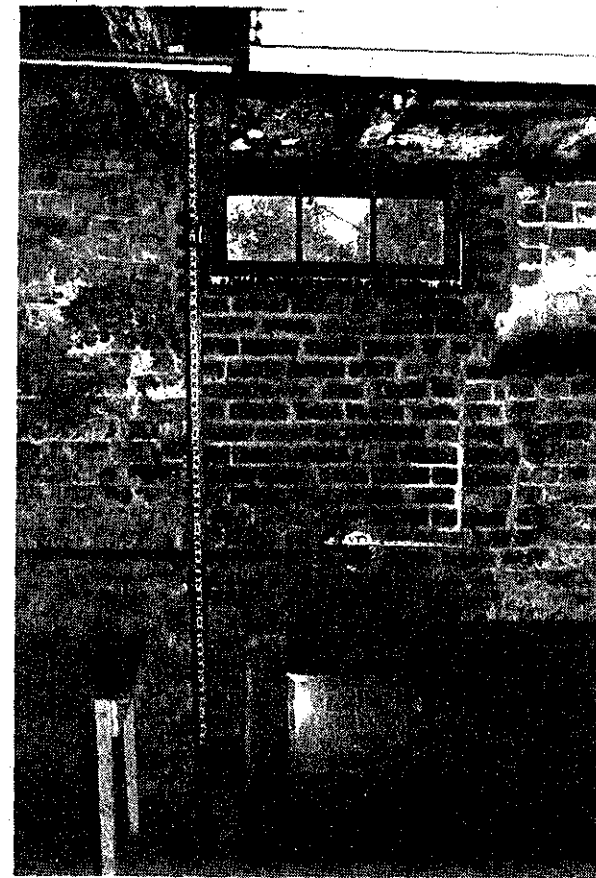
Illustration 67  
Manor House, basement  
Interior, Room B-05  
Detail south wall

Note: Patch closed access  
to 1935-54 greenhouse

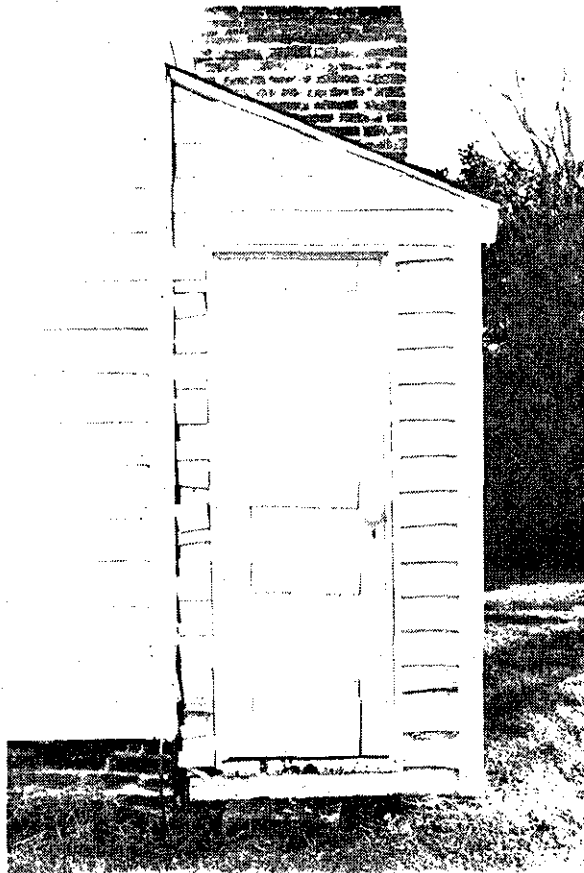
Illustration 78  
Outside kitchen  
West elevation, bathroom  
addition

While obviously a poor quality addition, the bathroom addition appears to have been stabilized. The existing asphalt shingles were most likely wood shingles originally.

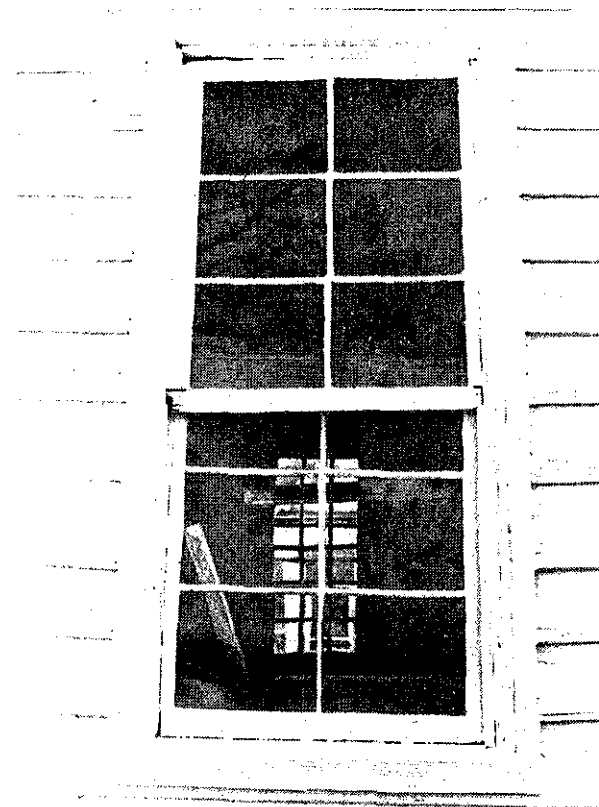
Illustration 79  
Outside west elevation,  
north window

The windows are basically weathertight. The north window on the west elevation is in the worst condition exhibiting deterioration at the head, meeting rail, and sill (see Illustration 79). The frames exhibit erosion of the surface, with a raised grain. All kitchen sash could be reconditioned replacing any damaged parts.

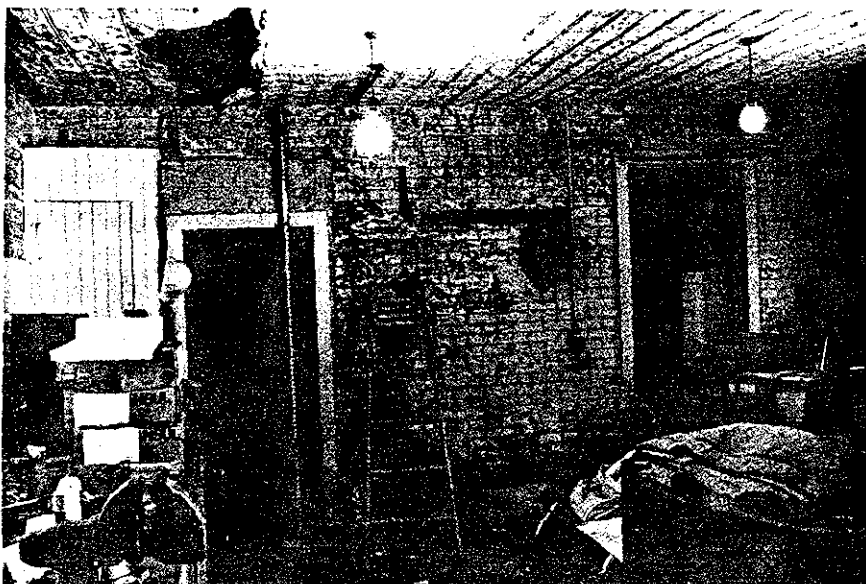
Illustration 90  
Carriage House  
Interior, central section  
West wall

Note: Trace of original window  
above door

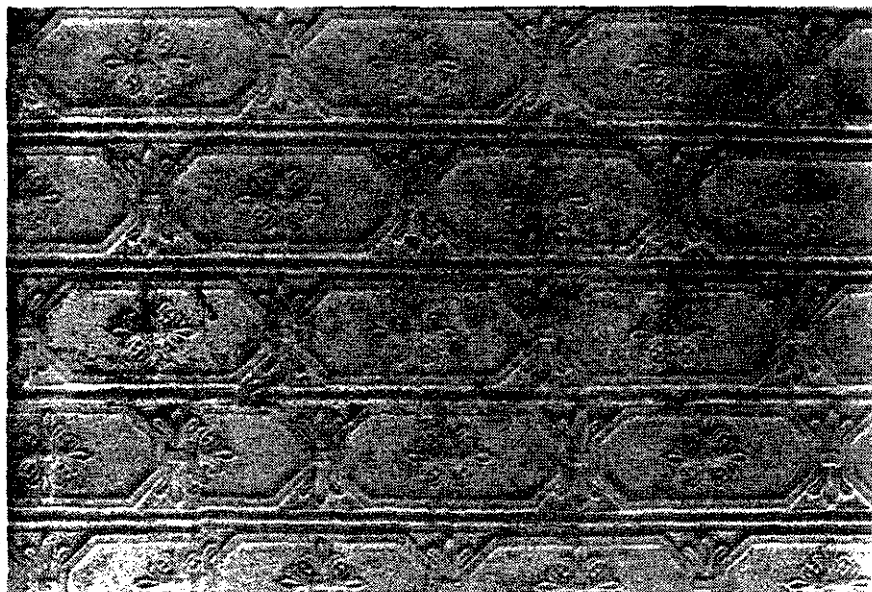
Illustration 94  
Carriage House  
Interior, central section  
Tin ceiling (fireproofing)

The interior metal cladding is badly rusted due to continuing roof leakage. No current leaking was noted. The drywall in the addition is deteriorated due to the water and should be removed.

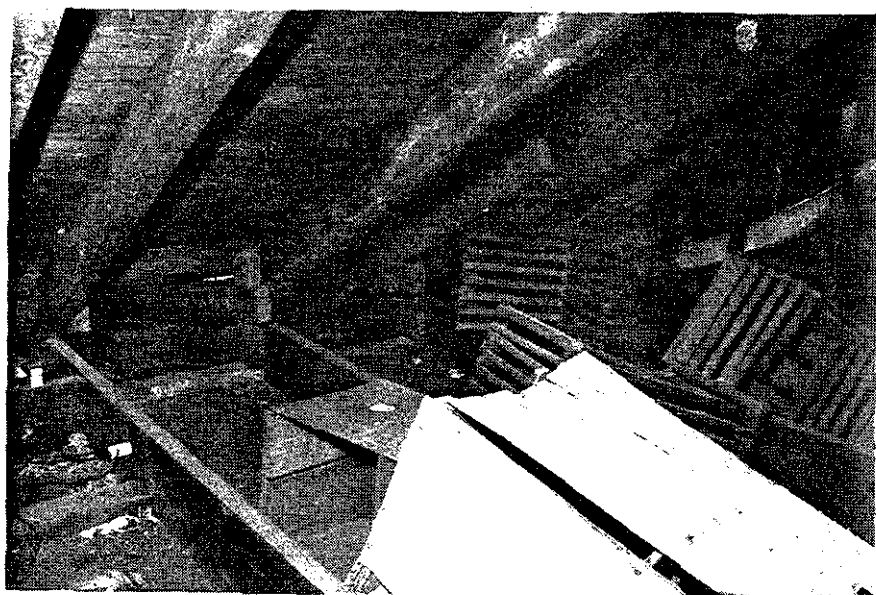
Illustration 95  
Carriage House  
Interior, attic  
framing from northwest

Note: Framing for east addition  
attached to other framing

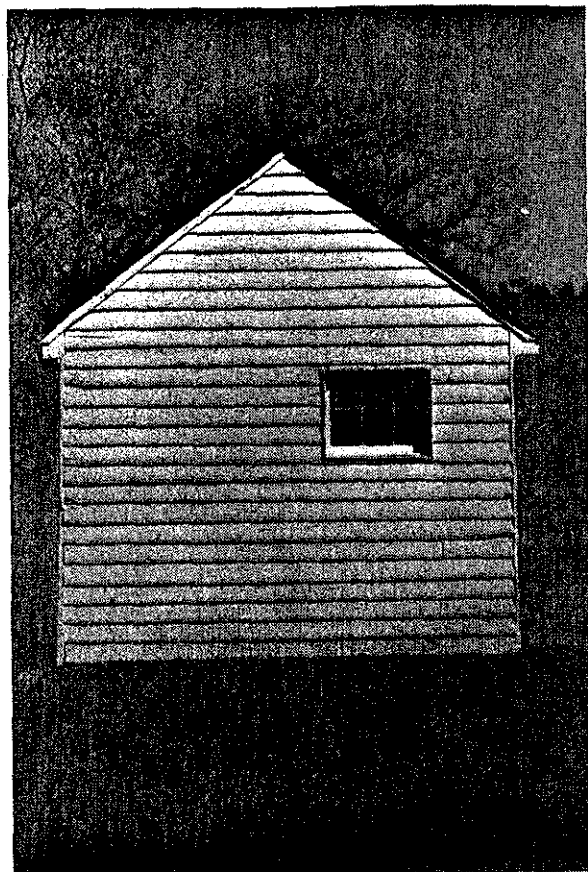
Illustration 97  
Old Smokehouse  
South elevation

Approximately 60 percent of the weatherboards on the building as a whole would require repair/replacement. The north elevation exhibits the worst deterioration with perhaps 80 percent of the weatherboarding requiring repair and replacement.

The corner moldings are severely deteriorated in three out of four corners with only the southeast molding in fair condition. Replacement is recommended in the three severe cases.

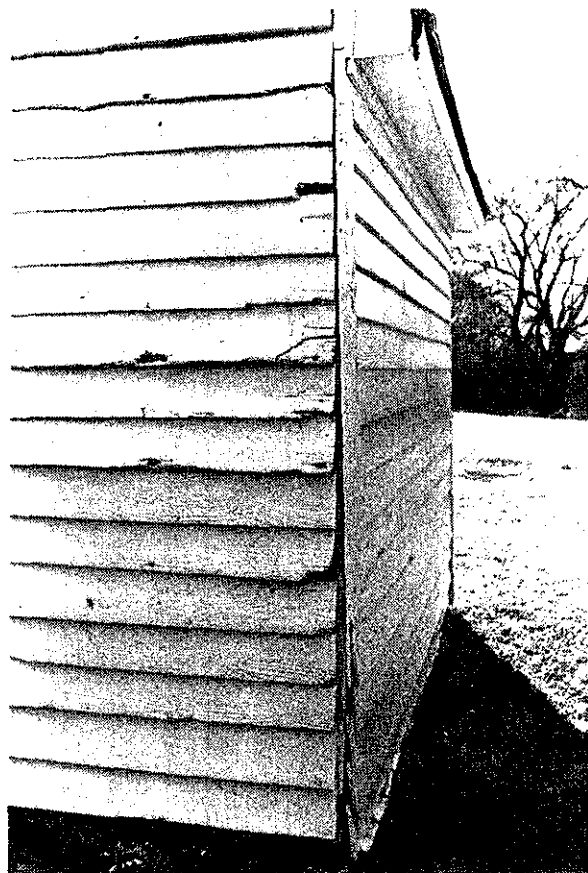
Illustration 103  
Old Smokehouse  
Northwest corner

Approximately 30 percent of the weatherboards are in need of replacement. The southwest and northwest corner trims show signs of significant deterioration and should be replaced.

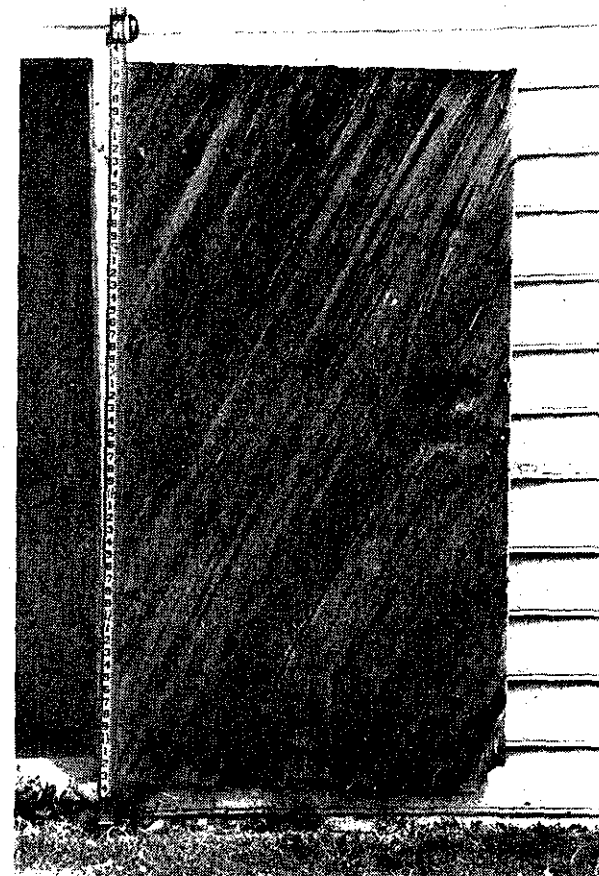
Illustration 111  
Smokehouse  
Interior, south door

The double-layered door has suffered moderate termite damage in the past, but no current activity was noted. The existing door will be satisfactory for many years. If a tighter fitting door is required to control pests, Dutchmen could be used to close the opening from the front or back layer of boarding.
