december 1976

## PERRY'S VICTORY AND INTERNATIONAL PEACE MEMORIAL MEMORIAL COLUMN AND PLAZAS

Historic Structure Report  
Memorial Column and Plazas  
Administrative and Architectural  
Data  
Perry's Victory and International  
Peace Memorial  
Ohio

DALTON-DALTON-LITTLE-NEWPORT

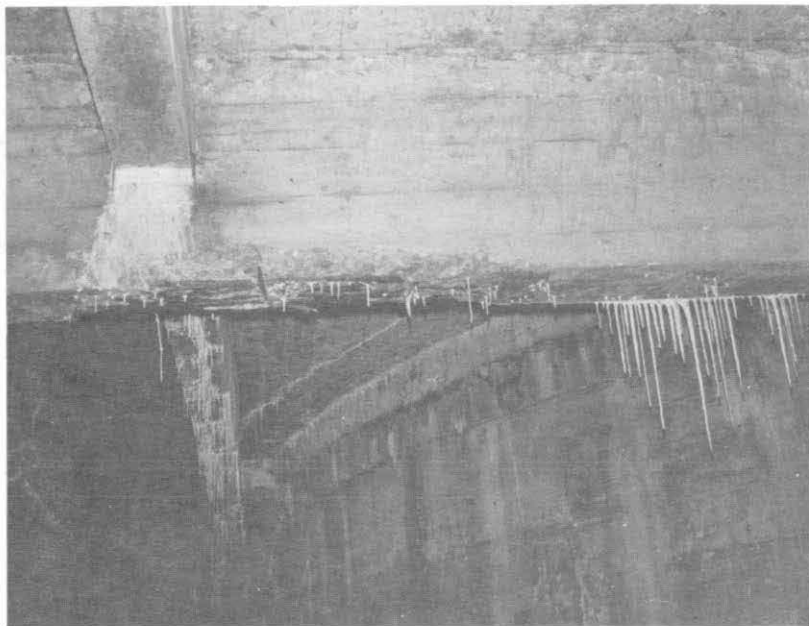
ILLUSTRATION 24. Top of column foundation at approximately southeast side, just below upper plaza.

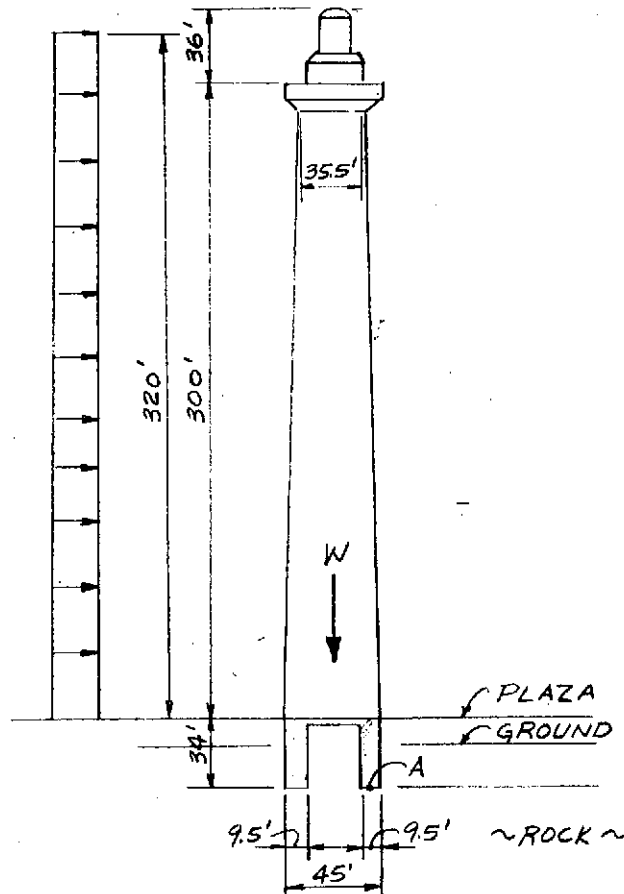
$$f = \frac{W}{A} \pm \frac{M_w}{S} = 34.7 \pm 9.4 = \frac{44.1 \text{ KSF} < 80 \text{ KSF O.K.}}{25.3 \text{ KSF}}$$

ILLUSTRATION 28. Calculation sheet for determining pressure under foundation and safety factor against overturning.

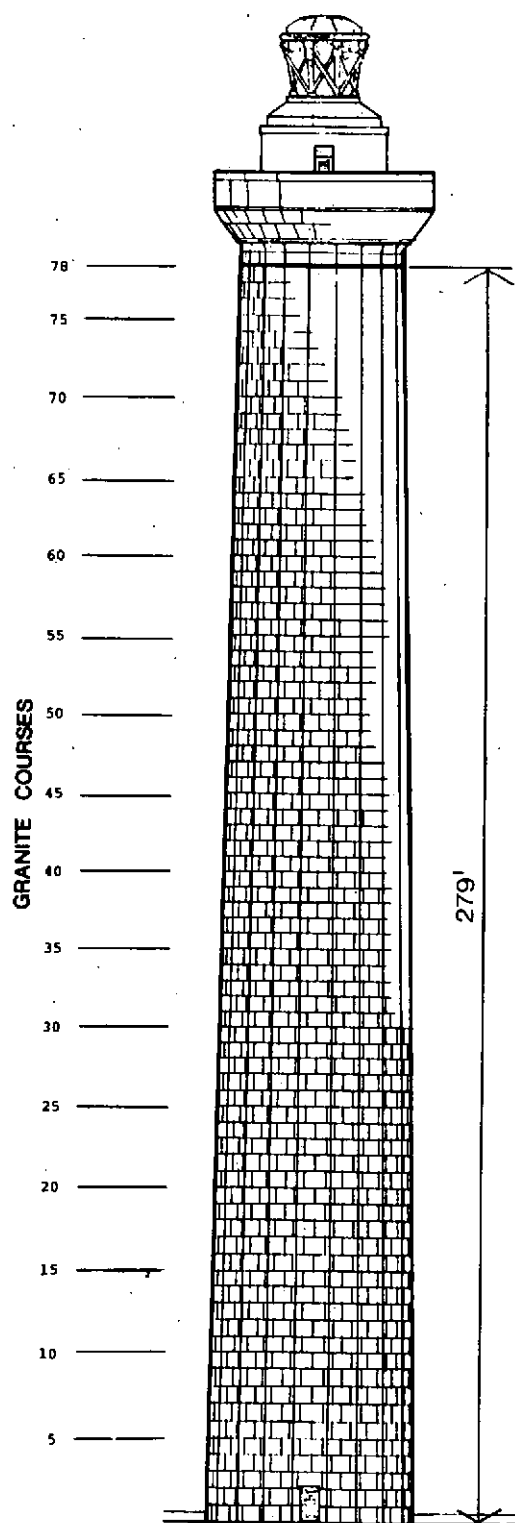
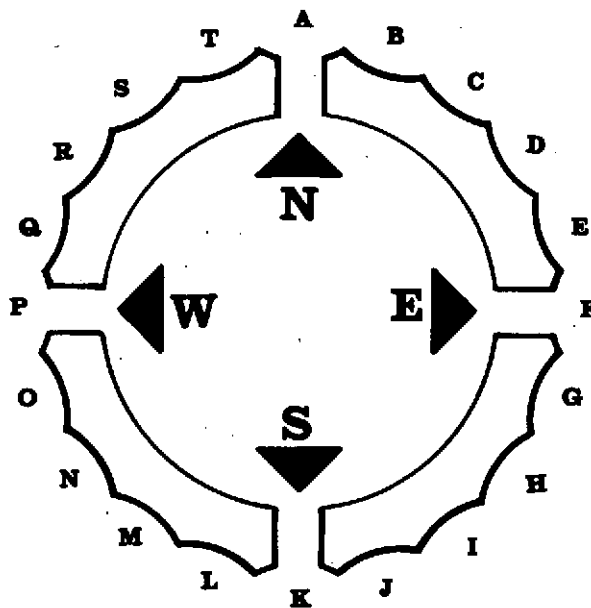
ILLUSTRATION 29. Diagram of column shaft-plan and elevation showing flutes and courses. Major cracks occur at approximately flutes L & M from the 10th to the 23rd and from the 34th to the 60th course.

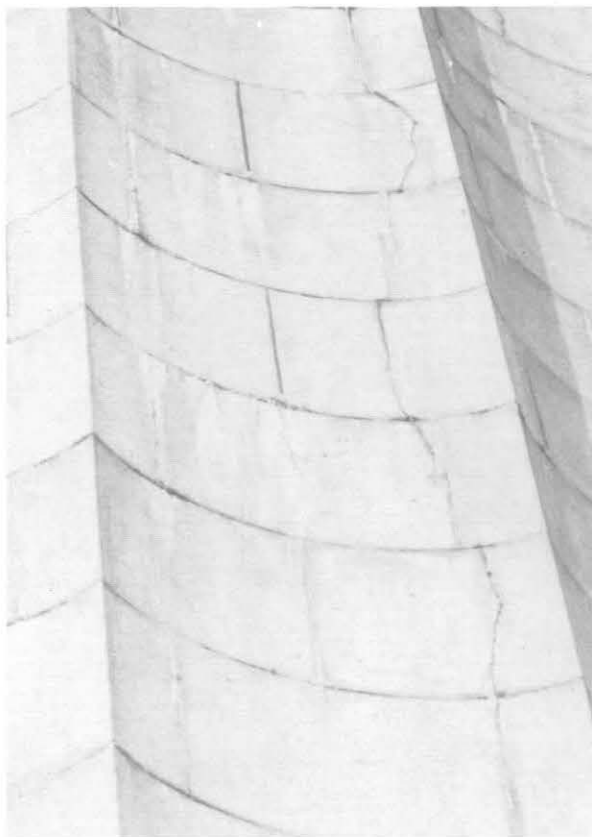
ILLUSTRATION 30. Detail of major crack on lower part of southwest side of column and some typical efflorescence.

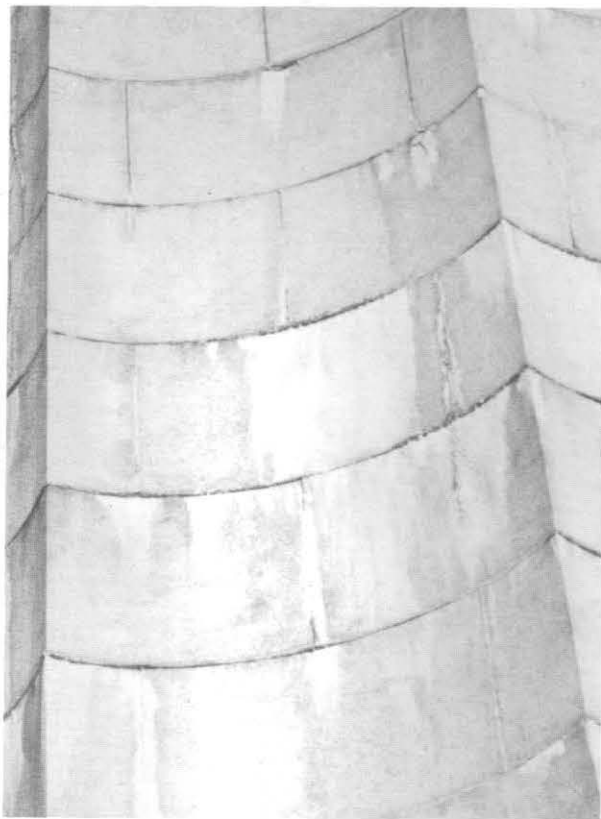
ILLUSTRATION 31. Overview of lower part of southwest side of column showing extent of major crack at flute M, courses 10 through 23.

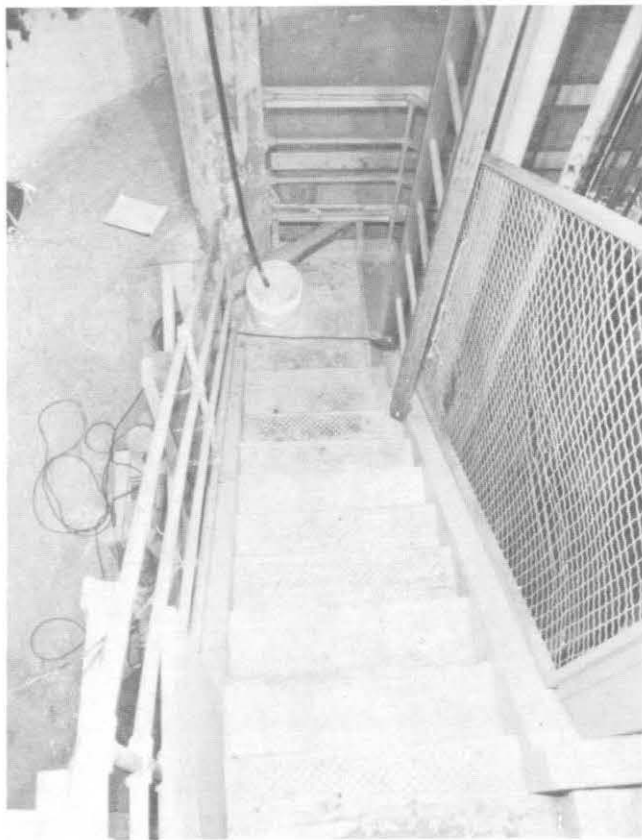
ILLUSTRATION 37. View of uppermost stair run and platform showing replacement safety tread and treads with cement wash only.

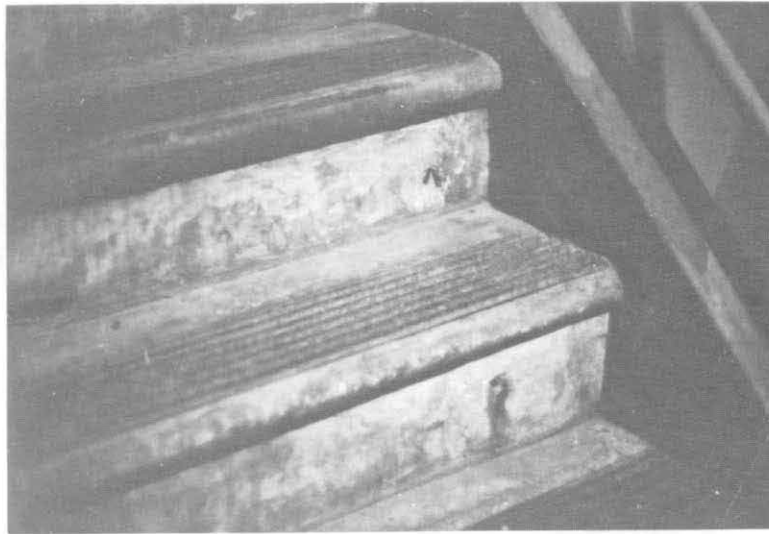
ILLUSTRATION 38. View of stair tread and riser showing the typical existing safety tread with round nosing in good condition.

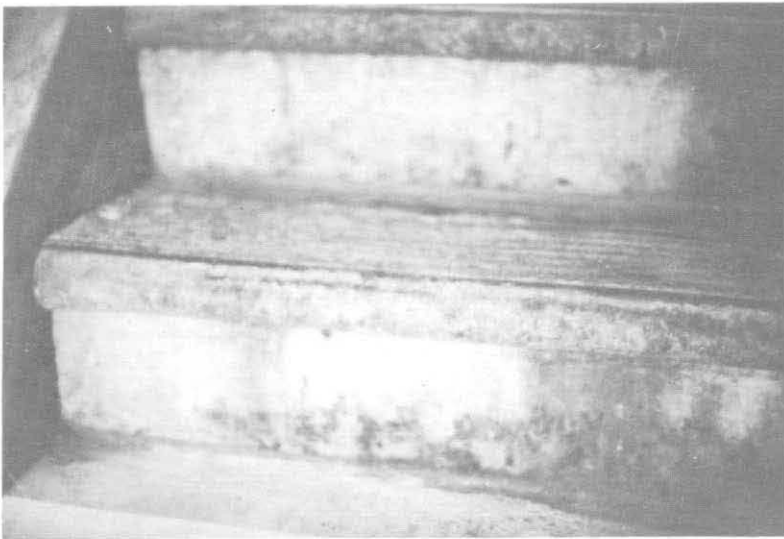
ILLUSTRATION 39. View of stair tread and riser showing the safety tread that has deteriorated due to moisture.

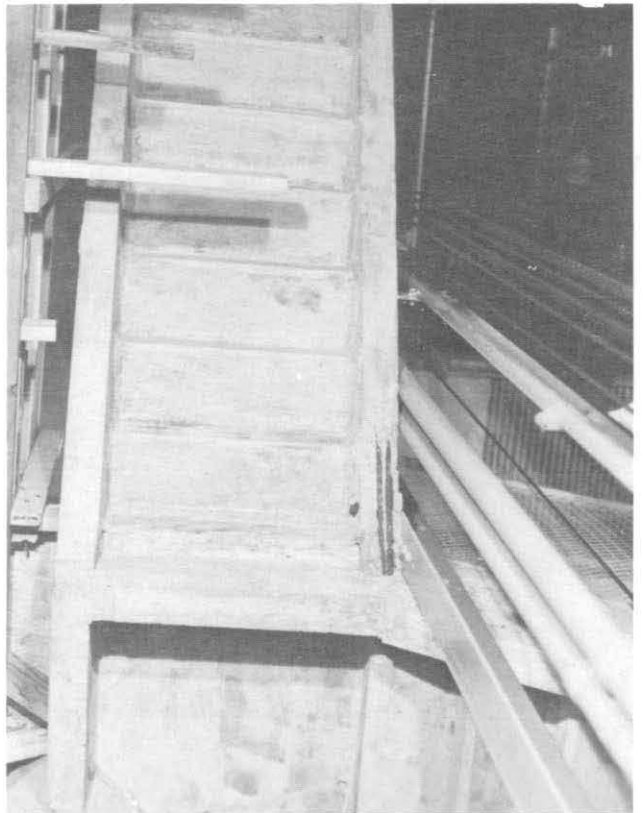
ILLUSTRATION 40. View of underside of stair showing spalled concrete and exposed reinforcing steel.

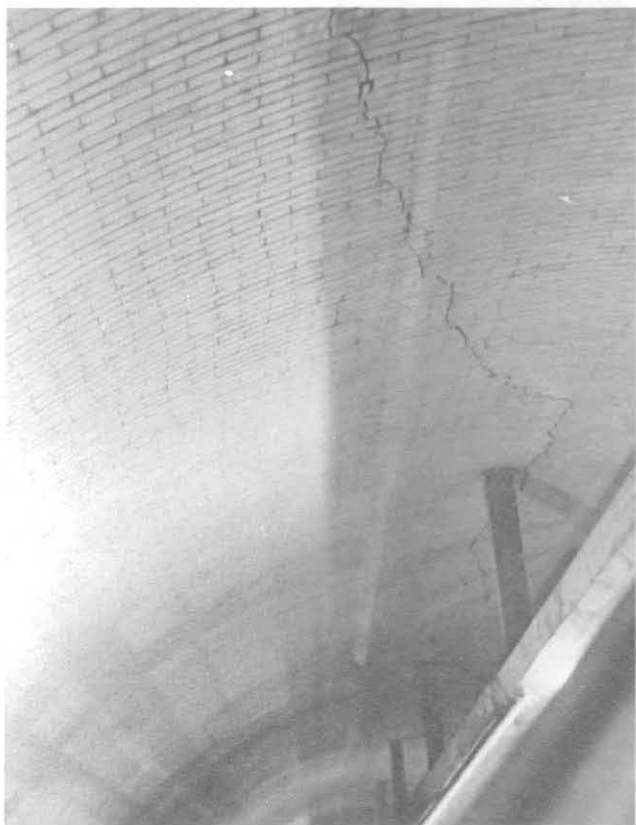
ILLUSTRATION 42. Typical view looking down column shaft showing octagonal column and column bracing into brick wall.

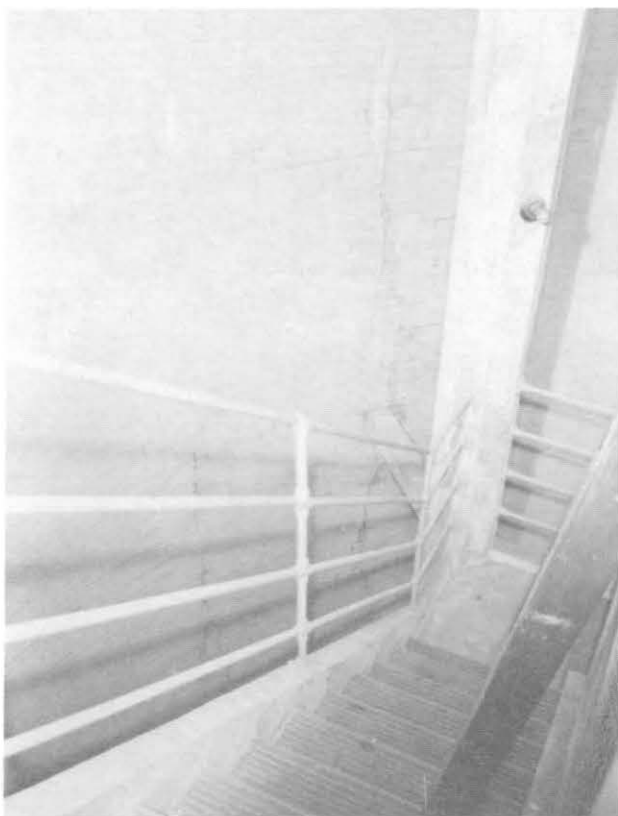
ILLUSTRATION 43. Typical view of stair run showing handrails and original lighting fixture for general illumination of shaft interior.

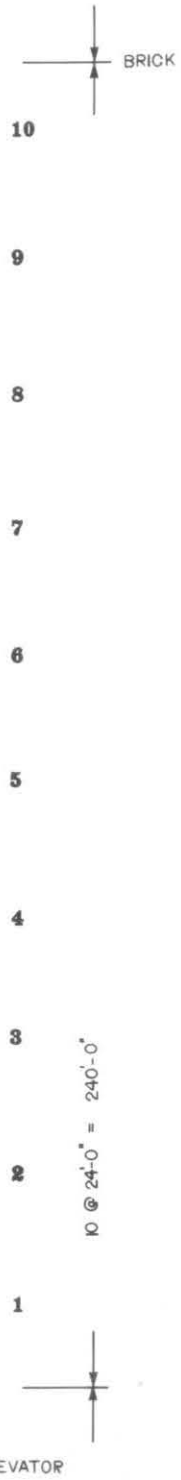
ILLUSTRATION 46. Diagrammatic plan and elevations of brick interior of column shaft showing approximate locations of cracks in brick lining. Horizontal lines in diagrams indicate every fourth stair landing level.

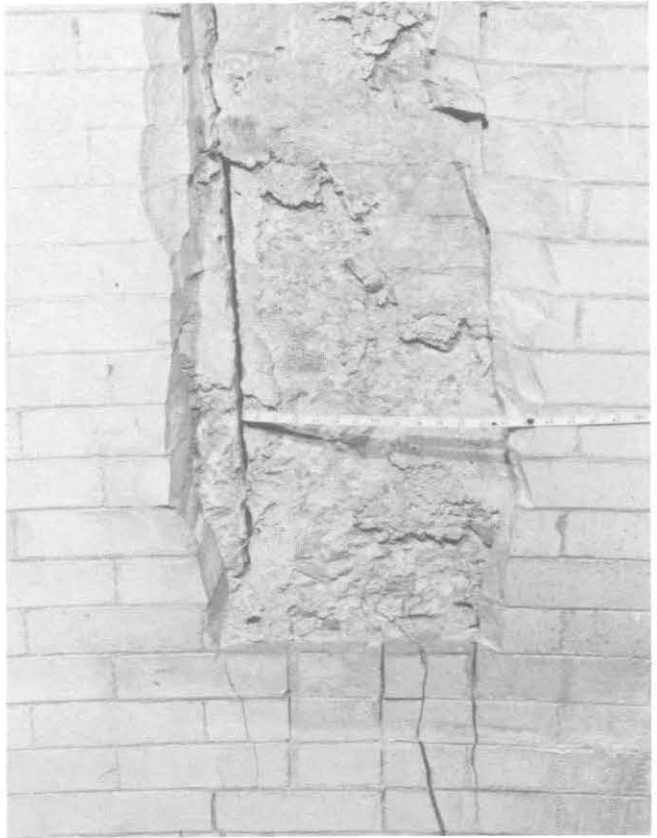
ILLUSTRATION 47. Detail view showing structural concrete with major crack; brick and mortar with wire loop, minimum depth of crack.

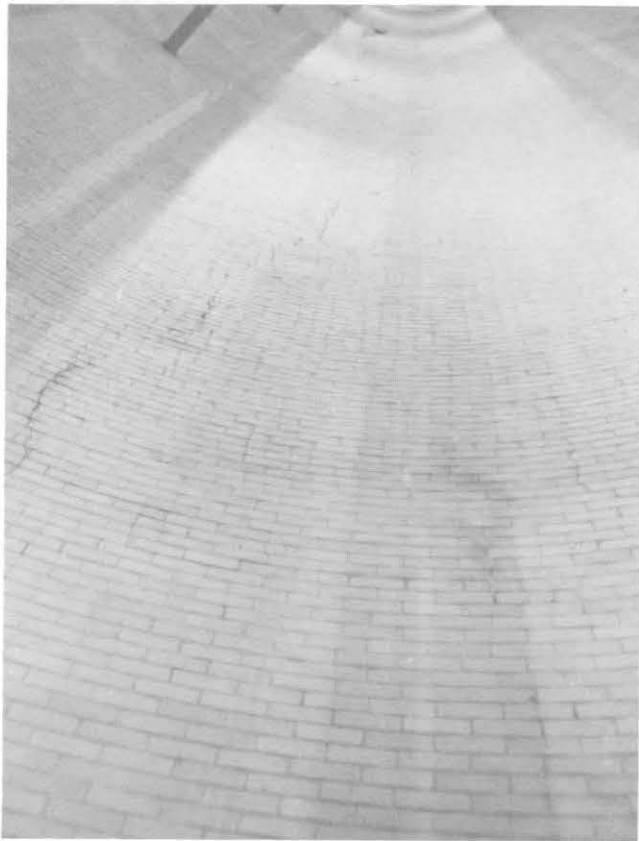
ILLUSTRATION 53. Overall view of column shaft at south quadrant showing major crack.

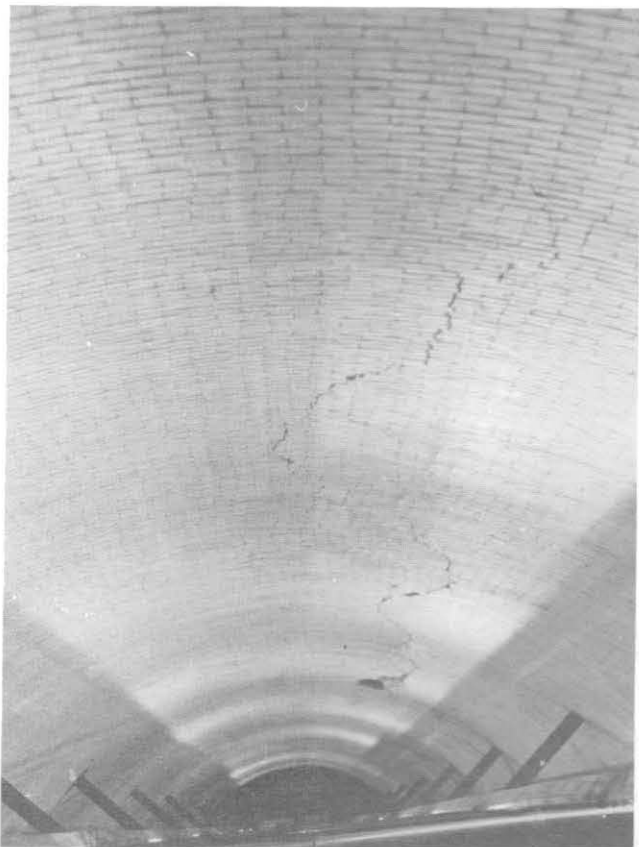
ILLUSTRATION 54. Overall view down column shaft at south quadrant showing major crack.

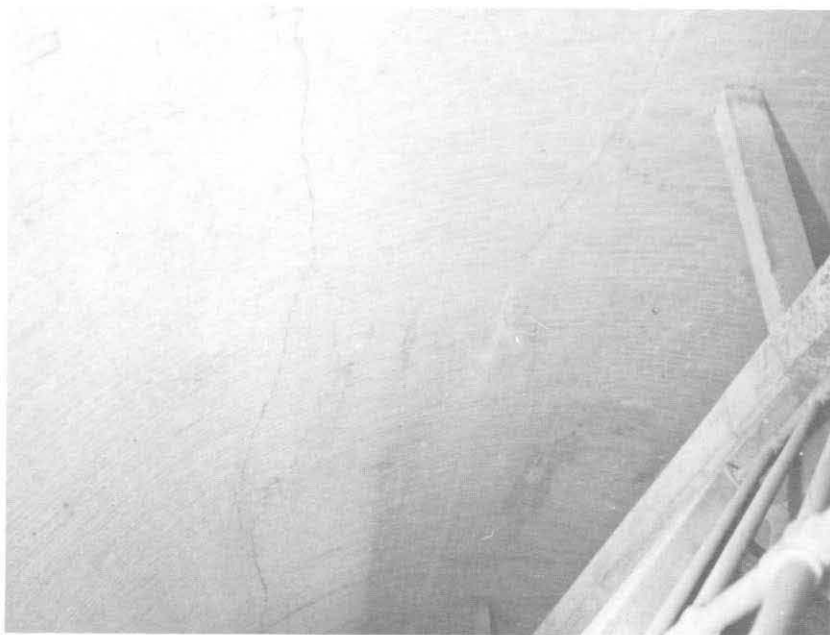
ILLUSTRATION 55. General view of brick crack in north quadrant of column shaft at approximately level 5.

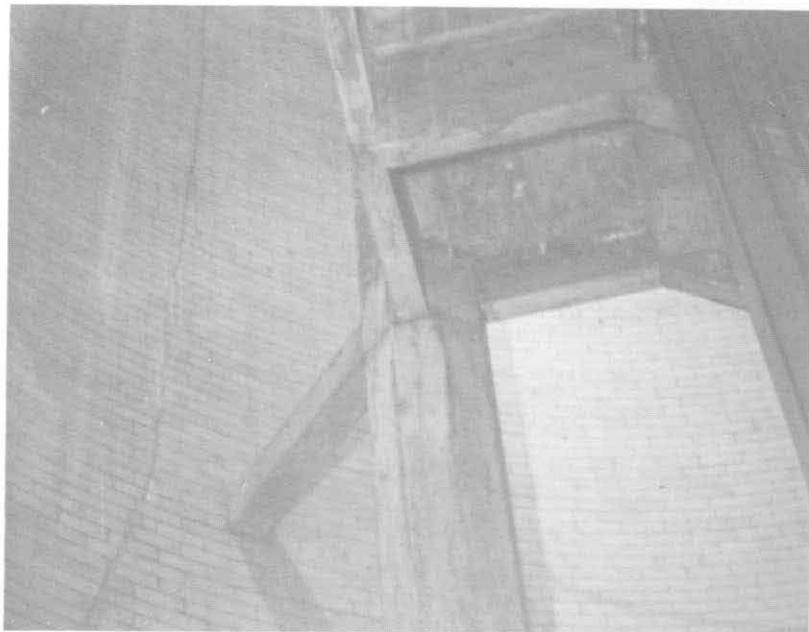
ILLUSTRATION 56. General view of brick crack in north quadrant of column shaft at approximately level 7.

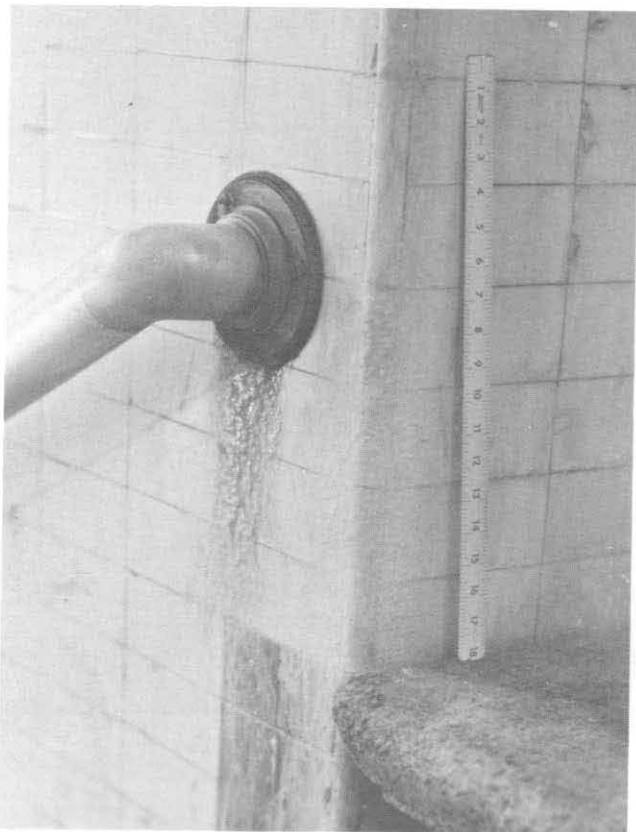
ILLUSTRATION 61. Detail view of existing condition at mid-level platform of exit stair from lower elevator landing.

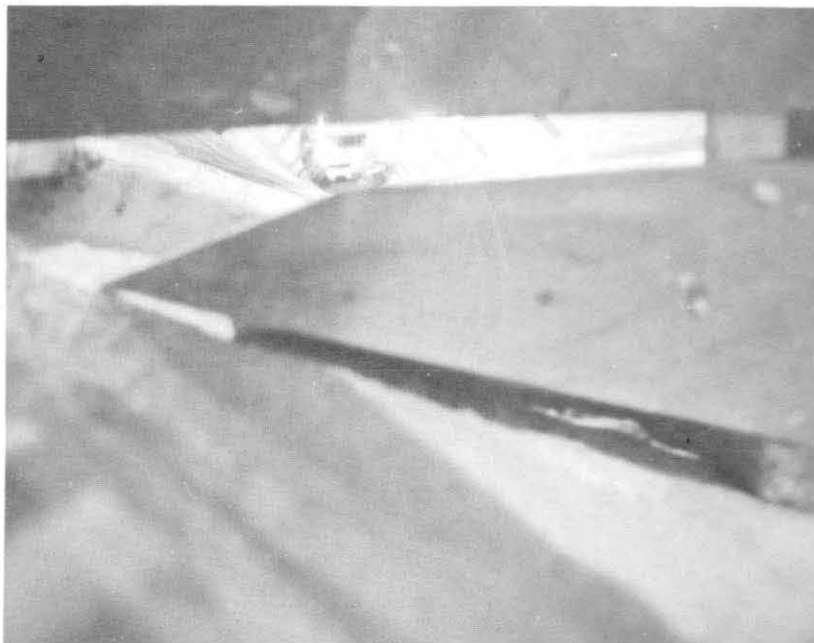
ILLUSTRATION 67. Detail view looking down on end of 2" by 4" beam bearing on granite ledge. View is looking through a joint in the plywood deck.

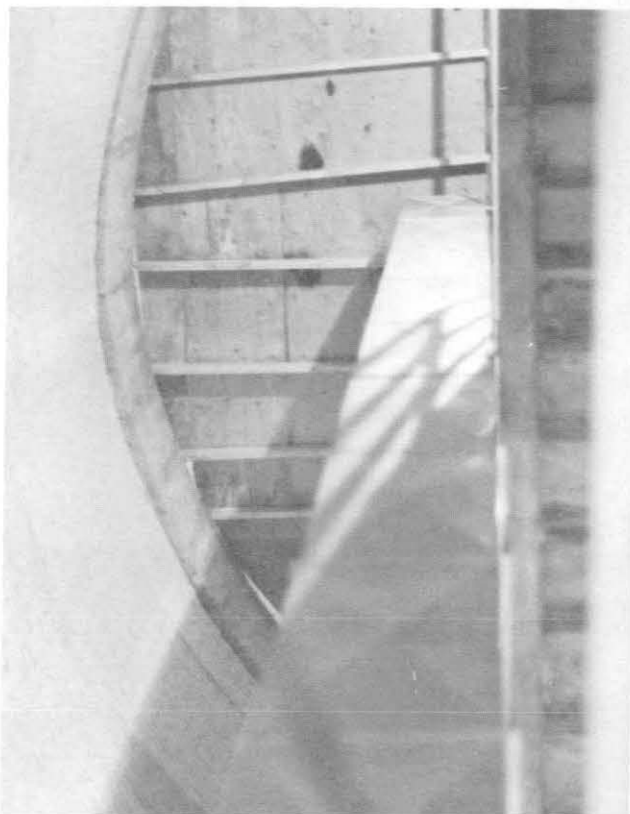
Structurally, the two platform constructions are very marginal; historically, they are an intrusion. Further, they are constructed of combustible material, and the use of combustible material is a violation of the Ohio Building Code. The use of combustible construction material and the storage of combustible maintenance materials shall not be permitted in a space that is the emergency exit for the public from the top of the column. It is recommended they be removed. Storage space should be provided in the basement space below the upper plaza as recommended in Chapter 5.

ILLUSTRATION 68. Partial view of underside of "temporary structure" platform located one level below upper elevator landing.

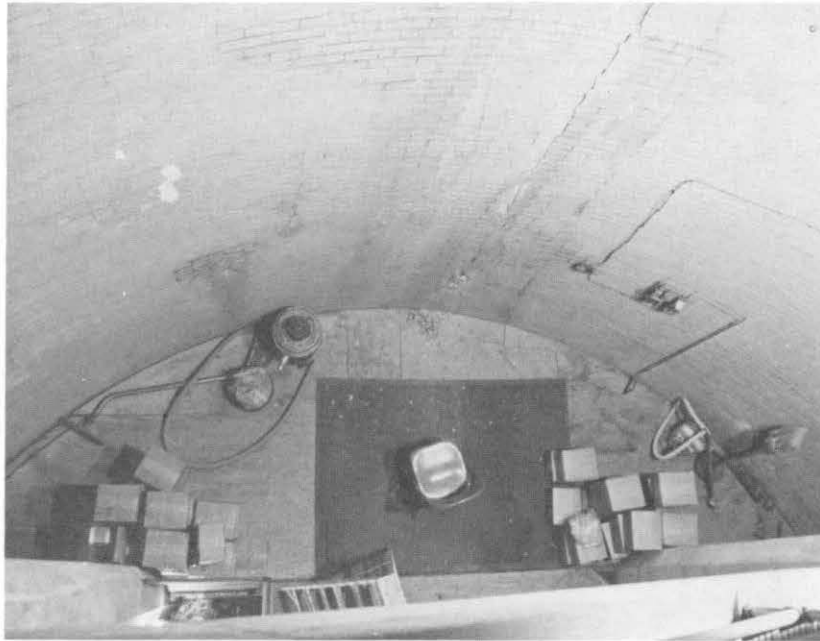
A third "temporary" structure is a platform two levels above the lower elevator landing. It is constructed of lightweight steel angles and wire mesh with a 1/4" plywood decking laid loosely on top of the mesh (69, 70). It also encloses the shaft from brick to stair rail. This platform was constructed by laying plywood on a horizontal existing wire mesh enclosure and was designed to prevent access to the column shaft by the public on the lower elevator landing below. It is used as a storage area for supplies used in maintenance work.

ILLUSTRATION 69. Partial view of "temporary structure" at the second level above lower elevator landing.

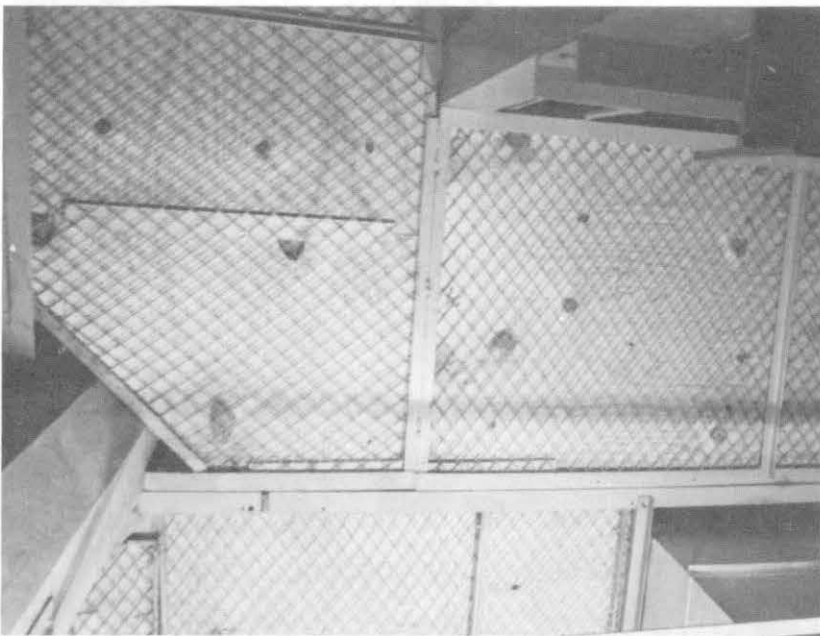
ILLUSTRATION 70. Partial view of underside of same platform as Illustration 69.

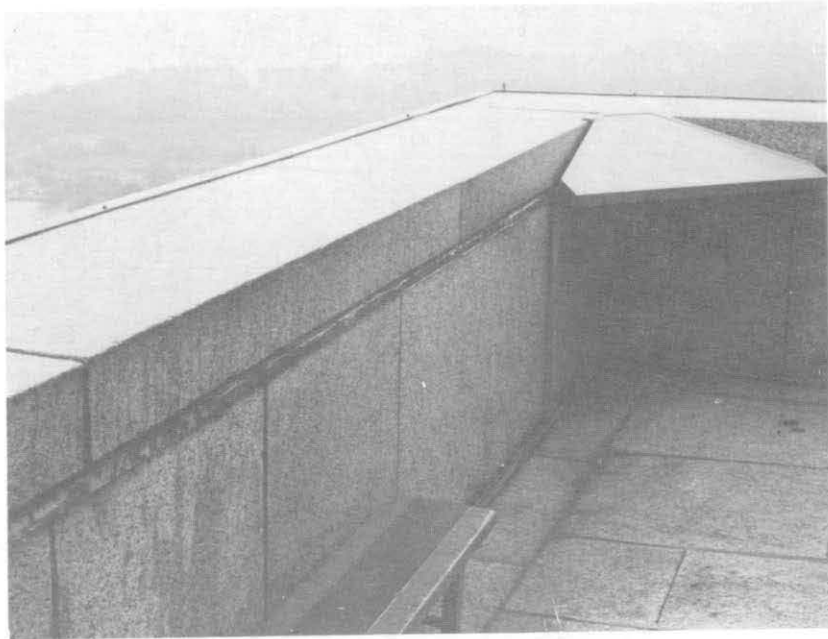
The capstone and inside surface of the parapet walls are in good condition (72, 73). The copper flashing under the capstone, thought to be installed in 1949, is in good condition. Throughout the parapet, all joints require joint sealer treatment as recommended in Chapter 2.

ILLUSTRATION 72. View towards northeast of parapet walls around observation gallery. Metal map of battle appears at corner.

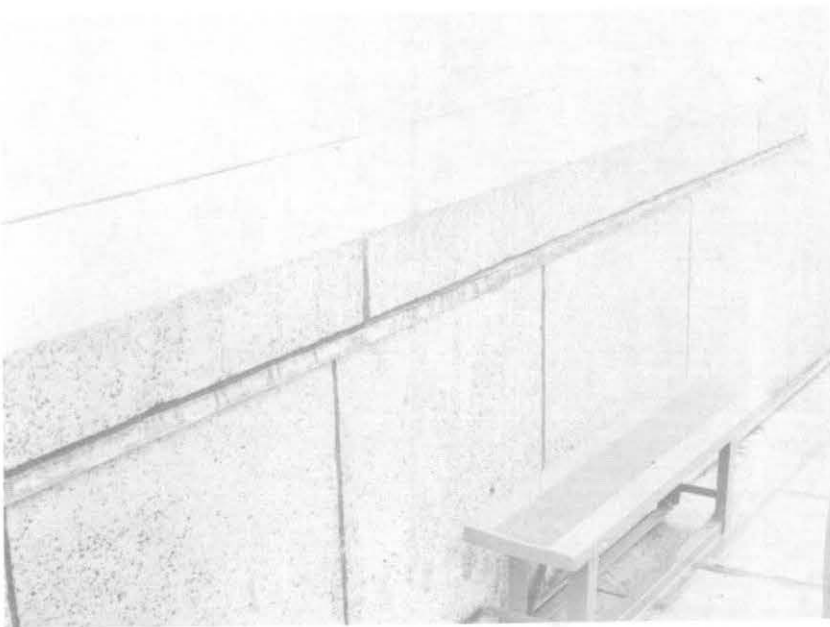
ILLUSTRATION 73. View of parapet wall on north side of observation gallery. Bench, conduits at floor and wall intersection, and cap flashing are not part of original construction.

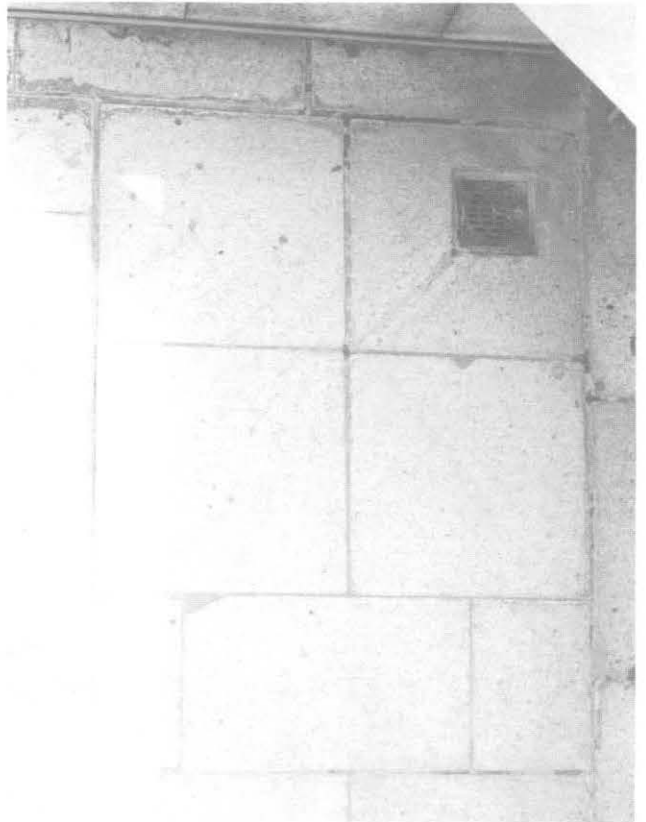
The granite stones which form the gallery floor are in good condition except for unsightly dripping from caulking sealings (74). The joints of these granite paving stones need repair. In 1949, the gallery floor was removed and a waterproofing membrane installed to help prevent water infiltration into the shaft. The stones were then replaced in their original pattern, and five expansion joints provided. These joints, filled with a black tar-like substance, are unsightly.

ILLUSTRATION 74. Plan view of southwest corner of observation gallery.

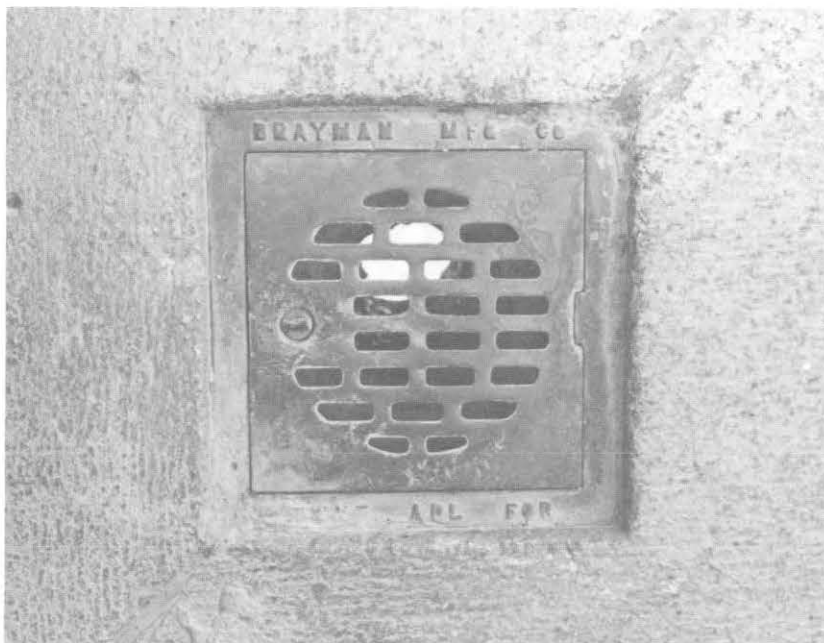
ILLUSTRATION 75. Detail of drain in southwest corner of observation gallery.

The existing floor drain and drain pipe should be replaced. The new floor drain should be furnished with an integral seepage pan and clamping collar to accept the waterproofing membrane and flash it directly into the drain body. The drain pipe would enter the column shaft and be piped downward, following the course of the original installation. The drain hole cored through the gallery deck and emerging from the underside should be filled and patched to remove all evidence of having been in existence. Refer to Chapter 11 for information about protection against freeze-up.

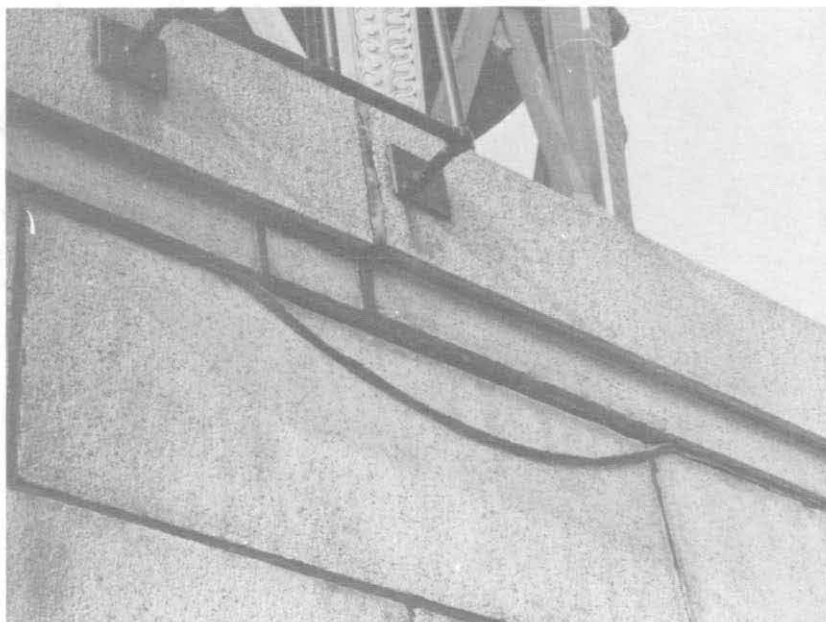
ILLUSTRATION 78. Detail at cornice of penthouse indicating sealant failure. Pipe railings were added with navigational lights at later date.

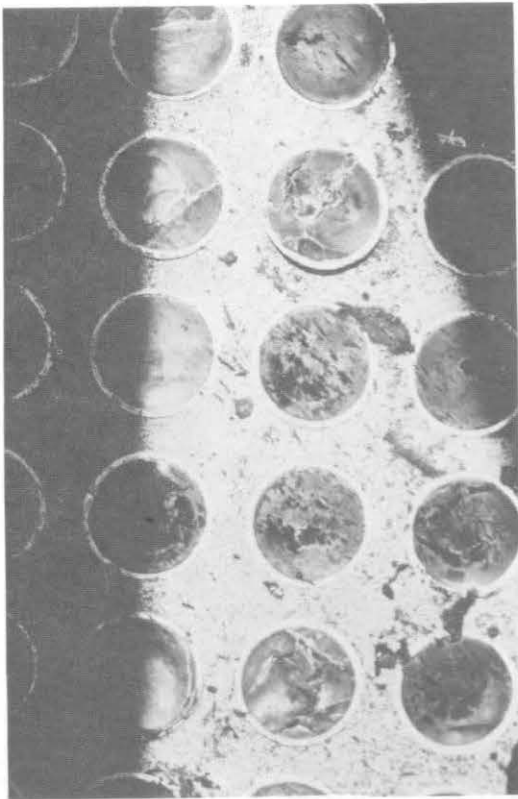
ILLUSTRATION 81. Detail of vault lights showing cracking and crazing of glass inserts.

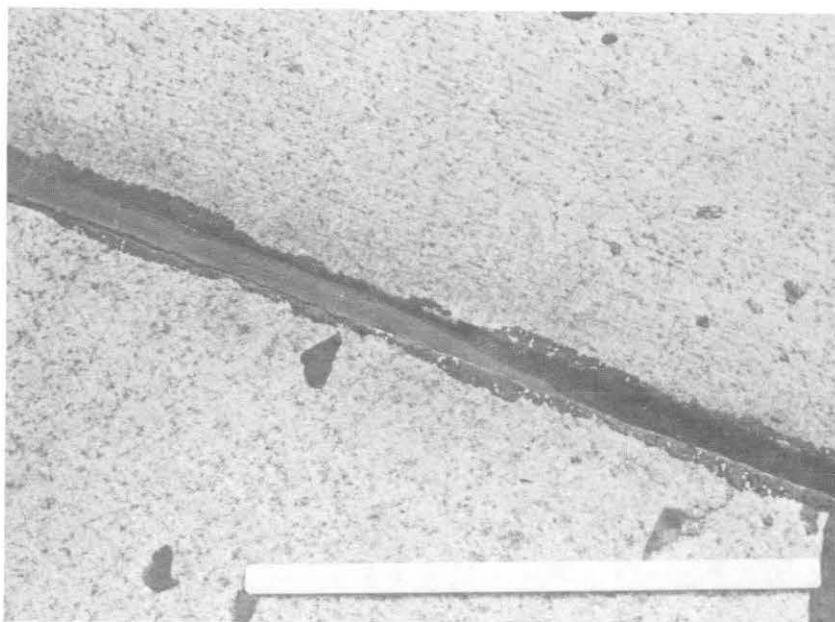
ILLUSTRATION 82. Detail of typical failure of sealant in joint on top of the penthouse.

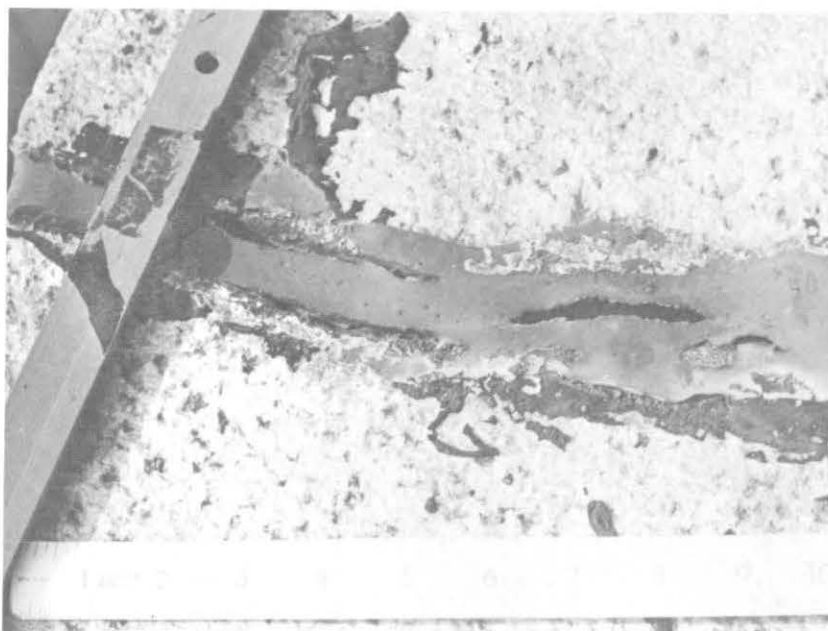
ILLUSTRATION 83. Detail of another typical failure of sealant in joint on top of the penthouse.

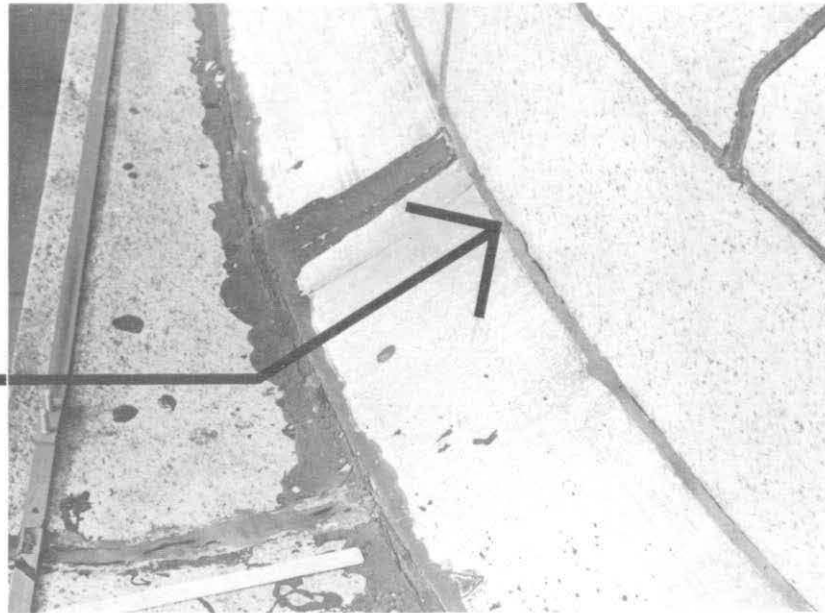
A sloping metal flashing has been installed at the juncture of the square and round forms. Originally, this juncture had a continuous gutter, but it was filled with concrete in 1924 and flashed with metal. The sloping metal flashing was installed in 1949. The granite stones are in good condition, but the joints are in poor condition (82, 83, 84). Several types of jointing compounds have evidently been used with a black tar-like substance most prevalent (84, 85). Much of the concrete roof slab has been

ILLUSTRATION 84. Detail of intersection of penthouse wall and round cupola-like truncated cone roof.

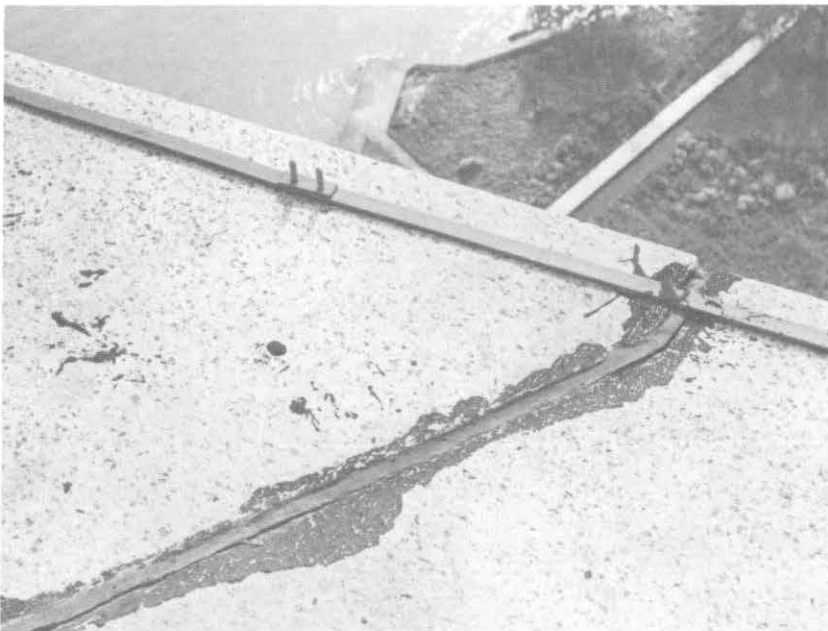
ILLUSTRATION 85. Detail of typical joint indicating improper removal of previous sealant prior to installation of new sealant. Metal bar is part of the lightning grounding system.

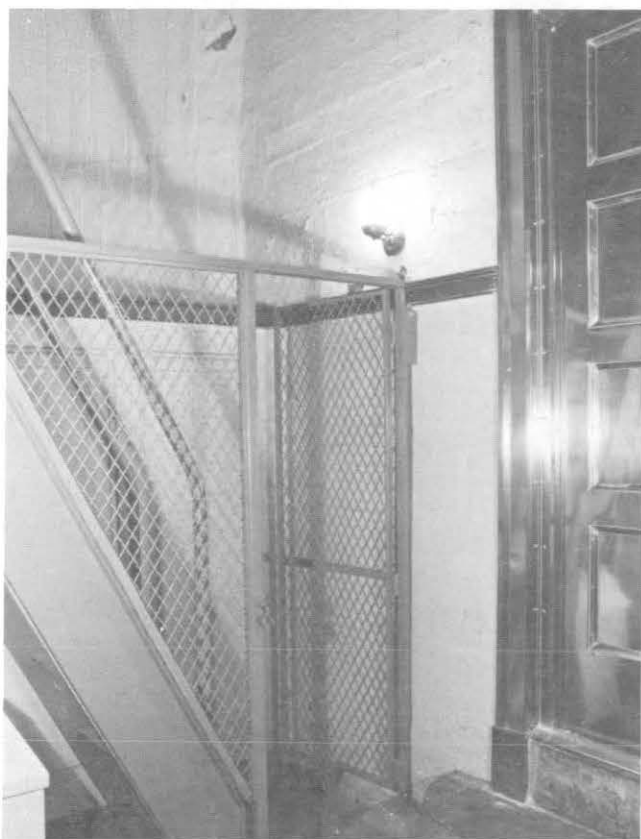
A pair of bronze doors on the north side of the upper elevator landing lead to the observation gallery (89, 88). A glazed transom above the doors is covered on the exterior by a decorative bronze grille matching that concealing the ventilation louvers. Structurally, the doors, jambs, transom and grille are in good condition. The door handles are missing from the west leaf, and the interior door handle is missing from the east leaf. These items should be replaced. A block of wood slipped through a handle pull is used to bolt doors closed (89). A proper latching device is needed to hold the doors closed, and weatherstripping would prevent heat loss in the winter. The exterior bronze finish has not weathered evenly and is streaked greenish-black. The interior bronze is polished to a high lustre, but only up to

ILLUSTRATION 87. View of north wall of upper elevator landing showing bronze door to observation gallery.

doorhead; the rest of the frame is not polished. All bronze should be treated to bring it to a dark bronze finish as discussed in Chapter 2. Joints around all door and louver frames should be cleaned and new sealant installed.

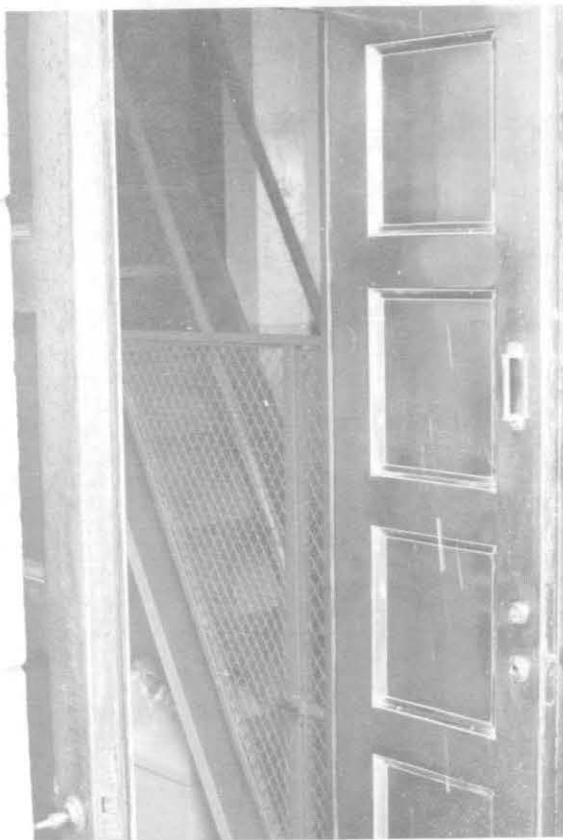
ILLUSTRATION 89. View of bronze door from observation gallery indicating faulty or missing hardware, lack of weather-stripping and dissimilar finish of bronze.

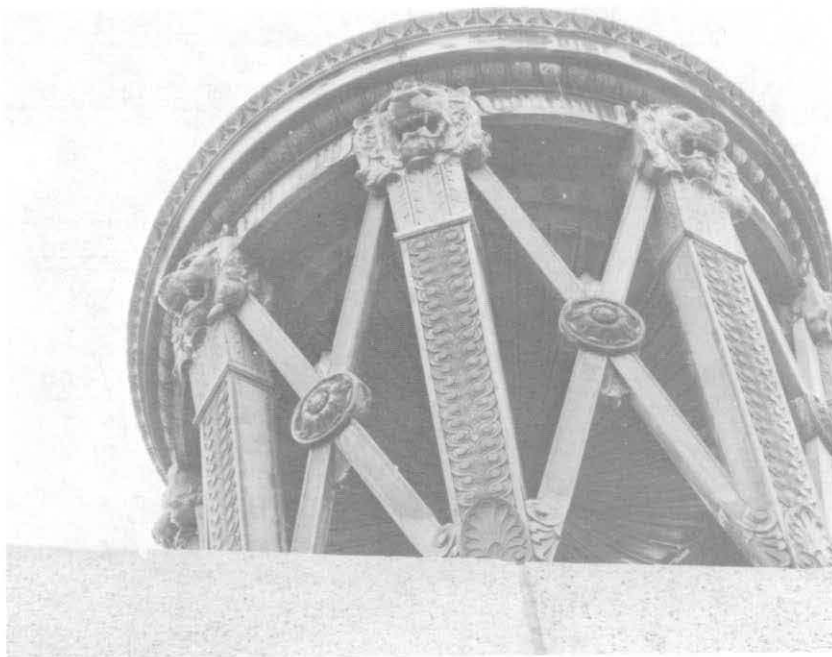
The bronze lantern, sometimes referred to as the "bronze urn," is a lens-shaped structure supported by eight legs attached to the top of the column penthouse (92). The lantern and the supporting legs are approximately 18'-0" high. The lantern consists of bronze castings with sculptured and flat bronze sheets, reinforced with steel and roofed with glass (93). The eight legs have sculptured lion feet at the bottom and lion heads at the top (94, 95). Some time after installation, a number of the original flat bronze sheets cracked and subsequently were patched with an additional layer of bronze sheet (96). Stainless steel sheet metal screws were used for this corrective work and for replacement of a number of original machine screws.

ILLUSTRATION 92. Bronze lantern on top of the penthouse,  
as seen from observation gallery.

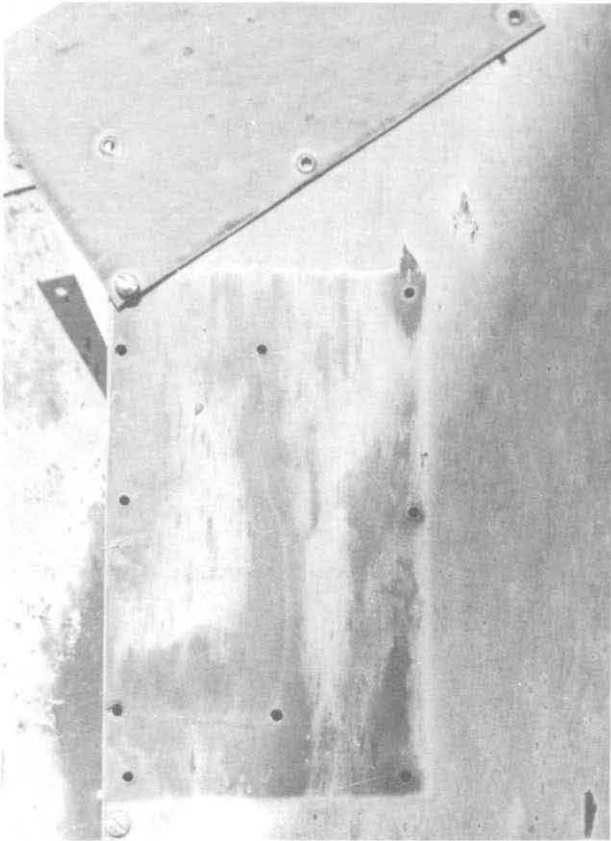
ILLUSTRATION 96. View of previous crack with cover plate removed.

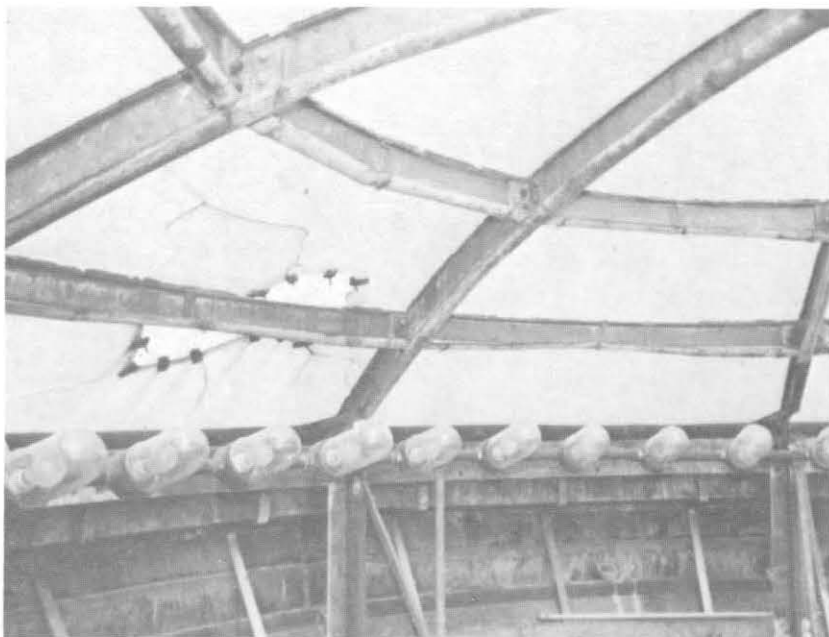
The interior of the enclosed portion houses thirty-seven incandescent fixtures mounted in a circle at the rim of the enclosure (98). These fixtures and other electrical items relating to the lantern are discussed in Chapter 12. Steel members which provide a framework for the enclosed structure are galvanized and in good condition (100, 101). Some of the connecting bolts and rivets show signs of rust, and these should be cleaned and spot painted with rust-inhibiting paint. The lantern is roofed with 1/2" thick sandblasted (opal) glass sections formed to the curvature of the lens shape of the enclosure and supported with galvanized steel members. Over 50 percent of the original glass segments are broken and have been replaced in various ways with plexiglas. The plexiglas itself has deteriorated and shattered, but has remained cohesive. The caulking into which the glass was set has dried and spalled (102). The joints in the original glass occur above structural supporting members, and, to eliminate uncontrolled leaking and icing, galvanized sheet metal gutters are suspended below all members with joints to channel rainwater to the outside at the rim (100). Waterproofing the lantern itself is not essential except to prevent the formation of ice during freezing and thawing winter cycles.

ILLUSTRATION 98. View inside of bronze lantern looking at skylight and light fixtures.
