december 1976

## PERRY'S VICTORY AND INTERNATIONAL PEACE MEMORIAL MEMORIAL COLUMN AND PLAZAS

Historic Structure Report  
Memorial Column and Plazas  
Administrative and Architectural  
Data  
Perry's Victory and International  
Peace Memorial  
Ohio

DALTON-DALTON-LITTLE-NEWPORT

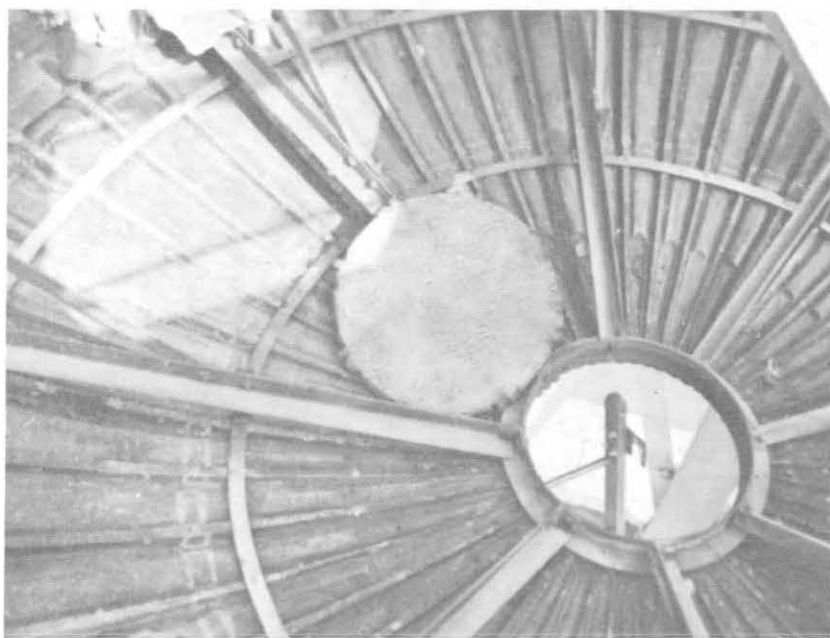
In the center of the convex sculptured sheet bronze bottom of the enclosed portion of the lantern is a 24" diameter access port (99). The port is covered with a 20 gauge improvised sheet metal cover. The cover is adequate and need not be replaced. However, it is rusty and should be painted to match the bronze patina and to inhibit further rusting.

ILLUSTRATION 99. View inside of bronze lantern looking down at access hole used to enter the lantern.

The original access hatch was removed by maintenance personnel because it was heavy and difficult to open. Maintenance personnel indicate that the original hatch is still on the park grounds. As an option, the original hatch cover could be reinstalled if the two latching devices were replaced with a single hinge, single latching device and a counter balance system to assist the operator in opening the cover. At present, the operator must stand on a ladder nine feet above the penthouse roof and use two hands over his head to operate the two latching devices on the cover. Once it is released, the full weight of the cover is in the hands of the operator. If the original hatch cover is reinstalled, opening the cover will be easier and safer than using the improvised cover.

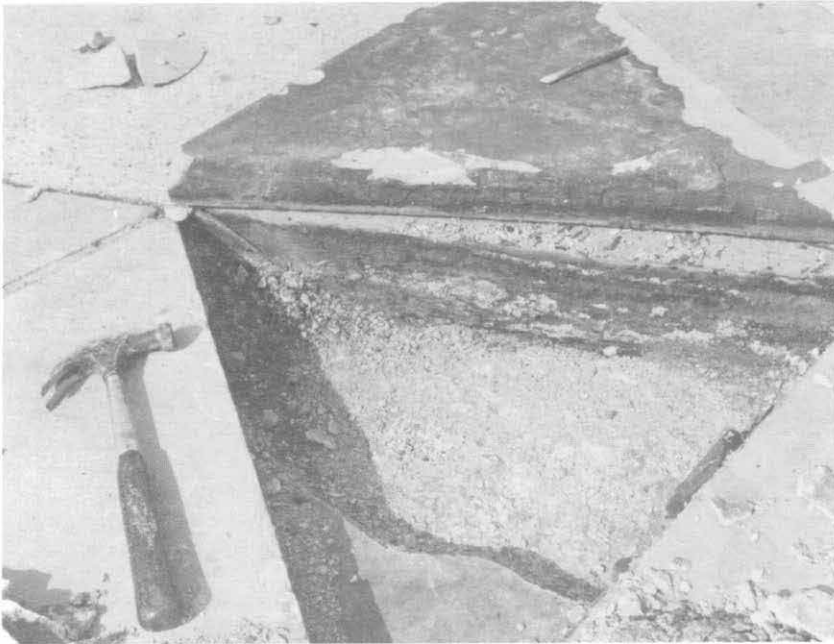
ILLUSTRATION 108. Detail view of edge of granite paver at foot of column. Note lack of waterproofing on the top of the slab.

To ensure structural soundness, all corroded, spalled, or otherwise deteriorated areas must be repaired. The most important repair is waterproofing. As long as water seeps through the concrete, corrosion, spalling, deterioration, and subsequent weakening of the plaza will continue. The paving must be removed, the top of slab cleaned and patched, and waterproofing installed. The paving would then be replaced, using existing paving where possible or entirely new paving.

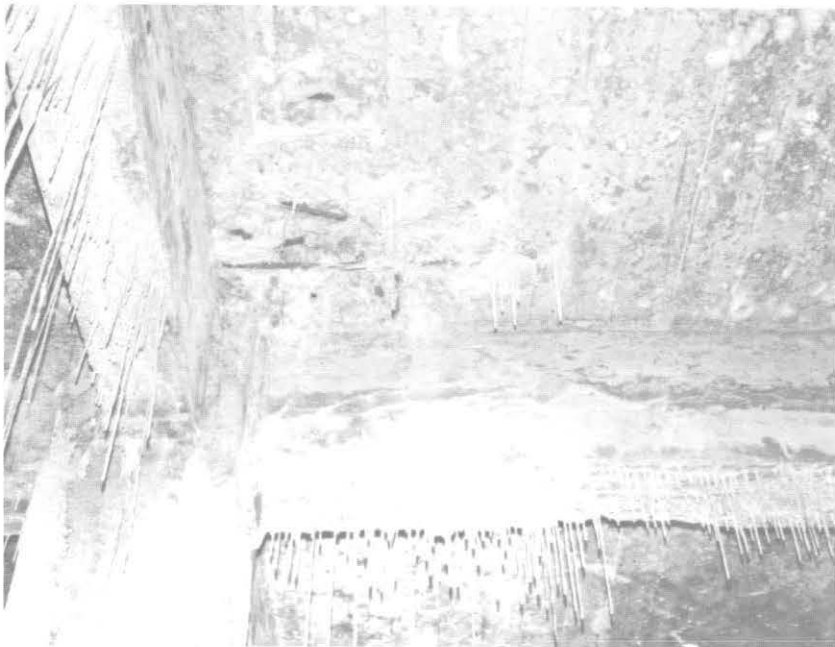
ILLUSTRATION 115. Detail view of typical beams to column intersection showing stalactites at various stages of formation.

The structure also requires cleaning and repairing from below (120). Stalactites must be removed. At the damaged, or spalled areas, all unsound concrete must be chipped away to sound aggregate. The exposed surface should be sandblasted to a clean surface and bright reinforcing rod. At this point the effective remaining area of bar could be determined. If more than 10 percent of the bar area is missing, then the original bar should be cut out and replaced with an equal area of new bar. (Caution must be exercised, for the remaining [uncut] steel must be capable of carrying the dead load or else the beam should be shored during repair.) The concrete has to be chipped back far enough so that a good lap-splice can be made. Then the sound concrete and reinforcing steel should be coated with an epoxy adhesive and the area then grouted to size and shape using at least 4000 psi concrete. All major and minor spalls should be repaired as outlined above.

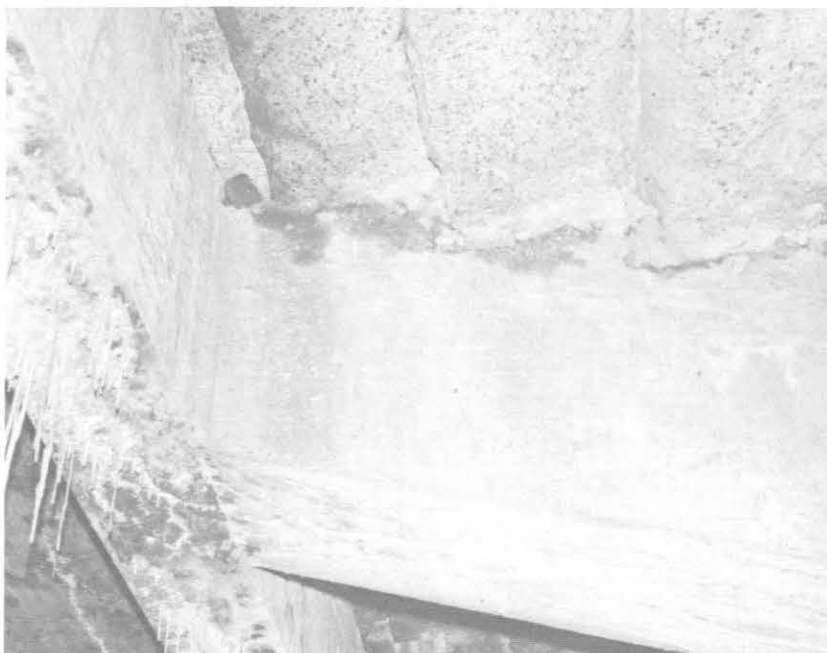
The granite steps on the south side of the upper plaza are supported by reinforced concrete beams only (121, 122); there is no concrete slab beneath the granite steps. There are many open joints between the stones in the granite steps. Some granite steps are not fixed, and the bedding for the stone has deteriorated. Underneath the wall which supports the lower side of steps, earth has been removed, probably by the action of water (122). This could undermine the stability of the south side of the lower plaza.

ILLUSTRATION 122. General view of stepped, sloping beams supporting granite steps.

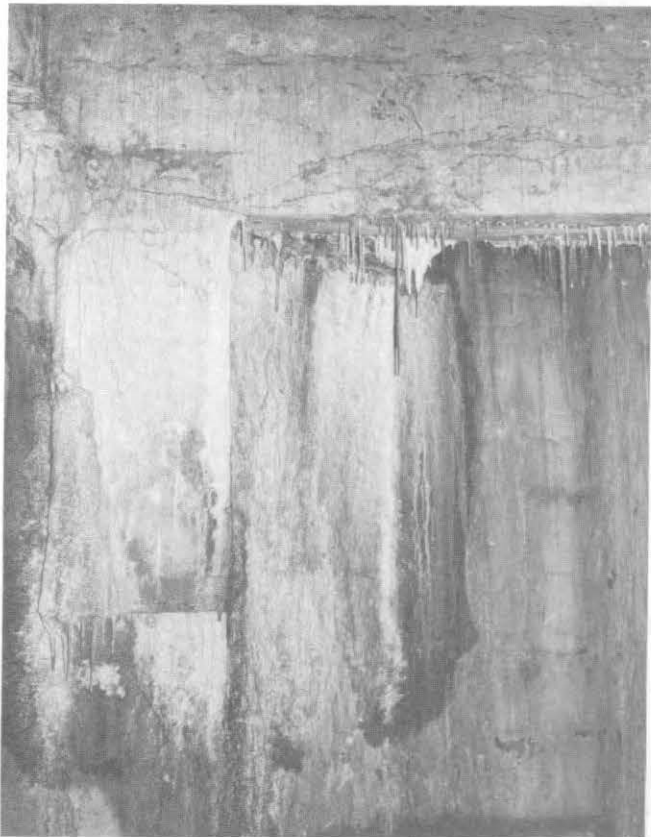
ILLUSTRATION 124. Detail view of heavy  
efflorescence at concrete shaft, below  
upper plaza.

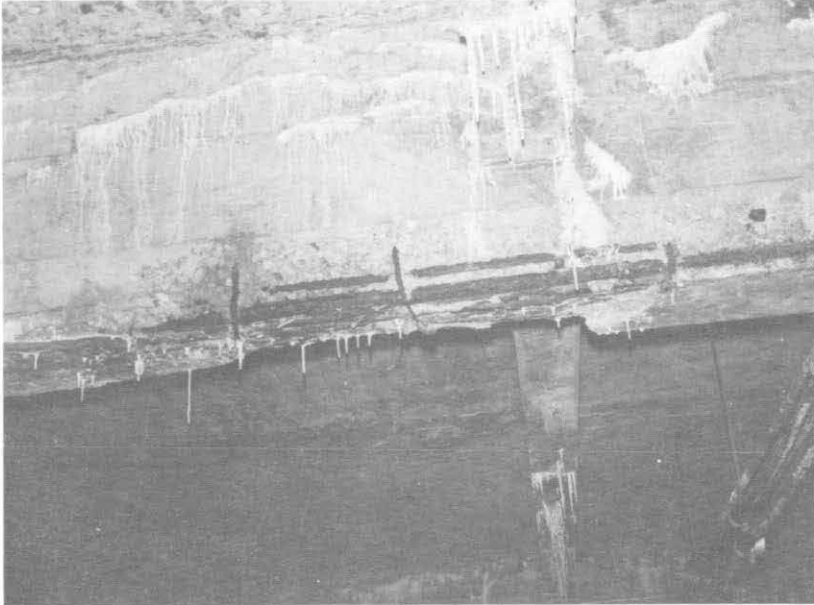
Water seeping through the concrete corrodes the steel reinforcing bars in the slab and supporting beams (123-128). As the steel reinforcing bars rust, they swell and spall the concrete. There is evidence of this continuing process in many places from below the upper plaza structure.

ILLUSTRATION 125. Detail of typical beam with rusting bars and spalled concrete.

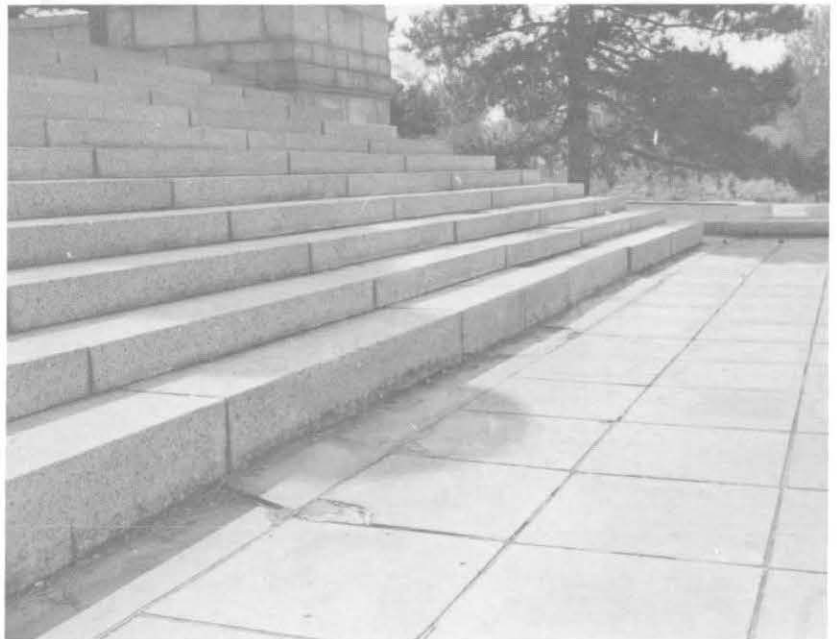
ILLUSTRATION 142. View along lower risers of granite steps looking toward the west. Note settling of lower plaza and misaligned steps.

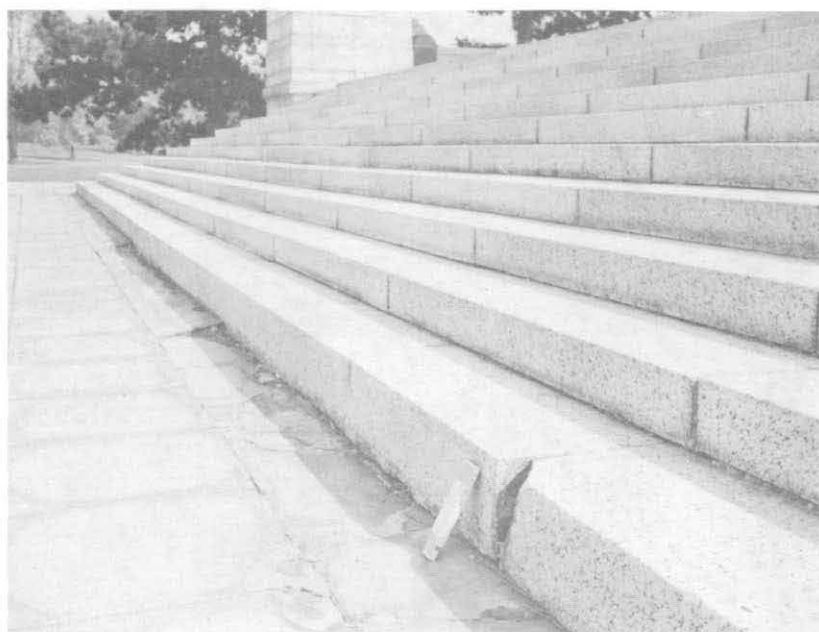
ILLUSTRATION 143. View along lower risers of granite steps looking toward the east. Note chipped stone and poor joints.

The entire lower plaza has settled approximately four inches (148-153)--the first riser of the main granite steps is 10" rather than 6" in height. This condition is hazardous and unsightly (142, 143). The granite curbing on the east, north, and west sides has several inches of exposed rough-cut granite, and several sandstone pavers are inclined because one edge of paver is on the rough cut while the other edge has settled (151).

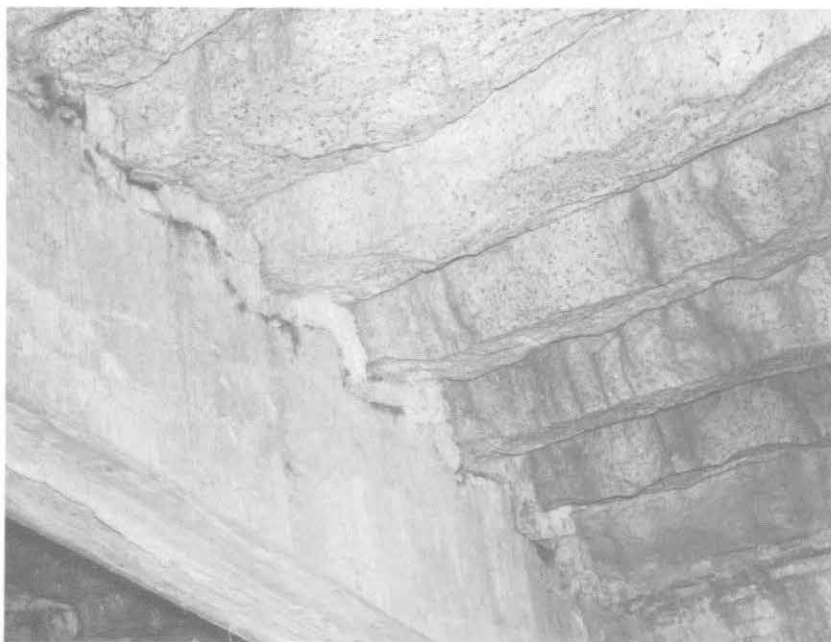
ILLUSTRATION 144. Detail view at underside of granite stair showing sloped and stepped support beam.

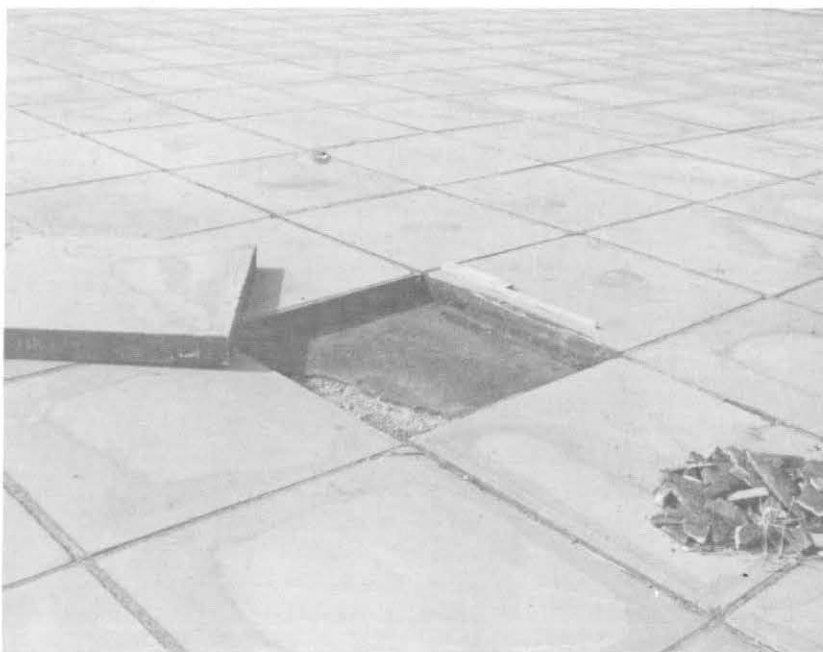
The plaza paving was completed in 1926; at present, all the paving is stained (147), and many pavers are cracked. Approximately 30 percent of the paving will need to be replaced. Although the sandstone pavers were intended to be a temporary paving to be replaced, when funds became available, with granite at least 4" thick, the sandstone pavers should be replaced in kind (cf. p. 122).

ILLUSTRATION 147.  
General view of  
lower plaza sand-  
stone pavers  
showing typical  
stained condition.

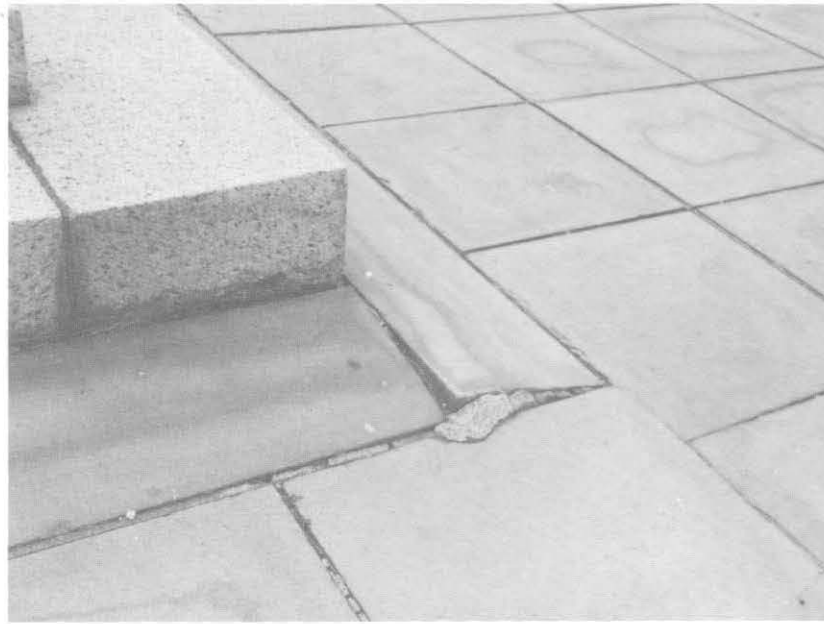
ILLUSTRATION 148. Detail view at east end of granite steps showing inclined pavers due to settling of lower plaza.

It is recommended that the lower plaza be raised to its original elevations (154). This could be achieved by removing the pavers and scraping off the setting bed (approximately 1-3/4") down to the

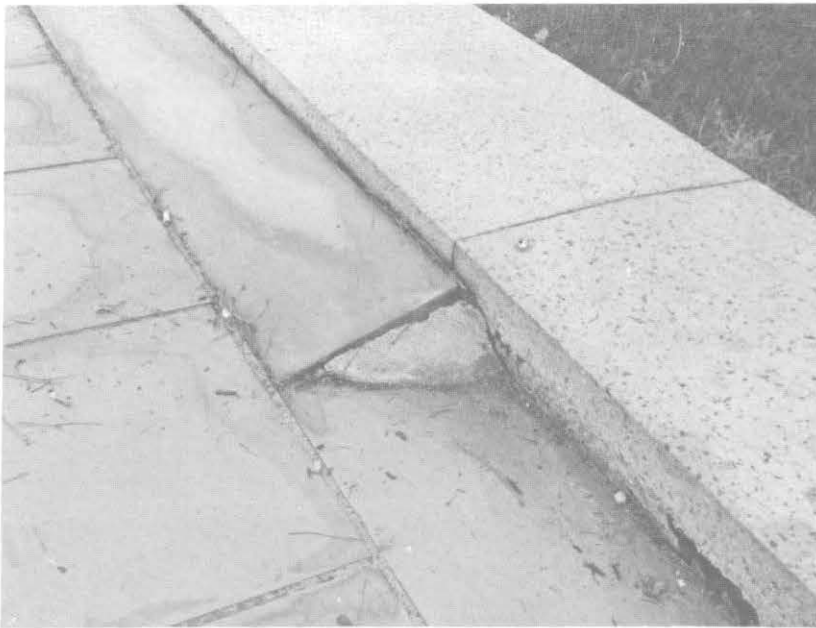
ILLUSTRATION 149. Detail view at east edge of lower plaza showing inclined pavers and flat pavers. Note rough cut of bottom edge of curbstone.

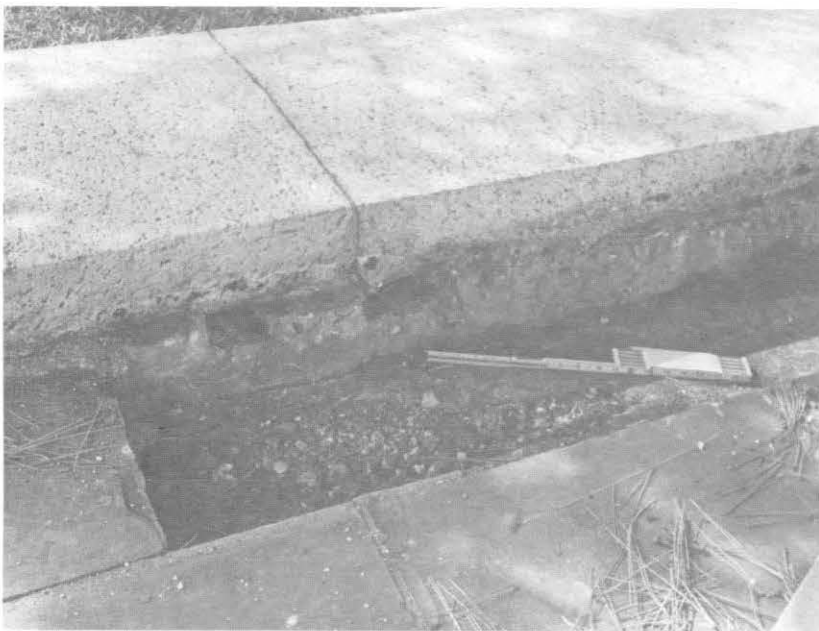
ILLUSTRATION 150. Detail view showing granite curb at the top of a concrete grade beam. Note that the top of the paver is about 2" below its original level, indicated by the line of rough to smooth granite.

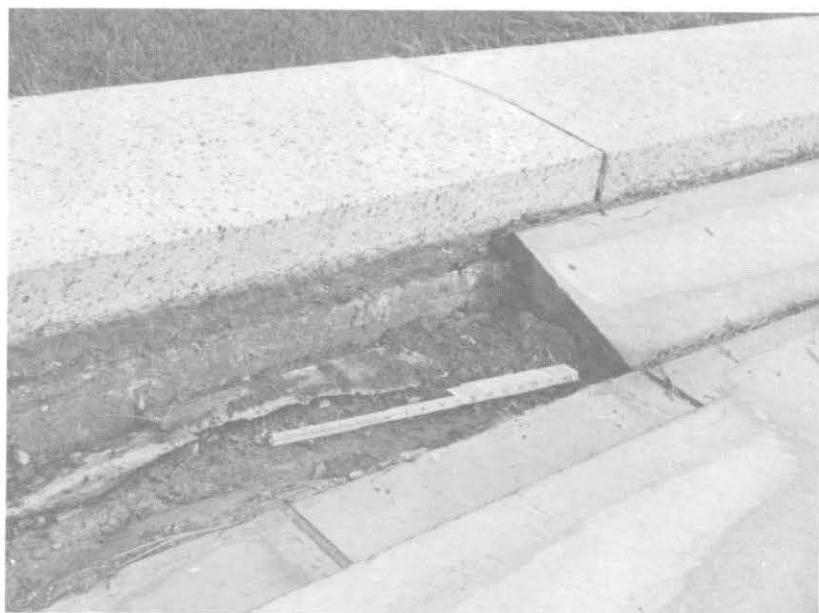
ILLUSTRATION 151. Detail view showing how the sandstone paver edge rests upon rough granite and/or concrete edge of grade beam.

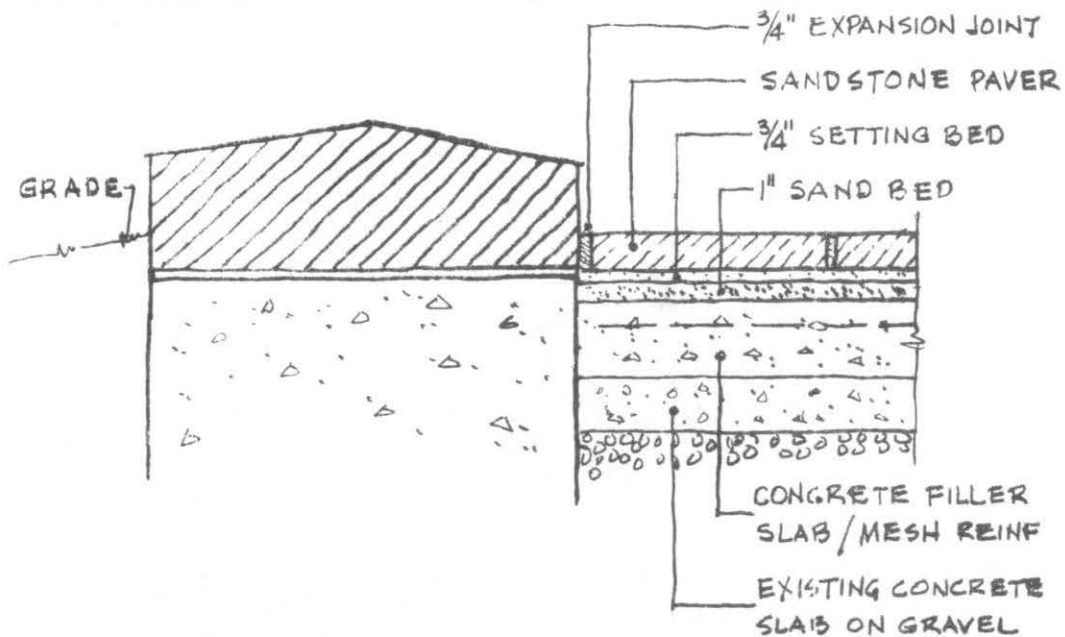
ILLUSTRATION 154. Sketch of revised construction of lower plaza with new concrete filler slab to raise paving to original elevations.

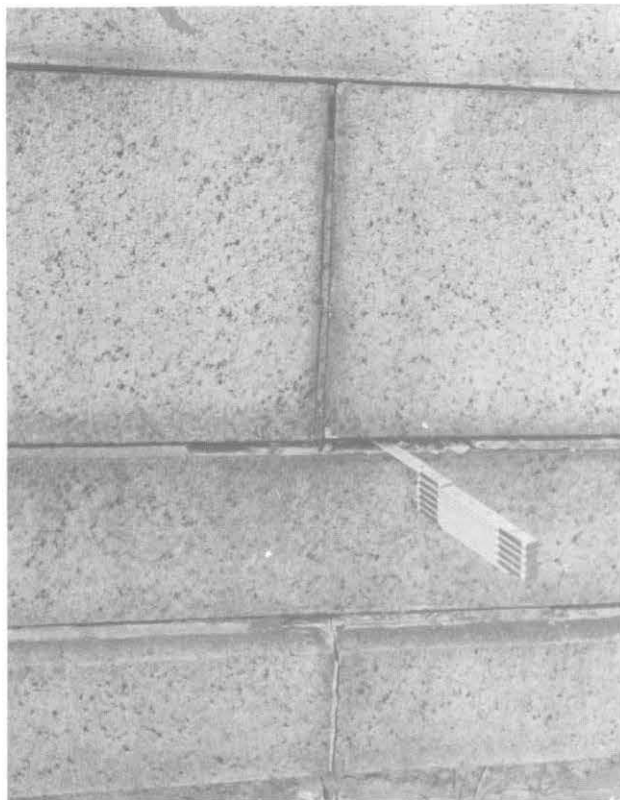
ILLUSTRATION 155. Detail view of typical mortar joints in granite retaining walls indicating poor condition of joints.

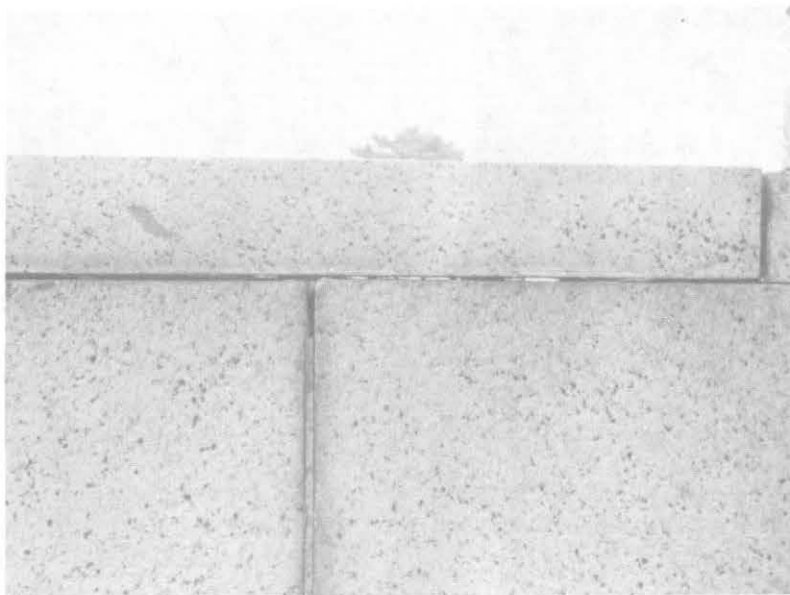
Illustration 156. Detail view of typical mortar joints in retaining walls. Note that daylight may be seen through horizontal joint indicating a lack of mortar.

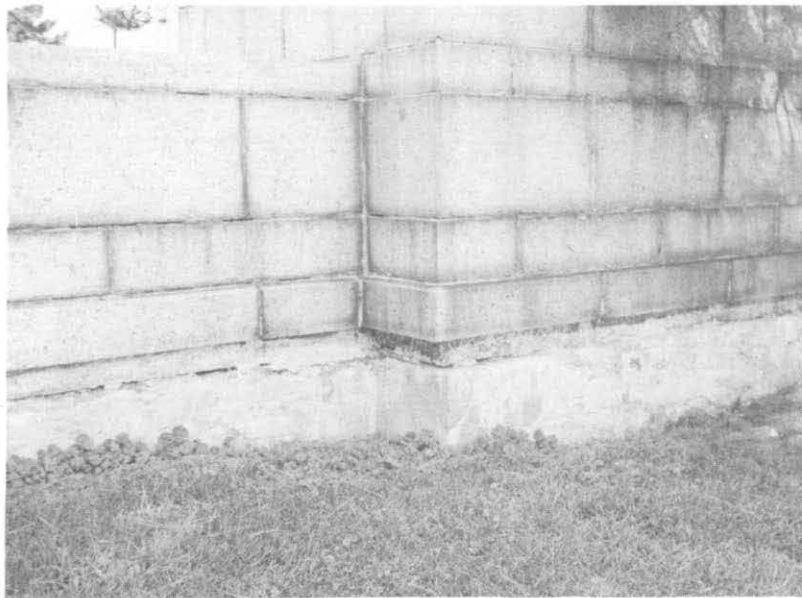
The main problem with the concrete walls occurs at the point where the granite block terminates and the concrete begins (157, 161-164). At this intersection, the concrete is cracked and spalled. The problem is not one of structural integrity but one of appearance, waterproofing, and conformance to historical standards. The original design drawings indicate that all granite blocks were to extend a minimum of 4" below the adjacent grades. That this was indeed done is evident because a stain can still be seen in the granite where it was in contact with the soil.

ILLUSTRATION 157. Partial view of southeast corner of retaining wall and lantern base. Note condition at intersection of concrete and granite.

To remedy this situation, all loose concrete must be removed and repaired using an epoxy type concrete. The first course of the granite, which is in contact with the concrete, has been cut back to form a recess which was filled with a sloping concrete surface, presumably to form a wash to help waterproof the intersection (134). This wash should be replaced. After repair of the wash and the concrete surfaces, which should extend to approximately 18" below the existing grades contiguous with the walls (136), the grades should be restored to their historically correct original grade.

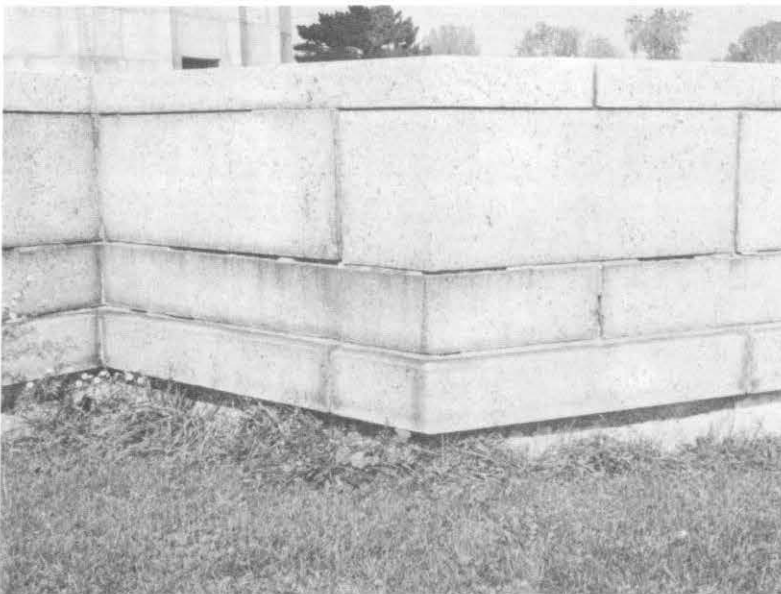
ILLUSTRATION 158. Partial view of southwest corner of retaining wall. Note lack of mortar in joints.

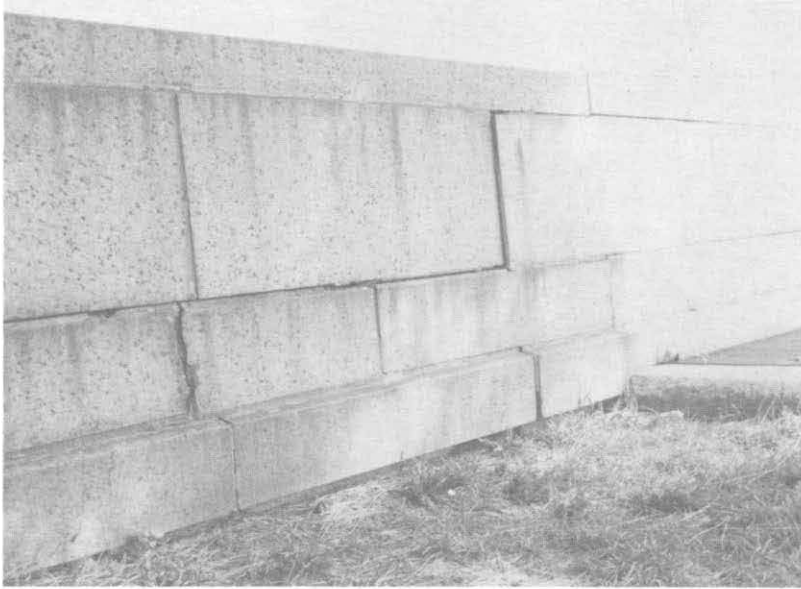
Improper mortar joints probably cause some granite blocks to shift out of line with the face of adjacent blocks (159). Water has penetrated behind the blocks, frozen, and caused the pressure which has shifted the blocks. Cracks in the blocks, and there are only a few, should be treated as follows. There are only three chipped blocks, one in the west wall and two in the south wall (160). The smaller chips may be patched with a mix of clear epoxy mortar and granite fines which match the color and vein. Larger chips may require dutchman (cutting wedges or slivers of granite and gluing them in place); or, a section adjacent to the chip may be removed and then replaced in kind. Replacing the stones is not warranted. The best estimate is that the cost (\$3-5 thousand each) is prohibitive, and furthermore, the corrective measures described are very satisfactory. Other defects in the block are of a very minor nature and do not warrant repair.

ILLUSTRATION 159. Partial view of west retaining wall of upper plaza. Note shifting of granite block face. Areaway at right is access to electric vault in basement.

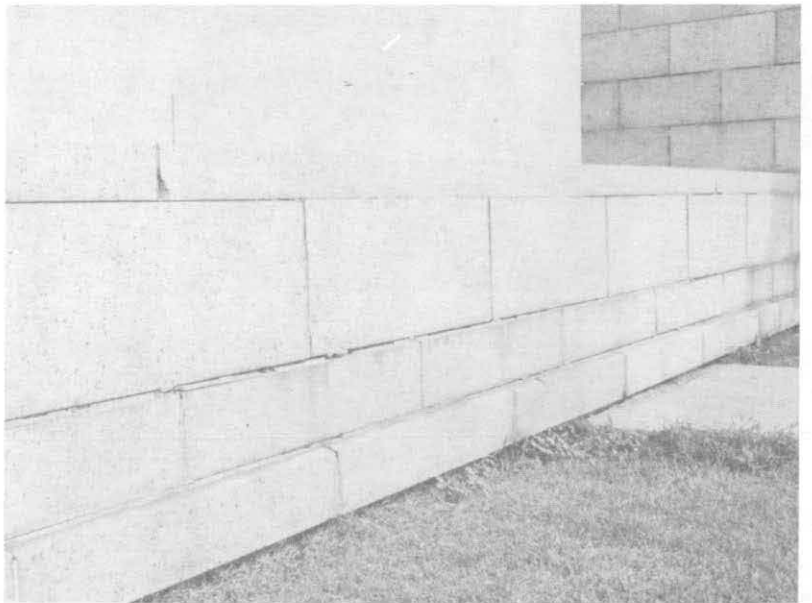
ILLUSTRATION 160. Partial view of west retaining wall showing poor mortar joints and chipped coping stone. Concrete pad at right is thought to be from former electrical transformer.

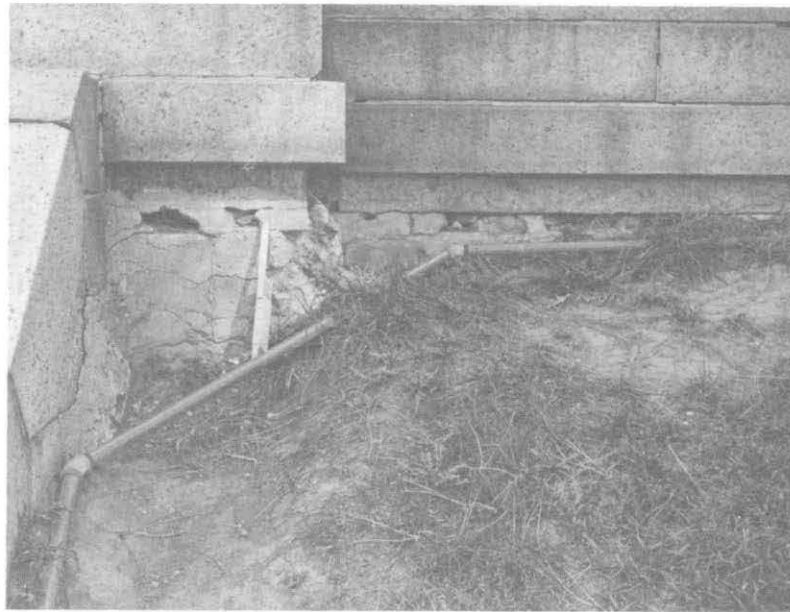
ILLUSTRATION 161. Detail view at northwest corner of retaining wall at junction of main granite steps showing deterioration of concrete. Pipe is water line for hose-bibb.

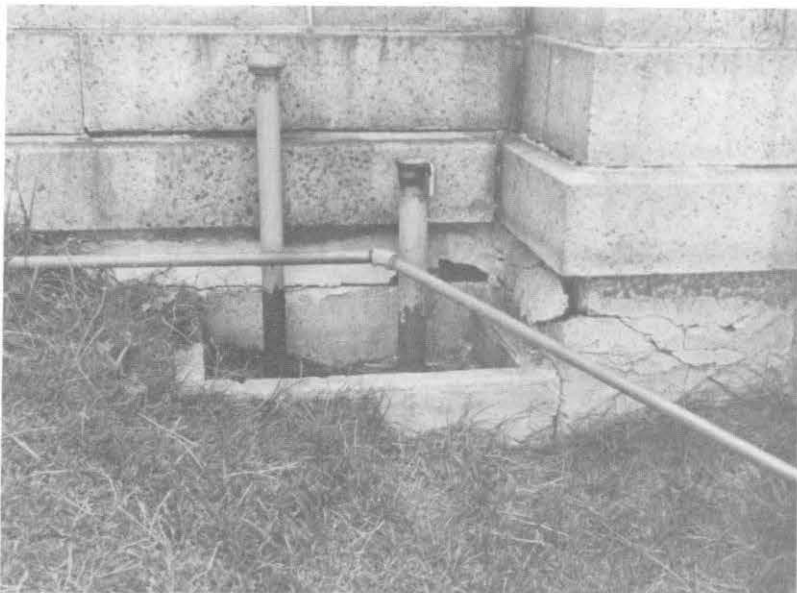
ILLUSTRATION 162. Detail view at northeast corner of retaining wall at junction of main granite steps. Horizontal pipe is water line for hose-bibb. Vertical pipes are supply and vent pipes for fuel oil storage tanks in basement.

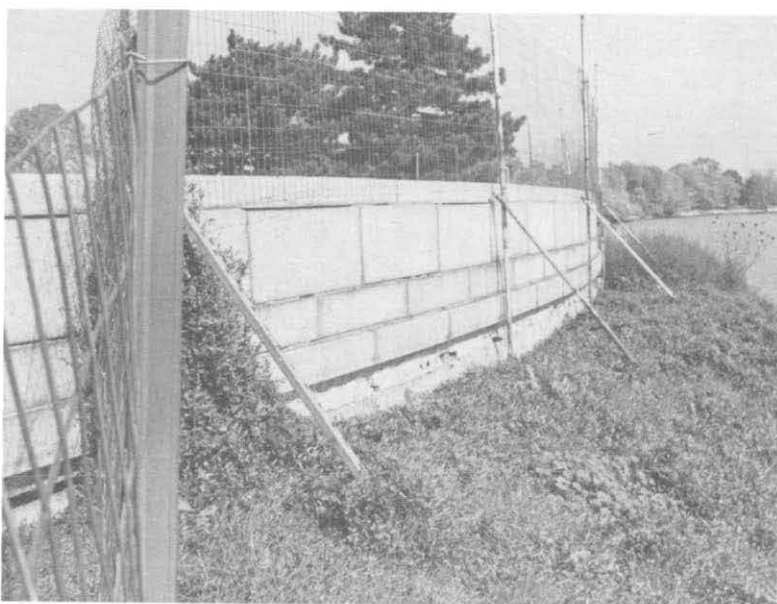
"Safety fences" have been installed on the upper plaza granite walls. The south fence is a temporary wire mesh fence, which was erected because of the erosion caused by the damaged seawall (163, 164). Soil erosion left a drop of approximately 12 feet from the top of the granite wall to the grade below. The south fence also restricts public access to the damaged seawall area. The east fence, a more permanent structure made of galvanized pipes and reinforcing rods welded together, straddles the top of the granite retaining wall (165, 166). It protects the public from a drop of approximately 15 feet from the public restroom area of the upper plaza to the pavement below. The retaining wall at the public restrooms on the east side is 2'-6" high and 2'-10" wide. In itself, it is not enough of a barrier to protect the public. These fences intrude upon the beauty of the Memorial and should be removed at the earliest possible time.

ILLUSTRATION 163. Partial view of south retaining wall of upper plaza showing temporary "safety fence."

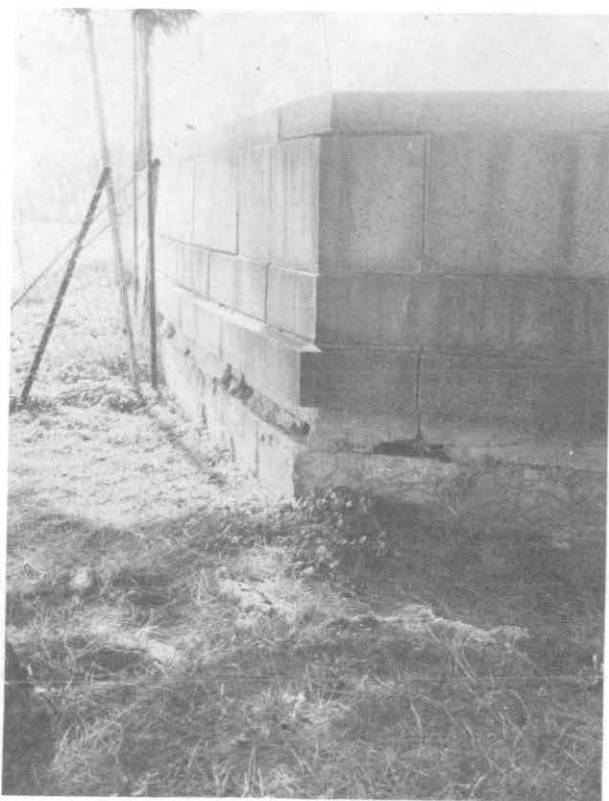
ILLUSTRATION 164. View of southeast corner of retaining wall showing concrete deterioration and lowered grade.

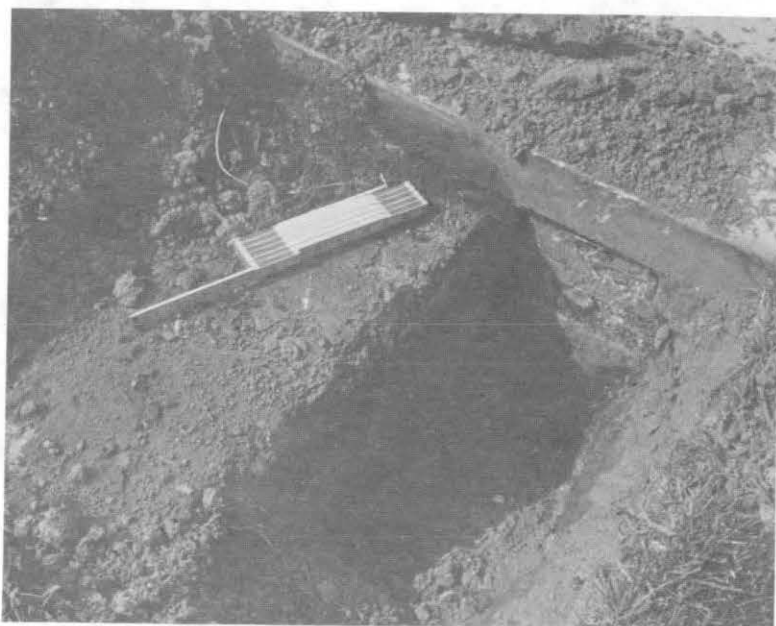
ILLUSTRATION 168. Detail view of a typical corner of a planting box showing curbstone, concrete fill and structure concrete slab below. Note that no waterproofing is evident.

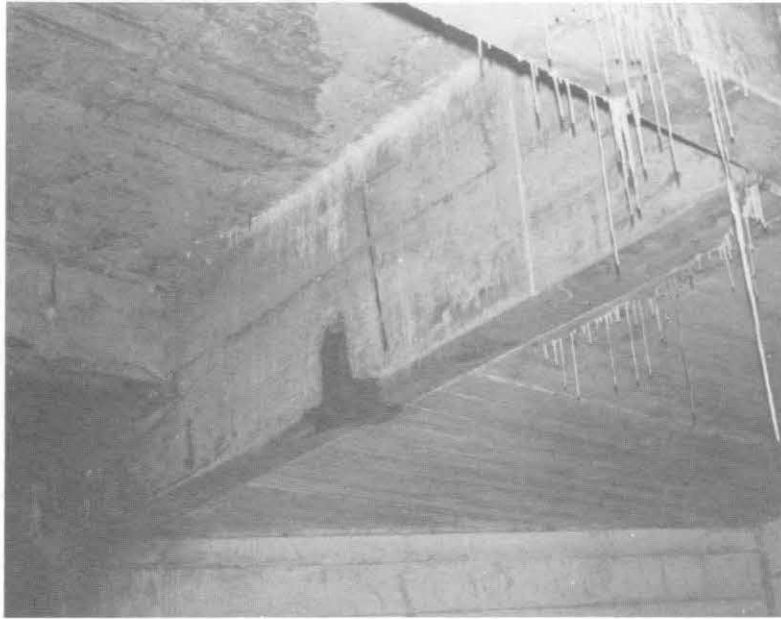
ILLUSTRATION 169. General view of underside of a planting box slab which is typically in the same plane as the bottom of the beam. Note that no drains were evident. Dark stain is probably seepage through bottom of box.

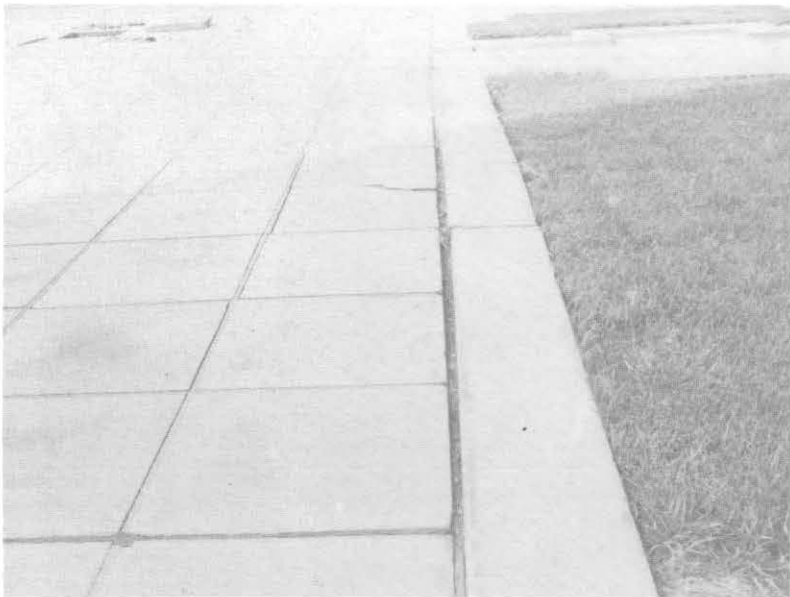
ILLUSTRATION 170. General view of upperside of a typical planting box. Note poor joints between sandstone pavers and sandstone curbstones. See Illustration 171 for section through planting box and recommended waterproofing.

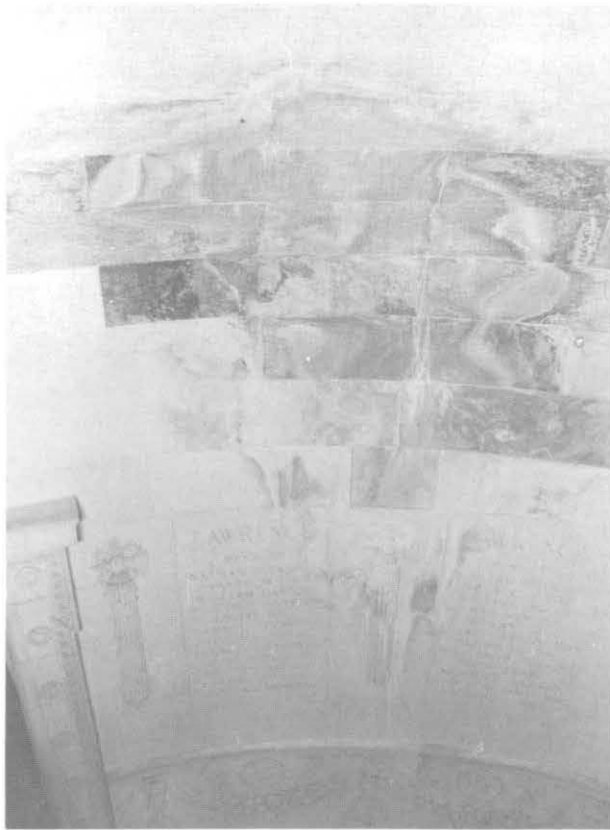
The domed ceiling, made of limestone, has a major stain between the south and west niches (177), with efflorescence and iron oxide staining evident. Immediately above the stained area, in the crawl space accessible from the elevator pit, the floor was wet. Quantities of a damp powder-like substance were found and when tested in the laboratory were identified as calcium carbonate and iron oxide.<sup>2</sup> The location of the major stain coincides with the location of the major crack in the column shaft; therefore, water may be readily infiltrating the column in the area above this stain, leaking into and forming puddles in the crawl space above the rotunda, and later penetrating the concrete and limestone.

This water and/or dampness, in addition to producing the splotch-like staining and efflorescence, has caused some of the limestone blocks (which may inherently contain iron oxide) to "rust." This theory is supported by the fact that only certain blocks show this rust-like stain, some more than others, but always defined by the mortar joint (177). This type of stain most likely penetrates the entire limestone block and therefore cannot be removed by cleaning. An attempt may be made to remove the stains by a cleaning process using poultices of Wyandot detergent left in place for 24 hours. However, iron oxide staining is very difficult to remove. If the stains persist, the only remedy will be to remove the damaged

The limestone commemorative panels have been stained by the same source of water as the rotunda ceiling (177); in fact, it is the same stain, extended to the commemorative panels. Two panels are marred; the balance are in good condition. The damaged panels may possibly be cleaned by the use of the poultice cleaning method. If the two stained limestone commemorative panels cannot be cleaned, an option is to replace them with new limestone panels that are an exact copy of the originals.

ILLUSTRATION 177. Detail view of stained limestone blocks and memorial engravings on southwest wall of rotunda.

limestone facing blocks and replace them with new limestone facing blocks. Assuming the water infiltration is stopped by the proper sealing of the joints on the exterior of the column, as recommended in Chapter 2, and the damp crawl space above the rotunda kept dry, as recommended in Chapter 10, the stains should not reoccur. Whatever decision is reached, it is imperative that the interior of the rotunda ceiling be thoroughly dry. After the interior is thoroughly dried and dehumidified, seal with 3M waterproofer along with the floor above.

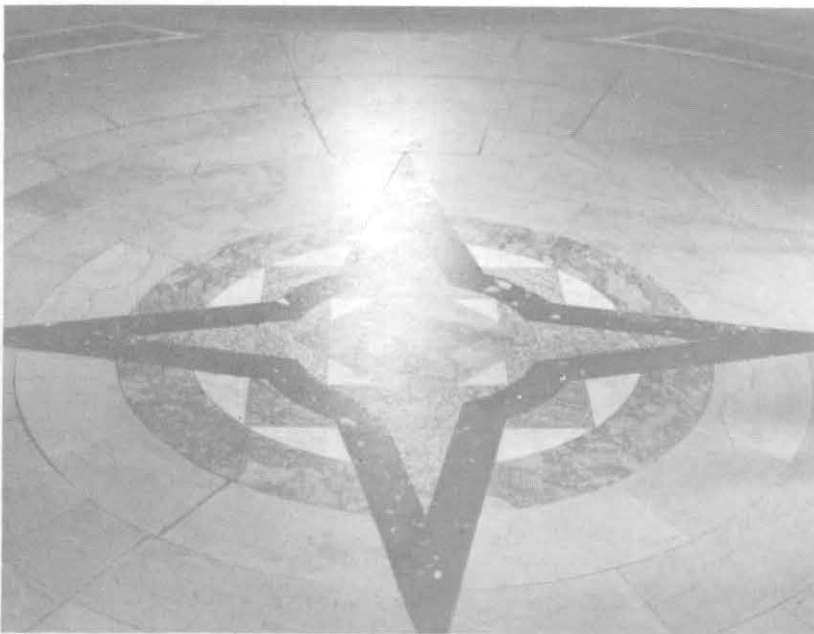
In general the marble floor and marble wall base are in good condition. The base has several flaws on its lower half, probably caused by water and/or ice damage (178). The rotunda floor has a history of being flooded. It is approximately 18" below the level of the upper plaza, and water infiltrates from the plaza and the column shaft. Contrary to the intent indicated in the original drawings, which portray waterproofing extending six feet beyond the column and indicate waterproofing six feet below the upper plaza slab, there is no waterproofing. Either method would have effectively prevented water infiltration. When the upper plaza is waterproofed according to the recommendations in Chapter 5 and the membrane turned up at the column shaft and properly sealed at the intersection of the granite blocks and paving stones, the problem should be solved. It is also necessary, of course, to stop the infiltration of water into the column shaft, and this is discussed in Chapter 2.

ILLUSTRATION 178. Detail view of decorative marble inlay of rotunda floor.

The rust stains on the marble floor are from flag bases and velvet rope stanchions. A cleaning method using a Wyandot poultice for 24 hours might remove these stains. If cleaning fails, the exposed surface of the marble will need to be rehoned or the marble replaced when the floor and base are removed and re-laid to install the rotunda heating system.

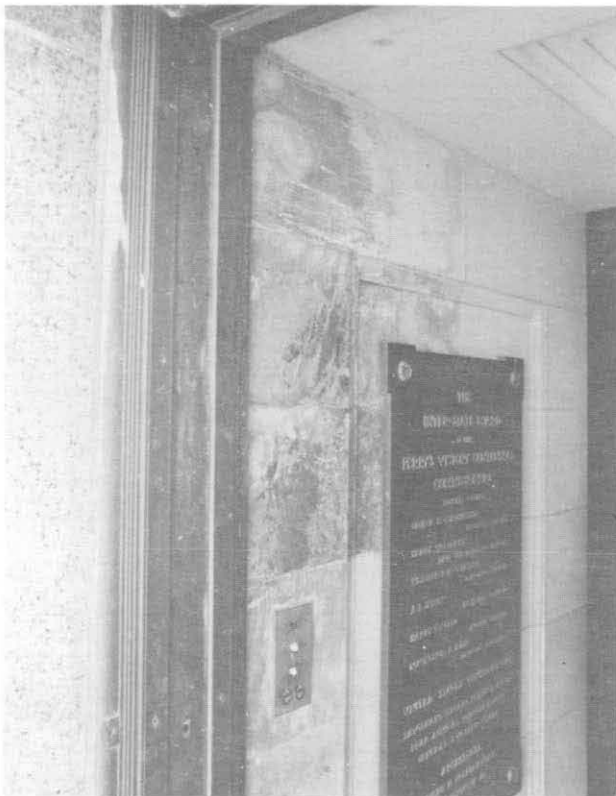
Each niche contains a bronze door with a glass light and bronze grille. The north, east, and west doors are sliding doors which have their pockets concealed in the column shaft. The pair of bronze doors at the south side are hinged, probably because this serves as the required exit from the column. The inside face of the south door is polished, which seems incongruous since none of the other doors are polished. The north door, which is the principal entry, requires repairs and a new doorstop. At present, the door can slide beyond the pocket, making retrieval difficult. The bronze frame of this door is not fastened properly and is somewhat corroded (181, 182). All other doors and frames appear sound.

ILLUSTRATION 181. Detail view of north door frame showing corrosion and missing frame screws.

All bronze requires cleaning, color treating and sealing as discussed in Architectural Bronze Metalwork in Chapter 2. In addition, it is recommended that all doors be weatherstripped to minimize air infiltration. Care must be taken to do this in an unobtrusive manner. Finally, all door frames should have all existing sealant removed and new sealant installed to make them weathertight.

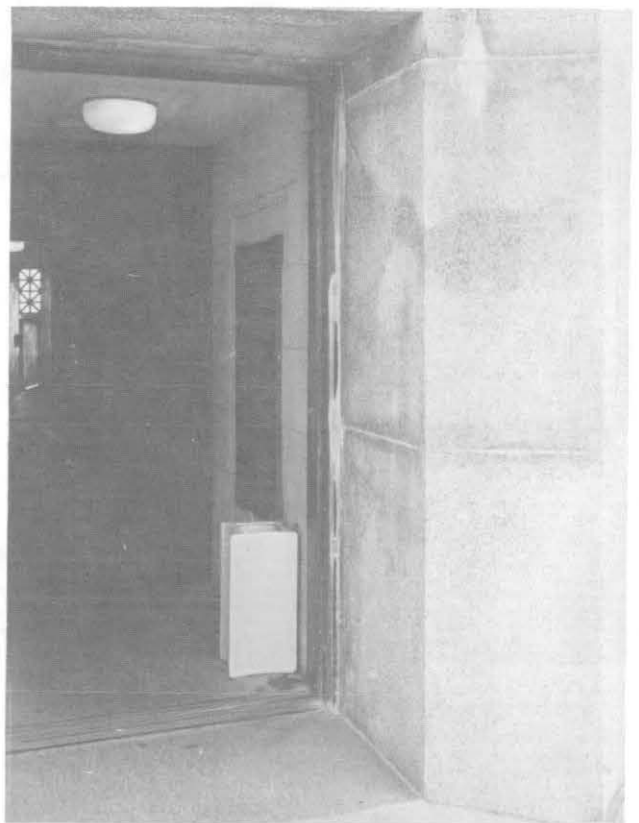
Each niche contains a ceiling-mounted lighting fixture consisting of a simple 12" round by 4" deep white glass dome without trim (182). They are not the original fixtures. There is no record of the original fixture design, and these fixtures are neat, attractive, and in good condition. Therefore, it is recommended that no work be done on these fixtures.

ILLUSTRATION 182. General view of north entry door. Note light fixture at ceiling of niche.

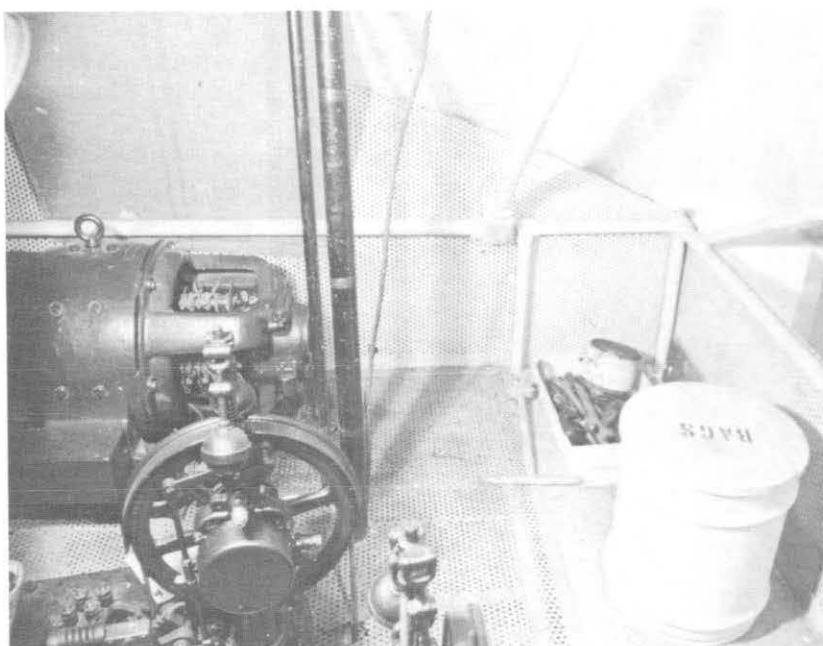
Operation of the elevator has no adverse effect on the heating and dehumidification system. Conversely, the heating and dehumidification system is probably the prime reason for the excellent condition of the structural steel and mechanism of the elevator

ILLUSTRATION 185. General view of elevator machine platform. Note clean appearance of equipment.

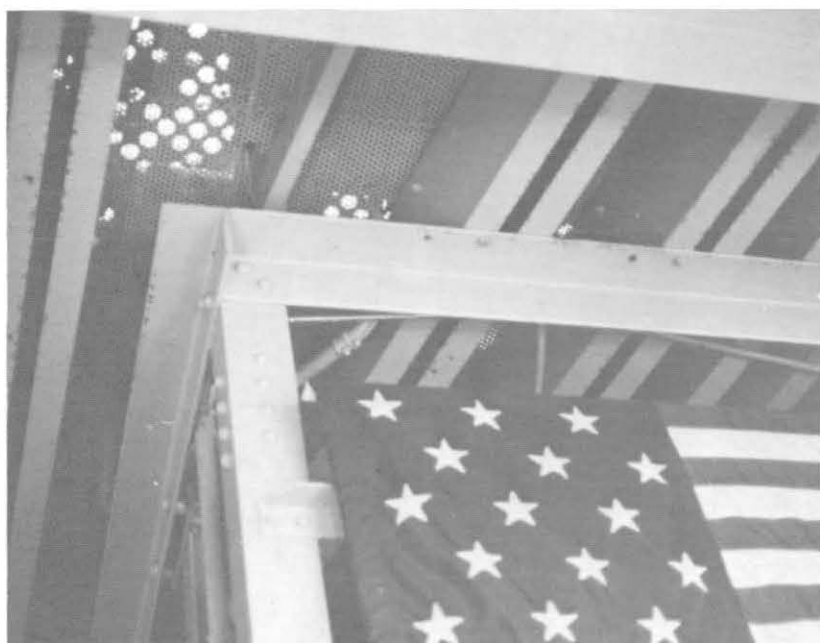
ILLUSTRATION 186. View of underside of elevator machine platform. Note perforated plate floor and glass vault lights above.
