december 1976

## PERRY'S VICTORY AND INTERNATIONAL PEACE MEMORIAL MEMORIAL COLUMN AND PLAZAS

Historic Structure Report  
Memorial Column and Plazas  
Administrative and Architectural  
Data  
Perry's Victory and International  
Peace Memorial  
Ohio

DALTON-DALTON-LITTLE-NEWPORT

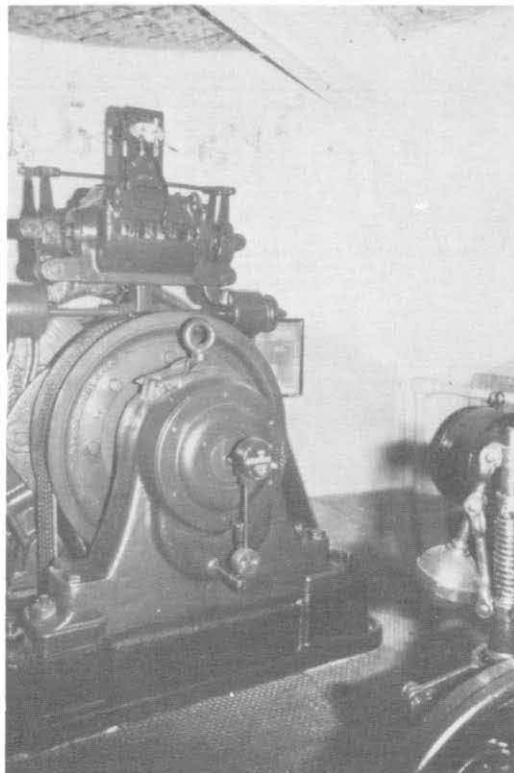
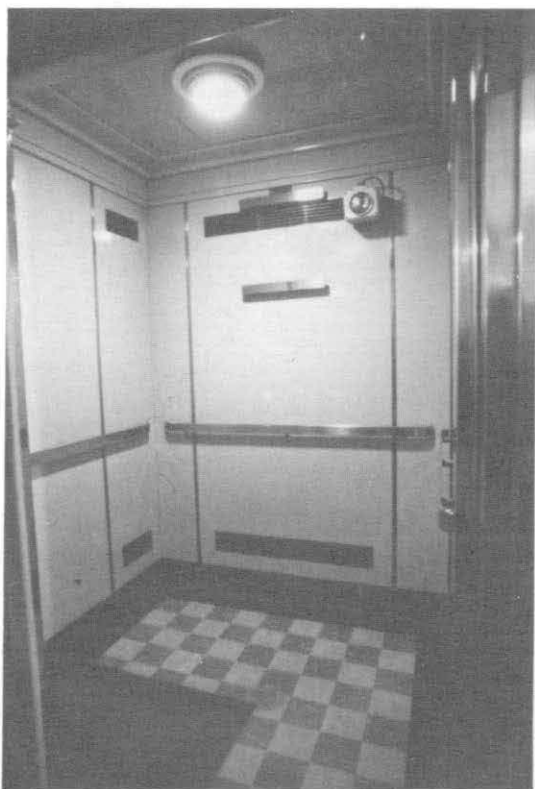
ILLUSTRATION 187. General view of elevator machine platform showing clean appearance of equipment.

ILLUSTRATION 188. View of Otis Elevator cab showing clean appearance.

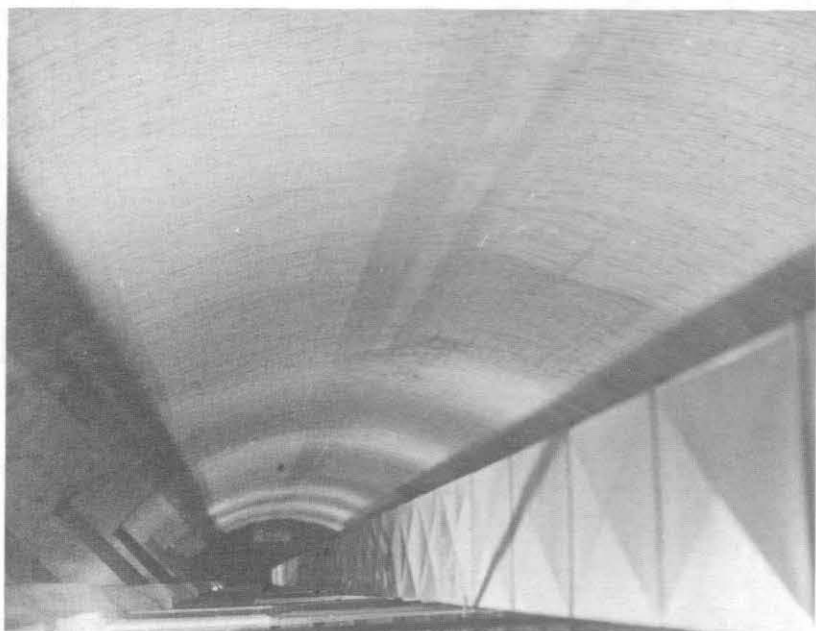
ILLUSTRATION 189. View of supply air duct within the column shaft. Photo taken from an upper level looking down.

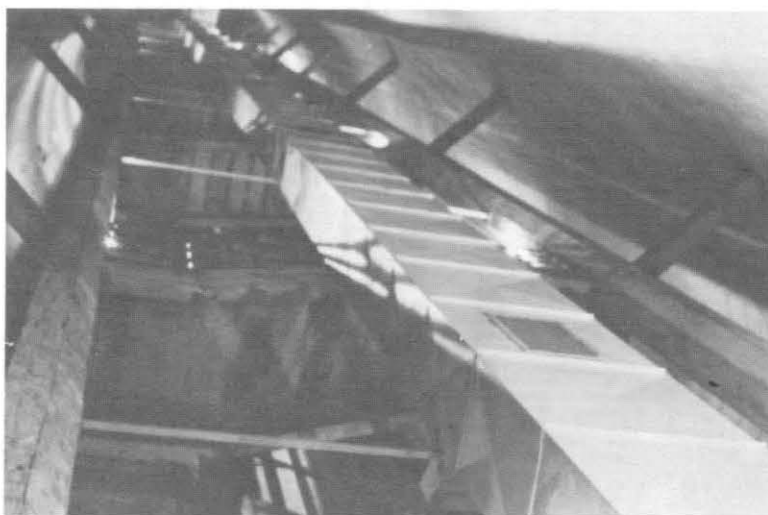
ILLUSTRATION 190. View of the return air duct within the column shaft looking up.

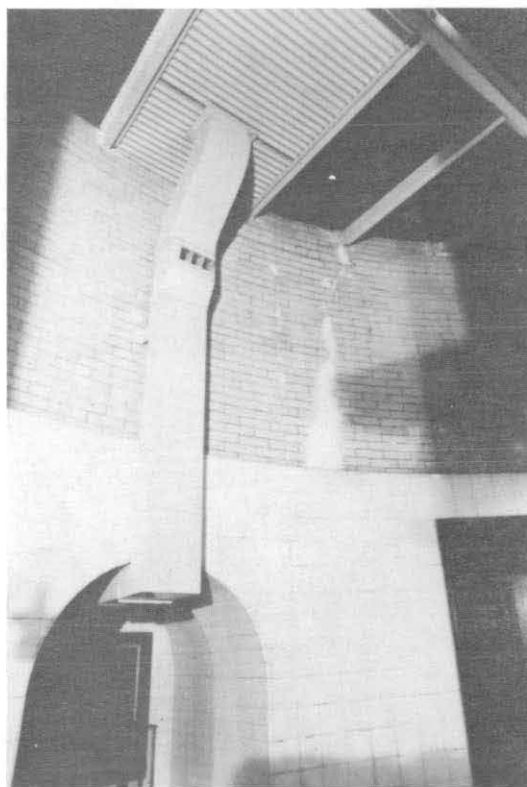
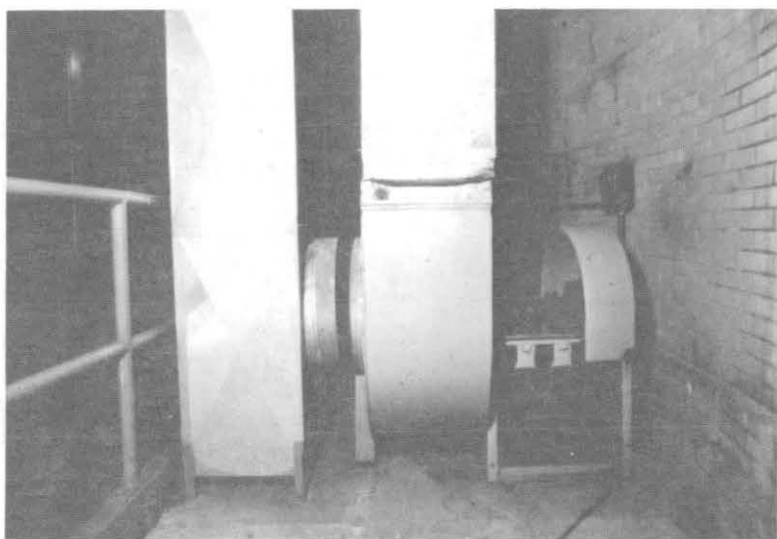
Supply (197) and Return (192) Air Fans: Both the supply and return air units have had the shaft bearings replaced. The condition of the scroll case and the motors appears to be good.

ILLUSTRATION 191. View of supply air duct at lower elevator landing and the underside of the equipment platform supporting the dehumidification equipment.

ILLUSTRATION 192. View of return fan and return air duct arrangement. Mounted on the equipment platform.

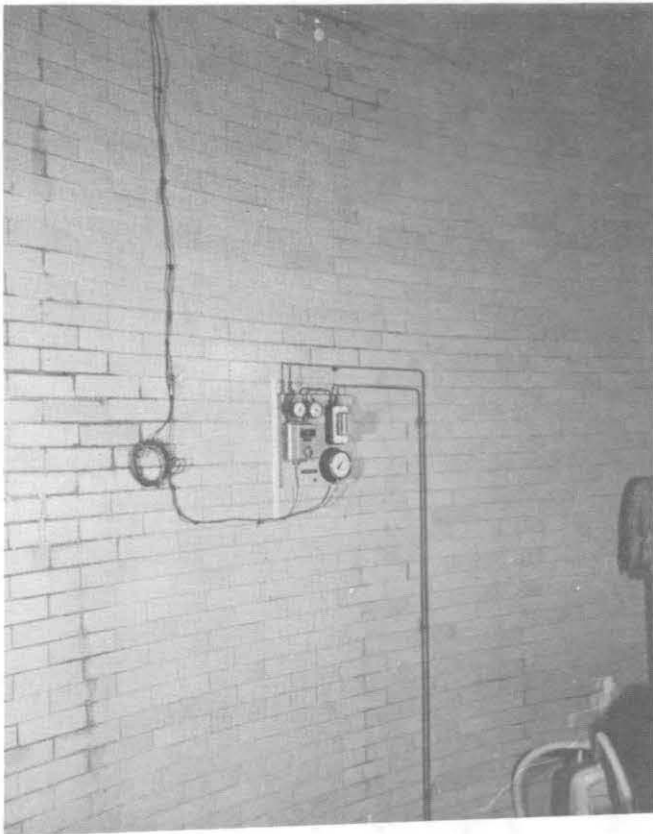
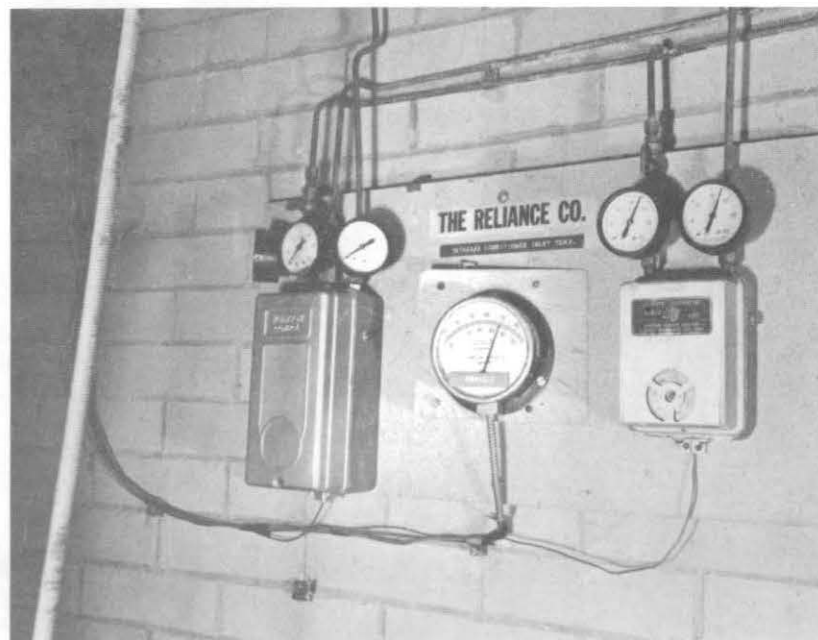
ILLUSTRATION 193. Showing arrangement and location of the averaging bulb temperature sensor and the humidity sensor on the interior column wall one level above the equipment platform.

ILLUSTRATION 194. Humidity and temperature controllers located on the interior column wall adjacent the dehumidification equipment. See Ill. 196.

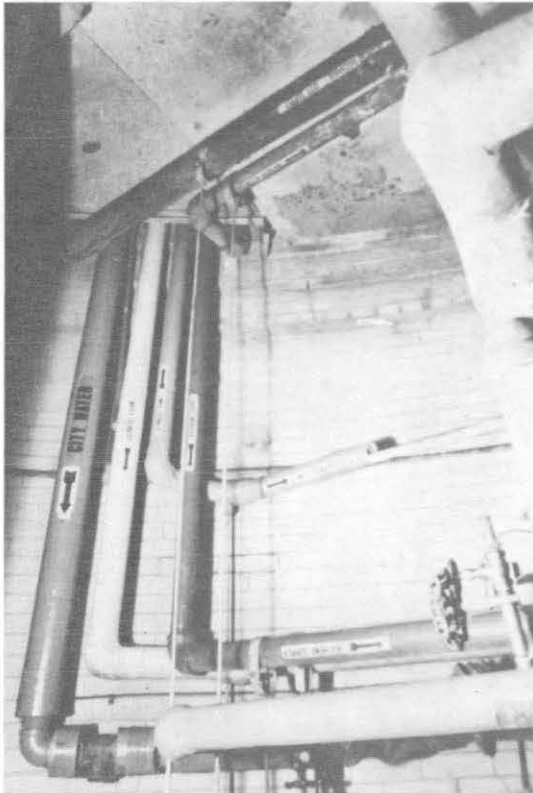
ILLUSTRATION 195. Showing condition and location of piping serving the dehumidification equipment. The pipe penetrates the equipment platform that supports the equipment located one level above the lower elevator landing. Note the condition of the insulation on the pipe in the center of the photo.

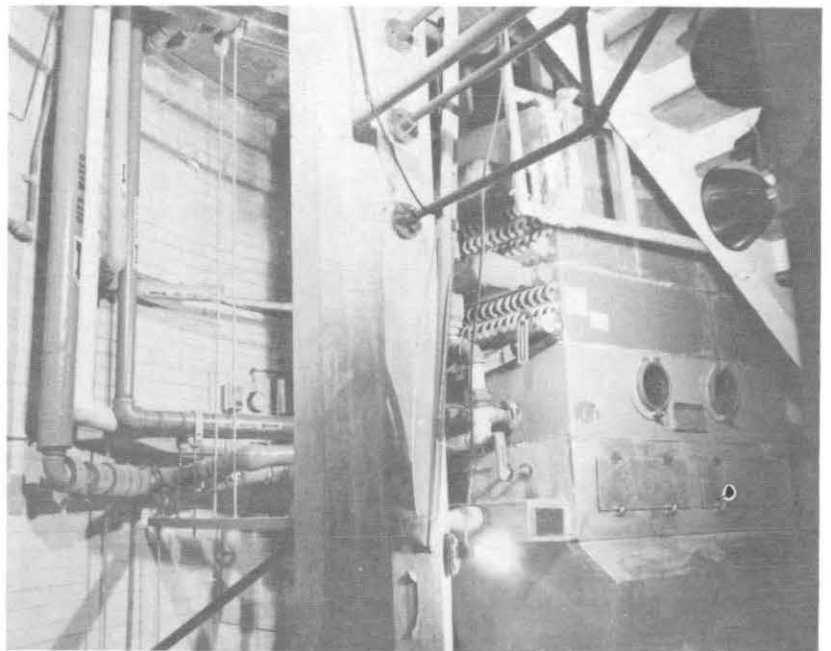
ILLUSTRATION 196. View of the conditioner section of the Kathabar unit, with piping and partial view of the master controls on the wall. See Illustration 194.

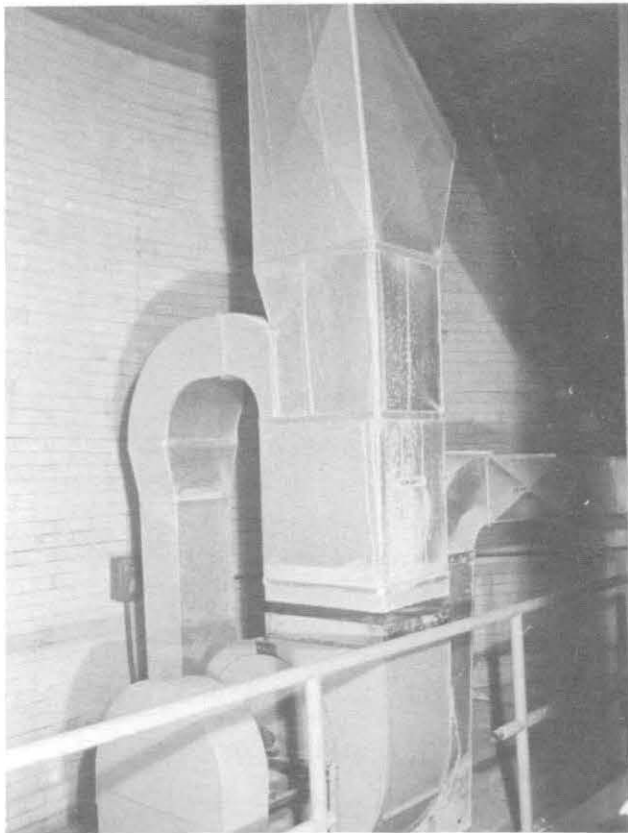
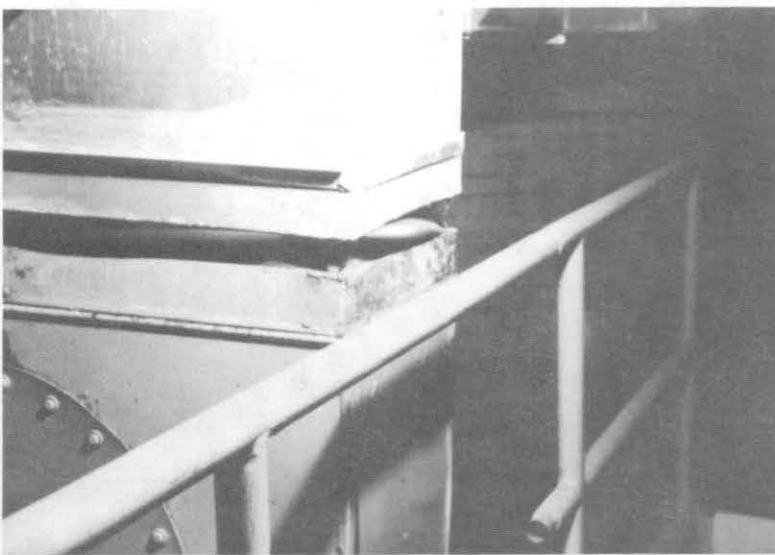
ILLUSTRATION 197. Supply air fan and duct arrangement. The curved branch take-off serves the lower elevator landing and the stairway to the memorial rotunda. See Illustration 191.

ILLUSTRATION 198. Close-up view of the supply air fan showing condition of flexible connection and slight corrosion of the metal.

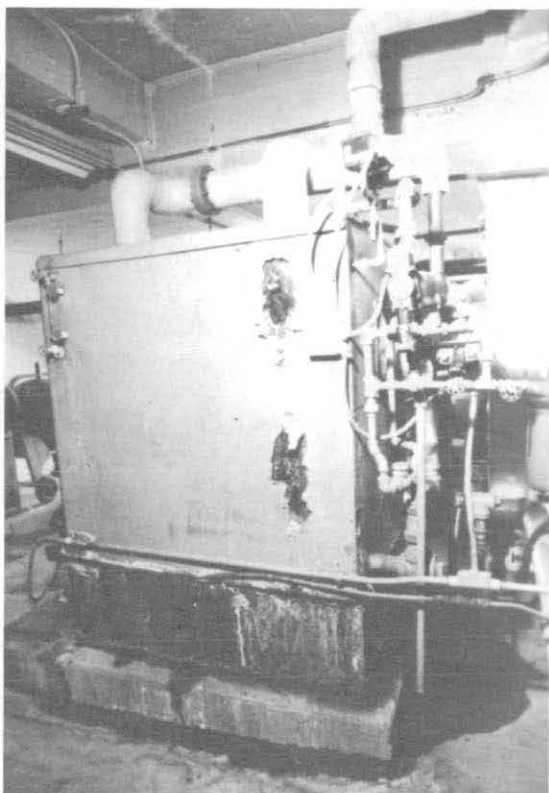
ILLUSTRATION 199. View of the boiler showing the poor condition of the insulated casing. Note the corrosion and moisture at the base of the boiler.

ILLUSTRATION 200. Condensate receiver and return pump. The condition of this unit and connecting piping is good. The air compressor and receiver in the background serves the automatic temperature controls for the system.

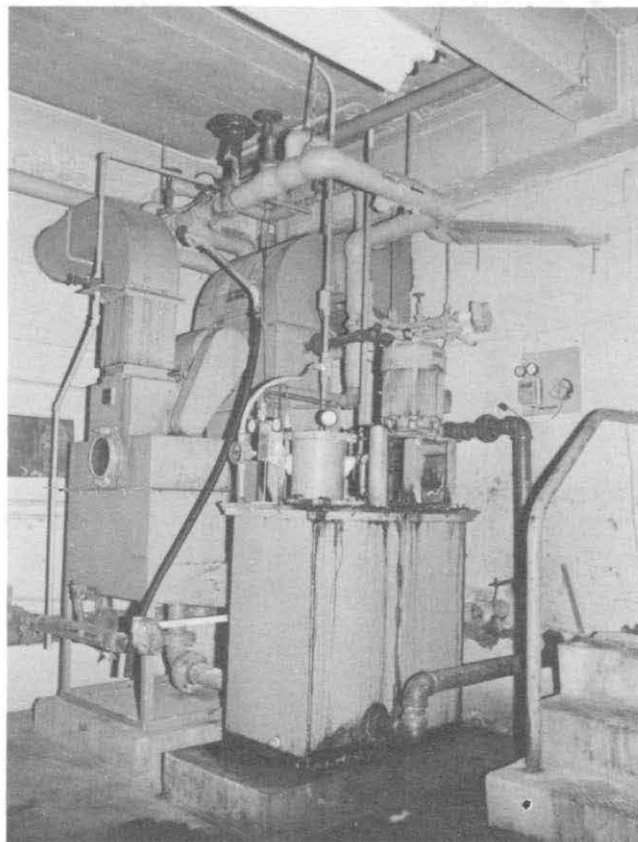
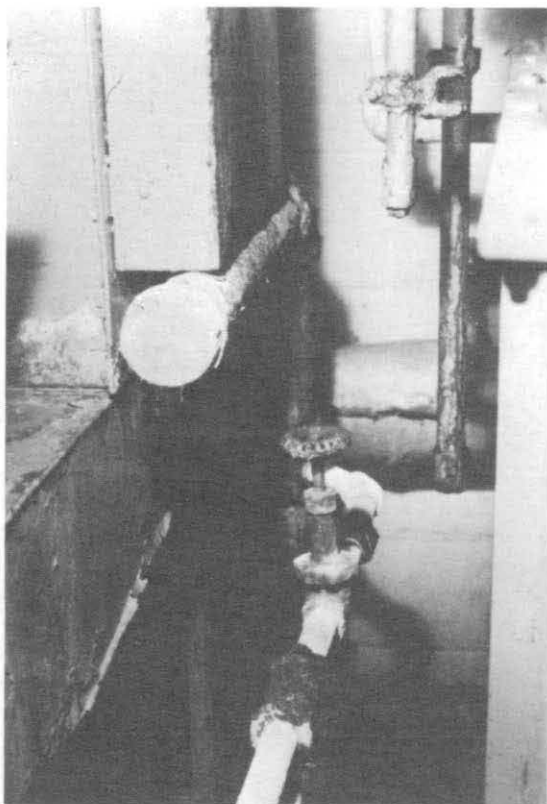
ILLUSTRATION 202. Closeup of piping located between the Kathene solution tank and the regenerating section showing the effects of corrosion.

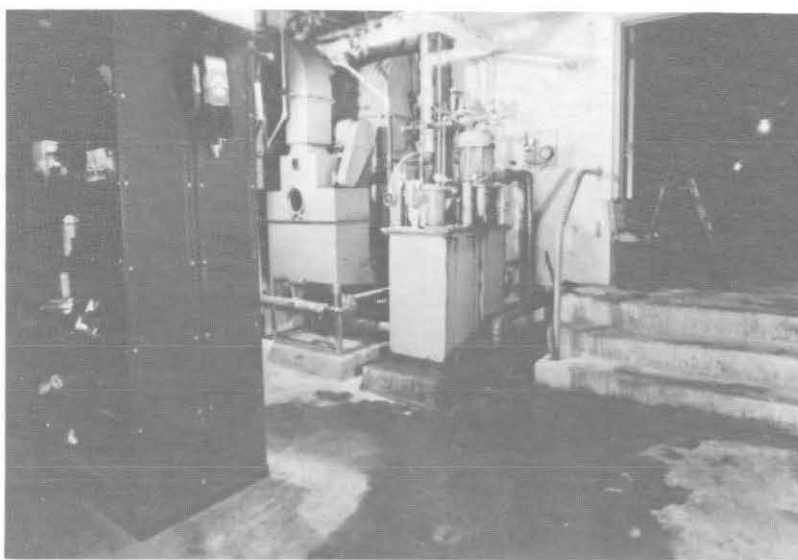
ILLUSTRATION 203. Kathene solution leaking from the tank keeps the floor continually wet.

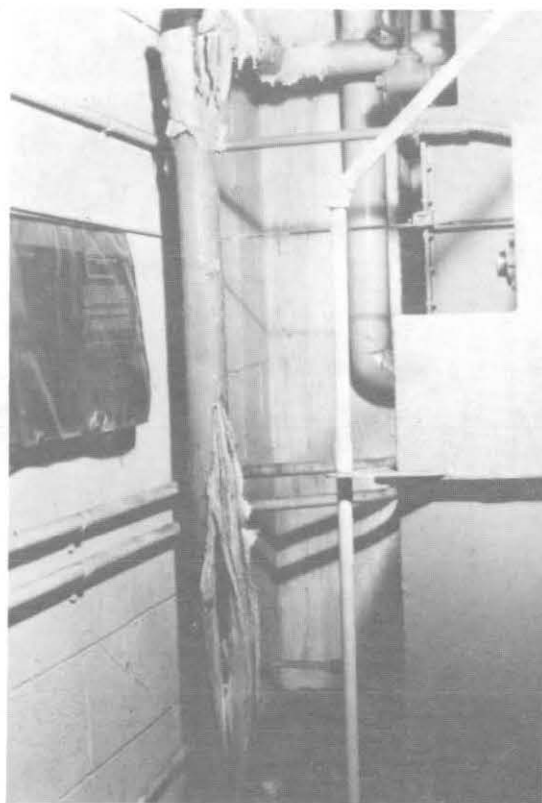
ILLUSTRATION 204. Steam pipe adjacent to the regenerating section. Note the lime-like deposit on the pipe at the top of the photo.

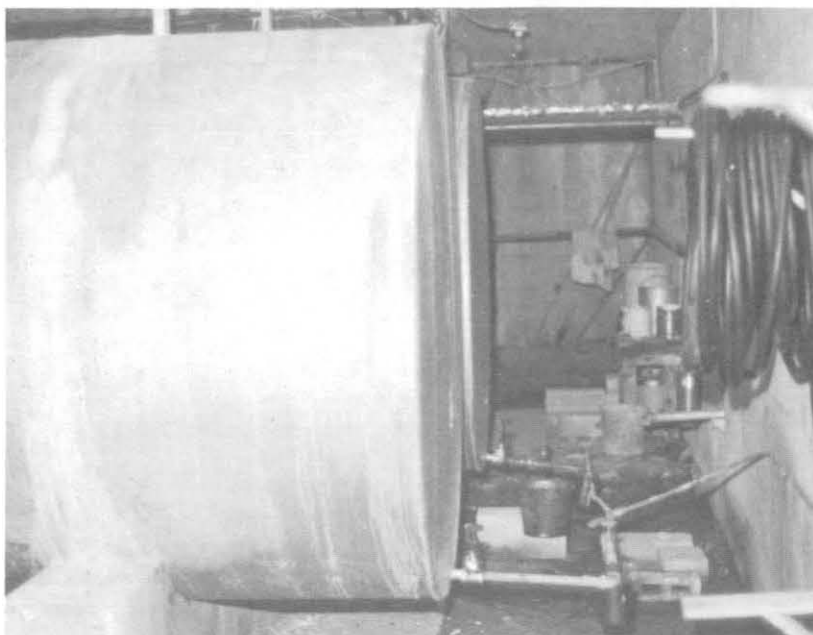
ILLUSTRATION 205. View of the fuel oil storage tanks. Note the pipe stubbed out from the wall immediately below the coiled hose is the discharge pipe from the sump pump in the equipment room located behind this wall.

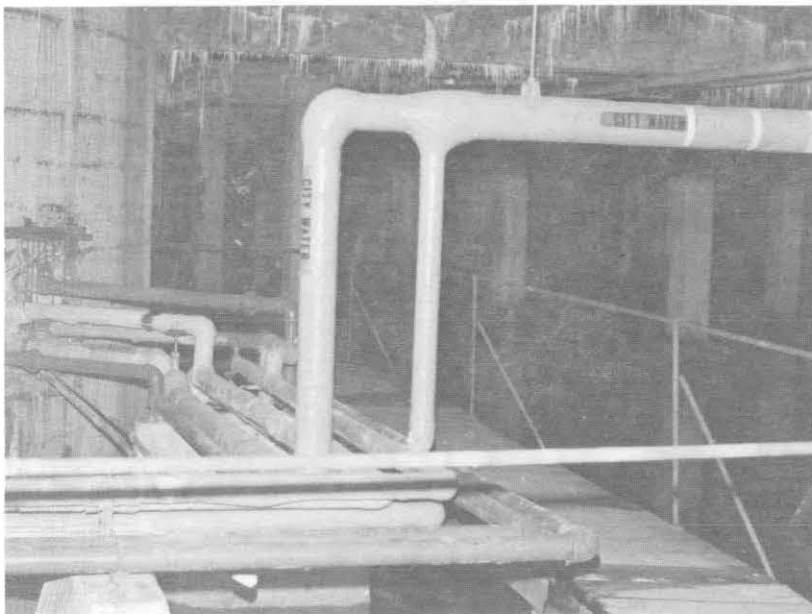
ILLUSTRATION 207. Overall view in the basement space near the north wall of the column shaft base. Note the catwalk above the standing water that covers approximately 70 percent of this area. The pipe at the left of the photo extends upward through the shaft wall to serve the dehumidification equipment located on the equipment platform above the lower elevator landing. Also see Illustrations 209 and 210.

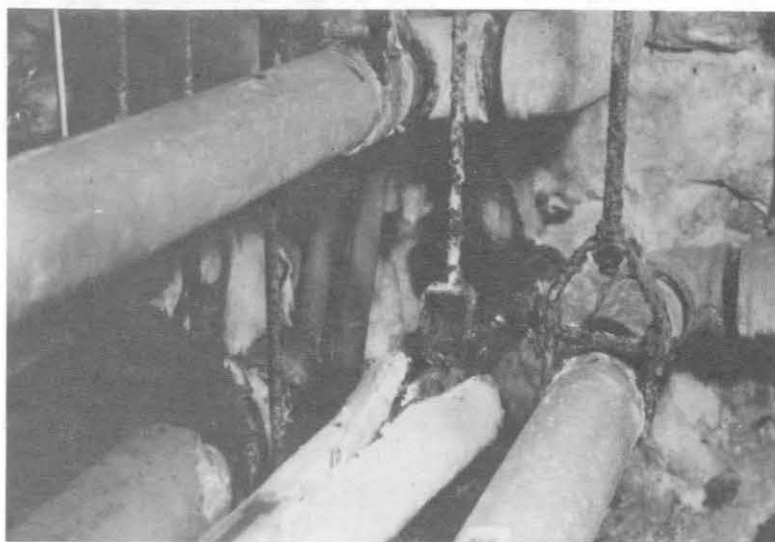
of severe corrosion at this point. The hangers and supporting steel are badly rusted (209, 210).

ILLUSTRATION 209. Close-up of pipe and hangers at the column shaft base. Note the poor condition of the hangers, pipe and insulation.

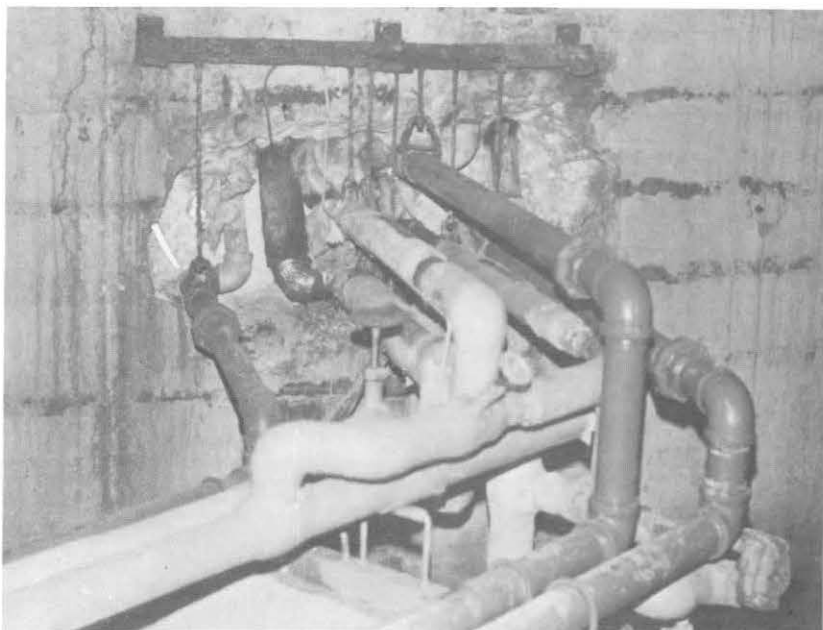
ILLUSTRATION 210. View of piping entering the base of the column shaft.

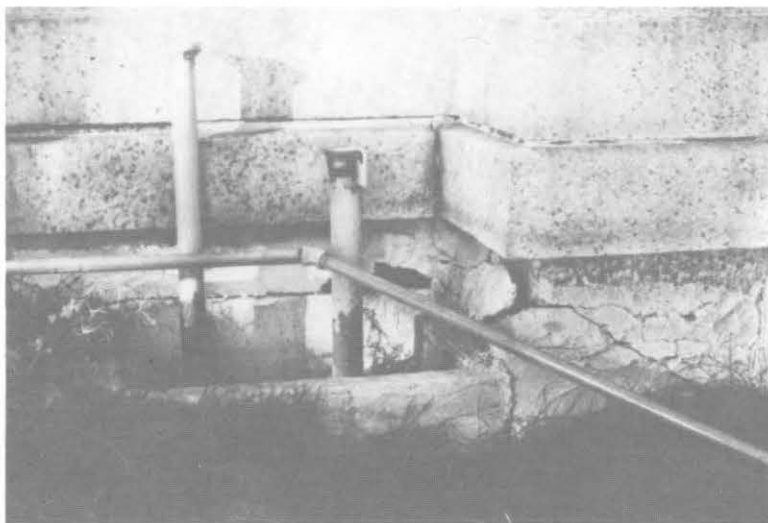
ILLUSTRATION 214. Close-up of the fill and vent terminals for the fuel oil tanks. The horizontal pipe is a waterline serving the hose-bibbs located about the plaza perimeter. This water pipe was designed as an underground line but emerges exposed and unprotected at several places throughout its run.

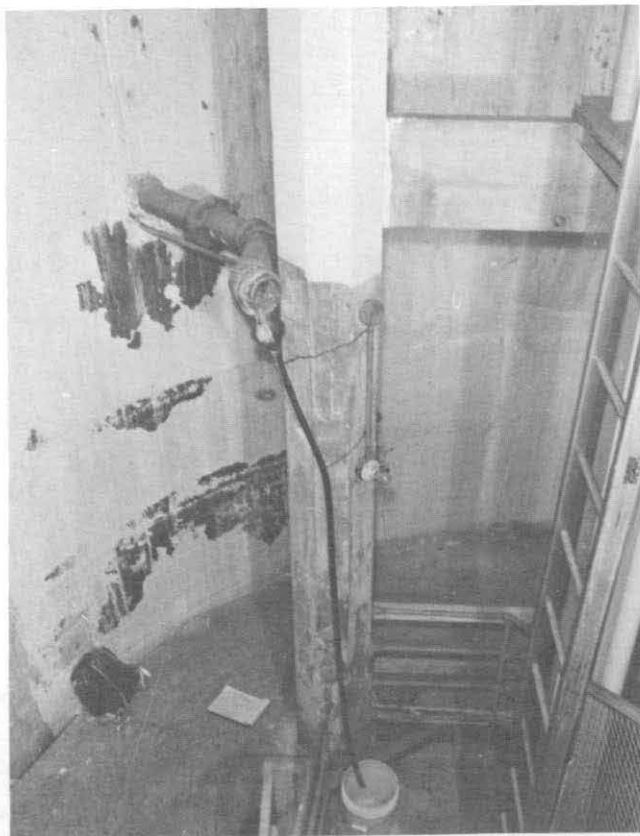
ILLUSTRATION 216. View of interior rainwater conductor serving the observation deck. The floor drain on the deck has been reworked for a free fall to the outside. However, during heavy rains, water will flow from this pipe into the bucket.

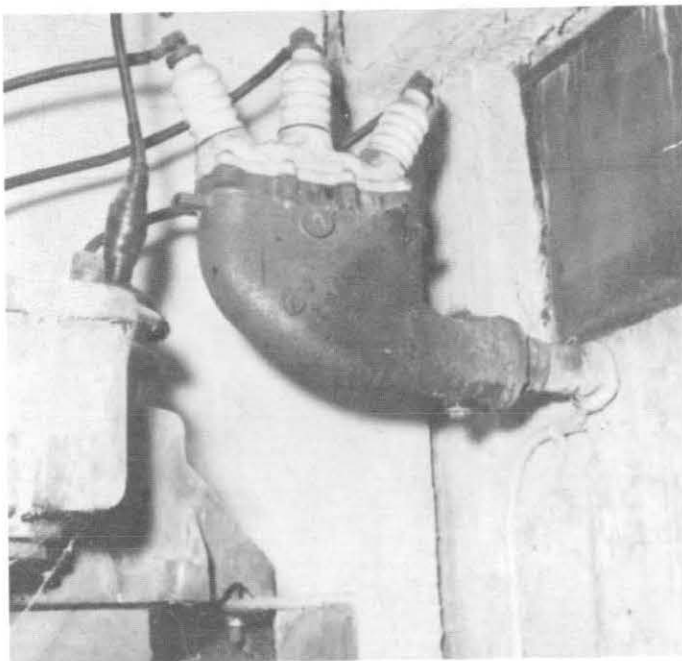
ILLUSTRATION 221. Incoming service wall mounted pothead. Note: Terminals should be tape insulated to prevent an arc over.

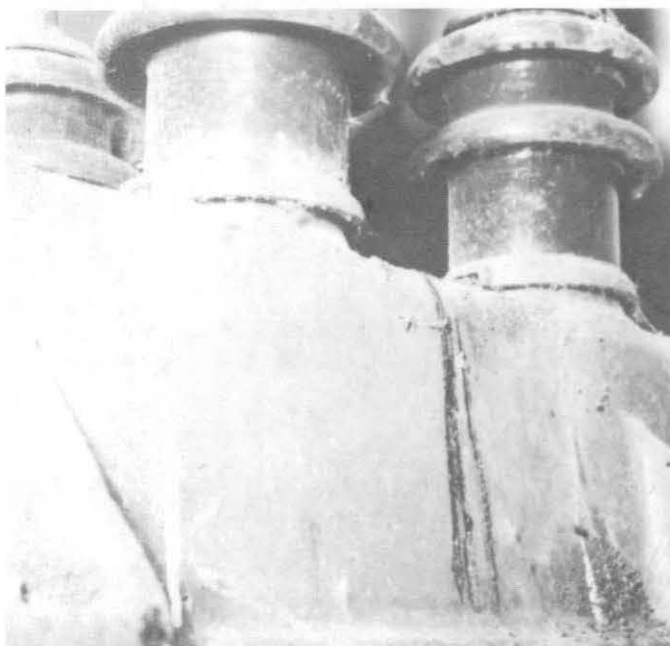
ILLUSTRATION 223. Main oil circuit breaker -  
insulators require cleaning.

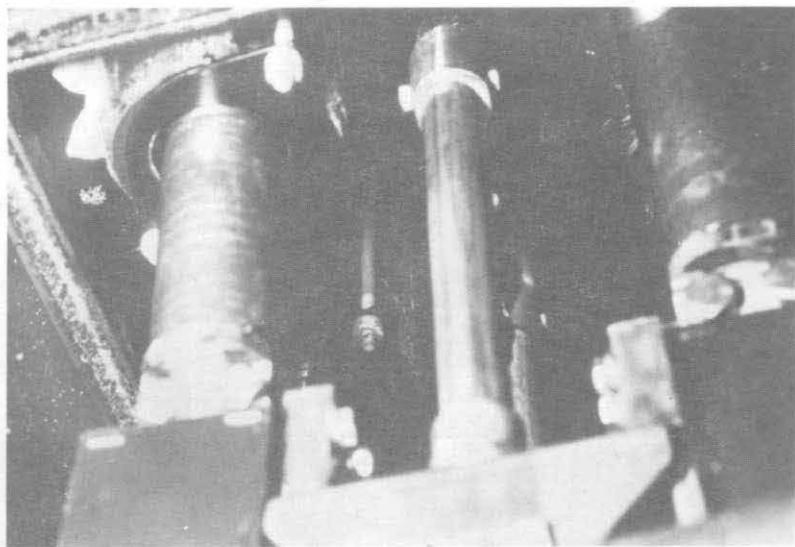
ILLUSTRATION 224. Main oil circuit breaker with oil  
pan lowered. Bushings inside should be cleaned.

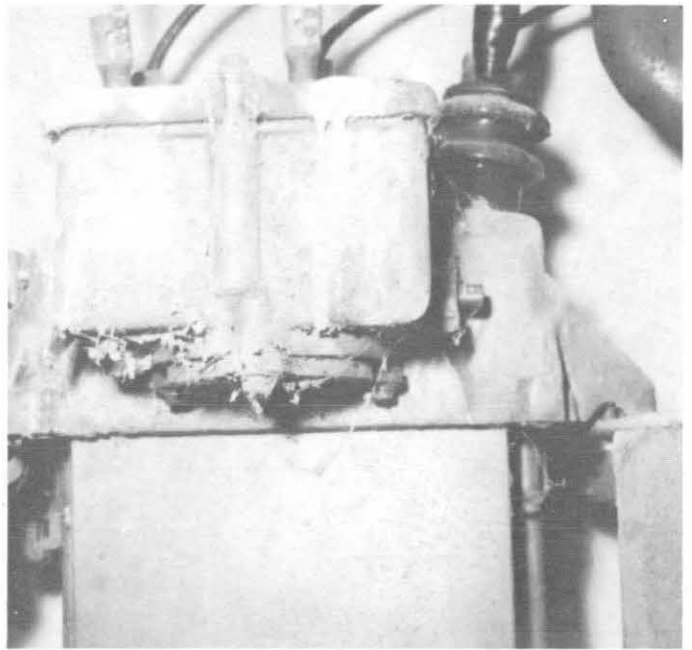
ILLUSTRATION 225. Main oil circuit breaker enclosure requires cleaning and painting.

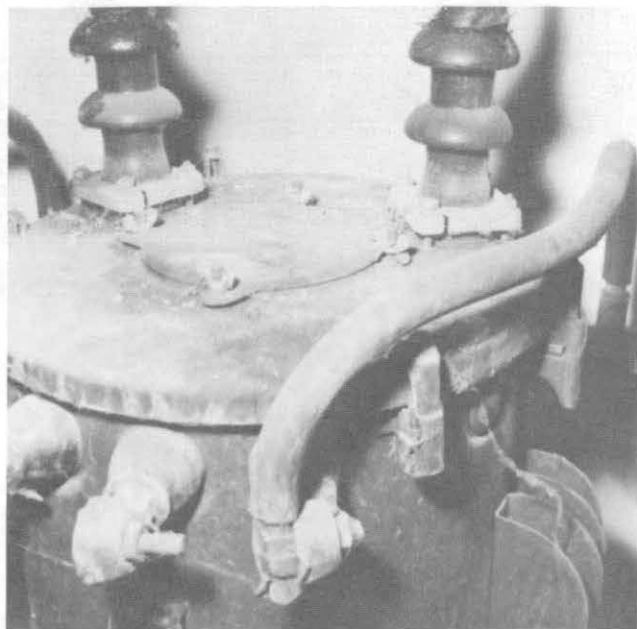
ILLUSTRATION 227. Typical transformer top. High voltage bushings are leaking and enclosures should be cleaned and painted.

| 4. Cleaning, taping, painting and repair of leaking bushings on three transformers | 600 |

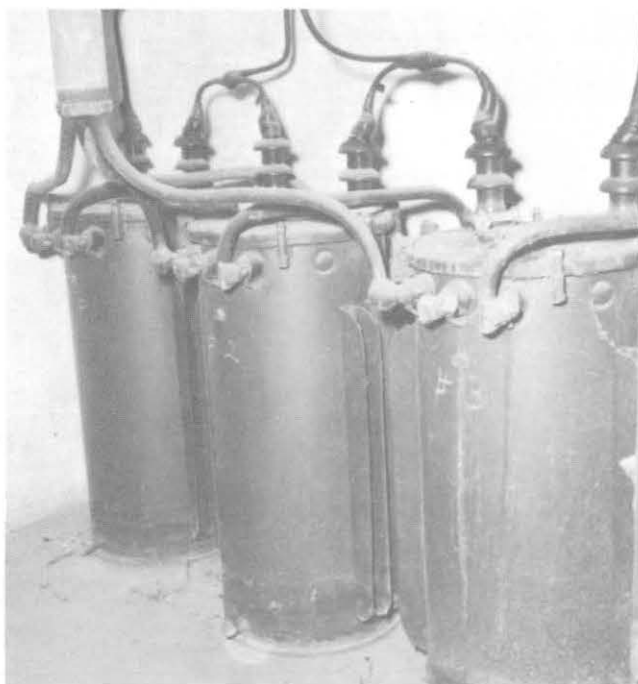
ILLUSTRATION 228. Main transformer bank. Note: Terminals in front should be tape insulated.

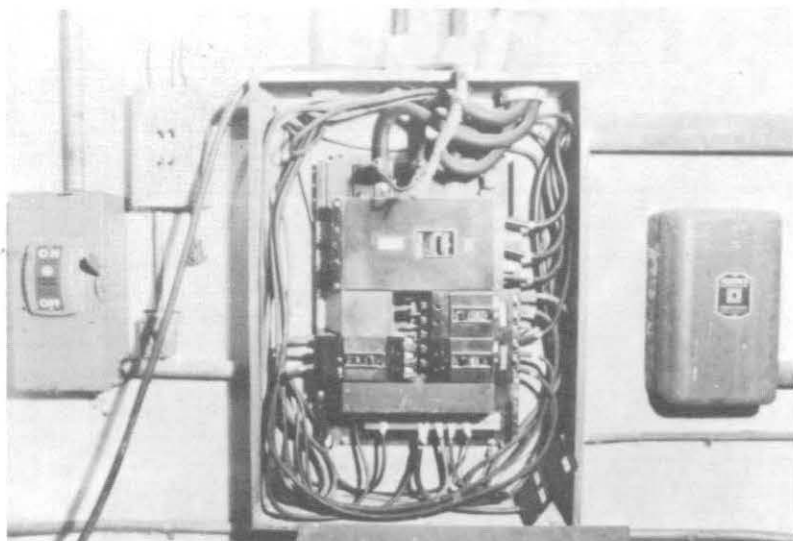
ILLUSTRATION 231. Main 120/208 volt panelboard with front cover removed. Enclosure should be cleaned and painted inside and out.

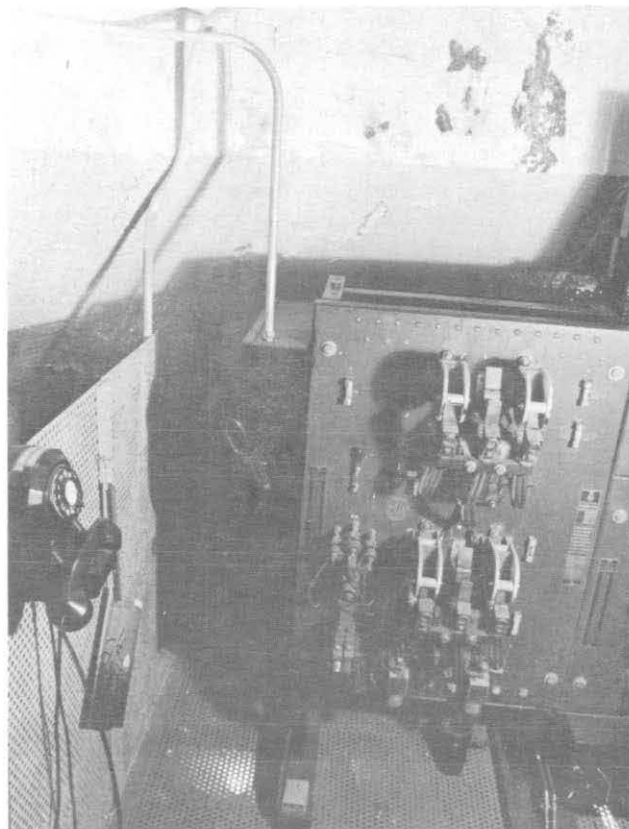
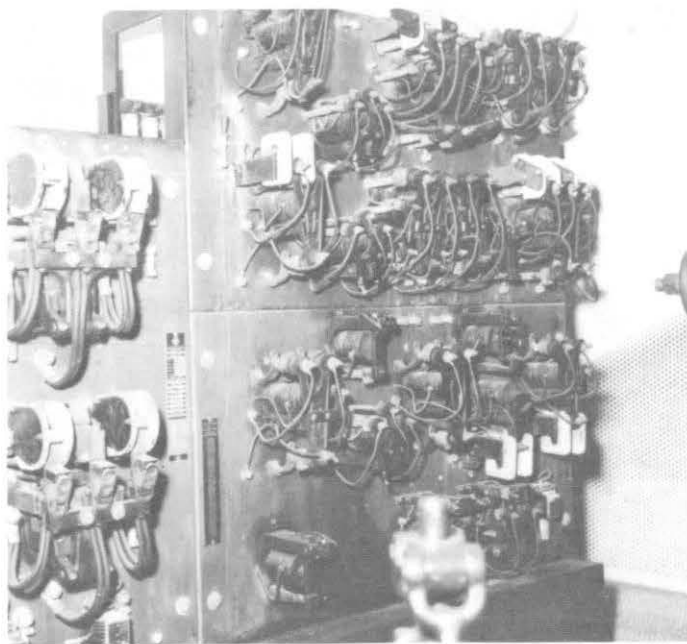
ILLUSTRATION 237. Elevator disconnect switch at elevator machine platform.  
Note: Screening at left should have opening to provide access.

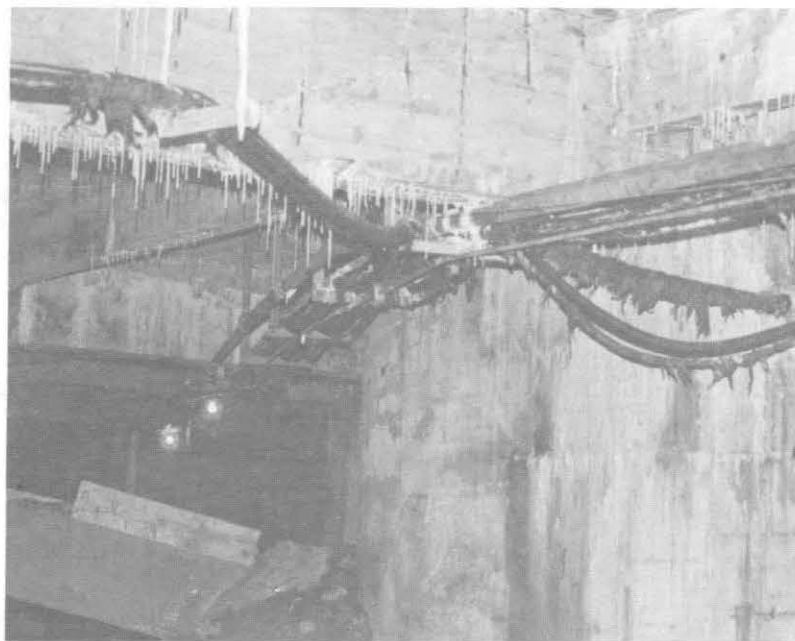
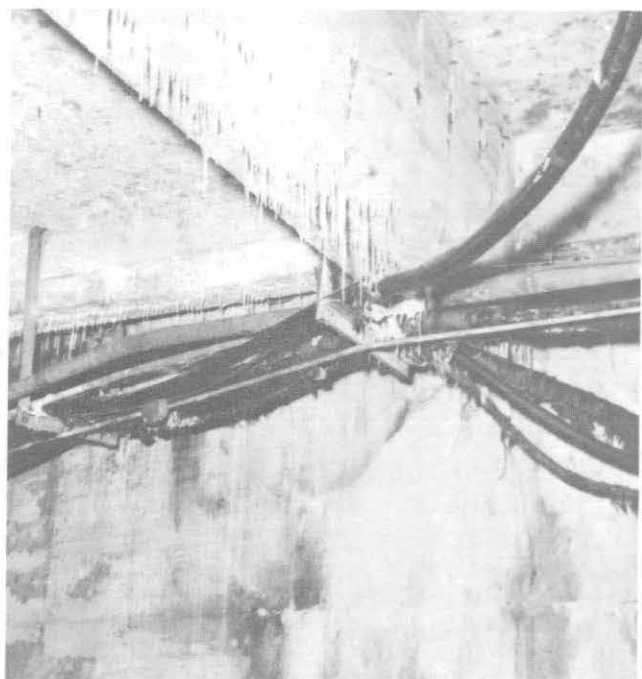
The existing wiring from the distribution equipment in the transformer vault room is a system of exposed multiconductor tray-type cables suspended on an angle iron support system fastened to the roof structure of the basement. These cables are feeders to the floodlight banks, the elevator, and the interior lighting panels. The cables are in a wet, cave-like basement location. Calcium carbonate stalactites that result as water leaks through the upper plaza slab are constantly dripping water and calcium carbonate solution onto the cables (241). This had had a deteriorating

effect on all the tray-type exposed cables installed in the basement area. Further, the tray cable is improperly supported on the angle iron supports (242). According to the National Electric Code, a tray cable should be physically supported its entire length to prevent high stress concentrations and damage to the cable insulation and outer covering. It is recommended that an approved ladder-type cable tray system be installed and the defective feeders replaced. The feeder cables that were tested and found to be in adequate condition should have the outer coverings repaired with a vinyl-type tape where these jackets have been damaged. The incandescent lighting fixtures hanging from the bottom of the angle support system should be moved and independently suspended. In addition, the feeder in conduit which supplies the boiler room panel should be moved and independently supported from the tray system.

ILLUSTRATION 241. Low voltage feeder runs in basement. Note damaged outer coverings.

| 8. | Repair of feeder cable jackets by taping and addition of additional cables supports to existing | 3000 |

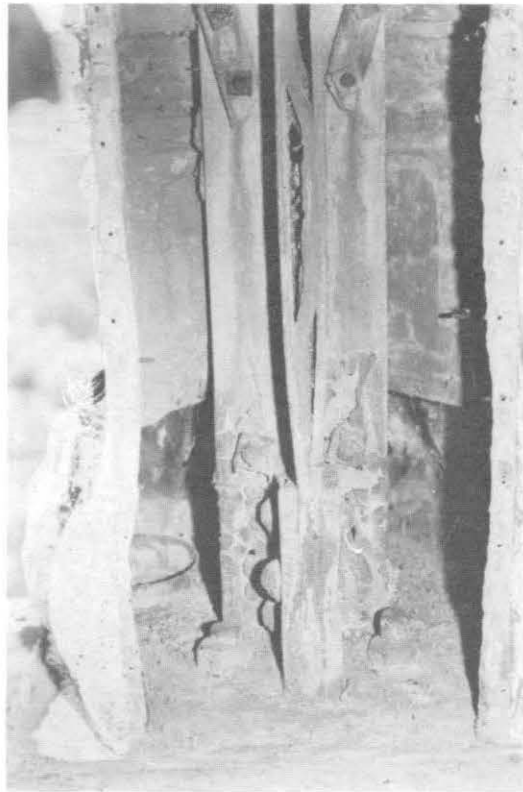
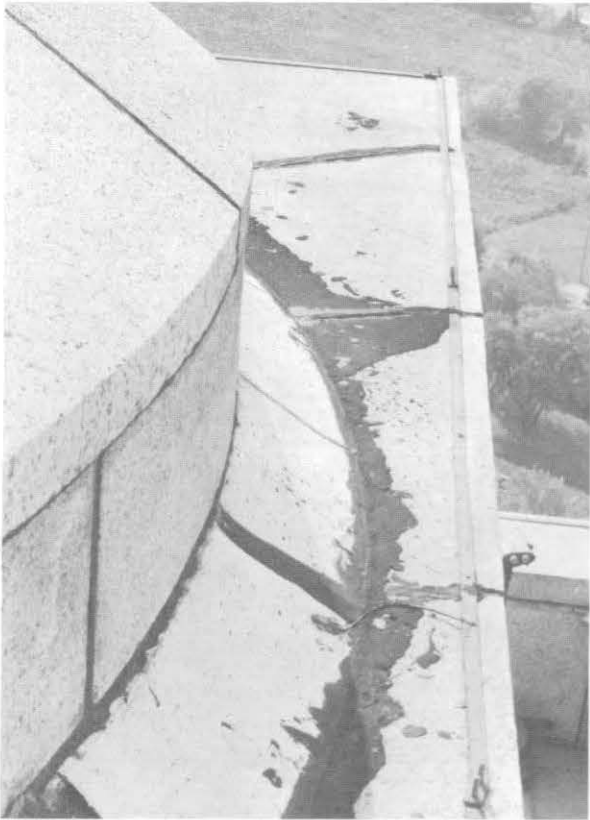
ILLUSTRATION 244. Typical (unacceptable) grounding of lantern base.

ILLUSTRATION 245. Grounding "down" conductors should be a bolted or cadwell type connection to structural steel inside lantern leg.

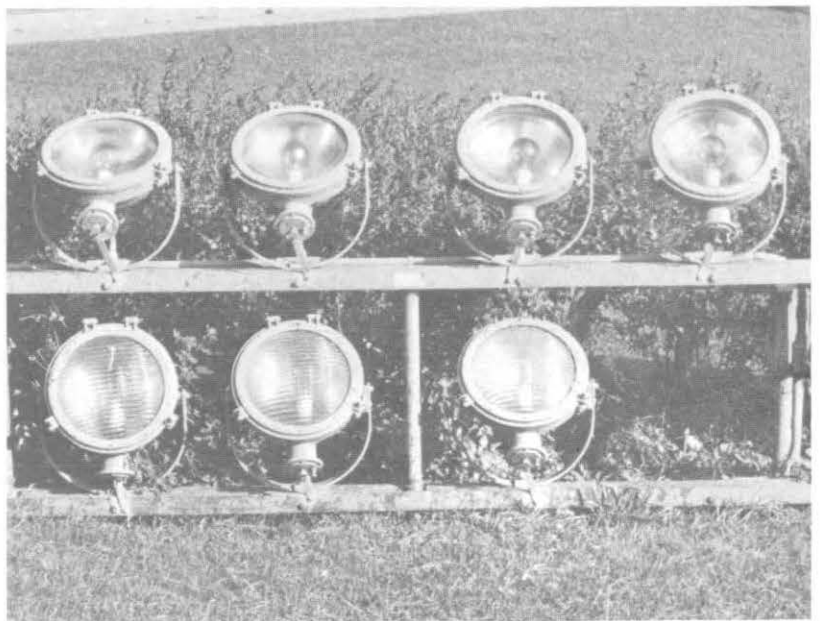
The original lenses of the fixtures are the clear type, but due to the unavailability of parts, twelve of the thirty-four lenses are replacement types that do not match the original (249, 250). Three of twelve are the diffused-type lens, the others are the coarse-stippled type. Six of the original clear lenses are cracked or broken, and one of the replacement coarse-stippled type lenses is cracked. Cracks in the lenses allow moisture to collect inside, and the water vapors tend to cause early lamp failures. In summary, of the 34 lenses in use, 18 are unsuitable for functional or historic purposes (250) either because they are not the original type or because they are cracked and broken. Since replacement lenses are not available, a mold would have to be made at a cost of approximately \$5,000 (see Ground Floodlights cost estimate at end of this chapter) to produce new lenses. This mold would be the property of the National Park Service and would have to be stored and shipped by the National Park Service to a lens manufacturer whenever new lenses were needed.

ILLUSTRATION 249. Northeast floodlight bank. Note stippled replacement lenses in bottom row.

To retain the existing banks of floodlights for present and future lighting of the Memorial, certain repairs and alterations will have to be made to insure safe and reliable operation. The fixtures themselves require complete refurbishing. The aluminum housings should be dismantled and thoroughly cleaned, possibly by sandblasting, and all adjustment screws and fasteners repaired or

replaced for proper lamp-to-reflector adjustment. The fabricated steel support frames will have to be raised to keep water out of the lower rows of fixtures and the circuit breaker boxes. The circuit breaker boxes are in poor condition and do not serve to safely protect the branch conductors (248). They should be replaced. A mold will have to be specially made to produce lenses for present and future use. It should be noted that any replacement part necessary for refurbishing or routine maintenance of the fixture will have to be specially made since manufacturer's replacement parts are no longer available. To minimize damage caused by vandalism and/or normal tourist use, a fence should be installed around each bank of floodlights.

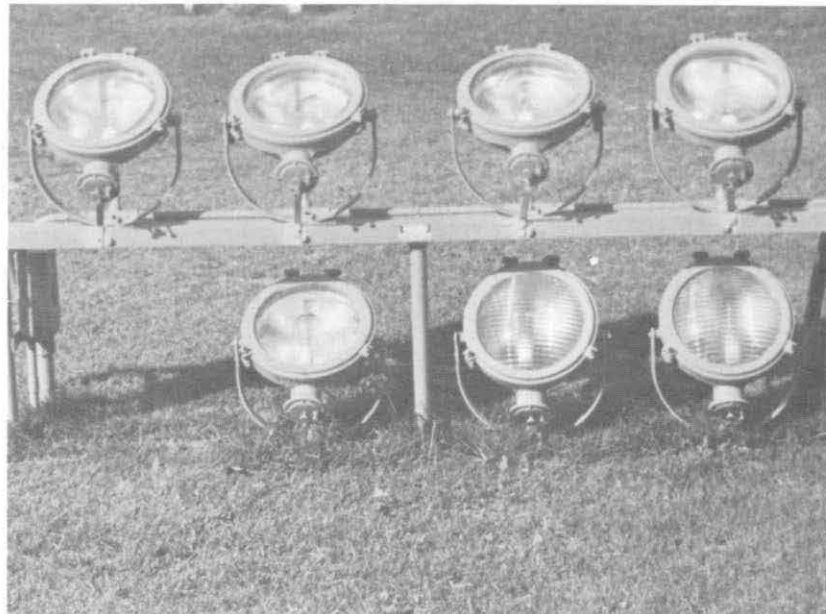
ILLUSTRATION 250. Northwest floodlight bank. Note cracked lens at top row, second from right, and stippled replacement type lenses bottom row.

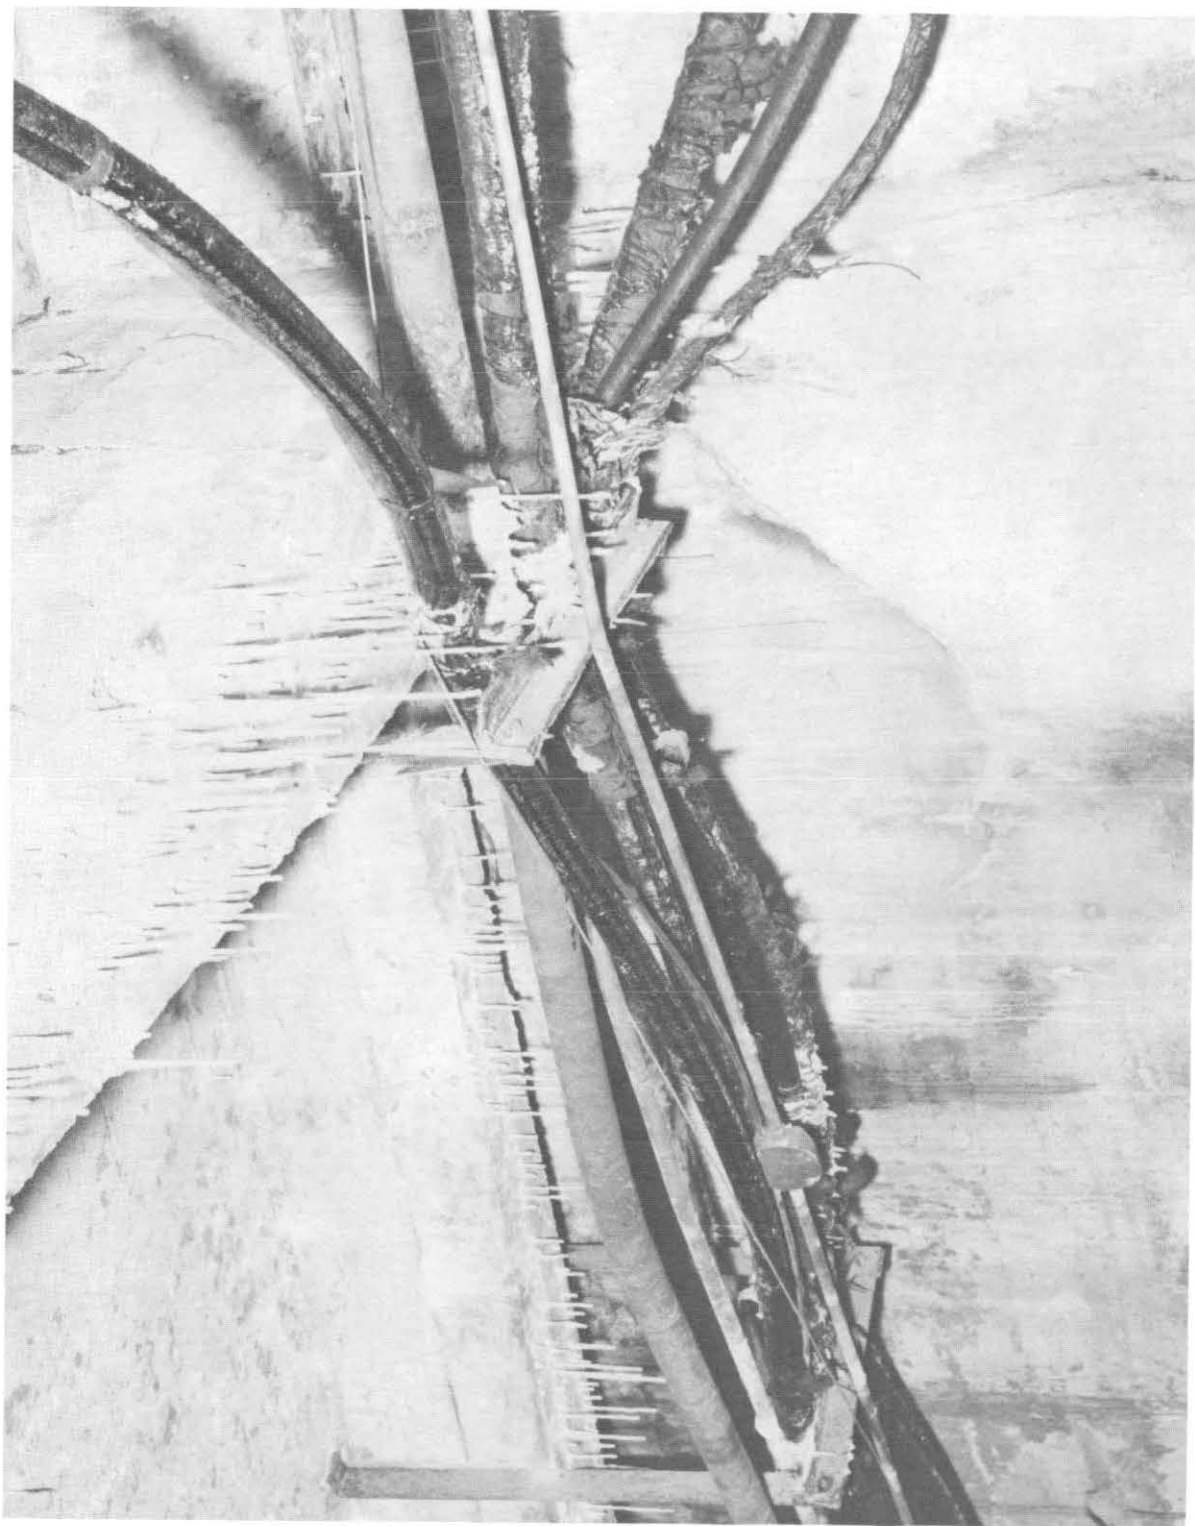
9c. BASEMENT CABLE See 9a.
