december 1976

## PERRY'S VICTORY AND INTERNATIONAL PEACE MEMORIAL MEMORIAL COLUMN AND PLAZAS

Historic Structure Report  
Memorial Column and Plazas  
Administrative and Architectural  
Data  
Perry's Victory and International  
Peace Memorial  
Ohio

DALTON-DALTON-LITTLE-NEWPORT

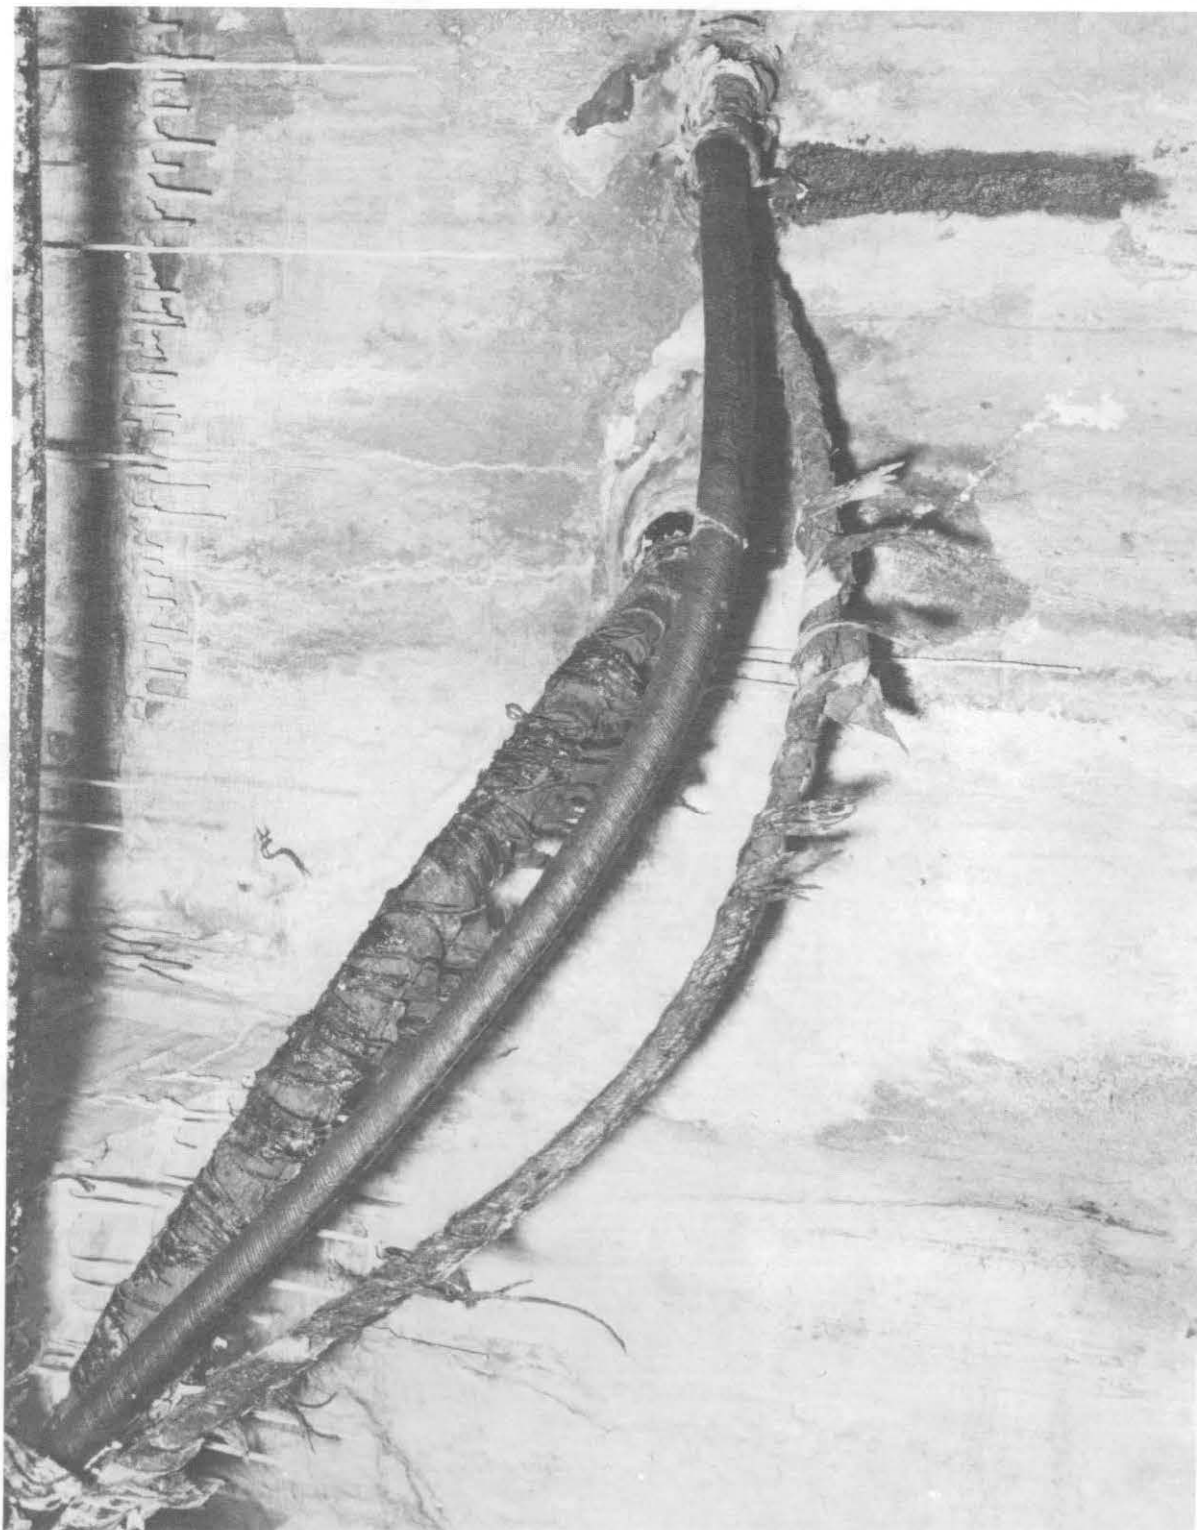
9d. BASEMENT CABLE See 9a.

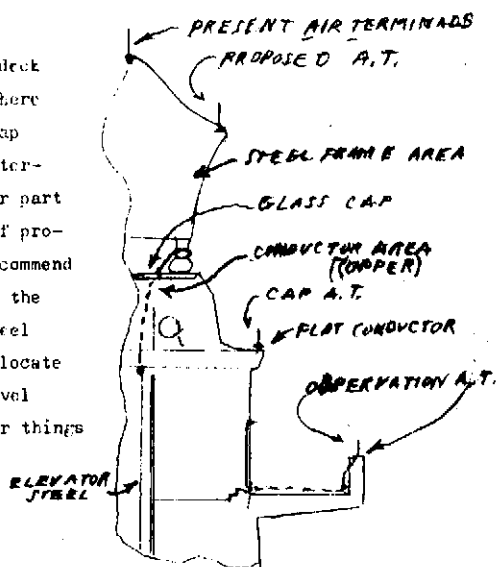
1. There are air terminals at the observation deck level that are broken and need renewing. There are air terminals right above this at the cap level which are in place. There are 4 air terminals located at the very top, at the upper part of the skylight. Due to lack of any cone of protection coverage at this height, I would recommend air terminals around the base projection of the skylight. These could be mounted to the steel framework in this area. You may want to relocate the air terminal on the observation deck level at a different spot to take safety and other things into consideration.

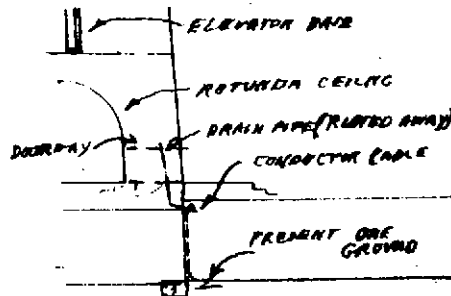
3. Ground location. This was visually checked and the conductor cable from the rusted away soil pipe down the wall to the present ground is apparently still in the same condition as when it was installed. There should be 2 down conductors from the elevator steel according to code requirements and this was not found.
