# Montgomery Co. Jail & Sheriff's Residence

## Condition Assessment and Treatment Plan

July 31, 2026

Seven Generations AE, Part of the Bodwé Professional Services Group

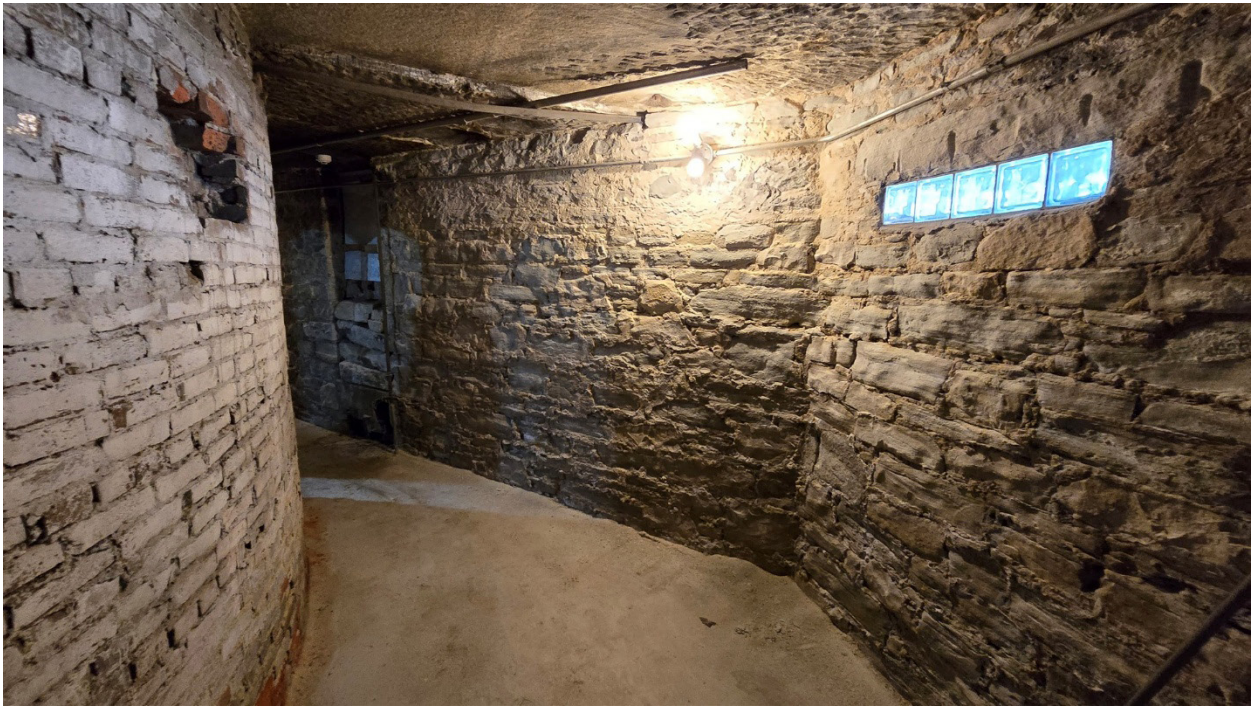
**Figure 2.11:** The rough limestone foundation of the jail.

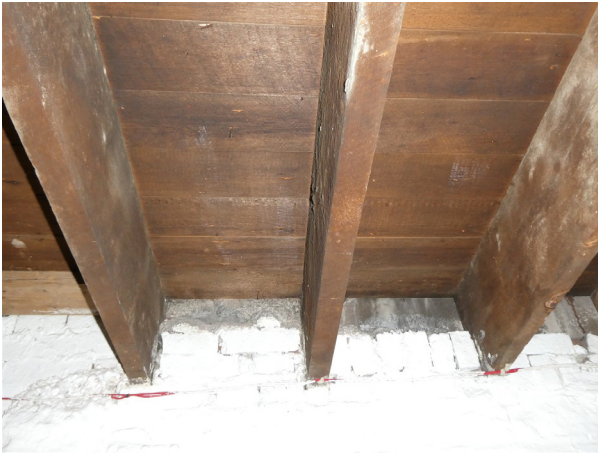
- Wood joists and decking were observed within multiple locations from the basement level. Much of the framing on the remaining floor levels were covered with finish materials and were not observed.
- Joists were typically measured to be made of nominal 2x10" lumber. Cross bracing was installed within the first-floor framing.
  - Minor: Joists and decking were typically found to be in good condition where they were visible.
- The basement of the rotary jail is finished with a concrete floor. The floor exhibits cracking as would be expected for a floor of its age.
  - Minor: The concrete flooring was found to be in reasonably good condition for its age.

**Figure 2.12:** The wood framing was visible in several locations in the basement. The wood joists are typically pocketed by the masonry walls.

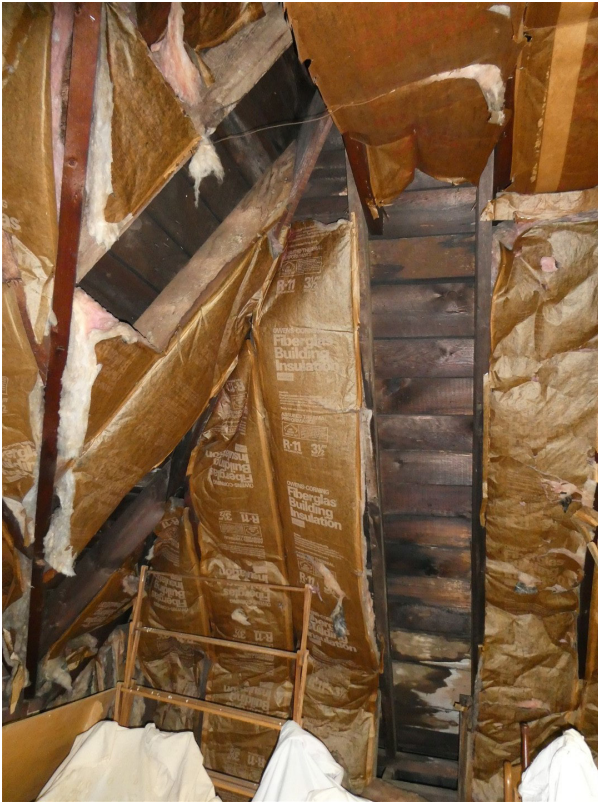
**Figure 2.15:** Typical view of the roof framing as seen from the attic level.

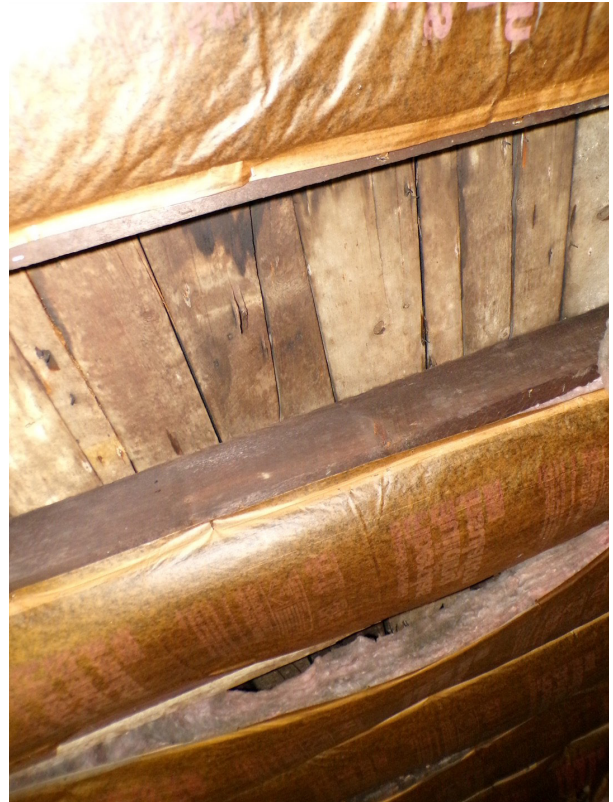
**Figure 2.16:** Board sheathing was used beneath the roofing.

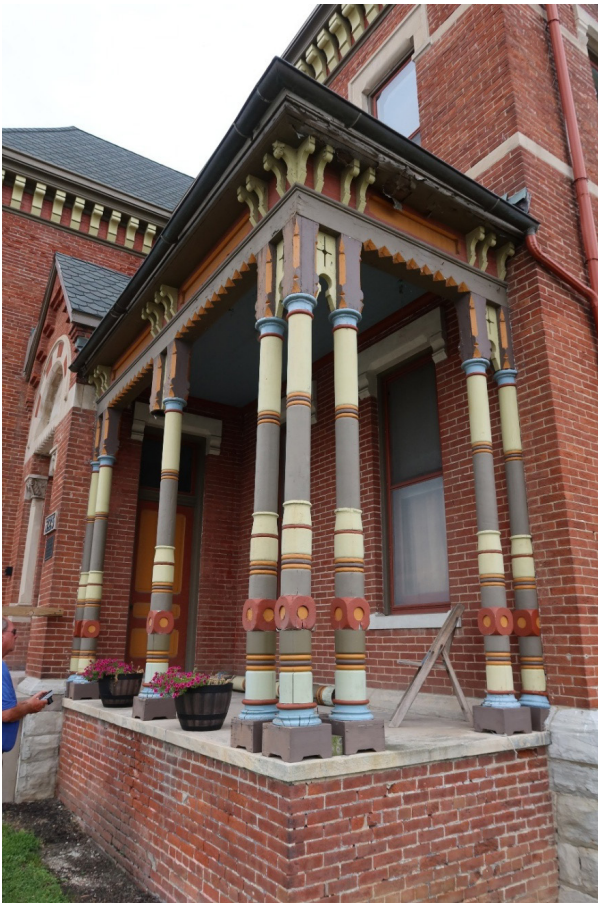
**Figure 2.17:** Historic wood front porch.

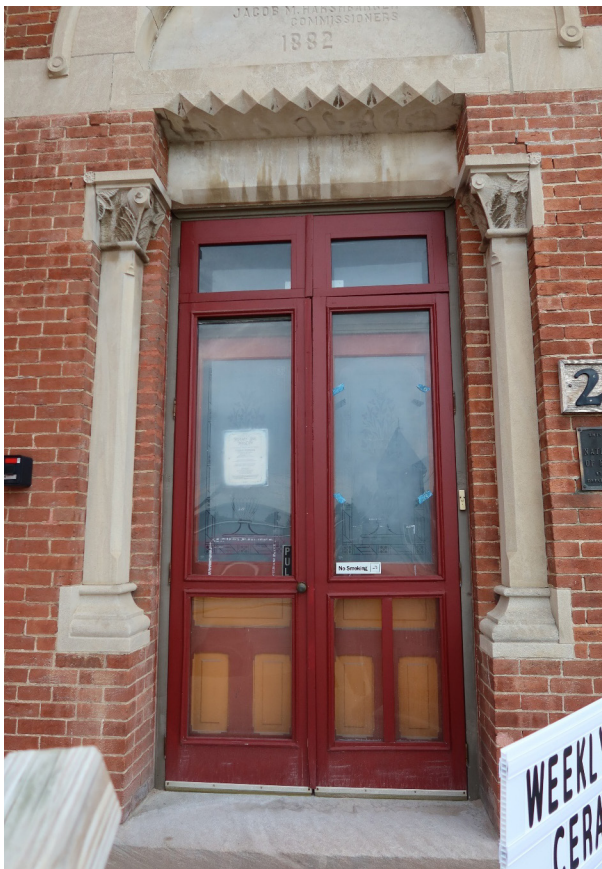
**Figure 2.36:** Front doors based on original doors with wood storm doors.

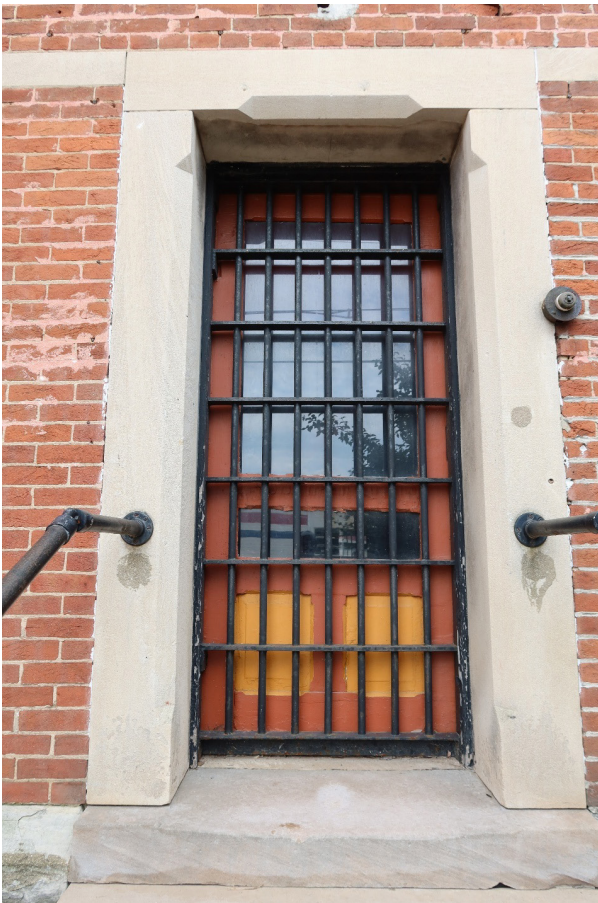
**Figure 2.39:** Guard room door with exterior bars.

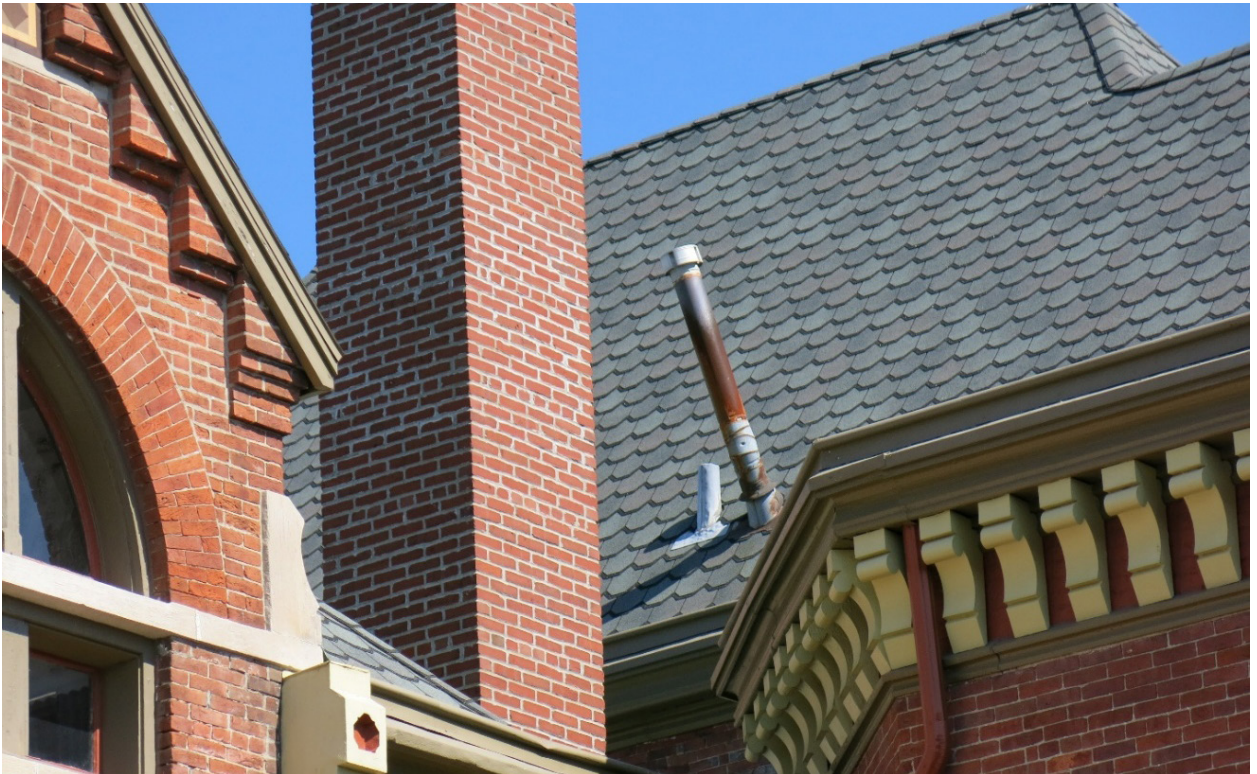
**Figure 2.45:** West face of house roof showing metal chimney.

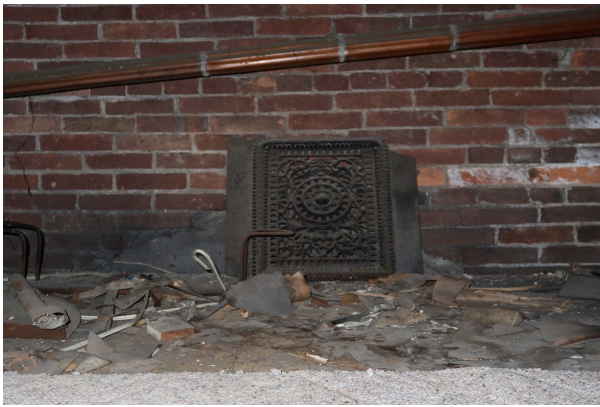
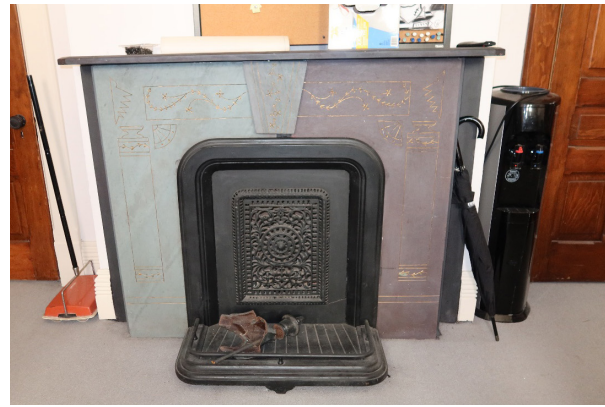
**Figure A.1:** Cast iron summer cover (left) stored in the residence vestibule's attic probably came from the original parlor fireplace. It matches the cover still in place in the southeast bedroom (right). The sitting room and north bedroom have summer covers of a corresponding design but a different shape.

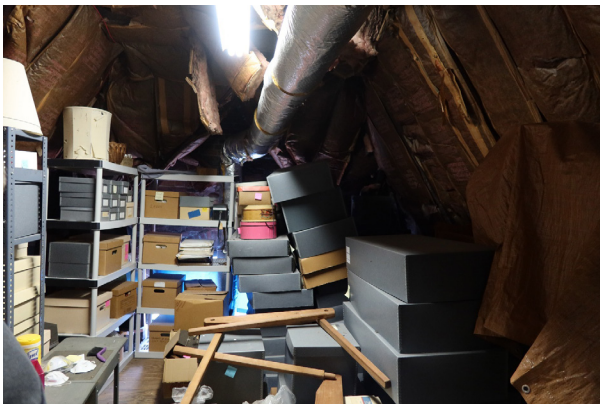
**Figure A.2:** A prior volunteer curator moved many artifacts to the unconditioned attic in preparation for collections storage improvements that never occurred. This is an unsuitable environment for artifact storage. Attic temperature was 92 degrees Fahrenheit at 10:00 a.m. during site visit.

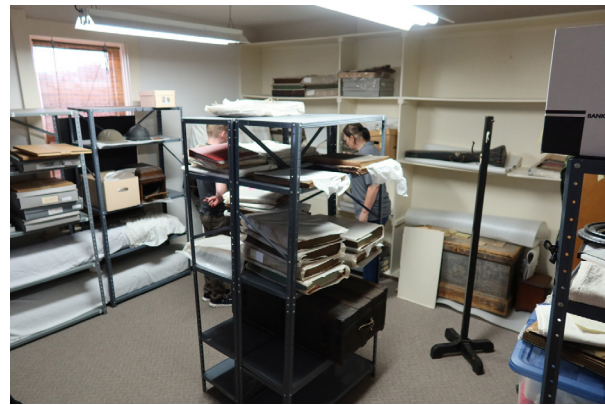
**Figure A.3:** Artifact storage in a semi-conditioned bedroom. The museum's collection includes many artifacts unrelated to its mission. Staff lack capacity to weed the collection. An agreement with the Carnegie Museum of Montgomery County and Crawfordsville District Public Library could transfer relevant objects to appropriate institutions and free up space in the building.

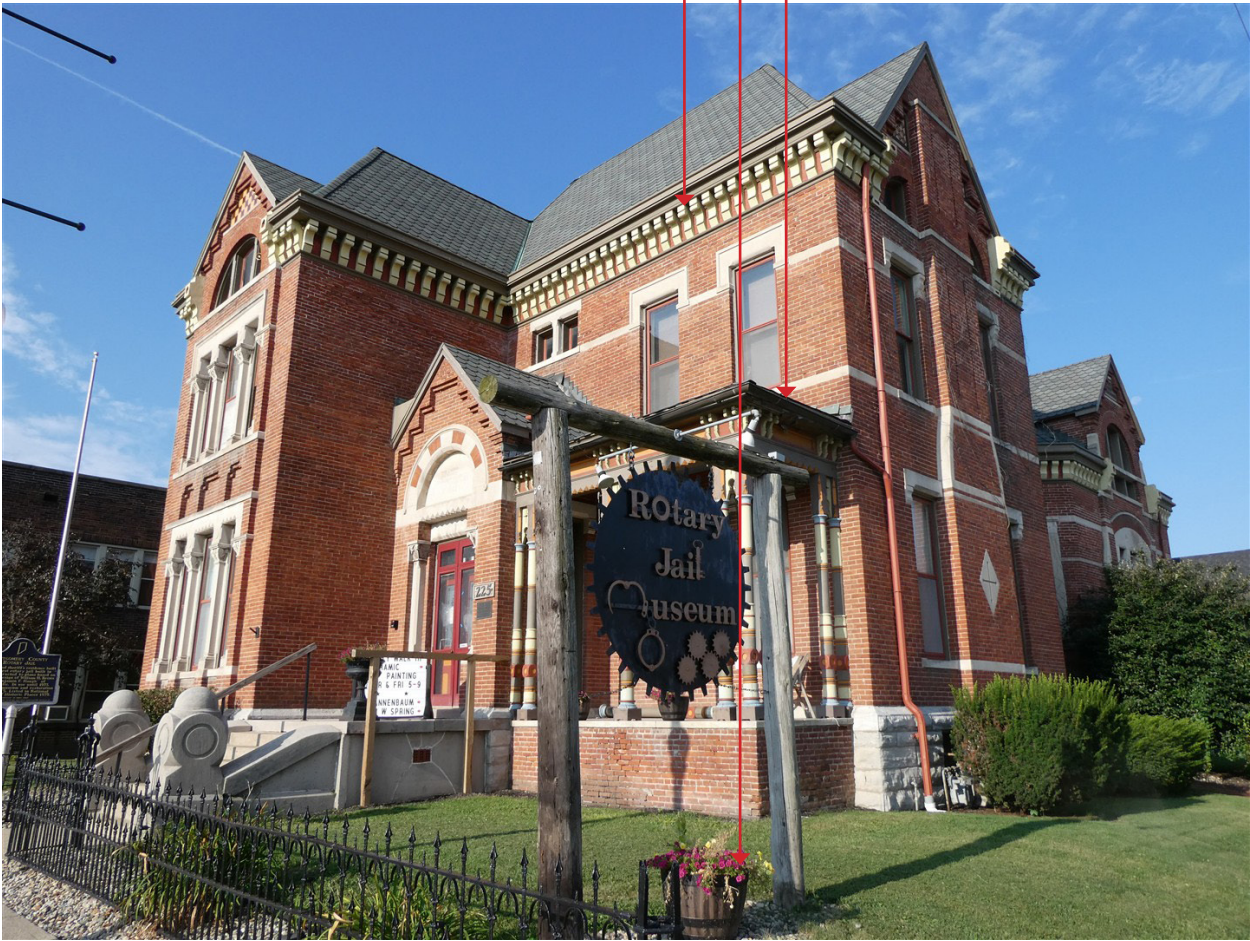
**NORTH ELEVATION**

**Figure D.2:** The Montgomery County Jail / Rotary Jail Museum in Crawfordsville, Indiana, facing southwest.

Repair or replace damaged cap of  
north fencepost.

Repair leaking gutter.

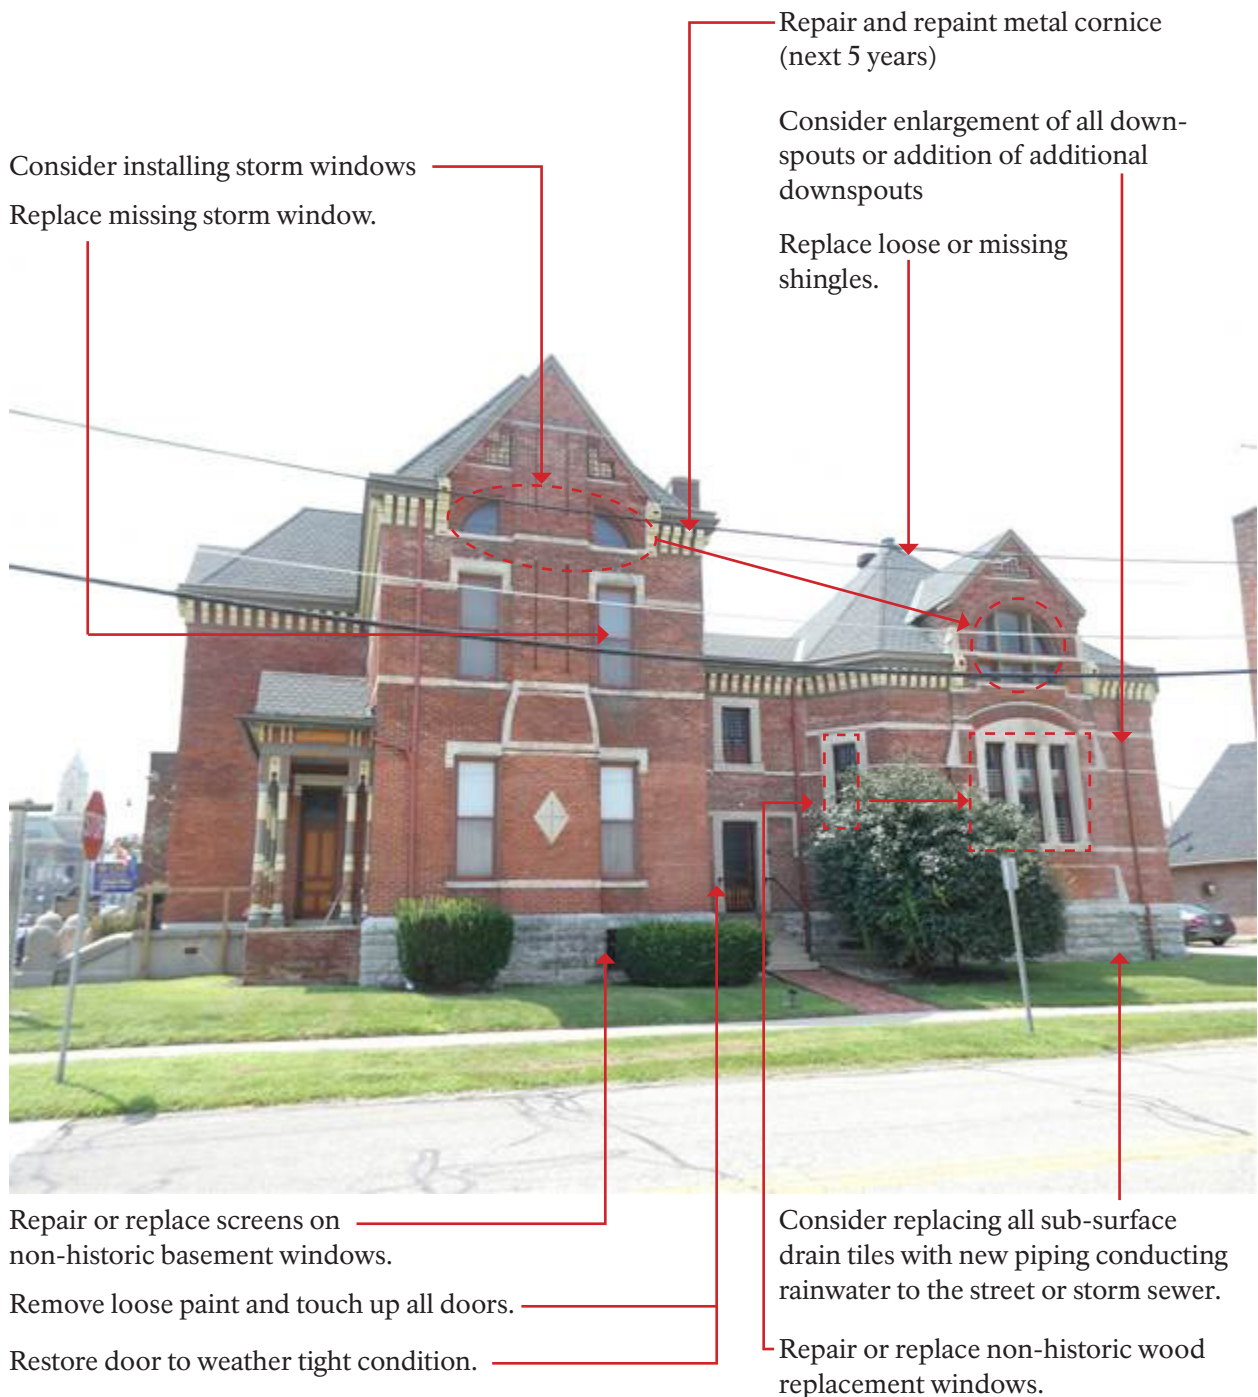
## WEST ELEVATION

**Figure D.3:** The Montgomery County Jail / Rotary Jail Museum in Crawfordsville, Indiana, facing south.

Repair and repaint metal cornice  
(next 5 years)

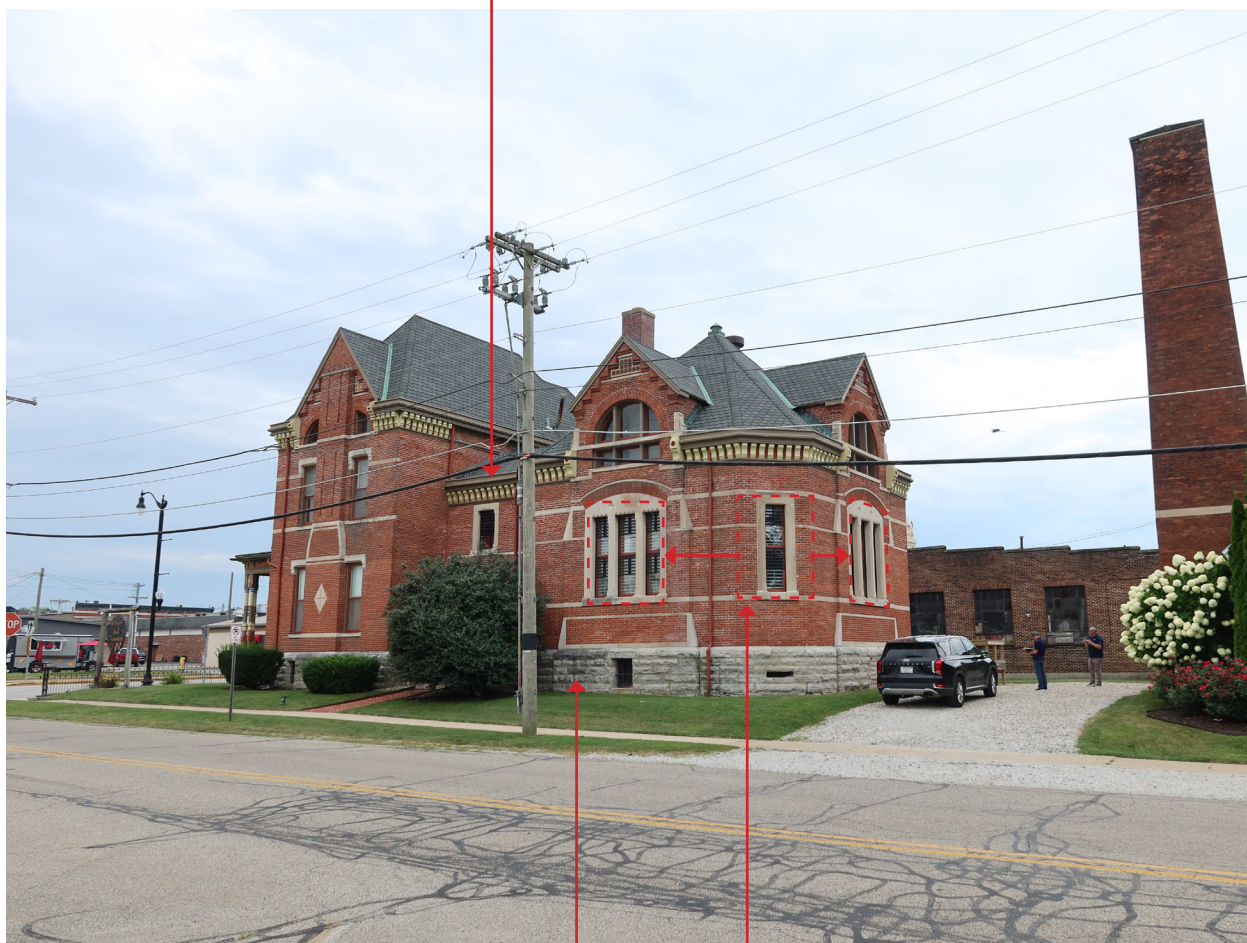
## NORTHWEST ELEVATION

**Figure D.4:** The Montgomery County Jail / Rotary Jail Museum in Crawfordsville, Indiana, facing southeast.

At interior basement walls of cellblock, repoint failed mortar joints. Construct short concrete wall to supplement eroded brick masonry in the circular wall beneath the rotary cellblock.

Repair or replace non-historic wood replacement windows.

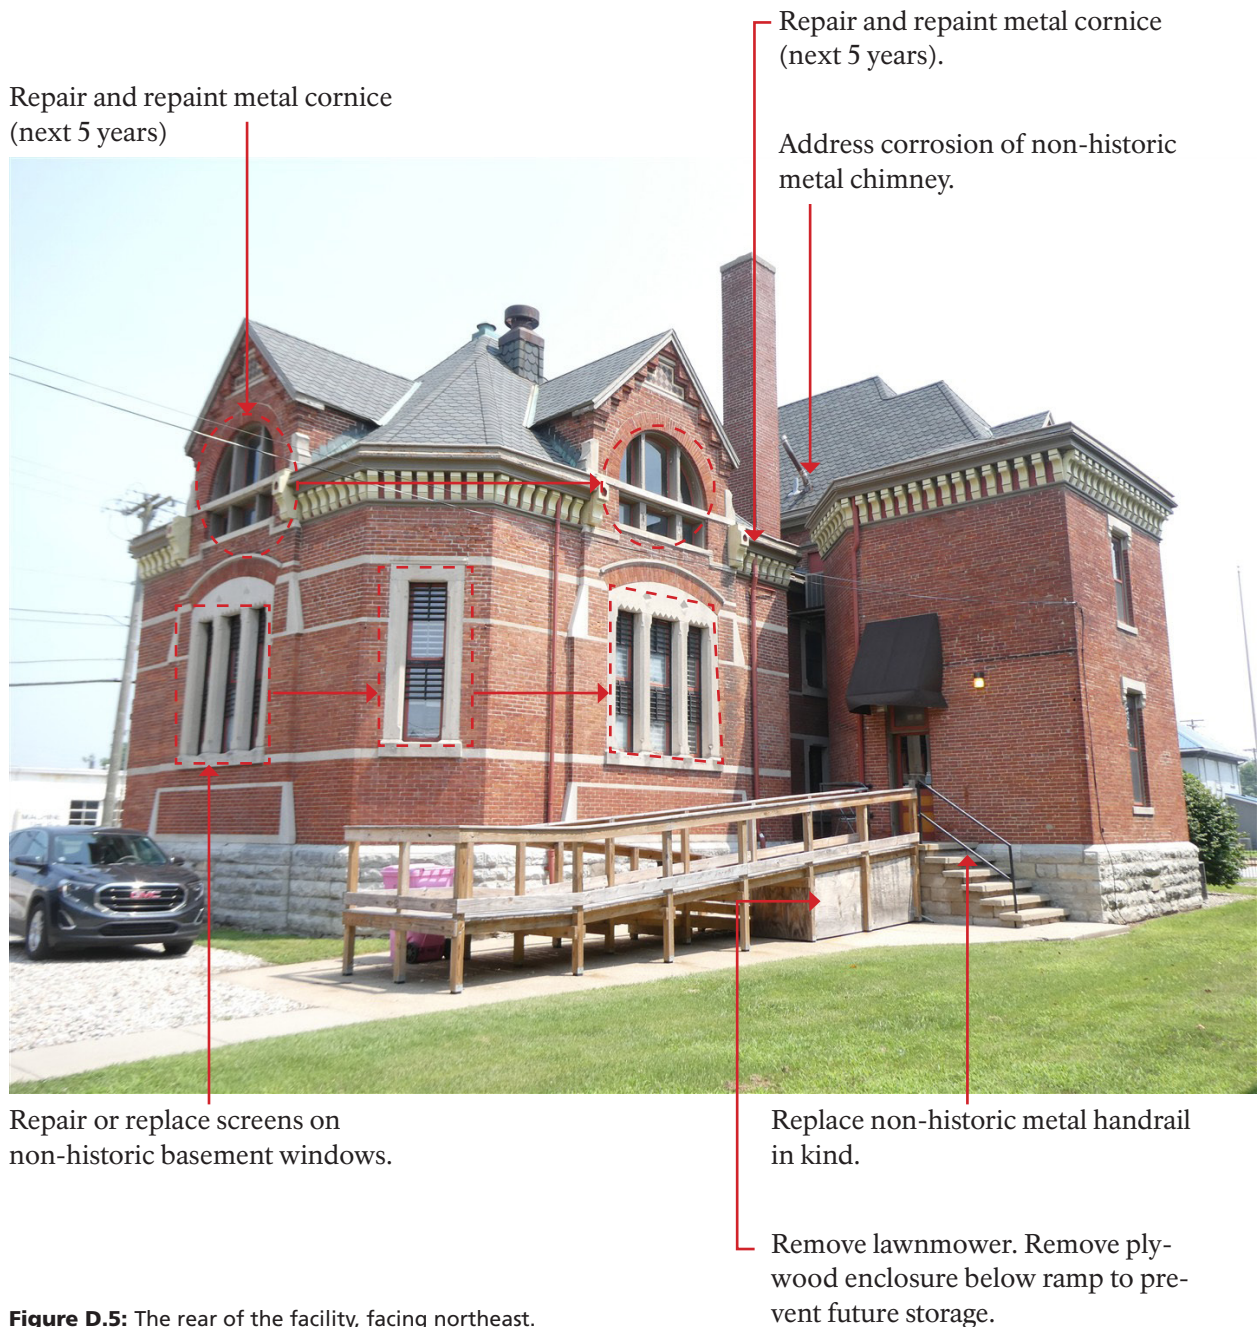
## SOUTHEAST ELEVATION

**Figure D.5:** The rear of the facility, facing northeast.

Remove bird's nest, close open joint in cornice bracket.

Consider installing storm windows.
