## CULTURAL LANDSCAPE REPORT

### PRAIRIE CREEK FISH HATCHERY

REDWOOD NATIONAL AND STATE PARKS , CALIFORNIA

JUNE 2020

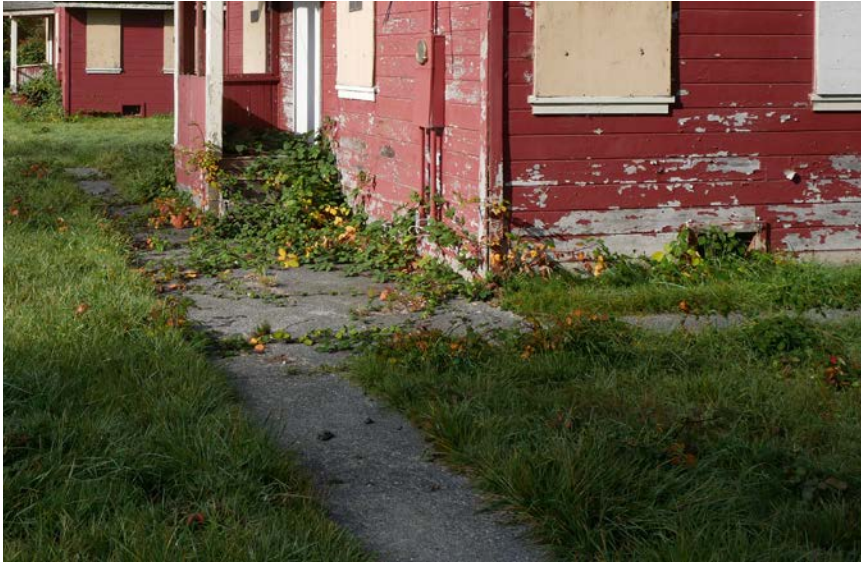
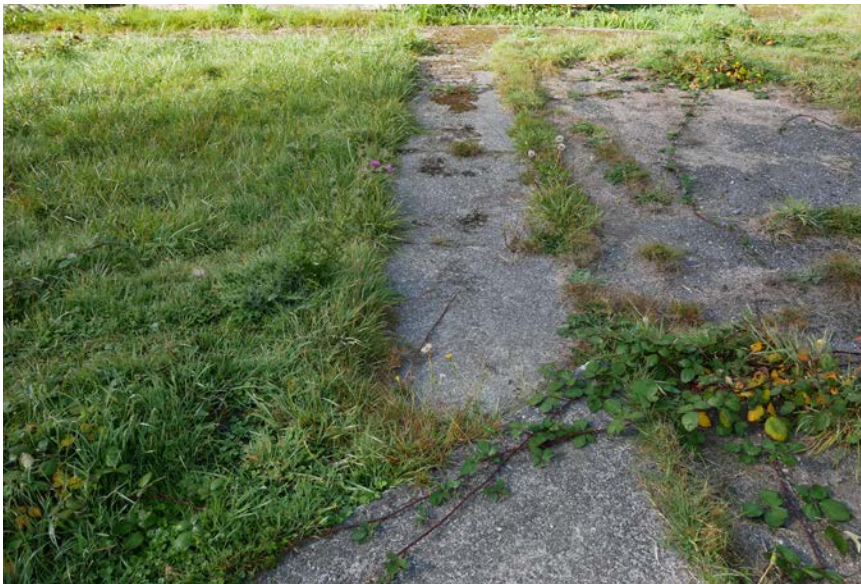
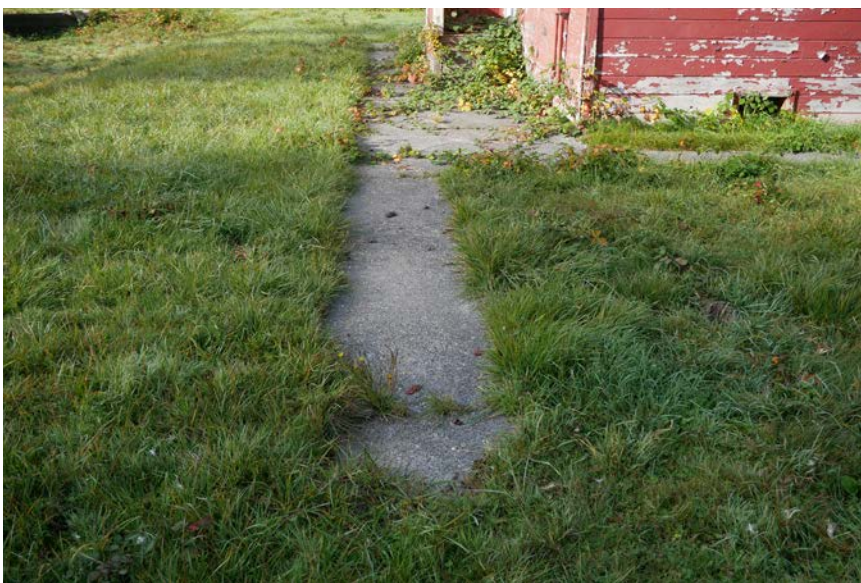
**Figure 43 :** Concrete sidewalk South of Assistant's House. (CLRG, 2019).

**Figure 44 :** Concrete sidewalk East of Assistant's House (CLRG, 2019)

**Figure 45 :** Detail of concrete sidewalk South of Assistant's House (CLRG, 2019).

Concrete sidewalks were located both north and south of the houses, as well as on the east side of each house, see Figure 43, Figure 44 and Figure 45, right. Although 18-inch wide straight sidewalks remain in place today in these locations, they were likely reconstructed when the raised rectangular tanks were built. This conclusion is based on observation during the 2011 CLI fieldwork, because concrete used in the sidewalks more closely matches that used in the tanks.

In addition, about 30 feet of sidewalk between the Superintendent's House and the Assistant Superintendent's house is missing. This may have happened at reconstruction or a later time. However, this is only a

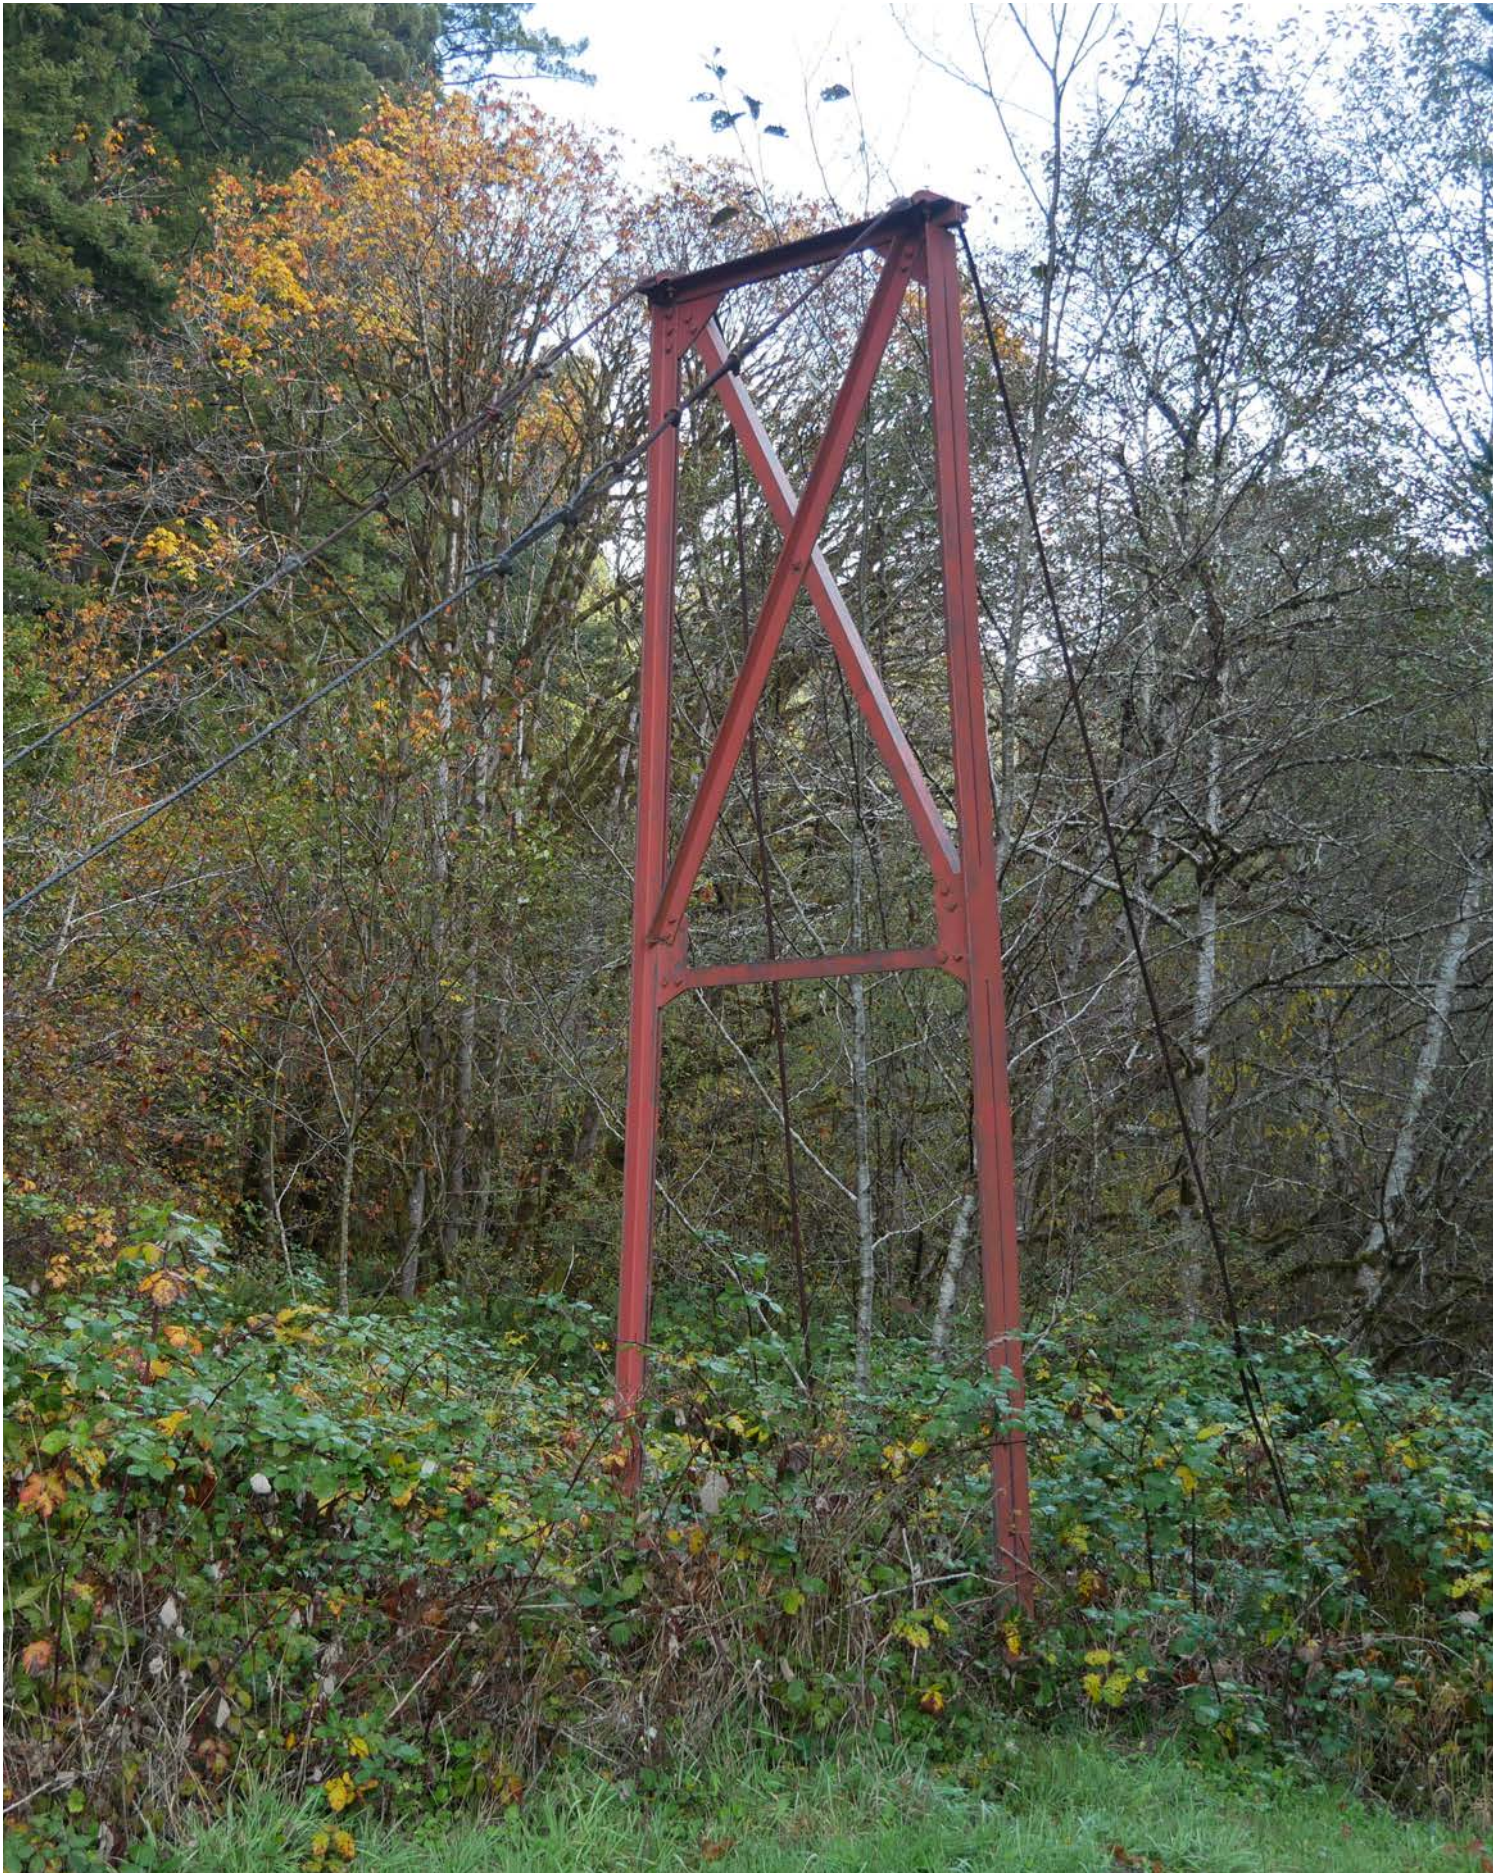
**Figure 46 :** Tower to support pipeline on north bank of Lost Man Creek. Tower on south bank, now no longer upright, contributing. (CLRG, 2019).

The structure, which originally served to carry the pipeline across Lost Man Creek, along with a wooden walkway atop the pipeline, is no longer intact. This structure was part of the original footpath from the Shed to the upper dam. It consists of a small suspension bridge with a steel tower on either side of the creek and steel cables. The towers are rectangular frames braced with crossing diagonal members in an X shape. Suspended from the cables are the pipeline and the wooden walk above it. The pipeline tower on the northside of Lost Man Creek exists upright in its original position, Figure 46, however, the tower on the south bank of Lost Man Creek has fallen over and the pipeline and wooden walk no longer exist.

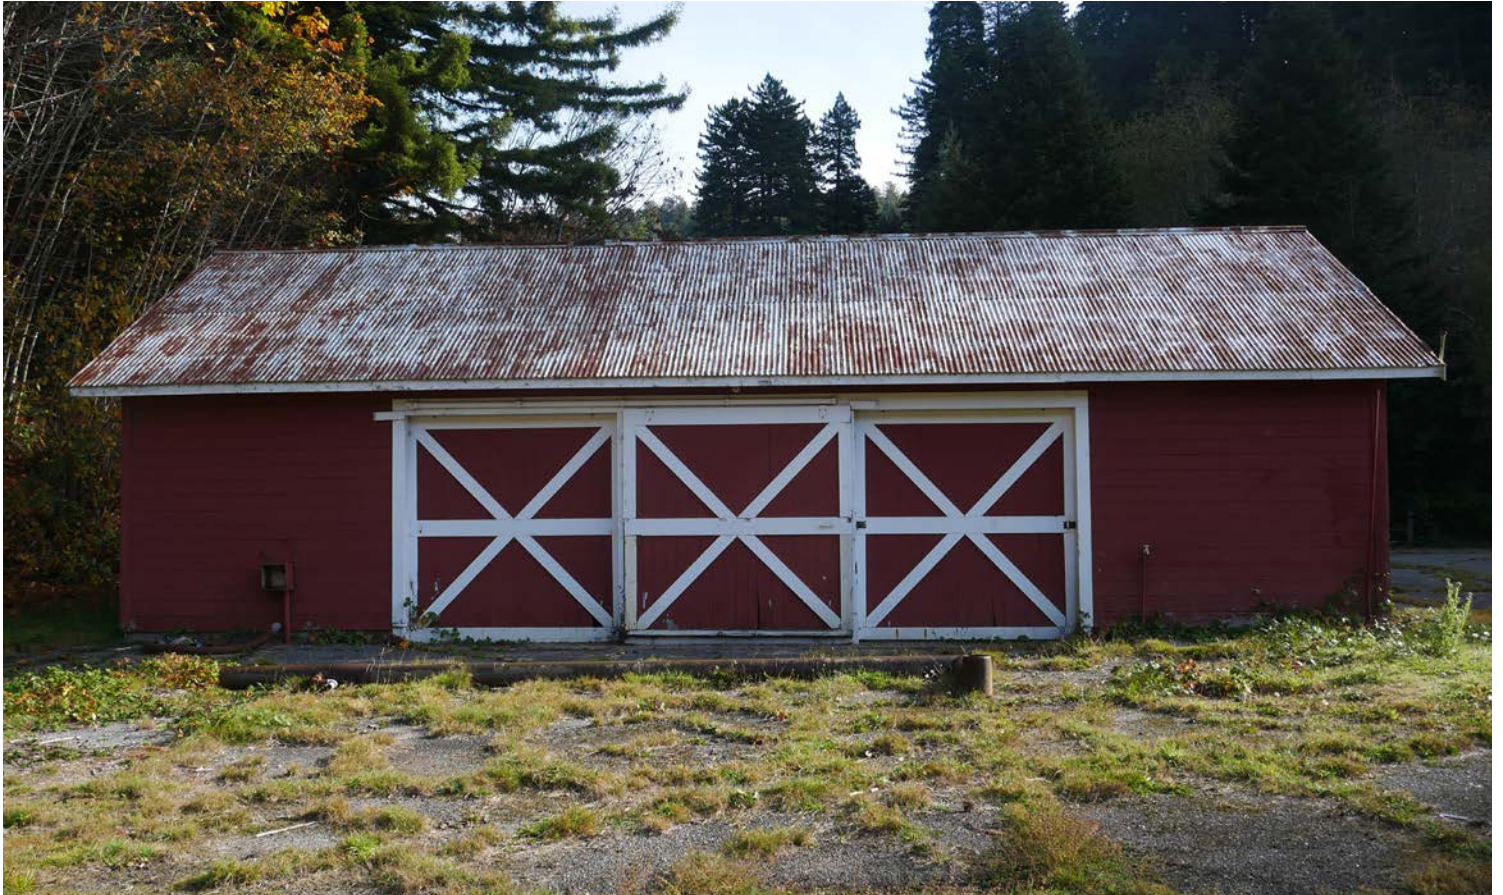
This building plays an important visual role in the complex due to its location closing the east end of the U-plan, and the strong geometry of its form and detailing, see Figure 50. It is a one-story side-gabled roof building, rectangular

**Figure 50 :** Garage-shop, contributing (CLRG, 2019)

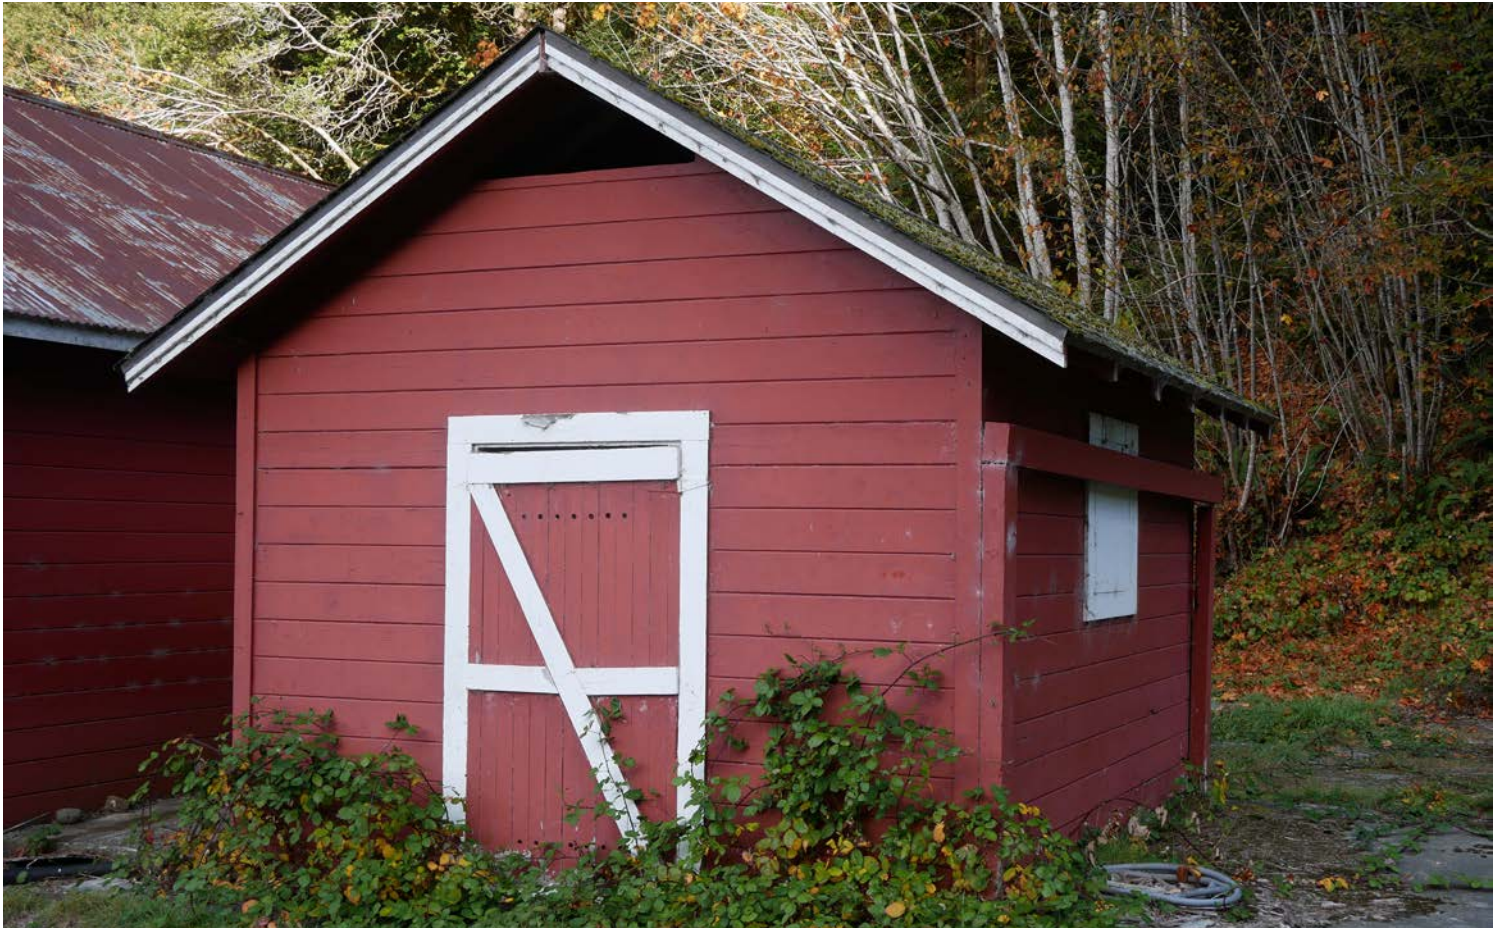
**Figure 51 :** Shed, contributing (CLRG, 2019)

A small rectangular one-story building (14 feet 6 inches by 12 feet), oriented on a north-south axis, positioned just east of the garage-shop, Figure 51. The shed is a simple asphalt shingled front-gabled roof structure built of wood stud (light) frame construction on a concrete foundation, it is clad in 7-inch tongue and groove V-joint siding with 1x4 inch corner lap-joint trim. Exterior openings are trimmed out with plain boards. The medium pitch roof has overhanging open eaves with exposed plain cut rafter ends with no fascia; the gable end rake has a medium two-part bargeboard detail. The south gable has an opening for an infill vent, similar in size to those still extant at the residences – although no vent remains. The single interior space is lit by awning type windows, one each centered in the east and west side walls. A diagonally braced site-built wood plank door mounted on surface mounted strap hinges provides entry to the one room space. No gutters or downspouts are evident. A simple post and beam timber frame stands at the east elevation; early photographs indicate some sort of lean-to shelter at the east side, whether canvas or a built roof is unknown. The interior was not visually accessible for inspection.

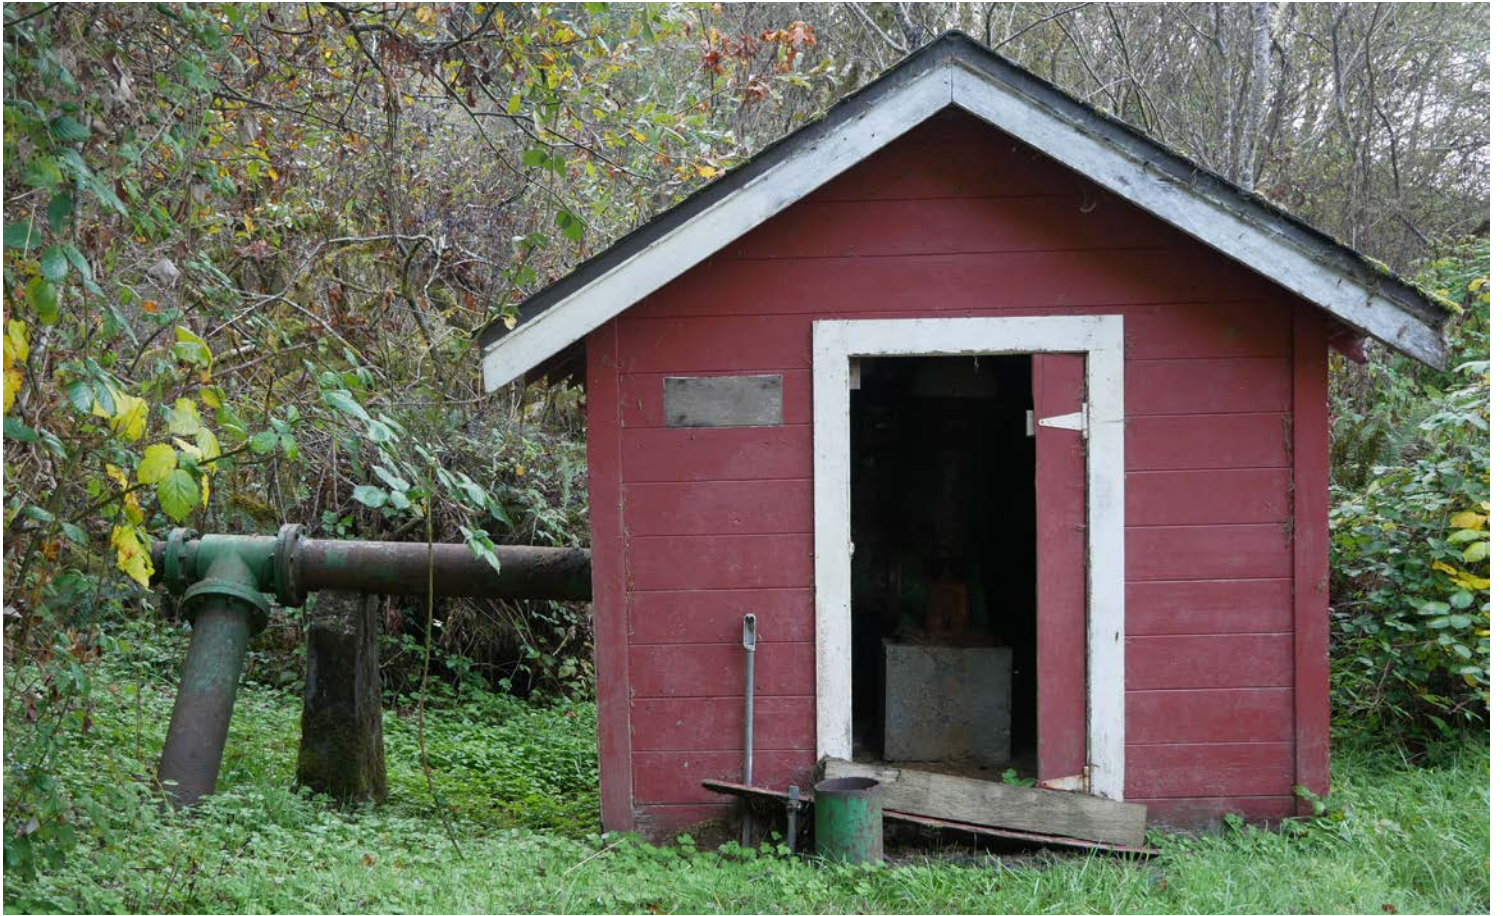
**Figure 52 :** Pump House (1962), near the south gate, outside of historic district boundary (CLRG, 2019)

in the 1960s on the north edge of Lost Man Creek, Figure 52. This is a stud-frame structure on a concrete perimeter foundation. It is clad in 7 ¼ inch tongue and groove V-joint siding with 1x4 corner trim; exterior openings are trimmed out with plain boards. It has a front-gabled roof with overhanging eaves and exposed rafters. The roof is clad in asphalt shingles. The building is ventilated by louvered openings on each side and a roof monitor. It has a wood door and no windows. There is a pipe running between the southeast side of the building and the ground above the creek. No gutters or downspouts are evident.

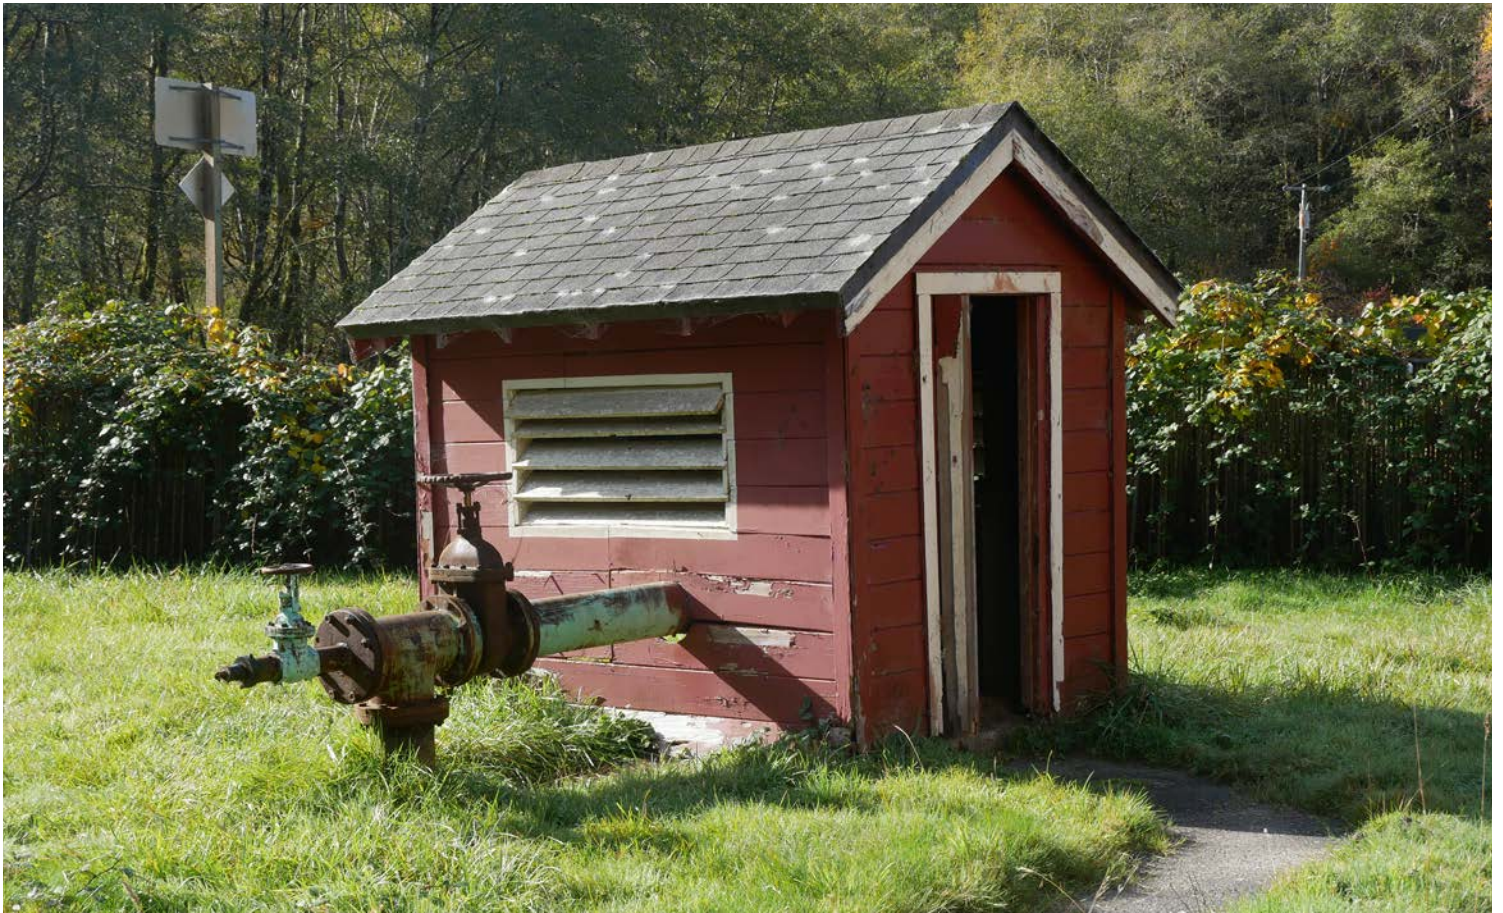
**Figure 53 :** Pump House (1971) south of Superintendent's House, outside of historic district boundary (CLRG, 2019)

This is a small rectangular one-story building (6 feet 3 inches by 8 feet 2 inches) oriented on a north-south axis, and located south of the superintendent's residence outside the boundaries of the parcel, Figure 53. The simple asphalt shingled front-gabled roof structure is built of wood stud (light) frame construction on a concrete slab foundation; clad in 7-inch tongue and groove V-joint siding with 1x4 corner lap-joint trim, it has a large wood louvered vents positioned high on the east and the west sidewalls for ventilation. Exterior openings are trimmed out with plain boards; the interior is unfinished with exposed framing. The gable roof overhanging eaves are open with exposed plain cut rafter tails (no fascia); gable end raked eaves have a large scale plain fascia. Both doors have been damaged and are missing. Inside is a 40-horsepower Holloshaft® Pump Motor. No gutters or downspouts are evident.

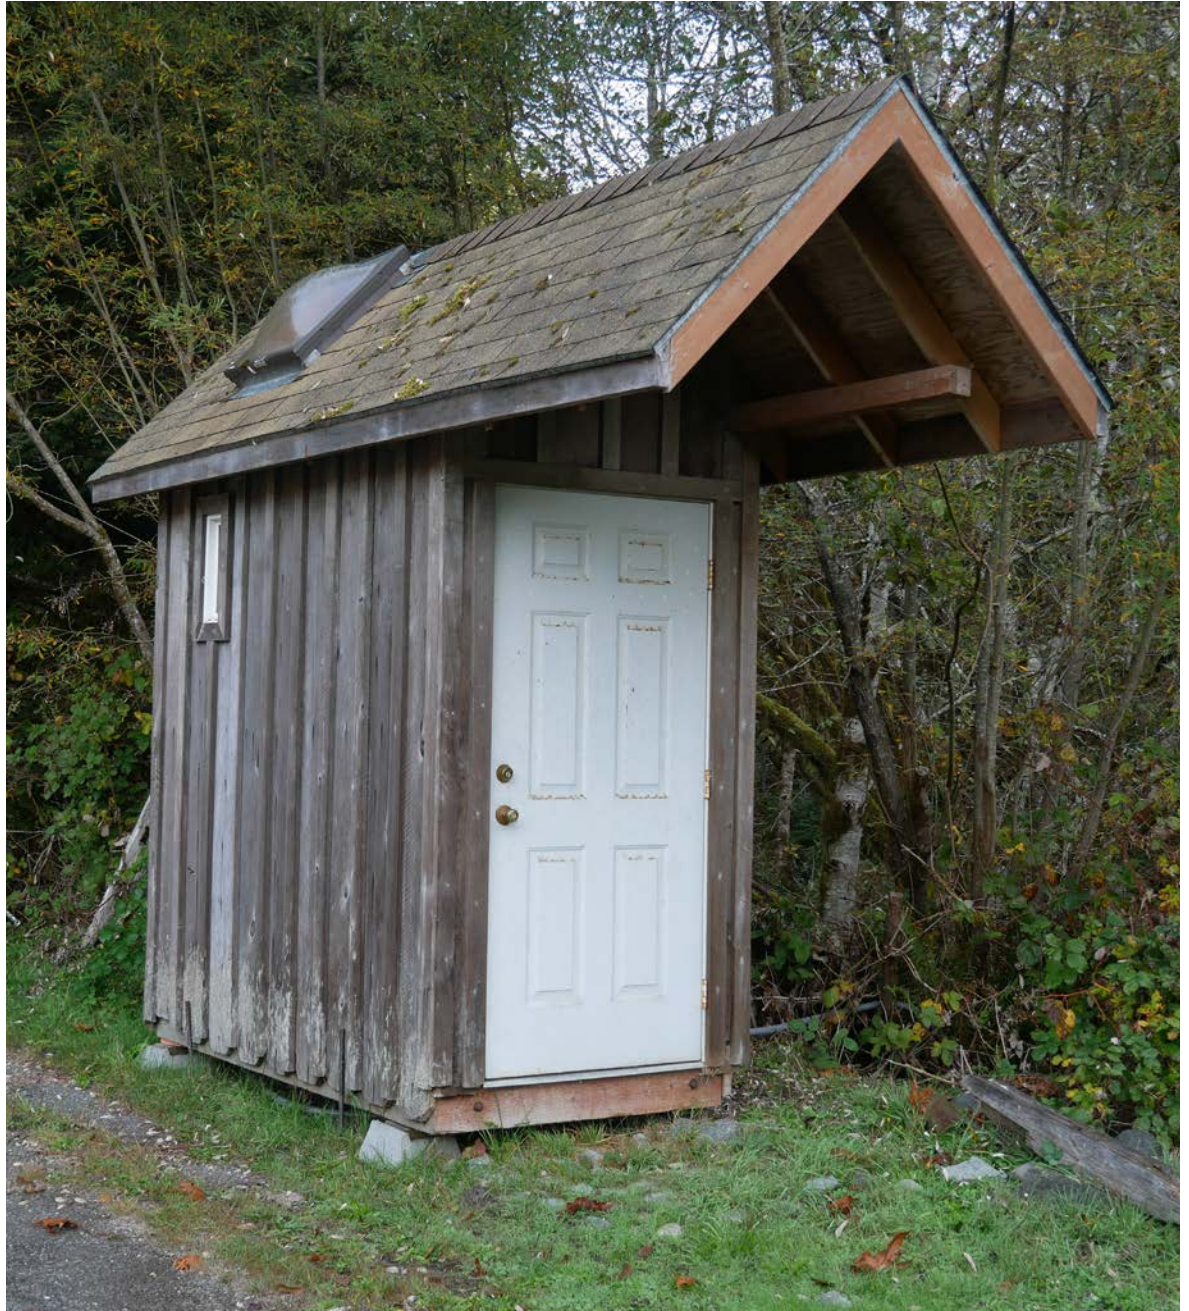
This is a small rectangular one-story pitched-roof gauging station with board and batten siding, see Figure 54 and Figure 55. The gauging station is oriented along the north bank of Dead Man Creek south of the Historic District Boundary. The structure is used for Dead Man Creek data collection by NPS.

**Figure 54 :** Gauging Station, view northeast, non-contributing. (CLRG,2019)

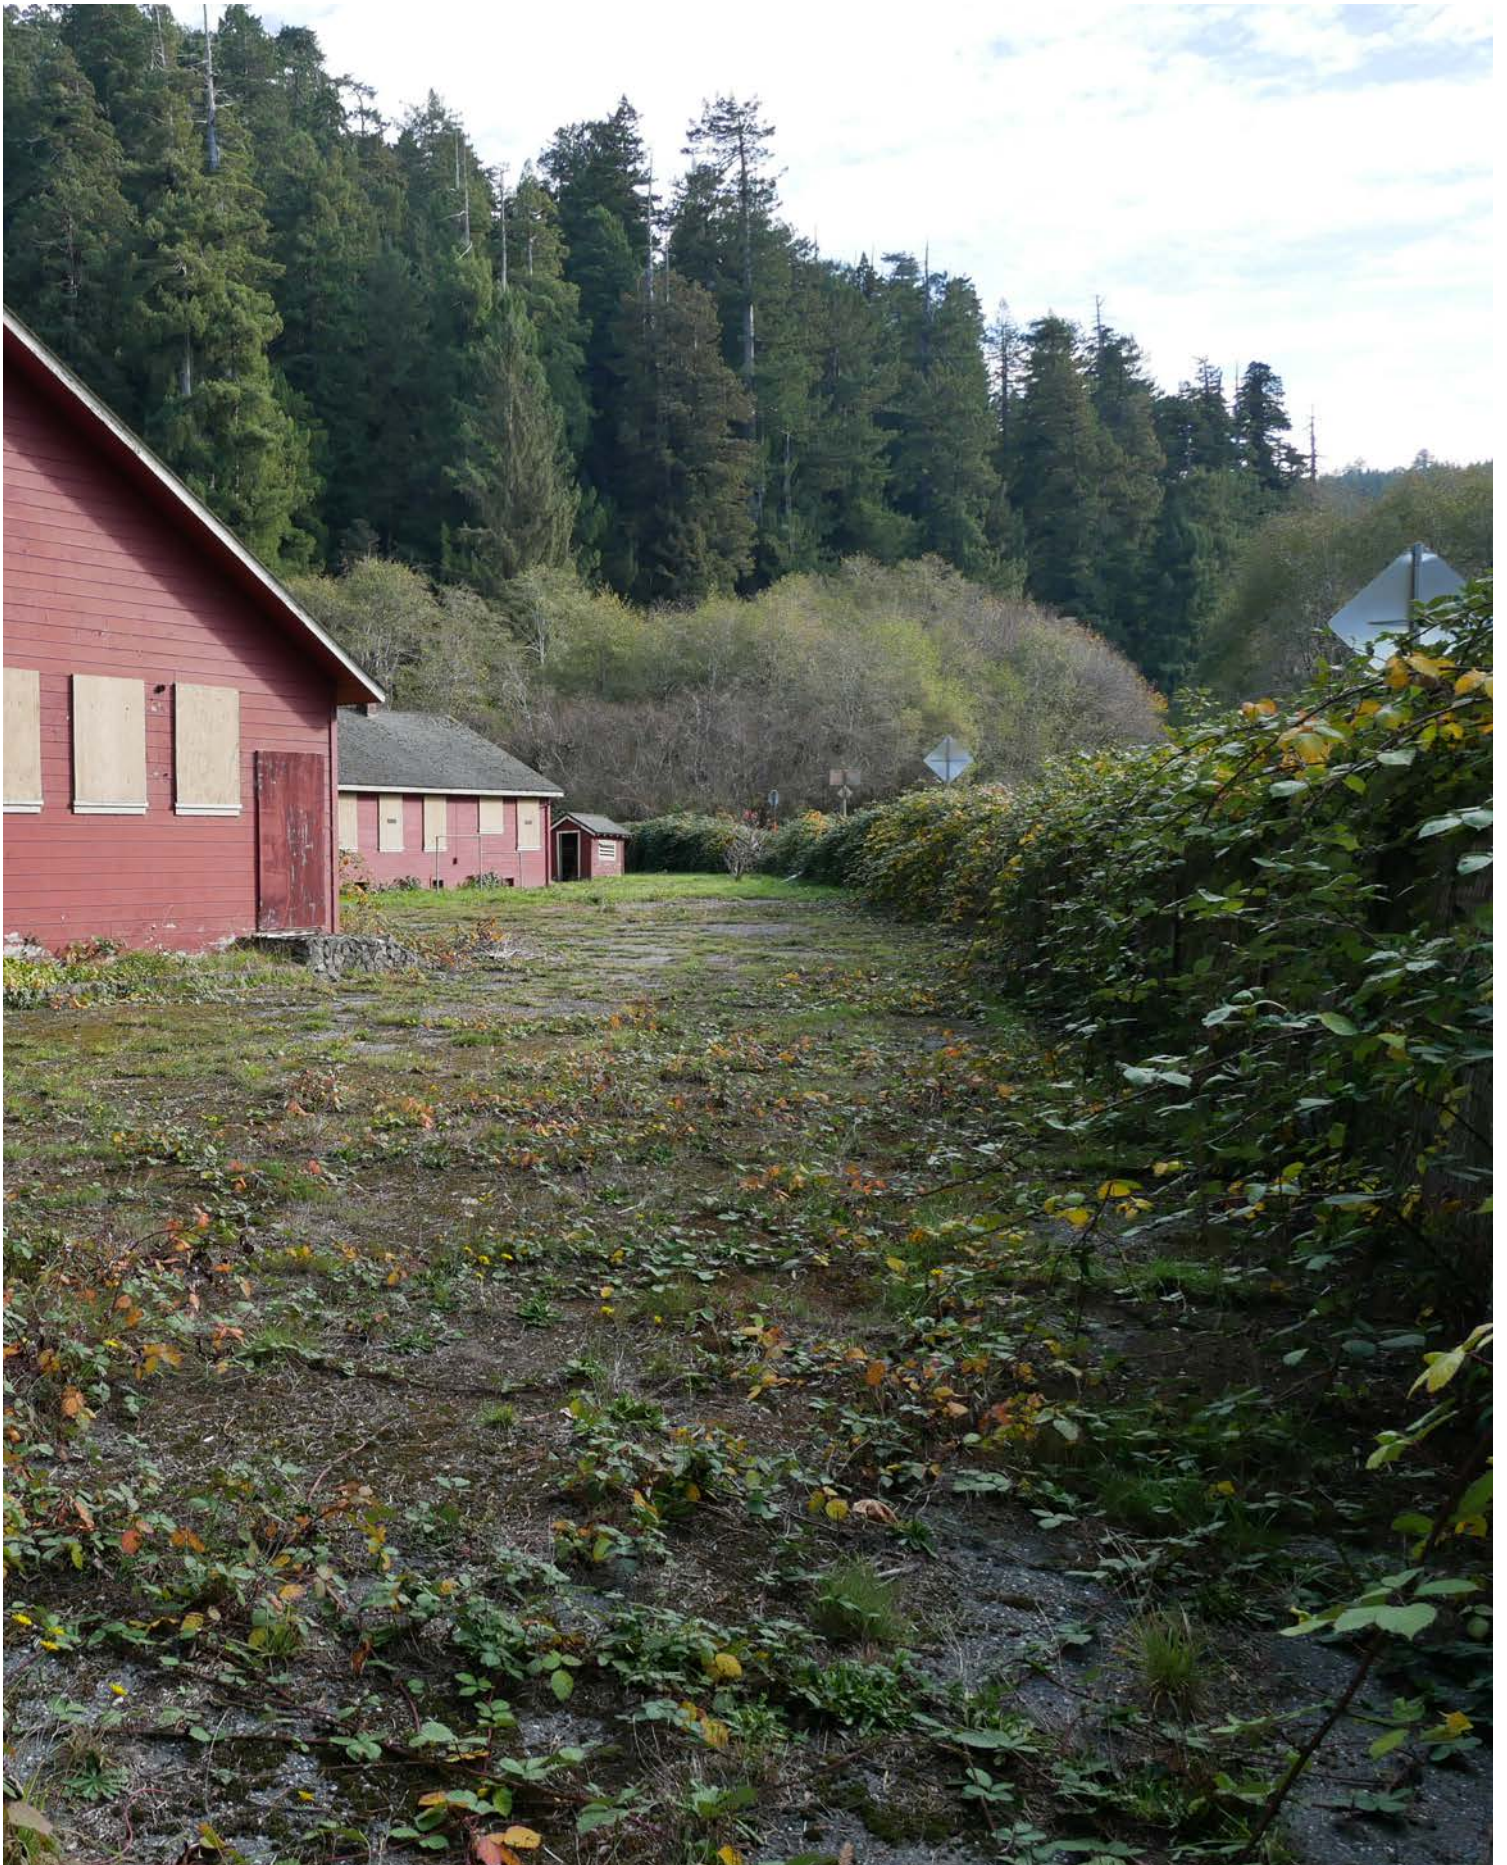
**Figure 70 :** Blackberries grow naturally in the area, and now are located along the perimeter chain link fence and at base of many buildings, non-contributing (CLRG, 2019).

significance, and is considered non-contributing. It blocks the original entrance to the site, and extends south below the parcel boundary. See Figure 70.

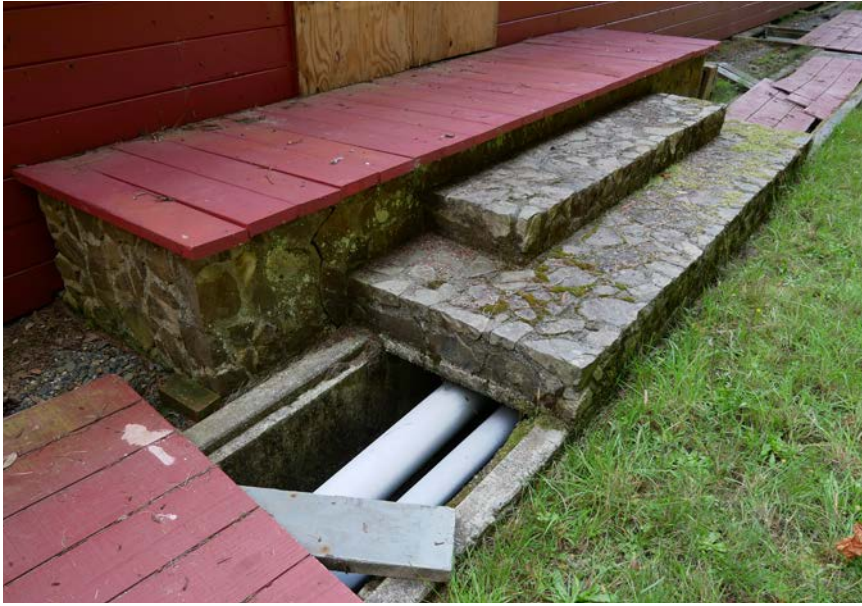
**Figure 84 :** Bottom-Concrete steps on east side of Hatchery building, undetermined (CLRG, 2019)

Concrete steps have been placed at two entrances to the Hatchery building, see Figure 84. The current steps were likely constructed when the raised rectangular tanks were built. This conclusion is based on observation during the 2011 CLI fieldwork, because the materials used in the steps more closely match that used in the tanks and the five round concrete tanks. It is unknown whether they replaced deteriorating concrete steps or wooden steps.

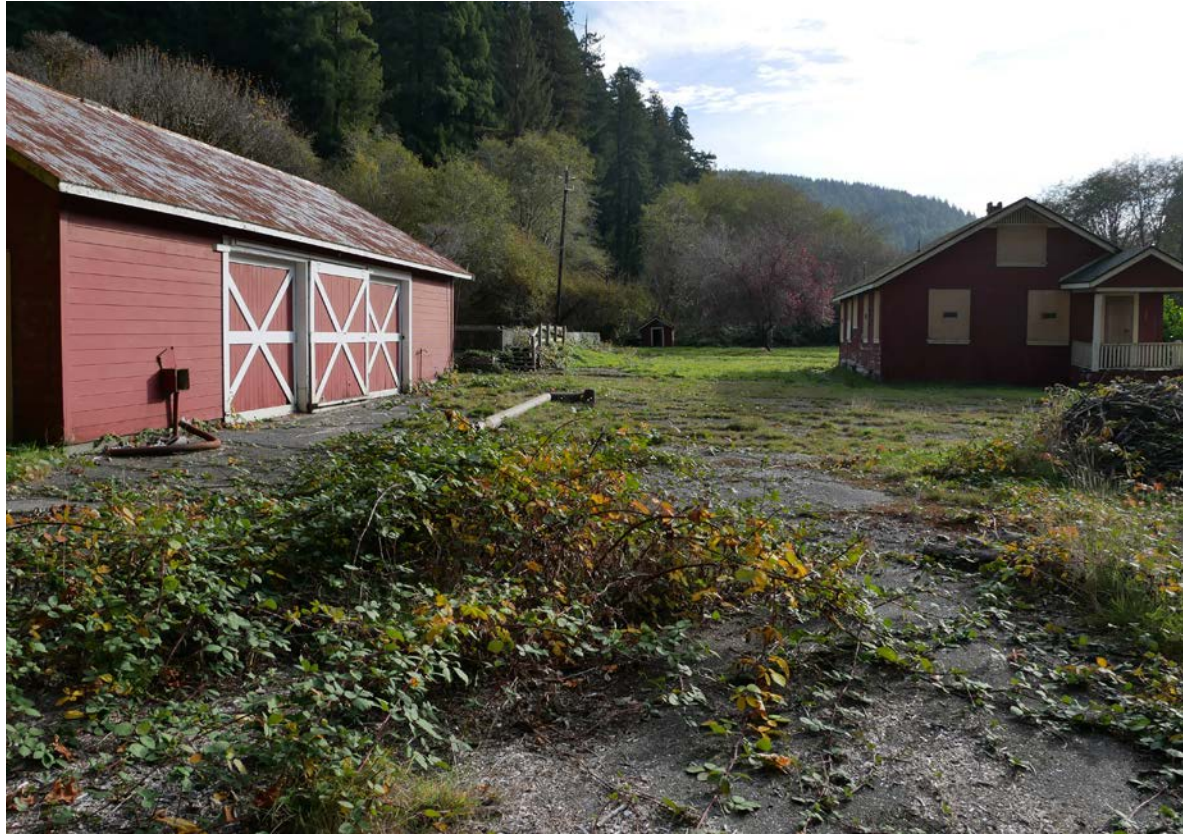
**Figure 86 :** Concrete paving north of Shed, non-contributing (CLRG, 2019)

The area north of the shed, as well as the area between the shed and the garage, was hardened with concrete. This likely took place when a mobile home was placed on the site for additional employee housing in 1981. This slab is on existing grade and is in contact with the bottom of the buildings' cladding, which has impeded drainage and caused the cladding to rot in places. This concrete slab is non-contributing.

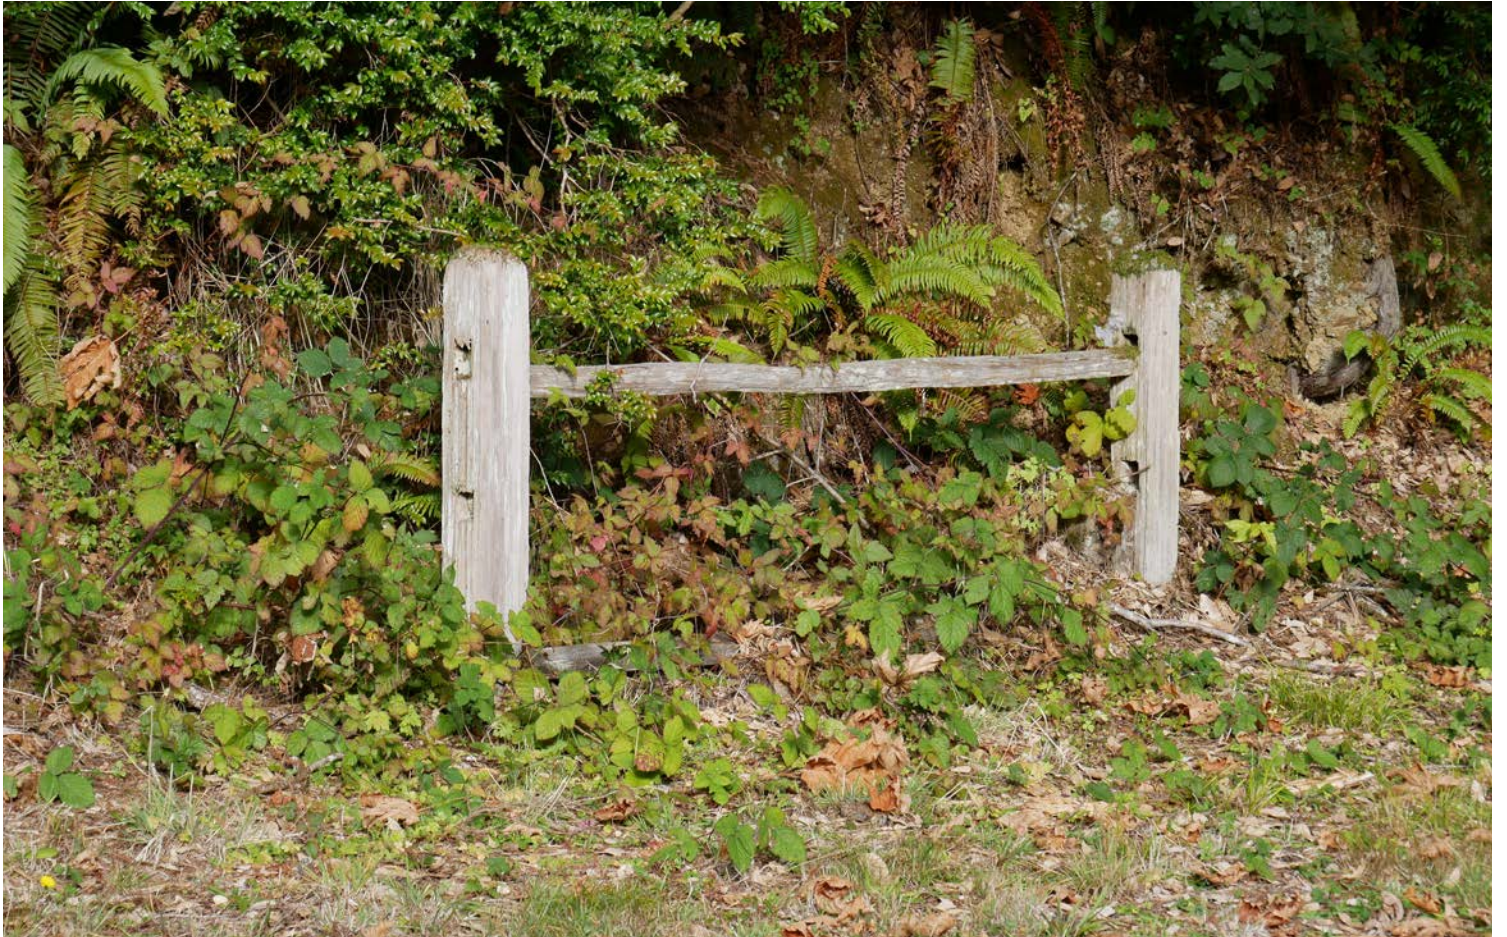
**Figure 87 :** Split rail fence remnant north of Hatchery building, situated between the round tanks farthest east, non-contributing (CLRG, 2019)

A split rail fence is located to the north of the five round water tanks outside the Hatchery building. See Figure 87. This type of fence is also located to the east of the driveway. The fence consisted of three split rails with posts approximately 9 feet on center. However, only one section of this fence still remains.

32. Consider re-introducing fish sculpture as site indicator; engage local artist and/or tribal community.
33. Maintain and interpret play structure.
34. Remove all split-rail fences.

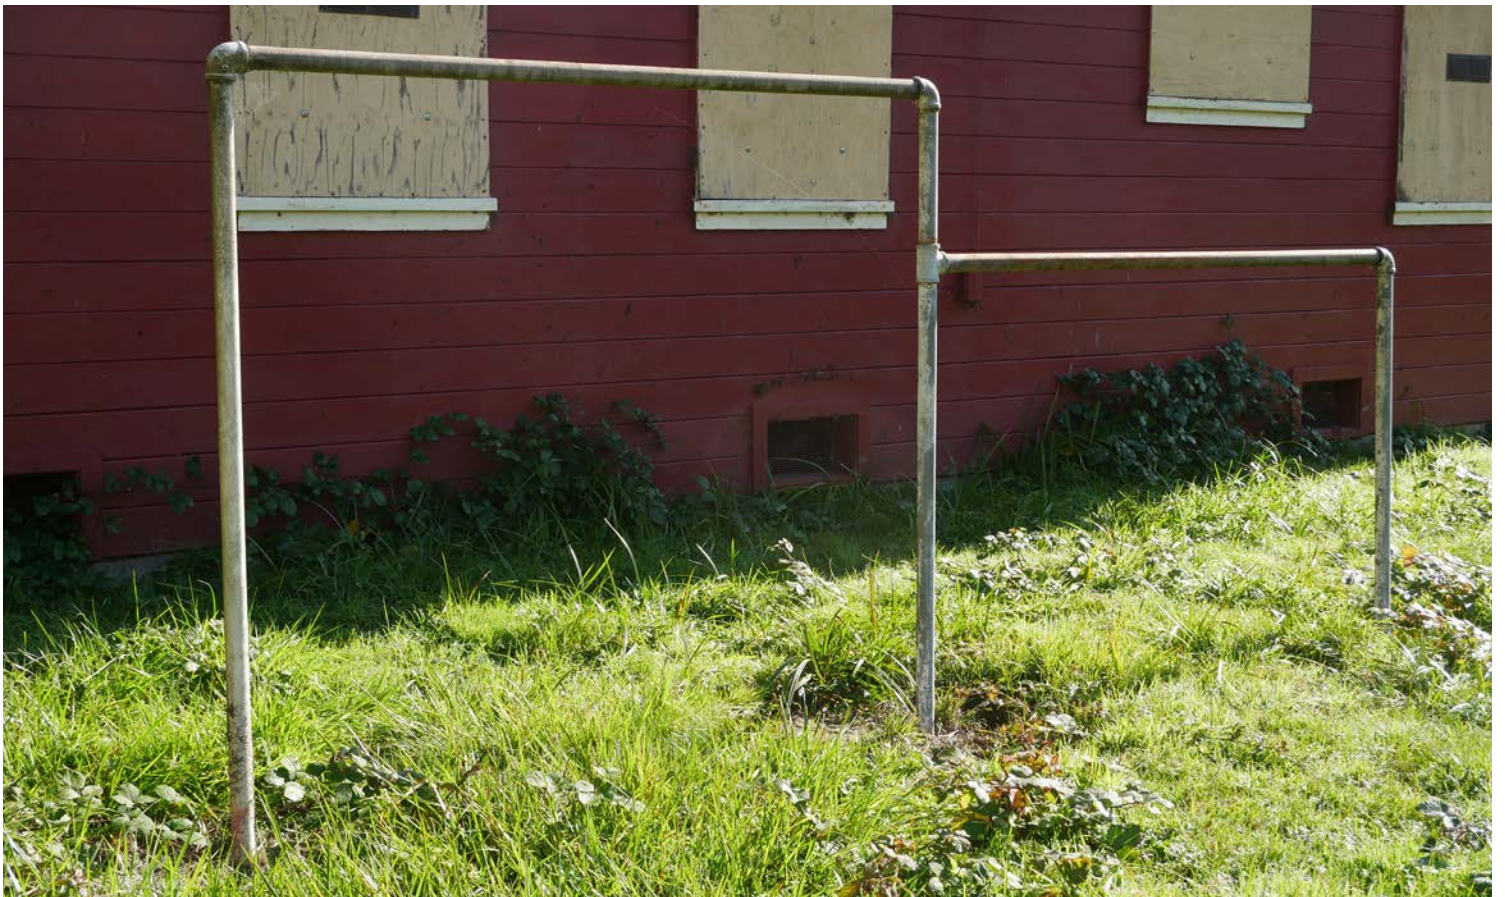
A freestanding pipe structure stands west of the Superintendent's house, see Figure 88. It is not mentioned in historical documents, and therefore its date of construction is unknown. The structure likely related to domestic activities of the house, and could have accommodated swings for children. It is constructed of segments of one inch water pipe, connected with standard elbows to form a free standing double u-shape.

**Figure 88 :** Pipe play structure west of Superintendent's House, undetermined (CLRG, 2019)

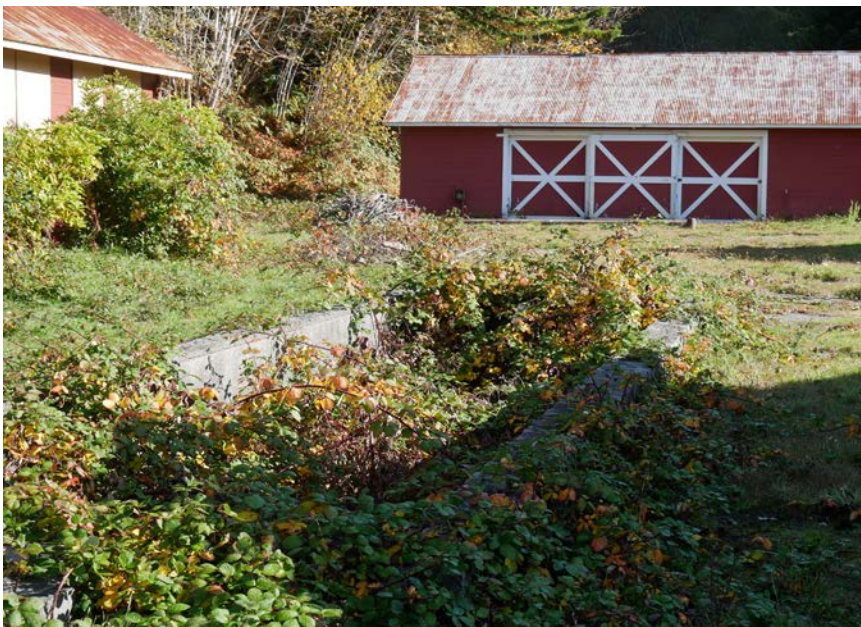
**Figure 89 :** Top-Features associated with the Dedication Pond include rock facing on the western concrete steps into the Hatchery building, non-contributing (CLRG, 2019)

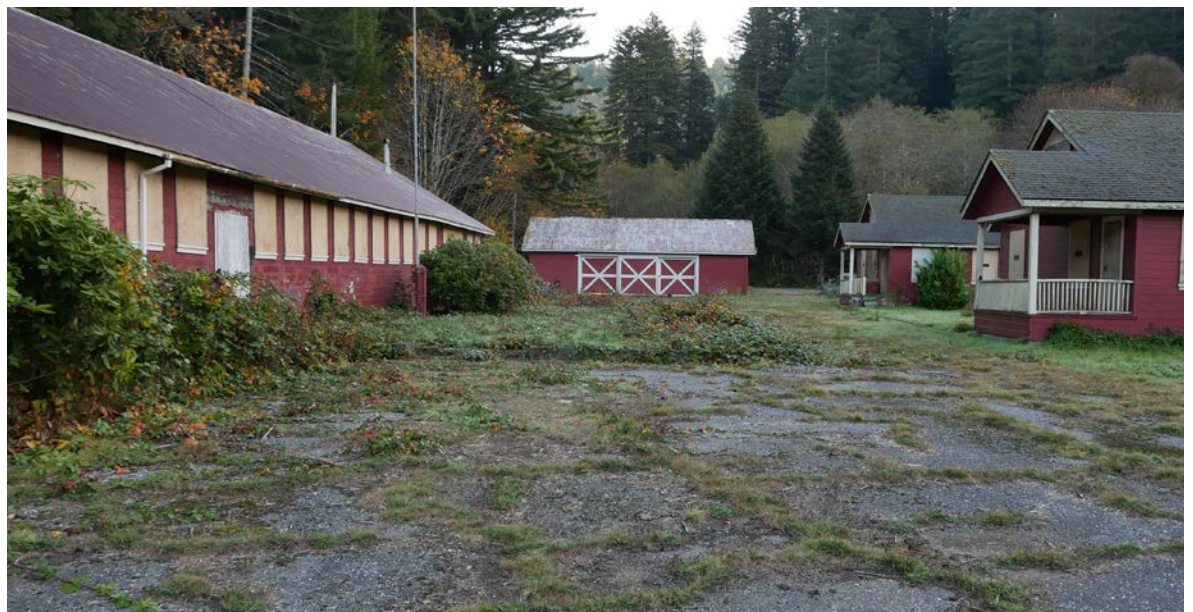
**Figure 98 :**

Right - Original Entry view from Highway 101 with limited vehicle use. (CLRG, 2019)

Note: dedication pond is overgrown with blackberries, minimal Juniper presence.

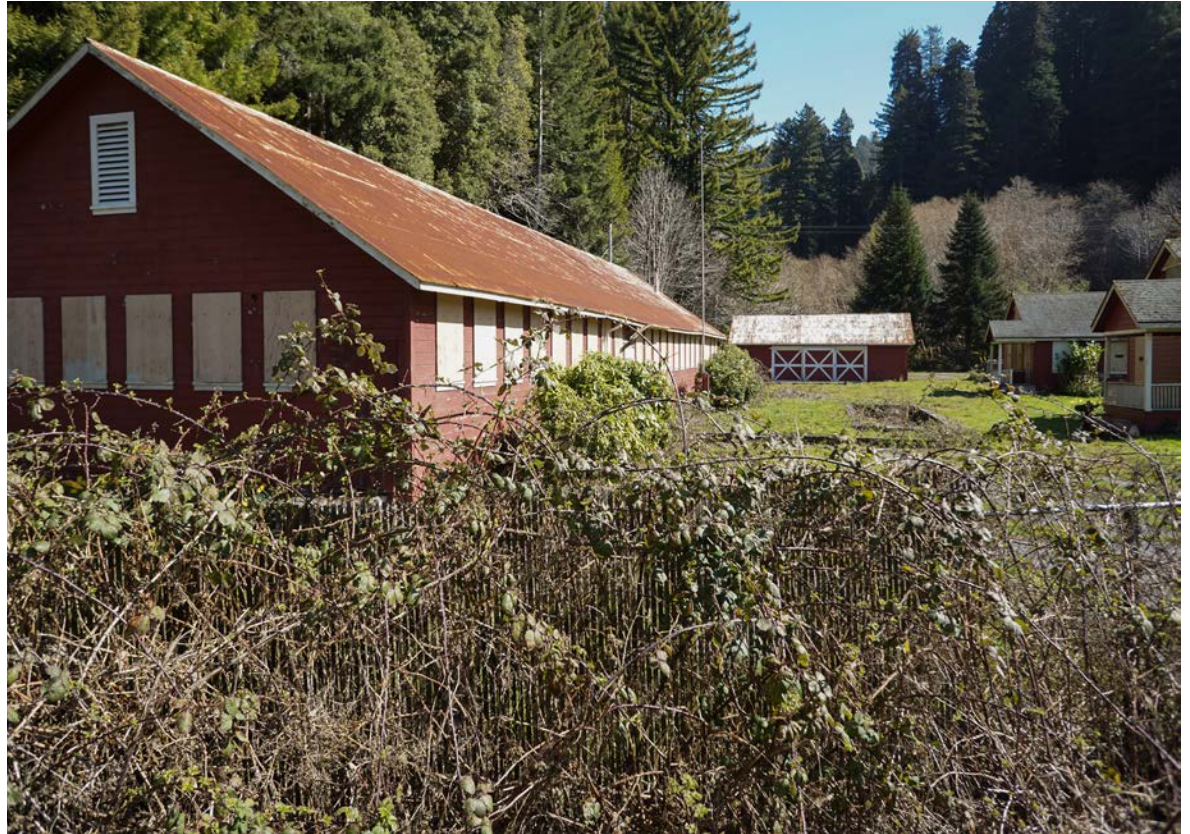
**Figure 112 :**  
Northeast view  
(2020) of existing  
conditions: Himalayan  
blackberries grow  
on chain-link  
fence in front of  
original entrance.  
Central open space,  
Hatchery Building,  
Garage, Assistant  
Superintendent's  
House and  
Superintendent's  
House in background  
(CLRG, 2020).
