## CULTURAL LANDSCAPE REPORT

### PRAIRIE CREEK FISH HATCHERY

REDWOOD NATIONAL AND STATE PARKS , CALIFORNIA

JUNE 2020

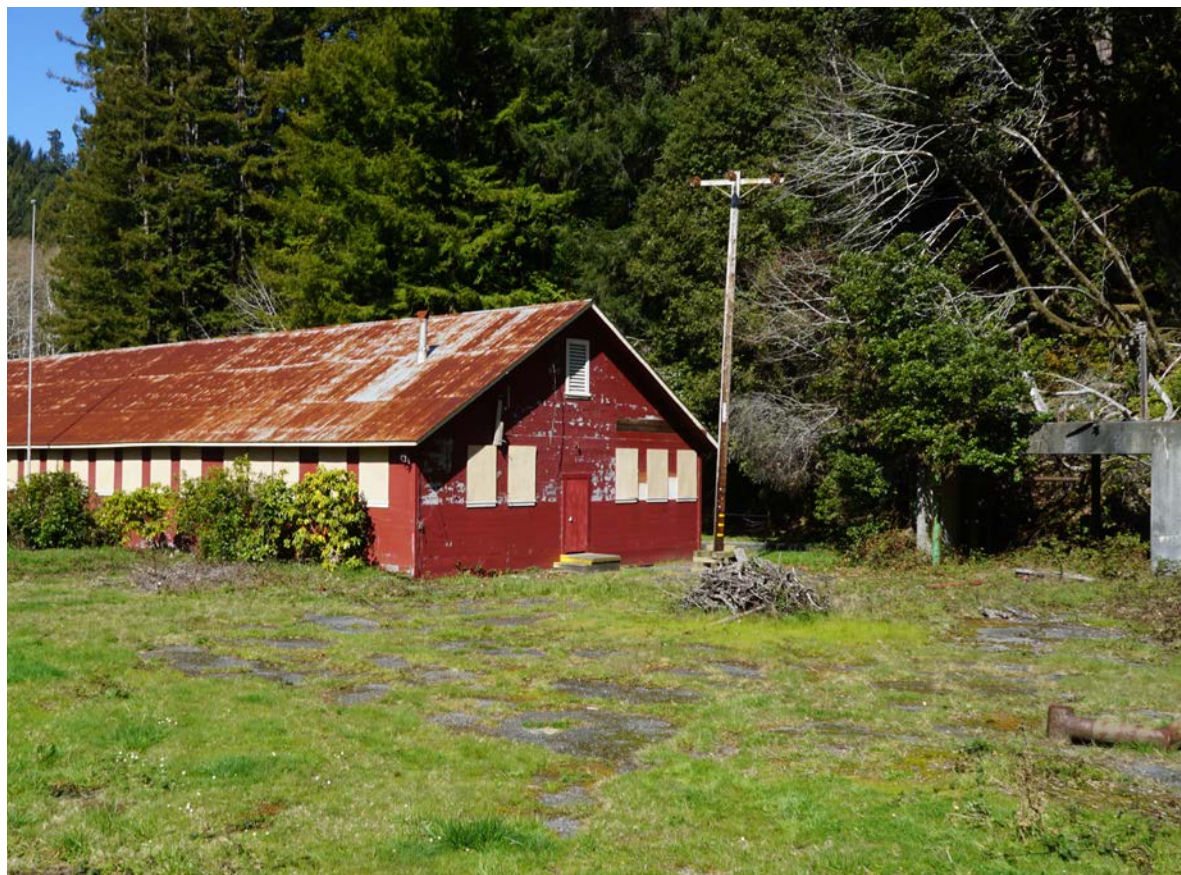
**Figure 115 :**  
Northwest view  
(2020) of existing  
conditions: Hatchery  
Building and Aeration  
Tower (CLRG, 2020).

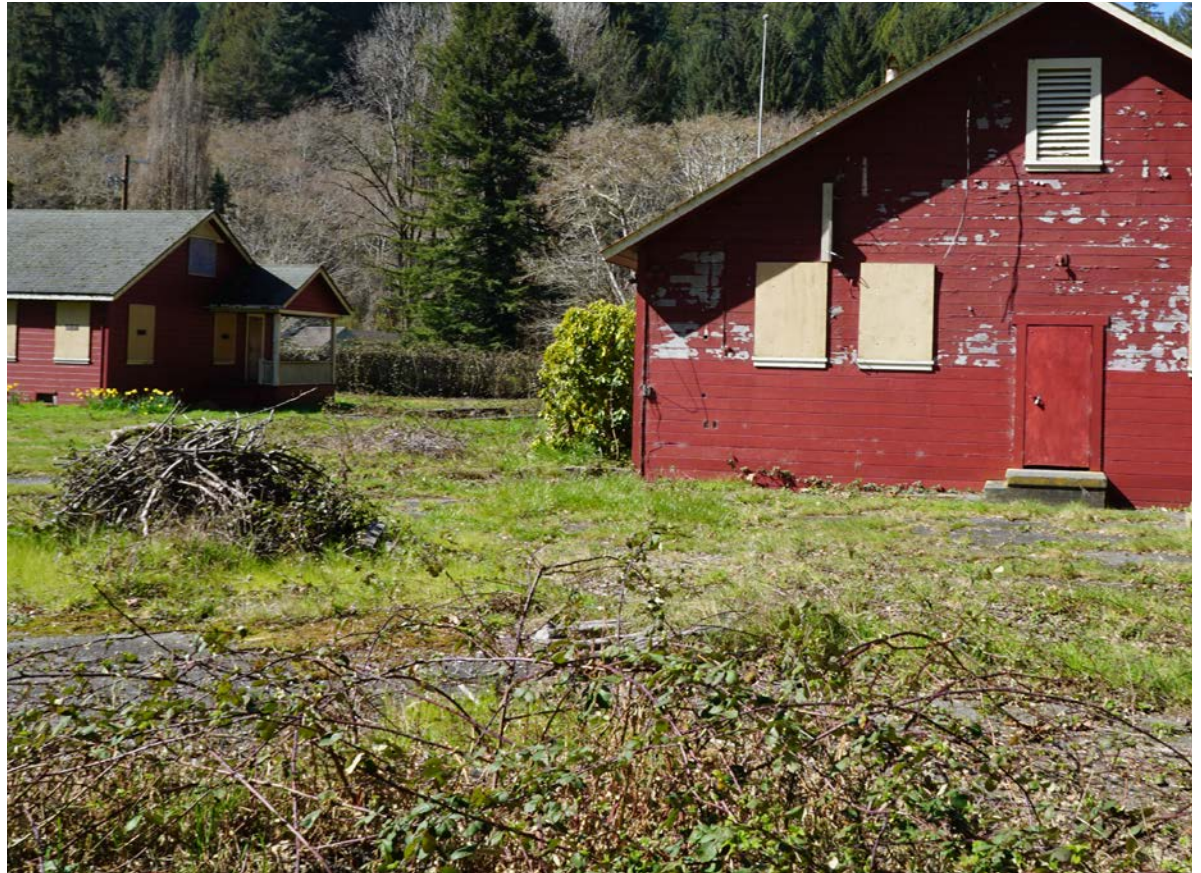
**Figure 117 :**  
Southwest view (2020)  
of existing conditions:  
Superintendent's  
House and Hatchery  
Building (CLRG,  
2020).

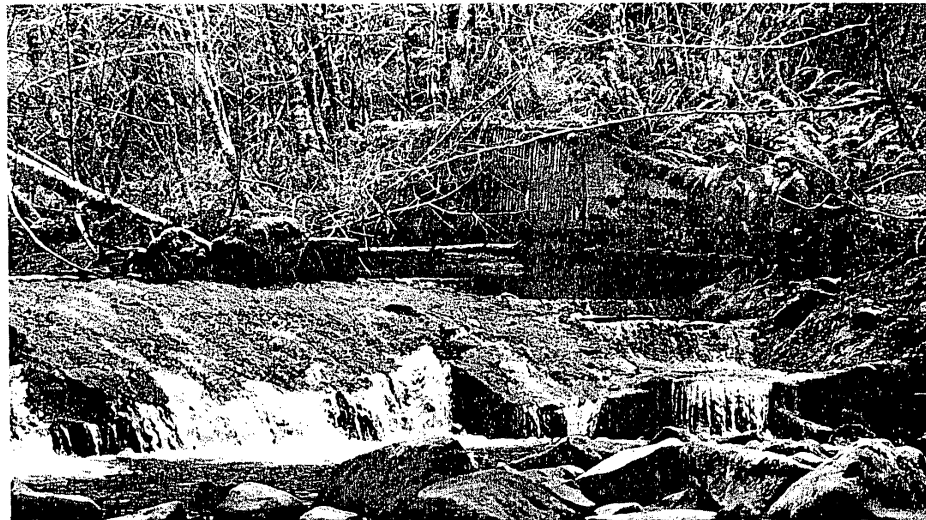
View of south end of dam, showing water intake, fish ladder, and south wing wall.

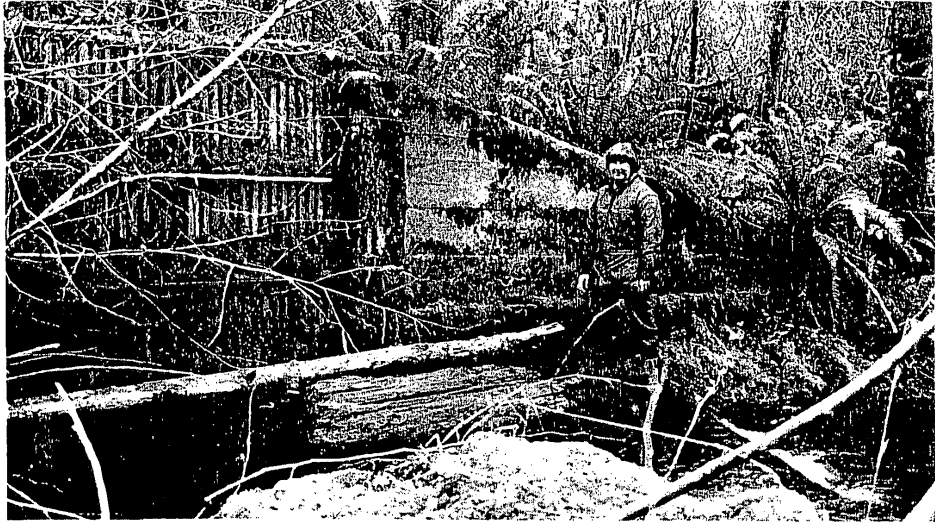
Close-up of water intake and south wing wall.

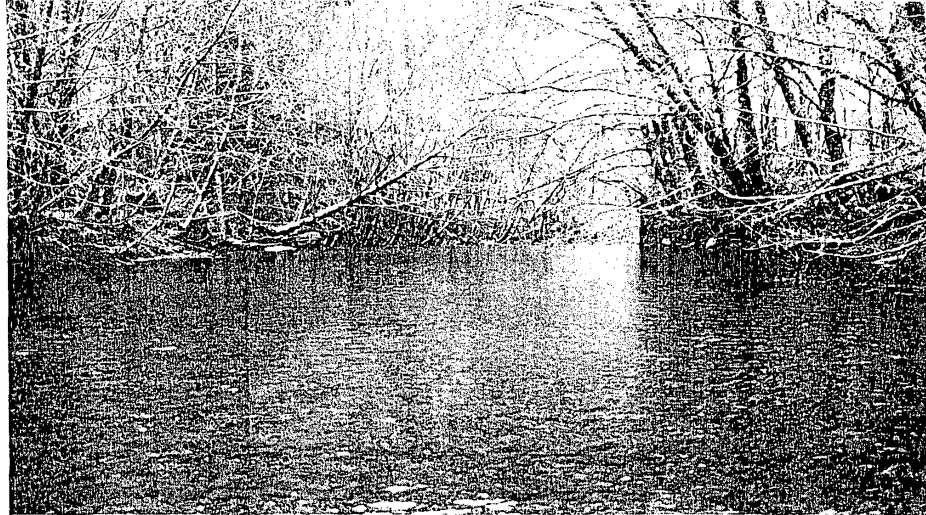
View upstream from top of the dam.

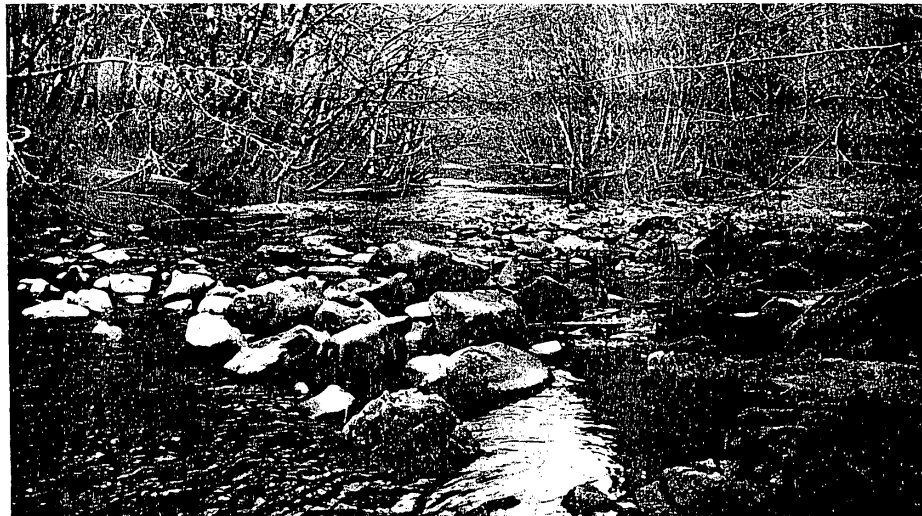
View downstream from top of the dam.

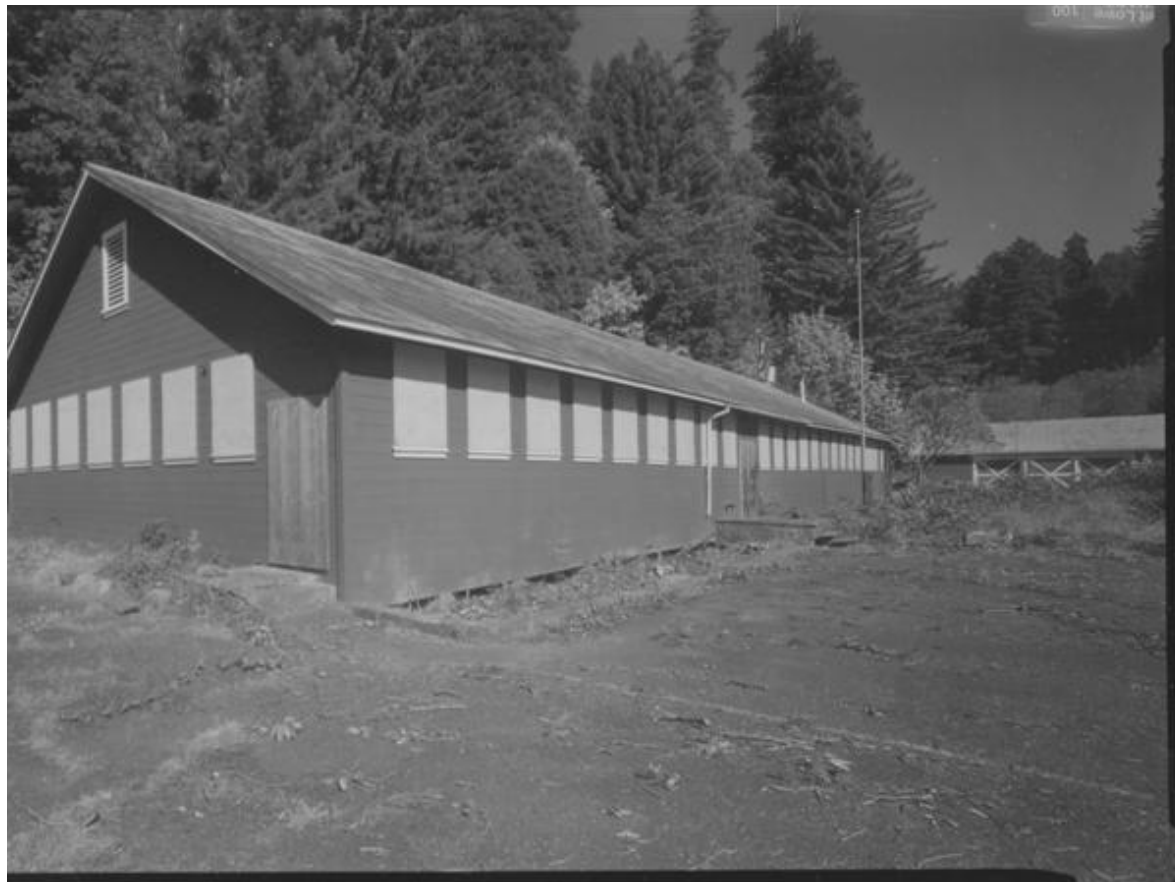
CA-334-4

Perspective view,  
Exterior of main  
hatchery building  
looking east,  
northeast.

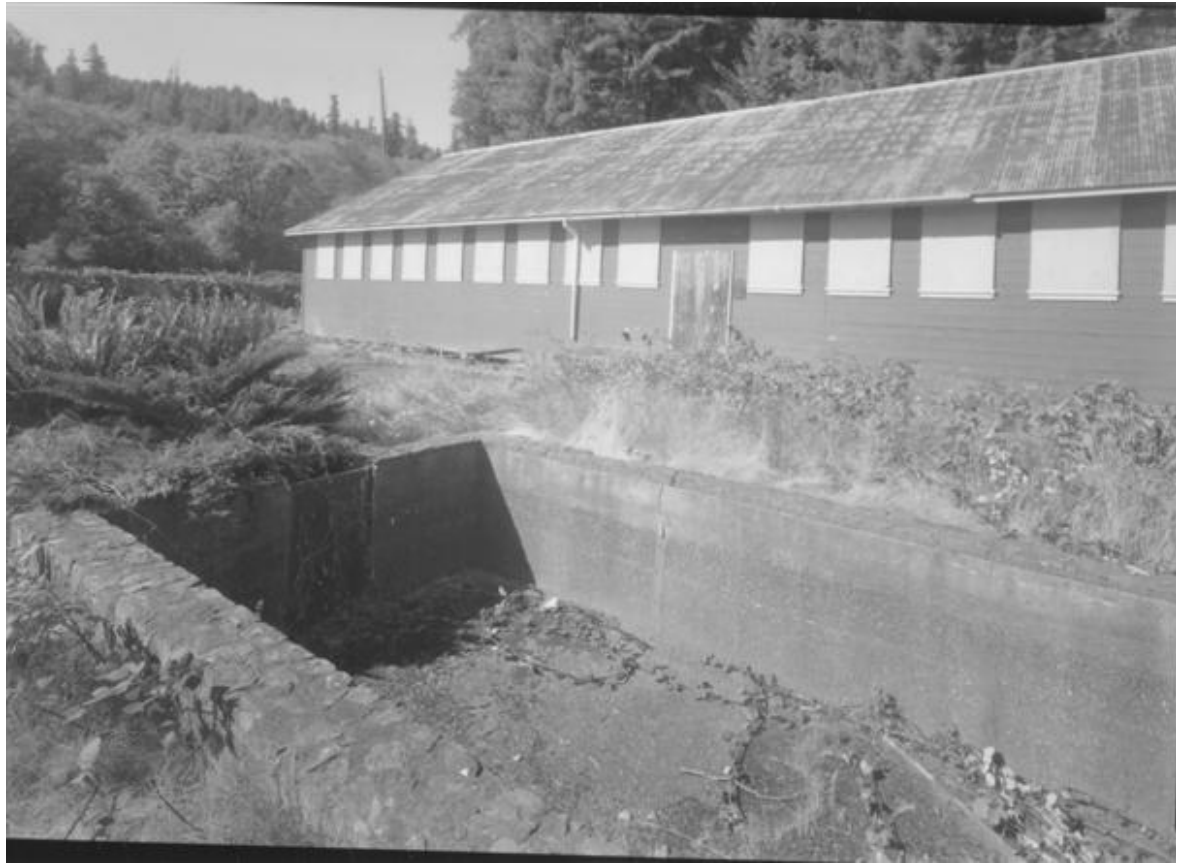
CA-334-32

Detail of gate, gate slots, and connection between the two segments of the rectangular rearing tank. Pump house (1962) at entrance is in the background. View to the southwest. Sic. Dedication Pond

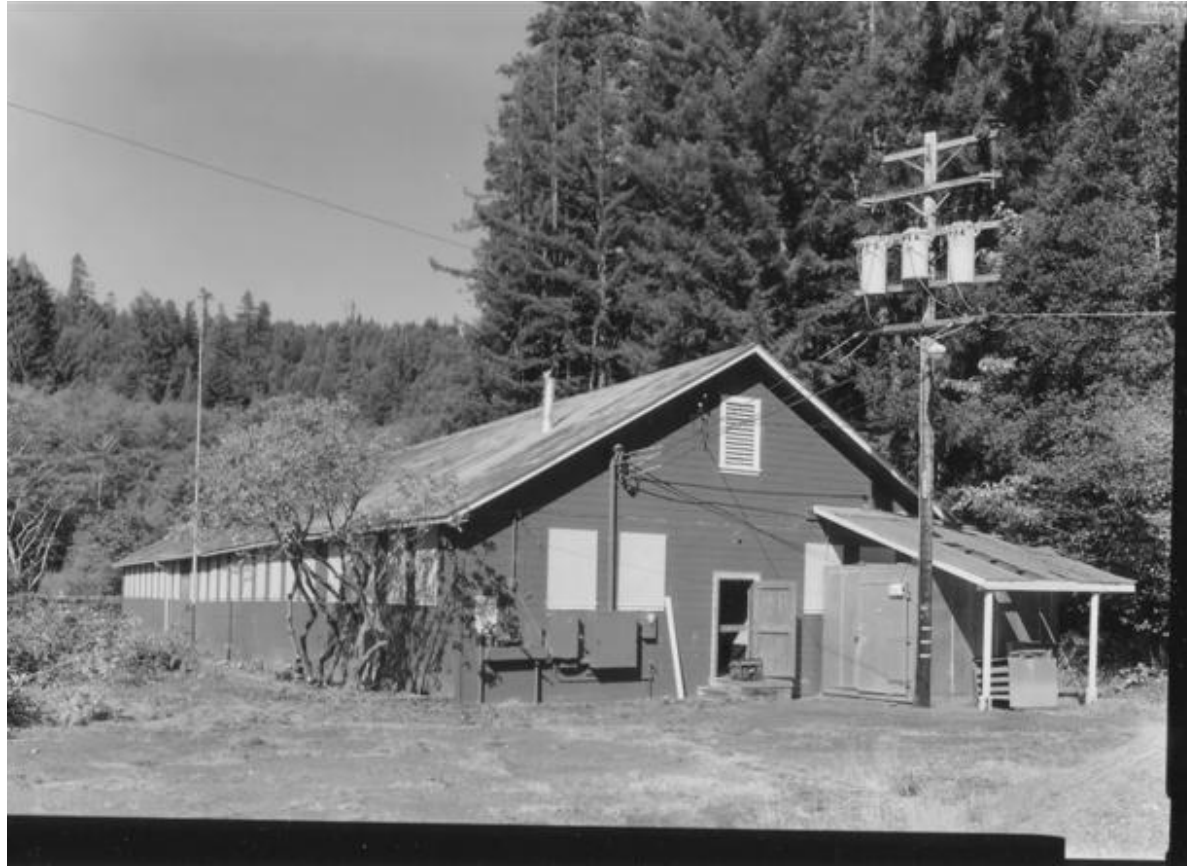
CA-334-5

Perspective view,  
Exterior of main  
hatchery building.  
View to the west,  
northwest.

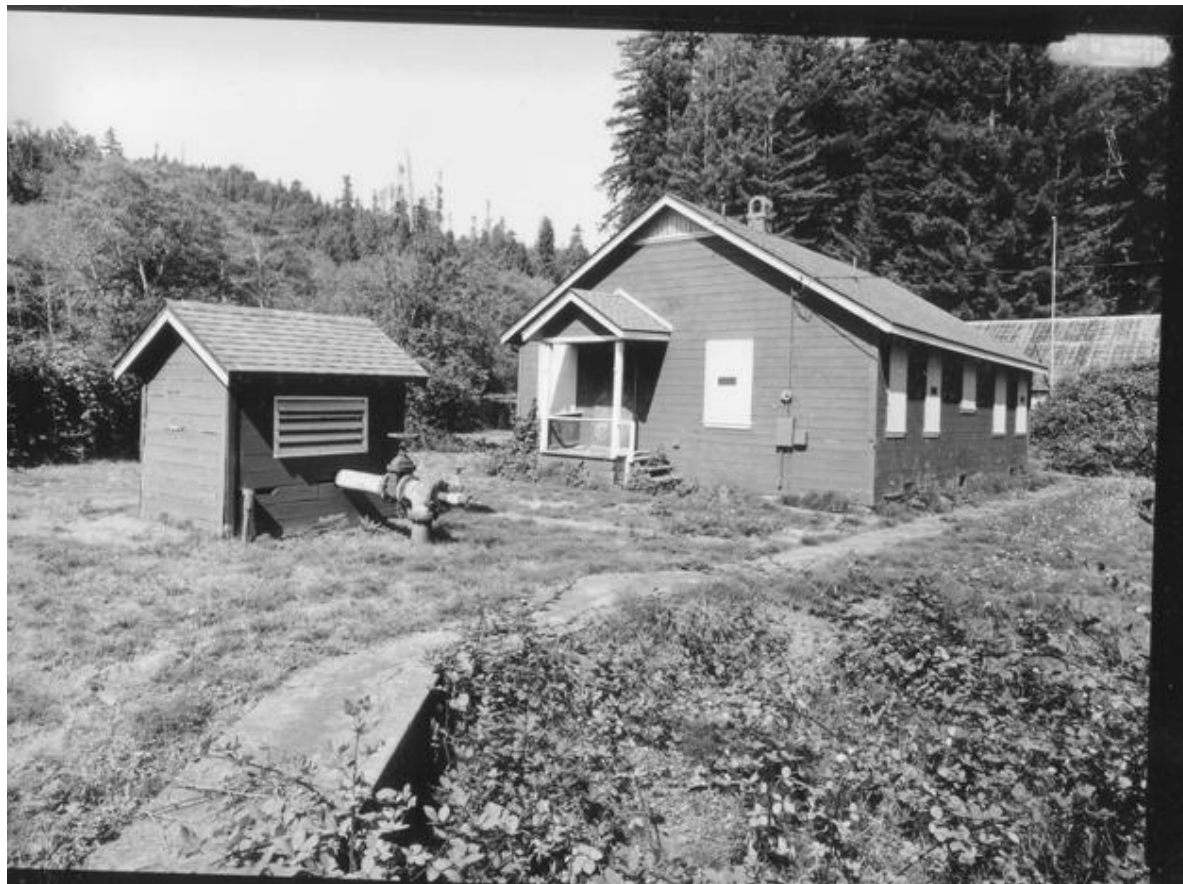
CA-334-18

Superintendent's quarters with pump house in the foreground and the hatchery in the background. View to the northwest.

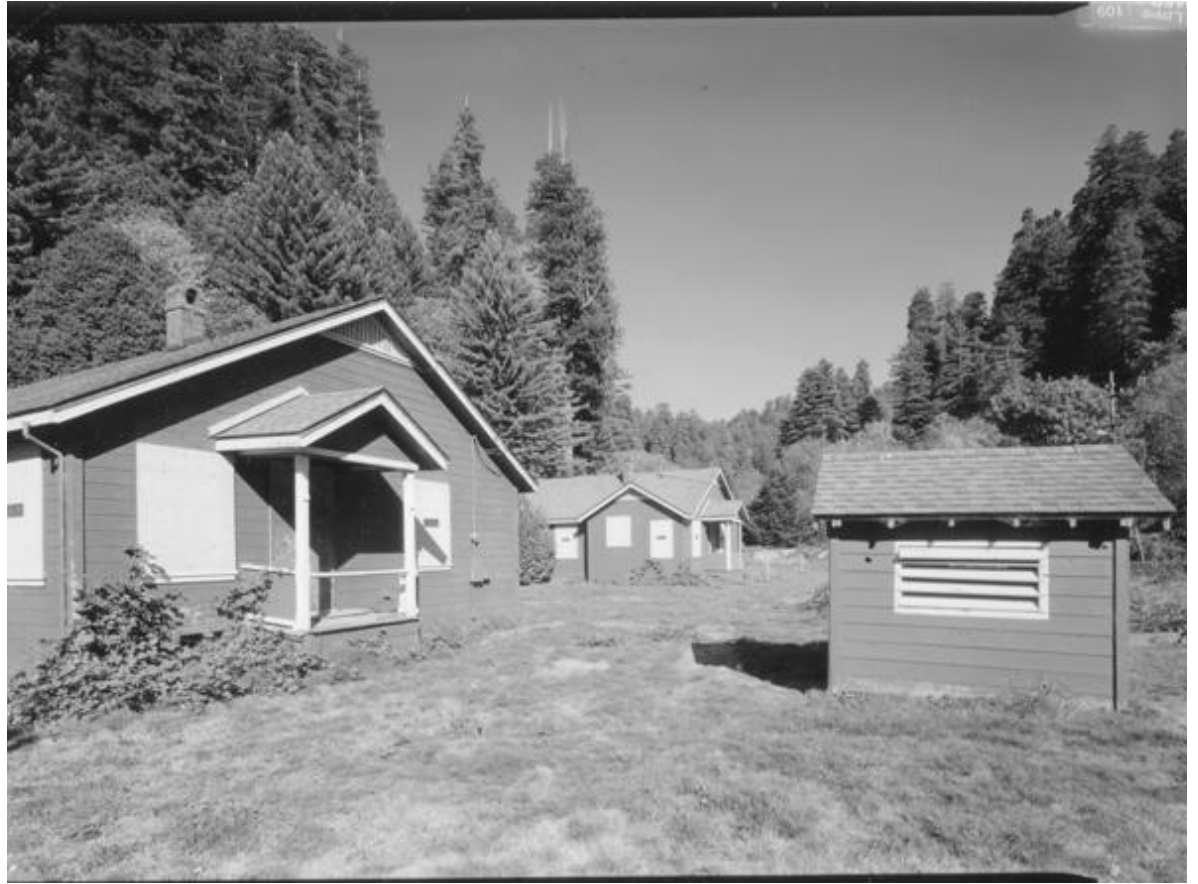
CA-334-20

Perspective of the superintendent's house, assistant superintendent's house, and pump house near Highway 101. View to the northeast.

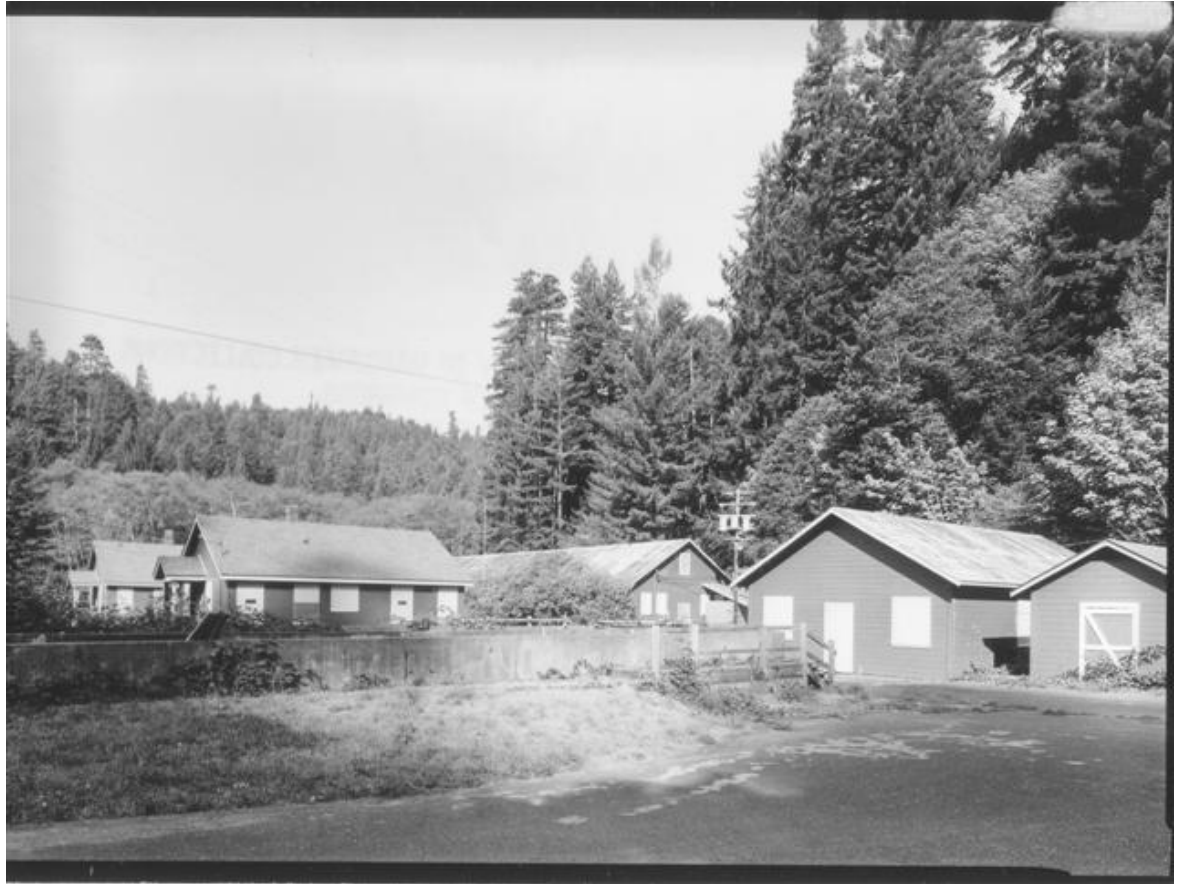
CA-334-33

Detail of pump that is attached to rectangular rearing tanks (pair).

Pump located on the north end of rearing tank. View to the northwest.

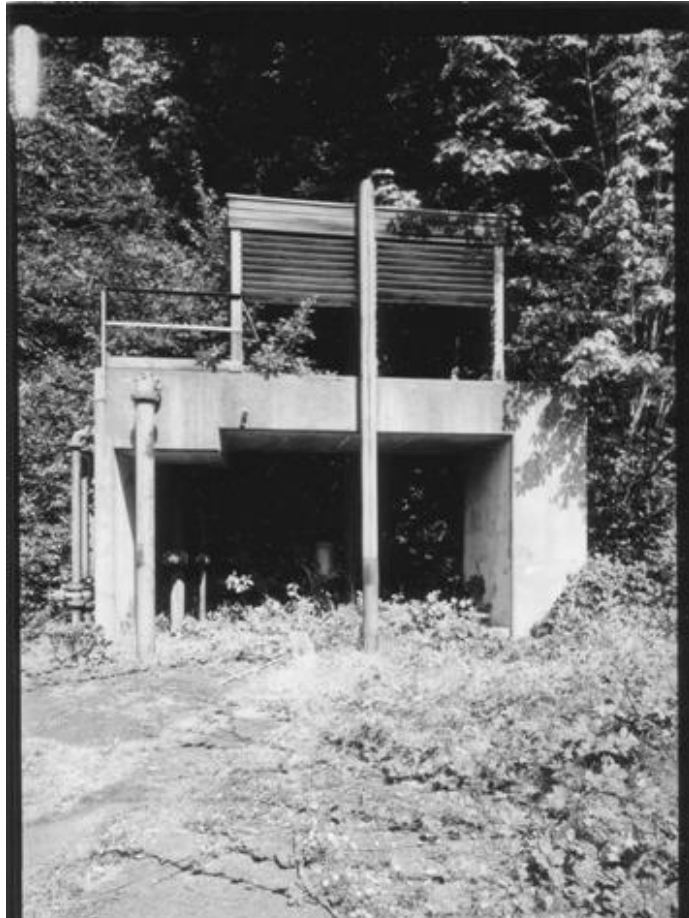
CA-334-35

Aeration tower/  
pump. View to the  
north.

15. Inspect, repair (as needed), clean and maintain five round tanks on north side of hatchery, using appropriate materials and techniques (tanks are non-contributing).
16. Maintain aeration tower concrete structure; remove wood components.
17. Remove rectangular above ground concrete tanks. Consider adding footprint interpretation of demolished third living quarters and filter house.
18. Remove dedication pond and replace with historically appropriate ornamental flower bed, with wood border edging (see detail drawing). Consider using native deer/elk resistant plants instead of ornamental flowers.

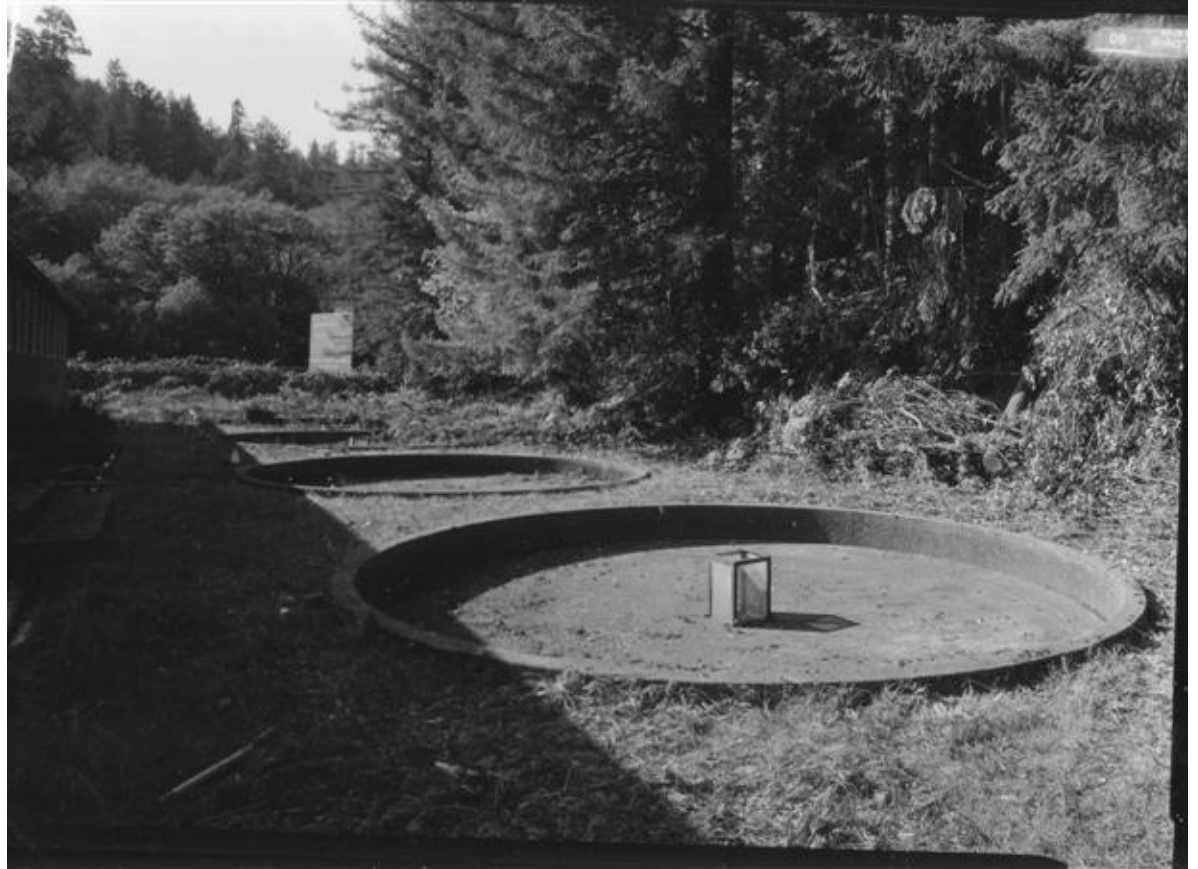
CA-334-34

Perspective circular rearing ponds on north side of hatchery. View to the west, northwest. Includes view of ditch and step up to hatchery building on left side of image.
