# Mission Espada North Gate

## Documentation, Condition Assessment, and Treatment Plan

The University of Texas at San Antonio  
Center for Archaeological Research | Center for Cultural Sustainability  
November 2019

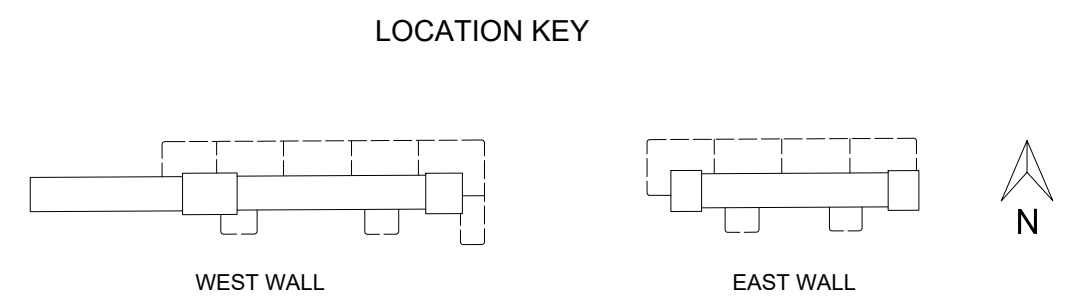
01  
CA 01

The north gate wall is structurally deficient, exhibiting a rotational movement along its length, easily visible as a severe lean to the south. The lean of the east section is worse than the west. The deficiency is most likely due to a combination of construction and environmental issues. Regarding quality of construction, the 1950s wall sections do not appear to be structurally connected to the Spanish Colonial foundation stones upon which they sit. Exacerbating the problem is the portland cement mortar utilized in the 1950s, which causes each large section of wall to behave monolithically as a free body unit of masonry, very heavy and not connected to the ground. Since the north gate wall sections bear upon colonial foundations without proper anchorage, any movement in bearing condition of the foundation stones translates to shifting of position for wall sections relative to the foundation stones below. Clay in soils, compressed by the weight of the stones when dry and expanded when wet, is a source of movement in bearing conditions. Another source is the vegetative growth (tree root, see Figure 3.3) found underneath the east section of wall when exposed by the archaeological excavation. Furthermore, the north gate feature is located at a drainage exit point for the compound (see Figure 2.2), resulting in water from rain dwelling in the soils as well as possibly causing some soil erosion over the years. The poor construction and unfavorable environmental issues in combination are the cause of the obvious deformation of the wall.

PLAN OF NORTH GATE SHOWING MEASURED DRAWING & PHOTOGRAMMETRY OF EXPOSED FOUNDATION STONES

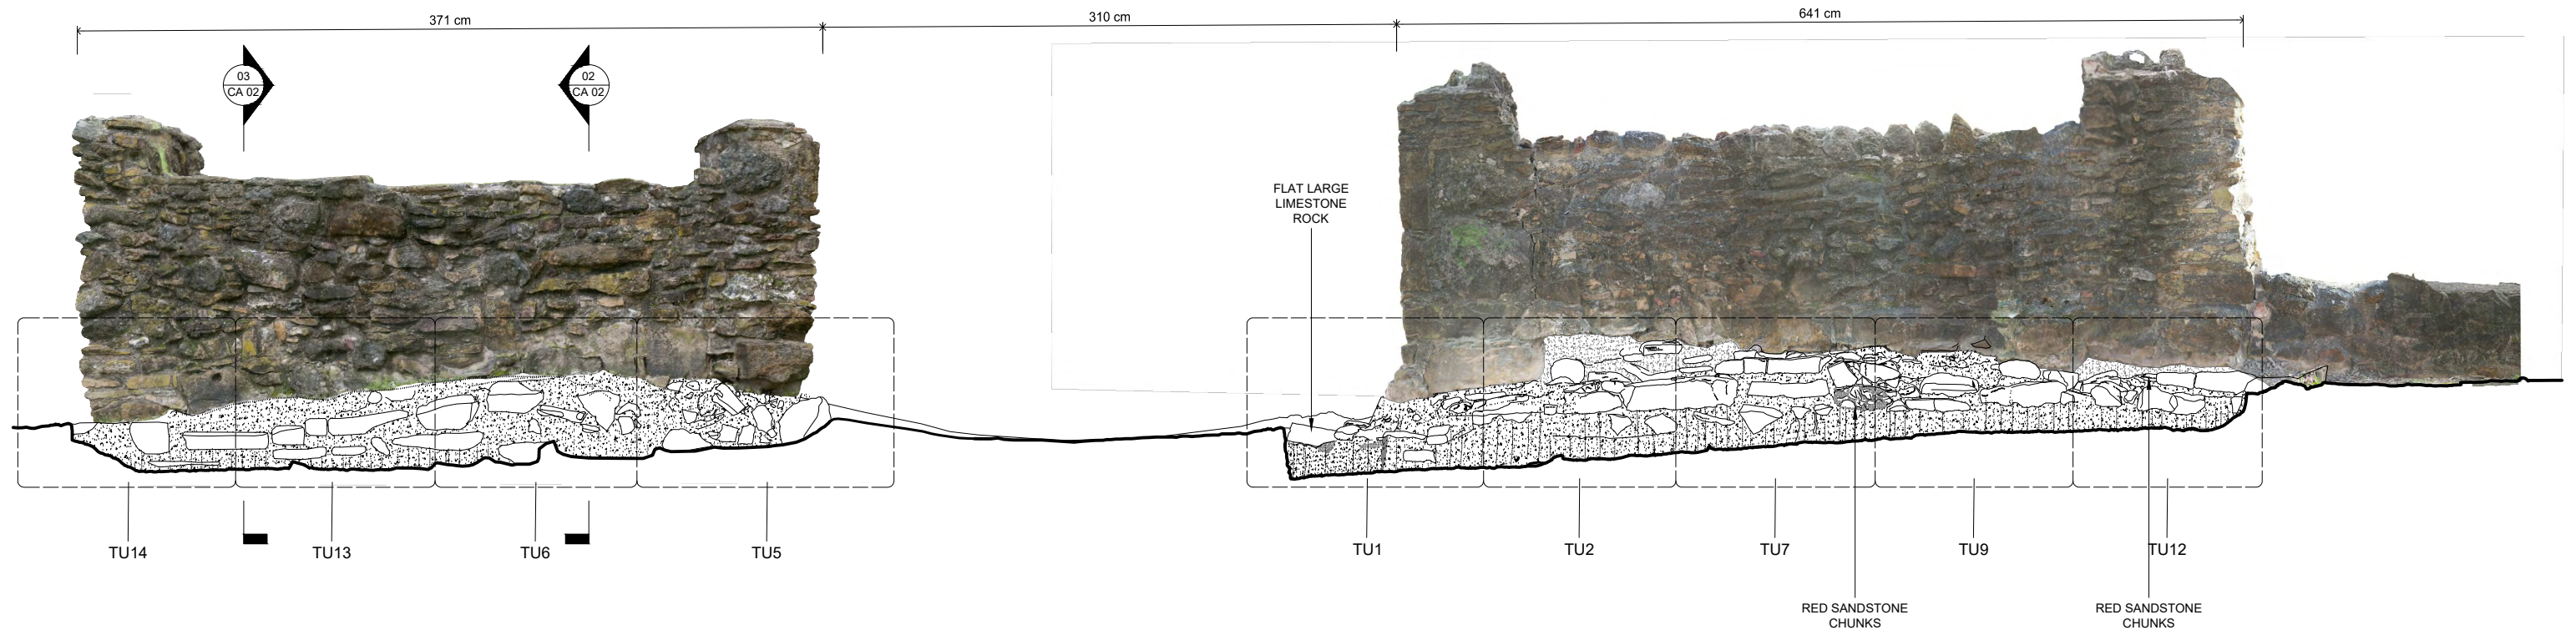
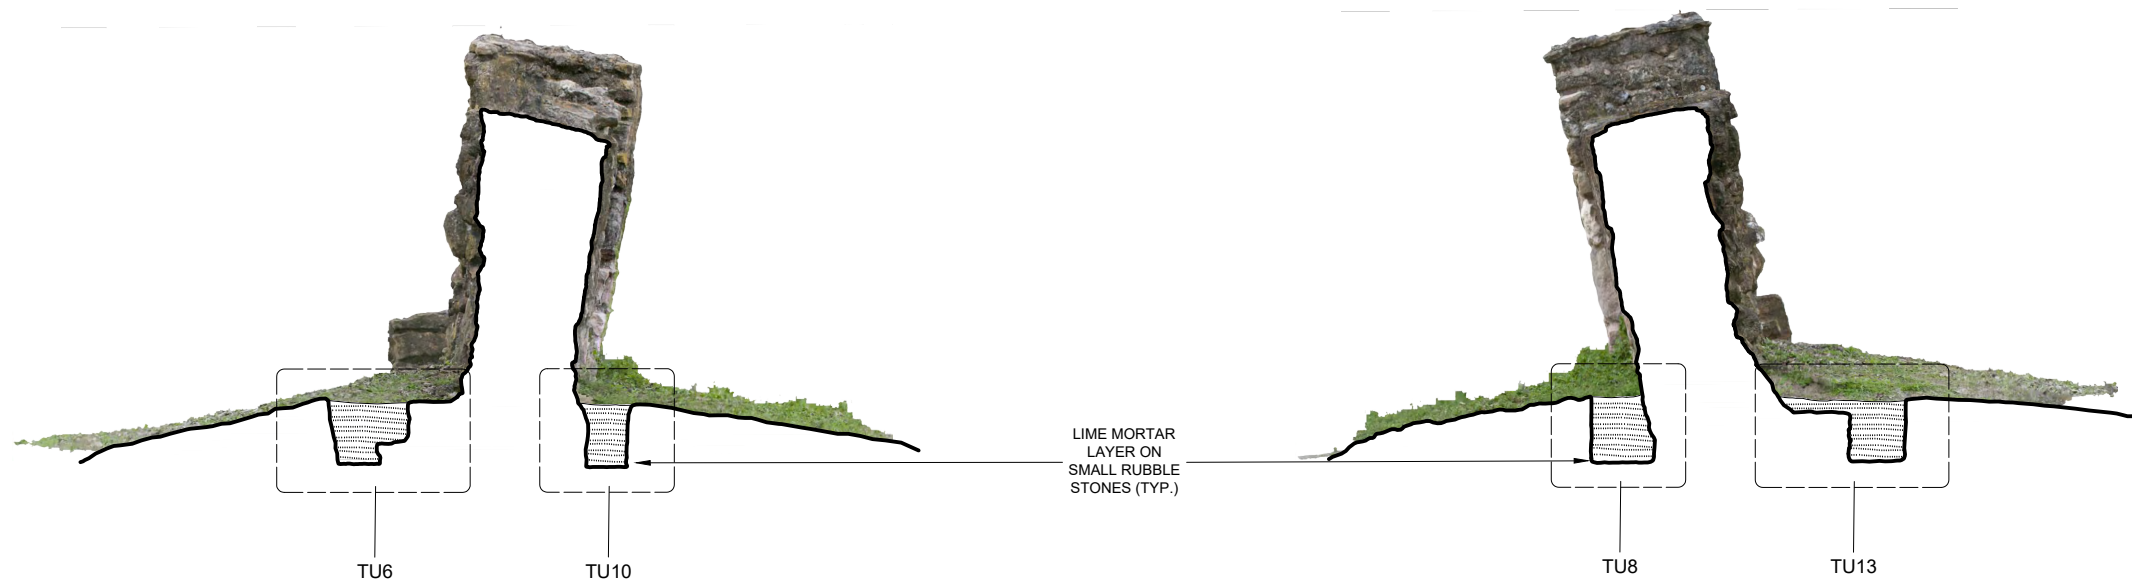
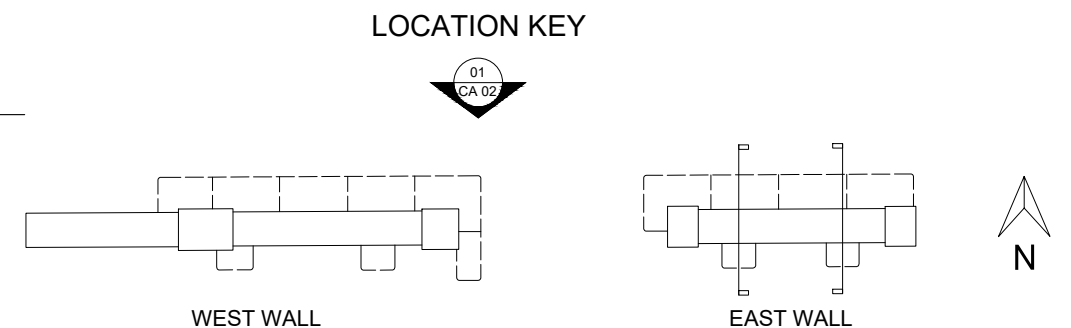
01  
CA 02 SOUTH ELEVATION OF NORTH GATE SHOWING MEASURED DRAWING & PHOTOGRAMMETRY OF EXPOSED FOUNDATION STONES

02  
CA 02 EAST WALL SECTION A

03  
CA 02 EAST WALL SECTION B

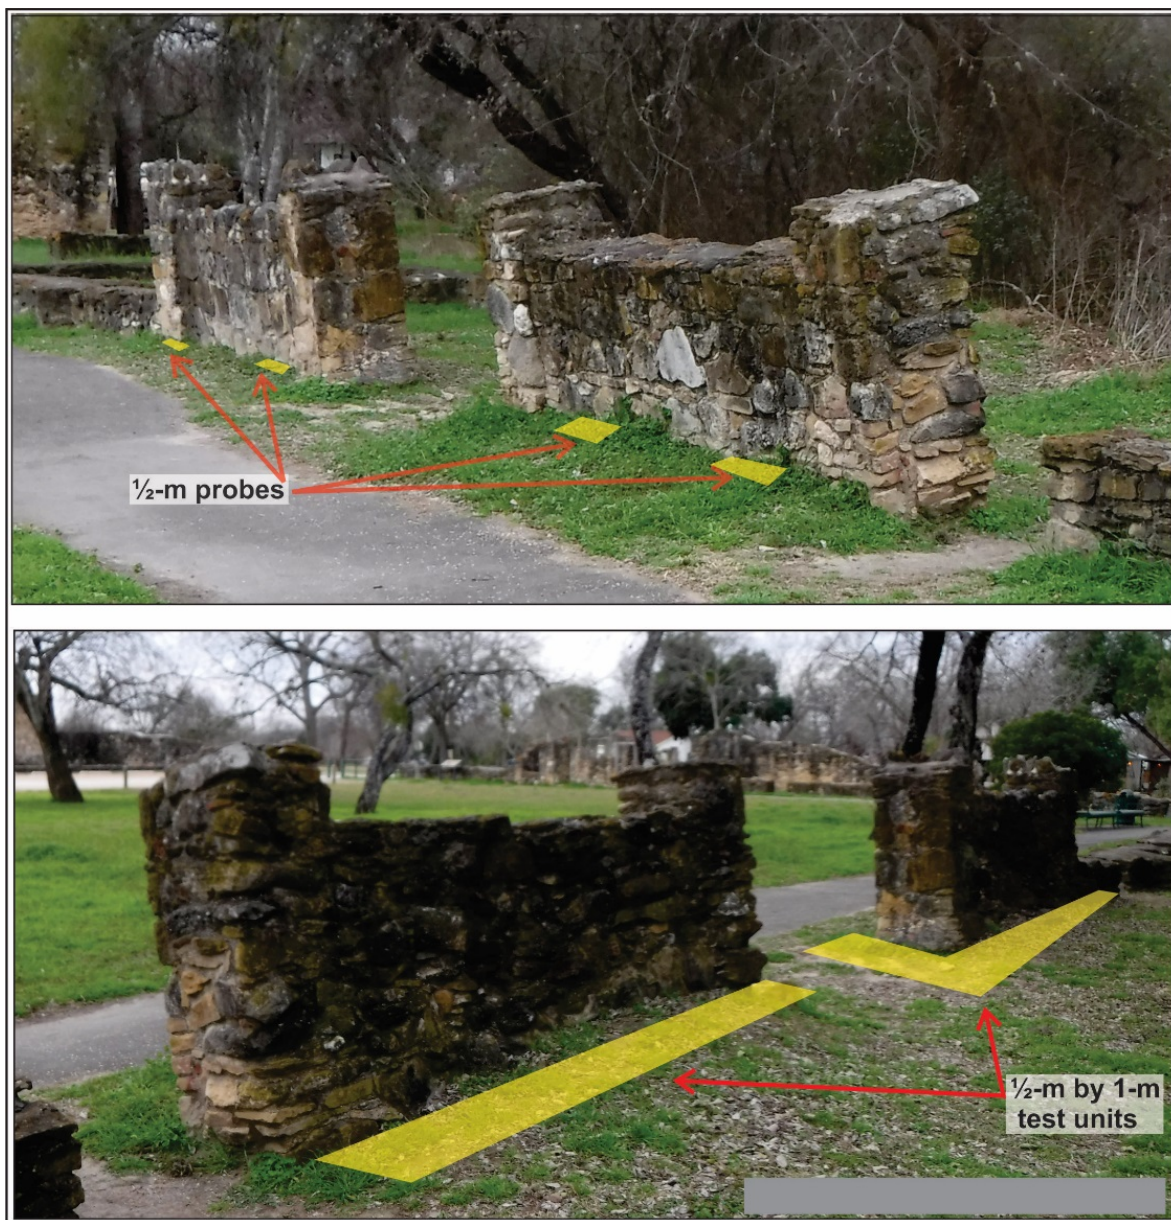
Figures 4.1 and 4.2: North gate showing the approximate location of probes and test units.

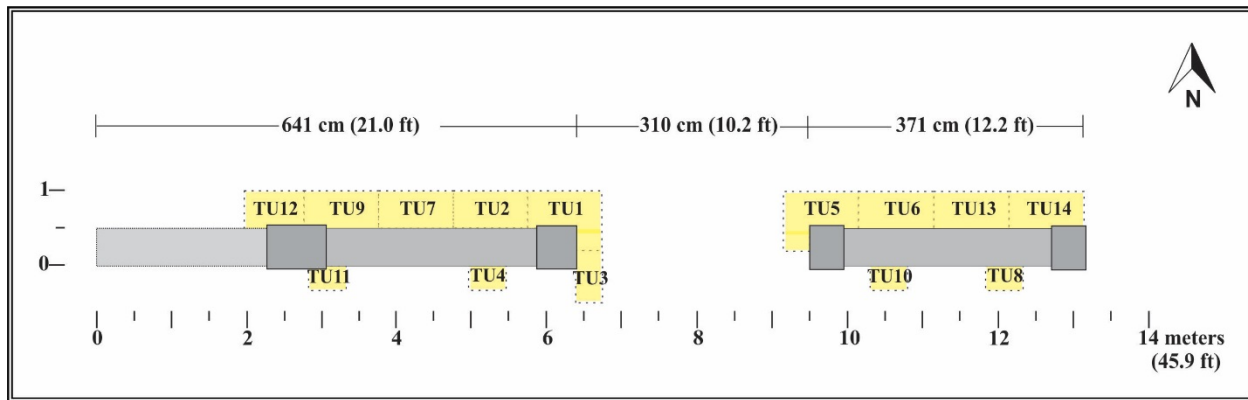
The four probes were intentionally small test units, 30 cm by 50 cm (11.8 by 19.7 in.), because these were placed along the tilting side of the wall segments (Figure 4.3). These test unit probes (TU4, TU8, TU10, and TU11) were excavated in one continuous level and to a depth of between 25 and 30 cm (9.8 and 11.8 in.). Excavated soils were screened through ¼-inch hardware cloth and the recovered artifacts transported to the CAR lab for processing.

Figure 4.3: Plan view of probes and test units; wall segments to scale.

Although not part of the formal testing, the area between the gate opening shown in Figure 4.3 was probed with a quarter-inch diameter rod to determine if the wall footing extended into this area. Five probes were arbitrarily made between the gate columns to depths of about 15 to 20 cm (5.9 to 7.9 in.). None of these probes hit any obstructions.

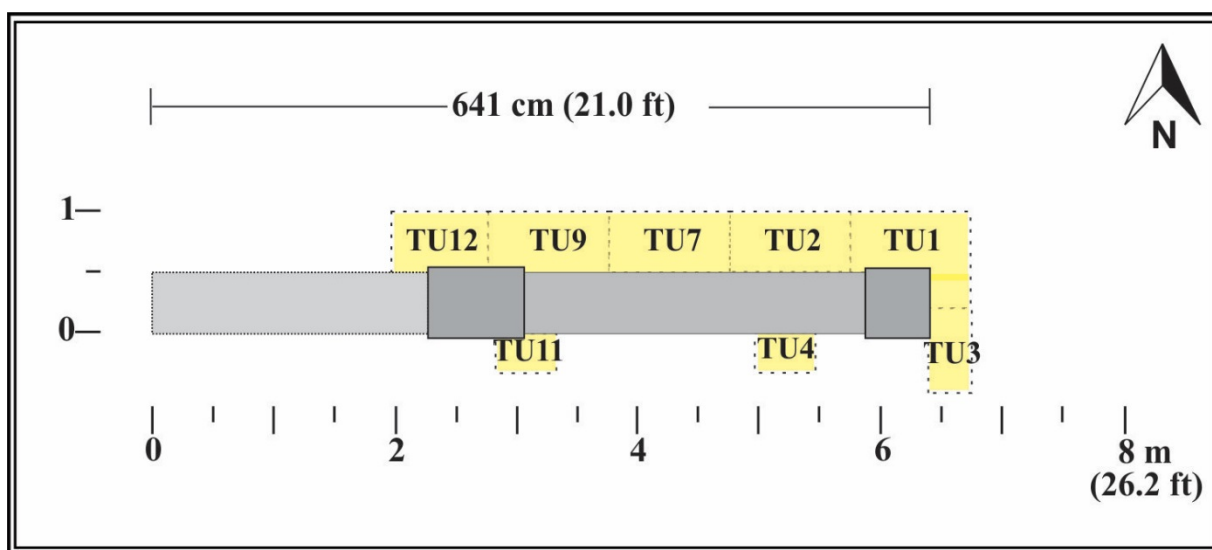
Five test units were excavated along the north-facing wall along with two half-meter probes at the south-facing wall (Figure 4.4). This discussion begins with Test Unit 1 (TU1), followed by TU2 and TU3. Test Unit 3 (TU3) was an extension of TU1 and was meant to explore the extent of the wall footings at that location. The discussion then shifts to TU7, TU9, and TU12. These test units were excavated in 10-cm (3.9 in.) levels to a depth of between 20 and 30 cm (7.9 and 11.8 in.) below surface; depths varied due to overburden and below grade wall footings. The two probes, TU4 and TU11, are considered last and these were excavated to about 20 cm (7.9 in.) below surface. Recovered artifacts will be noted in the following discussion, but the substance of these finds will be reserved for the conclusion of this section. Note that the Figure 4.4 plan view includes a section of low wall that abuts the west end column.

Figure 4.4: Plan view of west end wall segment.

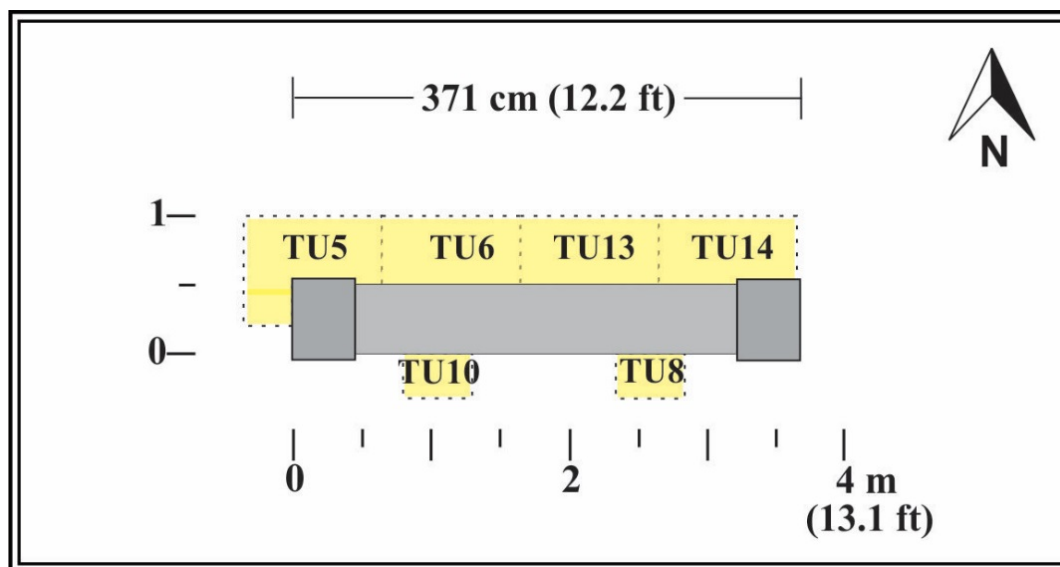
Four test units were excavated along the north-facing wall of the east wall segment (Figure 4.5). Two half-meter test unit probes were also excavated at the south-facing wall. Discussion begins with Test Unit 5 (TU5), followed by TU6, TU13, and TU14. The two test unit probes, TU10 and TU8, are considered last.

Figure 4.5: Plan view of east end wall segment.

Test Unit 5 was 50 cm by 100 cm (19.7 by 39.4 in.); note that part of the excavation wrapped around the column (see Figure 4.5). The limestone rubble wall footing was partially visible prior to excavation. These excavations removed 9 cm (3.5 in.) of fill. The footing extended about 20–25 cm (7.9–9.8 in.) away from the wall. The exposed wall footing seemed to have been inaptly formed, as the stones appear to have been haphazardly thrown into the wall trench, rather than stacked. The excavated soils were a loose sandy clay loam and included small to fist-size limestone cobbles, comprising 15 percent of the fill.
