National Park Service  
United States Department of the Interior  
San Antonio Missions National Historical Park  
Texas

# Historic Structure Report Mission Concepción Convento

100% Submission  
2019

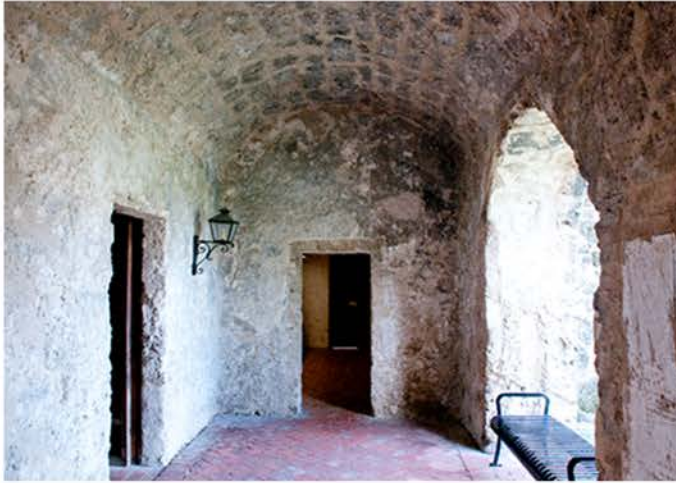
Figure 4.1: West corridor looking south (UTSA CCS)

South bay of west corridor walled off and arch filled to create refectory (Ivey 2018, p. 287)

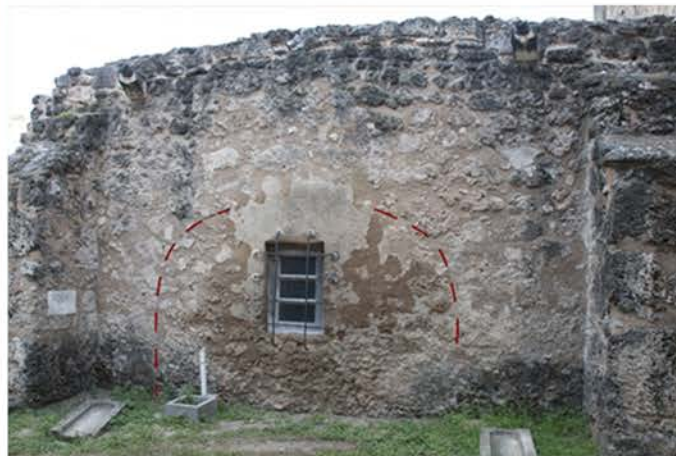
Figure 4.2: East corridor closed arch (UTSA CCS)

North bay of the eastern arcade converted to guest room (Ivey 2018, p. 289)

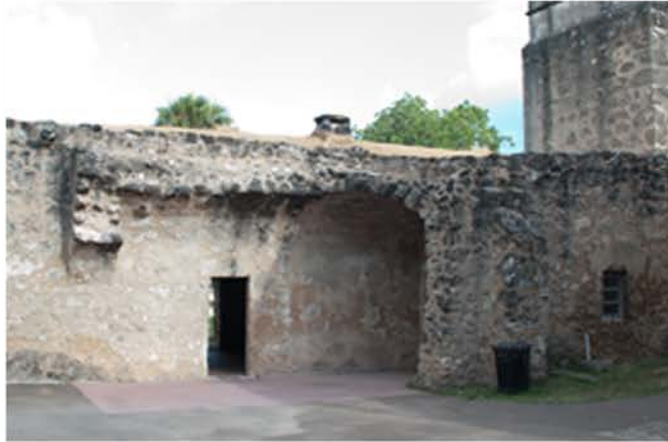
Figure 4.3: Remains of the east corridor (UTSA CCS)

Southeast corner of east corridor collapses (Ivey 2018, p. 282)

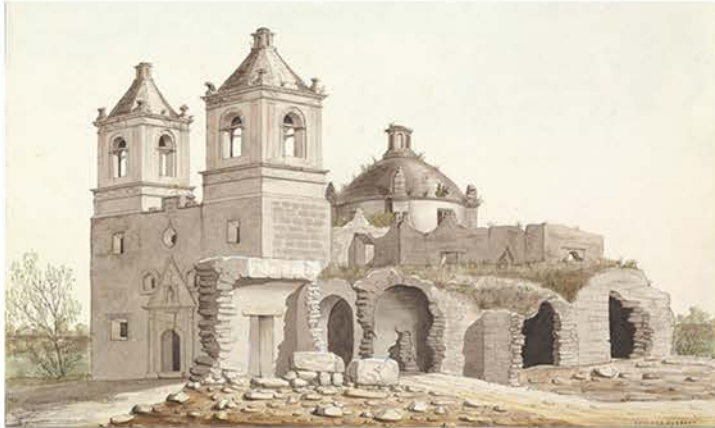
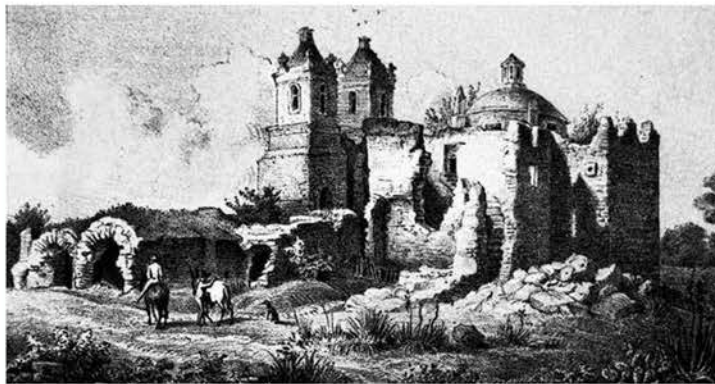
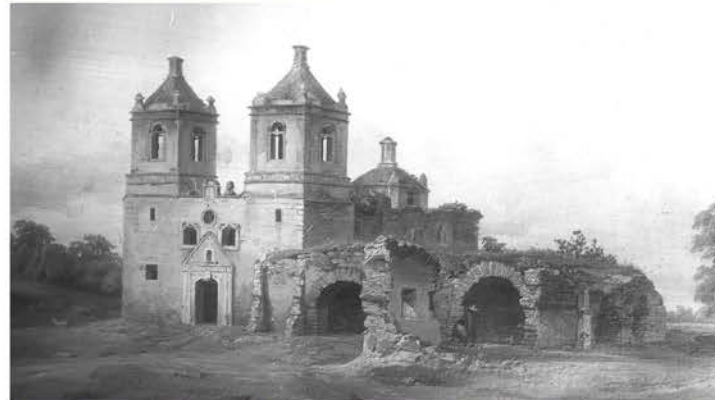
Drawings from this period show that the south walls of the refectory and the main row of cells have collapsed (Figures 4.4-4.6)

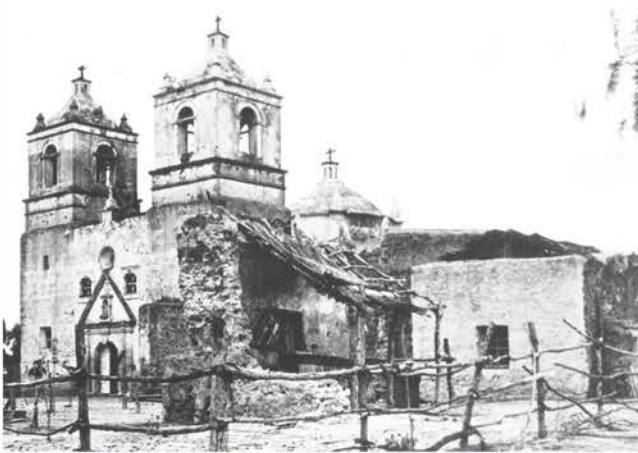
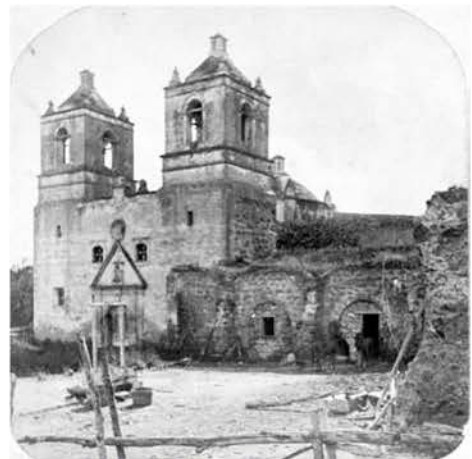
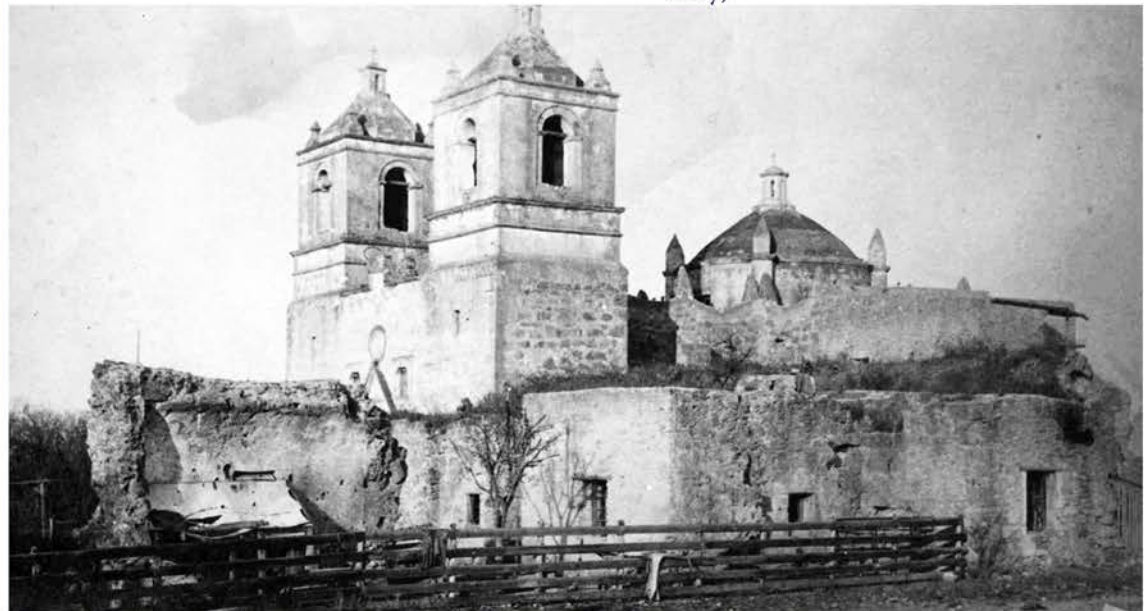
Pictures from 1868 to early 1880s show that the south end of the west corridor and the west end of the south wing have been closed (Figures 4.7–4.9)

Pictures from this period show that a new roof has been installed in the southeast corner of the portalito, which had collapsed after the removal of the granary.

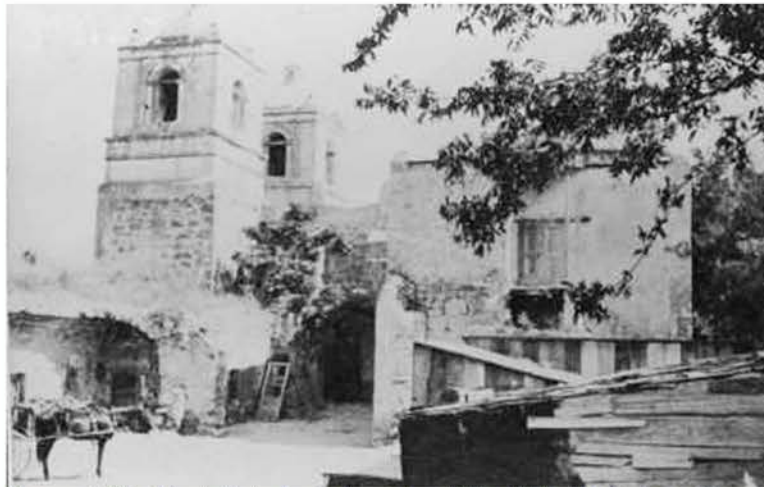
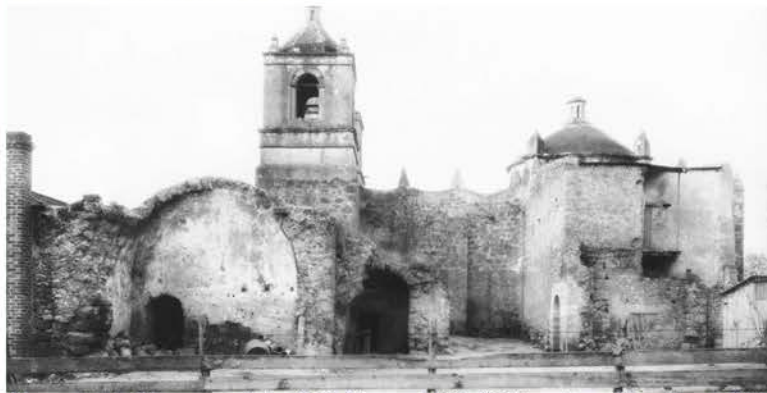
Pictures from the 1890s show that the part of the refectory and the south wing have been reroofed. (Figures 4.10-4.12)

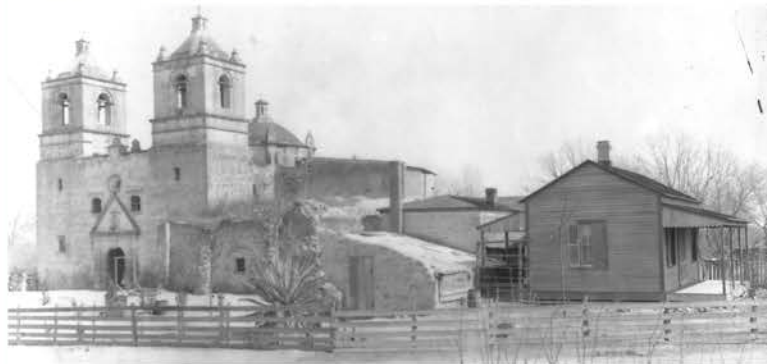
Figure 4.12: Photograph by Ernst Wilhelm Raba, 1911 (Raba Collection, San Antonio Conservation Society [SACS])

Pictures from the 1890s show that the ruins of the south wing have been closed, creating a room with a sloped roof.(Figure 4.12)

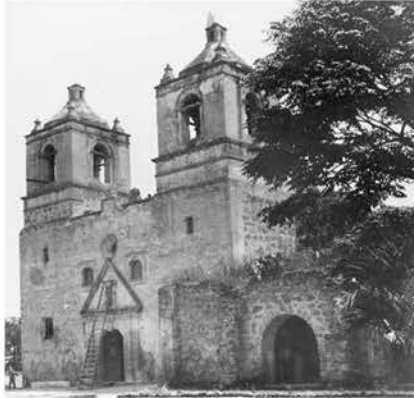
Figure 4.13: Unattributed photograph, ca.1910 (Southern Methodist University))

The arches of the west corridor were reopened ca.1910

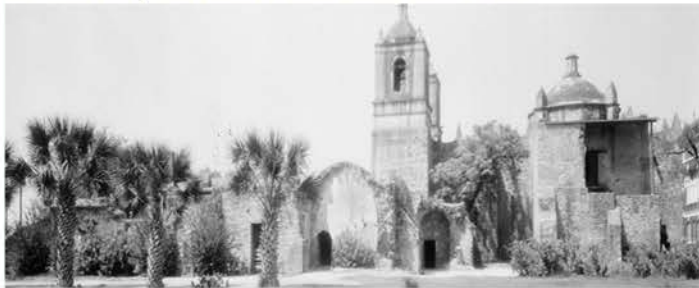
Figure 4.14: Photograph by Arthur W. Stewart, 1933 (HABS photographs, Library of Congress)

Picture from 1936 show that the window of the south wall of the refectory has been transformed into a door

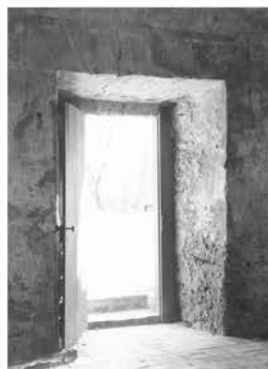
Figure 4.57: View of the door of the east wall of the Library (104 E). Date of photograph unknown (Institute of Texan Cultures)

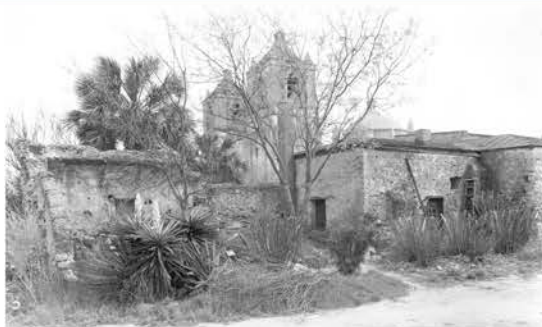
Figure 4.59: View of the southwest part. Photo indicates the western buttress of the kitchen's south wall was lower than the current one. 1945-50 photograph (National Park Service Archive)

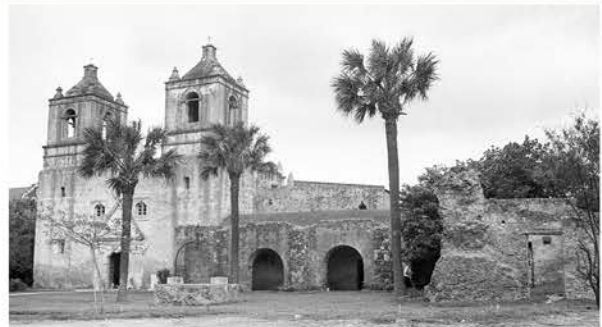
Figure 4.60: View of the southwest part. Date of photograph unknown (Institute of Texan Cultures)

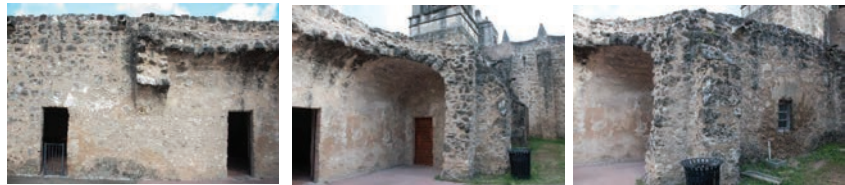
On the east façade of the L-shaped structure, traces of an old arch exist in the guest room since this east row was initially an arcaded corridor similar to the west side. In the upper part of the wall outside the guest room to the south, there are remnants of a barrel vault, now collapsed and missing, which used to continue south. The wall has one door formed with a jack arch, which is the only entrance to the guest room. In the southeast corner of the guest room there is a buttress perpendicular to the wall, similar in purpose and shape to those on the west façade of the structure. On the surface of what was meant to be an interior wall, different types of mortars and remains of plaster are visible. The exterior wall of the library and portería has two door openings made with limestone jack arches.

Figures 5.3 5.5: Images of east exterior walls.

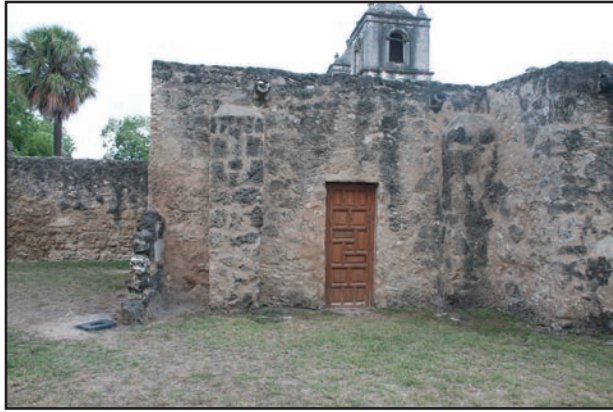
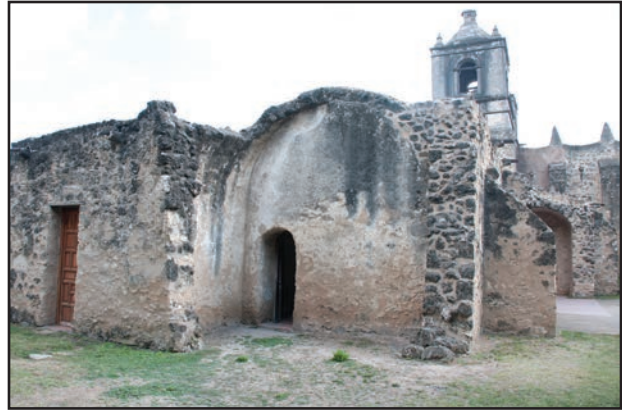
Figures 5.6, 5.7: Entrances to the kitchen (above left), refectory, and library.

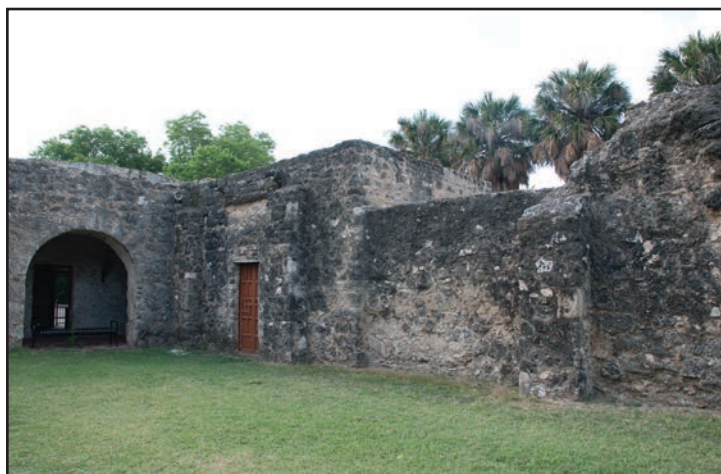
and is connected with it at its northeast corner. The kitchen has a door with timber lintel. Above the door, approximately 3.3 ft. (1 m) over it, there are two rows of flagstones. There are two buttresses, one in the east corner of the wall and the other between the door and the west corner.

Figure 5.8: North wall.

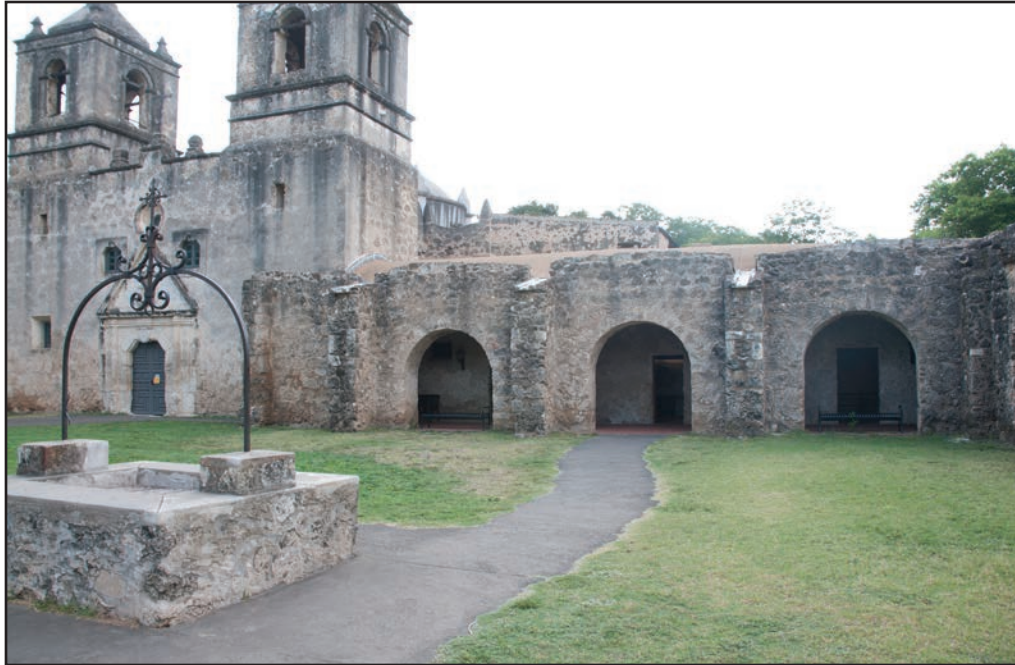
Figure 5.9, 5.10, 5.11 (From top): West wall, north wall of west corridor, and north exterior wall of guest room.

by five buttresses. The northern part is a blind wall, and there are three arches of different spans in the other three parts. From north to south the width of the arches are 6.1 ft. (1.85 m), 8.65 ft. (2.6 m), and 7.65 ft. (2.3 m). All three are 9.5 ft. (2.9 m) high. The first, third, and fourth buttresses, (starting to count from the north) correspond to a transverse arch in the corridor. The first, second, and third buttresses have canales in their upper parts for rainwater evacuation off the roof.

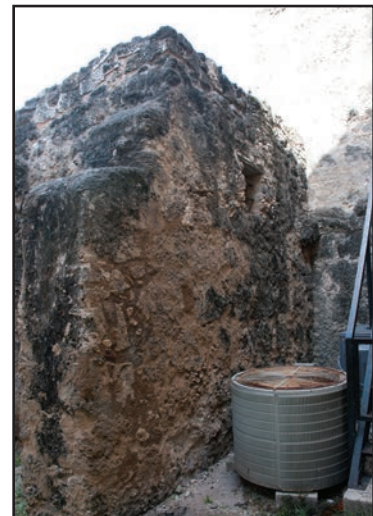
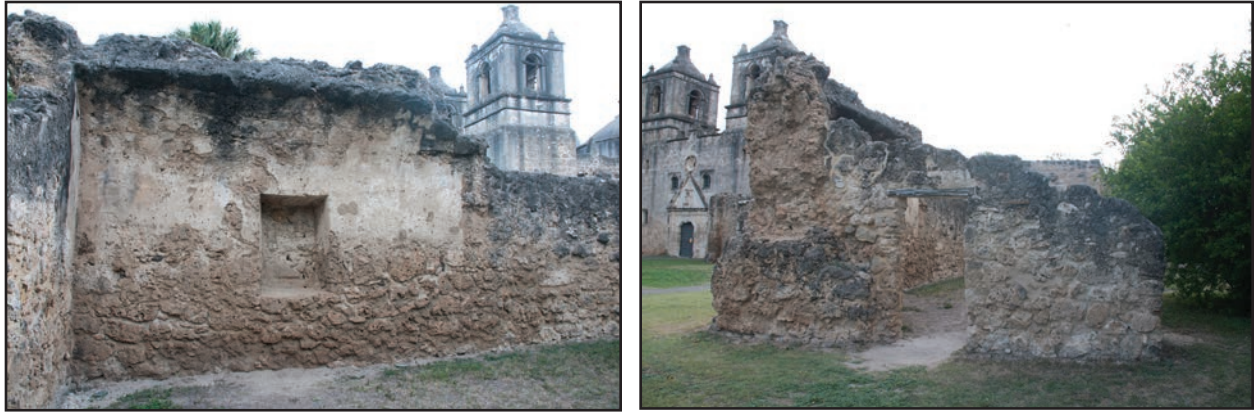
Figures 5.12, 5.13: Former interior north wall (photo at left) and west wall of ruins.

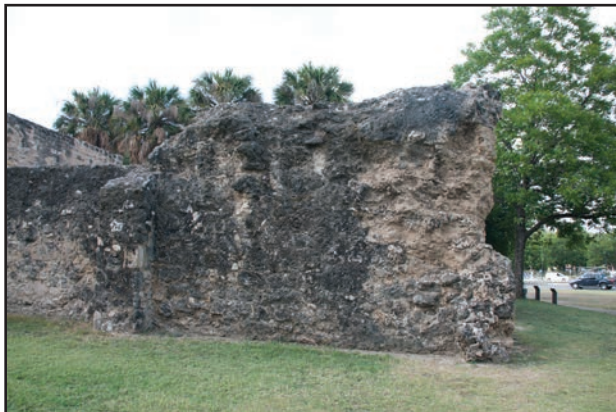
The north side of the freestanding wall has a buttress located where the height of the wall changes, corresponding to the point on the other side of the wall where evidence remains of a perpendicular partition wall.

Figure 5.14: North façade wall.

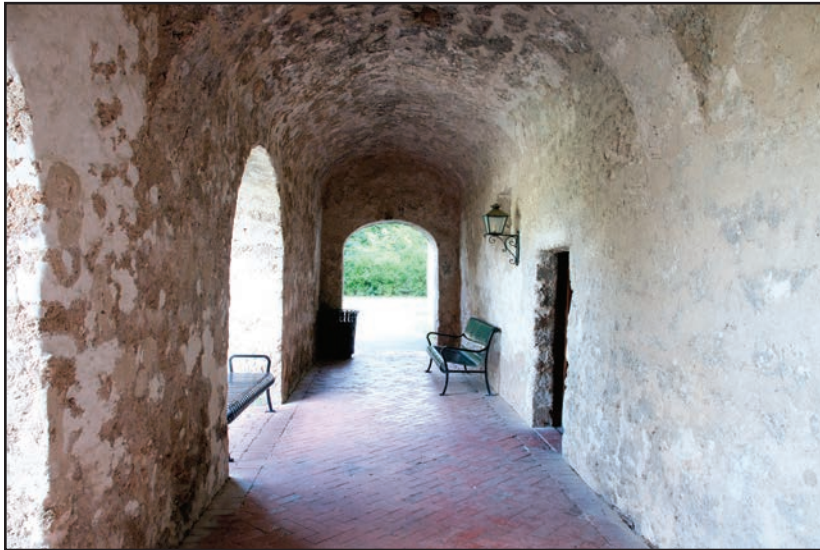
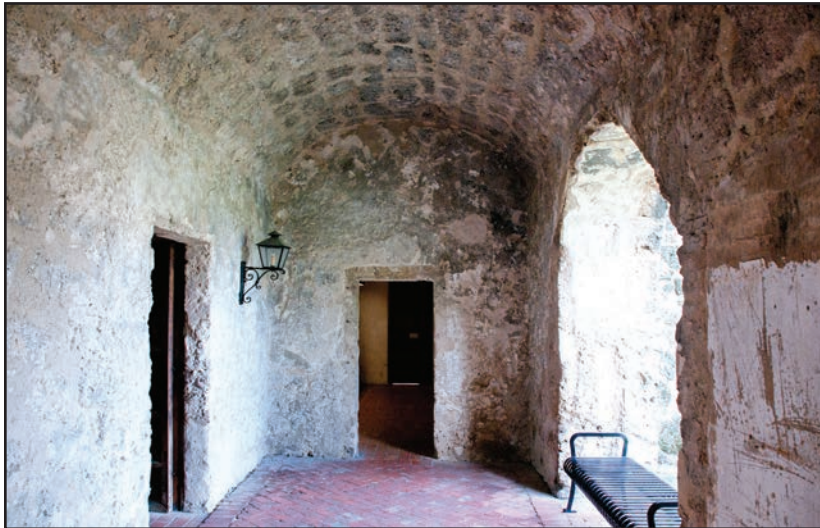
bays and a barrel-vaulted ceiling 11.7 ft. high (3.5 m). To the north, it is delimited by an arch that leads to the external area in front of the church's façade, and to the south, there is an arched wall with a rectangular door connecting it to the refectory. The external wall of the corridor is the arcade, and the facing wall has door openings to the interior rooms. The doors that lead to the three internal spaces of the main row are made with jack arches and have different dimensions. The door to the storeroom is the smallest of the three. The vaulted ceiling and some parts of the walls of the corridor have remains of plaster. In addition, one can see the presence of different types of mortars, limewash tests, and patching made with lime-based mortars. Also, in some areas around the doors and below the

Figures 5.15, 5.16: The corridor looking north (top photo) and south.

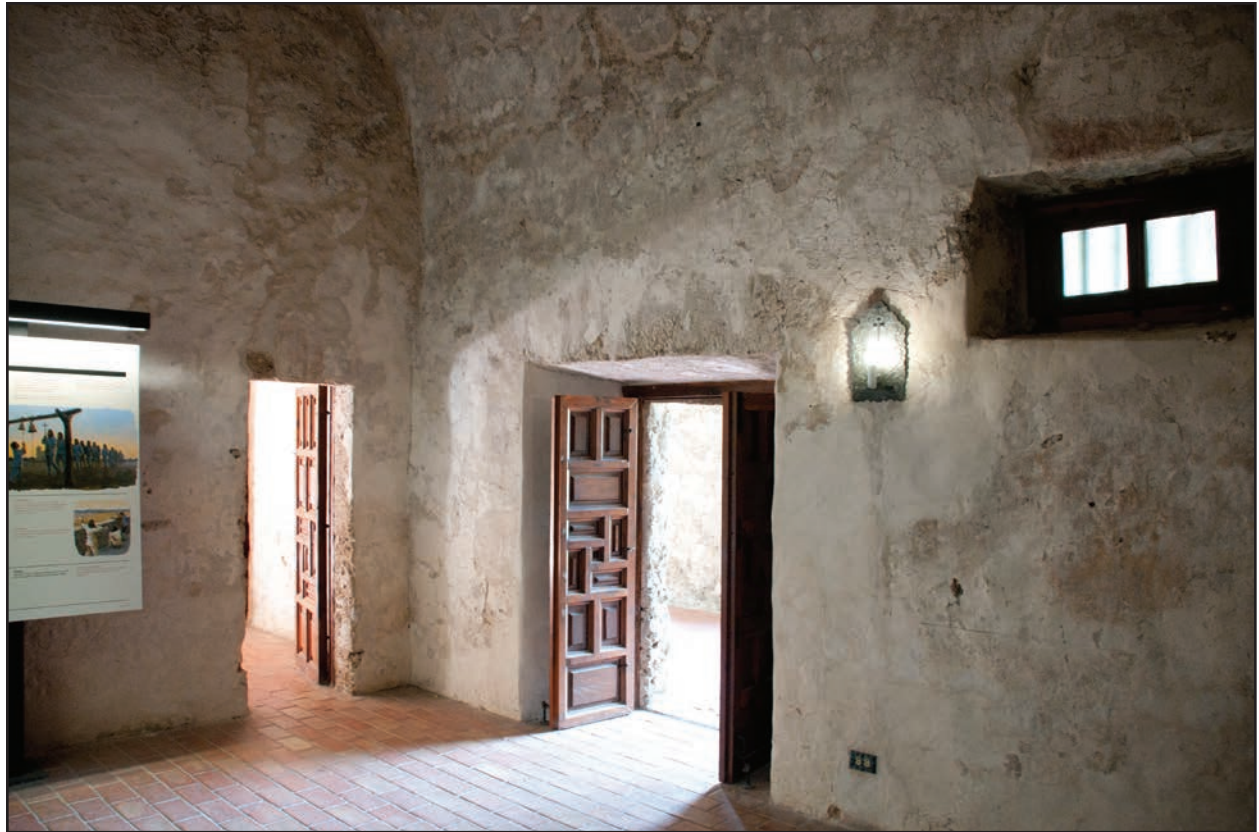
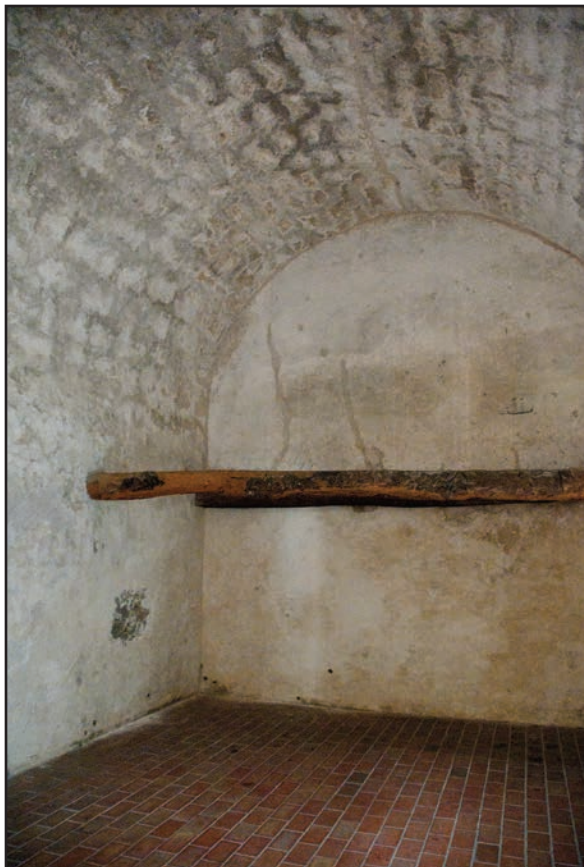
The “storeroom” cell is the northern cell of the main barrel vault. It is 14 ft. (4.2 m) wide and 25.3 ft. (7.7 m) long. The room has a barrel-vaulted ceiling and four openings: a door, a small window that connects it to the corridor, another door in its south wall that connect it to the portería cell, and a hole in the vault that goes through the roof. Both the walls and the vault of this space are covered with white plaster. In the north wall of the room and in the vault are two cracks that have been filled. A significant feature of this room is the presence of two timber beams crossing the space, one near the north wall (only separated from it by a couple of centimeters) and the other around the middle of the room, which are original from the colonial period. Also notable is the historical graffiti on the north end wall.

Figures 5.17, 5.18: The storeroom looking toward the southwest (top photo) and the north.

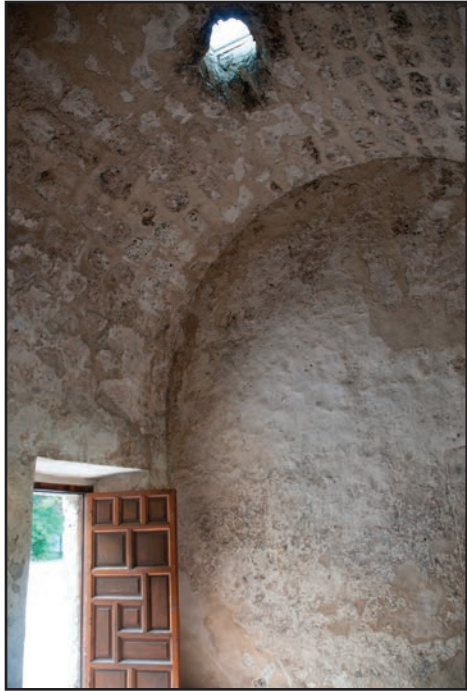
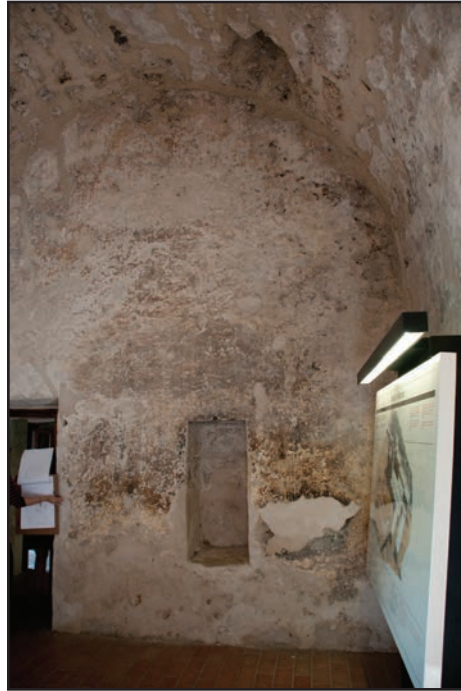
Figures 5.19, 5.20:  
Portería looking south  
(photo at far left) and  
north.

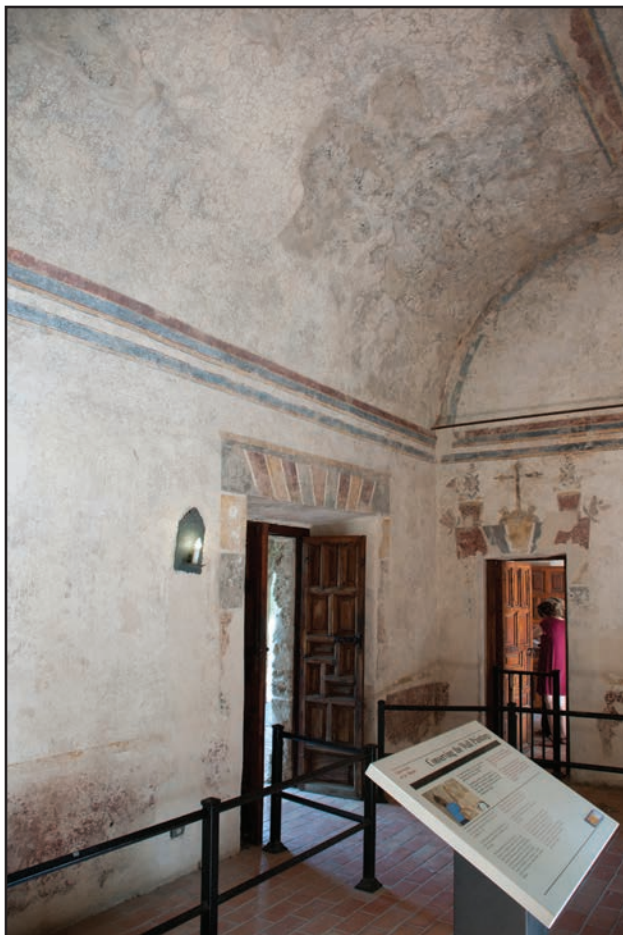
Figure 5.21: Library looking toward the northwest.

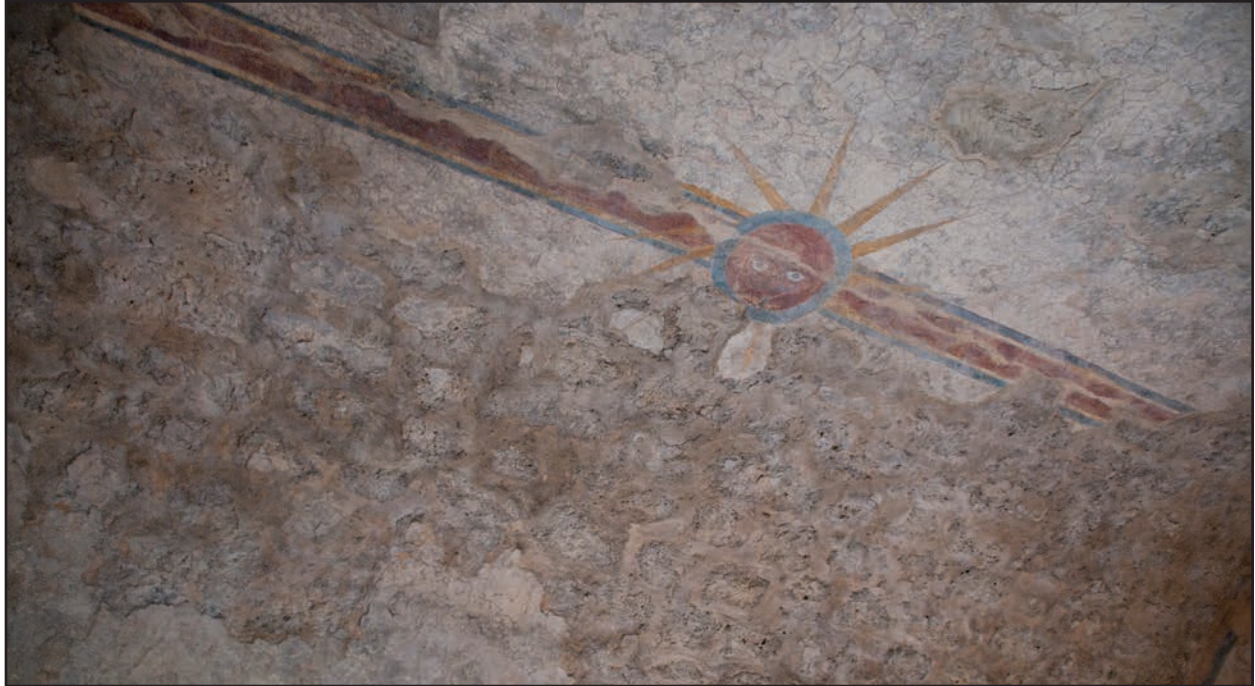
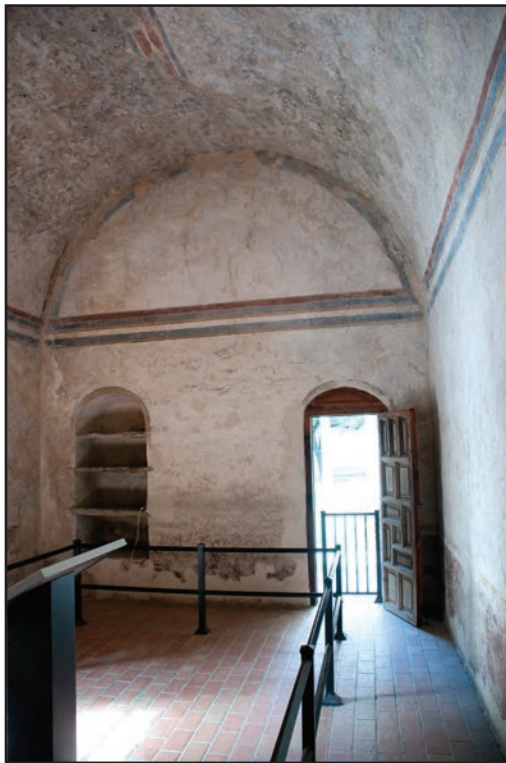
Figures 5.22, 5.23: South-facing view of library (photo above) and image of its vault (top photo).

cant remains of painted plaster. The decorations—based on red, blue, and yellow colors—exist around the doors, in the lower part of the wall (similar to a chair rail location), at the springline of the vault, in the end walls and in the highest areas of the vault. Decorative painting features dados on the walls and faux voussoirs architrave at the door heads. The painting technique consists of plastered surface prepared with limewash including pigments and possibly organic binder.

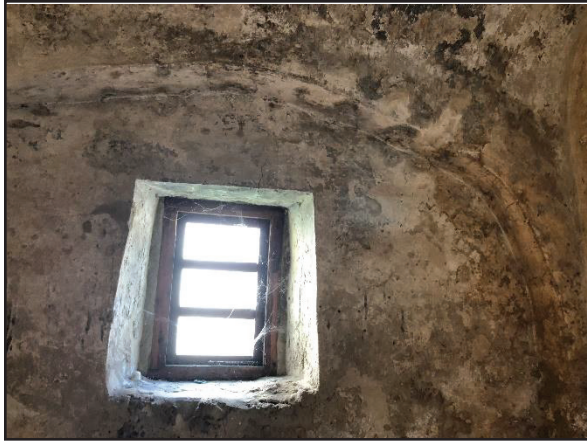
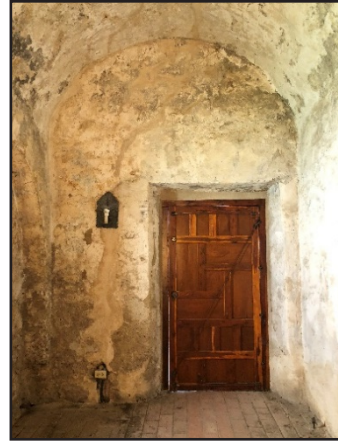
Figures 5.24, 5.25:  
Guest room looking  
toward the east (far left  
photo) and south.

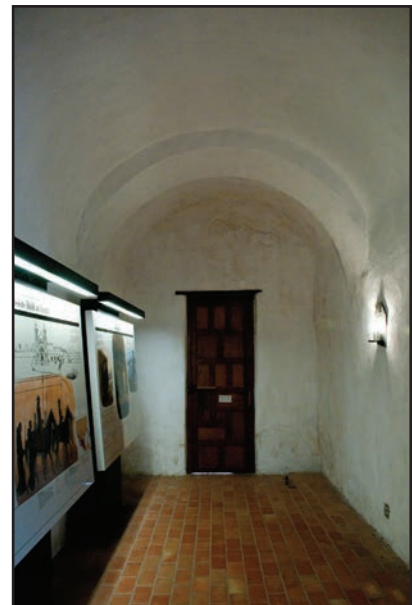
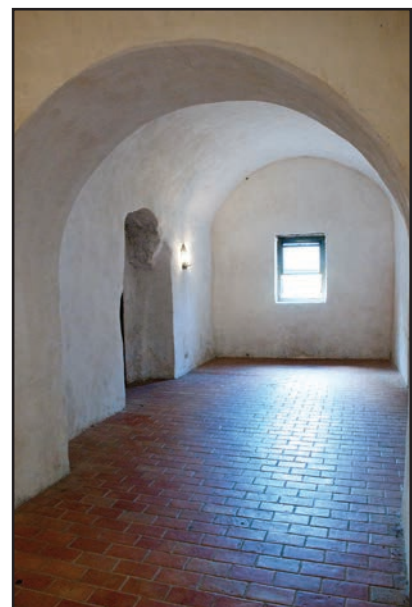
Figures 5.26, 5.27: Walls  
of the refectory (below)  
and kitchen (bottom  
photo) interiors feature  
a cement-based wash,  
painted white.

All the walls of these two spaces have a cement-based wash, painted white.

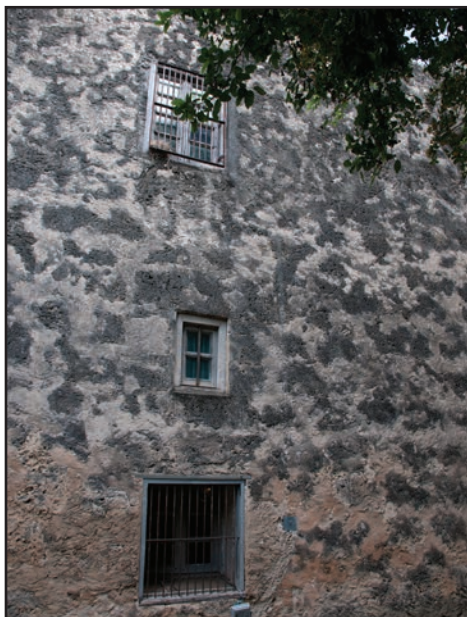
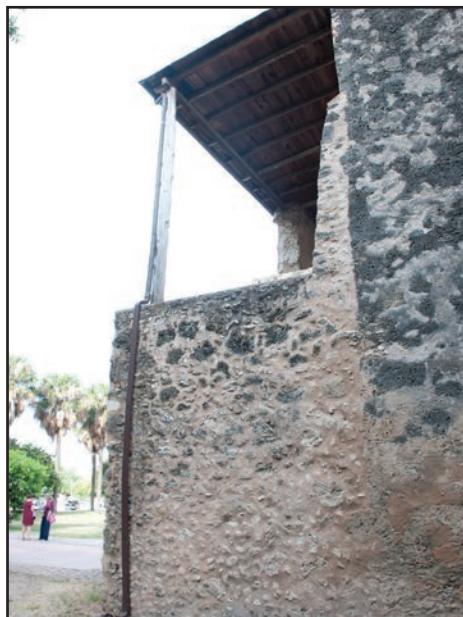
The east wall has two differentiated parts. The northern part is a continuation of the two-story high transept wall of the church. It has three openings, two small windows at the ground level and one window at the upper level. The southern part, however, is a one-story high wall that corresponds to the east exterior wall of the staircase. The masonry of this part, which is composed of small rubble stones and brown mortar, also differs from that of the northern part of the wall, which is built with larger stones and a mostly gray mortar, except in the bottom part of the wall where it has been repointed with brown mortar. In the southern end of the wall there is a wooden column over the one-story high wall that helps support the sloped roof.

Figures 5.28, 5.29:  
Exterior east wall of the  
Father President's office.

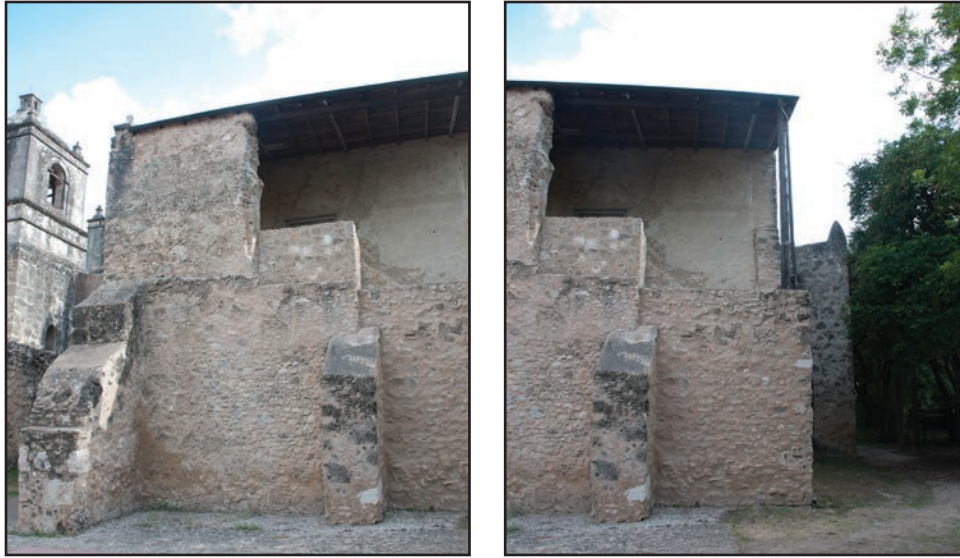
Figures 5.30, 5.31: Exterior south wall of the Father President's office.

The south wall, like the east wall, has two different parts—the east part, which represents almost 2/3 of the wall and is only one-story high, and the west part, which is two-stories high. In the eastern corner of the one-story part of the wall there is a wooden pillar that helps support the sloped timber roof, and in the eastern side of the two-story part of the wall, there is the start of an old window or arched opening that no longer exists. The wall is visually divided by two big buttresses, one 18.6 ft. high, placed in the western corner of the wall and another, 12 ft. high, located almost in the middle of the wall. The wall is built with small rubble stones—except in a small part around the height of 12 ft. in the western part of the wall, where some big stones can be found.

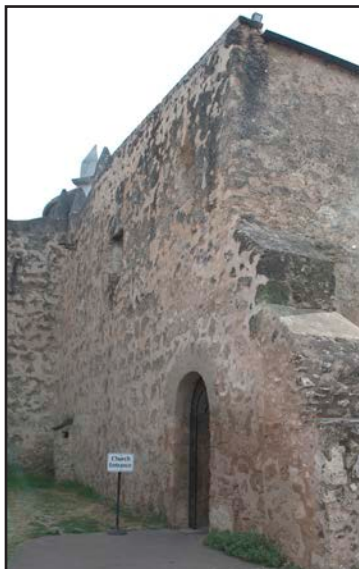
Figure 5.32: Exterior west wall of the Father President's office.

The west wall is a two-story wall that is a continuation of the transept wall of the church, and it is reinforced in the south corner by the 18.6 ft. high stepped buttress. The wall has three openings, one arched door in the south corner of the ground level and two windows in the upper level, one (Moorish element of Spanish Colonial style) window in the south part of the wall and a square window in the northern part of the wall. The masonry in the bottom part of the wall is more regular and is made with bigger stones than the upper part of the wall. This wall has been repointed with different types of mortars, including a cement mortar patching used to cover the bricks that formed the arch of the door.

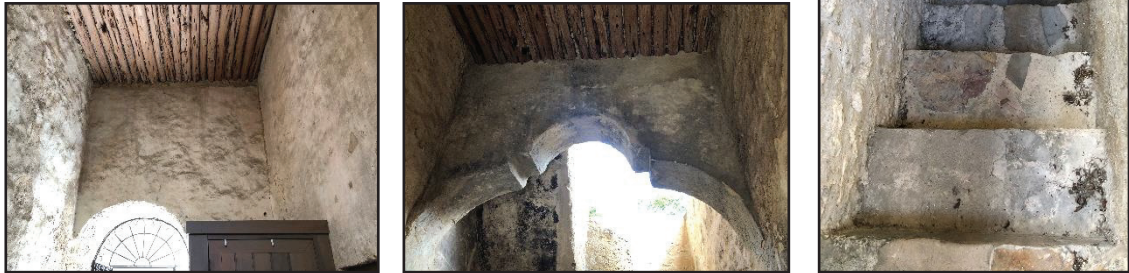
Figures 5.33–5.35: Staircase (photo at right) leading from the ground floor to the portalito outside Father President's office. Photo at left is the west wall of the staircase's ground level, and middle photo shows the Moorish arch under the landing of the upper-floor level.

upper-floor level. The walls are rubble stones finished with plaster, except in the west part of the south wall, where the stones are visible. The west part of the south and west wall have been painted recently. Flagstones treads were added to give the stairs a more regular shape.

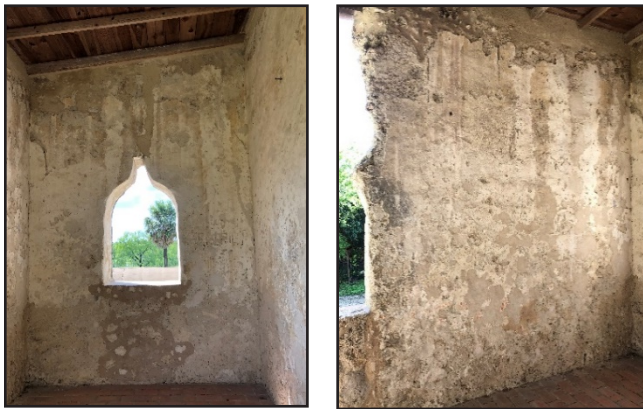
Figures 5.36–5.38: The portalito, a foyer outside Father President's office, includes a Moorish style window in its west wall (photo above left). Photos below left and above right show the room's south wall.

one Moorish style window in the west wall, which provides a view to the convento barrel-vaulted roofs. Both the east part of the south wall and the east wall of the room are missing. The three walls that delimit it have remains of plaster with some areas of painted plaster. These walls, especially the north one, have several mortar patchings that have been added over the different restoration campaigns. The portalito has a sloped roof built with timber beams and joists.

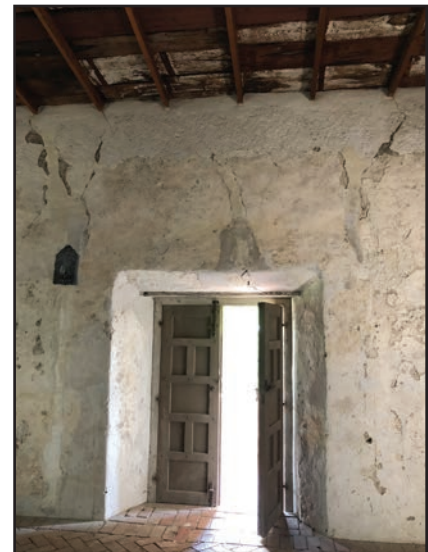
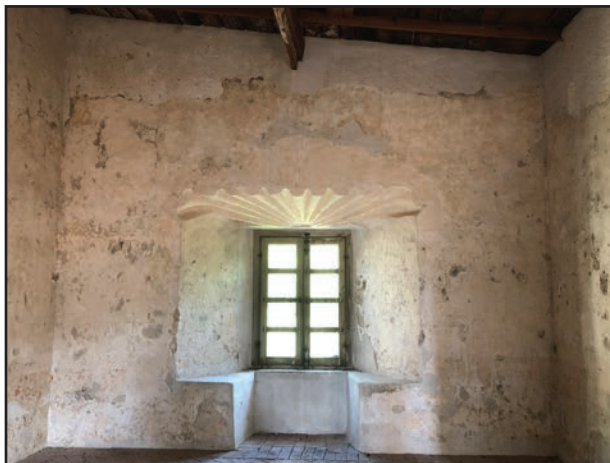
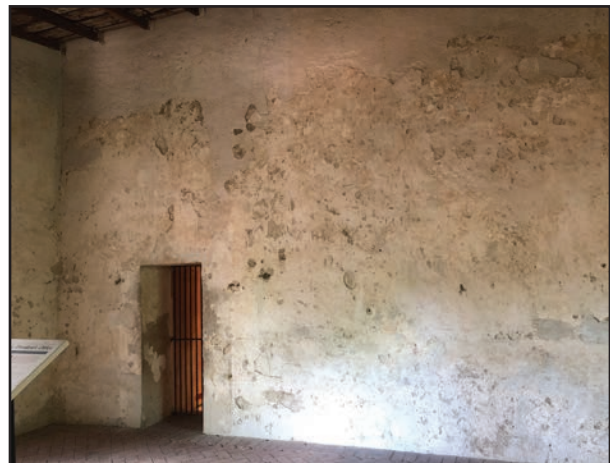
Father President's office is located above the sacristy, south of the church and north of the portalito. It is 18.2 ft. wide and 26 ft. long, and it has four openings—one rectangular “tribune” door that connects (audibly and visually) with the church chancel, one rectangular window in the west wall, one rectangular door in the south wall that connects with the portalito, and one rectangular window with decorative plaster seating and a transom formed in a clamshell shape. All walls have remains of plaster with some areas of painted plaster, and in the upper part of the walls there are remains of a latex paint applied in the 1980s. The shed roof consists of wood rafters and boards.

Figures 5.39–5.41: The Father President's office includes a tribune door leading to the church (photo lower right) as well as a window with decorative plaster seating and a clamshell-shaped transom. All four walls include remains of plaster. Photo upper right shows the south wall, which has a door connecting to the portalito.

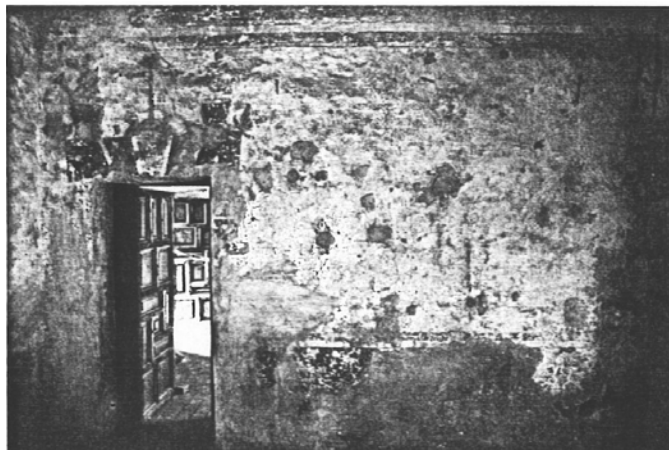
Figure 6.A.2: Mission Concepción library, view looking north, prior to 1988 conservation works. Reprinted from *Summary Project Report for the Paint and Plaster Conservation...*, by Anthony Crosby, 1988, p. 5.

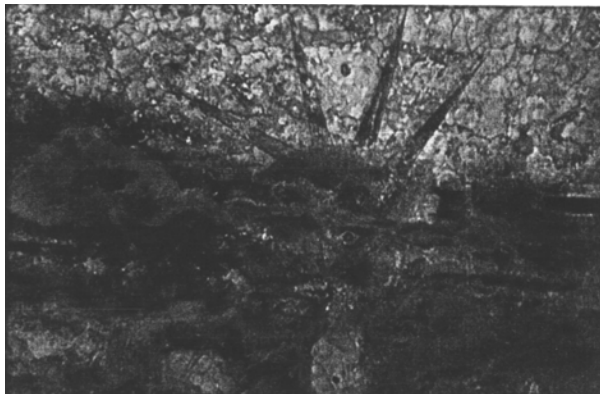
Figure 6.A.6: Vaulted ceiling in the library at mission Concepción with a detail of the “Eye of God,” showing patches and 20<sup>th</sup>-century repairs. Reprinted from *Summary Project Report for the Paint and Plaster Conservation...*, by Anthony Crosby, 1988, p. 12.

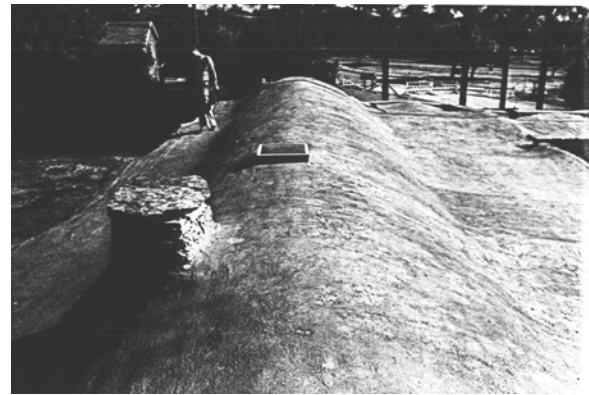
Figure 6.A.7: Roof condition in 1988. A design for roof replacement was carried out in 1988. Reprinted from *Summary Project Report for the Paint and Plaster Conservation...*, by Anthony Crosby, 1988, p. 10.

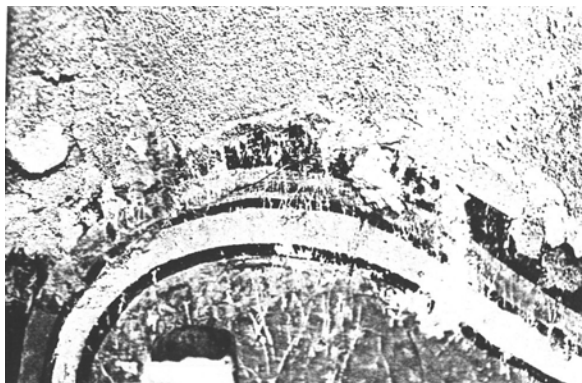
Figure 6.A.8: A painted volute after conservation treatment consisting of reattachment, consolidation, and application of stucco infill. Reprinted from *Summary Project Report for the Paint and Plaster Conservation...*, by Anthony Crosby, 1988, p. 15.

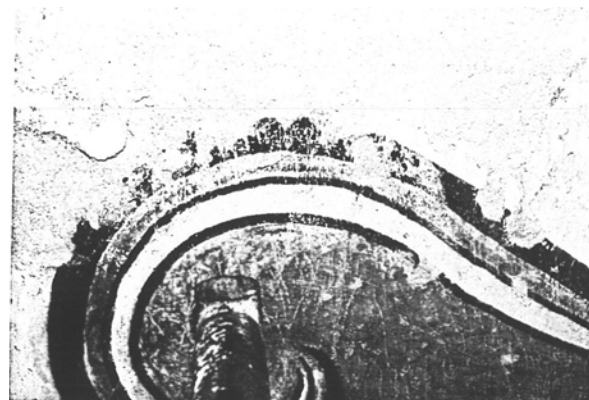
Figure 6.A.9: Example of reintegration of color carried out by the conservator. Reprinted from *Summary Project Report for the Paint and Plaster Conservation...*, by Anthony Crosby, 1988, p. 15.

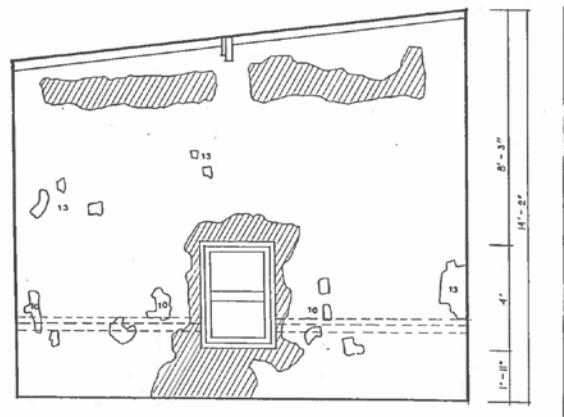
Figure 6.A.29: South wall. Corner of the room showing score lines of wainscot detail and original paint (C1).

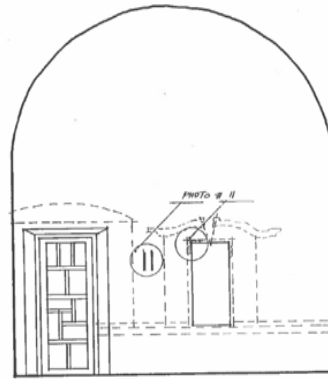
Figure 6.A.30: North wall—room #1

Figure 6.A.30: Room #1. North wall. Whitewash was removed from the North wall and patching of numerous areas added. Soot stains were visible at stove location.

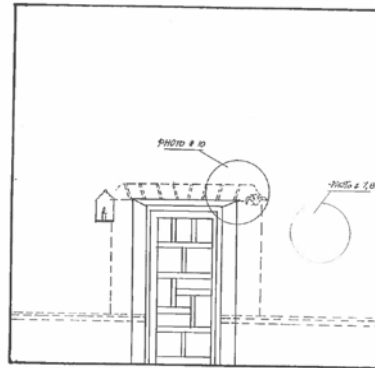
Figure 6.A.31: West wall—room #1

Figure 6.A.31: Room #1. West wall. Traces of wall decoration remained above the door of the west wall. Replastered areas.

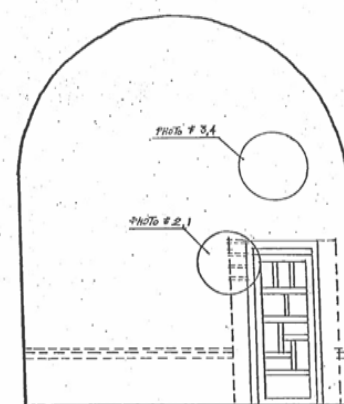
Figure 6.A.32: South wall—room #1

Figure 6.A.32: Room #1. South wall. Limewash and graffiti were removed and various patching treatments were carried out.

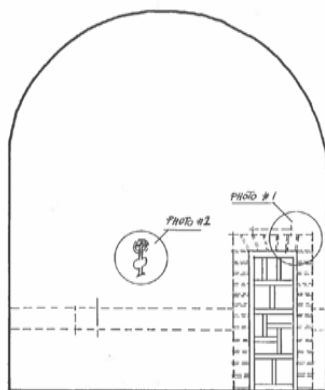
Figure 6.A.33: South wall—room #2

Figure 6.A.33: Room #2. Major restoration works were carried out in this room in the 1930s. The author reported major plaster repair works occurred in this room as part of the 1988 project. On the south wall, faint black line drawings in the center of the south wall and lines around the door frame were identified. The finish surface of these walls is smoother than in the portería.

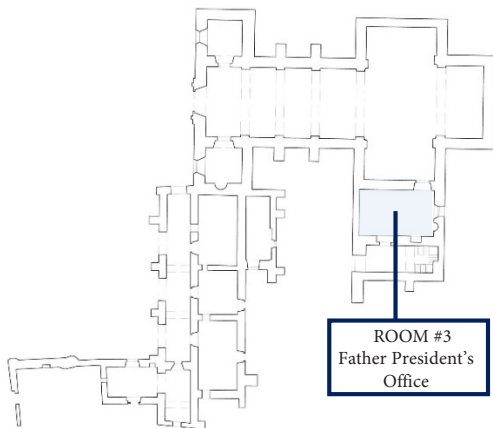
Figure 6.A.34: North wall—room #3

Figure 6.A.34: Father's President office. North wall. The east corner of this wall was cleaned removing the two layers of latex paint, exposing areas of original plaster.

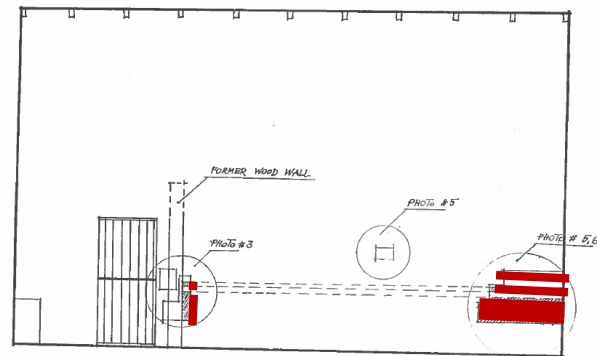
Figure 6.A.35: East wall—room #3

Figure 6.A.35: Father's President office. The cleaning treatment of the east wall exposed remnants of a wainscot with two stripes above it, all featuring red pigments.

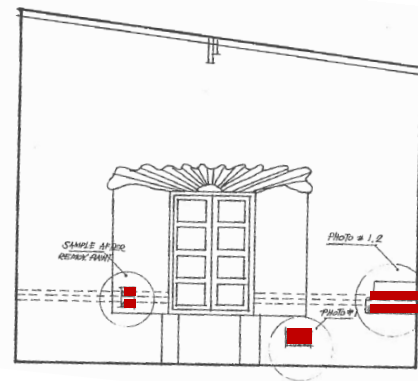
Figure 6.A.37: West wall—room #3

Figure 6.A.37: Father's President office. West wall. Samples of paint removal did not identify remnants of wainscot.

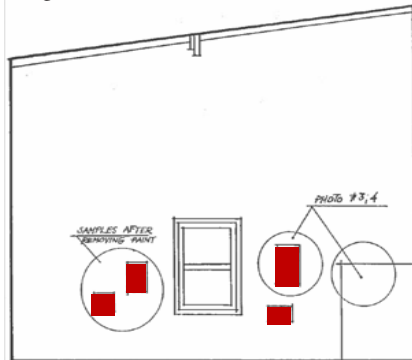
Figure 6.A.36: South wall—room #3

Figure 6.A.36: Father's President office. South wall. Wainscot was detected only on the eastern part. Probably a wood wall was interrupting the decorative motif of the wainscot.
