National Park Service  
United States Department of the Interior  
San Antonio Missions National Historical Park  
Texas

# Historic Structure Report Mission Concepción Convento

100% Submission  
2019

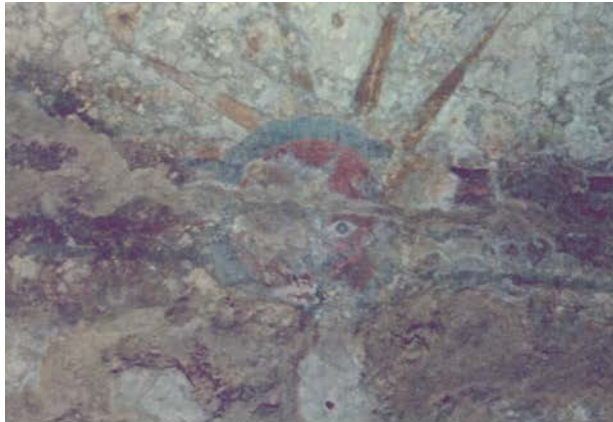
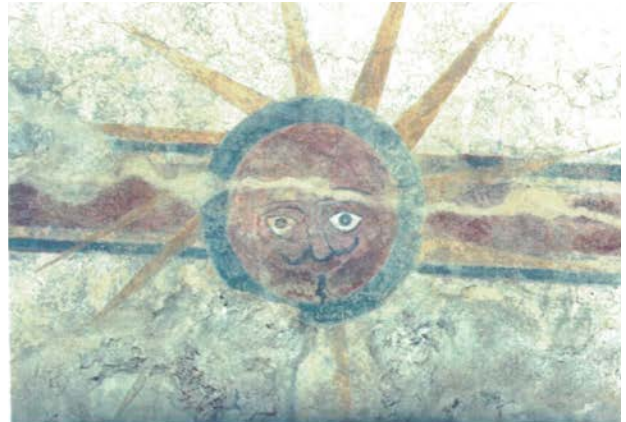
Figure 6.A.38: a) and b) Detail of the sun face —pre-treatment and post 1988 treatment condition. Reprinted from *1988 Conservation Project Completion Report...*, by Anthony Crosby, 1997, cover page.

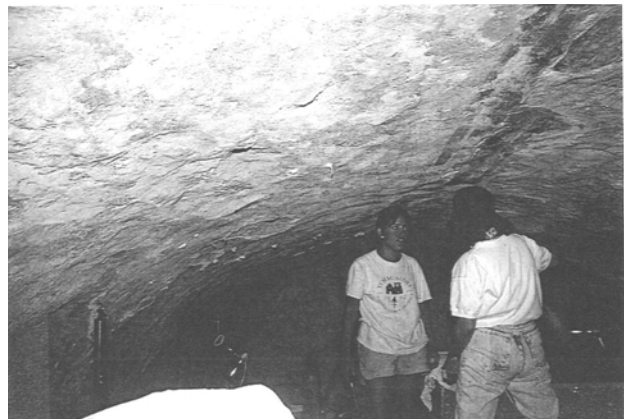
Figure 6.A.39: c) Library vault prior to conservation. Conservators B. Sullivan and C. Jary determining plaster delamination. Reprinted from *1988 Conservation Project Completion Report...*, by Anthony Crosby, 1997, p. 47.

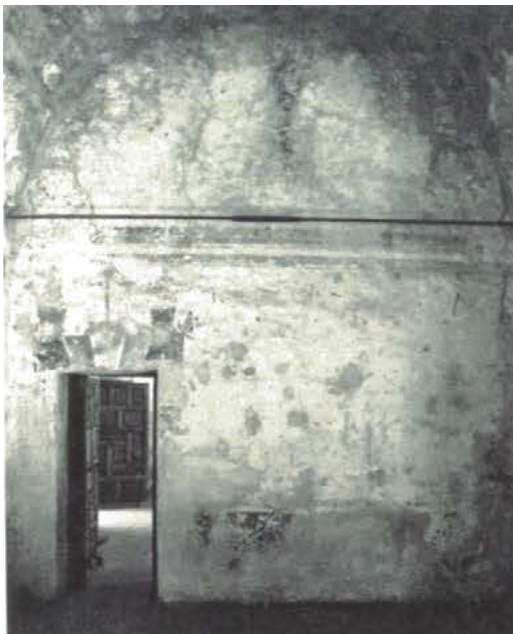
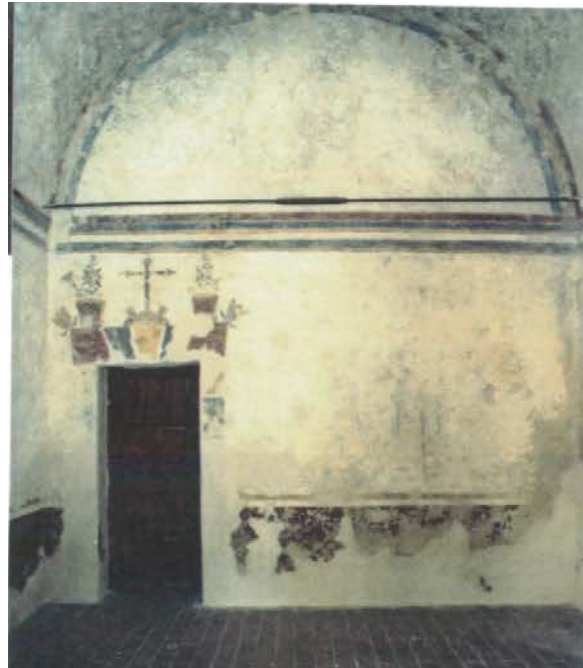
Figure 6.A.40: d) and e) Library north wall. Pre-treatment condition in July 1986 and post treatment in July 1988. Reprinted from *1988 Conservation Project Completion Report...*, by Anthony Crosby, 1997, p. 62.

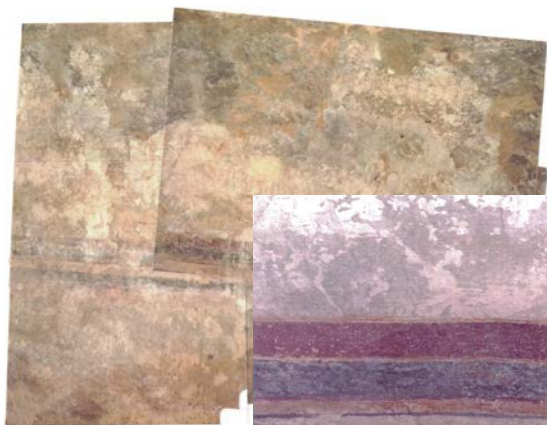
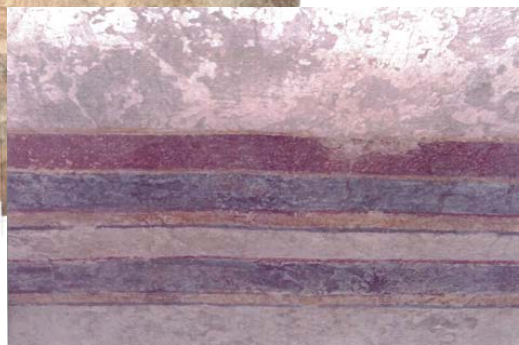
Figure 6.A.41: Cleaning—salts. Wall cornice prior to and after salt removal and cleaning. Reprinted from *1988 Conservation Project Completion Report...*, by Anthony Crosby, 1997, pp. 48-49.

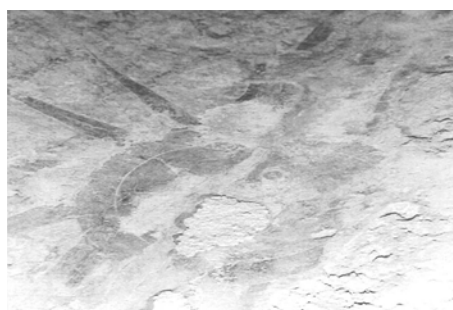
Figure 6.A.43: Cleaning—polticing with aluminum carbonate at sun face in library top vault. Reprinted from *1988 Conservation Project Completion Report...*, by Anthony Crosby, 1997, p. 50.

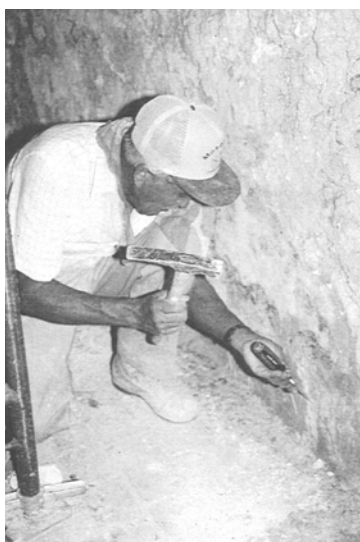
Figure 6.A.45: Hard plaster patching removal in the interior of the library east wall. Reprinted from *1988 Conservation Project Completion Report...*, by Anthony Crosby, 1997, p. 53.

| Treatment | Related Decay | Treatment description | Location |
|---|---|---|---|
| Removal of hard stucco repairs <sup>1</sup> | Patches | Mechanical removal with chisels and hammers, scalpels and knives. | Library |

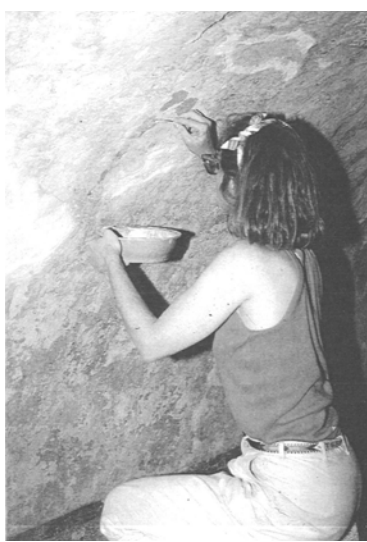
Figure 6.A.46: Filling the voids after hard plaster removal. Integration is carried out with a lime-based mortar, July 1988. Reprinted from *1988 Conservation Project Completion Report...*, by Anthony Crosby, 1997, p. 54.

| Treatment | Related Decay | Treatment description | Location |
|---|---|---|---|
| Filling of voids | | <ul style="list-style-type: none"> <li>• Application of a compatible mortar, made of crushed limestone and slaked lime in ratio 2 parts of lime and 3 parts of screened crushed limestone. The lime re-slaked overnight before the crushed limestone was added.</li> <li>• Mortar Lime/aggregate ration for filling holes, cracks, and depressions in the vault was one part of slaked lime and 3 parts of screened crushed limestone.</li> </ul> | Library. Arcade's arches |

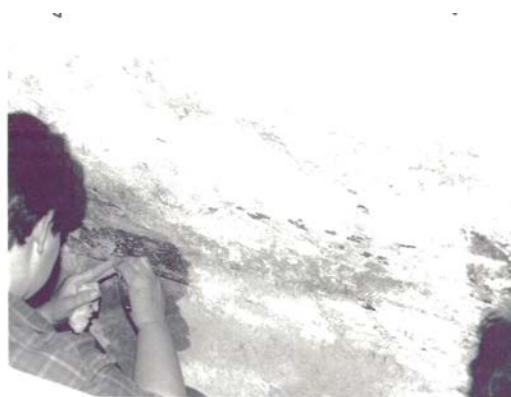
Figure 6.A.42: Cleaning—salt removal through mechanical methods, using chisels and hammers. Reprinted from *1988 Conservation Project Completion Report...*, by Anthony Crosby, 1997, p. 49.

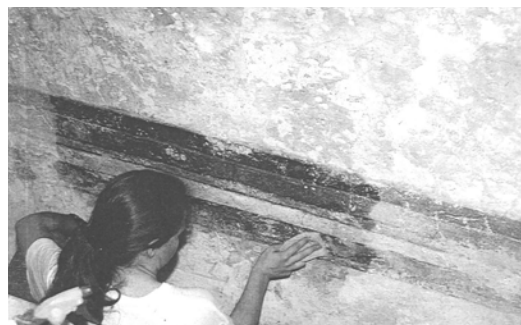
Figure 6.A.44: Cleaning—final phase through washing of the surface with a wet sponge. The cornice becomes more clear on each successive cleaning. Reprinted from *1988 Conservation Project Completion Report...*, by Anthony Crosby, 1997, p. 51.

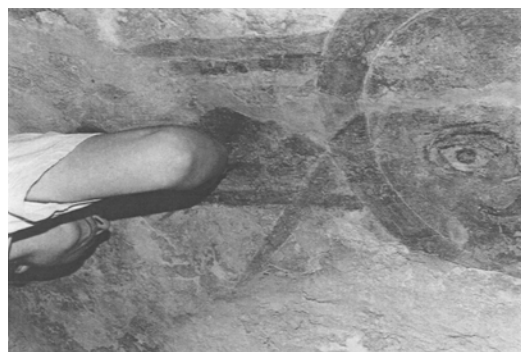
Figure 6.A.47: Library vaulted ceiling, detail—example of aesthetic integration/mitigation. After overall cleaning and reintegration with new plaster, the areas of new plaster patches are tinted to match color. Reprinted from *1988 Conservation Project Completion Report...*, by Anthony Crosby, 1997, p. 52.

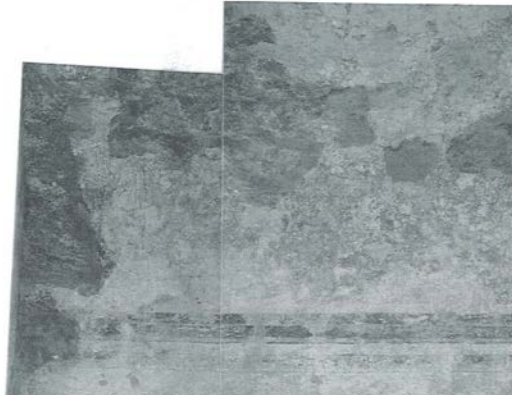
Figure 6.A.48: Library vaulted ceiling prior to treatment. Typical area showing the dark stones at the upper edge of the photograph and the dark areas of earlier repair, July 1986. Reprinted from *1988 Conservation Project Completion Report...*, by Anthony Crosby, 1997, p. 59.

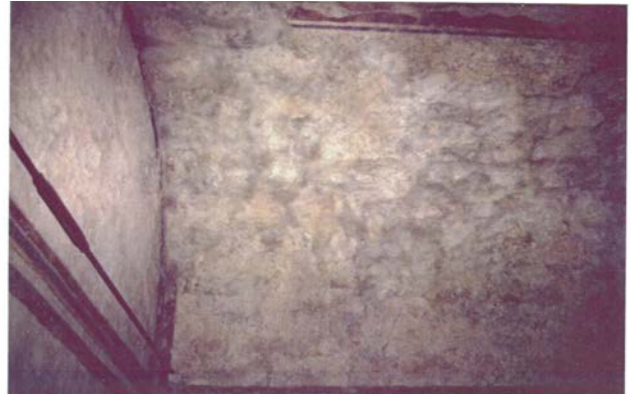
Figure 6.A.49: Library vaulted ceiling—example of aesthetic integration/mitigation. In the final integration treatment, the dark stones were tinted not to stand out from the surface, but to blend with the plaster, August 1988. Reprinted from *1988 Conservation Project Completion Report...*, by Anthony Crosby, 1997, p. 60.

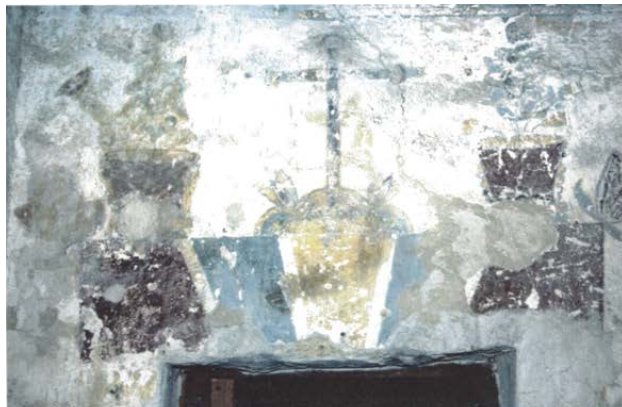
Figure 6.A.50: Pre-treatment condition of north door of the library, July 1986. Reprinted from *1988 Conservation Project Completion Report...*, by Anthony Crosby, 1997, p. 61.

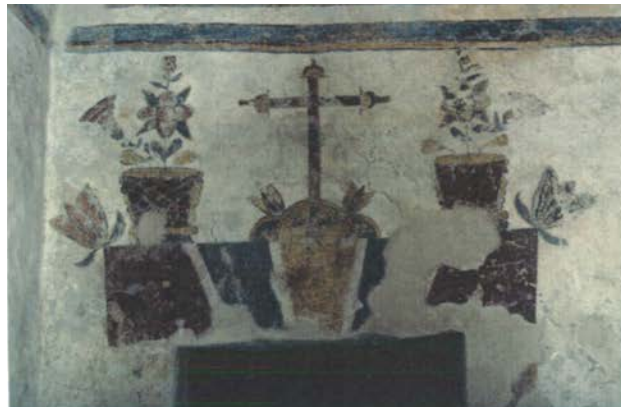
Figure 6.A.51: Post treatment conditions of the north door, August 1988. Reprinted from *1988 Conservation Project Completion Report...*, by Anthony Crosby, 1997, p. 61.

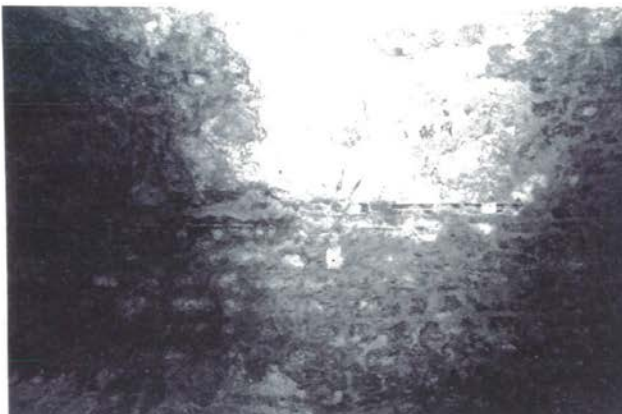
Figure 6.A.52: Pre-treatment condition of the vault at the library, July 1986. Reprinted from *1988 Conservation Project Completion Report...*, by Anthony Crosby, 1997, p. 63.

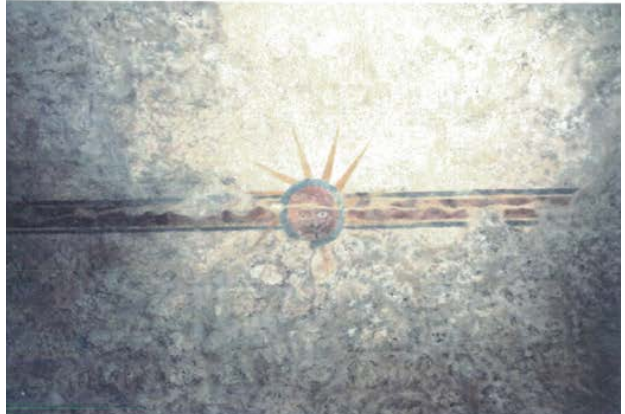
Figure 6.A.53: Post treatment conditions of the vault at the library, July 1988. Reprinted from *1988 Conservation Project Completion Report...*, by Anthony Crosby, 1997, p. 61.

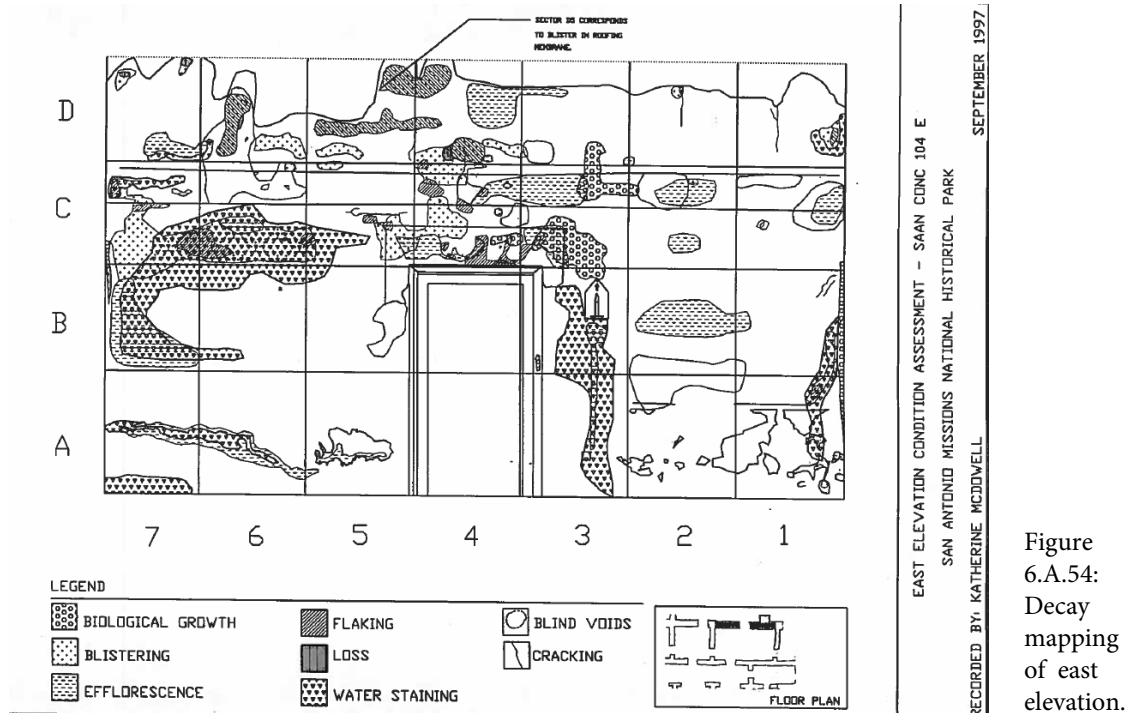
Figure 6.A.54: Decay mapping of east elevation.

Efflorescence was identified on numerous sectors. Two types of salts were observed: 1) fluffy salts, easy to remove; 2) hard salts. The lower part of the east wall, on the north side, featured efflorescence at a height of approximately 1 ft. (linked to rising damp), both on the repairs carried out in 1988 and on the original painted dado. On the south side, efflorescence was located at approximately 3 ft. from the floor and was associated with biological growth and water staining. Water staining was also observed in several areas of the wall. Presence of salts was observed in the area of the painted molding—"not breaking up the surface" on the south side, very hard on the north side. The painted band featured some flaking. The painted door architrave featured discrete areas of loss in the painted wash, salts, and blistering. Above the voussoirs were "pattern cracks" and a large crack. Above the painted band blistering was visible, mostly at the interface of plaster and cement patches as well as pattern cracking. Voids in the plaster, iron, and pins were also observed over the whole wall surface below the painted band.

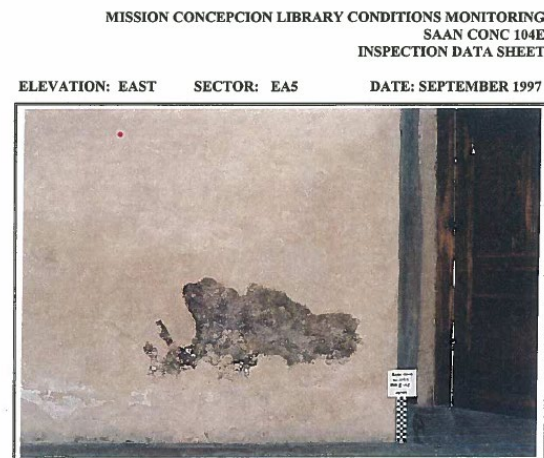
Figure 6.A.57: Sample of condition assessment form.

**CONDITION OF SECTOR EA5:**

Salts on the surface have a feathery appearance. These salts occur on both the repair (1988) and the original painted dado. They are different than the salt form above in level C. White webs also occur which may be attributed to insect infestation. During the removal of salts, two types of salts were observed. (1) Fluffy salts which are easy to remove. (2) hard salts, which sometimes came off in sheets, and were more difficult to remove with a brush.

**PHOTOGRAPH:** Roll 5 Negative 14  
8/22/99 - Additional water stains from rising damp.

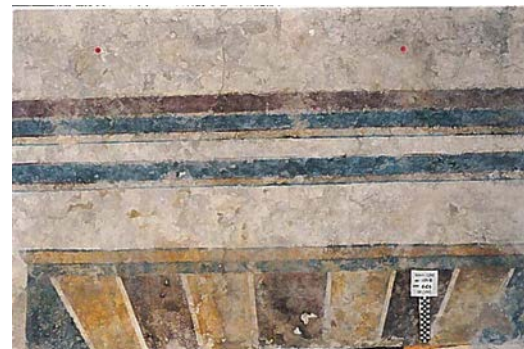
Figure 6.A.55: Sector EC4. Minute blisters, pattern cracks and one large crack were identified in this area.

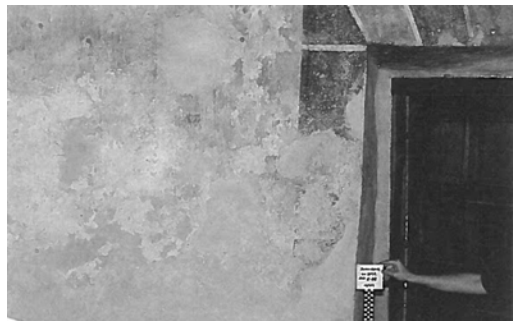
Figure 6.A.56: Sector EB5. Voids (detachment from the substrate) were identified in the area, showing also nails and iron pins. Stabilization was a chronic problem in this area.

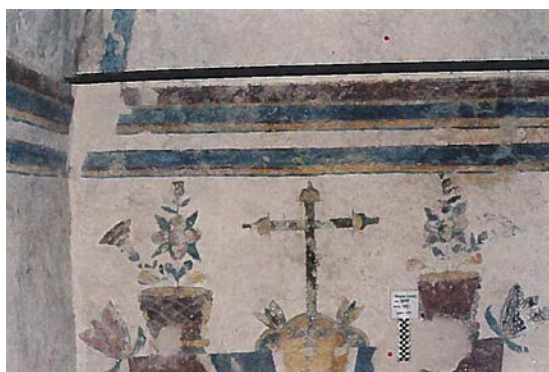
a

Figure 6.A.59: a) Sector NC1. Painted architrave. Exposed white surface is "chalky to touch" (powdering). Cracking throughout the architrave. The colored band shows erosion in circular pattern.

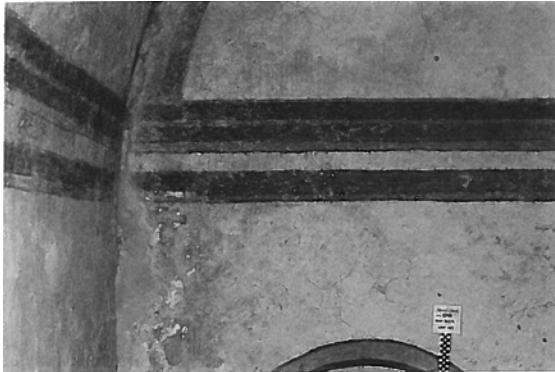
a

Figure 6.A.63: a) Sector SC4. Blistering and large flakes. The entry of water was identified in the exterior drainage at the south end of the library roof.

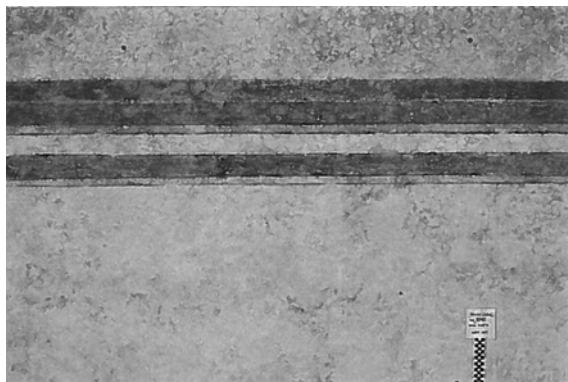
a

Figure 6.A.67: a) Sector WC3. Some blistering in the blue band as well as in limited area of the whitewash. Associate with some flaking. Very stable condition.

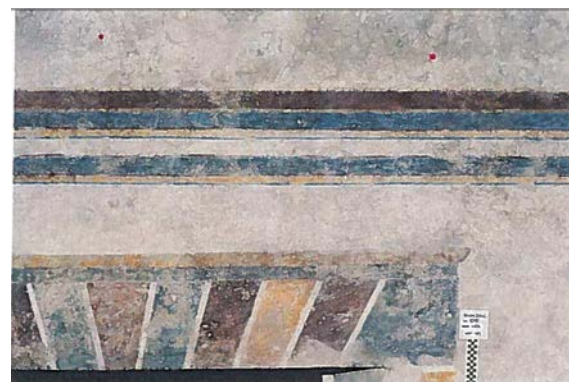
b

Figure 6.A.68: b) Sector WC6. Good condition of the painted architrave, with detachment of the plaster from the substrate ( large voids).

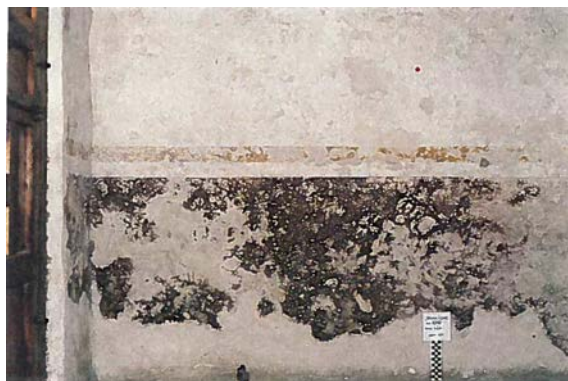
c

Figure 6.A.69: c) Sector WA1. Good condition of the dado, with white haze appearing throughout—not crystalline.

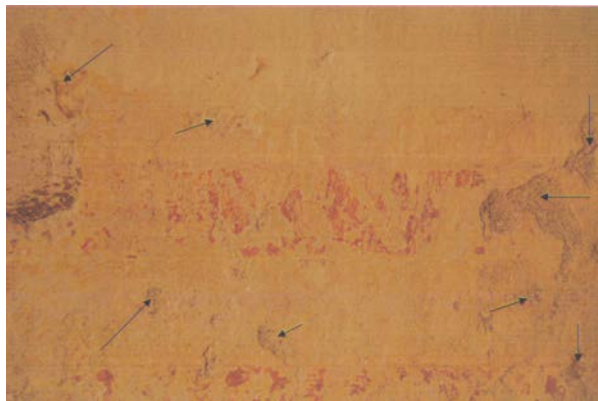
Figure 6.A.72: East wall. Sequence (from top to bottom) of a red pigment 2" band with incised lines, a 2" band with an ochre wall color, followed by a red pigment wainscot. Arrows indicate historic plaster losses. Reprinted from *Exposing Historic Wall Plasters...*, by Restoration Associates Limited, 2008, p. 11.

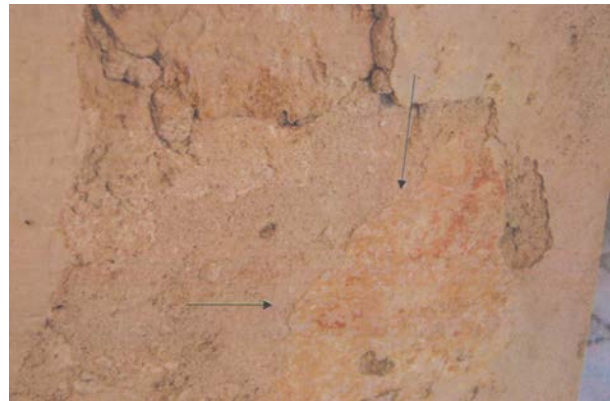
Figure 6.A.73: East wall. Cement patches applied over historic red plaster. Reprinted from *Exposing Historic Wall Plasters...*, by Restoration Associates Limited, 2008, p. 10.

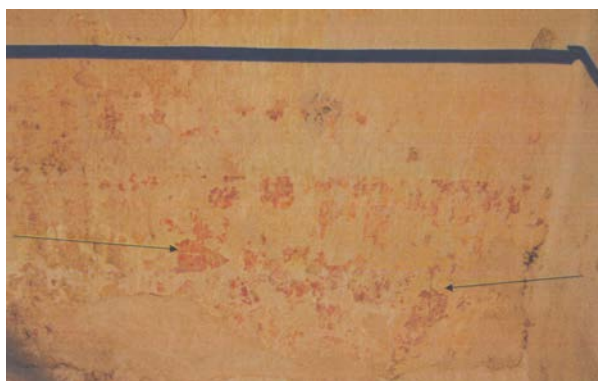
Figure 6.A.74: East wall—36" wainscot with evidence of red pigment, indicated by the arrows. Reprinted from *Exposing Historic Wall Plasters...*, by Restoration Associates Limited, 2008, p. 12.

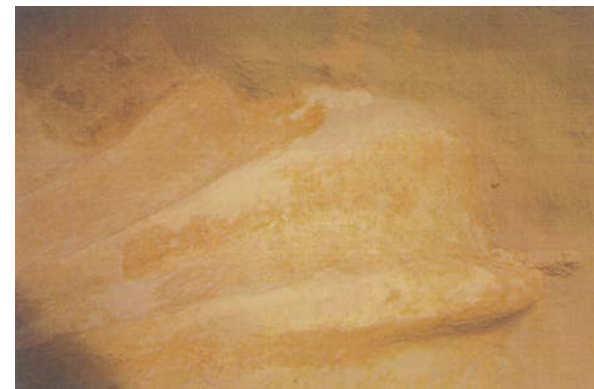
Figure 6.A.75: East wall. Historic tinted ochre lime wash. Reprinted from *Exposing Historic Wall Plasters...*, by Restoration Associates Limited, 2008, p. 13.

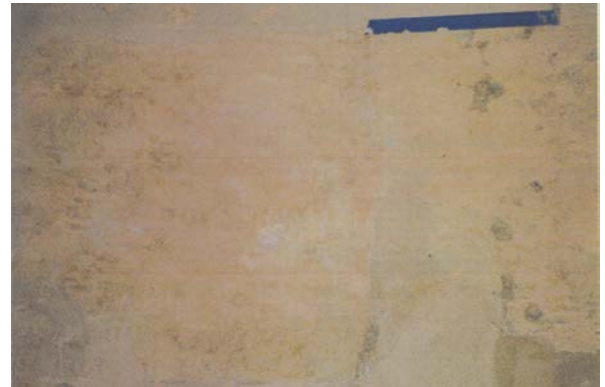
Figure 6.A.78: North wall. Interior door/window. Upper west section. The surface features historic ochre lime wash—with no evidence of incised lines. Reprinted from *Exposing Historic Wall Plasters...*, by Restoration Associates Limited, 2008, p. 13.

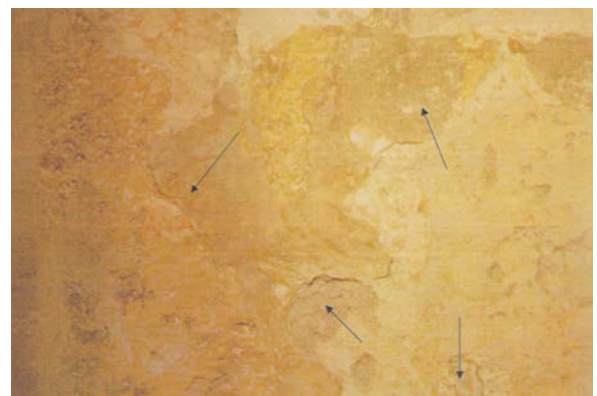
Figure 6.A.79: South wall. Arrows indicate cement plaster and historic plaster loss. Reprinted from *Exposing Historic Wall Plasters...*, by Restoration Associates Limited, 2008, p. 14.

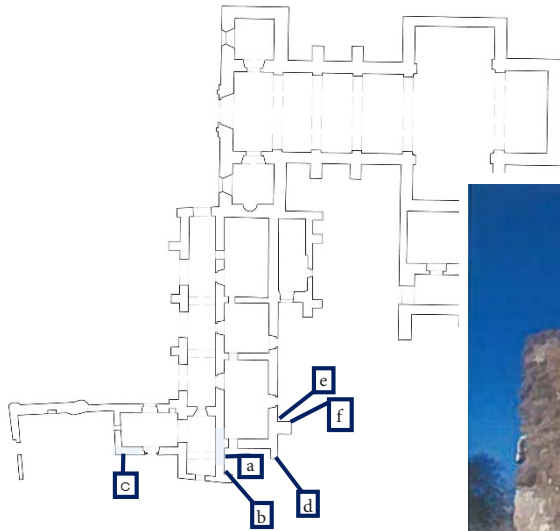
Figure 6.A.81: a) Emergency edge stabilization. Area is indicated by the arrow. Reprinted from *Documentation of South & East Exterior Walls...*, by Restoration Associates Limited, 2009, p. 4.

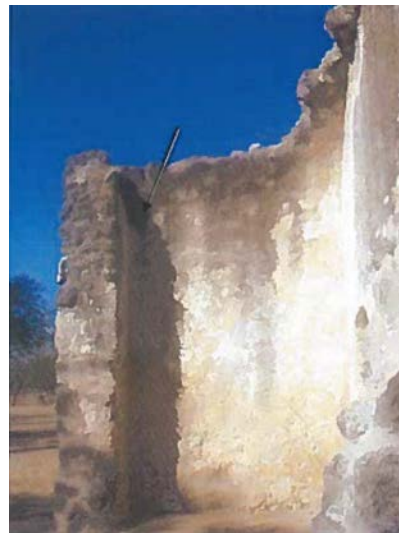
a

Figure 6.A.82: b) Emergency edge stabilization of Spanish Colonial plaster. Area is indicated by the arrow. Reprinted from *Documentation of South & East Exterior Walls...*, by Restoration Associates Limited, 2009, p. 5.

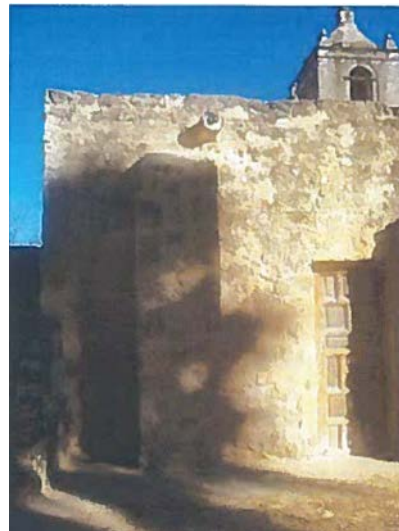
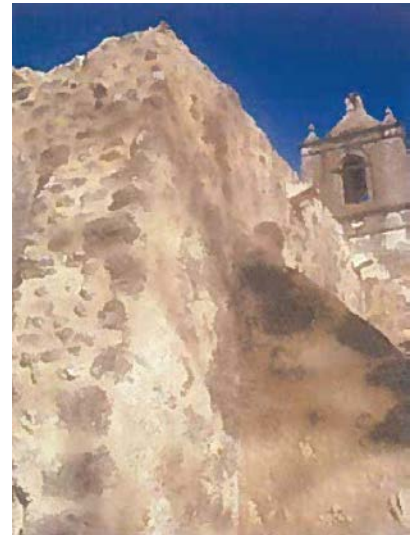
Figures 6.A.83, 6.A.84: c) and d) Portland cement was removed and the area repointed with lime mortar mix. Reprinted from *Documentation of South & East Exterior Walls...*, by Restoration Associates Limited, 2009, pp. 5-6.

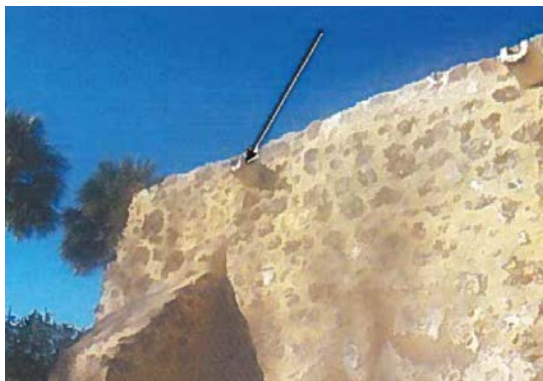
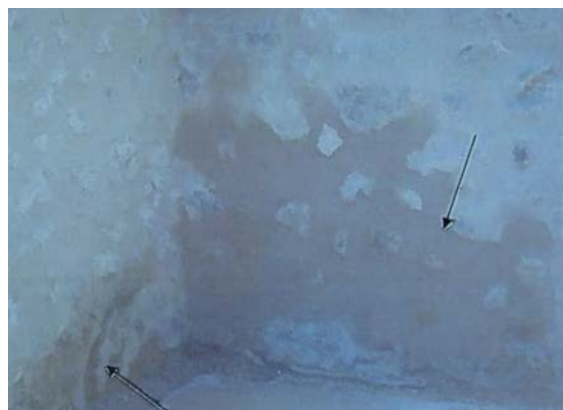
Figure 6.A.85, 6.A.86: e) and f) Rainwater runs through the canal creating splash on the hard surface, causing damp areas on newly repointed surfaces and damage to the painted surface of the interior. Reprinted from *Documentation of South & East Exterior Walls...*, by Restoration Associates Limited, 2009, p. 7.

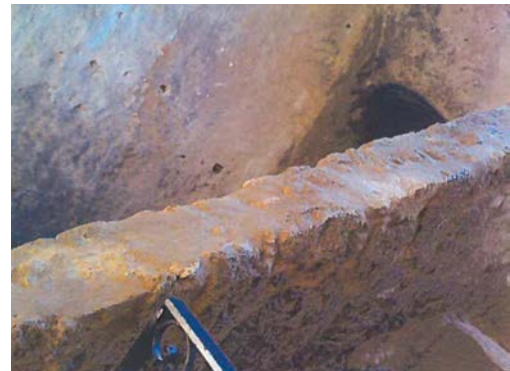
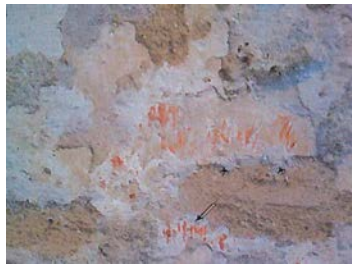
Figure 6.A.88: The stair wall required repointing featuring stone and mortar losses. Reprinted from *Documentation of South & East Exterior Walls...*, by Restoration Associates Limited, 2009, p. 8.

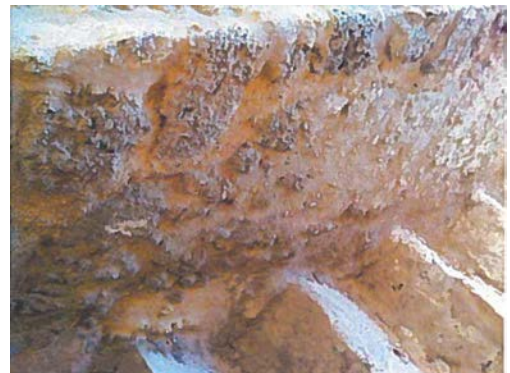
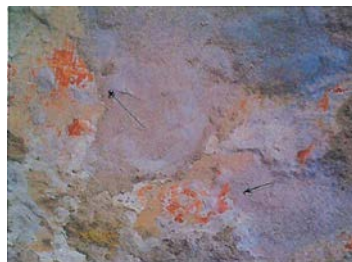
Figure 6.A.89: Removal and replacing of new steps. The photo also shows the presence of a large fracture between the steps and exterior wall. Reprinted from *Documentation of South & East Exterior Walls...*, by Restoration Associates Limited, 2009, p. 9.

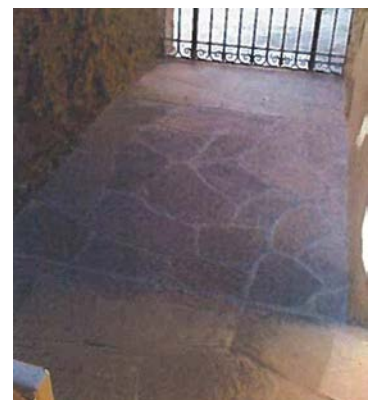
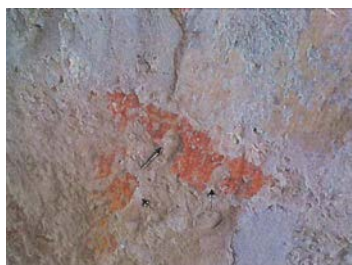
Figure 6.A.91: Areas showing edge stabilization, Portland cement patches overlapping Spanish Colonial plaster and graffiti. Reprinted from *Documentation of South & East Exterior Walls...*, by Restoration Associates Limited, 2009, p. 10-11.

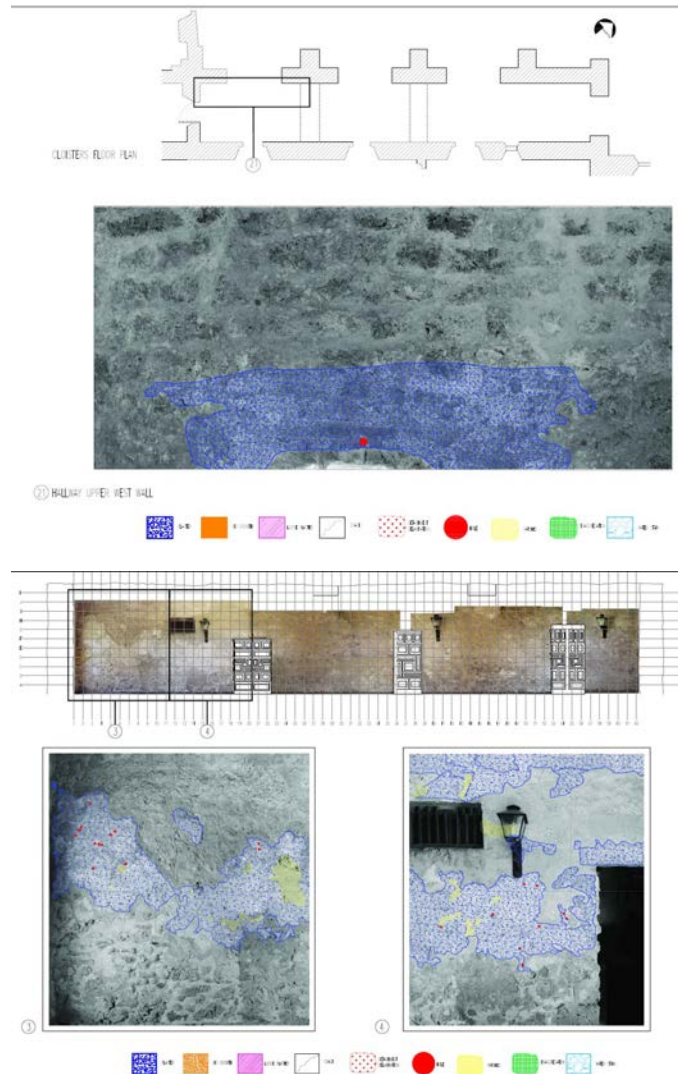
Figure 6.A.92: Example of decay mapping in the cloister wall. Evergreene conservators utilized photo elevation and photo documentation as base for the decay mapping, part of the condition assessment.

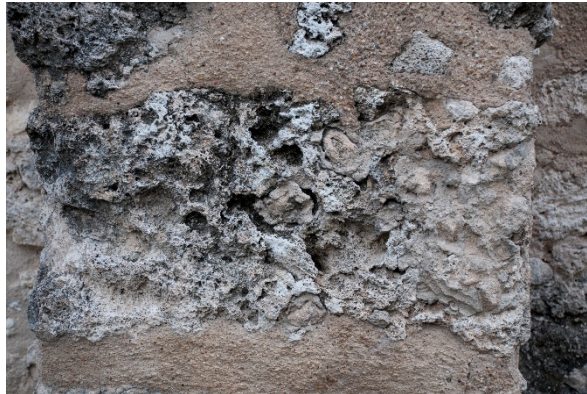
Figure 6.B.1: Detail of a sedimentary 'tufa' block. Tufa stone is characterized by an oversize porosity. The masonry was repointed with a brownish restoration mortar.

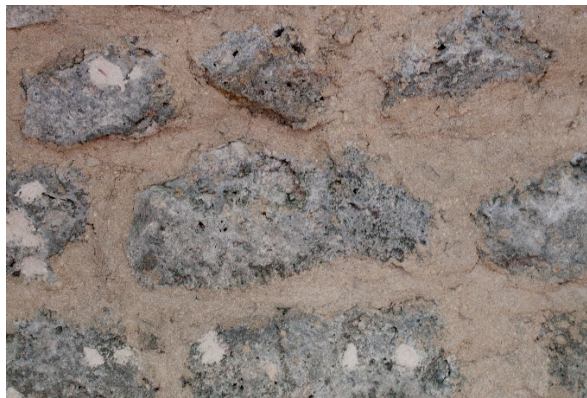
F.6.B.2 Detail of 'tufa' rubble used for the construction of the vaults (from the corridor). The masonry joints were repointed with restoration mortar.

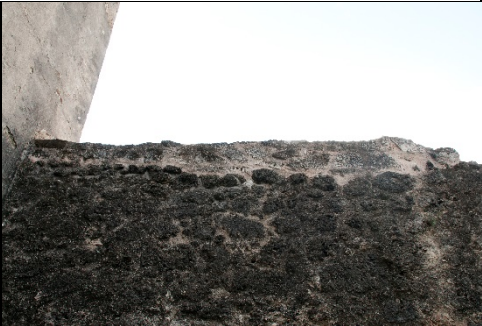
| A. | GENERAL DECAY PATTERN | | |
|---|---|---|---|
| A.1.a | BIOLOGICAL GROWTH | Colonization of stone materials by plants and microorganism such as bacteria, cyano-bacteria, algae, fungi, and lichens. It is widely spread all over the convento's structure. | |

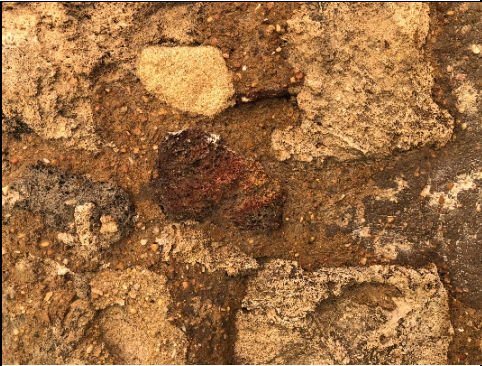
| A. | GENERAL DECAY PATTERN | | |
|---|---|---|---|
| A.2.a | DISCOLORATION | Change in stone color in one to three color parameters: hue, value and chroma. Present as mostly bleaching, gain value due to chemical weathering. | |

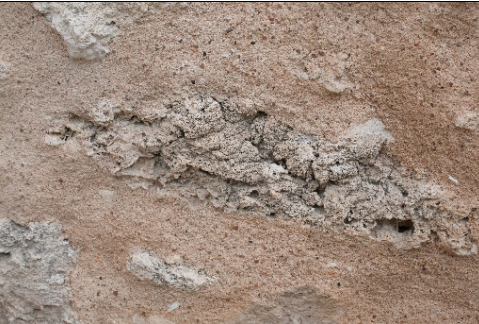
| A.2.b<br><br> | ENCROUSTATION | <p>Compact, hard, mineral layer adhering to the stone. Surface morphology and color are usually different from the one of the stone.</p> | |

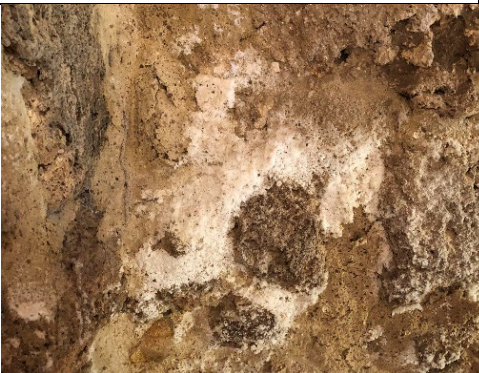
| A.2.c<br><br> | EFFLORESCENCE | <p>Whitish, powdery and whisker-like crystals on the surface, they are mostly poorly cohesive and commonly made of soluble salt crystals.</p> | |

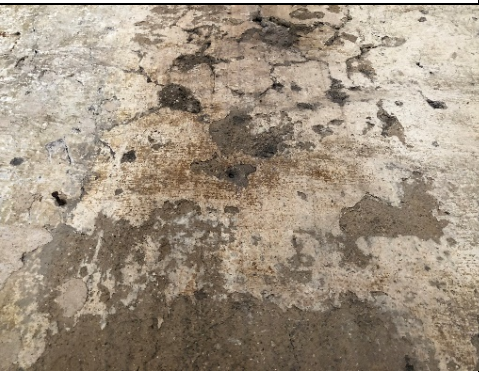
| A.2.d<br><br> | DEPOSIT | <p>Accumulation of exogenic material of variable thickness, characterized by a lack of adhesion to the stone surface.</p> | |

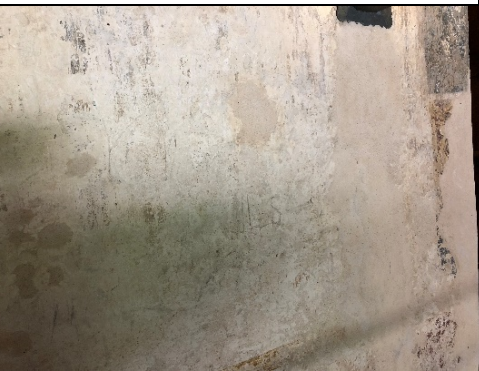
| A.2.f<br><br> | GRAFFITI | <p>Engraving, scratching, cutting or application of paint, ink, or similar matter on the stone surface. Here, some graffiti may be considered historic.</p> | |

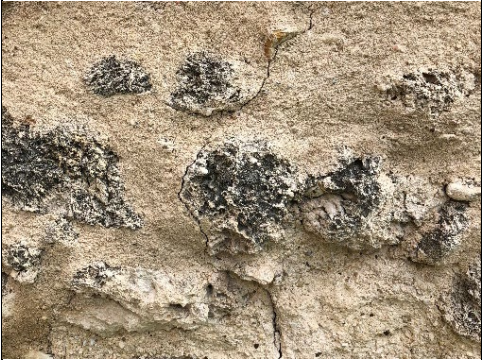
| B. | STRUCTURAL DECAY OF MASONRY | | |
|---|---|---|---|
| B.5.a.3 | HAIR CRACK | Minor individual fissure, visible by the naked eye, with width dimension smaller than 1 millimeter. | |

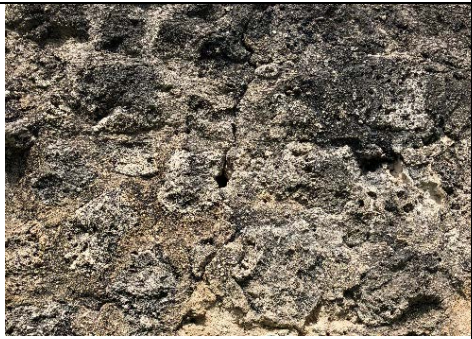
| B. | STRUCTURAL DECAY OF MASONRY | | |
|---|---|---|---|
| B.5.b | FRACTURES | Individual severe crack, visible by the naked eye and crossing the whole wall thickness. | |

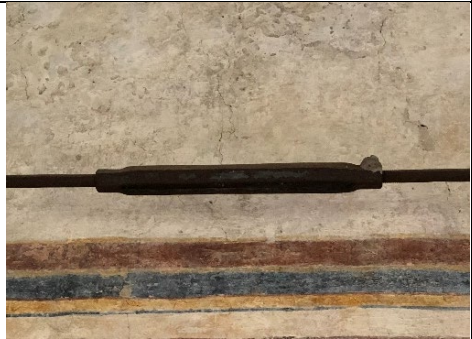
| B. | STRUCTURAL DECAY OF MASONRY | | |
|---|---|---|---|
| B.5.c | IRON CONNECTING ELEMENT | Presence of iron bars, horizontally crossing the corridor and visible at the naked eye, located at the extrados of the arches. Used to contrast the outward rotation of the structure. | |

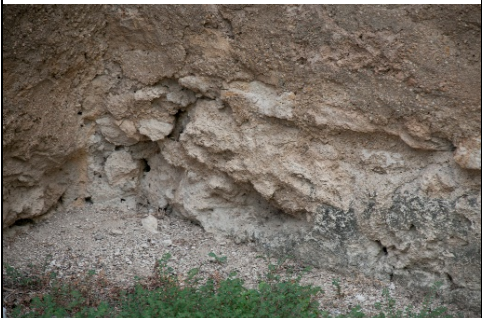
| B. | STRUCTURAL DECAY OF MASONRY | | |
|---|---|---|---|
| B.4.e.3 | MISSING PARTS/GAPS (STRUCTURAL) | Empty spaces, located in the place of previously existing stones creating structural discontinuity, reduced wall section and hollow places, holes. | |

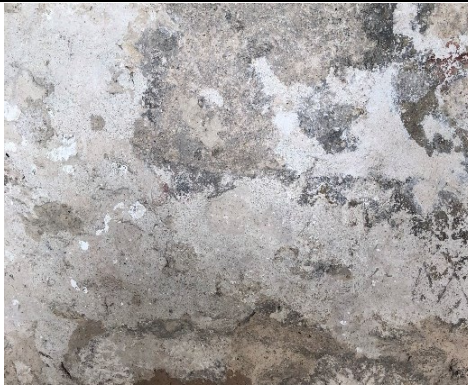
| B.4.g.1 | MORTAR PATCHING | Area filled with repair mortar, visible at the naked eye due to its color and aggregates. | |

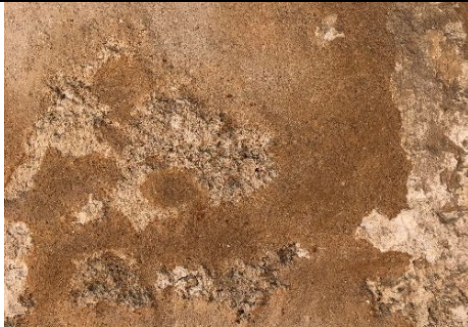
| B.4.g.2 | MORTAR PATCHING WITH BROWN MORTAR | Area filled with repair mortar, characterized by a brown visually color, contrasting with the surrounding masonry wall. | |

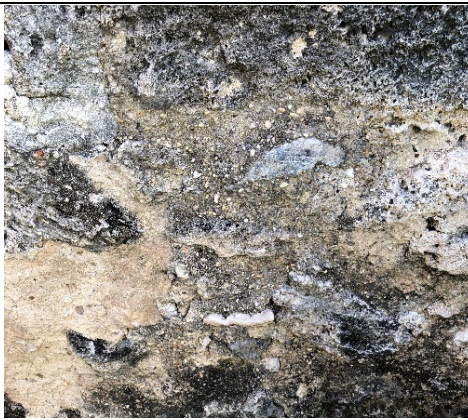
| B.4.g.3 | CONCRETE PATCHING | Area filled with repair mortar, with a cement component, featuring higher hardness and low porosity. | |

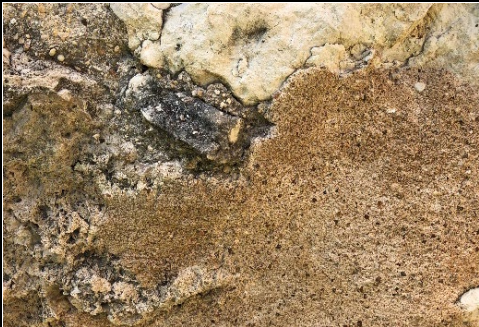
| C.3.a.1 | DETACHMENT OF THE EDGES | Loss of cohesion of the masonry with the wall substrate, located on the edges of masonry fragments. It may lead to water infiltration and accelerated decay. | |

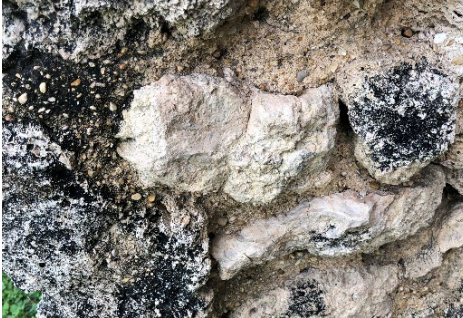
| C.3.f<br> | FRAGMENTATION | The complete or partial breaking up of a stone, into portions of variable dimensions, irregular in form, thickness and volume. | |

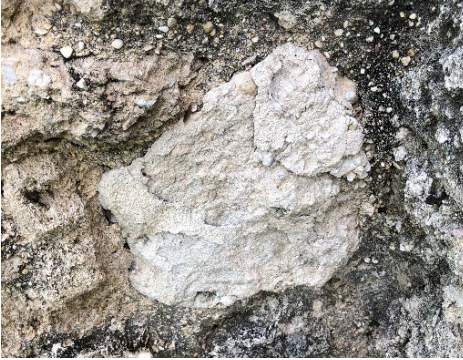
| C.3.g.1<br> | DELAMINATION | Detachment process affecting laminated stones, corresponding to a physical separation into several layers following the stone laminae. | |

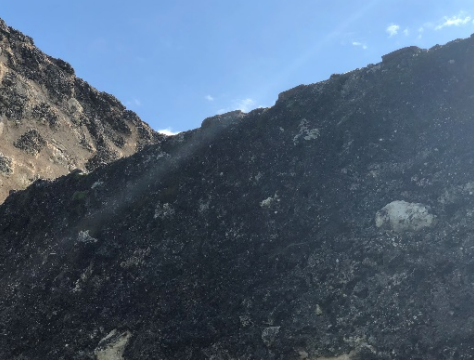
| C.3.c.1<br> | DISINTEGRATION OF THE CAPPING | Detachment of aggregates of grains, leading to a loss of continuity of the waterproof surface, producing as a consequence water infiltration. | |

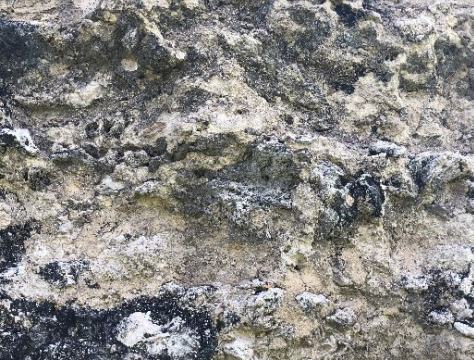
| C.3.c.2<br> | DISINTEGRATION OF THE STONE BLOCK WITH LOSS OF MATERIAL | Detachment of grains or aggregate of grains affecting the surface of the stone and can occur in that depth with loss of original material. | |

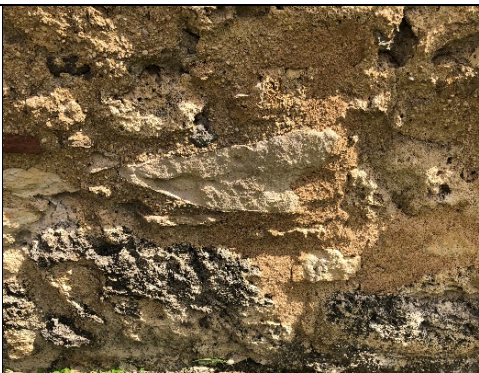
| C.4. Features Induced by Material Loss | | | |
|---|---|---|---|
| C.4.a.1 | EROSION OF THE STONE BLOCKS | Loss of original surface on the stone block, leading to smoothed shapes, due to chemical, physical, and/or biological processes. | |

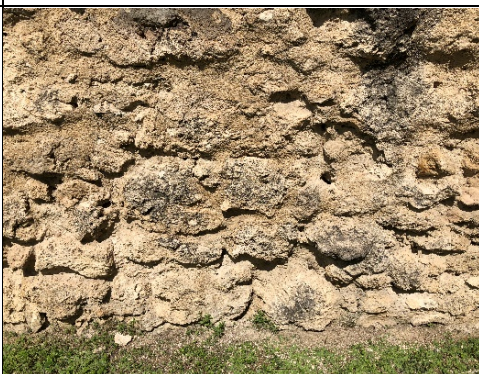
| C.4. Features Induced by Material Loss | | | |
|---|---|---|---|
| C.4.a.2 | EROSION OF THE MASONRY WALL | Loss of original surface on the masonry wall, leading to smoothed shapes, due to chemical, physical, and/or biological processes. | |

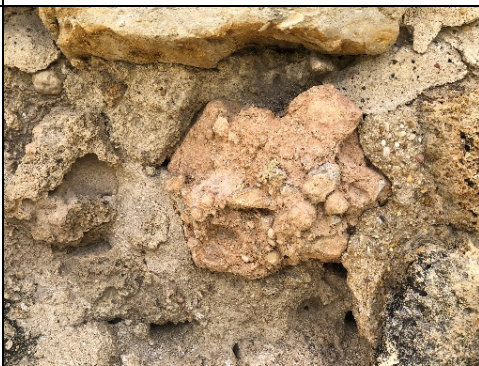
| C.4. Features Induced by Material Loss | | | |
|---|---|---|---|
| C.4.b.1 | DIFFERENTIAL EROSION OF THE STONE BLOCKS | Irregular loss of original surface, with formation of irregularity on the stone surface, found in heterogeneous stones containing harder zones. | |

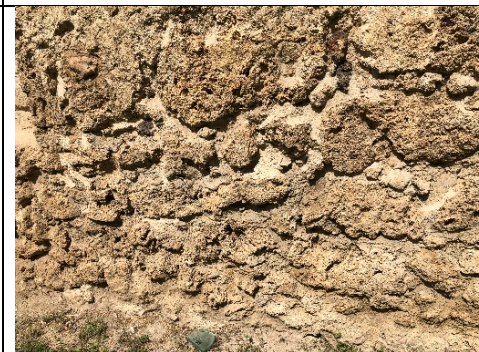
| C.4. Features Induced by Material Loss | | | |
|---|---|---|---|
| C.4.b.2 | DIFFERENTIAL EROSION OF THE MASONRY WALL WITH MORTAR LOSS | Loss of original surface leading to smoothed shapes occurring with different rate between the rubble stone and the joint mortar, which is almost completely missing. | |

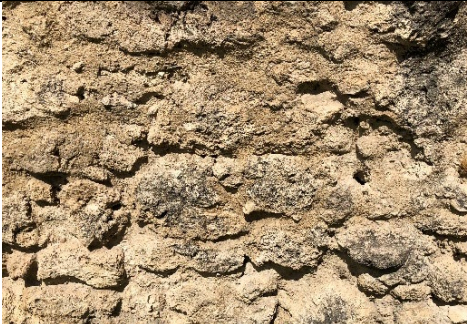
| C.4.d.1<br> | EROSION/LOSS OF JOINT MORTAR | Loss of the mortar located in the joints between stone rubble. | |

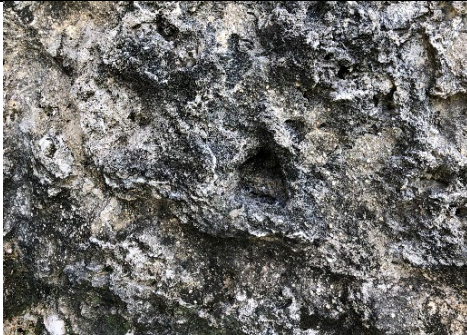
| C.4.e.2<br> | MISSING PARTS/GAPS (small non-structural): | Empty spaces, obviously located in the place of previously existing stone and joint mortar, not impacting the structural stability. Gaps are hollow place, holes. | |

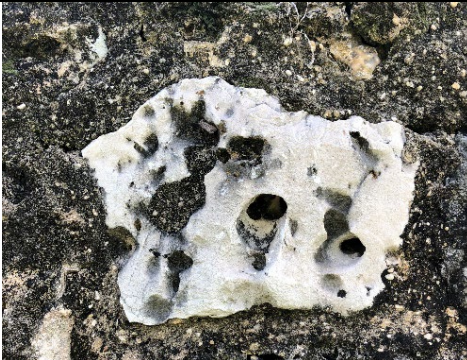
| C.4.f<br> | ALVEOLIZATION | Formation, on the stone surface, of cavities (alveoles) which it may be interconnected and may have variable shapes and sizes (generally centimetric). | |

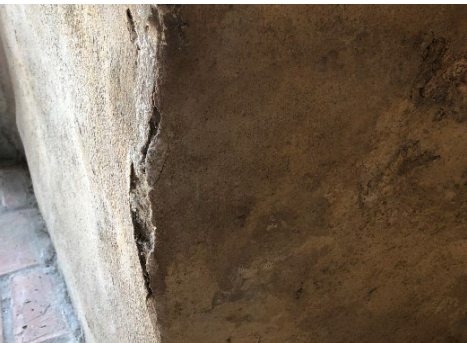
| D.3.a.2<br> | DETACHMENT OF EDGES | Loss of cohesion of the plaster with the wall substrate, located on the edges of plaster fragments. It may lead to water infiltration and accelerated decay. | |

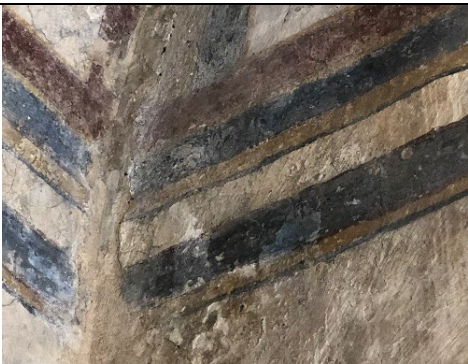
| D.3.a.3<br> | DETACHMENT OF THE EDGES IN PAINTED PLASTER | Loss of cohesion of the plaster with the wall substrate, located on the edges of plaster fragments. It may lead to water infiltration and accelerated decay. | |

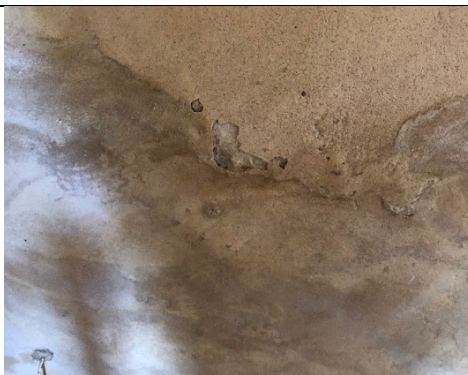
| D.3.b<br> | DETACHMENT OF SUBSTRATE | Loss of cohesion between the plaster and wall substrate, mostly not visible, but assessed through tapping. | |

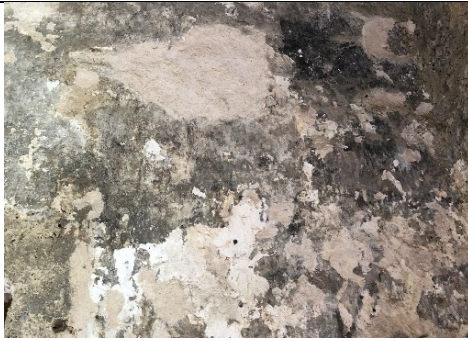
| D.3.c.3<br> | DISINTEGRATION/ CRUMBLING (LOOSE PLASTER) | Detachment of aggregates of grains from the plaster substrate, generally limited in size (less than 2 centimeters). | |

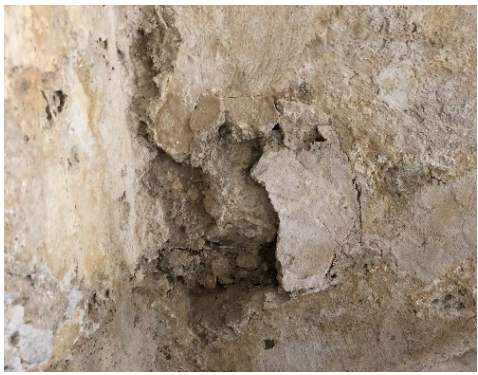
| D.3.d<br> | BLISTERING | Separated, air filled, raised hemispherical elevations on the face of the plaster surface, resulting from the detachment of the outer layer. | |

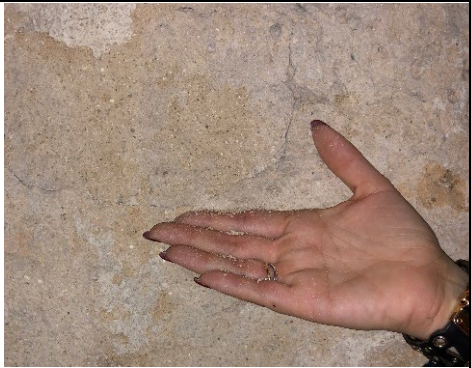
| D.3.e | POWDERING | Granular disintegration of aggregates made of finely grained plaster or stucco (considered as artificial stone). | |

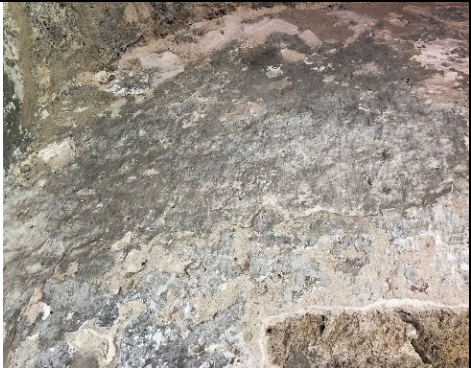
| D.3.g.2 | DELAMINATION OF PLASTER LAYERS | Detachment process affecting the plaster corresponding to a physical separation of the various layers. | |

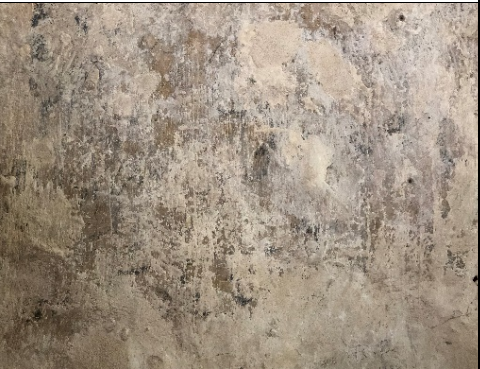
| D.4.a.3 | EROSION | Loss of original surface, leading to smoothed shapes and due to a variety of reasons related to chemical, physical, and/or biological processes. | |

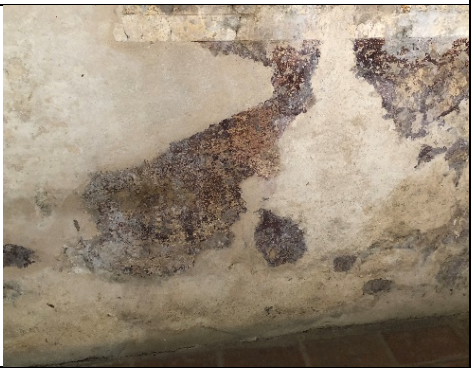
| D.4.a.4 | EROSION OF THE PAINTED FINISHES | Loss of original surface, leading to smoothed shapes and due to a variety of reasons related to chemical, physical, and/or biological processes. | |

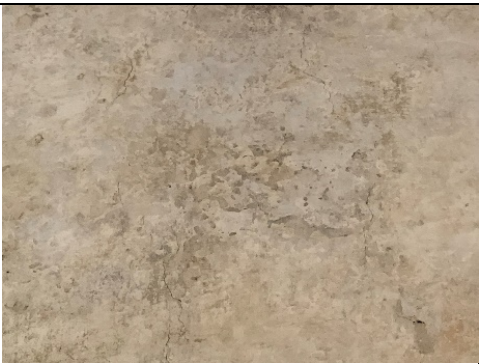
| D.4.b.3 | DIFFERENTIAL EROSION | Irregular loss of original surface, with formation of irregularity on the plaster surface, due to the presence of harder and larger aggregates. | |

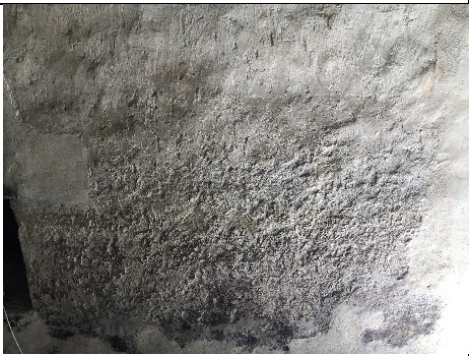
| D.4.c | MICROKARST | Network of small interconnected depressions due to partial and/or selective dissolution of calcareous surface exposed to water run-off. | |
