National Park Service  
United States Department of the Interior  
San Antonio Missions National Historical Park  
Texas

# Historic Structure Report Mission Concepción Convento

100% Submission  
2019

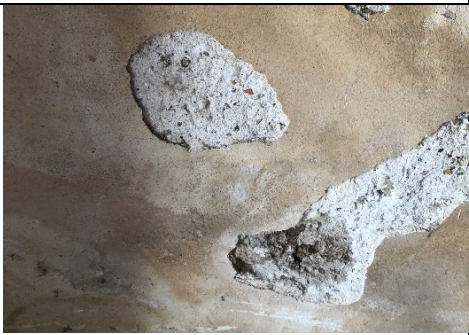
| D.4.e.3 | MISSING PARTS/GAPS (small non-structural): | Empty spaces, obviously located in the place of previously existing plaster/mortar parts, also denominated as 'lacunae.' Gaps are hollow place, holes. | |

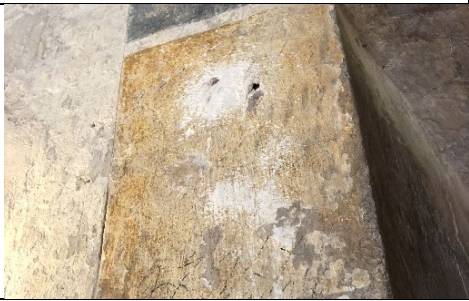
| D.4.f | MISSING OF PAINTED FINISH | Absence or loss of the superficial layer composing the painted plaster surface. | |

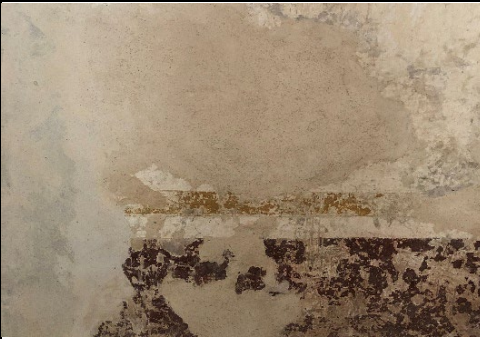
| D.4.g.2 | PATCHING | Area filled with repair mortar to fill gaps or lacunae (missing parts) made of mortar, visually contrasting with the substrate and featuring a rougher texture. | |

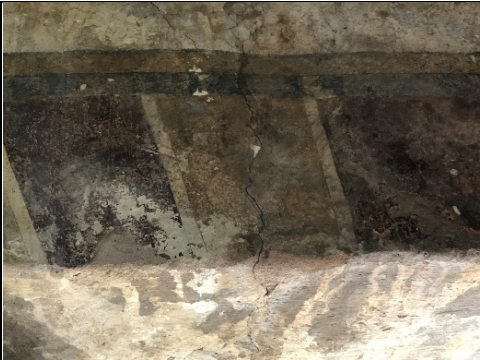
| D.5.a.2 | HAIR CRACK | Minor individual fissure, visible by the naked eye, with width dimension smaller than 1 millimeter. | |

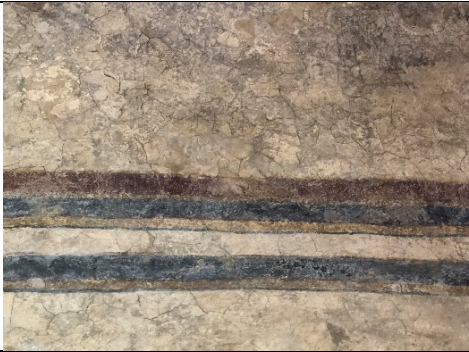
| D.5.b | CRAQUELÉ | Network of minor cracks, also called a crack network. | |

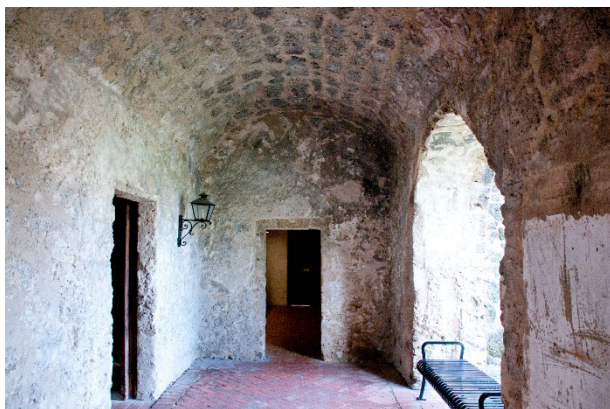
Figure 6.B.6: 104 A—View toward southern entry into the corridor. Note the south wall covered by various layers of historic plaster and finishes.

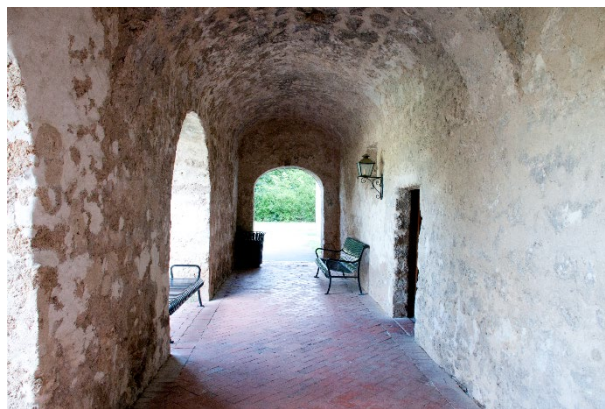
Figure 6.B.7: 104 A—View toward northern entry into the corridor. On the extreme left, the recent NHL (Natural Hydraulic Lime)-based patches are visible.

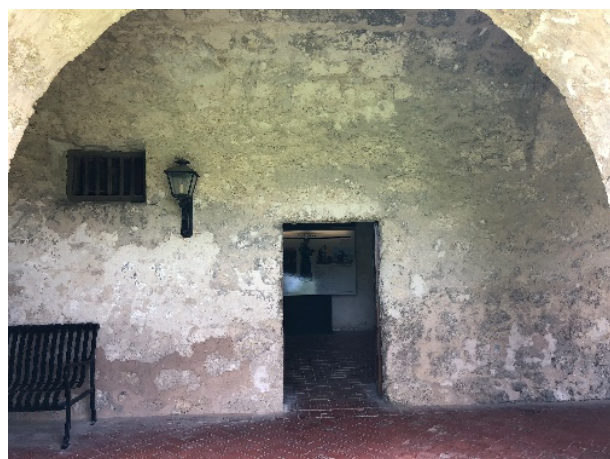
Figure 6.B.8: 104 A—East wall with door toward storeroom. On the left side of the door, a large remnant of historic plaster is visible, featuring erosion of its superficial finishes.

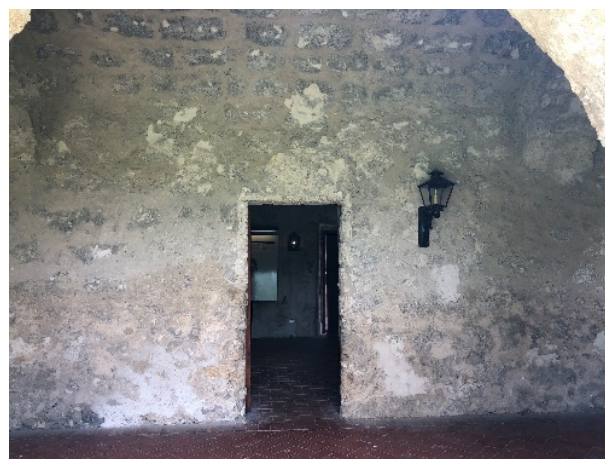
Figure 6.B.9: 104 A—East wall with door toward porteria. Around the door opening, large areas where limewash was applied directly on the tufa rubble masonry are visible.

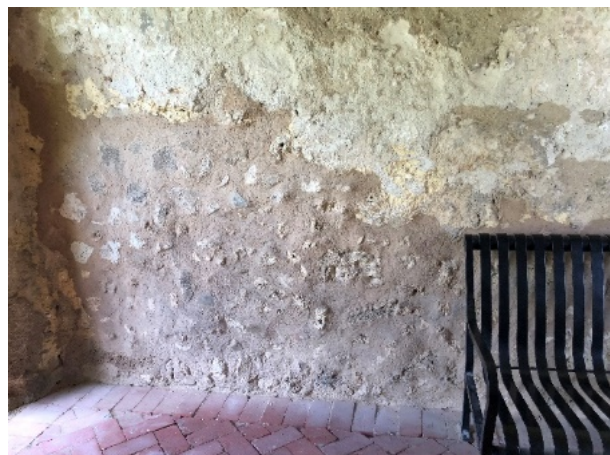
The area located on the north section of the wall features a large integration made of small limestone rubble and brownish mortar (section A1 and A2). This portion of the wall has a bench in front of it so it was not possible to assess the condition of the wall behind. The lower portion of the wall next to the door leading to the storeroom features brown patching. The south post of the door leading to the storeroom features some small missing parts on the edges at approximately 2 ft. from the ground level. The door leading to portería exhibits a higher number of missing parts on its lower section, on both of the lintels.

Figure 6.B.10: 104 A—Northern corner of the east wall (A1, A2), featuring brown mortar patching and masonry infill with irregularly laid small rubble limestone.

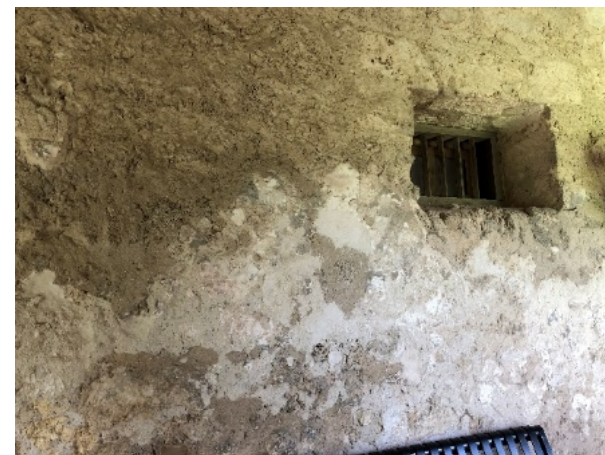
Figure 6.B.11: 104 A—Northern area of the east wall, showing erosion in the historic plaster.

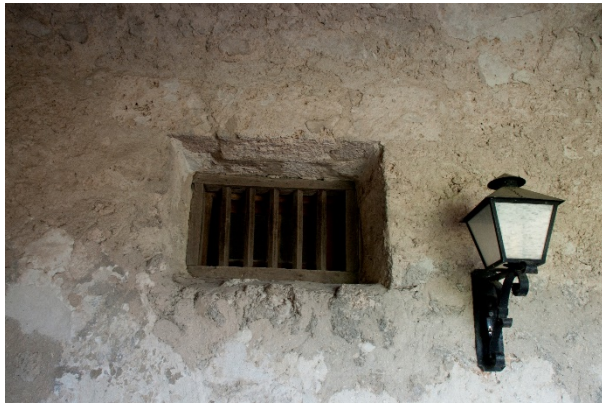
Figure 6.B.12: 104 A—East wall (B4, B5, C4, C5). Small window that connects with the storeroom. At the bottom part of the window there is some erosion of the historic plaster.

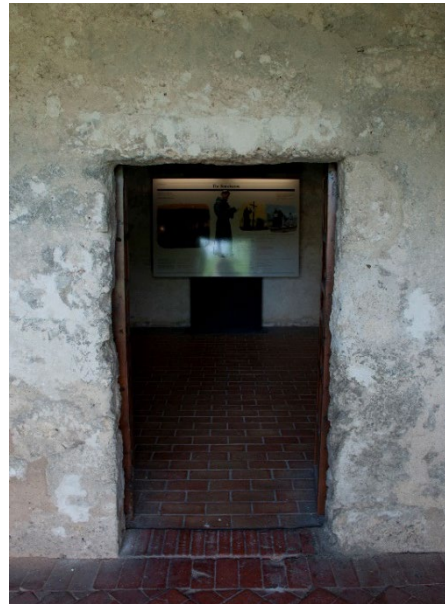
The architrave of the storeroom door also features remains of plaster, with some differential erosion, graffiti, one hair crack, and very well-executed patching which produce a material continuity of such plastered fragment. The central section of the wall exhibits the tufa stone wall with mortar joints and numerous mortar patchings (sections B8, B9 and B10 and part of B11), continuing in the sections B12, B13 and B14, only interrupted by a well-executed patching in the section B3. A vast area surrounding the library door is still covered by historic plaster, both in the middle and higher wall sections, with erosion of the painted finish (B15, B16, B17, B18, part of B19, C15, C16, C17, and C18). This area has a complex history of interventions, featuring various campaigns of plaster, also intersected by numerous areas with limewash applied directly on the tufa stones (B14 and B15). In order to report such complexity in the mapping, special notes have been created to identify the changes of the apparently homogeneous surface.

Figure 6.B.13: 104 A—East wall (A6, A7, B6, B7), door leading to the storeroom. On the left side of the door, a fragment of red painted plaster is still visible. The surrounding areas feature erosion of the historic plaster. The door architrave features extremely well-executed patching, perfectly blended with the surrounding areas. Their execution can be considered a reference point for future interventions

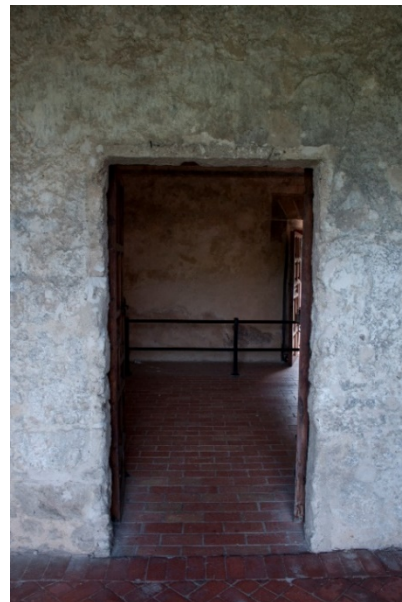
Figure 6.B.15: 104 A—East wall (A16, A17, B16, B17, C16, C17), door leading to the library. At the sides of the door there are areas where limewash has been directly applied to the tufa rubble stone. In the architrave of the door there are remnants of historic plaster.

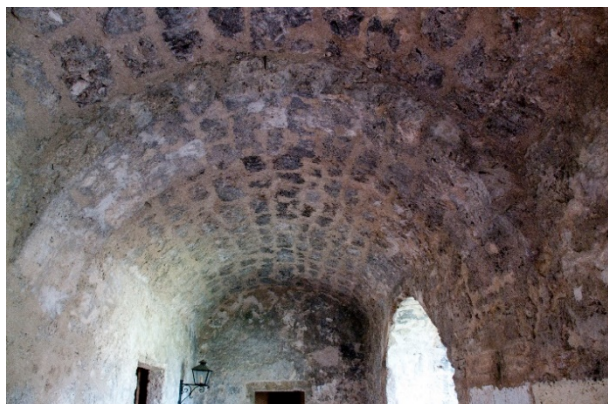
The majority of plaster on the vaulted ceiling is missing, with exposed stone masonry regularly laid and featuring non-historic mortar joints. Only the northern edge of the barrel has remnants of scratch coat, with presence of efflorescence and detachment of edges (C16, C17, A18, B18, C18).

Figure 6.B.16: 104 A—Vault looking south. The vault features regularly laid coursed blocks and modern mortar joints.

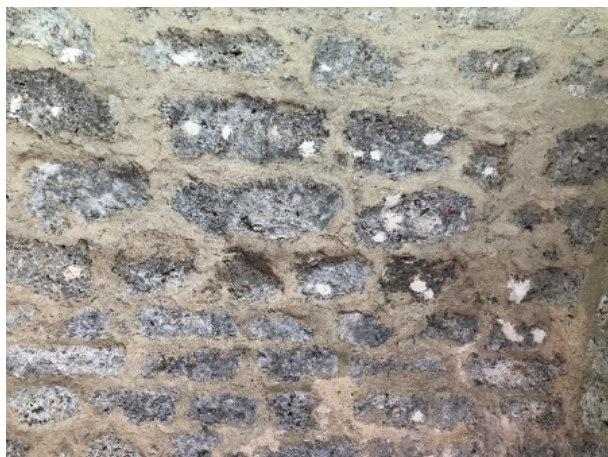
This area also features various small patching. Small mortar patches were also observed in the central section of the vault (from A8, B8, C8 to A12, B12, C12).

Figure 6.B.18: 104 A—Detail of the vault showing mortar patching.

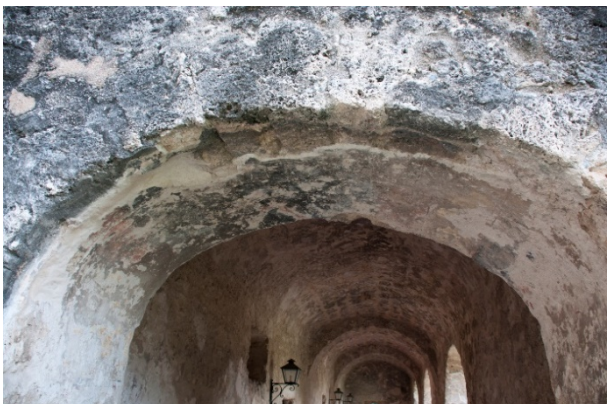
Figure 6.B.20: 104 A—Arch in the north wall of the corridor, remnants of painted plaster (red and yellow).

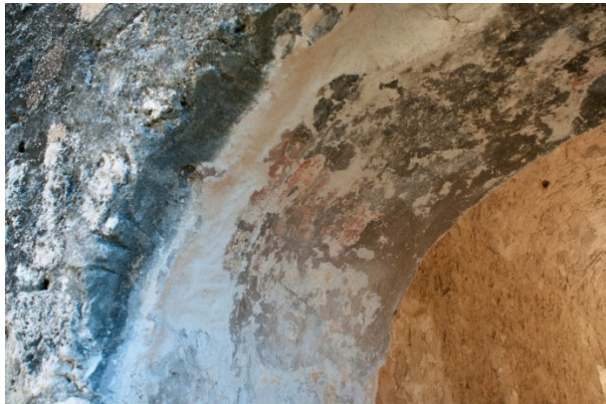
Figure 6.B.21: 104 A—Arch in the north wall of the corridor detail, remnants of painted plaster (red and yellow). The red and yellow faux voussoir colors are partially covered by a gray paint.

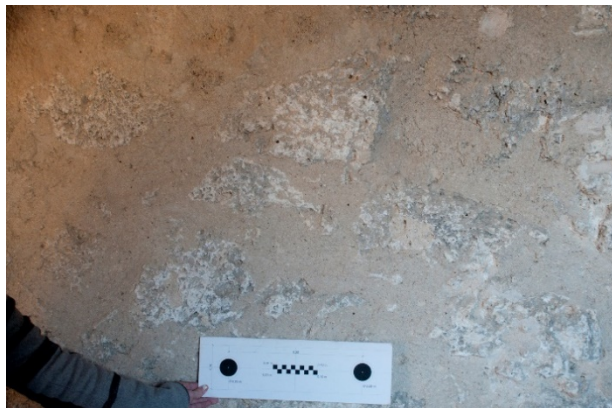
Figure 6.B.22: 104 A—Southern part of the east wall (B14, B15), limewash applied directly on the tufa rubble stone.

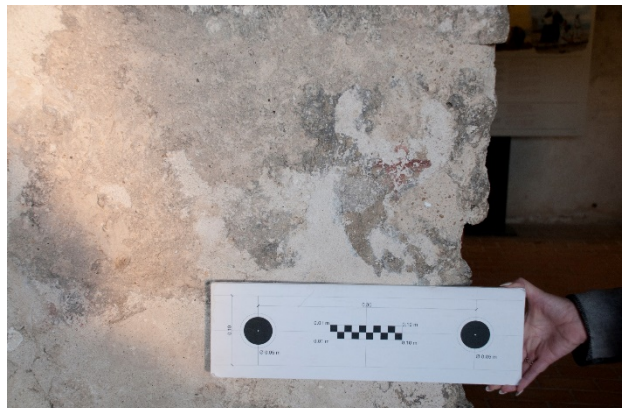
Figure 6.B.23: 104 A—East wall (B6), left jamb of the door that goes to the storeroom, remnants of painted plaster.

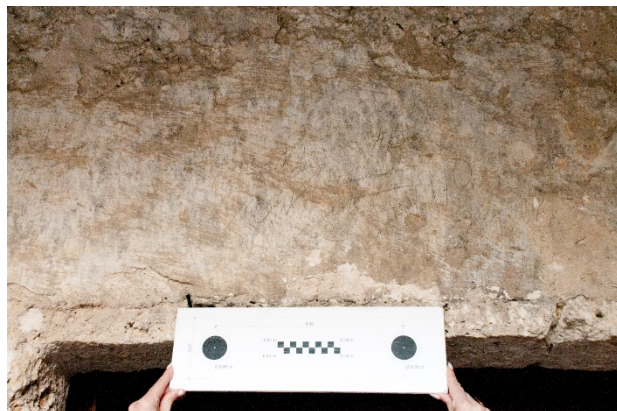
Figure 6.B.24: 104 A—East wall (C16, C17), historic plaster on the library door architrave featuring detachment of edges in its lower part, historic graffiti and historic incised patterns.

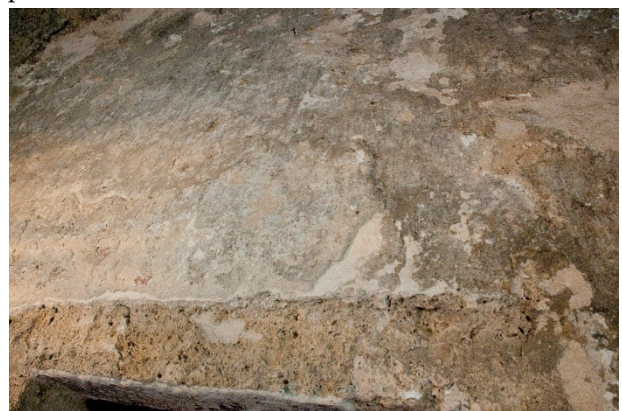
Figure 6.B.25: 104 A—Corridor. South wall (B2, B3), at least two layers of plaster are visible in the architrave of the door leading to the refectory. The area with no plaster on the architrave indicates that it was covered by a door frame, probably removed during some restoration work.

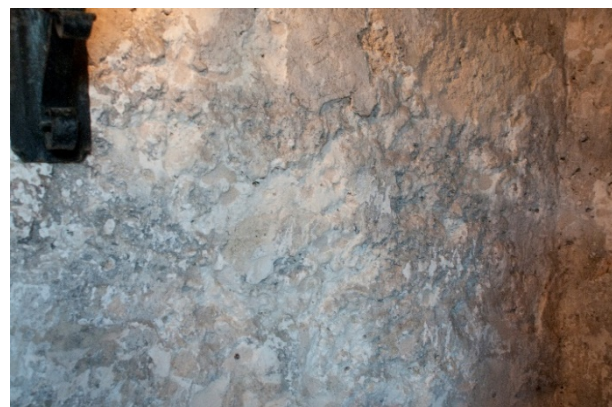
Figure 6.B.26: 104 A—Southern corner of the east wall (B18). The wall has different layers of plaster, and it features differential erosion of the painted plaster, detachment of edges, and graffiti.

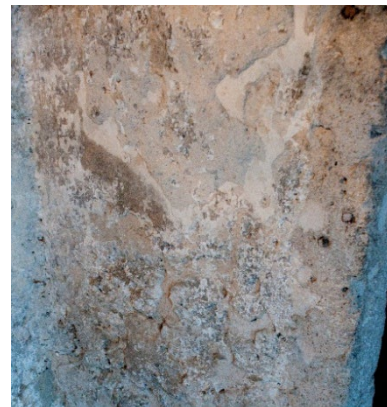
Figure 6.B.27: 104 A—South wall (A1), left part of the door. At the top of the picture two layers of plaster are observed featuring detachment and differential erosion. At the bottom part of the picture there is limewash directly applied to the tufa rubble stone.

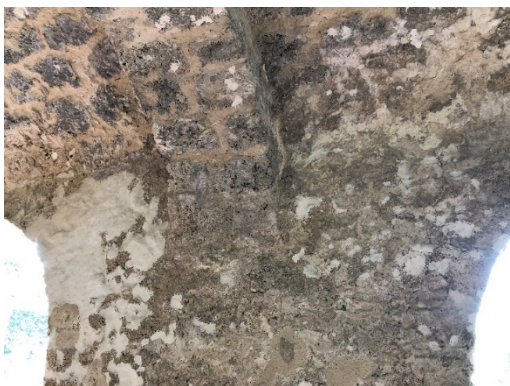
Figure 6.B.28: 104 A—West wall (C10, C11, C12), showing natural hydraulic lime-based mortar patchings that are compatible with the masonry but visually intrusive.

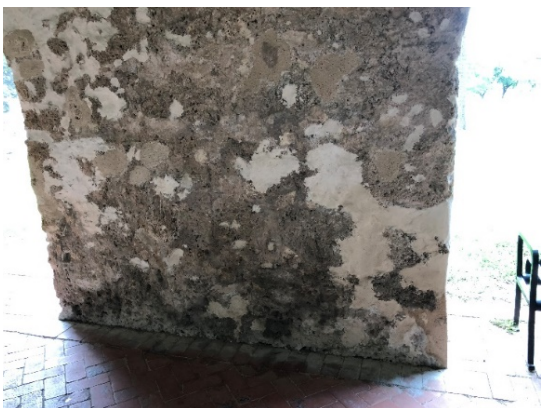
Figure 6.B.29: 104 A—West wall (A10, A11, A12, B10, B11, B12). Different types of mortar patching are visible: brown mortar and natural hydraulic lime-based mortar. Both are visually contrasting.

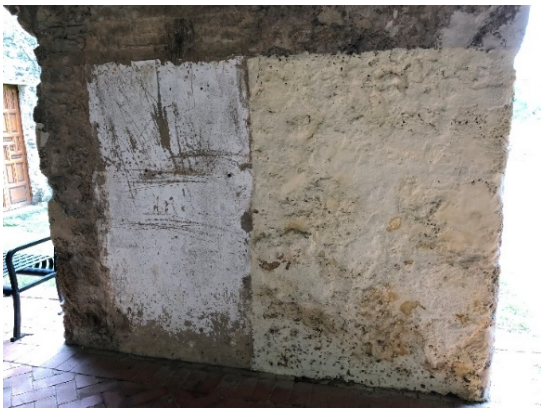
Figure 6.B.30: 104 A—West wall (A5, A6, A7, B5, B6, B7). Modern concrete patch and wash (left) and shelter coats of three layers (right). There are also natural hydraulic lime-based patchings (upper right corner of the image) which are compatible with the masonry but visually intrusive.

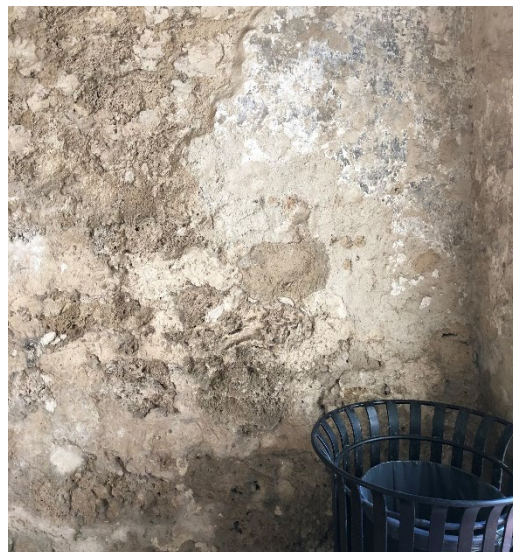
Figure 6.B.31: 104 A—Northern corner of the west wall (A18, B18). Powdering and differential erosion of the historic plaster.

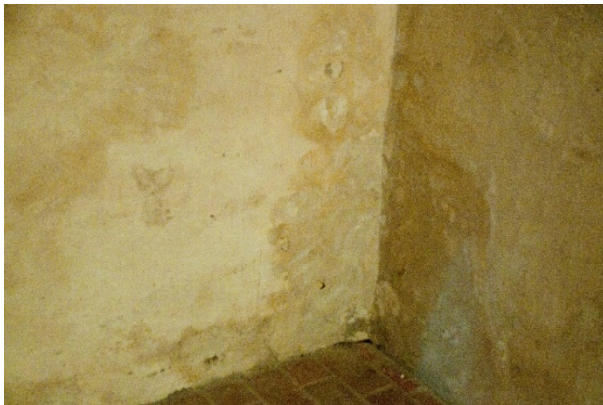
Figure 6.B.34: 104 B—North wall general view. The whole wall was replastered probably in the 1930s. It features a nice graffiti (located in the red box placed on the photo by the HSR team) representing a boat.

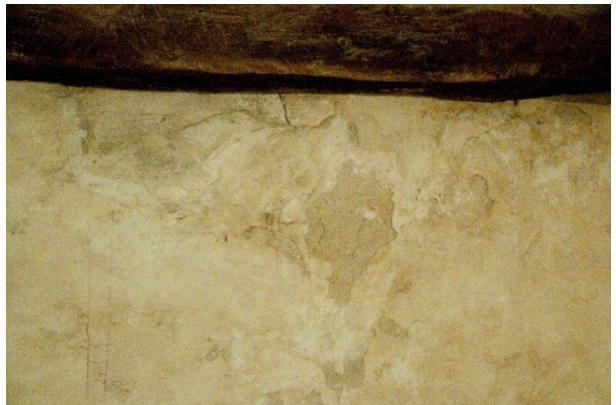
Figure 6.B.38: 104 B—North wall details (bottom photo, B2). Photos showing missing parts and detachment of edges of the historic plaster. In the upper photo we can see the addition of a plaster patching. The lower photo features detachment of edges of the plaster, patching, and efflorescence.

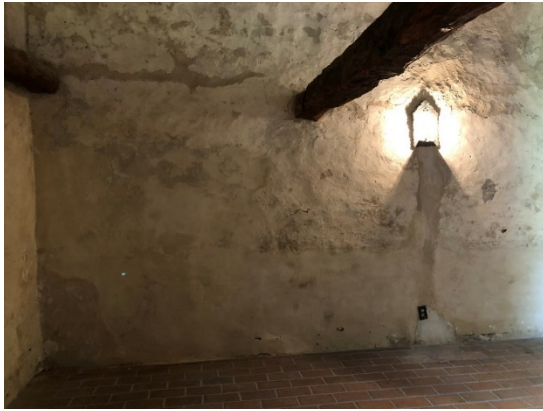
Figure 6.B.39: 104 B—East wall. The bottom part of the wall has been repaired with plaster patching, and it features efflorescence in the left corner.

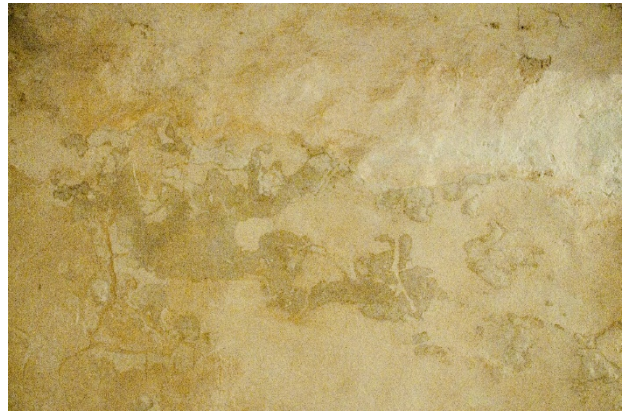
Figure 6.B.40: 104 B—East wall (B6, B7). Area in between the two timber beams. Plaster patching repair was added until this point, which also features a high level of humidity.

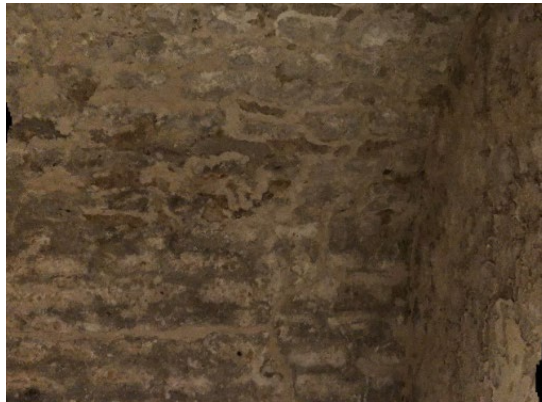
Figure 6.B.41: 104 B—Southeast area of the ceiling (C1, D1). Features efflorescence, repointed mortar joints roughly executed.

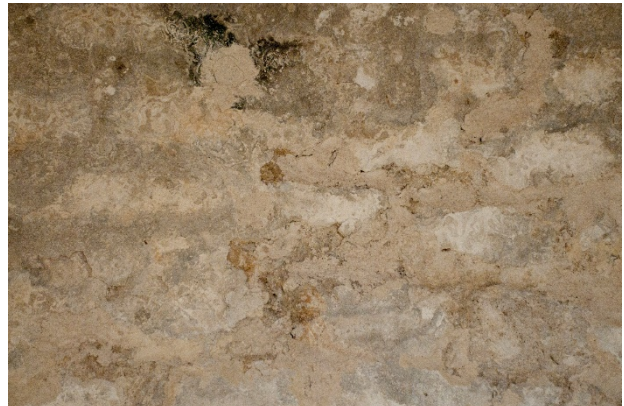
Figure 6.B.42: 104 B—Southwest part of the ceiling (H5). Features differential erosion on the remnants of historic plaster and different types of mortar patching.

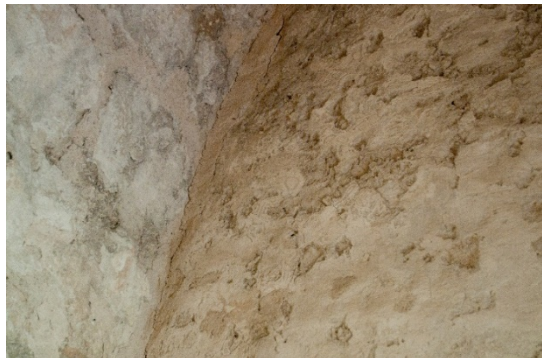
Figure 6.B.43: 104 B—Southeast corner (C4, D4). Features hair cracks in the corner plaster patching (which was probably added to repair a structural crack), and differential erosion of the historic plaster in the south wall.

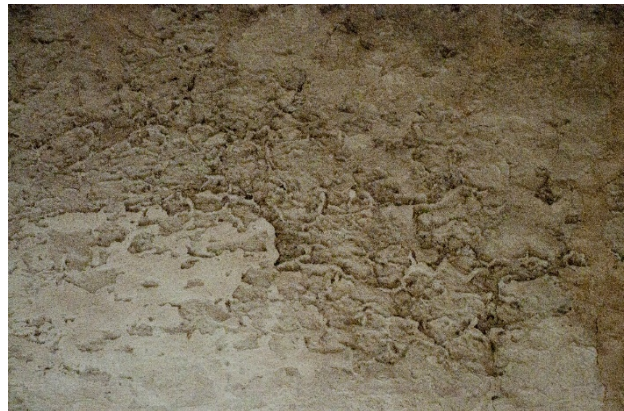
Figure 6.B.44: 104 B—South wall detail (D2, D3). The south wall of the storeroom has an extensive differential erosion of the plaster.

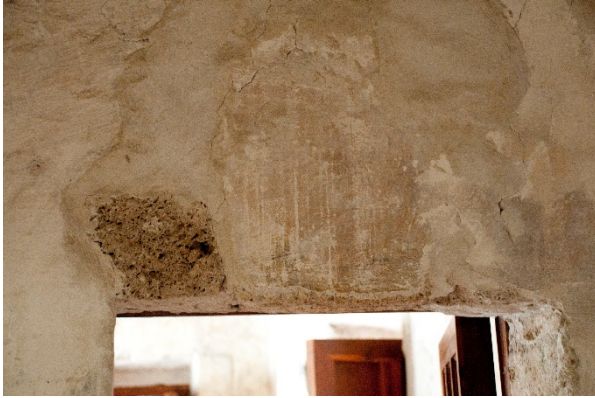
Figure 6.B.45: 104 B—South wall (B1, C1). Architrave of the door connecting with the porteria. Historic plaster featuring erosion, hair cracks, plaster patching, and historic incised patterns.

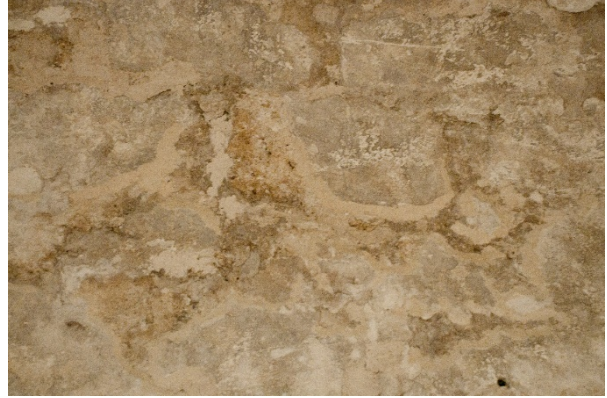
Figure 6.B.46: 104 B—Southwest part of the ceiling (D6, D7). Features differential erosion of plaster stabilized in a previous conservation campaign.

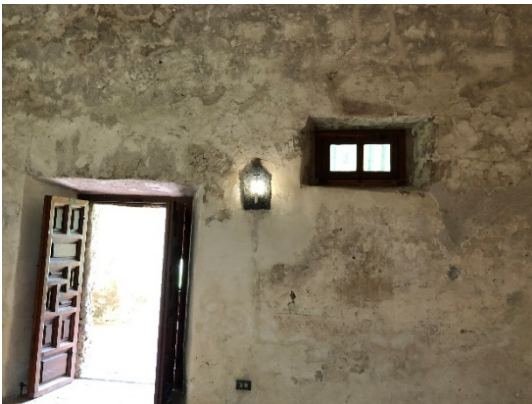
Figure 6.B.47: 104 B—West wall. Featuring plaster patching below the light and at the bottom of the wall, discoloration and graffiti below the window, and small remnants of painted plaster around the small window.

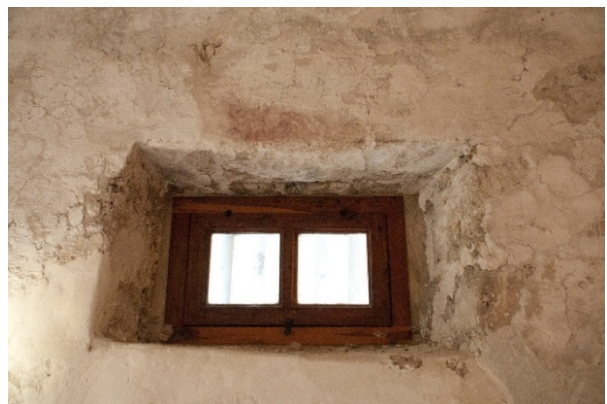
Figure 6.B.48: 104 B—West wall window detail (B4, C4). Detail of the remnants of painted plaster in the upper part of the window.

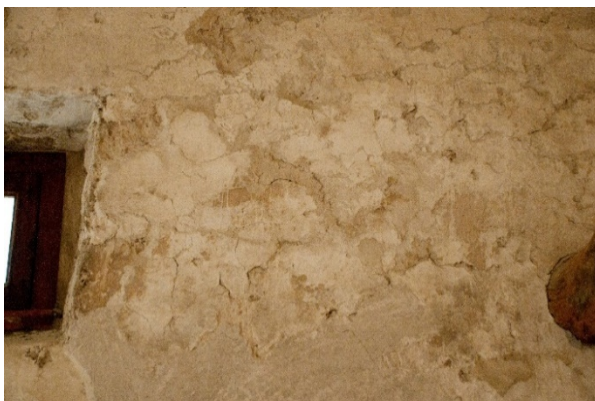
Figure 6.B.49: 104 B—West wall (B3, C3). Part between the small window and the southern timber beam features craquelé and differential erosion of the historic plaster.

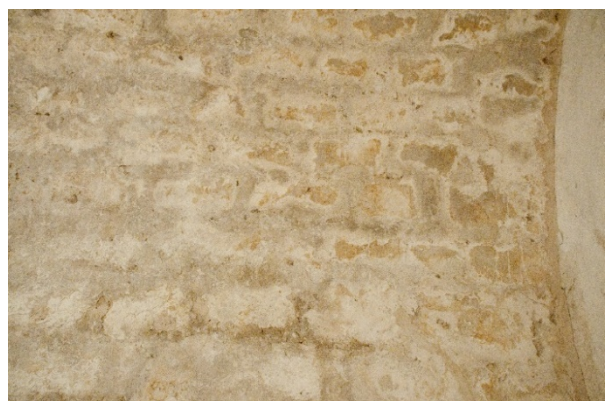
Figure 6.B.50: 104 B—Northwest part of the ceiling (C1, D1). Restoration mortar joints show discoloration due to efflorescence.

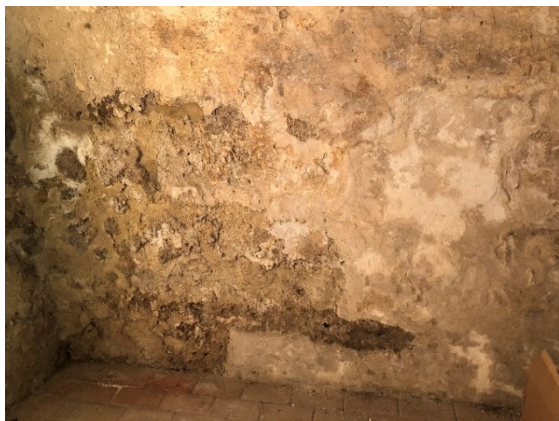
Figure 6.B.51: 104 C—Northern corner of the east wall (A6, A7, B6, B7). Surfaces feature a high level of deterioration with loss of plaster and abundant fluffy efflorescence.

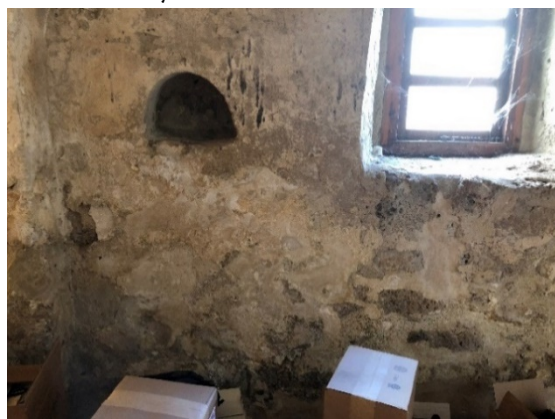
Figure 6.B.53: 104 C—East wall (A3, A4, B3, B4). High level of surface decay with efflorescence. Below the window sill are visible two major fractures around which mortar joints were repointed.

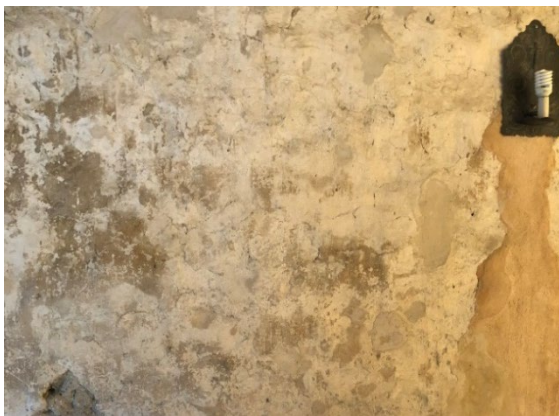
Figure 6.B.54: 104 C—West wall (B2, B3). In general the west wall is in better condition than the east, extensive craquelé, detachment of plaster from substrate, and numerous patchings of various dimensions.

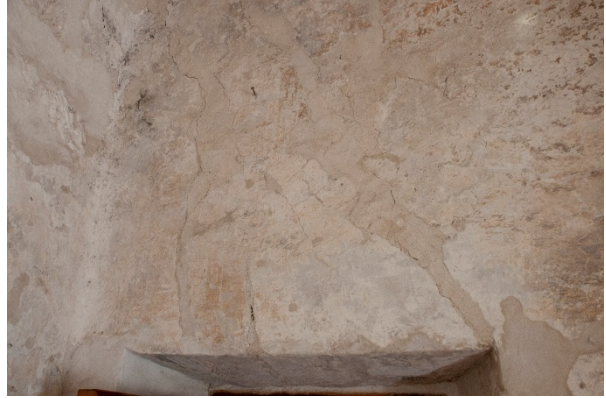
Figure 6.B.57: 104 D Portería—North wall (B4, C4). Architrave of the door leading to the storeroom. Features hair cracks in the patching plaster (probably added to repair a structural crack) and erosion of the painted plaster.

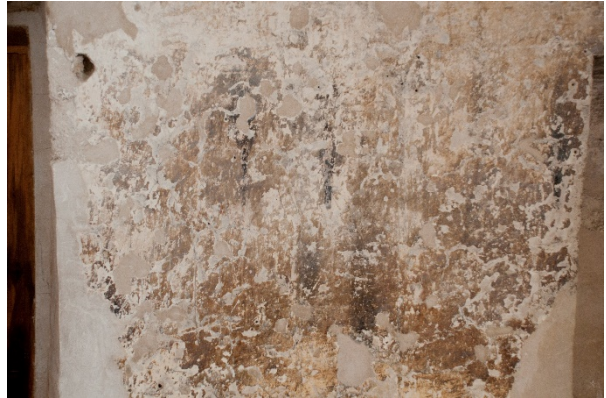
Figure 6.B.58: 104 D—Area between the door and the niche in the north wall (B3) features historic dark ochre colors and vertical black marks with dirt deposit. Small areas of visually intrusive patching.

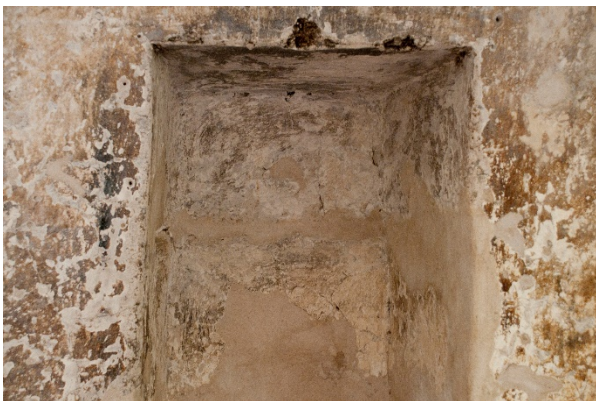
Figure 6.B.59: 104 D Portería—Niche of the north wall (B2). Features hair cracks and plaster patching inside the niche, and erosion of the painted plaster outside the niche.

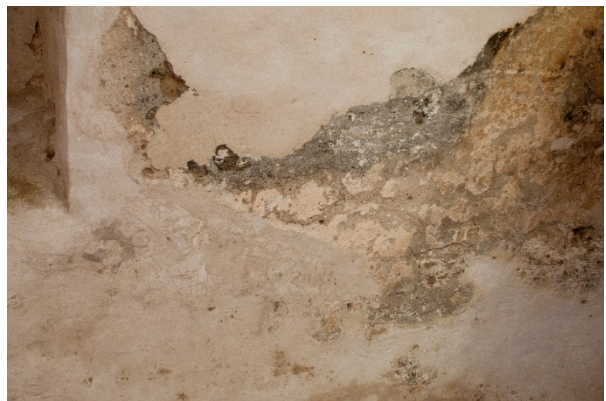
Figure 6.B.60: 104 D Portería—North wall, area right of the niche (A1, A2). Remnants of colored historic plaster that is highly eroded and numerous visually intrusive patches.

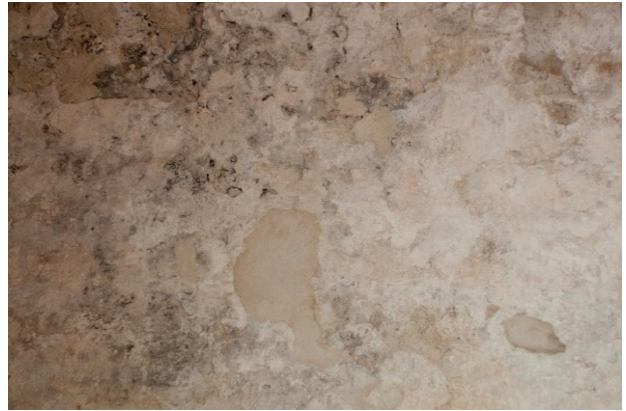
Figure 6.B.62: 104 D Portería—North part of the east wall (C4, C5). Visually intrusive patches are visible, surrounded by eroded historic plaster.

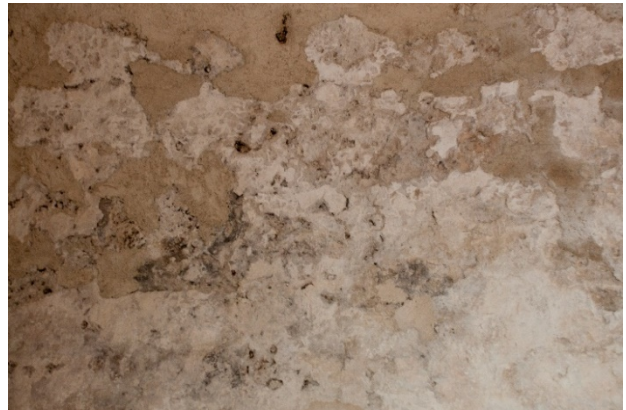
Figure 6.B.63: 104 D Portería—North part of the east wall (D4, D5) features discoloration and differential erosion of the plaster and intrusive brownish patchings.

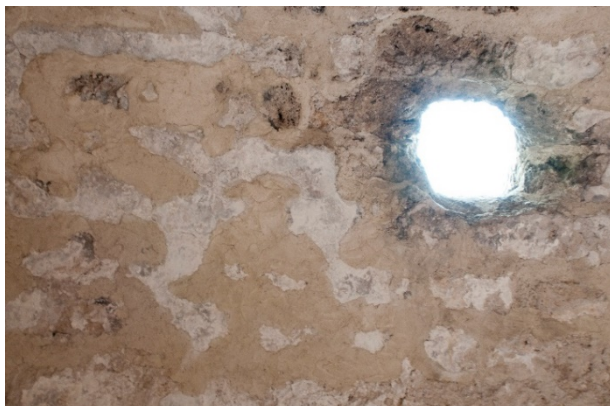
Figure 6.B.64: 104 D Portería—Ceiling (G2, G3) features remnants of historic plaster with efflorescence and roughly executed brown mortar repointing that partially covers the stone.

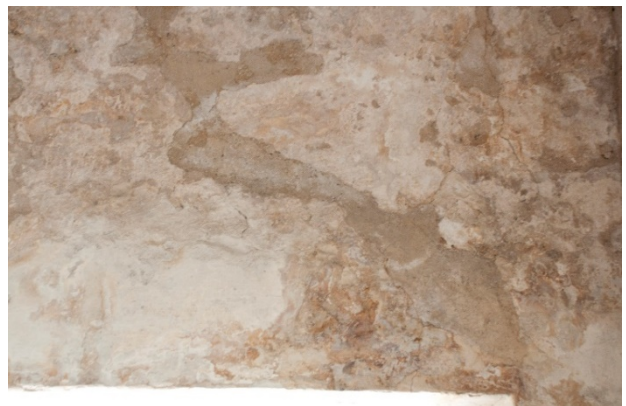
Figure 6.B.65: 104 D—East wall (C1), architrave of the door features eroded remnants of colored plaster and a visually intrusive plaster patching.

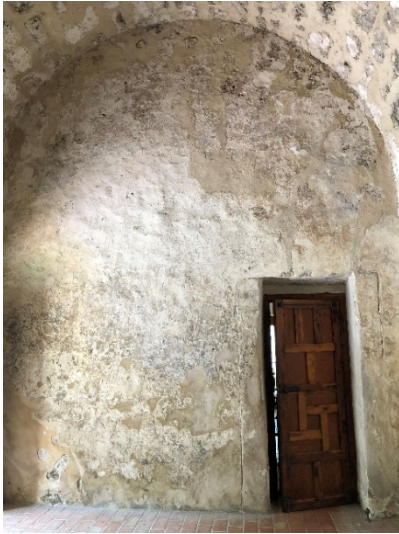
Figure 6.B.66: 104 D Portería—South wall. Historic plaster features large areas with differential erosion, the door architrave has a crack in the center.

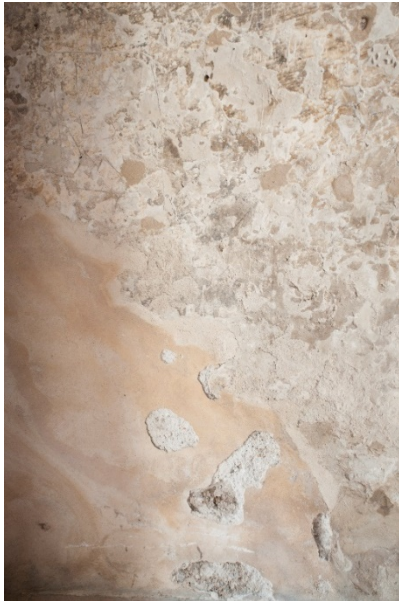
Figure 6.B.68: 104 D Portería—Left corner of the south wall (A3, A4). At the bottom left part of the image, blistering, efflorescence and detachment of the patching are visible. And at the upper right we see historic plaster featuring discoloration, differential erosion, and graffiti.

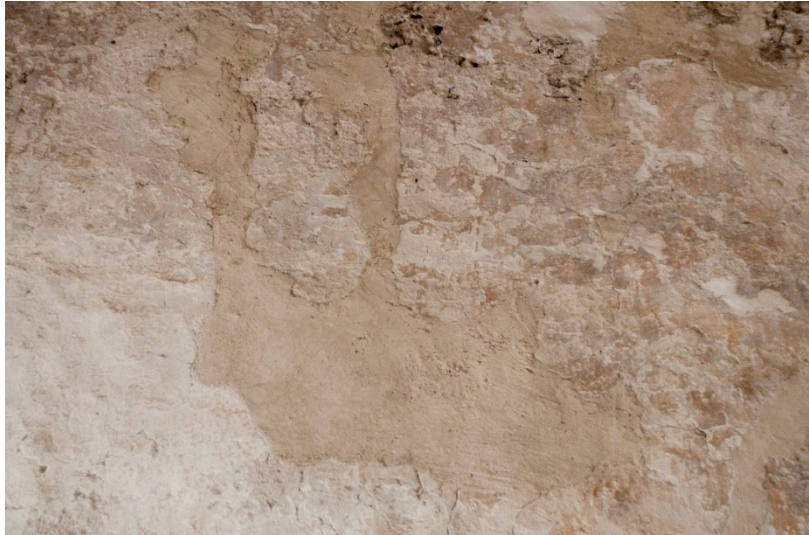
Figure 6.B.69: 104 D Portería—Upper part of the south wall (C2, D2). Showing plaster patching and discoloration and erosion of the historic plaster.

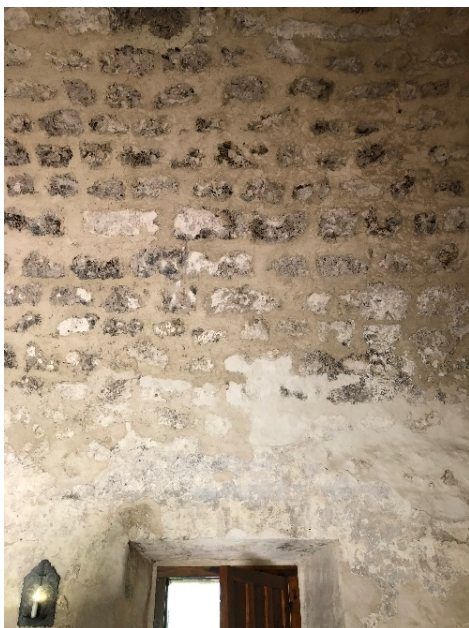
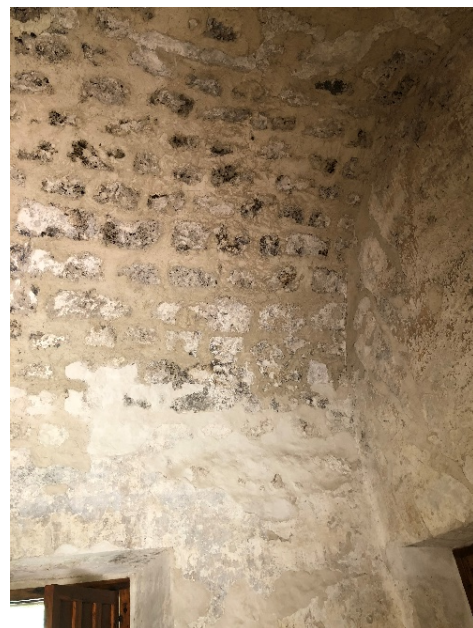
Figures 6.B.72, 6.B.73: 104 D Portería—Portions of the barrel-vaulted ceiling feature a surface made of roughly cut blocks with modern repointing of the joints. Stone blocks are characterized by a darker color, probably due to biological growth. Traces of whitewash are also presents on various blocks.

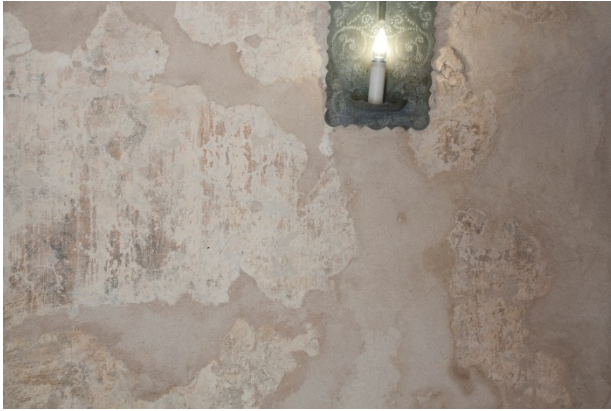
Figure 6.B.74: 104 D Portería—West wall (B4, B5), intrusive patching with discoloration in the edges and colored historic plaster with historic incisions and discoloration.

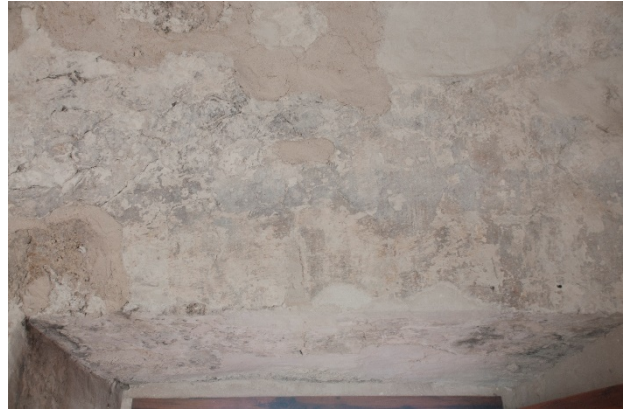
Figure 6.B.75: 104 D Portería—West wall, architrave of the door leading to the corridor (C3, C4). It features craquelé and historic incisions in the historic plaster and different types of patching, one brownish in the upper part of the wall and another more grayish in the architrave of the door.

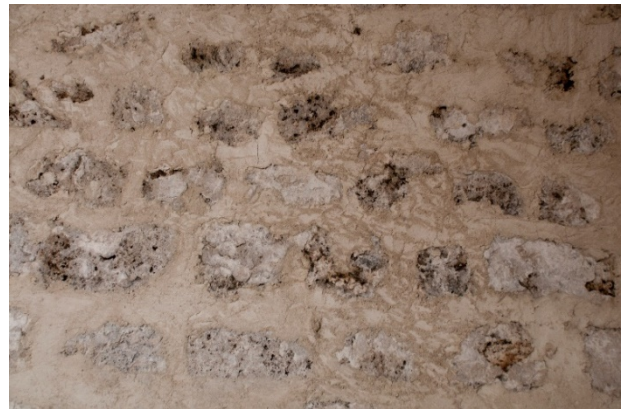
Figure 6.B.76: 104 D Portería—West part ceiling (F4, F5). Roughly executed mortar repointing that partially covers the stones.

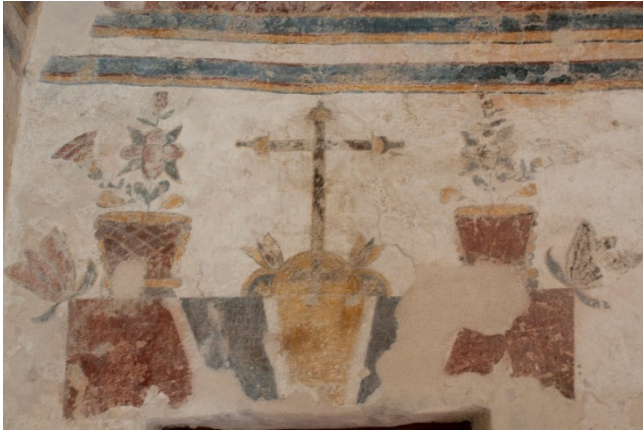
Figure 6.B.78: 104 E Library—North wall (B3, B4, C3, C4). Photo showing the painted decorations around the door that leads to the portería. Some non-intrusive patching has been added to give continuity to the plaster.

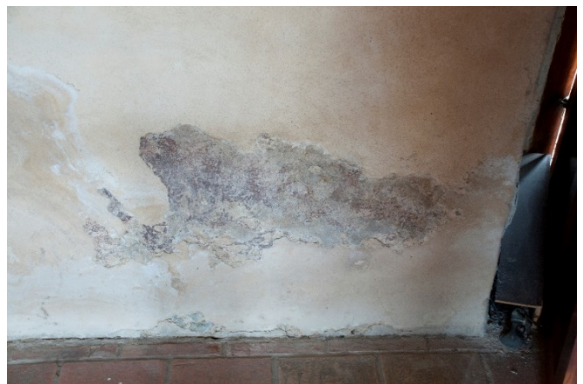
Figure 6.B.82: 104 E Library—East wall (A5). Features plaster patching surrounding the remnants of historic painted plaster. The painted finish show traces of efflorescence and erosion.

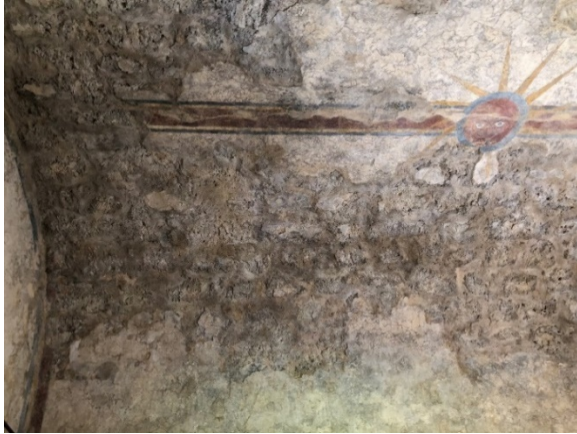
Figure 6.B.83: 104 E Library—On the ceiling, a crack is visible in the middle of the vault from north to south. The vaulted ceiling surface features several craquelé, detachment of edges, and loss of joints on mortar.

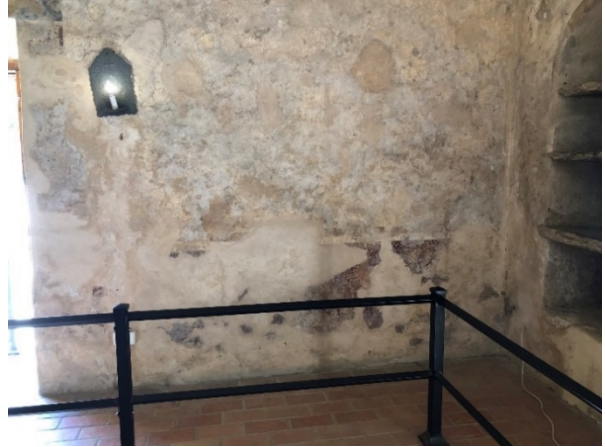
Figure 6.B.84: 104 E Library—East wall. Has multiple patchings. Painted plaster has erosion.

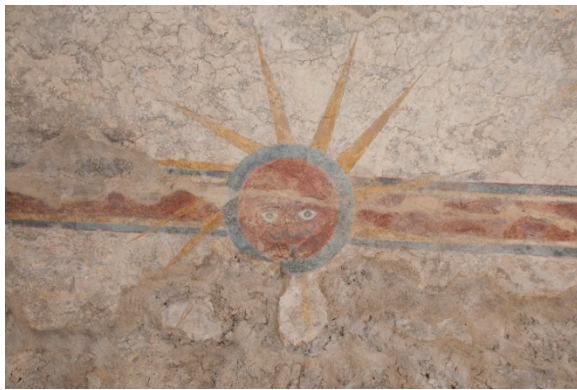
Figure 6.B.85: 104 E Library—Ceiling detail (F4, G4). Detail of the central painted decoration, which is characterized by a filled crack featuring a pinking mortar. A newer hair crack passes across the decoration. Craquelé in the plaster is also visible. Roughly executed mortar repointing covers a little corner of the drawing.

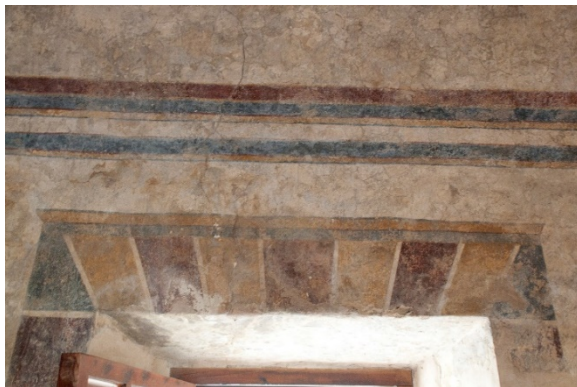
Figure 6.B.86: 104 E Library—Ceiling detail (C3, C4, C5). Decorative painted plaster around the door, representing faux voussoirs, and at the springer line of the vault. A crack in the architrave of the door is visible. Craquelé in the plaster and erosion of the painted finish.

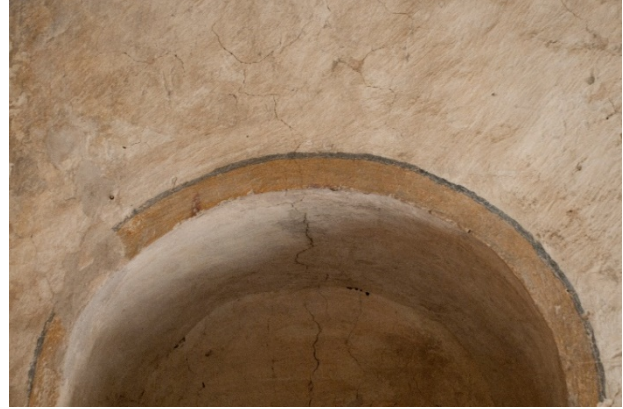
Figure 6.B.89: 104 E Library—South wall (B4, C4). Upper part of the 'bookshelf' niche. It features several hair cracks, including one in the middle of the arch. Discoloration of the historic plaster.

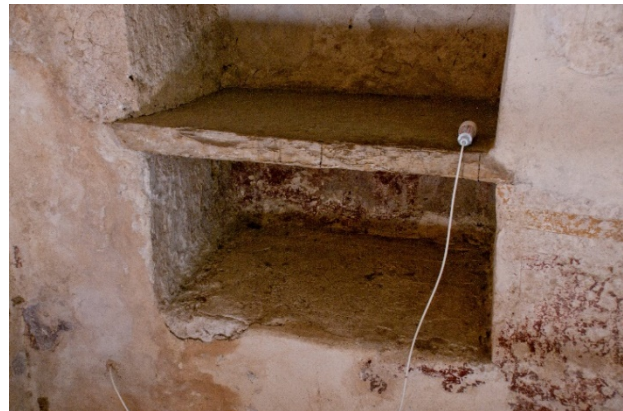
Figure 6.B.90: 104 E Library—South wall (A3, A4). Detachment and discoloration of the brownish patching on the bottom left of the 'bookshelf.' Around and inside the bookshelf there is erosion of the painted finish. All the southeast corner of the library should be an area of concern.

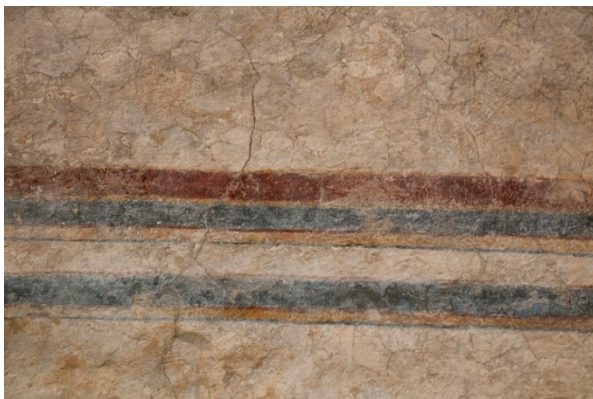
Figure 6.B.91: 104 E Library—South wall (C2, C3). It features decorative colored lines in the springer line of the vault and hair cracks in the historic plaster.

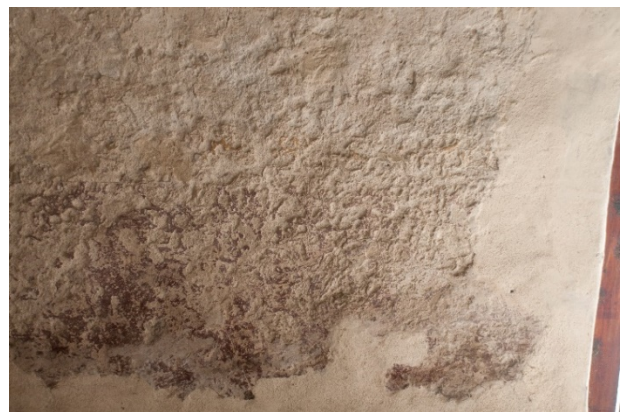
Figure 6.B.92: 104 E Library—South wall (A2). Bottom left corner of the door, showing patching around the jamb of the door and a strong differential erosion of the historic plaster.

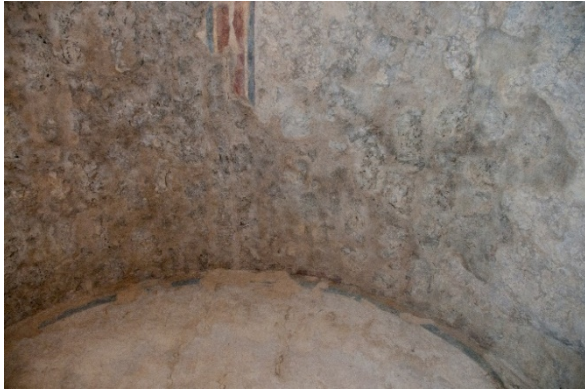
Figure 6.B.93: 104 E Library—South wall, connection of the south wall and the vault. The vault is crossed by a hair crack that goes through the middle, and when it approximates the walls divides in two in a Y shape.

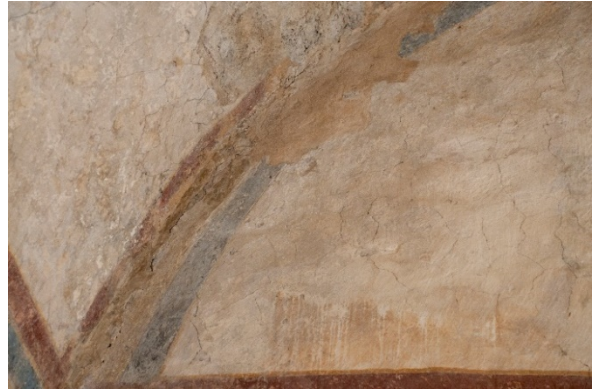
Figure 6.B.94: 104 E Library—South wall (D4), shows hair cracks, discoloration with flow marks, and historic incisions of the plaster. Intrusive brownish patching.

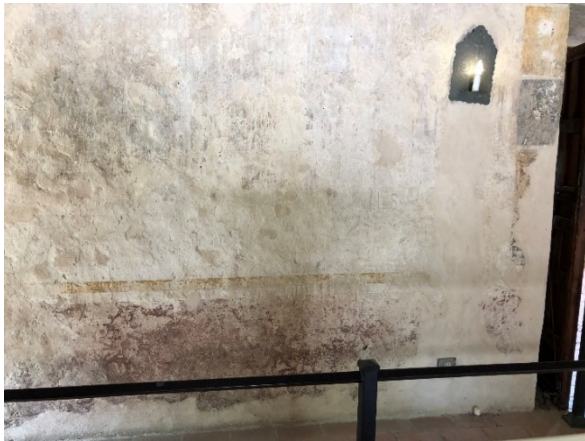
Figure 6.B.95: 104 E Library—West wall, the painted plaster features erosion.

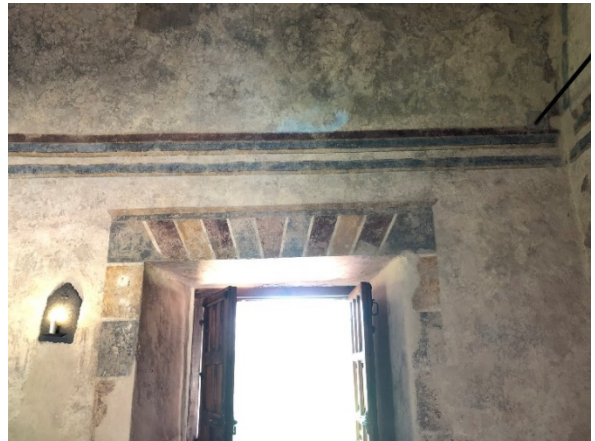
Figure 6.B.96: 104 E Library—West wall, door leading to the corridor, showing patching, craquelé, and erosion of the painted finish.
