National Park Service  
United States Department of the Interior  
San Antonio Missions National Historical Park  
Texas

# Historic Structure Report Mission Concepción Convento

100% Submission  
2019

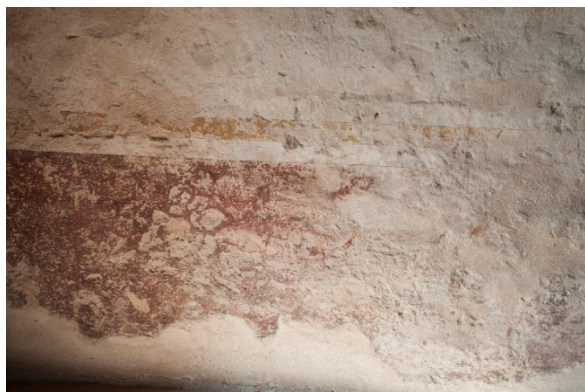
Figure 6.B.97: 104 E Library—West wall (A6). Bottom area of the wall features geometric decorative painted plaster (red and yellow) with well-executed plaster patching and differential erosion of the plaster surface.

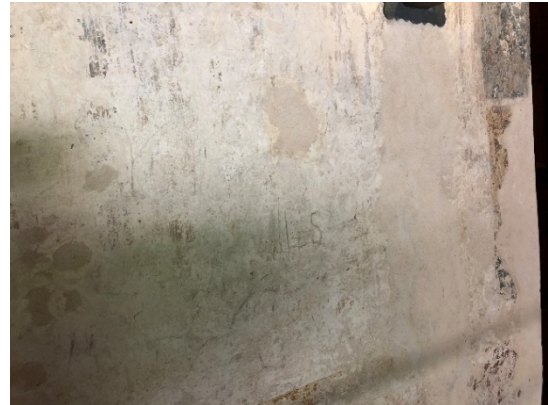
Figure 6.B.98: 104 E Library—West wall (A4, B4). Area on the left of the door. Visually intrusive patching under the modern lamp, historic incisions, and graffiti in the painted finish.

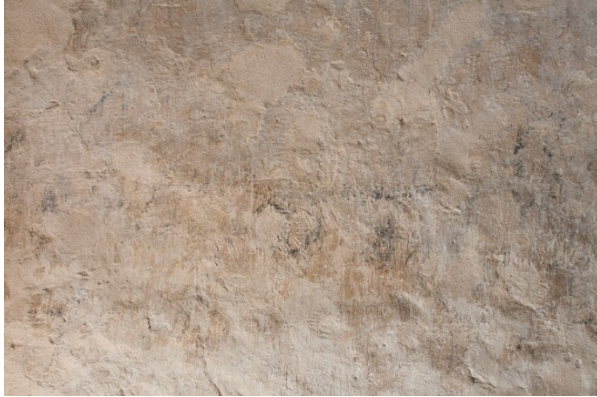
Figure 6.B.99: 104 E Library—West wall (B6). Its surface features well-executed and visually compatible patching, discoloration and historic incisions of the painted finish.

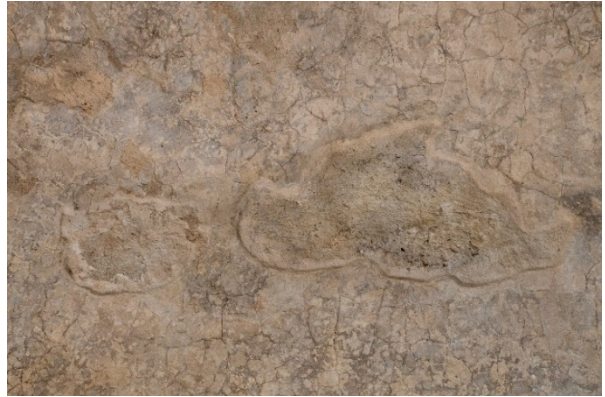
Figure 6.B.100: 104 E Library—West wall (D5). Craquelé of the historic plaster stabilized in one of the previous conservation campaigns. Intrusive brownish mortar patching.

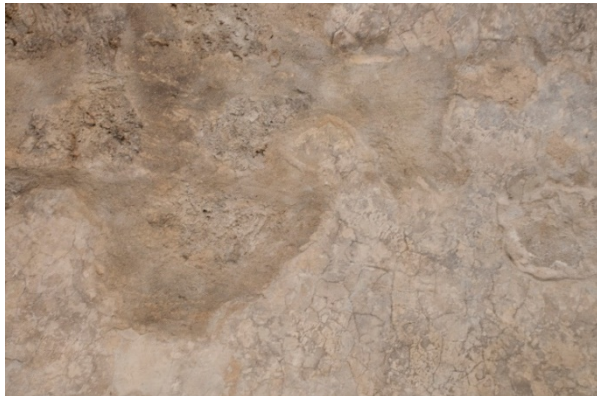
Figure 6.B.101: 104 E Library—West wall (D6). Craquelé of the historic plaster and roughly executed mortar repointing on the masonry of the vault, partially covering the stones.

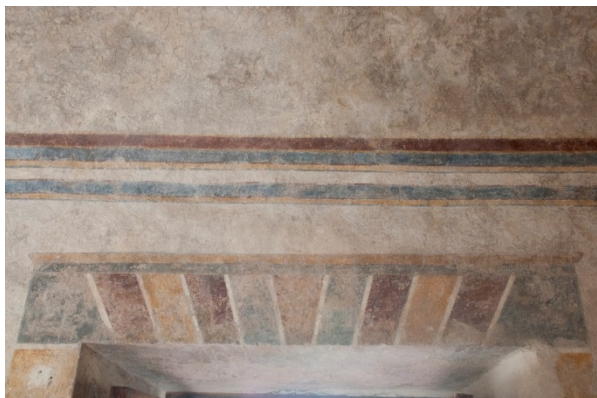
Figure 6.B.102: 104 E Library—West wall (C2, C3). Detail of the painted faux voussoirs above the door and painted architectural bands at the vault's springer line. They feature erosion of the painted finish and discoloration.

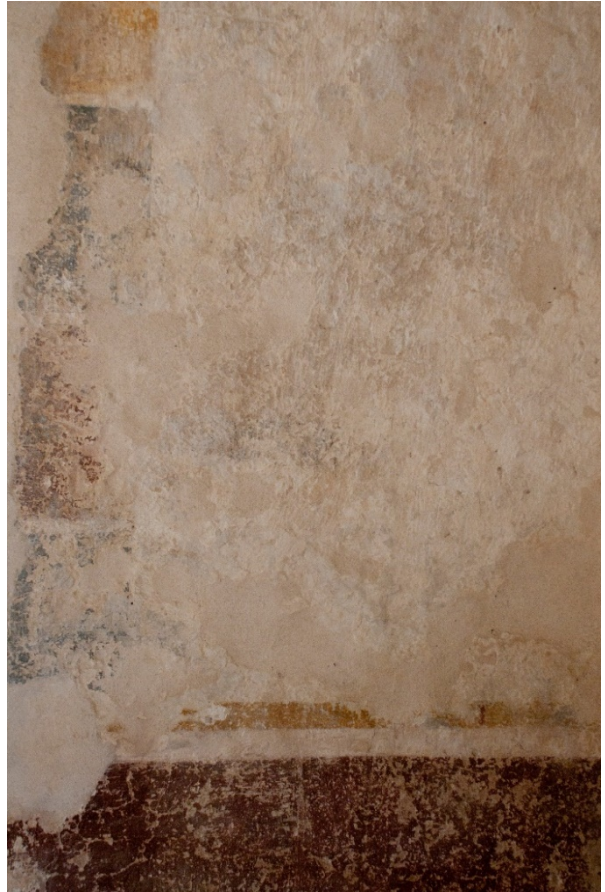
Figure 6.B.103: 104 E Library—West wall (A1, A2). Area on the right of the door. Decorative painted plaster with faux ashlar at the right jamb of the door. Two types of patching are featured—one visually harmonious that allows the visual continuity of the wall surface and another, with a more grayish tone, that is not visually blended.

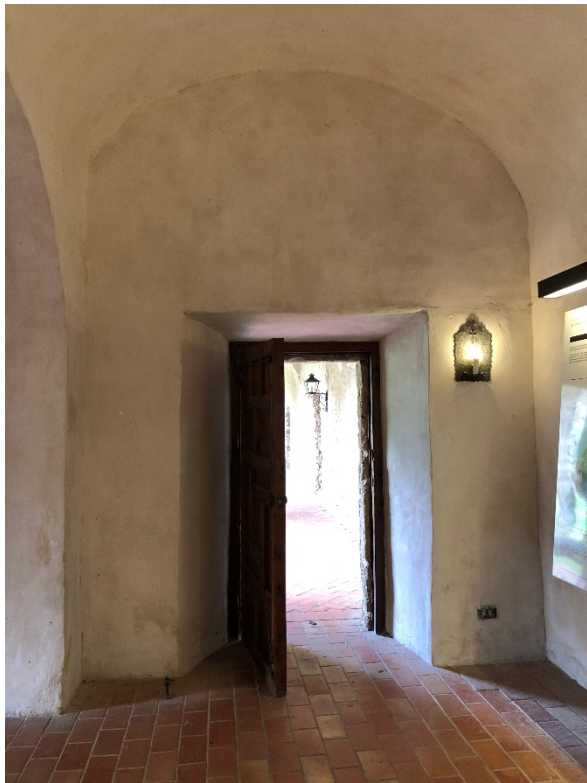
Figure 6.B.104: 104 F Refectory—North wall. Modern plaster covers the wall surfaces of the refectory.

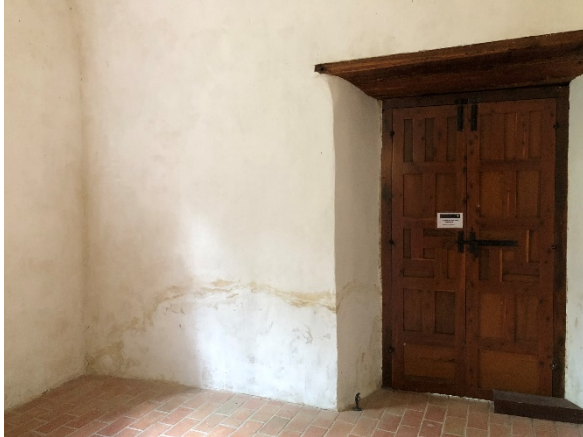
Figure 6.B.108: Room 104 F Kitchen—North wall toward the west corner. Rising damp up to approximately 2½ ft. produced erosion and detachment of the modern paint layer.

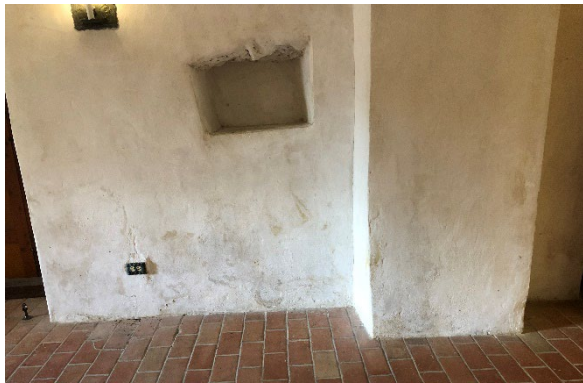
Figure 6.B.110: Room 104 F Kitchen—North wall. Stains due to moisture, likely the result of both rising damp and water ingress from the door during rain season.

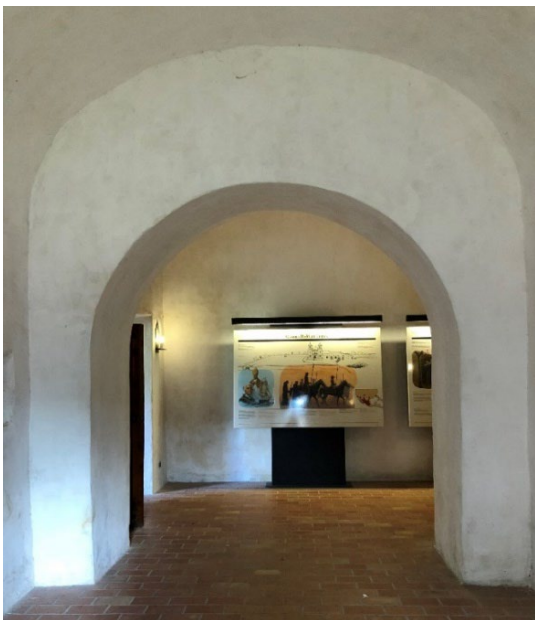
Figure 6.B.112: Room 104 F Kitchen—East wall featuring an arch opening as a connection to the refectory. Modern surfaces are in fairly good condition.

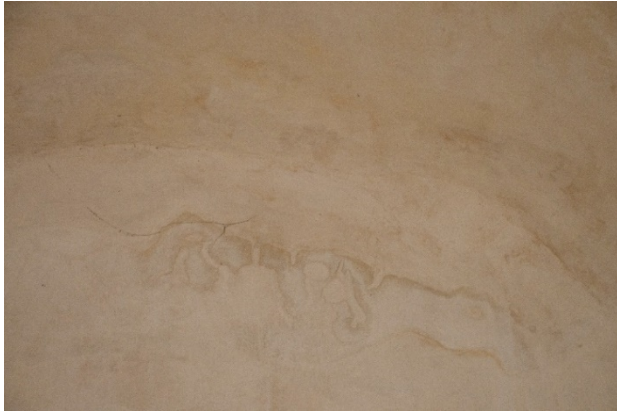
Figure 6.B.113: 104 F Refectory—South wall. Stain due to water infiltration from the roof and wall.

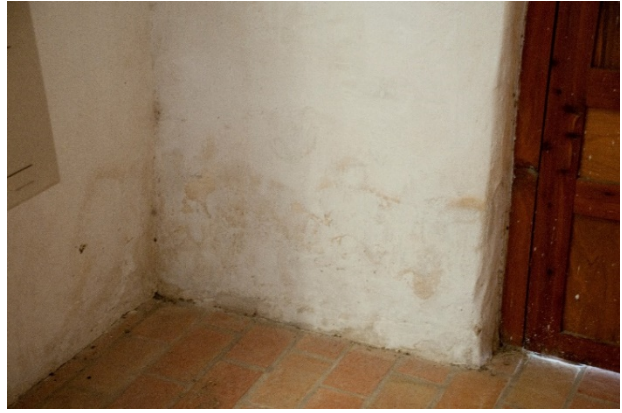
Figure 6.B.114: 104 F Refectory—South wall. Rising damp in the wall, which produces stains.

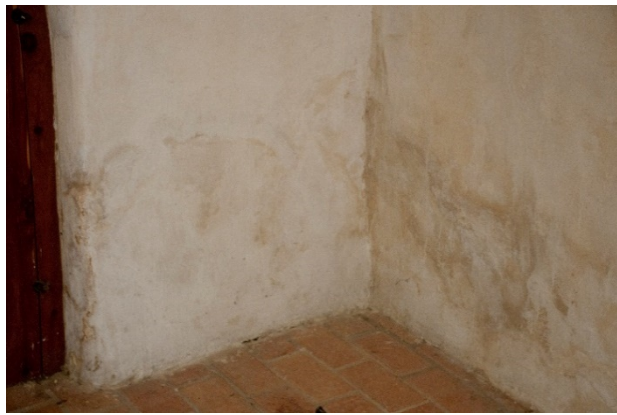
Figure 6.B.115: 104 F Refectory—South wall. Rising damp produces erosion of the plaster finishes, associated with stains. Stains produced by the presence of iron and manganese in the water composition.

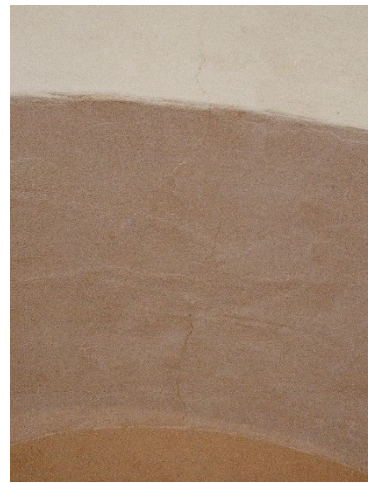
Figure 6.B.116: 104 F Kitchen. Hair crack in the middle of the arch in between the refectory and the kitchen.

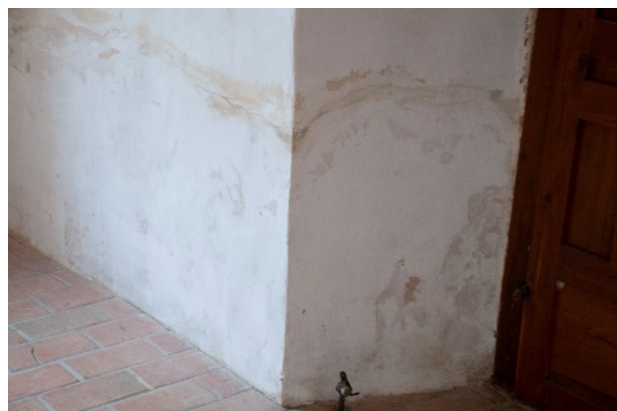
Figure 6.B.117: 104 F Kitchen. Rising damp in the wall, which produces stains and erosion of the surface.

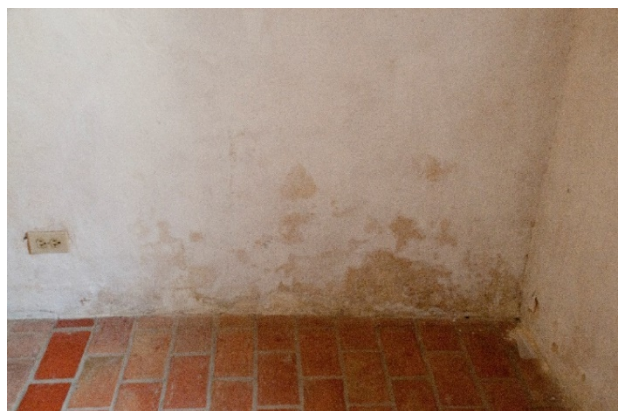
Figure 6.B.118: 104 F Kitchen. Rising damp in the wall, which produces stains and erosion of the surface.

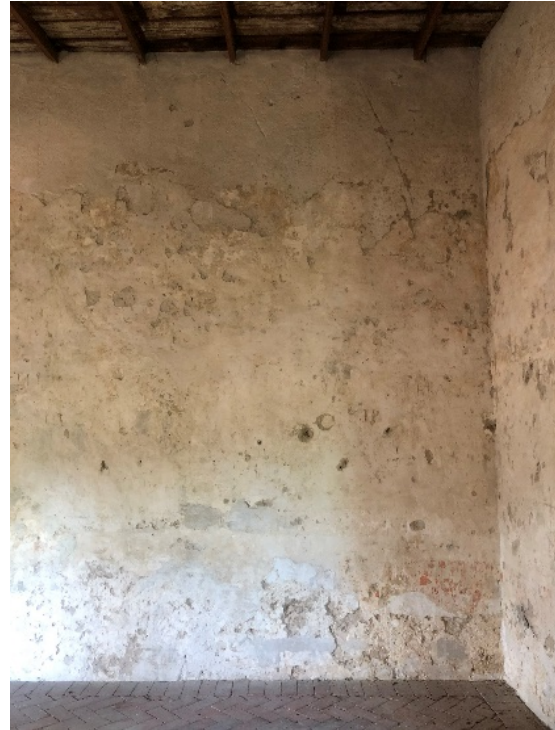
Figure 6.B.120: North wall. Remnant of red pigments are visible on the wainscot area at the northeast corner.

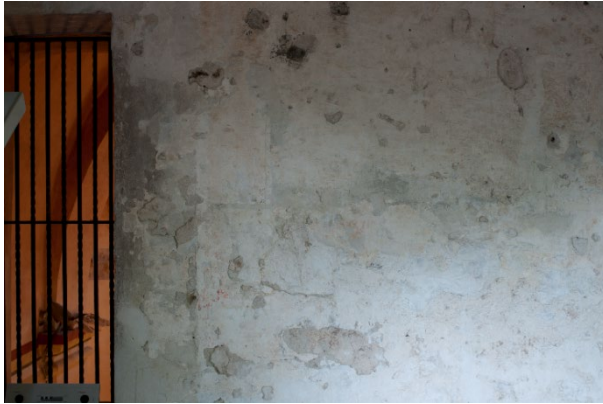
Figure 6.B.126: North wall (B5, B6). The area features numerous missing parts of the plaster.

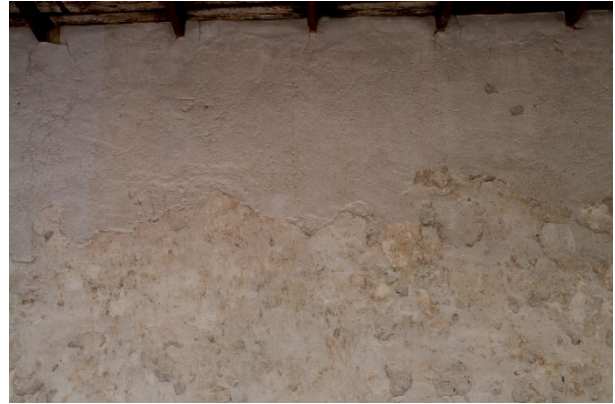
Figure 6.B.127: North wall (D4, D5). Shows the meeting point of the historic plaster and the latex paint from 1980s.

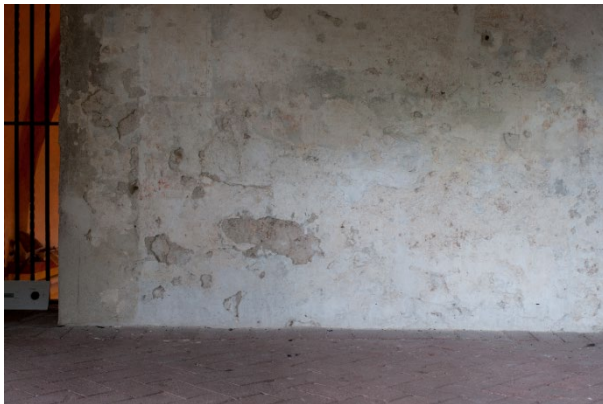
Figure 6.B.128: North wall (A4, A5, A6). Exhibits missing parts, differential erosion of the plaster and patching on the jamb of the door.

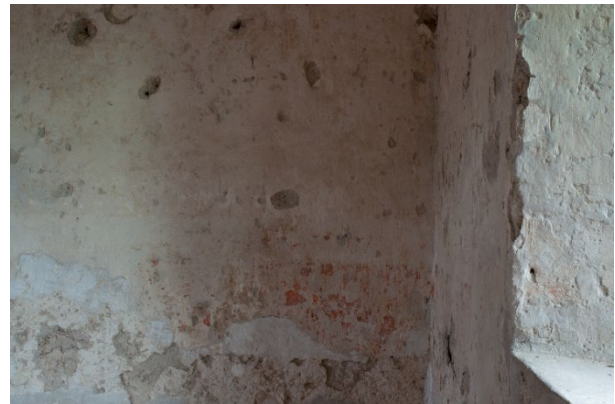
Figure 6.B.129: North wall (A1, B1). Shows the remnant of painted plaster in a red/orange color. The surface features erosion of the painted finish and historic graffiti.

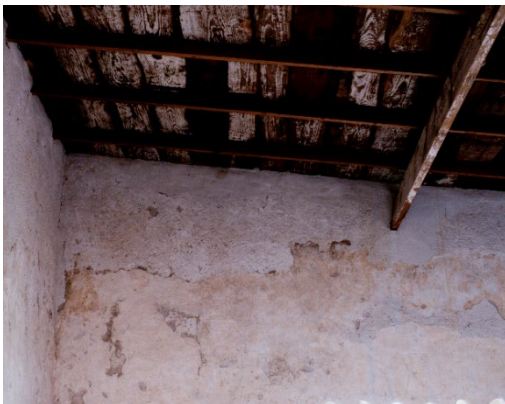
Figure 6.B.130: East wall (D4, D5, E4, E5). A crack is visible in the corner of the wall. Under the ceiling is a large area with latex paint.

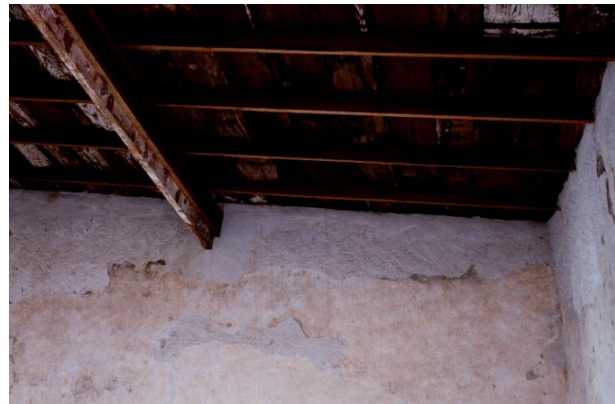
Figure 6.B.131: East wall (D1, D2, D3). Exhibits several visually intrusive patchings.

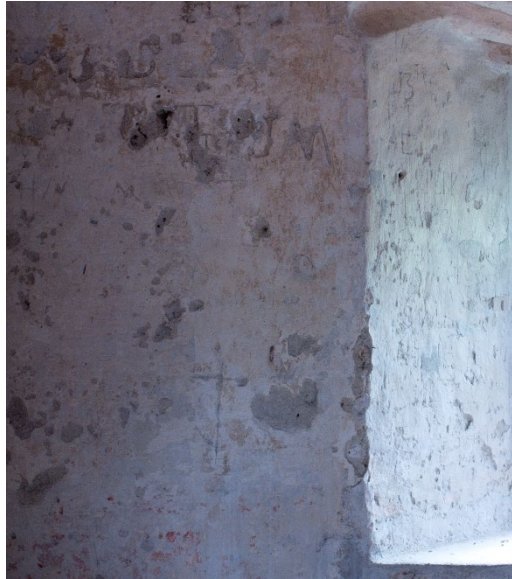
Figure 6.B.132: East wall (B4, B5). Features several intrusive patches, historic graffiti, and painted plaster (red/orange color) on the bottom part.

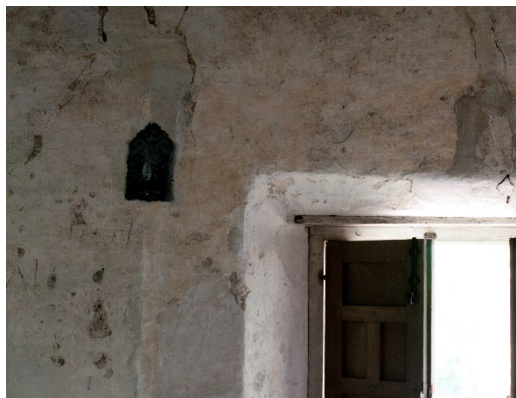
Figure 6.B.134: South wall (B5, C5, C4). Features several cracks, graffiti, and different types of patching.

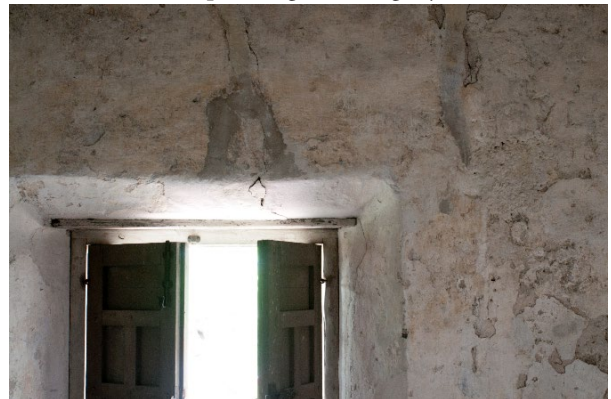
Figure 6.B.135: South wall (C4, C3, B3). Features several cracks, erosion of the painted finish, and missing parts of the plaster.

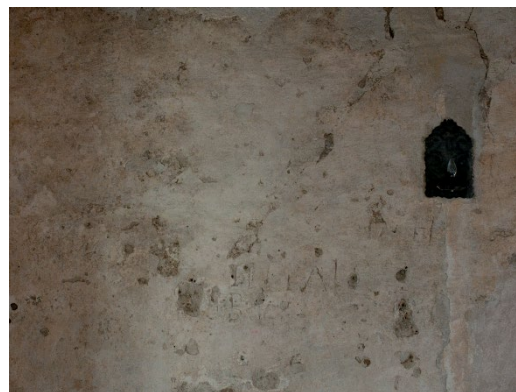
Figure 6.B.136: South wall (B5, B5, C5, C6). Exhibits numerous missing parts, graffiti, and erosion.

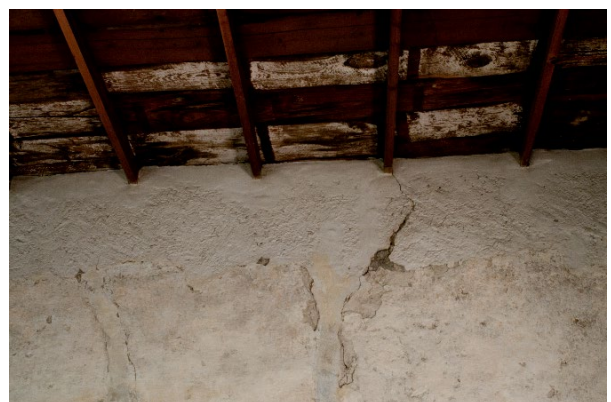
Figure 6.B.137: South wall (D2, D3, D4). Exhibits a crack starting from the wooden rafter and extending downward.

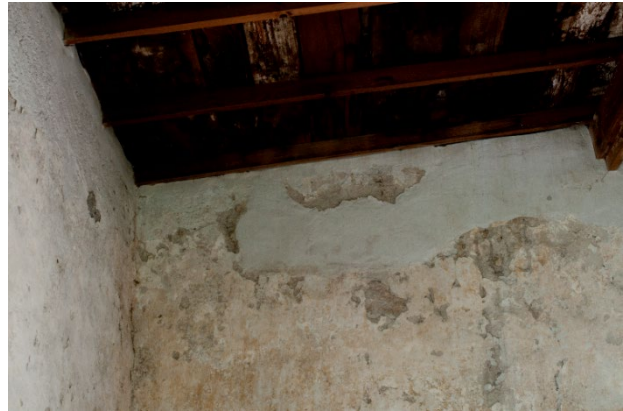
Figure 6.B.139: West wall (D4, D5). Shows the latex paint added in 1980s and erosion of the historic plaster.

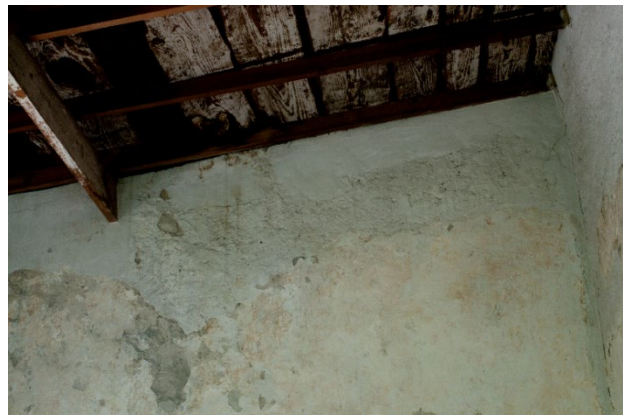
Figure 6.B.140: West wall (D1, D2, D3). Shows the latex paint added in 1980s and erosion of the historic plaster.

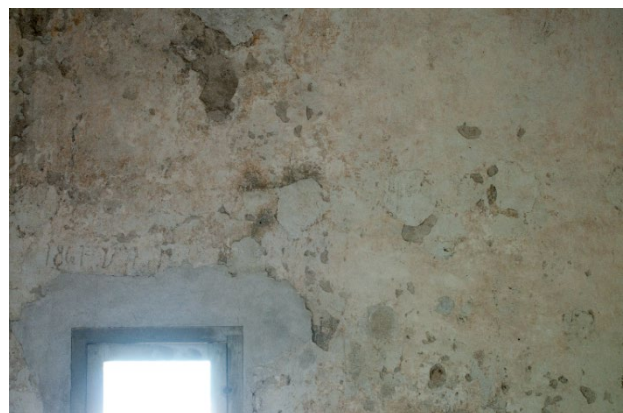
Figure 6.B.142: West wall (B3, B2, C3, C2). Features visually intrusive patching surrounding the window, historic graffiti, and numerous missing part of the painted finish and the plaster.

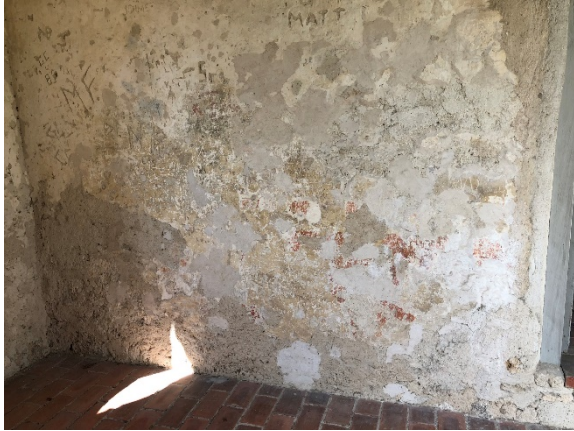
Figure 6.B.147: North wall. West part of the wall, left of the door. The surface features remnant of historic painted plaster (red/orange color), different types of patching, and historic graffiti.

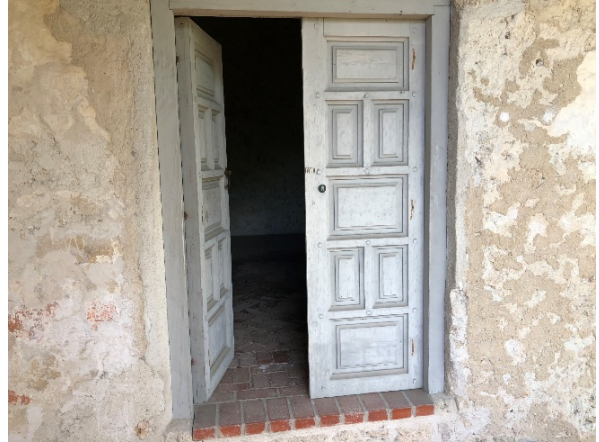
Figure 6.B.148: North wall. Door leading to Father President's office. Features brown mortar patching.

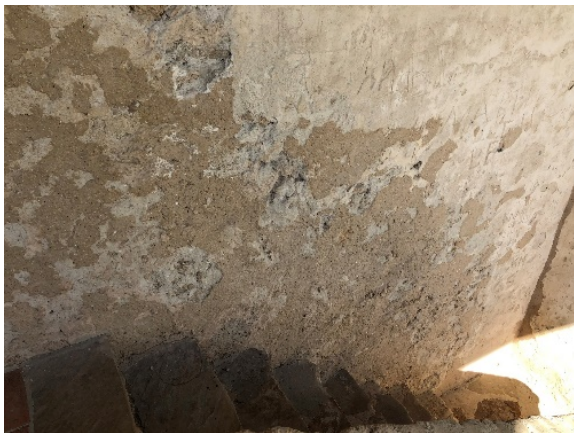
Figure 6.B.149: North wall. East section of the wall, above the stairs. Exhibits several missing parts and brown mortar patching.

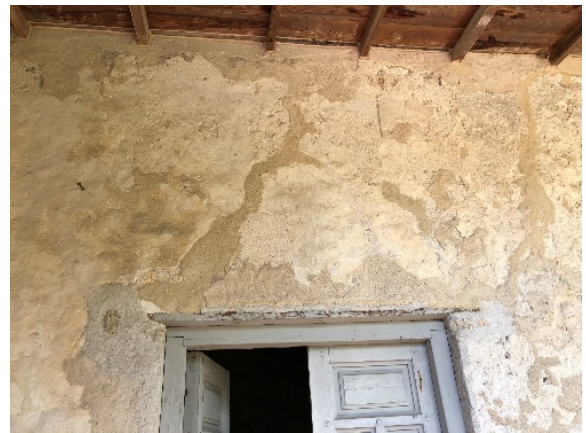
Figure 6.B.150: North wall. Area above the door. The door architrave features a filled crack starting from the left corner.

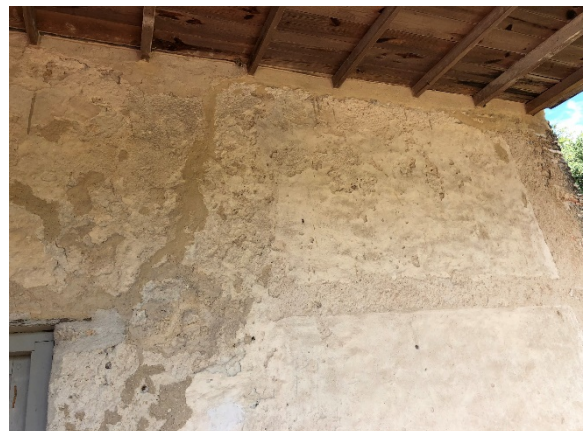
Figure 6.B.151: North wall. Upper east corner. Shows historic graffiti and mortar patching in the shape of a horizontal line.

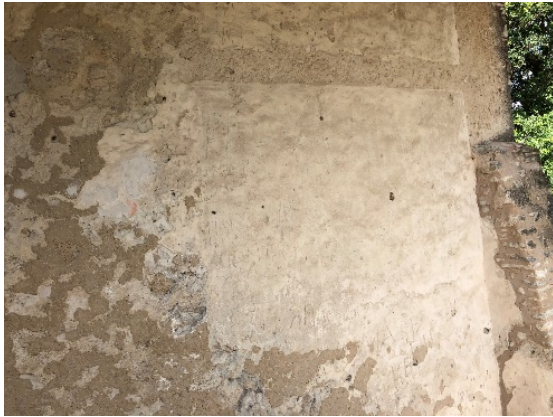
Figure 6.B.152: North wall. East end. Exhibits brown mortar patching in the left side, missing parts, and historic graffiti.

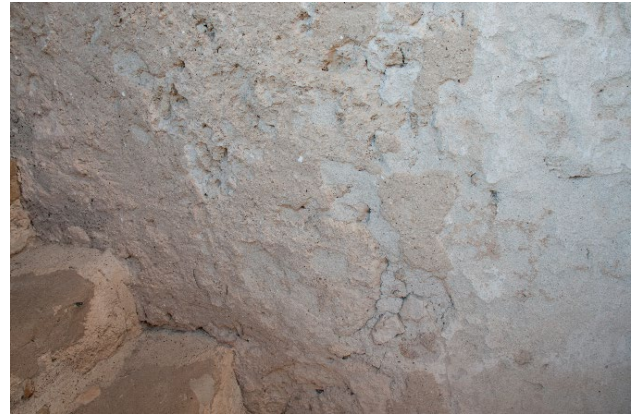
Figure 6.B.153: North wall. East end, view toward the steps. A crack separates the steps from the wall. Patches of different generations cover the wall surface.

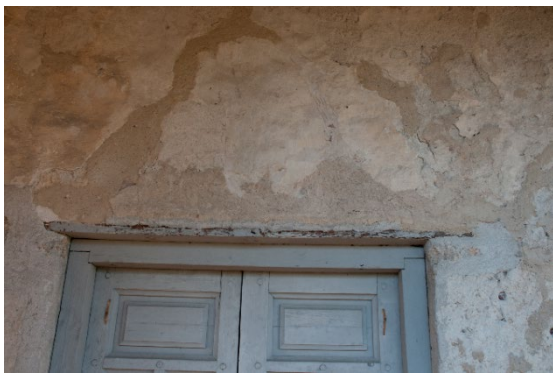
Figure 6.B.154: North wall. Area above the door. Features different types of mortar patching and an old crack that has been filled.

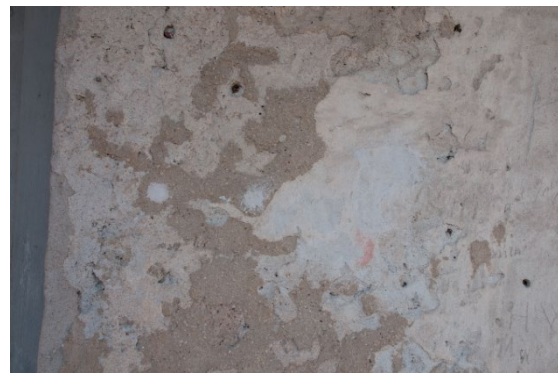
Figure 6.B.155: North wall. Area right of the door. It exhibits different types of mortar patching (one brownish and one grayish), traces of historic painted plaster (red/orange color), historic graffiti, and missing parts.

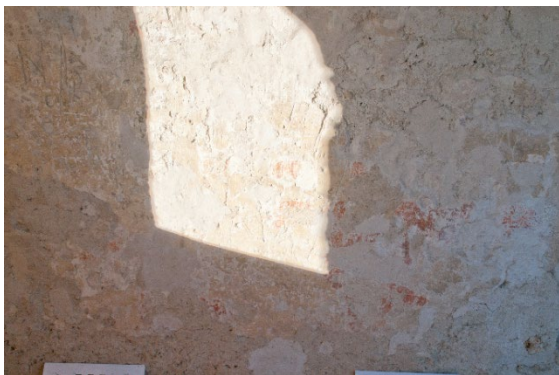
Figure 6.B.156: North wall. Area left of the door. Exhibits remnants of historic painted plaster (red/orange color) and different types of patching and historic graffiti.

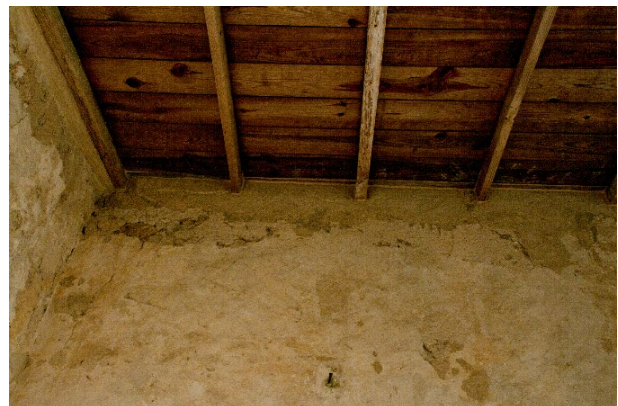
Figure 6.B.157: North wall. Upper left corner. Features a crack going down from the roof rafter, concrete patching on the upper part connecting to the roof, and disintegration of the plaster.

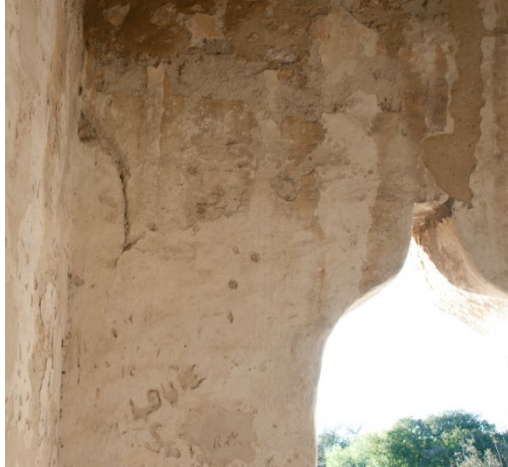
Figure 6.B.158: West wall. Upper left area. Features a crack starting from the corner of the wall, concrete patching in the connection with the roof, and detachment of edges of the plaster.

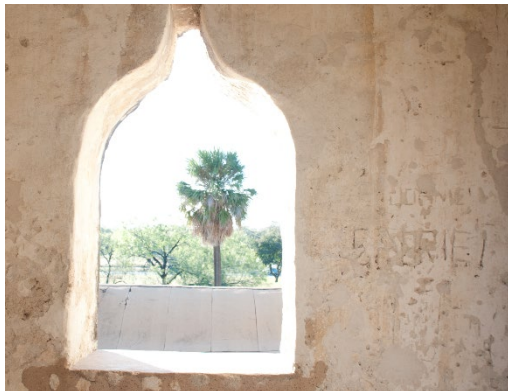
Figure 6.B.160: West wall. Moorish style window. Features different types of patching and historic graffiti.

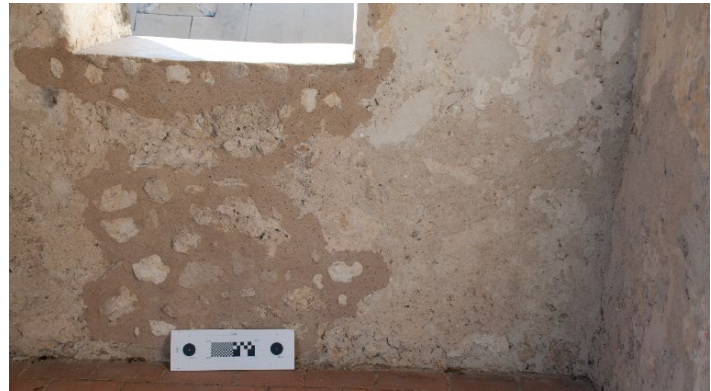
Figure 6.B.161: West wall. Bottom part of the wall under the Moorish style window. It features different types of mortar patches, the large brown patching is unfinished and visually contrasting.

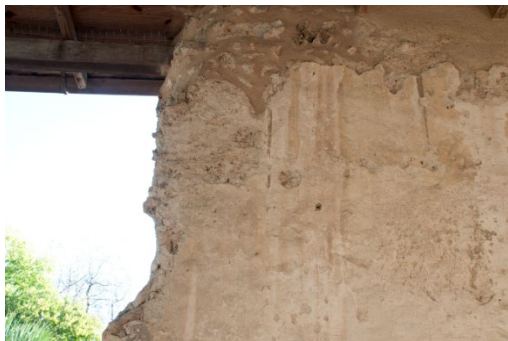
Figure 6.B.162: South wall. Upper left part. Features brown mortar patching near the connection with the roof and discoloration of the plaster.

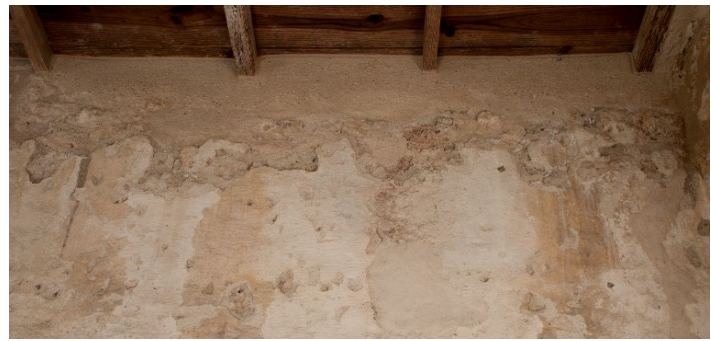
Figure 6.B.163: South wall. Upper right part. Shows mortar patching in the connection with the roof and detachment of edges of the plaster.

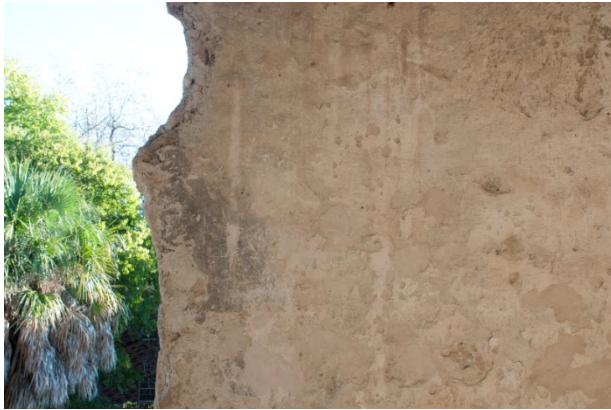
Figure 6.B.164: South wall. Middle area. Features well-executed patching that allows for the continuity of the plaster, remnants of painted plaster and graffiti.

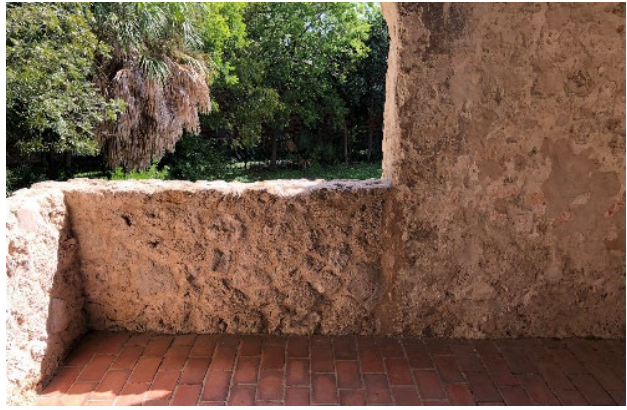
Figure 6.B.165: South wall. Left part. Shows the connection of the historic part of the wall (right), with the later addition of the parapet (left).

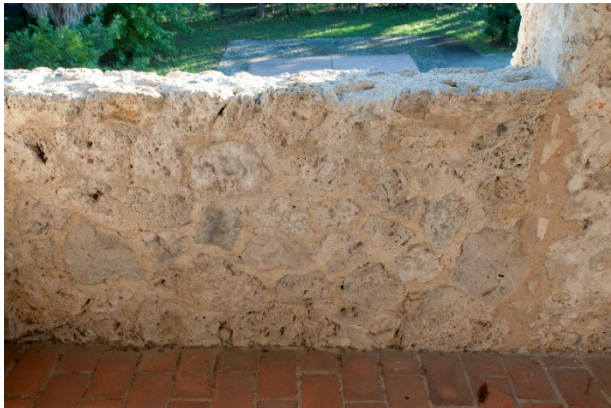
The upper level is mostly covered with historic plaster (probably 18<sup>th</sup> century like the adjacent west wall), with the exception of the parapet, which was built later with rubble stones. The parapet only exhibits some missing parts.

Figure 6.B.166: South wall. Detail of the parapet. A later addition to the historic construction, the parapet has no plaster and only features some missing parts.

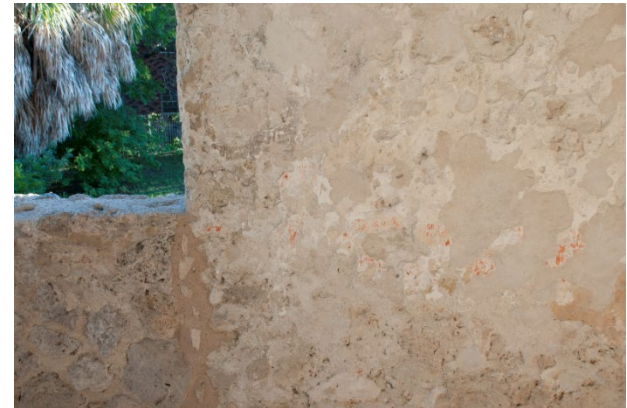
Figure 6.B.167: South wall. Detail of the connection of the wall with the parapet. Features different types of patching, remnants of painted plaster (red/orange color), and historic graffiti.

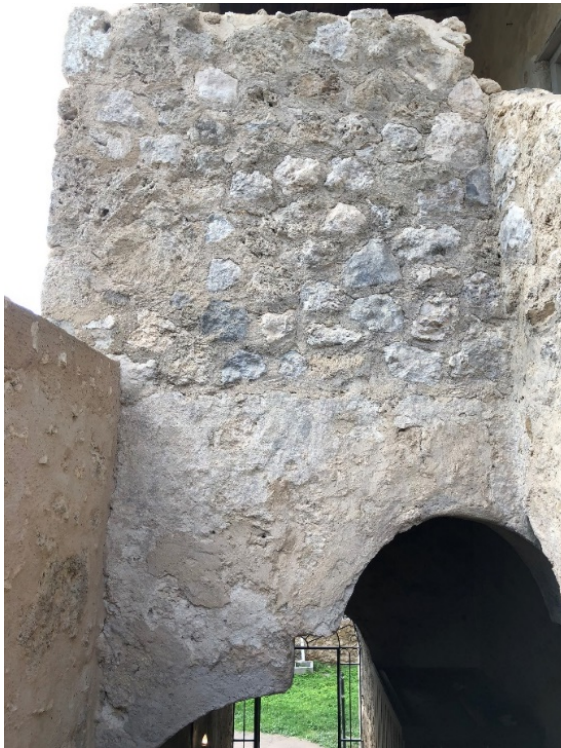
Figure 6.B.171: West wall of the staircase features patches of mortar possibly done in different times.

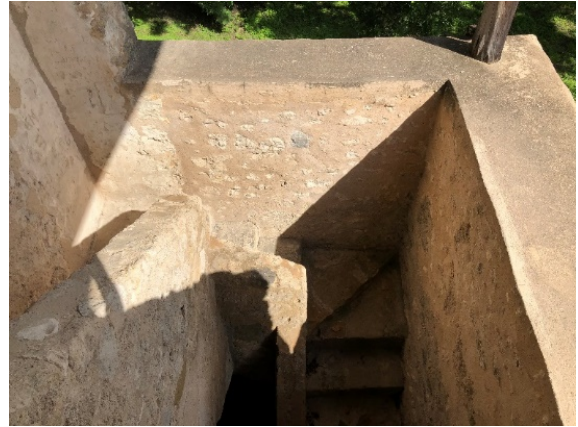
Figure 6.B.169: East wall of the staircase features brown mortar patching, in generally good condition.

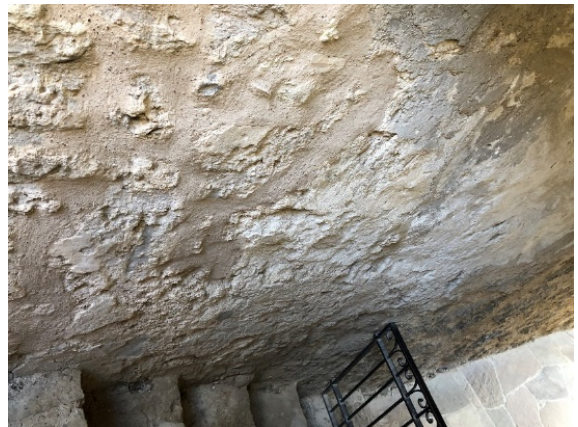
Figure 6.B.170: South wall of the staircase. Brown mortar patching restoration is in generally good condition.

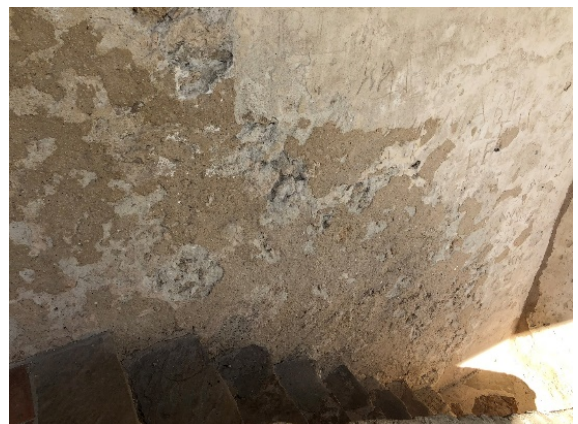
Figure 6.B.172: North wall of the staircase features brown patches that are visually not compatible, graffiti, and parts of missing mortar.

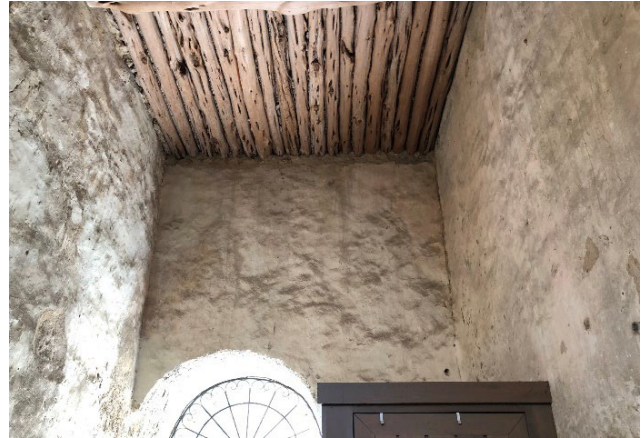
Figure 6.B.174: West wall in good condition.

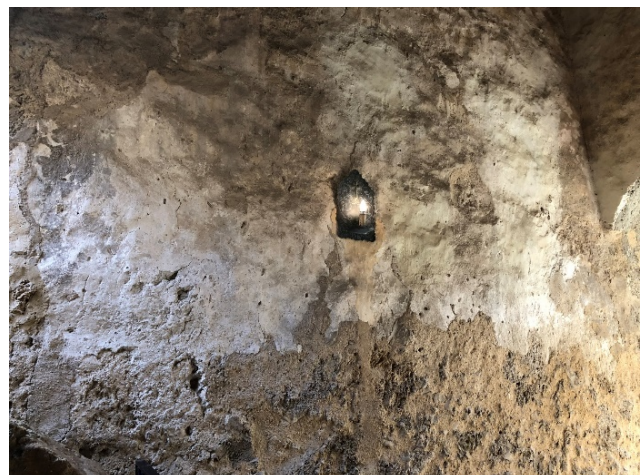
Figure 6.B.177: South wall features mortar patching of different periods and its partial erosion.

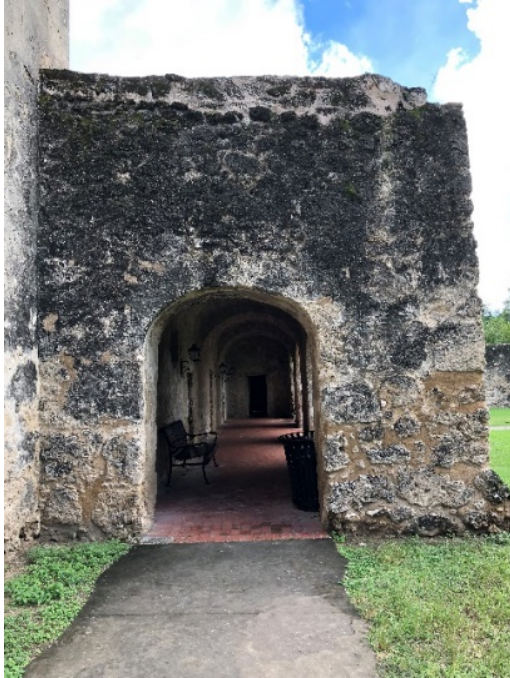
Figure 6.B.178: Exterior north elevation of the corridor. Dark film of biological growth featured on the top part.

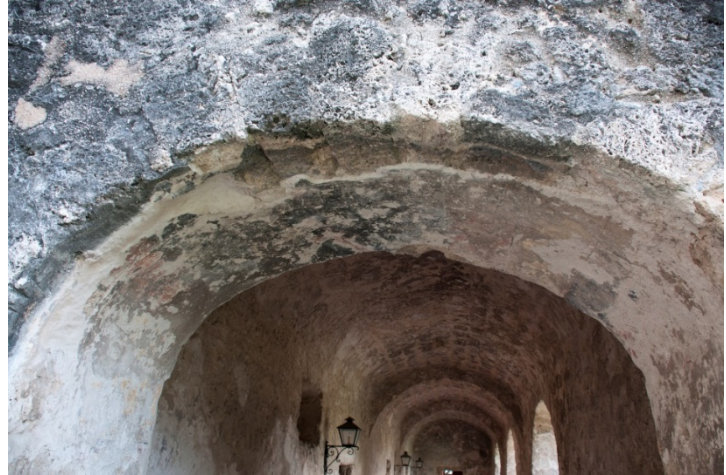
The intrados of the north arch has remnants of historic 18<sup>th</sup> century painted plaster. The edges of the plastered fragments, results of 1988 restoration work, remain in good condition. The plaster remnant of this area are clearly eroded, however this plaster in this arch is the most intact of the whole arcade. Here it is possible to understand the geometrical pattern of red and yellow faux voussoirs. Traces of red and yellow colors as well as the line separating the faux voussoir are clearly visible. A more recent gray paint layer (probably lime and water based) was applied over the faux voussoirs' decoration. This layer was not removed during the 1988 conservation works, although not from the structure's period of significant. A holistic preservation campaign for the remnants of historic painted and unpainted plaster should be carried out. The small area of the intrados not covered by historic plaster—with stone voussoirs—exhibits darkening flow marks of biological nature. Further details of historic plaster is explained in the general description of the corridor (104 A).

Figure 6.B.179: Exterior north elevation. Arch in the north wall of the corridor. Remnants of painted plaster (red and yellow).

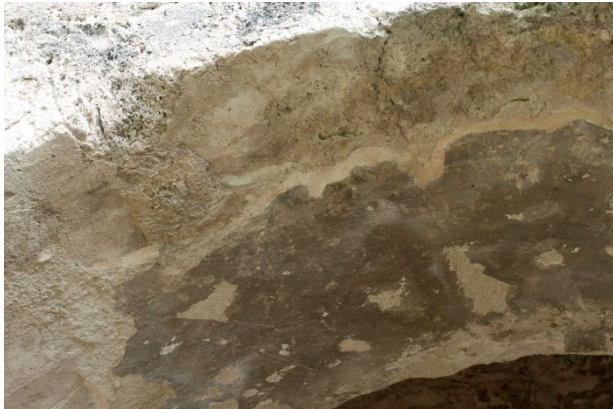
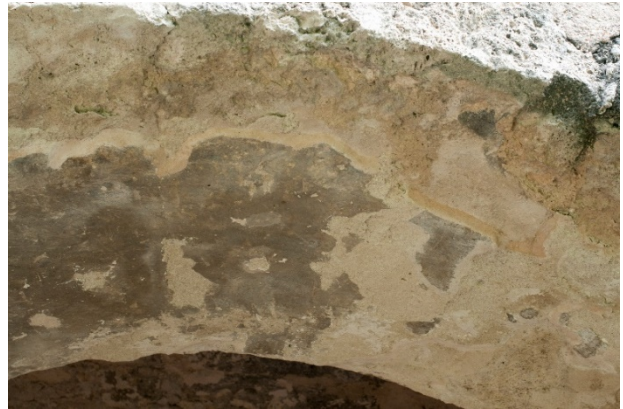
The intrados of the three arches feature several fragments of historic 18<sup>th</sup>-century plaster, stabilized in the conservation campaign of 1988. The edges of the plaster, stabilized in 1988, are still in good condition. The northernmost of the three arches features a large continuous fragment, partially covered with a gray paint finish, with mild erosion of its surface. The part of the plaster fragment is made of arriccio, with irreversible loss of the most superficial layers. Various mortar patches are visible on the north post of the arch. The south post features disintegration of the plaster remnants.

Figures 6.B.182, 6.B.183: Exterior west elevation. North arch of the west arcade. Remnants of painted plaster with edge stabilization from the conservation campaign of 1988. Detachment of edges of the painted finish.

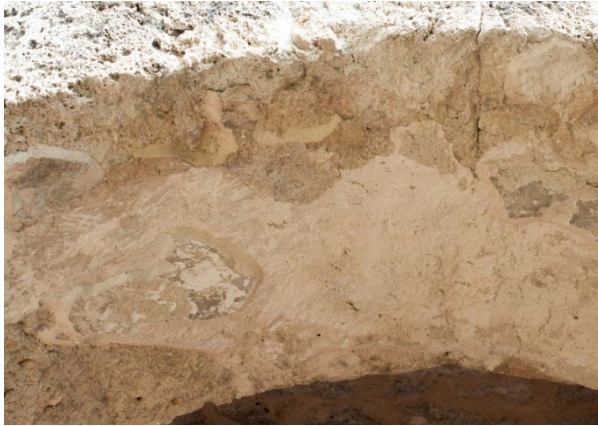
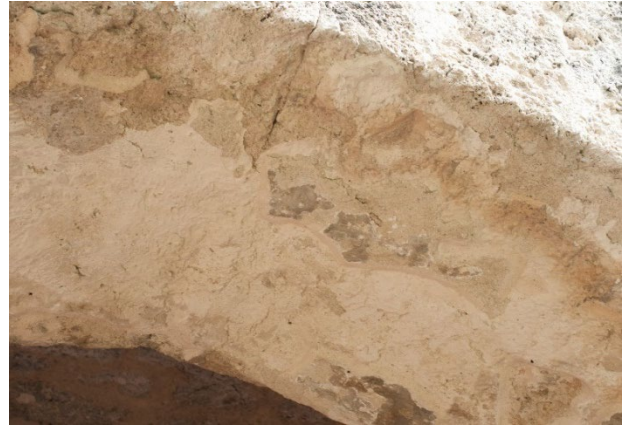
Figures 6.B.186, 6.B.187: Exterior west elevation. Middle arch of the west arcade. Remnants of painted plaster with edge stabilization from the conservation campaign of 1988.

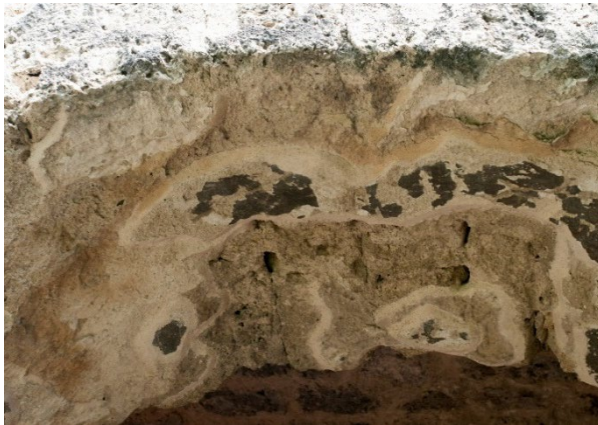
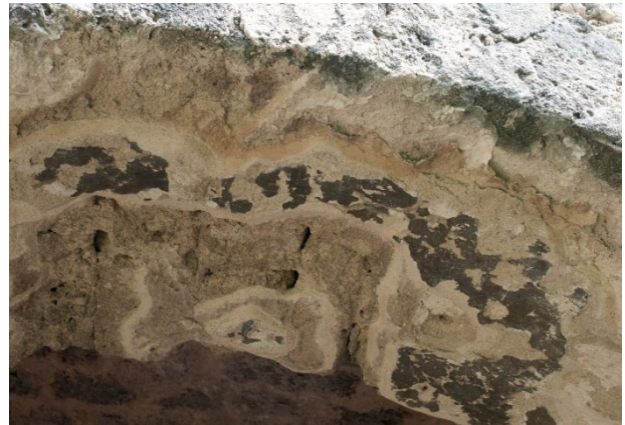
Figures 6.B.188, 6.B.189: Exterior west elevation. South arch of the west arcade. Remnants of painted plaster with painted finish and edge stabilization from the conservation campaign of 1988. Detachment of edges of the plaster layer.

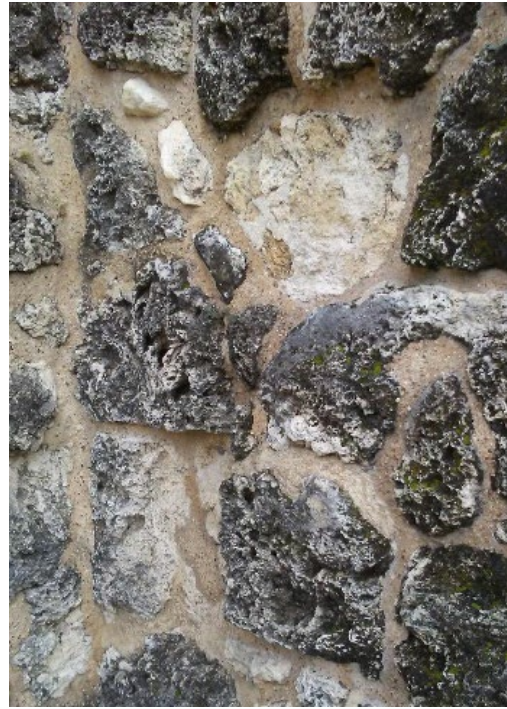
Figure 6.B.191: Detail of buttress with evident biological colonization.

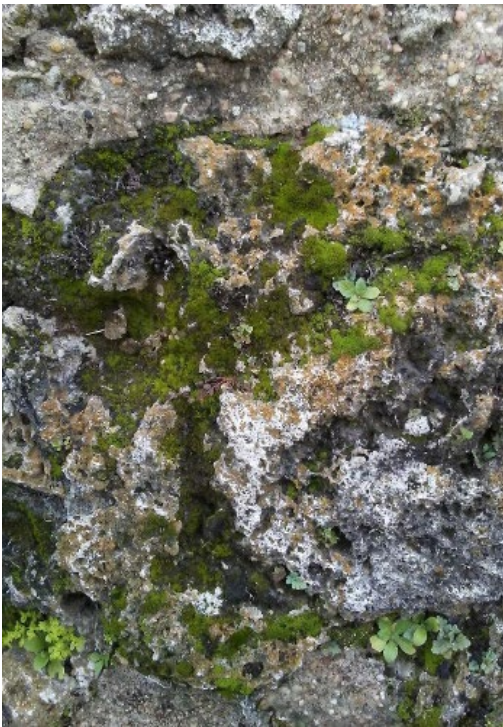
Figure 6.B.192: Detail of moss and plant growth.

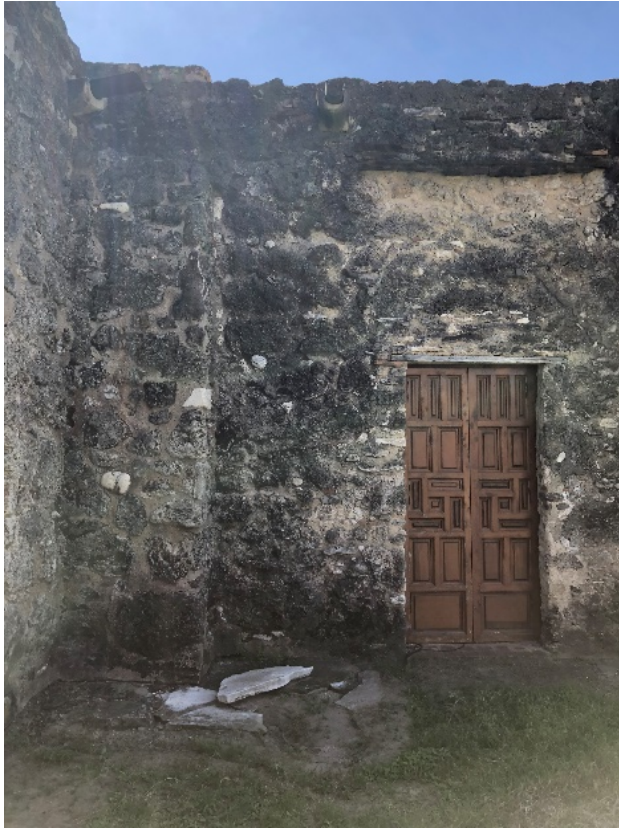
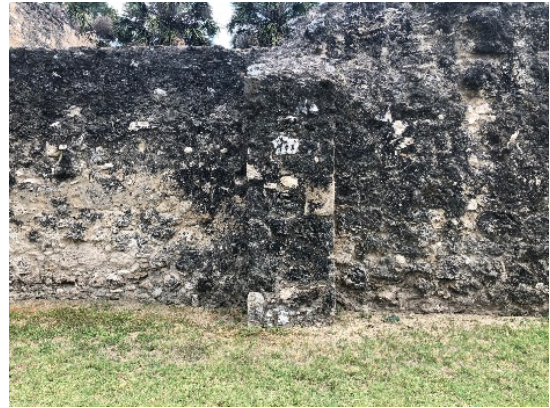
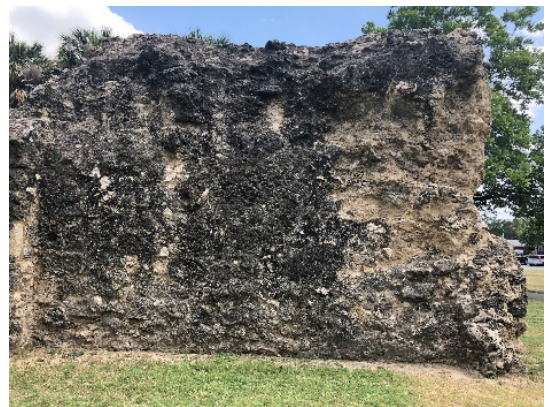
Figures 6.B.193, 6.B.194, 6.B.195: Northern wall covered in thick layer of algae, plants, and moss. The wall surface also features high level of stone erosion, fragmentation, and delamination.

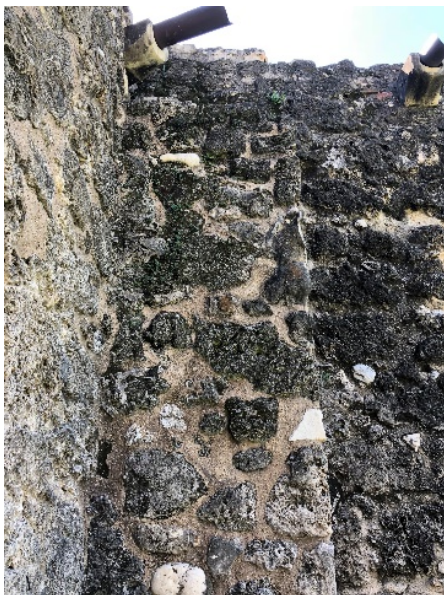
Figure 6.B.196: Buttress located at the corner between north and west facade is characterized by a rich biological growth, also exacerbated by the presence

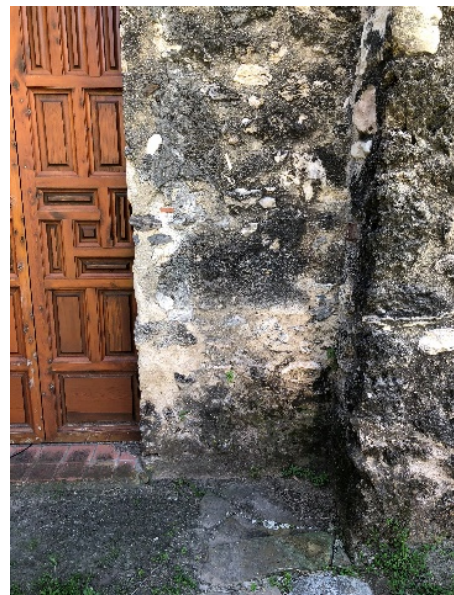
Figure 6.B.197: Right jamb of the door, where rising damp and high levels of moisture help the flourishing of biological growth.
