National Park Service  
United States Department of the Interior  
San Antonio Missions National Historical Park  
Texas

# Historic Structure Report Mission Concepción Convento

100% Submission  
2019

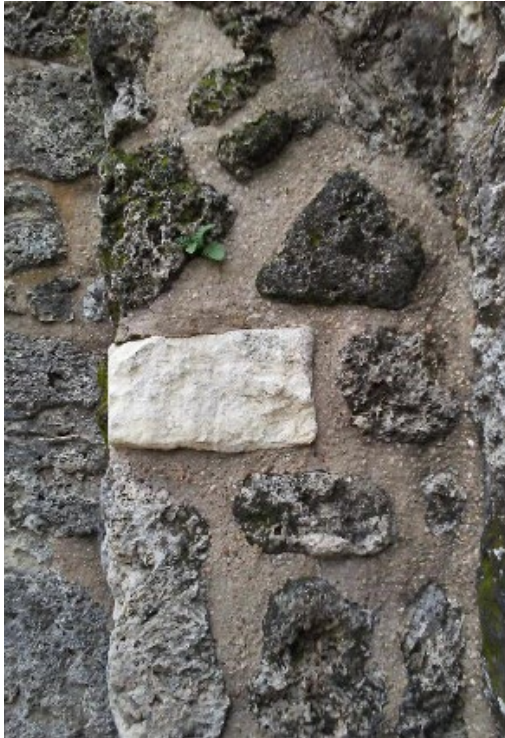
Figure 6.B.198: Infill Austin limestone block. Note the recent mortar repointing.

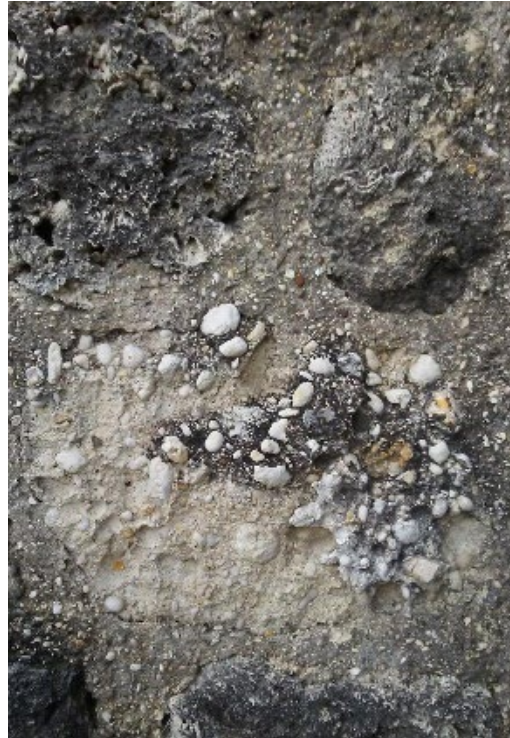
Figure 6.B.199: Differential erosion of a pisolithic rubble.

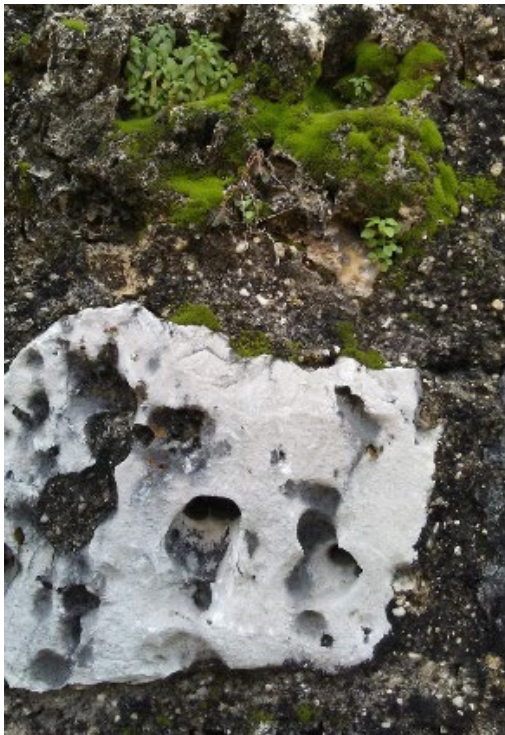
Figure 6.B.200: Detail showing moss (above) and a compact limestone rubble featuring alveolization.

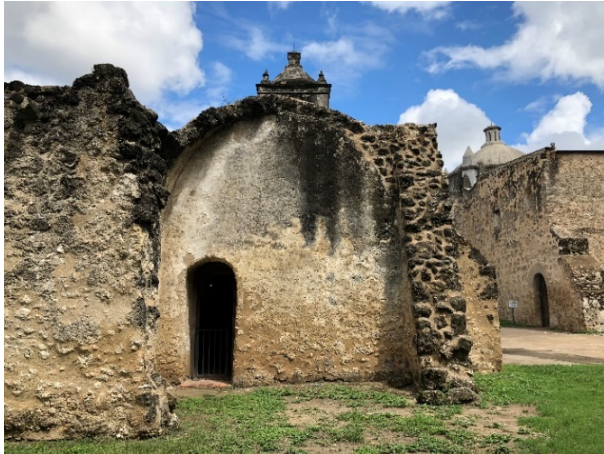
Figure 6.B.201: South wall (segment B), corresponding to the library.

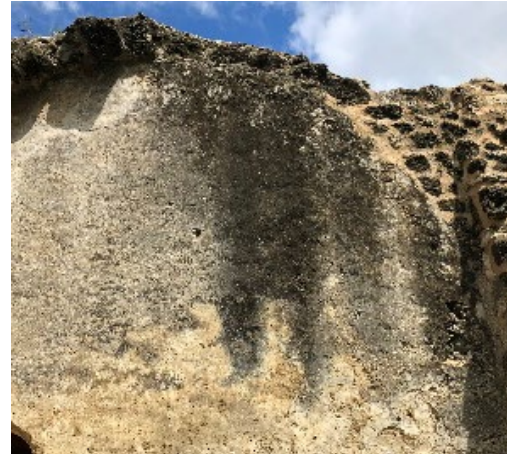
Figure 6.B.202: Segment B close up. The 18<sup>th</sup> century plaster is covered by a thick patina of biological origin with typical rain flow marks.

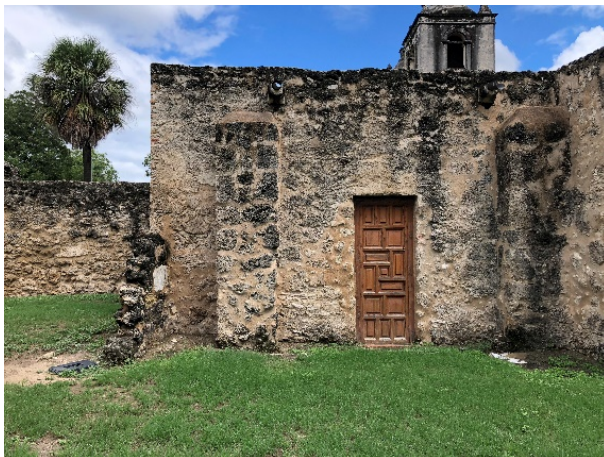
Figure 6.B.203: South wall (segment D), corresponding to the kitchen. Features darkening of biological origin with flow marks from the parapet.

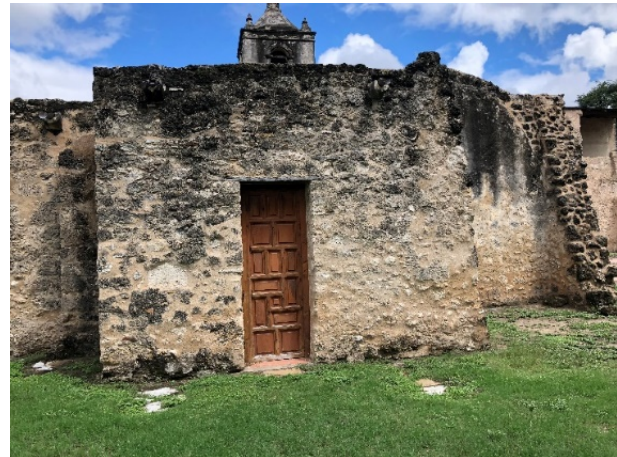
Figure 6.B.204: South wall (segment C), corresponding to the refectory. Also features biological growth, with a darker patina on the parapet.

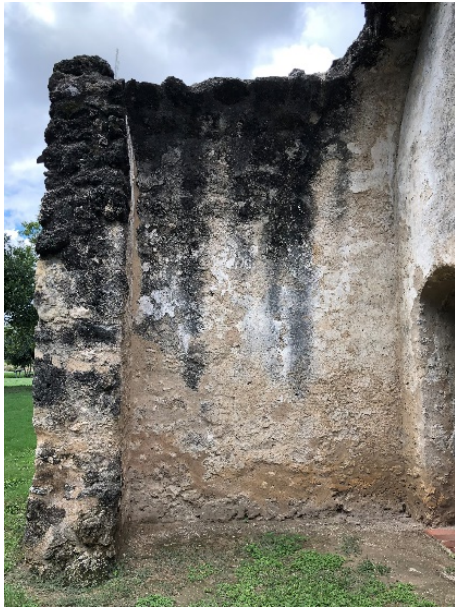
Figure 6.B.206: East wall (segment C), corresponding to the refectory. Features remnant plaster and a thick patina of biological origin.

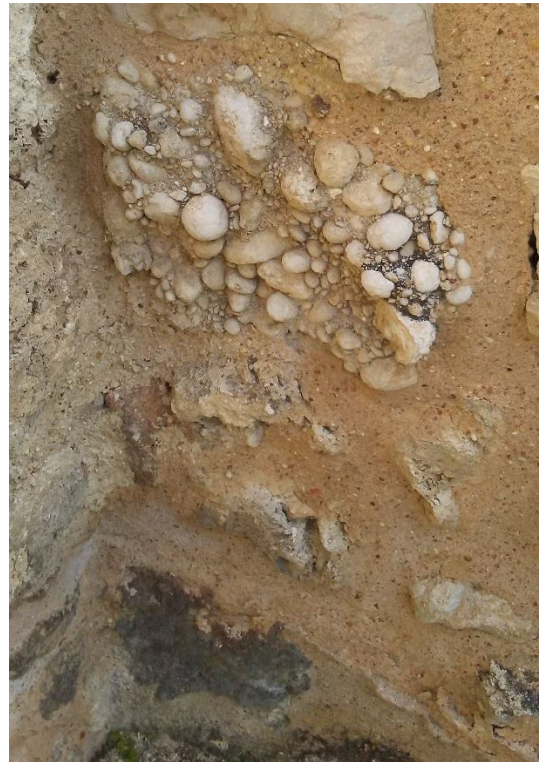
Figure 6.B.210: More pisolithic rubble, with its typical differential erosion.

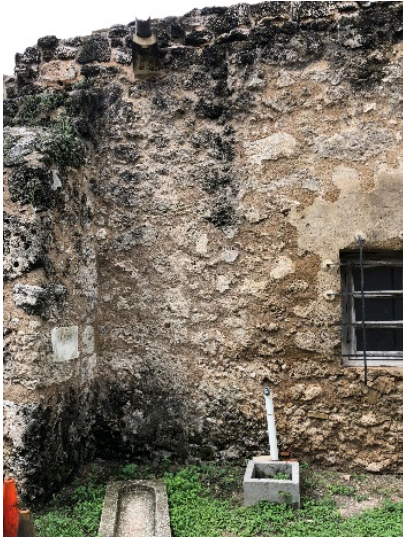
Figures 6.B.212–6.B.214: East wall (segment A), corresponding to the guest room. This wall affected by biological growth, moist areas, stone fragmentation, delamination, and erosion.

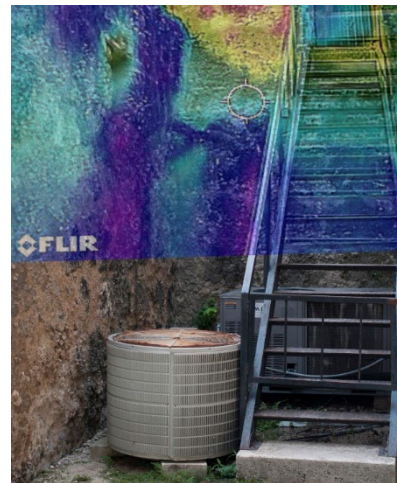
Figures 6.B.215–6.B.216: North wall of the guest room. The condition of this wall is critical, with thick layers of biological growth and wall erosion. High moisture contents are enhanced by incorrect water drainage both at the roof and ground levels.

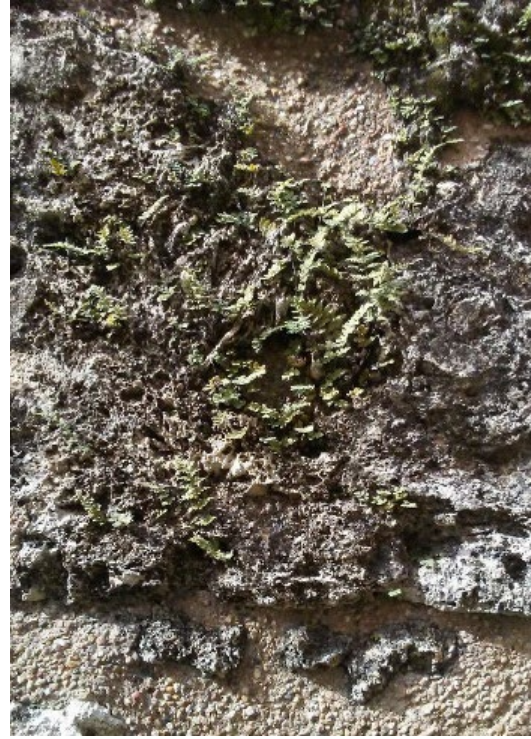
Figure 6.B.218: Detail of dark biological growth on tufa block.

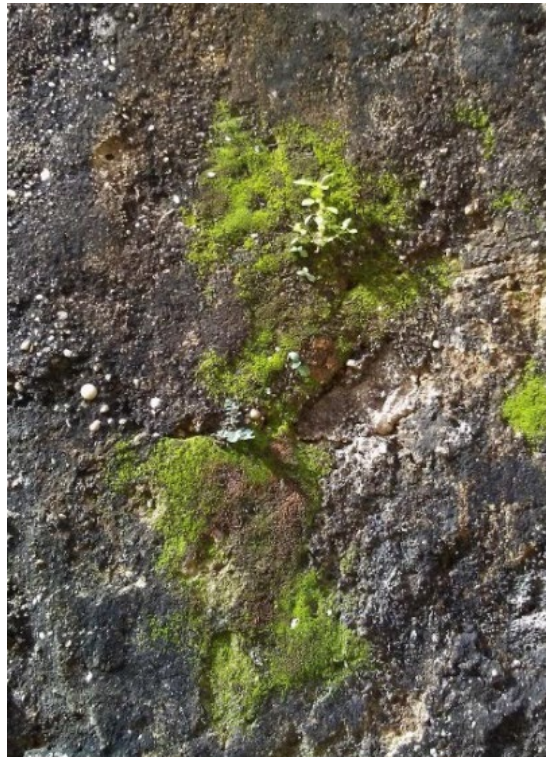
Figure 6.B.219: A dark-colored, thick layer of algae and moss completely covers the top part of the northmost buttress.

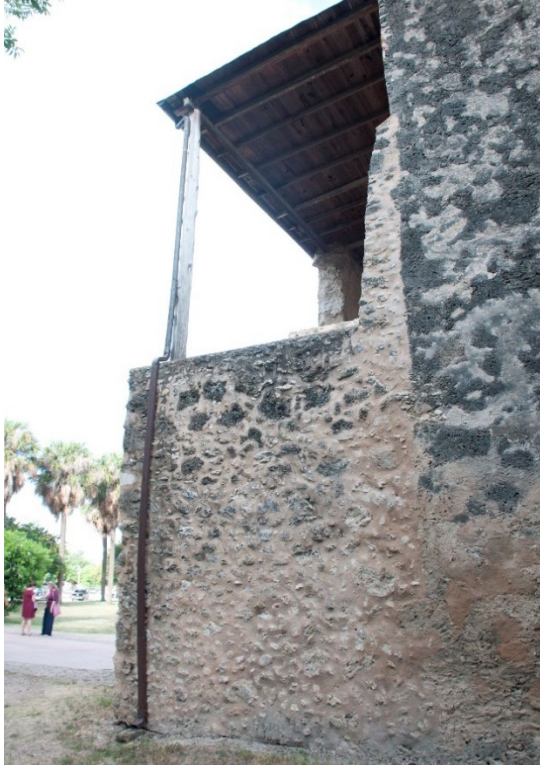
Figure 6.B.220: Exterior east wall, corresponding to the staircase, features a change in the masonry type, with wall made of small rubble and recently repointed brownish mortar.

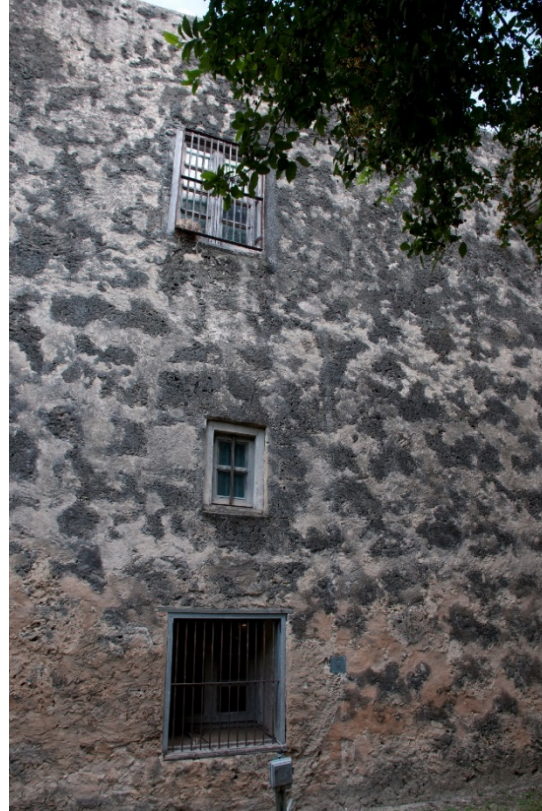
Figure 6.B.221: Exterior east wall, which features darkening of biological origin only on the tufa blocks. By contrast, the mortar repointing appears less receptive to biological colonization. Note the recent brown mortar patching on the lower portion of the wall.

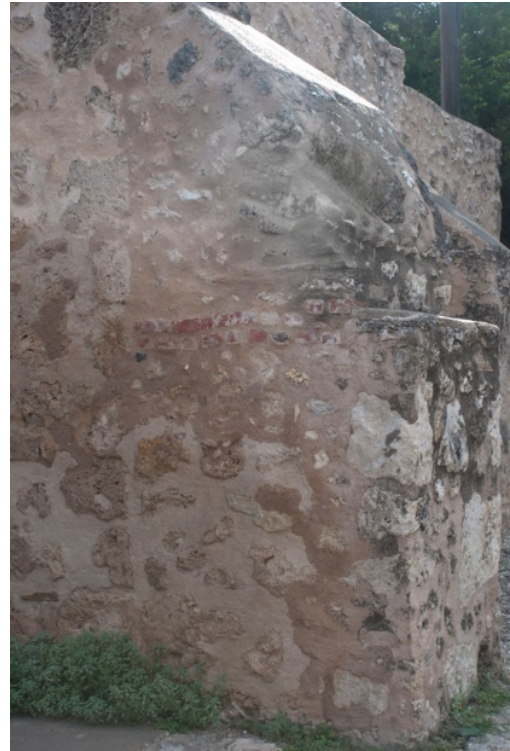
Figure 6.B.225: Exterior southwest buttress, reshaped after 1890s. Note the different types of repointing material

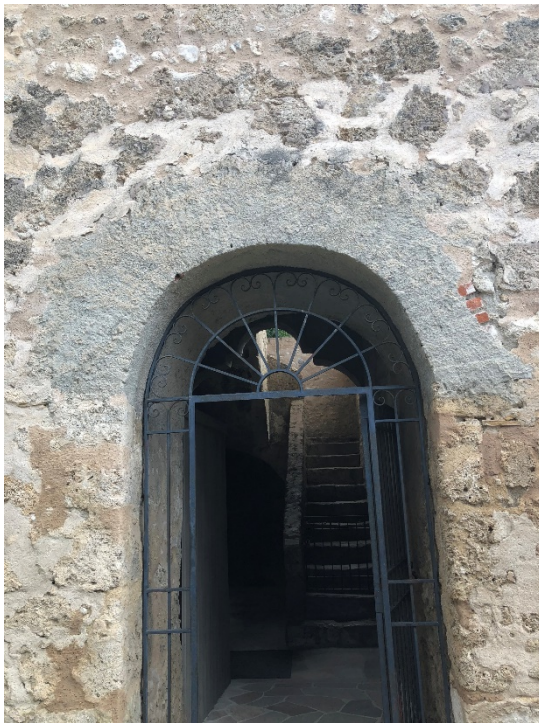
The arched entrance to the staircase (103 C) and sacristy features a rough cement finish covering the brick arch, both modern interventions. The area above the arch features an atypical repointing of the mortar joints, made with a white-colored mixture, possibly containing natural hydraulic lime (NHL). A buttress is located on the southern edge of the façade. The buttress’s surfaces, as well as the portion of the wall next to the door, were recently repointed with mortar that differs in color and composition. One is characterized by a brownish-red color, and probably is the NPS mixture, the other one is dark white/gray, and probably is made with NHL.

Figure 6.B.226: Exterior west wall. Arched door of entrance to the staircase. Cement mortar finishing was applied over the bricks composing the arch.

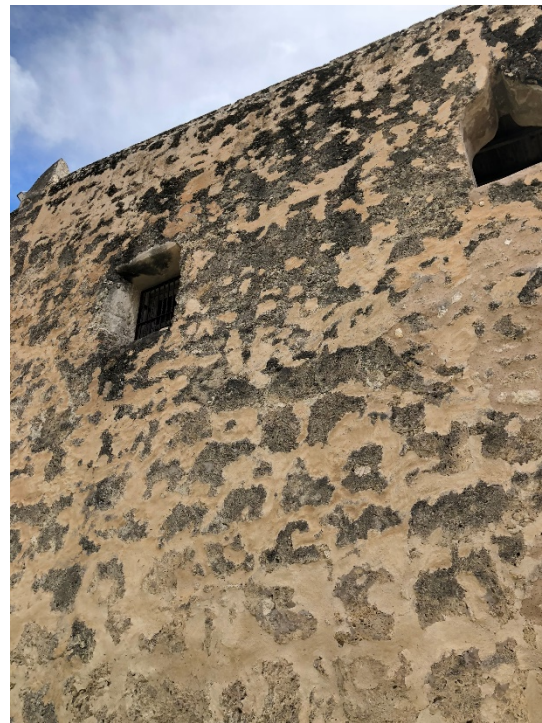
Figure 6.B.227: Exterior west wall. Upper part of the wall features brown mortar repointing, roughly executed, covering part of the stone. The tufa stone has a dark color, due to biological growth imbued into the stone cavities.

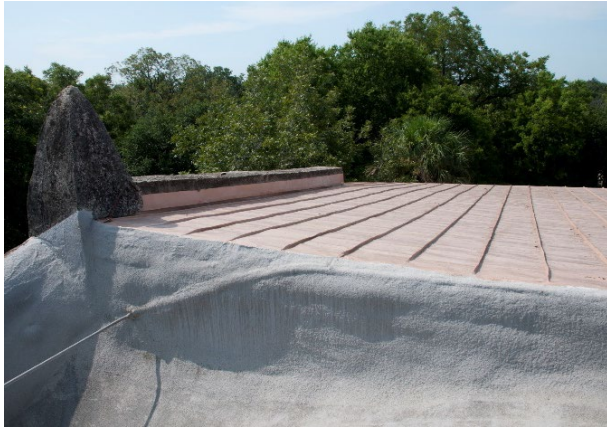
Figure 6.B.228: View of the roof of the Father President's office. The overall condition is good.

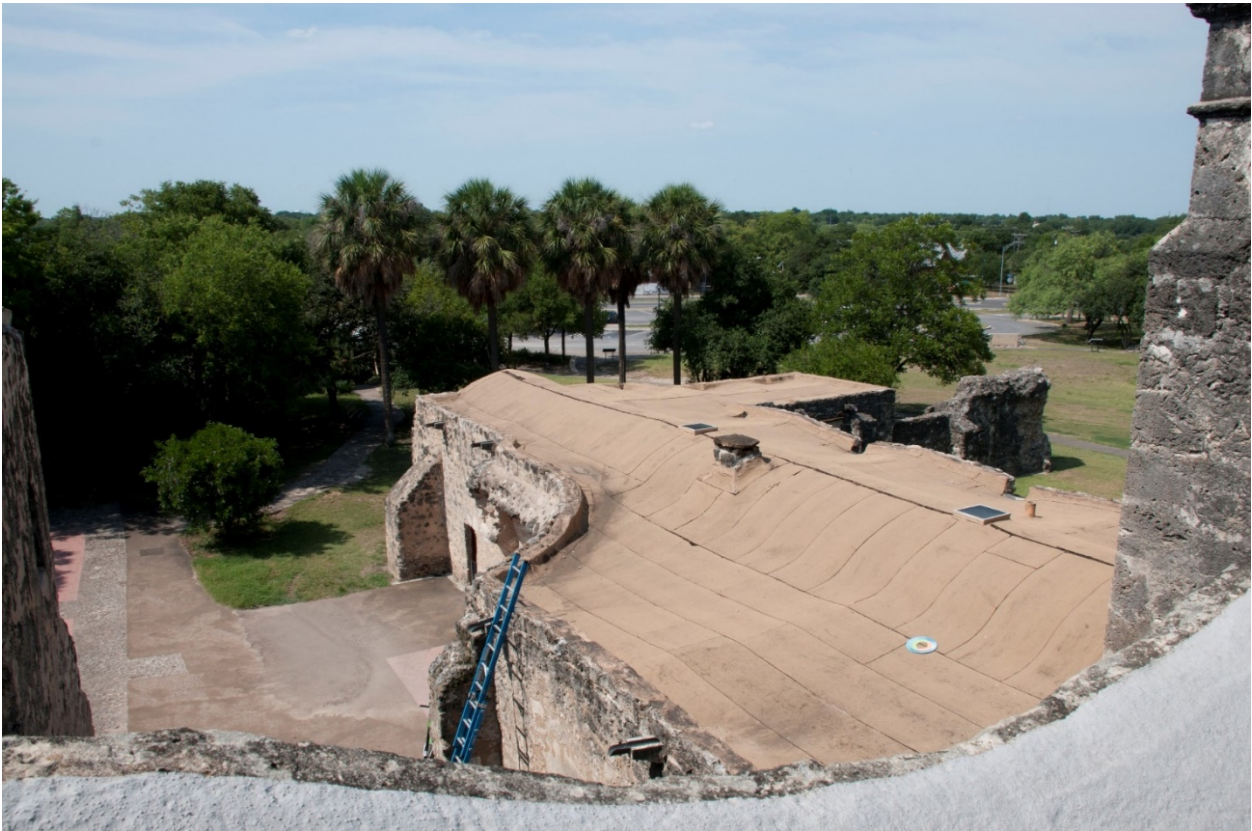
Figure 6.B.230: Convento roof. View from roof of the church. The asphalt-base roof is still performing correctly, but it has reached the end of its useful life. It requires a redesign to improve rainwater drainage in some areas. The most urgent areas are the north and east.

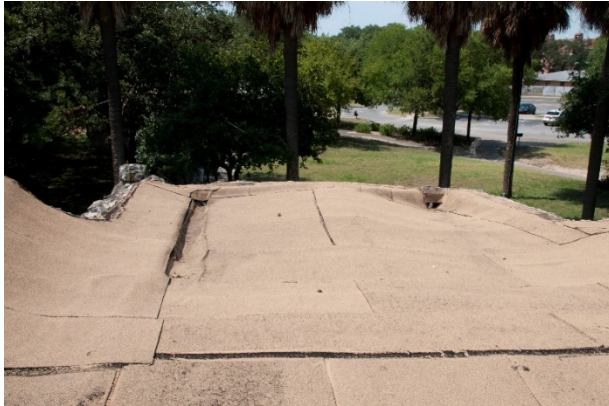
Figure 6.B.237: Roof of the convento. Photo facing south, showing the roof of the refectory.

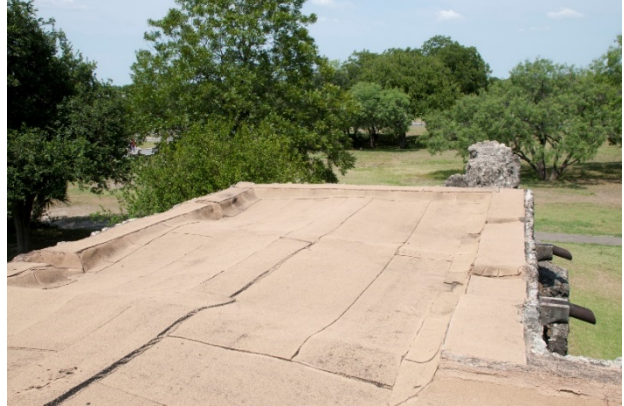
Figure 6.B.238: Roof of the convento. Photo facing west, showing the roof of the kitchen.

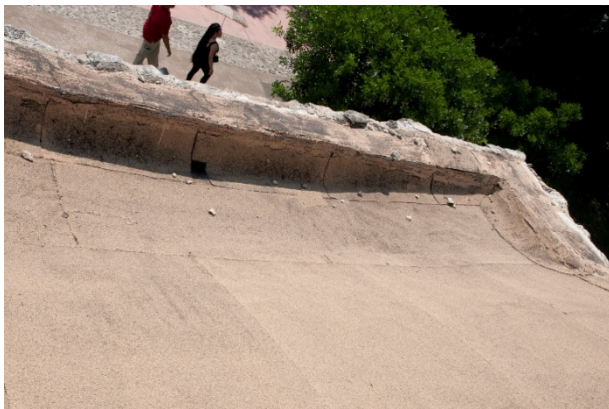
Figure 6.B.239: Roof of the convento. Photo facing southeast, showing the southeast corner of the roof of the library.

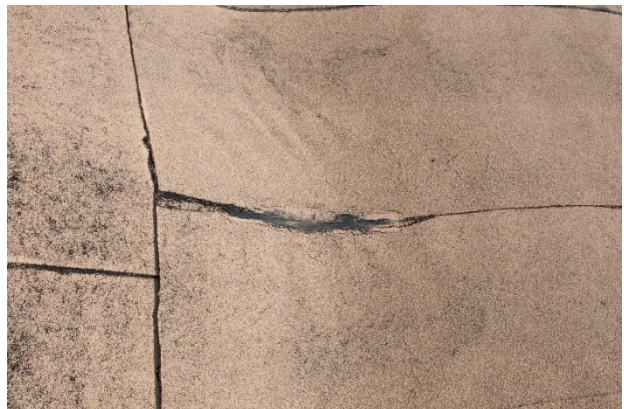
Figure 6.B.240: Roof of the convento. Detail of the roof.

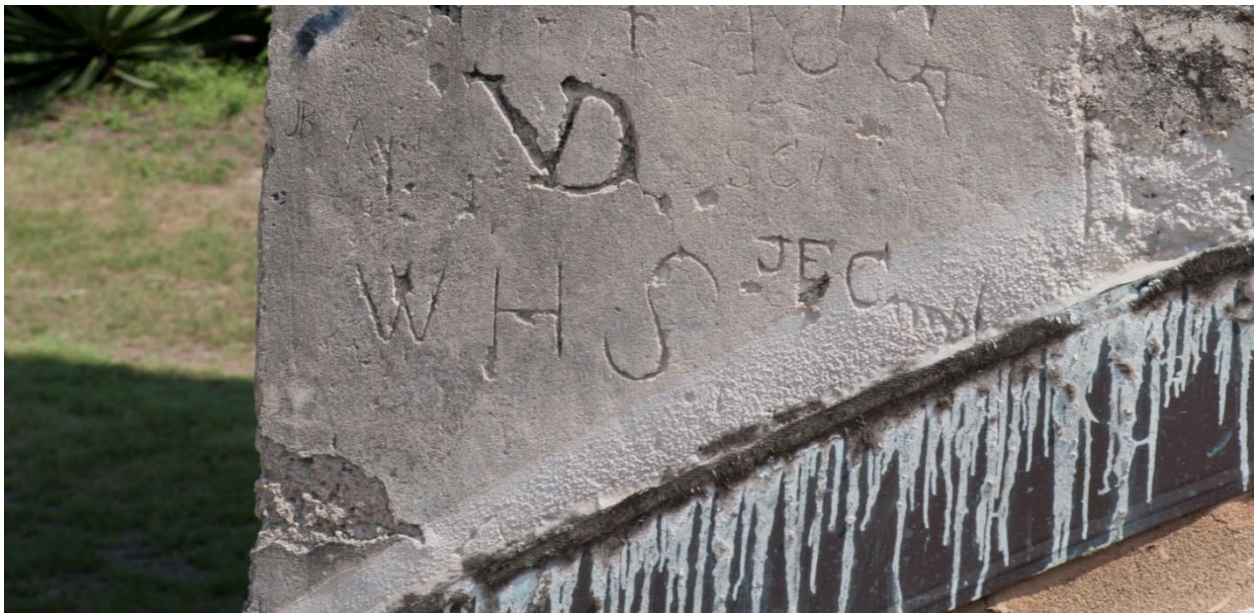
Figure 6.B.241: Roof of the convento. Detail of the connection between the convento's roof and the south tower of the church. Large areas of flashing are no longer attached to the wall of the church tower.

- The roof material has reached the end of its useful life and must be replaced, including all metal flashing that connects to the south tower.
- Stones were added at the time of the previous roof project to increase the height of the parapet. The added stones alter the historic appearance. Design of the new roof project should carefully consider options to return the wall to the height it had during the period of significance.

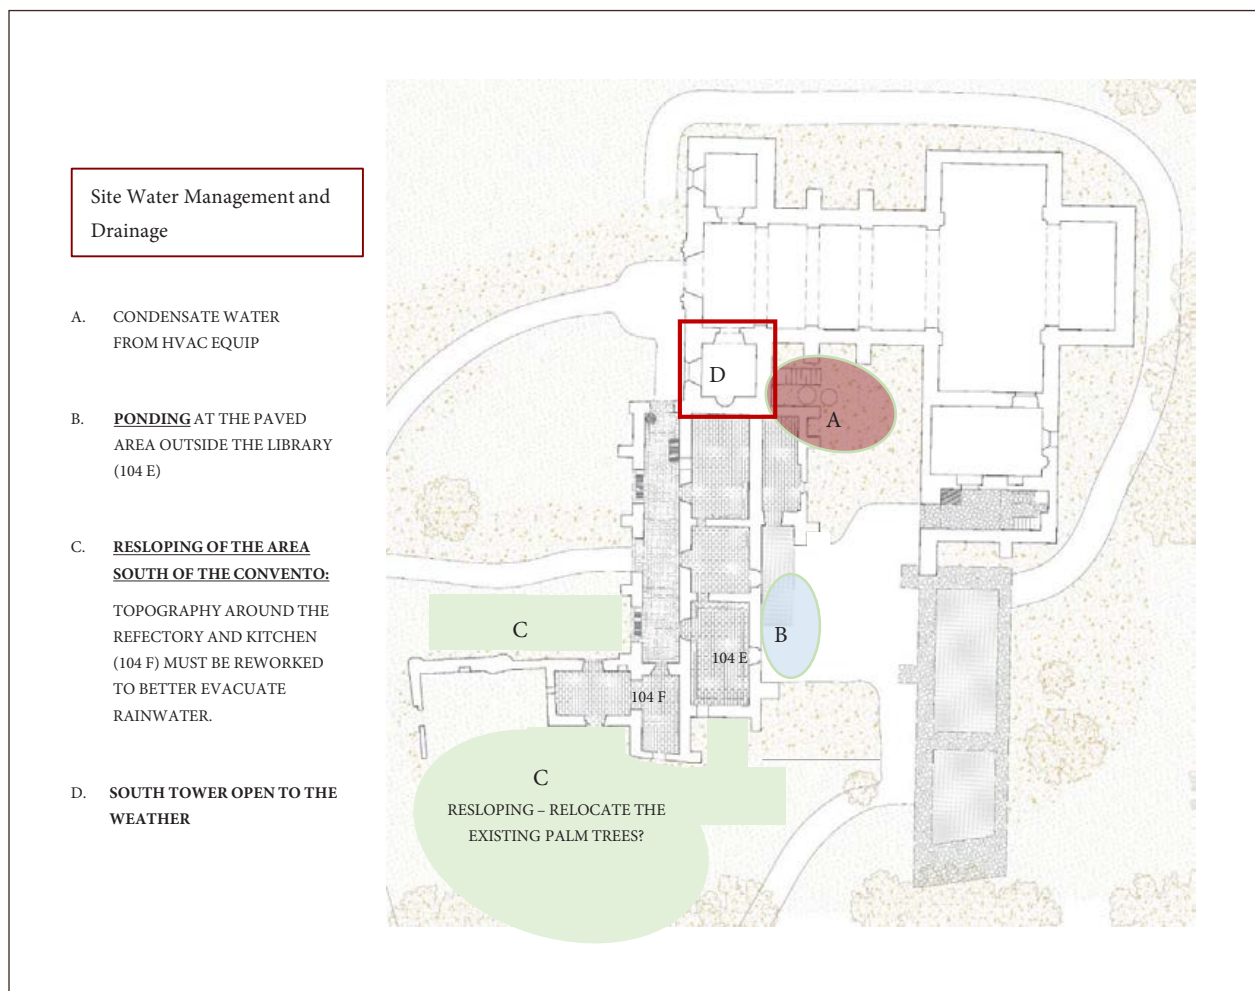
Topography adjustments are needed to better evacuate rainwater away from the walls, especially outside the library (104 E) and around the refectory and kitchen (104 F). Ruins now buried to the south of the convento must be considered in design decisions regarding site drainage, and protected. See Figure 9.2 below.

Figure 9.2: Plan of Mission Concepción convento showing areas in need of attention for site water management and drainage improvements.

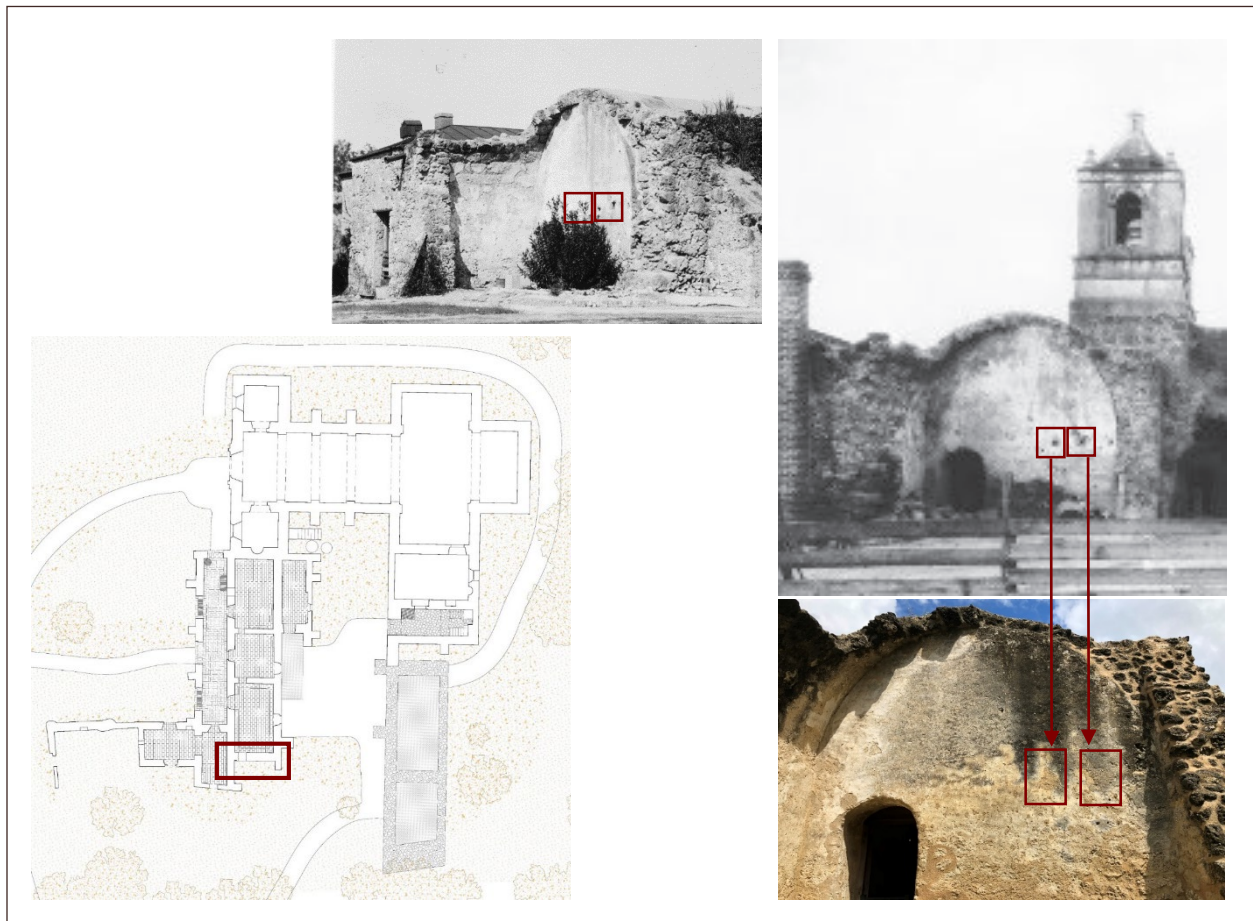
The small celda space which once existed to the south of the library room needs better interpretation. There are masonry pockets in the end wall which once held wood beams. These should not have been covered because they are an interpretive element which allows visitors to better understand the colonial architecture and read the change over time.

Figure 9.7: Proposed treatment of the 'celda,' south wall of the library. Wall preservation: reopen masonry pockets that held wooden beams; clean biological growth; reattach plaster.
