National Park Service  
United States Department of the Interior  
San Antonio Missions National Historical Park  
Texas

# Historic Structure Report Mission San José Convento

Final Submission  
2019

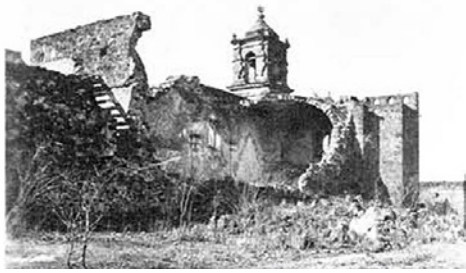
Figure 4.40: Northeast view, showing the collapse of part of the north wall of the church and the convento. The shadows of the timber beams of the roof of the convento can be seen in this ca. 1877 photograph (ITC UTSA).

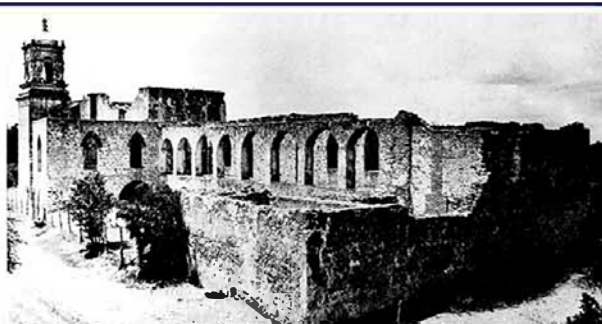
Figure 4.52: Southeast view, demonstrating that the window in the south wall of the east part has been closed. Moreover, a crack in the east wall of the refectory is visible. Unattributed photograph, ca. 1900s, (Nelson, 1998, p. 75).

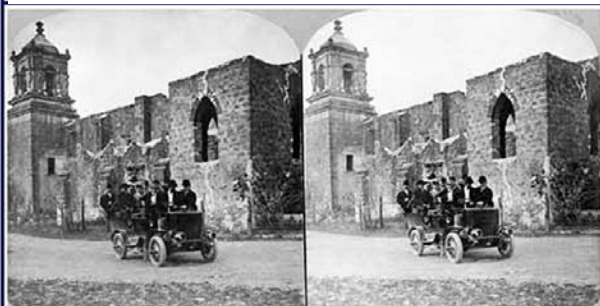
Figure 4.53: South view. Several cracks are visible in the south and east walls of the portería. Stereo-Ti:avel Co. photograph, 1909 (SMU Library).

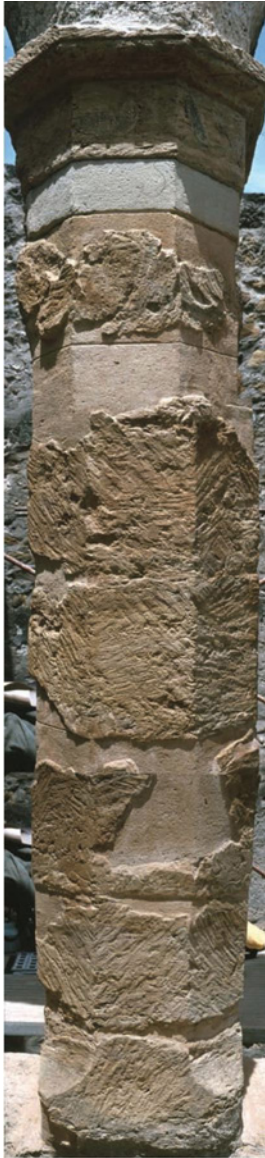
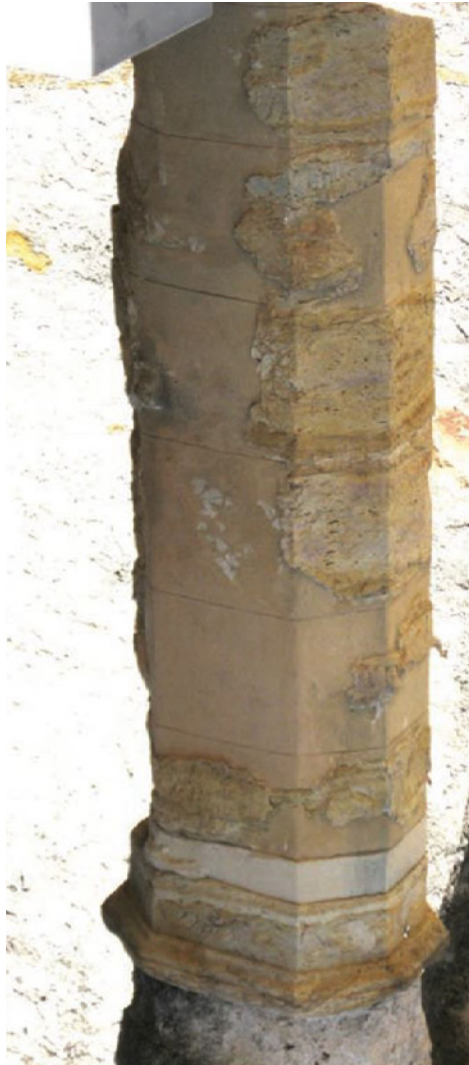
Figure 6.A.3  
Reprinted from *Evaluation of Proposed Consolidation Treatments for the San José Convento Column*, by Kalen McNabb, 2012, p. 13.

“Comparisons between the 1993 [Figure 6.A.3] and 2011 [Figure 6.A.4] photographic conditions assessments of the column in combination with field examination and SEM micrography indicates that the original consolidation was successful in restoring grain to grain cohesion of the disaggregated and flaking stone. Extensive cracking has formed and expanded on various sides of several of the drums. This deterioration is believed to be due to the stone’s inherent expansive clays which swell when exposed to water, generating stress and increasing the rate of cracking.” (McNabb, 2012, p. 35)

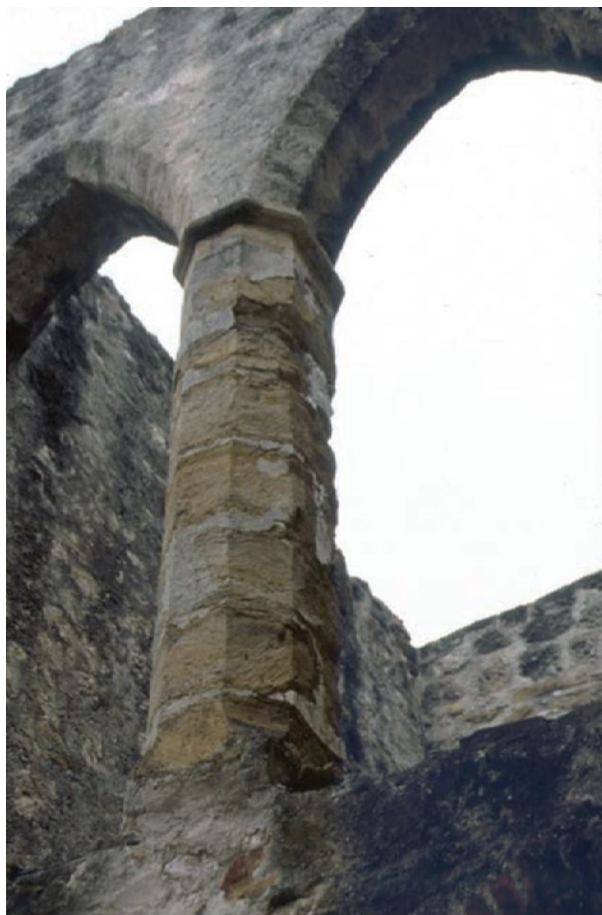
Figure 6.A.5: The southeast elevation of the column prior to the 1993 treatment.

The column before the 1993 treatment showed bedding and repair mortar characterized by a high amount of gypsum (calcium sulphate dehydrate).

Since gypsum is water soluble, weathering produced its dissolution, with subsequent infiltration and recrystallization into the stone.

The recrystallization of gypsum produced pressure into the stone pore walls, causing cracking and delamination.

In addition, the swelling of inherent clay within the limestone created further pressure within the stone pores.

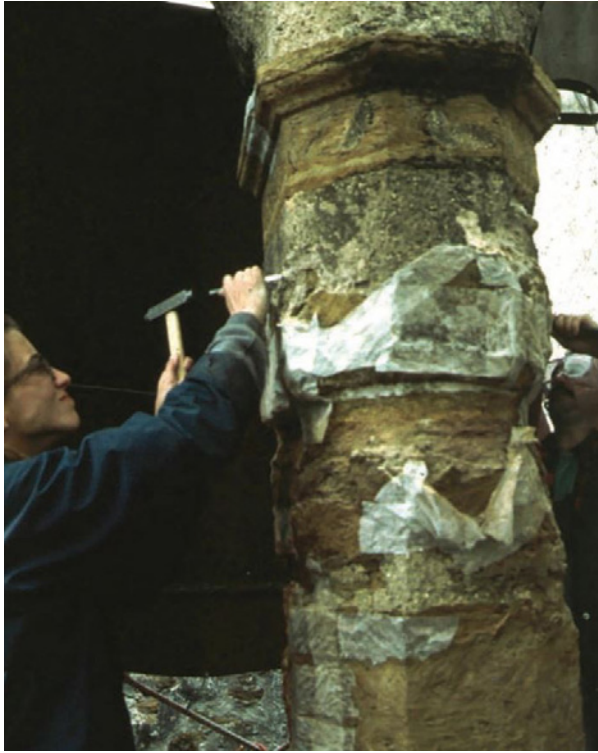
Figure 6.A.7: Application of facings to protect fragile areas during removal of lime and gypsum patches.

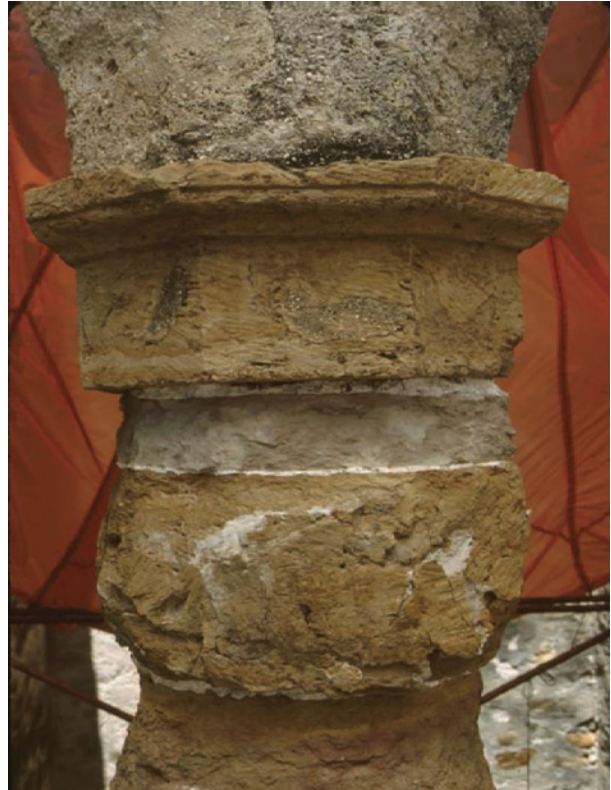
Figure 6.A.8: The column after the removal of patches.

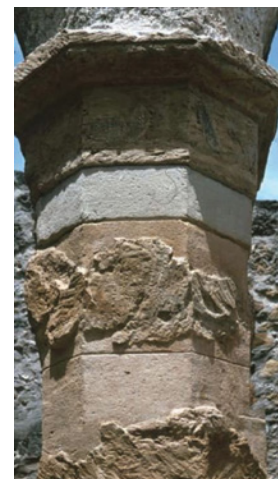
Figure 6.A.9: The Column after treatment.

Monitoring of the water repellent coat, with periodical replacement of a methyltrimethoxysilane product.

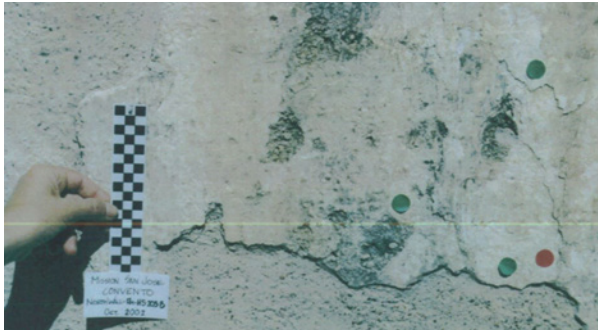
Figure 6.A.10: Room HS 203 B—North wall. Detachment of plaster edges. Presence of biological growth. Reprinted from *Mission San José y San Miguel de Aguayo—Inventory & Condition Assessment Survey and Documentation Report of Spanish Colonial Plasters and Mortars*, by Restoration Associates Limited, LLC, 2002, p. 47.

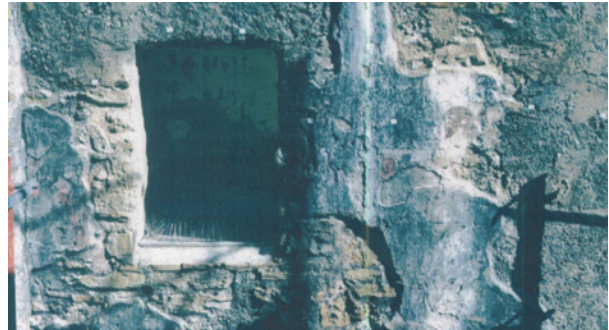
Figure 6.A.11: Room HS 203 C—North wall. Detail of Spanish Colonial plaster with heavy biological growth. Reprinted from *Mission San José y San Miguel de Aguayo—Inventory & Condition Assessment Survey and Documentation Report of Spanish Colonial Plasters and Mortars*, by Restoration Associates Limited, LLC, 2002, p. 65.

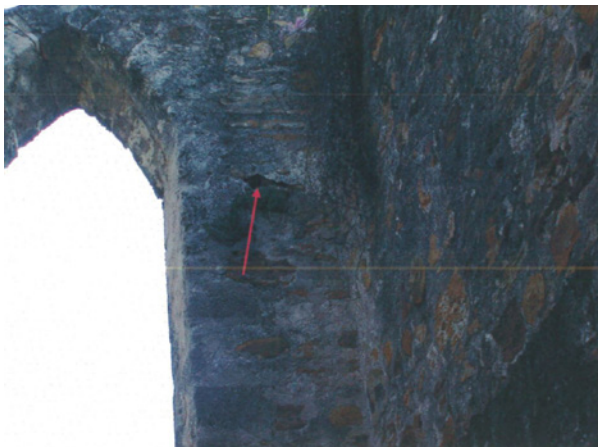
Figure 6.A.13: Room HS 203 D—North wall. Mortar loss. Reprinted from *Mission San José y San Miguel de Aguayo—Inventory & Condition Assessment Survey and Documentation Report of Spanish Colonial Plasters and Mortars*, by Restoration Associates Limited, LLC, 2002, p. 82.

- HS 203 D** North wall: GOOD/FAIR. Lower section: FRAGILE, with blind voids and efflorescence.  
West wall: FAIR.  
South wall: FRAGILE.  
East wall: FAIR/GOOD.

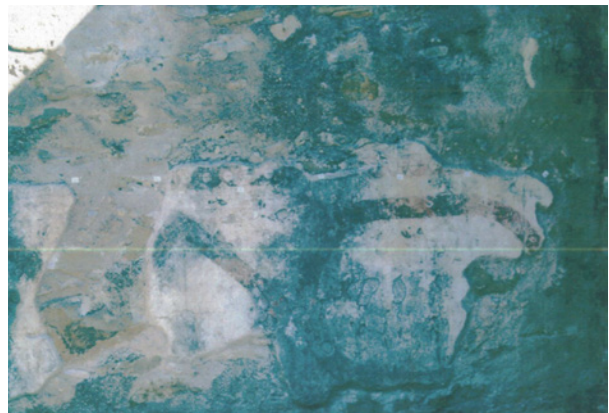
Figure 6.A.12: Room HS 203 C—North wall. Detail of decorated Spanish Colonial plaster with biological growth. Reprinted from *Mission San José y San Miguel de Aguayo—Inventory & Condition Assessment Survey and Documentation Report of Spanish Colonial Plasters and Mortars*, by Restoration Associates Limited, LLC, 2002, p. 66.

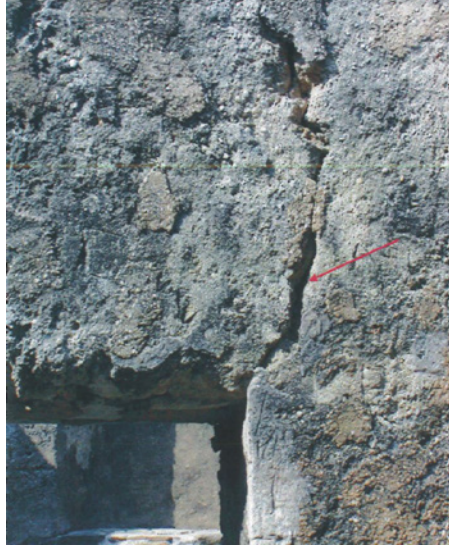
Figure 6.A.15: Kitchen—Eastern Wall in 2002. Crack in the upper section of the opening toward the refectory. Reprinted from *Mission San José y San Miguel de Aguayo—Inventory & Condition Assessment Survey and Documentation Report of Spanish Colonial Plasters and Mortars*, by Restoration Associates Limited, LLC, 2002, p. 102.

**KITCHEN  
AND REFECTORY** The walls were described as stable but fragile. Cracks were identified and shown in photos. Spanish Colonial plaster fragments were observed in multiple areas. Emergency stabilization of masonry mortars was recommended.

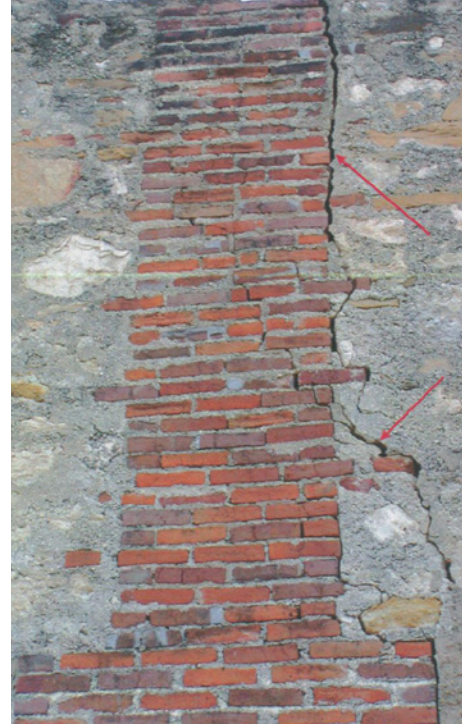
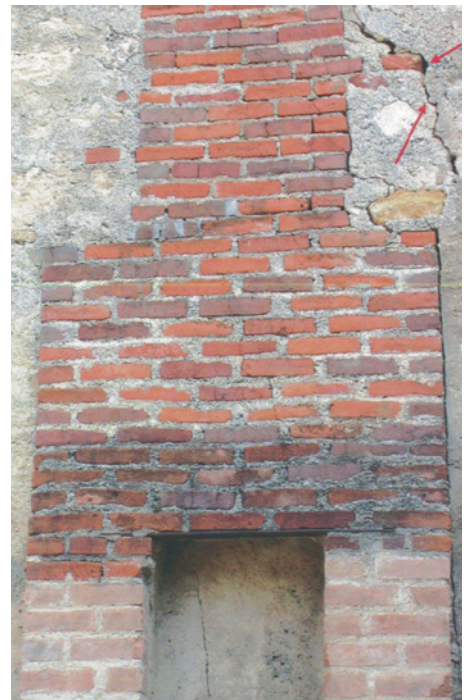
Figures 6.A.16, 6.A.17: Kitchen—Northern Wall in 2002. Large crack from the uttermost section of the wall extending down to the oven height. Reprinted from *Mission San José y San Miguel de Aguayo—Inventory & Condition Assessment Survey and Documentation Report of Spanish Colonial Plasters and Mortars*, by Restoration Associates Limited, LLC, 2002, pp. 96–97.

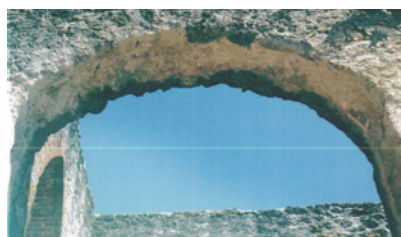
Figure 6.A.19: Arch 2 A—Detail of existing condition of remnants of Spanish Colonial mortar. Reprinted from *Mission San José y San Miguel de Aguayo—Inventory & Condition Assessment Survey and Documentation Report of Spanish Colonial Plasters and Mortars*, by Restoration Associates Limited, LLC, 2002, p. 121.

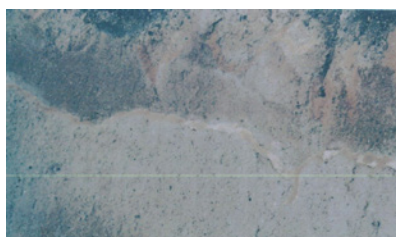
Figure 6.A.20: Arch 1 B—Detail of previous conservation treatments involving edge stabilization carried out with a slightly pinkish mortar. Reprinted from *Mission San José y San Miguel de Aguayo—Inventory & Condition Assessment Survey and Documentation Report of Spanish Colonial Plasters and Mortars*, by Restoration Associates Limited, LLC, 2002, p. 127.

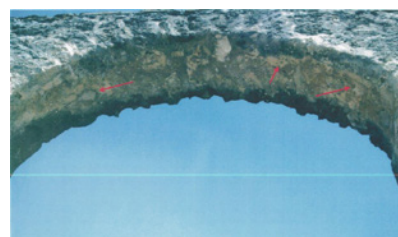
Figure 6.A.21: Arch 2 C—Detail of existing condition of remnants of Spanish Colonial mortar requiring consolidation. Reprinted from *Mission San José y San Miguel de Aguayo—Inventory & Condition Assessment Survey and Documentation Report of Spanish Colonial Plasters and Mortars*, by Restoration Associates Limited, LLC, 2002, p. 139.

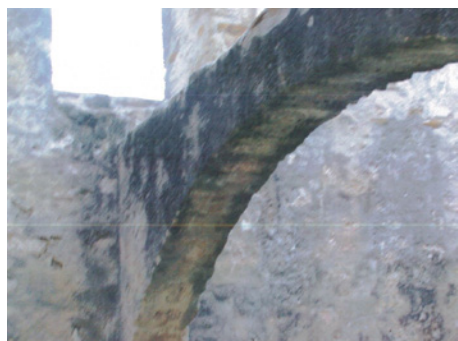
The 2002 report assessed the transverse arches as stable. The report cited biological growth, lichens, losses of pointing mortars, and capping with modern mortar.

Figure 6.A.27: Room HS 203—Typical condition of transverse arches. Reprinted from *Mission San José y San Miguel de Aguayo—Inventory & Condition Assessment Survey and Documentation Report of Spanish Colonial Plasters and Mortars*, by Restoration Associates Limited, LLC, 2002, p. 191.

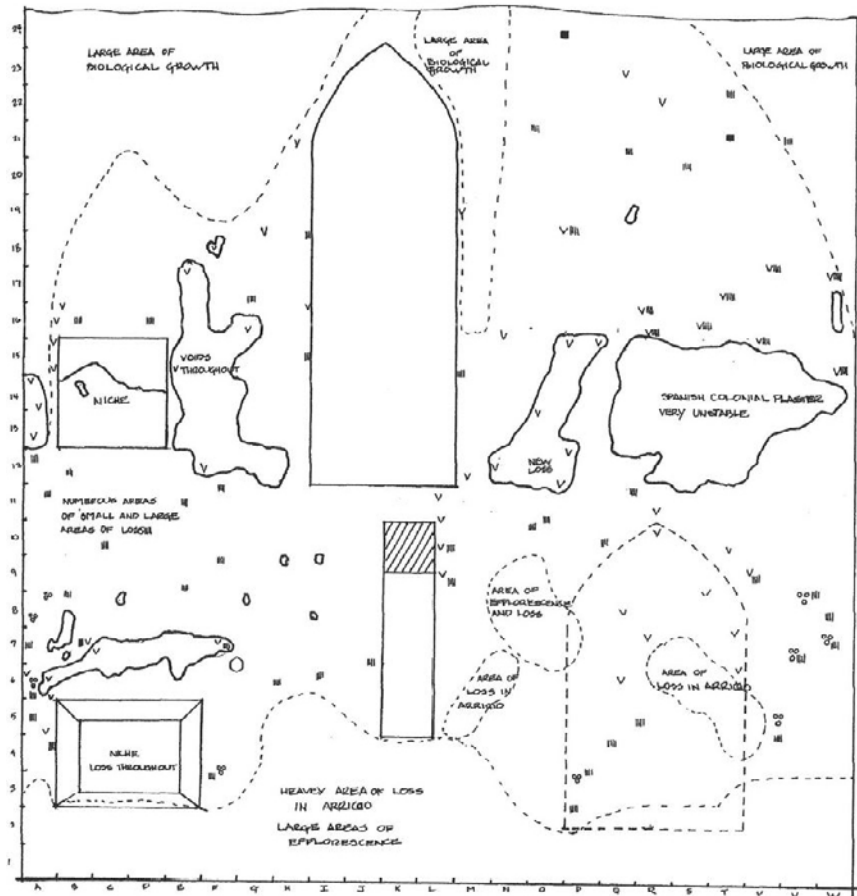
- HS 203 C** North wall upper level is in FAIR CONDITION with biological growth.  
Lower section of north wall is FRAGILE. Deteriorating limestone shows large losses.  
West wall: FAIR/GOOD.  
South wall: FRAGILE but STABLE.  
East wall: GOOD.

Figure 6.A.28: Room HS 203 C, Interior Elevation—Existing condition in September–December 2002.

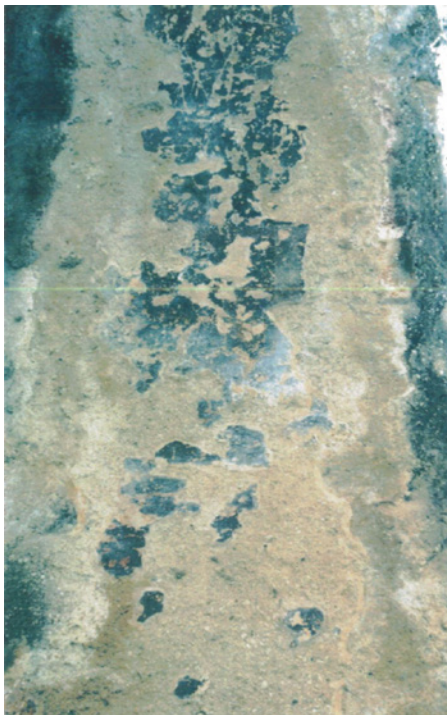
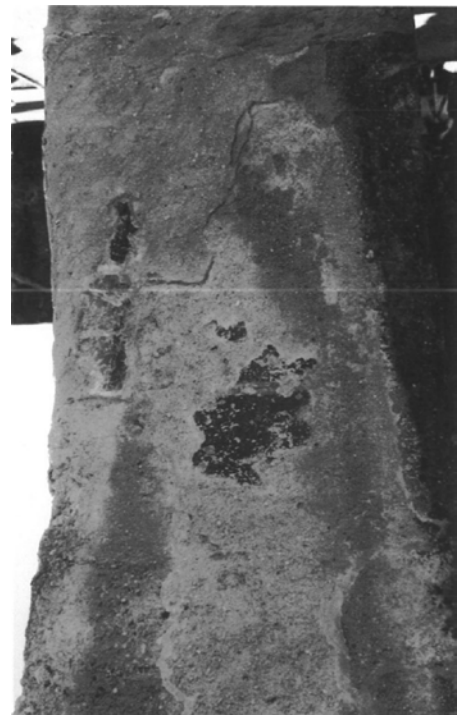
Figures 6.A.29, 6.A.30: Arch 1 D level 1 Detail of Spanish Colonial Plaster fragments.

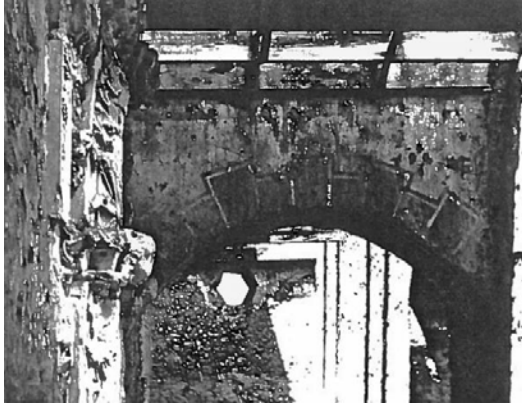
Figure 6.A.31: Arch perpendicular to sacristy — before 1938.

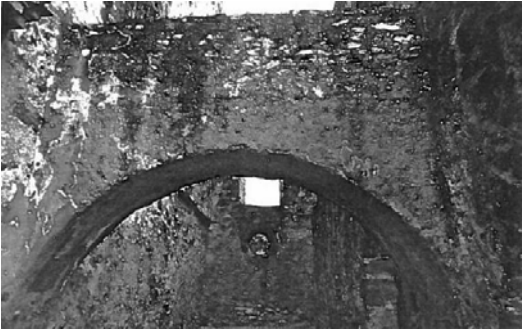
Figure 6.A.32: Arch perpendicular to sacristy — 1994.

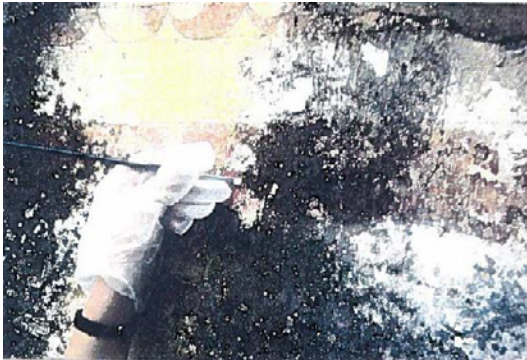
Figure 6.A.33: HS 203C — Dry brush cleaning of painted plaster.

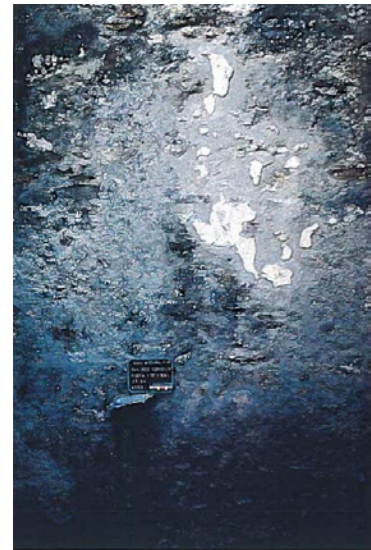
Figure 6.A.35:  
HS 203 A —  
Fragment 3  
after  
treatment.

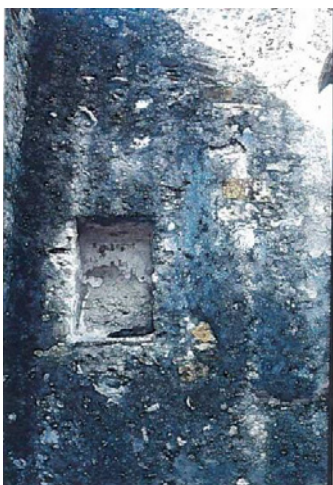
Figure 6.A.38: HS 203 C  
Before treatment.

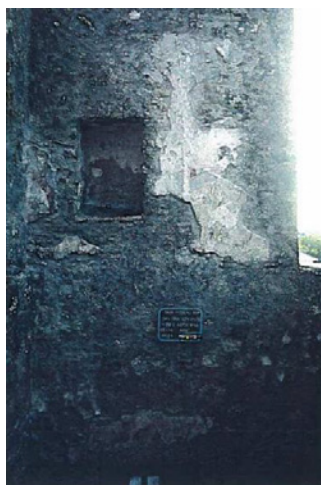
Figure 6.A.39: HS 203 C  
After treatment.

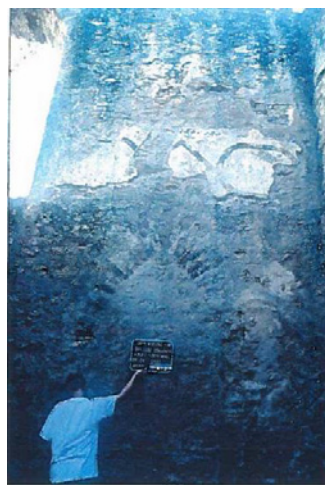
Figure 6.A.40: HS 203 C  
After treatment.

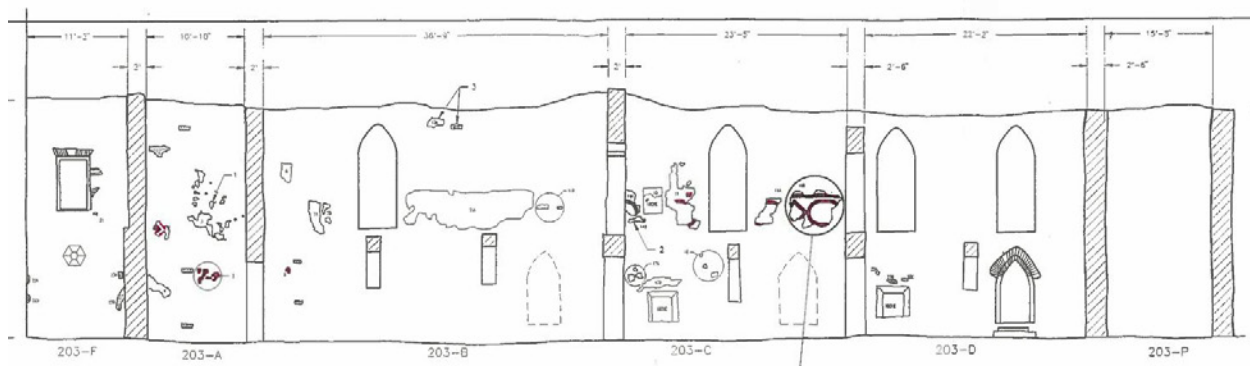
Figure 6.A.42: Building Section—Convento plaster/paint remnants after treatments.

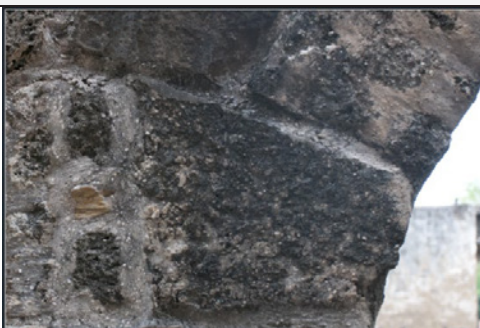
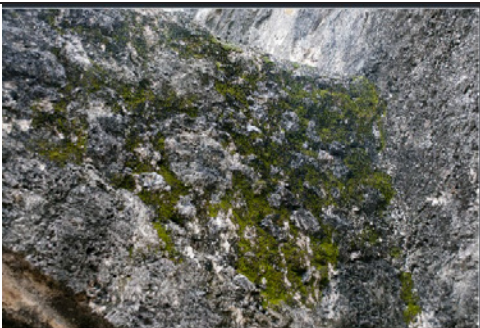
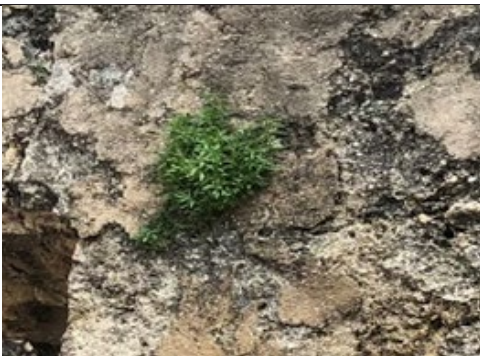
| A. GENERAL DECAY PATTERN | | | | | |
|---|--|--|--|---|---|
| <div> <div>A.1.a</div> <div>BIOLOGICAL GROWTH</div> <div> <div>Colonization of stone materials by plants and micro - organisms such as bacteria, cyano- bacteria, algae, fungi, and lichens. It is widely spread all over the convento's structure.</div> <div> </div> </div> </div> | | | | | |

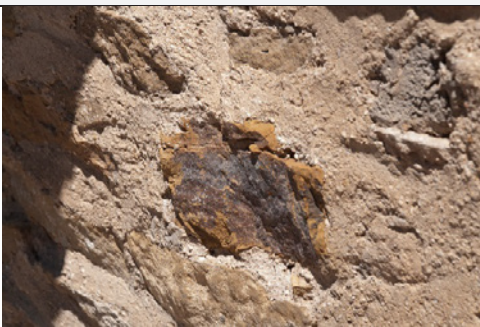
| A. GENERAL DECAY PATTERN | | | | | |
|---|--|--|--|---|---|
| <div> <div>A.2.a</div> <div>DISCOLORATION</div> <div> <div>Change in stone color in one to three of color parameters: hue, value and chroma. Present as mostly bleaching, gain value due to chemical weathering.</div> <div> </div> </div> </div> | | | | | |

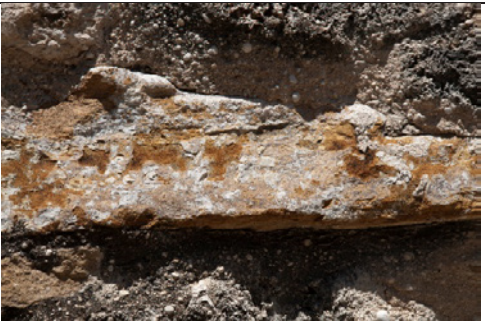
| <div>A.2.b</div> <div>ENCrustATION</div> <div><p>Compact, hard, mineral layer adhering to the stone. Surface morphology and color are usually different from that of the stone.</p></div> <div></div> <div></div> |

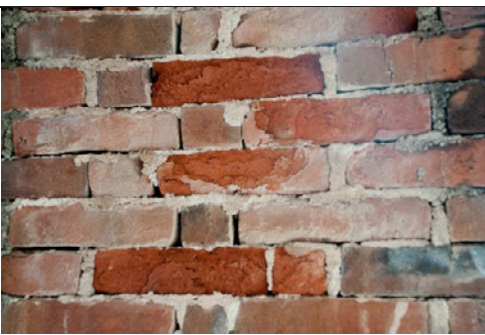
| <div>A.2.c</div> <div>EFFLORESCENCE</div> <div><p>Whitish, powdery, and whisker-like crystals on the surface, they mostly are poorly cohesive and commonly made of soluble salt crystals.</p></div> <div></div> <div></div> |

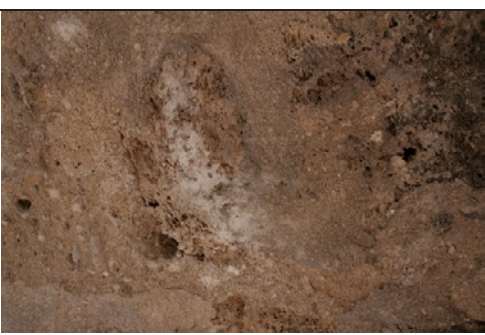
| <div>A.2.d</div> <div>DEPOSIT</div> <div><p>Accumulation of exogenic material of variable thickness, characterized by a lack of adhesion to the stone surface.</p></div> <div></div> <div></div> |

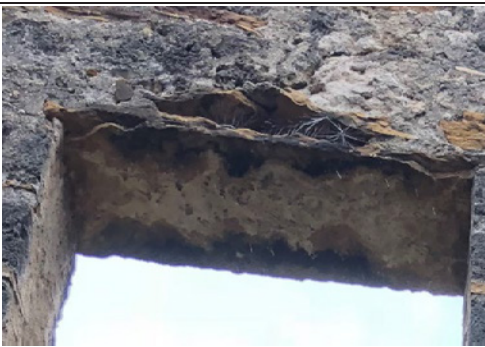
| <div>A.2.e</div> <div>BIRD DROPPING</div> <div><p>Specific type of deposit, bird droppings are made of excrement and feces (guano) with high soluble salt content, potentially corrosive.</p></div> <div></div> <div></div> |

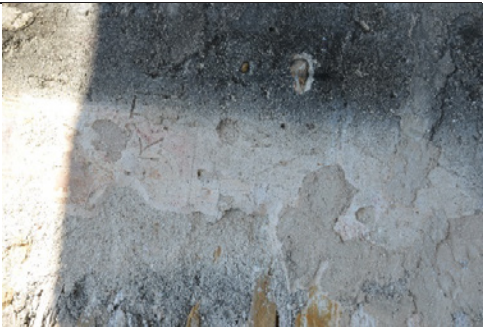
| A.2.f | GRAFFITI | Engraving, scratching, cutting, or application of paint, ink, or similar matter on the stone surface. Here, some graffiti may be considered historic. | |

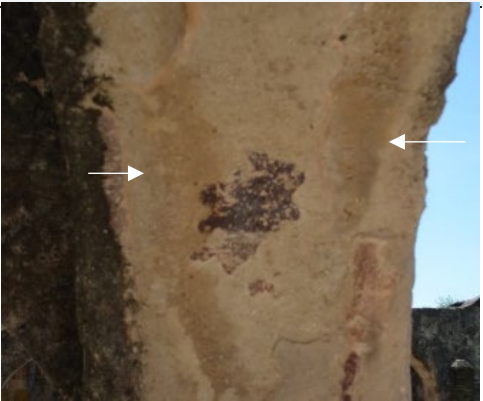
| B.3. Detachment | | | |
|---|---|---|---|
| B.3.a | DETACHMENT OF EDGES | Loss of cohesion of the plaster with the wall substrate, located on the edges of plaster fragments. It may lead to water infiltration and accelerated decay. | |

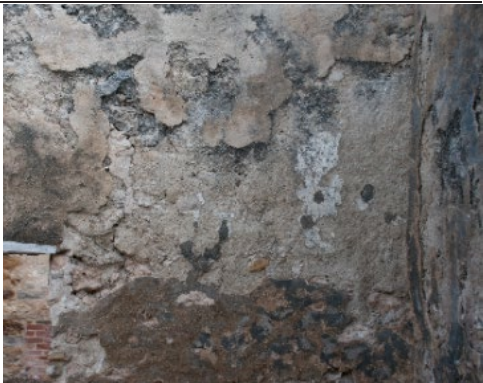
| B.3. Detachment | | | |
|---|---|---|---|
| B.3.b | DETACHMENT | Loss of cohesion between the plaster and wall substrate, mostly not visible, but assessed through tapping. | |

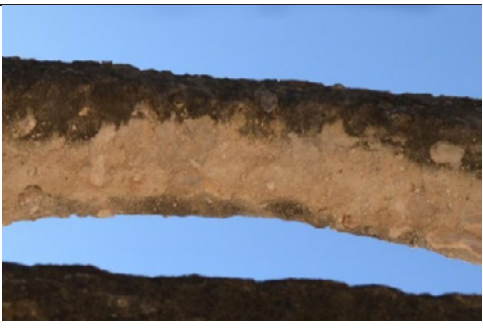
| B.3. Detachment | | | |
|---|---|---|---|
| B.3.c | DISINTEGRATION CRUMBLING | Detachment of aggregates of grains from the plaster substrate, generally limited in size (less than 2 centimeters). | |

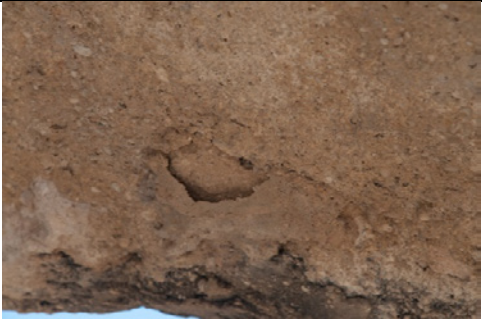
| B.3.d | BLISTERING | Separated, air filled, raised hemispherical elevations on the face of the plaster surface, resulting from the detachment of the outer layer. | |

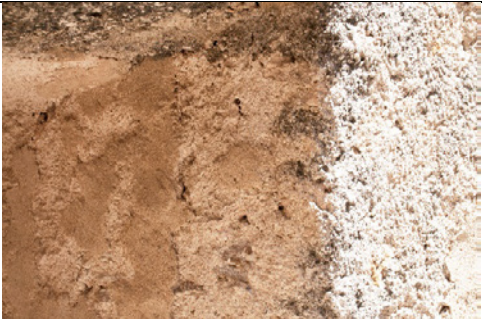
| B.3.e | POWDERING | Disintegration of aggregates made of fine grains. | |

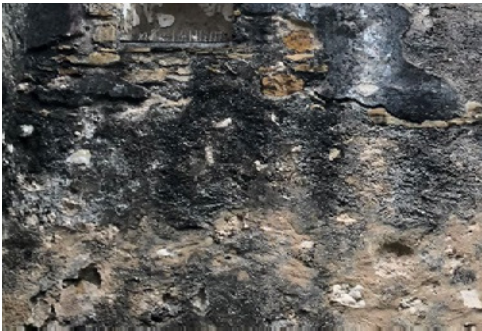
| B.4.a | EROSION | Loss of original surface, leading to smoothed shapes and due to a variety of reasons related with chemical, physical and/or biological processes. | |

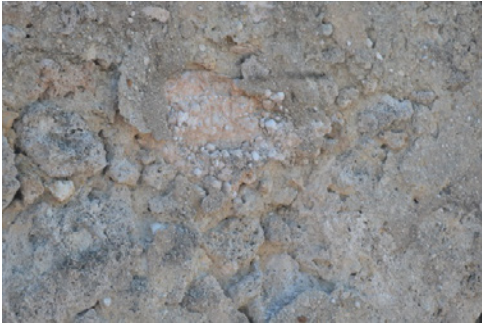
| B.4.b | DIFFERENTIAL EROSION | Irregular loss of original surface, with formation of irregularity on the plaster surface, due to the presence of harder and larger aggregates. | |

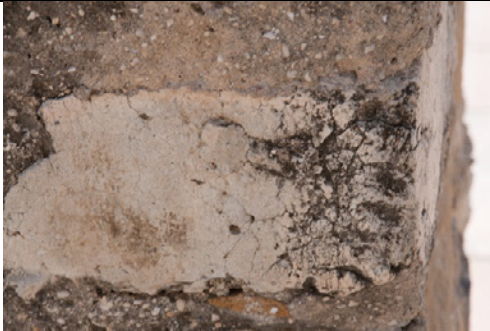
| | B.4.c | MICROKARST | Network of small interconnected depressions due to partial and/or selective dissolution of calcareous surface exposed to water run-off. | |

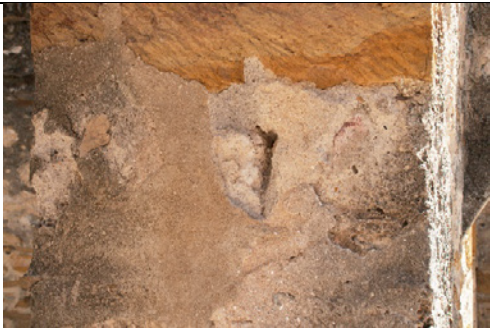
| | B.4.e.1 | MISSING PARTS/GAPS<br><br>(small non-structural): | Empty spaces, obviously located in the place of previously existing plaster/mortar parts, also denominated as “lacuna.” Gaps are hollow place, holes. | |

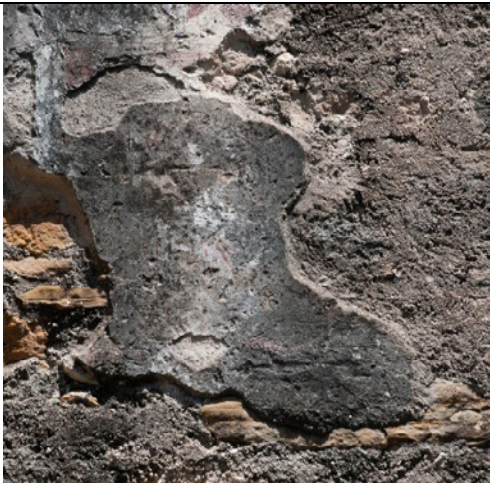
| | B.4.f | PITTING | Point-like millimetric or submillimetric shallow cavities, usually cylindrical or conical shapes, not interconnected. Mostly biogenically or chemically induced. | |

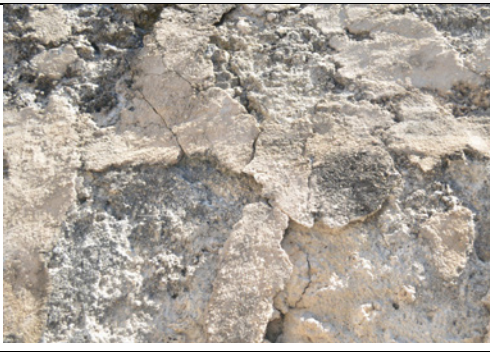
| | B.5.a.1 | HAIR CRACK | Minor individual fissure, visible by the naked eye, with width dimension smaller than 1 millimeter. | |

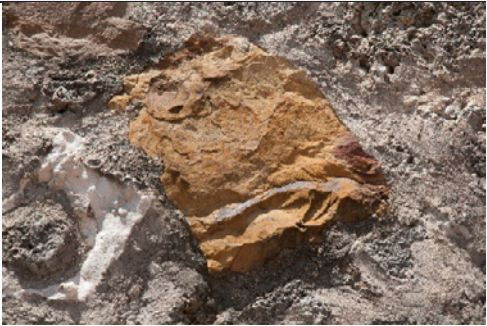
| C.3 Detachment | | | |
|---|---|---|---|
| C.3.f | FLAKING | Detachment in thin flat or curved scales of submillimetric to millimetric thickness, looks like fish scales. | |

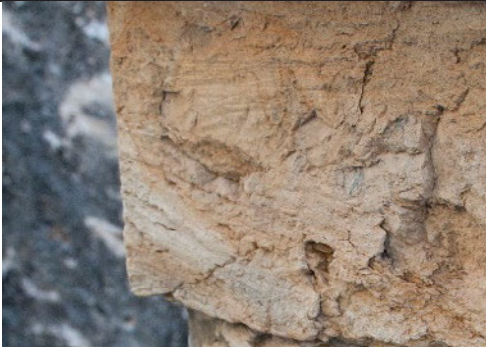
| C.3 Detachment | | | |
|---|---|---|---|
| C.3.h.1 | FRAGMENTATION | The complete or partial breaking up of a stone, into portions of variable dimensions, irregular in form, thickness and volume. | |

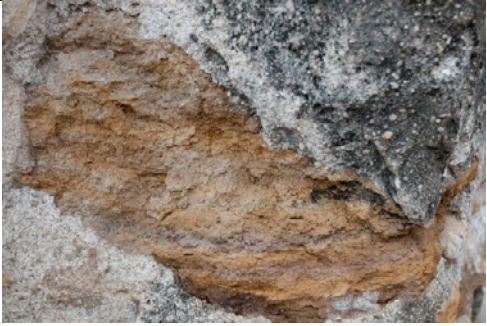
| C.3 Detachment | | | |
|---|---|---|---|
| C.3.g | DELAMINATION | Detachment process affecting laminated stones, corresponding to a physical separation into several layers following the stone laminae. | |

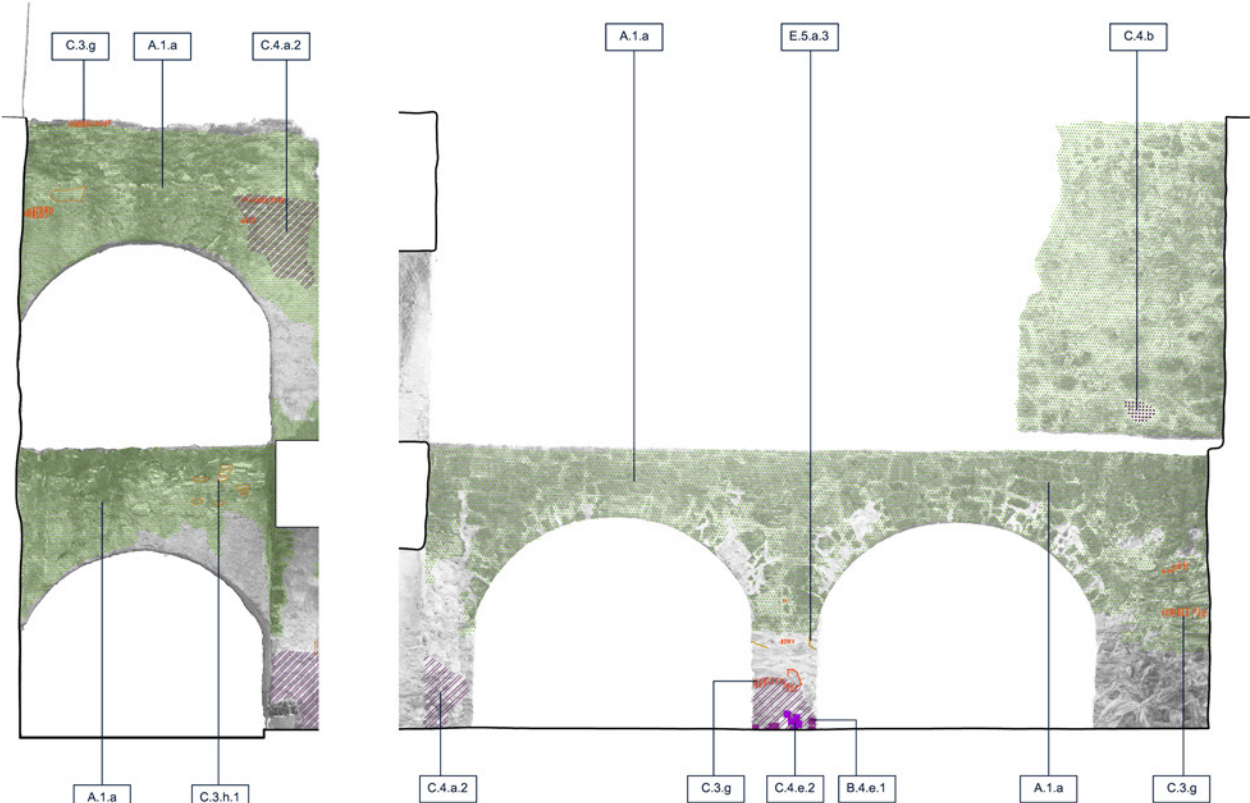
203 S

This wall has no remnant of historic plaster. The overall condition of the wall is fragile, because of the presence of numerous cracks on the ground floor and the complex texture characterizing the ground floor. Biological growth is spread on the whole wall surface, with a more intense pattern located on the tufa rubble stone, above the sacristy door. Other areas with a higher concentration of biological growth are the north corner and the surface below the window, due to higher rainwater absorption. The southern section of the ground floor shows traces of a walled arch, with cracks, one running diagonally above the stone voussoirs and, another, with a vertical pattern, in the arch infill. The whole ground-floor wall shows numerous voids, advanced erosion, with associated stone delamination, in the wall lower section up to approximately 3½ ft. above the ground, next to the sacristy door.

The ground floor is characterized by numerous cracks: starting from the southern corner, fractures are located above the arched-lancet windows, on its southern section, with a sub-vertical direction, extended until the capping, with cracks visible from the top. Another vertical deep crack is located on the ground floor where there is a change in the thickness of the wall section. Above the sacristy entrance door, there is evidence of filled cracks starting from the capping and separating in two cracks, shaping the form of a natural arch above the sacristy door.

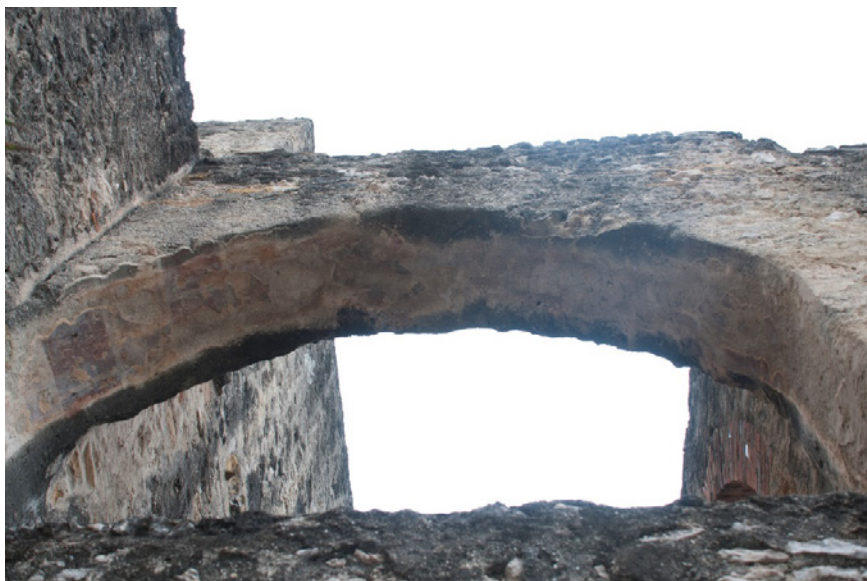
Figure 6.B.2: Room HS 203 S—North wall, upper-level arch showing the remnants of historic painted plaster in its intrados.

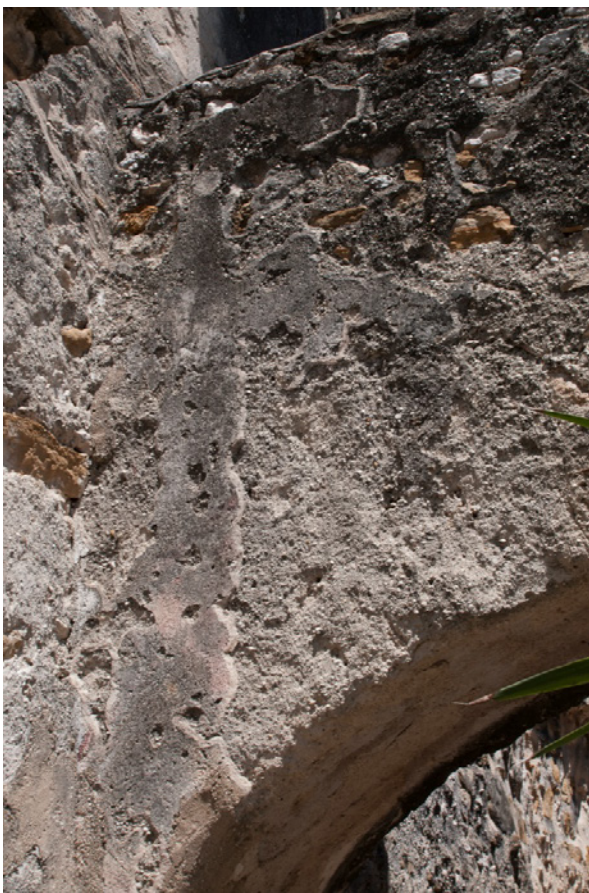
Figure 6.B.5: Room HS 203 S—North wall, lower-level arch. Detail of the left corner of the arch which features remnants of historic plaster.

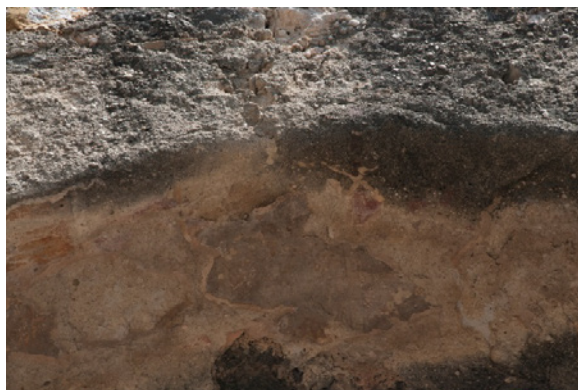
Figure 6.B.3: Room HS 203 S—North wall, upper-level arch. Detail of the painted plaster showing detachment of edges.

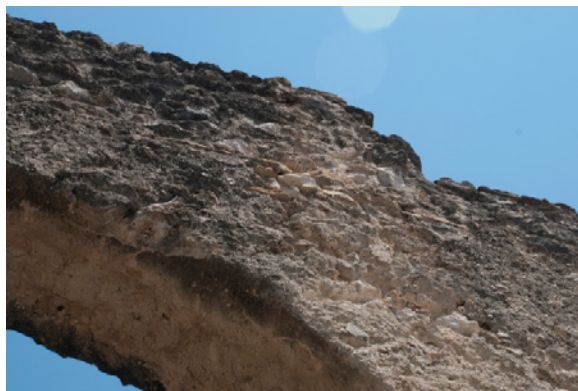
Figure 6.B.4: Room HS 203 S—North wall, upper-level arch. Upper right corner of the arch exhibiting erosion of the masonry wall.

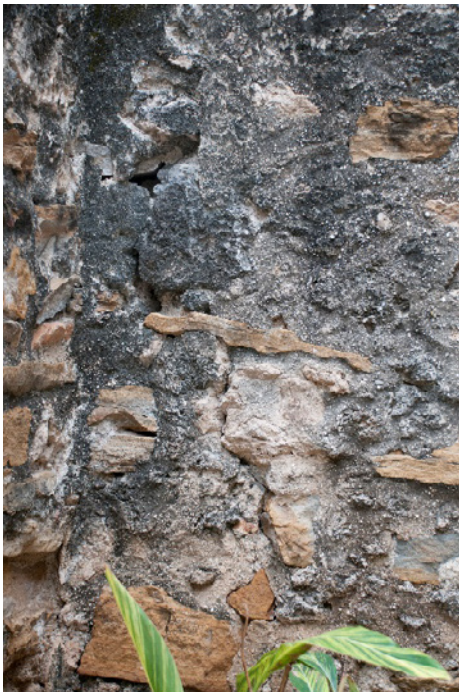
Figure 6.B.8: Room HS 203 S—South wall, south corner. Diagonal crack is located on the east corner of the south wall.

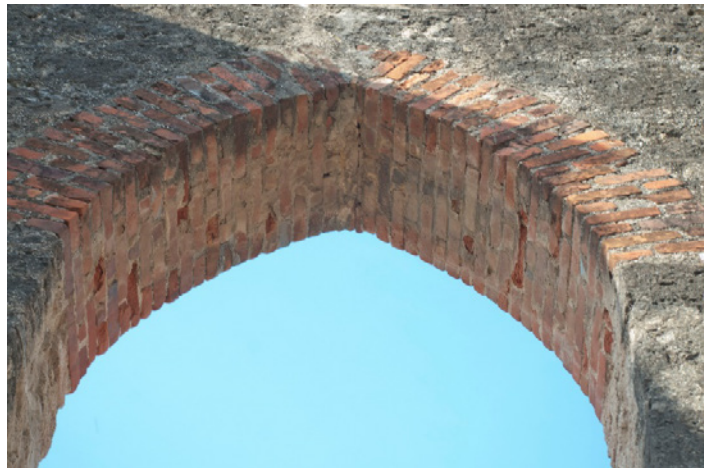
Figure 6.B.9: Room HS 203 S—South wall, upper-level lancet arch. Fragmentation of the bricks composing the arch.

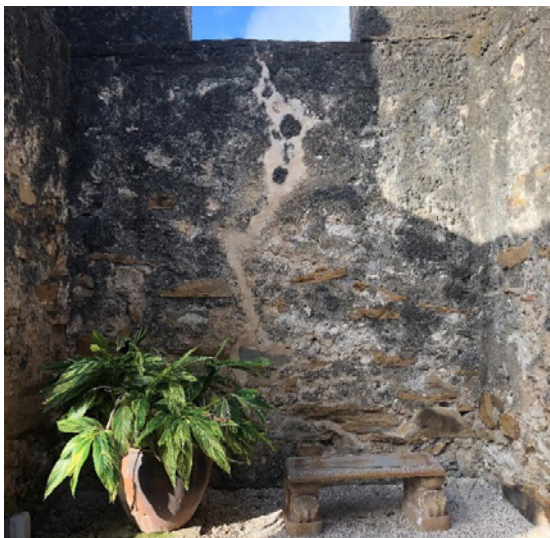
Figure 6.B.10: Room HS 203 S—South wall lower level. General view exhibiting a big crack that has been filled and a thick layer of vegetation growth.

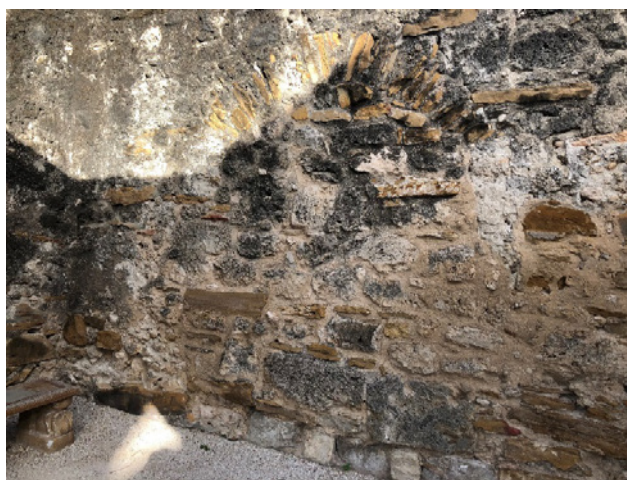
Figure 6.B.13: Room HS 203 S—West wall, south corner. Cracks are visible above the sandstone arch line. Biological growth is more developed in the upper corner.

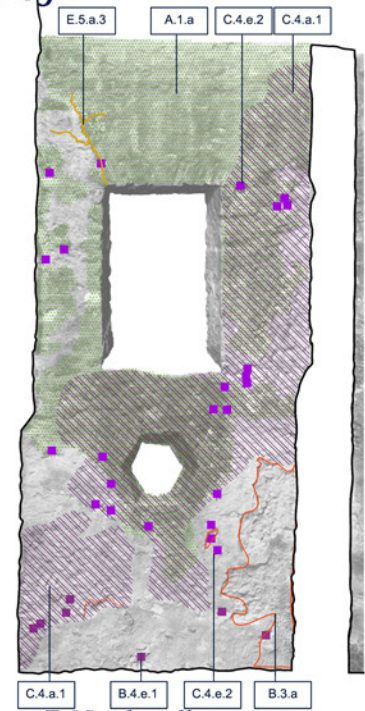
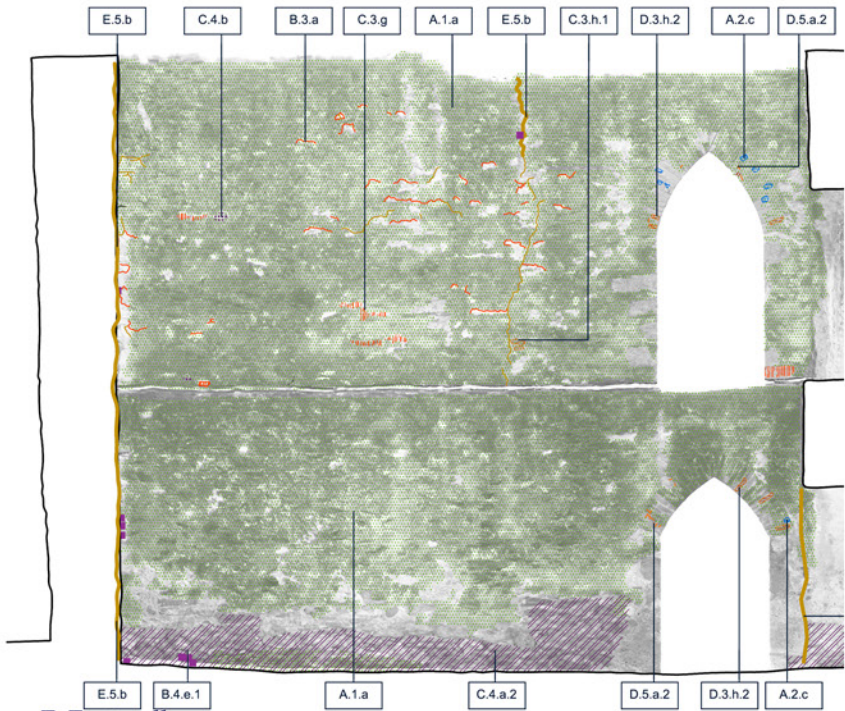
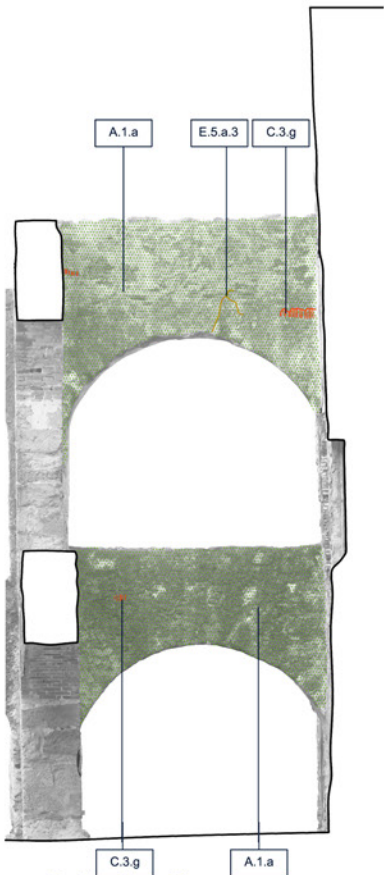
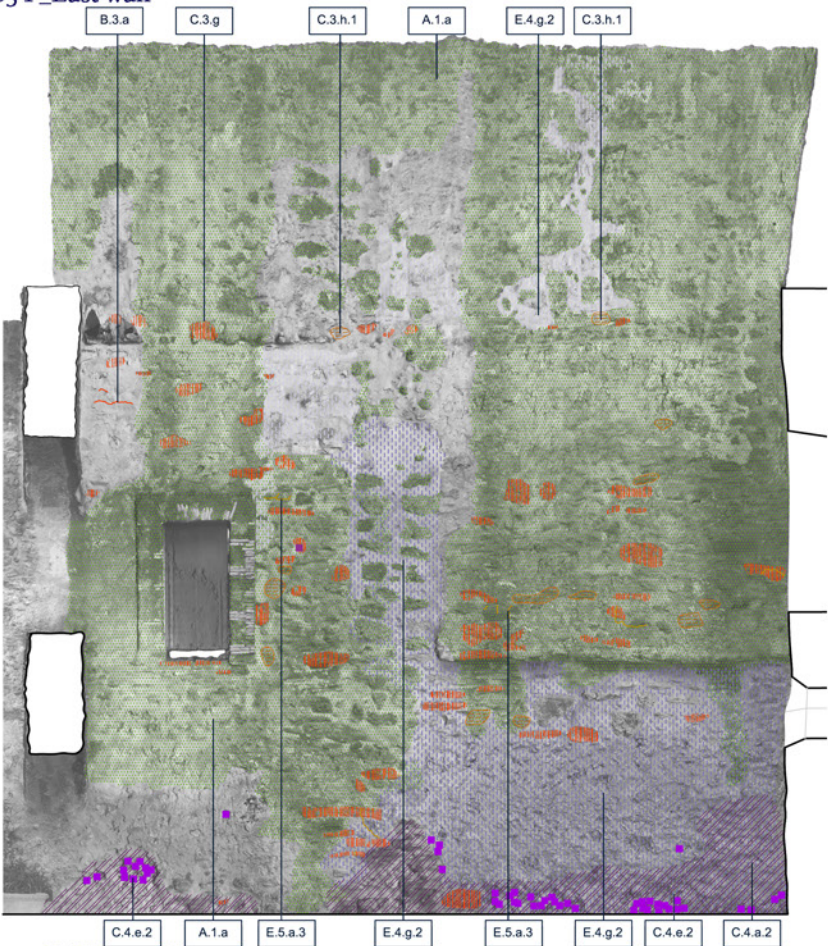
203 F

all wall surface condition is fair/fragile, with detachment of the existing mortar from the substrate. Presence of biological growth is visible on the lower level, and it is also concentrated under the rectangular window. The lower level eastern section of the wall shows evidence of erosion, with a few missing parts; in the wall lower section, the surface is characterized by spread voids. In the lower 3 ft. of the wall, there is visible detachment of restoration mortars from the wall substrate, with associated detachment of edges. Mortar powdering is occurring in the plaster scratch coat located on the wall eastern section. A visible crack extends diagonally across the wall to the window starting from the upper west end of the north wall—at 1½ feet below the capping.

The wall has no evidence of historic plaster finish. The overall condition of the wall is fair/fragile. The wall shows a high accumulation of biological growth all over the surface, until the lower section of the wall, which shows evidence of erosion of the masonry, with loss of joint mortar. Various limestones as well as sandstones are in states of fragmentation or delamination in various sections of the wall. The erosion of the lower part of the wall is advanced, until approximately 3 ft. from the grade level, with associated loss of mortar joints and few voids. On the lower level, there is also evidence of carved graffiti on the red bricks in the wall's southern section. The red bricks lining the two superimposed lancet-arched doorways are characterized by loss of material, cracks, fragmentation of bricks, efflorescence, and powdering. This wall is characterized by the presence of three cracks. One large crack is located on the northern corner, where this wall encounters the north wall. These two walls are connected only through two flagstones, showing clearly that the east wall was built in a later phase (this is also confirmed by the presence of finished colored plaster in the northern wall in the area underneath the east wall thickness). The crack

is due to a lack of connection and to an outward movement of the north facade that happened sometime after the 1860s Benedictine construction. A fine crack crosses all the wall height, from the bottom to the top, and is located almost at the center of the wall, ideally aligned with the longitudinal wall separating the arcaded porticos from the convento's rooms. The third crack is located on the southern corner, at the intersection of the connecting arch.

The wall is characterized by numerous mortar patchings as well as crack in-fills. Numerous sandstone blocks have evidence of delamination and fragmentation. The tufa rubble stones, however, do not show any visible features induced by material loss.
