National Park Service  
United States Department of the Interior  
San Antonio Missions National Historical Park  
Texas

# Historic Structure Report Mission San José Convento

Final Submission  
2019

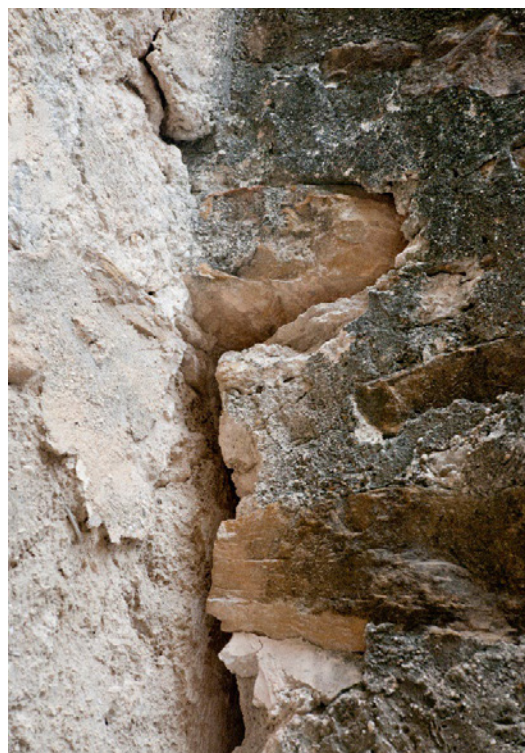
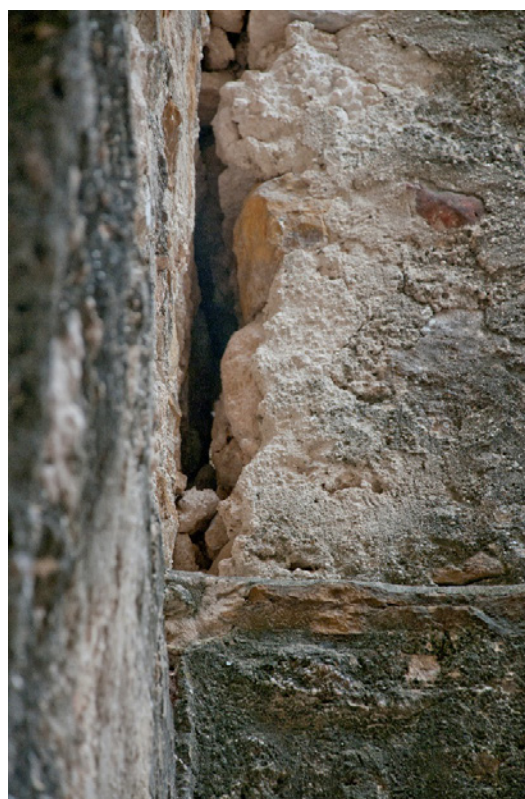
is due to a lack of connection and to an outward movement of the north facade that happened sometime after the 1860s Benedictine construction. A fine crack crosses all the wall height, from the bottom to the top, and is located almost at the center of the wall, ideally aligned with the longitudinal wall separating the arcaded porticos from the convento's rooms. The third crack is located on the southern corner, at the intersection of the connecting arch.

Figures 6.B.16 and 6.B.17: Room HS 203 F—East wall. Separation of 18<sup>th</sup>-century north wall from 19<sup>th</sup>-century perpendicular wall at the northern corner shows a stratigraphic sequence in the construction phases.

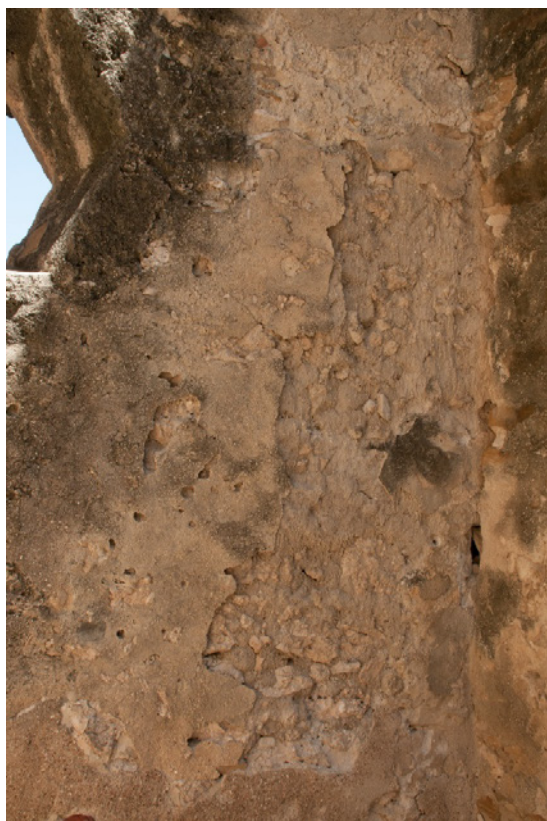
all wall surface condition is fair/fragile, with detachment of the existing mortar from the substrate. Presence of biological growth is visible on the lower level, and it is also concentrated under the rectangular window. The lower level eastern section of the wall shows evidence of erosion, with a few missing parts; in the wall lower section, the surface is characterized by spread voids. In the lower 3 ft. of the wall, there is visible detachment of restoration mortars from the wall substrate, with associated detachment of edges. Mortar powdering is occurring in the plaster scratch coat located on the wall eastern section. A visible crack extends diagonally across the wall to the window starting from the upper west end of the north wall—at 1½ feet below the capping.

Figure 6.B.15: Room HS 203 F—North wall. The wall features detachment of edges and erosion.

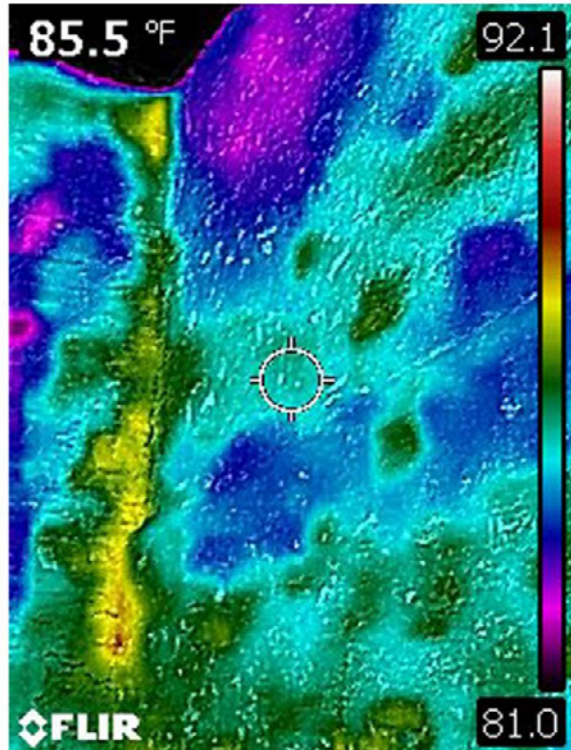
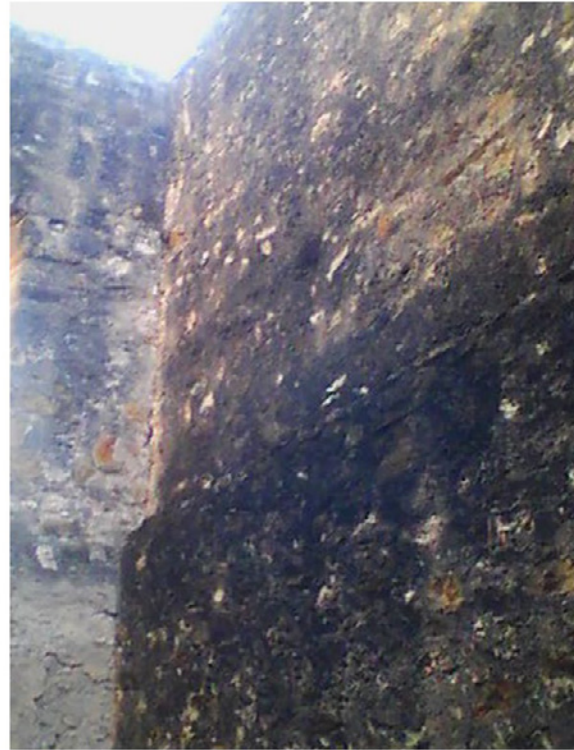
Figures 6.B.18 and 6.B.19: Room HS 203 F—East wall. Same view of the northeast corner. Left photo indicates the difference in temperature across the wall surface.

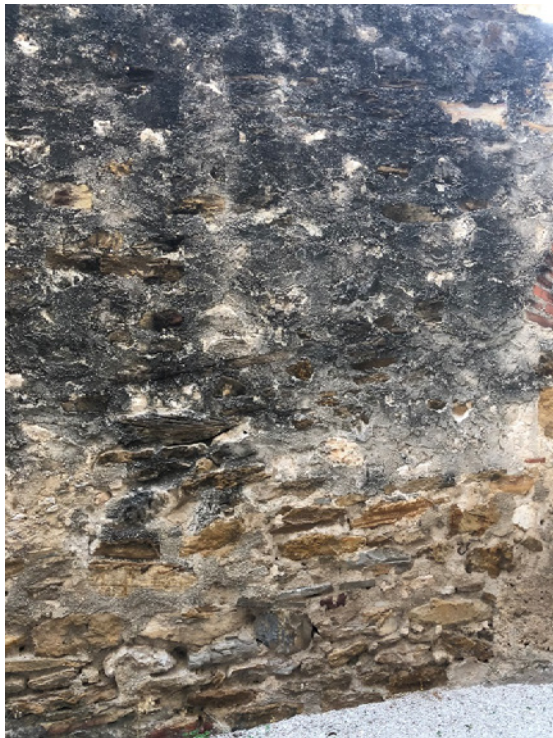
Figure 6.B.20: Room HS 203 F—East wall. Erosion and loss of mortar joint in the bottom part of the wall.

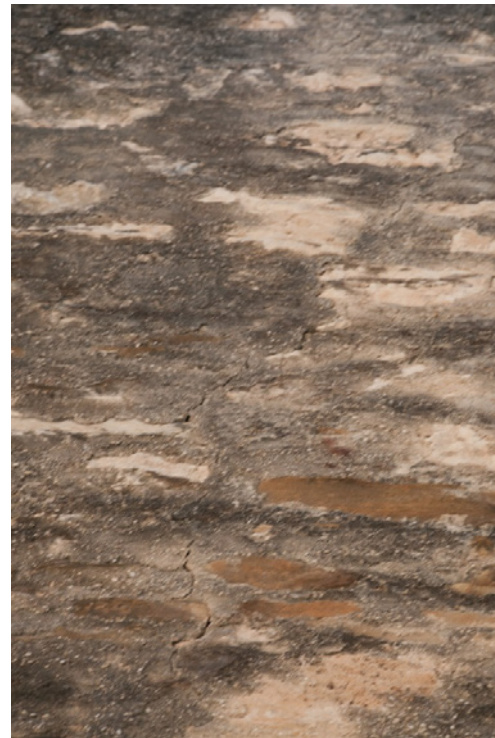
Figure 6.B.21: Room HS 203 F—East wall. Hair crack that becomes a fracture in the higher part of the wall. Corresponds to the location of the perpendicular wall of the adjacent room.

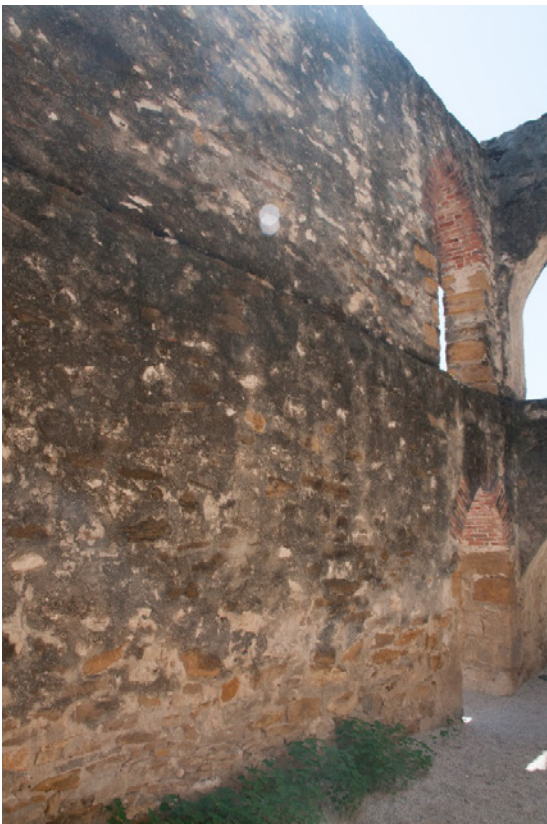
Figure 6.B.23:  
Room HS 203  
F—East wall.  
General view of  
the wall.

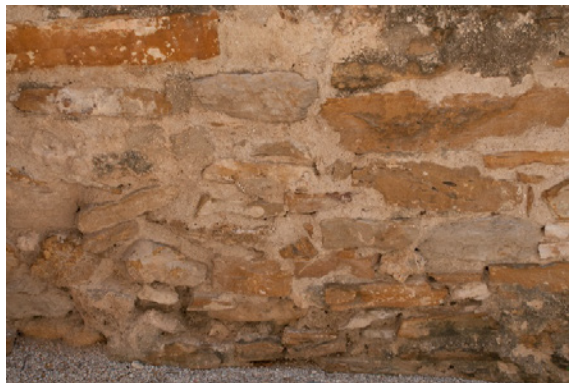
Figure 6.B.22: Room HS 203 F—East wall. Detail of the bottom part of the wall. Unlike the rest of the wall, it does not feature vegetation growth, but it exhibits erosion and loss of the mortar joints.

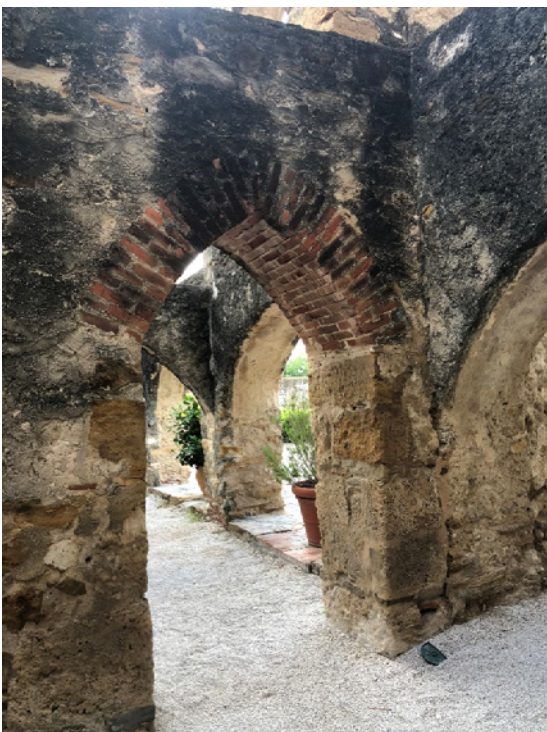
Figure 6.B.24: Room HS 203 F—East wall. Lancet arch in the southern end of the wall, which features a thick layer of vegetation growth in the area above the arch.

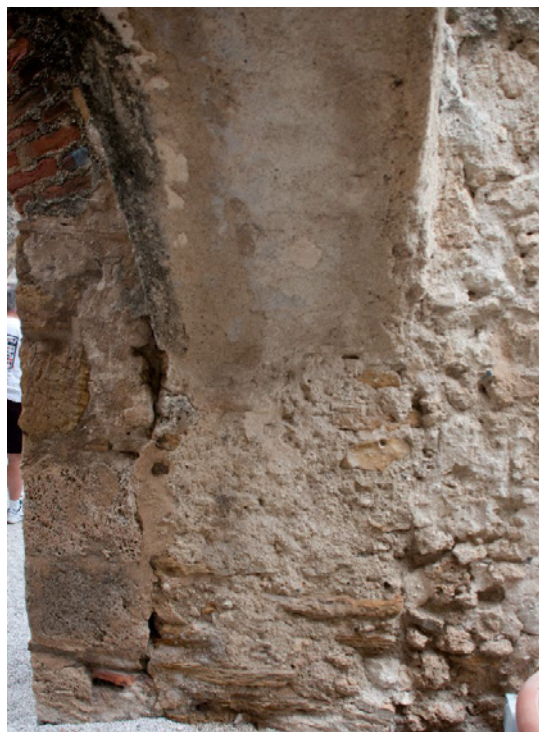
Figure 6.B.25: Room HS 203 F—East wall. The wall features a deep fracture at the corner with the south arcade.

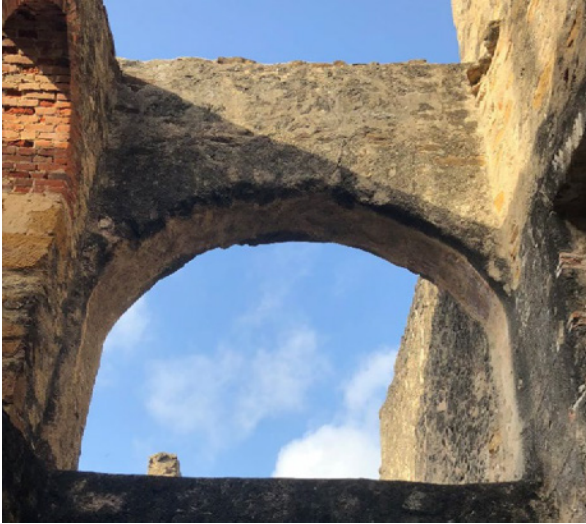
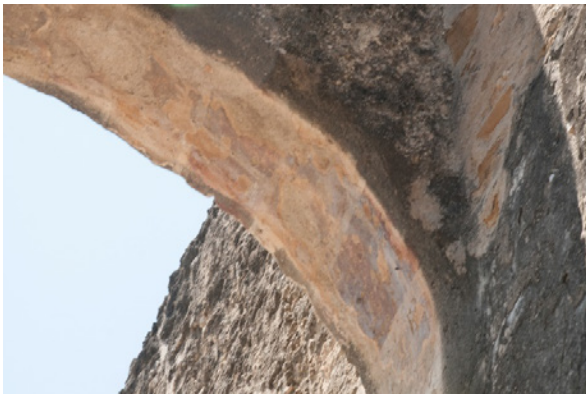
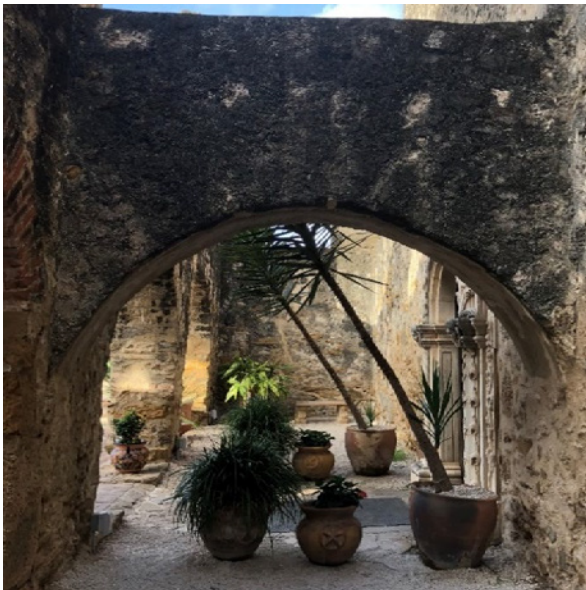
Figures 6.B.28, 6.B.29, and 6.B.30: Room HS 203 F—South wall. Figure 6.B.29 is a detailed photo of the intrados of the upper-level arch, showing the remnants of painted plaster (red color).

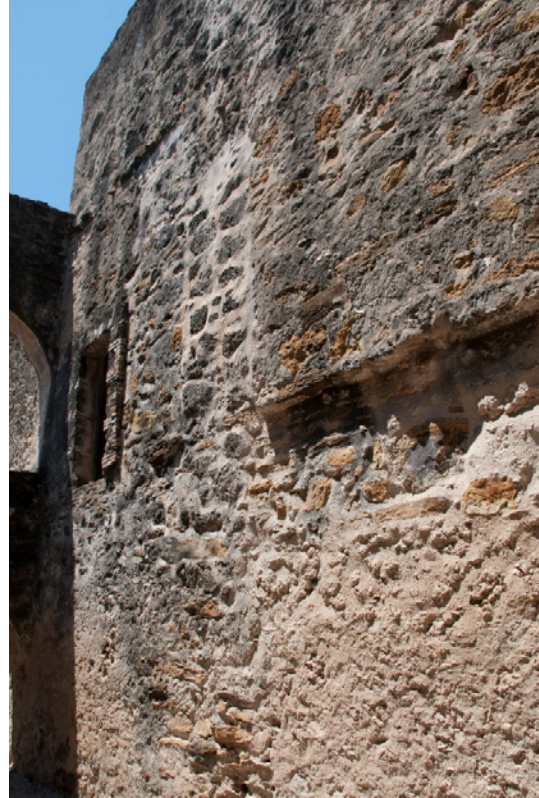
Figure 6.B.26: Room HS 203 F—West wall. General view.

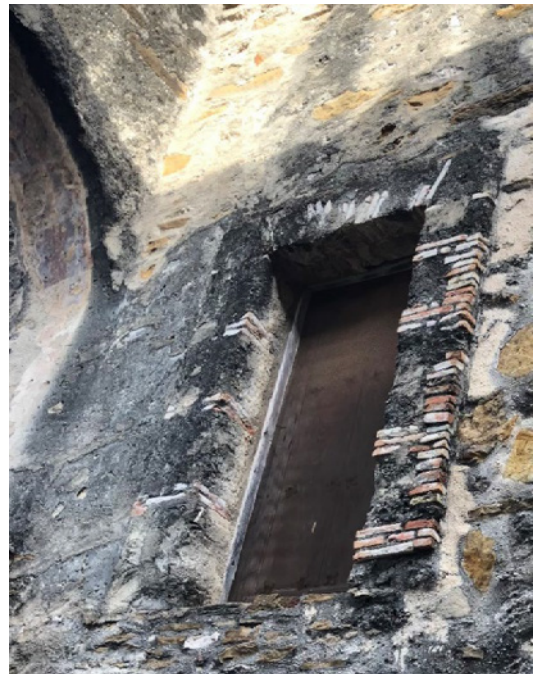
Figure 6.B.27: Room HS 203 F—West wall. Note the painted finish plaster under the arch and the biological growth on and around the door.

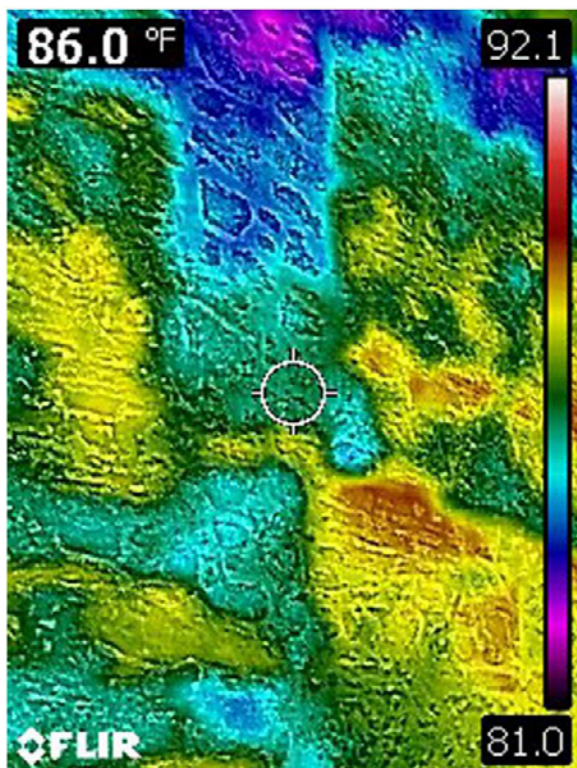
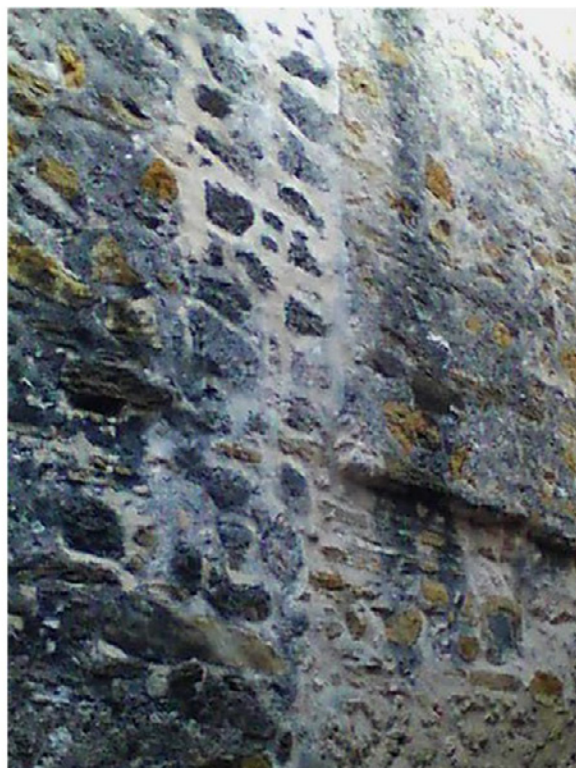
Figures 6.B.31 and 6.B.32: Room HS 203 F—West wall. Same portion of wall is shown in both photos. Left photo shows temperature differences in the wall, indicating different materials exhibit different temperatures. Areas with sandstones tend to be warmer, and 20<sup>th</sup>-century additions with cement-based mortars tend to be cooler.

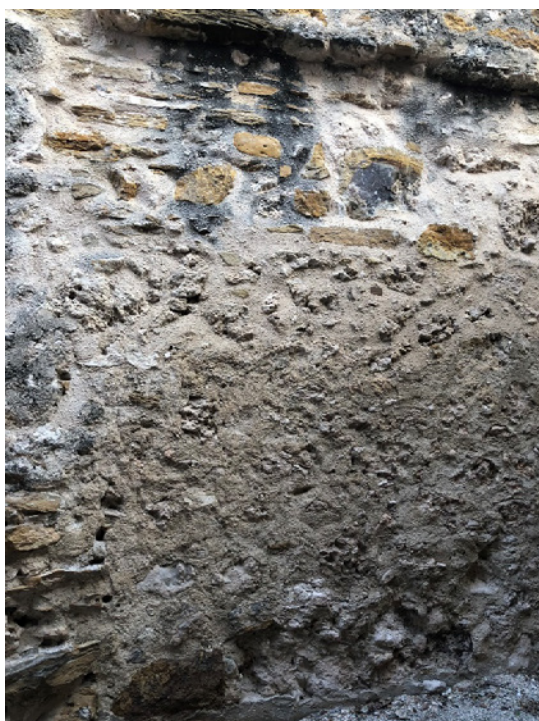
Figure 6.B.33: Room HS 203 F—West wall. Detail of the bottom part of the wall, which exhibits erosion and loss of the mortar joints.

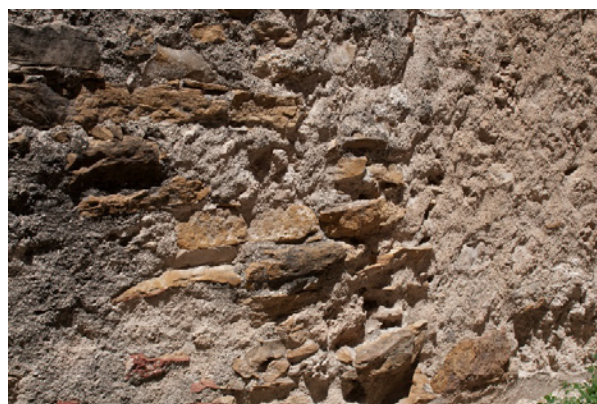
Figure 6.B.34: Room HS 203 F—West wall, which features vegetation growth in the upper part, erosion in the bottom part, and brown mortar patching.

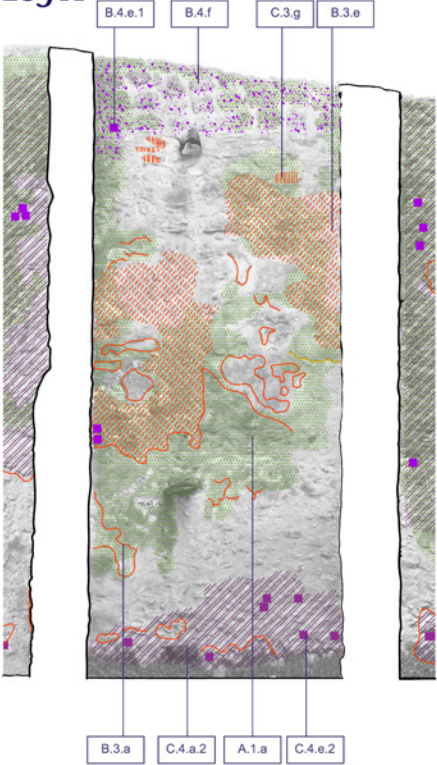
203 A\_North wall

This wall exhibits fragments of historic finished plaster dating to the Spanish Colonial period, probably around 1770s ( Bass, 1994). A small area of red pigment is still visible in the lower section. Plaster fragments show evidence of previous consolidation and edge stabilization. Plaster finishes, although characterized by biological growth, appear to be in fairly good condition, with no large-scale detachment from the substrate. The edges appear to be detached in some areas. On the west upper section, fragments of historic scratch coat (arriccio) remain in situ starting from 9.3 feet circa—showing detachment, missing parts, and detachment of edges. The overall condition of the wall is good.

The top of the wall is crowned by three layers of rubble tufa stone (built in 1930s by Harvey Smith), with a characteristic porosity—mapped as pitting. In the upper level, there is also evidence of delamination of several sandstones. Remnant of historic scratch coat is still visible on the western section of the wall, and continues behind the west wall. Scratch coat has evidence of erosion and powdering. Powdering is also visible on the wall eastern section.

The northwest corner—where the west wall abuts the north wall—has a fracture, which begins at approximately 20-ft. high and continues until the ground level, with the widest opening in the lower section.

The lower section of the wall is mostly covered by modern, well- executed patching mortar, which has evidence of erosion in the lower 3–4 ft. of the wall, with numerous voids. Such decay is evidence of rising damp with associated presence of sub-efflorescence.

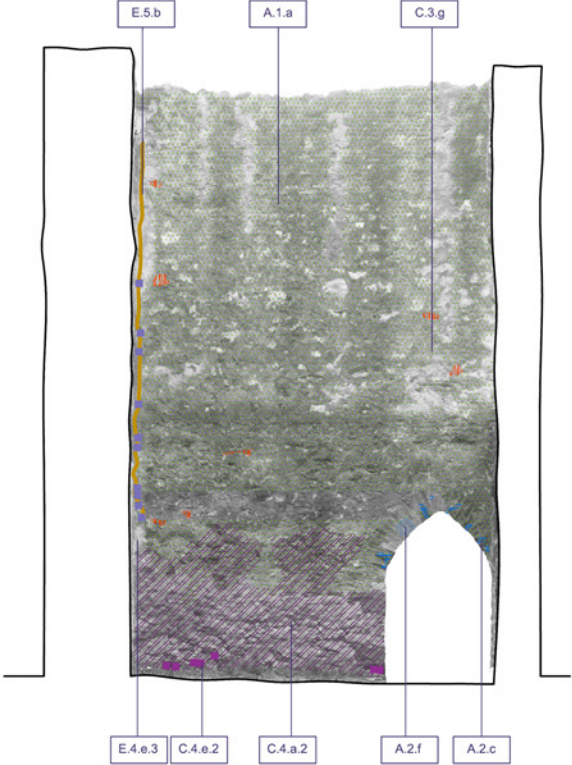
203 A\_East wall

This wall does not show any remnant of Spanish Colonial plaster, further proof that it is 1860s construction. The overall condition of the wall is fair/good, with the exception of the lower 6 ft. of the wall, until the connection to the ground. Biological growth darkens the wall surface, in areas affected by rainwater run-off. The heaviest accumulation of biological growth is visible in the southeast corner, where rainwater runs, as well as on the higher part of ground floor. The lowest part of the ground floor has missing joint mortar, with a high level of

The northern corner—where the east wall abuts the north wall—has a deep fracture, which extends from approximately 2 ft. below the capping down to 6 ft. above the grade level, with the widest opening in the upper section.

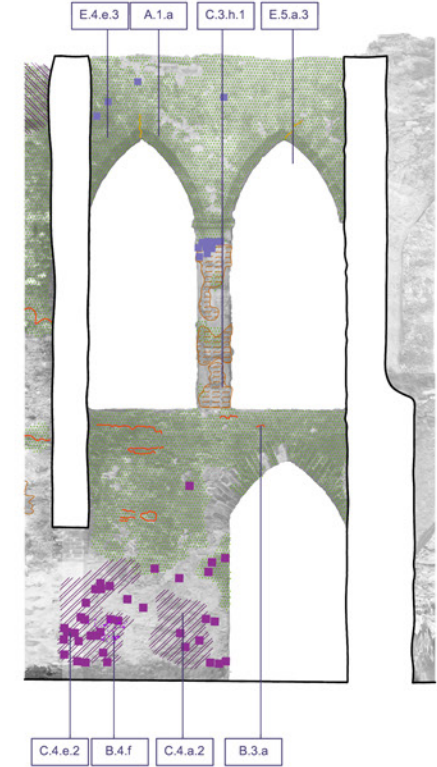
203 A\_South wall

This wall cannot have remnants of Spanish Colonial plaster since it was constructed during the Benedictine era (1860–1867). The overall condition of the wall is fair/fragile, with recent hair cracks located at the keystone of both tufa stone, pointed-arched openings of the upper level. A thick layer of biological growth characterizes the whole wall surface, both in the upper level and on the ground level under the opening sills. The area of the so-called octagonal column, which was consolidated in early 1990s (see pp. 79–80), shows high level of fragmentation and detachment of the sandstone block surface. The stone blocks also have numerous missing parts. The mortar for the shaft of the column appears to be stable with areas of detachment. The lower section of the south wall is in fragile condition, patched with recent mortar, and shows a high level of erosion until approximately 5 ft. above the ground, with numerous voids, sometimes even 5 inches wide.

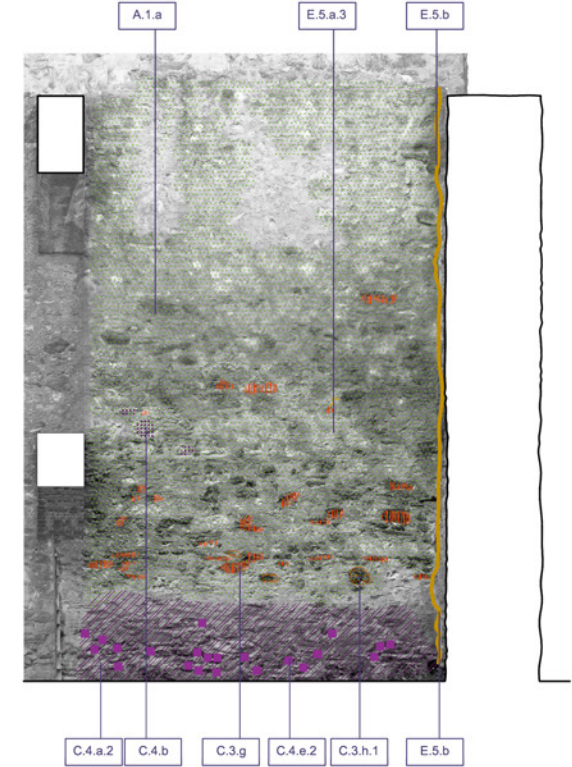
203 A\_West wall

This wall cannot have remnants of Spanish Colonial plaster since it was constructed during the Benedictine era (1860–1867). The overall condition of this wall is good, with the exception of its lower section, which is highly eroded. The wall is characterized by a differential erosion of the masonry wall, where the feathering mortar is more intact than the adjacent stones. Here sandstones have a highly developed delamination pattern. Such stones have losses that create recesses into the wall surface up to  $\frac{3}{4}$  inch. The recesses are facilitating rainwater ingress into the wall. The lower section of the wall has evidence of a high level of erosion of the recent patching mortar, resulting in missing mortar joints and delamination of numerous sandstones. The northern corner—where the west wall joins the north wall—has a deep fracture, which begins at the capping and continues until the grade level, with the largest gap at 4 ft. above the grade level.

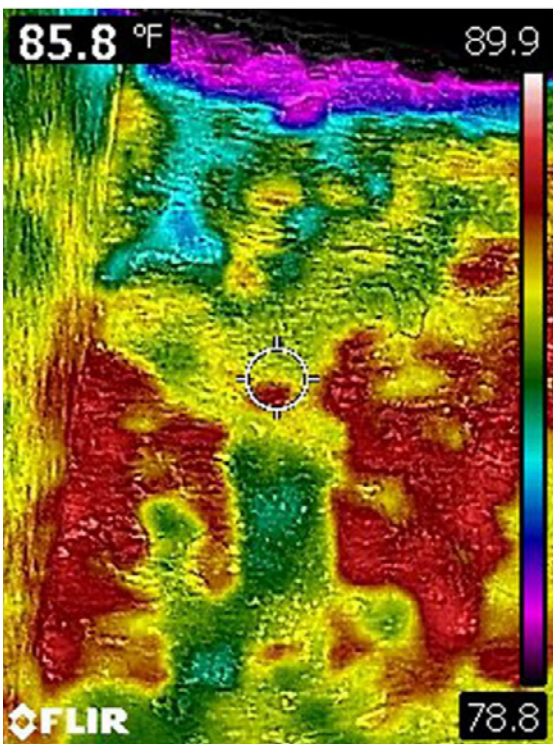
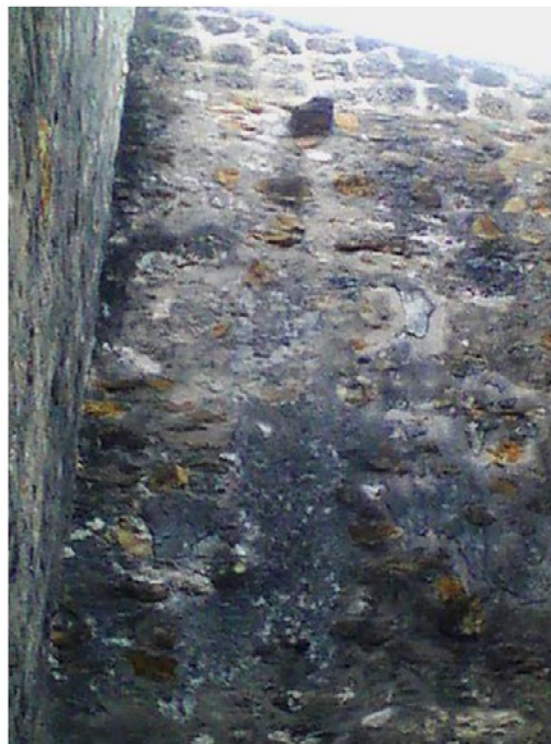
Figures 6.B.35 and 6.B.36: Room HS 203 A—North wall. Same portion of wall is shown in both photos. Left photo shows temperature differences in the wall, indicating different materials exhibit different temperatures. Considering that the wall has areas of old plaster and mortar patching, the difference of temperature can also be due to the detachment of these surfaces.

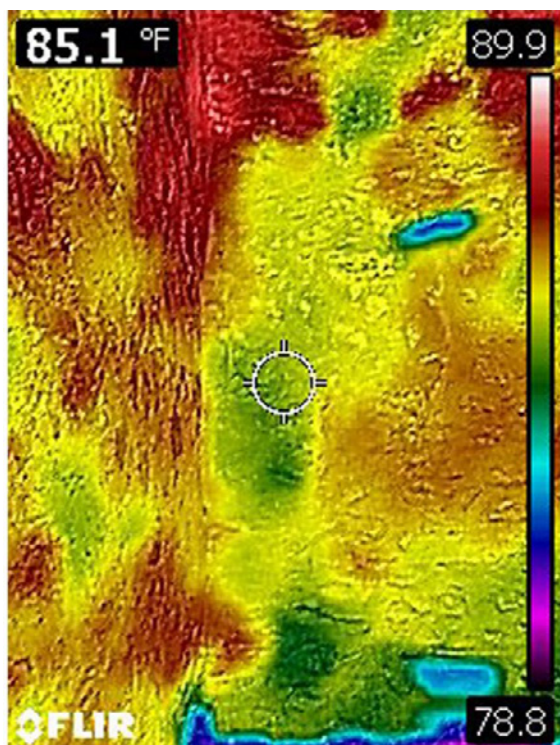
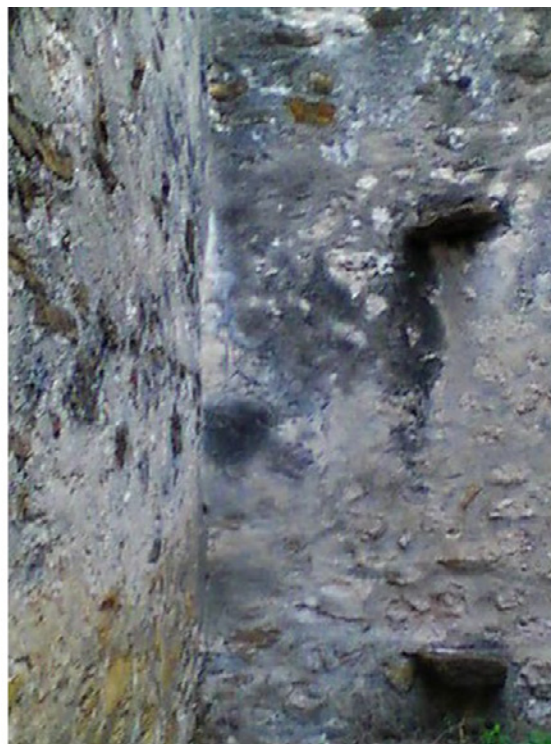
Figures 6.B.37 and 6.B.38: Room HS 203 A—North wall. Same portion of the wall—the left corner detail—is shown in both photos. Left photo shows temperature differences in the wall.

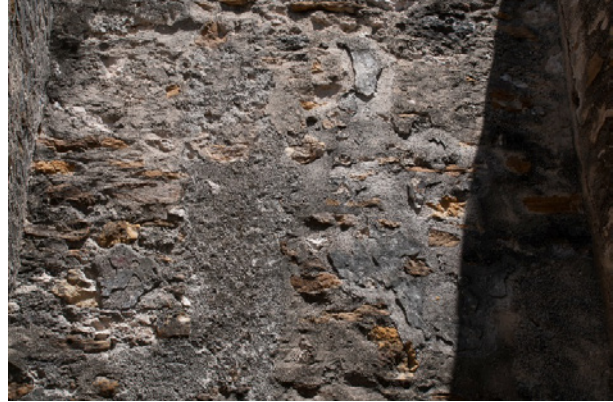
Figure 6.B.39: Room HS 203 A—North wall, detail of the middle part of the wall. Features remnants of historic plaster. Exhibits erosion and vegetation growth.

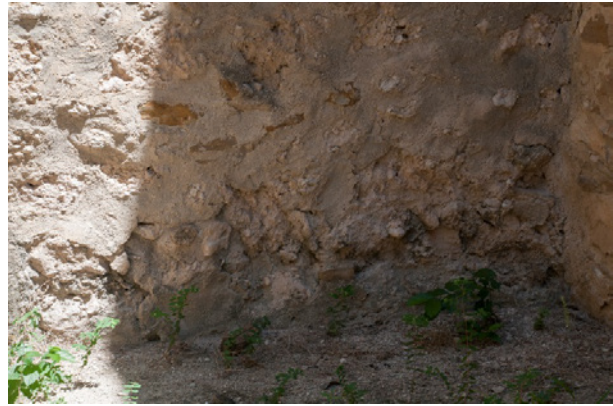
Figure 6.B.40: Room HS 203 A—North wall, detail of the bottom part of the wall showing erosion of the masonry wall and detachment of edges of the mortar patching.

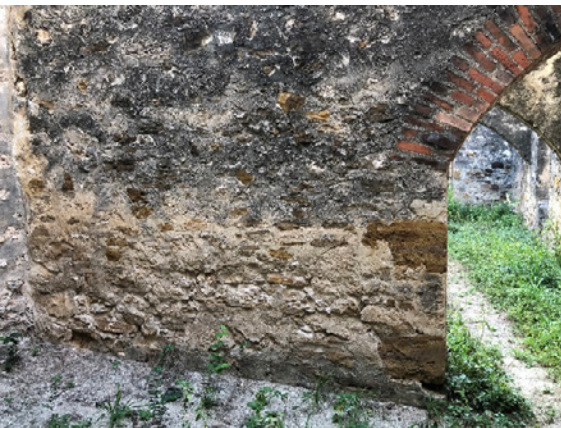
Figure 6.B.42: Room HS 203 A—East wall, which features erosion and loss of mortar joints in the bottom part and vegetation growth in the upper part.

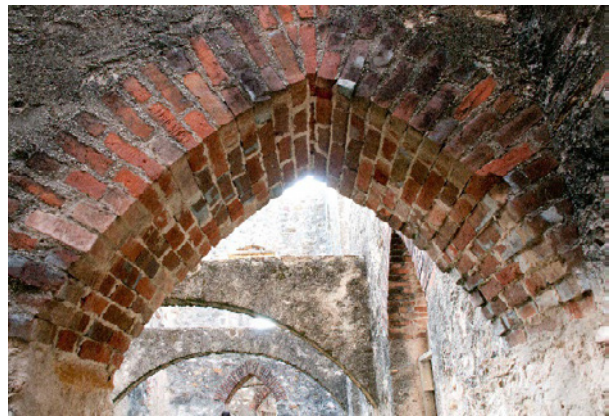
Figure 6.B.41: Room HS 203 A—East wall. Detail of the brick lancet arch, which features vegetation growth above and efflorescence in the intrados.

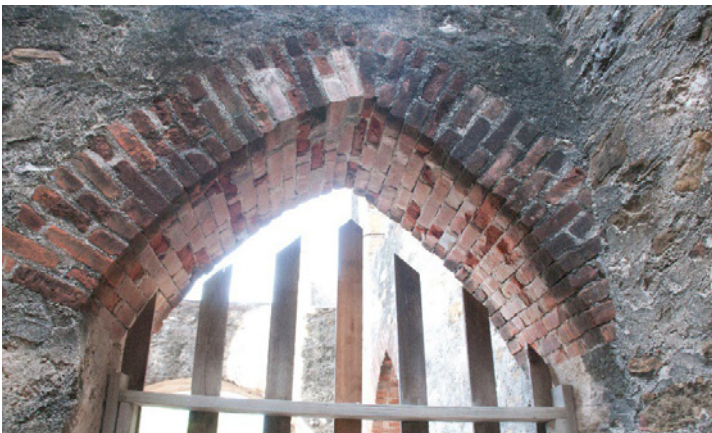
Figure 6.B.45: Room HS 203 A—South wall. Detail of the lancet arch that leads to HS 203 E features fragmentation of the bricks in the intrados.

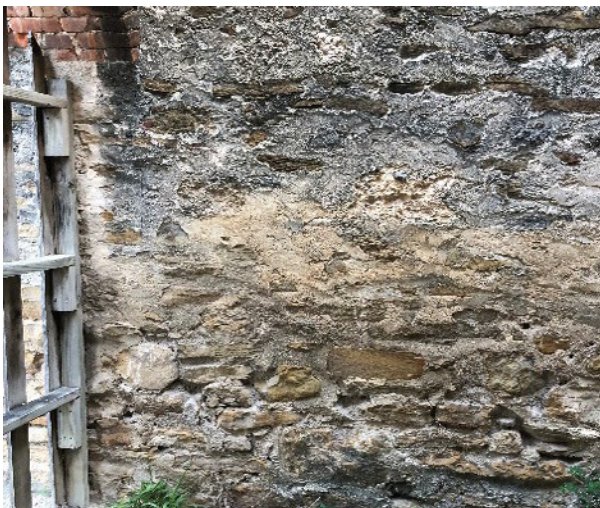
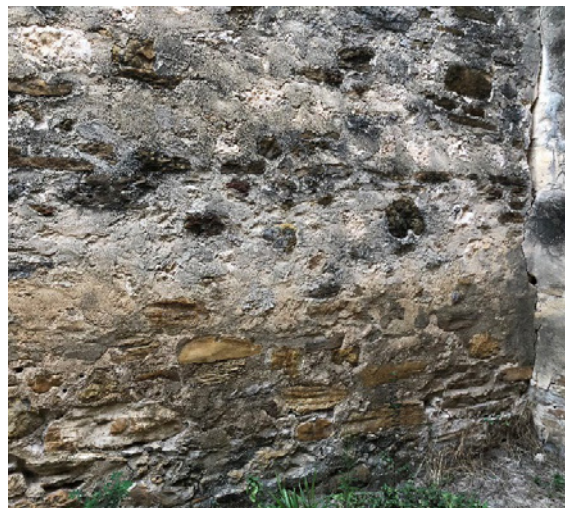
Figures 6.B.46 and 6.B.47: Room HS 203 A—West wall. Patching mortar at the base of the wall has been eroded.

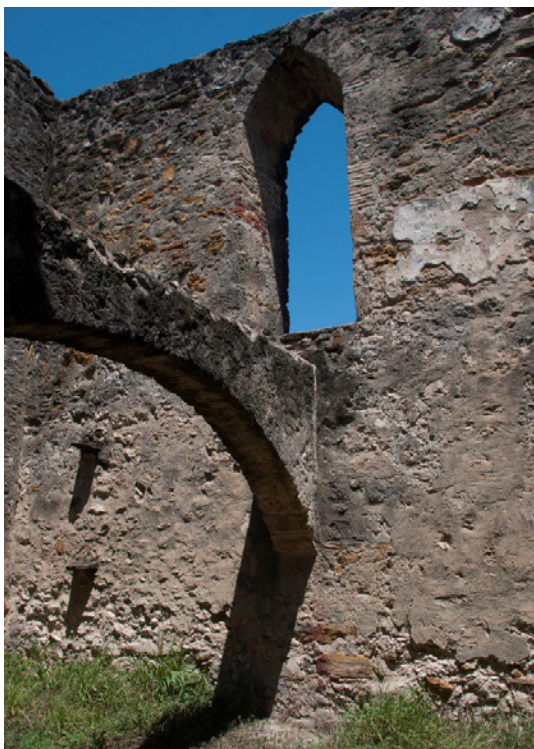
Figure 6.B.48: Room HS 203 D—North wall, left area. General view.

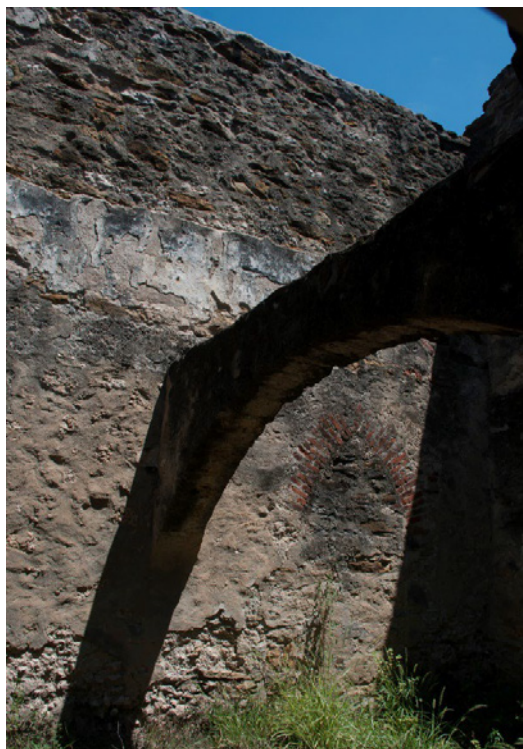
Figure 6.B.49: Room HS 203 D—North wall, right area. General view.

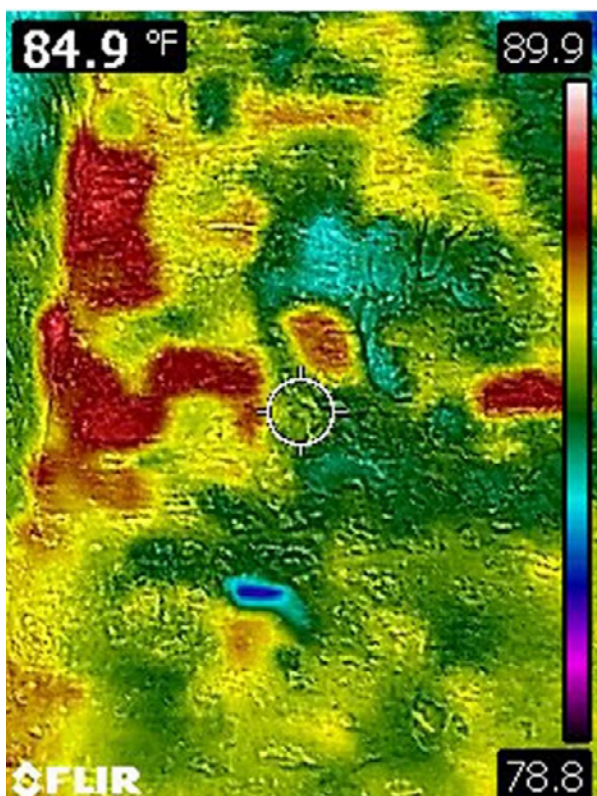
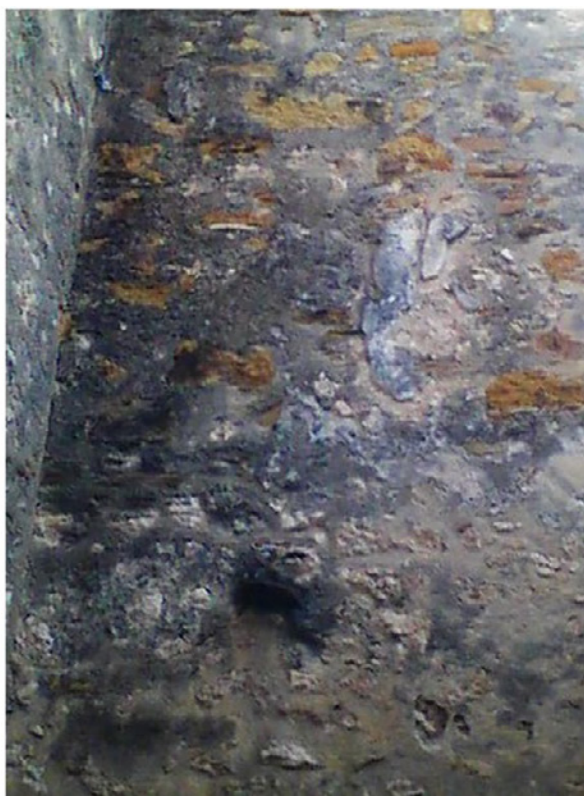
Figures 6.B.50 and 6.B.51: Room HS 203 D—North wall. Same portion of wall—its left area—is shown in both photos. Left photo shows temperature differences in the wall.

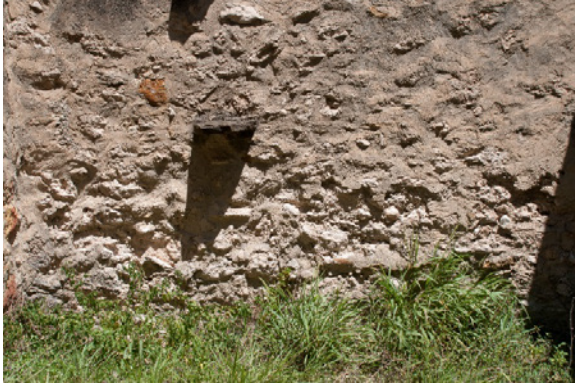
Figure 6.B.52: Room HS 203 D—North wall. Bottom left corner features erosion and missing parts.

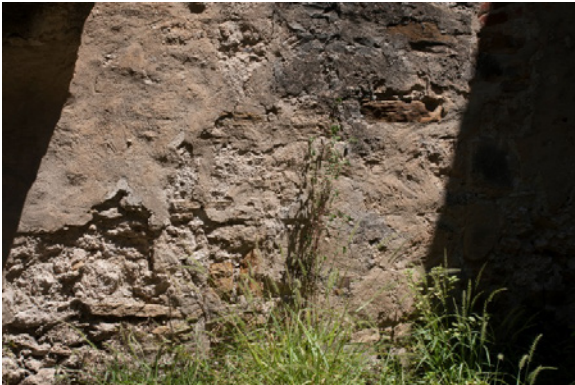
Figure 6.B.53: Room HS 203 D—North wall. Bottom right area exhibits erosion of the bottom part of the wall due to rising damp and detachment of edges of the arriccio.

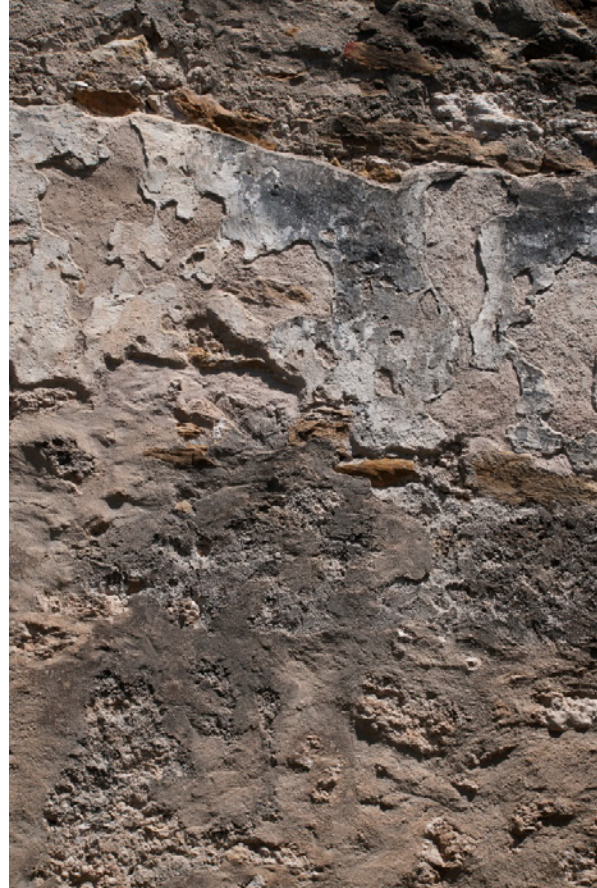
Figure 6.B.54: Room HS 203 D—North wall. Detail of the historic plaster remains just to the right of the window. The historic plaster features vegetation growth and detachment of edges.

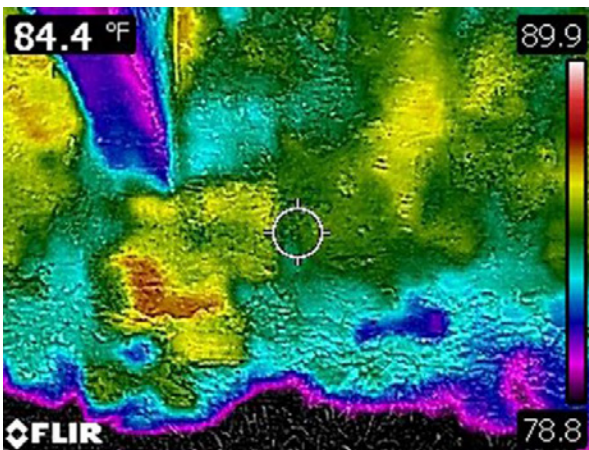
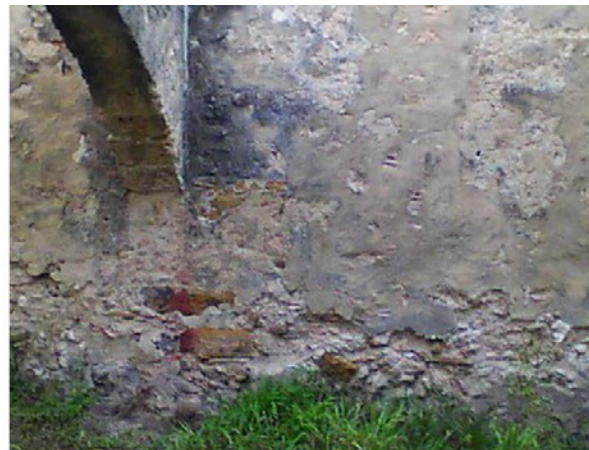
Figures 6.B.55 and 6.B.56: Room HS 203 D—North wall. Same portion of wall—a detail of the right area—is shown in both photos. Left photo shows temperature differences in the wall. The light blue part corresponds to the eroded area of the wall due to rising damp and to the area near the transverse arch where there is an accumulation of vegetation growth. The darker blue area surrounded by light blue could be caused by the detachment of the *arriccio* (plaster scratch coat) at that point.

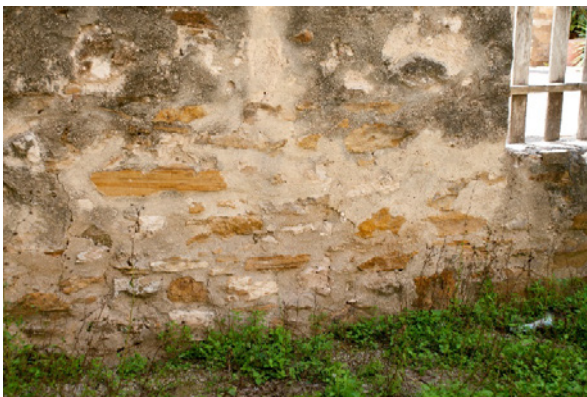
Figure 6.B.62: Room HS 203 D—South wall. Detail under the left transverse arch features vegetation growth in the higher parts and detachment of the mortar repointing edges.

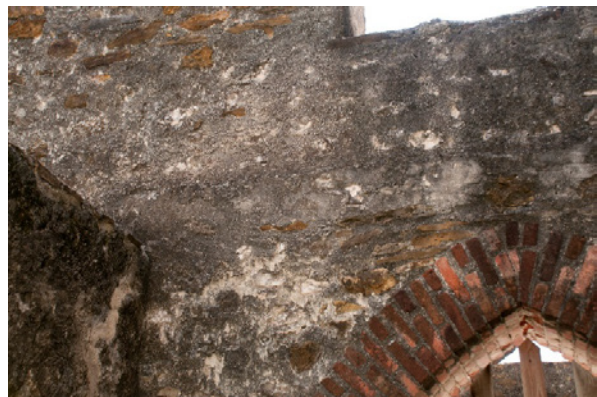
Figure 6.B.63: Room HS 203 D—South wall. Detail above the right bottom lancet arch features vegetation growth and erosion.

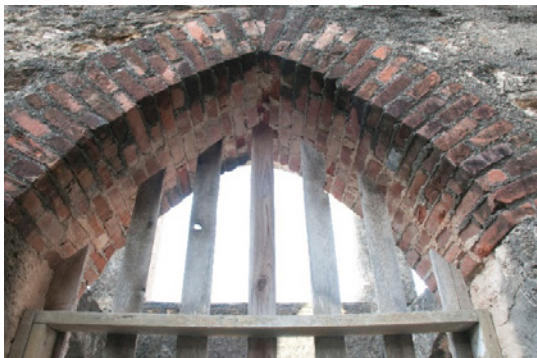
Figure 6.B.64: Room HS 203 D—South wall. Detail of the right bottom lancet arch features vegetation growth, efflorescence, and fragmentation of the brick in the intrados of the arch.

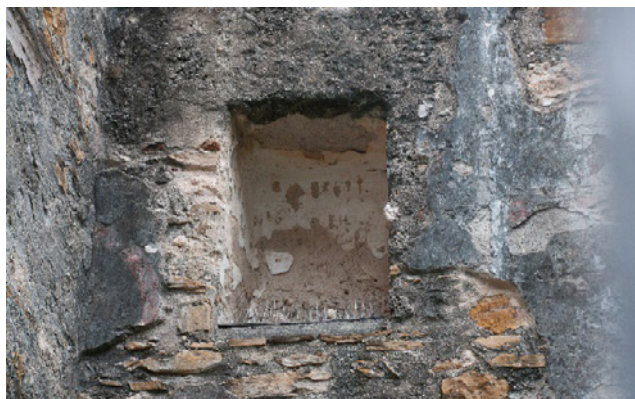
Figure 6.B.70: Room HS 203 C—North wall, upper level. Niche N06 with a fragment of Spanish Colonial plaster finish. Surrounding the niche are historic remains of painted plaster with a visible red color.

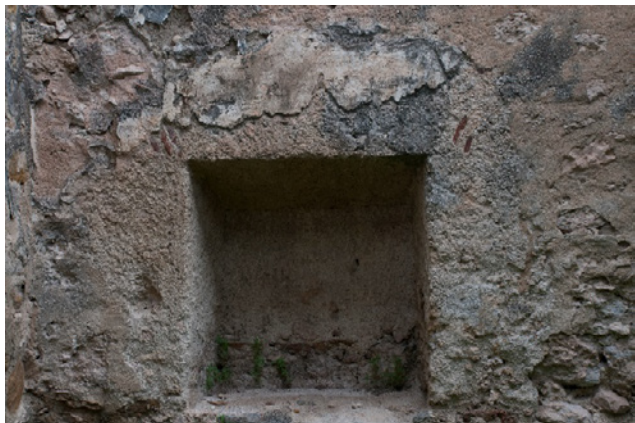
Figure 6.B.71: Room HS 203 C—North wall, lower level. Niche N01 with a fragment of Spanish Colonial plaster finish.

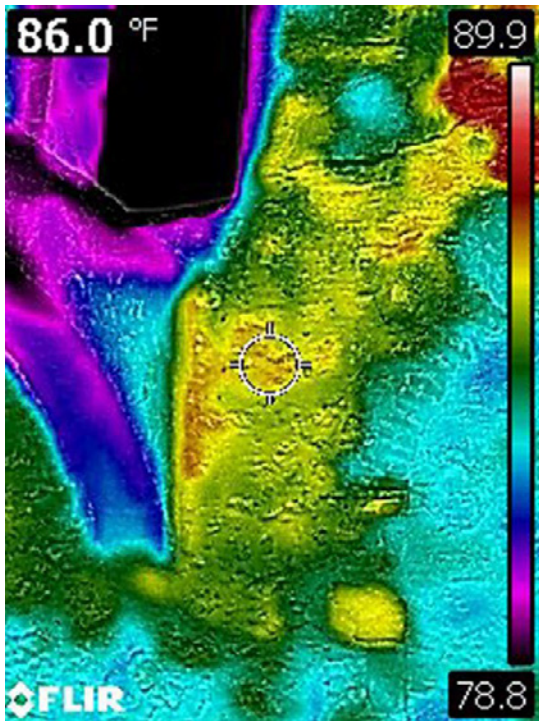
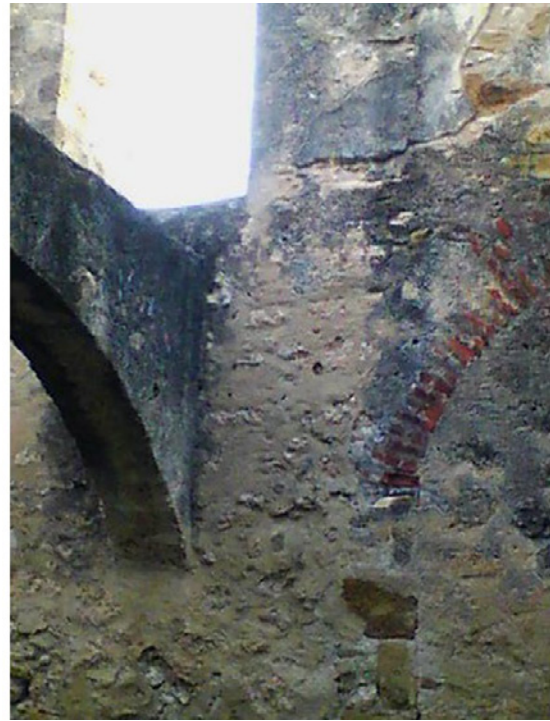
Figure 6.B.72 and 6.B.73: Room HS 203 C—North wall. Both images show the same view of the north wall area to the right of the transverse arch. Left photo shows temperature differences in the wall. Temperature changes in the bottom part appear to be due to rising damp, and those in the right part due to the presence of the former door opening D02, now closed in with masonry infill.

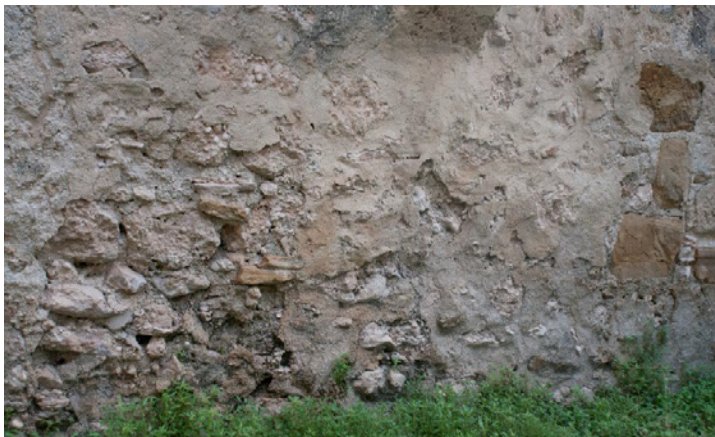
Figure 6.B.74: Room HS 203 C—North wall. Detail of the area below the transverse arch. It features erosion and missing parts.

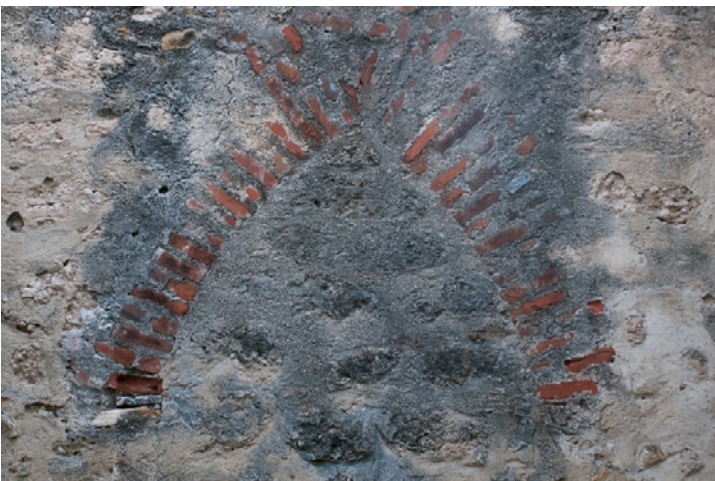
Figure 6.B.75: Room HS 203 C—North wall. Detail of the closed door in the right part of the wall, which features vegetation growth and detachment of edges of the repointing mortar.

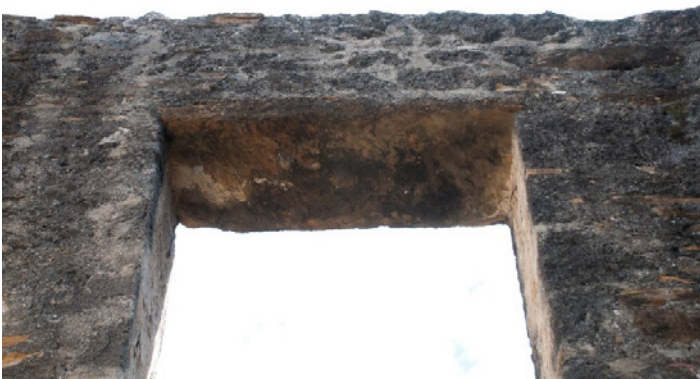
Figure 6.B.78: Room HS 203 C—East wall. Detail of the upper-level door D26, which features a thick homogeneous layer of biological growth and delamination in the flagstone.

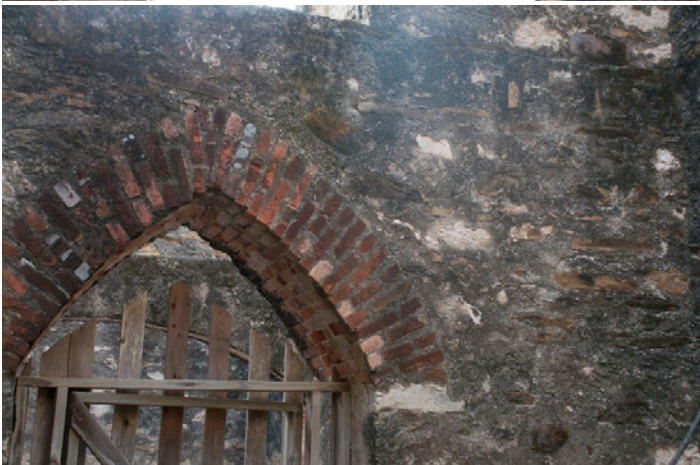
Figure 6.B.79: Room HS 203 C—East wall. Detail of the lower-level door D14, which features delamination of stones and fragmentation and efflorescence in the bricks.
