National Park Service  
United States Department of the Interior  
San Antonio Missions National Historical Park  
Texas

# Historic Structure Report Mission San José Convento

Final Submission  
2019

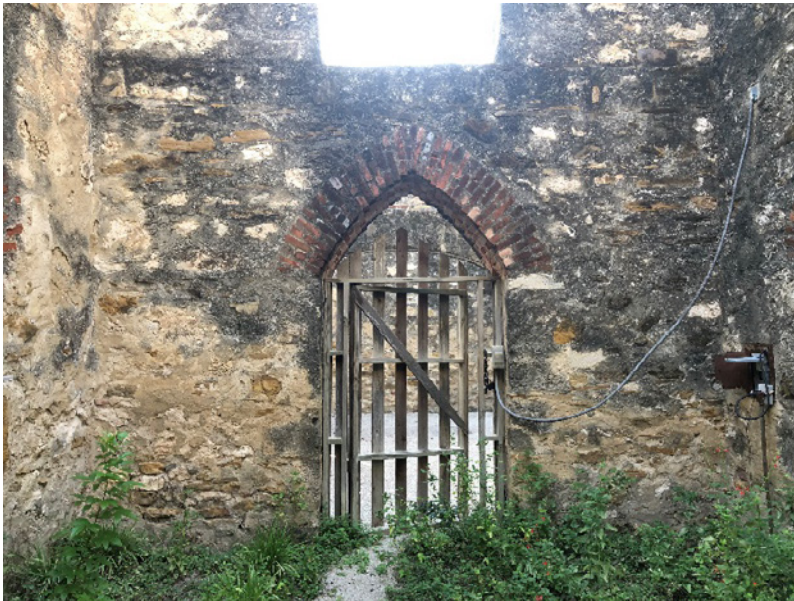
Figure 6.B.81: Room HS 203 C —East wall. General view of the lower level, which exhibits a layer of vegetation growth except in the bottom part where erosion of the masonry wall is occurring.

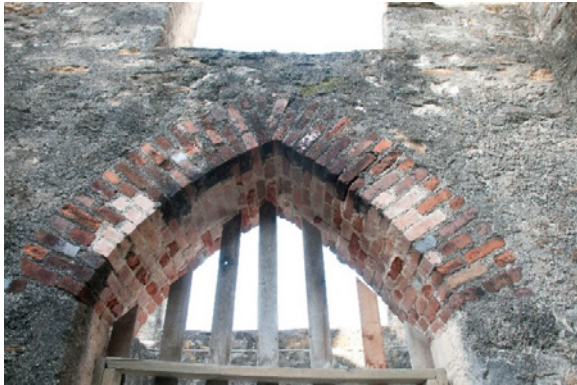
Figure 6.B.82: Room HS 203 C—South wall. Detail of the right bottom lancet arch W05, which features fragmentation and efflorescence in the intrados of the arch.

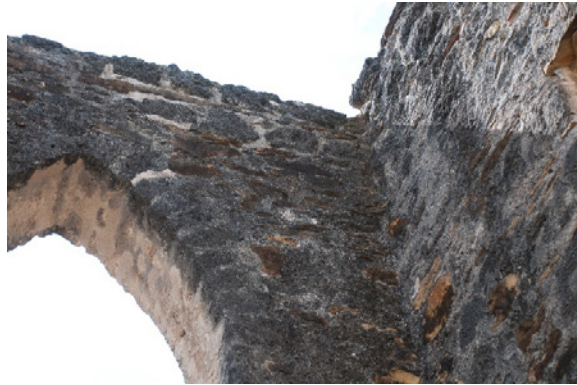
Figure 6.B.83: Room HS 203 C—South wall. Detail of the southwest corner, which exhibits a thick black layer of biological growth and erosion.

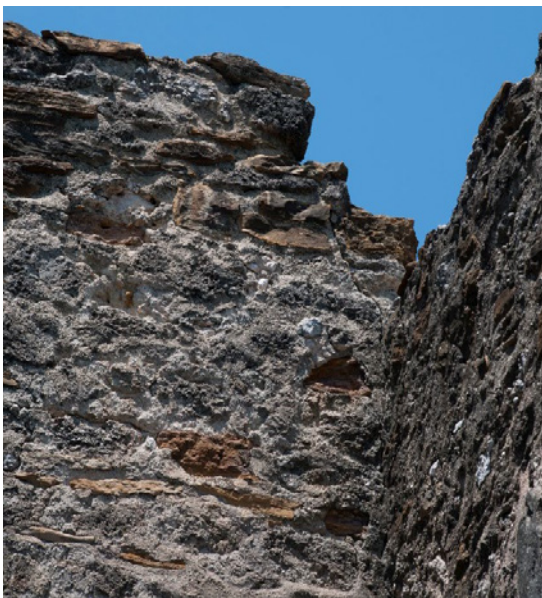
Figure 6.B.84: Room HS 203 C—West wall. Detail of the northwest corner, showing a crack that starts in the coping of the wall.

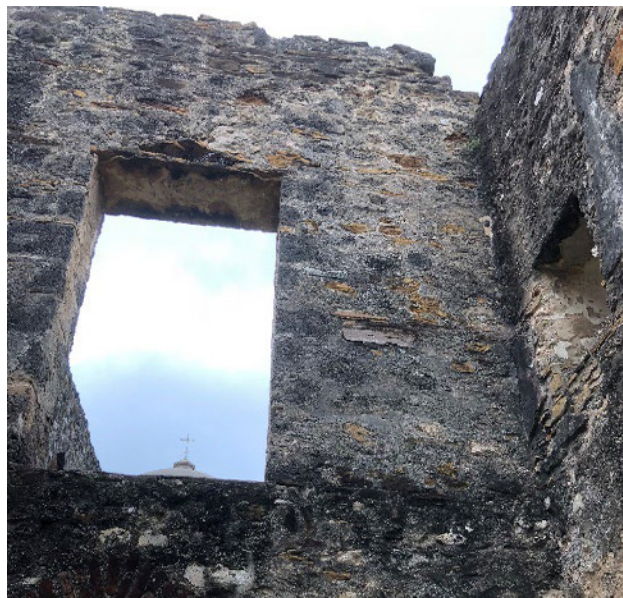
Figure 6.B.85: Room HS 203 C—West wall. Upper level exhibits erosion and delamination of stones in its upper right corner.

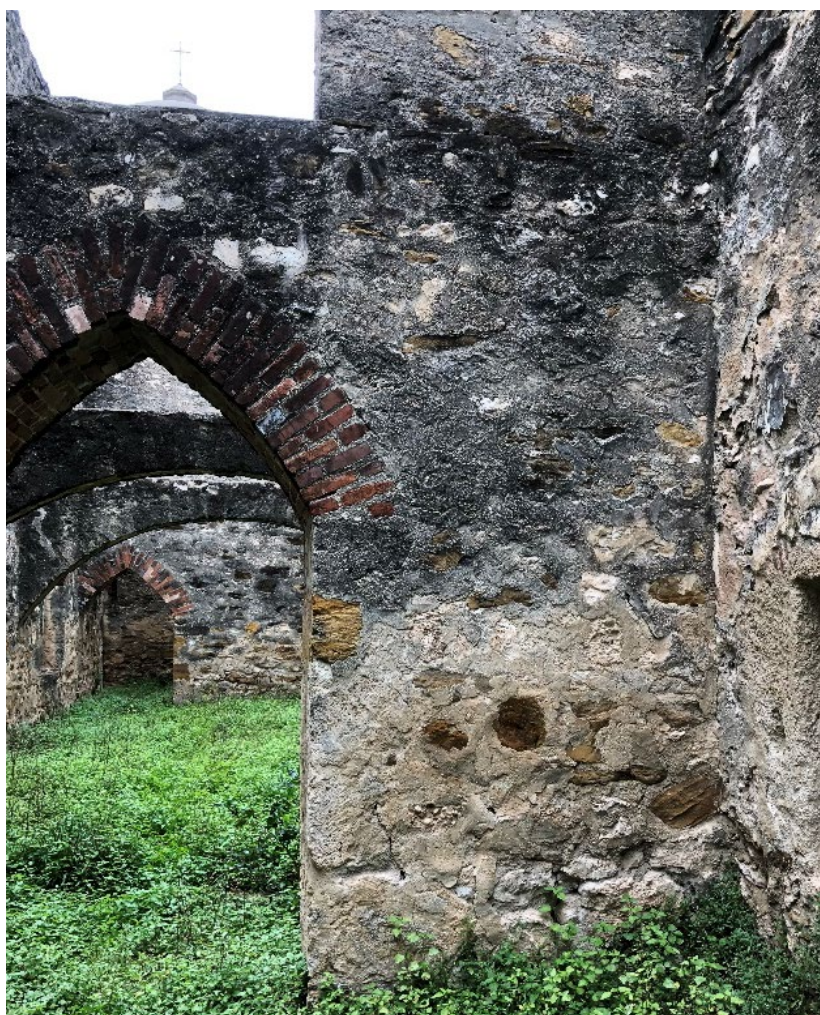
Figure 6.B.86: Room HS 203 C—West wall. Bottom right corner features biological growth, inconsistency in type of mortar used for repointing, erosion of the bottom part, and loss of mortar joints.

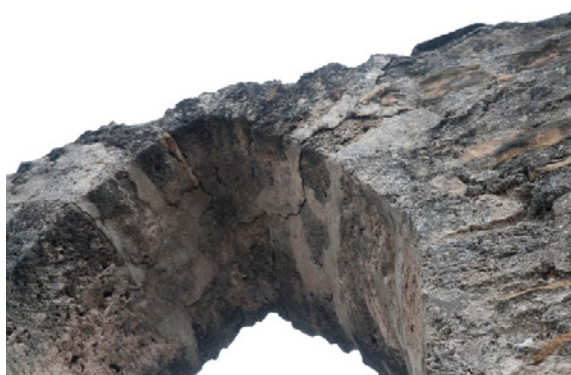
This wall has no evidence of Spanish Colonial finish plaster. The condition of the wall is fragile/fair, because of the windows' structural fractures—located on the top of the wall—as well as the strong erosion at the base of the wall.

Figure 6.B.88: Room HS 203 B—North wall. Left upper window W11 showing a fracture near the keystone of the lancet arch.

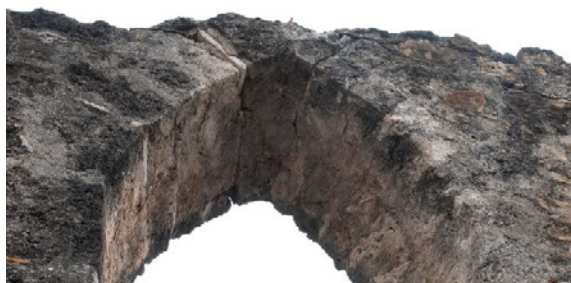
Figure 6.B.89: Room HS 203 B—North wall. Right upper window W12 also showing a fracture near the keystone of the lancet arch.

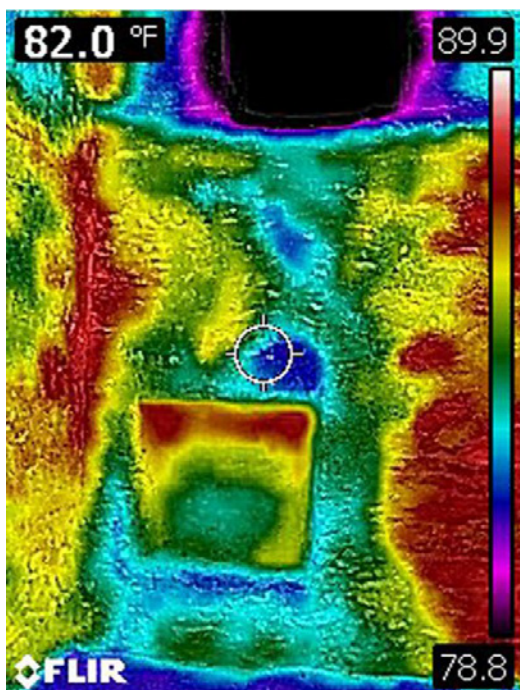
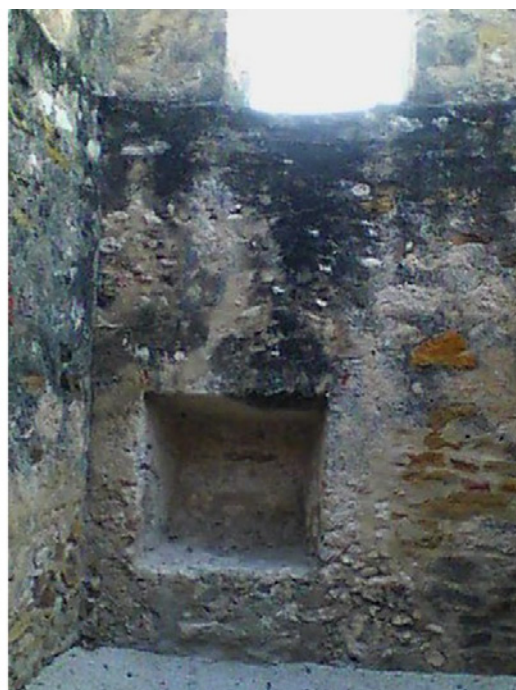
Figures 6.B.90 and 6.B.91: Room HS 203 B—North wall. Both images show the bottom left area of the wall. The differences in temperature are caused by the different construction materials and the presence of humidity.

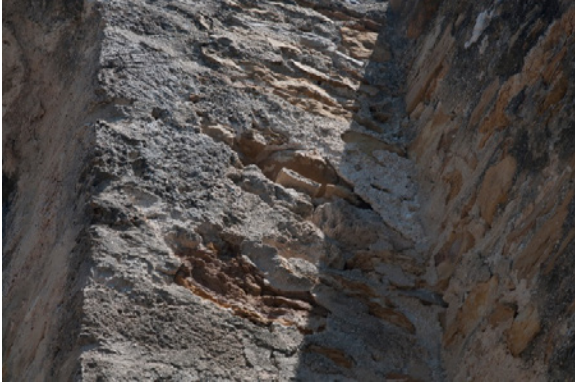
Figure 6.B.92: Room HS 203 B—North wall. Upper right corner features numerous holes and fragmentation of the stones.

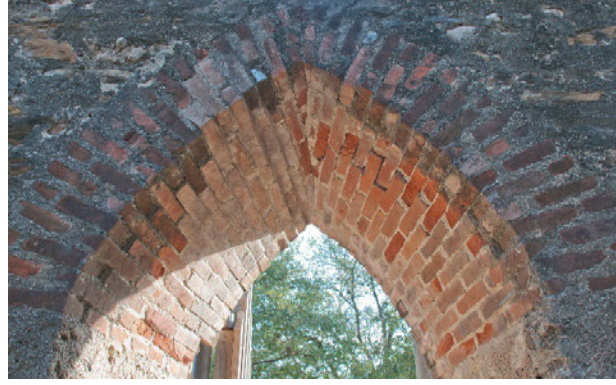
Figure 6.B.93: Room HS 203 B—North wall. Detail of the brick lancet door D03 in the right part of the wall, which features several holes in the masonry wall, and efflorescence and powdering of the bricks.

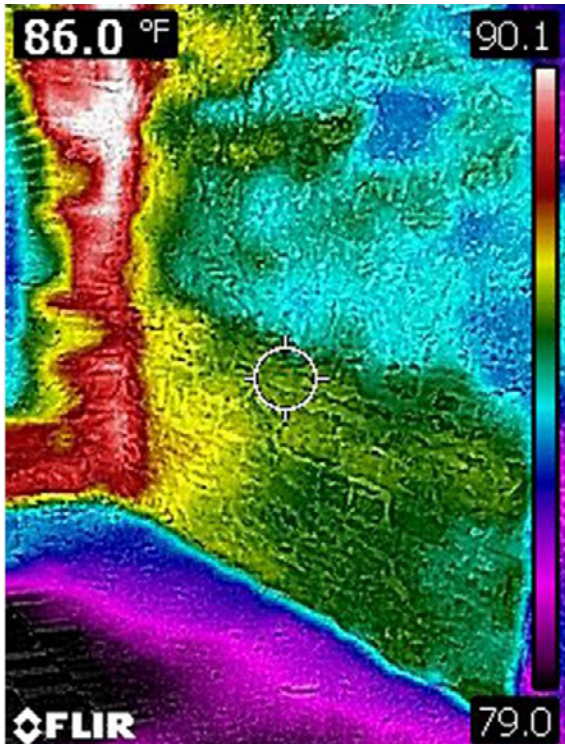
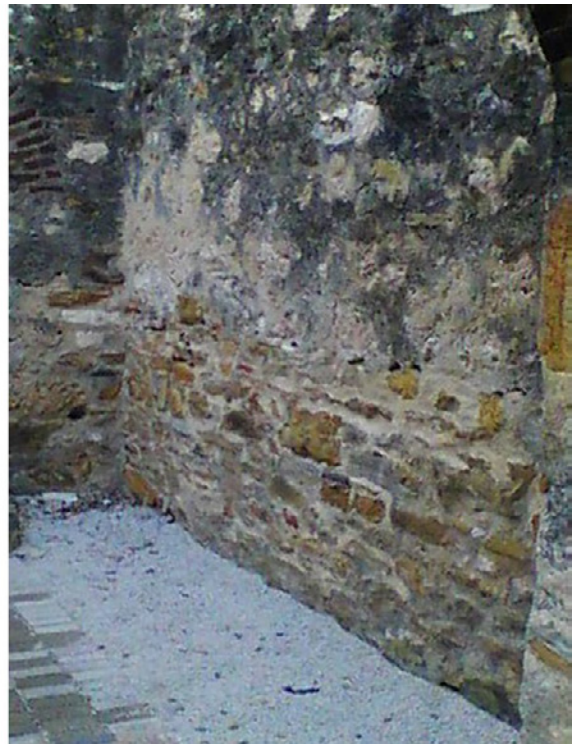
Figures 6.B.94 and 6.B.95: Room HS 203 B—East wall. Both images show the bottom area of the wall. Left photo shows temperature differences in the wall. The colder area of the wall corresponds to the area with a higher level of vegetation growth. The photo on the right also features several delaminated sandstones in the bottom part of the wall and numerous holes.

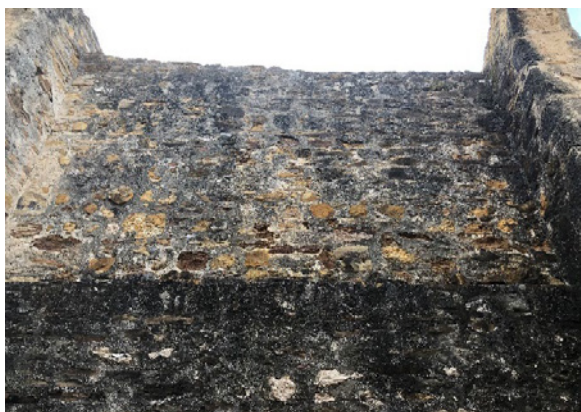
Figure 6.B.96: Room HS 203 B—East wall. Upper part of the east wall, which exhibits a thick black layer of vegetation growth in its bottom part and delamination of the stones in its upper part.

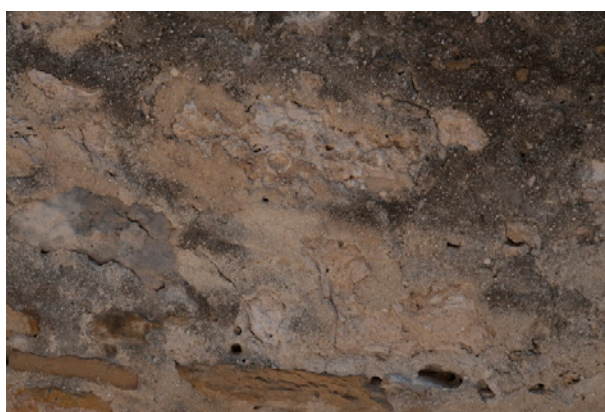
Figure 6.B.97: Room HS 203 B—East wall. Detail of the bottom part of the wall, which features vegetation growth and differential erosion of the stone blocks.

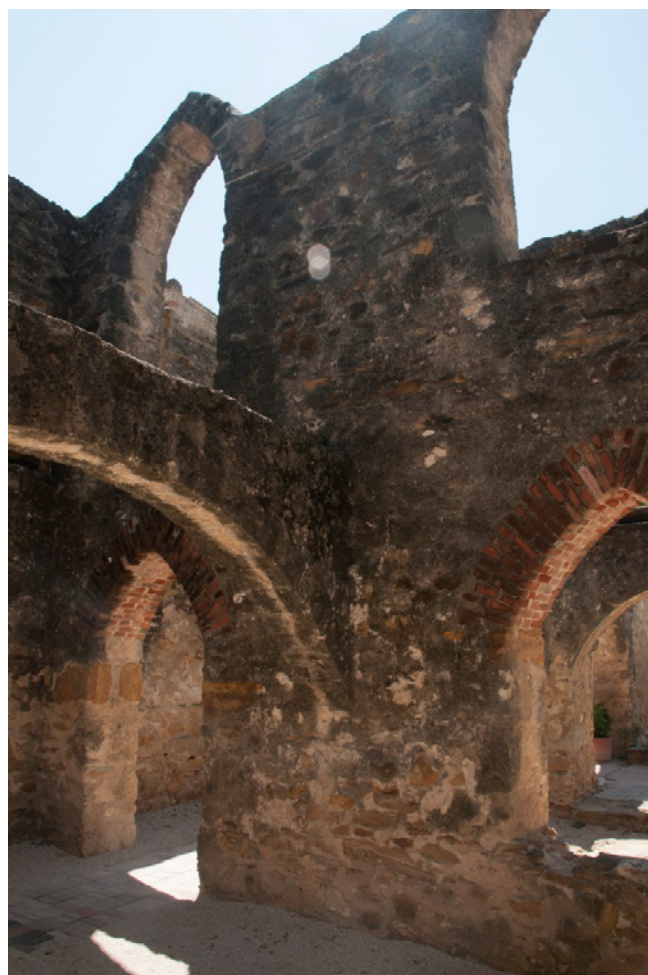
Figure 6.B.100: Room HS 203 B—South wall. General view. Vegetation growth and erosion in the lower part of the wall.

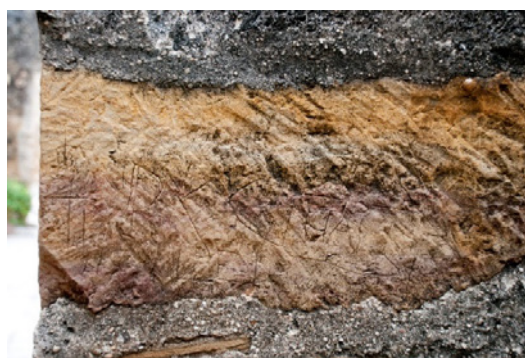
Figure 6.B.98: Room HS 203 B—South wall. Detail of a sandstone in the jamb of door D06, which exhibits marks from a chisel and graffiti.

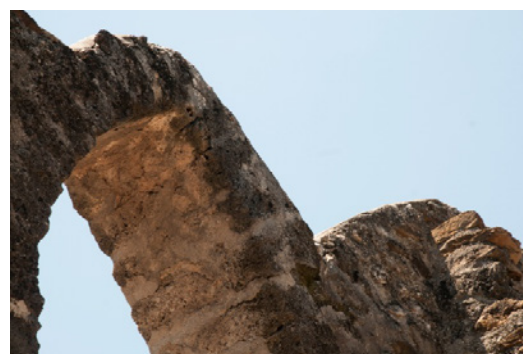
Figure 6.B.99: Room HS 203 B—South wall. Detail of the upper right window W12, which features a small crack and cement-based mortar repointing in the intrados of the arch.

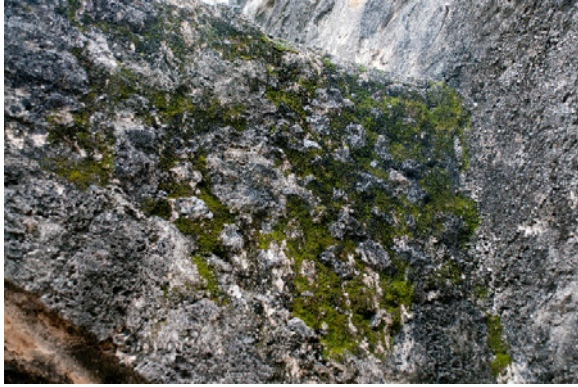
Figure 6.B.101: Room HS 203 B—Transverse arch. Detail featuring moss in its southern end.

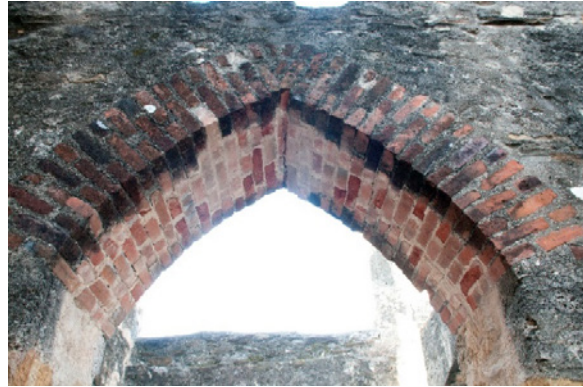
Figure 6.B.102: Room HS 203 B—South wall. Detail of the lower left arch (door D06), which features biological growth and fragmentation of the bricks.

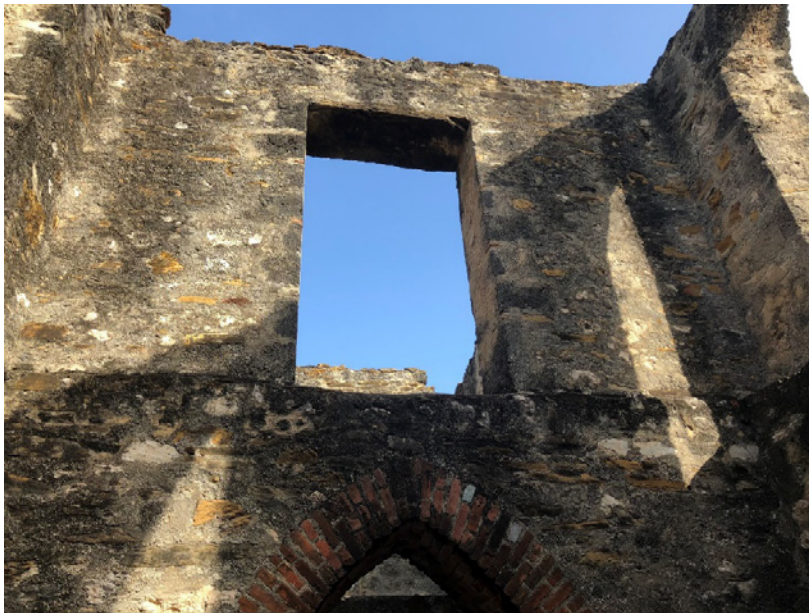
Figure 6.B.103: Room HS 203 B—West wall. Upper level general view, which exhibits a homogeneous layer of biological growth.

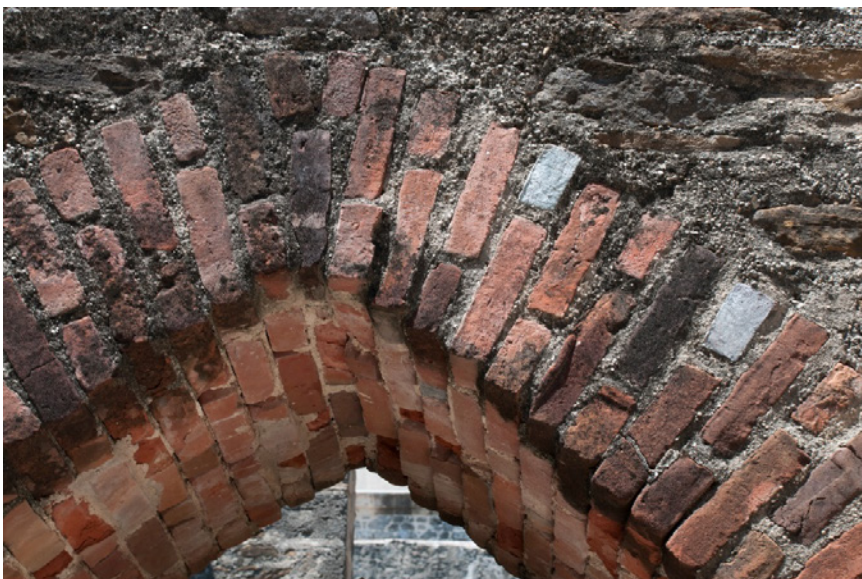
Figure 6.B.106: Room HS 203 B—West wall. Detail of the lower-level door D14, which features biological growth, fragmentation, and efflorescence.

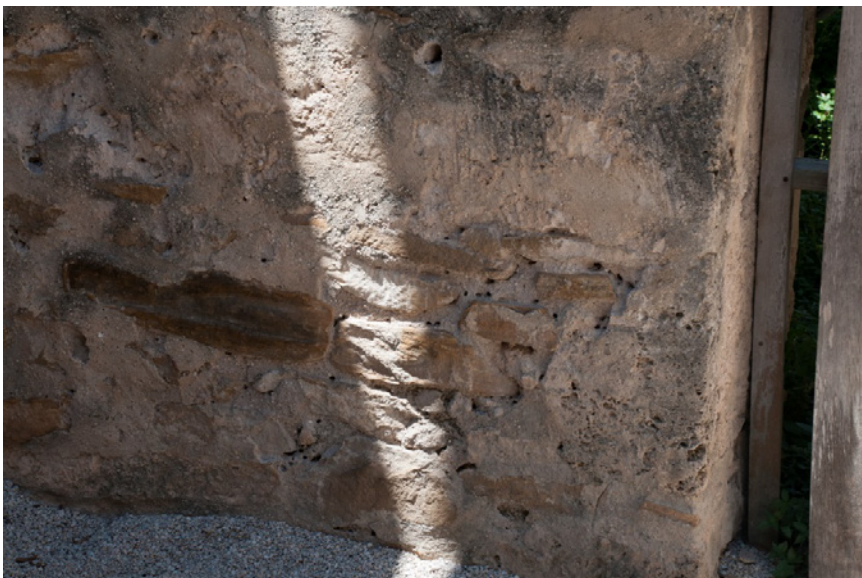
Figure 6.B.107: Room HS 203 B—West wall. Detail of the area left of the lower-level door D14, which exhibits numerous holes and loss of mortar joints.

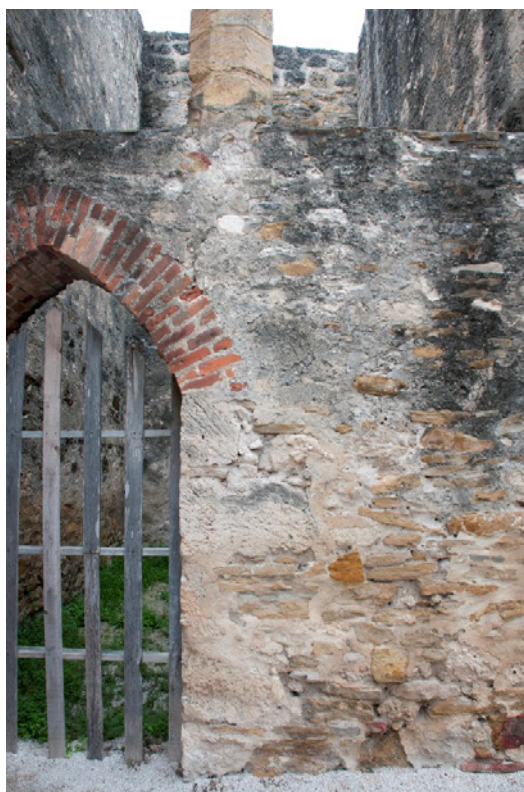
Figure 6.B.110: Room HS 203 E—North wall. Area under the octagonal column, which features several cracks and erosion in the bottom part of the wall.

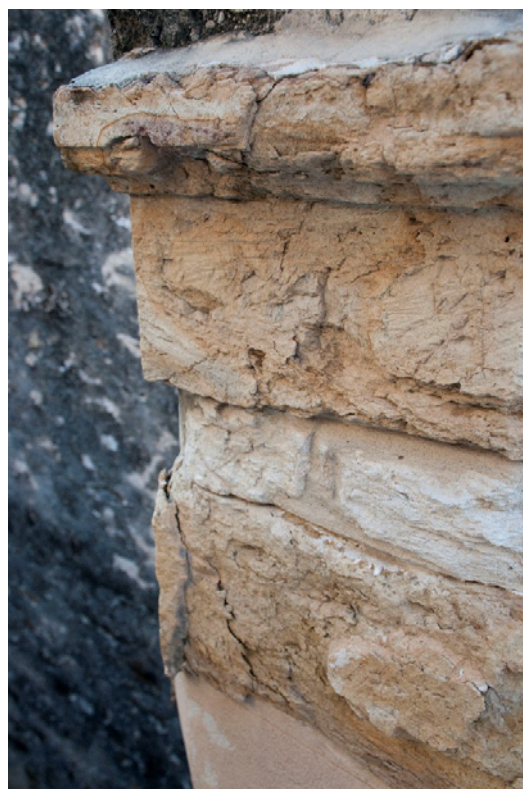
Figure 6.B.111: Room HS 203 E—North wall. Octagonal column, which features fragmentation of the sandstones.

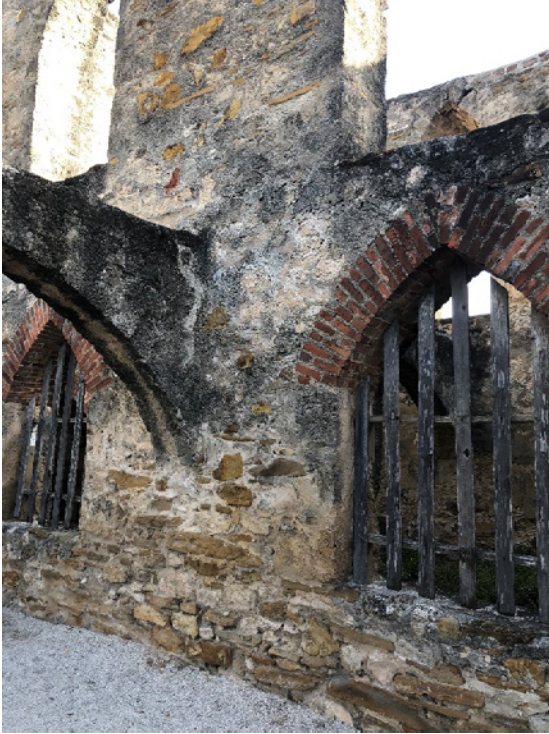
Figure 6.B.112: Room HS 203 E—North wall. Note biological growth and filled crack on the transverse arch. Erosion of the lower wall section.

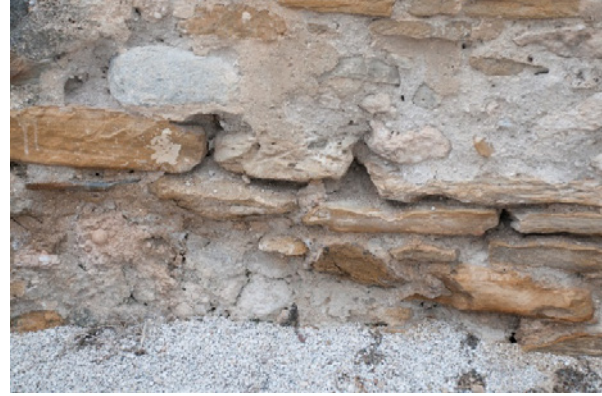
Figure 6.B.113: Room HS 203 E—North wall. Erosion of the masonry. Detail showing loss of joint mortar.

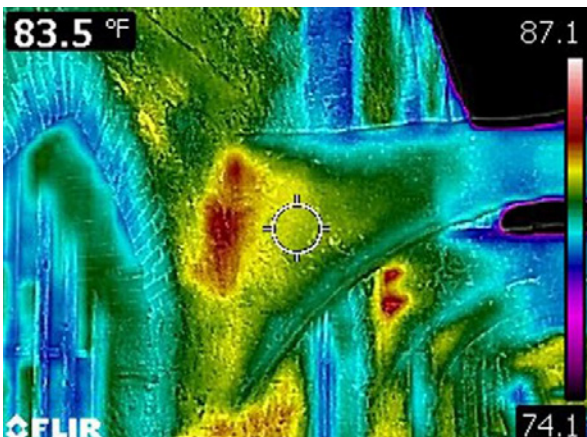
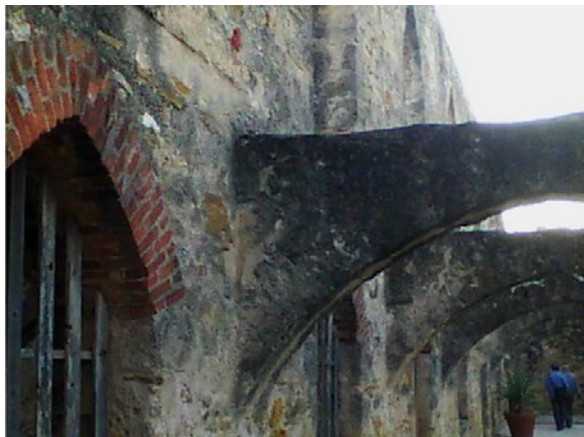
Figures 6.B.116 and 6.B.117: Room HS 203 E—North wall, transverse arches. Both images show the same view of the wall's bottom area. Left photo shows temperature differences in the wall.

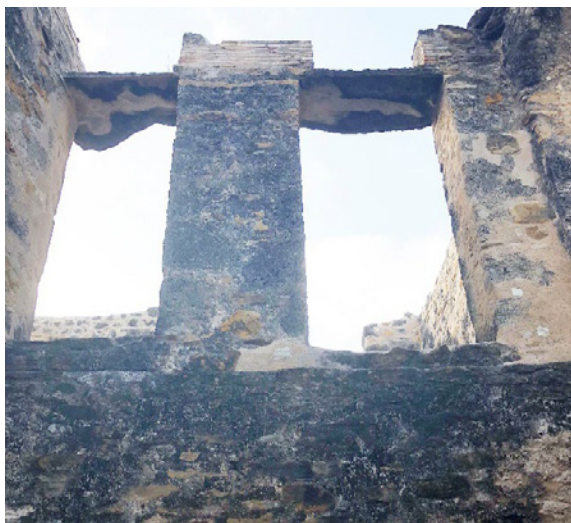
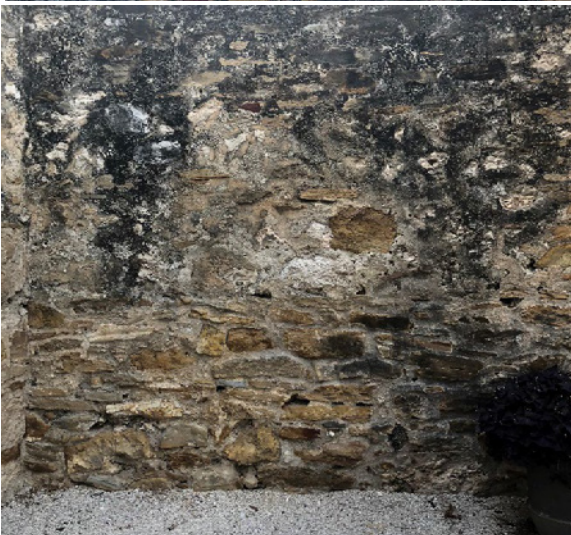
Figures 6.B.118 and 6.B.119: Room HS 203 E—East wall. Biological growth, erosion of the masonry, delamination of stones and numerous holes.

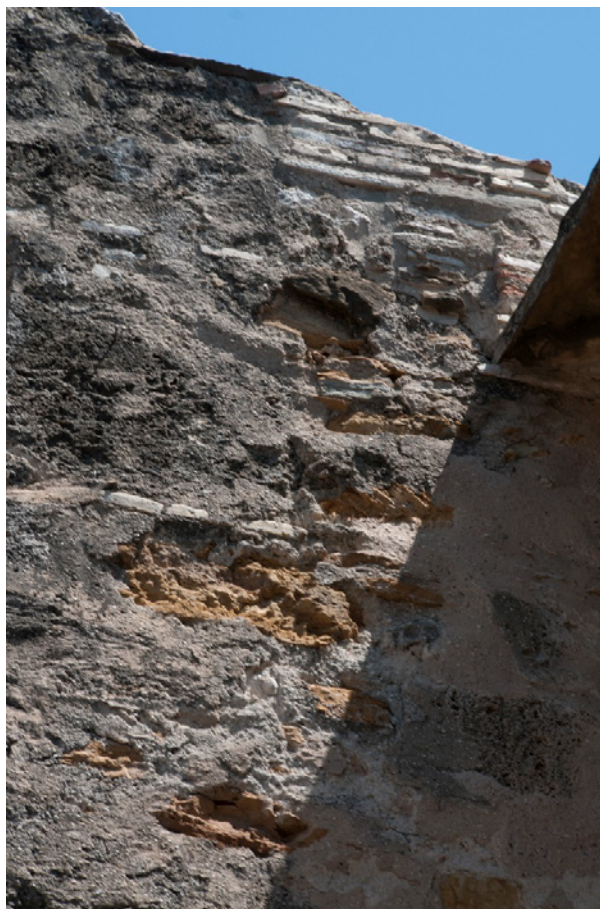
Figure 6.B.120: Room HS 203 E—Northeast corner, which features fragmentation of the stones (mainly the sandstones) and addition of bricks in the upper right corner.

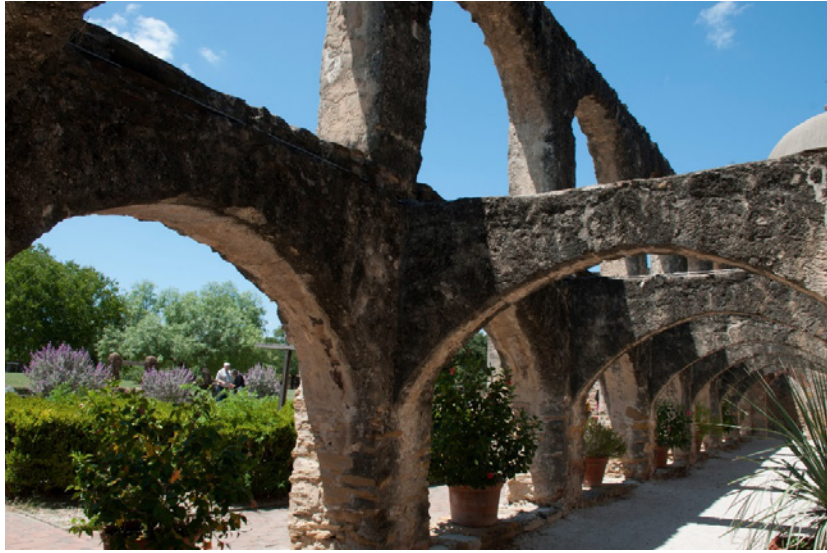
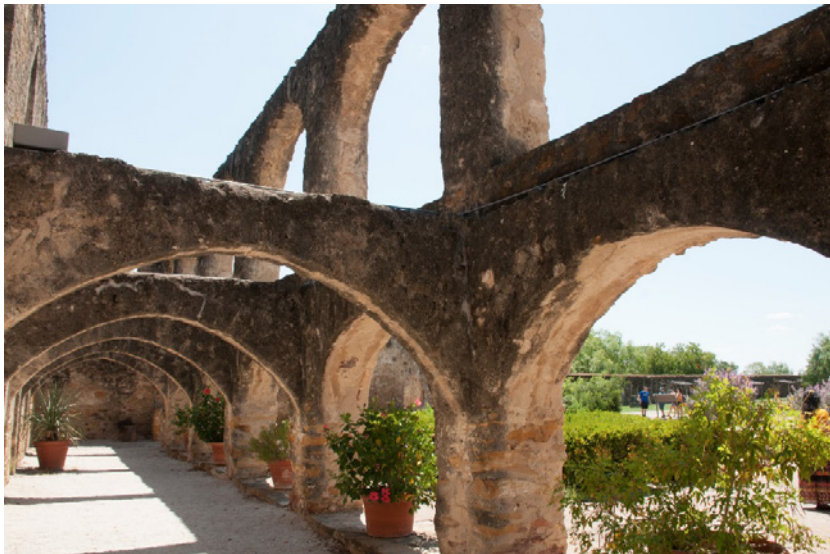
Figures 6.B.121 and 6.B.122:  
Room HS 203 E—South wall.  
General views, features a thick  
black layer of biological  
growth and erosion of the  
lower parts of the pillars.

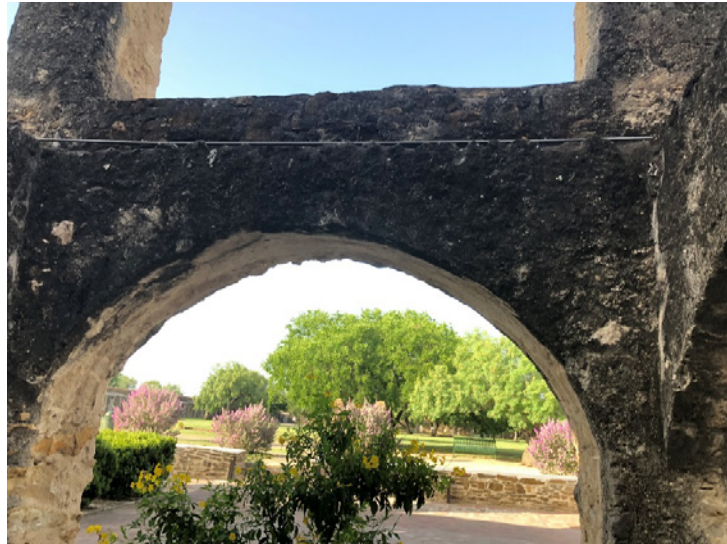
Figure 6.B.124: Room HS 203 E—South wall. Detail of the thick  
black layer of biological growth.

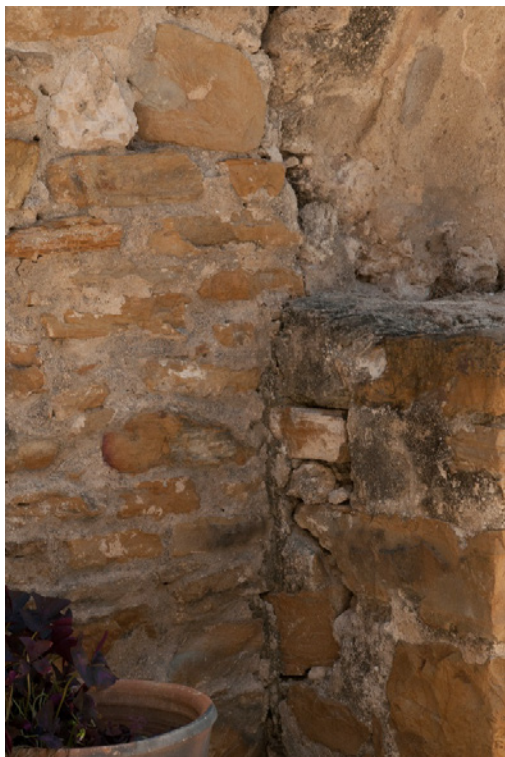
Figure 6.B.125: Room HS 203 E—Southeast corner, features a fracture in the connection of the south arcade and the east wall.

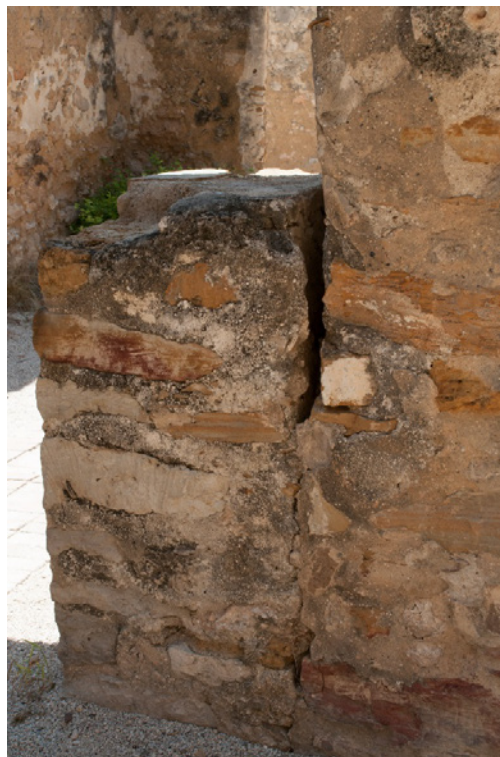
Figure 6.B.125: Room HS 203 E—South wall. Detail of the fracture in the connection of the south arcade and the parapet.

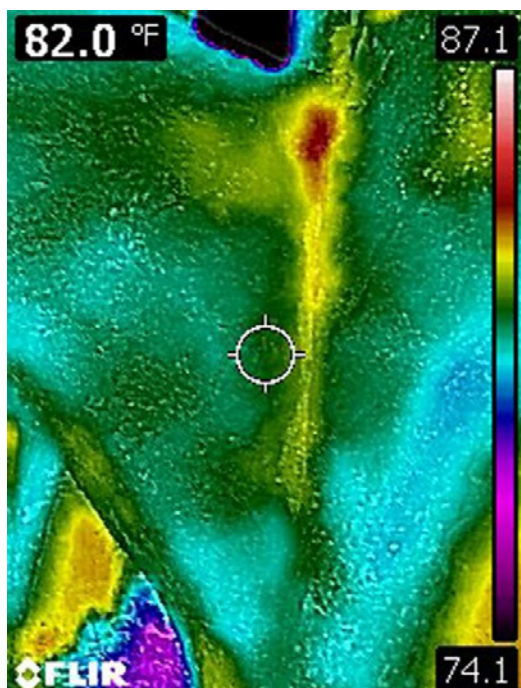
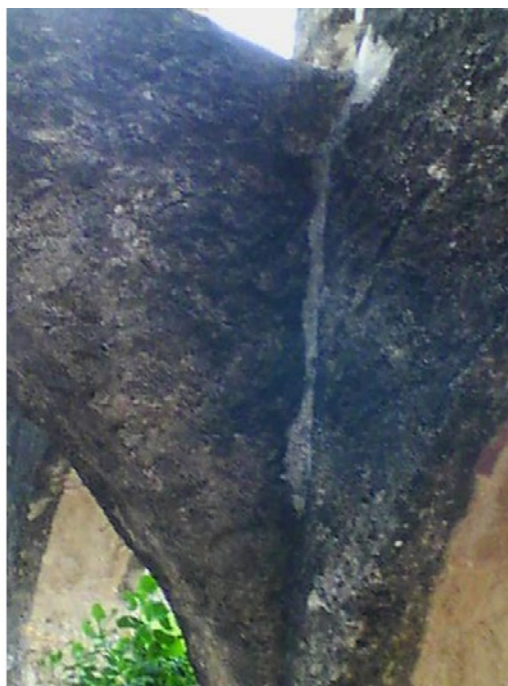
Figures 6.B.127 and 6.B.128: Room HS 203 E—South wall, transverse arch detail. Both images show the same view of the bottom area of the wall. Left photo shows temperature differences in the wall. The cement-based mortar used for filling the crack in the connection of the transverse with the south wall appears hotter than the materials used elsewhere in the wall.

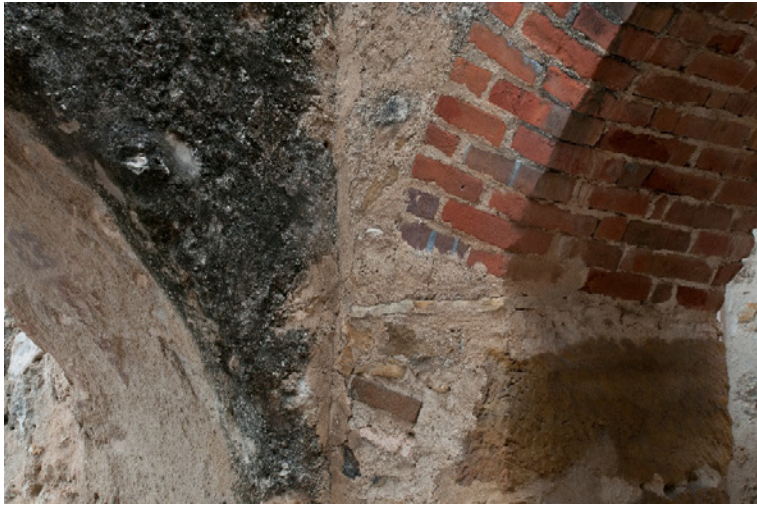
Figure 6.B.130: Room HS 203 E—Southwest corner, which features a thick layer of biological growth.

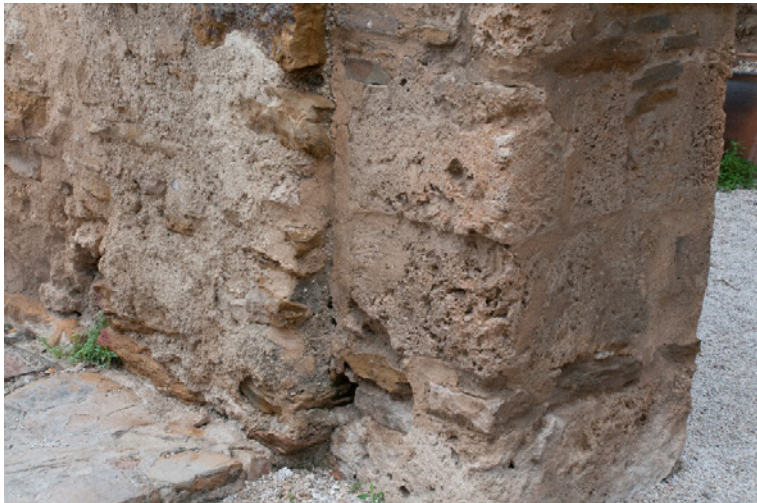
Figure 6.B.131: Room HS 203 E—Southwest corner, which features erosion and loss of mortar joints in the lower part.

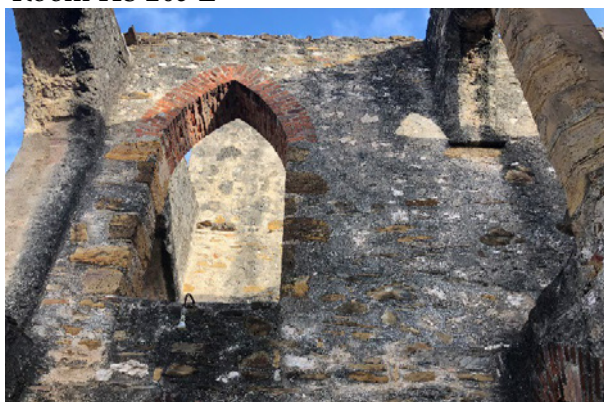
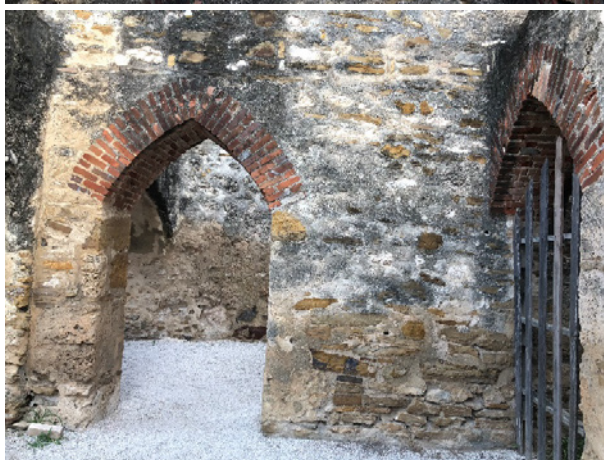
Figures 6.B.132 and 6.B.133: Room HS 203 E—West wall. Biological growth, concentrated under the door D24, associated with efflorescence under the arch. Erosion and loss of mortar joints in the lower part of the wall.

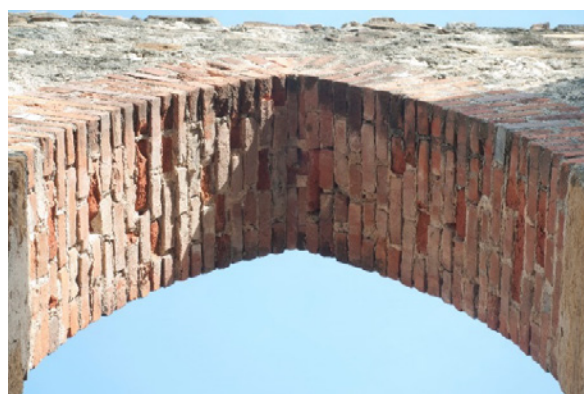
Figure 6.B.135: Room HS 203 E—West wall. Detail of arch at door D24 (upper-level) which features efflorescence, fragmentation, and powdering in the intrado.

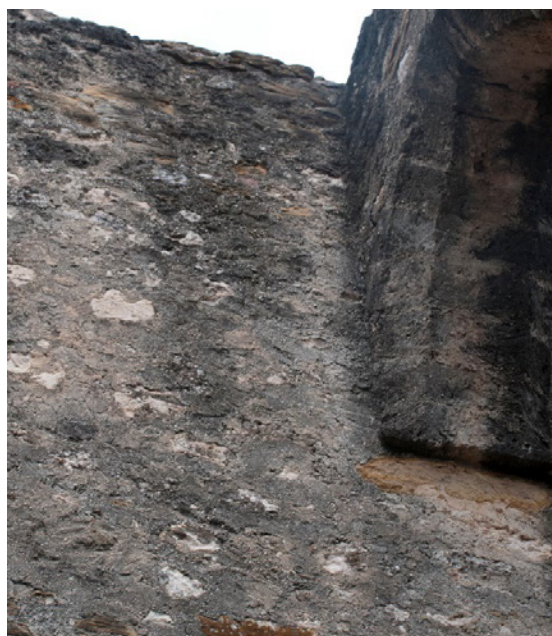
Figure 6.B.134: Room HS 203 E—West wall. Detail of the upper-level connection with the north wall. Features a hair crack slightly left of the corner.

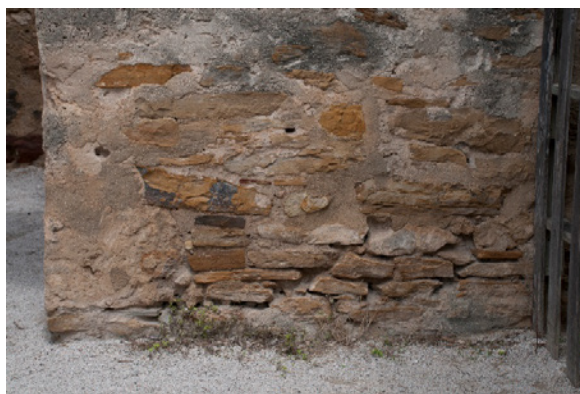
Figure 6.B.136: Room HS 203 E—West wall. Detail of the lower right area of the wall, which features erosion of the masonry wall and loss of mortar joints.

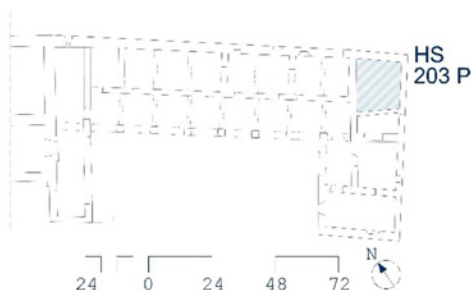
**Room 203 P**

The surface of the walls have been recently treated with new grouting mortar. Grouting mortar was prepared by NPS personnel. Numerous sandstones have evidence of delamination and fragmentation, due to the hardness of the mortar previously in place. The west wall lower section has evidence of rising damp.

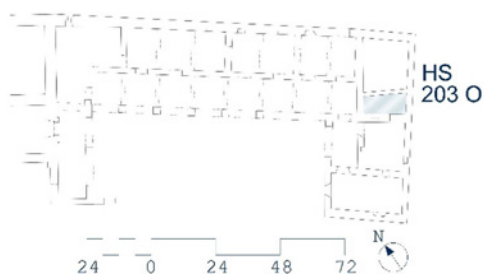
**Room 203 O**

The surface of the walls have been recently treated with application of a new grouting mortar. Grouting mortar was prepared by NPS personnel. Only a few sandstones have evidence of delamination and fragmentation. One crack is visible on the west wall at the capping of the access door located on the upper level.

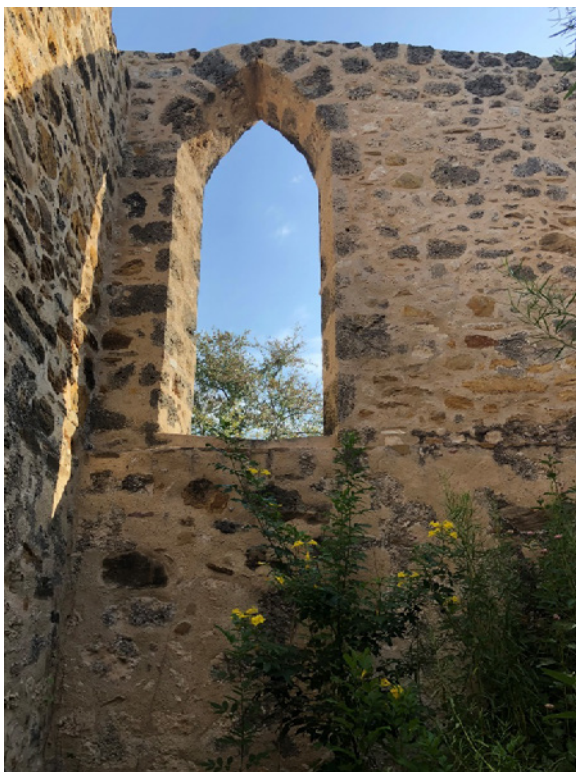
Figure 6.B.137: Room HS 203 P—North wall. The wall has been repointed recently. The limestones show a layer of biological growth.

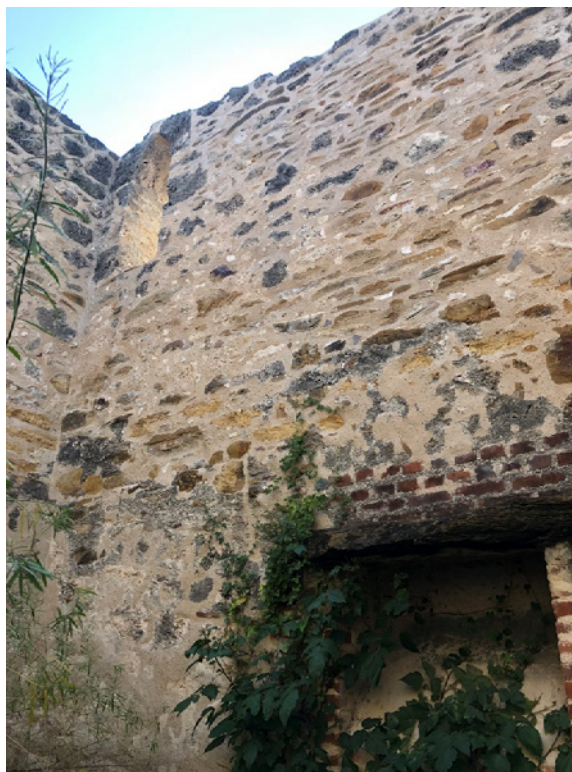
Figure 6.B.138: Room HS 203 P—East wall. The wall has been repointed recently and features several fragmented sandstones.

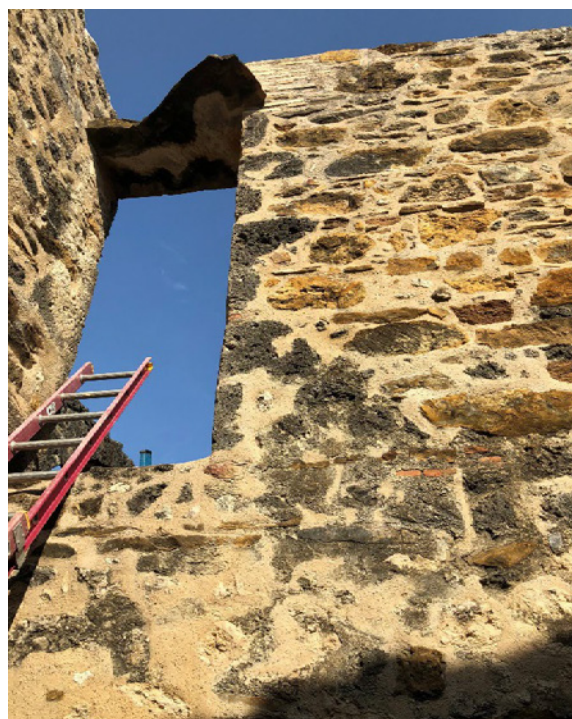
Figure 6.B.141: Room HS 203 P—West wall, which features biological growth and fragmentation in the sandstones.

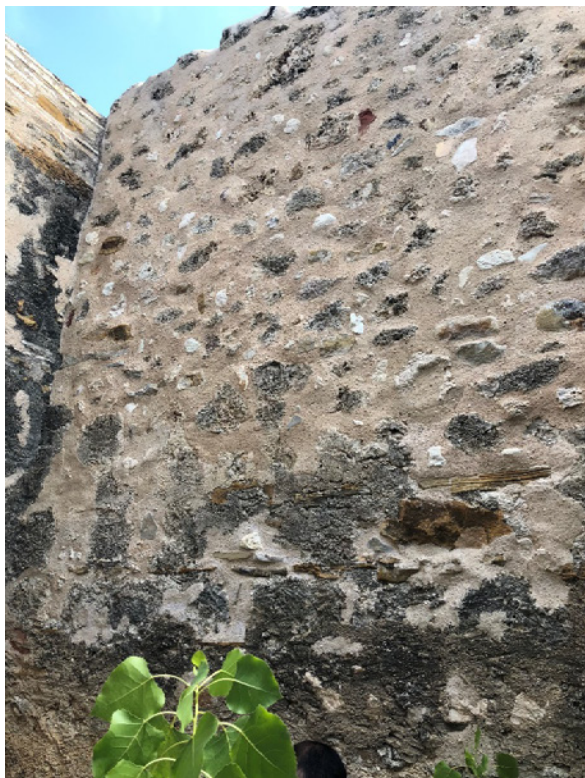
Figure 6.B.142: Room HS 203 O—North wall. The walls in this room have been recently repointed. Biological growth is present.

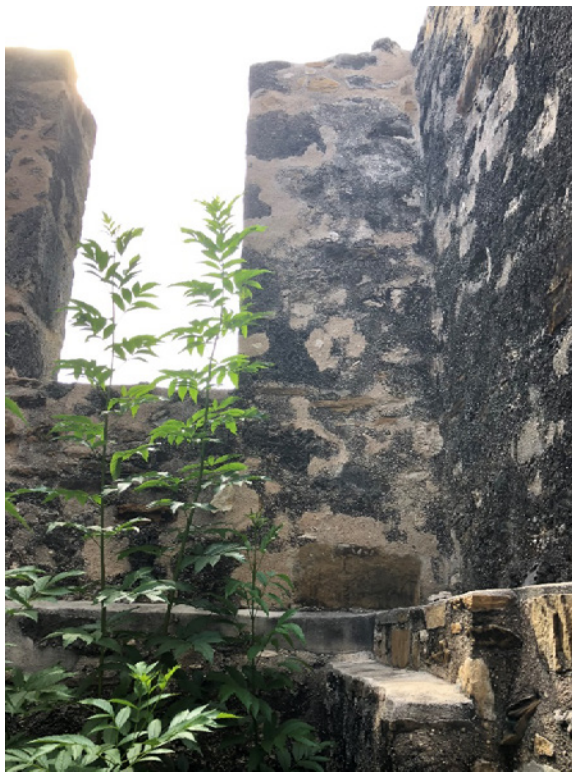
Figure 6.B.143: Room HS 203 O—East wall, which features biological growth and some fragmentation in the sandstones.

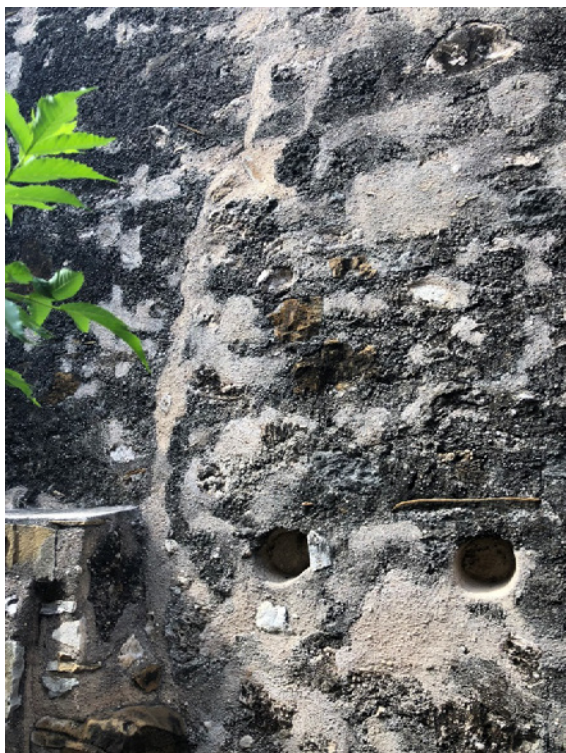
Figure 6.B.144: Room HS 203 O—South wall, which features biological growth and regular holes that might have been the location of wooden beams.

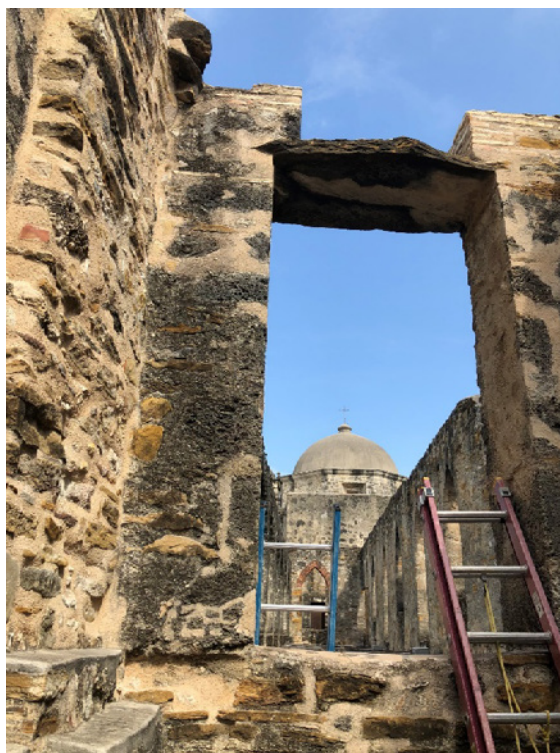
Figure 6.B.145: Room HS 203 O—West wall, which exhibits biological growth and fragmentation in some sandstones.

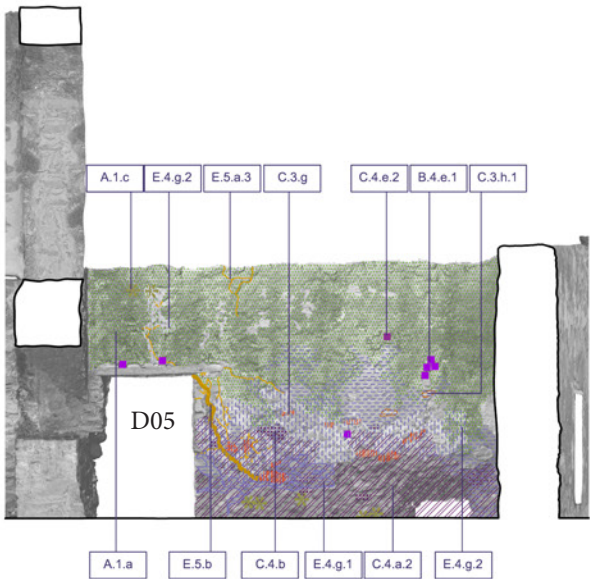
203 H\_East wall

This wall does not have evidence of historic Spanish Colonial plaster, although it can be dated to the Spanish Colonial period, built after the construction of the arcades. The condition of this wall is fragile, fragmented. Plants grow within the wall close to the grade level and on the northern upper section. Biological growth is located on the top half wall, characterized by a gray feathering mortar. The lower part of the wall is characterized by presence of significant mortar and concrete patching—including a characteristic hard brown mortar feathering, showing detachment of edges, detachment from the substrate, and erosion.

One filled deep fracture is located in the center of the stone wall architrave of the door, which also features a historical reinforcement made of a wood architrave. The space between the two architraves is roughly filled, showing hair cracks and voids. The southern post of the door is the result of a repair effort, made of infill materials and featuring a deep diagonal crack surrounded by several hair cracks. The surface in this area includes significant mortar and concrete patching, and the few rubble stones have evidence of delamination and fragmentation. Above this area, another crack is visible at the termination, reaching the wall capping. For this wall, as well, conservation treatments should focus on an effective aesthetic presentation to emphasize the historical value of the surfaces and the whole space, which has been considered marginal in the overall interpretation of the convento's structures.
