National Park Service  
United States Department of the Interior  
San Antonio Missions National Historical Park  
Texas

# Historic Structure Report Mission San José Convento

Final Submission  
2019

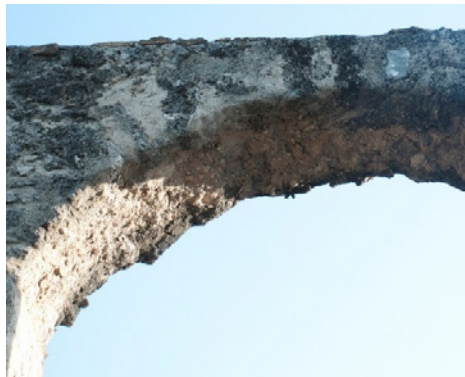
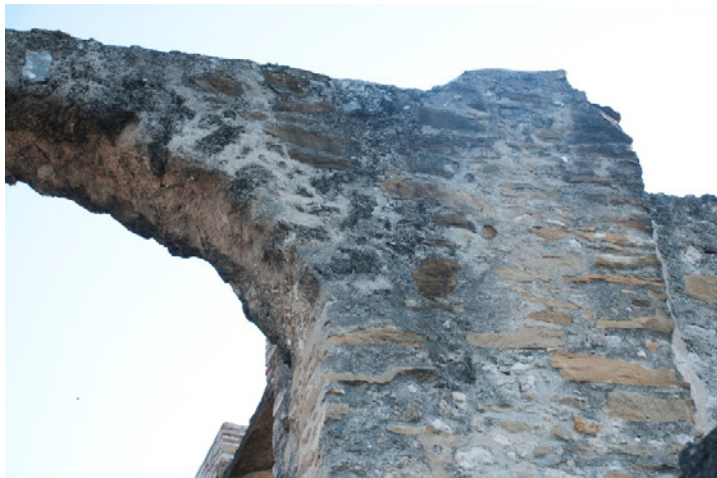
Figures 6.B.146 and 6.B.147: Room HS 203 H—North wall upper-level arch, which features fragmentation and delamination of stones in its right side.

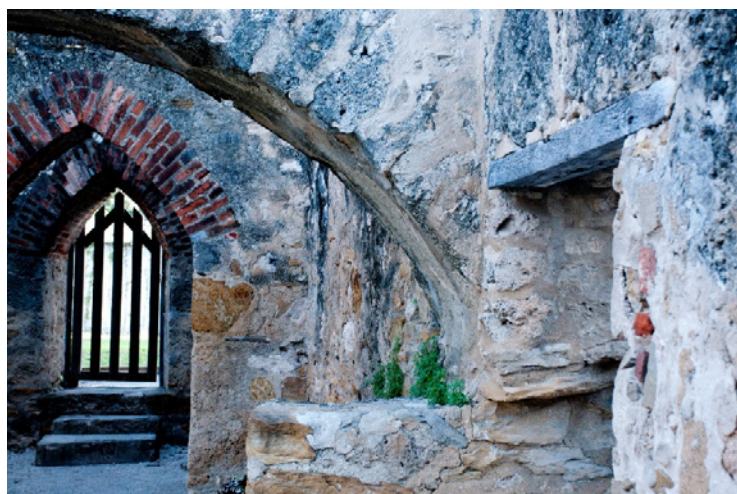
Figure 6.B.148: Room HS 203 H—North wall. Lower level arch 1H, right corner. Features a crack between the parapet and the east wall.

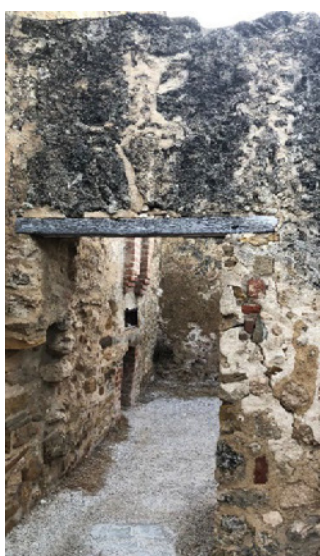
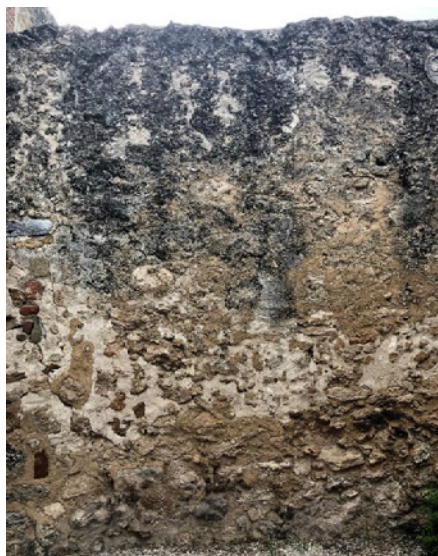
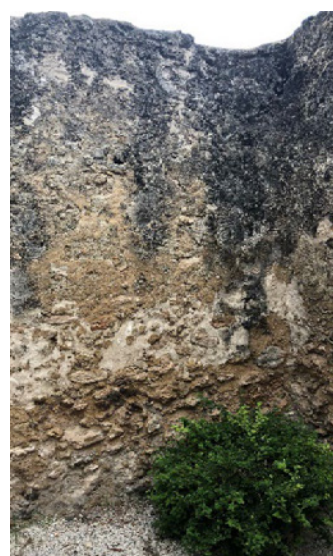
Figures 6.B.149, 6.B.150, and 6.B.151: Room HS 203 H—East wall. General view. Features vegetation growth in the upper part of the wall and erosion in the lower part.

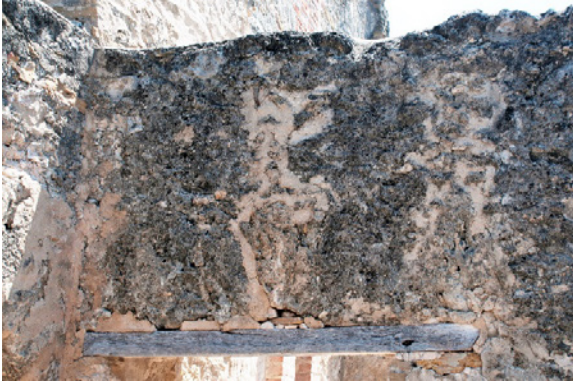
Figure 6.B.152: Room HS 203 H—East wall. Detail above the door D05. Features erosion of the masonry wall and a crack starting in the middle of the wooden architrave that has been filled with mortar.

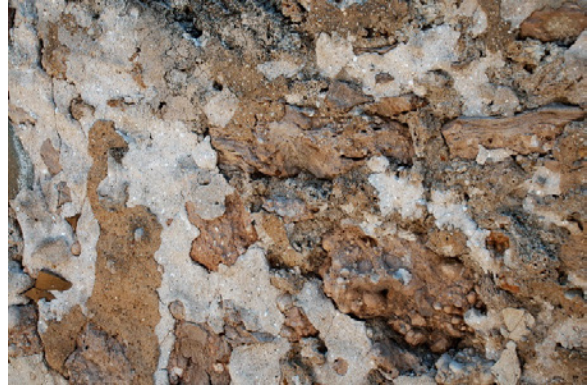
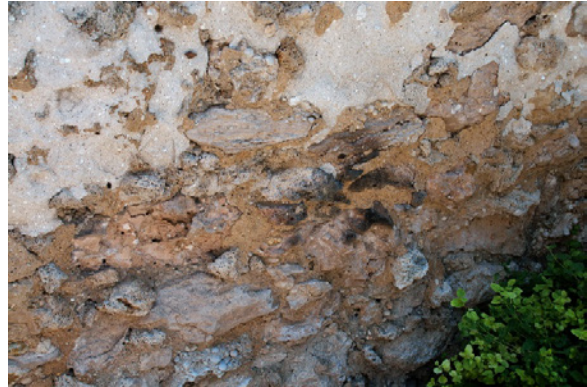
Figure 6.B.155: Room HS 203 H—East wall. Same view of the a detail of the right jamb of door D05 and nearby wall. The differences in temperature are caused by the different construction materials and the presence of humidity. Features a fracture that starts in the upper right corner of the door and develops diagonally downward.

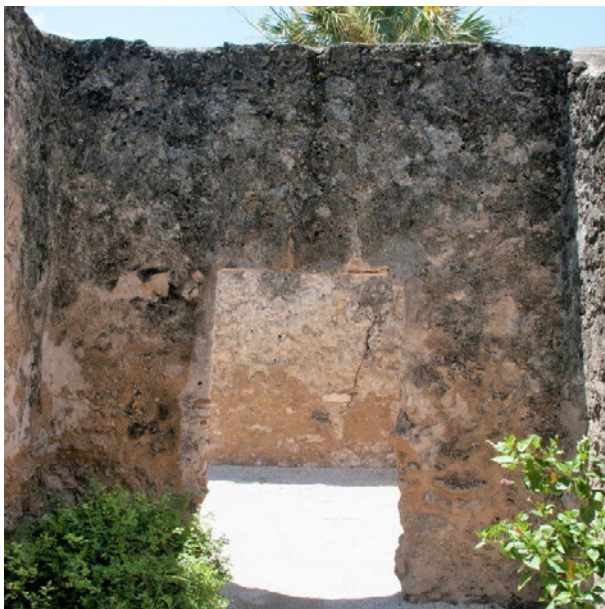
Figure 6.B.156: Room HS 203 H—South wall. General view. Features vegetation growth in the upper part of the wall and erosion in the lower part.

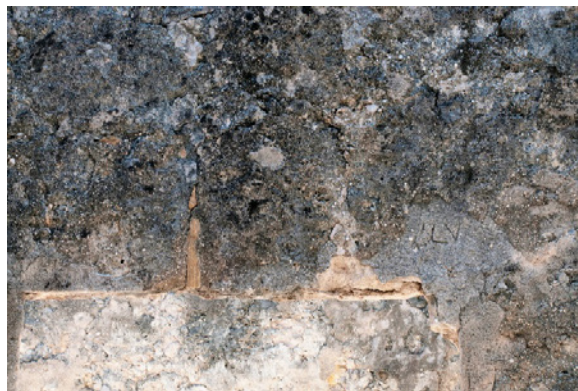
Figure 6.B.157: Room HS 203 H—South wall. Detail of the architrave of the door D04. Features two cracks in the middle and middle right of the architrave, mortar patching with graffiti and detachment of the mortar below the door.

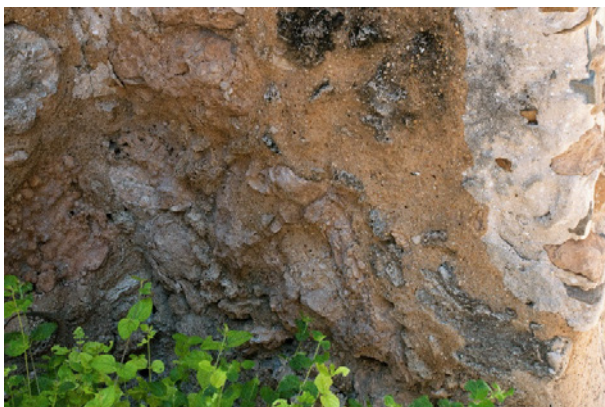
Figure 6.B.158: Room HS 203 H—South wall. Detail of the bottom left corner of the wall. Exhibits visually contrasting mortar patchings, erosion of the stone blocks and missing mortar joints.

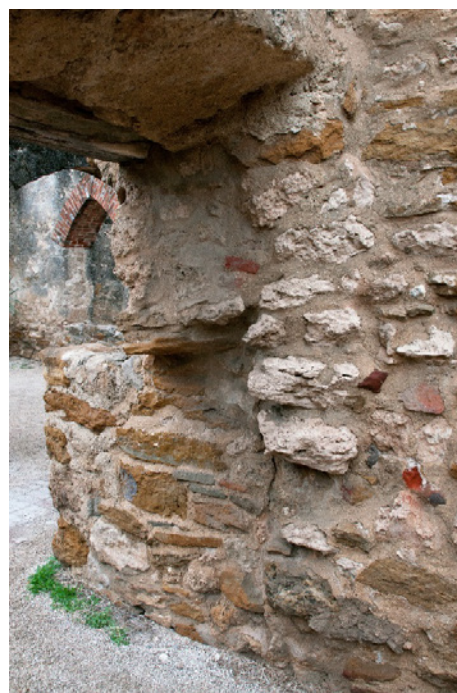
Figure 6.B.161: Room HS 203 K—North wall. Detail of the left corner of the wall. Features a crack in the middle of the door D05, erosion of the wall and fragmentation of stones.

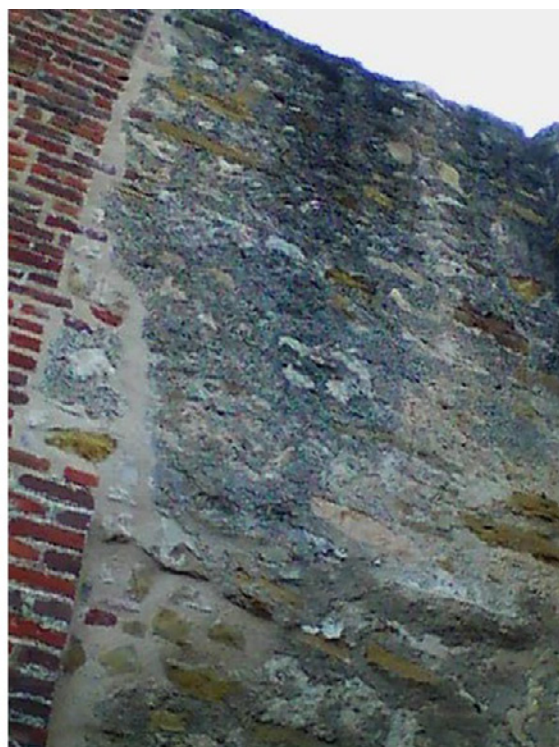
Figures 6.B.162 and 6.B.163: Room HS 203 H—North wall. Same view of the right part of the wall. The differences in temperature are caused by the different construction materials, the presence of humidity and the presence of the flue inside the chimney.

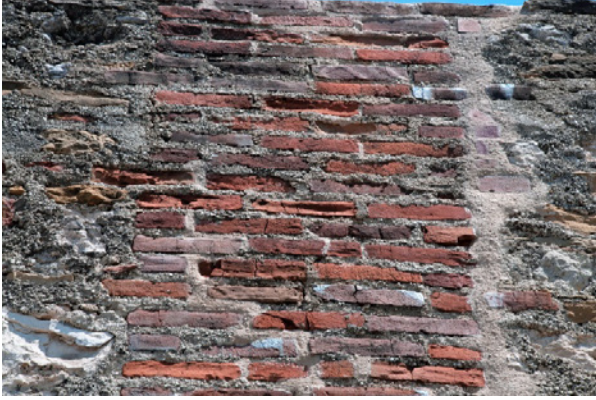
Figure 6.B.164: Room HS 203 K—North wall. Detail of the higher part of the chimney. Features cracks, efflorescence and fragmentation of the bricks.

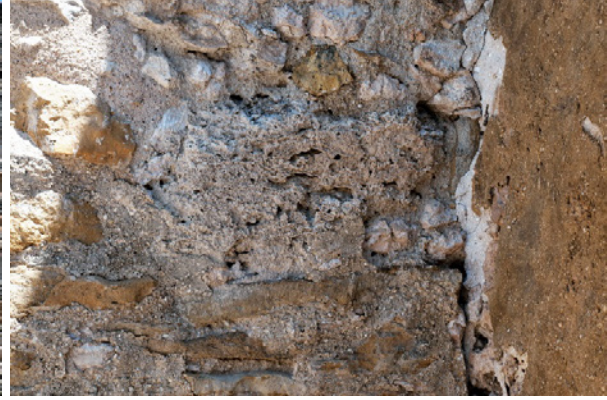
Figure 6.B.165: Room HS 203 K—North wall. Detail of the lower right corner of the wall. Features a crack in the connection of north and east walls and numerous holes.

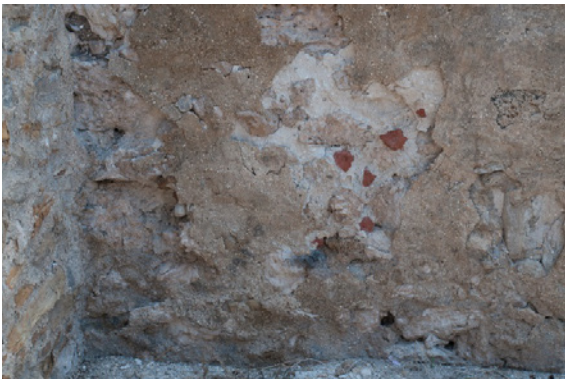
Figure 6.B.167: Room HS 203 K—East wall. Detail of the lower north corner. Features erosion, missing parts and detachment of the mortar patching.

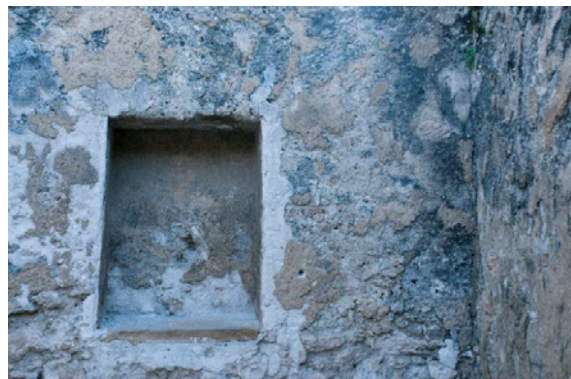
Figure 6.B.168: Room HS 203 K—East wall. Detail of the right corner. Exhibits erosion and several holes in its lower part, and visually contrasting brown mortar patchings.

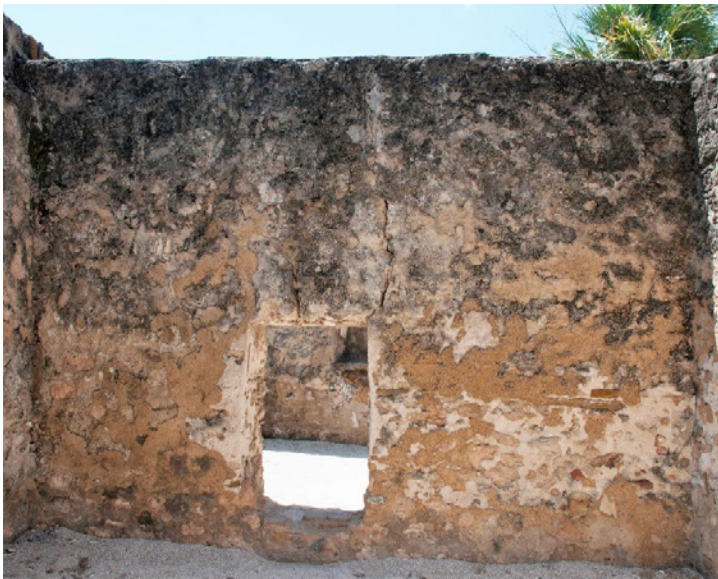
Figure 6.B.169: Room HS 203 K—South wall. General view. Feature biogrowth in the upper part, erosion in the bottom area and visually disturbing mortar patchings.

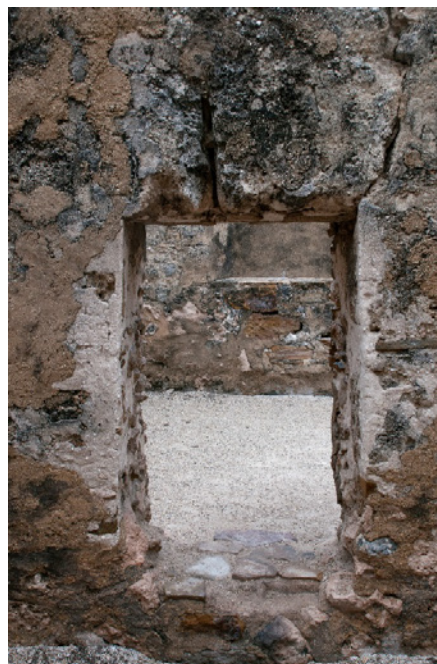
Figure 6.B.170: Room HS 203 K—South wall. Detail of the door D13 featuring a fracture starting in its upper right corner.

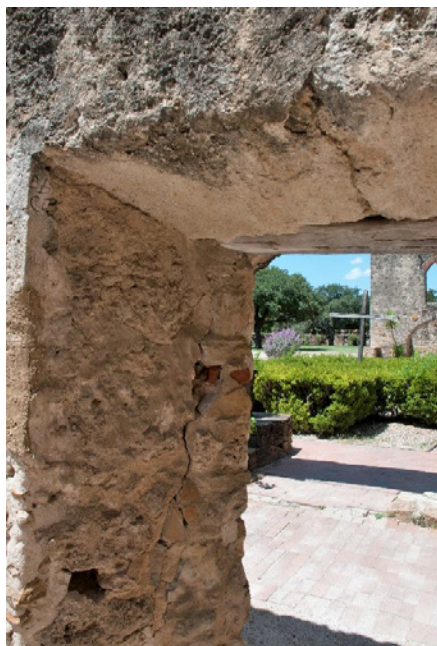
Figure 6.B.172: Room HS 203 K—West wall. Left jamb of the door D05. Features a diagonal fracture that starts under the wooden architrave.

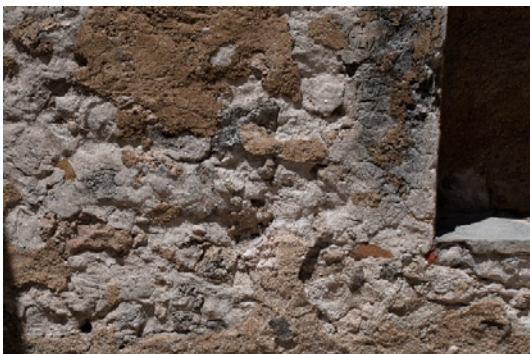
Figure 6.B.173: Room HS 203 K—West wall. Area left of the niche. Features erosion and detachment of edges of the mortar patching.

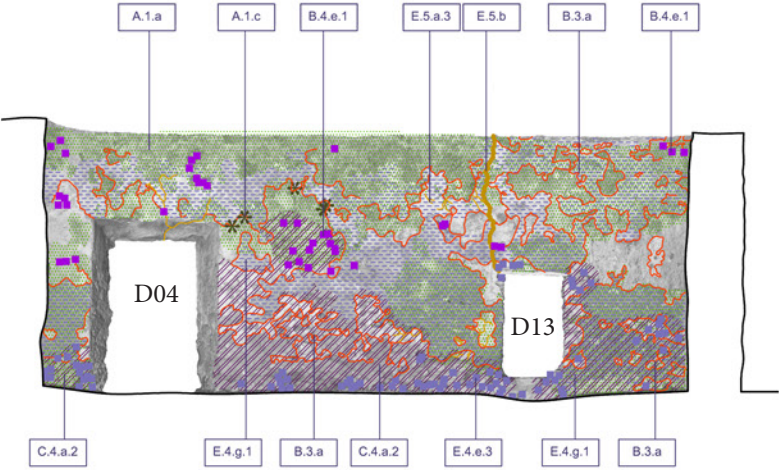
203 R\_North wall

of historic scratch coat (arriccio). The overall condition of the wall is fragile/fragmented, with the presence of a deep fracture above the little opening on the wall's east side. The surface finishes—patches—are definitively in fragile condition.

The wall has evidence of structural decay: The small opening/door located on the east section of the wall features one deep fracture on its west corner, reaching the wall capping. The architrave of this opening is made of a wooden lintel and appears to be added in a later phase. The large door located on the wall's west section features a deep fracture separating in the center of the masonry architrave.

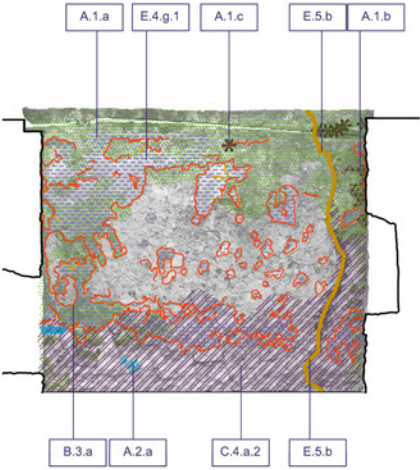
203 R\_East wall

This wall has no evidence of Spanish Colonial plaster finishes. The overall condition of the wall is fragile, due to the presence of structural discontinuities, such as large fractures.

detachment of edges and detachment from the substrate and large areas with loss of mortar. A large fracture, running from the top to the bottom of the wall, is located on the wall southern section and is most probably not active. In fact, a 1930s Harvey Smith historic survey indicated the presence of this crack, which was also later described in 2002 by Restoration Associates.

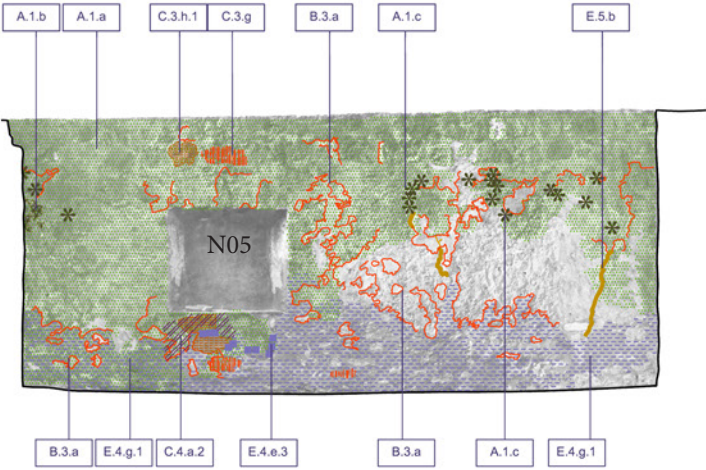
203 R\_South wall

This wall has no evidence of Spanish Colonial finish plaster. The overall condition is fair with surface finishes—patches most likely made of cement-based plasters—in fragile condition. Numerous small plants grow on the wall surface, located mostly on the east edge and on the west section of the wall. There is presence of biological growth, especially on the uppermost part of the wall and with a higher concentration on the east corner. The niche is feathered by a brown mortar finish, dated after 1917, which adheres adequately to the wall substrate. Similar finishes are found in other areas of the wall and are characterized by detachment of edges and detachment from the wall substrate.

The area under the niche has evidence of fragmentation and erosion of the surface. The lower section of the wall shows evidence of masonry erosion, due to rising damp and high moisture content in the masonry. One large fracture is located on the west section of the wall, running from the grade level up to approximately 5 ft., where it appears to have wider opening. The crack, filled with gray mortar, continues with a sub-vertical layout, to encounter the corner of the wall.

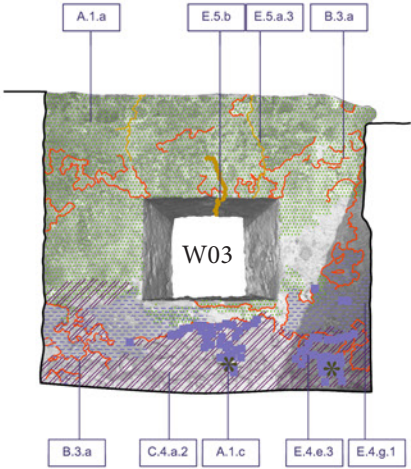
203 R\_West wall

This wall has no evidence of Spanish colonial plaster finish, however some areas still retains fragments of historic scratch coat. The overall condition of the wall is fair, featuring some structural issues. The wall has had numerous mortar repairs—the most evident is a scratch coat layer with a brownish color, which shows detachment of edges.

1. A large deep fracture is located at the center the window.
2. A second fracture is located approximately 1 ft. higher, toward the north wall.
3. The third crack starts on the southern upper edge of the window and features a diagonal pattern. The crack reaches the capping, which is also fractured.

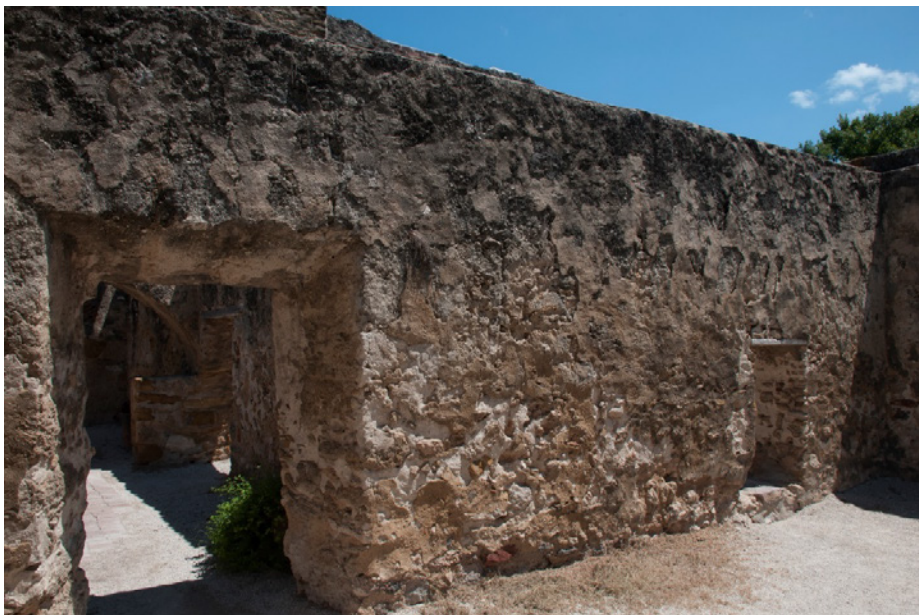
Figure 6.B.174: Room HS 203 R—North wall. General view. Features roughly executed patching.

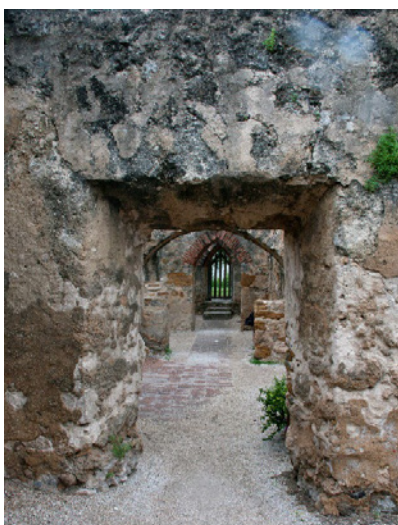
Figure 6.B.175: Room HS 203 R—North wall. Detail of the left door D13. Features a crack in the middle of the architrave.

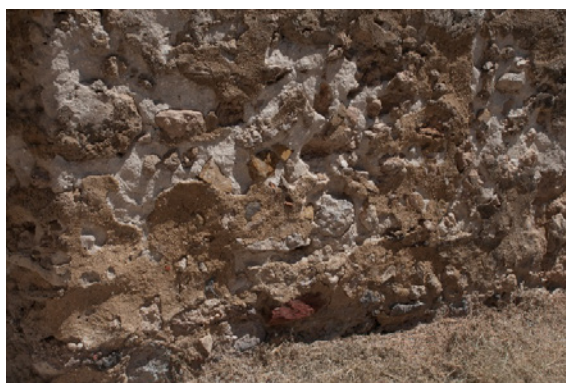
Figure 6.B.176: Room HS 203 R—North wall. Detail of the bottom part of the wall. Features erosion, missing parts and detachment of the patching.

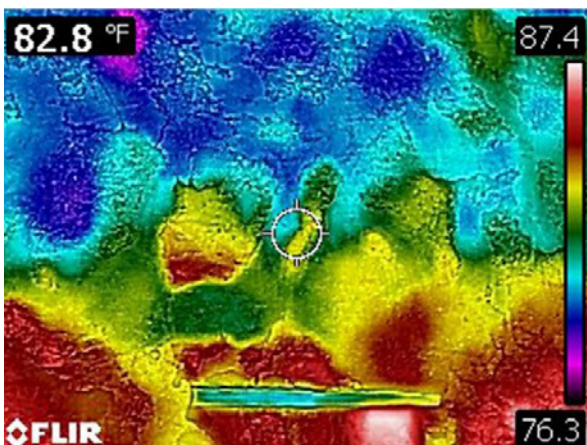
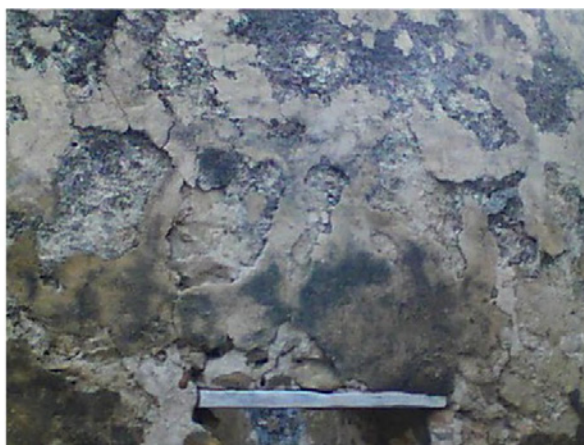
Figures 6.B.177 and 6.B.178: Room HS 203 R—North wall. Same view of the area above the right door. The differences in temperature are caused by the different construction materials, the presence of humidity and the detachment of the patching.

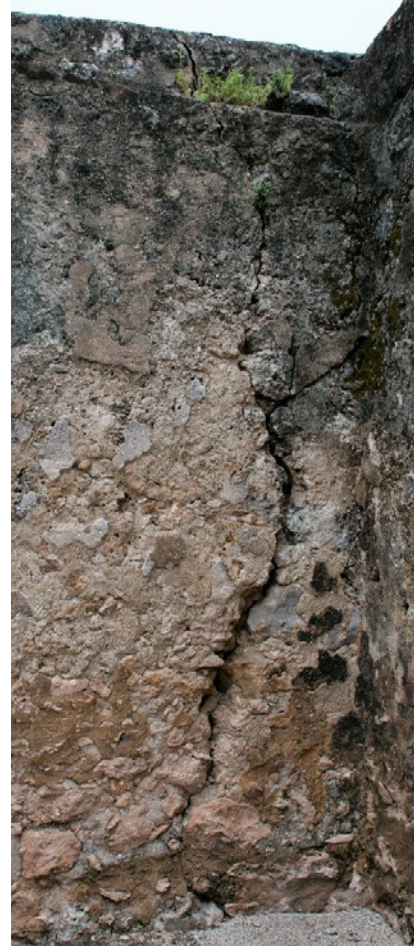
Figure 6.B.180: Room HS 203 R—East wall. Detail of the fracture in the southern end of the wall.

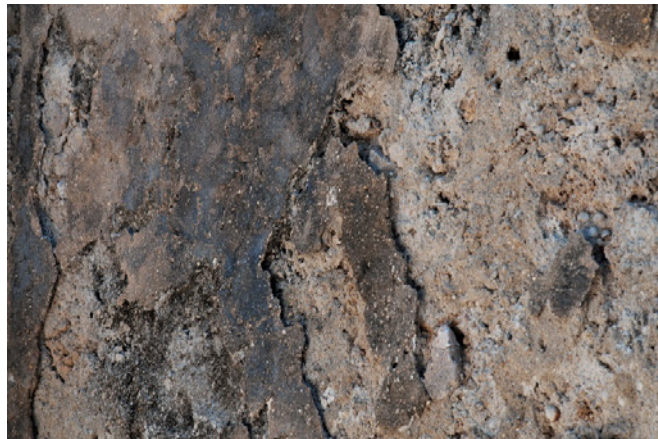
Figure 6.B.181: Room HS 203 R—East wall. Detail showing the biological growth and the detachment of the patching.

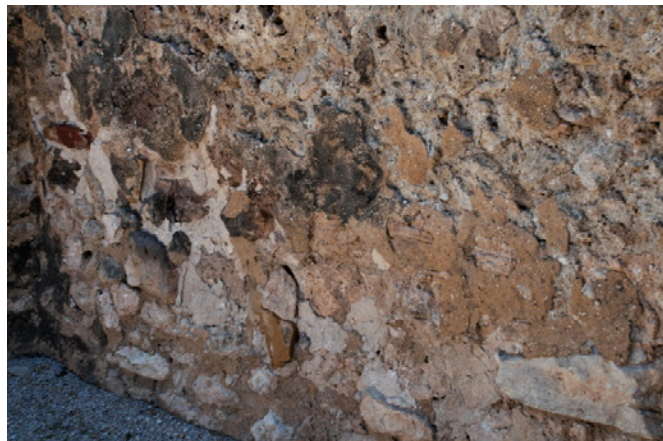
Figure 6.B.182: Room HS 203 R—East wall. Detail of the bottom part of the wall. Exhibits a high level of erosion of the wall and detachment of the patching.

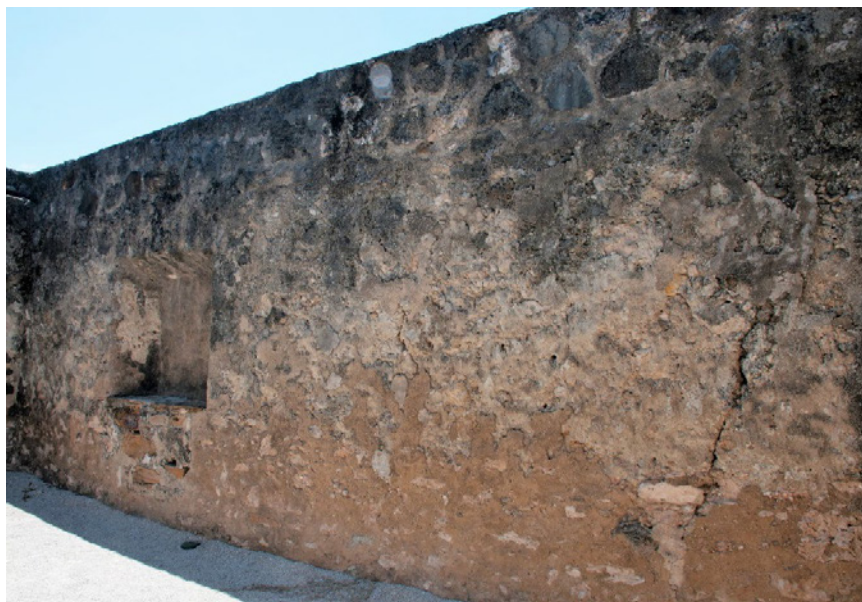
Figure 6.B.183: Room HS 203 R—South wall. General view. Feature biological growth in its upper part and visually contrasting patching in the lower area.

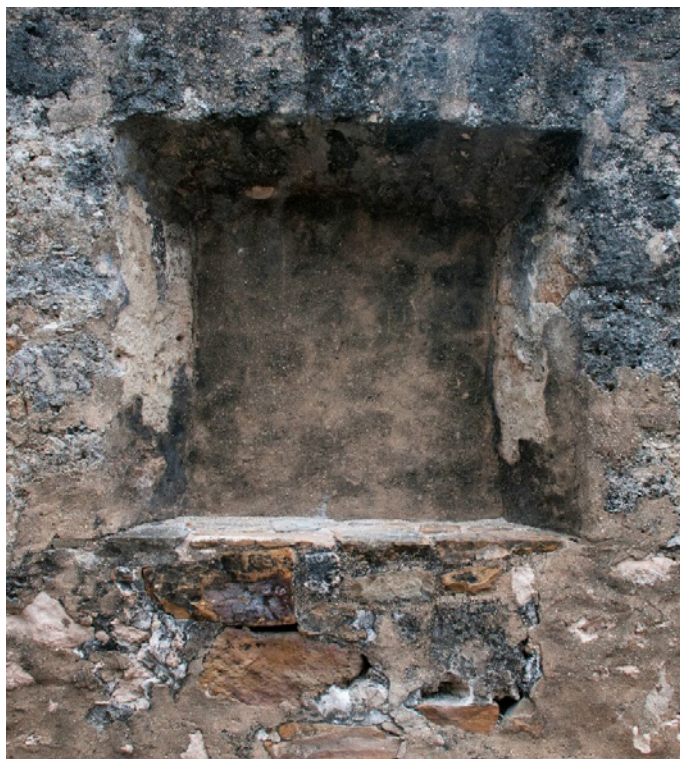
Figure 6.B.184: Room HS 203 R—South wall. Detail of the niche N05. Features biological growth surrounding it and erosion of the masonry wall, numerous holes and detachment of the patching in the area below the niche.

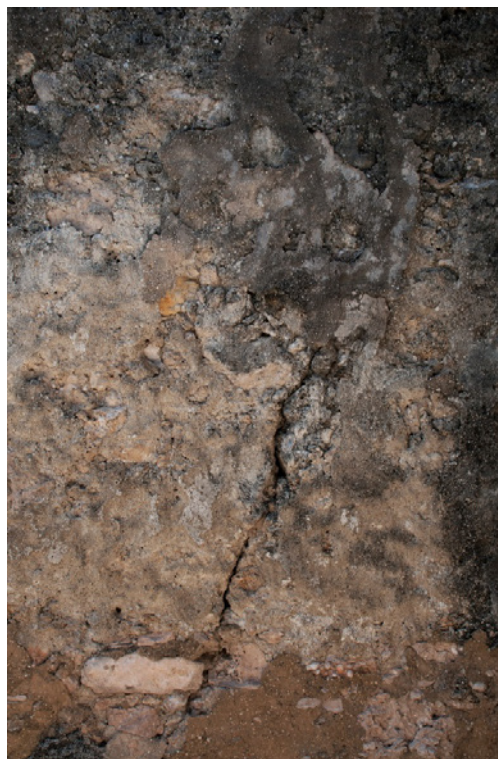
Figure 6.B.185: Room HS 203 R—South wall. Detail of the crack in the right part of the wall. Features different types of patching and erosion in the lower area of the wall.

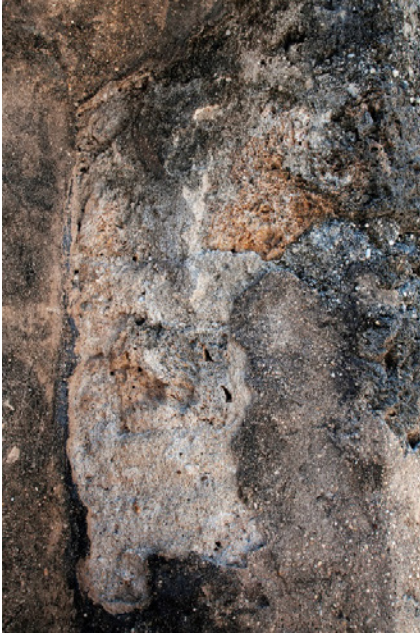
Figure 6.B.186: Room HS 203 R—South wall. Detail of the right jamb of the niche. Features biological growth and detachment of mortar patching.

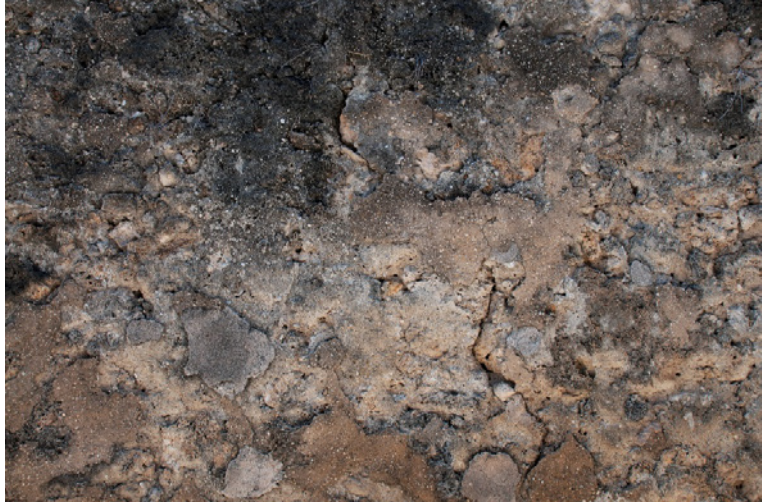
Figure 6.B.187: Room HS 203 R—South wall. Detail of the middle part of the wall. Exhibits cracks, biological growth, dry plants, erosion and different visually disturbing patching that show detachment of edges.

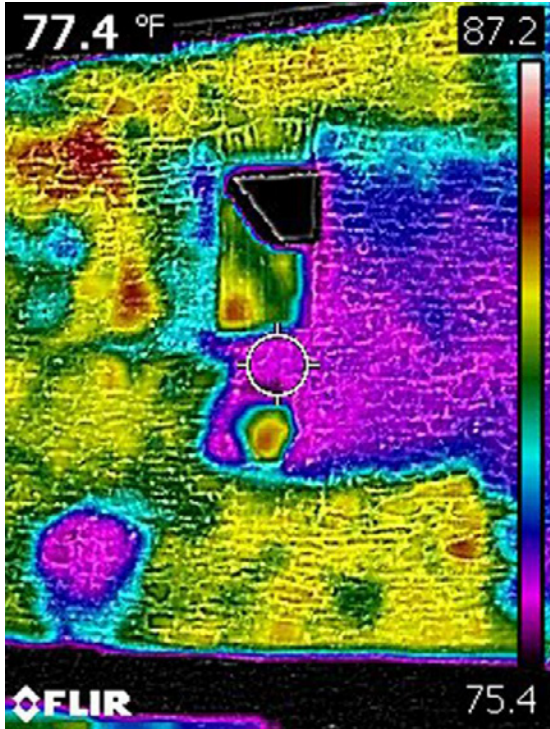
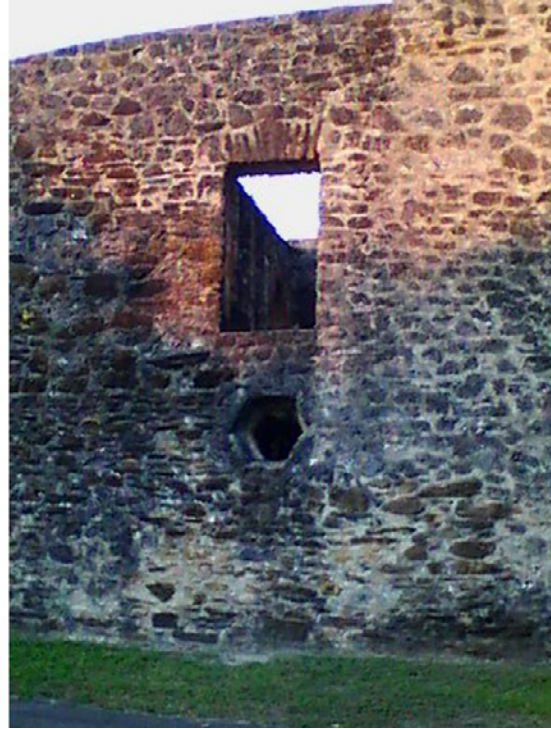
Figures 6.B.192 and 6.B.193: Exterior walls—North wall. Same view of the western end of the wall. The differences in temperature are caused by the different construction materials corresponding to different construction and reconstruction campaigns. The pink circle shape in the bottom left part of the photo features an infill.

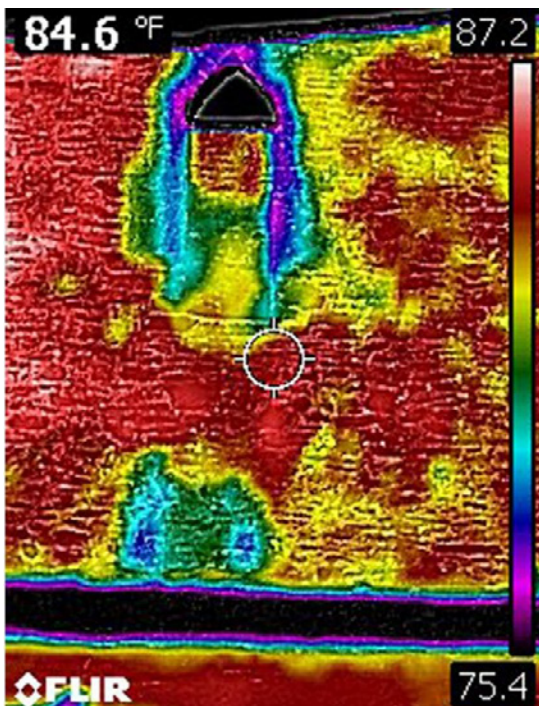
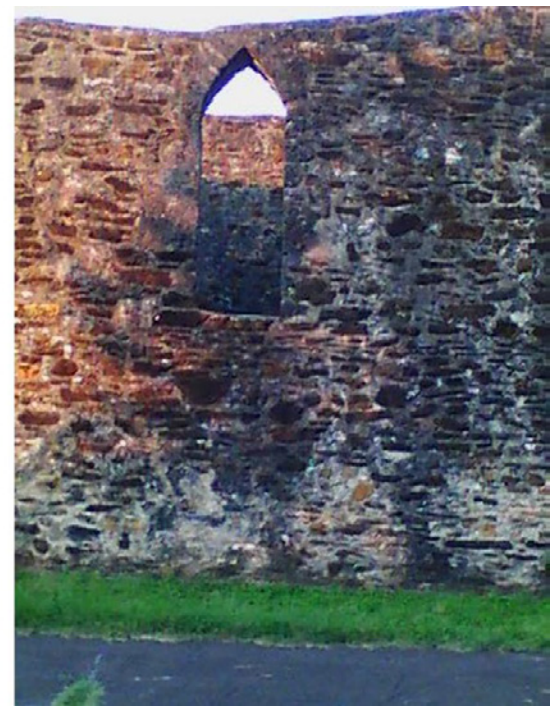
Figures 6.B. 194 and 6.B.195: Exterior walls—North wall. Area corresponding to the 203 D room. The differences in temperature are caused by the different construction materials and moisture content of the wall. It seems that in the bottom part of the wall below the window, there is an area that has been filled.

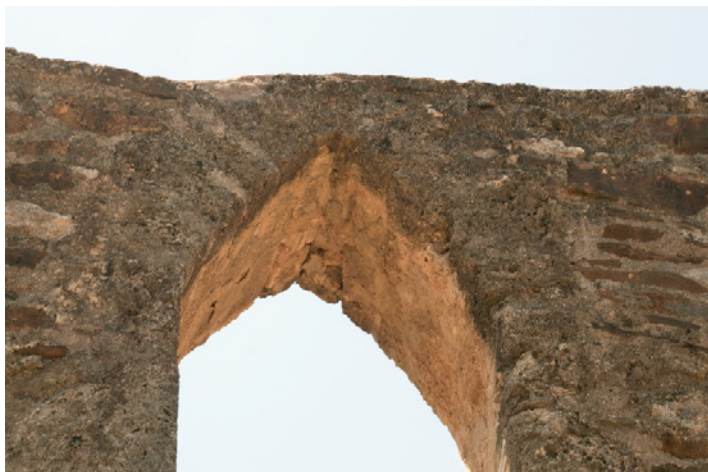
Figure 6.B.196: Exterior walls—North wall. Detail of the window W09 leading to room 203 D. It shows that the crack visible from the inside is not passing through the whole thickness of the wall.

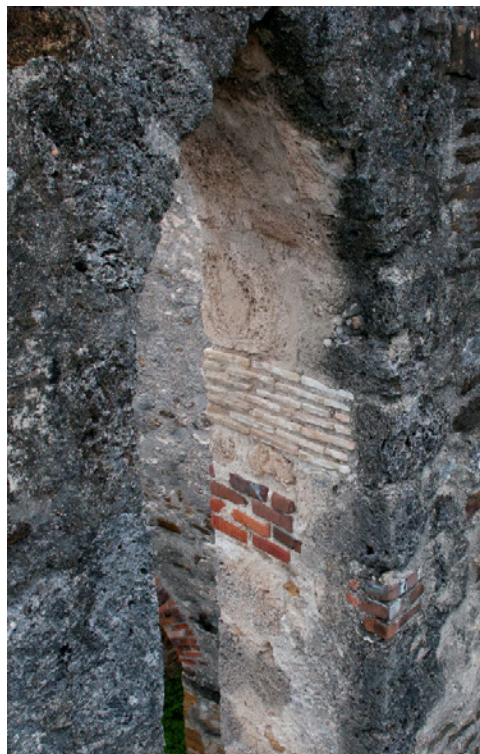
Figure 6.B.197: Exterior walls—North wall. Detail of the window W09 leading to room 203 D. Features additions of different types of bricks, probably used for repairs.

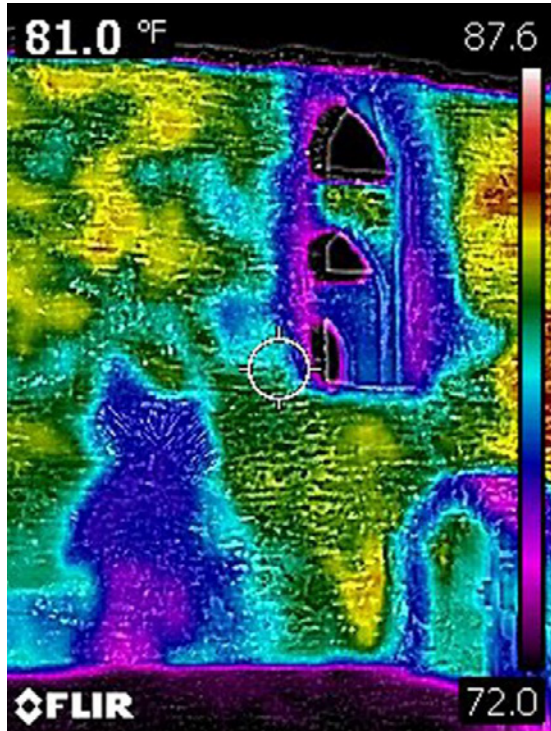
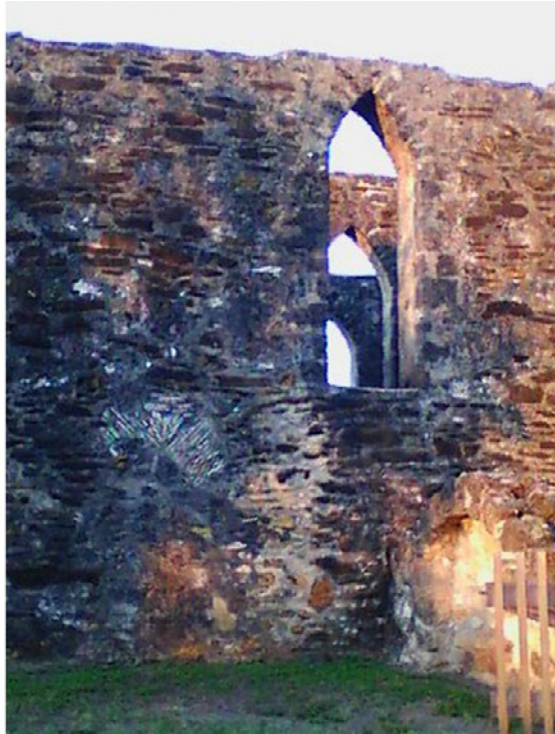
Figures 6.B.200 and 6.B.201 : Exterior walls – North wall. Area corresponding to the 203 C room. The differences in temperature are caused by the different construction materials and moisture content. The left dark blue area correspond with a filled door D02.

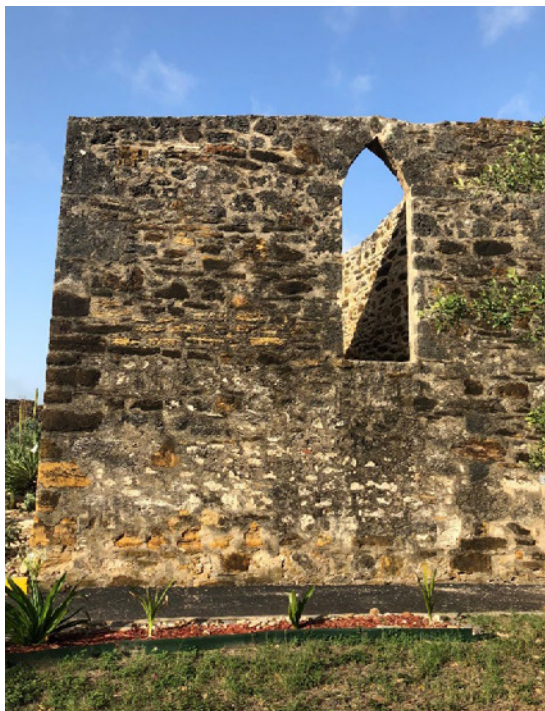
Figure 6.B.204: Exterior walls—North wall. Eastern end of the wall. Features erosion in the bottom part of the wall and multiple fragmented stones caused by the use of a repointing mortar stronger than the stone.

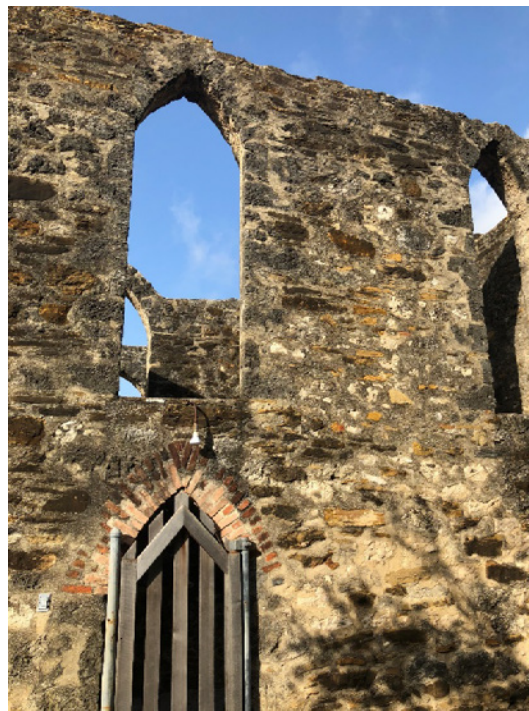
Figure 6.B.205: Exterior walls—North wall. Part corresponding to room 203 B. Features erosion in the bottom area, fragmentation of stones and fractures in the windows W12 and W11.

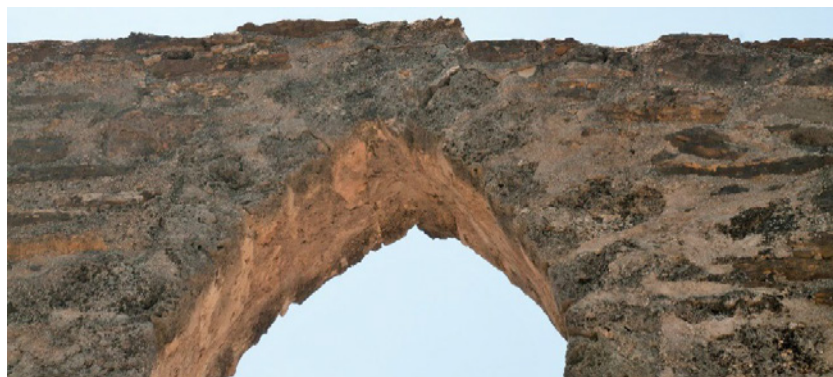
Figure 6.B.206: Exterior walls—North wall. Part corresponding to room 203 B. Right window (W11). Features the crack near the keystone that passes through all the thickness of the wall.

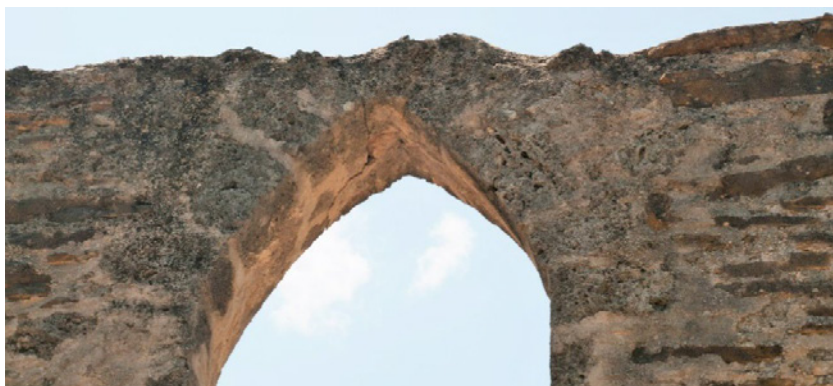
Figure 6.B.207: Exterior walls—North wall. Part corresponding to room 203 B. Left window (W12). Features the crack near the keystone that passes through all the thickness of the wall.

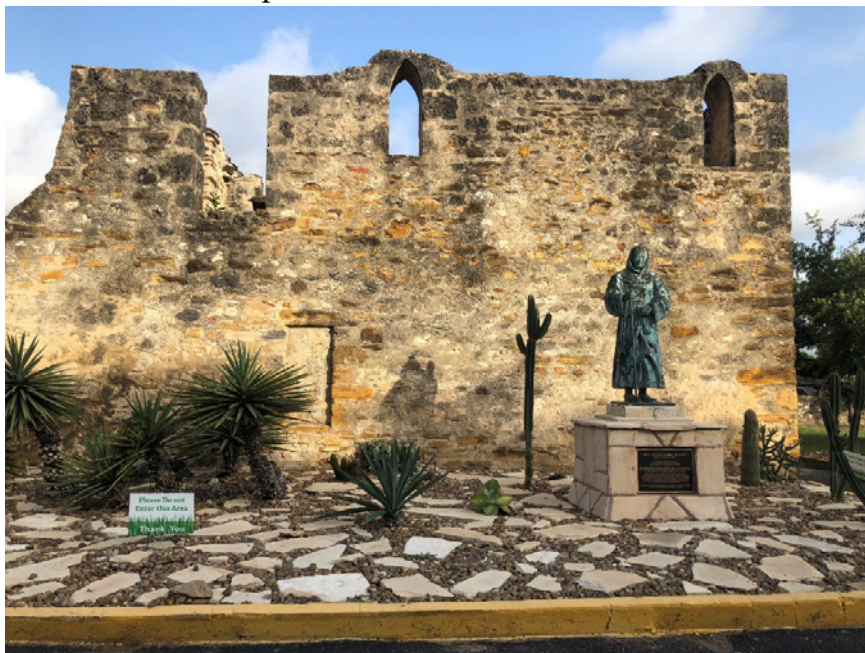
Figure 6.B.208: Exterior walls—East wall. Norther end of the wall. General view. Features vegetation growth in its upper part, erosion in the bottom and delamination in the stones.

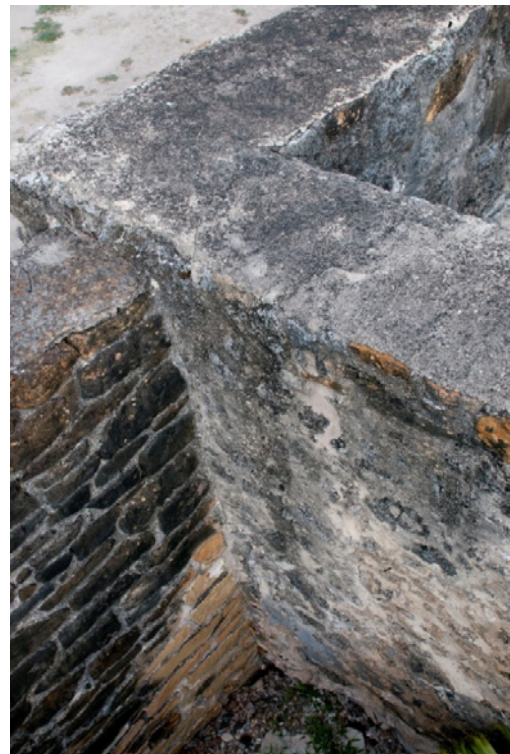
Figure 6.B.214: Exterior walls—East wall. South corner. Detail of the capping, featuring the fracture also visible on the vertical walls.

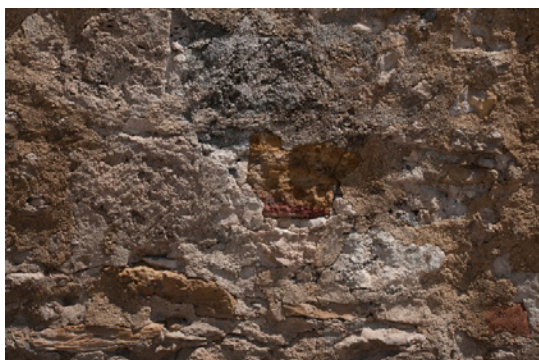
Figure 6.B.217: Exterior walls—South wall. Detail of the mid bottom part of the wall. Features delamination in the stones and erosion of the masonry wall.

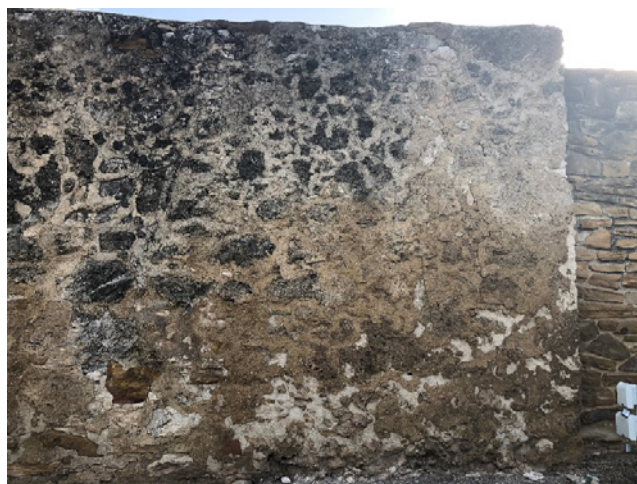
Figure 6.B.218: Exterior walls—South wall. East corner. Features several cracks, vegetation growth in the upper part, erosion in the bottom and multiple visually contrasting patching, which exhibit detachment of edges.

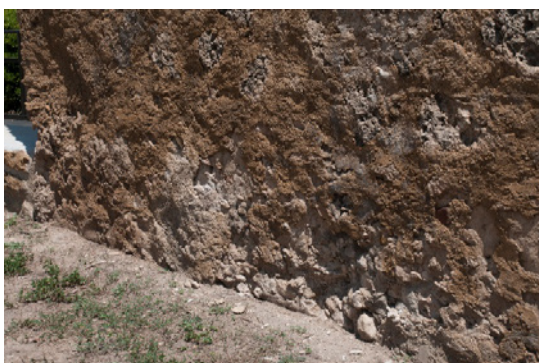
Figure 6.B.219: Exterior walls—South wall. Detail of the west bottom end of the wall. Exhibits erosion of the masonry wall and detachment of the visually intrusive patching.

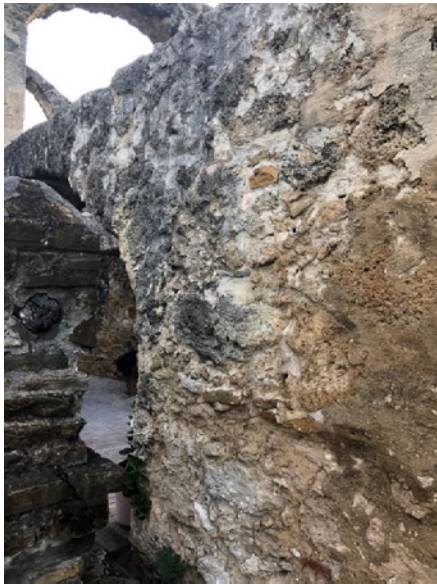
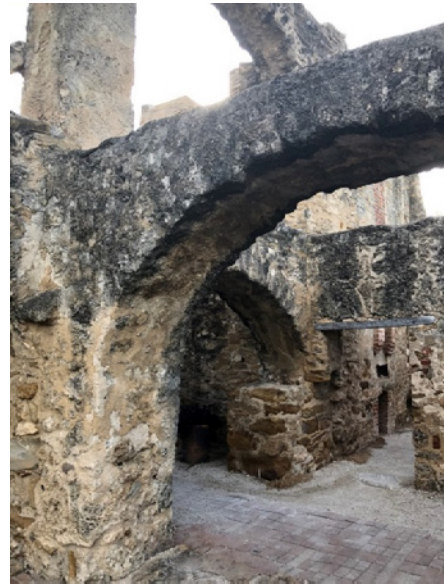
Figures 6.B.225 and 6.B.226: Exterior walls—West wall. Area corresponding to room 203 H. Exhibits vegetation growth in the arch and a high level of erosion.

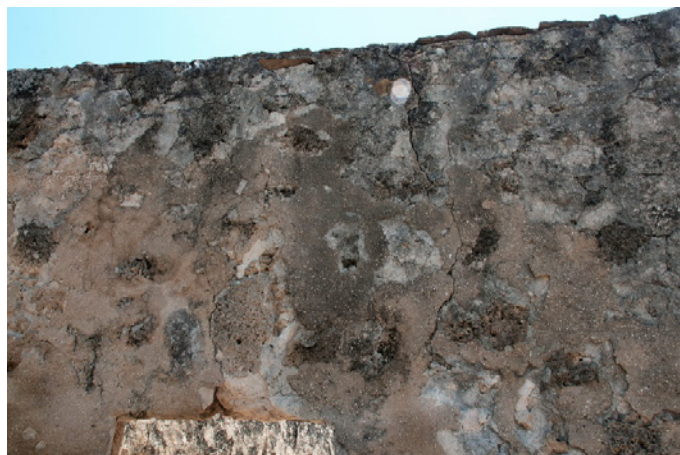
Figure 6.B.227: Exterior walls —West wall. Detail of the area above the window W03, featuring multiple cracks and detachment of the visually contrasting patching.

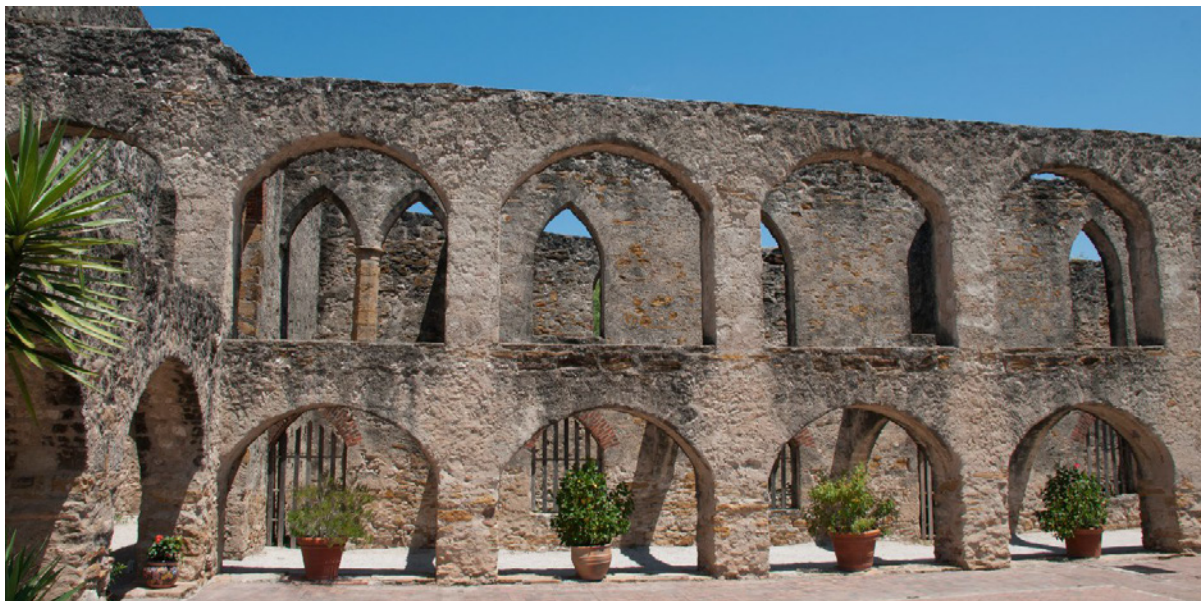
Figure 6.B.228: Exterior walls—Cloister south wall. General view. Features vegetation growth concentrated in the higher part of the wall and under the upper level arches. It also exhibits a high level of erosion in the bottom part of the pillars.

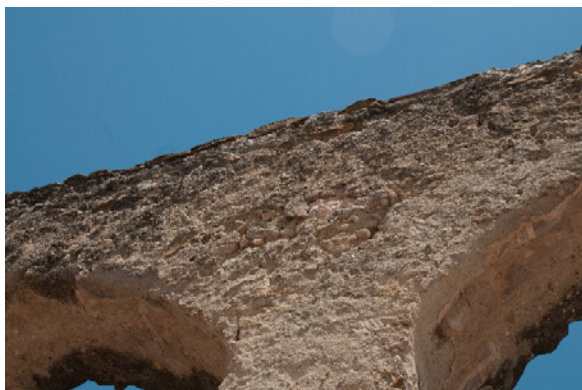
Figure 6.B.229: Exterior walls—Cloister south wall. Detail of the upper level, featuring erosion and detachment of the historic painted plaster in the intrados of the arch.

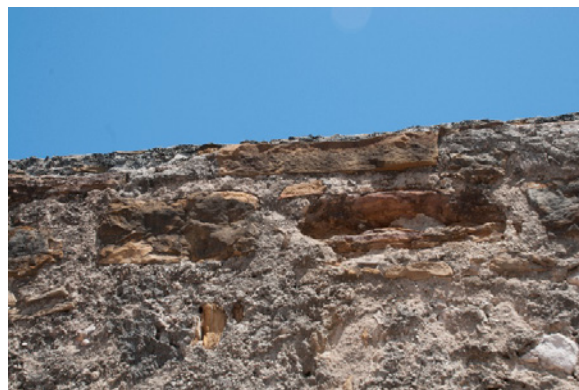
Figure 6.B.230: Exterior walls—Cloister south wall. Detail of the higher part of the lower level showing fragmentation in the stones.
