National Park Service  
United States Department of the Interior  
San Antonio Missions National Historical Park  
Texas

# Historic Structure Report Mission San José Convento

Final Submission  
2019

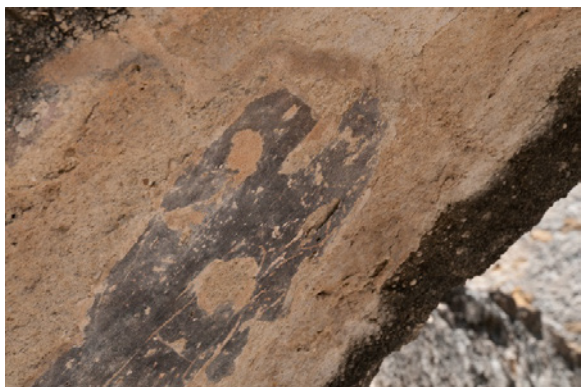
Figure 6.B.231: Exterior walls—Cloister south wall. Detail of the intrados of a lower level arch. Features detachment of the painted plaster remains.

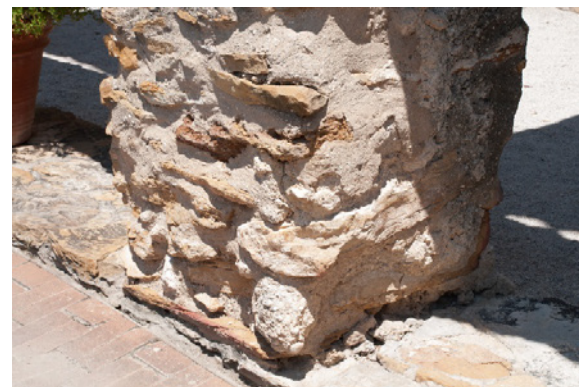
Figure 6.B.232: Exterior walls—Cloister south wall. Detail of the erosion and loss of mortar in the lower part of the pillars.

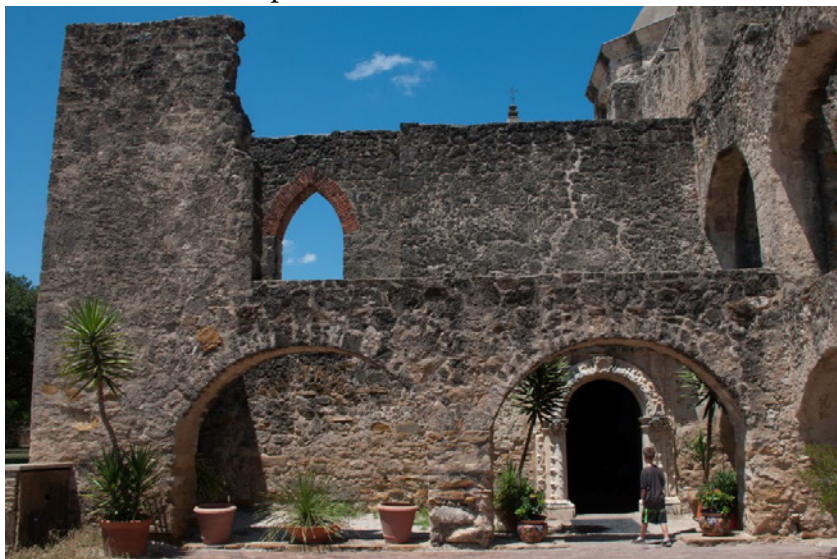
Figure 6.B.233: Exterior walls—Cloister west wall. General view. Features vegetation growth and erosion in the lower part of the pillars.

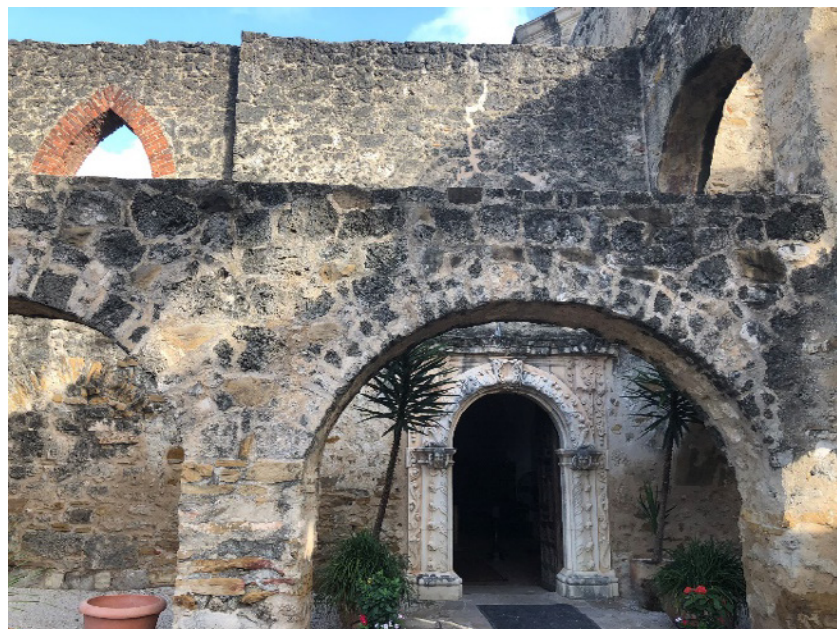
Figure 6.B.234: Exterior walls—Cloister west wall. Detail of the right arch. Masonry changes between the bottom of the pillar and the arch due to the collapse in 1940s and its later reconstruction.

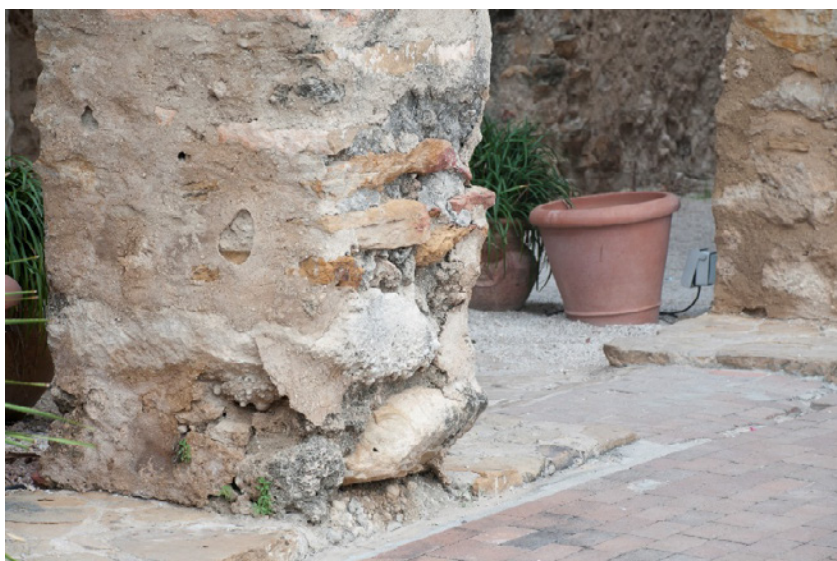
Figure 6.B.235: Exterior walls—Cloister west wall. Detail of erosion and loss of mortar in the middle pillar.

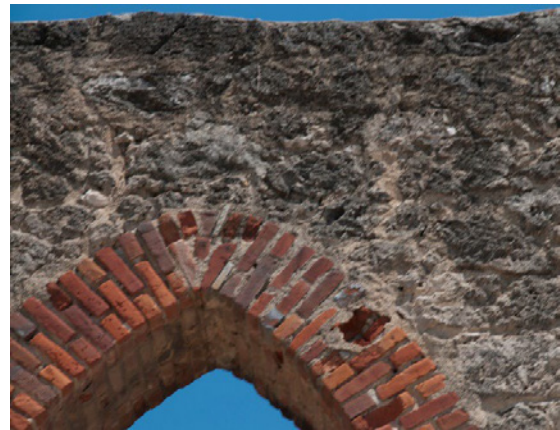
Figure 6.B.238: Exterior walls—South wall. Detail of the brick lancet arch of window W21. Features several missing parts, fragmentation of the bricks and efflorescence.

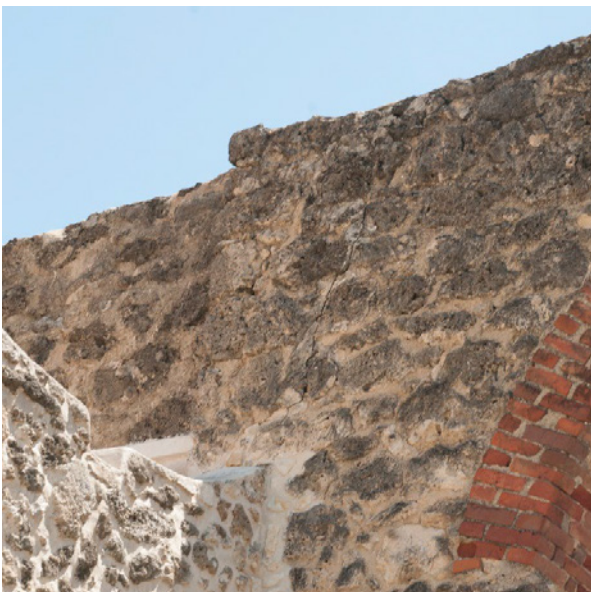
Figure 6.B.243: Exterior walls—West wall. Features a crack starting in the connection with the sacristy and going until the coping of the wall.

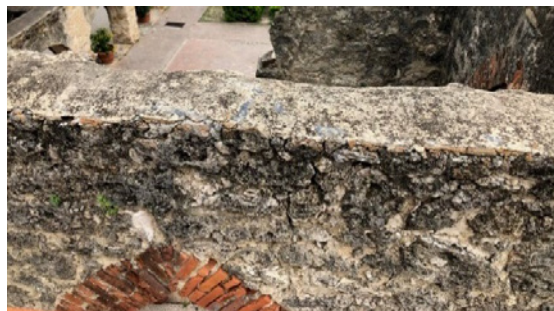
Figure 6.B.240: Exterior walls—West wall. The top of the wall features numerous hair cracks and disintegration of the wall capping.

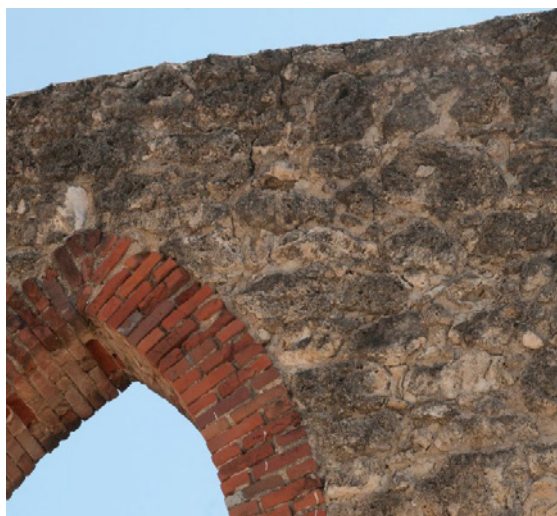
Figure 6.B.241: Exterior walls—West wall. Crack from the brick arch going until the coping of the wall.

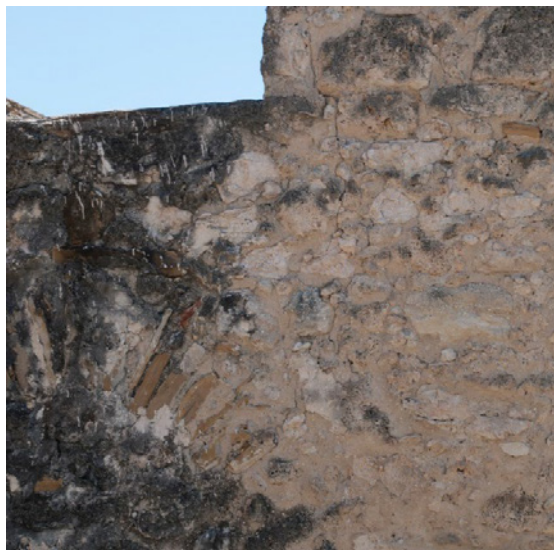
Figure 6.B.242: Exterior walls—West wall. Note the crack above the sandstone voussoirs shaping the arch line of former door D12.

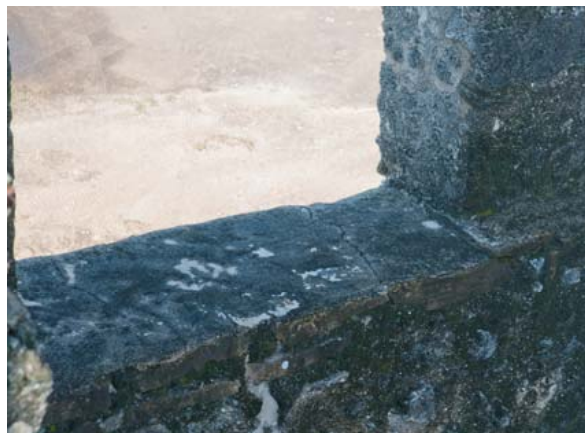
Figure 6.B.248: 203 S—South wall. Detail of the crack in the sill of window W21.

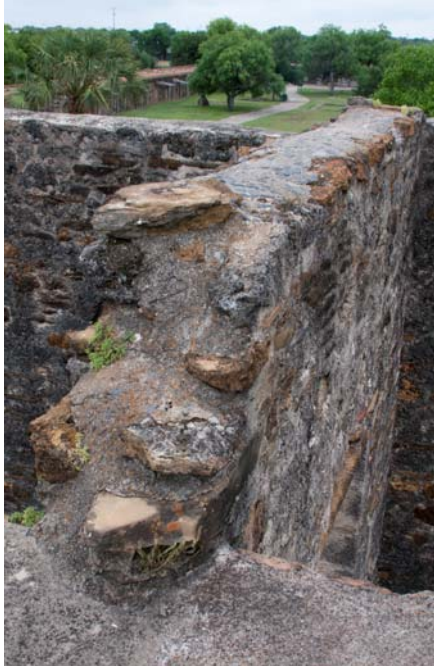
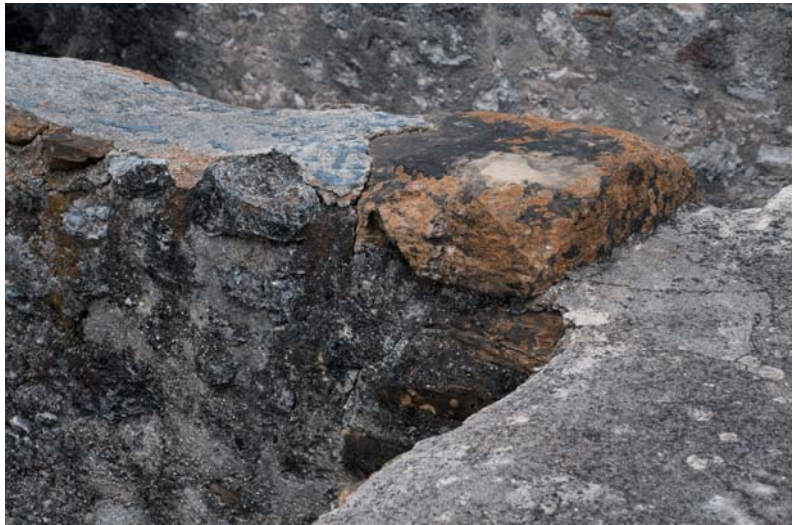
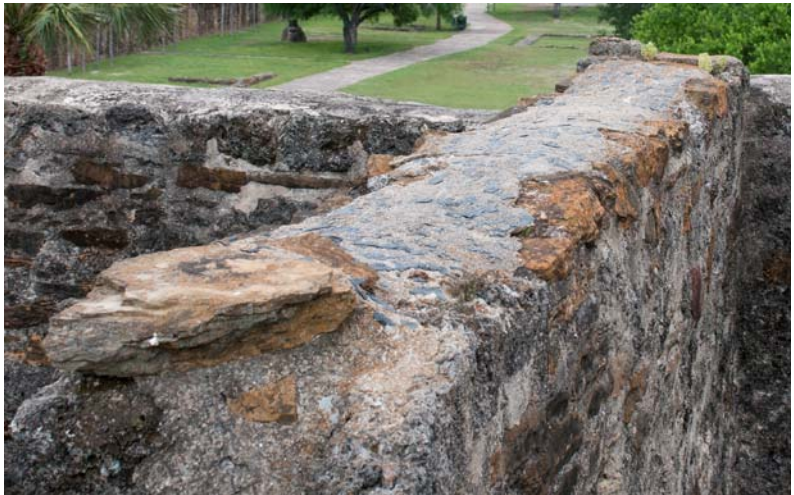
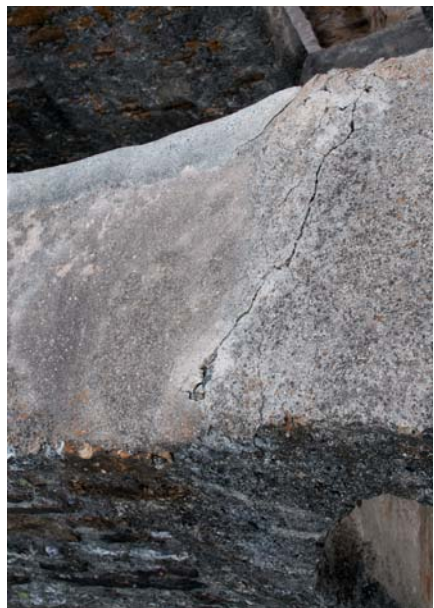
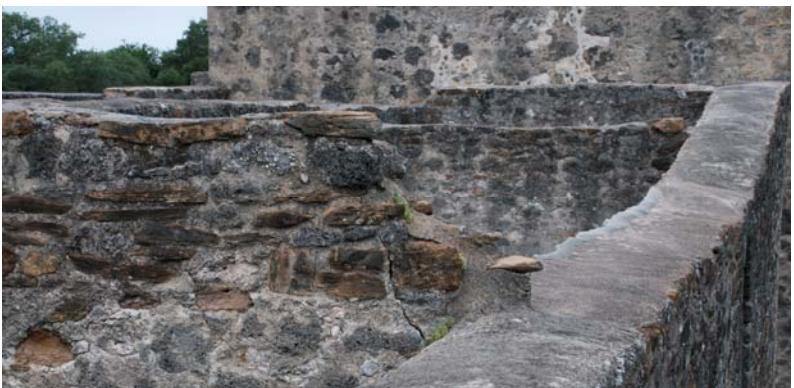
Figures 6.B.251–6.B.253: Wall between 203 D and 203 C—Views of the wall connection, exhibiting a diagonal fracture.

Figure 6.B.254: 203 D—Window 12. Fracture, with associated loss of restoration joint mortar

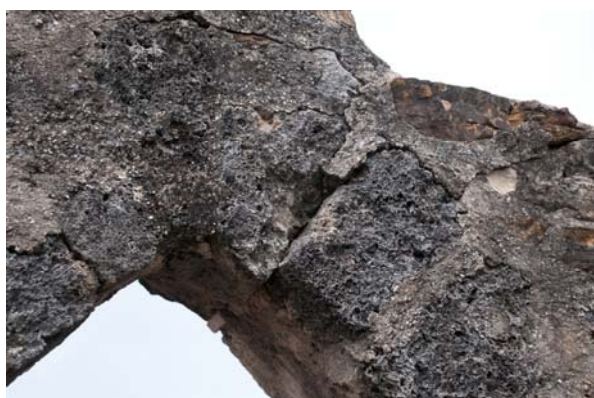
Figure 6.B.256: 203 B—North wall, Window 12. Fracture, with associated loss of restoration joint mortar.

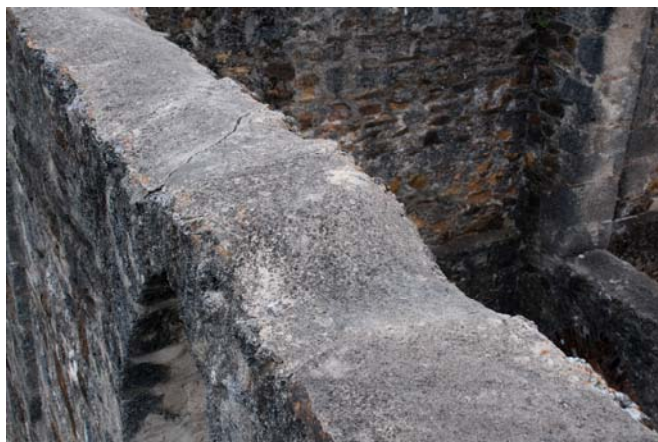
Figure 6.B.255: 203 B—North wall, Window 11. Fracture. View of the coping.

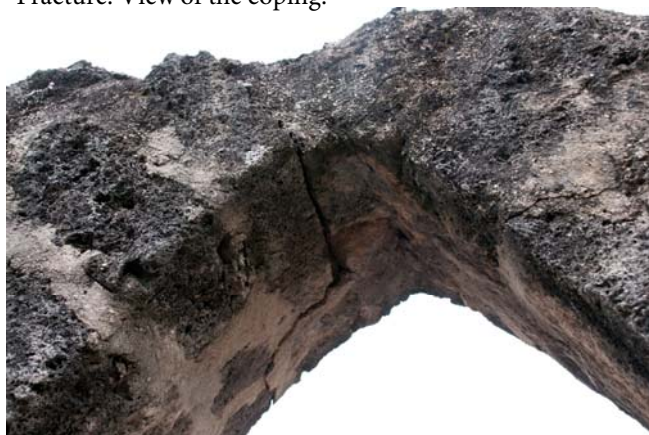
Figure 6.B.257: 203 B—North wall, Window 11. Fracture. View of the intrados of the arch.

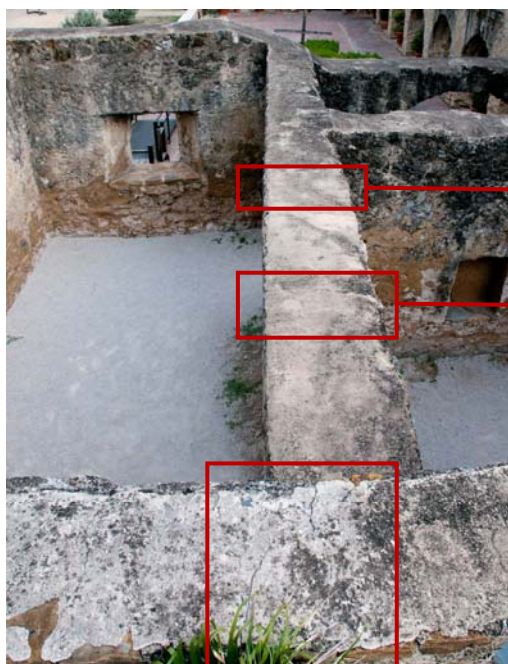
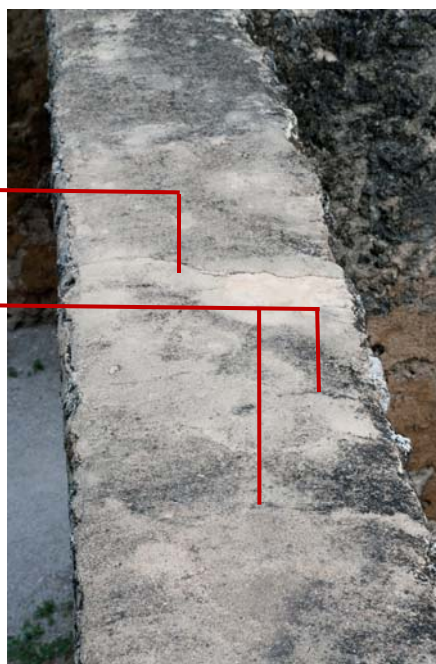
Figures 6.B.258a, 6.B.258b: Walls between 203 R and 203 K. Views of the cracks on the coping.

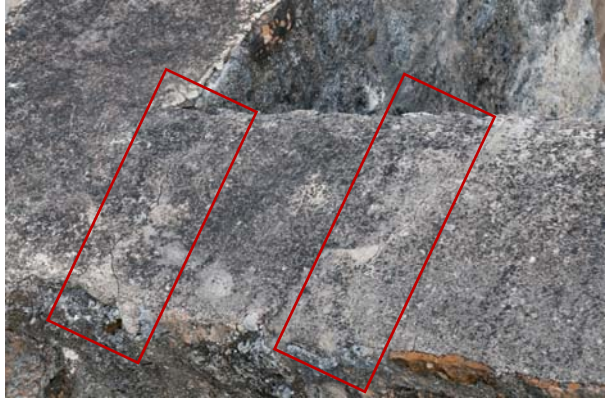
Figure 6.B.259: 203 R—East wall. Detail of the coping with the two cracks highlighted.
