**HISTORIC  
STRUCTURES  
REPORT  
CROOK HOUSE  
SEPTEMBER 1984**

**SAN JUAN ISLAND  
NATIONAL  
HISTORICAL PARK**

CROOK HOUSE  
HISTORIC STRUCTURES REPORT

English Camp  
San Juan Island National Historical Park  
San Juan Island, Washington

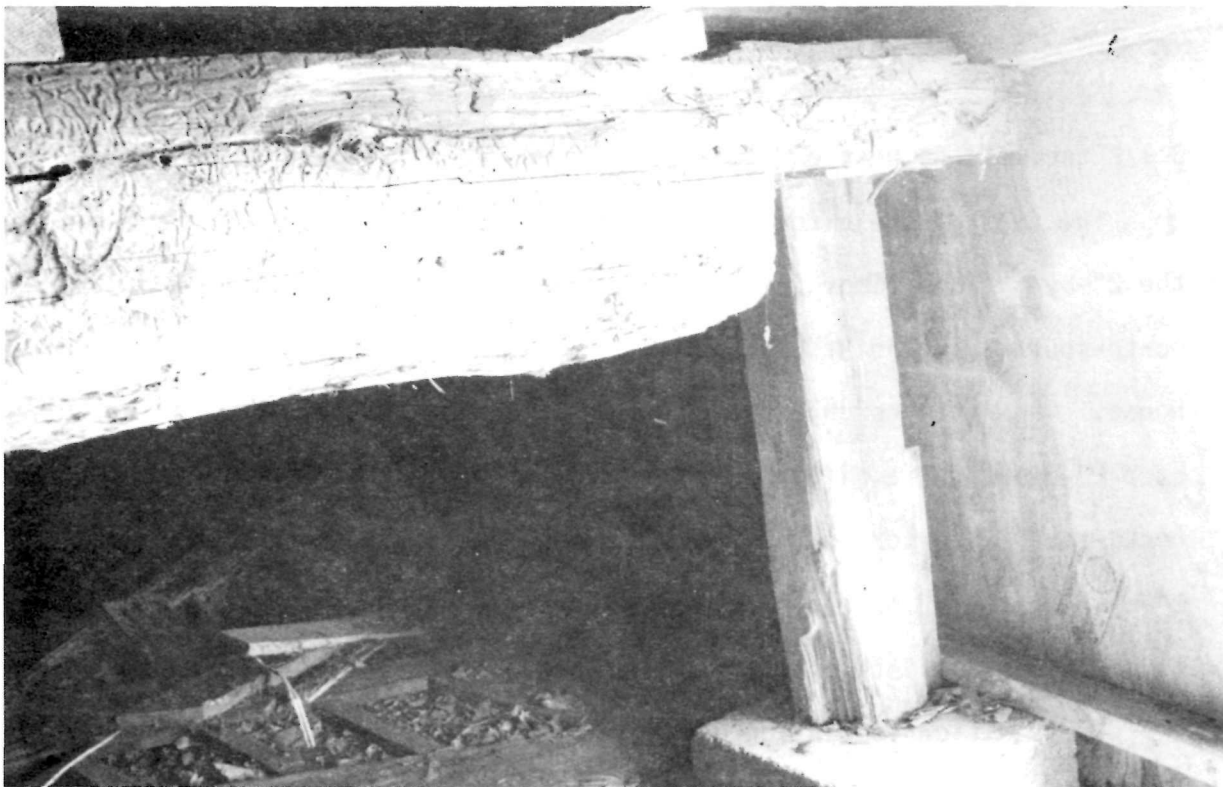
The FOUNDATION of the house consists of 6"-by-8" wood posts set on 16" square pre-cast concrete pads (Figure 34). The posts support five equally-spaced, peeled cedar log girders, each approximately 16" in diameter, with a slight taper as they run from east to west. The girders run continuously to the west end of the porch structure. Many of the posts have wood shims, indicating an earlier leveling or compensation for the girder taper.

In general, the foundation and floor framing appear to be in very good condition with little evidence of insect rot or decay. One exception is the southern-most girder under the porch's west end. Advanced deterioration of the girder and floor joists in the area due to moisture penetration needs to be stopped and damaged sections replaced. Appropriate design details should prevent further occurrences of the problem. The crawl space is dry and well-ventilated.

FIGURE 34 Crook House foundation, west end under porch, 1984. Photo by Barry Schnoll, National Park Service.

- Replace rot damaged girder section, porch floor joists, and porch deck areas in southwest corner with pressure treated lumber, properly detailed to prevent reoccurrence of problem.

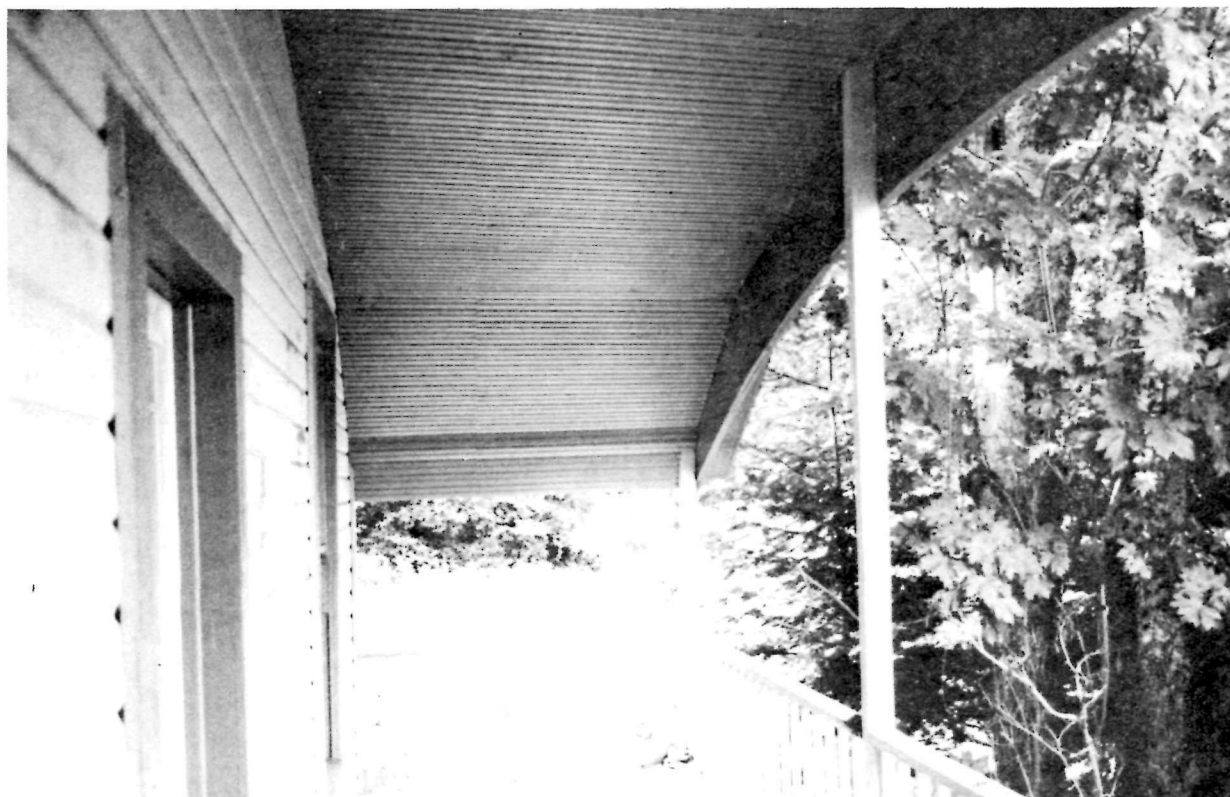
The second floor porch structure consists of 2"-by-6" girders between the 4"-by-4" columns and between the columns and the house. Running north-south between the girders are 2"-by-6" joists. All structural connections are butt jointed and toenailed. A 1"-by-4" ledger is attached to the house wall to help support the deck. The deck is a 1"-by-5 1/4" tongue-and-groove beaded board with the pattern facing down and visible as the first floor porch ceiling. It extends 2" on all sides beyond the structural supports. The ceiling of the second floor porch is a similar beaded board, which varies in height, and roughly follows the gable end arch (Figure 36).

FIGURE 36 Beaded board ceiling of second floor porch, 1984. Photo by Barry Schnoll, National Park Service.

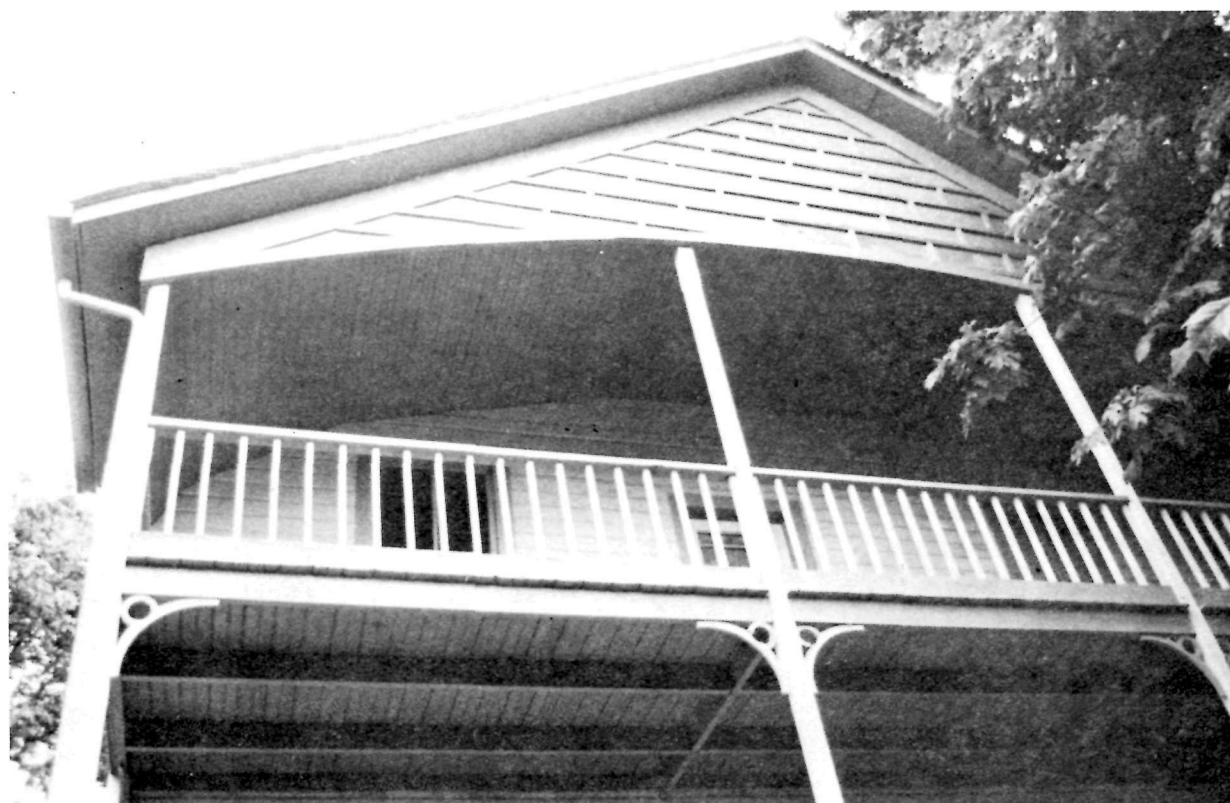
The gable end pattern is board and batten construction, although it is mainly decorative. A layer of 1"-by-9" boards are attached between the columns and roof structure, with batten strips applied horizontally and vertically. The curved lower trim strips are cut from flat 1"-by-4" material and pieced together (Figure 37).

FIGURE 37 Crook House porch with distinctive gable end treatment, 1984. Photo by Barry Schnoll, National Park Service.

- Repair or replace damaged decorative porch brackets to match existing.
- Install a drip board at base of bevel edge siding to channel water away from skirting below.

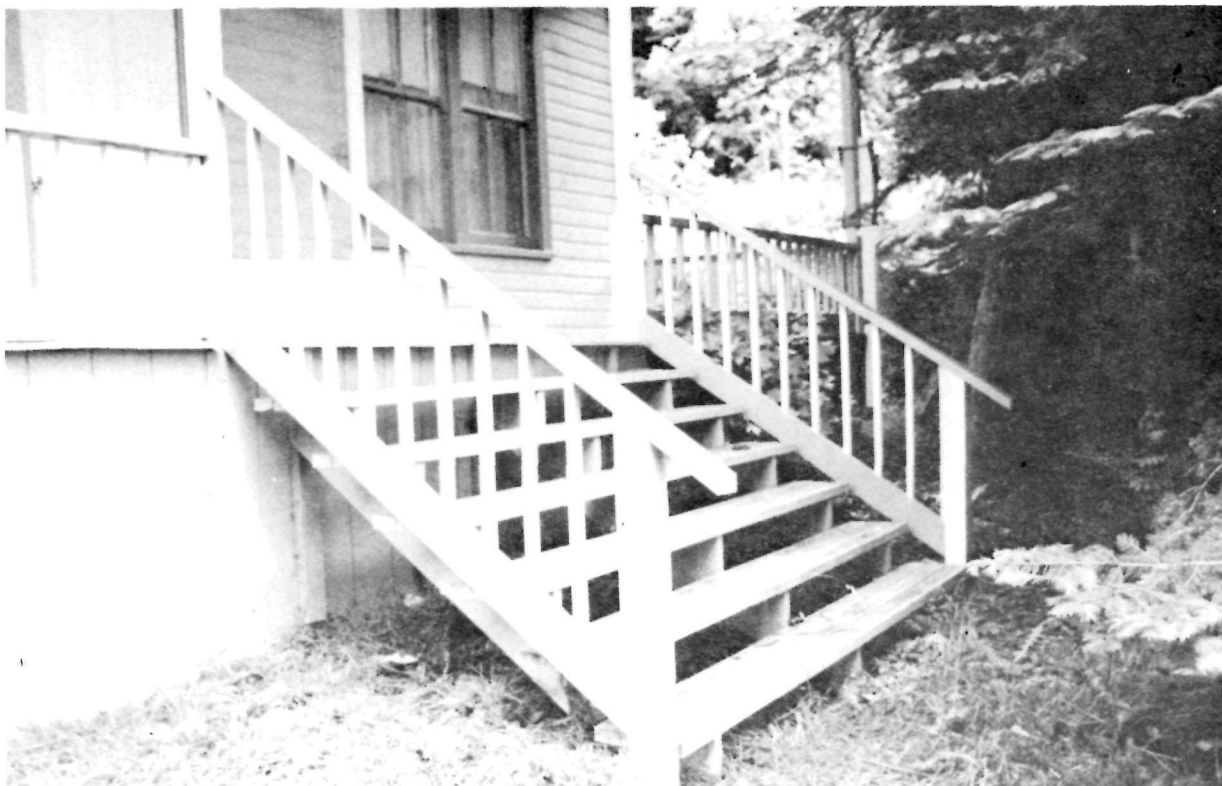
STAIRS to grade from the porch have a similar railing construction. Each step consists of three 2"-by-4"s laid flat resting on three evenly spaced 2"-by-12" stringers. Where the stringers meet the porch structure, a 2"-by-4" upright adds support (Figure 38).

FIGURE 38 West porch steps of Crook House, 1984. Photo by Barry Schnoll, National Park Service.

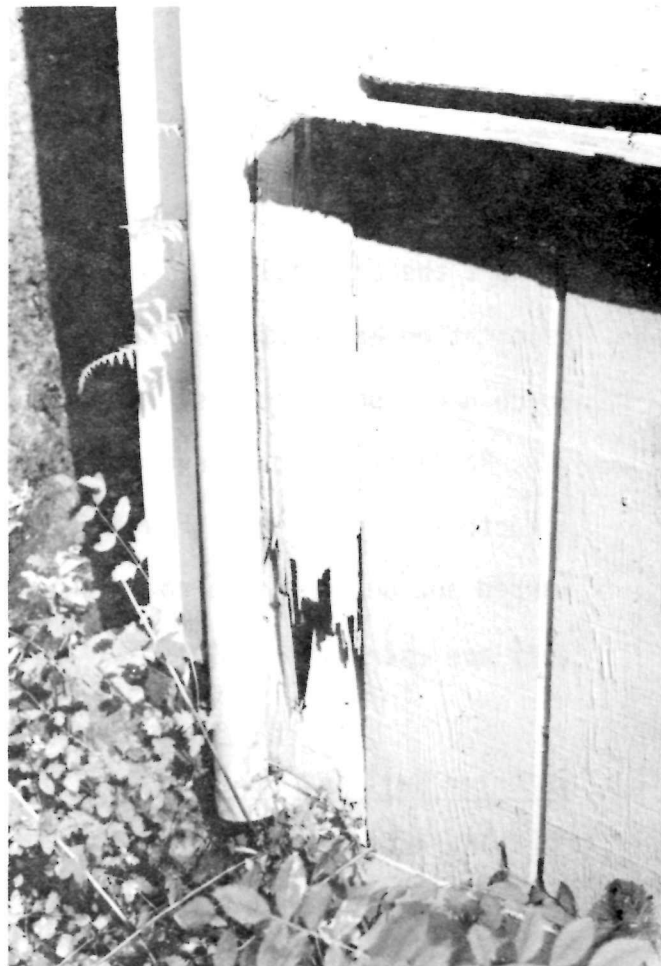
Railings on both levels are in a weakened condition due to loose structural connections (Figure 42). The second level floor deck is badly warped and beginning to rot along the edges. Floor joists supporting the deck are extremely loose at all butt joints.

FIGURE 42 (Right) Second floor porch railing. The top rail is separating from the column and the balusters are loose, 1984. Photo by Barry Schnoll, National Park Service.

- Provide structural framing hardware at all toenail conditions on second floor porch; use only anti-corrosive material.
- Renail second floor porch deck as needed.

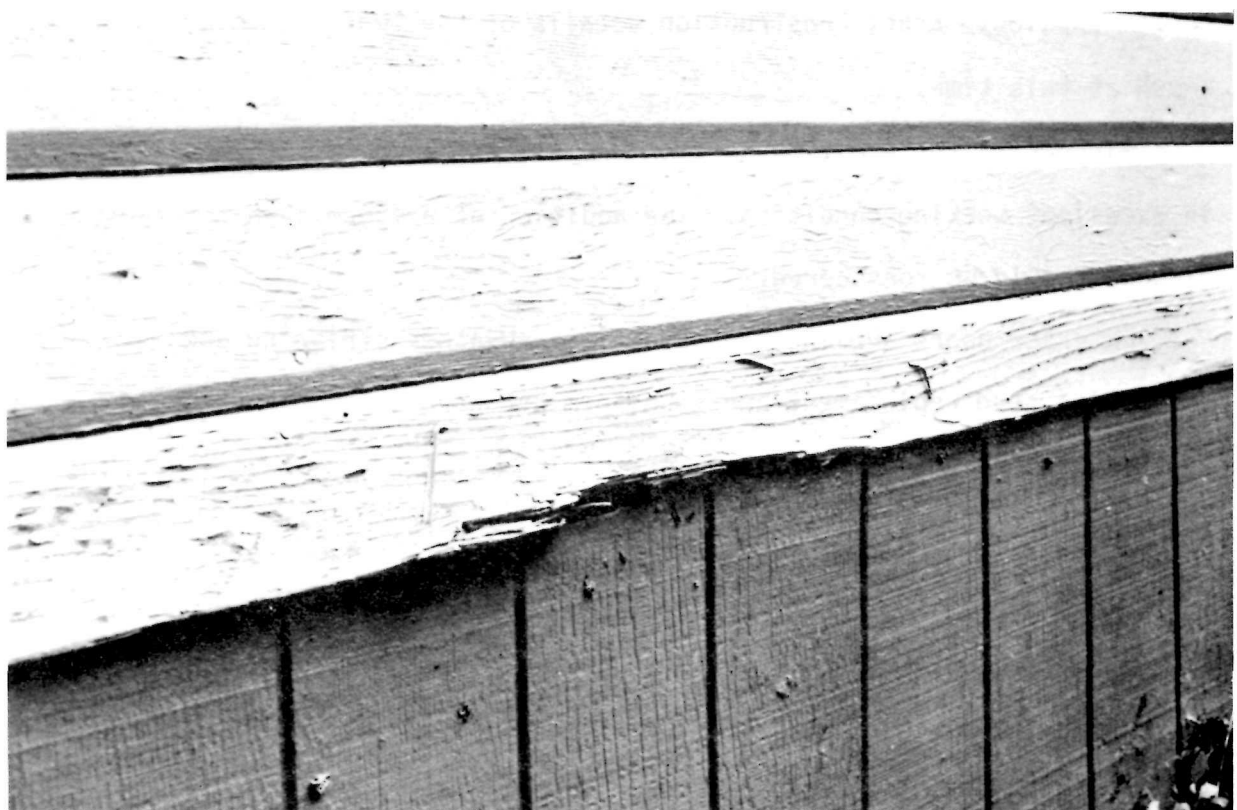
The exterior skin of the building is painted 1"-by-5" bevel edge shiplap cedar siding applied directly to the wall studs (Figure 44). An asphalt shingle roof with metal flashing is laid over a 1/2" plywood roof deck. Wood gutters with metal ends are found on the existing roof structure, yet do not appear in the historic photos. The entire roof system and gutters are in poor condition and in need of major repair and replacement (Figure 45).

The skirting is basically in good condition, but adequate care should be taken to remove soil, vegetation and debris from contact with

FIGURE 44 Bevel edge shiplap siding and T1-11 skirting, south wall of Crook House, 1984. Photo by Barry Schnoll, National Park Service.
