historic structure report

architectural data

OFFICERS' QUARTERS HS-11,
LAUNDRESS' QUARTERS HS-6, AND
ENGLISH CAMP HOSPITAL HS-18

DENVER SERVICE CENTER
HISTORIC PRESERVATION DIVISION
NATIONAL PARK SERVICE
UNITED STATES DEPARTMENT OF THE INTERIOR
DENVER, COLORADO

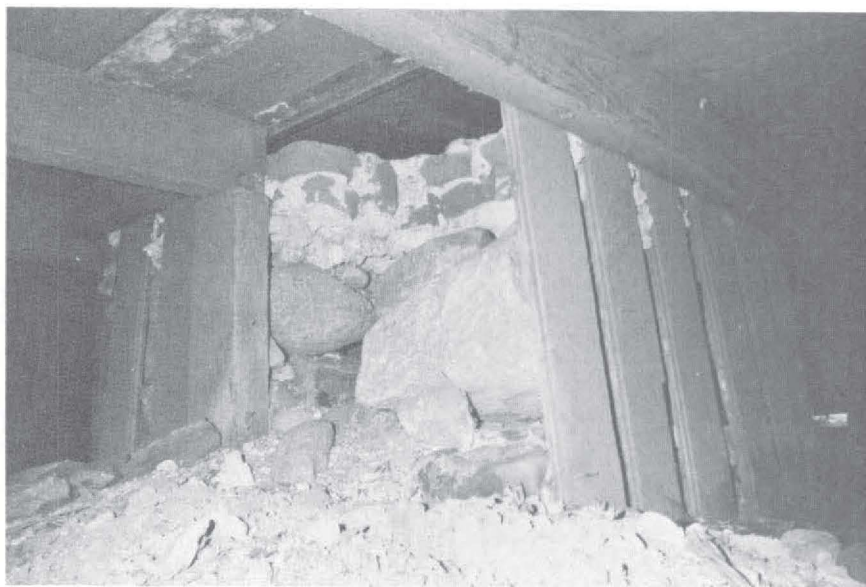
McRae House/Officers' Quarters, HS-11. East end in attic of the basic military structure, ca. 1860. Note the vertical planks on the east gable at the left. The tops of the south wall planks can also be seen beyond.

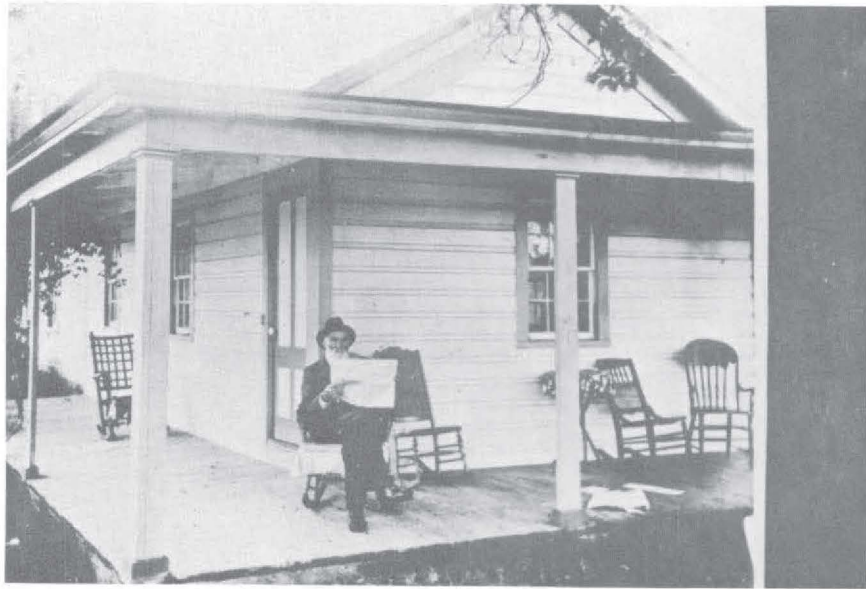
Warbass House/Laundress' Quarters, HS-6, at Kwan Lamah site, just before it was relocated to American Camp. The right half and the porch were taken off before the move. Room 1 is on the left and Room 2 is on the right. The chimney shown is between these rooms, but it is now gone.

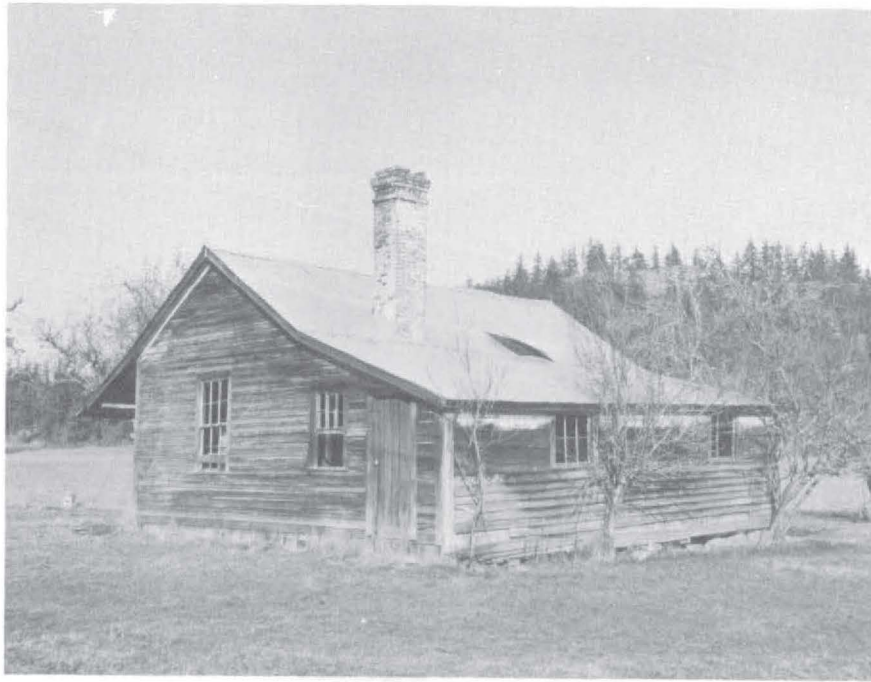
FIGURE 23.

The nature of the Hospital's original foundation may yet be determined by archeological investigation. Photographs taken in 1969 indicate that prior to its relocation the building was supported by timber sill beams on loose stone footings at various points (see Figure 23).

English Camp Hospital, HS-18, at the Lawson farm. The lean-to at the left and the overhang at the right were removed before relocating the original structure at English Camp. This end contains Rooms 1 and 2. Note the joint in the siding between the structure and the lean-to. The date is March 1969.

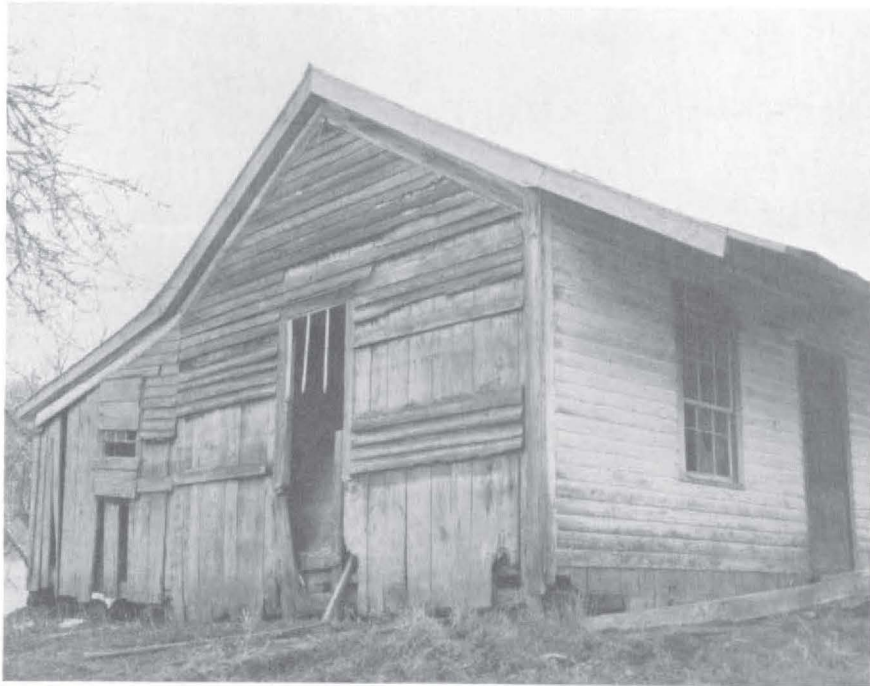
FIGURE 24.

Corner boards occur at the southeast and northwest corners, and there is evidence of a missing corner board at the deteriorated southwest corner. The siding on the east wall is cut off flush with the corner at the northeast, indicating that the siding here was continuous with the former lean-to addition. The siding on the east, then, is no earlier than the lean-to. The 1969 photographs of the Lawson farm support this (compare Figures 22 and 26). These photographs also show the siding interrupted on the west end where the lean-to begins, suggesting that the siding there could be original (compare Figures 23 and 24).

English Camp Hospital, HS-18, after its relocation at English Camp. The west elevation is shown, which is the same end shown in Figure 23. The structure is on temporary footings.

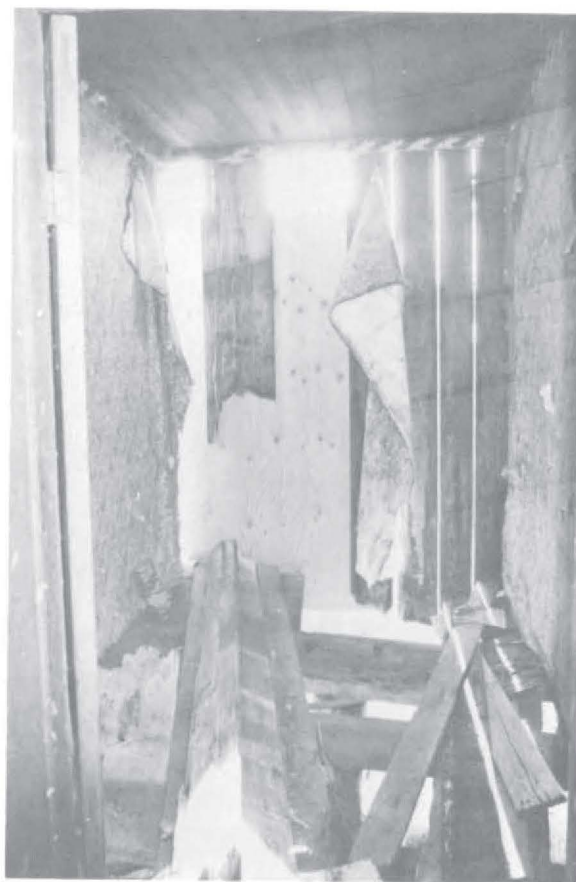
FIGURE 28.

All walls are finished with wallpaper applied to a canvas-type fabric tacked to the wall planks. There is some evidence of whitewash between the wallpaper and fabric. The base trim was not covered. The plate at the ceiling is covered with a wallpaper border. The wallpaper/fabric canvas coverings are loose, and some are hanging partially free of the walls, torn and water stained. Some areas are missing. This material is extremely deteriorated and is not considered salvageable (see Figure 28).

English Camp Hospital, HS-18. Interior of Room 2. Note the extremely poor condition of the fabric except at the ceiling. The plywood behind the wall planks attempts to protect the structure from weather. Wallpaper is still extant on the side walls, but is in poor condition.
