# GENERAL PHILIP SCHUYLER HOUSE KITCHEN AND KITCHEN PASSAGEWAY

Historic Structure Report Addendum

**NOVEMBER 2022**

**JOHN G. WAITE ASSOCIATES, ARCHITECTS**

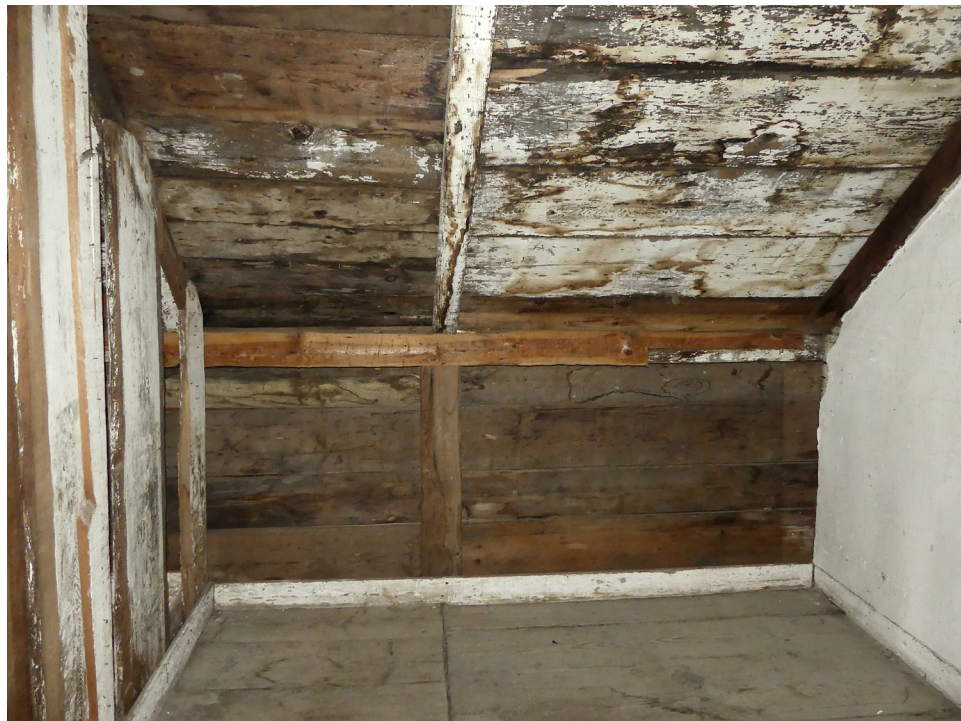
Figure 112. South room (207), looking south. Note the original brick nogging has been removed (compare with Figure 46). JGWA, 2019.

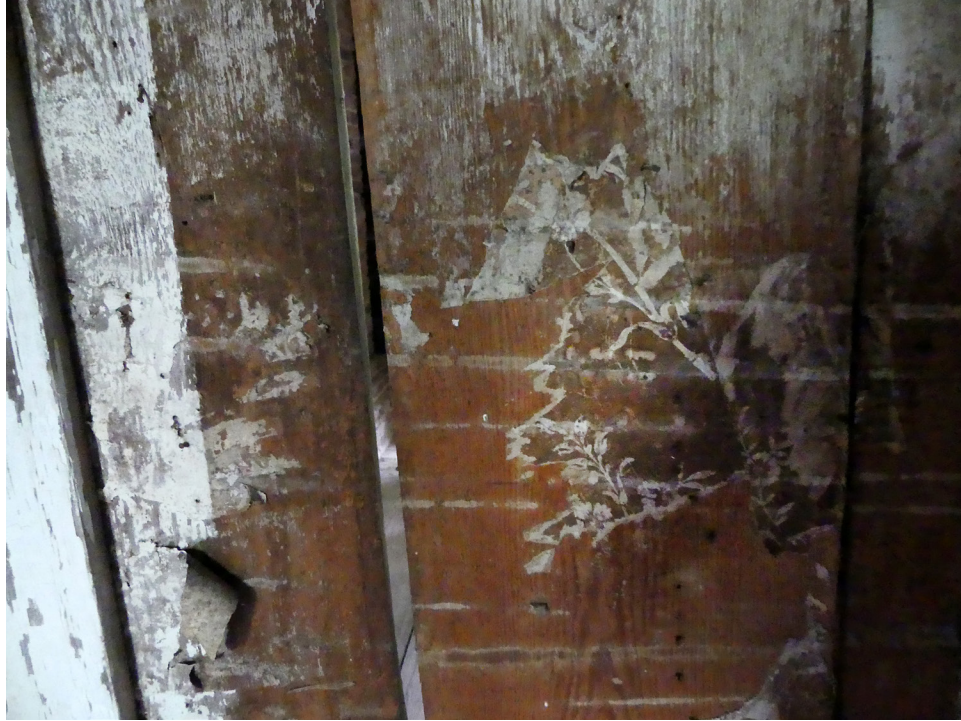
Figure 113. Fragments of eighteenth-century wallpaper on the boards forming the east partition of the south room (207). JGWA, 2020.

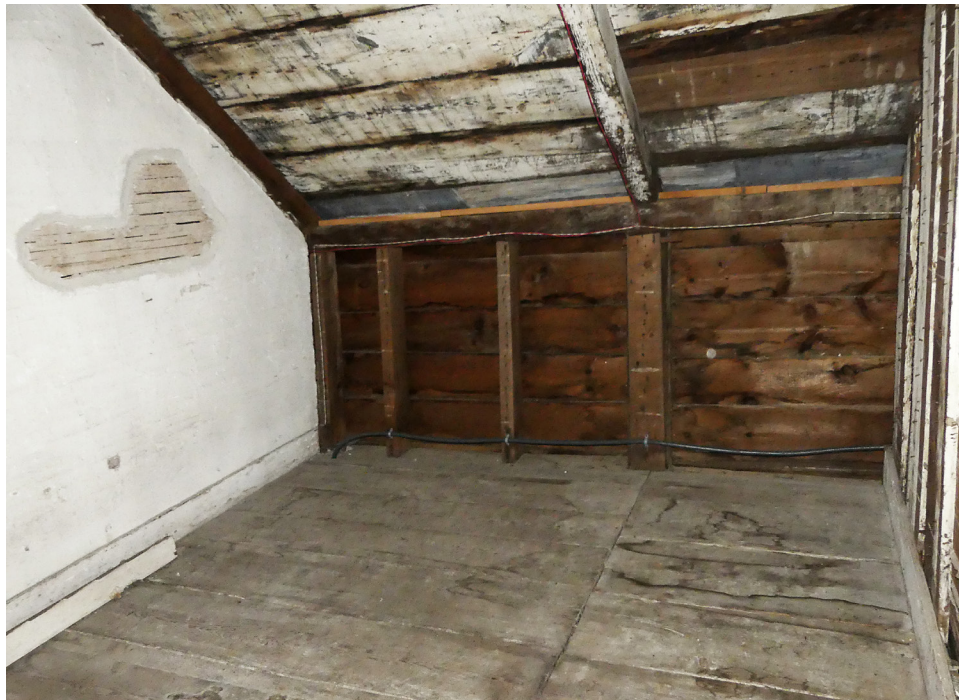
Figure 115. North room (208), looking north. Note that the brick nogging has been removed. JGWA, 2020.

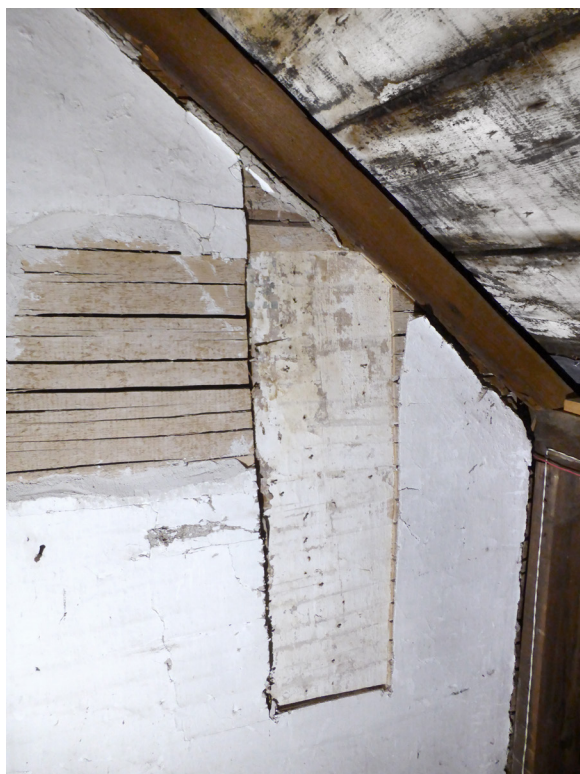
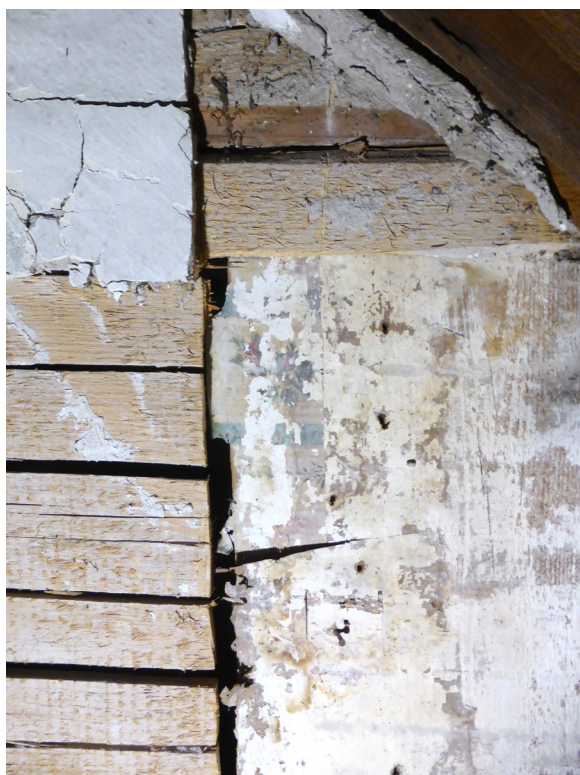
**Figure 116. North room (208) wallpaper probe. A section of plaster was removed from one of the board “studs” to reveal early nineteenth-century wallpaper remnants on the vertical wood plank partition. JGWA, 2021.**

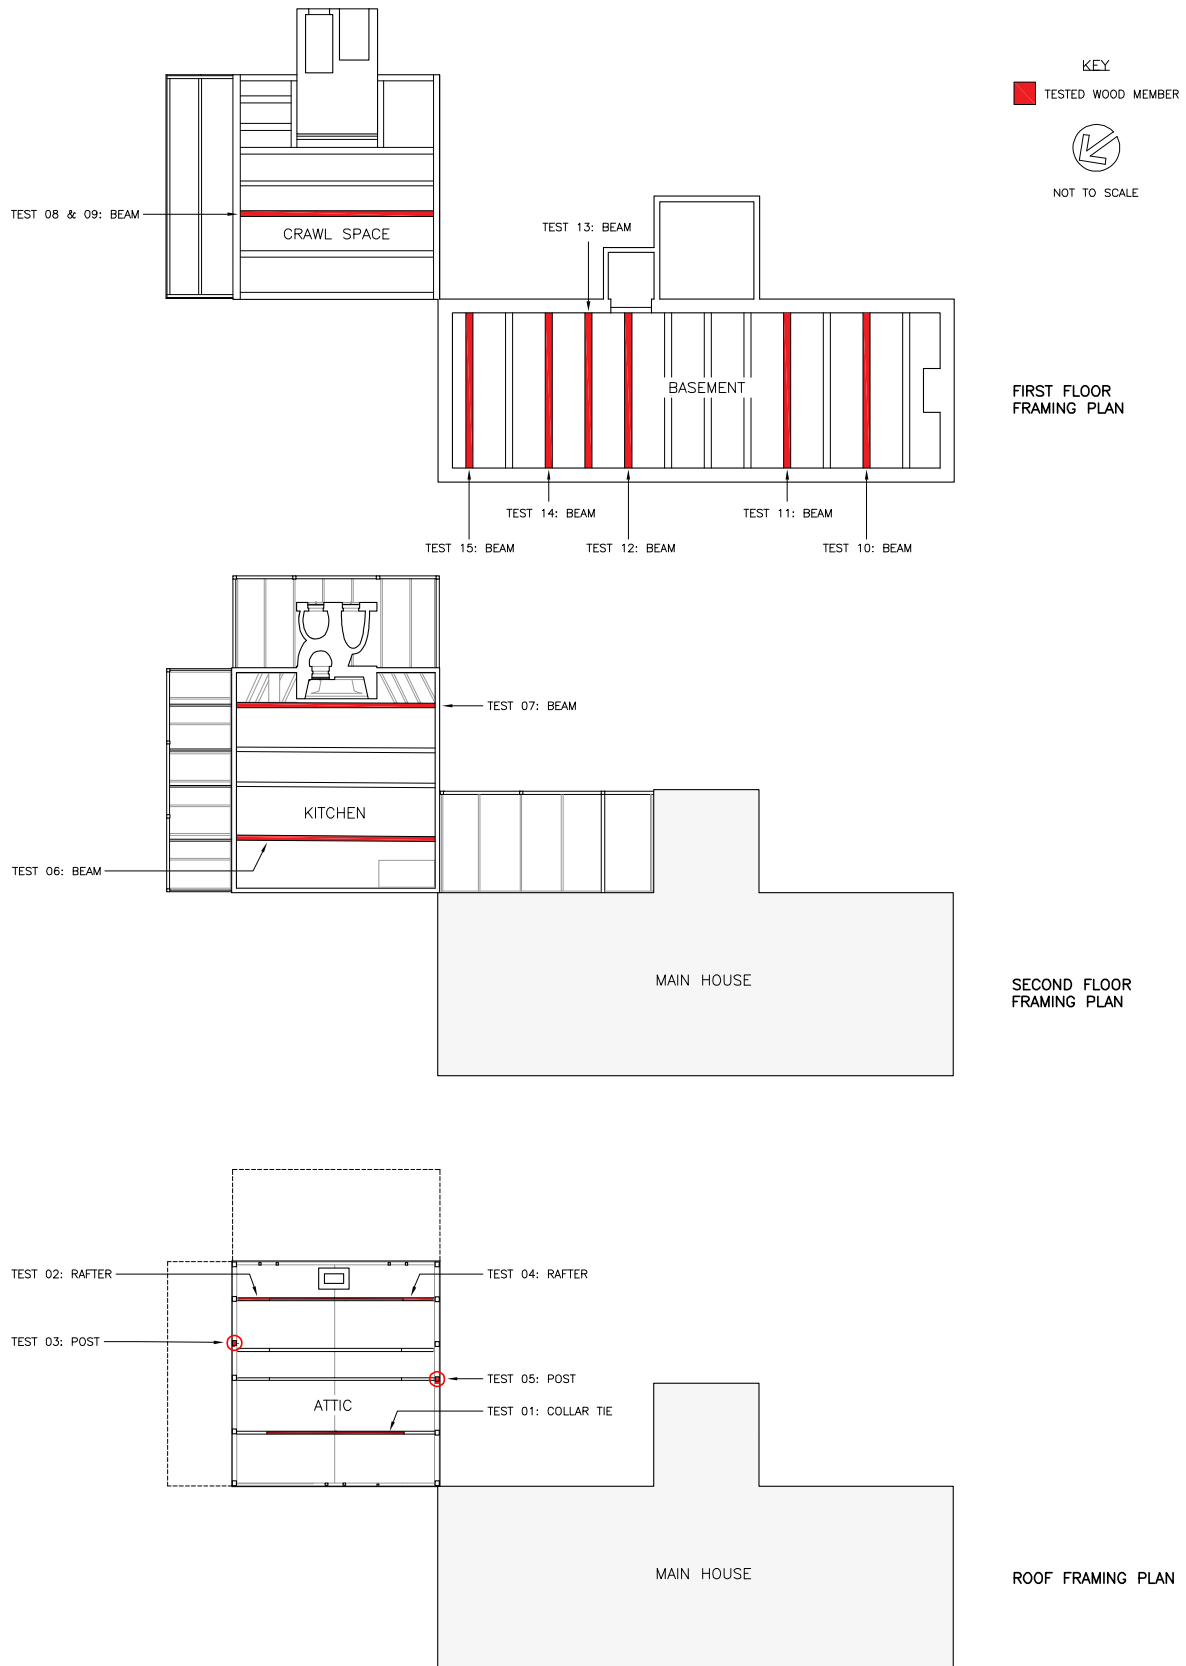
The results of the dendrochronological dating of the timbers collected from the Schuyler House are summarized in **Table 1** and **Figures 1 & 2**. A total of 15 samples from 14 timbers were analyzed in the laboratory: all were pitch pine (*Pinus rigida*.). All 15 provided absolute dates. Of the 15 dated samples, 6 had bark/wane indicating the precise cutting year. All of the other 9 samples had outermost extant rings lying chronologically congruent with the indicated cutting year; field notes indicate that several of these had bark and/or wane present at the start of sampling, lost together with some few rings due to surface degradation during extraction.

**Figure 1.** Schematic diagram showing the test locations of the 15 pitch pine samples taken and dated from the General Schuyler House.

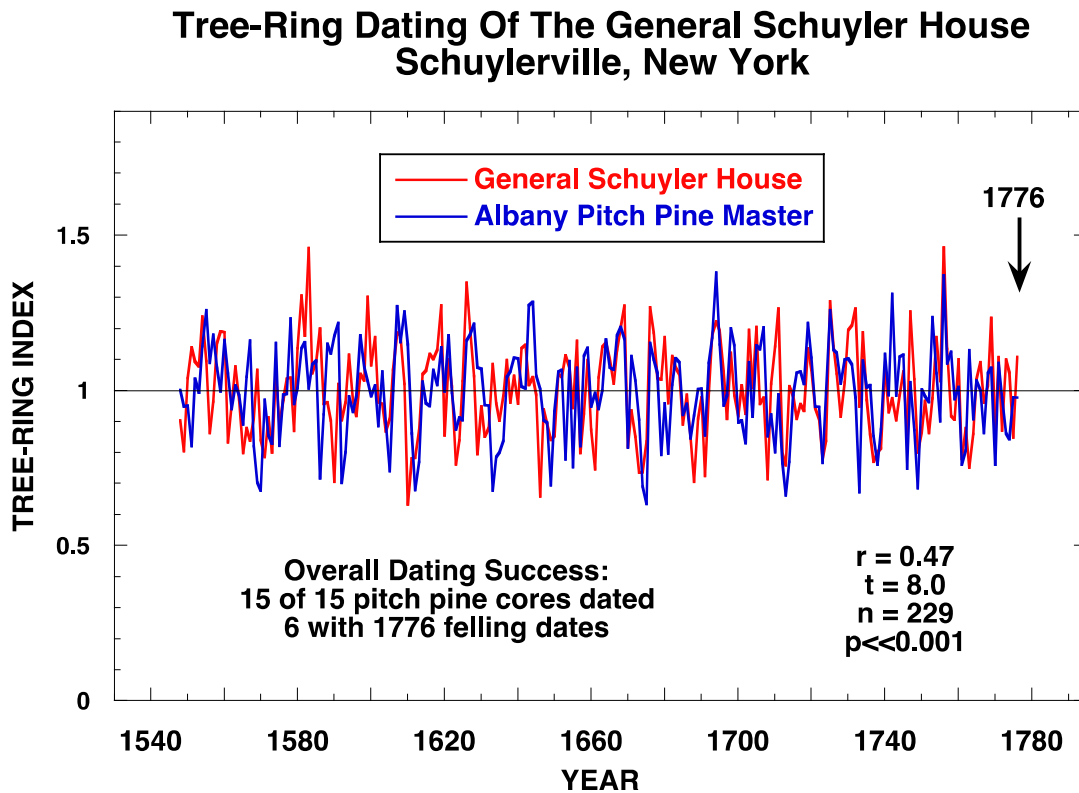
**Figure 2.** Comparison of the composited pitch pine chronology from the timbers of the Schuyler House, Schuylerville, New York against an independent, historical pitch pine master chronology from northern New York.

The strength of cross-dating indicated ( $t=8.0$ ) is statistically very strong ( $t>>3.5$ ) and the 1776 ring was completely formed, thus indicating that the timbers used to construct the General Schuyler House were felled sometime between the end of the 1776 growth season and before the start of the 1777 growth season.
