HISTORICAL OVERVIEW AND ASSESSMENT OF CIVILIAN  
CONSERVATION CORPS ROCK WORK ALONG GENERALS HIGHWAY FROM  
ASH MOUNTAIN TO GIANT FOREST IN SEQUOIA NATIONAL PARK

HARLAN D. UNRAU  
HISTORIAN  
WESTERN TEAM  
DENVER SERVICE CENTER

AUGUST 1988

#### E. PHOTOGRAPHS OF EXISTING ROCK WORK CONDITIONS

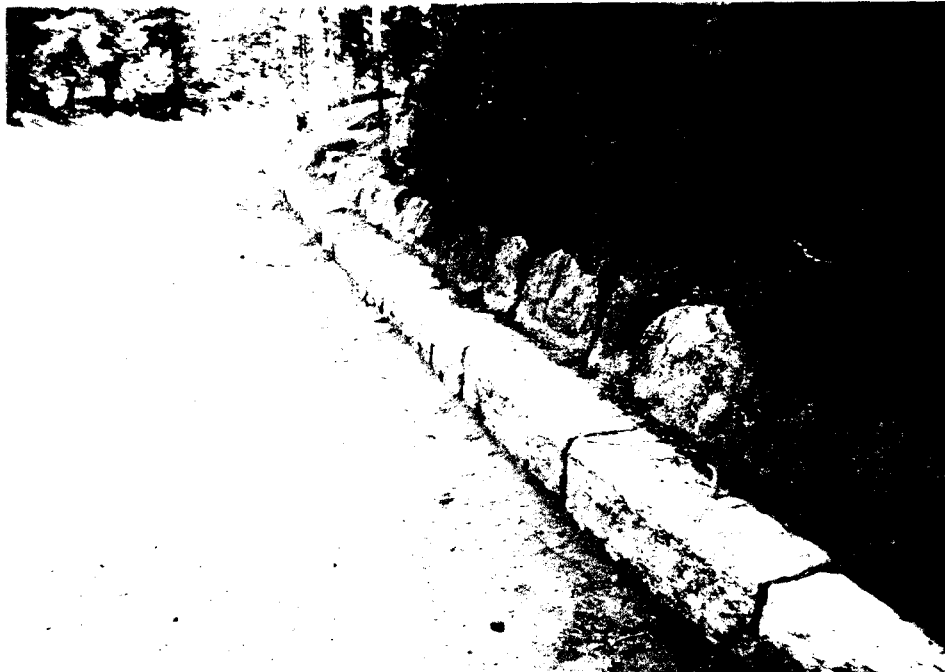
Photograph No. 3 -- Cut stone curbing and rock bench  
along highway across from Giant Forest Market Plaza

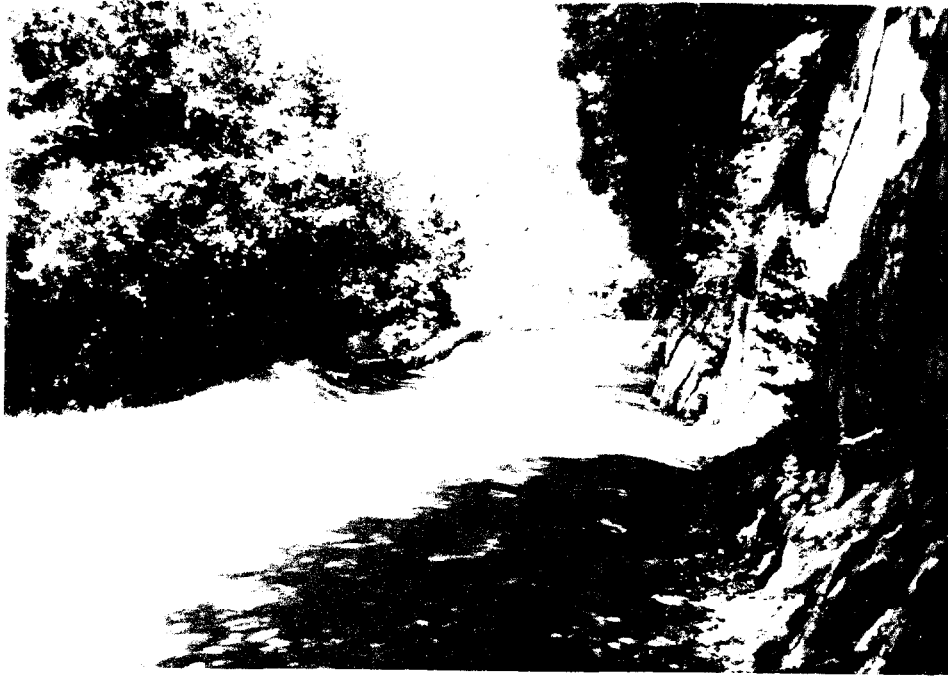
Photograph No. 19 -- Parapet wall on downslope side  
of highway just above Granite Spring  
(4.7 Miles below Giant Forest Market)

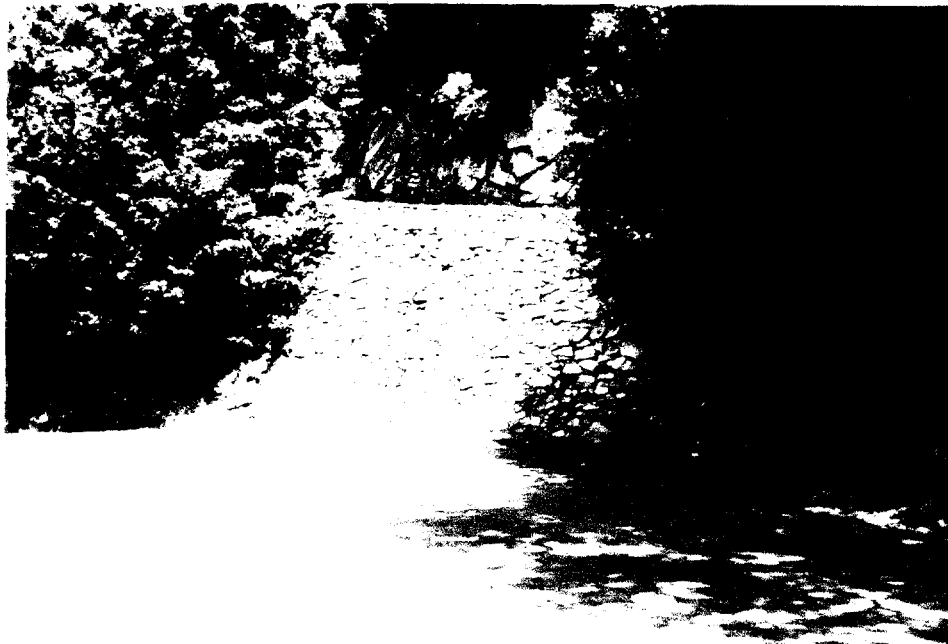
Photograph No. 20 -- Stone retaining wall on S-curve just above  
Granite Spring; parapet wall in Photograph No. 19 forms  
top of this retaining wall

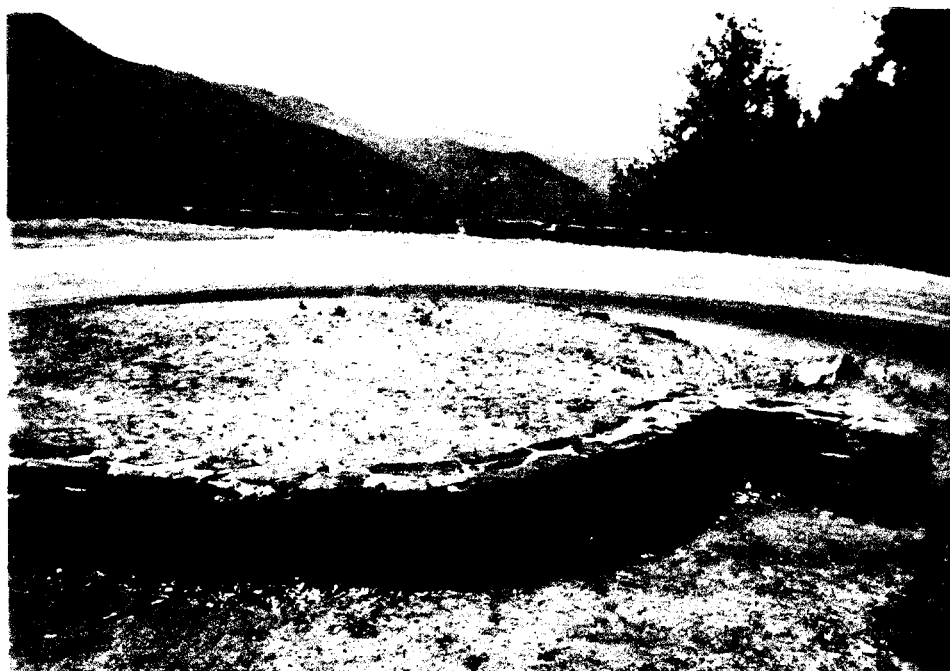
Photograph No. 23 -- Amphitheater Point parapet wall on downslope  
side of highway in background and circular platform parapet  
wall on upslope side of highway in foreground  
(5.55 miles below Giant Forest Market)

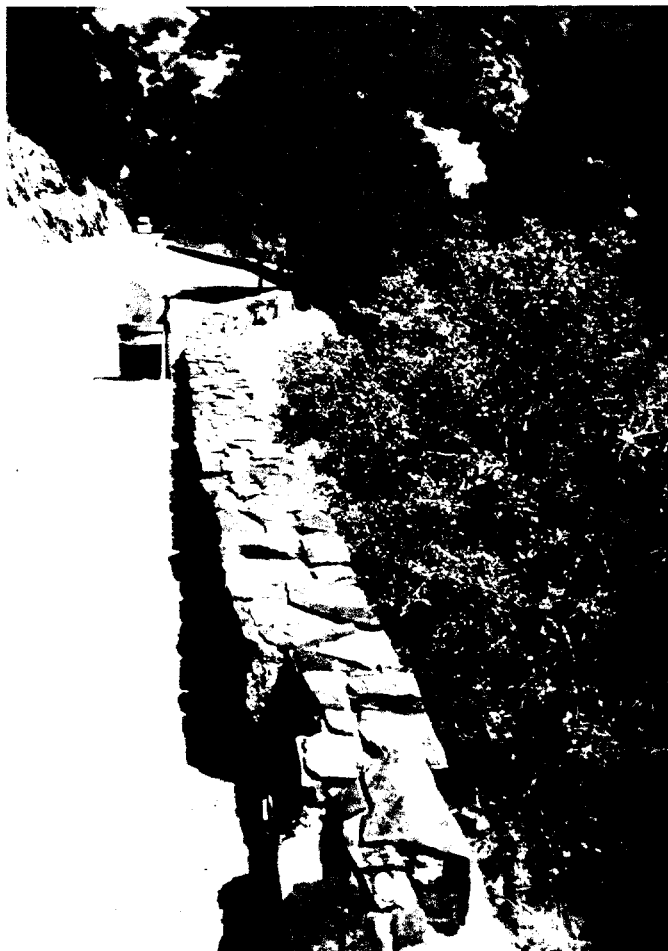
Photograph No. 24 -- Amphitheater Point overlook  
parapet wall along downslope side of highway  
(5.55 miles below Giant Forest Market)

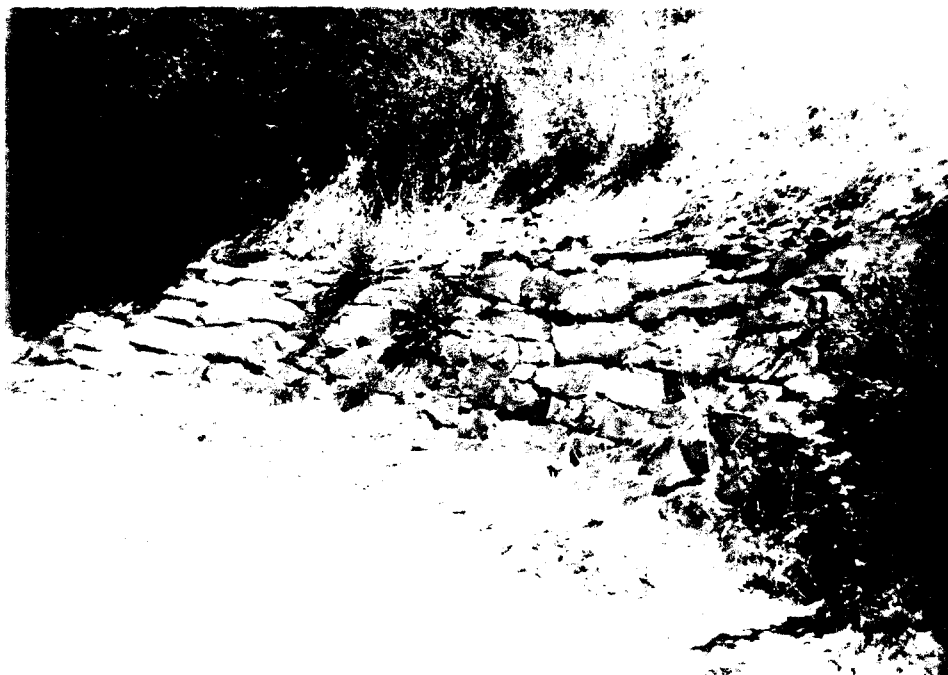
Photograph No. 27 -- Sloping retaining wall along upslope  
side of highway just above Black Oak Corner  
(6.5 miles below Giant Forest Market)

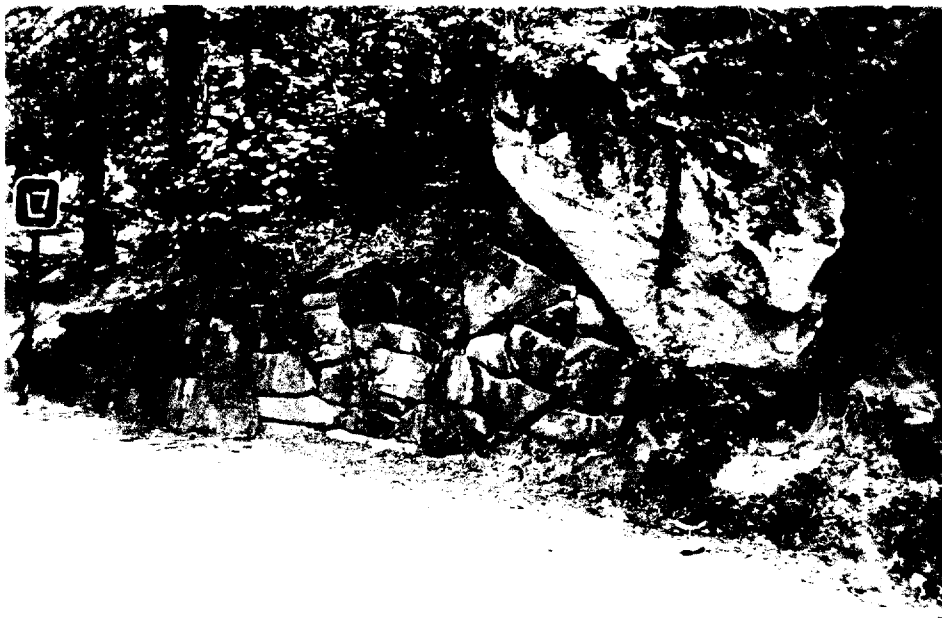
Photograph No. 29 -- Big Fern Spring rock work along upslope side of highway; watering station at left (6.95 miles below Giant Forest Market)

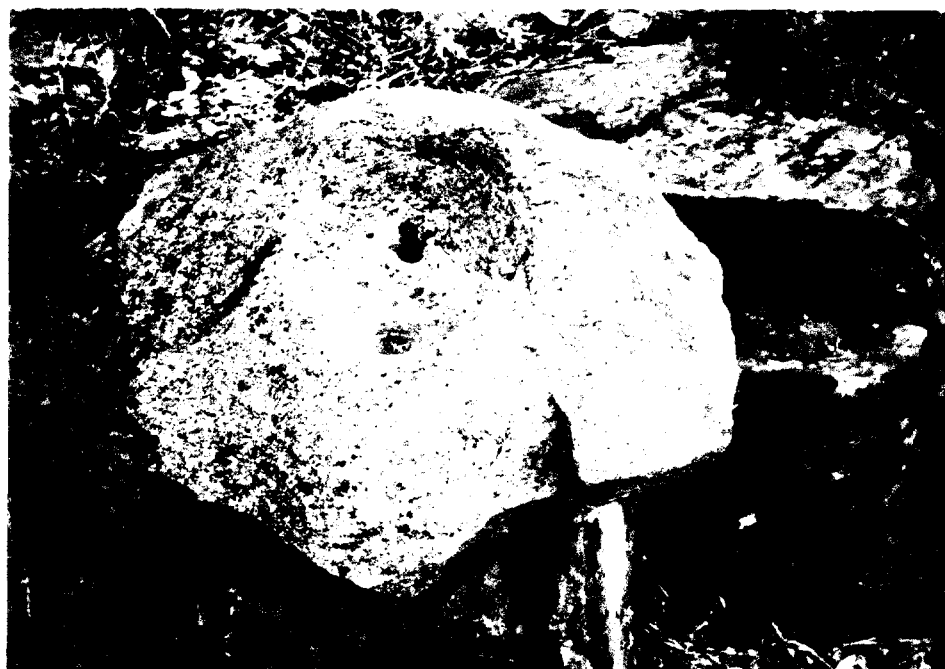
Photograph No.32 -- Big Fern Spring stone water  
fountain on upslope side of highway  
(6.95 miles below Giant Forest Market)

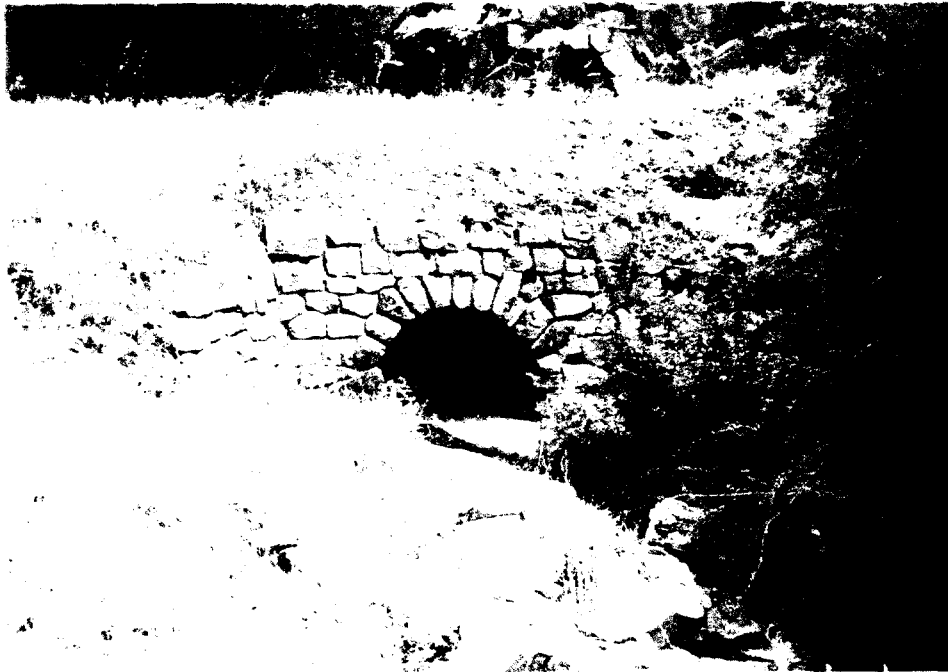
Photograph No. 33 -- Double stone culvert  
headwalls on S-curve along highway  
(7.95 miles below Giant Forest Market)

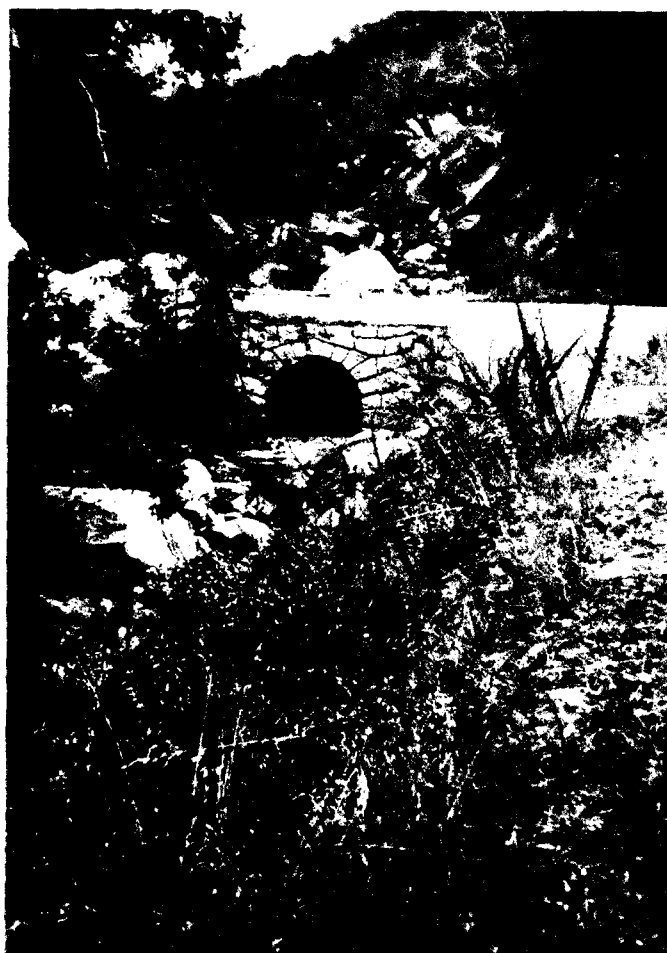
Photograph No. 38 -- Double stone culvert headwalls  
on S-curve along highway  
(10.15 miles below Giant Forest Market)

4. After culverts with rock head walls have been lengthened/widened the rock head walls should be replaced using the original stone.

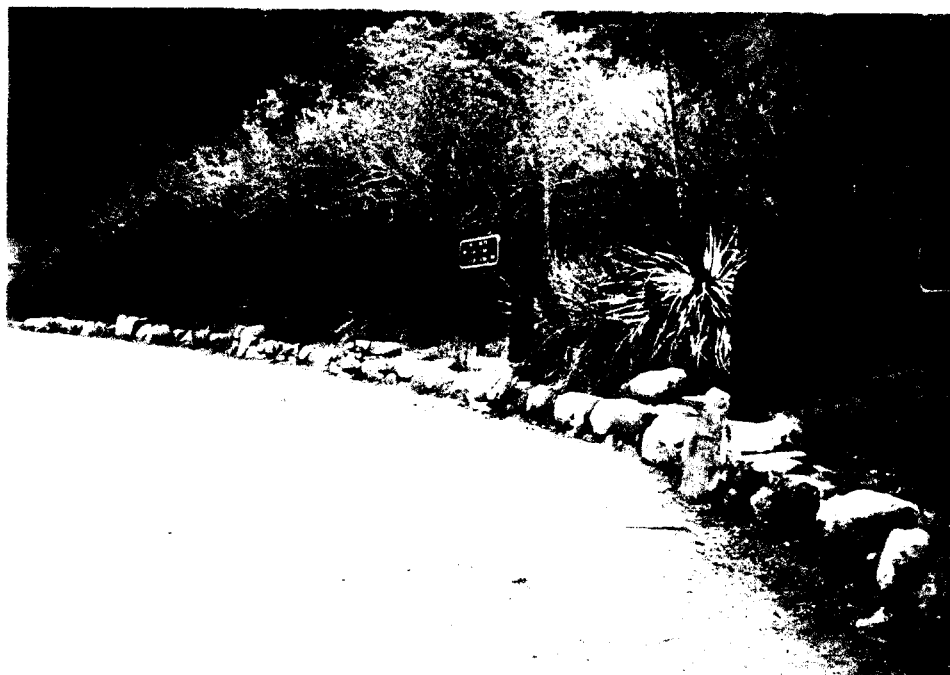
Photograph No. 39 -- Hospital Rock stone curbing and  
five-post watering station along upslope side of highway  
(10.25 miles below Giant Forest Market)

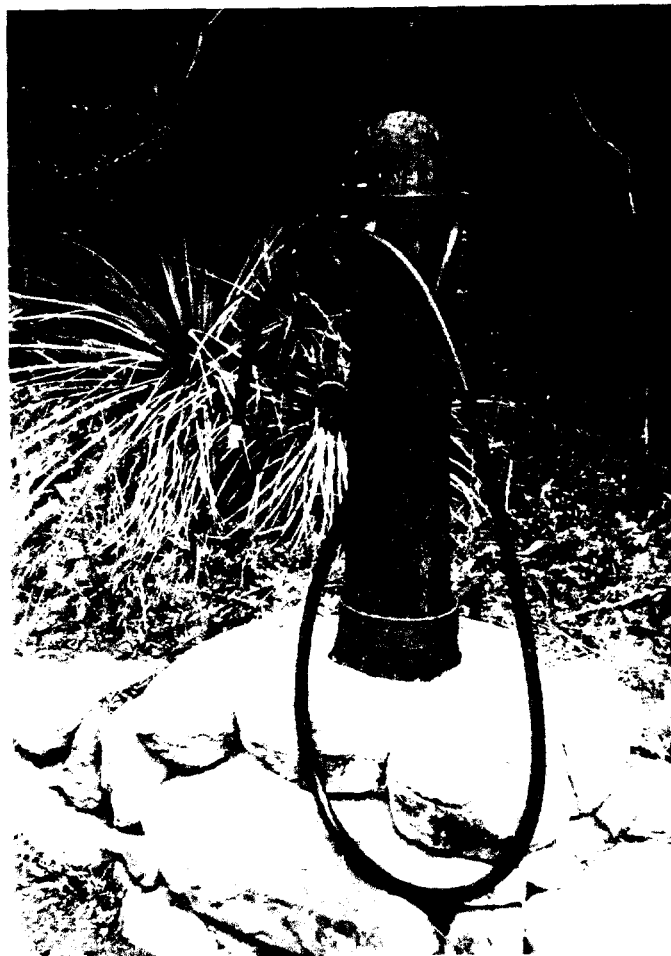
Photograph No. 40 -- Close-up of Hospital Rock watering station  
post and curbing along upslope side of highway  
(10.25 miles below Giant Forest Market)

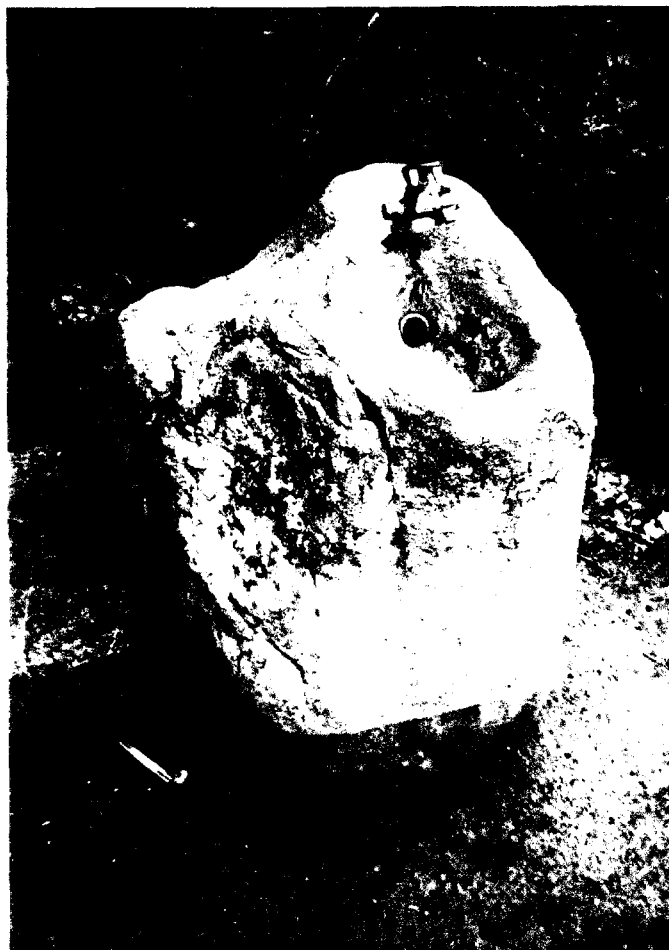
Photograph No. 41 - Hospital Rock stone drinking  
fountain along upslope side of highway  
(10.25 miles below Giant Forest Market)

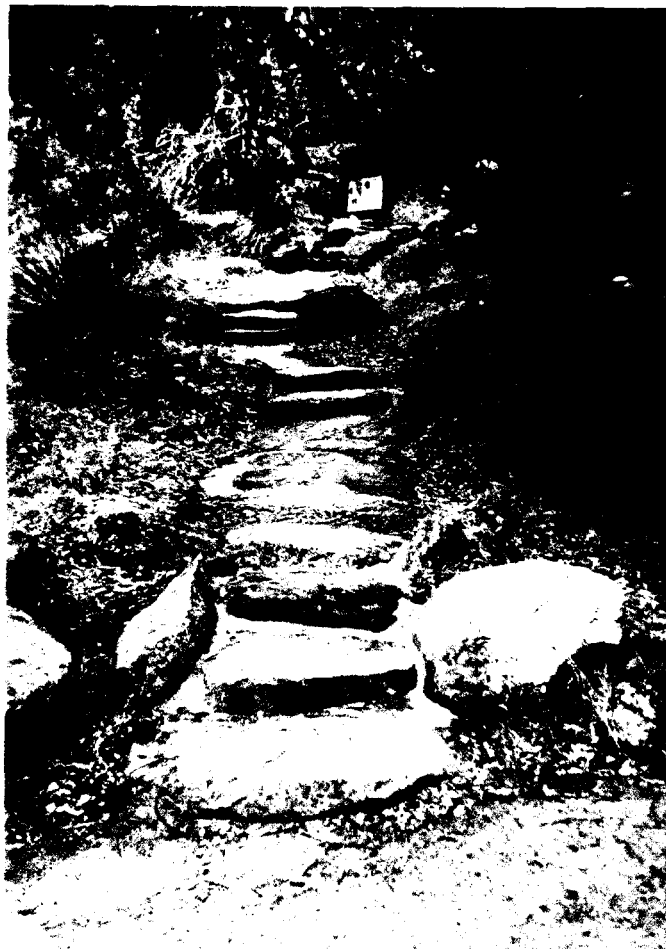
Photograph No. 42 -- Cut stone masonry steps leading to  
exhibit at Hospital Rock along upslope side of highway  
(10.25 miles below Giant Forest Market)

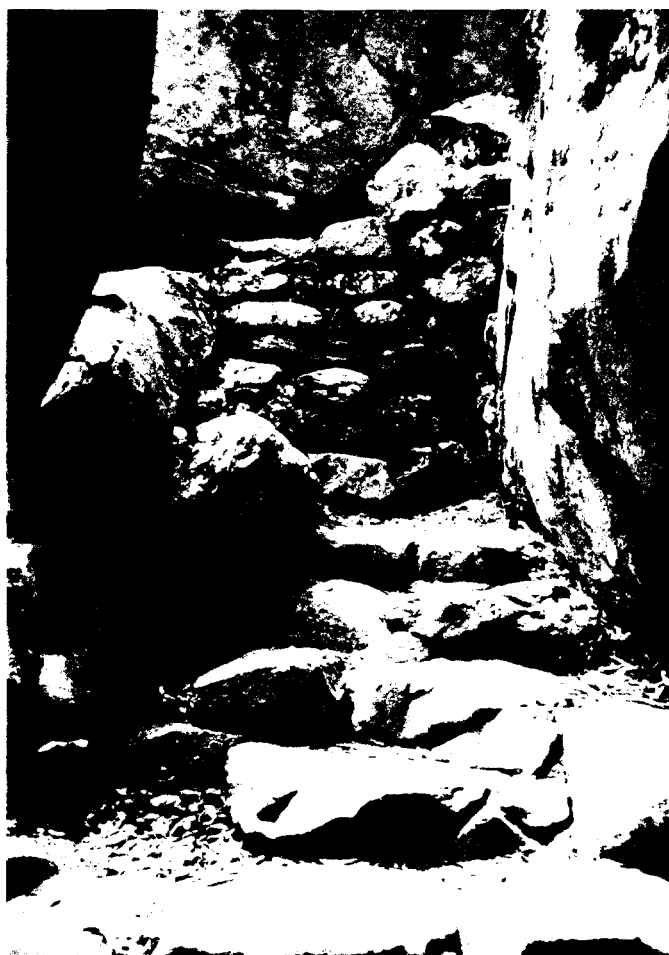
Photograph No. 44 -- Hospital Rock river trail stone work  
(10.25 miles below Giant Forest Market)

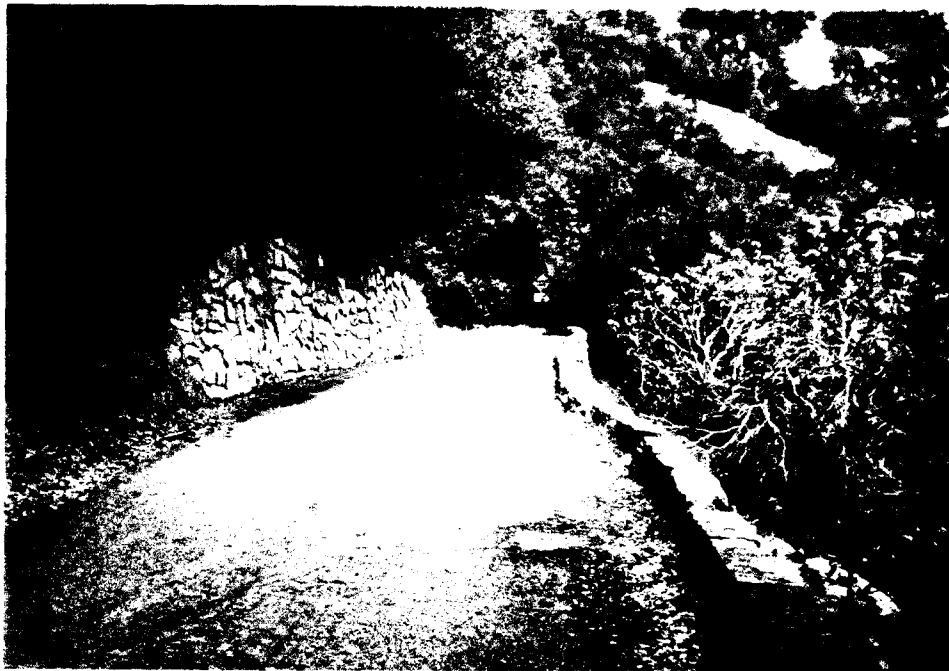
Photograph No. 45 -- Buckeye Flat Camp Road stone retaining wall and parapet wall curbing near Hospital Rock (10.25 miles below Giant Forest Market)

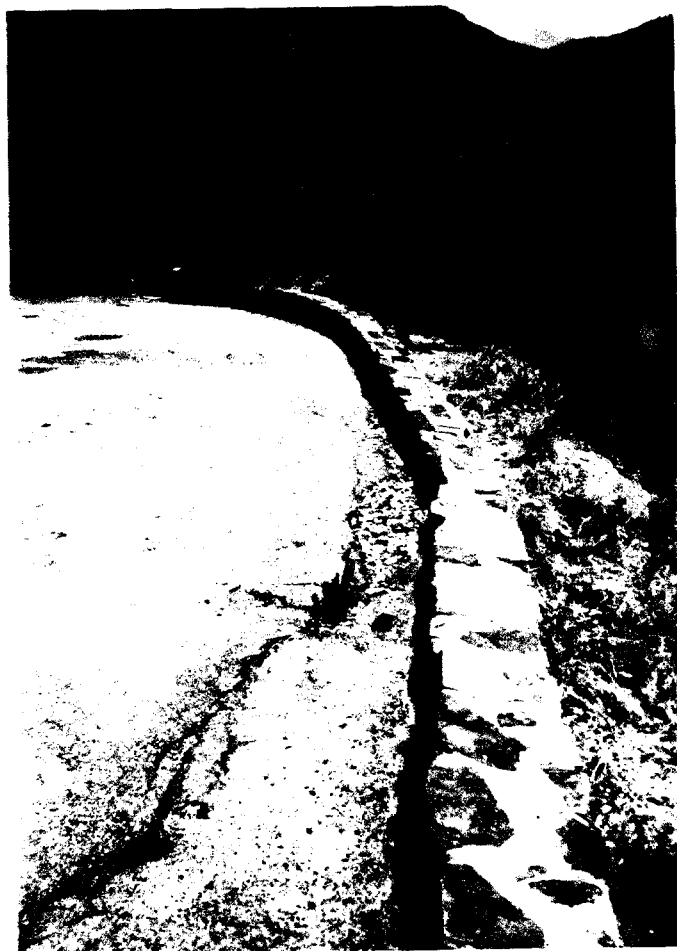
Photograph No. 46 -- Mt. Stewart turnout parapet  
wall along downslope side of highway  
(11.0 miles below Giant Forest Market)

2. All widening of the highway from the south park entrance to Giant Forest should be conducted on the downslope side of the roadway. Where parapet walls along the highway, turnouts, and overlooks are impacted, they should be replaced with concrete and stone veneer using the rock from the impacted walls. This would ensure that such walls meet present highway safety standards and yet blend with the rustic, rural character of the road. Stone gutters should also be replaced using the original stone.

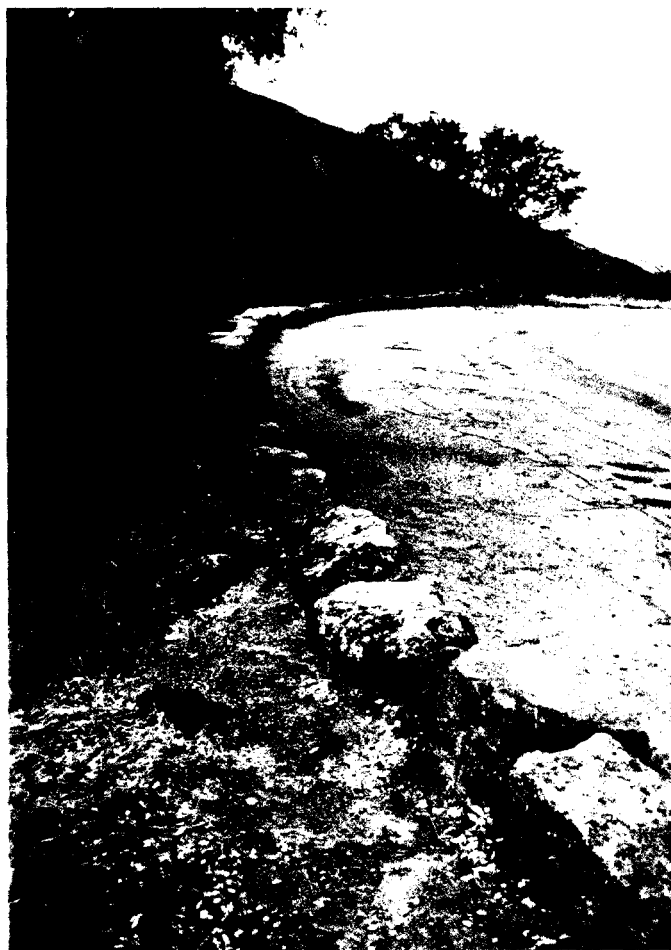
Photograph No. 47 --- Stone or boulder parapet wall lining  
typical turnout on curve of downslope side of highway  
(11.2 miles below Giant Forest Market)

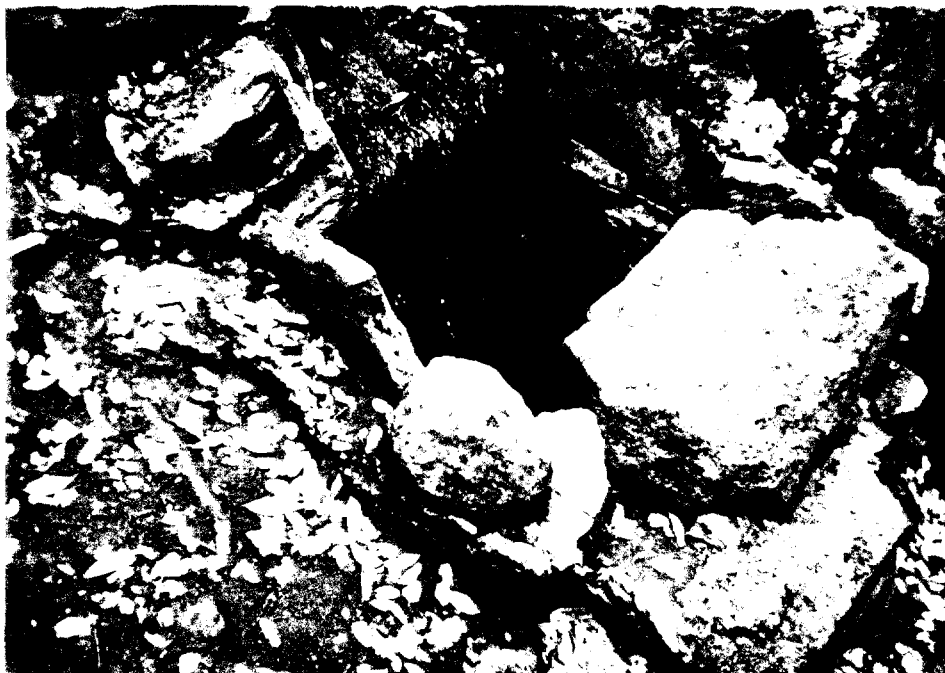
Photograph No. 48 -- Culvert and drain along upslope  
side of highway just above Tunnel Rock  
(13.7 miles below Giant Forest Market)

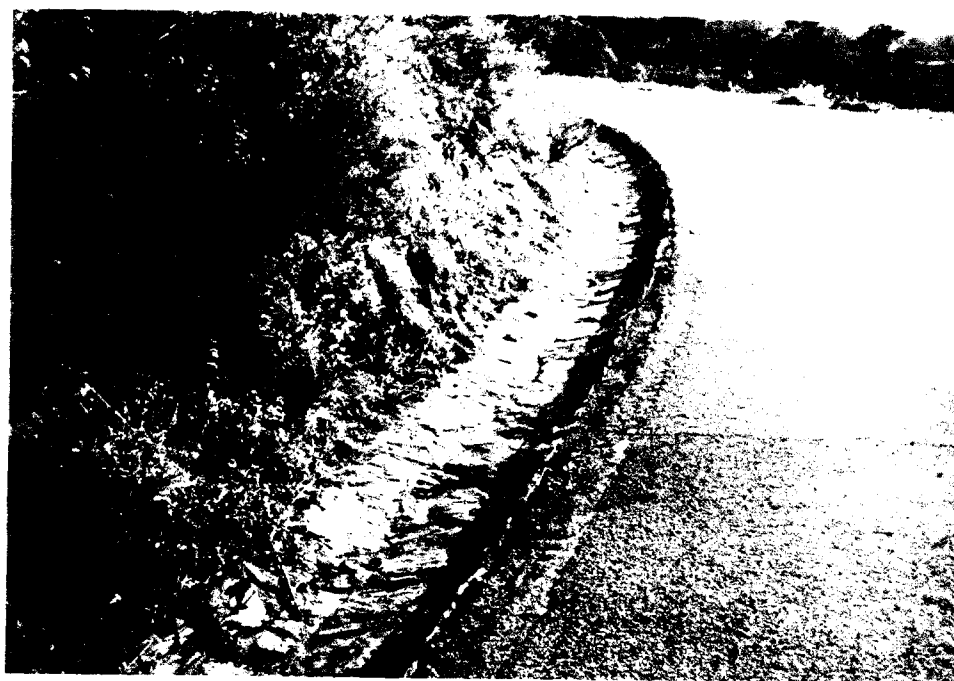
Photograph No. 52 -- Stone-lined gutter on upslope  
side of highway near Ash Mountain  
(15.1 miles below Giant Forest Market)

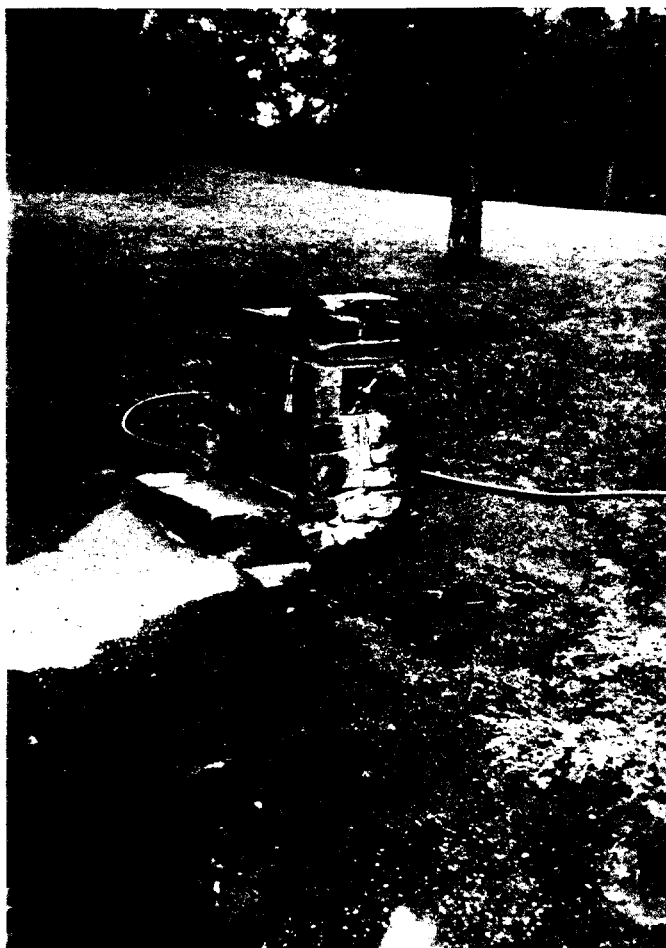
Photograph No. 56 -- Cut stone drinking fountain along  
highway across from Ash Mountain Visitor Center  
(15.1 miles below Giant Forest Market)

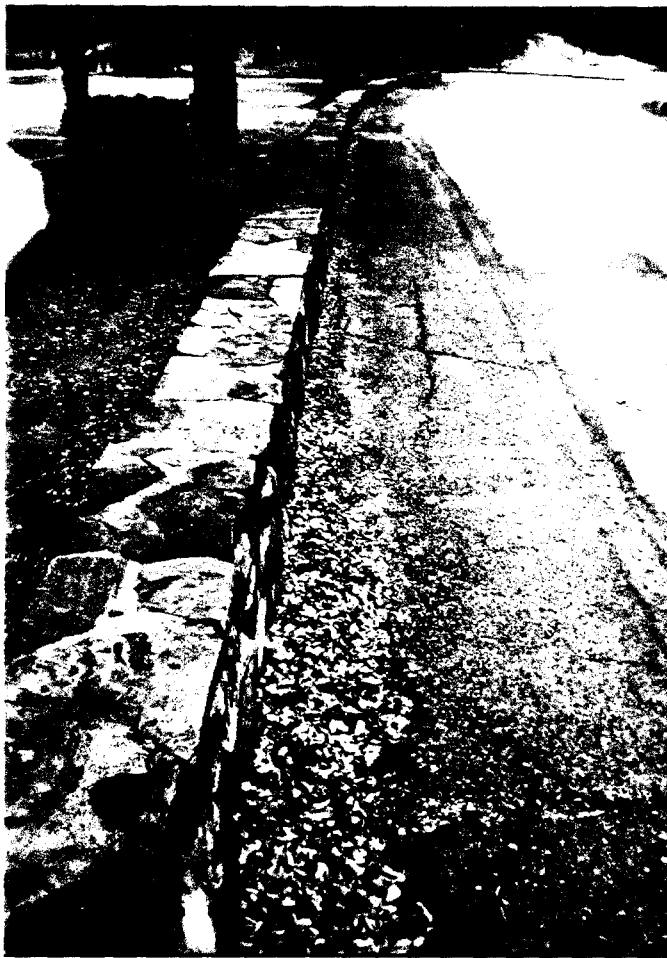
Photograph No. 58 -- Stone parapet wall along highway with  
Ash Mountain Visitor Center parking lot in upper left  
(15.1 miles below Giant Forest Market)

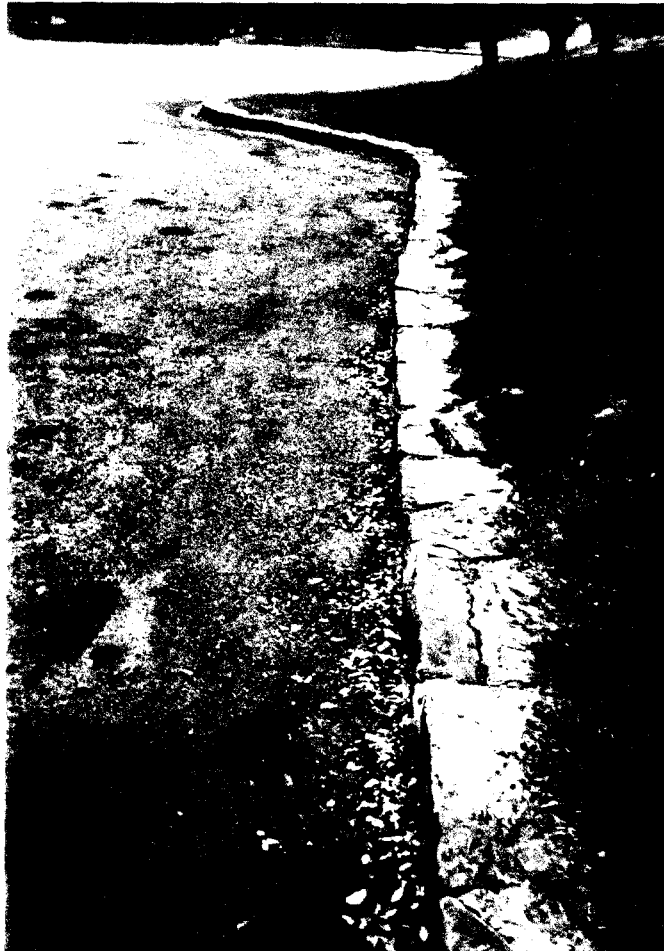
Photograph No. 59 -- Stone curbing on turnout along highway  
across from Ash Mountain Visitor Center  
(15.1 miles below Giant Forest Market)

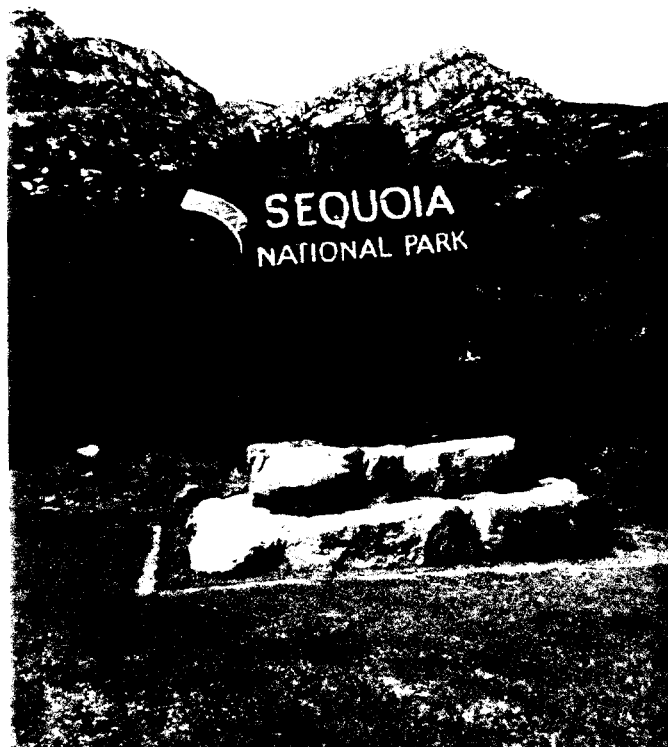
Photograph No. 65 -- Distinctive Sequoia National Park Indian head  
sign at turnout just above south park entrance  
(15.9 miles below Giant Forest Market)

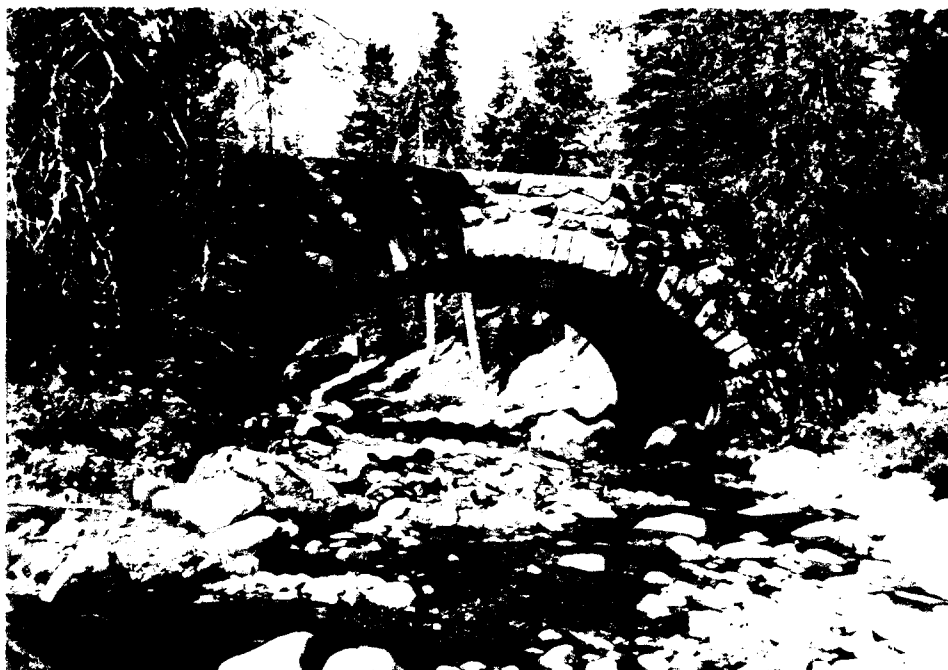
Photograph No. 74 -- Masonry rock parapet wall on bridge over  
Marble Fork of Kaweah River on upslope side of highway

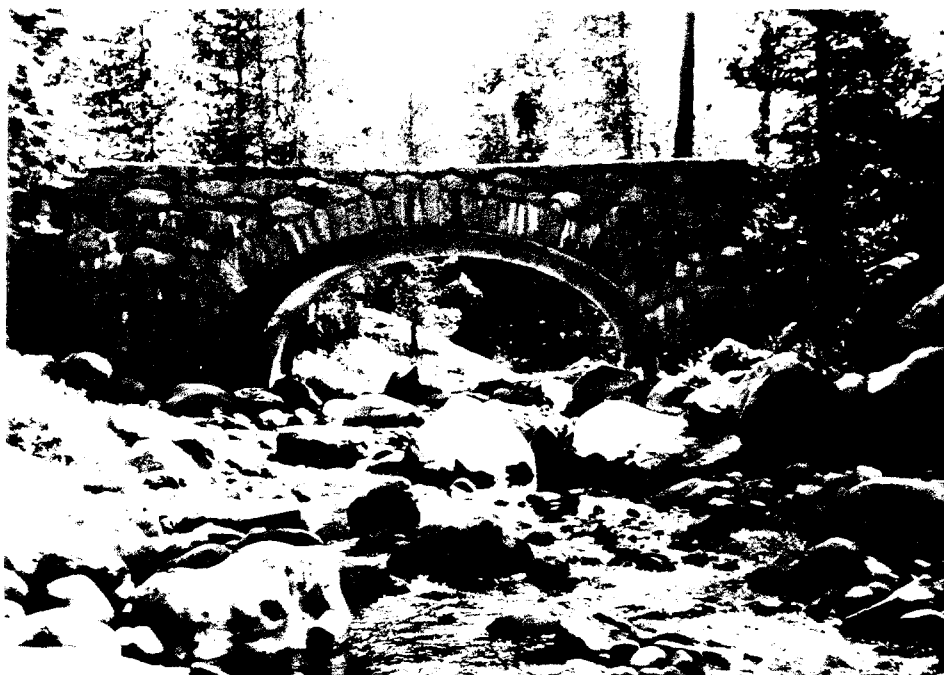
Photograph No. 75 -- Stone bridge over Marble Fork  
of Kaweah River looking upstream

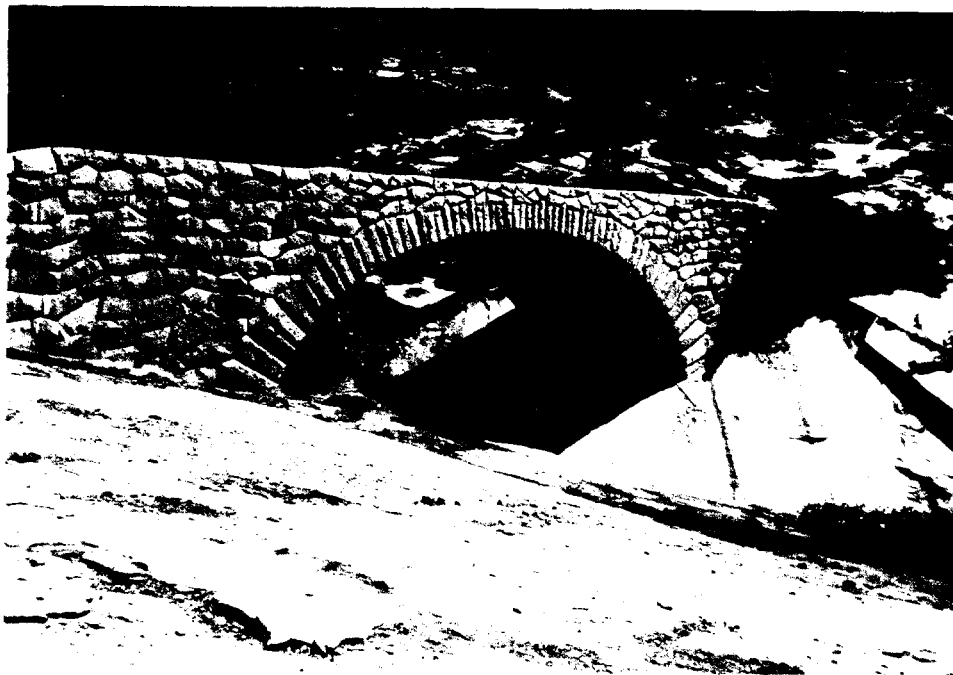
Photograph No. 78 -- Stone masonry culvert; upstream side  
(4.55 miles above Giant Forest Market)

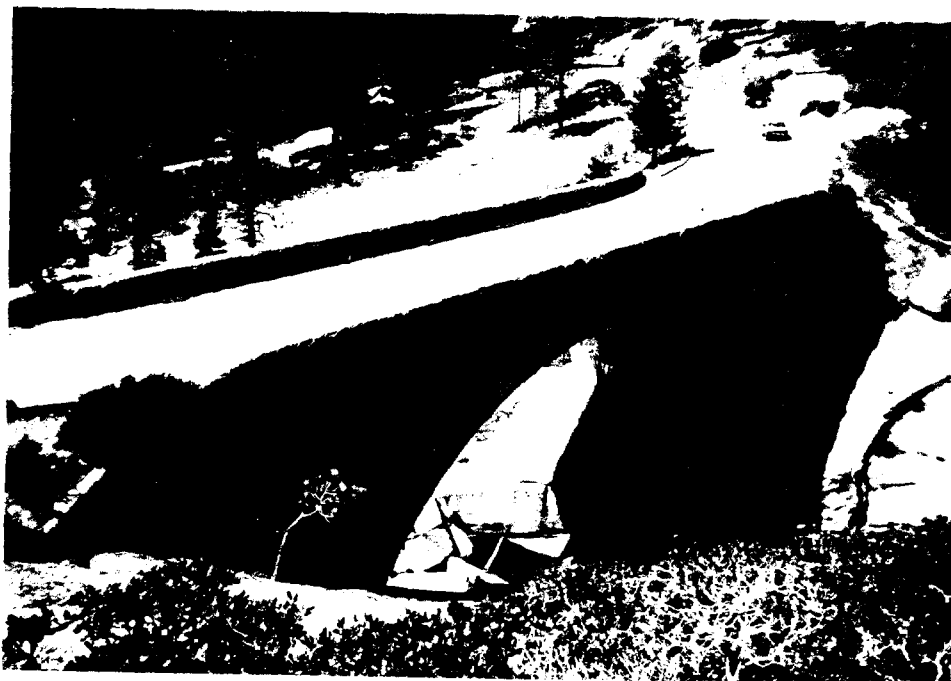
Photograph No. 80 -- Clover Creek Bridge stone parapet wall along downslope side of highway

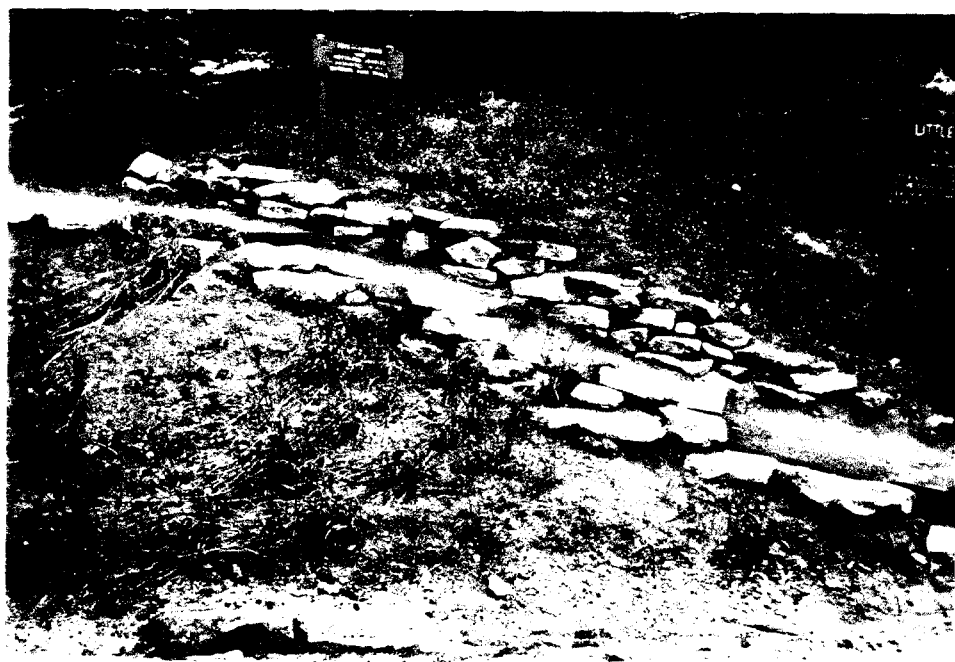
Photograph No. 85 -- Rock-lined Little Baldy trail  
head along upslope side of highway

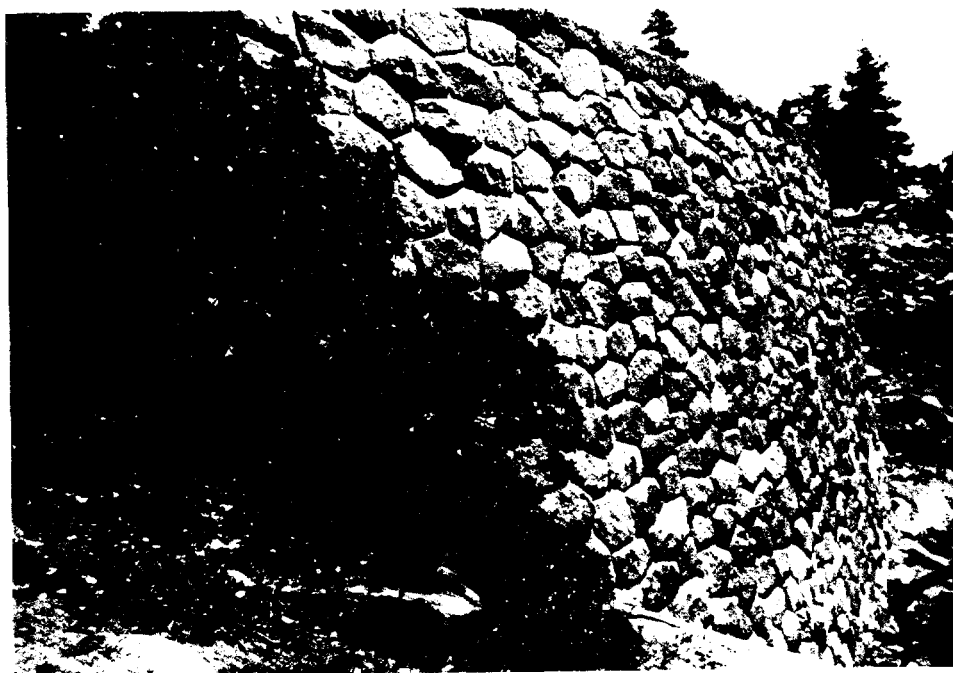
Photograph No. 93 -- Masonry parapet wall along downslope side of highway just above Redwood Mountain Grove turnout
