Civilian Conservation Corps  
Technical Building  
Historic Structure Report  
Piney River, Shenandoah National Park  
Luray, Virginia  
September 2020

# Civilian Conservation Corps (CCC) Technical Building

Shenandoah National Park

Lowell, Massachusetts  
September 2020

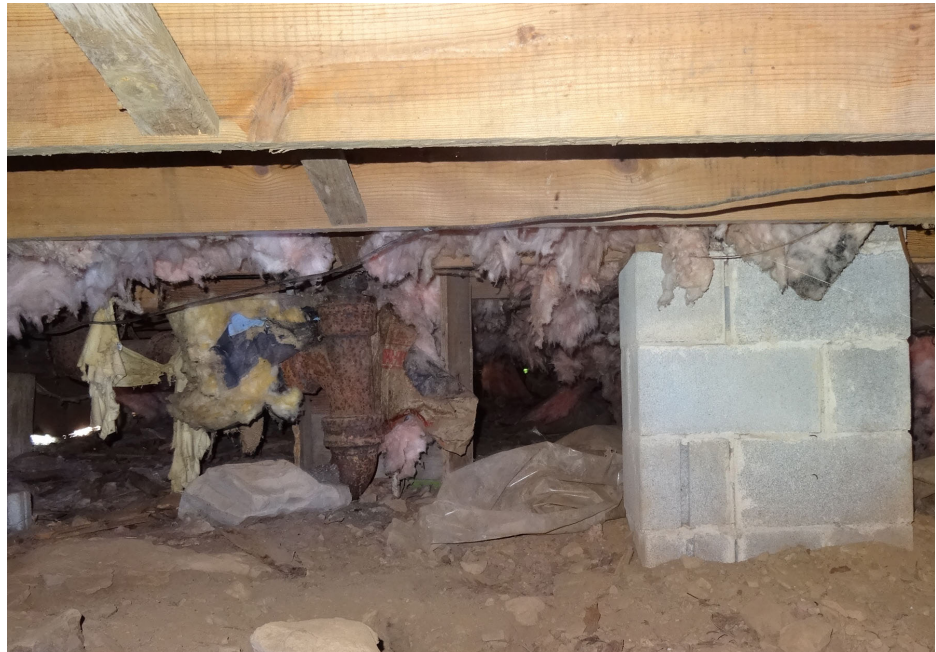
in places. Cast iron plumbing pipes are centrally located near the concrete block chimney. (Figure 4.3) The central brick chimney is covered with stone veneer. The ell and northwest corner of the main structure is inaccessible to inspection, but from the exterior it is clear that floor joists are resting on the ground.

**Figure 4.3.** (top) Crawlspace, looking north at concrete block chimney and plumbing pipe, August 24, 2020. (Image by Brinnen Carter)

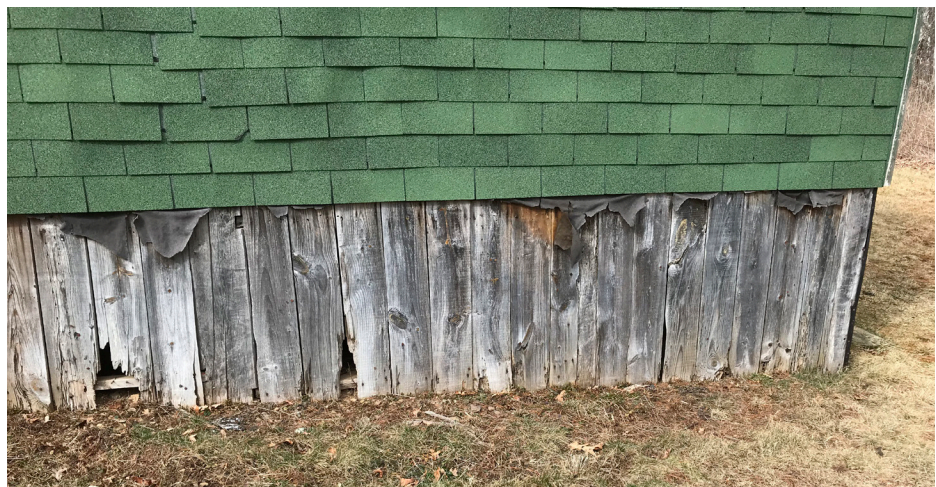
The crawlspace is enclosed with vertical wood boards covered with a mixture of materials, from asphalt siding to wood shingles. As seen from the exterior, the east elevation has a mix of textured green or black asphalt siding covering crawlspace openings. Vertical wood boards cover the south elevation crawlspace. (Figure 4.4) The west elevation crawlspace covering is vertical and horizontal wood boards. The north elevation crawlspace has vertical wood boards covering its opening. All of the crawlspace vertical wood coverings are attached to horizontal nailer boards located below the structure's plate and mortised into the top of the foundation pier logs. Another vertical board is mortised into the bottom of the foundation pier logs.

**Figure 4.4.** (right) South elevation crawlspace vertical wood covering, February 25, 2020. (Image by author)

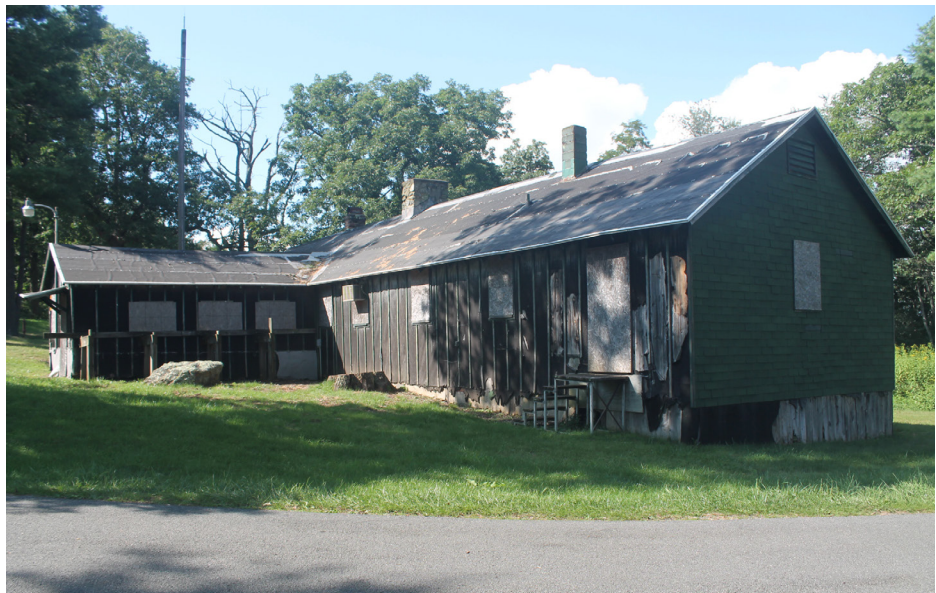
The main structure has a wood-frame, side-gabled roof with open rafter tails. The rafter tails on the west elevation have additional wood shims on their underside. (Figure 4.5) The west ell has a front-gabled roof covered in black tar paper and has open rafter tails. Half-round metal gutters are attached to the ell's north elevation roof line and the main structure's west wall roof line. The roof valleys and around the chimneys have spotty coverage of textured gray asphalt sheeting. (Figure 4.6)

**Figure 4.6.** (right) CCC Technical Building, southwest oblique, August 24, 2020. *(Image by author)*

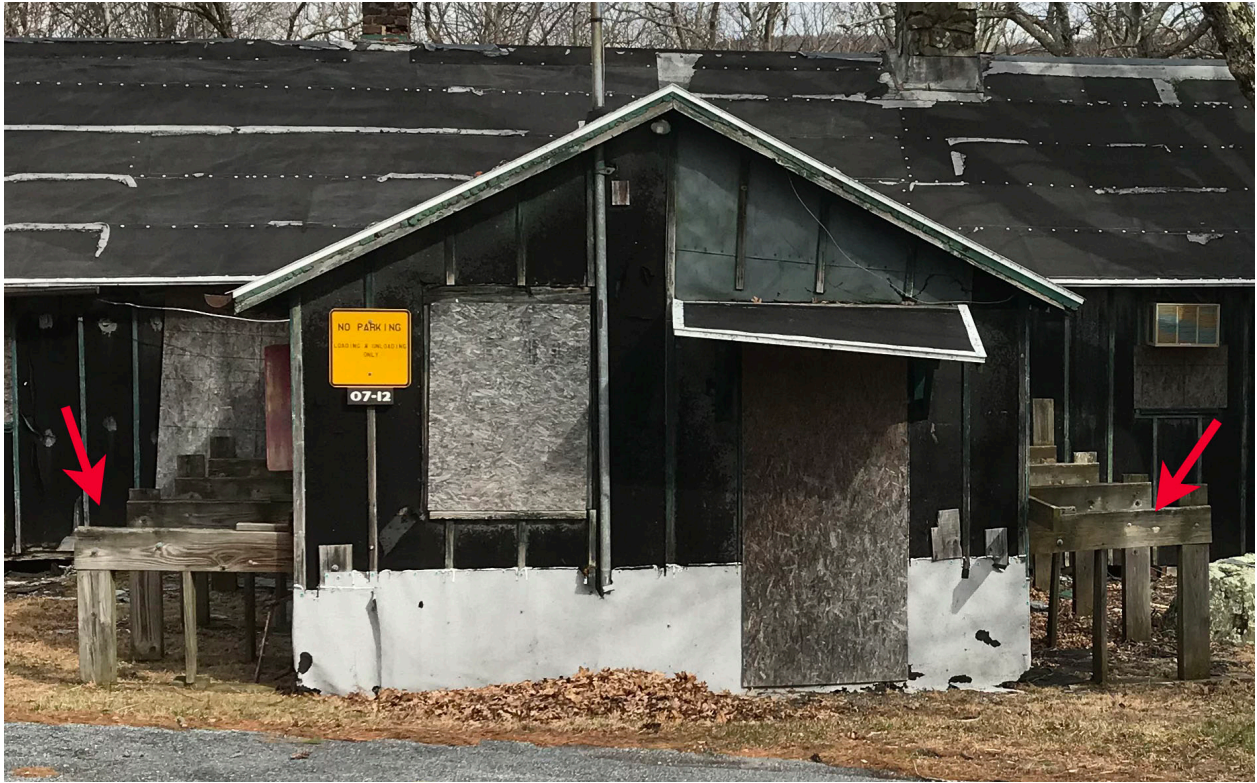
**Figure 4.9.** Ell, west elevation, February 25, 2020. *(Image by author)*

their gable peaks. A water spigot is located on the east elevation, north of the porch. Two propane tanks are located on the northeast corner of the building. Two electrical meters are attached to the northwest wall. The north and south walls of the ell are supported with four large wood buttresses. A metal pole with a commercial-sized streetlight is attached to the ell's west elevation. There is a fire extinguisher and box attached to the north ell wall. (Figure 4.9)

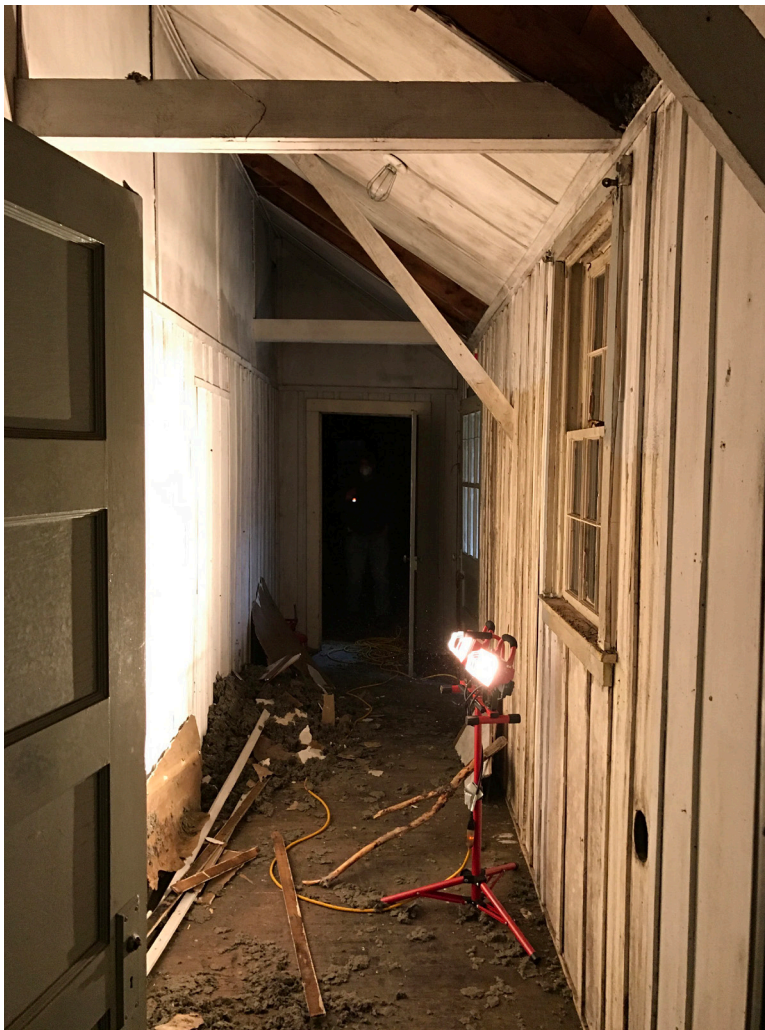
**Figure 4.13.** R101 looking north, February 25, 2020. *(Image by author)*

measures 4 feet 11 inches wide by 21 feet 1/2 inch long. Its vaulted, sloped ceiling is covered with white-painted drywall and wood battens. The ceiling measures 11 feet 2 inches at its highest point. A portion of the drywall ceiling has collapsed, revealing wood attic framing. There is a bare bulb light fixture surrounded by a wire cage centrally located on the ceiling. Wood bracing runs from the attic framing to the east wall. Two evenly spaced horizontal wood framing members run from the east wall to the west wall. They are comprised of two 2-inch by 6-inch boards framing a 2-inch by 3-inch board. (Figure 4.13) The light is controlled by a light switch located north of D101.1. The floor is covered with 2 1/2-inch-wide wood boards running in an east-west direction.

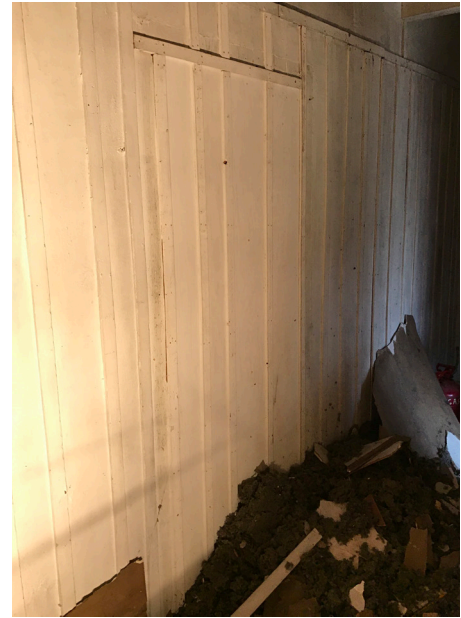
framing reveals a closed-up door opening centrally located on the west wall. (Figure 4.15)

**Figure 4.15.** (top right) R101, west wall infill, February 25, 2020. (Image by author)

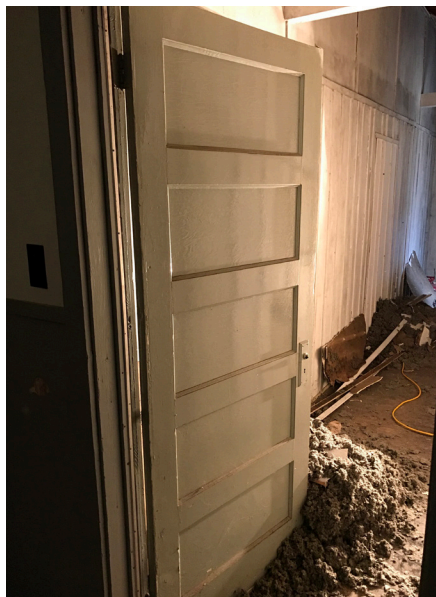
**Figure 4.18.** (above) R101 looking north towards D101.3, February 25, 2020. *(Image by author)*

butt hinges. The interior of the door has a metal backplate and the knob is missing. (Figure 4.18) The exterior of the door has a metal backplate and metal doorknob.

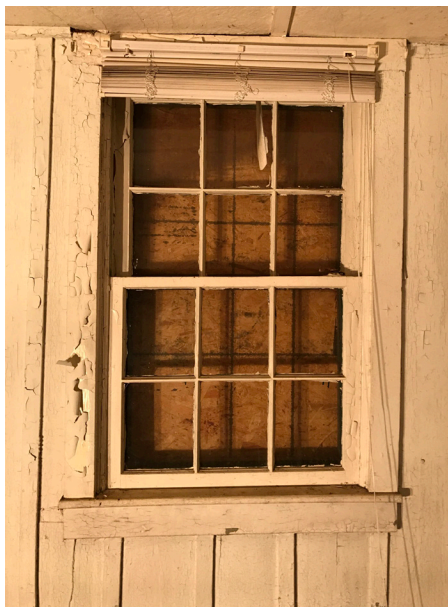
**Figure 4.23.** (left) R102, looking east at W102.1, February 25, 2020. *(Image by author)*

Three window openings are located on the east wall (W102.1, W102.2, W102.3). They each measure 3 feet 10 inches by 2 feet 5 inches and are filled with six-over-six, double-hung sashes. The top rails of the lower sashes contain window locks. Although constructed with a rope/weight system, both ropes are missing on all three windows. W102.1 and W102.3 have blinds attached to the upper trim, and all three windows have curtain rod hardware attached. The window trim measures 3 inches wide. (Figure 4.23)

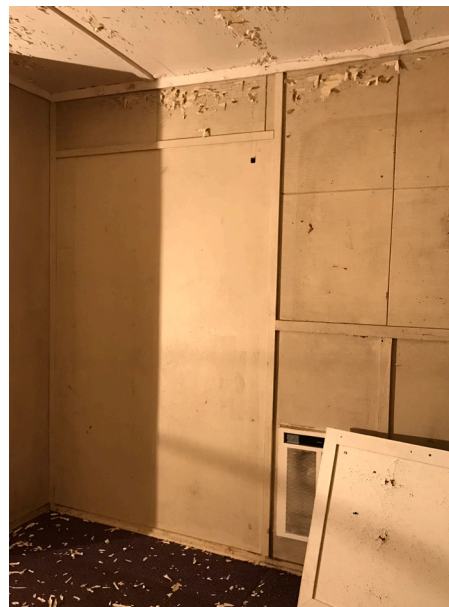
**Figure 4.24.** (right) R103 looking toward west, wall infill, February 25, 2020. *(Image by author)*

The wood-framed walls are covered with wood board and battens that are painted white and lined with 2-inch, two-piece baseboard with quarter-round trim. There is a smoke alarm and thermostat attached to the exterior east wall of the closet. A metal clothing hook is mounted to the exterior north wall of the closet. Two electrical outlets are mounted on the north wall east of W103.3. Another electrical outlet is located on the south wall west of D103.1. Two "Voice Data" boxes are mounted near the floor on the east wall near the northeast corner. A Patton brand electric wall heater is centrally located on the west wall. The west wall contains a wood framed-in area where a door opening once existed. (Figure 4.24)

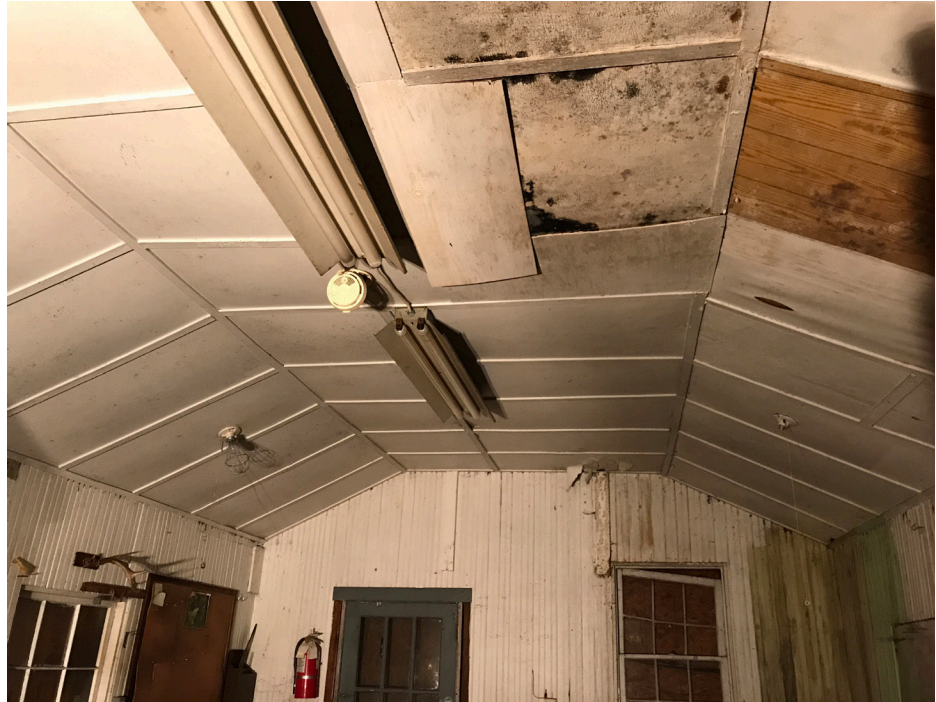
**Figure 4.34.** (above) R105 looking west, February 25, 2020. *(Image by author)*

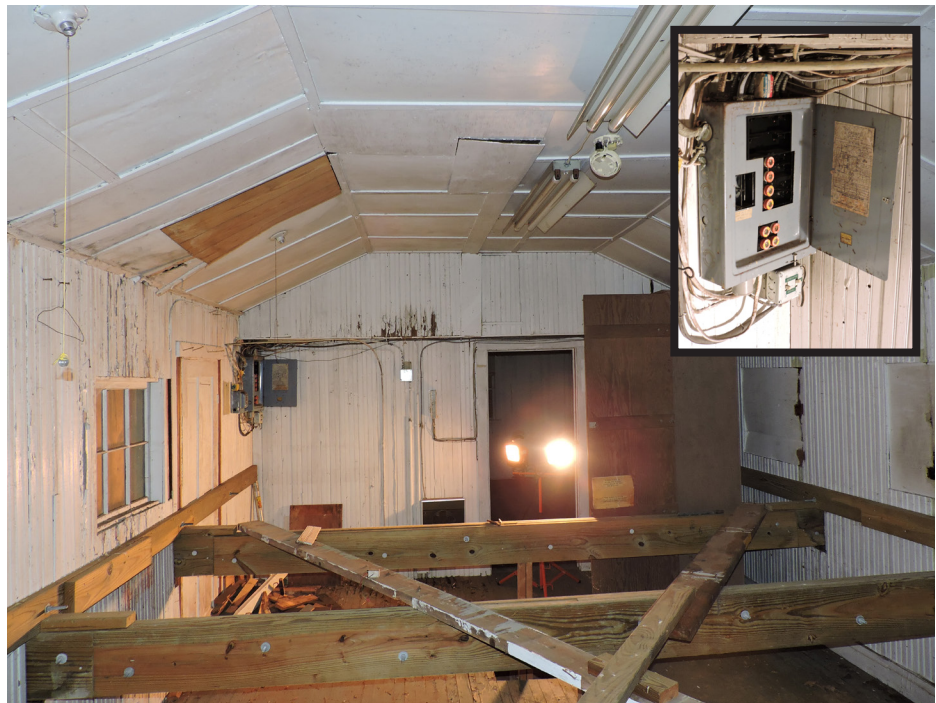
of wire and conduit running to the ceiling and floor. An electrical outlet is located at baseboard level in the southeast corner. The northeast corner contains two fuse boxes. Both are labeled “General Switch Co.” Two generator switches are located below the largest of the two boxes. Electrical conduit runs from the floor to an electrical outlet located west of W105.4. (Figure 4.35) A hinged opening is located above D102.1.

**Figure 4.35.** (right) R105 looking east. Inset image: fuse box located in northeast corner, 2015. *(Images by Susan Hollister)*

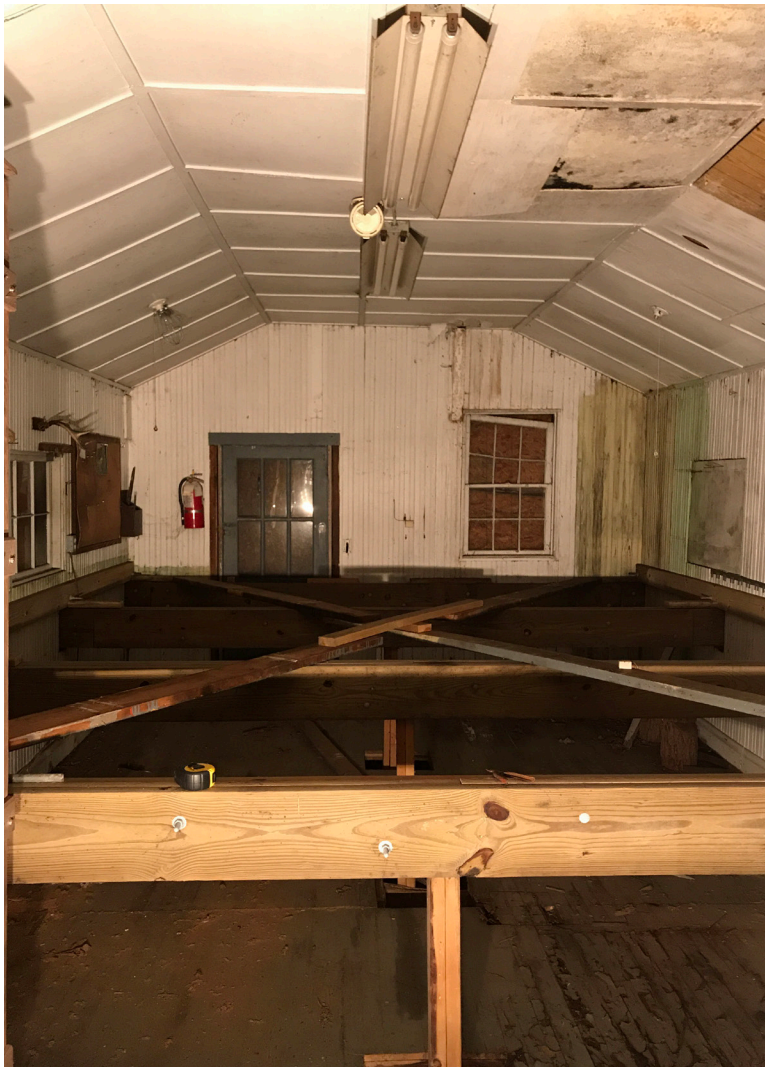
**Figure 4.36.** R105 looking west, February 25, 2020. *(Image by Eric Breitreutz)*

and northeast corners of the larger boards. 2-inch by 4-inch posts support the larger boards and are anchored below floor level. (Figure 4.36)

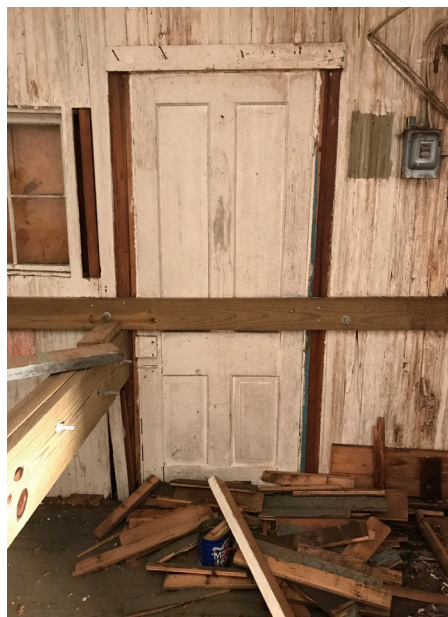
There are three entrance doors in R105 (D105.1, D105.2 & 102.1). D105.1 is an outside entry and is located on the north wall. It is currently boarded up from the outside of the building and although visible, it is inaccessible to inspection. A 5½-inch by 1½-inch board is attached to the larger support system that dominates the room and runs across D105.1 to the northeast corner. The opening is filled with a wood, raised four-panel door hung on two butt hinges and, on the interior, contains a rim lock and slide lock. D105.2 is an outside entry located on the west wall. (Figure 4.37) It also is visible but inaccessible to inspection. One of the large support boards runs up against and across the door. It is also boarded up on the exterior. The opening is filled with a wood, raised two-panel door with six lights above. It appears to be nailed into the door opening, as there are no visible hinges on which the door could hang. The door contains a slide lock and padlock

**Figure 4.37.** (left) R105 looking north at D105.1, February 25, 2020. *(Image by author)*

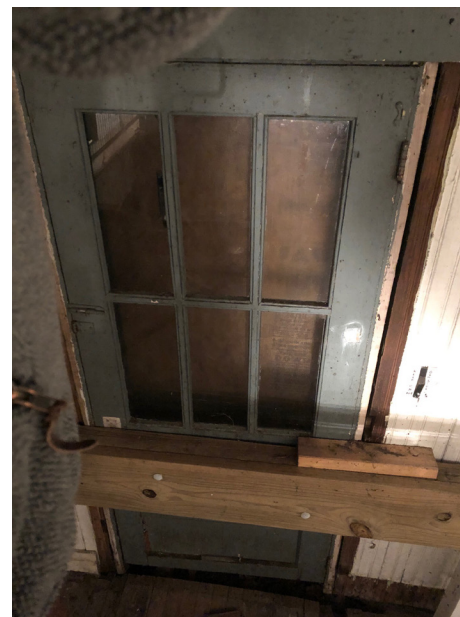
**Figure 4.38.** (right) R105 looking west at D105.2, February 25, 2020. *(Image by Eric Breitreutz)*

hardware. There is a metal doorknob backplate, but the doorknob was removed to accommodate one of the large support boards. Curtain hardware is located on either side of the lights. (Figure 4.38) D102.1 is an interior entry located on the east wall (for door description go to R102). All doors are surrounded by plain, wood, 3½- to 3¾-inch trim.

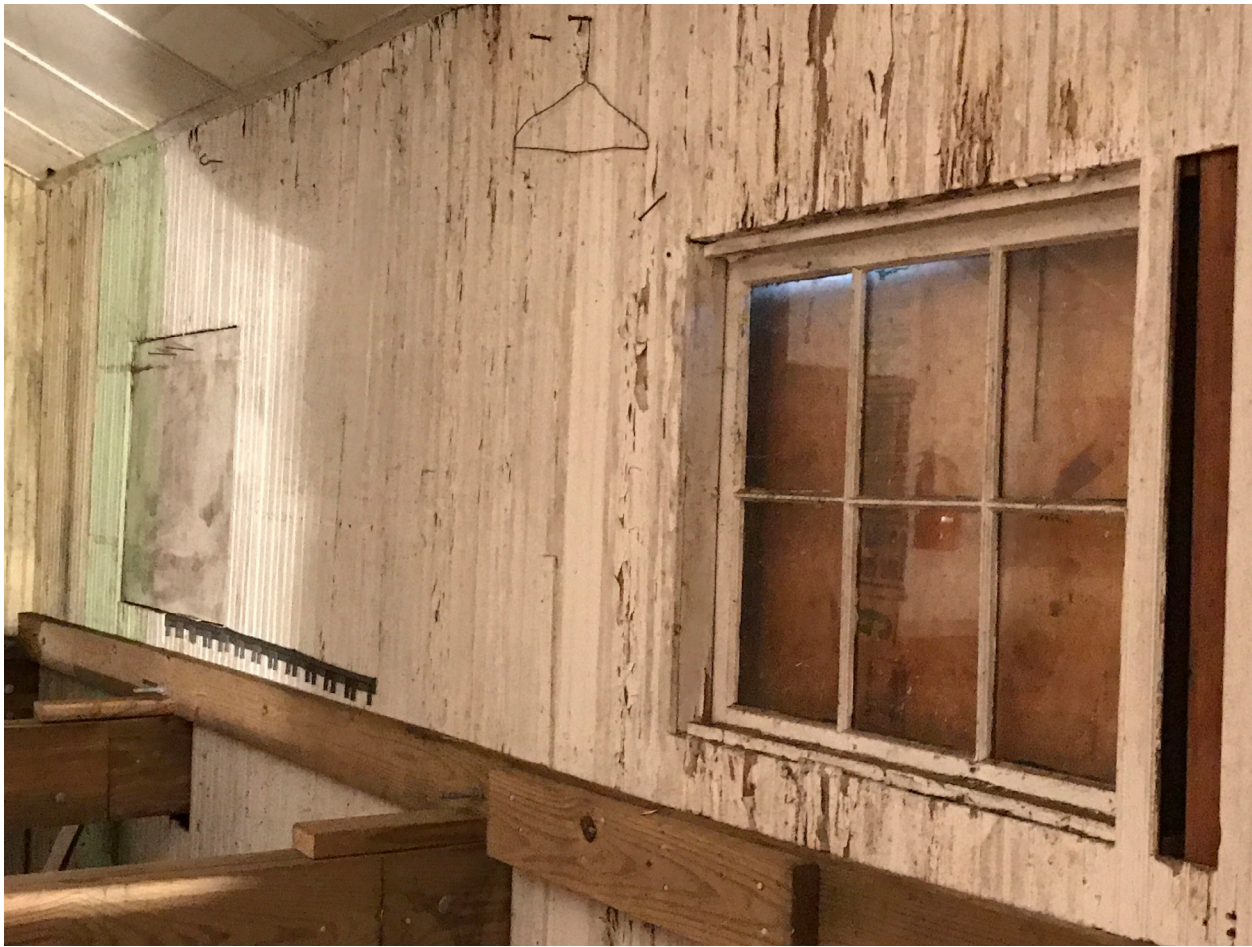
**Figure 4.39.** R105 looking northwest at W105.1 and W105.2, February 25, 2020. *(Image by author)*

There are six window openings in R105 (105. 1, 2, 3, 4, 5, 6). They are all boarded up from the outside and are inaccessible to inspection. The north wall contains two windows. W105.1 is located west of D105.1 and is filled with a wood, fixed, six-light sash. W105.2 is located on the north wall near the northwest corner. It is inaccessible to inspection as it is also boarded up from the inside. (Figure 4.39) W105.3 is located on the west wall north of D105.2. It is filled with wood, double-hung sashes. W105.4 is located on the south wall near the southwest corner. It is filled with a wood, fixed, six-light sash. W105.5 and W105.6 are inaccessible to inspection as they are also boarded up from the inside of the building. There is no visible trim around any of the windows. Although the three visible windows have sashes that are constructed with a rope/weight system, both ropes are missing from both windows.

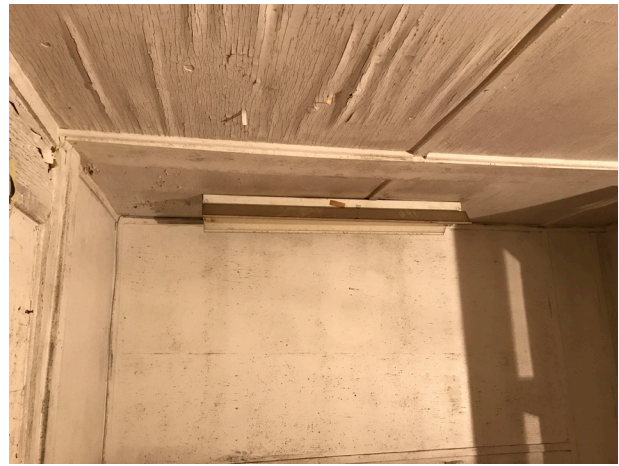
**Figure 4.41.** (right) R106 wall trim on the ceiling (Image taken by the author, February 25, 2020).

wood-framed ceiling is 7 feet 9 inches tall and is covered with white-painted wall board and battens. The ceiling contains two fluorescent lights controlled by a light switch located east of D106.1. Electric conduit runs from one of the lights, across the ceiling, and down the north wall to an electrical outlet. Another electric conduit runs from the light to a small, round, flush-mount light fixture. A ceiling fan is located nearby. (Figure 4.40) Wood trim is attached to the ceiling at where a wall was removed. (Figure 4.41) The floor is covered with carpet. Underneath is asphalt, square tile. (Figure 4.42)

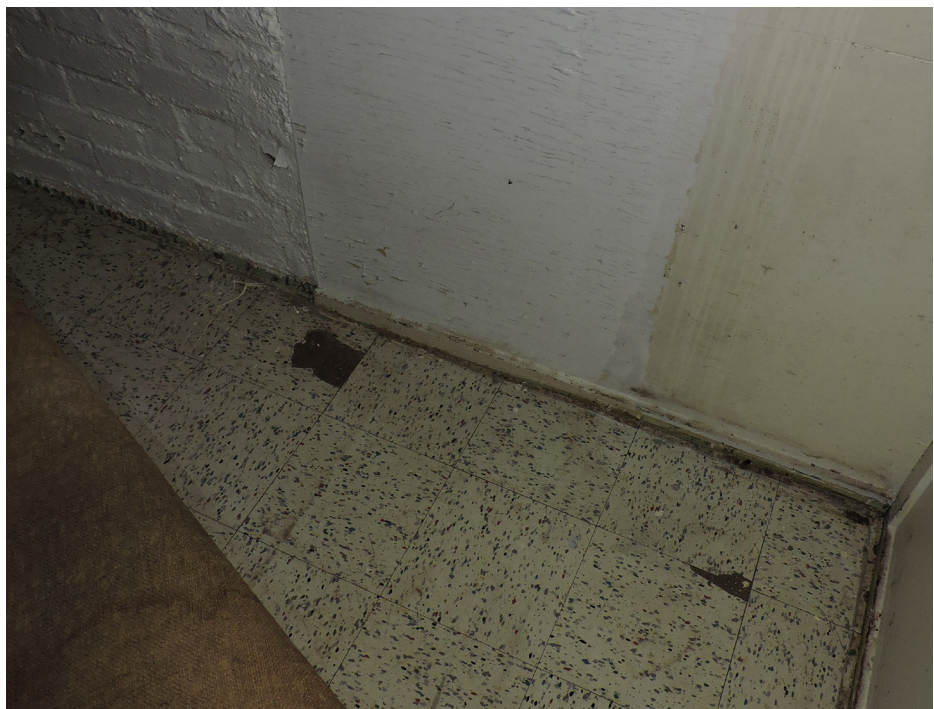
**Figure 4.42.** R106 flooring (Image taken by Susan Hollister) 2015.

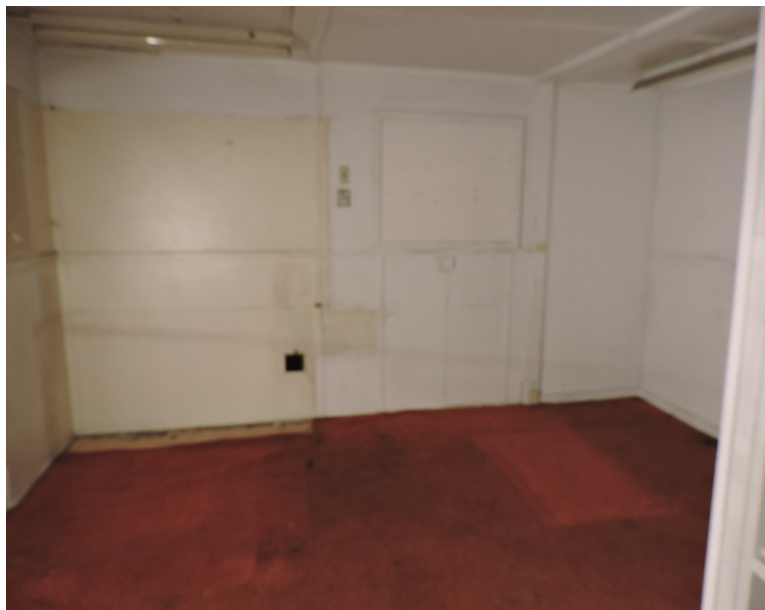
**Figure 4.46.** (left) R106, looking west towards W106.1, February 25, 2020. (Image by author)

A window opening is located on the west wall near D106.1 and measures 4 feet by 2 feet  $\frac{3}{4}$  inches. It contains a single six-light, fixed sash with a window air conditioner located above. (Figure 4.46) Although it has sashes that are constructed with a rope/weight system, both ropes are missing.

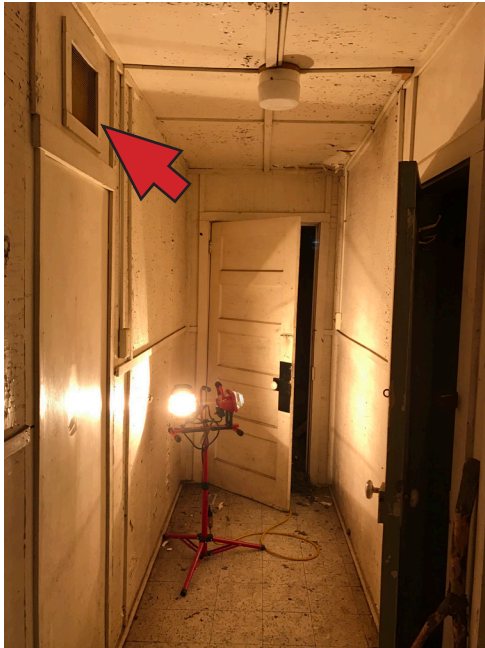
**Figure 4.48.** R107 looking east, February 25, 2020. Note closed-up door opening below mesh screen on north wall. (Image by author)

The wood-framed walls are covered with white-painted wall board and battens. The walls are lined with a batten-style  $\frac{1}{2}$ -inch chair rail. The north wall contains a closed-up doorway which is outlined with wood trim. Above the closed-up door opening is a small opening filled with wire mesh. (Figure 4.48) There is a tub/shower enclosure located in the northwest corner of the room. The tub is covered with a raw piece of flakeboard,

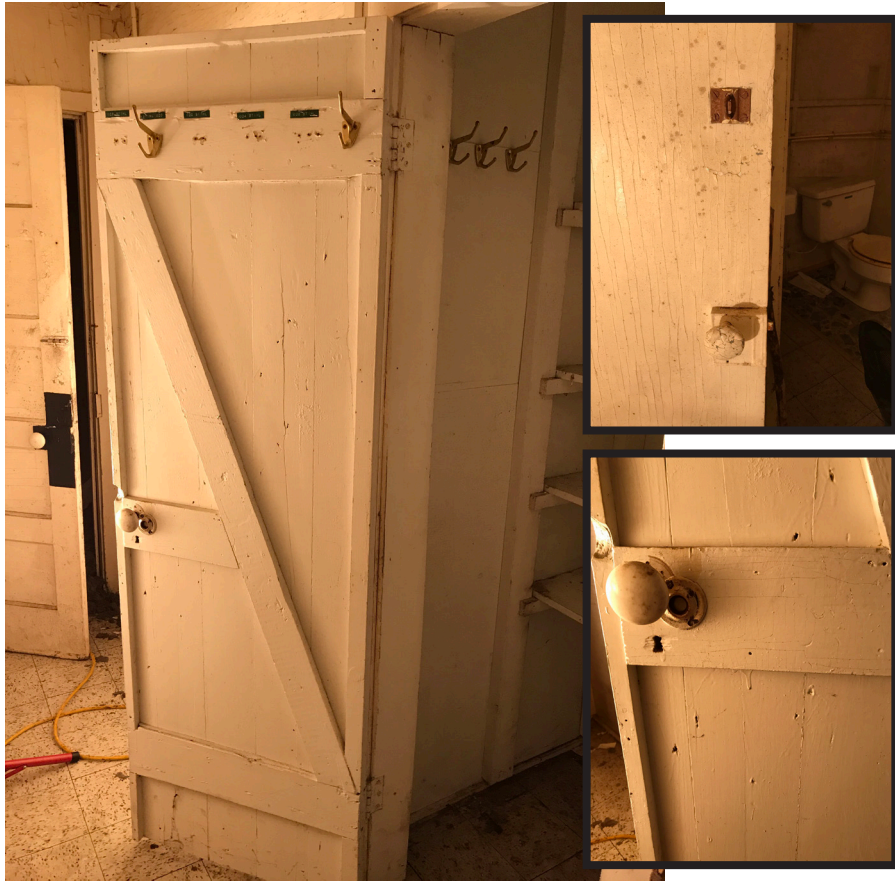
**Figure 4.52.** R107 CL107 door. Inset A: Exterior hardware. Inset B: Interior hardware, February 25, 2020. (Image by author)

The closet doorway (D107.2) is filled with a wood door hung on two butt hinges and is framed with 3-inch, plain, wood trim. The interior of the door is made of board and battens with “Z” framing. There is a white porcelain knob and metal backplate, and a separate metal backplate (empty), attached to the interior of the door. The exterior of the door and doorframe have padlock hardware. The exterior of the door has a rim lock and metal doorknob. (Figure 4.52)

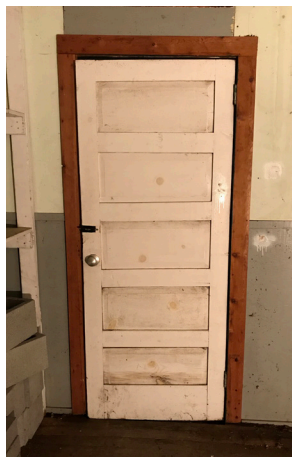
There are two entrance door openings in R108. The interior door opening is located on the north wall in the northeast corner (D101.2—for full description see R101). The exterior door opening (108.2) is located on the west wall in the southwest corner and measures 3 feet by 6 feet 7 inches. It is filled with a raised five-panel wood door hung on two butt hinges. The exterior of the door is inaccessible to inspection, as it has been boarded-up on the outside. The interior of the door contains a modern silver-toned doorknob and a metal slide lock. The door is framed by 3-inch plain, wood trim. (Figure 4.56) The closet doorway located on the north wall is filled with a raised four-panel wood door hung on two butt hinges (D108.1) and measures 2 feet 6 inches by 6 feet 6½ inches. The exterior of the door has a metal rim lock with a white porcelain knob, and padlock hardware. The interior of the door contains a doorknob backplate and is missing the knob. There is a mortise, metal keyhole, and a rough keyhole, carved into the wood located on either side of the missing knob. (Figure 4.57)

**Figure 4.57.** (center) R108, looking north at D108.1, February 25, 2020. (Image by author)

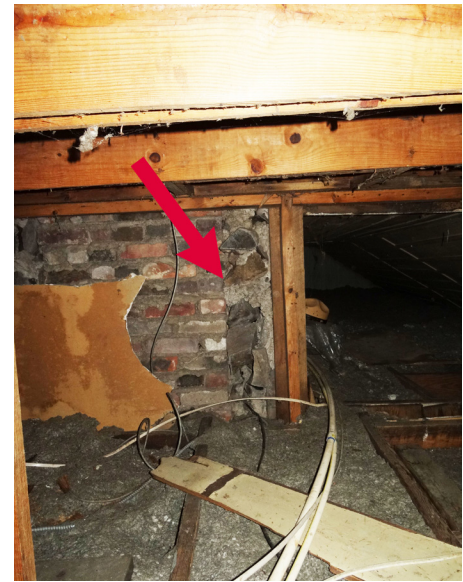
**Figure 4.60.** (above right) Attic, looking north at the south face of central brick chimney. Note: the stone veneer on its east face, and the painted reused bricks on its south face, August 24, 2020. (Image by Brinnen Carter)

are covered with white paint. It has a stone veneer on all but its south face. (Figure 4.60)

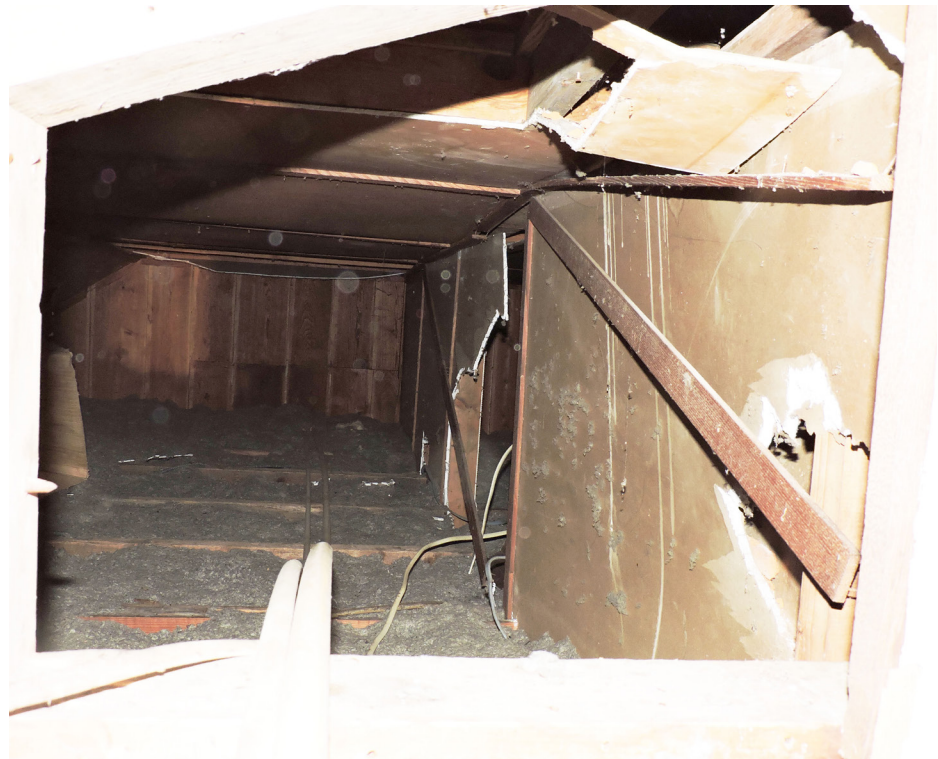
**Figure 4.61.** (right) Attic, looking north to space over R104, 2015. (Image by Eric Breitzkreutz)

An access hole is framed into the north wall of the finished space that leads to attic space above R103 and R104. The space above R104 has sheets of drywall and wood battens attached to some of its wall and ceiling framing. Its north wall is made of the vertical wood boards that make up the exterior north wall of the building. The space above R103 is not visible or accessible. (Figure 4.61)

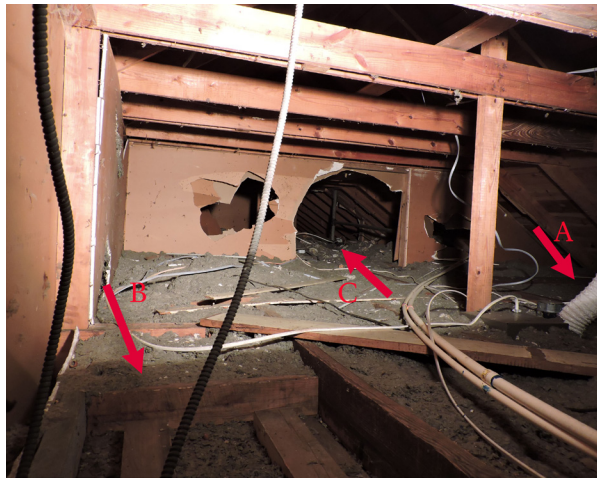
**Figure 4.62.** (above) Attic, looking south. A: Plastic/Wire hose. B: Closed up attic hatch. C: Attic space above R107 and R108, 2015. (Image by Eric Breitreutz)

from the ceiling fan in R106. A closed up, wood-framed access hatch is located within the ceiling joists at the east wall near the central chimney. (Figure 4.62) Another framed-in access hatch is located between the main chimney and the nearest collar tie. The central chimney's south wall is made of reused brick. (Figure 4.63) The second and third spaces, located above R107 and R108, are located to the south of this space.

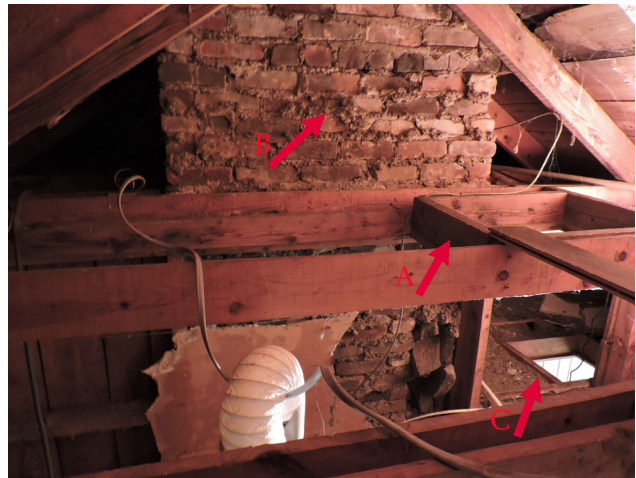
**Figure 4.63.** (above right) Attic, looking north. A: Framed-in attic hatch. B: Reused brick on central chimney south face. C: Attic hatch located in R102, 2015. (Image by Eric Breitreutz)

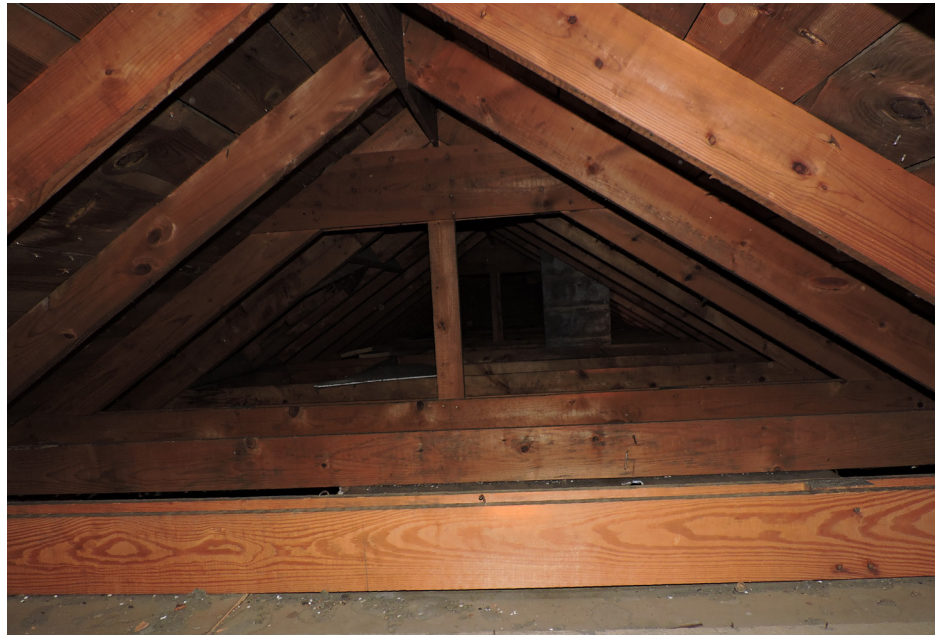
**Figure 4.64.** (right) Attic, looking south towards cement block chimney, 2015. (Image by Eric Breitreutz)

The second space (over R107) has metal piping running along the west roof slope. A plain wood post rests on a ceiling joist and runs to a collar tie above. Another wood post runs from a collar tie to the ridge board with a wood gusset plate attached to it and the rafters. (Figure 4.64) Blue paint can be seen on a joist near where the metal pipe is attached to a joist. (Figure 4.65) Drywall and wood battens are attached to some of the ceiling and walls. Drywall is attached to both sides of the east wall framing. The drywall on the outside of the framing provides a wall surface for the vaulted west wall in R101. (Figure 4.66)

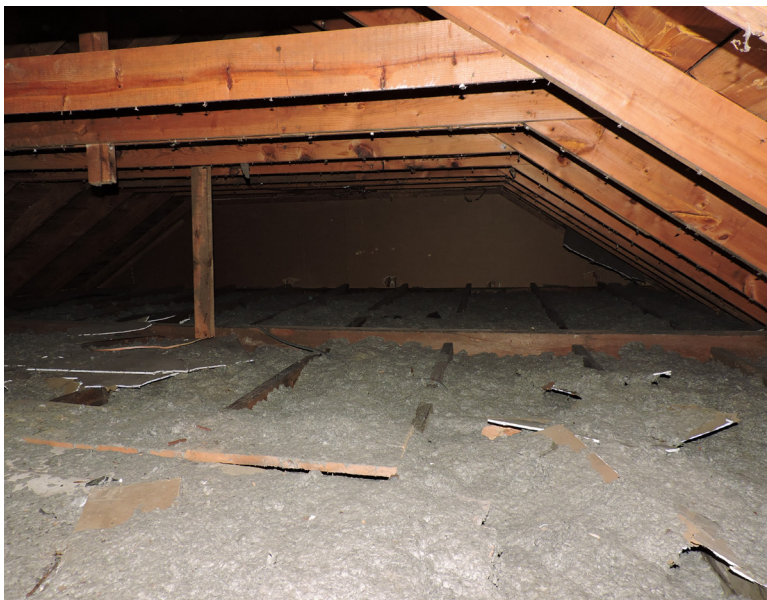
ceiling and walls. A wood support post runs from a ceiling joist to a collar tie. Another wood post runs from a collar tie to the ridge board. A summer beam runs parallel with the rafters tying together the joists running perpendicular to the rafters. (Figure 4.67) Green paint can be seen on top of a board running east-west on the south wall. A wood-framed area between two rafters is located above the collar ties on the east slope of the roof. (Figure 4.68)

**Figure 4.67.** (bottom left) Attic, looking south, 2015. *(Image by Eric Breitreutz)*

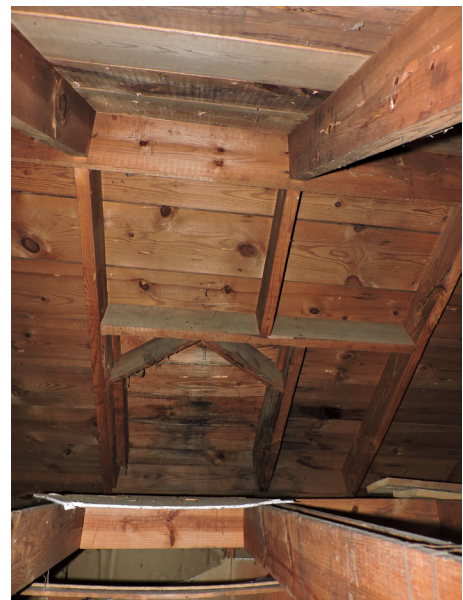
**Figure 4.68.** (bottom right) Attic, looking east, 2015. *(Image by Eric Breitreutz)*
