# HISTORIC STRUCTURE and CULTURAL LANDSCAPE REPORT

South Manitou Island Light Station  
(Historic Structures 51-120 A-I)

Sleeping Bear Dunes National Lakeshore  
Empire, Michigan

January 29, 1999  
Final Report  
Project # 94117.01

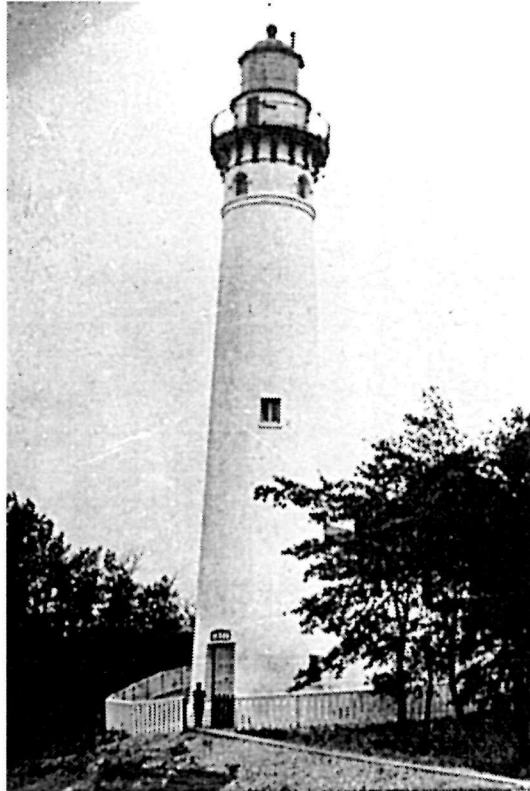
Photographic analysis appears to indicate that fence design but probably not fence locations changed several times during this period. This degree of change may reflect the vulnerability of fences to wind, sand, and water; or, perhaps, the change is attributable to experimentation with various designs to find a more effective way of using fencing to control the effects of windblown sand on the residential/light tower cluster. What may be the second fence on the site (or possibly a reworking of the first fence depicted during the preceding period) appears in the undated photo from the early twentieth century (Figure 15). This fence also has narrow pickets but they do not extend above the top rail. A third fence design with broad pickets appears to have been more enduring than its predecessors. It appears both in the circa 1910 (Figure 9) and circa 1928 (Figure 10) photographs of the station from the west, and in an undated photograph of the front of the Light Tower (Figure 16). The fence, which is white, appears to be about chest high on a human figure standing near

the Tower's door. Since the figure is presumed to be an adult male, the height of the fence is likely to have been approximately four feet.

Figure 16 View of the South Manitou Island Light Tower and surrounding picket fence, circa the early 1900s.

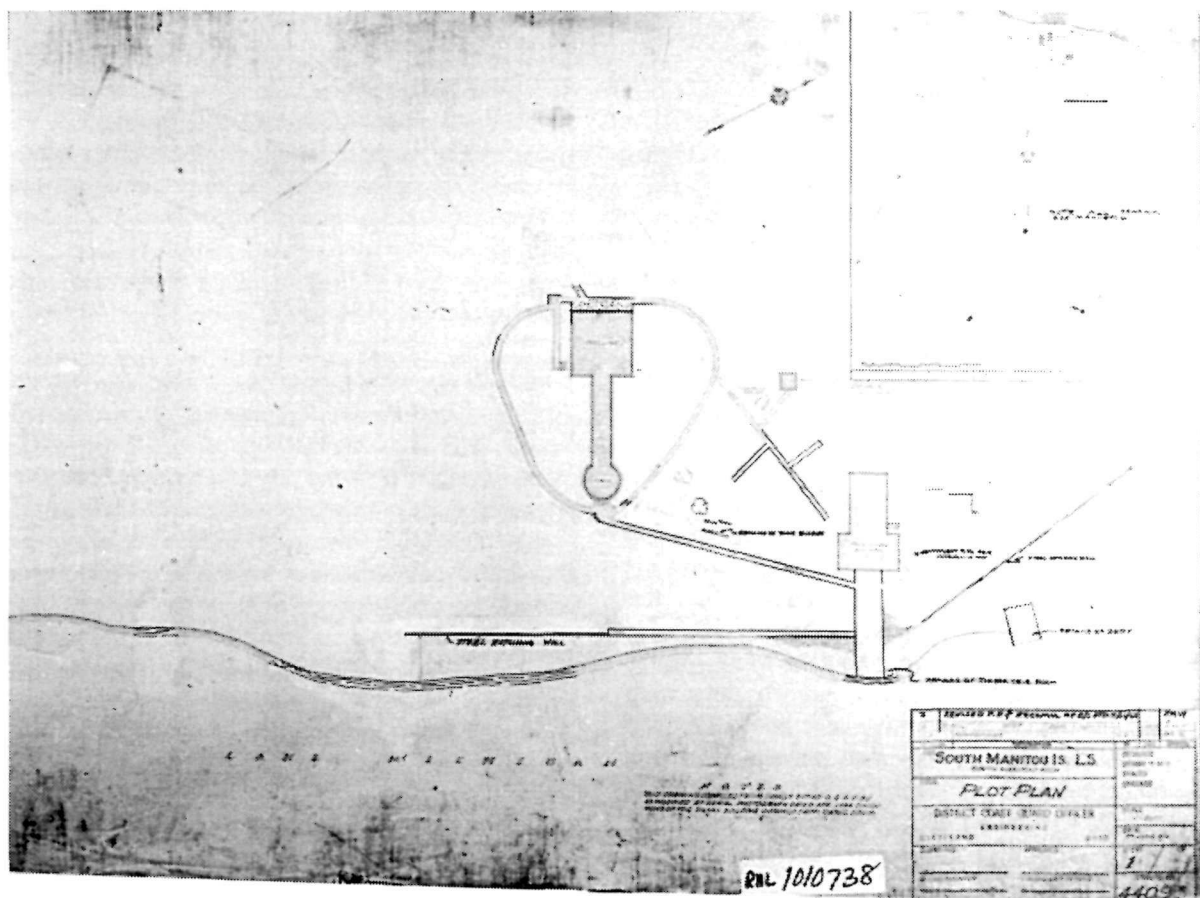
*Figure 22 The 1944 South Manitou Is. L.S. Plot Plan , prepared by the U.S. Coast Guard in 1944,*

plan provides the best known documentation of the complete light station prior to its closure in 1958. In addition to depicting the site's buildings, the plan also includes the stone-filled timber cribs and three timber jetties developed for shoreline protection. The timber jetty nearest the lookout tower is identified as in "poor condition."

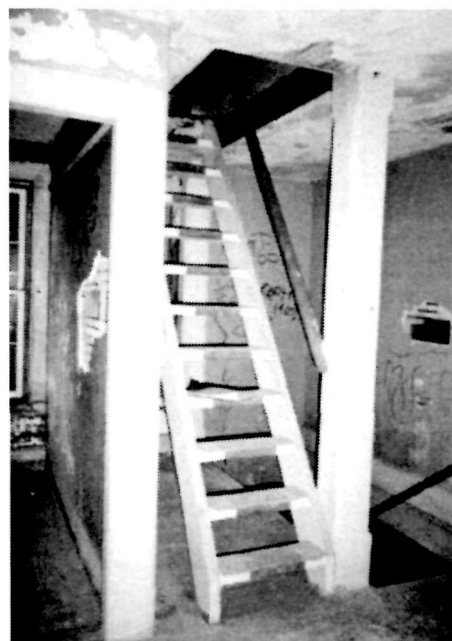
There are several existing elements in the attic of the dwelling that were constructed in conjunction with the original roof lantern. The attic contains only one finished room, which is approximately 6'-7" x 13'-6". (The remaining attic space is unfinished and uninhabitable.) The room is finished with materials similar to those found throughout the floor levels of the dwelling below. Access to the attic from the second floor below is via a wood ship's ladder (Figure 1) in the central hall, (Room 202). This stair, along with the simple handrail along the south wall and the newel post at the opening at the top of the stair, is the only remaining element intact from the original balustrade that surrounded the opening. A second newel post lies on the

**Figure 1** View of the wood ship's ladder at the second floor central hall of the Dwelling, which leads up to the attic, 1994. Note the "scoop" at the corners of the wood treads and the painted runner.

floor of the hall below, and several wood pieces, which appear to be part of this balustrade, were found stored in the pantry in the basement. Furthermore, an additional portion of the balustrade is currently being stored in the National Park Service's museum collection on the mainland for future reinstallation or replication.

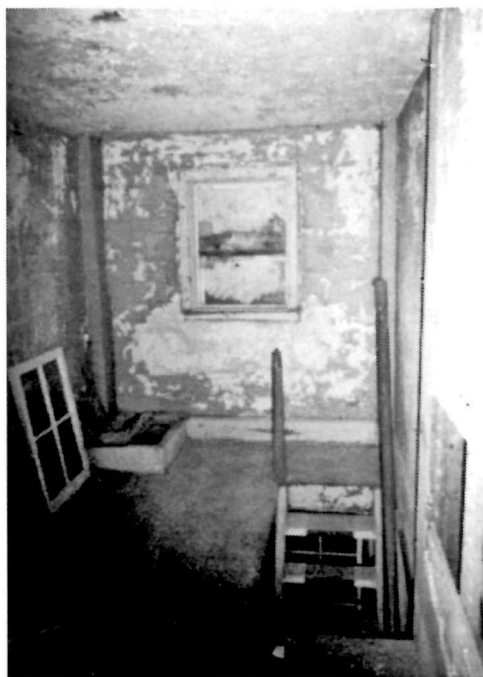
A raised 25" x 26" wood platform, which is 8" above the floor level, remains partially intact at the northeast corner of the finished portion of the attic, as seen in Figure 2. This wood platform served as a base for a second ship's ladder which led up to the roof lantern. This ship's ladder is no longer extant, but is presumed

**Figure 2** View looking east in the finished portion of the Dwelling's attic, 1994. The raised wood platform at the northeast corner once supported a ship's ladder, which led up to the roof lantern.

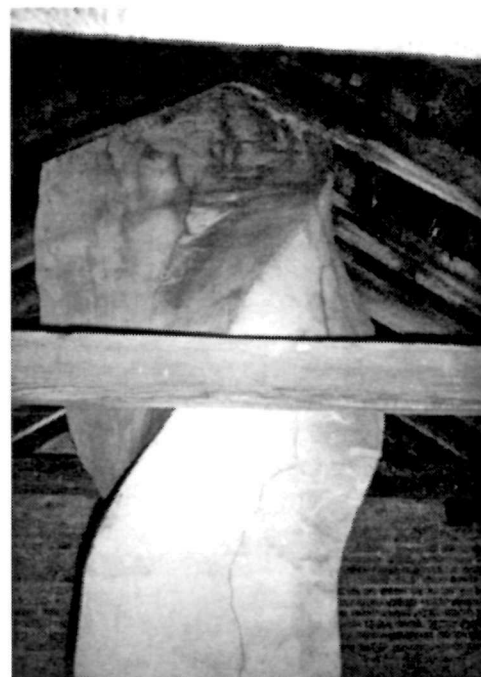
**Figure 4** View looking north into the unfinished attic space at the spiraling, plaster covered chimney in the Dwelling, 1994.

The chimney configuration of the dwelling, which spirals through the attic rafters before meeting the roof ridge, most likely also dates to the 1858 construction. The exterior brick surface of this chimney, as seen in Figure 4, is finished with plaster. The plaster was most likely applied for fire protection, and not for aesthetic purposes, as the surrounding space is uninhabitable. The twist in the chimney is for aesthetic purposes: it insures that the long side of the chimney is perpendicular to the ridge of the roof, the typical orientation.

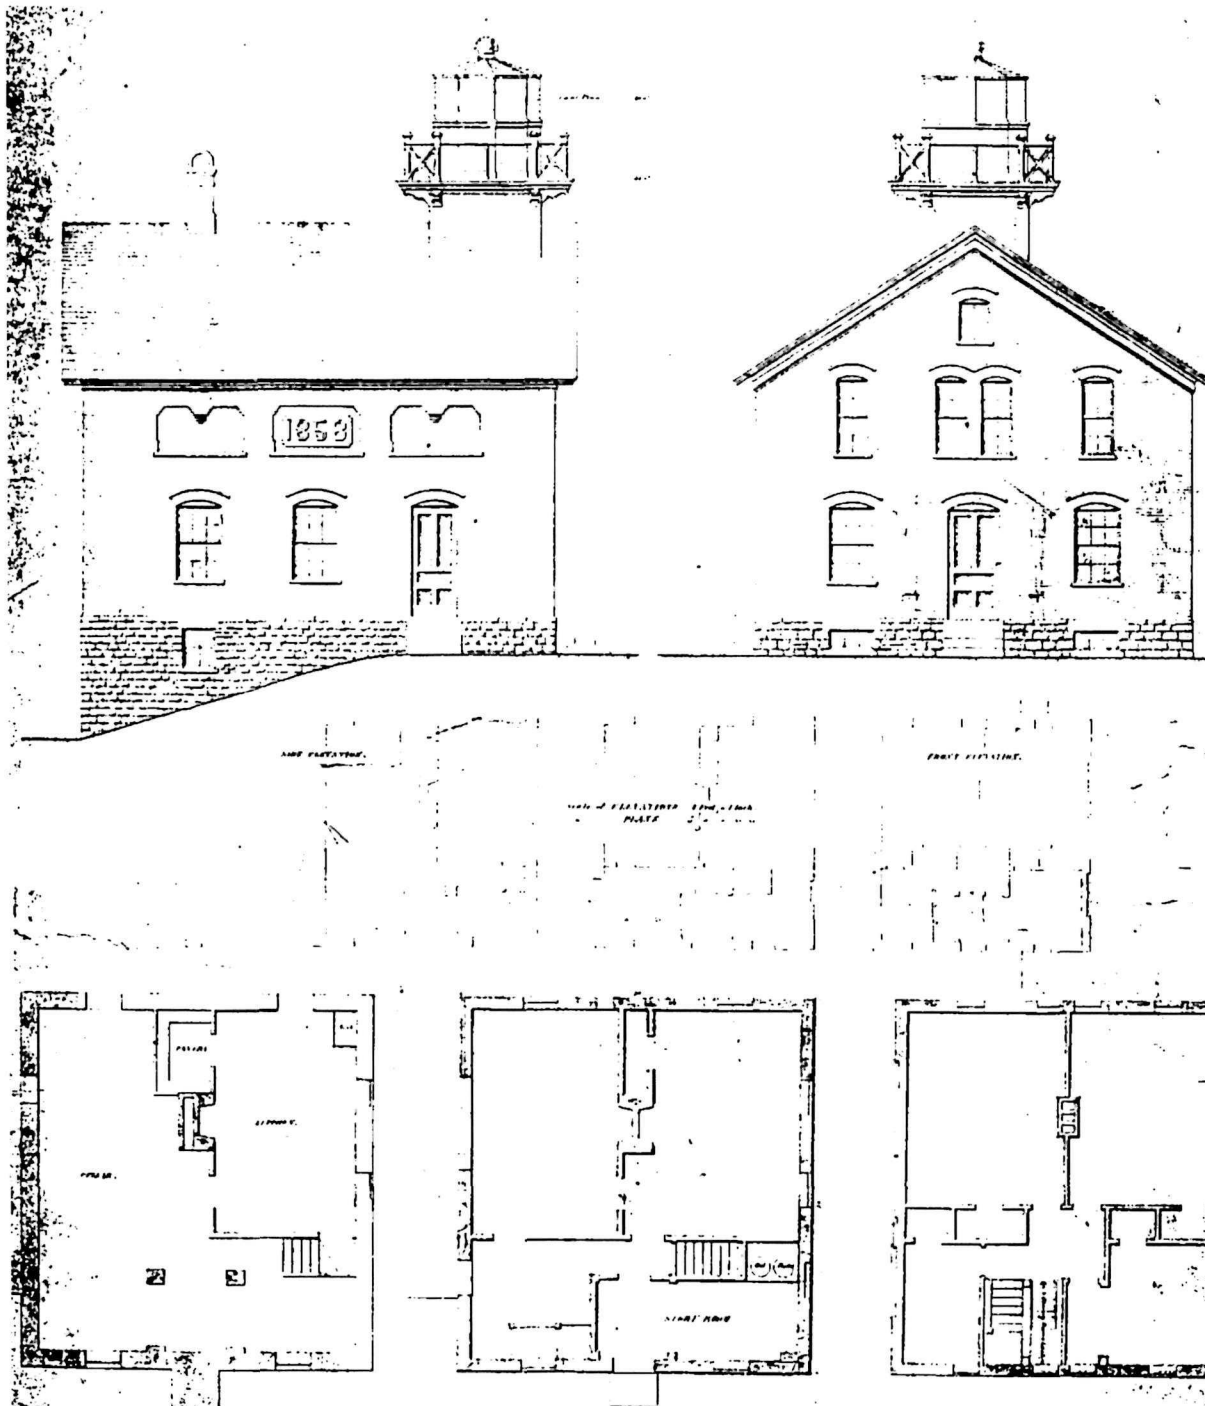
Figure 5 1858 Construction drawing for the South Manitou Island Lighthouse (Keeper's Dwelling with attached roof lantern).

An original feature of the 1858 dwelling is Door [I-2]. Although there is no known photographic evidence, a historic drawing of the east elevation, (Figure 5), indicates that this door, which currently connects Room 102 of the dwelling with the passageway, was an exterior door before the construction of the passageway in 1871. The threshold appears to have been a few feet above grade with exterior stone steps that led to grade.

Figure 5 also shows the kitchen sink located (as it is currently) at the northwest corner of the kitchen. Historic documentation suggests, however, that the cistern, located below it, was not constructed until several years later. The 1868 annual report from the District Engineer to the Chairman of the Lighthouse Board includes a request that “Copper eavetroughs and conductor should be provided and a proper cistern [installed].”<sup>2</sup> This statement suggests that even if a cistern was included in the original construction, it was inadequate.

As seen in Figure 5, the exterior appearance of the dwelling has not been altered much since its initial construction. The drawing of the south elevation, however, indicates one original feature which is no longer extant. This feature is a decorative, presumably metal, chimney cap. Although some early historic photographs (Figure 7) indicate its presence, it appears to have been removed by the turn of the century. Its removal was probably due to deterioration, followed by the lack of necessity for replacing it. Later historic photographs, such as Figure 8, indicate that the corbelled bricks at the top of the chimney were painted a color different than the rest of the chimney, presumably to resemble a cap.

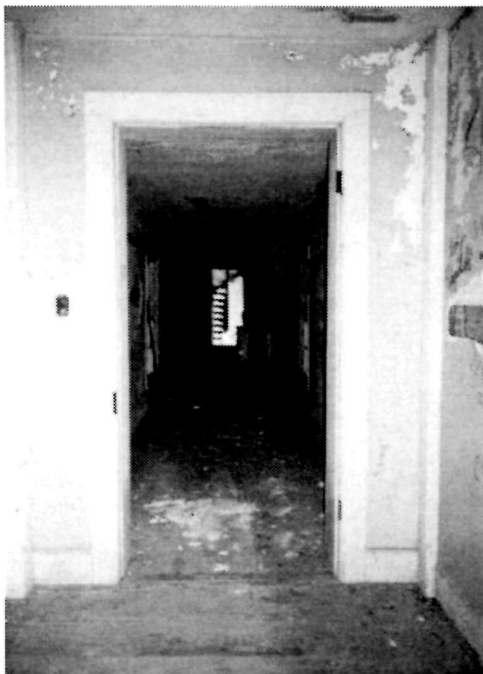
**Figure 6** View of the Passageway looking east through Door I-2 from Room 102, 1994. Prior to the construction of the Passageway, this was an exterior entrance door into the Dwelling.

Figure 6 is a photograph of the opening in its existing condition; the wood panel door is no longer extant.

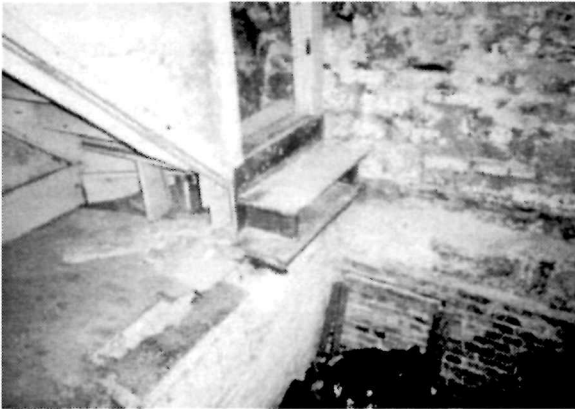
**Figure 11** View looking northwest in the storage room (Room B-03) in the Dwelling, 1994. Note the door opening at the left leading from the stair, which has one step leading into this room that is precariously hanging over the subcellar.

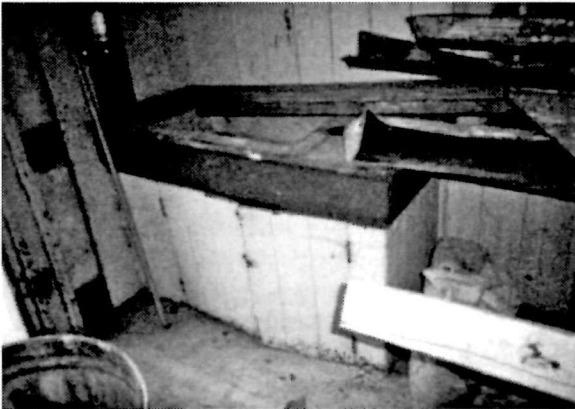
**Figure 12** View looking at the northwest corner of the kitchen (Room B-05) in the Dwelling, 1994. Note the area of missing wood wainscot at the left edge of the photo, revealing an earlier wall treatment.

Figure 12 shows an area of the west wall of the kitchen (Room B-05) where the wood wainscot has been removed along the exterior door opening, revealing another finish beneath the wainscot. This underlying finish consists of plaster, which extends down to a wood baseboard, and is identical to that found throughout the upper floors of the dwelling. Wood furring strips were nailed directly onto the plaster surface of the walls to provide a nailing surface for the wood wainscot. It is unknown at this time when the present wood wainscot was installed.

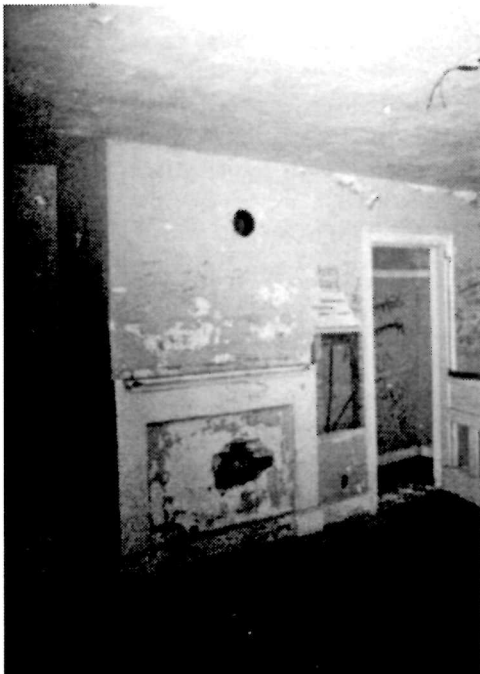
Physical investigation and historic drawings (Figures 5 and 13) indicate that all three of the fireplaces in the dwelling, two at the first floor and one at the basement, originally had open fireboxes. Some time after the original construction of the building, possibly with the introduction of wood or gas burning stoves, each of the fireplaces was infilled with brick and finished with plaster and wood baseboard trim. Furthermore, there is a circular opening at each chimney face which indicates the connection of a stovepipe. A historic wedding photo of Keeper Burdick and his wife taken in 1907, in front of the Parlor's (Room 105) fireplace, reveals that by this time the firebox was already infilled. Physical investigation in 1994 revealed that the infill had been removed, with the exception of the wood baseboard. The other two fireplaces in the dwelling, although damaged by vandalism, were still infilled during physical investigation, as seen in Figures 14 and 15.

**Figure 14** View of the fireplace at the south wall of the parlor (Room 108) in the Dwelling, 1994.

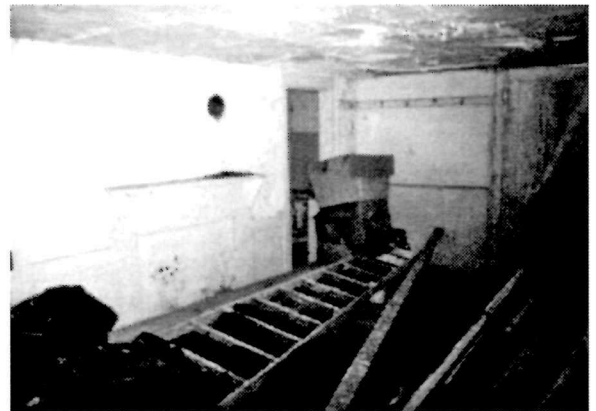
**Figure 15** View looking toward the southwest corner of the kitchen (Room B-05) in the Dwelling. Note the overall deteriorated condition of the surfaces and finishes, and that the fireplace remains infilled with brick and plaster.

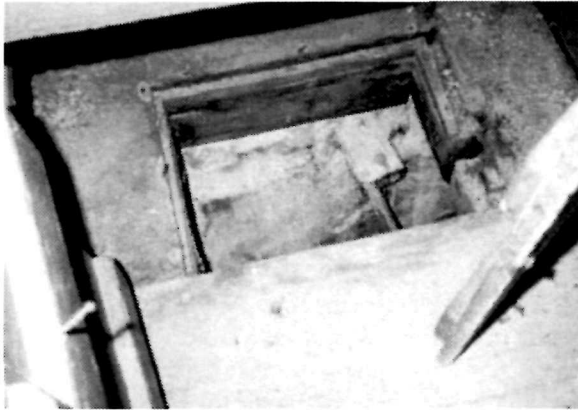
This recommendation made by the engineer was never carried out, however. Nine years later, the 1910 *Description Of Buildings, Premises, Equipment, Etc.* indicates the continued presence and use of the cistern. It says that the "...cistern under [the] dwelling [is] 7'4" x 7'6" x 2 1/2" [with a capacity of] 1017 gals... [the] cistern is of brick, cement coated, [and] cleaned out annually."<sup>10</sup> However, this description does indicate that, in contradiction (or maybe because of) the engineer's 1901 letter, the cistern was properly maintained and "cleaned out annually". The cistern remained, whether used or not, throughout the lifetime of the station. Physical investigation of the cistern in 1994 (Figure 16) revealed that it was only 6'-6" deep. The lesser depth than that stated in 1901 may be due to the buildup of debris from the lack of use and neglect since the abandonment of the station.

**Figure 16** View looking down into the cistern located at the northwest corner of the basement of the Keeper's Dwelling, 1994.

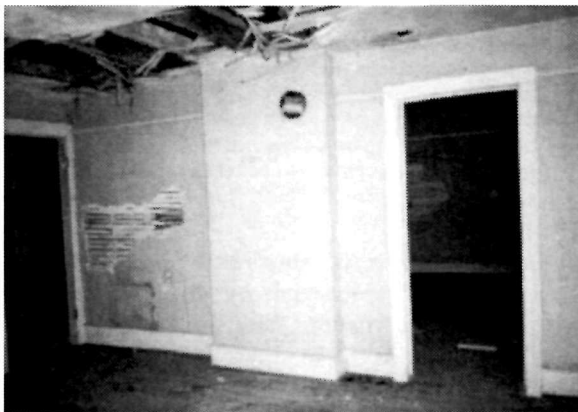
**Figure 17** View of the south wall in the northwest bedroom (Room 204) in the Keeper's Dwelling, 1994. Note the rust at the plaster surface from the metal duct within the wall framing (at the bottom left corner of the photograph).

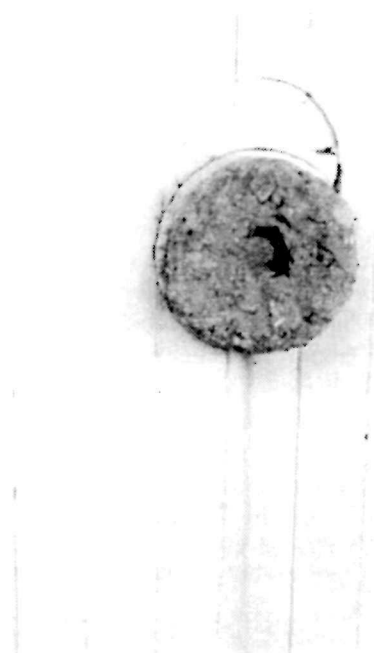
Physical investigation revealed a concrete "plug" in the former stovepipe opening in the wall of the tower at the watchroom level, (Figure 19). It is assumed that a stove was installed, in conjunction with the watchroom floor (as indicated in the engineer's request in 1899), to provide heat for the keeper during his nightly shifts. However, there is some evidence that a stove, although not adequate, was installed on the landing some years prior. One historic photograph taken prior to 1901 indicates the possible presence of a stovepipe with a slightly different configuration than the one installed in 1901, and physical investigation revealed two separate openings, suggesting a relocation (Figure 19). One of the openings was patched with a piece of the wood wainscot and the other was filled in with concrete in 1991 by the National Park Service as a safety precaution for visitors in the tower.

*Figure 19 Detail view of the concrete "plug" in the former stovepipe opening at the workroom of the Tower, 1994. There is also another circular marking in the wood wainscot, suggesting that the opening was relocated.*

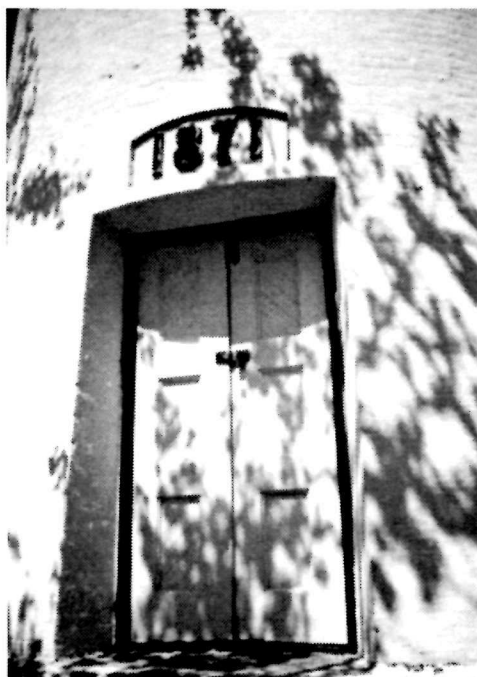
Physical investigation also revealed that the current three-panel doors at the Tower are in good condition, and have little deterioration or paint buildup, as seen in Figure 21. A document of the National Park Service says that, "[the] historic wood door[s] of [the] tower [were] rebuilt for [the] 1980 season," thereby substantiating the notion that the current doors are replacement doors.<sup>19</sup> One important feature of these replacement doors is that they have a three-panel configuration while historic drawings (Figures 9 and 10) reveal that the original set of doors had a five-panel configuration.

**Figure 21** Detail view of the wood panel doors leading into the base of the Tower, 1995.

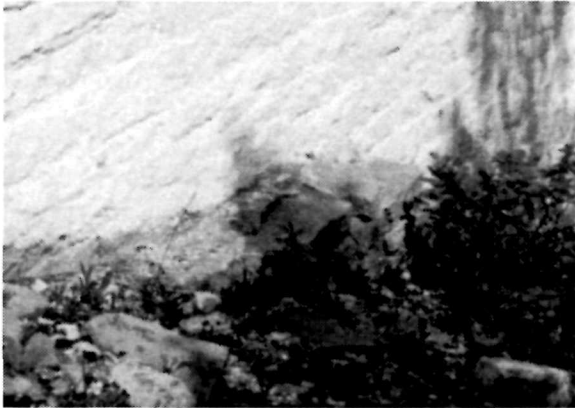
**Figure 22** Detail view of the exposed, unfinished stone along the south elevation of the Passageway, 1994.

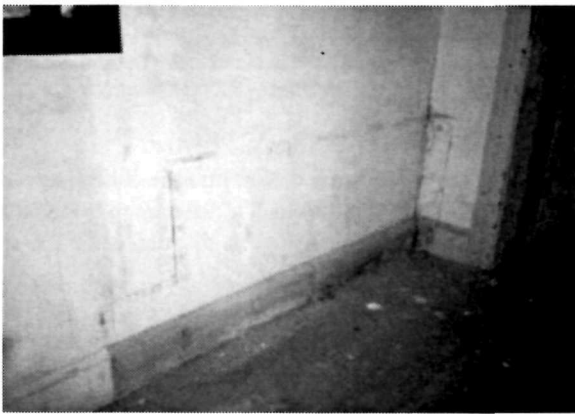
Physical investigation revealed the ghosted profile of a cabinet at the northeast corner of the passageway, (Figure 23). Figure 23 also reveals a joint in the wood baseboard at the ends of the ghosted image, indicating

where the baseboard had been replaced. Due to the close proximity of the demarcation of the tower, it is most likely the result of either a desk used by the keeper during the evenings and/or storage shelves for equipment that was used in the tower. One likely assumption is derived from the recollections of Fred Burdick whose father was the keeper from 1908 through 1928. In a taped interview with the National Park Service, Fred recalls that there was a floor cabinet in this location, which was used to store replacement glass panels for the tower's lantern. They would be safely stored here

**Figure 23** View of the northeast corner of the Passageway, 1994. Note the ghosted outline on the plaster, and the coinciding joint where the wood baseboard has been replaced.

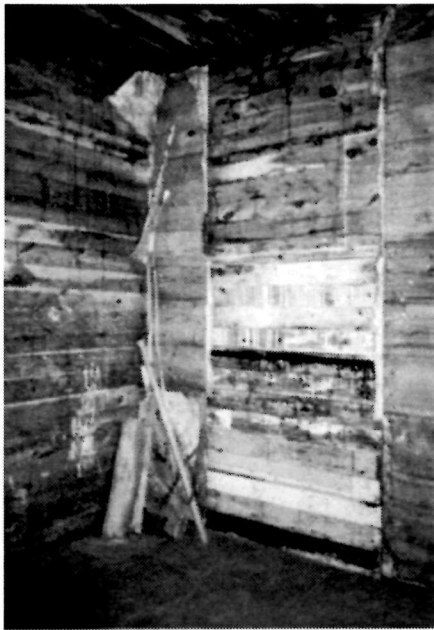
a large area of infill in the west wall of the coal room (Figure 28). It appears that there had once been an opening between the coal room and the work room, which extended from the floor to the ceiling.

**Figure 28** View looking toward the southwest corner of the coal room in the Fog Signal Building, depicting wood infill, possibly from a former opening, 1994.

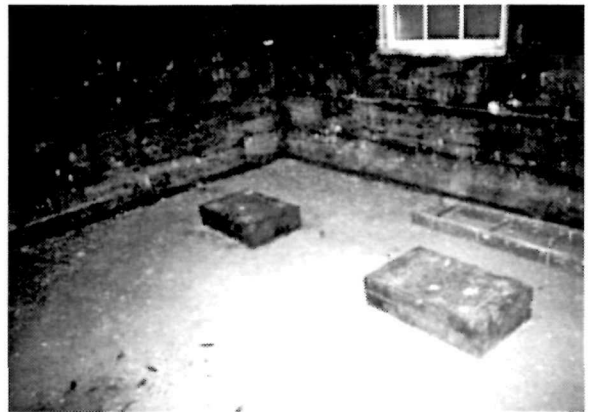
As part of the abandonment of the station, the fog signal operation was discontinued and most of the related equipment removed by 1958. Figure 31 shows the interior of the building in 1994, with only fragments of elements left, including: concrete pads from the Kohler generators, from air compressors, connections through south wall to exterior well, cabinet along west wall of machinery room. As was the case throughout the South Manitou Island Light Station, following the departure

**Figure 31** Interior view looking northeast inside of the Fog Signal Building, 1994.

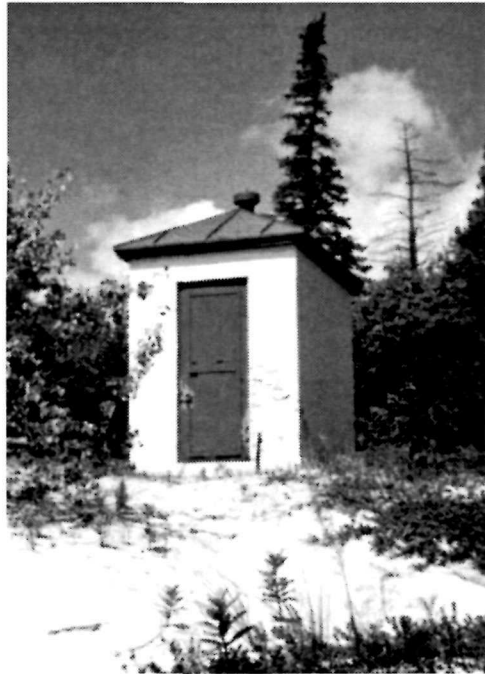
Although all of the brick oil houses were similar, the type of brick varied. Physical investigation revealed that the exterior brick surface at South Manitou Island was covered with several layers of paint. This is not typical, and was not observed at several other light stations around the Great Lakes which have similar brick oil houses. Generally, these other brick oil houses had exterior walls of unfinished brick. One assumption about the applied finish on the South Manitou Island brick oil house is the presence of several different types and colors of bricks beneath the paint surface. Paint was therefore applied to camouflage the incompatible masonry throughout walls. Some of the brick types found in the walls are unique to the station, suggesting that it is likely that the structure was constructed with excess bricks brought to the station from other stations by a lighthouse tender.

**Figure 32** View of the Brick Oil House at the South Manitou Island Light Station, 1994.

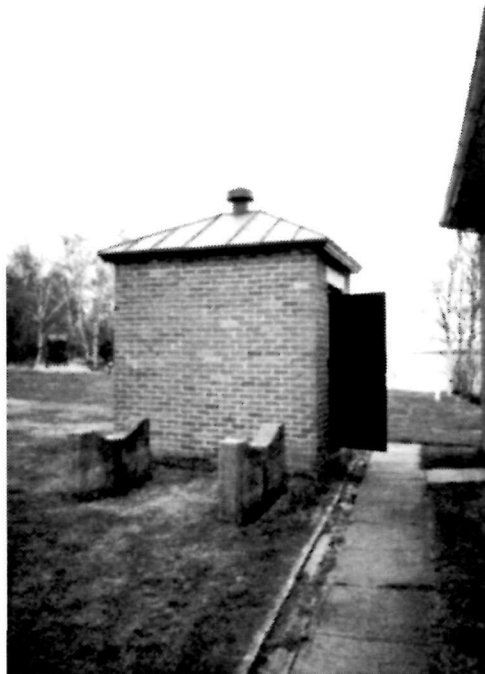
A National Register Form completed for the South Manitou Light Station, however, states that the exterior of the brick oil house was unfinished. It is not known whether this is an incorrect statement, or if the deteriorated areas of the brick surface were covered with parging and painted after the National Register Form was completed. Based on its condition, it appears that this is an incorrect statement, due to the apparent age of the parging and paint.

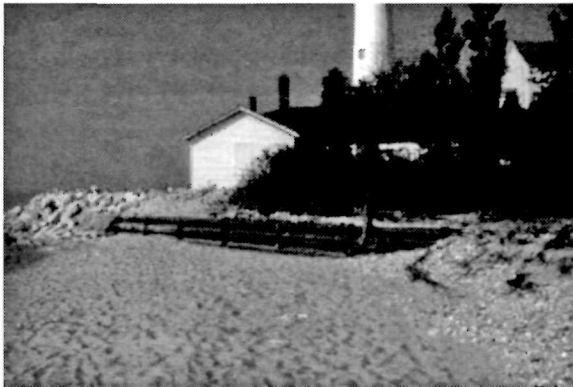
**Figure 13** Iron and rock shoreline protection at the South Manitou Island Light Station, 1995.

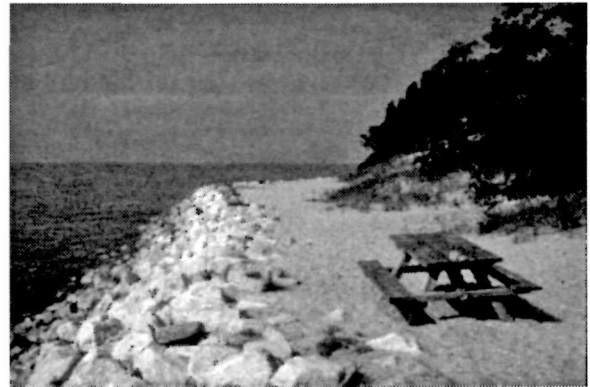
**Figure 14** Sandy terrace and boulder revetment at the South Manitou Island Light Station, 1995.

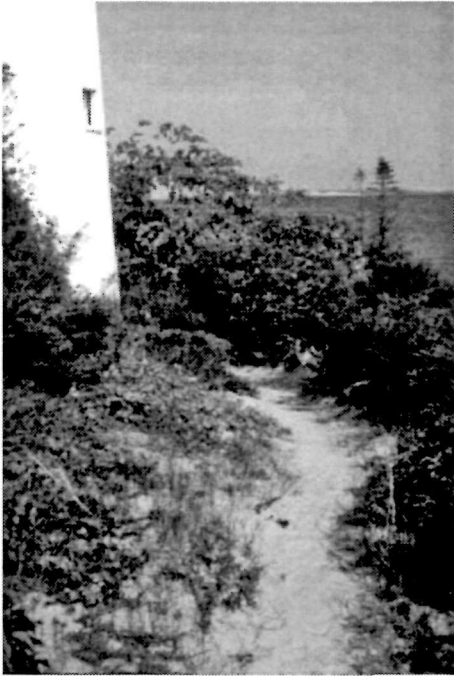
**Figure 20** View of the sand drifts over the sidewalk south of the Keeper's Dwelling, 1995.

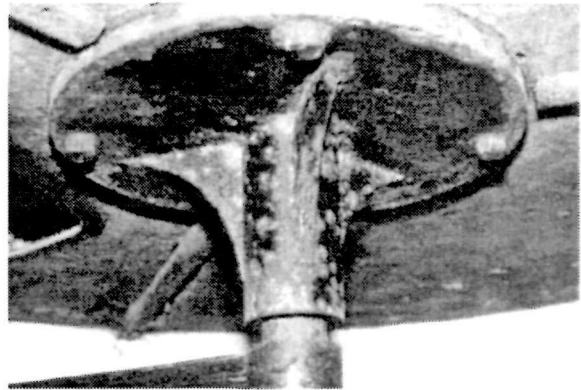
*Figure 1 View of the top connection of the Spiral Stair, 1995.*

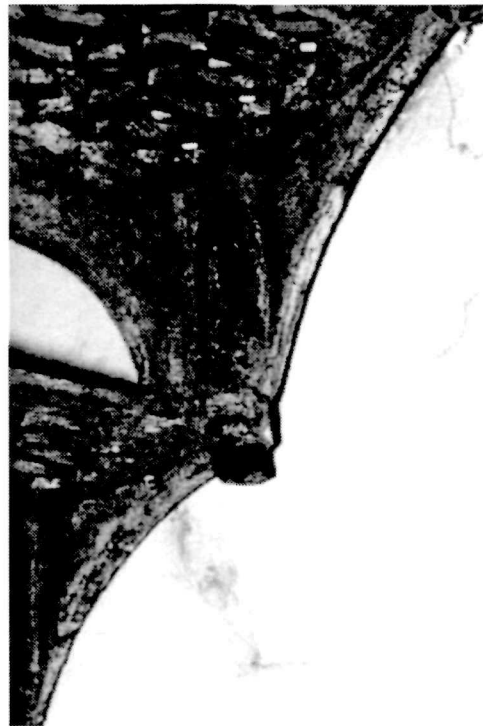
*Figure 2 View of the exterior edge of the Spiral Stair, 1995.*

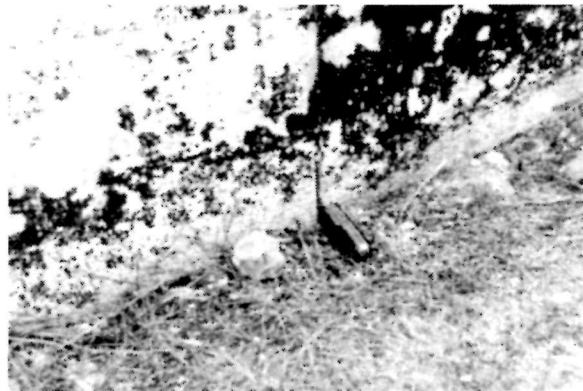
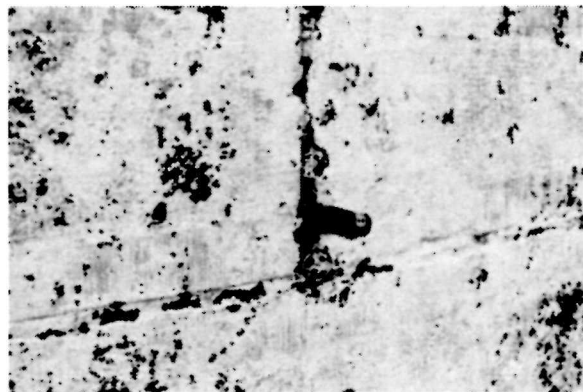
However, the tower is in need of some attention. The stone base of the tower has open masonry joints, which have lost mortar as shown in Figures 4 and 5. Note that a pocket knife blade can easily be inserted into the soft joints with little resistance (less resistance than a soft wood and comparable to wood rot) up to the hilt of the knife to a depth of two to three inches. The mortar may have become soft due to a leaching of the lime component, but more resistance to the blade penetration would be expected. It is suspected that the joint has lost mortar from weathering and has become packed with soil and other organics. This condition allows moisture to enter the joint with a long-term deleterious effect. Water penetration causes a freeze/thaw deterioration of the stone masonry, and results in cracking of the brick masonry above the stone work. The deterioration is progressive, and particularly acute for the Light Tower due to the severe seasonal weather exposure and high moisture shoreline location. Some minor hairline cracking was observed in the brick work, and appears to be a migrating extension of an open stone joint just below.

*Figure 4 View of the soft joints at the base of the light tower, 1995.*

*Figure 5 View of the soft joints at the base of the Light Tower, 1995.*

stone, and will cause the destruction of the stone adjacent to the joint due to normal structural movements. The mortar should match the color and texture of the historic mortar. The Tower's base should be inspected by park personnel on a yearly basis (early in the spring) to determine the extent of mortar loss in the stone jointing. Repointing of the Tower's base will likely have to be done on an ongoing basis also. This type of attention to external moisture penetration will prevent further base deterioration and will prolong the life of the tower.

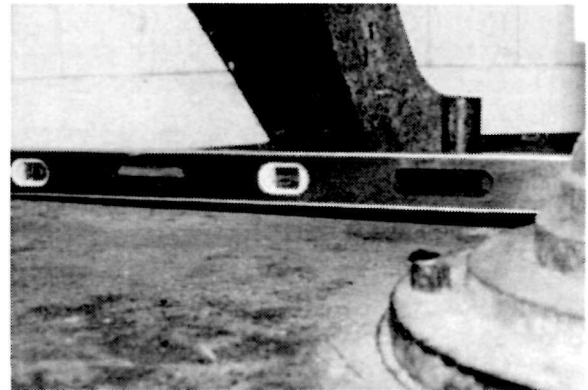
The stair assembly has moved downward a total of 2 inches or more in the past. This was further verified by the fact that the first tread below this landing slopes 2-1/8 inches. The vertical distance from the level 5 landing to the level 4 landing measured 138 inches. There are 17 risers at 8 inches each between these landings, which equals 136 inches. That leaves 2 inches of movement to make up the rest of the vertical dimension. This also means that most of the previous movement has been accommodated in the distance between the level 5 and level 4 landings in previous repairs. The National Park Service staff have been monitoring the stair's movements for some time. These records were reviewed, and it appears that any significant movement has been arrested by previous repairs. Any recorded historical movements are either insignificant, or could be attributed to normal measurement variation. Documentation for these repairs has been reviewed, but the nature and method of repair are unclear at this time. The presumed cause of the movement is also not clearly defined in historical information.

**Figure 6** View of the promenade landing (Lantern Room) which slopes to the middle of the Tower, 1995.

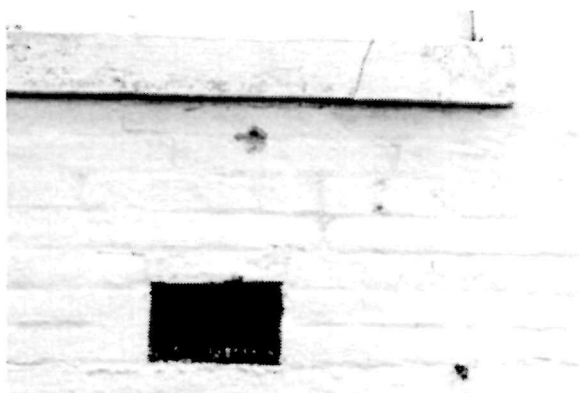
The stone window sill of the westerly window of the north wall (P-4) shows a moderate crack as though the stone is split throughout its width, (Figure 9). This does not pose any serious structural concern at this time, and can be protected by sealing or injecting the crack. The stone foundation wall on the south side of the passageway shows a ragged outcropping of laid up stone at the base of the wall. This condition appears to be the

**Figure 9** View of the north wall of the Passageway, showing the window sill crack, 1995.

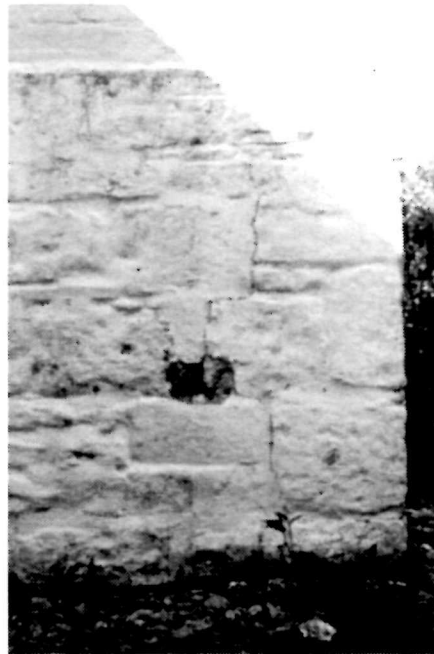
The east foundation wall shows signs of distress on the north side of the Keeper's Dwelling, as shown in Figure 10. The corner appears to be cracking and there is significant loss of stone and mortar. There is some indication of previous extensive repairs in this area, and the brick masonry above this area also shows signs of previous repairs and some present surface spalling. The cracking and deterioration patterns are not consistent with differential settlement. They may be caused by a combination of thermal expansion and contraction, and moisture penetration. The structure undergoes the extremes of seasonal temperature variation, with no tempering from internal heating which produces the maximum of volume change and associated distress. Moisture penetration (driven or condensate) into the cracked distressed areas further aggravates the problem by leaching mortars, and through freeze/thaw expansion and contraction. There is little that can be done about the cause of this problem in the absence of thermal tempering of the building. The present condition should be repointed and repaired. This area will probably need ongoing periodic maintenance.

**Figure 10** View of the foundation wall distress of the east wall of the Keeper's Dwelling, 1995.

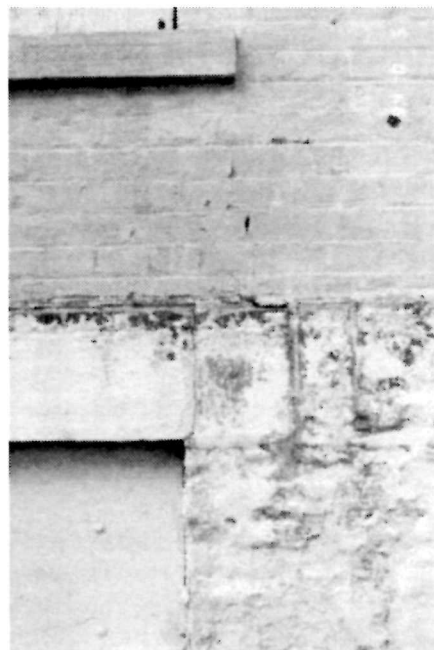
The east wall at the south side of the Dwelling also shows signs of age/environment-related deterioration. The head stone of the basement window on this side shows an apparent vertical through crack near the north jamb. This crack is shown in Figure 11. The brick work above this location shows hairline stepped cracking. The head stone should be either replaced or epoxy-injected to restore its integrity as a load carrying element. The wall cracking above should be repointed to prevent moisture penetration and related progressive damage. Paint flakes and some spalled surface areas were recorded near the south corner of this wall, as shown in Figure 12. The causes for this spalling were discussed previously.

**Figure 11** View of the east wall of the Keeper's Dwelling, south side, showing the window head stone cracking, 1995.

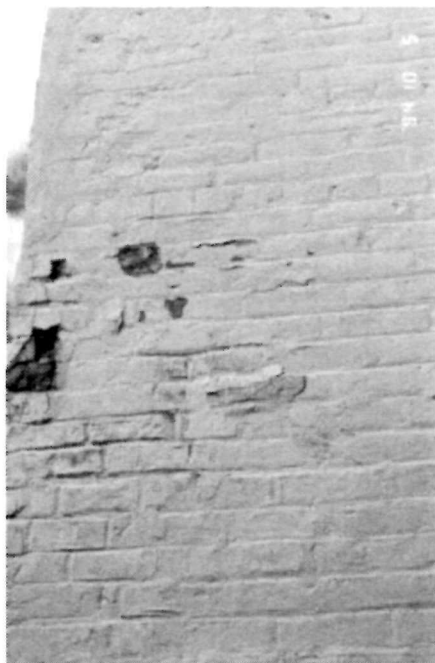
**Figure 12** View of the east wall of the Keeper's Dwelling, south side, showing surface spalls near corner, 1995.

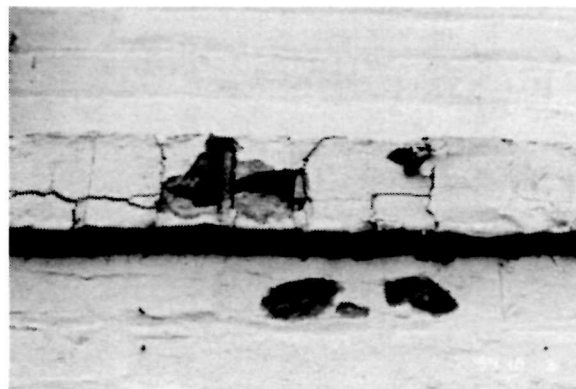
Similar deterioration was recorded for the north wall of the Keeper's Dwelling. There are numerous localized areas of brick surface spalls on this wall, as well as peeling paint. The stone basement wall shows hairline joint cracking in some locations. The first floor window sill, located toward the east end of this wall, shows signs of severe deterioration, as shown in Figure 13. The sill is badly fractured and delaminated. Organic material has filled in some of the cracks, and a small plant is growing out of this material. This sill is beyond repair and should be replaced. The condition at this window sill appears to be an isolated moisture/thermal occurrence, and bears no relation to any major structural movement or failure.

**Figure 13** View of the deterioration at the north wall window sill, 1995.

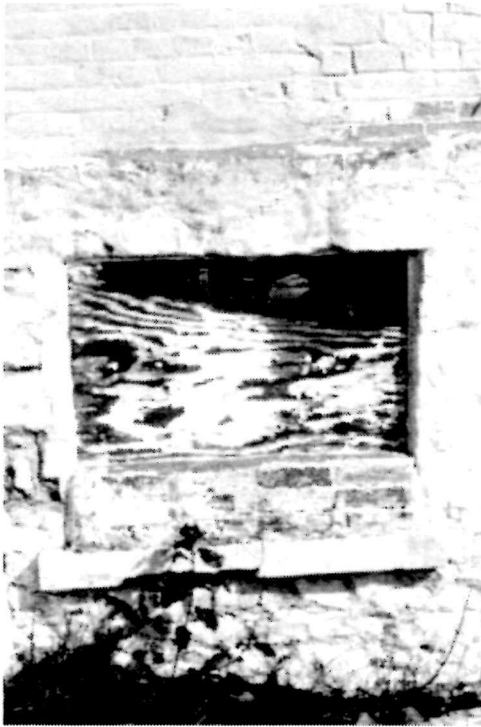
The localized spalling and cracking problem continues on the south wall of the Keeper's Dwelling. The stone foundation wall to the west of the stairs has been extensively repaired in the past. These repairs appeared to be reasonably sound at the time of the survey. The basement window located to the east of the stairs is in poor condition with sill cracking and shifting. The stone masonry surrounding this window is also in poor condition, as shown in Figure 14. The wood sill and jambs at the inside of this window have severely rotted away, indicating large volumes of moisture penetration at this location.

**Figure 14** View of the south wall of the Keepers Dwelling, showing the east basement window, 1995.

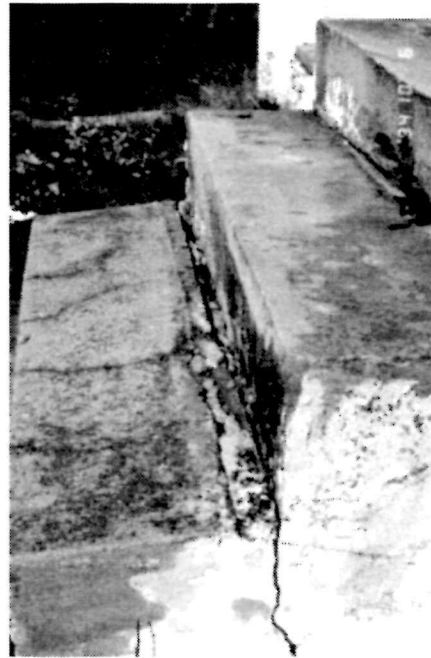
**Figure 16** View of the stair distress at the south exterior stair of the Keeper's Dwelling, 1995.

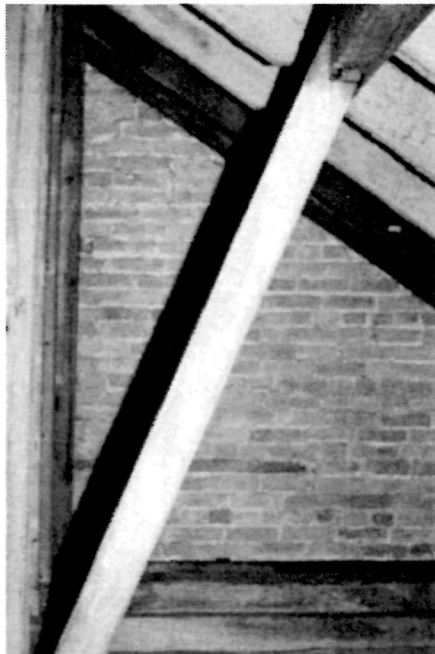
The roof framing, at first glance, appears to be simple and straightforward. The north-south spanning rafters are supported at the exterior walls, and are notched to rest on east-west beams located about 8 feet inside the exterior bearing walls. Collar ties located near the beam height are positioned on each side of the spiraling chimney, and near the end of the attic level platform for the original light tower, which was part of the Keeper's Dwelling (see drawings S.05 and S.09 of Appendix A). 4" x 4" wood struts extend diagonally upward from the attic floor level to the beam on each side, and are birds' mouth joined into the beam bottom, providing support for the beam as shown in Figure 17.

**Figure 17** View of the diagonal strut and birds mouth jointing in the attic of the Keeper's Dwelling, 1995.

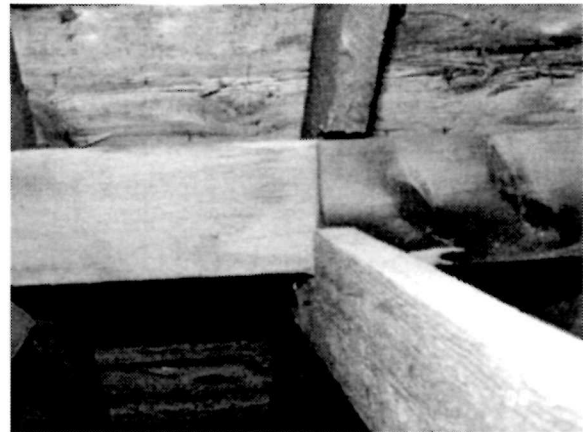
However the beam is butt-jointed slightly west of its mid-length at the collar ties at that location (see Figures 18 and 19). The beam joint is a straight through-cut which clearly interrupts the beam's continuity. This means that the collar ties must pick up the forces that the beam carries from the rafters, and, in turn, return those forces to the rafters near the cut. Additionally, the rafters do not impose a full load to the beam, but partially span half the width of the structure while sharing load with the beam. The entire roof system becomes a complex, interdependent, load-carrying system due to this unusual jointing. The butt joint may have been

**Figure 18** View of the beam butt joint at the north side of the roof, 1995.

No load analysis was performed for the roof since it appears to have performed very well over its history. An appropriate verifying analysis should be performed as a part of any rehabilitation effort. This would include determining and verifying local snow and wind loads. All existing codes refer to local officials to dic-

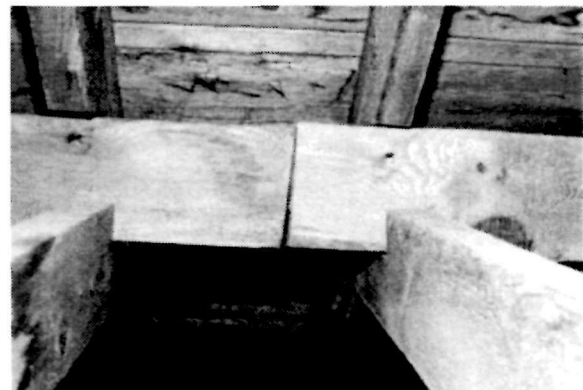
**Figure 19** View of the beam butt joint at the south side of the roof, 1995.

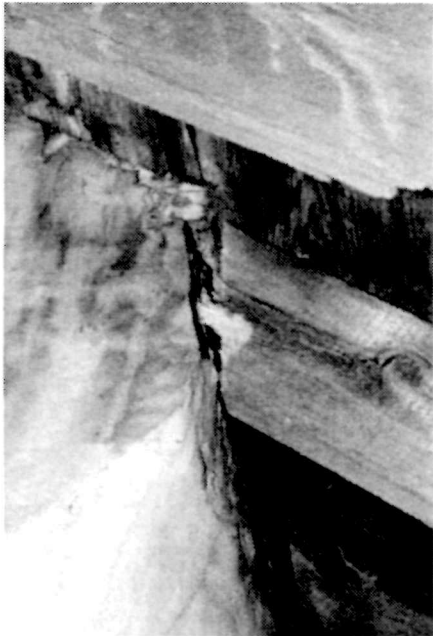
**Figure 20** View of a rafter cut at the spiraling chimney of the Keeper's Dwelling, 1995.

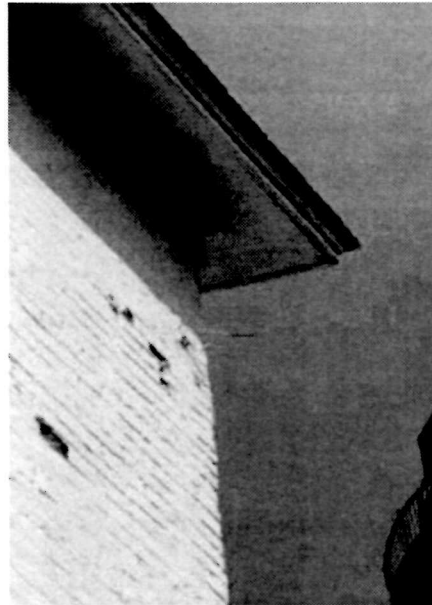
All of the foundation walls are rough ashlar stone. The Keeper's Dwelling's walls at the first and second floors (of all four elevations) are yellow brick laid in common bond with three courses of stretchers for every course of headers. There are several areas of failing paint and spalling brick, especially at the east corner of the south elevation, several of which have been covered over with a tooled parging to represent brick. However, much of this parging has also failed and pulled loose from the brick surface (Figure 27). There is another area of tooled parging at the brick above the western-most window (D-10) of the first floor. Furthermore, physical investigation revealed the accelerated deterioration of interior materials and finishes caused by water infiltration at these deteriorated areas of brick.

*Figure 27 View of the southeast corner of the Keeper's Dwelling, 1994. Note the deteriorated and spalling brick and the metal bracket which previously supported a downspout.*

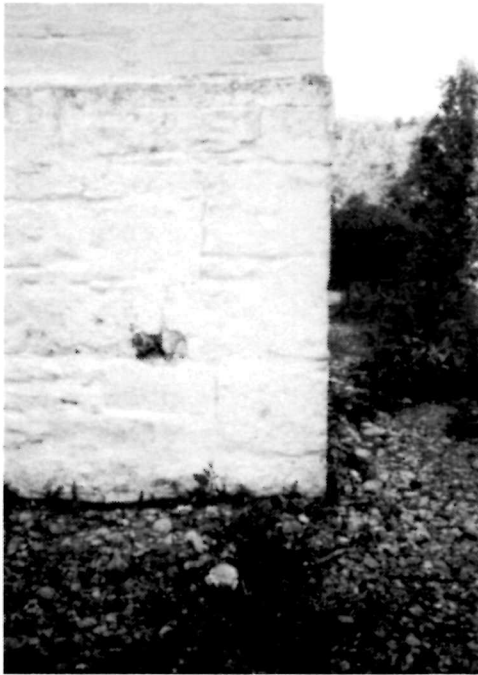
A crack in the parging applied over the foundation at the west end of the wall follows the profile of the cut stone quoining at the corner of the building, (Figure 31). At the top of the foundation wall, near the east end of the dwelling, there is a flush lintel stone, which has no opening to support (Figure 32). The reason for this

**Figure 31** View of the northeast corner of the stone foundation wall at the Keeper's Dwelling, 1994. Note the cracking of the cementitious parge coat along the profile of the cut stone quoining.

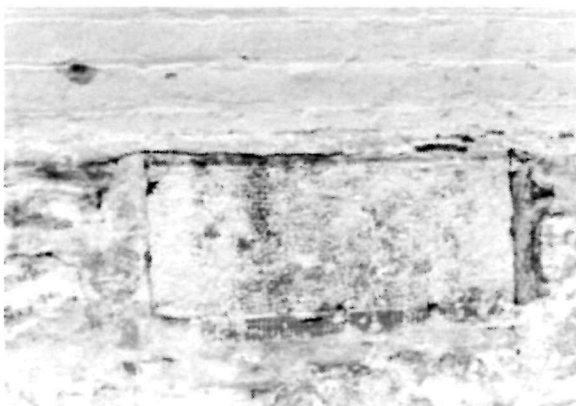
**Figure 32** Detail view of the flush stone lintel (its purpose unknown) located near the east end of the north elevation of the Keeper's Dwelling, 1994.

unique condition is currently unknown, and there is no evidence of a historic opening in this location. This stone is smaller in size and placed higher on the wall than the other stone lintels that actually support the window openings.

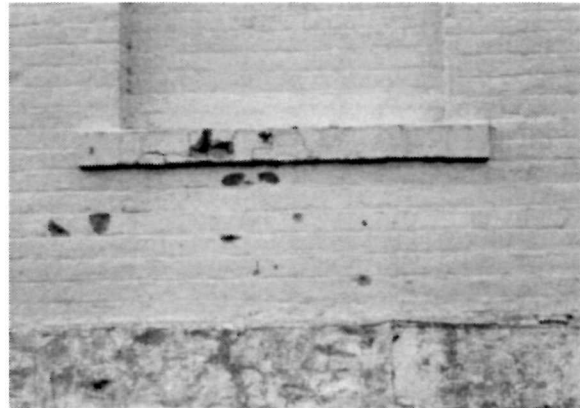
**Figure 33** Detail view of the deteriorated brick sill, and the wall surface below, at the false window opening at the east end of the north elevation, 1994.

There are several areas of spalling brick along the north elevation, especially below the west brick recess at the second floor, and at the brick sill of the false window (Figure 33). An area of the brick surface at the east end of the wall, just above the foundation, appears to be coated with an excessive amount of parging that is crudely tooled to resemble mortar joints (Figure 28). With the exception of the aforementioned areas, the overall brick surface of the north elevation has experienced only minor blemishes and cracks.
