# HISTORIC STRUCTURE and CULTURAL LANDSCAPE REPORT

South Manitou Island Light Station  
(Historic Structures 51-120 A-I)

Sleeping Bear Dunes National Lakeshore  
Empire, Michigan

January 29, 1999  
Final Report  
Project # 94117.01

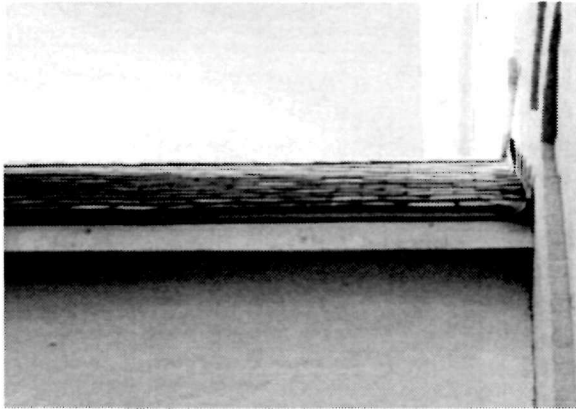
National Park Service records indicate that the roof of the entire Passageway was re-shingled in 1980. Photographs of this work reveal that the roof was stripped down to the wood rafters, and was entirely rebuilt. The new wood sheathing boards appear to be either 1 x 8s or 1 x 10s spaced horizontally, close together. The maintenance records also indicate that, "a 65# felt was installed, the eaves were enclosed to match [the] existing style, and that the replacement shingles were those that had been removed from the keeper's dwelling."<sup>2</sup> However, Kim Mann, Sleeping Bear Dunes National Lakeshore Superintendent, states that no shingles were reused from the Keeper's Dwelling. Rather, the roof shingles in place were cut from asbestos board and sent to the island from the mainland. There is no apparent surface damage, with the exception of the southeast corner at the intersection of the Tower where several shingles are missing. The metal flashing at the intersection of the Passageway's roof and the east wall of the Keeper's Dwelling is pulling loose (Figure 36), and

**Figure 36** Detail view looking south at the intersection of the Passageway's roof and the east wall of the Keeper's Dwelling, 1994.

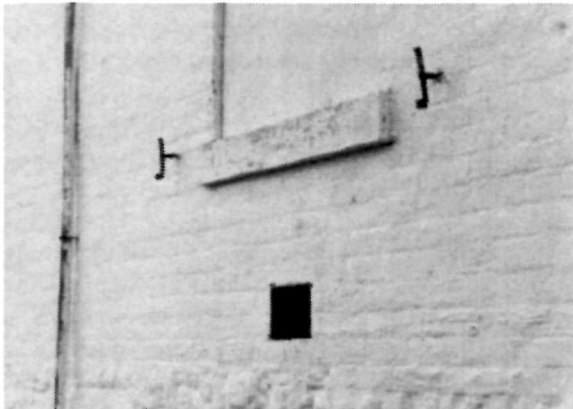
**Figure 39** View of Window P-3 at the north elevation of the Passageway, 1994.

underlying brick, and have deteriorated in several areas. The west window (P-4) has a cracked sill, and there are several cracks in the masonry between the sill and the metal ventilation grille directly below it. There are a few remaining rusted metal hooks placed horizontally from each other along the elevation which, based on historic photographs, formerly supported a piece of surface mounted piping or metal conduit. There is also a 2 inch diameter, galvanized conduit running vertically the full height of the Passageway approximately 7'-10" west of the Tower. Two painted metal shutter holds were observed at the east window, (P-3), each one 12" from the window opening (Figure 39). These are the only remaining shutter holds left on the building of those that were likely located at all of the windows. A small number of tagged historic shutter hardware exists and is now located in archival storage, in the Sleeping Bear Dunes headquarters building.

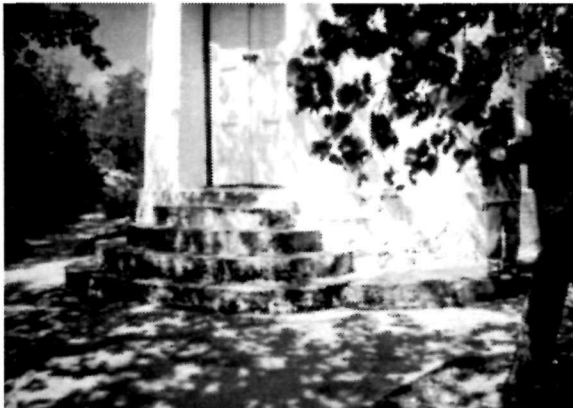
**Figure 40** Detail view of the stone steps at the base of the Tower, 1994.

The base of the Tower, which extends approximately 12" - 14" above grade, consists of large cut-stone blocks, which are approximately 12" in height. The stone blocks also curve to form the circumference of the Tower while tapering slightly upward. Furthermore, the base protrudes approximately two inches out from the brick face of the Tower, with the top of the stone cut at an angle to act as a water table. The base appears to have once been coated with several layers of a black paint or an asphalt-type coating, but during physical investigation most of this finish had worn off (Figure 40). National Park Service records indicate that the last application of the black finish was in 1980.

Several of the mortar joints at the stone base of the Tower have deteriorated. Some have been repointed, but the replacement mortar appears to have also failed. There is a large joint between the concrete walk and the base of the Tower which appears to have been previously repaired with an infill material, however, this

material has failed and cracked, allowing the width of the joint to continually widen.

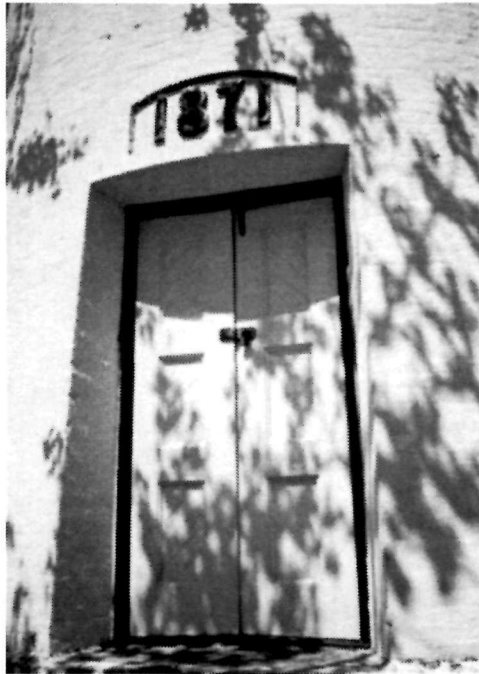
*Figure 41* Detail view of the pair of doors at the base entrance into the Tower, 1994.

The stone steps also have the remnants of several layers of a black paint or asphalt-coating on them, similar to that observed at the base. There are several gouges and areas where the concrete has cracked and broken loose at the steps, appearing to be almost “gnawed” from snow, water, and ice buildup. The faces of the steps have the same bush-hammered tooling as that found at the stone sills of the Dwelling. The pair of wood doors at the entrance to the Tower are in good condition, with no evidence of paint buildup or failure observed (Figure 41). According to National Park Service records, these doors were fabricated and installed in 1980.

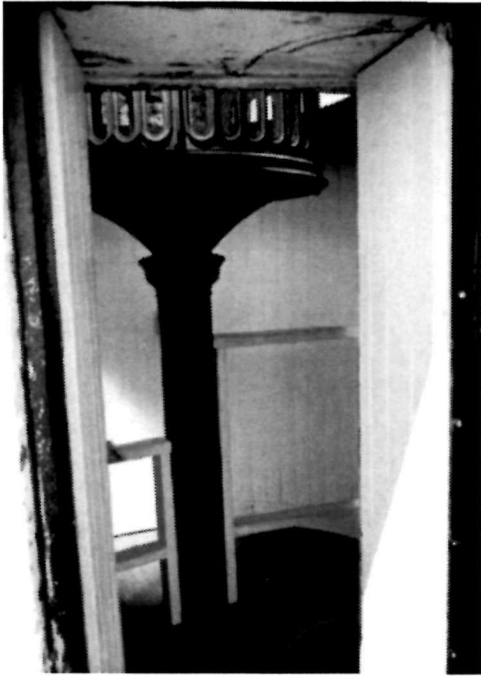
The walls of the lantern room are lined with a wainscot, comprised of 2 3/8" wide tongue-and-groove, beaded, wood boards. The metal pedestal, which once held the Fresnel lens, has experienced excessive oxidation (Figure 46). Furthermore, all of the brass ventilator caps are missing. The door opening leading onto the exterior platform has a cast iron frame and sill, which have also rusted.

**Figure 46** View looking into the Lantern Room of the Tower toward the cast iron pedestal, which formerly supported the third order Fresnel lens, 1994.

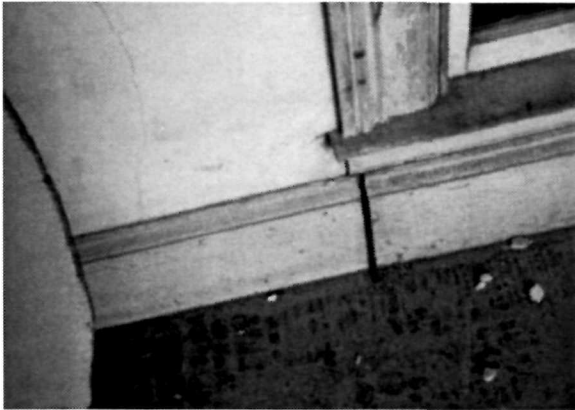
**Figure 47** Detail view of the separating joint in the wood baseboard beneath a window in the Passageway, a typical condition beneath all four of the Passageway windows, 1994.

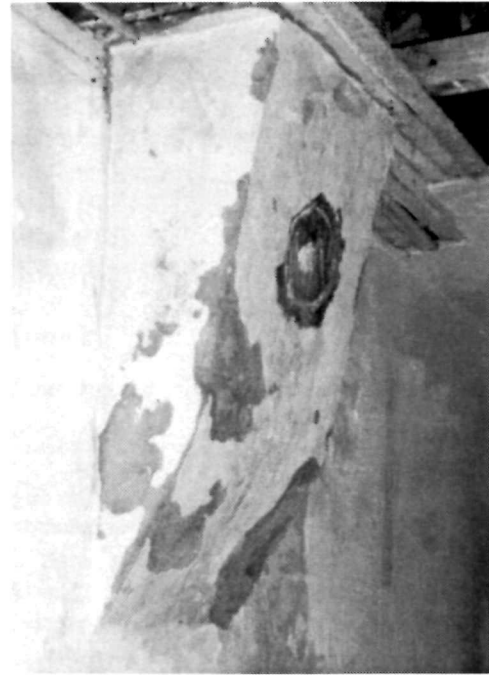
**Figure 48** Interior view of the chimney in the Passageway, which is corbelled in from the wall approximately 5'-0" above the floor, 1994.

The chimney is corbelled out from the south wall, beginning approximately 5'-0" above the floor. The stepped profile of the brick is not visible because the

surface is finished with plaster, giving it smooth, rounded edges (Figure 48). The stovepipe hole had once been plastered over, however, most of the plaster was worn off during the 1994 physical investigation.

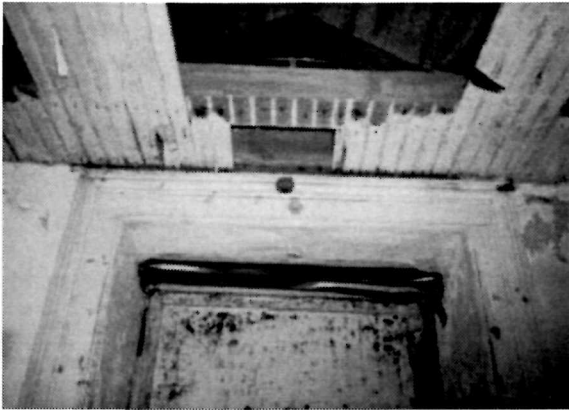
**Figure 49** Detail view of the head of the door opening between the Passageway and the Tower, 1994. Note the small circular opening through which the electrical conduit to the Tower was formerly fed.

At the east door leading into the Tower, (Door I-1), there is a huge gouge in the stone jamb on the south face. There is also a circular hole cut through the wall of the Tower above the door. According to the historic electrical drawing, this was where the electrical conduit ran to provide light to the Tower, (Figure 49).

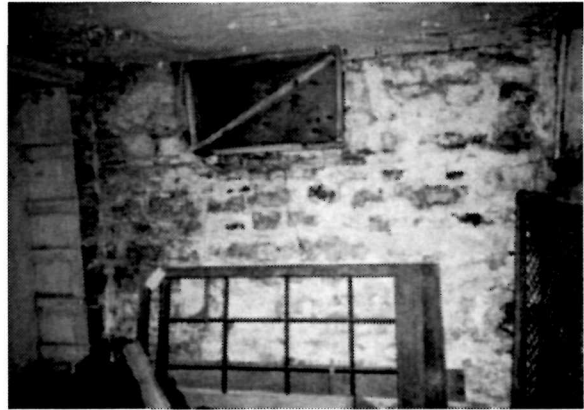
**Walls:** The west wall has the same finish as its opposite face, which is in the Kitchen (Room B-06). The south and east walls are rough stone, which are covered with a parging that is scored to resemble large masonry blocks (Figure 50). It appears that several layers of whitewash were applied over the tooled surface,

**Figure 50** View of the east wall in the southeast basement storage room (Room B-01) of the Keeper's Dwelling, 1994. Note the remnants of the parging that was tooled to resemble masonry.

but most of both the whitewash and the parging have worn off. The window at the east wall (D-7) has been removed from its opening and infilled with blocking and plywood (Figure 50). The window at the south wall (Window D-1) is also missing from its opening. The painted wood window framing is severely deteriorated and the sill is missing, thus, exposing the rough stone opening. The north wall is divided by two piers, which were constructed to support the original roof lantern that was located directly above them. The east pier is rough stone which extends as a pilaster from the east basement wall, while the west pier is constructed of yellow brick, which is painted. The wall surfaces between the piers are lined with wood planks and shelving brackets all of which are covered with whitewash. The shelves these brackets once supported are no longer extant.

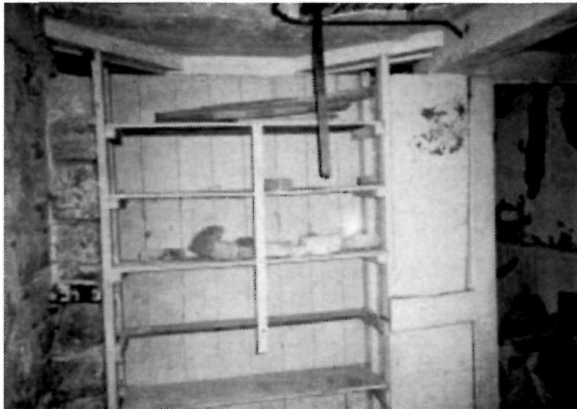
**Figure 51** View of the south wall of the northeast basement storage room (Room B-02) in the Keeper's Dwelling, 1995.

east are "worn" bare. A large area of the north wall at the northwest corner of the room has been covered with parging. The south wall is a mirror image of its other face, (which is in Room B-01), consisting of wood planks which line the space between the two piers. The painted wood shelves remain intact between these piers (Figure 51).

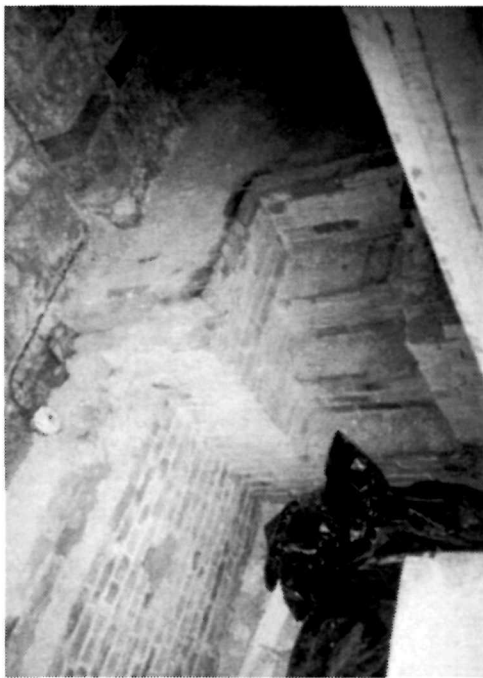
**Figure 52** View looking down into the subcellar (Room B-03) of the Keeper's Dwelling, from the stair, 1994. Note the steep brick-lined steps leading down into the subcellar, and the exposed conduit of a former light fixture.

**Floor:** There are three steps leading down into the subcellar from the floor of the storage room above. The steps and the floor of the subcellar are lined with red brick, (Figure 52).

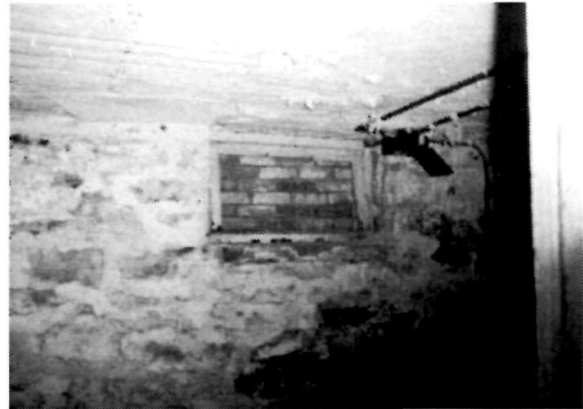
**Figure 53** View of the east wall in the northeast basement storage room (Room B-03) of the Keeper's Dwelling, 1994. Note that most of the parging has worn or broken off of the stone wall surface.

The window opening at the east elevation above the subcellar, (Window D-6), is infilled with unpainted brick. The wood frame is partially intact and covered over with green paint, (Figure 53).

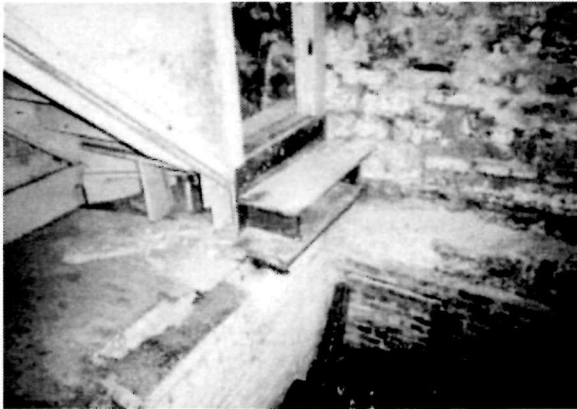
**Figure 54** View of the stair that hangs precariously over the subcellar (Room B-03) in the Keeper's Dwelling, 1994

Although the door has been removed (as at most interior openings of the dwelling), there is an opening (Door B-1) leading into the area of the subcellar, Room B-03, which remains. During physical investigation, this opening was temporarily blocked with wood members, as it is dangerous because it leads to a step that is precariously hanging over the subcellar, the floor of which is some 5'-0" below, (Figure 54).

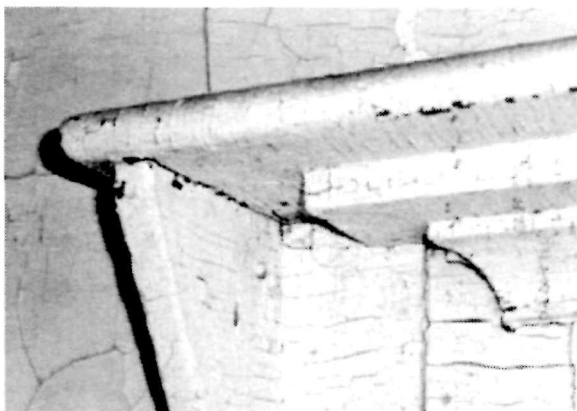
**Figure 56** Detail view of the wood fireplace mantle in the Keeper's Kitchen (Room B-05), 1994. Note the paint buildup and excessive cracking.

The fireplace is trimmed with a wood mantle and casing, both of which have extensive paint buildup (Figure 56). Several of the nails connecting the pieces of wood comprising the mantle have rusted and stained the paint surface. A few pieces of wood are missing and the east vertical member has a deep, vertical split spanning its entire height.

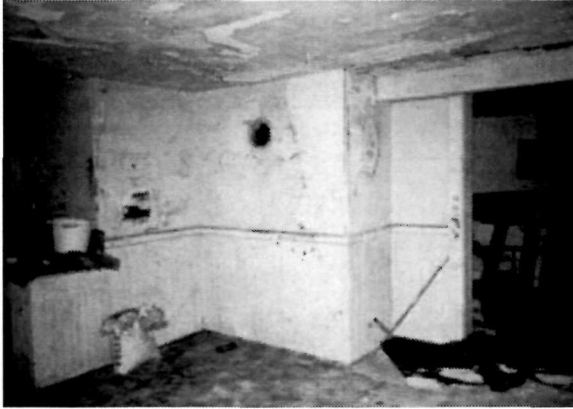
**Figure 57** View looking northwest in the Assistant Keeper's Kitchen (Room B-06). Note the deterioration of the plaster at both the ceiling and walls.

extensive paint buildup at the wainscot, which is accelerating peeling and revealing an extensive amount of the wood beneath, which is splitting along the grain. The plaster surface above the wainscot, which has either deteriorated or is missing at several locations throughout the room (Figure 57), is most likely the result of water infiltration. There is also a wood coat hook rail on the west wall near the exterior door.

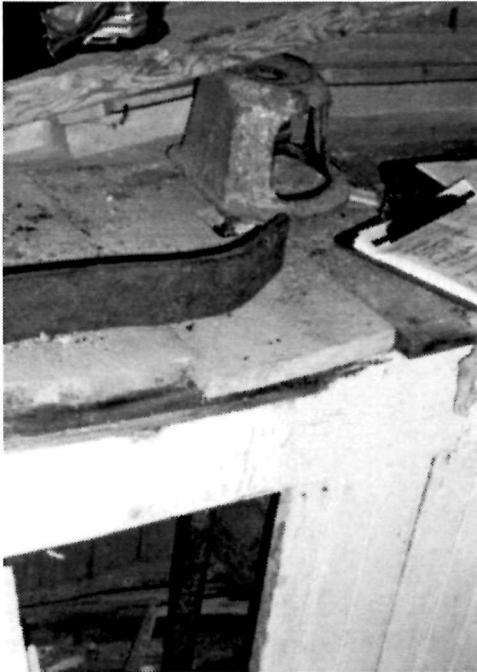
**Figure 58** Detail view of the wood beaded board cabinet and the remaining piece of the metal hand pump at the sink in the northwest corner of the Assistant Keeper's Kitchen (Room B-06), 1995.

*Other:* There is a wood cabinet and a piece of the hand pump from the cast iron kitchen sink at the northwest corner of the room. The wood is weathered and several parts of the cabinet are missing. The sink has been removed and unfinished boards have been placed across the counter surface (Figure 58).

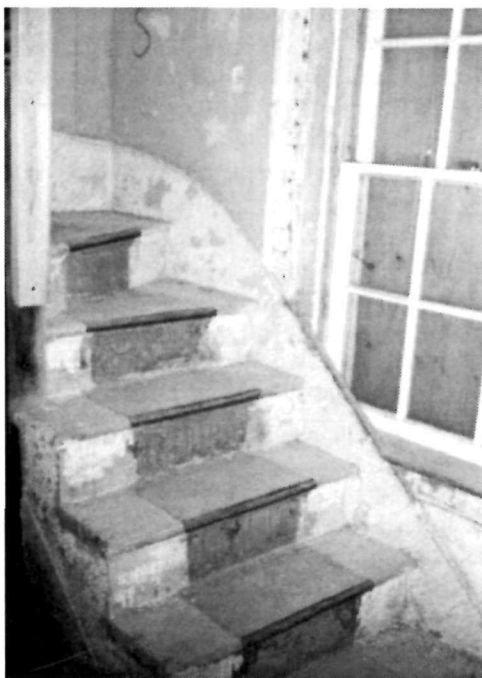
**Figure 60** Detail view of the face of the stair risers that are painted a darker gray to give the appearance of a continuous stair runner, 1994.

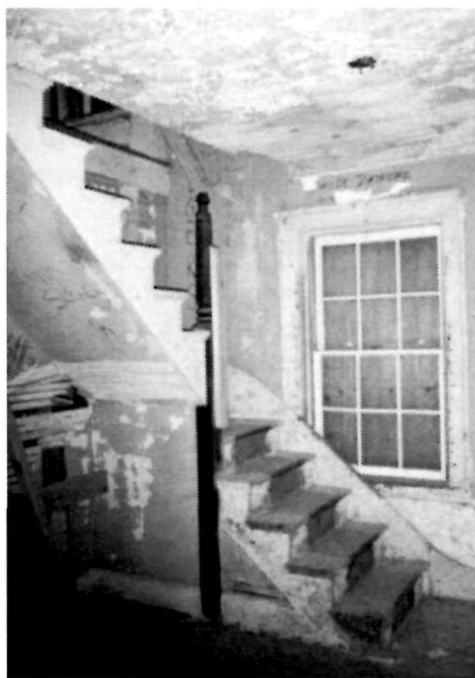
**Figure 62** View looking northeast in the Entrance Hall (Room 101) toward the stair, 1994. Note that the balustrade and some of the tread nosing are missing at the stair, and the deteriorated condition of the adjacent plaster surfaces

**Stairs:** The wood stairs leading to the second floor at the northeast corner of the room have excessive paint buildup along the stringers, while most of the paint has worn off of the exposed surface of the treads. A 17" wide strip of vinyl was formerly attached to each tread with metal nosing. Several pieces of this vinyl remain, although they have deteriorated and are falling apart. The face of each riser (the portion that is the same width as the vinyl pieces on the treads) is painted a darker gray to give the appearance of a continuous stair runner (Figure 60). There is evidence that the balustrade consisted of spindle balusters that were let into the treads, but none of the balusters are extant. The only remaining element of the balustrade is the intermediate newel post, which extends alongside the stair to the floor for support, however, its newel cap is missing (Figures 61 and 62). This newel post appears to be mahogany, with a dark stain and a clear finish applied to it.

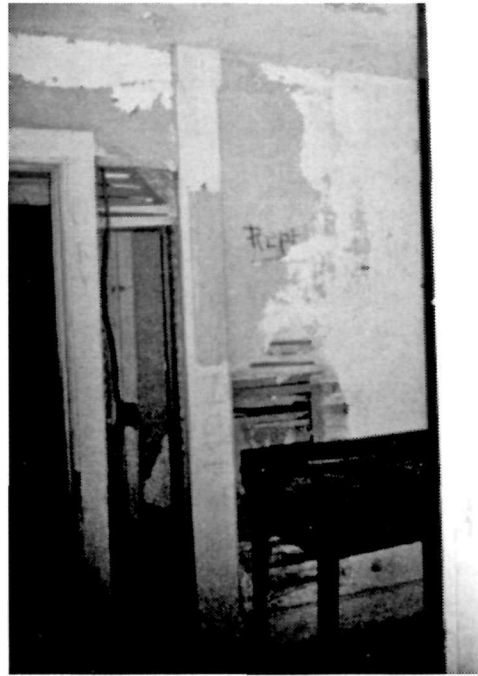
**Figure 63** View of the west wall in the Keeper's Office (Room 102), 1994. Note the ghosted outline in the paint at the chamfered wood post, indicating that something was previously hung (and painted around) in this location.

**Other:** There are four chamfered wood posts (two each along the east and west walls of the room), which extend continuously from their basement pier supports through to the attic where they once supported the former roof lantern. A demarcation in the paint surface of the west post indicates the ghosted profile outline of a plaque or other object previously hung here (Figure 63).

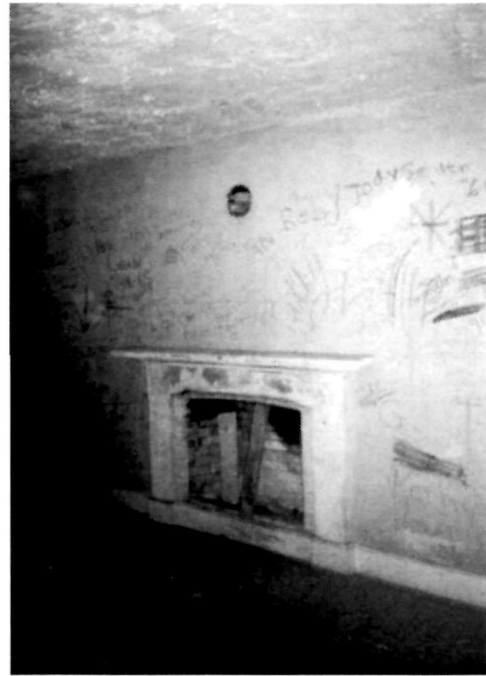
**Figure 64** View of the fireplace along the north wall of the South Parlor (Room 104), 1994. Note that although the brick and plaster infill has been removed at this fireplace, the baseboard remains across the opening.

(behind and including the wood baseboard) remains (Figure 64). The metal chimney bar, which supports the brick opening, is exposed and has rusted. The metal cover is missing from the stovepipe hole, revealing the sheet metal lining of the shaft. The outline of the former cover is ghosted on the paint surface, and the area that would have been beneath the edges of the cover reveals a different color of paint than the exposed, top layer. There are five nail holes across the front of the wood mantle, with one large one at each side of the firebox opening.

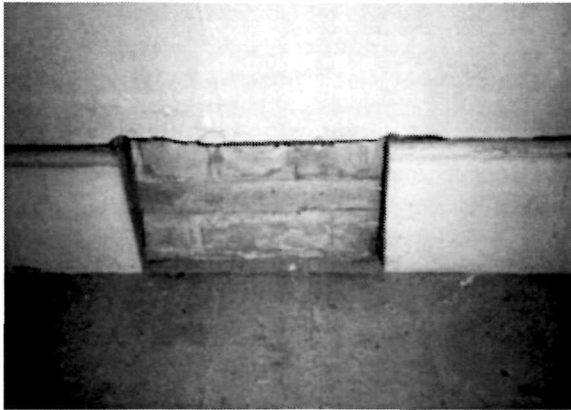
**Figure 65** Detail view of the south wall of the southeast bedroom (Room 201), 1995. The wood baseboard has been cut and removed, exposing the wood nailer within the brick coursing to which the baseboard is attached.

**Walls:** A 14" wide piece of the wood baseboard is missing along the south wall approximately 3'-7" from the west wall, revealing that the plaster did not continue behind the baseboard. A wood member, the same height as the brick (to keep coursing), is visible within the

brick coursing, and was presumably used as a nailing surface for the baseboard attachment (Figure 65). This condition is likely typical at all of the exterior walls of the Dwelling. The physical investigation revealed a piece of wood attached to the baseboard of the south wall, about 2'-0" from west wall, which is presumed to have served as a door stop.

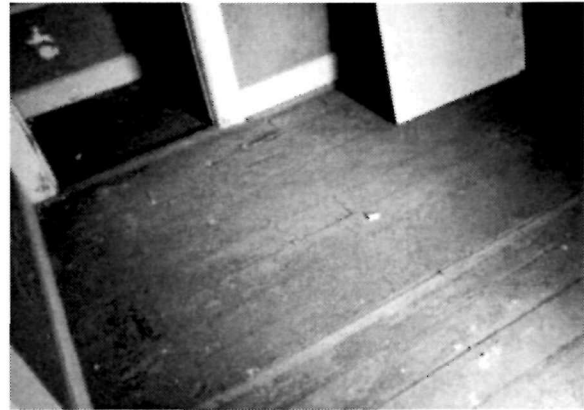
**Figure 66** View looking southwest at the floor of the Stair Hall (Room 202), 1995. The heavy paint buildup has caused the paint to fail and loosen in large chunks.

**Floor:** Excessive paint buildup has created cracking, and the paint has failed leaving either large "clumps" of paint or areas of bare wood across the entire floor surface (Figure 66). A rough board has been nailed over the floor, approximately 15" - 18" in length, at the threshold of Door I-15 (leading into Room 203). All four doors leading into this hall have wood threshold saddles.

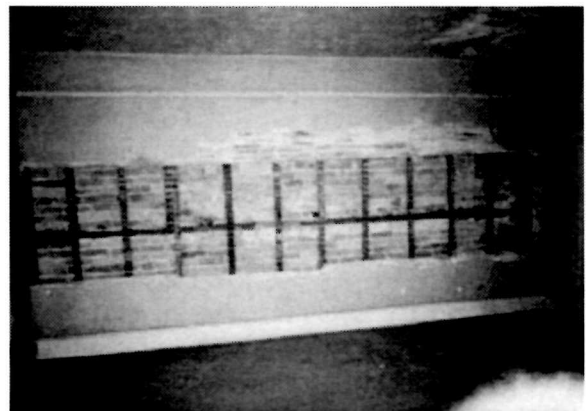
*Figure 67* View of the north wall in the northwest bedroom (Room 204), 1994. The large area of missing plaster has revealed a wood plate within the brick coursing, presumably incorporated as a nailing surface for the wood lath.

deliberately removed either for exploration or as a result of vandalism. This area exposes the interior surface of the exterior brick wall, including a wood member which is incorporated into the brick coursing approximately 4'-0" above the floor (Figure 67). This detail was likely constructed to provide a nailing surface onto which the wood lath could be nailed. Presumably, there is another wood member beneath the plaster near the ceiling which provides a nailing surface for the picture molding. This condition is likely typical at all of the exterior walls of the Dwelling. Signs of water infiltration at the chimney are evidenced by the spalling and deteriorating plaster, and rust stains from the former metal stovepipe hole cover. There are several areas of damage due to vandalism at both the south and east walls. There are also signs of water damage below window D-19. The wood picture molding, which extends around the entire room except at the chimney face, has the same profile as that of the picture molding seen in Room 203. There is also a painted shoe mold attached to the baseboard at all of the walls.

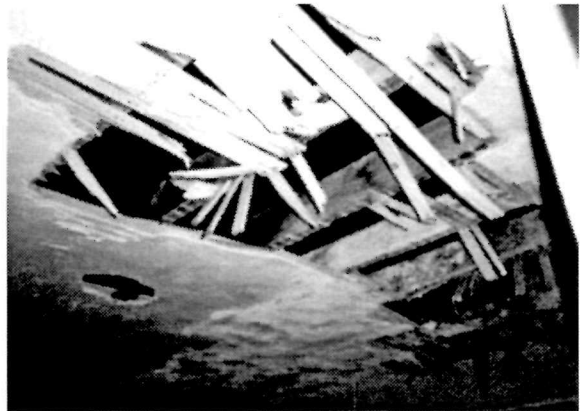
**Figure 68** View of the ceiling in the southwest bedroom (Room 205), 1994. Note the large amount of missing plaster and broken lath, both the result of vandalism.

*Ceiling:* Over three-quarters of the ceiling plaster and lath is completely missing, with only the nails that used to hold the lath in place remaining (Figure 68).

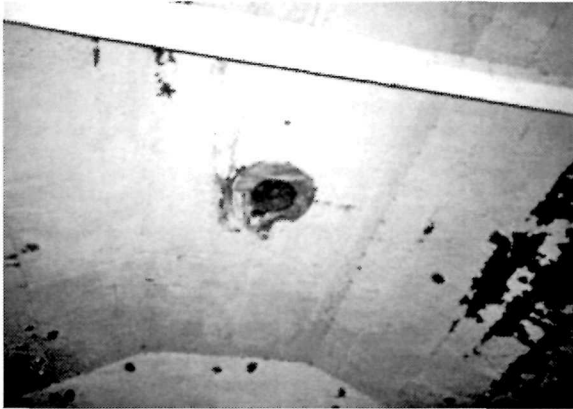
The ceiling of the east section of the building, referred to as the Machinery Room after the two individual buildings were connected, is covered with painted sheet metal that has rusted extensively (Figure 69). The walls in this section of the building were originally all covered with sheet metal also, but most of it has either been removed

**Figure 69** Detail view of an opening in the ceiling of the Fog Signal Building, 1995. A metal chimney stack once extended through this opening.

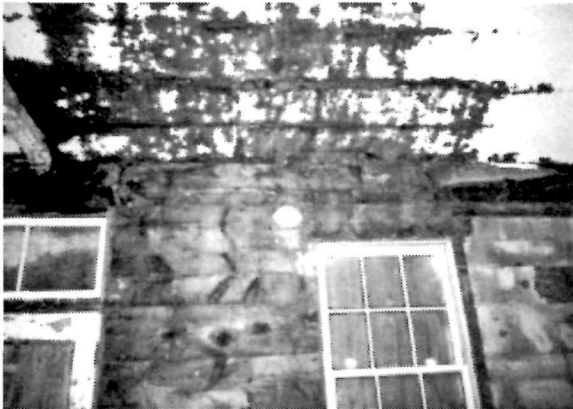
**Figure 70** View of the south wall of the Machinery Room in the Fog Signal Building, 1995. Note the circular opening just above the window.

or has fallen off. The exposed walls are comprised of 12" wide boards from the floor up to approximately 5'-0" above the floor, and of 6" wide boards from this level to the ceiling (Figures 70 and 71). The large furnace, which once heated the space, remains near the northwest corner of the space (Figure 72). The concrete slabs that formerly supported the diesel generators also remain in the northeast area of the room (Figure 73).

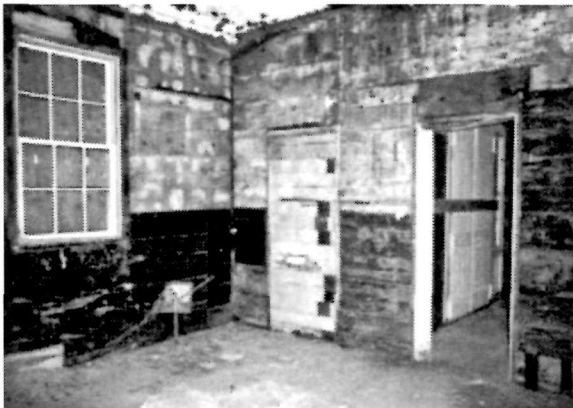
**Figure 71** View looking toward the southwest corner of the east wing of the Fog Signal Building, 1995.

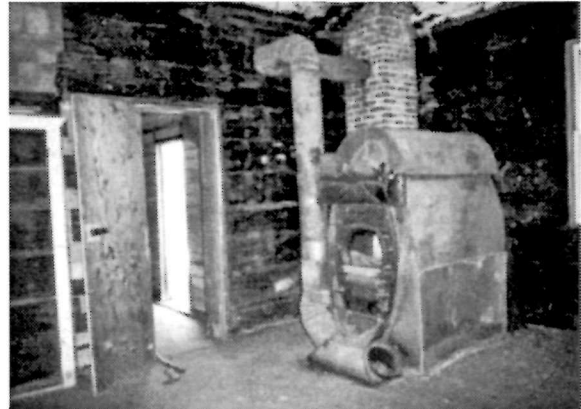
**Figure 72** View looking toward the northwest corner of the Machinery Room in the Fog Signal Building, 1994. The furnace was installed by the Coast Guard.

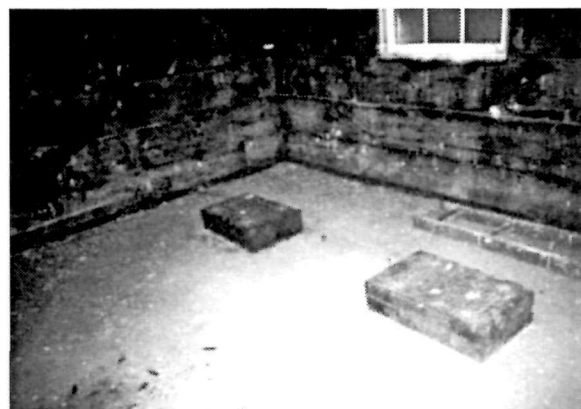
**Figure 73** View looking toward the northeast corner of the Machinery Room in the Fog Signal Building, 1995. The concrete pads formerly supported two diesel generators.

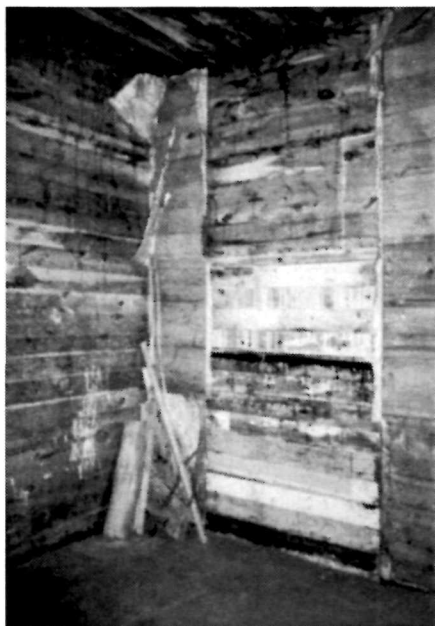
**Figure 74** View looking at the southwest corner of the Coal Bin in the Fog Signal Building, 1995.

There appears to have been an opening, which extended from the floor to the ceiling, at the west wall of this room and into the machinery room. Physical investigation revealed part of the wall infilled with miscellaneous sized wood boards (Figure 74).

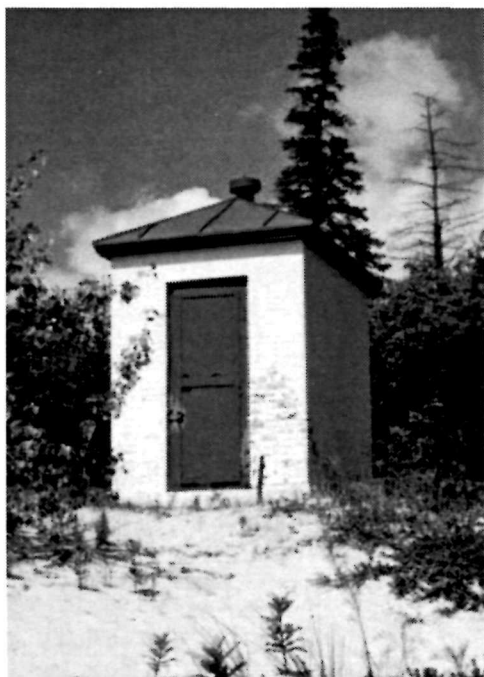
**Figure 75** View of the Brick Oil House at South Manitou Island Light Station, 1994.

The exterior brick walls are coated with several layers of the same beige color paint as the exterior brick walls of the Keeper's Dwelling, (Figure 75). In several areas, the paint has either deteriorated and is peeling, or is completely gone, exposing a mixture of underlying paint colors and different brick types. There are at least three types of brick exposed: red, yellow, and yellow iron spot. There are several large areas on each of the four elevations which are covered with parging ranging from 1/4" to 1/2" in thickness, which is crudely scored to resemble brick mortar joints (Figure 76). Physical investigation revealed that most of the parging is deteriorated and falling off of the underlying brick surface. Furthermore, at the east elevation, north of the door, there are signs of deeper deterioration, including spalling brick and missing mortar (Figure 77).

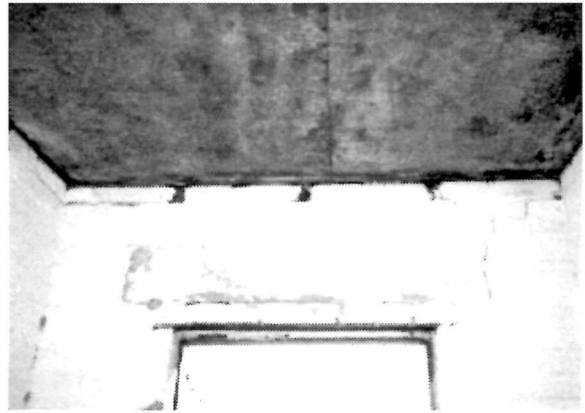
*Figure 78 Detail interior view of the door head and ceiling of the Brick Oil House, 1994.*

The painted concrete floor of the brick oil house is approximately 1" higher than the stone sill at the door, and there is a steel threshold at the door. The interior surface of the brick walls is painted white (Figure 78). The paint has worn off in several areas, exposing the inner brick wythe, which appears to be entirely comprised of yellow iron spot brick. The ceiling is galvanized sheet metal. It is assumed that there is wood framing at the roof above the galvanized ceiling, as is typical for this building type, but it could not be seen without destructive investigation. There are 10 1/4" holes, which form a circle in the ceiling, to provide ventilation in this once highly flammable space.

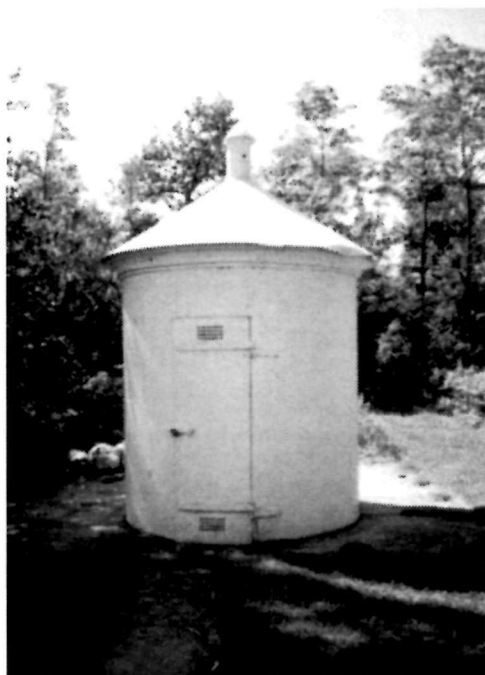
**Figure 79** View of the Metal Oil House in its present location at the South Manitou Island Life-Saving Station, 1994.

few times since then. At one point it was "rolled to somewhere in the village and used as a jail."<sup>6</sup> Later it was relocated (date unknown) to behind the historic South Manitou Island U.S. Life Saving Station where currently stands (Figure 79).<sup>7</sup>

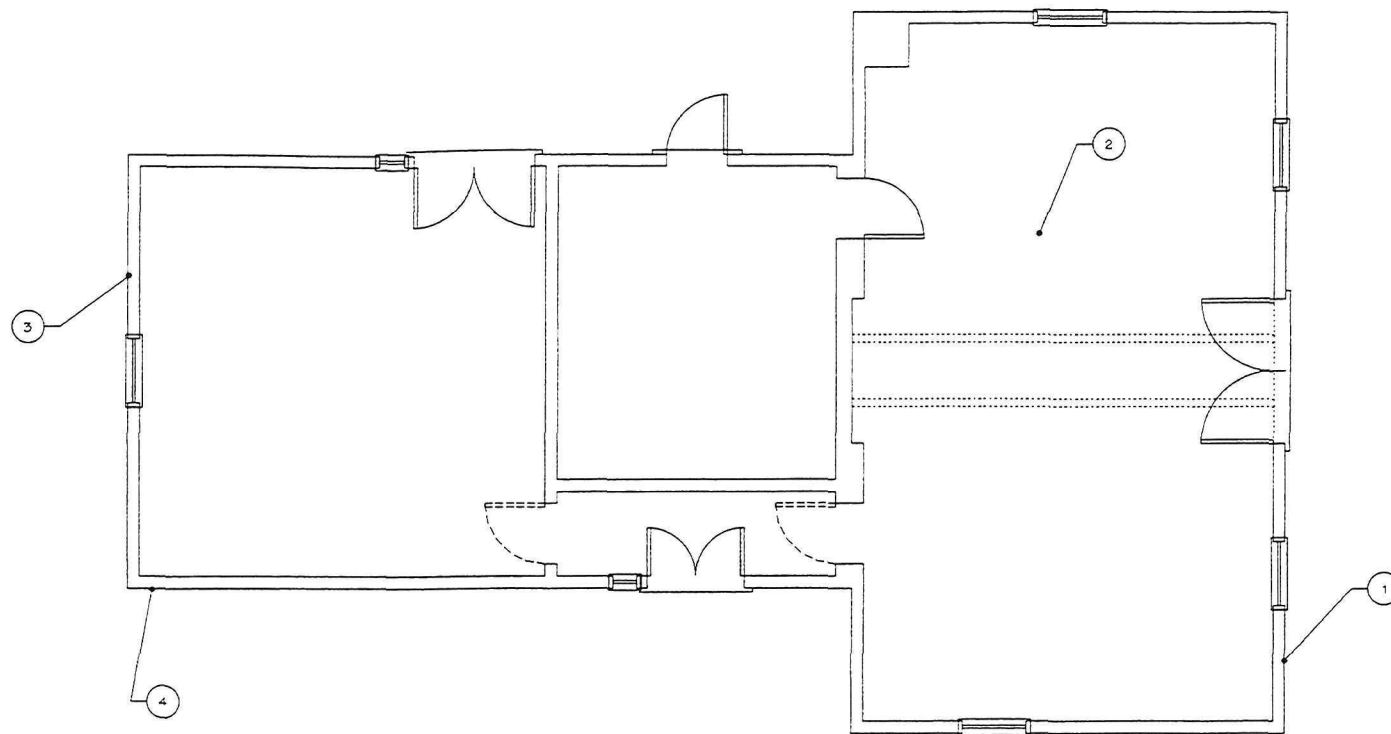
## FOG SIGNAL BUILDING PLAN

- 1- Concrete foundation cracking observed along the east wall.
- 2- Extensive water staining on the interior wood surfaces of this part of the building.
- 3- Concrete foundation only at the corners of this building. Probed several locations to a considerable depth and found no foundation. Suspect that a wood sill beam is relied on to carry floor loads to corners.
- 4- Wood sill beam remnants exposed at this location. Beam shows severe wood rot and has completely rotted away near the corner.
