# Delassus-Kern House

STE. GENEVIEVE NATIONAL HISTORICAL PARK  
STE. GENEVIEVE, MO

## Historic Structure Report

PMIS 311634  
OCTOBER 2024

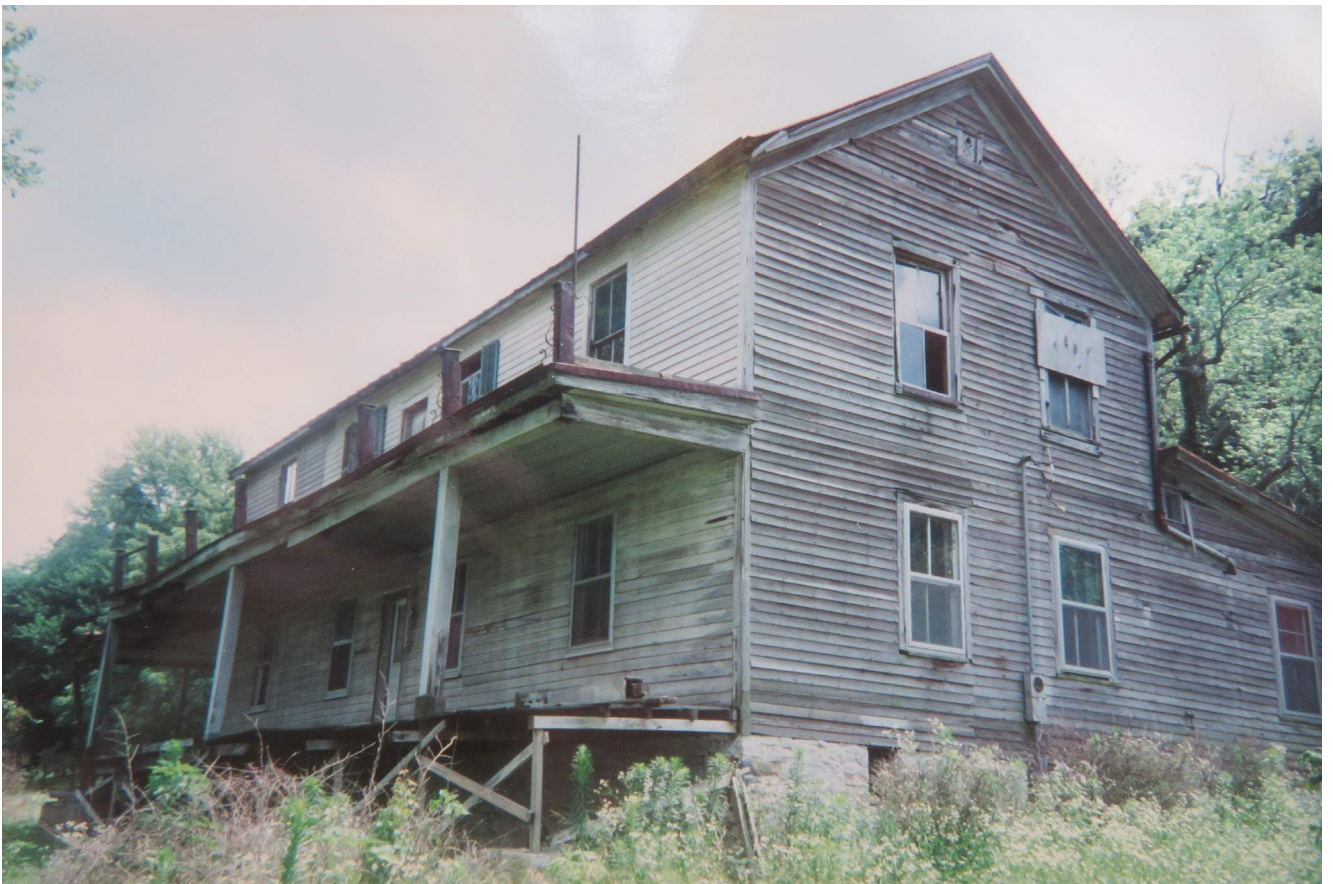
Figure 29. Photograph c. 1995, looking southwest, showing the poor condition of the house and the collapsing double porch. (Source: MoDNR Felix Vallé House archives)

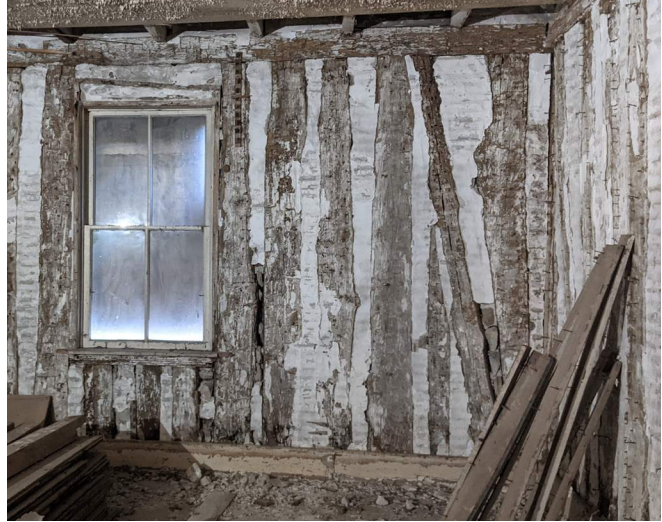
Figure 37. The east wall of Room 106 at the Delassus-Kern House. Note the steeply pitched brace on the right. (Source: MoDNR Felix Vallé House archives.)

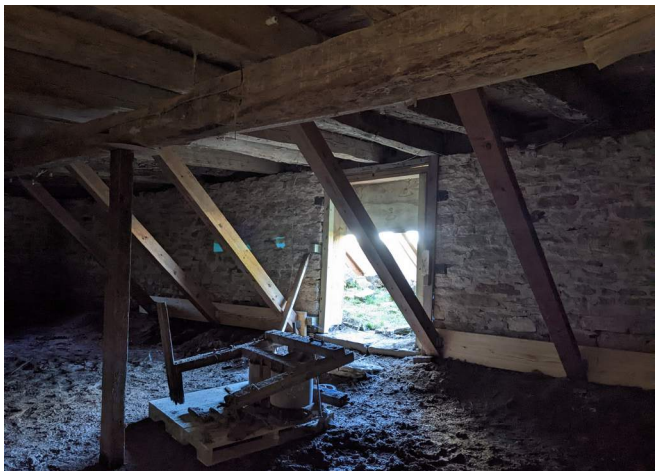
Figure 44. Room 001, looking northeast, showing the shoring in the basement. (Source: RRJ 2023)

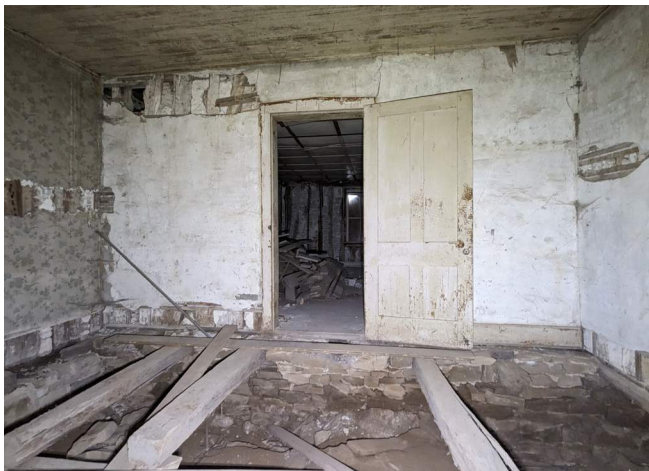
Figure 46. Room 103, looking east, showing missing floor framing. (Source: RRJ 2023)

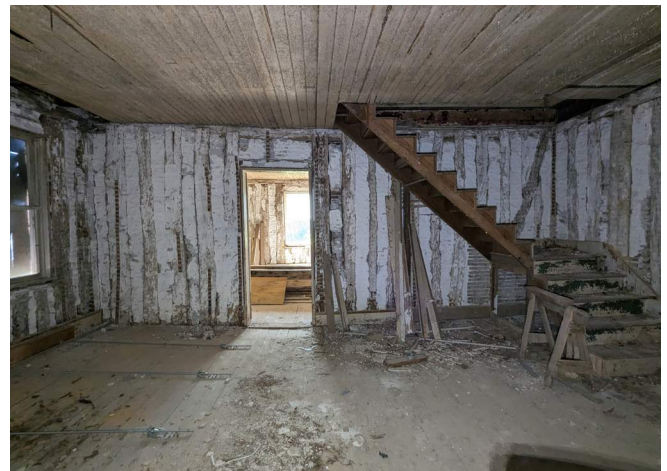
Figure 47. Room 105, looking south, showing the exposed vertical logs. (Source: RRJ 2023)

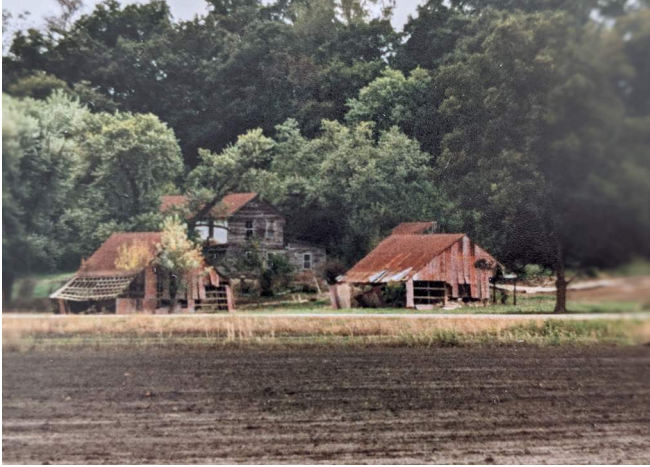
Figure 65. A 1993 photograph of the property showing the condition of the grounds and outbuildings immediately after the flood. (Source: Ste. Genevieve NHP archives)

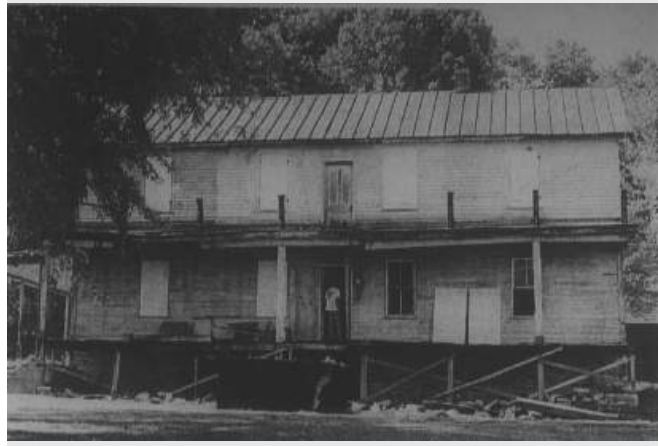
Figure 66. An image of the house from 1996 that shows the poor condition of the house from the flood damage. (Source: *Ste. Genevieve Herald*, October 9, 1996, p. H)

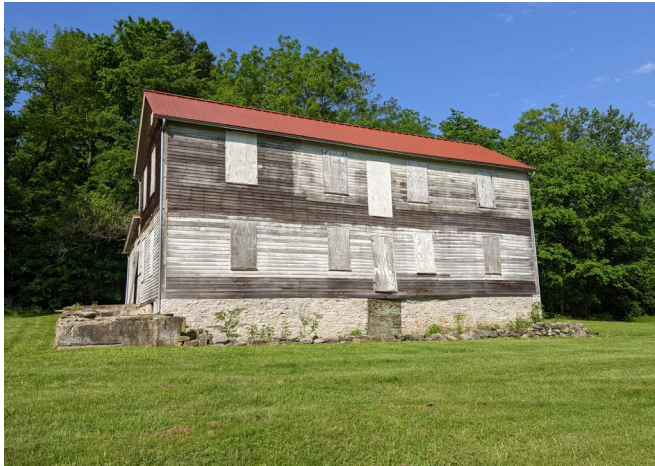
Figure 67. The east exterior wall before shoring installation. (Source: RRJ 2022)

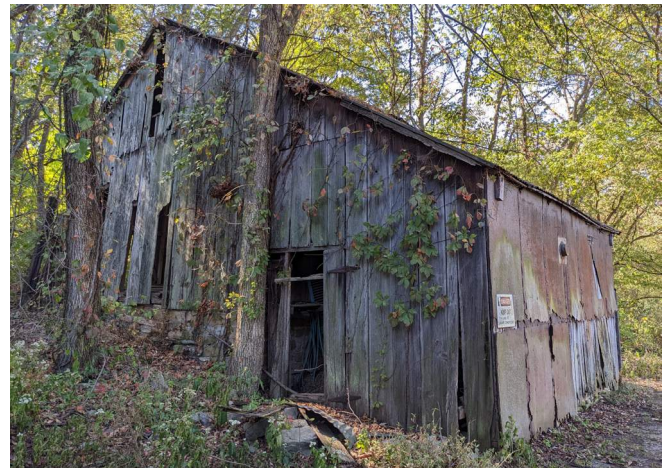
In general, the woodshed is in poor condition. The vertical wood cladding is severely weathered throughout, and extensive deterioration is found in the lower portion of the west elevation exterior wall. The wood cladding on the south wall has failed due to extensive water damage. The steel roof and other steel elements show uniform corrosion. The interior of the woodshed is full of various types of construction materials and debris.

Figure 68. The woodshed from the south, showing deterioration of the wood siding and structure. (Source: RRJ 2023)

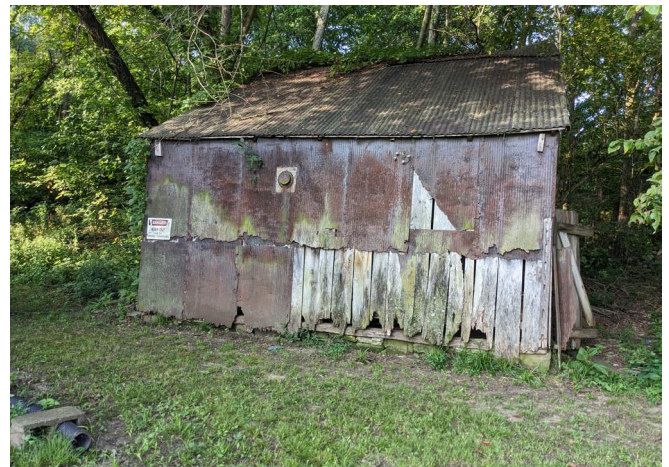
Figure 69. View west toward the wood shed. (Source: LSH-LA, 2023)

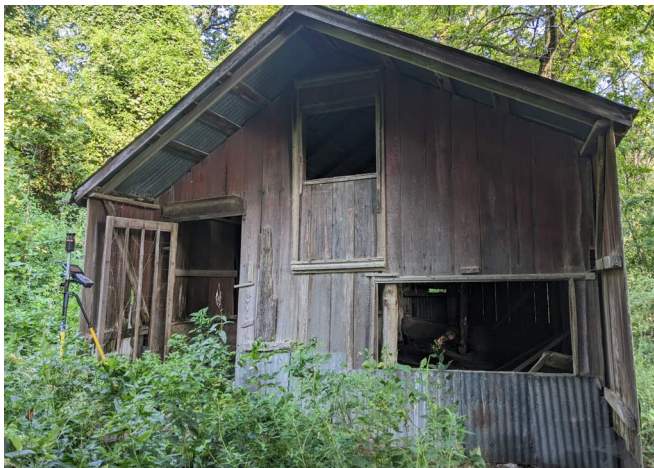
The chicken house is constructed with vertical posts placed in the ground with a concrete foundation wall that infills around the wood posts. The exterior walls of the building are sawn lumber that are anchored with wire nails, indicating a post-1900 construction date. Weathered finishes indicate that the chicken house was once painted red. Corrugated steel is used for the roof of the structure and is also fastened to the base of the east wall. The chicken house is in fair condition. The exterior paint has failed due to exposure and general weathering, allowing for further weathering of the underlying wood. The roof shows uniform surface corrosion but is otherwise intact. A gutter system was once installed on the east and west elevations of the structure but is severely corroded and non-functional. A few of the concrete foundation walls visible inside the chicken house have shifted or fallen. The door is no longer functional, and there are no coverings over the other openings.

Figure 70. View west toward the chicken house. (Source: LSHLA, 2023)

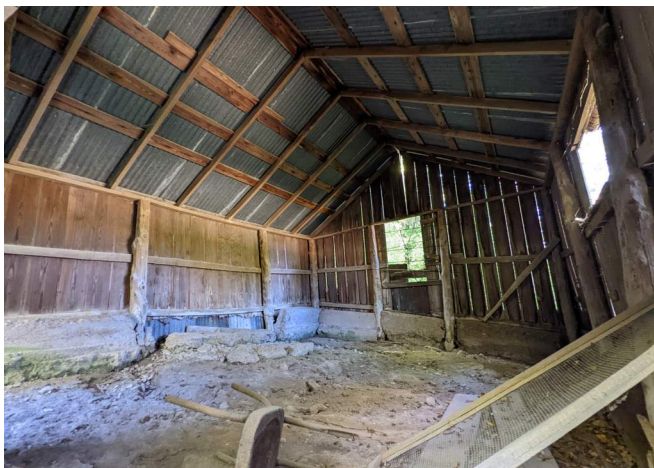
Figure 71. View of the chicken shed interior. (Source: RRJ 2023)

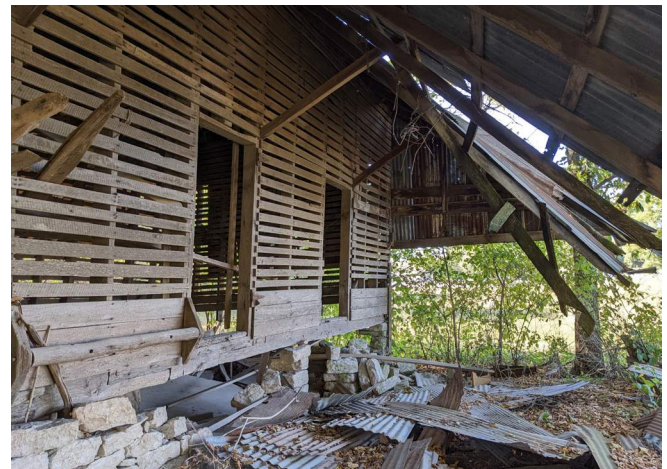
The corn crib is an elevated wood structure supported by a stone masonry foundation. Circular sawn lumber was used to construct the slatted wood walls present on the east, north, and west elevations which allow for airflow within the structure. The south elevation of the structure is clad in corrugated metal. The side-gabled roof is also corrugated metal and provides a deep overhang on the east and west elevations. Overall, the corn crib is in poor condition. The stone masonry foundation is partially intact; however, portions of the east and north walls have collapsed and require reconstruction. The floor beam along the north elevation is displaced from the foundation and wall framing. This beam will need to be reinstalled or supplemented. Most of the elevated floor framing and flooring are missing. The exterior slatted walls are mostly intact and in fair condition. The roof is corroded and has reached the end of its service life.

Figure 72. East exterior wall of the corn crib, showing deterioration of the foundation and roof overhang. (Source: RRJ 2023)

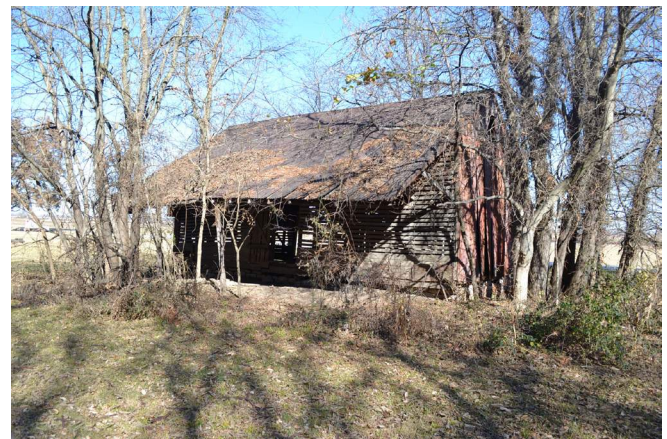
Located in a wooded grove north of the house is a corn crib that measures 34 feet 8 inches by 15 feet 7 inches with a wide roof overhang. The wood-frame building sits on a high stacked-stone foundation. The walls are widely-spaced wood board separated by openings for air circulation. The gable roof, which extends as a wide overhang to the east and west, is clad with corrugated metal as are portions of the north and south walls. The finished floor is elevated approximately 2-1/2 feet above the adjacent grade. The building is in deteriorated condition and being overtaken by successional vegetation.

Figure 73. View northwest toward the corn crib. (Source: LSHLA, 2023)

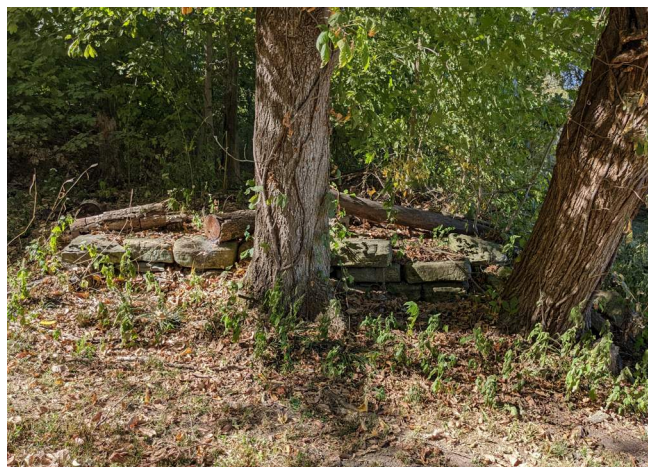
The foundation walls of an old smoke house are present between the extant chicken house and the Delassus-Kern House. Three to four courses of cut stone are all that remain of this structure. The use of stone walls rather than concrete may indicate this structure is earlier than other extant outbuildings on the property.

Figure 74. Ruins of the smoke house, located to the south-west of the main house. (Source: RRJ 2023)

The smoke house ruins pose no life-safety risk, so little intervention is required.

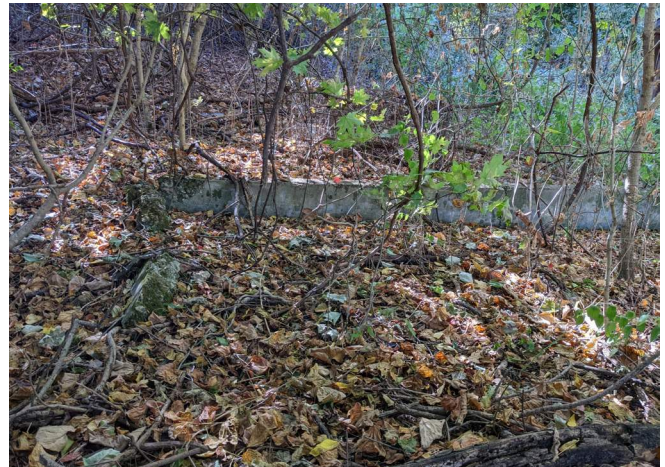
The concrete foundation walls remain of a former chicken house and are located a few feet south of the other remaining chicken house structure. The use of a poured concrete foundation indicates that this chicken house may post-date the extant chicken house and other outbuildings which have stone foundations. The concrete is a large aggregate mix, which appears similar to the concrete used for the retaining wall along US-61, which likely predates improvements to the roadway performed in 1926.

Figure 75. Ruins of the chicken house. (Source: RRJ 2023)

The chicken house ruins pose no life-safety risk, so little intervention is required.

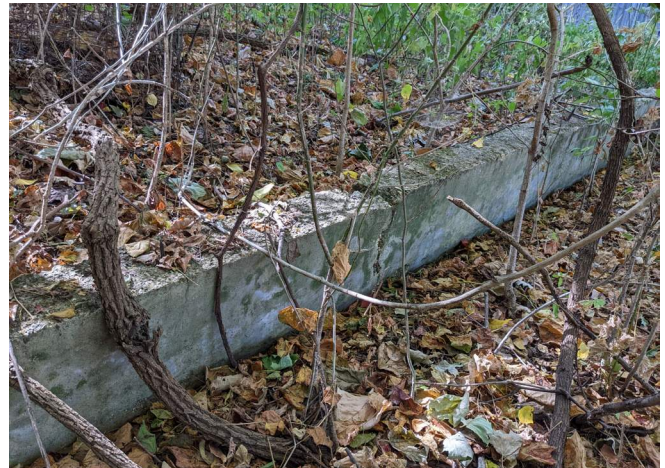
Figure 76. Ruins of the chicken house foundation. (Source: RRJ 2023)

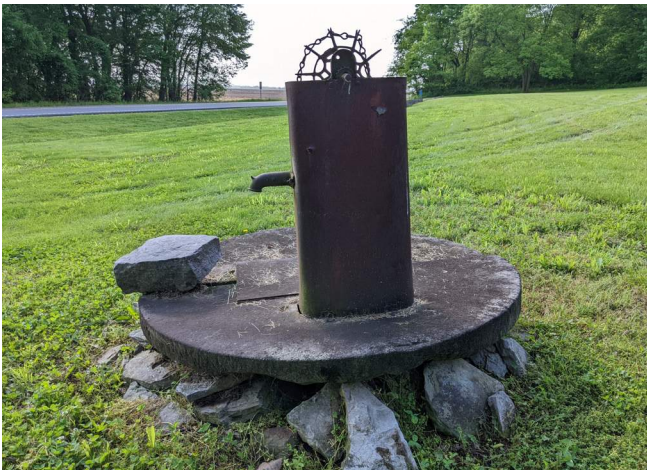
Figure 77. East yard cistern with historic pump. (Source: RRJ 2023)

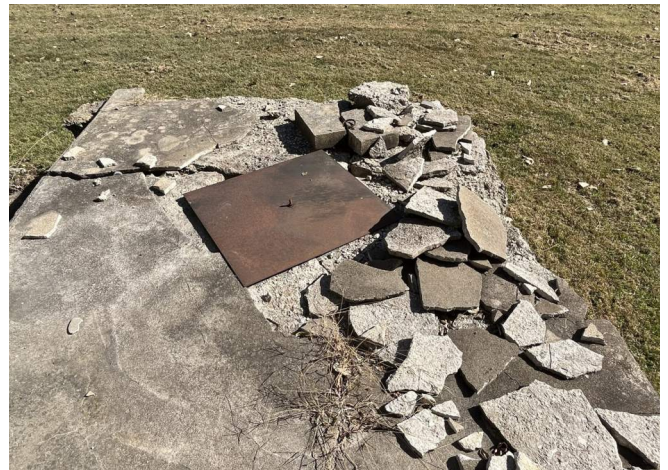
Figure 80. Porch cistern, showing deteriorated concrete and loose metal plate cover. (Source: RRJ 2023)

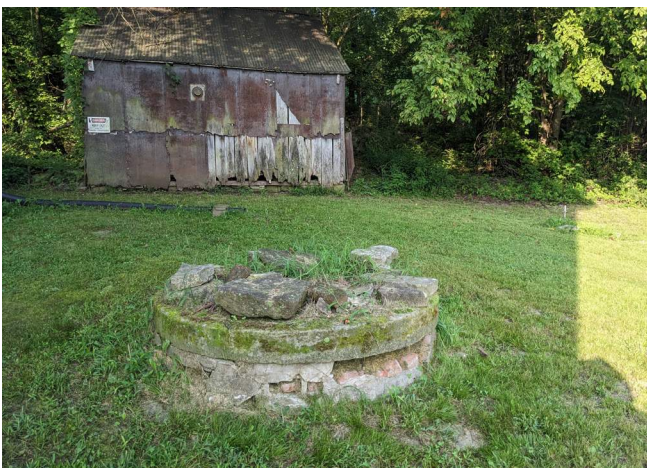
Figure 78. North yard cistern, adjacent to north exterior wall of house. (Source: LSHLA 2023)

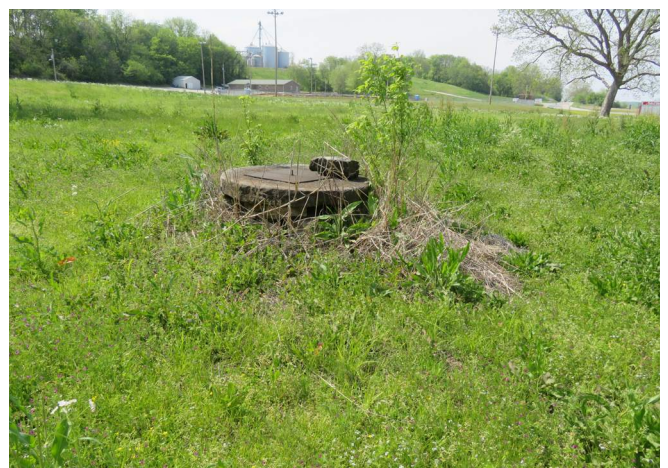
Figure 81. Barnyard well or cistern in the field to the north of the house. (Source: RRJ 2023)

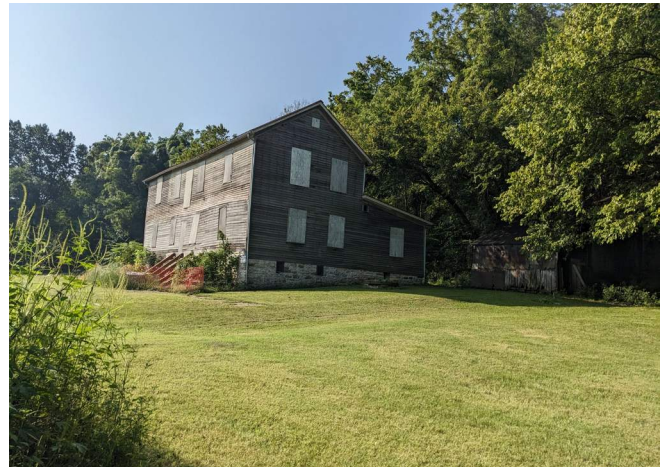
The driveway is not paved. It is a relatively level grass surfaced route. The driveway is graded to be level as it approaches the house. The land to the north of driveway has been graded to form a terrace. The driveway once continued into the hilly terrain behind the house. The trace of the road as it continued is visible on the hillside.

Figure 84. View south toward the house with the graded landform of the driveway visible. (Source: LSHLA 2023)

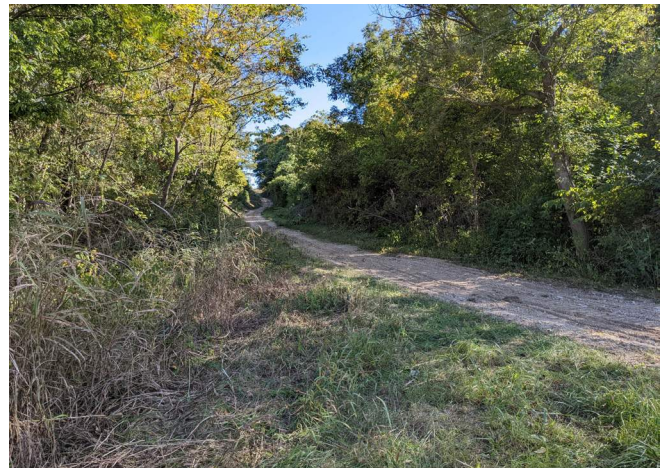
Figure 85. View looking southwest along the drive at the top of the bluff. Per historic aerial photographs, the main driveway formerly connected with this road, which now must be accessed through the adjacent property to the north. (Source: RRJ 2023)

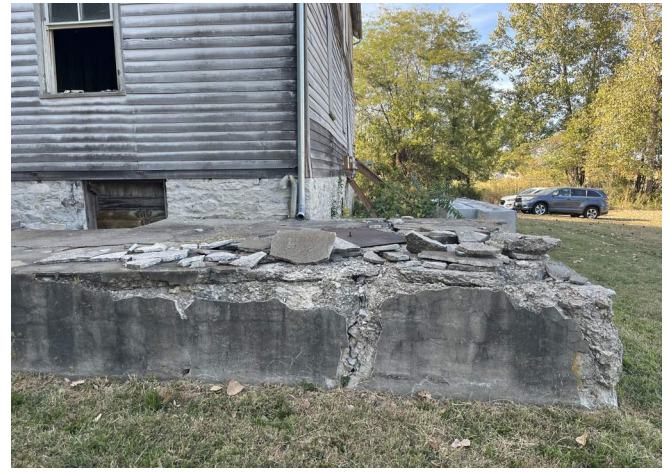
A paved concrete landing is present on the south side of the house, which was once part of the galleries. The concrete topping is severely cracked and has detached along the stairs and southeast portion of the landing, where the porch cistern is located. The majority of the concrete topping has failed creating tripping hazards at several locations.

Figure 87. Deteriorated concrete landing. (Source: RRJ 2023)

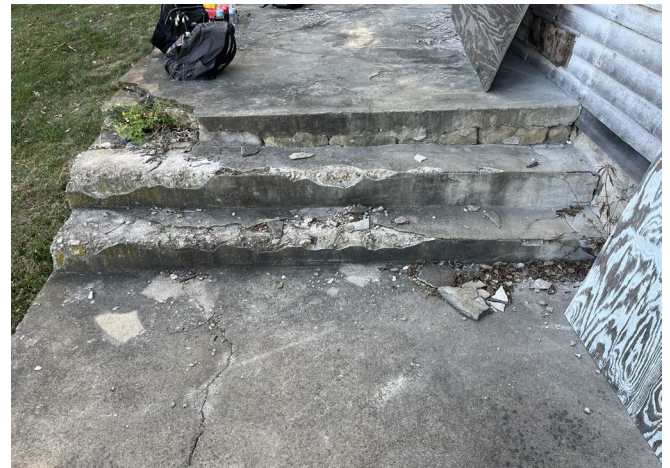
Figure 88. Deteriorated concrete steps. (Source: RRJ 2023)

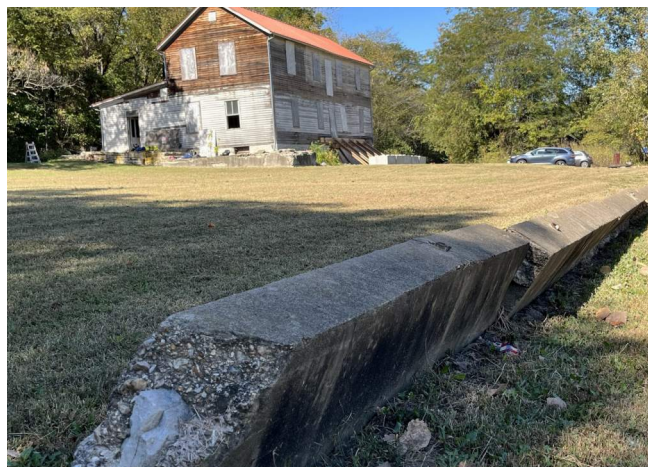
The concrete retaining wall is cracked through the full depth of the wall at several locations and is out of plumb.

Figure 89. Displacement and distress to the concrete retaining wall, looking north. (Source: RRJ 2023)

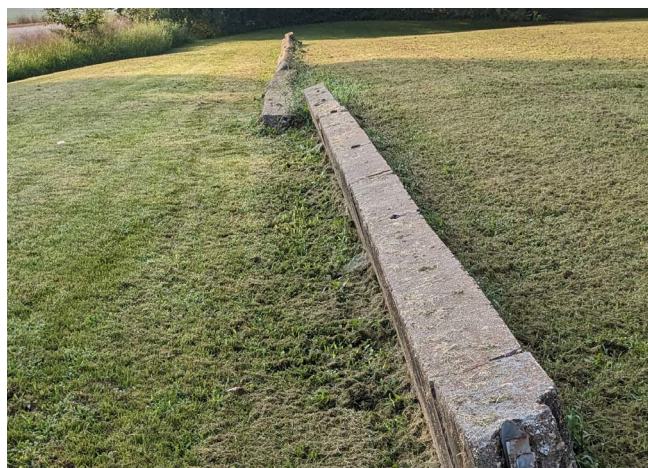
Figure 90. Displacement and distress to the concrete retaining wall, looking south. (Source: LSHLA 2023)

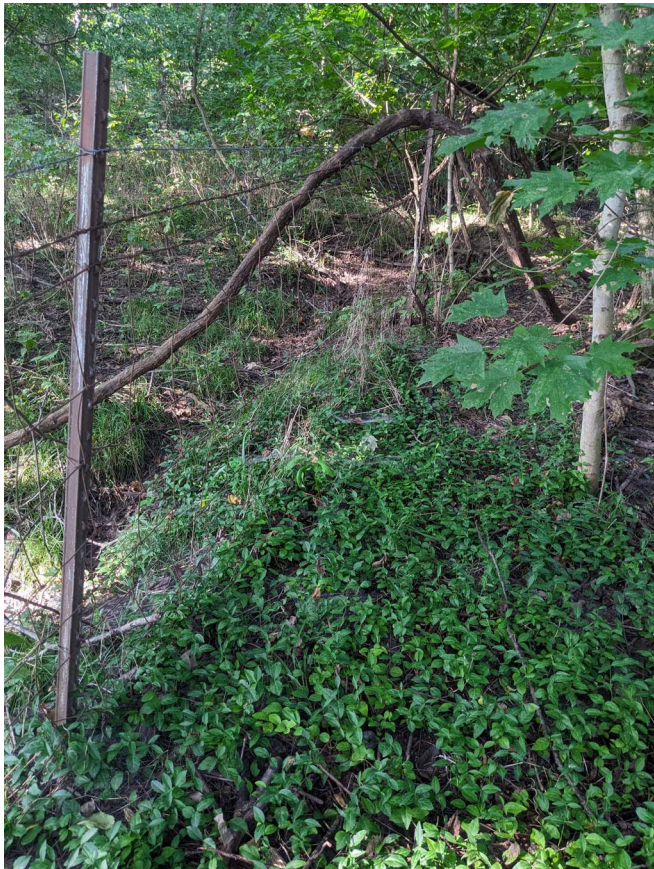
In some locations, the fencing was partially collapsed or vegetation was displacing the fencing wire.

Figure 92. View toward fencing located along the southern boundary of the property, showing secondary growth of woodland and non-native plants. (Source: LSHLA 2023)

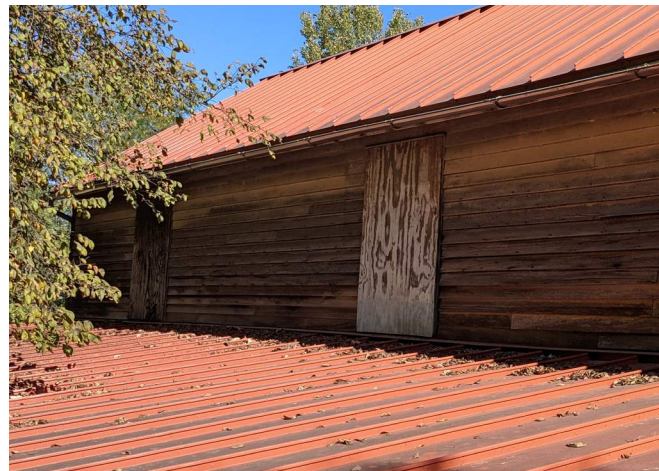
The roof is in good condition, but tree trimming is recommended for all trees that touch the first-story roof along the west wall. The drainage system is in good condition, but minor corrosion is present along the underside of the gutters. Additionally, gutters along the west roof edge are full of leaves and should be cleaned to maintain proper drainage.

Figure 95. View of the standing seam metal panel roofing from the west. (Source: RRJ 2023)

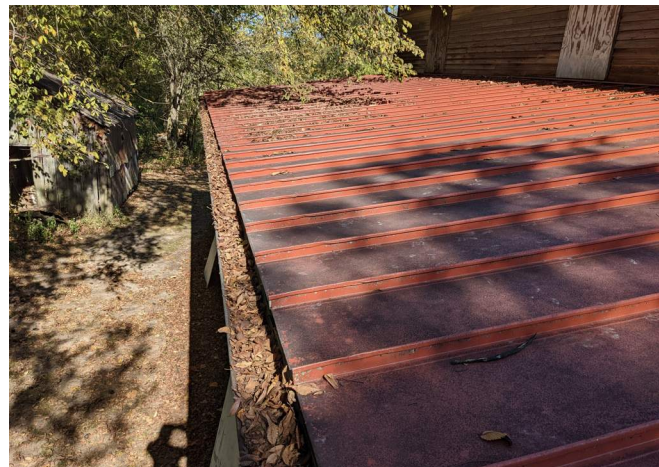
Figure 96. View of the standing seam metal panel roofing from the west, showing the gutters full of leaves. (Source: RRJ 2023)

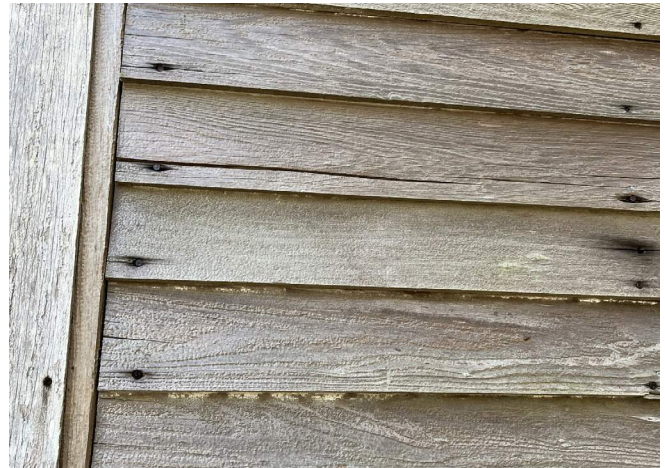
The existing lap siding shows varying degrees of weathering throughout the house. The siding is secured into vertical logs with exposed nails. Warped, split and broken siding was also identified in isolated locations. There are also penetrations in the siding at several locations from previous utilities. The existing lap siding boards are in fair condition, meaning that they are generally performing as intended but with limited remaining service life. Several holes created by squirrels were observed.

Figure 97. Weatherboard siding, showing exposed nails, along with splits in the wood boards. (Source: RRJ 2023)

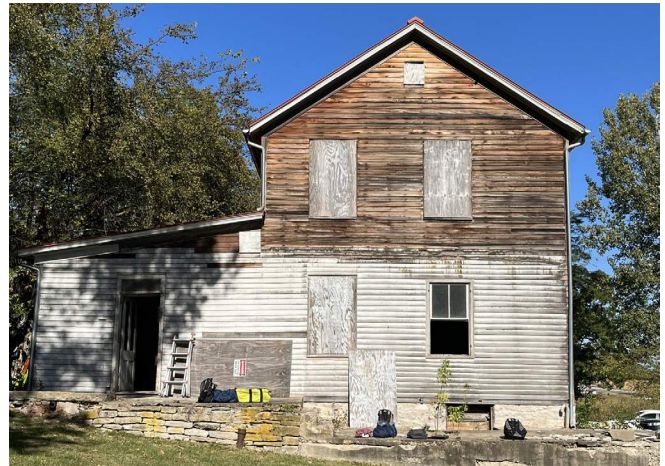
Figure 98. South exterior wall, showing localized replacement of siding at the upper level. (Source: RRJ 2023)

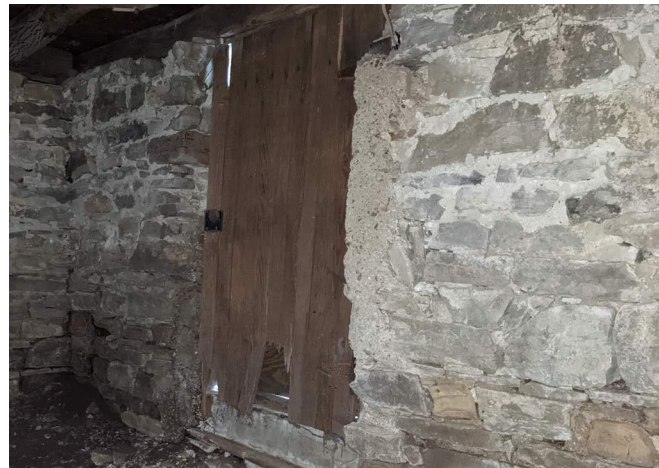
- **Door D001A** is missing, and the rough opening is covered in plywood. Door D001B could be used as a template to create an appropriate replacement door.
- **Door D001B** is a wood, batten style door with wire nails. A knob and rim lock were present at the interior. Metal strap hinges were also present. Overall, this door has failed and is currently covered in plywood.
- **Door D101A** is a wood door with a raised, four-panel configuration. The top two panels were removed, possibly to provide light into the kitchen. This door is of a similar style to the door visible in the c. 1895 photograph and may be a 19th century door. It is also possible that this door was repurposed from another location on the house at an undetermined time. The door knob was missing. The escutcheon and lock were present but were damaged and likely are not

Figure 99. D001B, a batten style door. (Source: RRJ 2023)

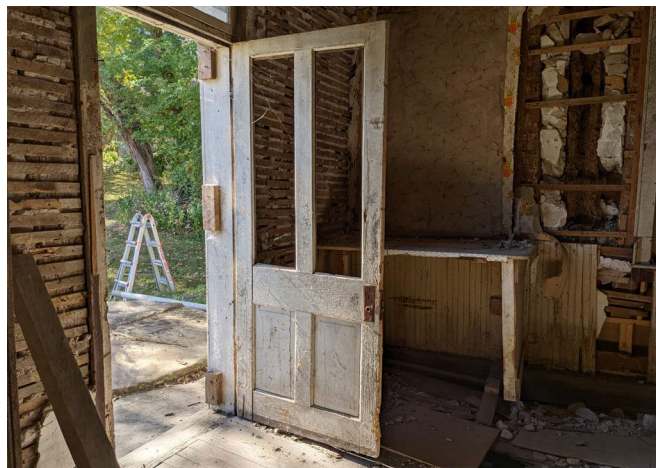
Figure 100. Door 101A, the kitchen door. (Source: RRJ 2023)

repairable. The hinges match those found upstairs at D201 but are not original to the current location. A transom was present at this location. The door trim was partially missing. Several layers of paint were noted at the interior and exterior of the door. Both sides of the door were painted white over light blue. Overall, this door was in poor condition but can likely be restored, along with the transom.

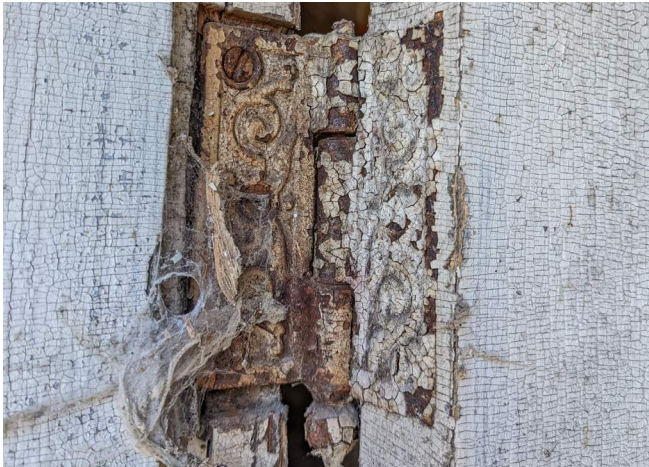
Figure 102. Replacement hinge on Door D101A. (Source: RRJ 2023)

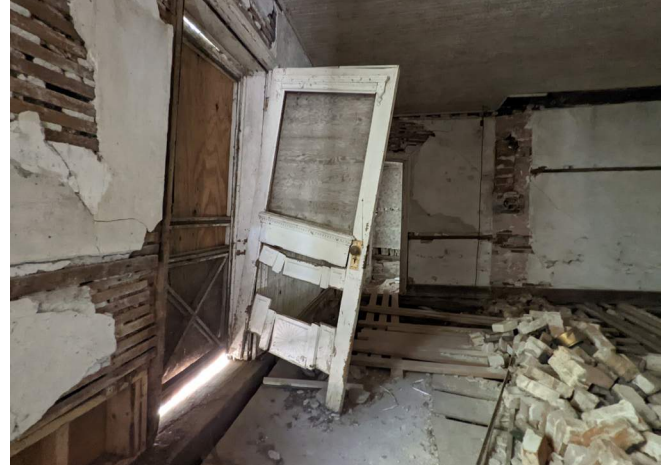
- **Door D102A** is the back door on the west wall and is in failed condition with multiple missing components. The door has a raised, nine-panel configuration on the lower half with a spiral sunburst in the center panel, and the upper portion of the door contained a single lite. A decorative hood and sill were present at the lite. This door appears to date to the 1903 renovation or shortly after, as it appears in the early photographs of

Figure 103. Door D201A, the back door, in a failed condition. (Source: RRJ 2023)

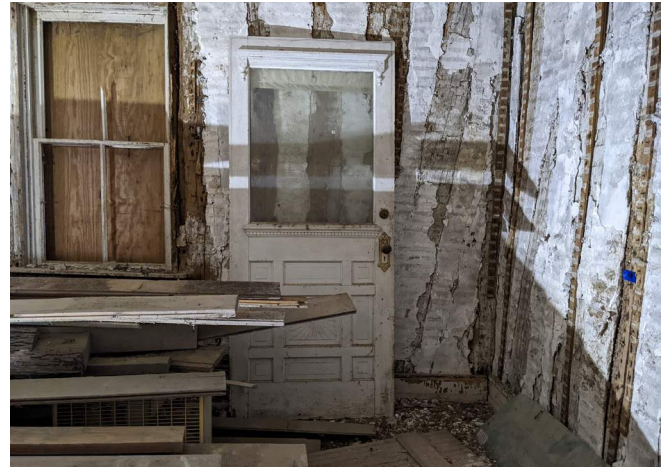
Figure 104. Unattached door in Room 106, likely Door D105. (Source: RRJ 2023)

- **Door D105** was missing. An unattached door was stored in Room 106 that was of the same style as Door D102A; based on photographs from the 1990 Volz and Associates condition assessment report, this is likely the missing door for D105.<sup>1</sup> An ornamental knob and escutcheon and a modern 20th century deadbolt were present. The unattached door is in fair condition and can be restored. The contents of

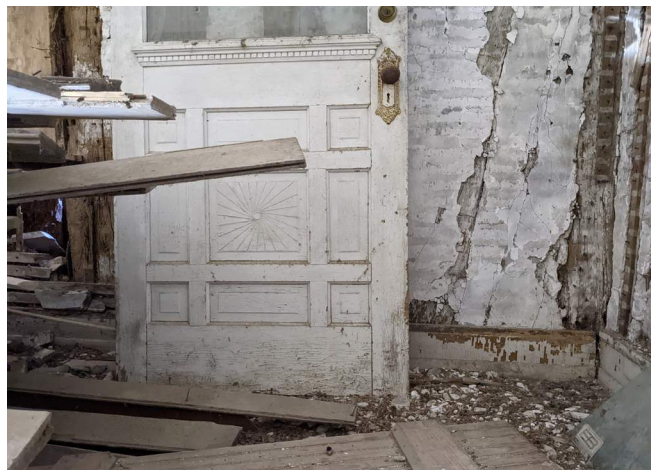
Figure 105. Detail of panels and sunburst design of the unattached door, likely Door D105. (Source: RRJ 2023)

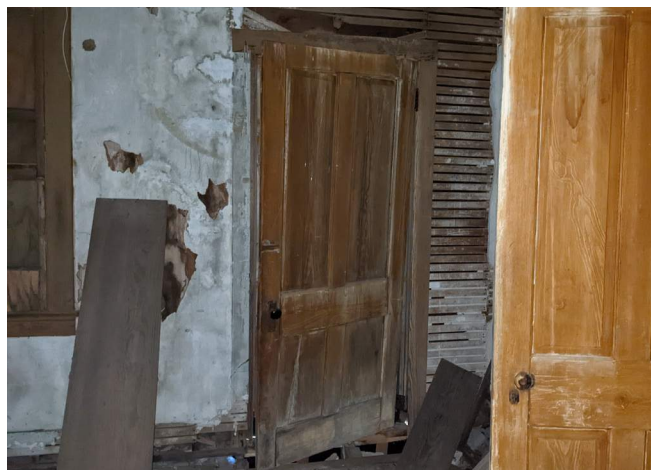
- **Door D203B** once provided exterior access to the second level of the east gallery. The door is a wood door with a raised, four-panel configuration, with the upper panels larger than the lower. The joints have failed and some water damage and cracked panels were noted. The door trim was partially missing. The interior knob was black porcelain. An escutcheon with a simple style was present, but loose. The deadbolt and latch were still in place and a later addition slide lock latch was also present. Butt hinges with ball finials were present. The lower hinge had pulled out of the jamb. Generally, the door was in poor condition but likely can be restored. This may be a repurposed interior door.

Figure 106. Door D203B, which former lead to the upper level of the east gallery. (Source: RRJ 2023)

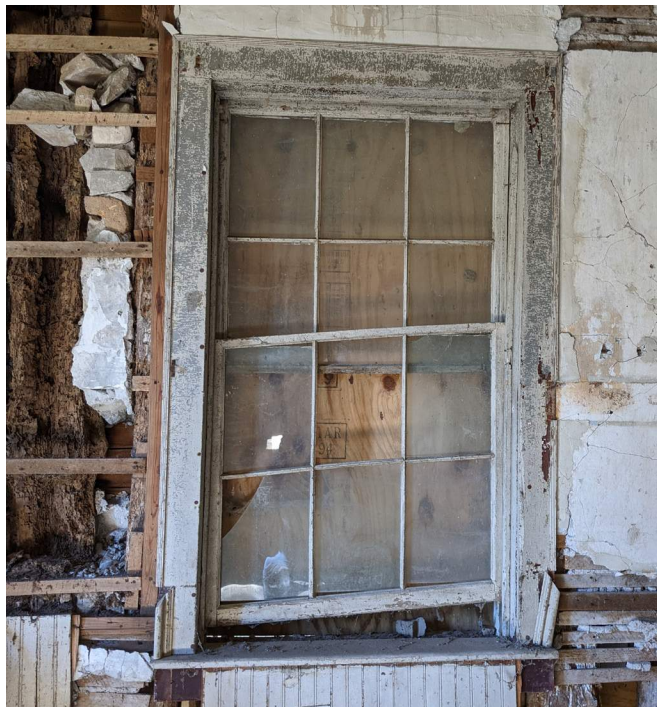
**W101** was a 6-over-6 wood sash window. The bottom sash and several lites were damaged. The muntins were very thin. The 6-over-6 windows present in Rooms 101, 102, and 103 may predate the 1903 alterations to the house.

Figure 108. W101, showing the rectangular casing with the applied perimeter trim. (Source: RRJ 2023)

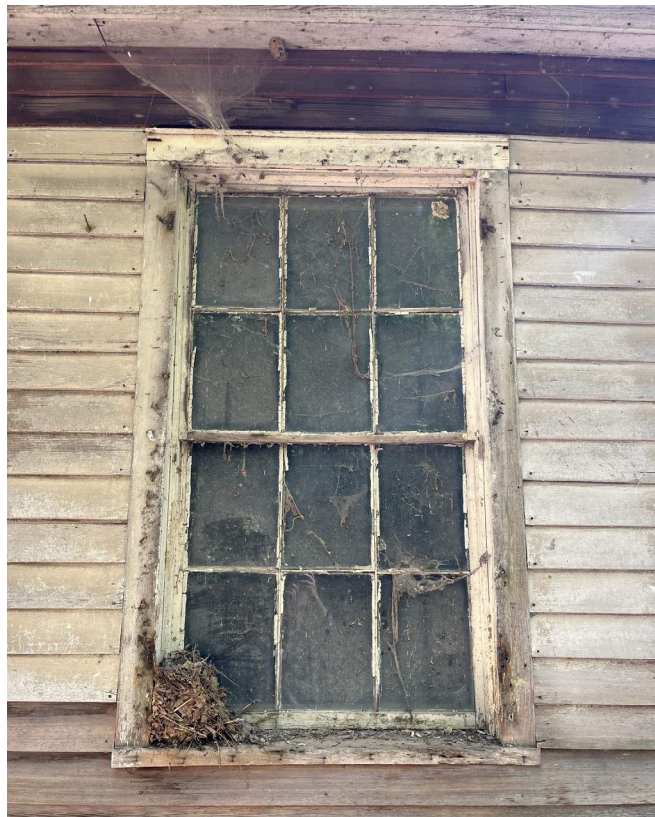
Figure 109. W102A, a first floor window on the west wall, likely a window unit that predates the 1903 alterations to the house. (Source: RRJ 2023)

**W102A** was a 6-over-6 wood sash window. The sashes had damage and deterioration but were mostly intact. The glass appeared to be modern 20th century float glass. The casing was a rectangular style with wide applied perimeter moulding with an ogee interior edge and a projecting stool; the apron was missing and may have been removed when the wainscoting panels were installed. The window casing is similar in style to that on the inside faces of Door D101B, Door D102A, and Door 103A. No hardware was present. Evidence of previous stains and paints were noted. The oldest color was a dark brown paint, and the newest finish layer was a white paint. Overall, the window was in poor condition.

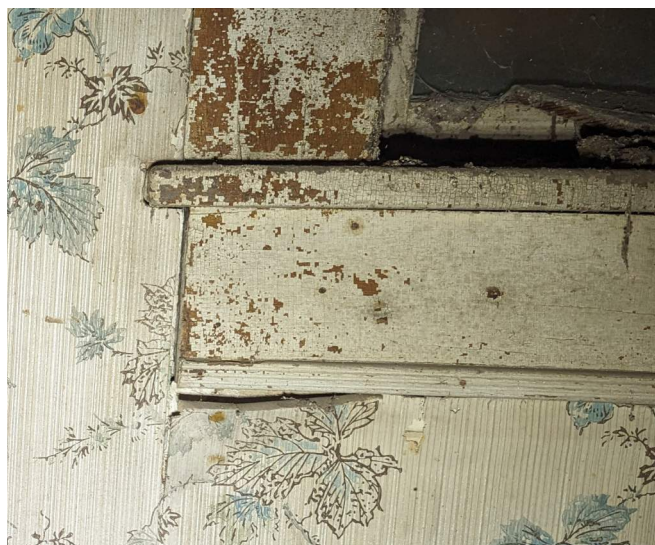
Figure 111. Applied moulding at the apron of W103A. (Source: RRJ 2023)

**W103A** was a 6-over-6 wood sash window. Two of the lites were damaged, and some deterioration was noted on the lower sash. The casing was a simple rectangular profile with a very narrow fluted moulding applied at the head. The stool and apron were intact, and a fluted applied moulding was present at the base of the apron. No hardware was present. Overall, the window was in poor condition.

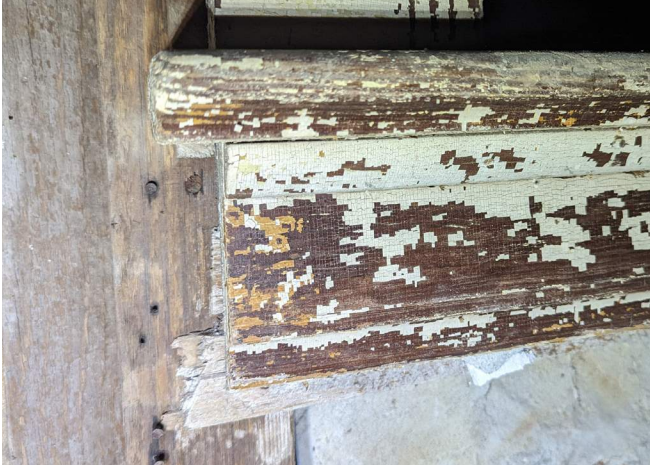
Figure 112. Apron of W104A. (Source: RRJ 2023)

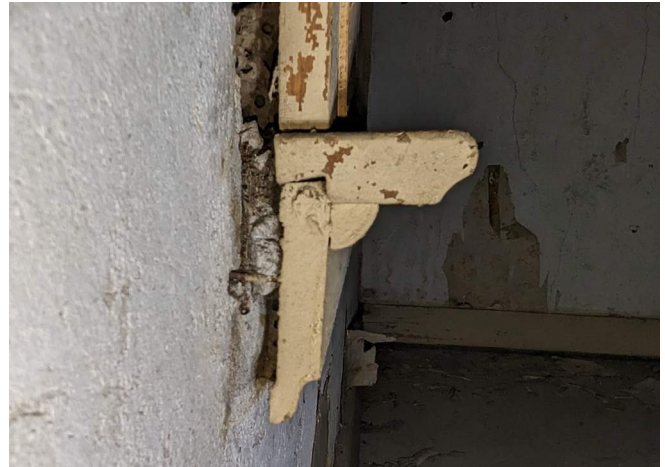
Figure 115. Profile of the stool and apron at W201B. (Source: RRJ 2023)

**W201B** was covered with plywood but is likely a 2-over-2 wood sash window. The casing was present and was similar to that found at W204B. Evidence of previous stains and paints were noted. The oldest color was a dark brown stain/paint followed by a later layer of dark cream or yellow paint. Overall, the window was in fair condition.

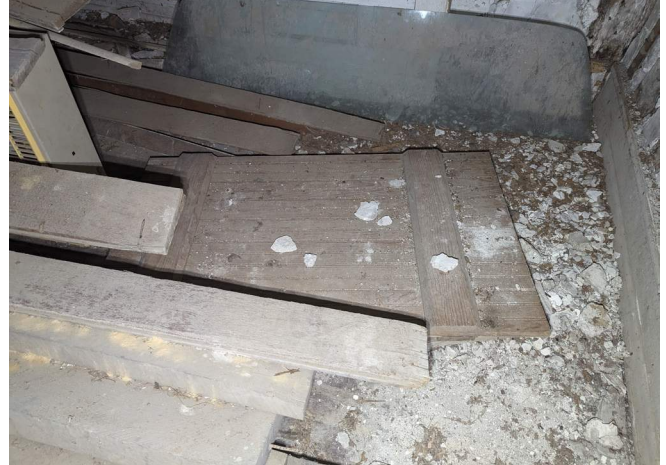
The earliest available photographs of the house depict louvered shutters at each of the windows. While none of the shutters are currently in place on the exterior walls, remnants of louvered shutters are present inside the house, stored in the second floor bedrooms along with remnants of window screen inserts. In the crawlspace under Room 102, a small batten-style wood shutter is present, and another is present in the debris in Room 104; these may have been an early shutters for one of the basement level ventilation windows. Two larger batten-style shutters were stored in Room 104; these generally appear to be the correct size for a typical window at the house, but their date of use and original placement is not currently known. Several damaged louvered shutters were observed in the debris on the second floor; these are not suitable for reuse but can serve as a template for reproduction units.

Figure 119. Small batten-style shutter in the debris in Room 104 (Source: RRJ 2023)

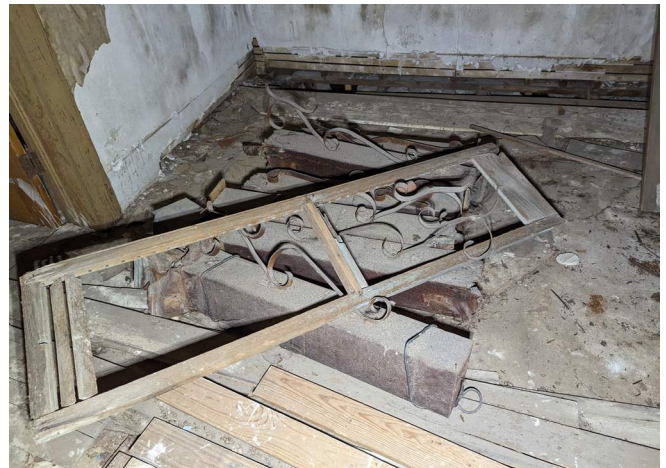
Figure 120. Damaged louvered shutter in the debris in Room 204 (Source: RRJ 2023)

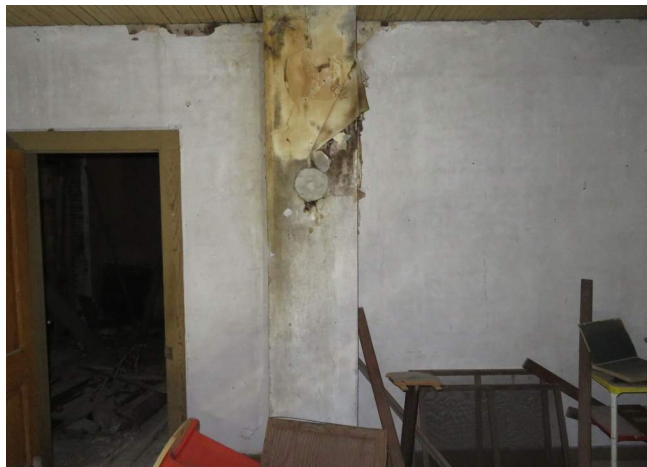
Figure 121. Chimney in Room 204, showing capped opening for the stove flue. (Source: RRJ 2023)

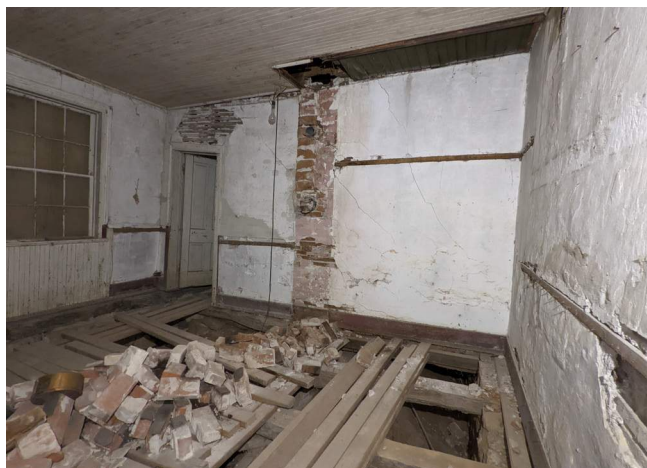
During the most recent roof replacement project c. 2016, all four brick chimneys were partial demolished, such that they no longer extend above the roofline.

Figure 122. Collapsed chimney in Room 102, with brick rubble still present in room. (Source: RRJ 2023)

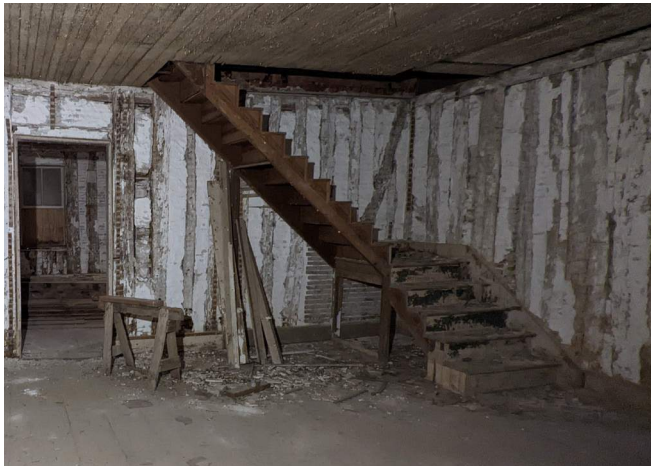
The stairs were in poor condition and were fragile. Access to the stairs should be restricted to park staff until repairs can be performed.

Figure 125. Stairs in Room 105, looking south. (Source: RRJ 2023)

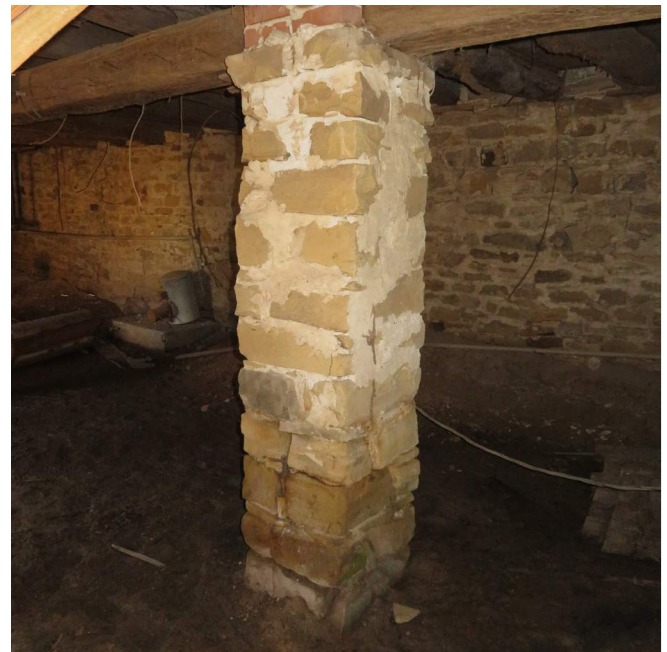
Masonry piers within the basement appeared to be in fair condition. The pier bases exhibited mortar loss, and isolated cracking was observed in the brick units above the transition from stone to brick masonry within the south pier.

Figure 127. Stone masonry pier supporting the wood floor girders (Source: RRJ 2023)

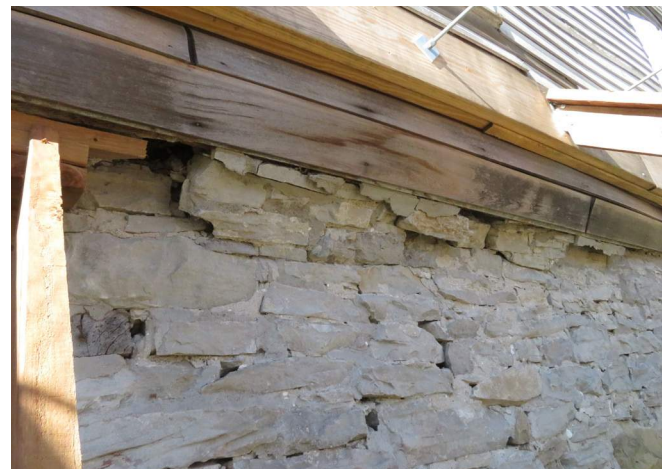
The east foundation wall was observed to be a maximum of four degrees out-of-plumb and has moved out-of-plane immediately below the log top sill plate. The top courses of the foundation wall (exterior half) have been displaced by the bulging wall above.

Figure 128. Displacement of the top course of stone masonry due to distress of the east log wall. (Source: RRJ 2023)

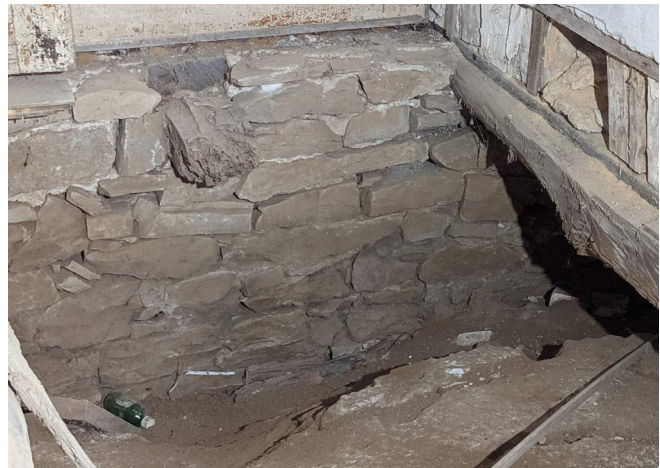
There are several areas where mortar around the stones was missing allowing for water intrusion and pest infiltration. Evidence of extensive re-pointing at the east face of the interior basement wall was observed.

Figure 130. Deterioration of mortar joints at the west foundation wall/demising wall between Rooms 103 and 104 (Source: RRJ 2023)
