# Delassus-Kern House

STE. GENEVIEVE NATIONAL HISTORICAL PARK  
STE. GENEVIEVE, MO

## Historic Structure Report

PMIS 311634  
OCTOBER 2024

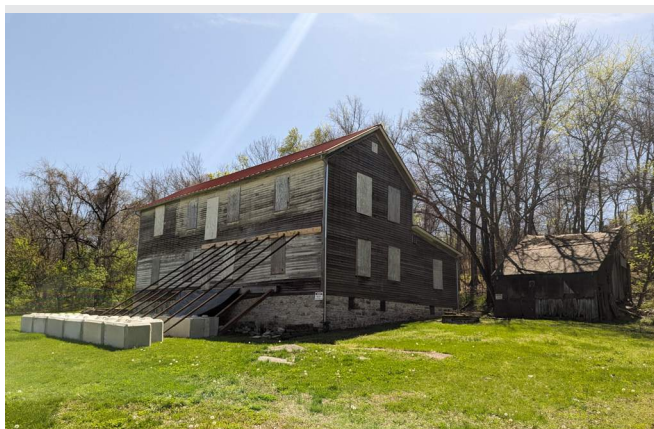
Figure 132. Exterior bracing at east wall. (Source: RRJ 2024)

Interior shoring and exterior bracing was installed by NPS in 2023 to stabilize the east wall until repairs can be performed. Access to the interior and immediately around the building should be limited to park staff performing necessary inspection or maintenance work. The shoring and bracing should be left in place until the building can be made safe.

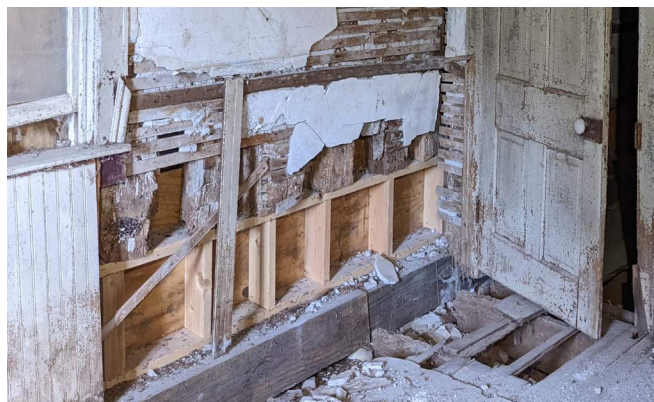
caused damage and localized failure of the log walls and second floor framing. Along the west wall in Rooms 101, 102, and 103, the lower 16 inches of the vertical logs wall along the west exterior wall were removed and replaced with a dimensional lumber knee wall between the south exterior wall and Door D102. These alterations are believed to have occurred following the Missouri DNR's acquisition of the property, sometime after 1990, as the knee wall was not present at the time of Volz and Associates's 1990 condition assessment report.

Figure 133. Stud wall construction at the west wall in Room 101. (Source: RRJ 2023)

Other areas of framing and vertical logs showing significant water and pest deterioration, particularly in Rooms 101, 102, and 103, will need to be replaced in kind. The wood stud wall infill at the base of the west wall should be analyzed by a structural engineer to determine if additional strengthening or bracing is needed.

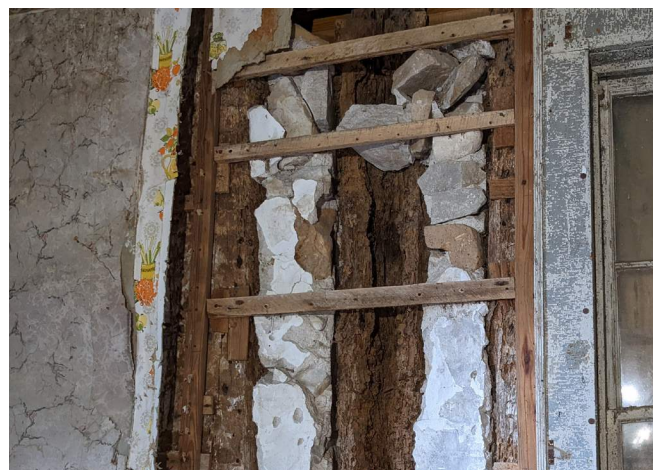
In Room 101, severe water and termite damage have caused several logs to fail on the west wall. In Rooms 101 and 102, water intrusion around the chimneys have

Figure 135. Termite and water damage to logs on the west wall of Room 101. (Source: RRJ 2023)

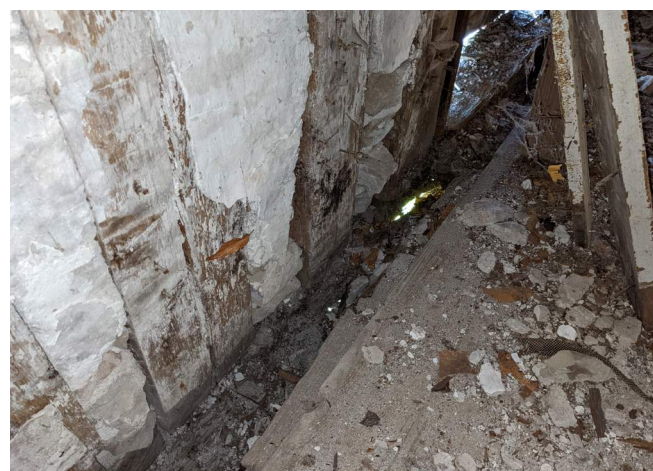
The vertical log construction at the east exterior wall has failed and poses an hazard to the stability of the structure. The failure was caused by deterioration of the top and sill plates due to long-term water infiltration at the entry doors on the first and second levels.

Figure 136. Displacement of the east wall of Room 105, looking at base of wall at failed sill plate. (Source: RRJ 2023)

Extensive repairs and likely significant reconstruction of the logs and pierrotage are needed at the east wall, along with replacement of the failed top and sill plates.

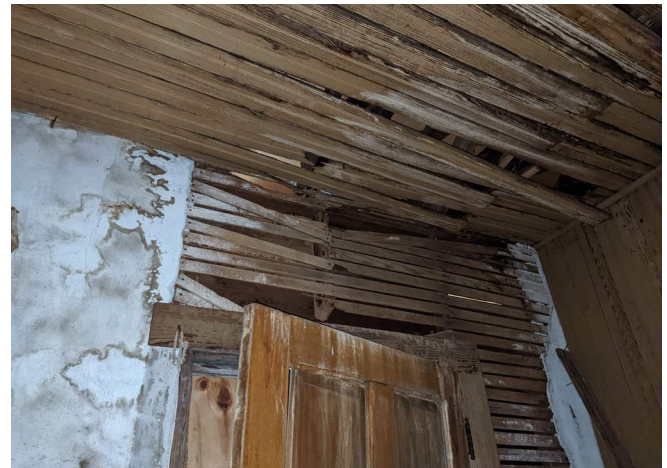
Water intrusion at the exterior door in Room 202 has caused deterioration and distress of the wall and floor framing immediately around the door opening. Additionally, the displacement of the east log wall may have compromised the support for the wall and floor along the east.

Figure 137. Damage to roof framing and wall framing in Room 202. (Source: RRJ 2023)

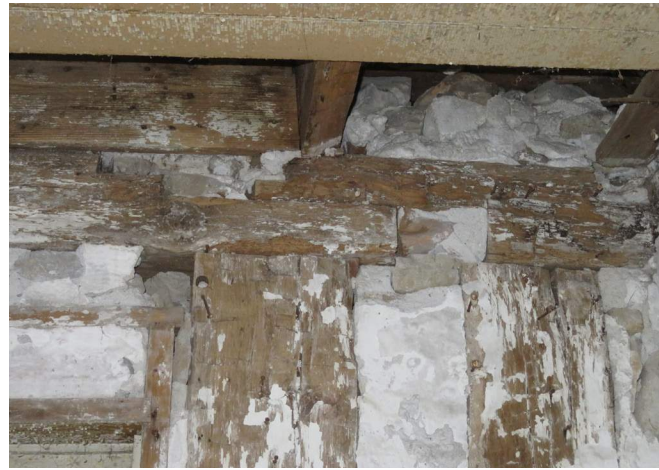
Figure 139. Open half-lap splice at top plate in Room 105. (Source: RRJ 2023)

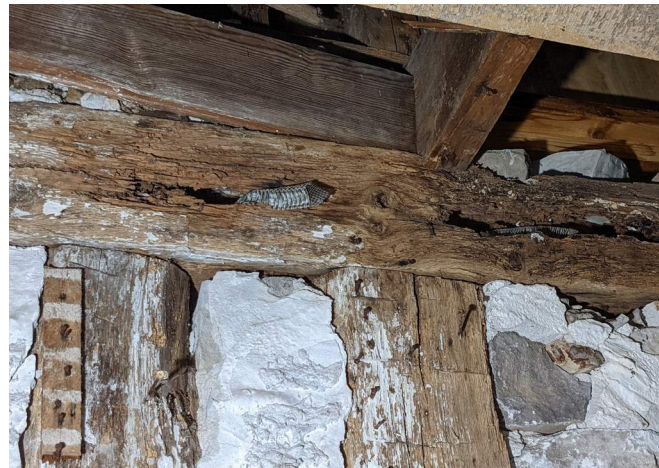
Figure 140. Deterioration of the top plate in Room 105. (Source: RRJ 2023)

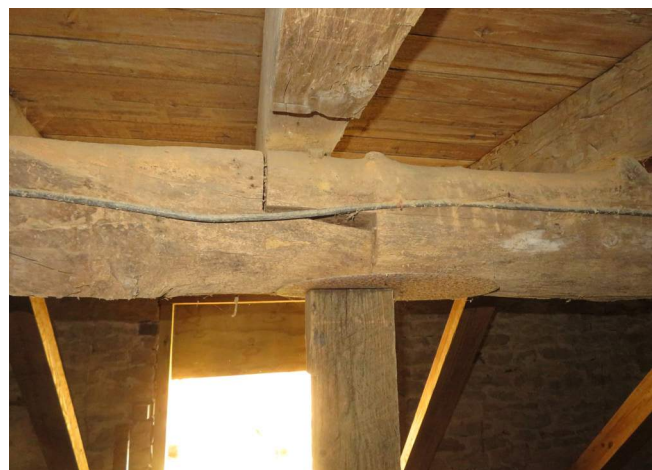
Figure 142. Splice in north-south girder at the wood post. (Source: RRJ 2023)

A nominal 4x6 post is present at the midspan of the central girder directly below a splice within this member. The girder splice contained two 1" wood dowels. The vertical post extends into the soil within the basement and exhibits some signs of wood decay at the base.

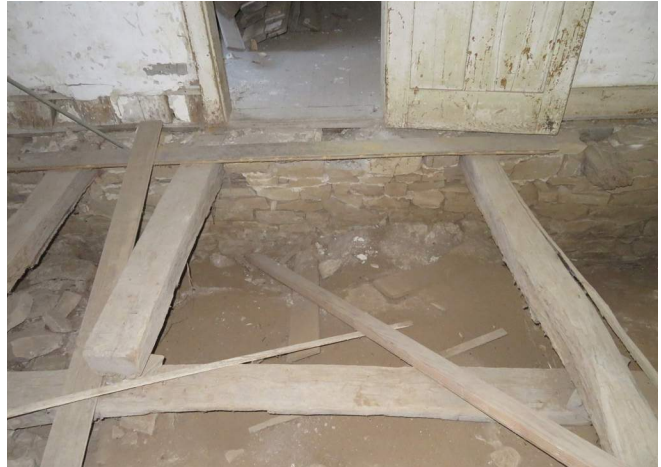
Joists within Rooms 101, 102, and 103 extend from the interior masonry wall approximately 62 to 78 inches westward where they bear on a north-south timber girder. This girder was observed to bear directly upon soil within Rooms 102 and 103, and framing was obscured by planking in room 101. HABS drawings also indicate that these joists were each sistered with a 2x dimensional lumber members, likely a repair. These “sister” members are no longer extant in Room 103, and multiple were missing within Room 102.

Figure 143. Damaged floor framing in Room 103. (Source: RRJ 2023)

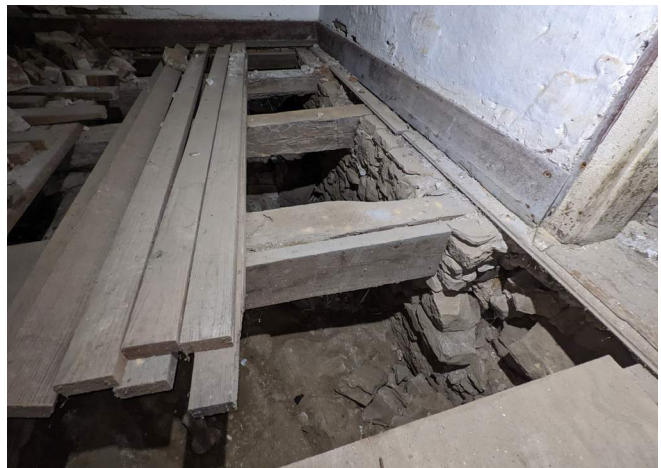
Figure 144. Damaged floor framing in Room 102. (Source: RRJ 2023)

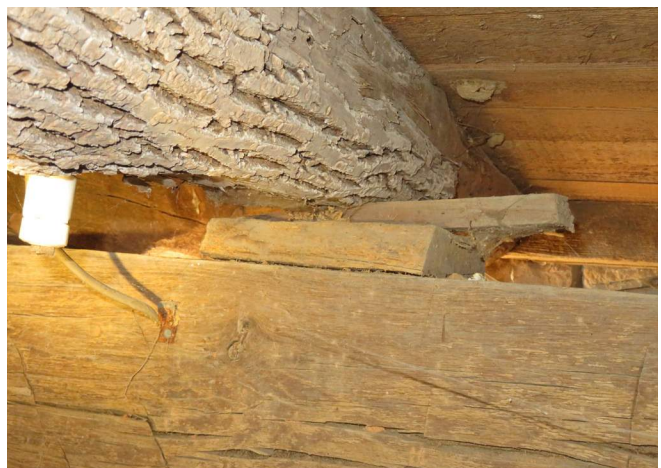
girders are present, spanning in series between the south masonry wall, the south masonry pier, the north masonry pier, and the north wall. Typically, the joists did not bear upon the girders at their midspans, and a gap was present; shims had been installed at some joints.

Figure 145. Shims between girder and floor joist. (Source: RRJ 2023)

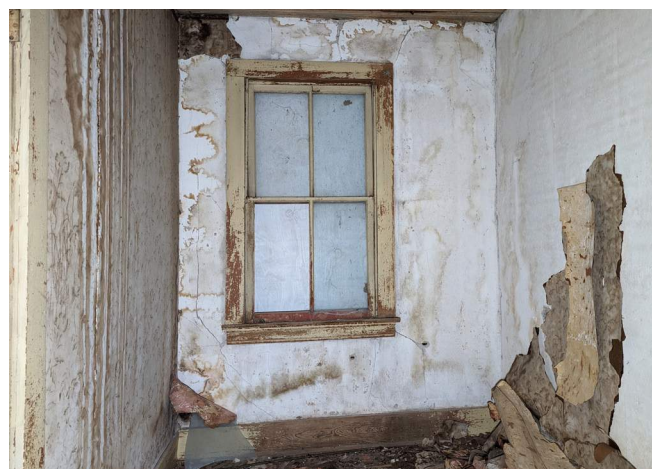
The floor framing was generally in good condition except in the area around Door D204B and along the east wall in Room 202, where the joists were damaged by long-term water intrusion through the roofing.

Figure 146. Deterioration of the floor framing in Room 202, under Window W202. (Source: RRJ 2023)

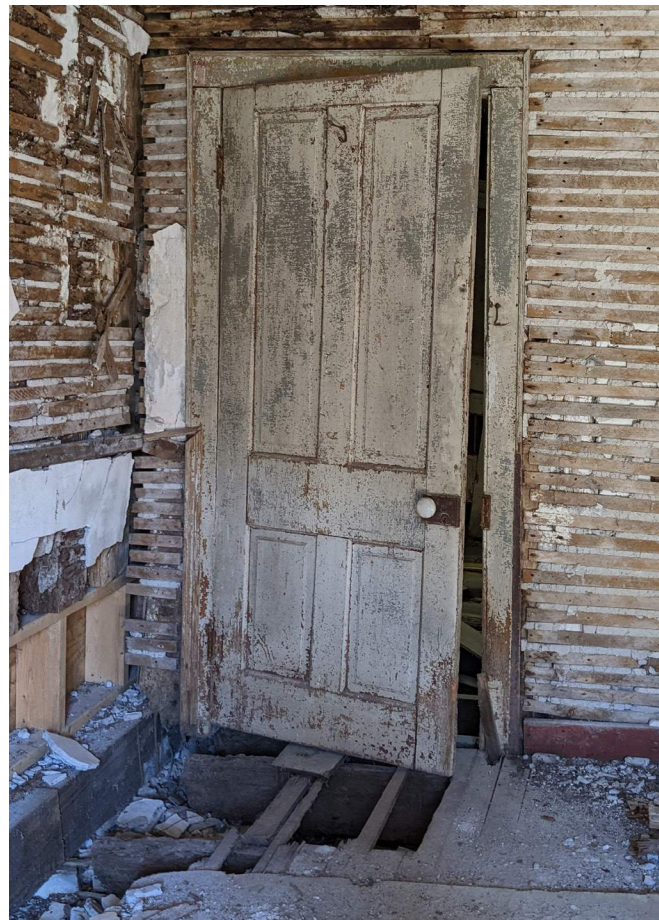
**Door 101B** is a wood door with a raised, four-panel configuration on both sides. Some separation at the joints was noted. A white porcelain knob, rim-lock, strike plate, and butt hinges were present. The rim lock was rusted, but likely can be restored. The strike plate matched the rim lock, and both appeared to be original to the door possibly along with the knob and key plate. The hinges were later replacements, evidenced by scars from

Figure 149. Door D101B, showing the south face. (Source: RRJ 2023)

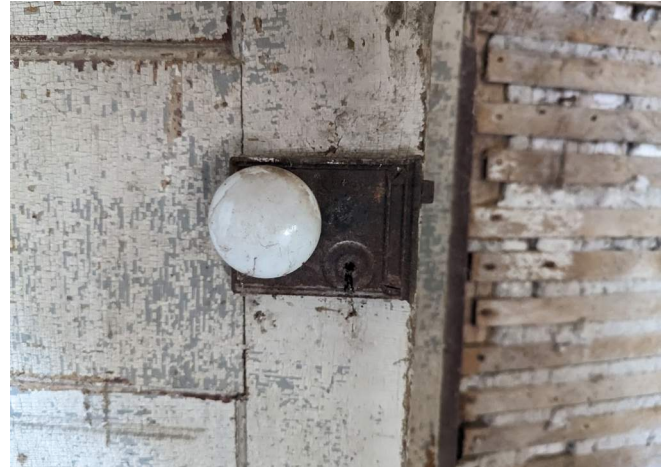
Figure 150. Historic rim lock and porcelain knob on D101B. (Source: RRJ 2023)

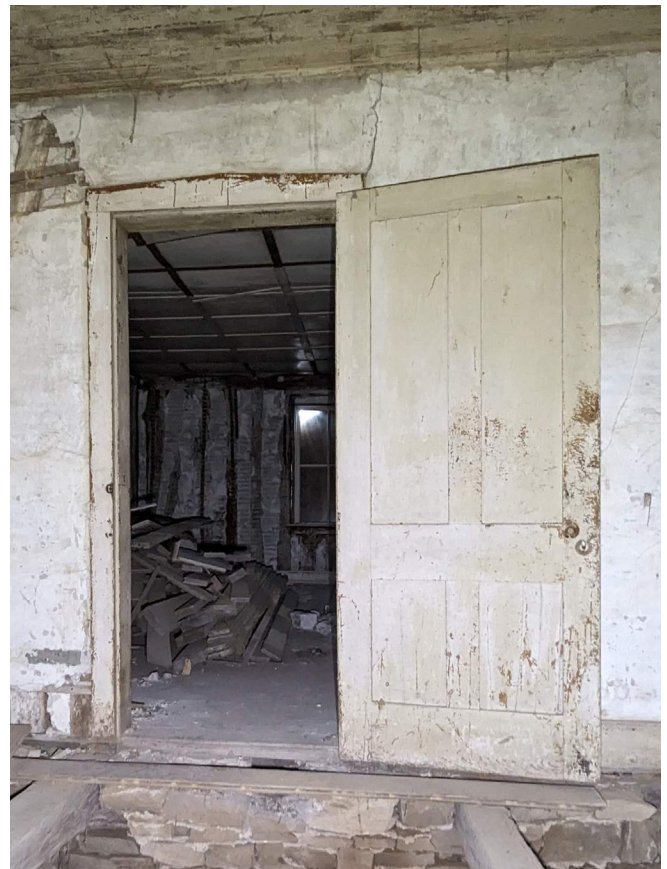
**Door D103B** is a wood door with a flat, four-panel configuration on both sides. The doorknob was missing. The door casing in Room 103 was painted cream over an earlier stain and had a pediment at the head; this casing may original to the 1830s. The trim was missing at the Room 104.

Figure 151. Door 103B, looking east, showing the pedimented casing. (Source: RRJ 2023)

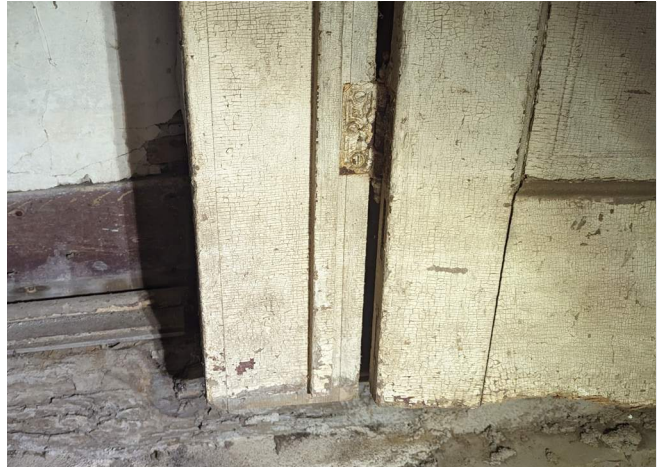
**Door 103A** is a wood door with a raised, four-panel configuration on both sides. The casing was present and was simple in profile with no pediment. The original doorknob was missing, and a later replacement was installed higher on the door with a rim lock. There was evidence of an older slide latch, but that hardware was not present. The hinges may be original and match those found on D201. Several layers of stain/paint were noted on the door with the oldest layer being a stain followed by maroon and white/light brown paint.

Figure 152. Jamb trim at D103A. (Source: RRJ 2023)

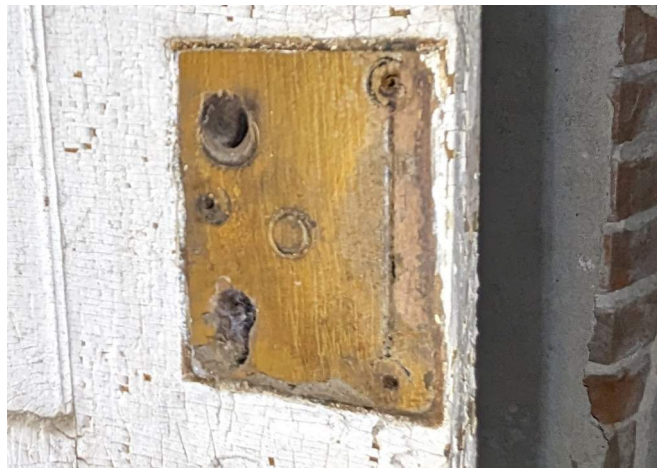
**Door D104** is a wood door with a flat, four-panel configuration on both sides. There was evidence of multiple color layers paint. The oldest layer was a stain with faux-graining, followed by cream, light blue, and white paint layers. The order of the paint layers was difficult to determine. The doorknob was missing but a small escutcheon was present. The existing butt hinges appear to be replacements. A previous rim lock is missing, and this area exposes the original faux graining. The trim is missing at the head, and it is possible that the door frame once was pedimented.

Figure 153. Faux graining exposed on the north face of D104. (Source: RRJ 2023)

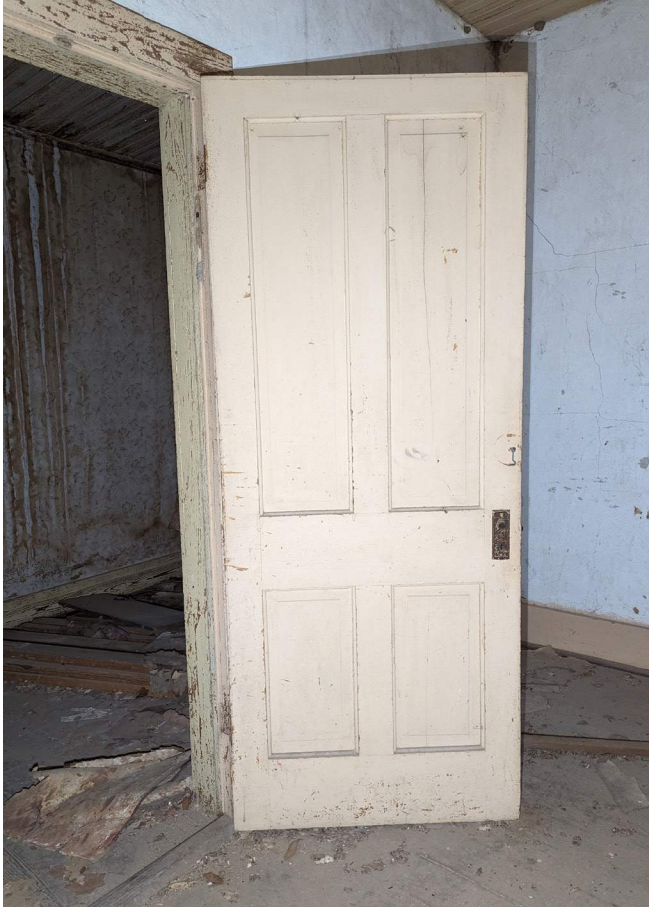
**Door D201** is a wood door with a raised, four-panel configuration on both sides. The knob is missing but an ornamental brass escutcheon was present. The hinges match and appear original. The deadbolt and latch were present. The hardware can be restored and the door knob can be replaced with a historic knob in an appropriate style. The door casing is painted wood with a simple profile. Several layers of stain and paint were present. The oldest layer was a light brown color and was most likely stained, the next layer appeared light green, and the newest layer was cream.

Figure 156. D201, showing the north face. (Source: RRJ 2023)

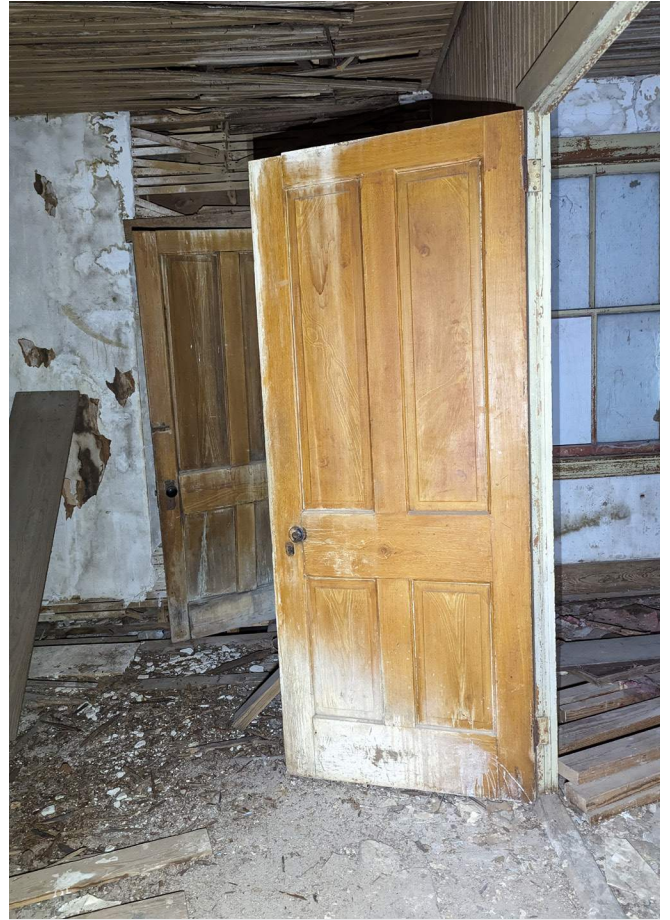
**Door D204** is a wood door with a raised, four panel configuration on both sides. The doorknob is missing, but an ornamental escutcheon was present. This escutcheon matches the one present at Door D201. The top hinges are replacement butt hinges with ball finals. The bottom hinge is original and matches Door D201. A simple door trim was present. Two stain/paint layers were noted on the trim; the oldest layer was a stain, and a newer layer of dark green paint were noted. The door is unpainted, but a stain was present. The door itself is faux-grained.

Figure 157. D204, showing faux graining on south face. (Source: RRJ 2023)

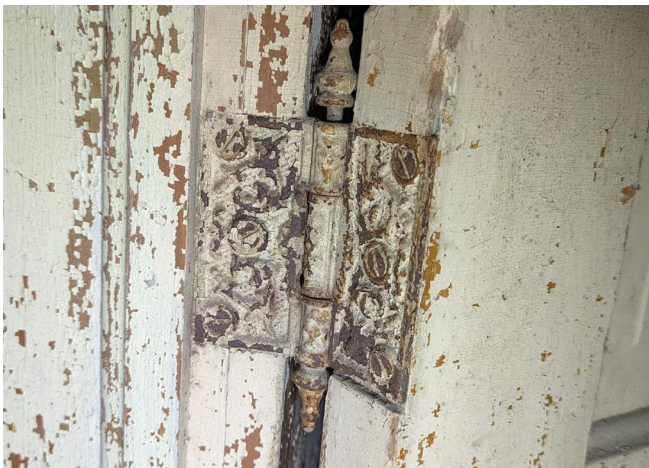
Figure 154. Ornamental hinge on D201. (Source: RRJ 2023)

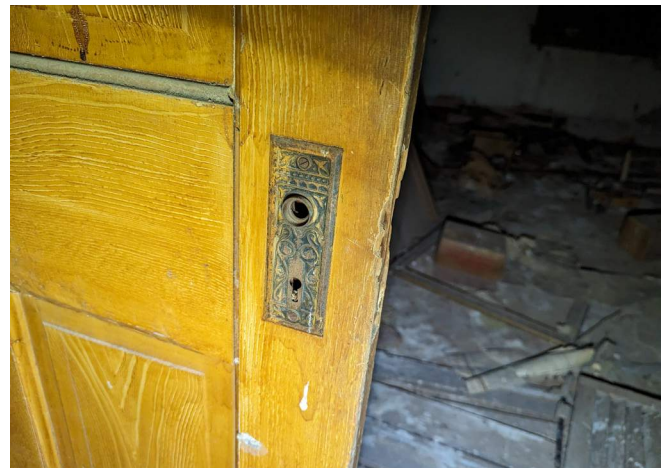
Figure 155. Faux graining and ornamental escutcheon on D204. (Source: RRJ 2023)

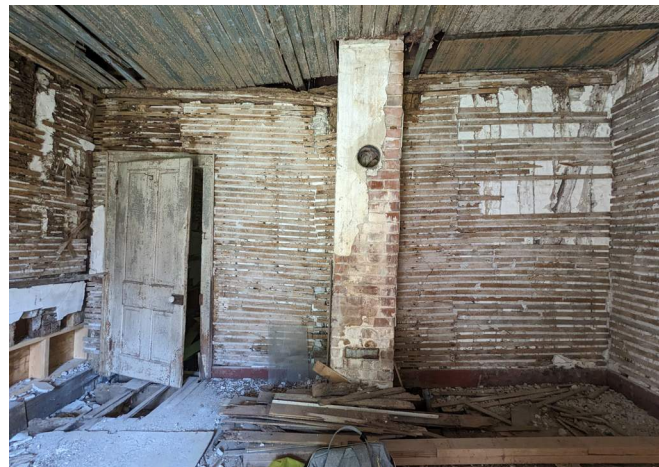
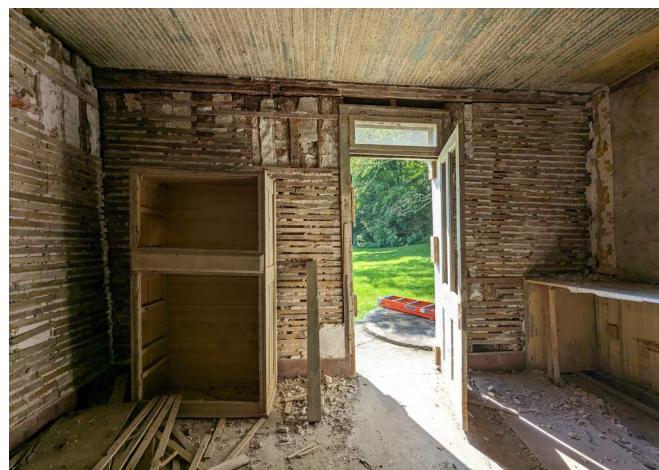
Wood decking was present in Room 101. The flooring was heavily deteriorated in this room, with areas of high distress present in the vicinity of doorways and at the location of a former bathroom at the wall separating Rooms 101 and 106.

Figure 158. Room 101, looking north. (Source: RRJ 2023)

Figure 159. Room 101, looking south. (Source: RRJ 2023)

Portions of deteriorating plaster and exposed lath were visible on the remainder of the west wall, in addition to white-painted wainscoting and a chair wall. The north, south, and east walls of this room retained portions of wood lath still attached to the vertical log wall framing.

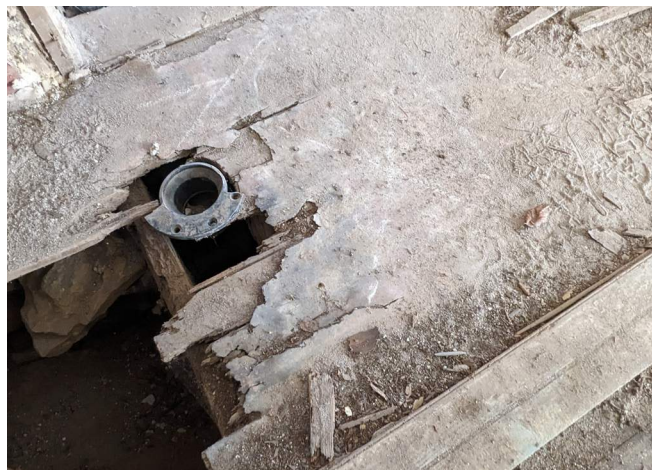
| C | INTERIORS | | | | |
|---|---|---|---|---|---|
| | | C302001 | 101 Flooring | Failed | High |

Figure 160. Failed flooring around plumbing riser. (Source: RRJ 2023)

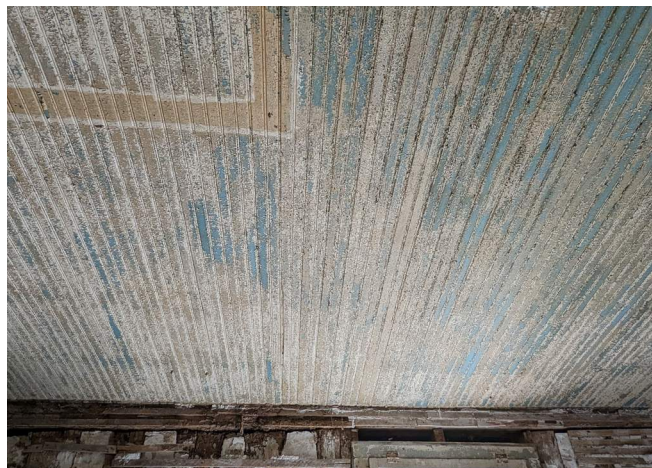
Ceiling finishes in Room 101 consisted of painted beadboard. The panels appeared to have been painted white at some time, however, blue paint was visible below failing white paint in Room 101. The beadboard is of undetermined date.

Figure 162. Ceiling beadboard in Room 101. (Source: RRJ 2023)

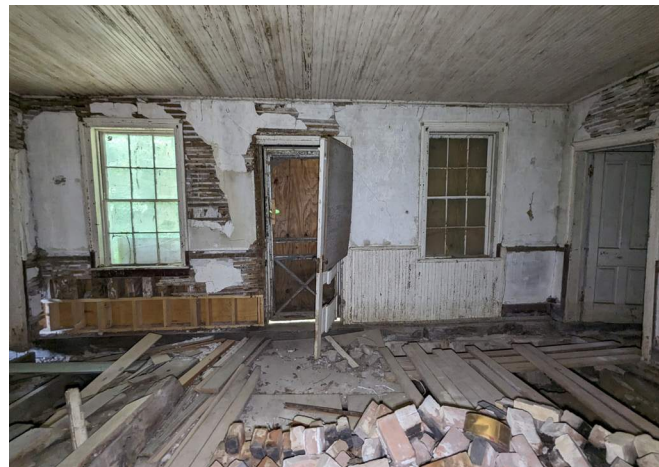
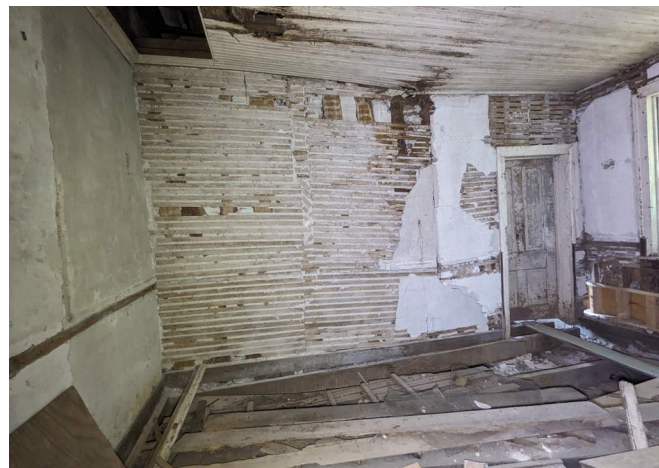
The majority of the wood plank flooring in Room 102 was missing, and the floor structure had failed. Any flooring that was present was in poor condition.

No wallpaper remnants were visible in Room 102. The south wall retained less than half of its plaster. Wood lath was present where plaster was missing along this wall. The west wall retained over half of its plaster. Portions of plaster were missing at the southern half of the west wall at the location of a previous bottom plate repair attempt. Plaster along the north and east walls were heavily cracked and missing in areas.

Figure 163. Room 102, looking west at the back door. (Source: RRJ 2023)

Figure 164. Room 102, looking south, note the loss of plaster on the south interior wall. (Source: RRJ 2023)

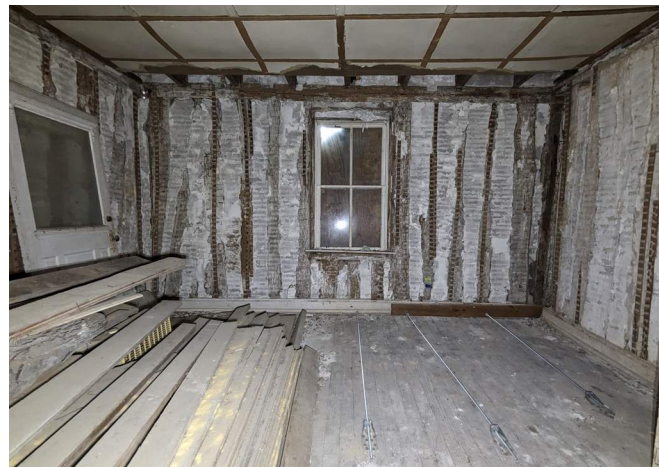
Vertical logs and infill were exposed at all four interior walls within Room 104. Limewash was observed on the faces of the logs behind the furring, indicating that the logs were likely originally whitewashed before plaster was later applied to the interior walls. The room was formerly plastered, but the plaster was removed in the 1990s and only remnants of sawn lath remain in place. Marks from two different patterns from lath were present: a diagonal pattern in the northwest corner where the lath was applied directly to the logs and a horizontal pattern in all other locations where the lath was applied to vertical battens. This suggests two different eras of interior plaster, as early 19th century diagonal lath has been observed at other log structures in Ste. Genevieve, including the front room of the privately owned Vital St. Gemme Beauvais House. The horizontal lath appeared

Figure 171. Room 104, looking east towards the distressed east wall. (Source: RRJ 2023)

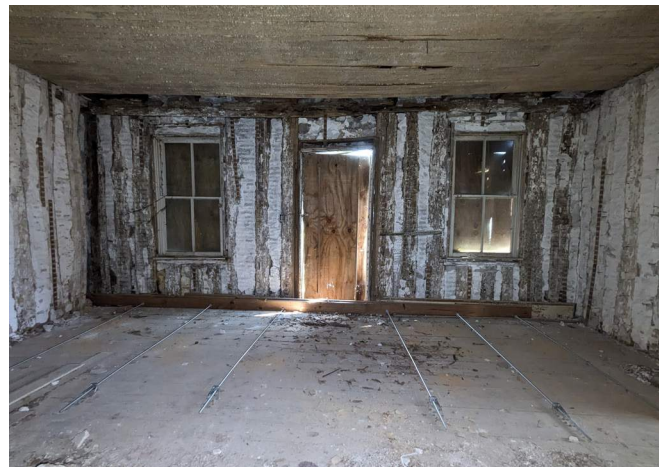
Wood flooring was present in Room 105. The condition of the flooring was variable but generally poor with areas of deteriorated boards and deflected flooring. Areas of high distress were typically present in the vicinity of doorways.

Figure 176. Room 105, looking east, showing the floor bracing that was installed before the 2023 shoring. (Source: RRJ 2023)

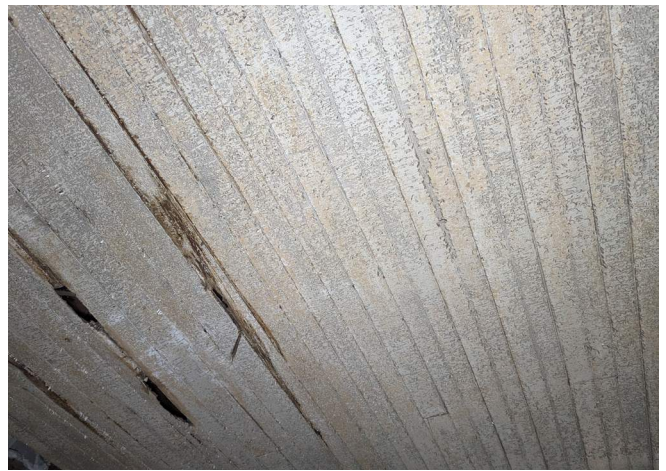
Ceiling finishes in Room 105 consisted of beadboard panels. The panels appeared to have been painted white. The beadboard had been removed along the east wall and in other areas, likely in the 1990s during investigation fo the house.

Figure 179. Distress to beadboard ceiling in Room 105.  
(Source: RRJ 2023)

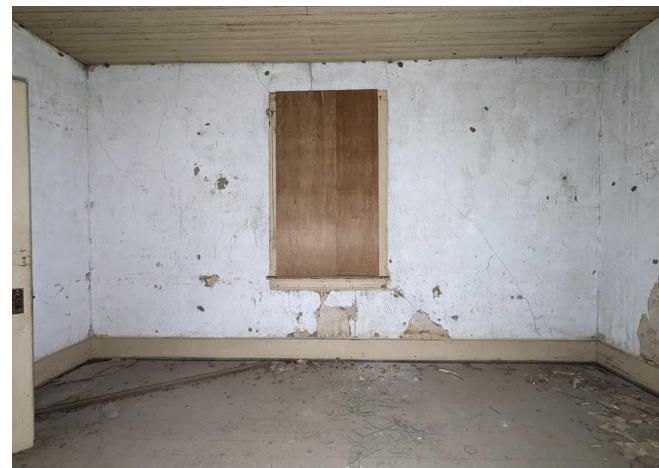
A wallpaper (WP-1) remnant was present in Room 201. The wallpaper had a cream background with a pink and yellow floral pattern and was applied directly to the plaster. The date of the wallpaper is undetermined. Plaster was present at all four walls, showing signs of deterioration and exposure to water under the windows.

Figure 186. Room 201, looking east, showing damage to the plaster under the failed window. (Source: RRJ 2023)

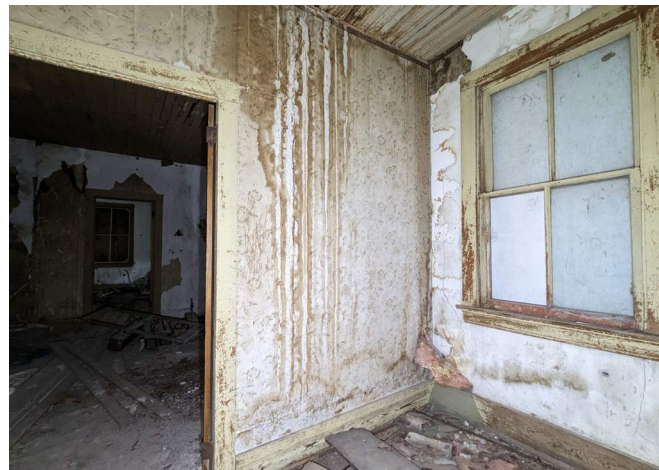
Seven fragments of different types of wallpaper were noted within Room 202. The remaining walls featured cracked plaster; the plaster on the east wall exhibited water damage from a previous roof leak.

Figure 191. Room 202, looking northeast, showing the damage to the walls and flooring from the previous roof leak. (Source: RRJ 2023)

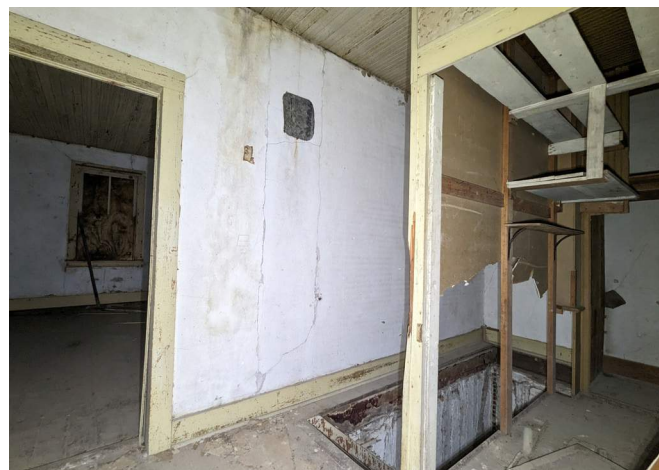
Figure 192. Room 202, looking southwest, showing the closet framing to the right and the stairwell. (Source: RRJ 2023)

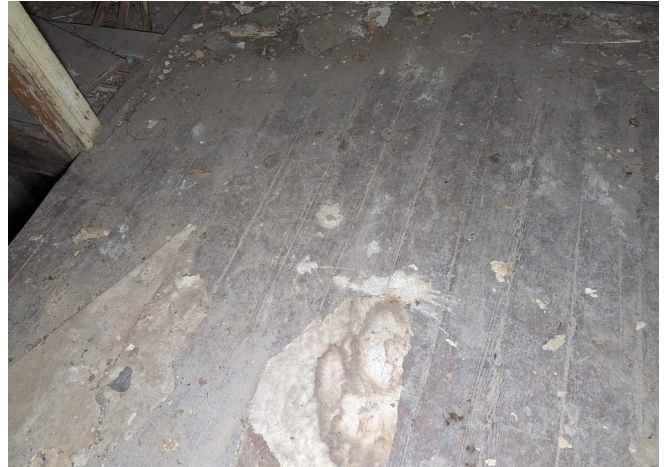
Wood flooring was present in Room 202. Along the east wall, the flooring exhibited failed planks from water damage from a previous roof leak.

Figure 193. Typical flooring in Room 202. (Source: RRJ 2023)

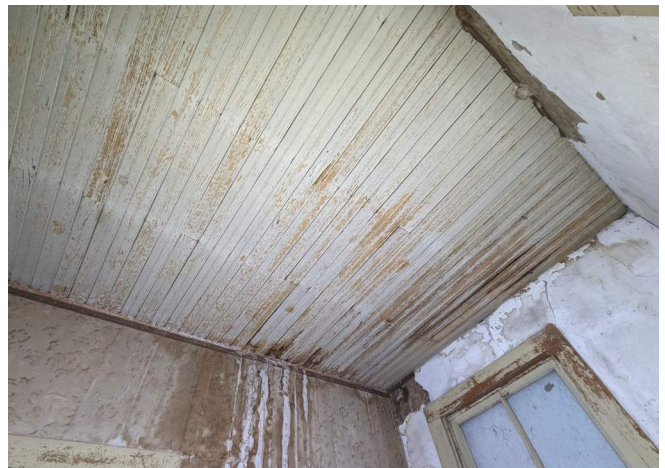
Ceiling finishes in Room 202 consisted of beadboard panels. The panels appeared to have been painted white. Water damage was present at the east wall.

Figure 194. Beadboard ceilings with water damage in Room 202. (Source: RRJ 2023)

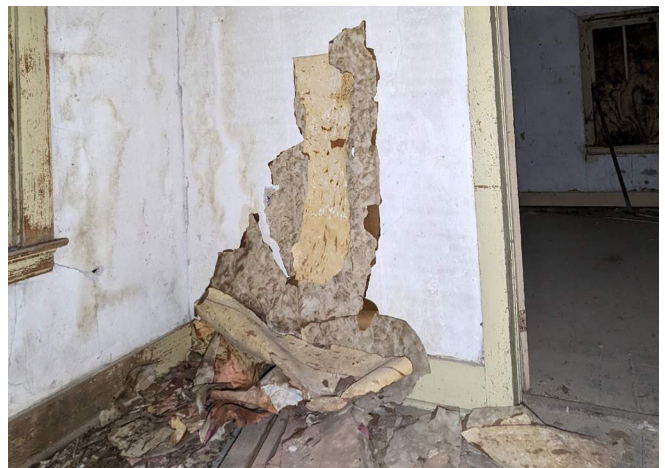
Figure 195. Multiple layers of wallpaper were present in the southeast corner of Room 202. (Source: RRJ 2023)

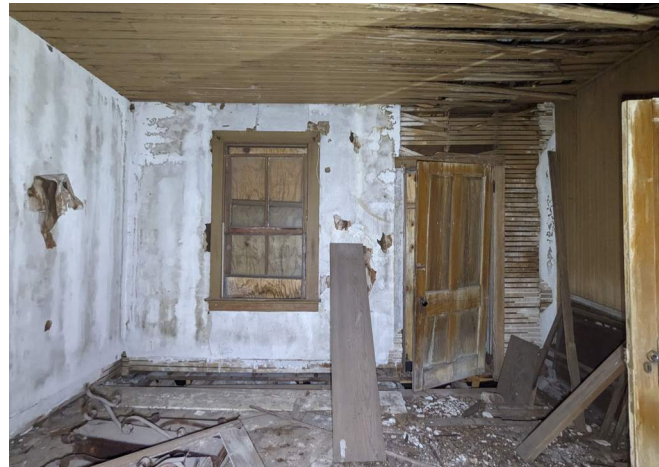
Wood flooring was present in Room 203. Along the east wall, the flooring exhibited failed planks from water damage from a previous roof leak.

The south wall of Room 203 was finished with beadboard panels. The west and north walls retained much of their wallpaper. The wallpaper (WP-5) was heavily water-damaged, and the original color and pattern could not be determined. The plaster on these walls was also water-damaged. The east wall had retained several very small wallpaper remnants, featuring floral, Greek key, and brocade patterns. Plaster was missing in the vicinity of

Figure 196. Room 203, looking east towards the water damage to the ceiling, walls, and flooring around the door. (Source: RRJ 2023)

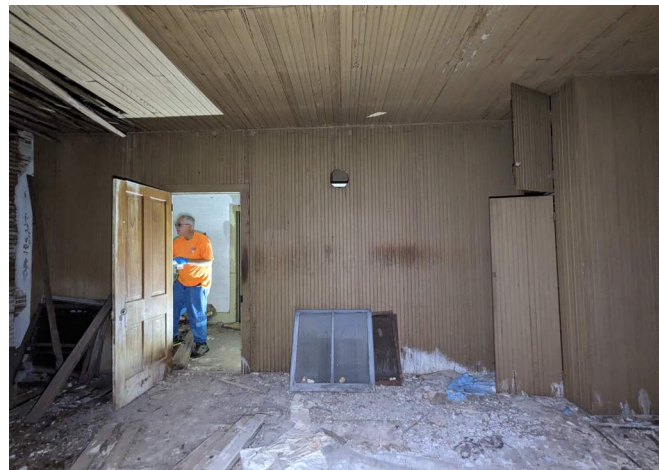
Figure 197. Room 203, looking south at the beadboard wall panels. (Source: RRJ 2023)

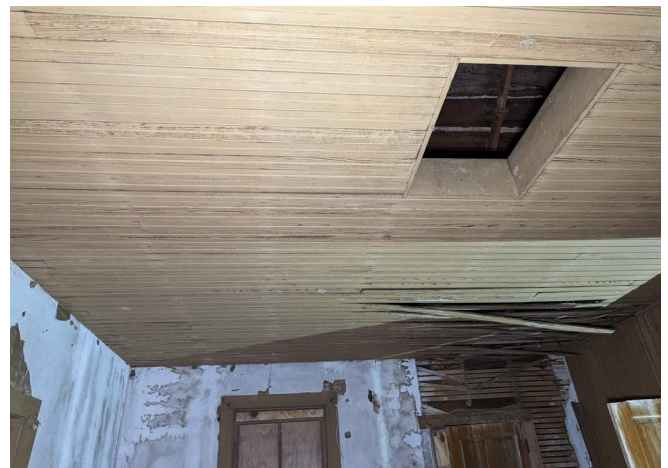
Ceiling finishes in Room 203 consisted of beadboard panels. The panels appeared to have been painted brown. The panels were water damaged at the east wall due to a previous roof leak.

Figure 201. Beadboard ceiling with the attic access hatch in Room 203. (Source: RRJ 2023)

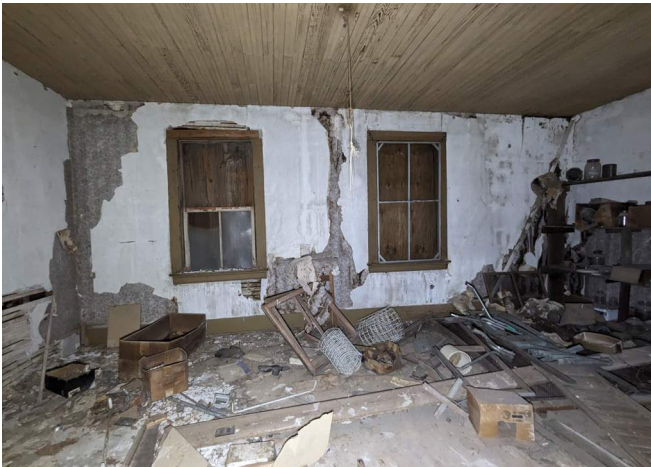
Figure 202. Room 204, looking north. (Source: RRJ 2023)

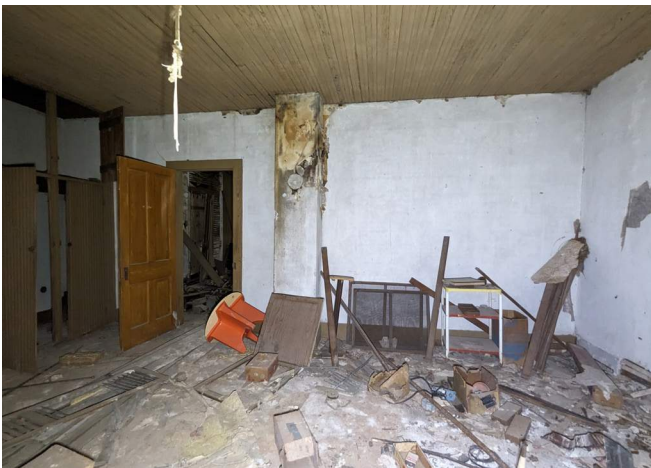
Plaster was present at all four walls. Plaster at the south wall exhibited severe water damage at a brick masonry chimney.

Figure 203. Room 204, looking south. (Source: RRJ 2023)

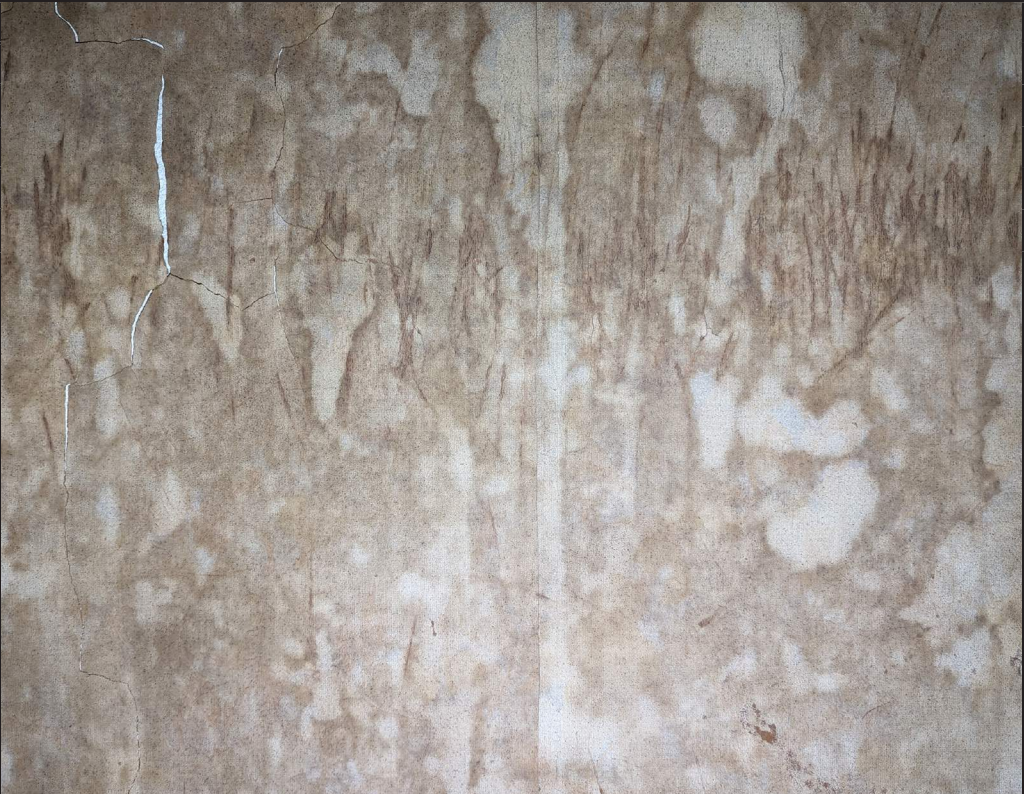
| ID: | WP-5 | |

| Heavily oxidized and water damaged; the pattern was not able to be determined. Applied directly to the plaster. | | |

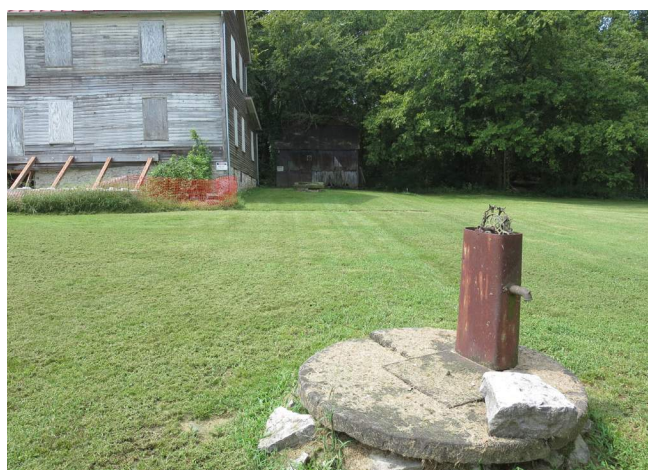
The Delassus-Kern House currently has no external water utility to the house. An abandoned well or cistern with a manual pump resides on the site, located approximately 40-50 feet east of the house. Municipal water supply from the City of Ste. Genevieve does not extend to the parcel. The closest supply main is located approximately one-third mile north of the house, at the intersection of US-61 and Bourbon Road.

Figure 207. Existing well located 40-50 feet northeast of the house. (Source: Alvine 2023)

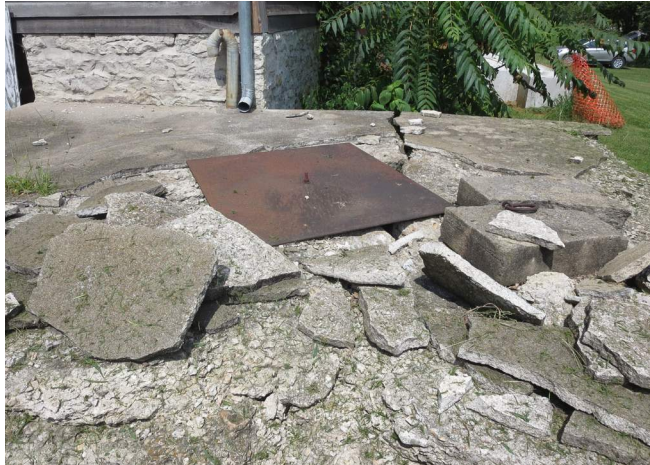
Figure 209. Second cistern located near the southeast corner of the house. (Source: Alvine 2023)

It appears that all of the cisterns have been abandoned in place. The cisterns appear to be quite old but no evidence is available stating that the cisterns would have been present or constructed with the house was constructed.

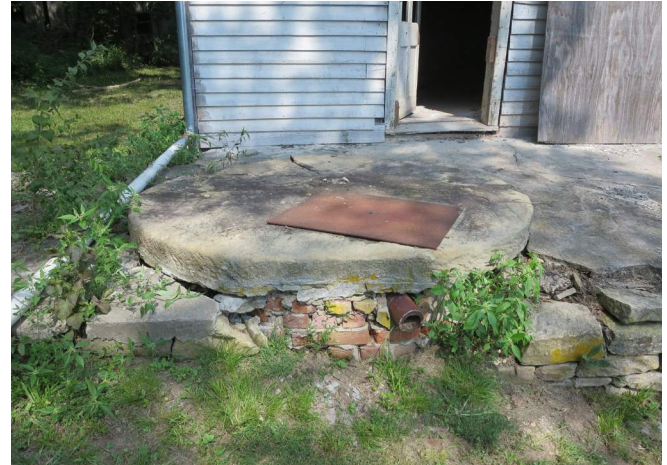
The southwestern cistern has a clay pipe near to the top of the cistern which extends from below the concrete lid, allowing a means of overflow to grade. The same overflow pipe is not present at the other cistern I, but the overflow may have been removed.

Figure 208. First cistern located near the southwest corner of the house. (Source: Alvine 2023)

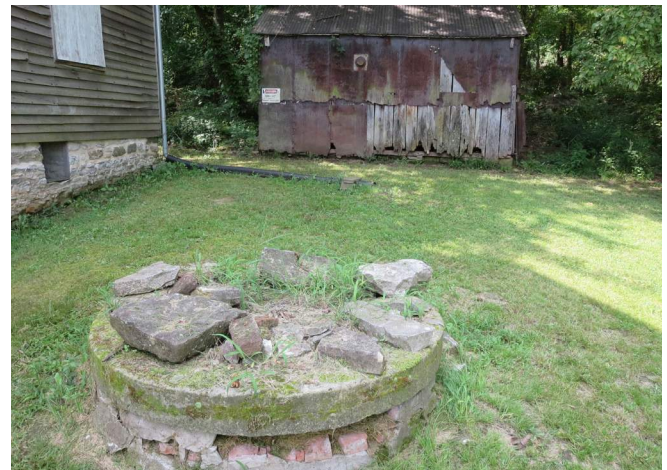
Figure 210. Third cistern located on the north side of the house. (Source: Alvine 2023)

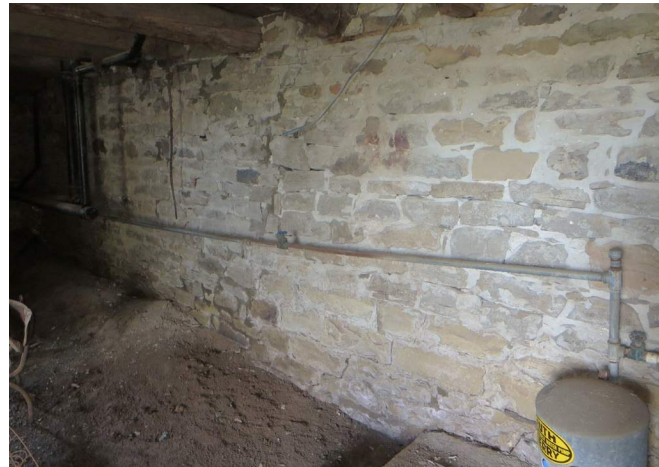
Figure 211. Existing 1-inch galvanized water line along the west all of the Basement level where the line extends through the south exterior wall. Note the offset in the piping down to the abandoned pump at the center of the room. (Source: Alvine 2023)

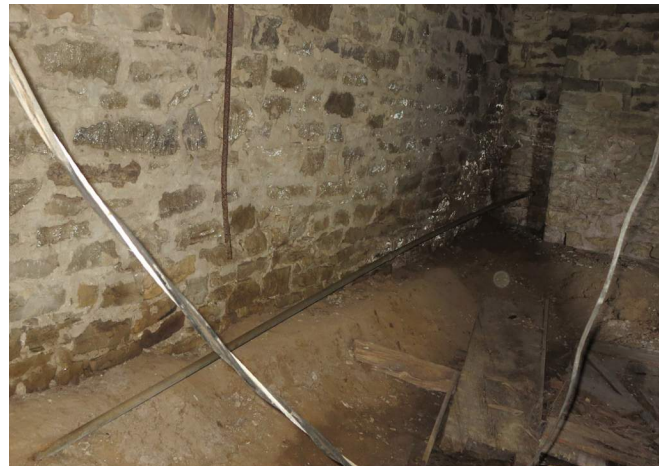
Figure 212. Existing 1-inch galvanized water piping along the west wall where piping is laying on the dirt floor from where it has been disconnected at the vertical pipe offsetting down to the pump at the center of the Basement space. (Source: Alvine 2023)

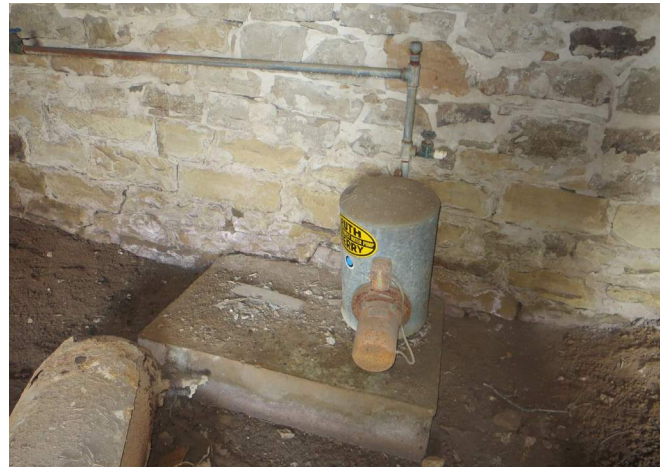
Within the Basement level is an abandoned water pump that resides on a thick concrete pad. The pump may have been used to pump water to the First level or higher as part of the house's internal water system. Any piping which may have existed has been removed at the First and Second levels.

Figure 213. Photo of existing abandoned water pump located on concrete pad in Basement level in house.. (Source: Alvine 2023)

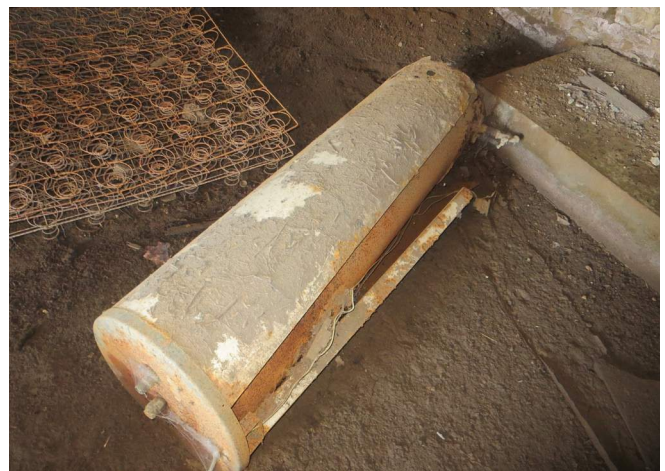
Lying next to the concrete pad on the dirt floor is an abandoned water heater which is approximately 14-inch diameter by 3 to 4 feet in length. The water heater may have been located on the concrete pad next to the pump. Both of these two items do not appear original to the house but have been abandoned over the years as the house has been unoccupied for some time.

Figure 214. Photo of existing abandoned water heater lying on dirt floor next to concrete pad. The water heater may have located on the concrete pad at one time. (Source: Alvine 2023)

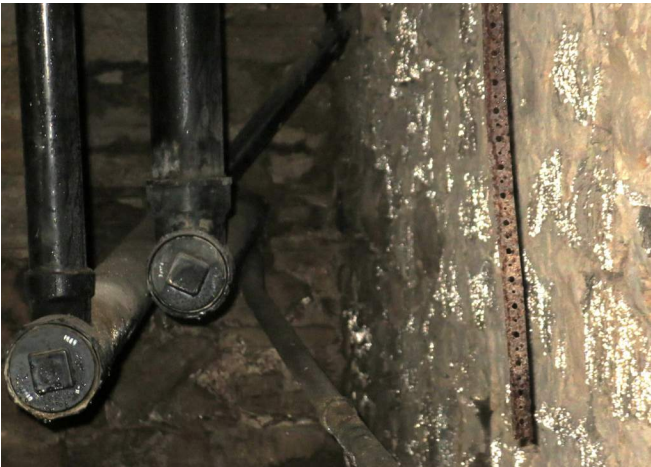
Figure 216. Existing sanitary pipes routing along west wall to the south existing wall where lines extend through foundation wall. (Source: Alvine 2023)

Remnants of two 4-inch sanitary waste pipes are present in the basement level. The piping currently extends from the southeast exterior wall adjacent to the galvanized water piping. The sanitary pipes extend northwest along the west wall of the basement for a distance of approximately 15-feet. The line closest to the west wall extends up to the main level maintaining a 4-inch size. The other adjacent line extends up to the main level as a 2-inch line where it branches off to the west and horizontally to the northwest below the main level floor. At the main level, the piping terminates with two floor flanges and a third cut-off pipe level with the floor. This appears to be the extent of the sanitary piping.

The sanitary piping appears to be ABS (acrylonitrile butadiene styrene) sewer pipe and fittings. The age of the piping is unknown. It is clear that this piping is not original to the house. Based on the configuration of the piping flanges at the floor that the piping may have served some sort of floor-mounted plumbing fixtures which have since been removed.
