# Delassus-Kern House

STE. GENEVIEVE NATIONAL HISTORICAL PARK  
STE. GENEVIEVE, MO

## Historic Structure Report

PMIS 311634  
OCTOBER 2024

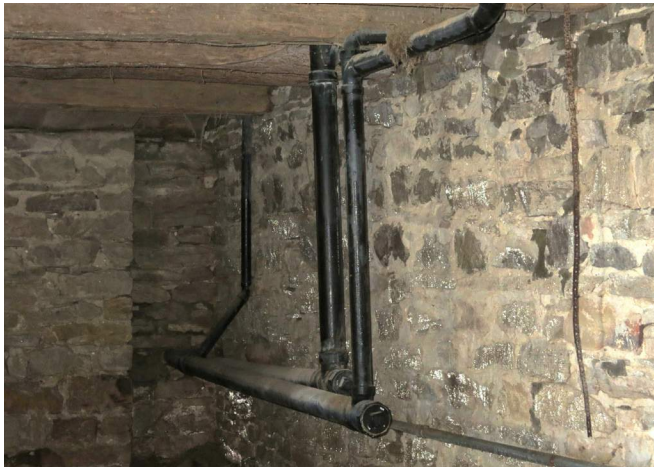
Figure 215. Existing 4-inch sanitary piping located at the west wall of the Basement routing south through the south Basement wall. (Source: Alvine 2023)

Remnants of two 4-inch sanitary waste pipes are present in the basement level. The piping currently extends from the southeast exterior wall adjacent to the galvanized water piping. The sanitary pipes extend northwest along the west wall of the basement for a distance of approximately 15-feet. The line closest to the west wall extends up to the main level maintaining a 4-inch size. The other adjacent line extends up to the main level as a 2-inch line where it branches off to the west and horizontally to the northwest below the main level floor. At the main level, the piping terminates with two floor flanges and a third cut-off pipe level with the floor. This appears to be the extent of the sanitary piping.

The sanitary piping appears to be ABS (acrylonitrile butadiene styrene) sewer pipe and fittings. The age of the piping is unknown. It is clear that this piping is not original to the house. Based on the configuration of the piping flanges at the floor that the piping may have served some sort of floor-mounted plumbing fixtures which have since been removed.

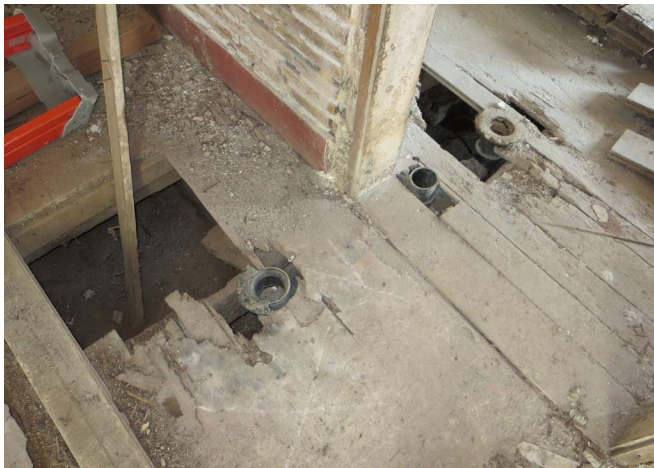
Figure 217. Existing sanitary pipes penetrating the First level floor. (Source: Alvine 2023)

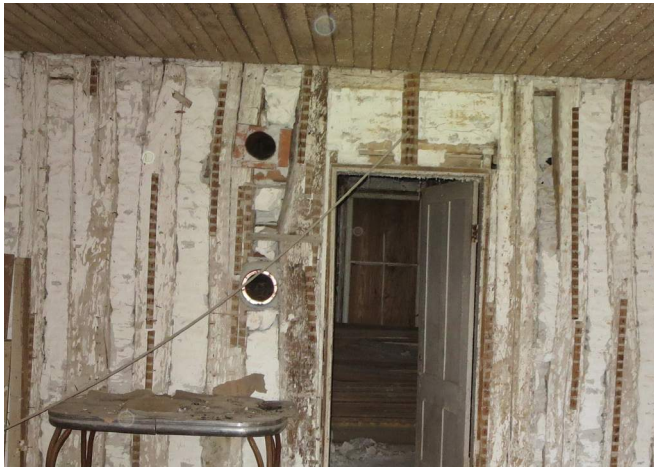
The Delassu-Kern House does not have any heating, ventilating or air conditioning including no mechanical equipment or ductwork. There is no evidence of any equipment that may have been in place at the house. In the basement, remnants of fireplace foundations exist providing evidence that fireplaces once existed in the house providing heat. The fireplaces were removed during an extensive remodel of the house in the 1890s. Chimneys and wood burning stoves were added along with constructing the second level as part of the house remodel. The stoves have since been removed.

Figure 218. Existing round openings in the north wall of Room 105 indicate where wood stoves were connected to the chimney in the room to the north. (Source: Alvine 2023)

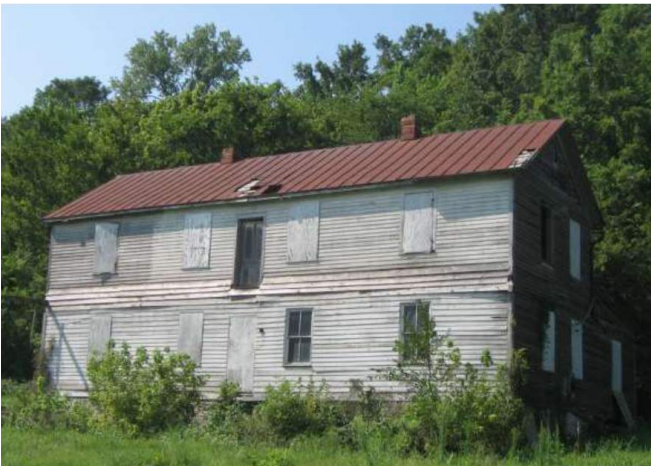
Exterior views of the house before 2016 show that four brick chimneys for stoves were present, but they were removed when the roof was replaced .

Figure 220. Photograph of Kern house c. 2011 when the chimneys existed at the roof (Source: Alvine 2023)

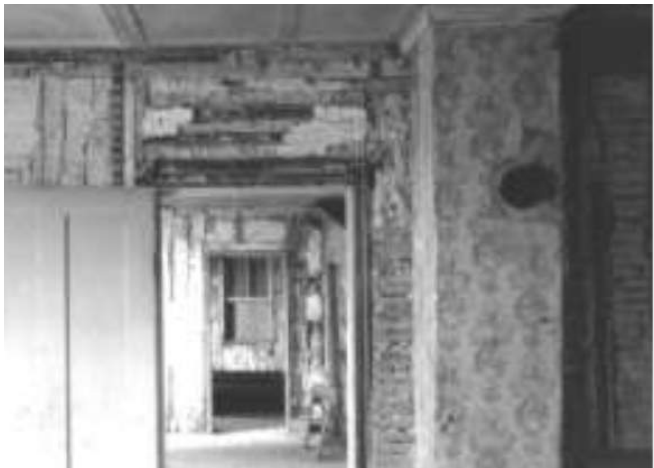
Figure 219. Existing first level on the other side of the same wall where a chimney exists where another round opening is present for a wood stove connection. (Source: Alvine 2023)

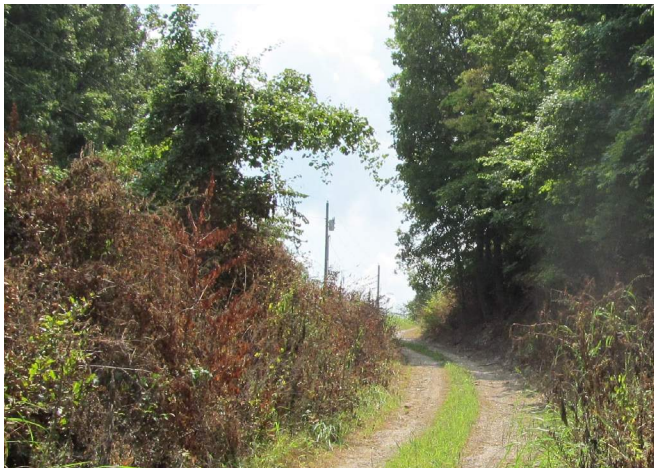
At one time, the Kern House had electrical power supplied to it. Currently, the building has no electrical power supplied to it. On the west side of the building, up on the hill, there is an electrical utility company, overhead power line.

Figure 221. Photograph of existing overhead electrical line near building site. (Source: Alvine 2023)

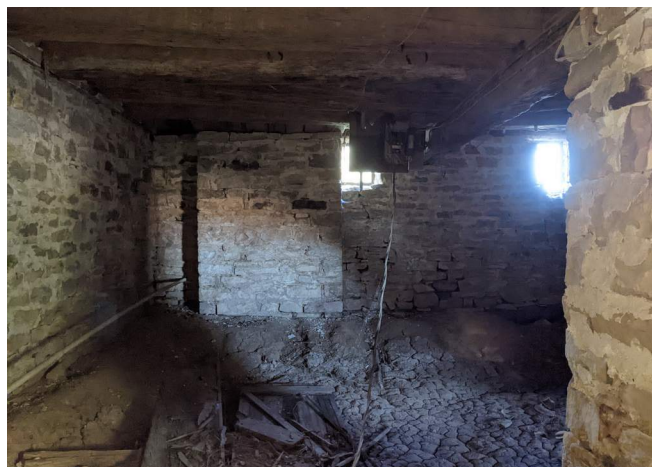
In the basement, there is an existing 240/120-volt, 1-phase, 6-circuit, plug-fuse panel. This panel is not active. There is no electrical power supplied to the panel, and the panel does not have branch circuits connected to it.

Figure 222. Fuse panel in basement, mounted to the floor structure in the upper right of the photograph. (Source: RRJ 2023)

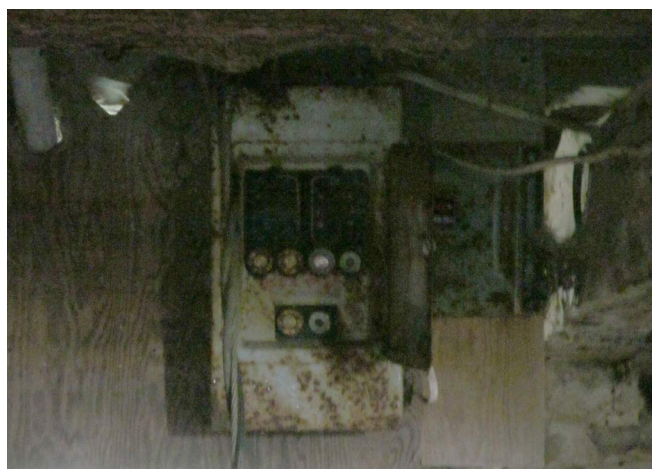
Figure 223. Photograph of existing, not-active 240/120-volt, 1-phase, 6-circuit, plug-fuse panel in basement. (Source: Alvine 2023)

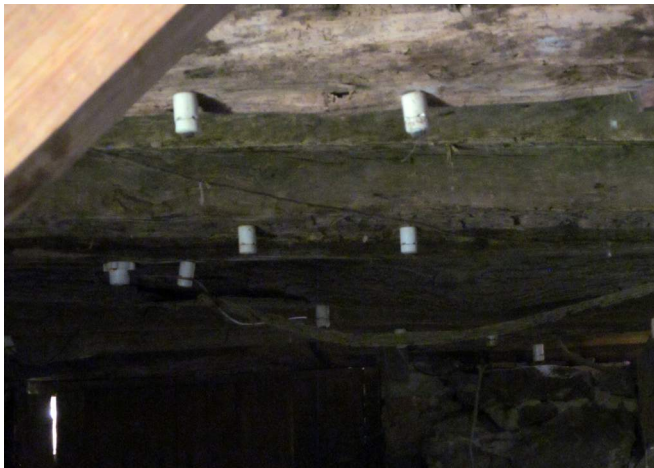
The first type of electrical wiring installed in the building was the knob-and-tube-type as visible in the basement.

Figure 224. Photograph of remaining know-and-tube wiring. (Source: Alvine 2023)

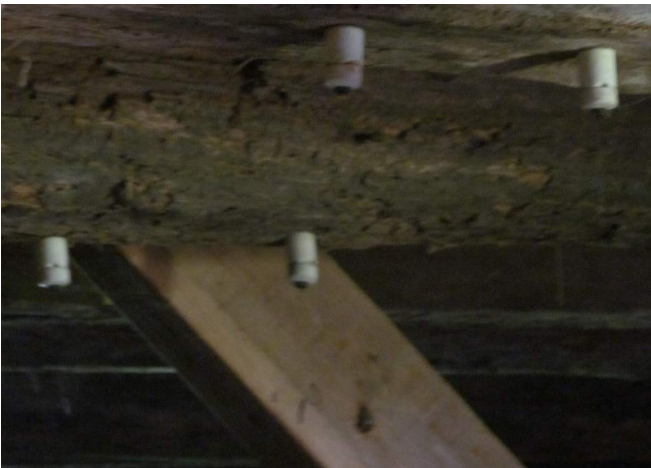
Figure 225. Photograph of remaining know-and-tube wiring. (Source: Alvine 2023)

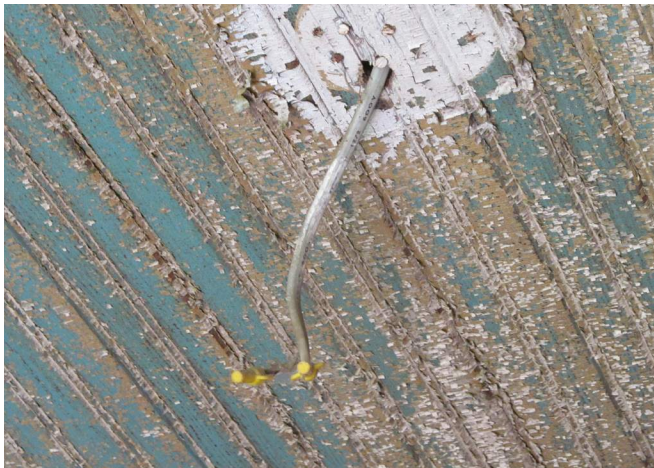
There are no branch circuits in the building. There are a few lengths or non-metallic-sheathed cable visible in the building, but these are not connected to electrical load, lighting, fixtures, or devices.

Figure 226. Photograph of remaining non-metallic sheathed cable. (Source: Alvine 2023)

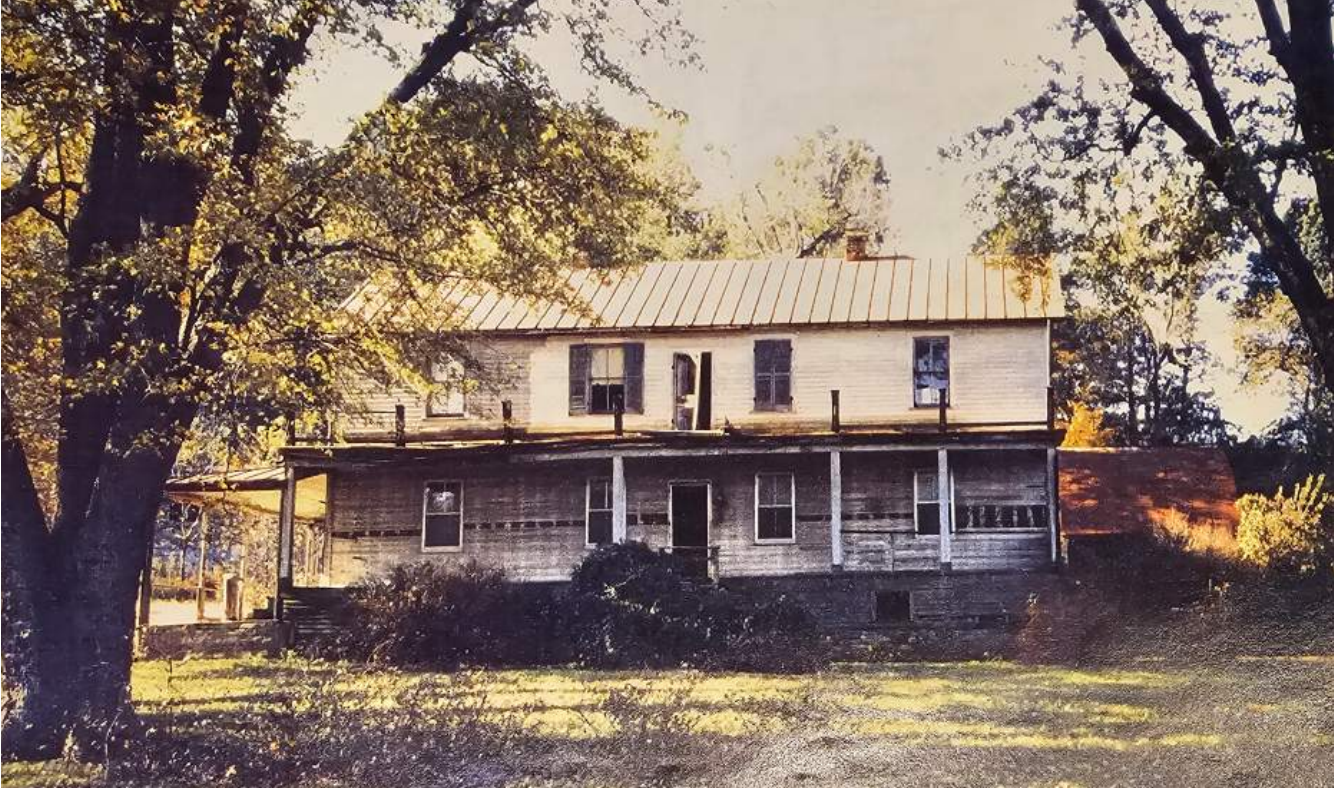
Figure 26. The east exterior in 1990, showing continued deterioration of the exterior. (Source: Volz and Associates, "Pierre Delassus de Luziere House (Kern House) Condition Assessment Report").

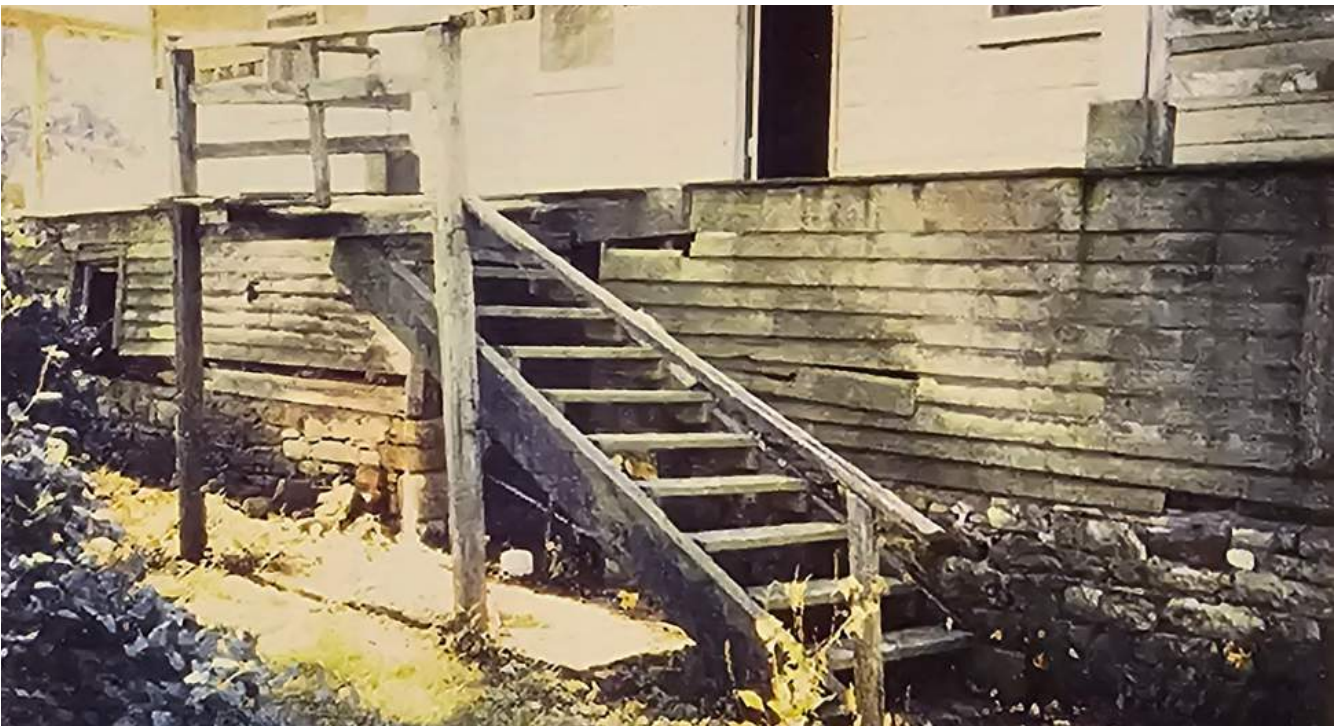
Figure 27. 2000 photograph of the east porch stairs; note that the left flight is now missing. (Source: Volz and Associates, "Pierre Delassus de Luziere House (Kern House) Condition Assessment Report").

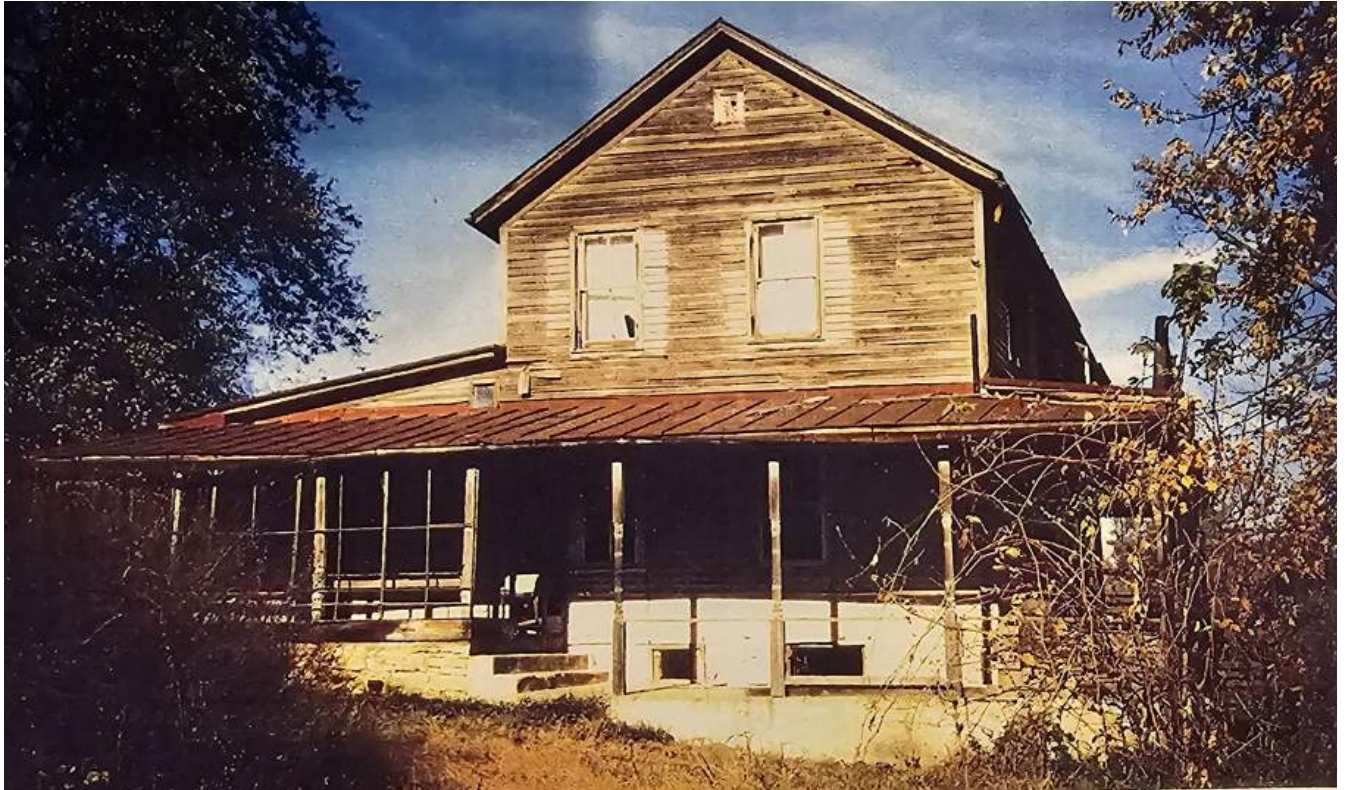
Figure 28. The south exterior wall in 1990, showing continued deterioration of the exterior. (Source: Volz and Associates, "Pierre Delassus de Luziere House (Kern House) Condition Assessment Report").

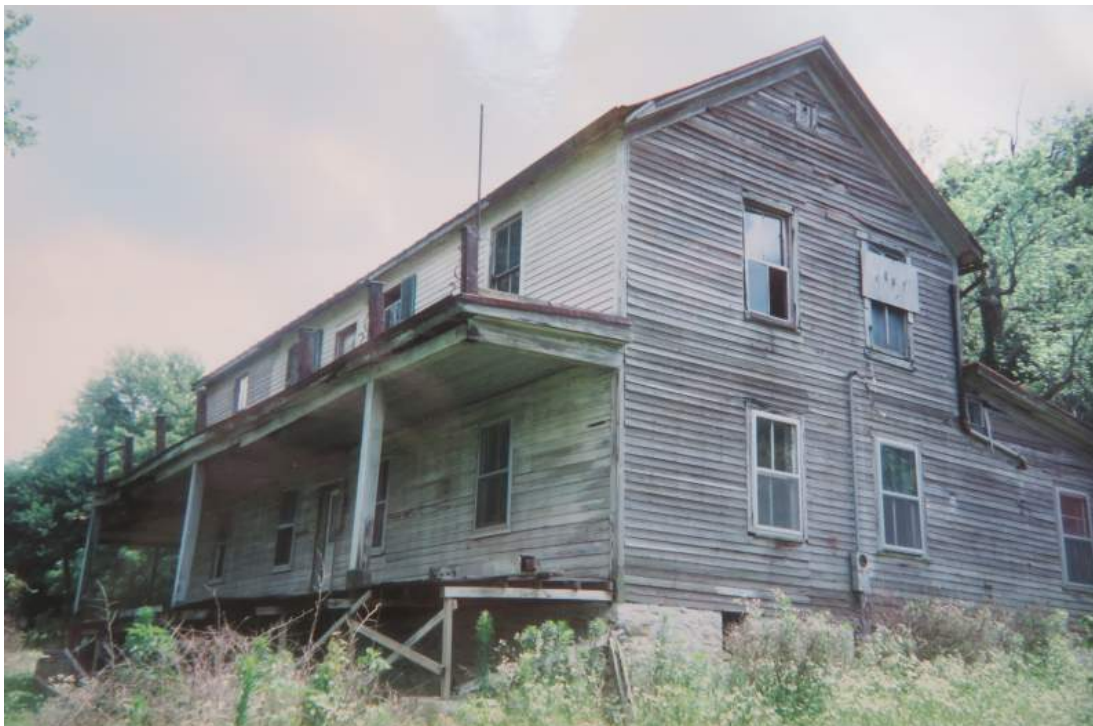
Figure 31. Photograph c. 1995, looking southwest, showing the poor condition of the house and the collapsing double porch. (Source: MoDNR Felix Vallé House archives)

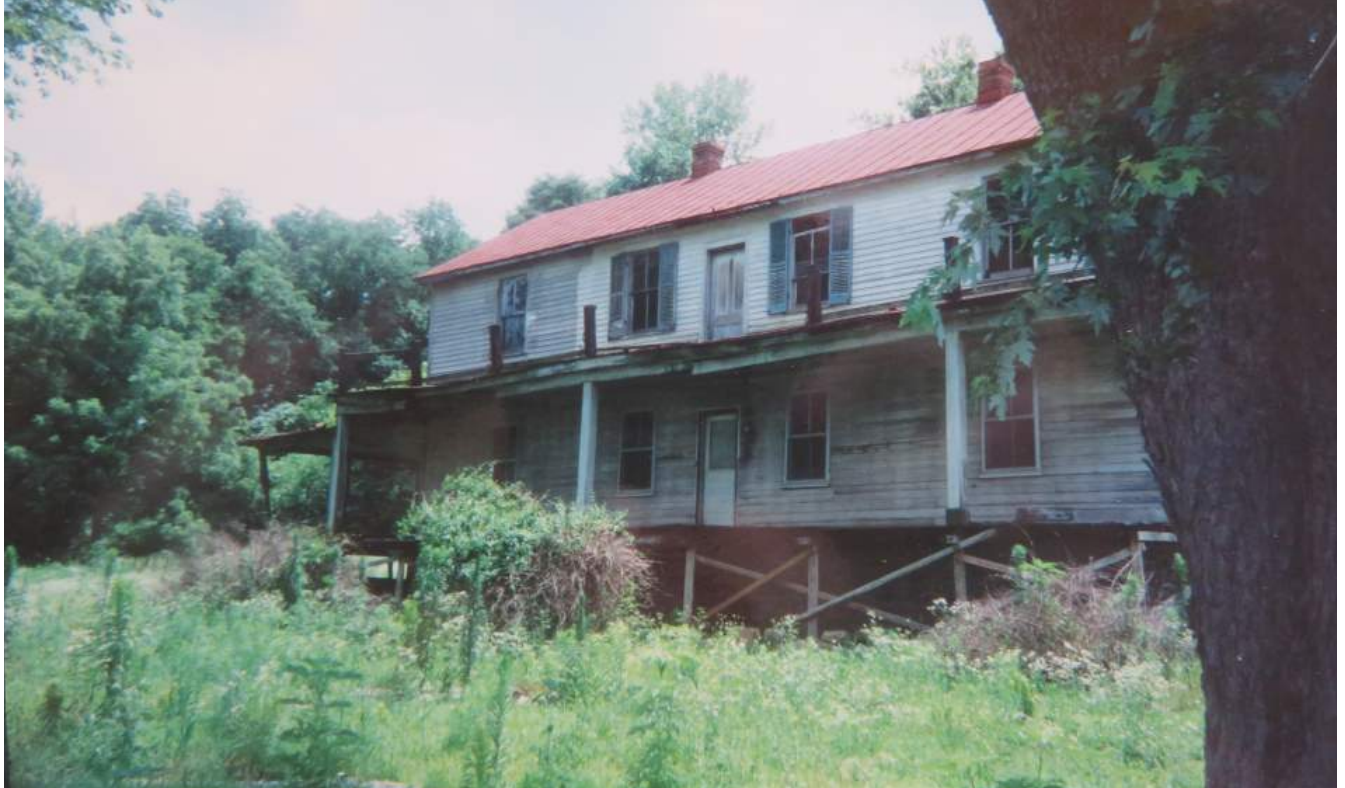
Figure 32. Photograph c. 1995, of the east exterior wall, showing the poor condition of the house and the collapsing double porch. (Source: MoDNR Felix Vallé House archives)

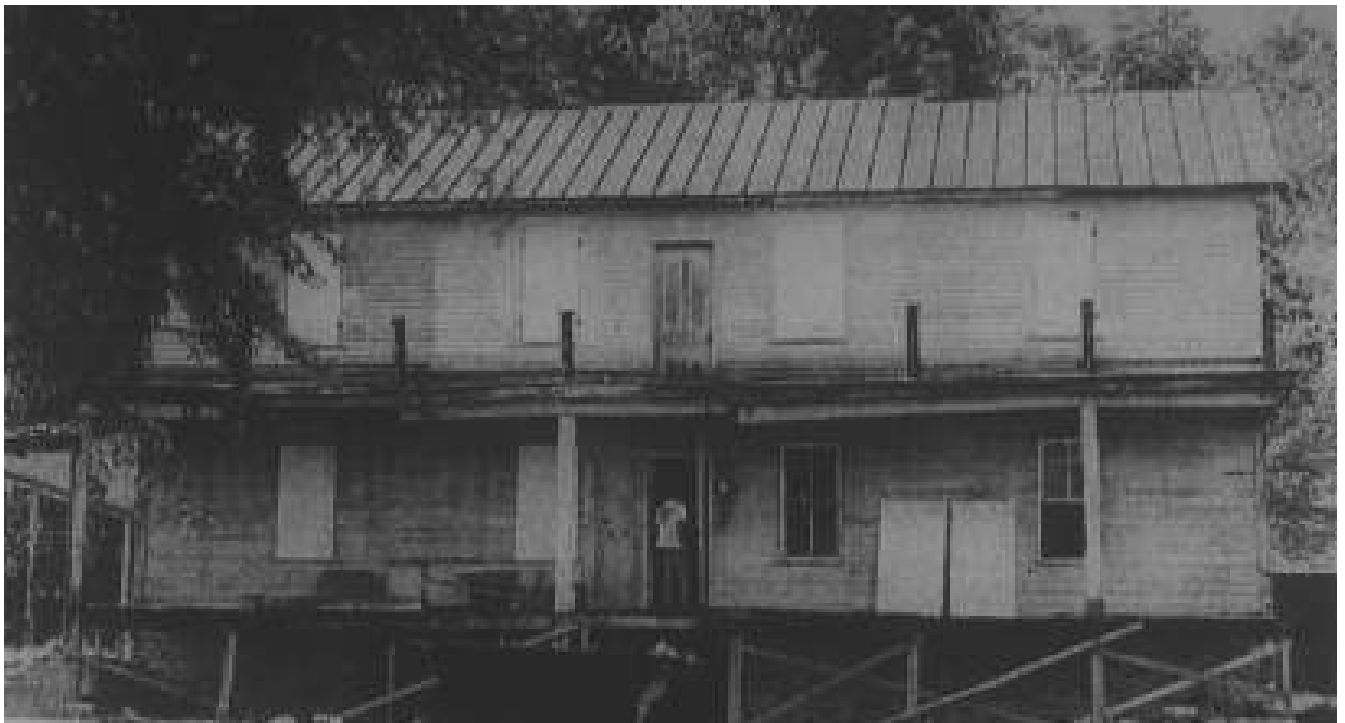
Figure 33. October 1998, showing the continued deterioration of the exterior. (Source: Evans, Mark. "DNR Ties to Unravel Mystery of De Luziere House," *Ste. Genevieve Herald* (October 9, 1996): 1B.)

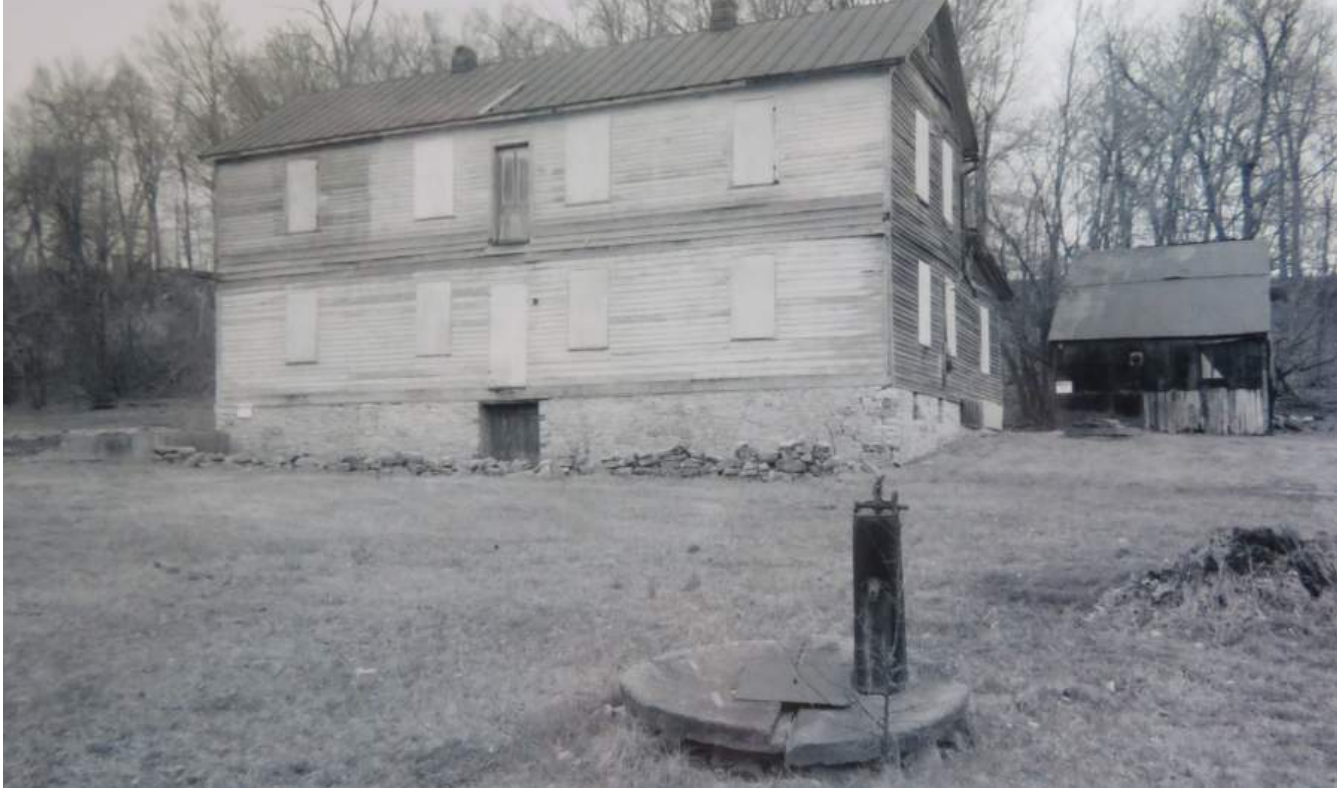
Figure 34. Photograph taken in July 2000, looking west, after the porches have been removed. Note that the large tree visible in previous photographs is now a deteriorated stump at far right. (Source: MoDNR Felix Vallé House archives)

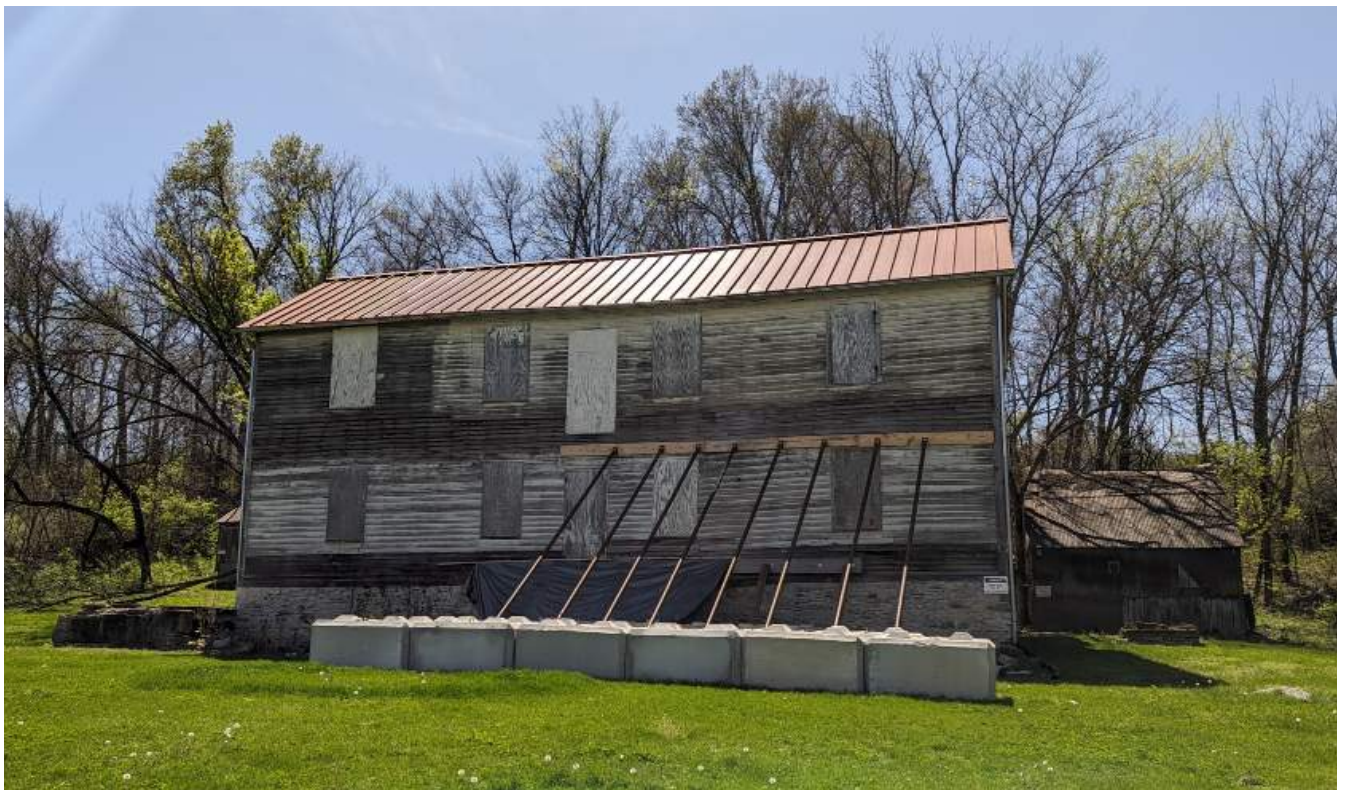
Figure 41. April 2024, after installation of the second floor bracing. (Source: RRJ 2024)

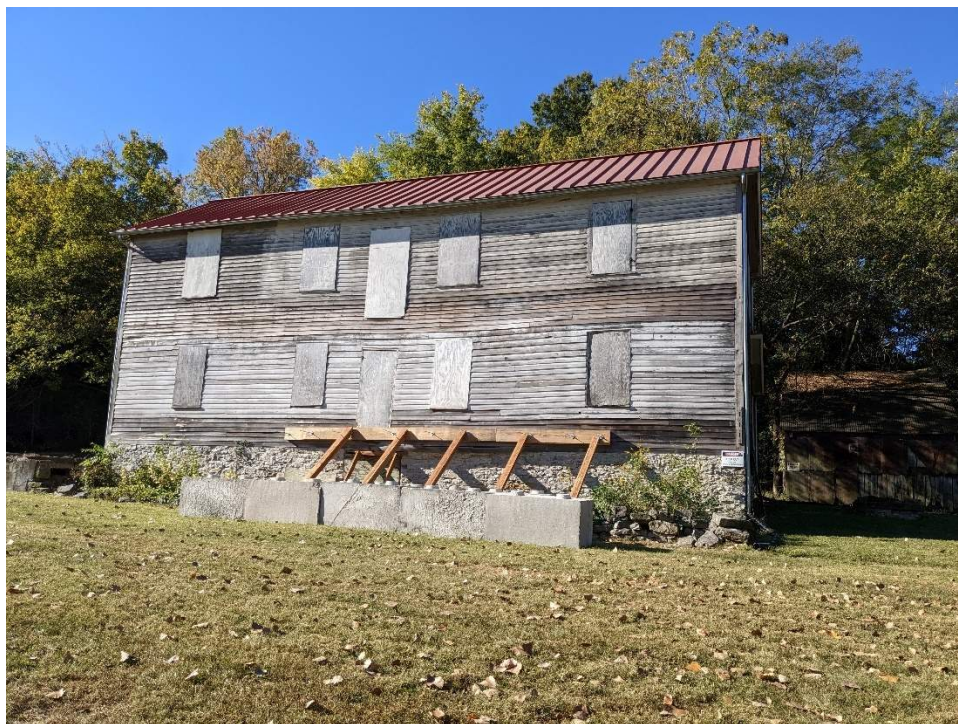
Photo 5. East (main) exterior wall of the Delassus-Kern House in October 2022, with first-floor shoring in place.

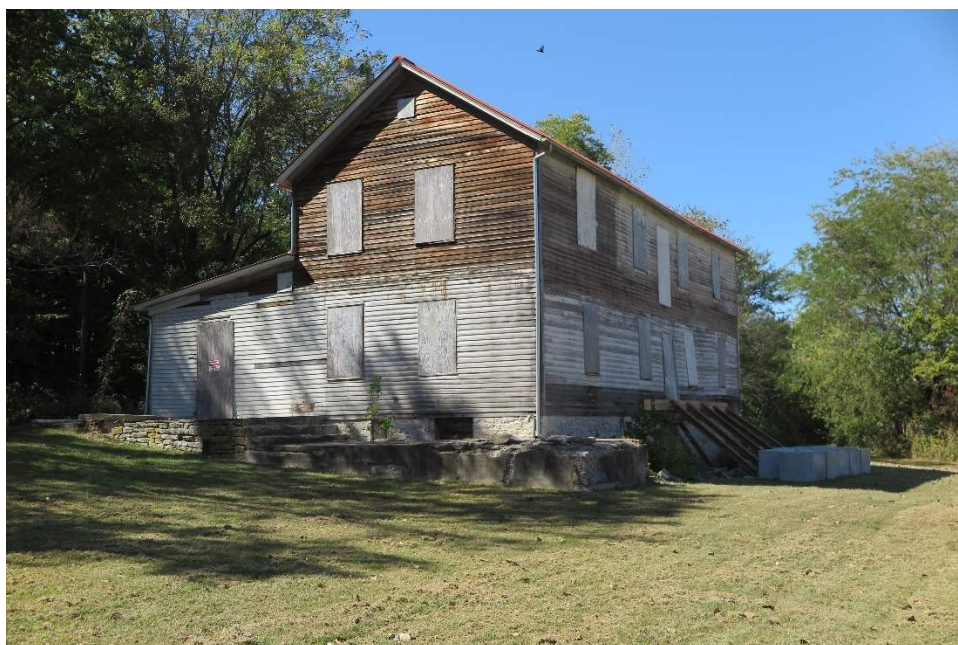
Photo 6. Southeast corner of the Delassus-Kern House in October 2022, with first-floor shoring in place.

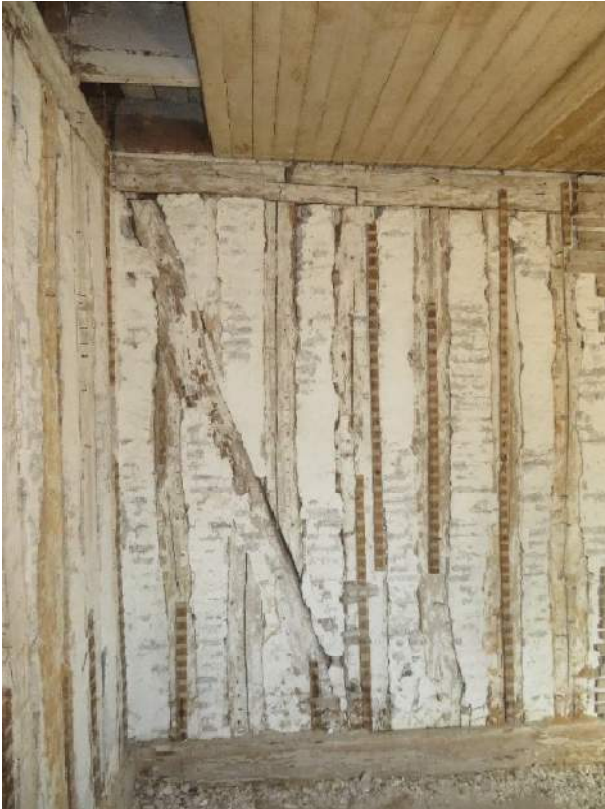
Photo 20. Typical interior vertical log wall with diagonal member within room 106.

Diagonal logs were observed near the ends of several walls and serve as lateral bracing for the structure (Photo 20). Diagonal logs were observed in the following locations:

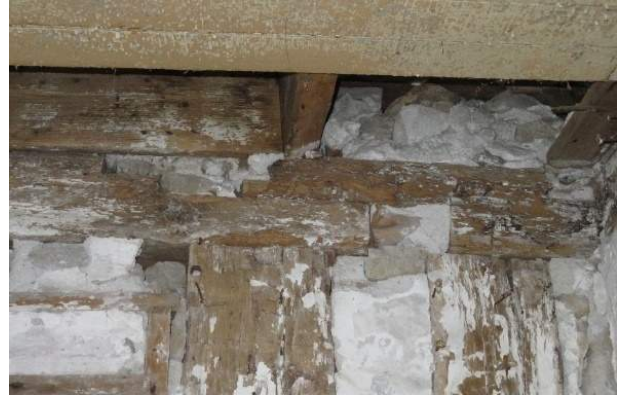
Photo 21. East wall top plate splice within room 105. The splice appears to have been constructed in this "open" position, with pierrotage infill placed between members.

The top plate at the east wall was observed to be spliced south of window W105B (Photo 21). This splice was observed to be open, with pierrotage infill between vertical faces of the splice. It appears that the splice was installed in this open configuration, perhaps indicating a lack of fit as part of the original construction. Notches were observed at the top of the

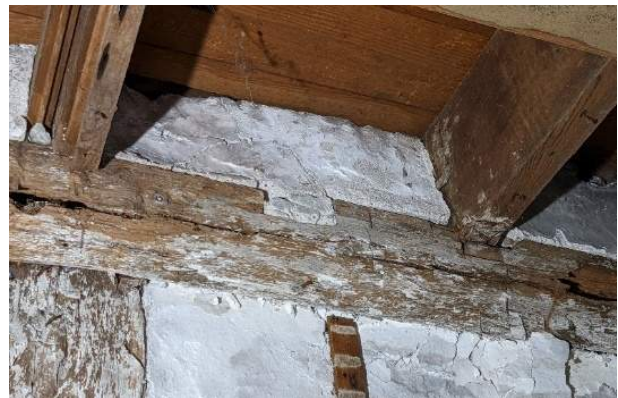
Photo 22. Vertical log top plate at the east exterior wall within room 104. Second-floor joists sit atop the existing top plate. Notches at the top of the top plate were likely created to receive the original roof framing members.

top plate at regular intervals (Photo 22). It is likely that these notches once received original roof framing members.

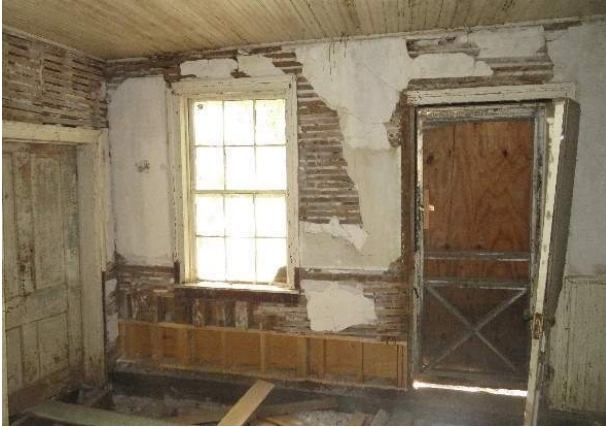
Photo 23. The west vertical log wall as viewed from within Room 102. The dimensional lumber knee wall and replaced bottom plate extend along approximately half of this wall between the south wall and the exterior door.

At the west exterior wall, a portion of the sill plate has been replaced between from the south exterior wall to within 8-inches north of Door D102A. Similarly, the lower 16-inches of the vertical logs wall along the west wall were removed and replaced with a dimensional lumber knee wall between the south exterior wall and Door D102 (Photo 23). These alterations are believed to have occurred following the Missouri DNR's acquisition of the property. The top plate of the west wall was typically concealed by

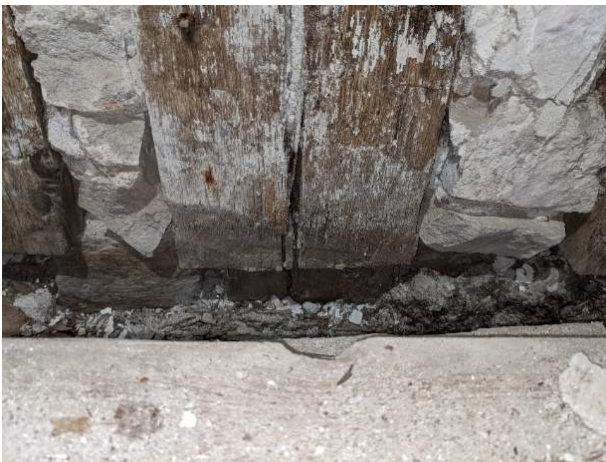
Photo 24. Lower termination of vertical log walls within room 105. The tenon at the log end is visible where the sill plate has heavily deteriorated.

where the fireplaces likely stood. Logs are typically mortised into the bottom plates (Photo 24) and nailed to the top plates.

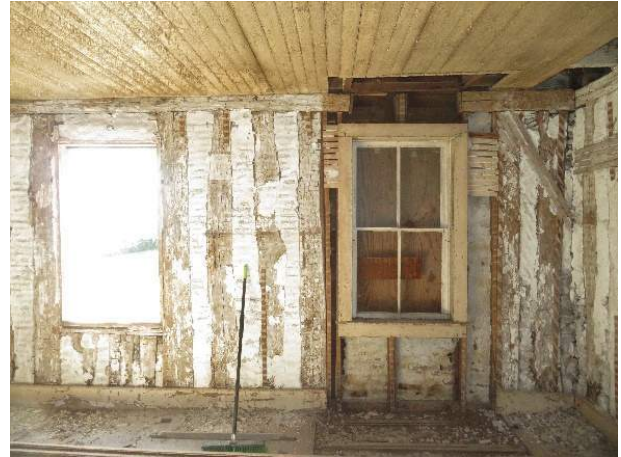
Photo 25. The south vertical log wall as viewed from within Room 106, showing dimensional lumber framing at the righthand window. This was the previous location of a stone masonry chimney. Note the original log framing at the lefthand window opening.

The top plates at north and south wall are likewise constructed of two distinct members, interrupted at the previous chimney location (Photo 25). The north top plate extends 27-inches east of the interior north-south wall into room 104 (Photo 26). The south top plate extends 24-inches east of the interior wall into room 106.

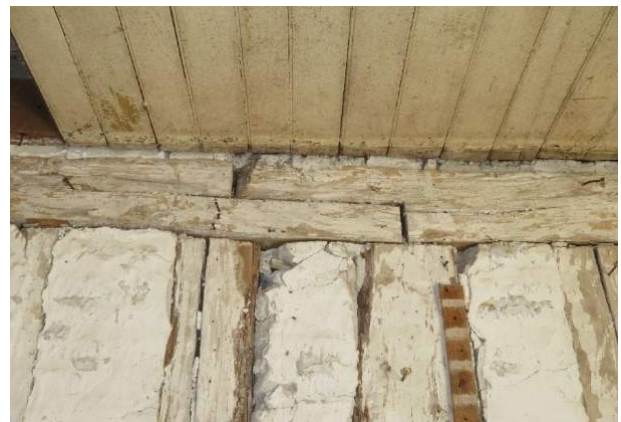
Photo 26. Typical top plate wall splice within north wall of room 106. Splices were observed to have one 1-inch wood trenail pinning the splice in place.

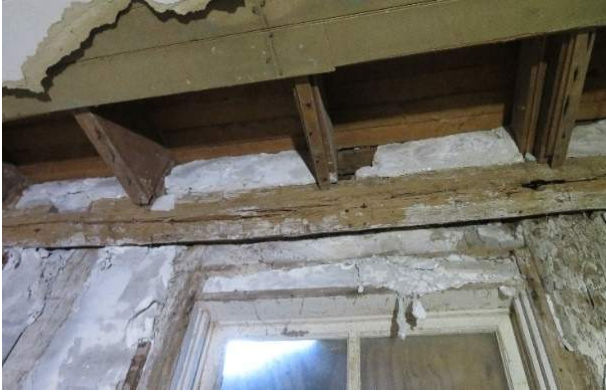
Photo 27. East wall top plate distress within room 104. The top plate has split through its mid-height, and is crushing and rotating. The lower face of the top plate is visible.

The vertical log wall at the east exterior wall has failed in place and threatens the overall stability of the structure (Photo 27 and Photo 28). The top plate of the interior wall separating rooms 101 and 102 has failed in the vicinity of a masonry chimney.

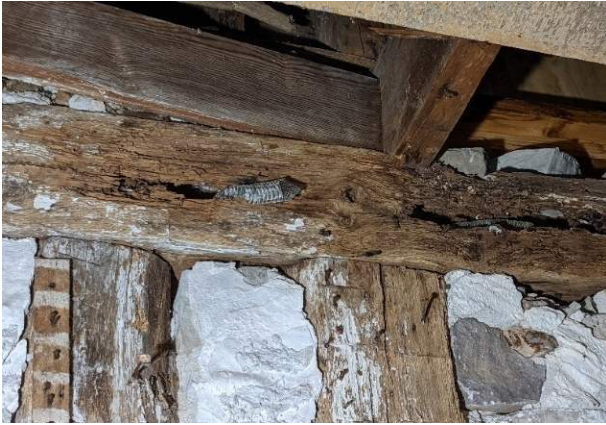
Photo 28. East wall top plate distress within room 105. Pest and water damage to the top plate has created large voids in the timber section, allowing for further animal-related deterioration as evidenced by snakeskin caught between rough surfaces.

The top plate at the exterior east wall has moved out of plane approximately 5½-inches near the intersection with the interior wall separating room 104 from room 105. The top plate has split and exhibits crushing and/or pest damage at its interior vertical face. The top plate also exhibited distress at its intersection with the interior wall separating rooms 105 and 106.

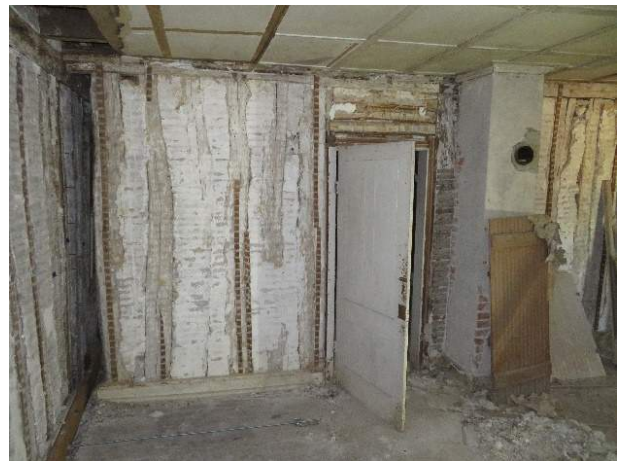
The east exterior vertical log wall has moved out-of-plane relative to the masonry wall below. Where the interior wall separating rooms 104 and 105 abuts the exterior east wall, the pierrotage has either been removed or has dislodged (Photo 29). The wall separating rooms 105 and 106 also exhibits separation and pierrotage loss where this wall abuts the exterior east wall.

Photo 29. Pierrotage has dislodged where the east-west interior wall separating rooms 104 and 105 abuts the laterally displaced east exterior wall (gap at left).

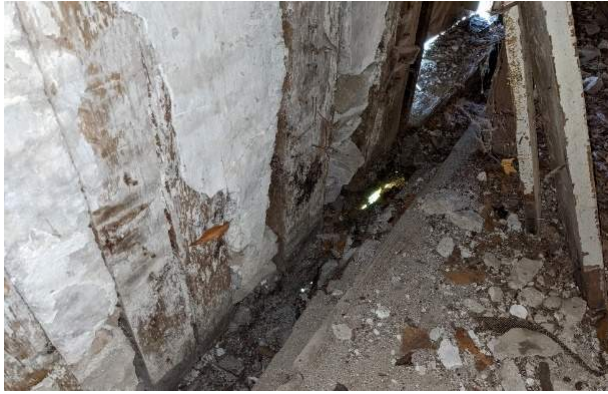
The bottom plate at the exterior east wall has moved approximately 7-inches out of plane near Door D105 (Photo 30 and Photo 31). The bottom plate showed a split in the interior vertical face at approximately half-depth along the entire east wall but also exhibited a vertical longitudinal split along the majority of its length. Below door D105, the bottom plate was

Photo 30. East wall bottom plate distress near exterior door within room 105. The bottom plate has split vertically, crushed, rotated, and deteriorated as the vertical log wall moved out of plane, exposing the notched lower ends of vertical logs. Daylight is visible below the door threshold.

observed to have suffered severe section loss due to a combination of moisture and pests. The bottom plate was also observed to have crushed and rotated at this location.

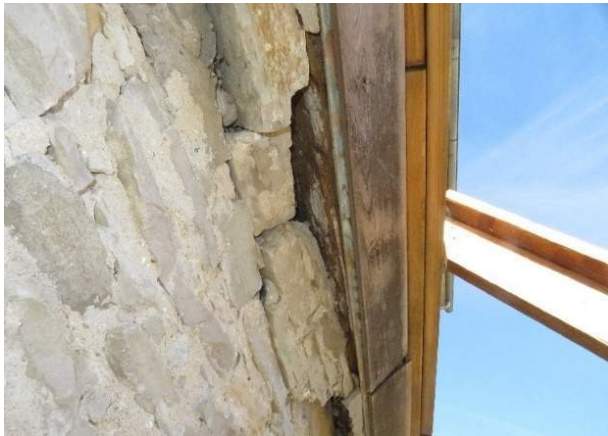
Photo 31. Underside of east wall bottom plate visible from exterior where the log wall and top course of stones have moved out of plane. The exposed log surface shows evidence of moisture and pest damage.

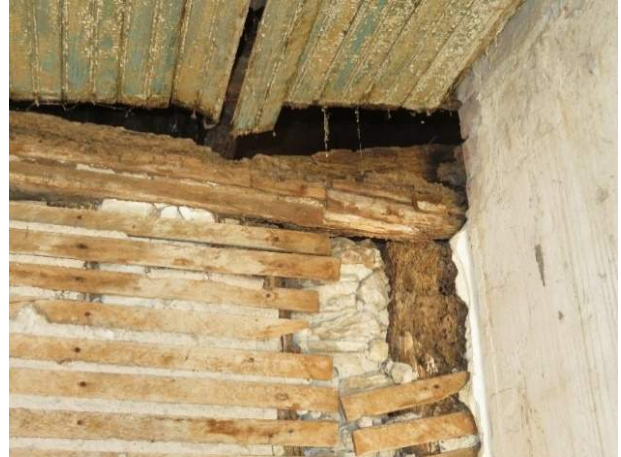
Photo 32. Failed top plate within the wall separating rooms 101 and 102 at room centerline.

The top plate of the interior wall separating rooms 101 and 102 has failed adjacent to a partially extant brick masonry chimney (Photo 32). Total section loss was observed at this location, likely due to termite activity and water infiltration.

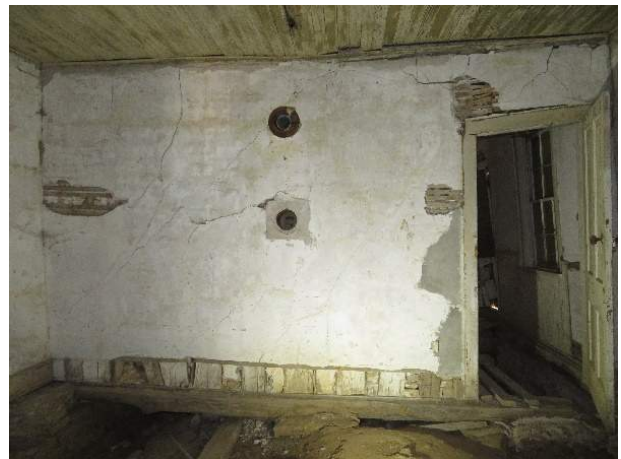
Photo 33. Rotated door framing and cracked interior finishes observed within the south wall of room 103.

Walls in the vicinity of doors D101B and D103A exhibited extensive movement of the west wall relative to the interior walls. Doors 101B and D103A cannot close due to differential vertical movement of the two door jambs (Photo 33). Plaster finishes

exhibited diagonal cracking immediately east of the two doors.

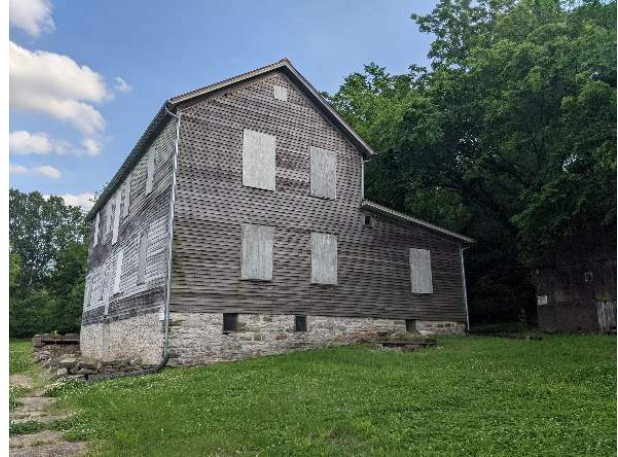
Photo 34. The masonry foundation walls, as viewed from northeast. The height of masonry walls increases from west to east, as the ground level slopes down toward the Common Field.

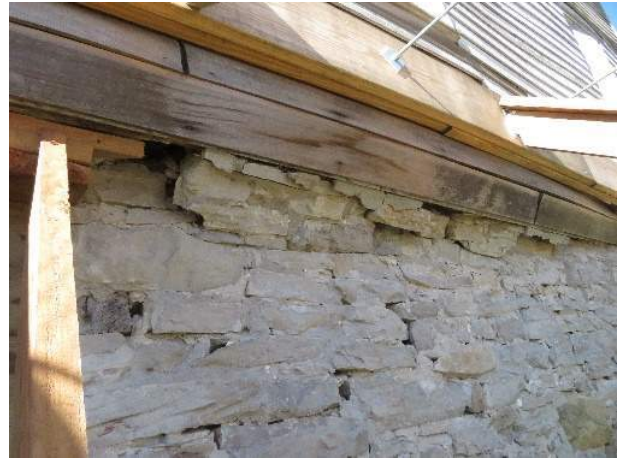
The stone and mortar on the north, west, and south walls were in good condition with minor deterioration and soiling in isolated areas. The east foundation wall was observed to be approximately four degrees out-of-plumb and distressed in the vicinity of the vertical log wall that has moved out-of-plane immediately above. Several stones in the top courses of the foundation wall have been displaced by the log movement above (Photo 35).

Photo 35. Lateral displacement of the outer course of the east masonry foundation wall near the middle of the wall.

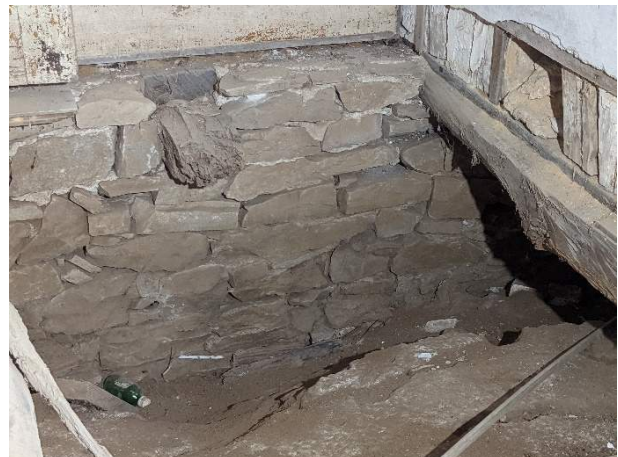
At the foundation wall supporting the interior wall, areas of mortar loss and loose stones were observed (Photo 36).

Photo 36. Missing mortar within interior masonry wall west face as viewed from room 103.

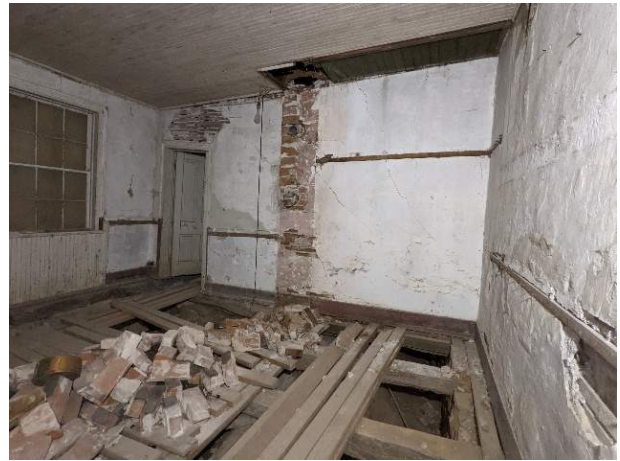
Photo 39. The interior chimney within Room 102 has collapsed or been disassembled.

The chimney within the north wall of room 102 has collapsed southward (Photo 39). The bricks are still present within room 102, though many have fallen into the crawlspace below. The remaining chimneys are in fair condition. At the second floor, the interior finishes covering the chimney in room 204 show signs of significant water infiltration at the chimney location, likely predating the roof replacement project (Photo 40).

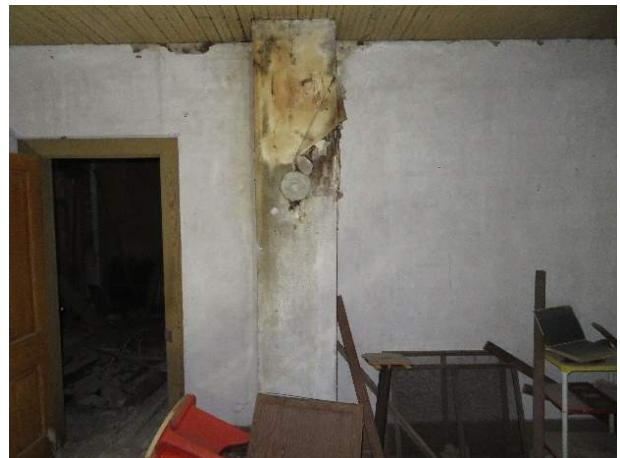
Photo 40. Interior chimney within Room 204 exhibiting moisture-related deterioration to finishes.

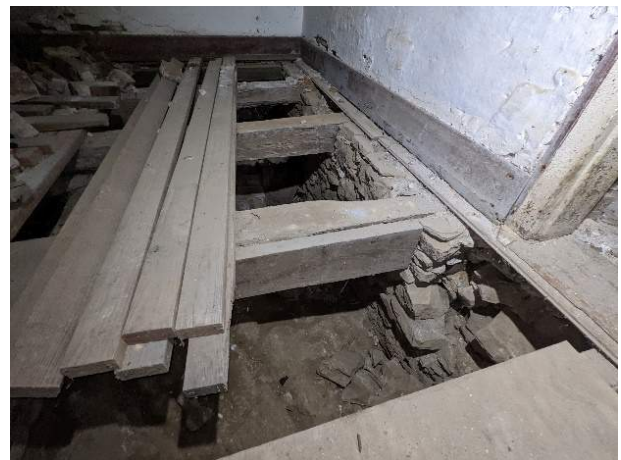
Photo 42. Joists within room 102.

Joists within the west rooms extend from the interior masonry wall approximately 62 to 78-inches westward and have been cut (Photo 42). The beams were likely supported at midspan by a girder (Photo 43); this girder was observed to rest directly upon soil within rooms 102 and 103, but the floor framing was obscured by planking in room 101. HABS drawings also indicate that the joists were each sistered with a 2x member at an undetermined date. These “sister”

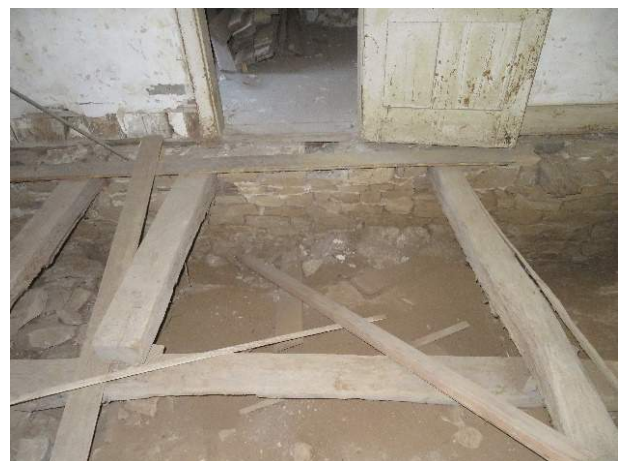
Photo 43. Framing joists and girder resting on ground within room 103.

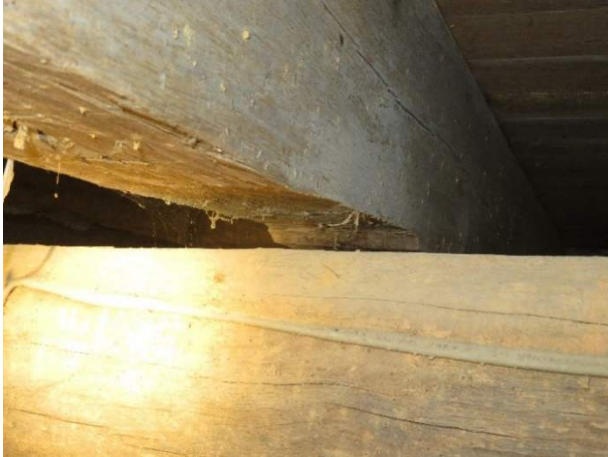
Photo 44. Gap observed between joist 9 and girder.

Typically, joists were observed to not bear upon the three girders at their midspans (Photo 44). Approximately seven joists had been shimmed in place to reestablish bearing (Photo 45).
