# Delassus-Kern House

STE. GENEVIEVE NATIONAL HISTORICAL PARK  
STE. GENEVIEVE, MO

## Historic Structure Report

PMIS 311634  
OCTOBER 2024

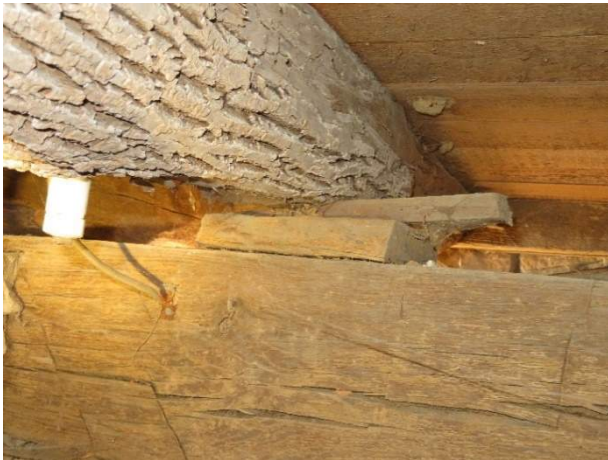
Photo 45. Shims present between joist 21 and girder.

Typically, joists were observed to not bear upon the three girders at their midspans (Photo 44). Approximately seven joists had been shimmed in place to reestablish bearing (Photo 45).

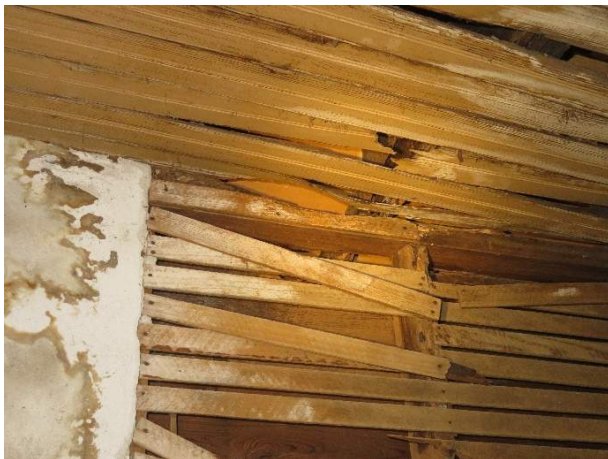
Photo 51. Top plate distress above exterior wall at second floor.

The second-floor framing is in fair condition. Top plate distress and distress to the floor joists were observed above door D203B, where evidence of past water infiltration was observed and has damaged the structure and interior finishes (Photo 51).

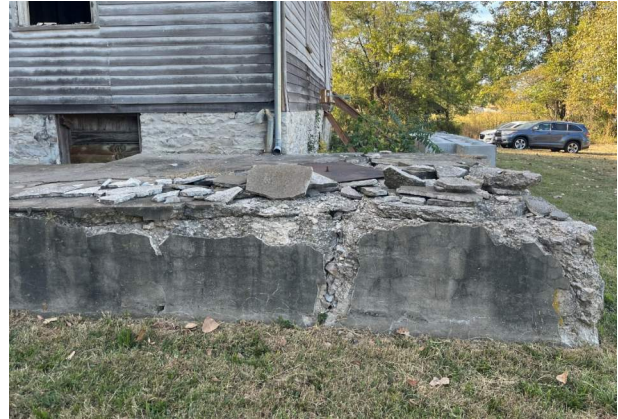
The concrete topping is severely cracked and had debonded along the stairs and southeast portion of the porch (Photo 53 through Photo 55), resulting in pitted and uneven walking surfaces.

Photo 53. South view of deteriorated concrete topping at south elevation.

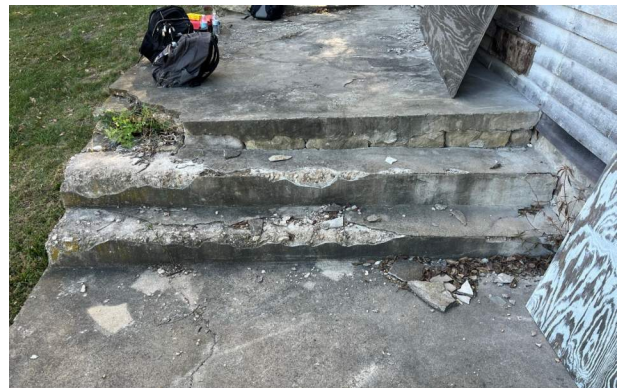
Photo 54. Deteriorated concrete topping at steps to south entrance.

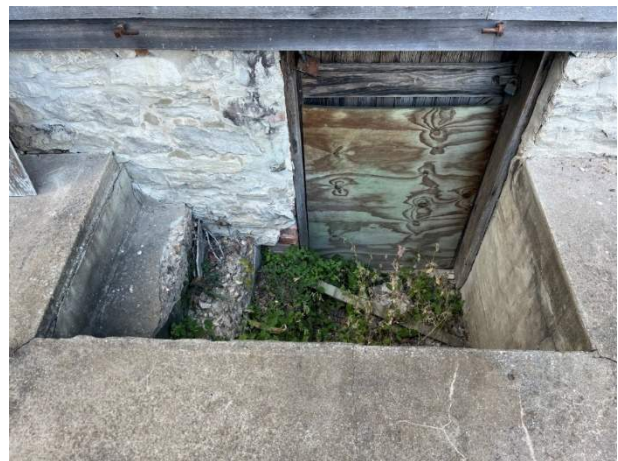
Photo 55. Deteriorated concrete topping at steps to south basement entrance.

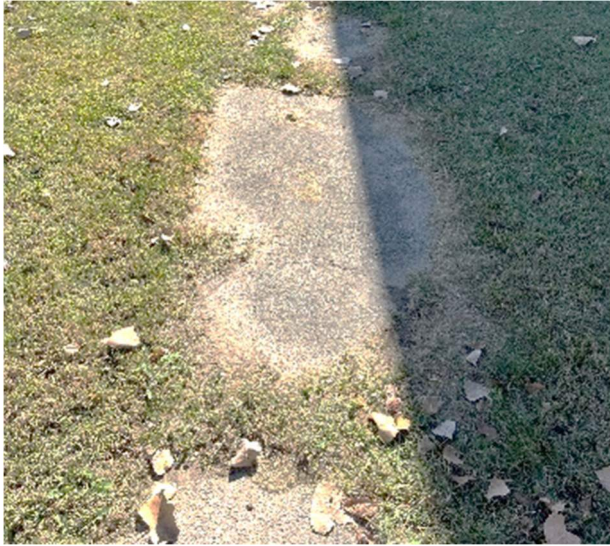
The concrete walkway is in poor condition (Photo 56). The walkway has sunken and cracked.

Photo 56. Deteriorated concrete walkway.

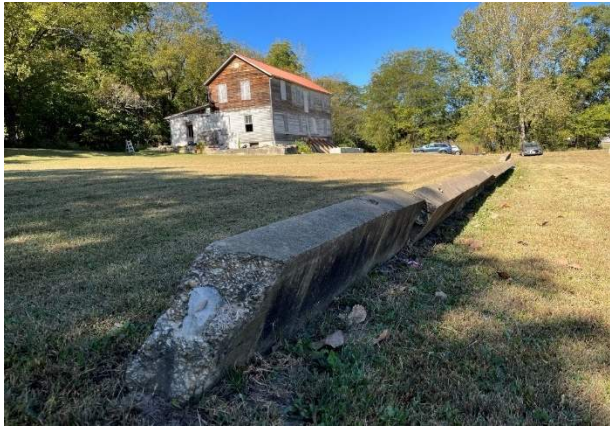
The concrete retaining wall is cracked through the full depth of the wall at several locations and is out of plumb. This element is in poor condition; however, no intervention is needed since it serves no current function and is not a life-safety hazard.

Photo 57. Concrete retaining wall at eastern edge of property

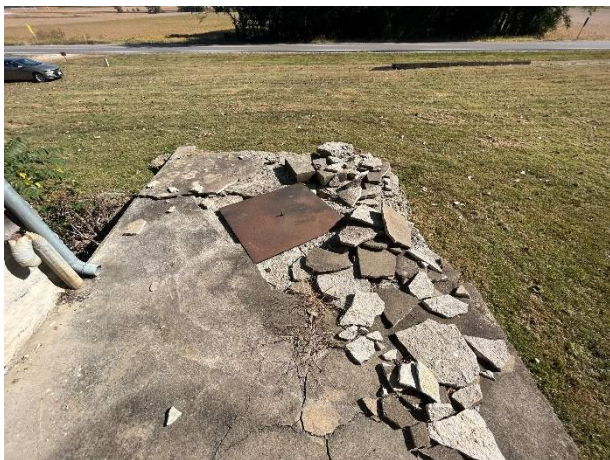
Photo 58. Cistern at the southeast corner of the house, with a metal cap and distressed concrete.

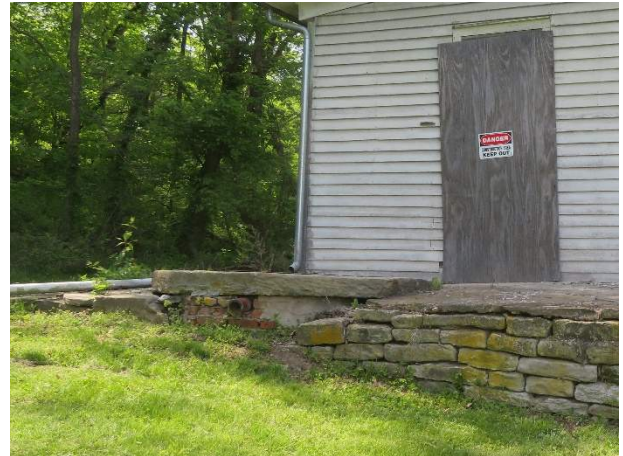
Mortar is missing from the exposed brick walls of the southwest and north cisterns. The steel lid on the northeast cistern is out of place and poses a tripping

Photo 59. Cistern at the southwest corner of the house, with a stone cover and distressed stone and brick masonry.

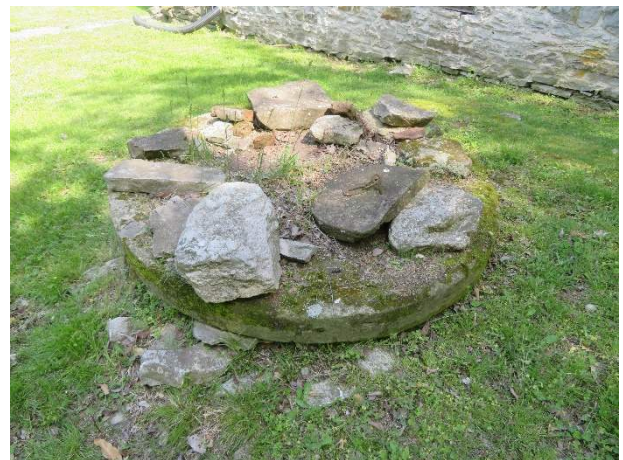
Photo 60. Cistern on the north side of the house. This cistern has also not been backfilled.

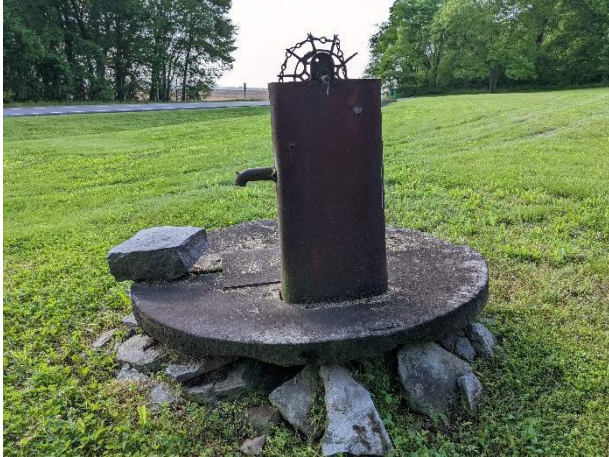
Photo 61. Cistern on front lawn is distressed. The cistern has not been backfilled and is partially filled with water.

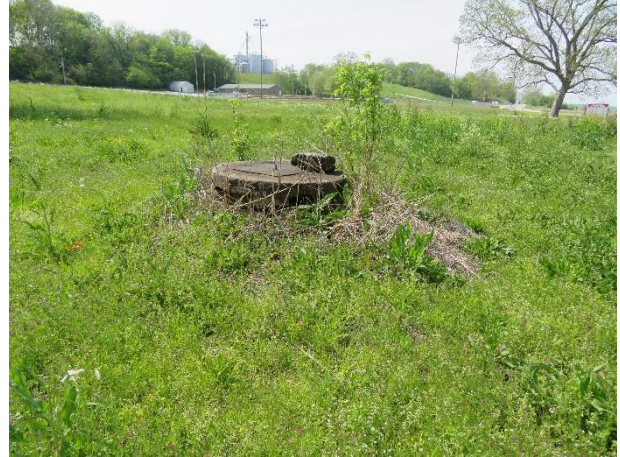
Photo 63. Well in the field to the north of the corn crib with a stone cap. The well had not been backfilled.

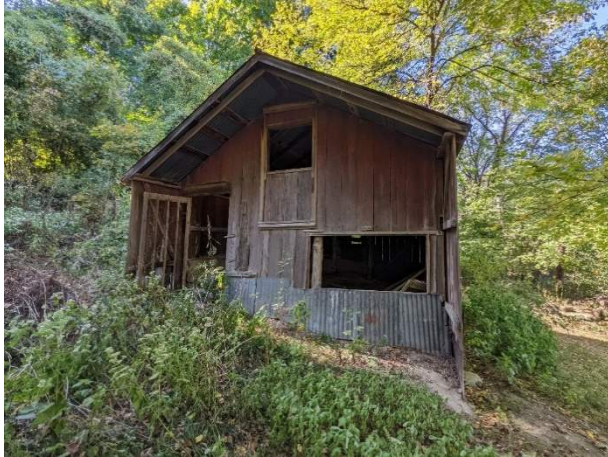
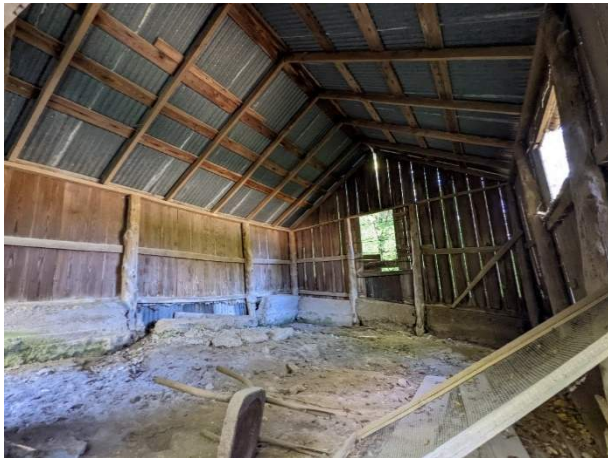
The chicken house is in fair condition. Exterior paint coatings have worn away, leaving wood siding and trim exposed and subject to weathering. The roof shows uniform surface corrosion but is otherwise intact. A gutter system was once installed on the east and west sides of the structure but is severely corroded and non-functional. A few of the concrete foundation walls visible inside the chicken house have shifted or fallen. The door is no longer functional, and there are no coverings over the other openings. The structure appears fragile but currently stable; however, further stabilization would be necessary prior to opening for access by visitors.

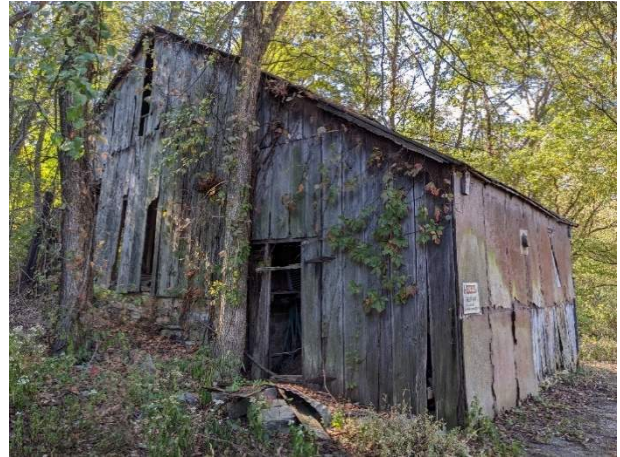
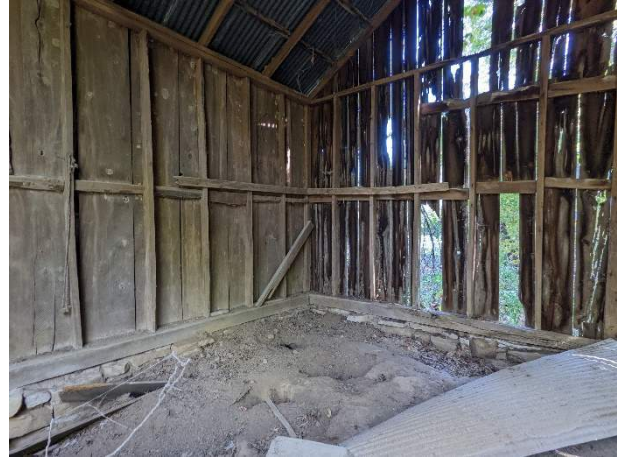
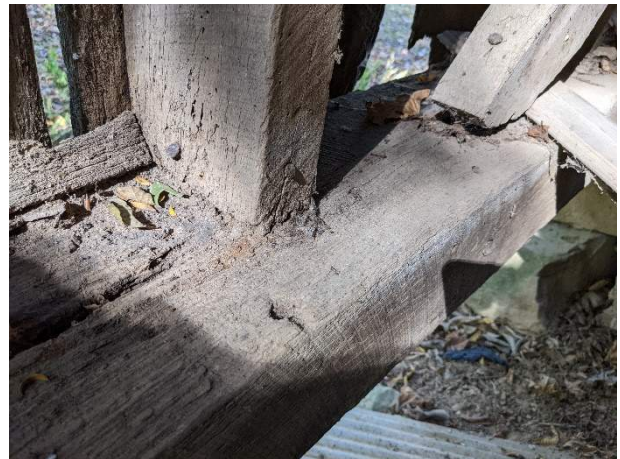
In general, the woodshed is in poor condition. The vertical wood cladding is severely weathered throughout, and extensive deterioration is found in the lower portion of the west exterior wall. The wood cladding on the south wall has failed due to extensive water damage. Corrugated steel panels were installed along the east wall of the structure. The steel roof and other steel elements show uniform corrosion. The interior of the woodshed is full of various types of construction materials and debris. The framing of the woodshed generally appears stable (Photo 68 and Photo 69); however, full replacement of the exterior cladding is required to prevent further deterioration of the structure. The contents of the interior should be inventoried prior to disposal or reuse.

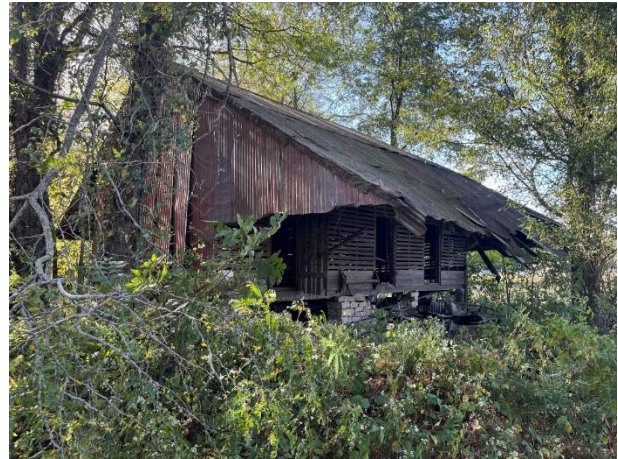
Overall, the corn crib is in fair to poor condition. The stone masonry foundation is distressed; portions of the east and north walls have collapsed and will need

Photo 70. Exterior of corn crib.

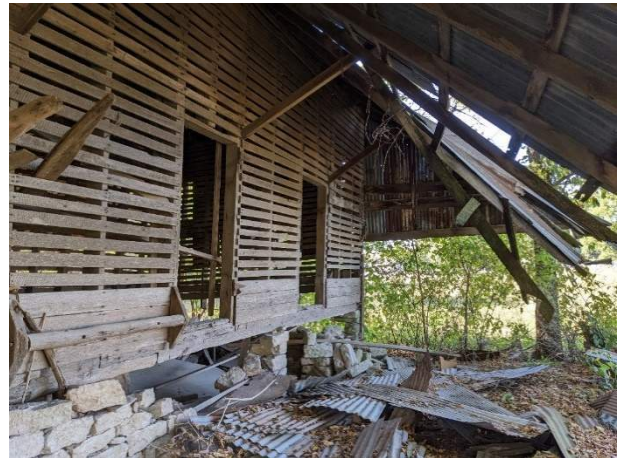
Photo 71. Roof overhang of corn crib at east.

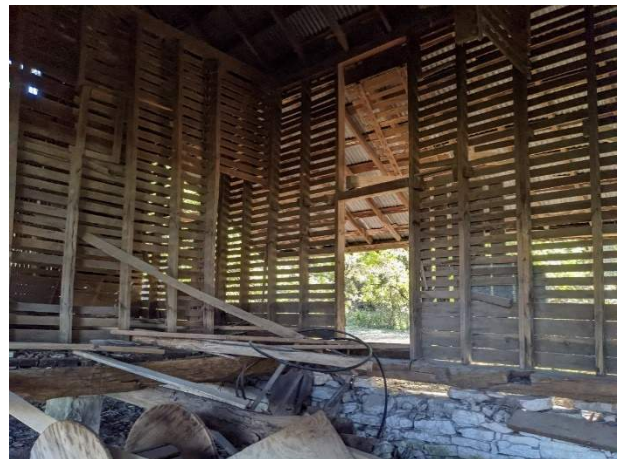
The corn crib is an elevated wooden structure supported by a stone masonry foundation (Photo 70 through Photo 72). Circular sawn lumber was used to construct the slatted wood walls present on the east, north, and west walls which allow for airflow within the structure. The south wall of the structure is clad in corrugated metal. The side-gabled roof is also corrugated metal and provides a deep overhang on the east and west walls.

Photo 72. Interior of corn crib including slatted walls, masonry foundation, and access opening

to be rebuilt. The floor beam along the north wall is displaced from the foundation and wall framing. This beam will need to be reinstalled. Most of the elevated floor framing and flooring have been removed but there are remnants of these materials inside the structure. The exterior slatted walls are mostly intact and in good condition. The roof is corroded and has reached the end of its service life. Full replacement of the roofing is recommended. Stabilization of the structure of the roof overhang is also necessary. The contents of the interior should be inventoried prior to disposal or reuse.

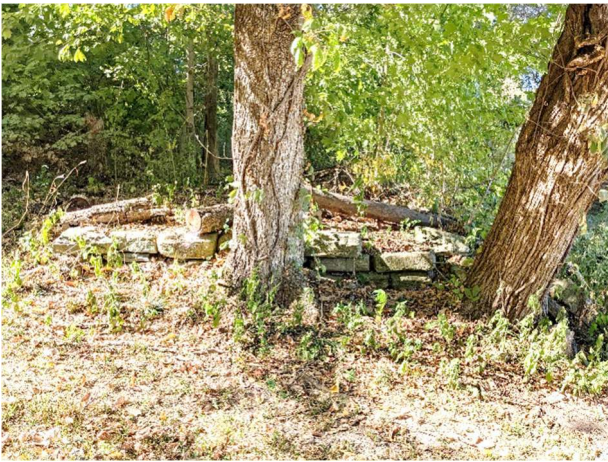
Photo 73. Foundation of former smoke house.

Several remnants of other structures were noted throughout the property. The foundation walls of an old smoke house are present between the chicken house and the north wall of the Delassus-Kern House (Photo 73Photo 74). Three to four courses of cut stone are all that remain of this structure.

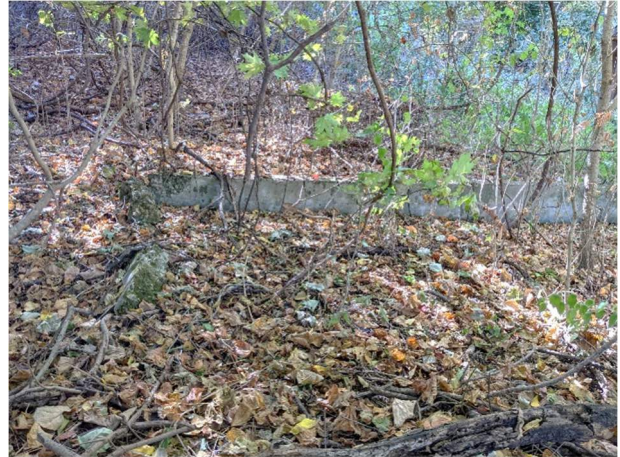
Photo 74. Remaining foundation of former chicken house.

The concrete foundation walls remain of a former chicken house are located a few feet south of the other remaining chicken house structure (Photo 74).

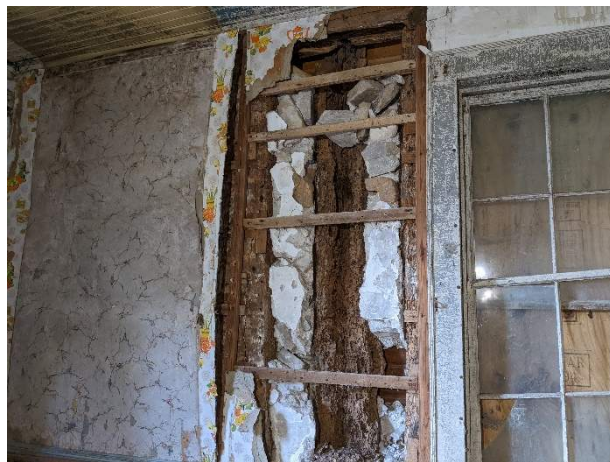
Photo 75. Termite damage to vertical logs in Room 101.

the physical investigation (Photo 75). No live insects were observed, and no entomological analysis was performed within the scope of the structural assessment to verify insect species. In some cases, the damage observed followed well-recognized patterns of insect activity; in other cases, it may be possible that multiple insect vectors are responsible for the damage observed.

Presence of mud tubes on wood surfaces suggest past infestation with an unknown termite species. It appears that the termite damage is in most instances restricted to wood that also shows signs of advanced decay. Some wood boring insects prefer wood that is already softened or degraded by wood decay fungi, and although the signs of insect damage can appear more alarming than wood decay, insects are secondary wood deterioration organisms that almost exclusively infest wood with already compromised structural integrity.

This cycle may take place over and over again within the protected confines of the affected structure. This is a long-term infestation and has caused significant structural damage but has been mostly confined to the outer 2 inches of the affected logs.

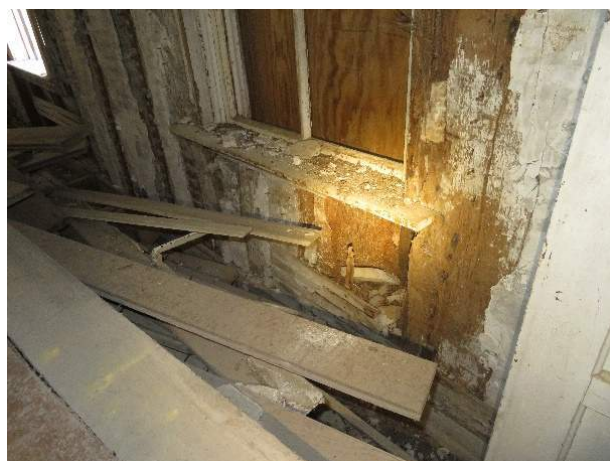
Damage from larger animal pests was also observed at the house (Photo 76). Common animal pests in Missouri include squirrels, mice, and rats, burrowing animals like groundhogs, birds, and bats. Controlling damage from animal pests is typically approached through sealing potential entry points, eliminating

Photo 76. Animal damage to vertical log near a hole in exterior cladding below window W104B.

attractive nuisances like overhanging trees or woodpiles, and performing regular inspections for signs of infestation. Cruelty-free repellent treatments like ultrasonic devices, ammonia-based repellants, and predator urine are often anecdotally described as effective, but in practice, may have limited or inconsistent success. No active animal infestations were observed, but evidence of burrowing animals, squirrels, and snakes were observed in the house.

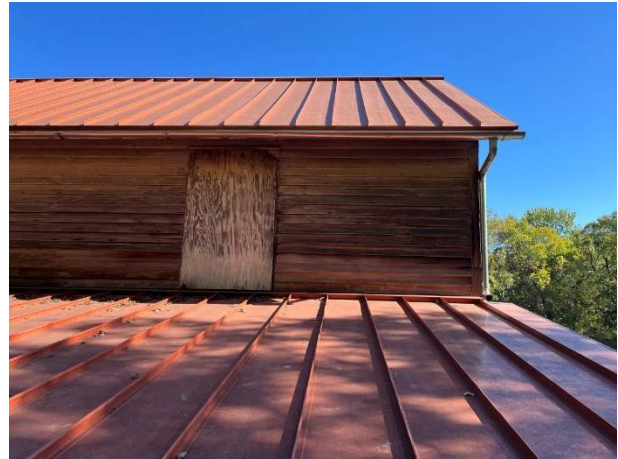
The existing standing seam sheet metal roof was installed in approximately 2012 (Photo 77 and Photo 78). At this time the brick chimneys were removed, and a new roof drainage system was installed.

The roof is in good condition. No deficiencies were noted on the roof, but tree trimming is recommended for all trees that touch the first-story roof along the west wall.

Photo 77. First and second story roofs at West wall.

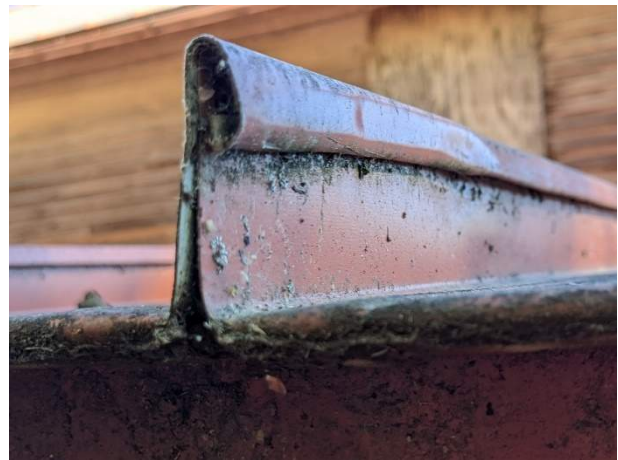
Photo 78. Standing seam of sheet metal roof.

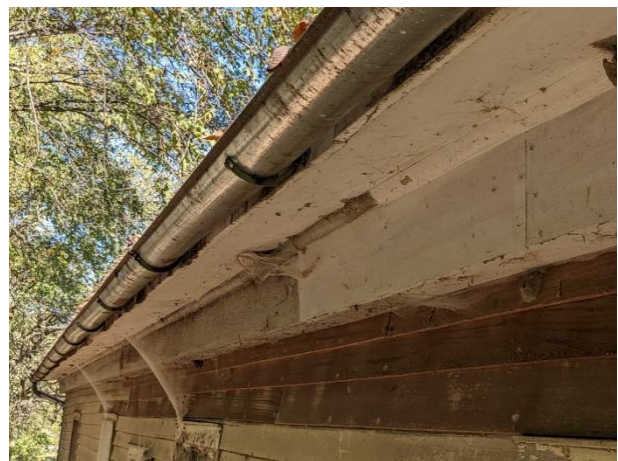
Galvanized steel gutters are present along the full length of the east roof edge and both roof lines along the west roof edge. Downspouts are present at the four corners of the house. The southeast downspout drains onto the concrete porch along the south wall. The downspout at the southwest corner extends beyond the porch to drain into the adjacent grass. Corrugated plastic drainage extension pipes are attached to both downspouts on the north wall to facilitate drainage away from the foundation walls. Two downspouts are attached to the second-story gutters along the west wall and drain directly onto the first-story roof (Photo 79).

Photo 79. West gutter showing anchored gutter hangers and visible corrosion on gutter.

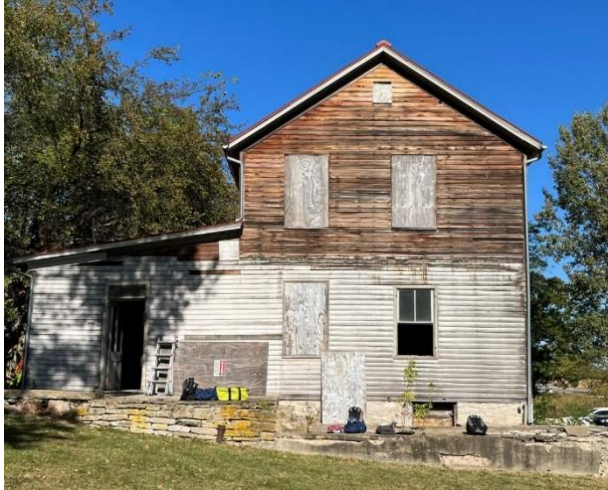
Photo 80. South wall showing whitewashed older siding at first floor and later aged replacement siding at second floor.

of whitewash is present on the siding at the first level, but the siding at the second level is unpainted (Photo 80); these repairs were likely performed by MoDNR in the 1990s.

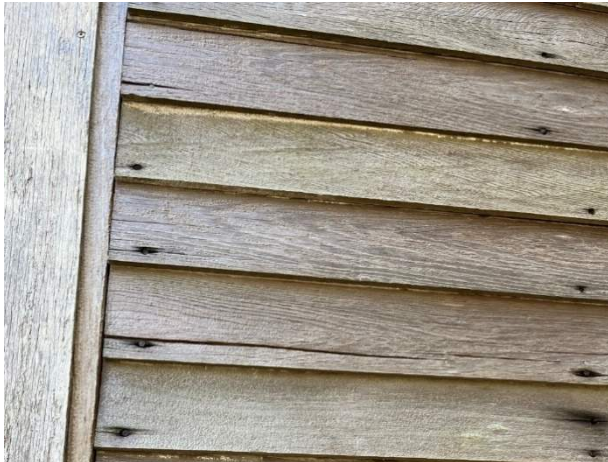
Photo 81. General weathering of lap siding and one split board of siding at north wall.

The existing lap siding shows varying degrees of weathering throughout the house (Photo 81) and isolated areas of damaged from other causes such as animals. The siding is secured into vertical logs with exposed nails. Nails are aligned vertically and are spaced according to the location of structural vertical logs. Loose nails are present in some areas of lap siding, primarily at the south wall. Warped, split and broken siding was also identified in isolated

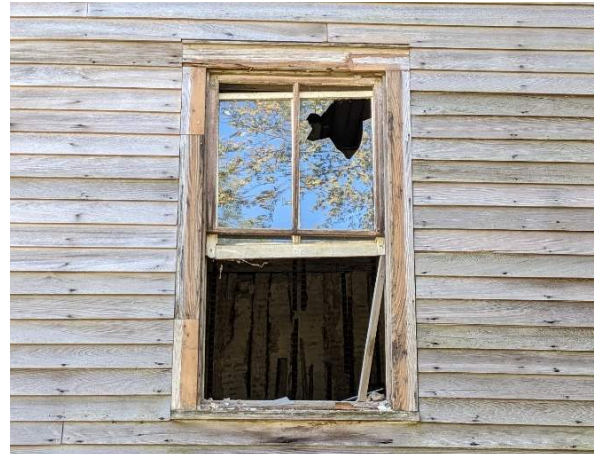
Photo 82. Window 104A on north wall, showing typical 2-over-2 windows installed after the second floor was added.

There are 24 wood double-hung sash windows throughout the House. Window lite configurations vary between 2-over-2 and 6-over-6, depending on side of the building (Photo 82 and Photo 83). The ages of the existing windows are currently unknown. The 6-over-6 style may date to before the alteration of the house c. 1900. The 2-over-2 style can be seen in photographs of other houses in Ste. Genevieve around the turn of the 20th century, including known historic photos of the Delassus-Kern House, and appears to be original to the c. 1900 alterations.

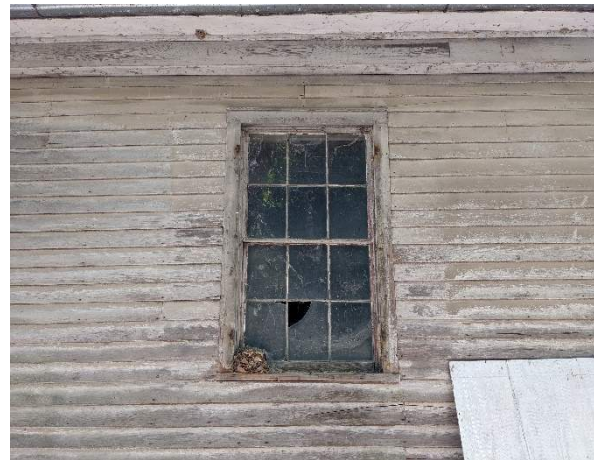
Photo 83. Window 103A on west wall, showing 6-over-6, double hung sash.

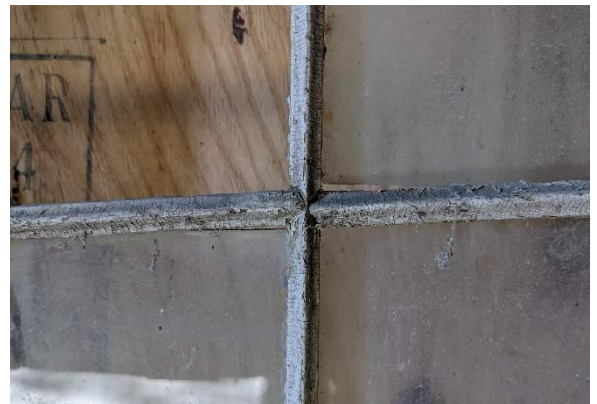
Photo 84. Delicate muntins at the 6-over-6 windows. Further research is needed to determine an approximate age of these window units compared to the 2-over-2 units.

All doors and windows at the House are in poor condition. None of the doors or windows are fully operable. The wood window frames and muntins are severely weathered and/or rotted and there are broken panes of glass in most windows (Photo 84). There are large gaps around the framing for the basement vents that provide the opportunity for pest infiltration.

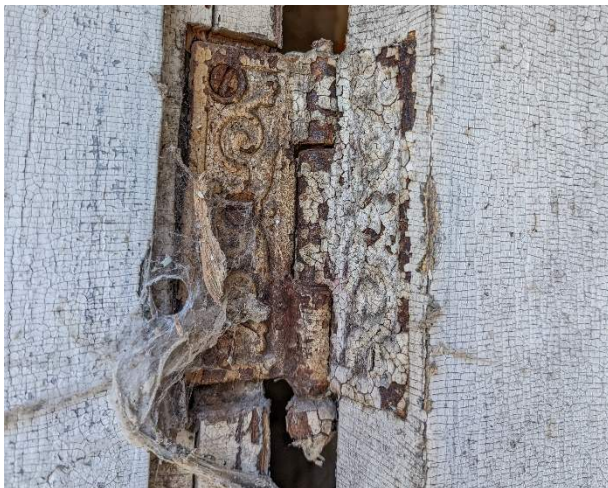
Photo 86. Historic but not original hinge at Door 101A.

There are six exterior doors at the Delassus-Kern House; two at the basement level, three at the first floor (Photo 85) and one on the second floor that once led to the upper level of the gallery on the east facade. The doors are of varying styles and have miscellaneous, unmatched hardware (Photo 86). The doors appear to date to various periods of time, and likely no original doors are extant. Further investigation and research are needed to determine if any of the doors predate the c. 1900 alterations.

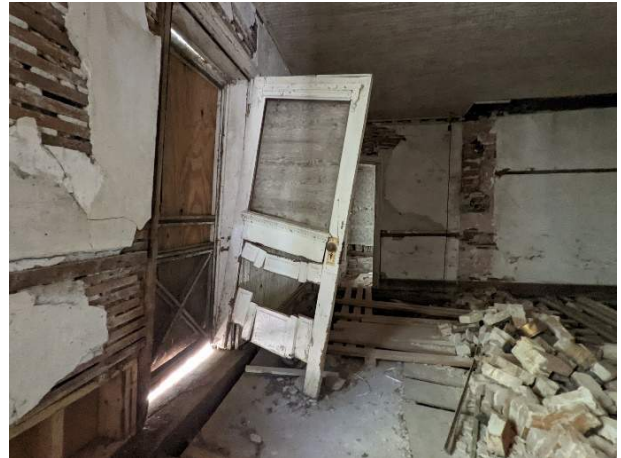
All doors at the House are in poor condition (Photo 87 through Photo 89). None of the doors are fully operable. The wood frames and doors are severely weathered and/or rotted and there are broken panes of glass in glazing openings.

Photo 87. Door 102A with ornamental panels in failed condition.

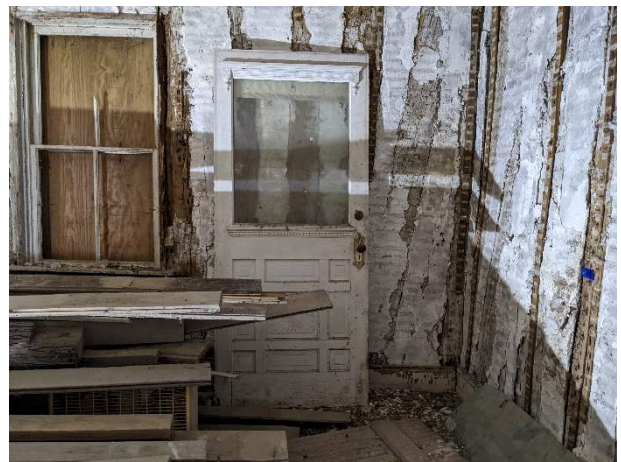
Photo 88. Exterior door stored in Room 106, similar to Door 101A but in better condition. Possibly the door from Room 104.

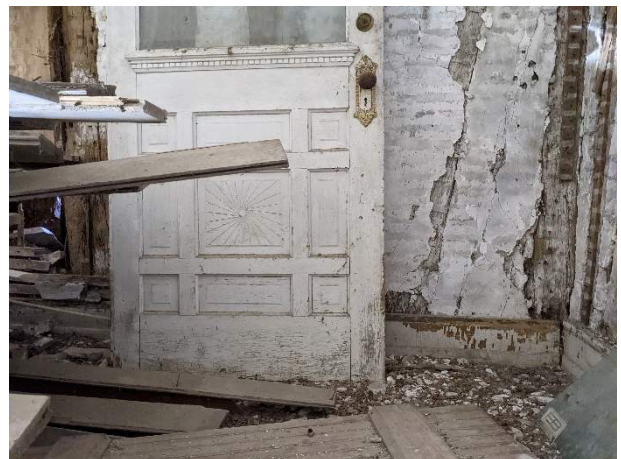
Photo 89. Ornamental panels and moulding on exterior door, with ornate hardware.

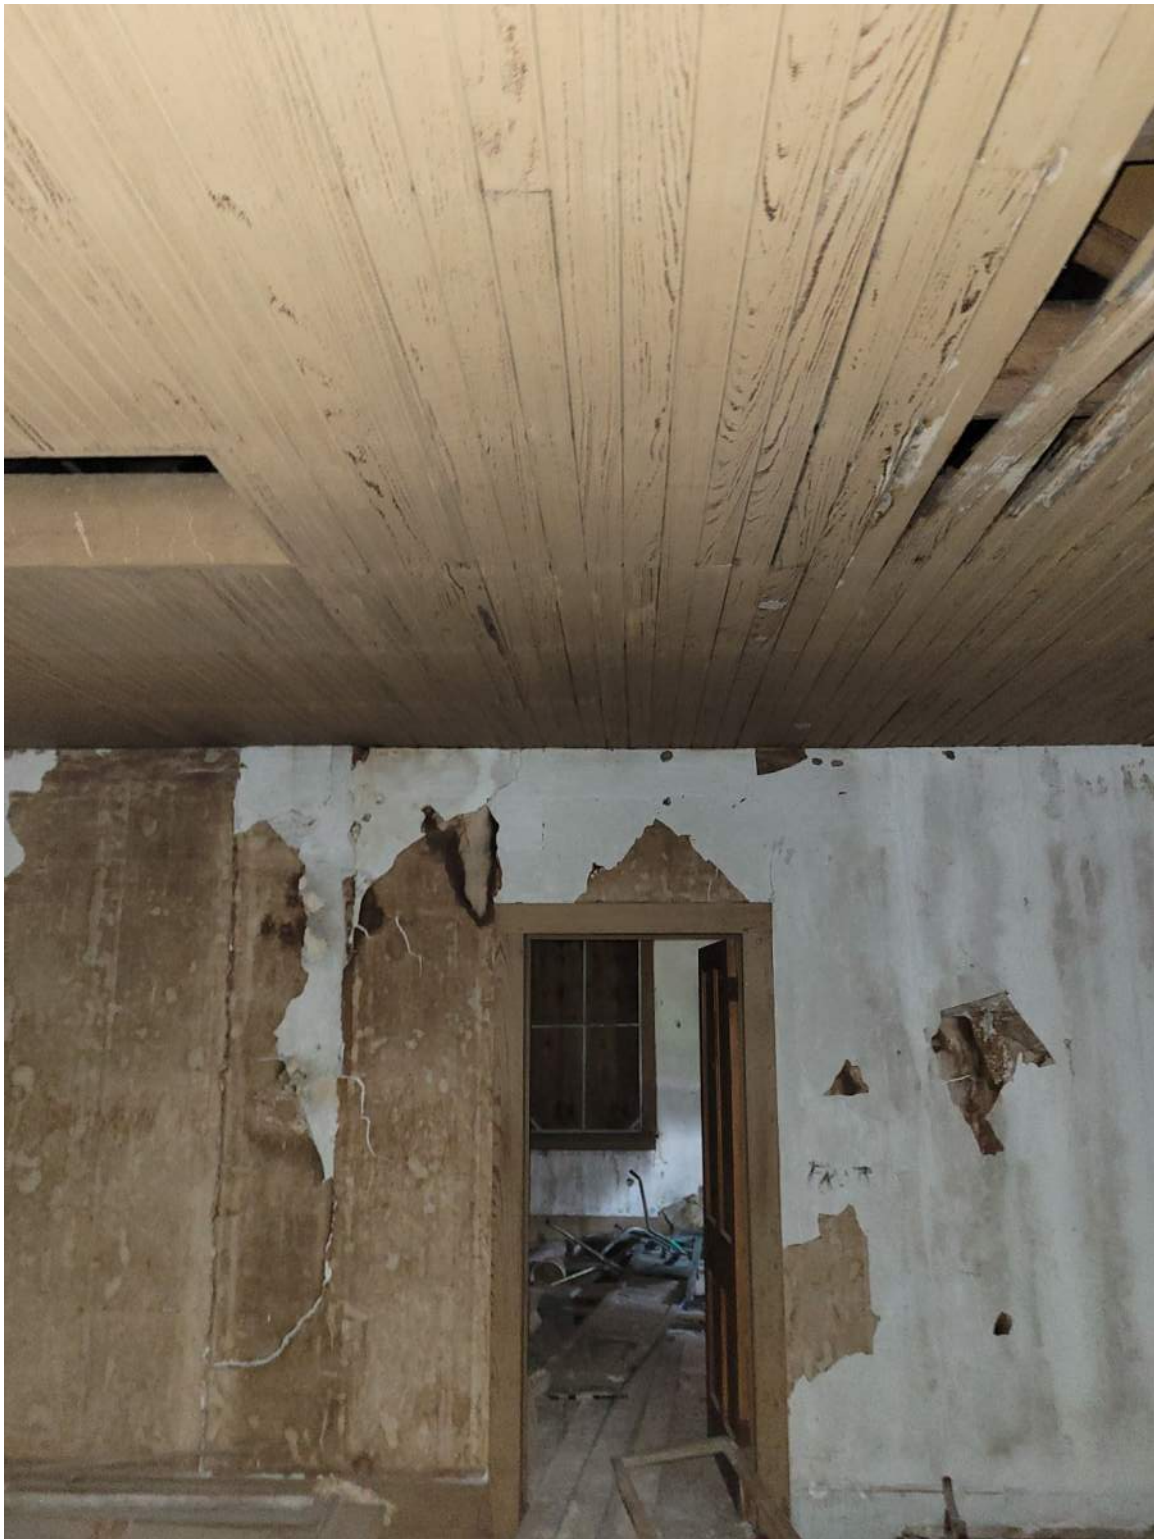
**Photograph 19:** LBP closet door frame Room 203.

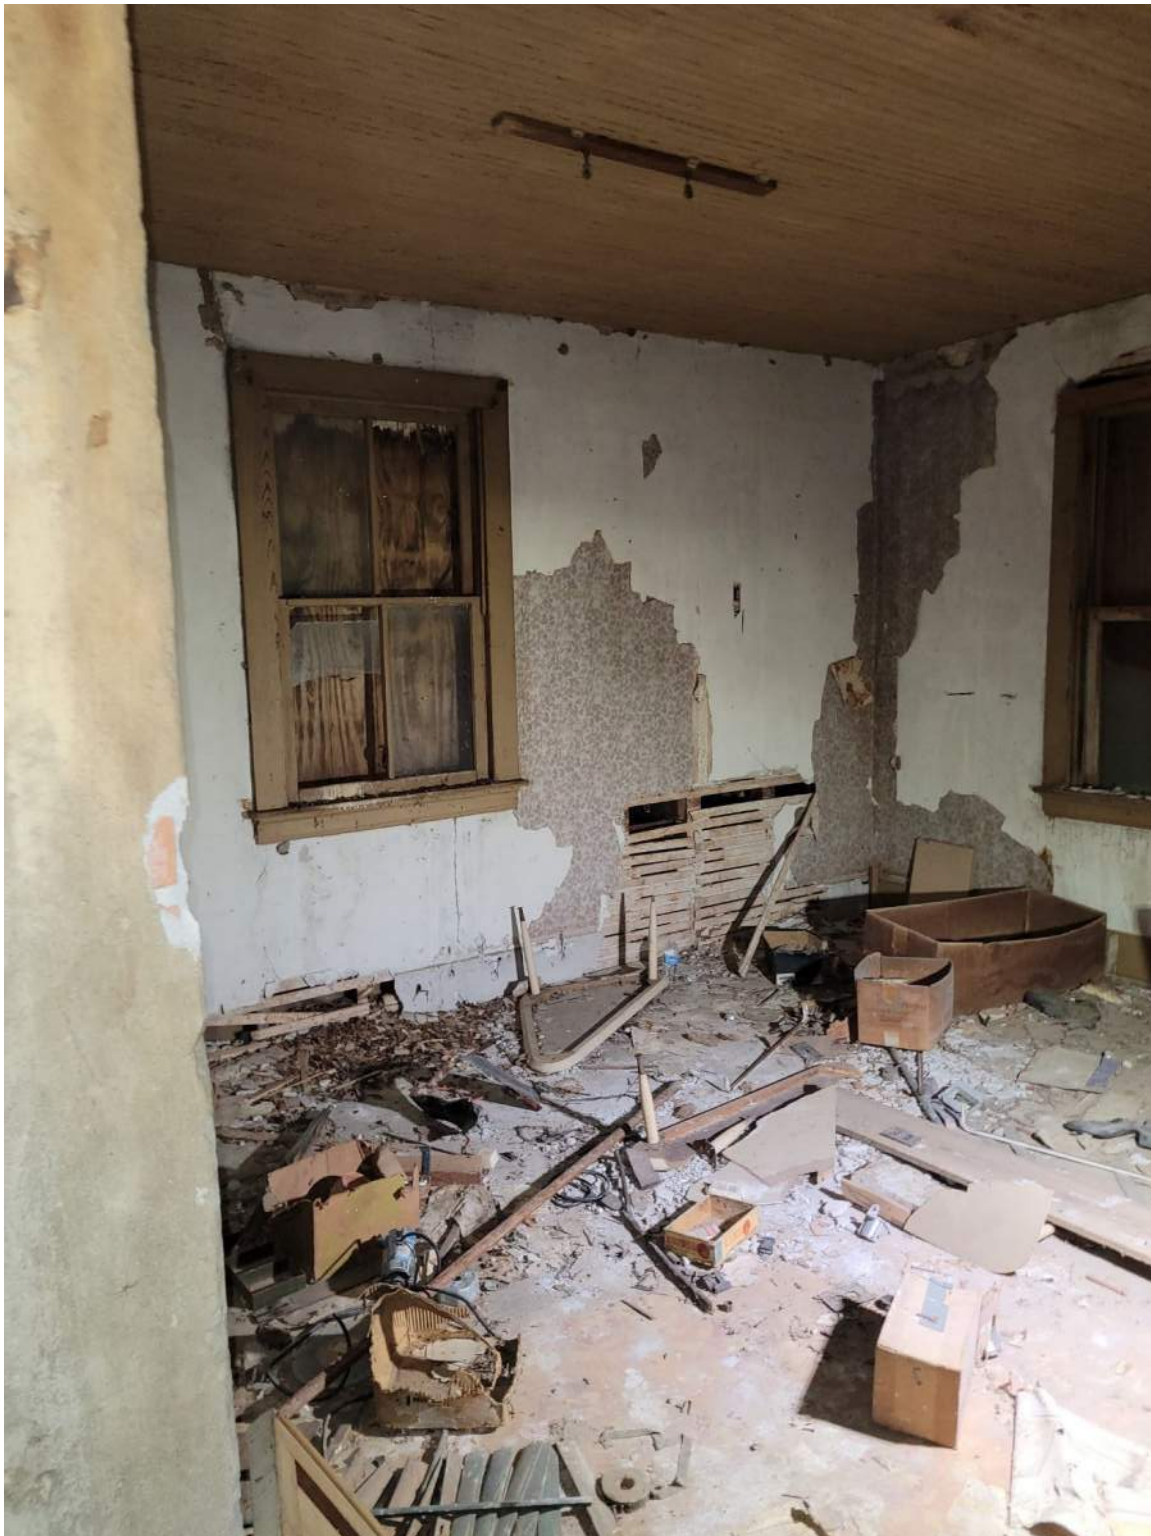
**Photograph 20:** LBP window, window frame, and baseboard Room 203.

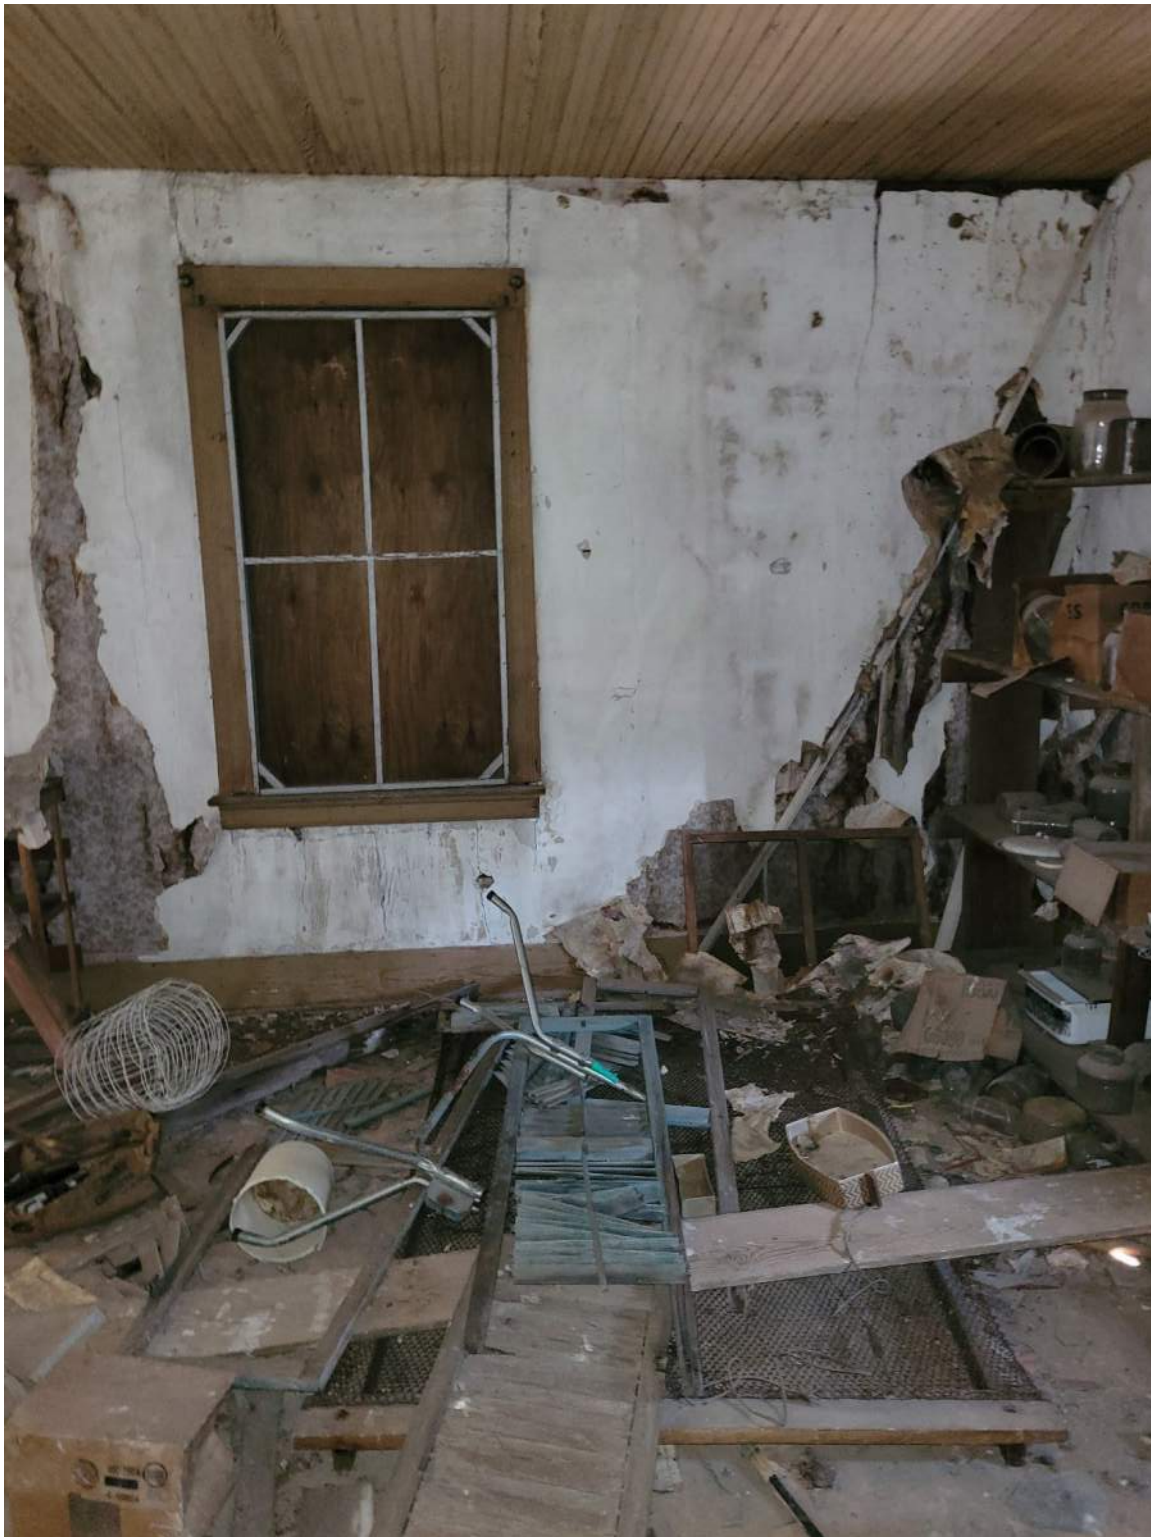
**Photograph 21:** LBP window, window frame, and baseboard Room 204.

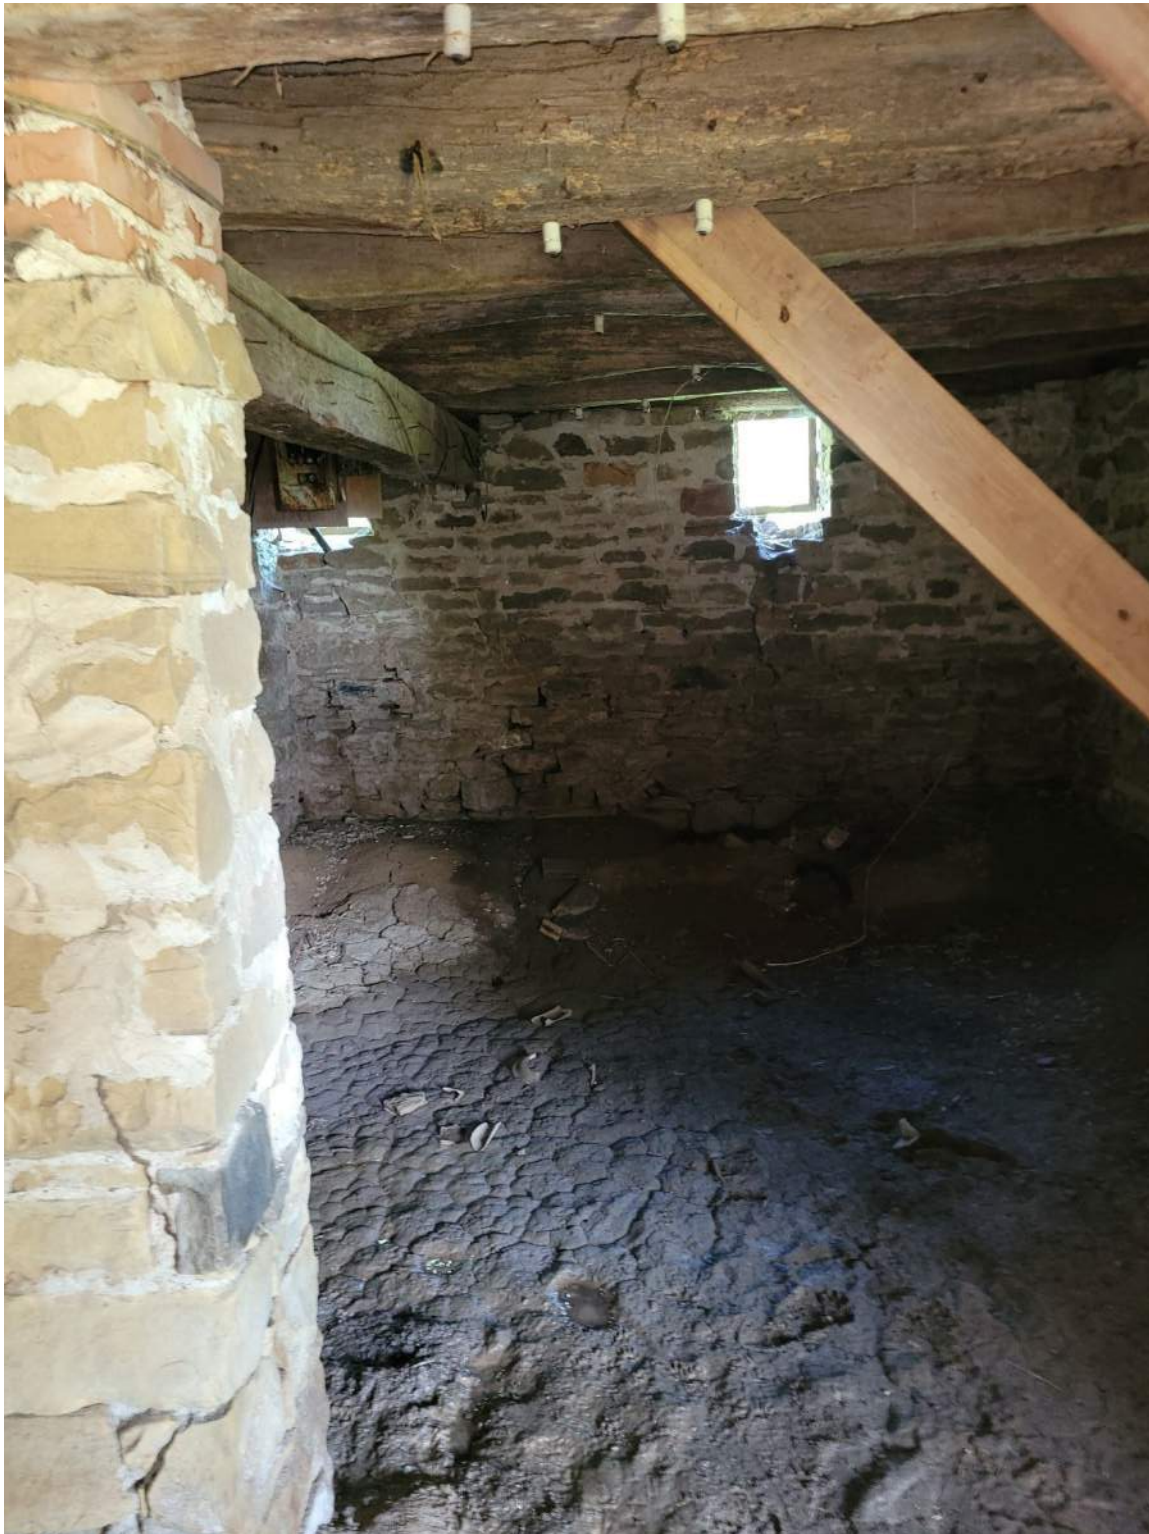
**Photograph 22:** View of basement no suspect hazardous materials observed.

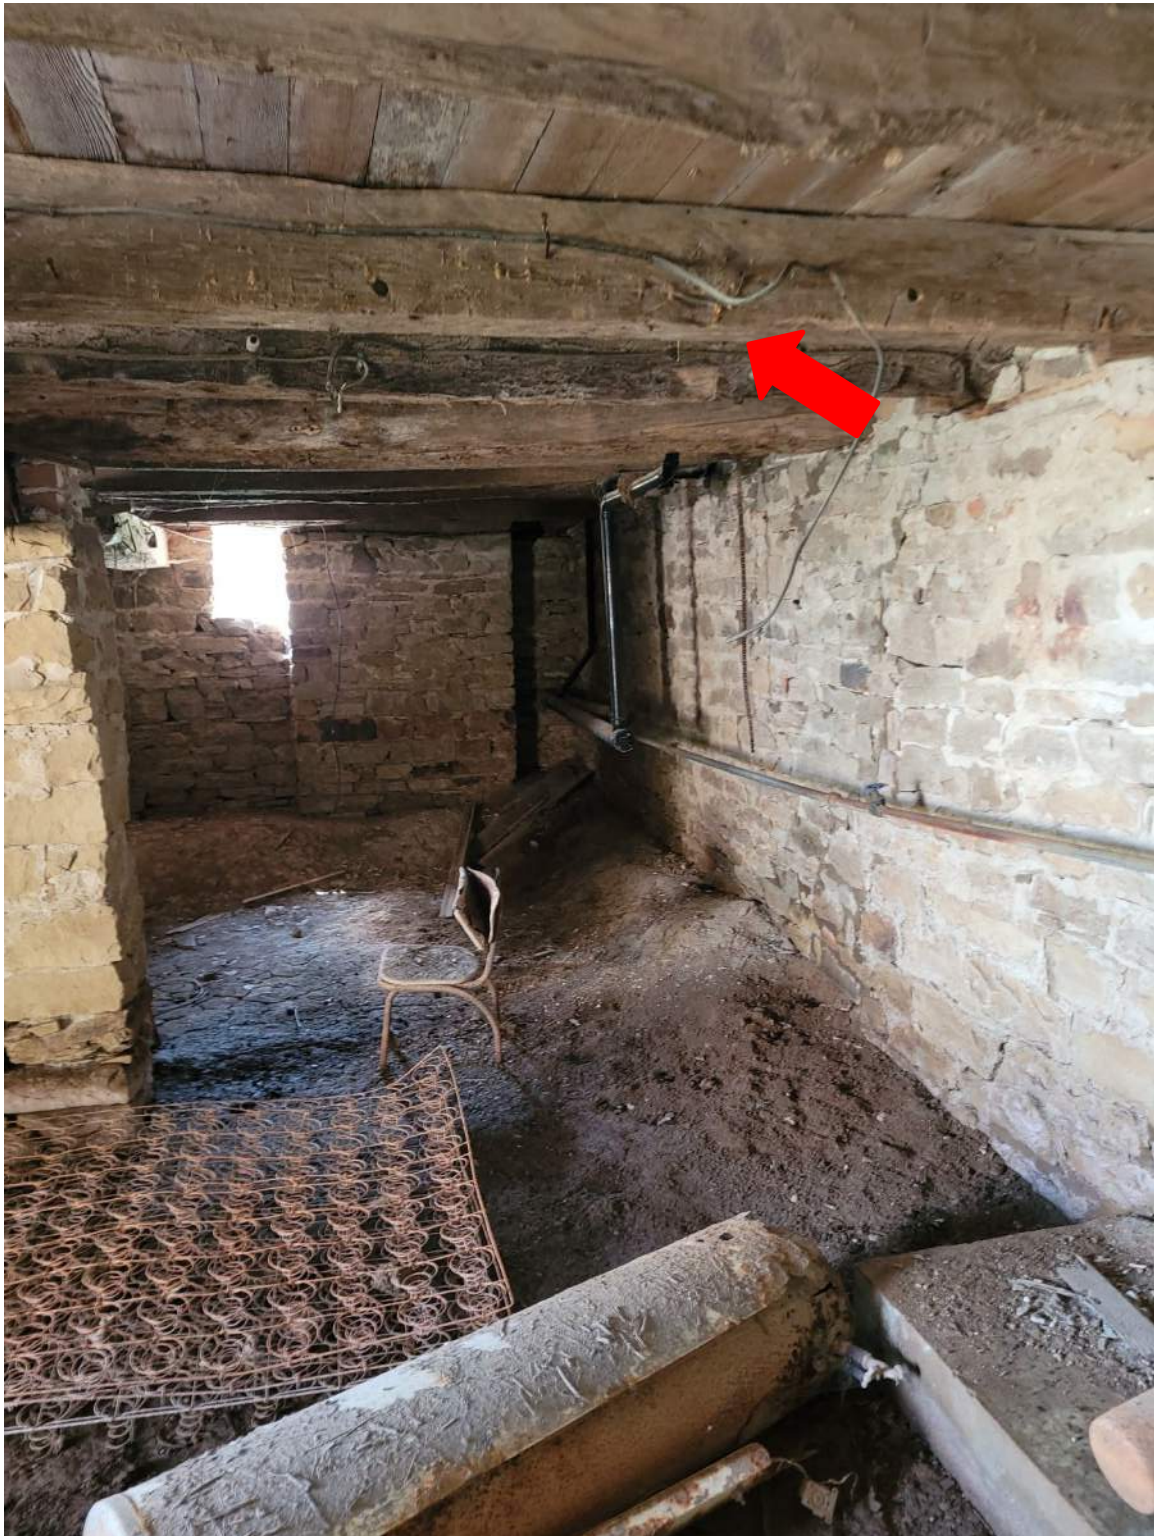
**Photograph 23:** Non asbestos electrical wiring in basement Room 001.
