# Delassus-Kern House

STE. GENEVIEVE NATIONAL HISTORICAL PARK  
STE. GENEVIEVE, MO

## Historic Structure Report

PMIS 311634  
OCTOBER 2024

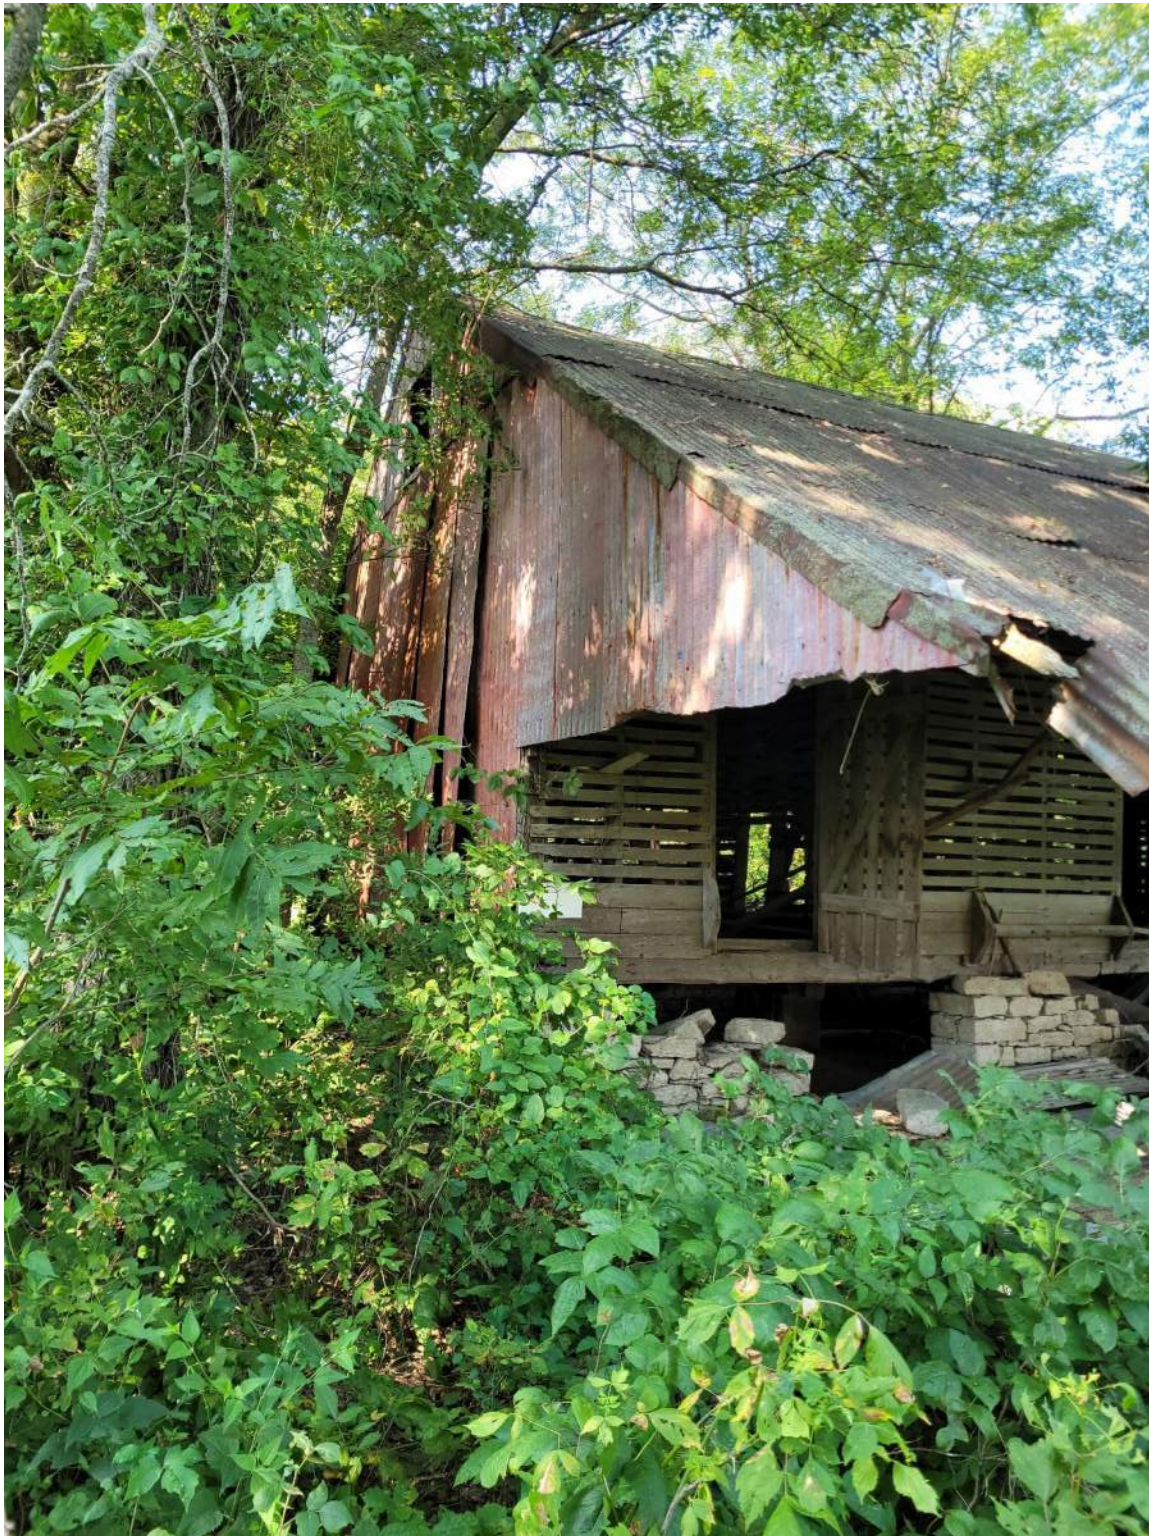
**Photograph 24:** Non-asbestos and non-LBP north shed.

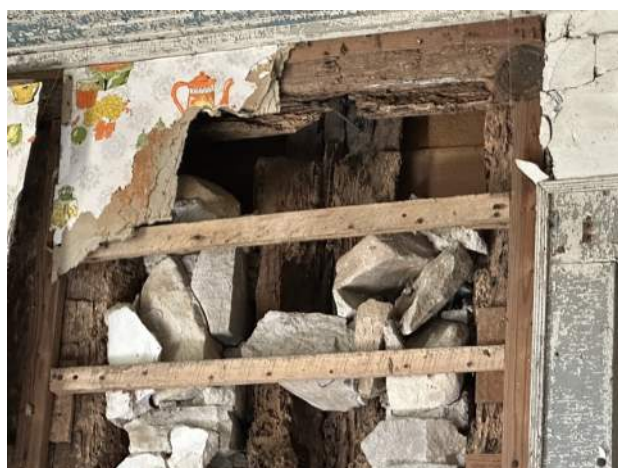
Wood decay fungi are the principal deterioration agents responsible for the material loss and reduction in structural integrity of vertical wall logs, floor beams, sill and top plates (Figure 5). Surface decay, detected by wood probing, is limited to sapwood of oak logs or entire surfaces of logs constructed with non-durable species such as cottonwood. Fungal decay in oak sapwood is often accompanied by the powderpost beetle damage. Deteriorated oak sapwood usually appears punky (less resistance) in resistance drilling profiles. Internal decay was frequently found in heartwood of oak logs. Internal voids cannot be readily detected by visual inspection and surface probing, except when deterioration extends to and is visible on the surface (open internal voids) and required resistance drilling.

**Figure 5. Severe deterioration and void in the vertical wall logs and top plate on the west wall. Room I.**

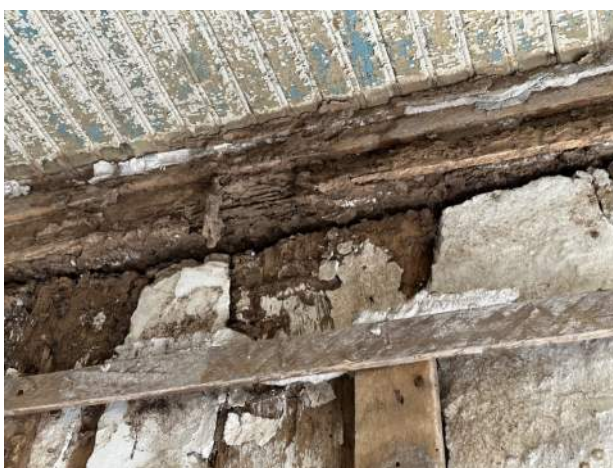
**Figure 6. Termite damage in the top sill and vertical logs. Room I.**

Evidence of a damage caused by a variety of wood-boring insect species was observed in the wood members. Termite damage is common in vertical logs and generally concomitant with fungal decay, suggesting that termites infest wood already compromised and softened by wood decay fungi (Figure 6). The evidence of powderpost beetle infestation, including pin-size emergence holes (pinholes) and powdery frass, are present throughout the building (Figure 7).

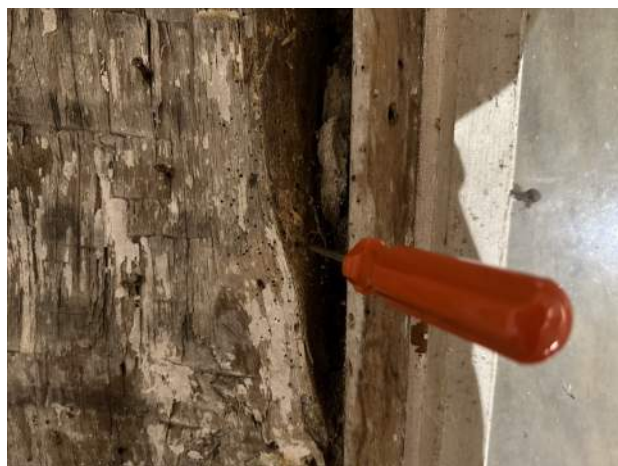
**Figure 7. Powderpost beetle pin-size emergence holes and damage restricted to the sapwood of oak.**

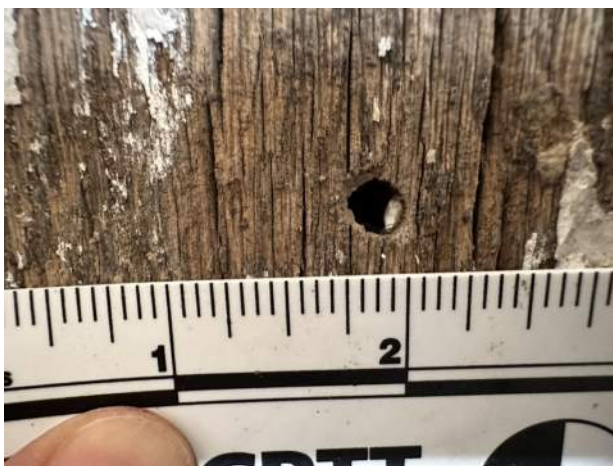
**Figure 8. Large wood-boring beetle emergence holes measuring 1/4 inch in diameter.**

Some vertical wall logs also have larger round emergence holes measuring approximately ¼ of an inch in diameter, confirming infestation with a large wood-boring insect such as Cerambycid beetles (Figure 8). The beetle emergence holes generally have weathered edges suggesting that the holes are old. Other signs of an active infestation, including adult insects or larvae were not observed. Although these insects are capable of creating large tunnels, the infestation appears less extensive and the damage seems less significant compared to other wood deterioration mechanisms

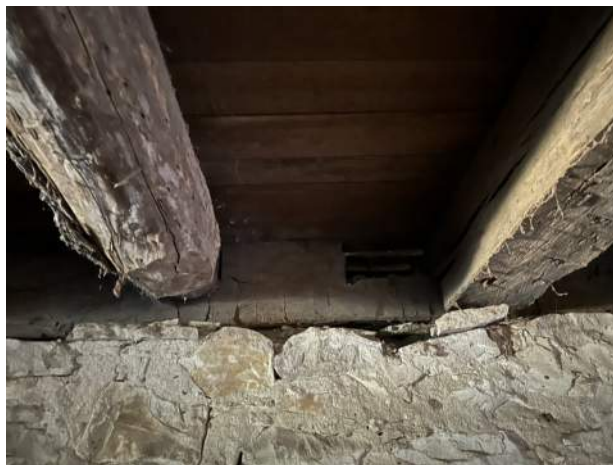
**Figure 10. Opening in the sill beam cut out to accommodate the beam replacement. Round log on the left appears original to the building.**

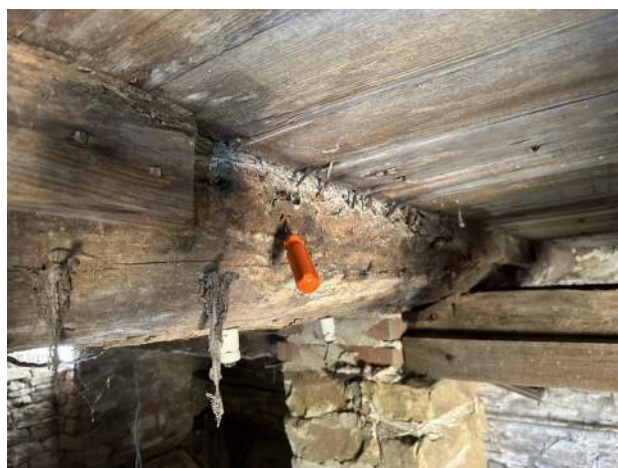
**Figure 11. Floor beam B15. Note moisture stains on the flooring boards and the beam. Surface wood decay is confirmed by probing with an awl.**

Wood moisture contents were between 16% and 18% for floor beams and around 15% for sill plates at the time of assessment. These wood moisture contents correspond to expected values for the building basement and respective weather conditions for the building site and the time of assessment. Wood moisture contents in the building basement are currently below the 20% required for active growth of wood decay fungi. Wood moisture stains, suggesting moisture intrusion, were observed in most locations exhibiting extensive wood decay, including areas adjacent to the east foundation wall and around both chimneys where the girder and floor beams are in contact with masonry (Figure 11). Building elements that have been exposed to elevated

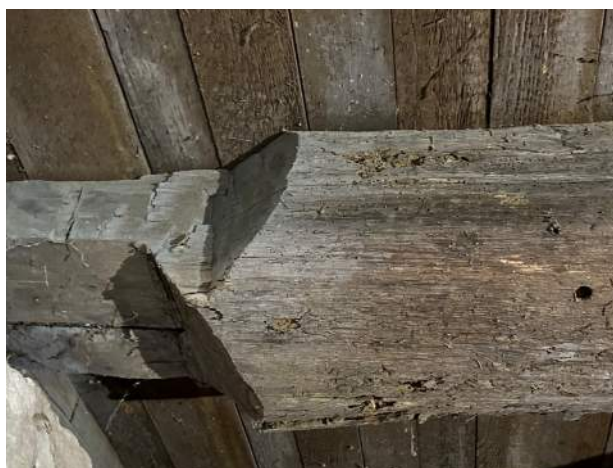
**Figure 12. Pin-size powderpost beetle emergence holes on the wood surface.**

Visual inspection and probing confirmed the presence of pinholes and punky consistency of wood surfaces consistent with powderpost beetle damage (Figure 12). Some beams, especially on the north side of the basement, have pinholes surrounded by fresh, wood-colored, dust-free frass, indicating recent and possibly active infestation. The powderpost beetle damage in (white) oak is restricted to sapwood, measuring approximately 1-1 ½ inches in width along the log circumference. The oak heartwood is considered naturally durable, and the powderpost beetles normally do not colonize healthy heartwood. The deterioration pattern and the amount of damage in beams made with other wood species depend on the species' natural durability and susceptibility to insect attack. It should be noted that the powderpost beetle activity was also observed in the black walnut floor beam.

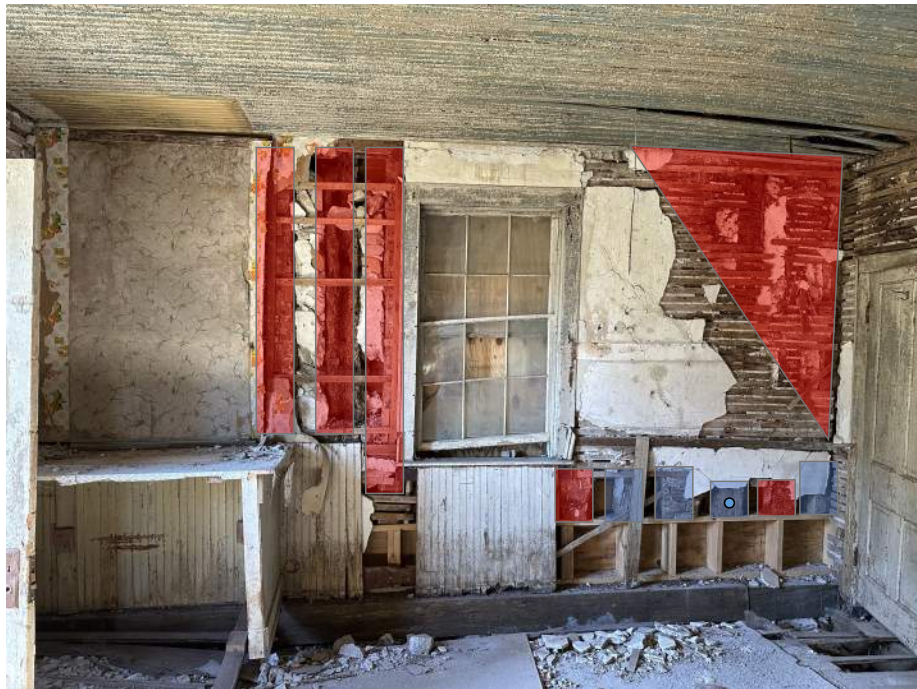
**Figure 16. Section of west wall. Room I.**

have failed due to advanced fungal decay and concomitant termite damage (Figure 16). Moisture stains and debris collected between the lathe and logs in the upper northwest corner of the wall suggest deterioration of the logs behind the lathe. The middle part of the west wall in Room II is covered with wall finishes and was not investigated (Figures 17 and 18). Short sections of the original logs between the knee wall and the window in Room II are severely deteriorated with large internal voids extending to the surface. Logs on the north end of the west wall, accessed using visual inspection and drilling through an existing test opening, appeared in good condition (Figure 19). The original west wall sill, which remains between the door in Room II and the northwest corner of the building, is in good condition, lacking any internal voids, as confirmed by resistance drilling (Figures 18 and 19). The top plate in Room I appears significantly deteriorated, based on the visual assessment.

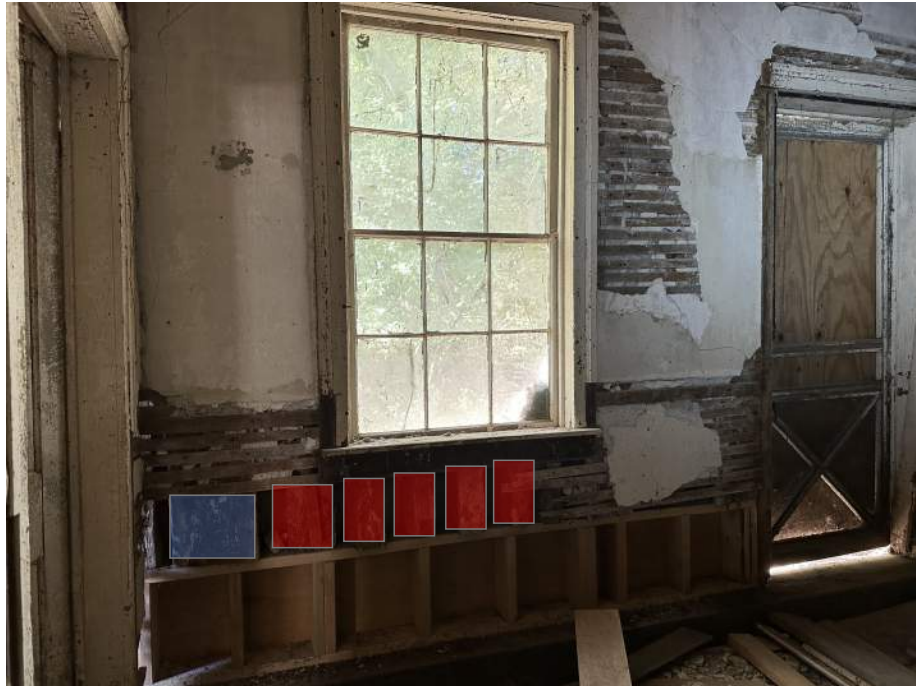
**Figure 17. South section of the west wall. Room II.**

The condition of the wall logs ranges from poor-to-good, with severity of damage and material loss decreasing from the south end (Room I) to the north end of the wall (Room III). Individual west wall sections are shown in Figures 16-19, and annotated corresponding to the visual inspection findings (areas) and resistance drilling locations (dots) with less (blue) or more (red) than approximately 50% profile loss. The deterioration of the west wall follows the pattern of prolonged moisture intrusion from the exterior in the southwest corner, resulting in advanced wood decay and termite damage in this location. The condition of wall members improves further from the southwest corner toward the north end of the west wall. The damage was addressed during a prior repair campaign by replacing the sill plate and lower sections of the wall logs on approximately half of the west wall – from the southwest corner to the door in Room II. The knee wall repair was constructed with dimension lumber and is inappropriate to the historic construction. The remaining parts of the original wall logs are in variable conditions. Several logs on the left of the south window in Room I

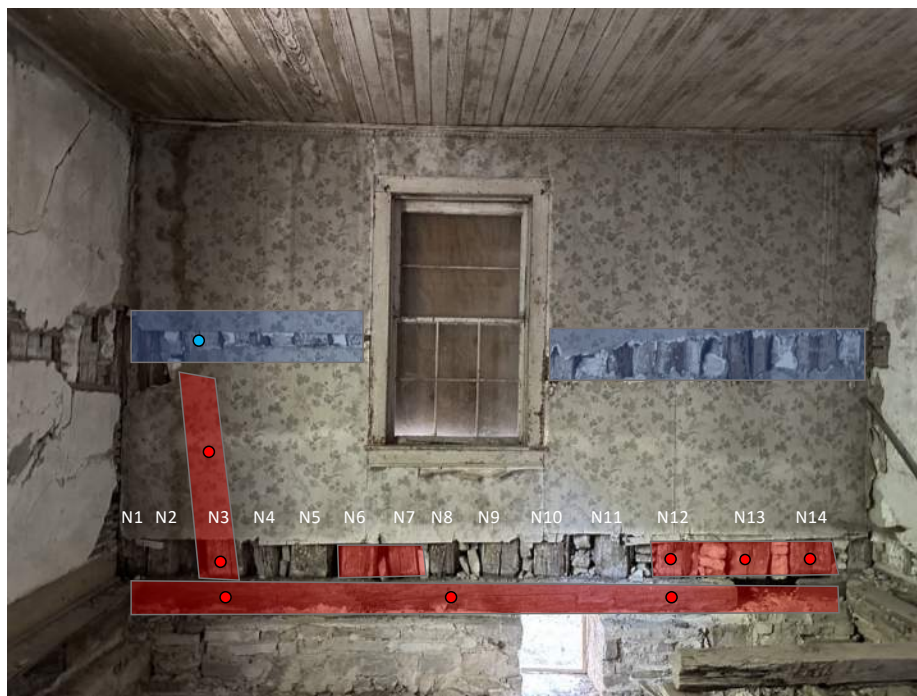
**Figure 20. Section of the north wall. Room III.**

The original sill comprises two beams. The sill beam on the west has a void along its length ranging in depth between 2 ½ and 7 inches and extending to the interior face in some locations (Figure 20). A section of the second sill beam in Room III is missing due to decay. The top plate on the north wall in Room III is not visible.

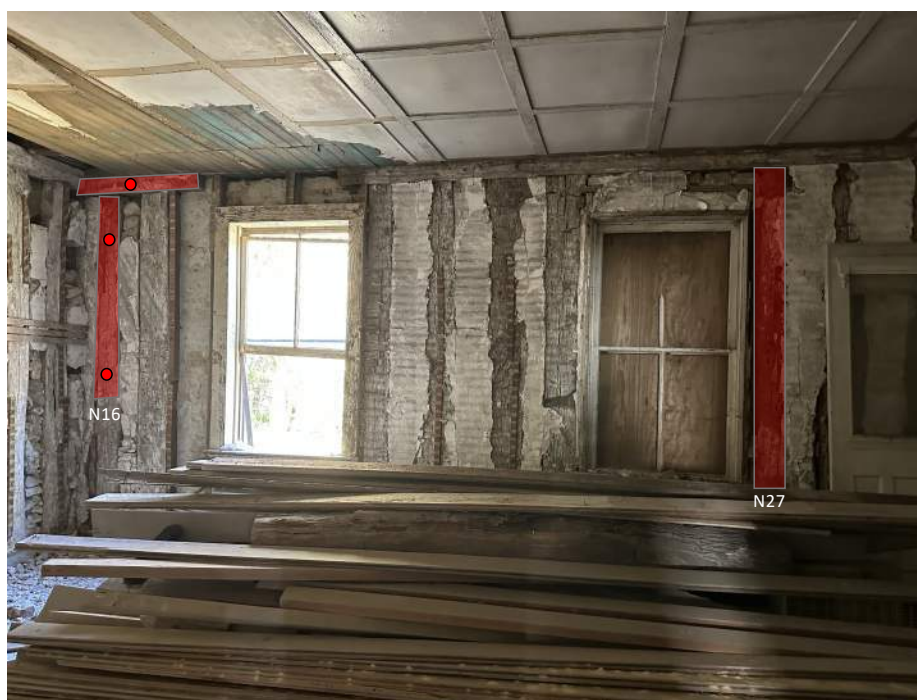
**Figure 21. Section of the north wall. Room IV.**

inaccessible due to the lumber stored in the room at the time of assessment (Figure 21). The upper section of log N16 and the top plate in the west corner are deteriorated and have large internal voids. The severity of deterioration decreases downward with the distance from the top plate. The original top sill and wall logs around the west window in Room IV are missing or were replaced with dimension lumber when the window was installed at a later period after initial construction. The logs under the east window are deteriorated or missing. The diagonal log (N31) on the east side of the north wall is sound, as confirmed by resistance drilling. Generally, logs on the east end of the north wall and the top sill, which were accessible only for visual assessment from a distance, appear in good condition.

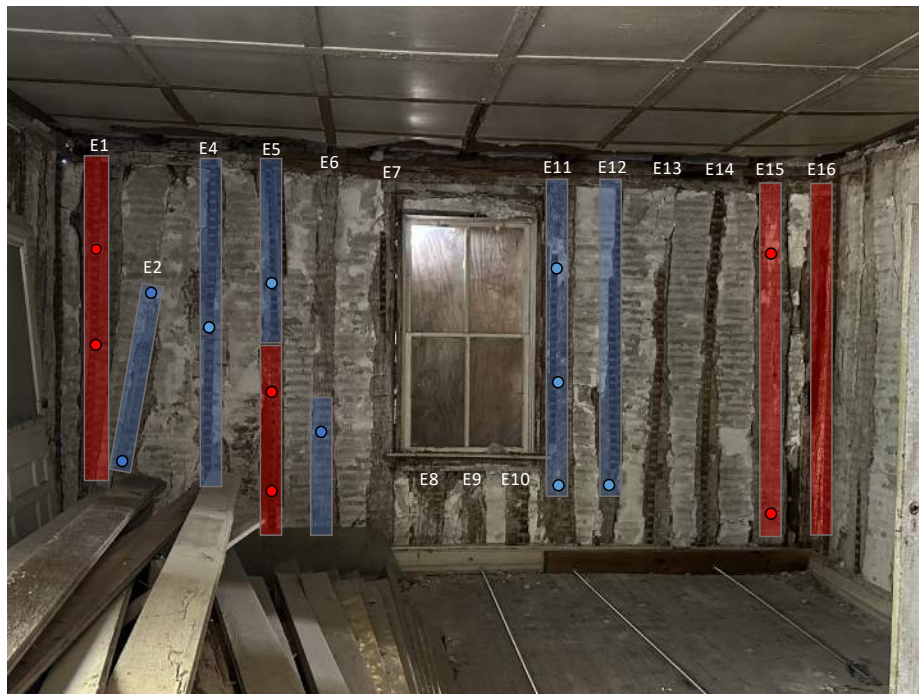
Figure 22. Section of the east wall. Room IV.

The first log (E1), the diagonal brace (E2) in the northeast corner, and logs E5, E6, E15, and E16, visible in Room IV, have internal voids of different depths (Figure 22). Vertical logs in Room V appear to be in sound condition, except for the log segments of E26 and E27, which have large internal voids (Figure 23). Vertical logs E44 and the upper part of the diagonal log on the south end of the wall (E47) visible in Room VI also have large internal voids, as confirmed by resistance drilling (Figure 24). The entire first-floor top plate on the east elevation has significant deterioration and deflection and was exempt from the assessment, based on RRJ team recommendations.

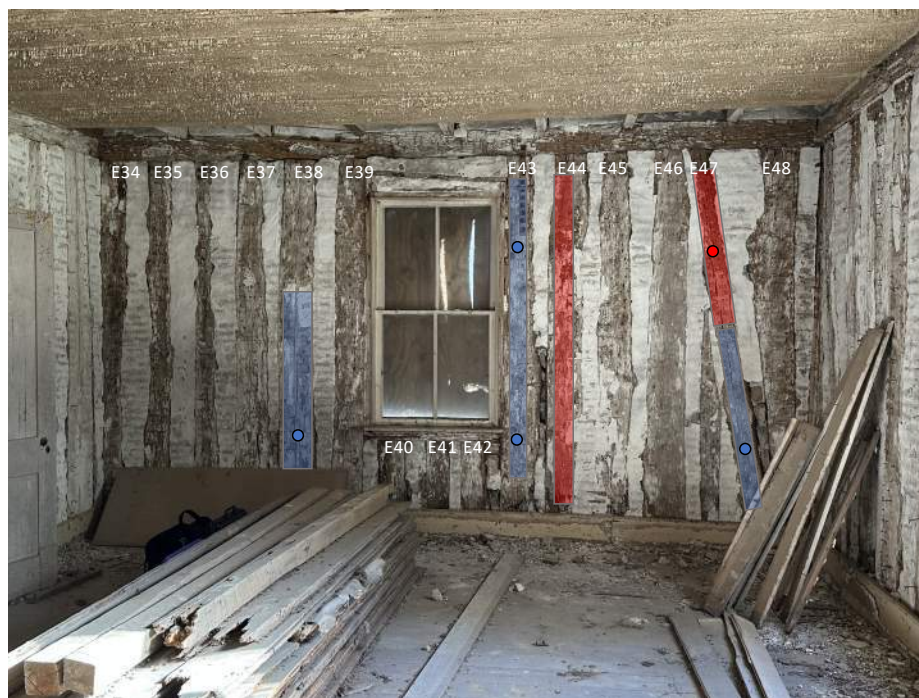
Figure 24. Section of the east wall. Room VI.

The east wall logs were investigated from Rooms IV, V, and VI. The condition of east wall vertical logs ranges from poor-to-good (Figures 22-24). Highlighted areas (visual inspection) and dots (resistance drilling locations) correspond to less (blue) and more (red) than approximately 50% profile loss. Most logs have some level of fungal or insect deterioration of the sapwood.

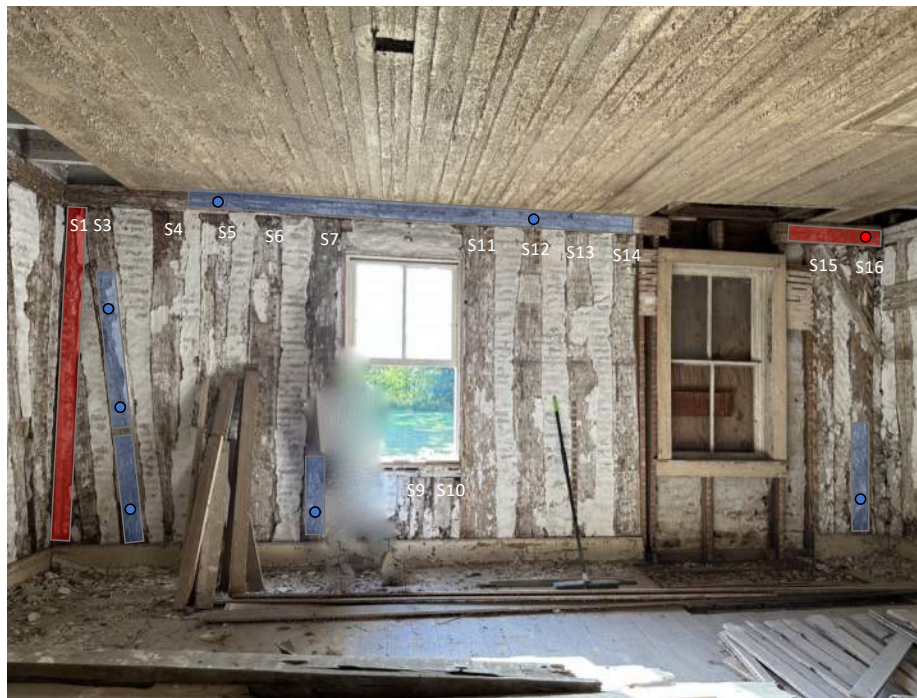
Figure 25. Section of the south wall. Room VI.

Exterior logs on the south wall were accessed from the interiors of Rooms VI and I (Figures 25 and 26). The condition of logs ranges from poor-to-good. First vertical log in the southeast corner has advanced fungal decay and termite damage, as determined by visual assessment. The lower part of diagonal log S3 has a one-inch internal void (Figure 25). Other wall logs appear sound, apart from the sapwood damage common to most exterior wall logs. The original logs surrounding the west window in Room VI have been replaced by new wood framing, and the top plate is missing in this section. The remaining visible sections of top plate show evidence of fungal decay and insect damage. The resistance drilling profiles of top plate suggest either a punky interior or a wood species with a lower density than the wall logs.

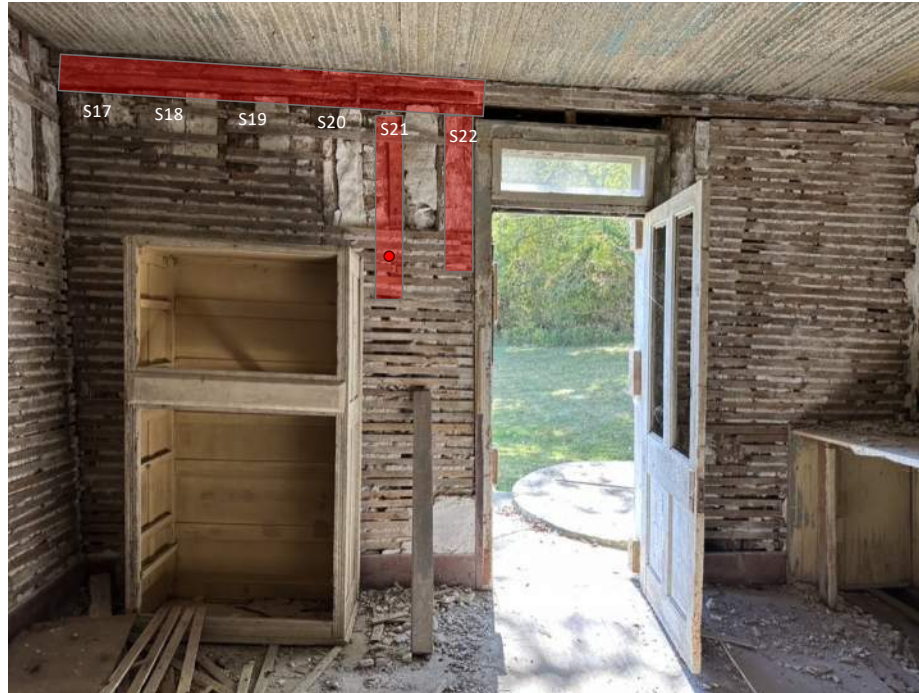
Figure 26. Section of the south wall. Room I.

The south wall logs in Room I are largely concealed by plaster and lathe, but there are visible signs of advanced wood deterioration, especially in the upper section of the wall logs and the top plate. Resistance drilling confirmed a large void in one on of the logs in this area suggesting that deterioration is not superficial and does extend to the log interior (Figure 26).

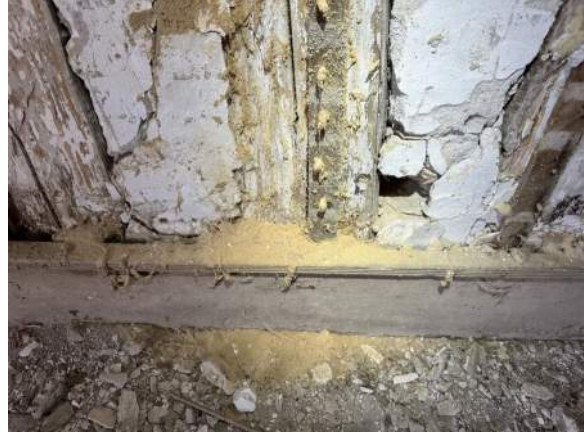
The condition of interior wall logs ranges from poor-to-good. Fungal decay and termite damage were observed on the west end of the partition wall between Rooms I and II, particularly above the door. The leading cause of deterioration is powderpost beetle damage, which is apparent on most interior wall surfaces (Figure 29). Fresh frass collected on the walls and accumulated beneath wall logs and numerous beetle emergence holes suggest long-term and presently active infestation. Powderpost beetle is known to be destructive and capable of causing extensive damage to hardwoods like maples and poplars. Unlike oak, heartwood of these species often lacks natural resistance to the powderpost beetle attack, rendering the wood susceptible to damage throughout the entire cross-section.

**Figure 28. Lightly colored powderpost beetle frass from the interior wall logs.**

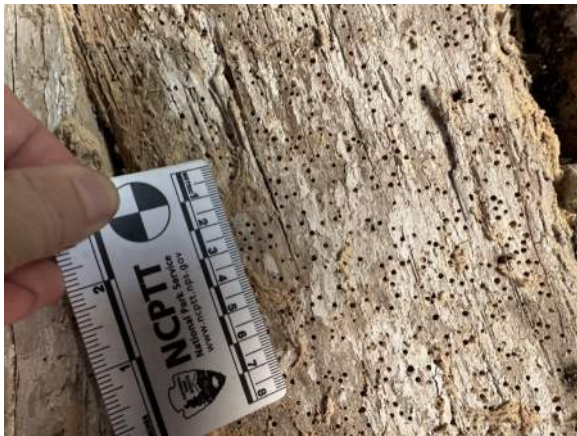
**Figure 29. Powderpost beetle emergence holes on the interior wall log.**

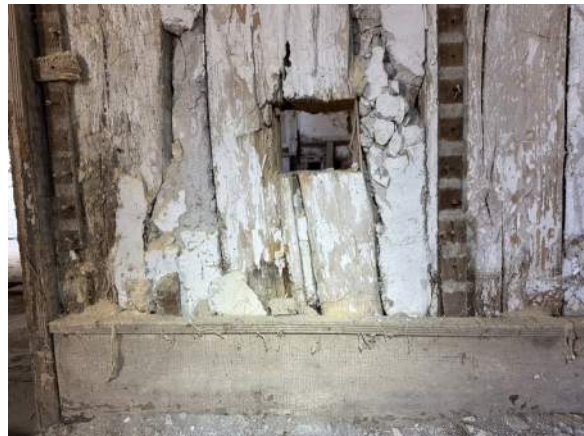
**Figure 30. Opening in the interior wall log.**

There are openings in the partition walls created during the occupancy of the building (Figure 30).
