# Jean Baptiste Vallé House

STE. GENEVIEVE NATIONAL HISTORICAL PARK  
STE. GENEVIEVE, MISSOURI

## Historic Structure Report

PMIS 311236  
OCTOBER 2024

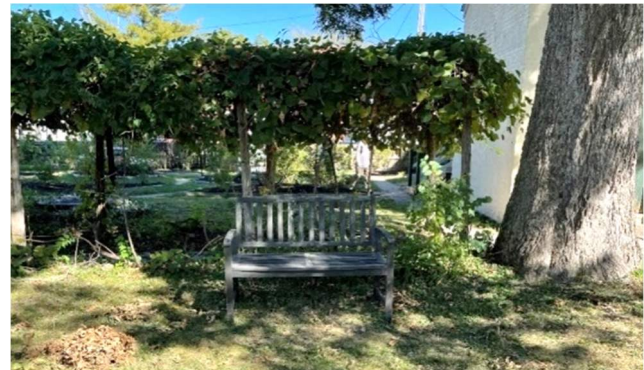
Figure 49. The grape arbor remains in its original alignment at the northwest corner of the house. The site of the former vegetable garden is now turf grass that extends throughout the landscape west of the house. (Source: LSHLA, 2022)

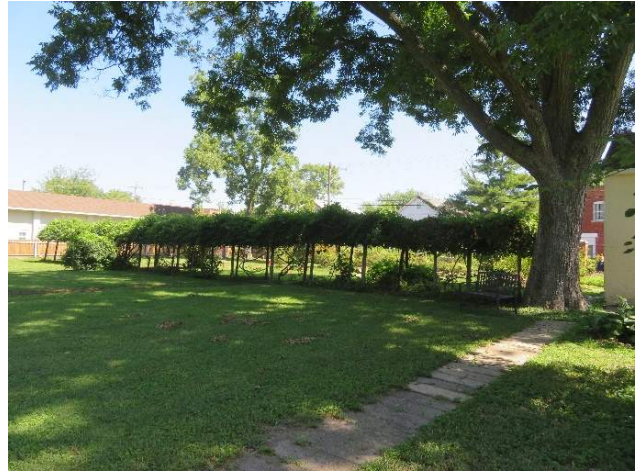
A wood grape arbor extends generally north-south from the northwest corner of the house toward the north property line (Figure 49). The arbor forms the western border of the parterre garden and separates it from the open turf grass area that dominates the northwest portion of the landscape. The arbor is composed of wood posts and beams notched and nailed to the posts. It stands approximately 8 feet in height from the top of the vines to the ground and is 70 feet long. Below the arbor is a cut stone pathway that leads through a gate to another pathway to the west entrance of the house. The arbor is covered with the thick growth of grape vines that challenges the strength of the wood structure (Figure 51).

Figure 51. Overview of grape arbor looking northeast. (Source: RRJ, 2022)

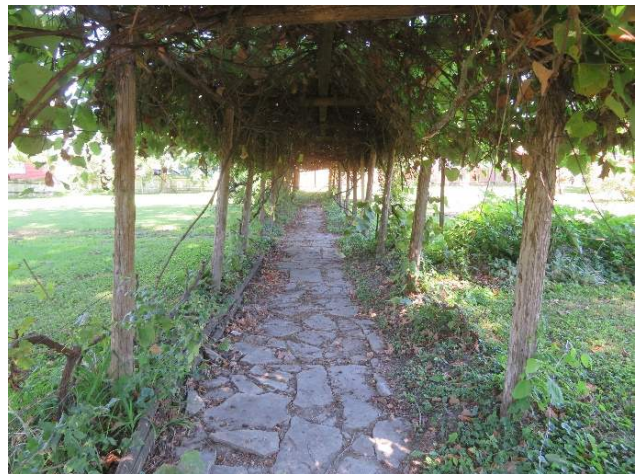
The condition of the wood members of the grape arbor are in fair to failed condition, with the condition of the arbor progressively worsening along its length from south to north (Figure 52 and Figure 53). At present, the grape arbor is closed off from pedestrian access with caution tape. Of the seventeen bays, ten bays contained at least one failed or missing member. Supplemental posts are present at two locations. In addition to failed and missing members, the arbor posts typically lean toward the east at an angle of up to twelve degrees, and in some locations, toward the south at an angle up to ten degrees. Deterioration of post bases was observed at multiple locations.

Figure 53. Grape arbor looking north. (Source: RRJ, 2022).

Since the initial assessment for the HSR, the grape arbor has been stabilized in place by NPS pending future repairs.

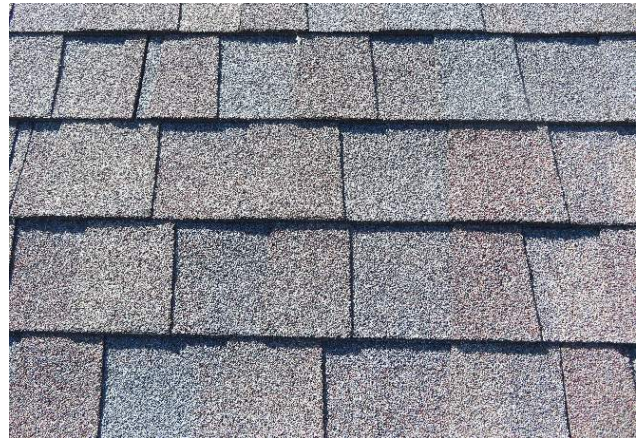
During extensive remodeling in the 1860s, the original hip roof was removed, a second floor was added, and a new gabled roof was installed. The gabled roof today is clad in laminated asphalt shingles (Figure 76) and two gable-roofed dormers project from the east and west roof slopes. The roof structure consists of vertical sawn, pine rafters. Ceiling joists measuring 3 by 5 inches are spaced about 2 feet 6 inches on center.

Figure 76. Laminated asphalt shingle roofing. (Source: RRJ, 2022).

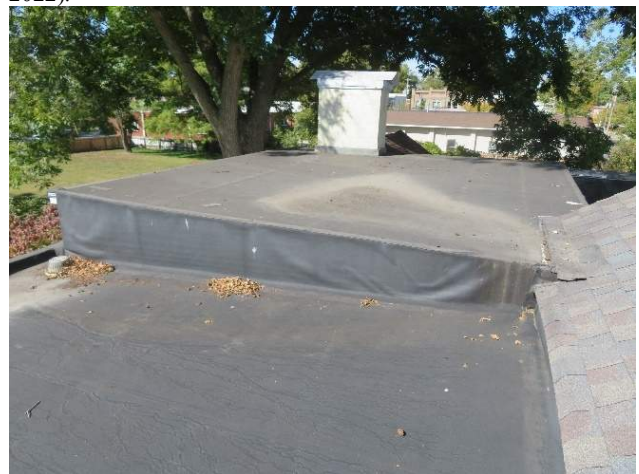
EPDM roofing was present above Rooms 108, 109 and 113 on the west wall as well as on the gallery roofs (Figure 77). The EPDM membrane in these areas was debonding and showed signs of age.

Figure 77. EPDM Roofing above room 109 and West Gallery (Source: RRJ, 2022).

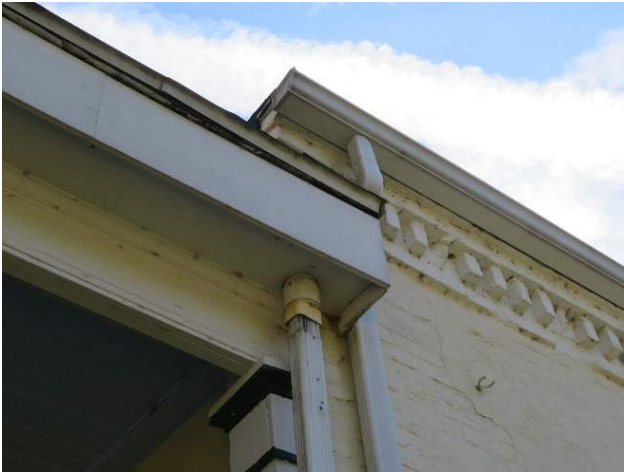
Figure 78. Downspout at roof eave. (Source: RRJ, 2022).

The roof slopes to drains connected to downspouts located at the eaves along the west gallery, north wall of east gallery and the east and south walls (Figure 78). At least one of the downspouts on the west wall discharges into a nearby cistern (Figure 79). The condition of the cistern was not assessed during this investigation. Two downspouts were located at each side of the east wall gallery, discharging water at the sidewalk along Main Street (Figure 80). One downspout was located on the south wall of the gallery and discharged water at the sidewalk along Market Street. A K-style hung gutter was present at the west wall of Room 113. A downspout from this gutter was located at the northwest corner of room 113. No drainage system was present on the roof of the tool shed, Room 110.

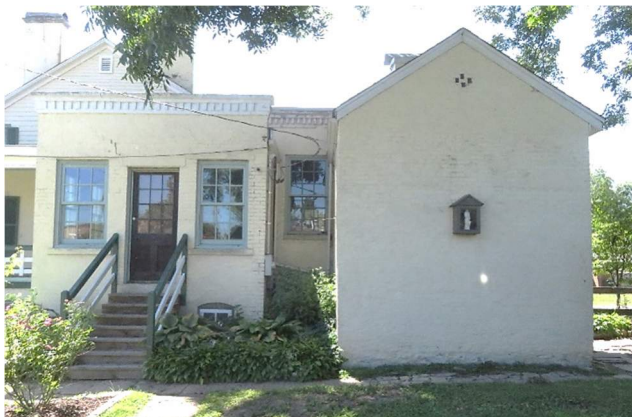
Figure 81. Masonry walls at tool shed and sunroom (Source: RRJ, 2022)

Step cracking, displaced brick, and peeling paint were common conditions found throughout the masonry (**Error! Reference source not found.**). The sunroom (Room 108), which is not original, showed the greatest amount of distress (Figure 81). Several step cracks and displaced bricks were noted on all three walls of the room. The steel lintels on the north wall of the sunroom were corroded and have failed. The sunroom parapet will need to be rebuilt.

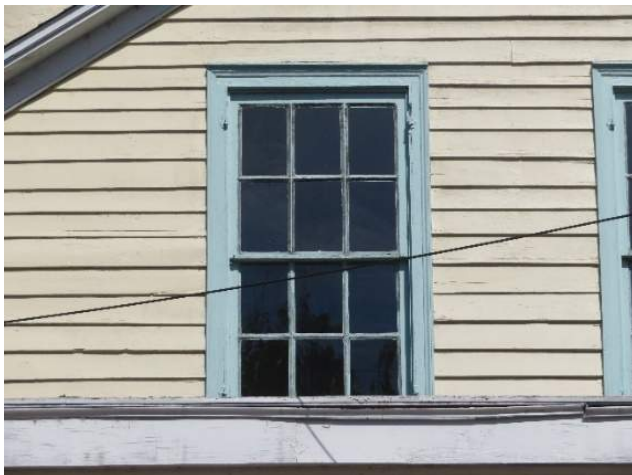
Figure 82. Weatherboard siding at the second floor (Source: RRJ, 2022).

The second-floor walls are framed with dimensional lumber and are clad in painted weatherboard siding which appeared to be in good condition (Figure 82).

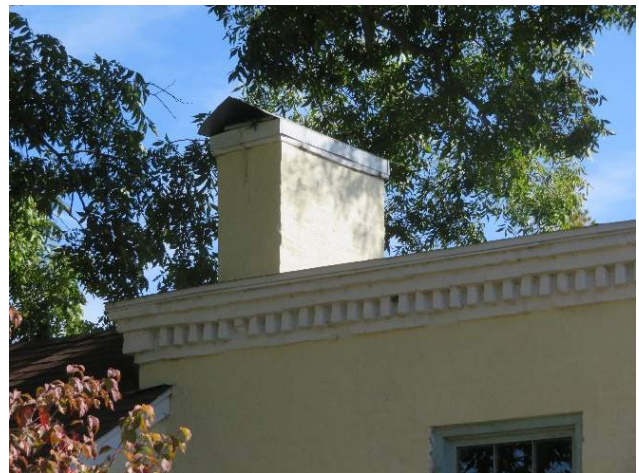
- The Northeast Chimney is located above Room 105.
- The Northwest Chimney corresponds to the abandoned fireplace in Room 106.
- The Southwest Chimney is also associated with an abandoned fireplace located in Room 104 (Figure 84).
- The Southeast Chimney is associated with the fireplace in Room 103.
- A fifth chimney is located in Room 113, or the office, in the southwest corner of the house. A sixth chimney is associated with the fireplace in the Kitchen (Room 109), in the northwest corner of the house (Figure 85).

Figure 85. Kitchen chimney. (Source: RRJ, 2022).

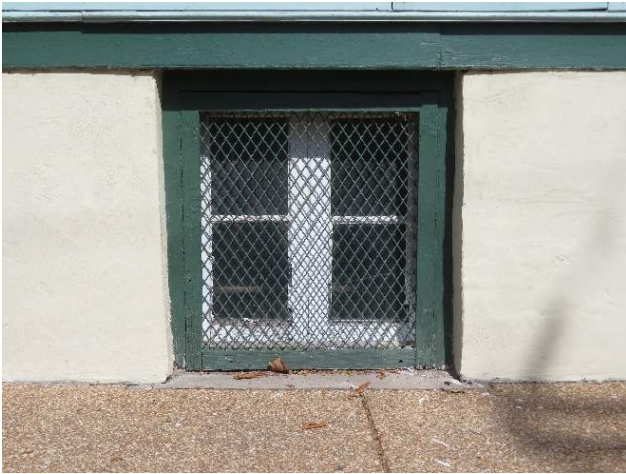
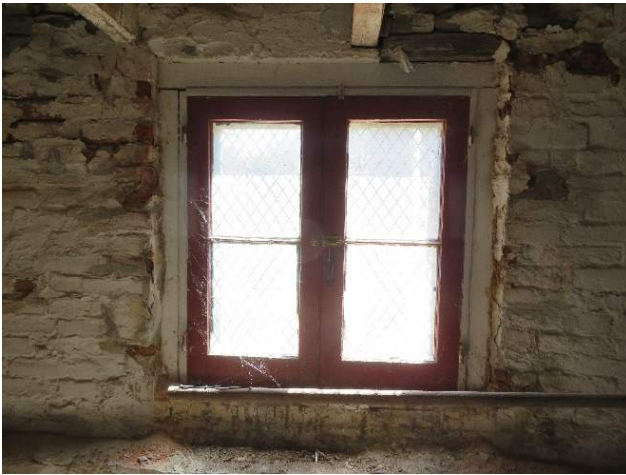
Figure 88. Exterior view of typical basement level Casement Window with metal mesh covering (Source: RRJ, 2022)

Figure 89. Interior view of typical basement level Casement Window with metal mesh covering (Source: RRJ, 2022).

**W013A to W013F** – The windows in basement Room 013 are one-over-one wood-framed shutter casement windows (Figure 88 and Figure 89). Typically, the upper portions of windows located within the basement were in good condition. The conditions of the other sections of each window varied, and the following deficiencies were noted:

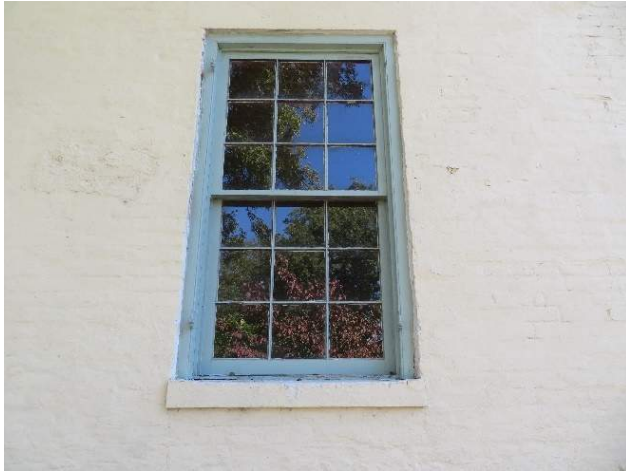
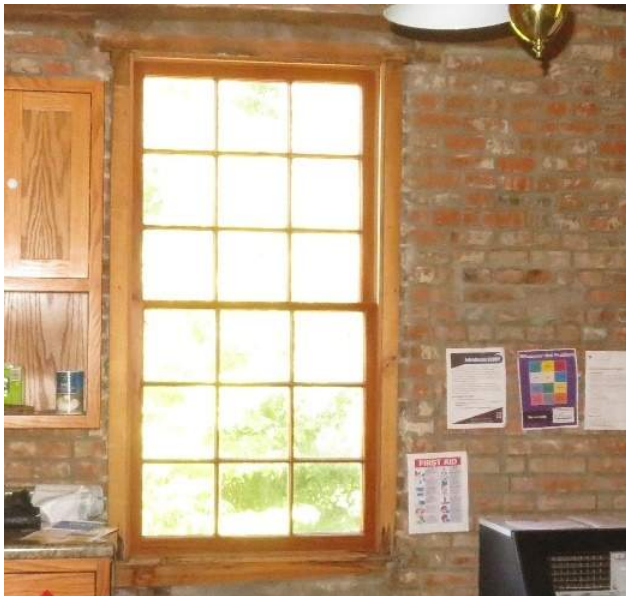
Figure 92. Exterior view of typical nine-over-nine double hung window (Source: RRJ, 2022)

Figure 93. Interior view of typical nine-over-nine double hung window (Source: RRJ, 2022).

**W109A** – W109A is a nine-over-nine double hung wood window (Figure 92 and Figure 93). The shutters were missing but shutter hardware was partially in place. The exterior paint and glazing putty were in fair condition. A stone, possibly limestone, sill was present at the exterior windowsill. The interior of the window was stained wood. An older hewn wood lintel was noted above the window. Some water stains were noted at the interior jamb of the casing. The lower sash was secured in place with screws into the jamb pocket. Overall, this window was in good to fair condition.

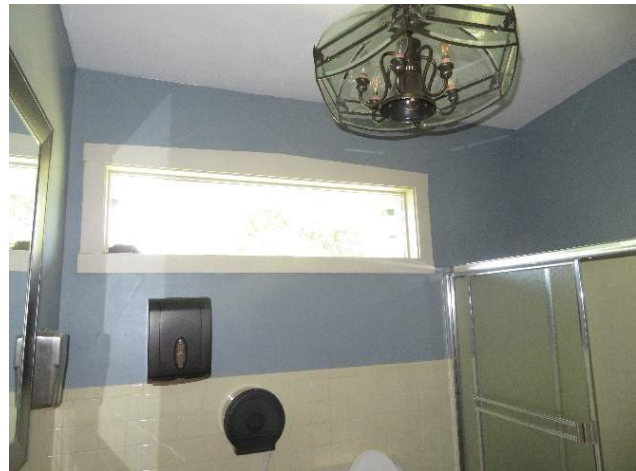
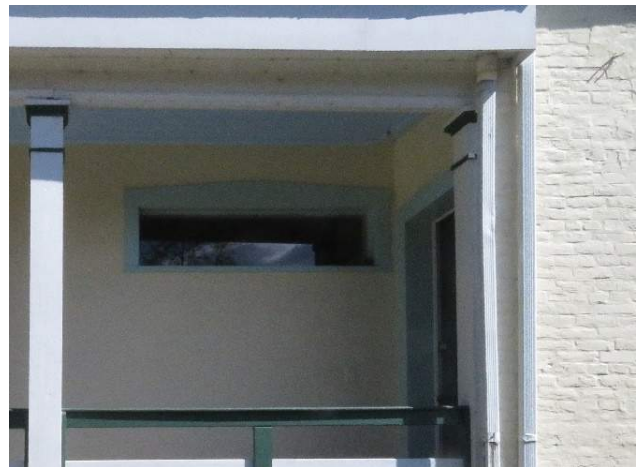
Figure 94. Interior view of Window W112 (Source: RRJ, 2022)

Figure 95. Exterior view of Window W112 (Source: RRJ, 2022).

**W112** – W112 is a clearstory bathroom window comprised of a single fixed lite (Figure 94 and Figure 95). The exterior casing and window in general were in good condition.

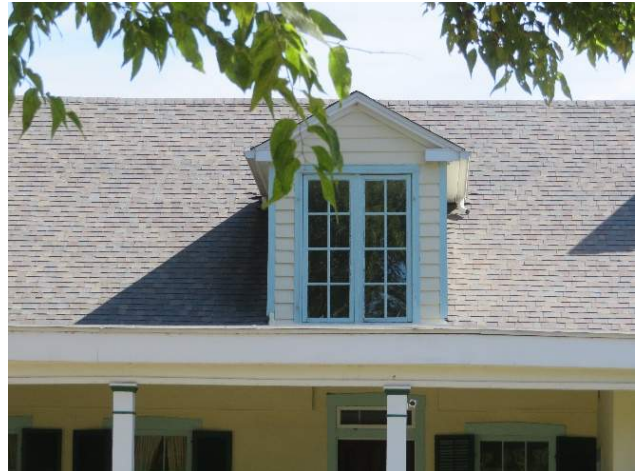
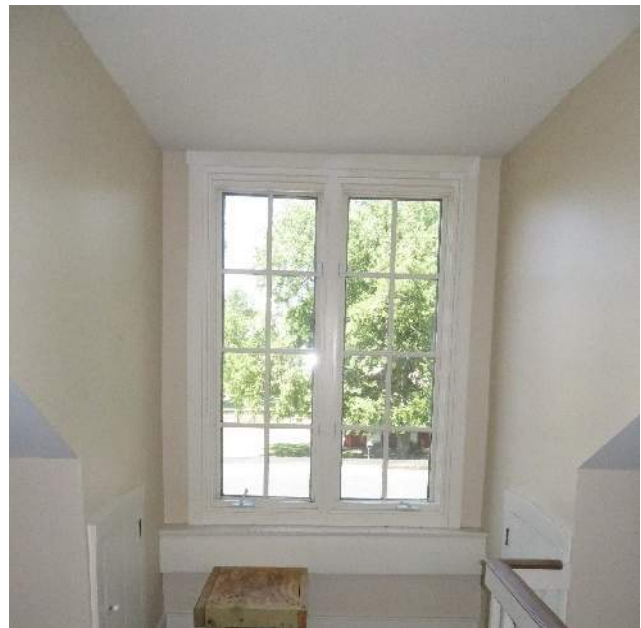
Figure 96. Exterior view of double casement window at second floor (Source: RRJ, 2022)

Figure 97. Interior view of double casement window at second floor (Source: RRJ, 2022).

**W201** – W201 is a double casement (French) wood window (Figure 96 and Figure 97). Each section contains eight lites each. This is a modern replacement unit with crank sash operators and sash locks. The

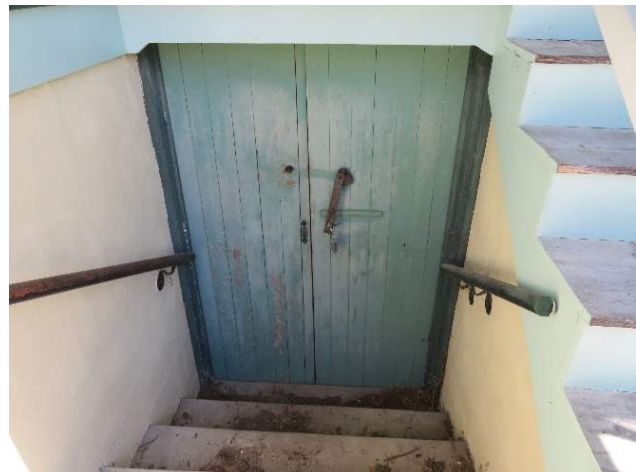
**D001** – D001 is the main entrance door to the basement (Figure 98). The door is constructed of vertical wood planks that were painted green. The door trim was painted dark green. A wrought iron (or wrought style) strap lock with a modern deadbolt and a wrought-style handle were present. Three strap hinges were present, and a slide bolt was located at the top on the inside face of the door. Overall, the door was in fair condition.

Figure 98. Exterior of basement entrance, Door D001. (Source: RRJ, 2022)

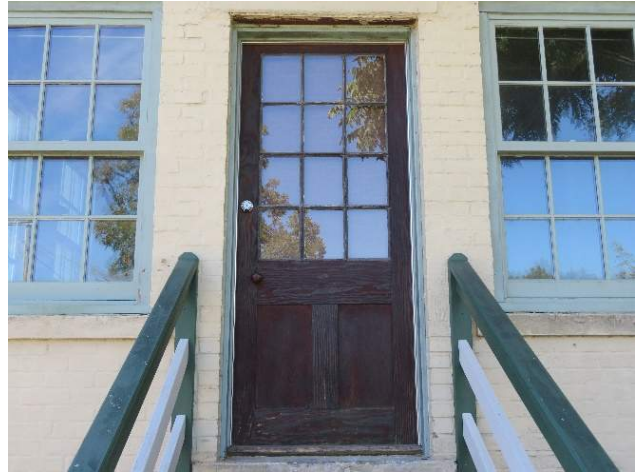
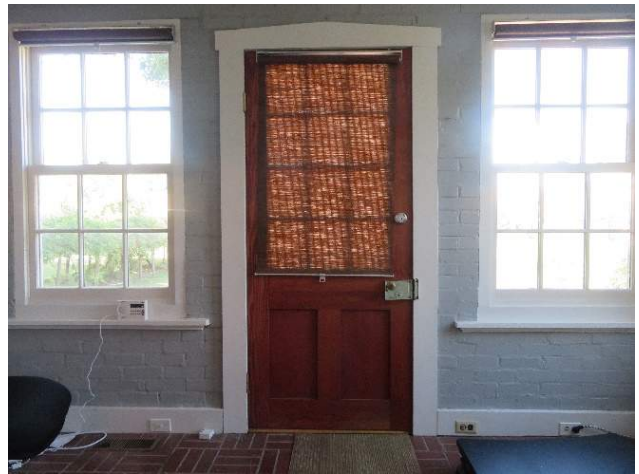
Figure 105. Exterior of Door D108. (Source: RRJ, 2022)

Figure 106. Interior of Door D108. (Source: RRJ, 2022)

**D108** - This stained wood door was comprised of a lower section of two flat panels and an upper section contained 12 lites (Figure 105 and Figure 106). A porcelain knob with a modern deadbolt was present at the exterior while a metal rim lock and brass door knob were present on the interior side of the door (Figure 107). The glazing putty was in poor condition, but the glass was in good condition. Significant corrosion was noted at the steel lintel above the door. Overall, the door was in fair condition.

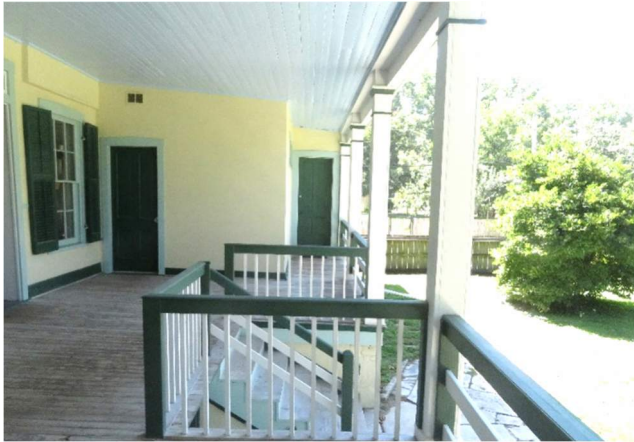
Figure 108. West porch showing Doors D112 (left) and D113A (right). (Source: RRJ, 2022)

**D112** - This door provides access to the west porch from Room 112 (Figure 108). The door is a four-panel door with raised panels and has an inward swing. The interior was stained, and the exterior was painted dark green. Brass butt hinges and a door stop at the interior were present. The exterior head casing had a slight pediment, and the rest of the casing had a squared edge. Minor separation of the wood at joints was noted but can be remedied by caulking or painting. The door was in good condition overall.

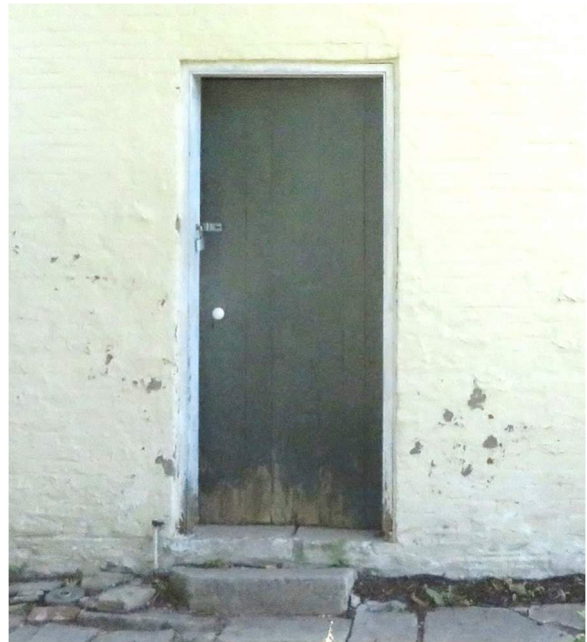
Figure 110. Exterior of Door D110 to tool shed. (Source: RRJ, 2022)

**D110** – This door provides access to the tool shed. It is a narrow board wood door that was painted green (Figure 110). Water related deterioration was noted at the base of the door and jamb boards (Figure 111). A

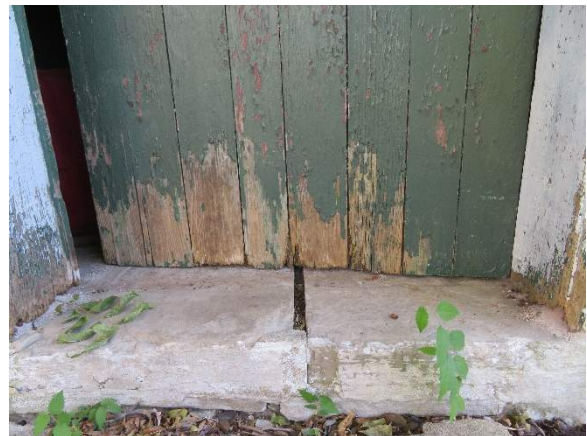
Figure 111. Weathered paint and wood at base of Door D110. (Source: RRJ, 2022)

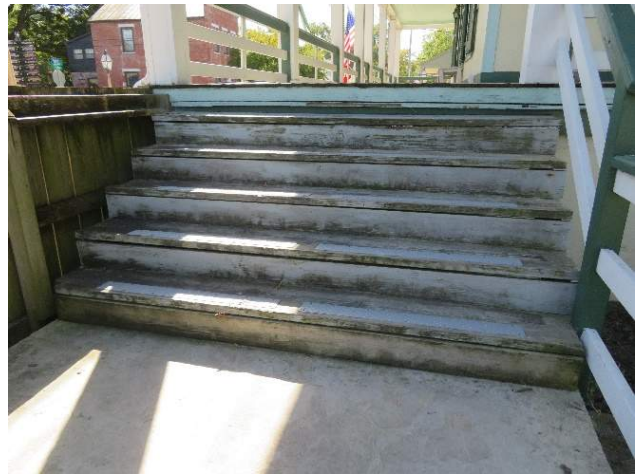
Three sets of stairs were present at the House providing access to the North Gallery, West Gallery, and Sunroom. Several loose treads and minor warping of the treads were noted at the north gallery stairs (Figure 115 and Figure 116). No railing was present at the east side of the north gallery stairs which could be a safety issue. One split tread was noted at the west gallery stairs; these treads were replaced in 2023 (Figure 117). The stair treads to the sunroom were replaced in 2023 (Figure 118). Overall, the exterior stairs are in fair condition.

Figure 115. Stairs to east gallery at north wall (Source: RRJ, 2022)

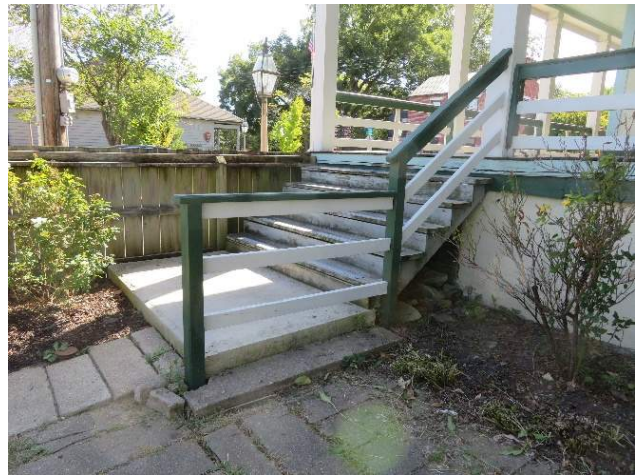
Figure 116. Railing at north stairs to east gallery (Source: : RRJ, 2022)

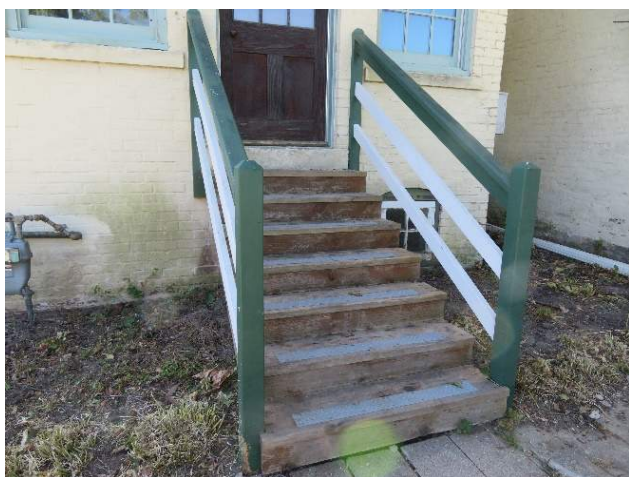
Figure 118. Stairs and handrails to sunroom; the treads have since been replaced. (Source: : RRJ, 2022)

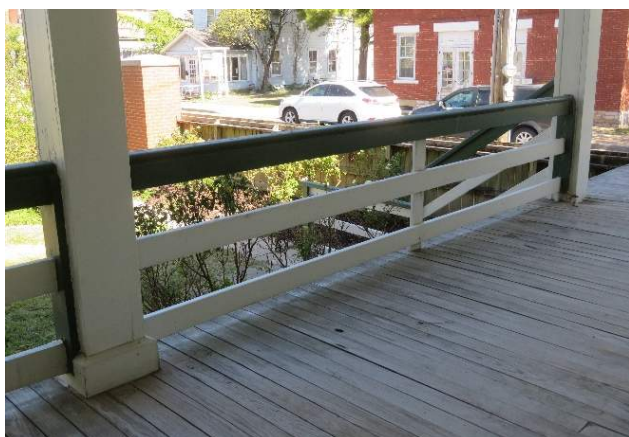
Handrails are present along the full perimeter of the remaining segments of the wrap around porch which is present to some extent on all four walls (Figure 119).

The railing along the north, east and south walls consist of a 4 x 1.5-inch top rail and nominal 2x mid-rail and bottom rails. The railing sections are connected to the gallery roof columns and singular intermediate railing posts. This railing consists of a 4 x 1.5-inch top rail with 2 x 2-inch intermediate vertical rails equally spaced across the span of the railing.

Several loose railings were identified on all sides and were likely insufficient to withstand code-required loads for safety railings. The railing configuration is likely historically appropriate but does not comply with the International Building Code provisions for safety railings for changes in height above thirty inches, regarding railing height above the walking surface, height and placement of midrails, and maximum allowable spacing between railings, pickets, or posts. Consideration should be made whether a sympathetic

Figure 119. Typical gallery handrails which do not comply with IBC safety provisions (Source: : RRJ, 2022)

modern safety railing should be installed at the south gallery. At a minimum, the rails should be repaired or replaced as required to withstand code-required loading of safety rails, which the 2018 IBC is a minimum of 50 pounds per linear foot for uniform loading, 200 pounds for a concentrated load on the top rail, and 50 pounds for concentrated loads on intermediate members or infill panels.

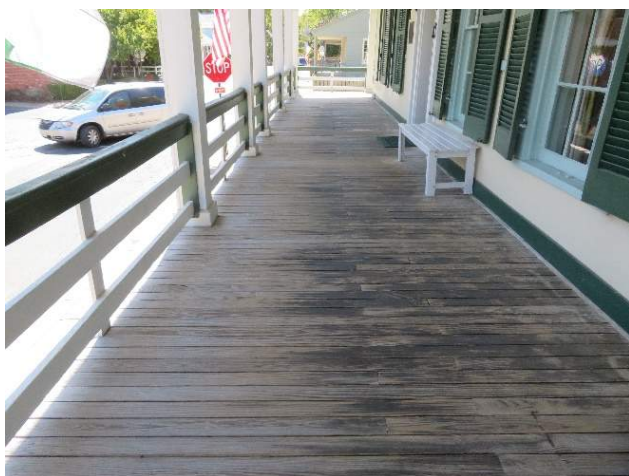
Figure 120. Weathered decking at east gallery; this has since been replaced with new decking (Source: : RRJ, 2022)

Wood decking is located at the west and east galleries (Figure 120). The decking is generally in fair condition. Areas containing wood rot and warped wood planks were identified on the west gallery, and buckling wood decking was noted at the northeast corner of the east gallery. Several areas of wood decay were noted on the base trim between the decking and foundation at the south and east walls. Note that the decking was fully replaced in Spring 2023.

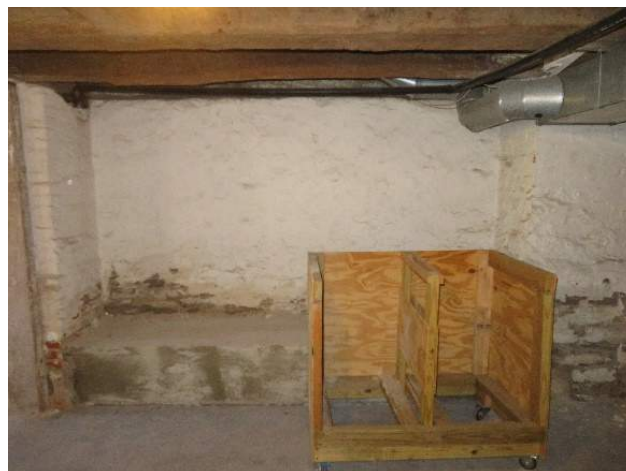
Apparent supplemental stone masonry foundations parged with cement were present within Rooms 3 and 11A (Figure 123 and Figure 124).

The stone foundations are visible in the 1960s Schram family renovation photographs, although the purpose of this construction is currently undetermined. Possibly, they were added to provide additional support to areas of the stone masonry foundation walls, possibly if the basement floor had been excavated to increase headroom.

Figure 123. Supplemental concrete foundation within Room 011A (Source: RRJ, 2022)

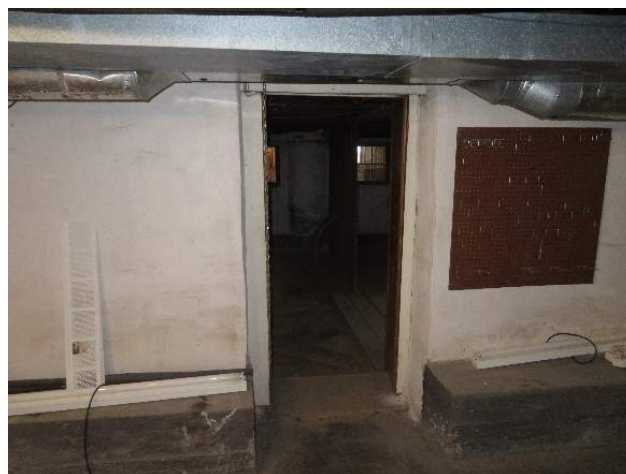
Figure 124. A Supplemental concrete foundation within Room 003. (Source: RRJ, 2022).

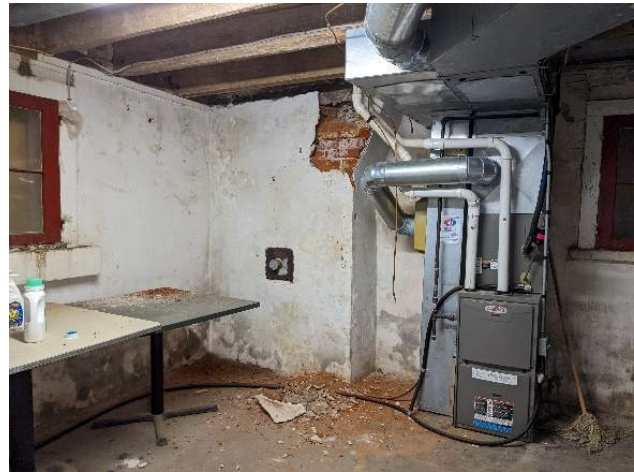
Brick masonry distress was observed at the northwest corner of Room 002, within a fireplace brick masonry foundation (Figure 125). Brick masonry distress was observed along the perimeter gallery walls within Rooms 010 and 013 (Figure 126). The most severe deterioration was observed at the northeast and southeast wall corners. The lower two feet of these walls serve as retaining walls and are exposed to runoff

Figure 125. Brick spalling in room 002. (Source: RRJ, 2022).

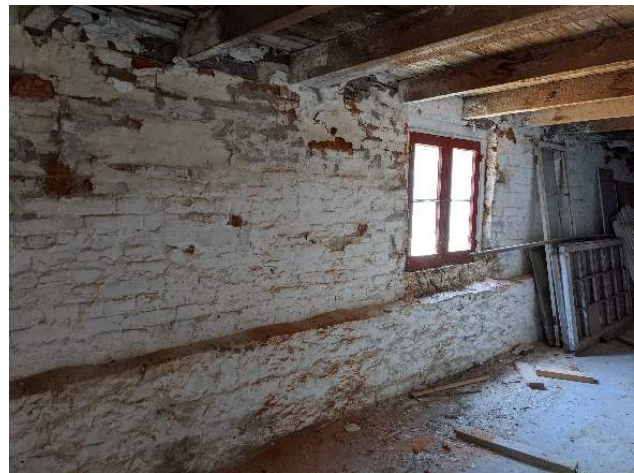
Figure 126. Brick distress including spalling in room 013. (Source: RRJ, 2022)

from the exterior sidewalk. In contrast, the masonry walls below the gallery at north within Room 012B showed markedly less distress at the interior.

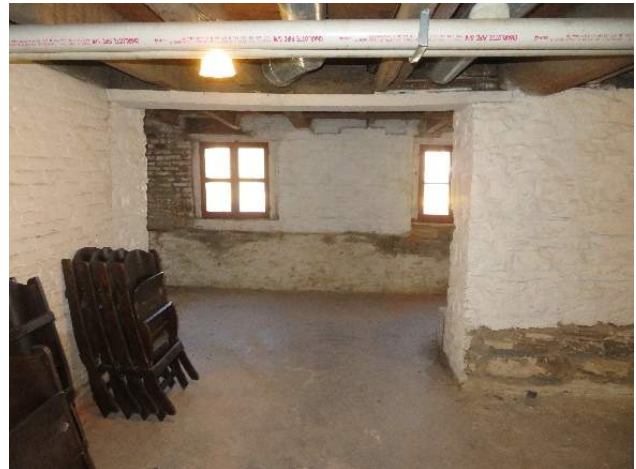
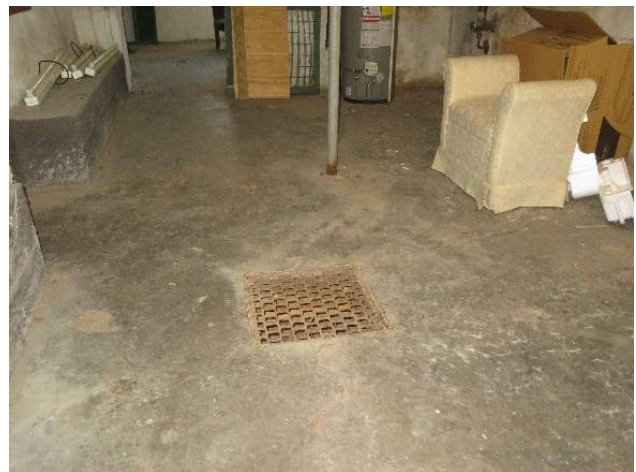
A concrete slab-on-grade is present within all basement areas with the exception of Room 009 (Figure 129 and Figure 130). The concrete slab is not original to the building's period of significance. The slab-on-grade is in serviceable condition and exhibits only very minor topside cracking. No trip hazards were identified.

Figure 129. Slab-on-grade within Rooms 011B and 013 (Source: RRJ, 2022)

Figure 130. Slab-on-grade and floor drain in Room 003. (Source: RRJ, 2022).

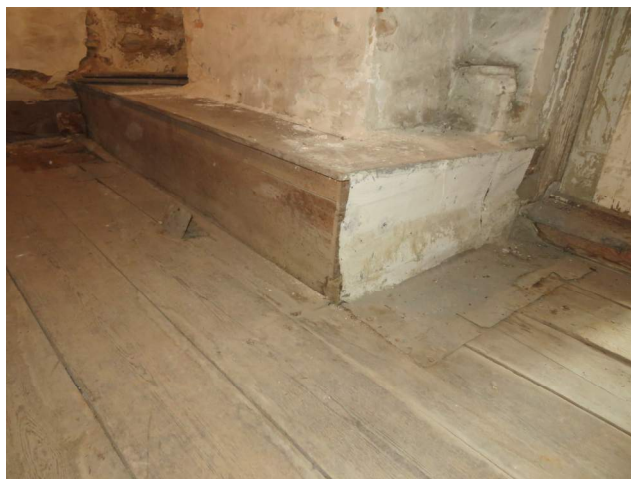
The floor within Room 009 consists of wood planking nailed directly to wood sleepers resting on the earth below (Figure 131 and Figure 132). The planking was largely absent within the north half of the room, as divided by a partition wall comprised of wood planks.

Figure 132. Floor planking observed in Room 009. (Source: RRJ, 2022).

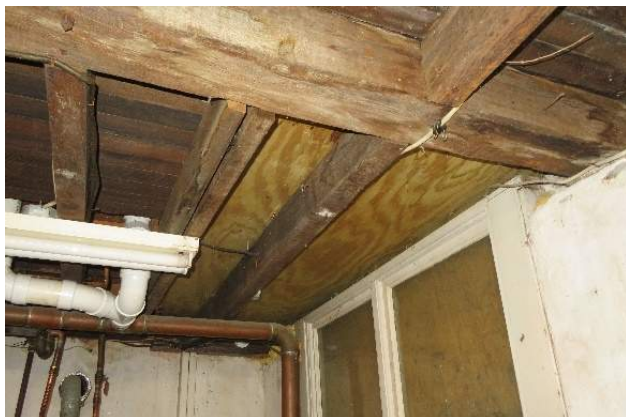
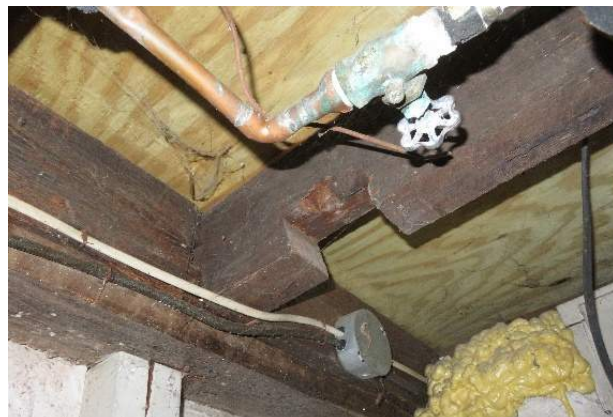
Subfloor decking was generally observed to be in serviceable condition; however, evidence of past water infiltration was observed. Supplemental joist

Figure 140. Plywood at room southwest. (Source: RRJ, 2022)

Figure 139. Plywood at room southwest. (Source: RRJ, 2022)

members are present near the southwest corner of the room, where a portion of the decking has been replaced with plywood (Figure 140 through Figure 139).

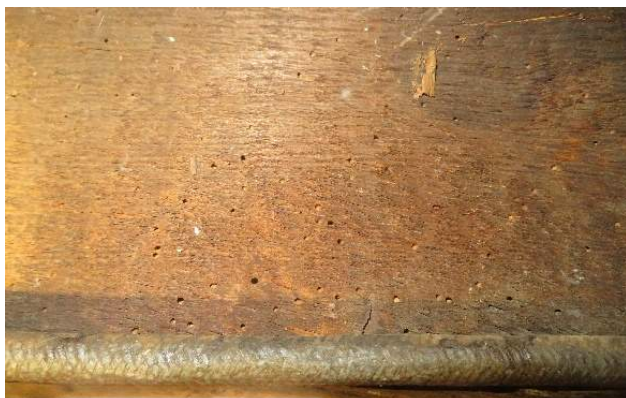
The framing within this room spans in the north-south direction and supports part of the west gallery above (Figure 137). Joists frame into a beam aligned with the south wall of the room, a beam aligned with the exterior wall of the bathroom above, and a beam aligned with the south side of the ascending exterior staircase. To the north of the latter beam, joists frame continuously over a partition wall into the room located immediately south. A supplemental metal post is present below the approximate mid-span of the beam below the bathroom wall. An area of missing decking near this post reveals a second layer of framing above. Joists were observed to be of dimensional pit-sawn lumber in fair to poor condition (Figure 138). The joists within this room appeared to be of the same dimension and vintage as those within Room 001. In addition, notches were observed within the bottom and sides of beam to accommodate conduit or piping both existing and no-longer-present. Evidence of powder post beetle infestation was visible within multiple beams. Resistance drilling of two joists in this room revealed no voiding, however, possible powder post beetle deterioration of up to one half inch was observed at the bottom of one of the drilled joists.

Figure 142. Evidence of powder post beetles. (Source: RRJ, 2022).

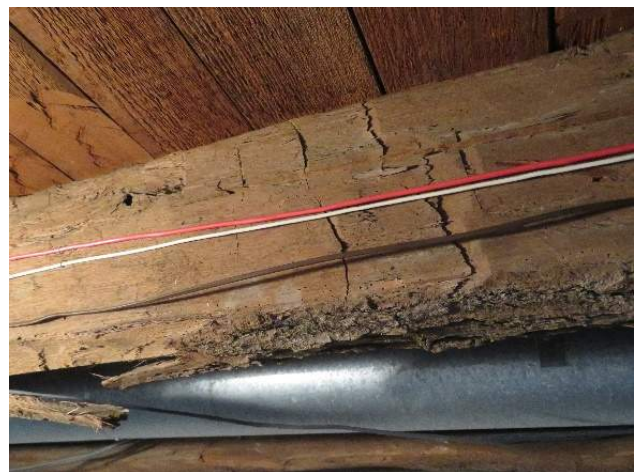
The joists were observed to be in fair condition with some evidence of powder post beetles at the bottom and sides of the joists (Figure 146). Resistance drilling of two joists in this room revealed no voiding, however, possible powder post beetle deterioration of one-half inches to seven-eighths of an inch was observed at the bottom of joists.

Figure 146. Hand hewn joist with tree bark and powder post beetle exit holes. (Source: RRJ, 2022).

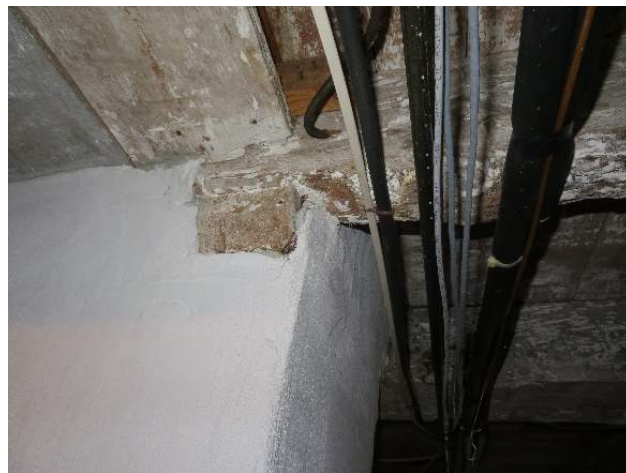
The joists in this room appeared to be in fair to poor condition (Figure 149). Evidence of powder post beetle infestation was observed at multiple joists, and moderate checking was observed within the vertical face of the southern-most joists where piping has been hung from wire hooks embedded in the face

Figure 149. Joist bearing detail at central masonry wall support. (Source: RRJ, 2022).

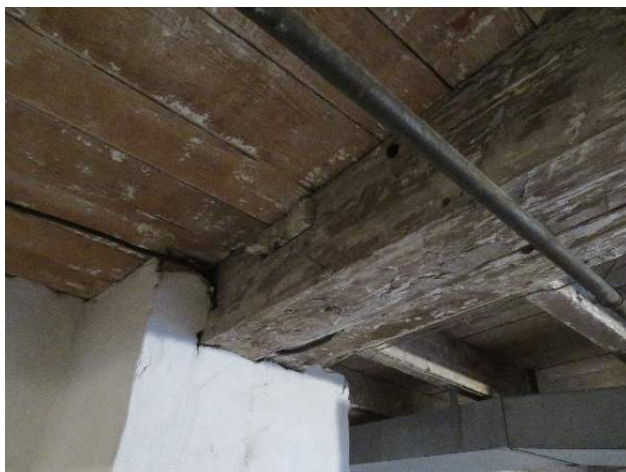
Figure 148. Missing diagonal brace within timber beam at north. (Source: RRJ, 2022)

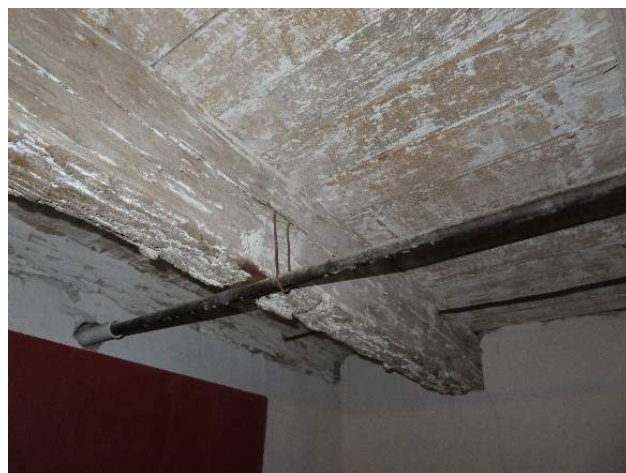
of the joist (Figure 150). Resistance drilling of two joists in this room revealed no voiding, however, possible powder post beetle deterioration of up to 1.75-inches was observed at the bottom of one of the drilled joists.

Figure 150. Checking at south-most joist. (Source: RRJ, 2022).

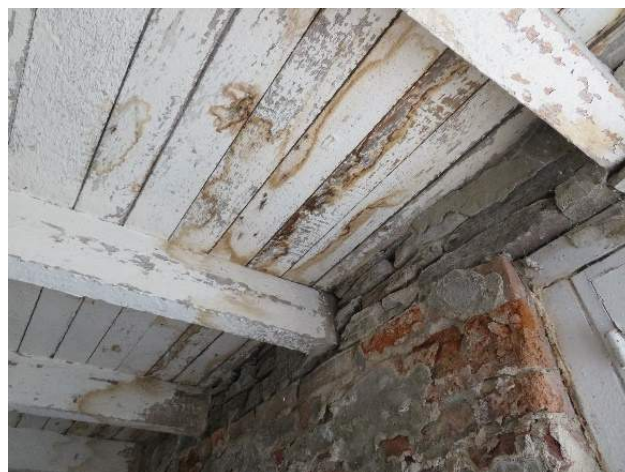
Subfloor decking was observed to be in fair condition, exhibiting evidence of previous water infiltration near the south masonry wall (Figure 157).

Figure 157. Planking and joists exhibiting staining related to water infiltration along the south exterior wall. (Source: RRJ, 2022).

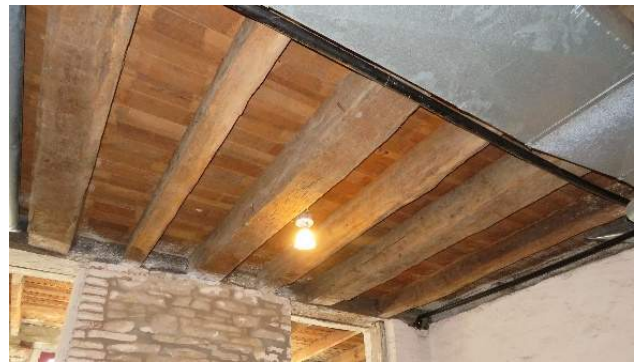
Framing within Room 011 showed the most variety in types of joists out of any room within the basement and within the entire house (Figure 158 through Figure 161Figure 159). One commonality between framing members is that joists typically span in the east-west dimension. However, the joists themselves varied widely in size and origin, ranging from whole logs to hand-hewn timbers to circular-sawn dimensional lumber. All three wood samples taken from Room 011 were determined to belong to the white oak group, however, it is possible that other species may be represented within this space.

Figure 158. Overview looking east-southeast. (Source: RRJ, 2022)

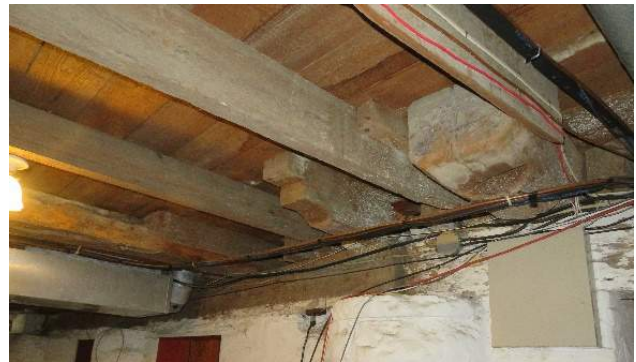
Figure 159. Overview looking south-southwest. (Source: RRJ, 2022).

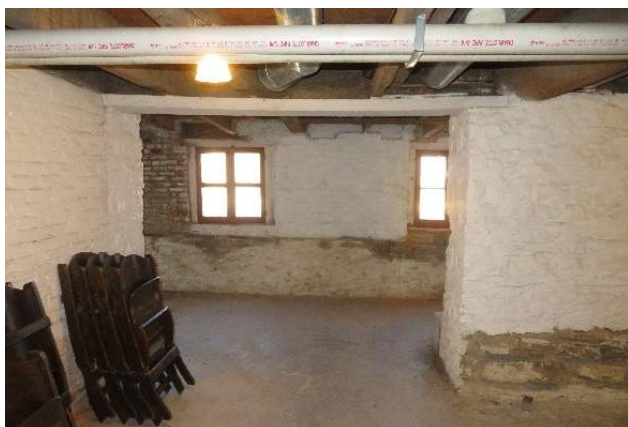
Figure 160. Overview looking east at room north end. (Source: RRJ, 2022)

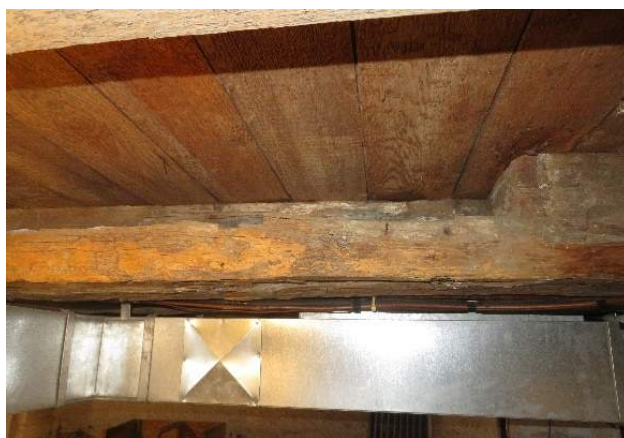
Figure 163. Notched joist at former fireplace location. (Source: RRJ, 2022)

Joists in this room were observed to be in good to poor condition. One joist was observed to be split horizontally where it is notched to frame into the timber sill at the southeast corner of this room (Figure 162). In addition, several joists appeared to have been modified to accommodate building features no longer extant (Figure 164 and Figure 165). For example, one nominally 10-inch square beam was observed to be notched for a length of approximately three feet in the vicinity of a previous fireplace location, just west of the south supplemental column (Figure 163). Resistance drilling of four joists in this room revealed possible powder post beetle deterioration of up to one-half inch at the bottom of the drilled joists and a two-inch void within one joist near the northernmost round pillar at the west wall of this room.

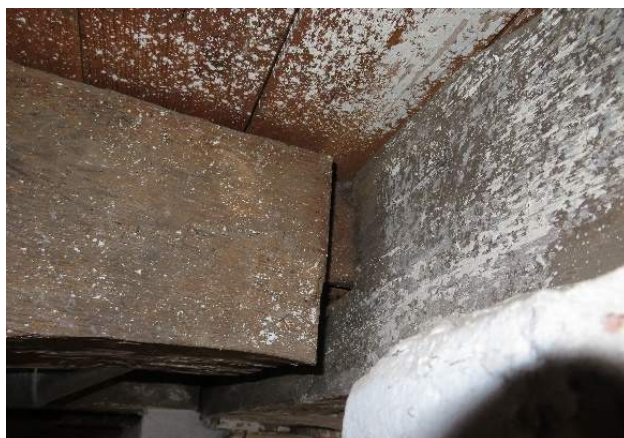
At the south half of Room 011, all joists qualify as timbers, meaning their smallest dimension exceeds five inches. These joists typically frame into the heavy timber sill plate at east via a half-dovetail lap joint, the sill is itself supported by a stone masonry wall. At least one instance of an empty half-dovetail joint was observed within the heavy timber sill, indicating that the floor framing configuration has changed over time. The heavy timber sill currently serves doubly as a header beam above masonry wall openings. At west, the timber joists typically bear atop another timber beam continuously supported by a masonry wall below. It appears likely that this beam once spanned open spaces between the masonry walls and interior round stone pillars. Joists from Room 009 also rest upon this same timber beam, and the ends of joists within Room 009 are visible from Room 011. Joists from Rooms 011 and 009 bear alternately along the length of the beam, and a variety of infill materials are present in between joists (Figure 167).

Figure 164. Half-dovetail lap joint at southeast corner. (Source: RRJ, 2022).

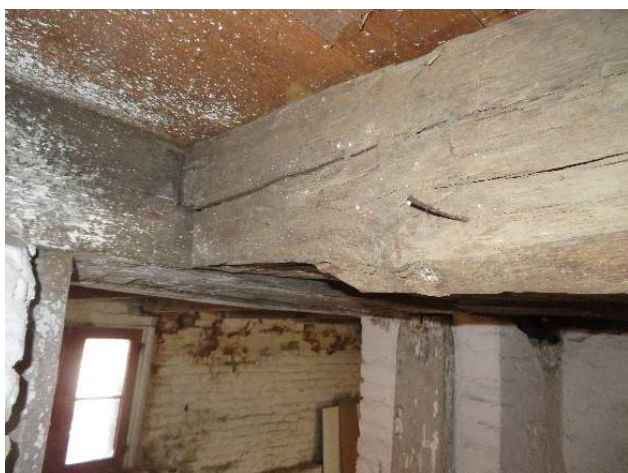
Figure 162. Split joist at southeast. (Source: RRJ, 2022).

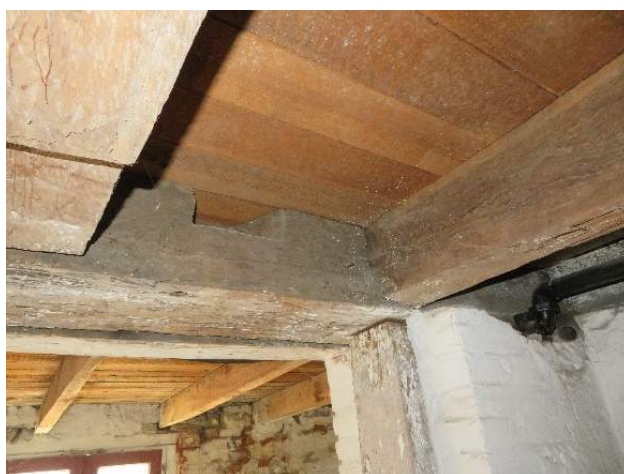
Figure 165. Un-used half dovetail lap joint at southeast corner. (Source: RRJ, 2022).

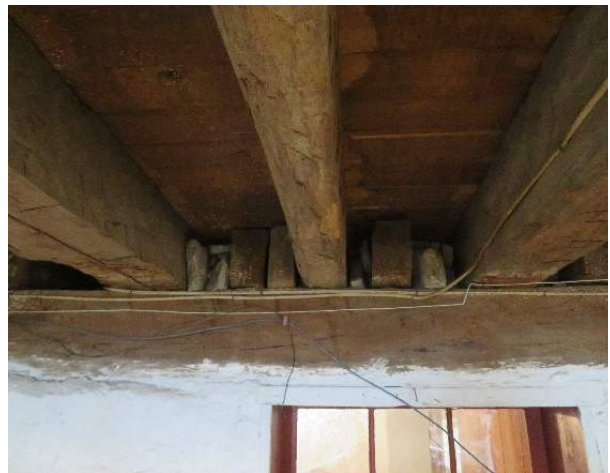
Figure 167. Joist ends and infill looking west. (Source: RRJ, 2022).

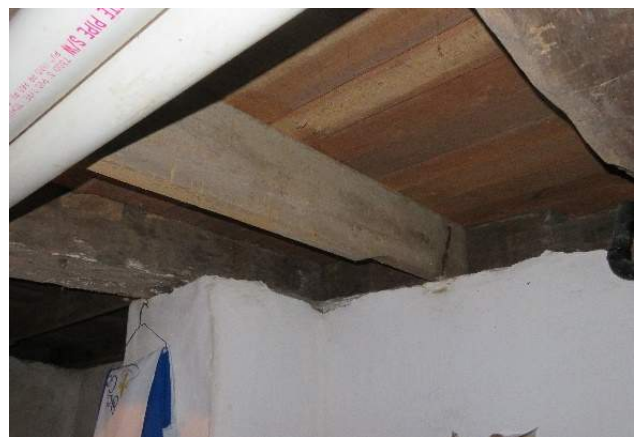
Framing within this room spans in the east-west direction. At east, beams frame into a heavy timber sill serving as the bottom plate of a vertical log wall via lap joinery. At west, joists rest atop a heavy timber beam resting atop a masonry wall (Figure 168). Joists from 006 and 012A bear alternately upon this beam, with a combination of brick, lumber and other infill in between. Within Room 012A, the ends of joists within Room 006 are visible, just as the ends of joists within Room 012A are visible from Room 006. The same timber beam extends southward beyond this room and forms a doorway header that also supports joists within Room 005 and 011. Joists consist of hewn members. The north-most framing member within this room is a timber larger than the typical joists, it is possible that this member serves doubly as the bottom plate of a vertical log wall. The north-most timber is also supported at its approximate midspan by a square lumber post abutting the room's central masonry pier.

Figure 168. Joist end bearing on the limestone foundation. (Source: RRJ, 2022)

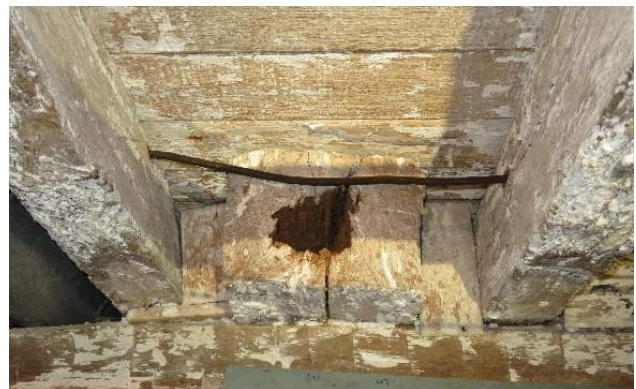
Figure 169. Hollow joist viewed from room 006. (Source: RRJ, 2022).

towards the west masonry wall (Figure 172). Joists in this room were observed to be in good to failed condition. Resistance drilling of the third joist from south was determined to be hollow. Although this joist measures ten inches square in section, a perimeter of solid wood of only 0.75 inches thick at bottom and up to 2.75 inches thick at sides remains of the section (Figure 169). This member cannot be relied upon to provide structural support to the floor framing system, and if left unaddressed, the loading originally carried by this joist will be distributed to the adjacent framing members and may lead to progressive overstress in those surrounding members. Resistance drilling of the heavy timber member suspected to serve as a vertical log wall bottom plate at north edge of this room revealed no voiding or pest-related deterioration.

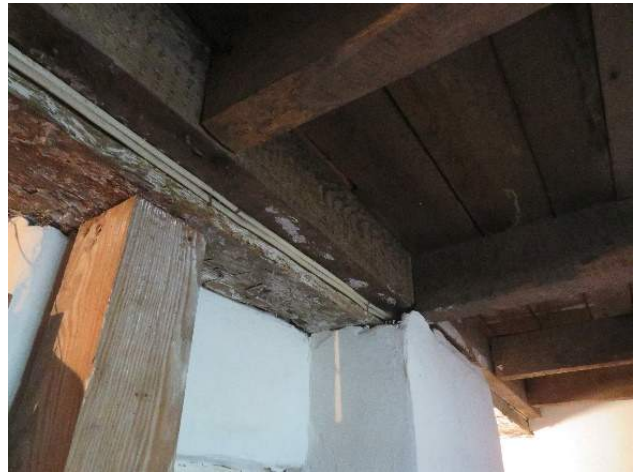
A supplemental column measuring nominally five inches square is located at the southeast corner of the masonry pier at approximately half-span of the joists in this room (Figure 171). The column supports a short beam spanning north-south to the masonry wall at south. This beam in turn supports a sawn joist sistering a nominally ten-inch square joist between midspan and the east wall of the room. At the southwest corner of the central masonry pier, a timber haunch is embedded into the masonry to support a short joist spanning

Figure 171. Supplemental post below sill plate, viewed from Room 007. (Source: RRJ, 2022)
