# Jean Baptiste Vallé House

STE. GENEVIEVE NATIONAL HISTORICAL PARK  
STE. GENEVIEVE, MISSOURI

## Historic Structure Report

PMIS 311236  
OCTOBER 2024

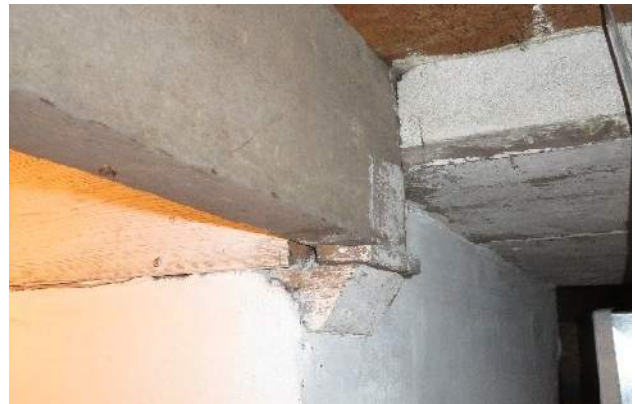
towards the west masonry wall (Figure 172). Joists in this room were observed to be in good to failed condition. Resistance drilling of the third joist from south was determined to be hollow. Although this joist measures ten inches square in section, a perimeter of solid wood of only 0.75 inches thick at bottom and up to 2.75 inches thick at sides remains of the section (Figure 169). This member cannot be relied upon to provide structural support to the floor framing system, and if left unaddressed, the loading originally carried by this joist will be distributed to the adjacent framing members and may lead to progressive overstress in those surrounding members. Resistance drilling of the heavy timber member suspected to serve as a vertical log wall bottom plate at north edge of this room revealed no voiding or pest-related deterioration.

Figure 172. Timber haunch supporting joist. (Source: RRJ, 2022)

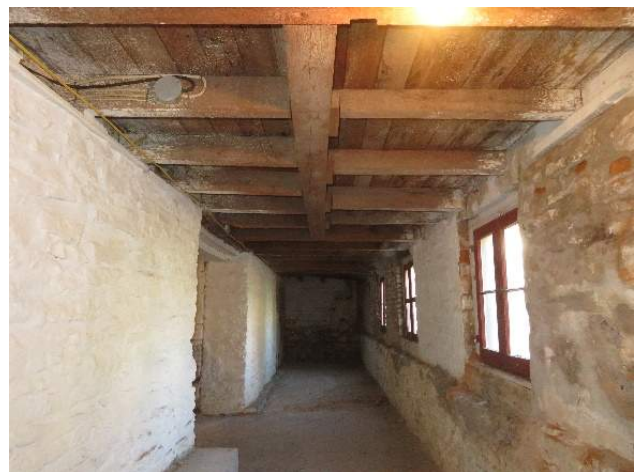
A supplemental beam is present at mid-span of joists immediately in front of the east main entry door (Figure 174). This beam measures nominally six by six inches square. Four short joists frame into the supplemental beam at east and five short joists frame into the supplemental beam at west (Figure 175).

Figure 174. Overview of additional beam, looking north. (Source: RRJ, 2022).

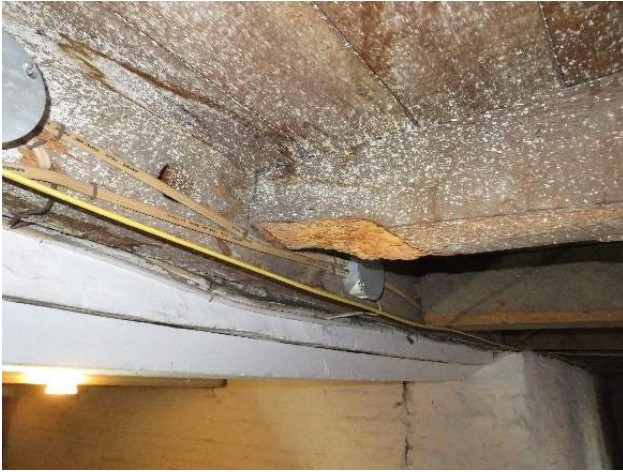
Figure 175. Bearing end of joists at shoring. (Source: RRJ, 2022).

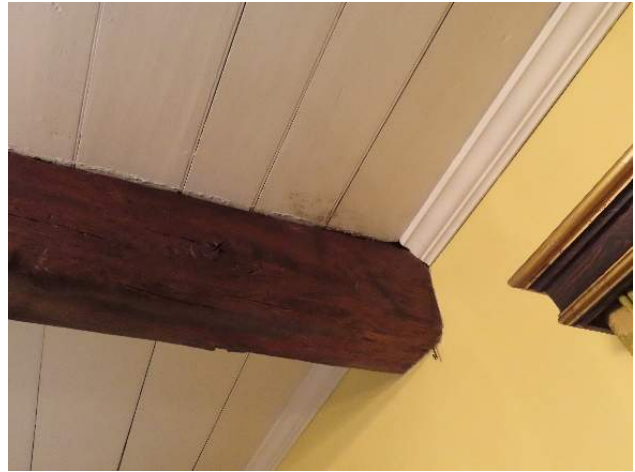
The framing, where visible, was observed to be in good condition. Fill material is present at the ends of joists within Room 104 (Figure 180). Slight rotation of one joist relative to interior finishes was observed at the west wall within Room 106 (Figure 181). Deflection of the beams was observed where beams intersected interior walls, however, the good condition of nearby interior finishes suggests that the deflection occurred well before interior finishes were installed and is not an ongoing concern.

Figure 181. Exposed joist separating from finishes in Room 106.  
(Source: RRJ, 2022).

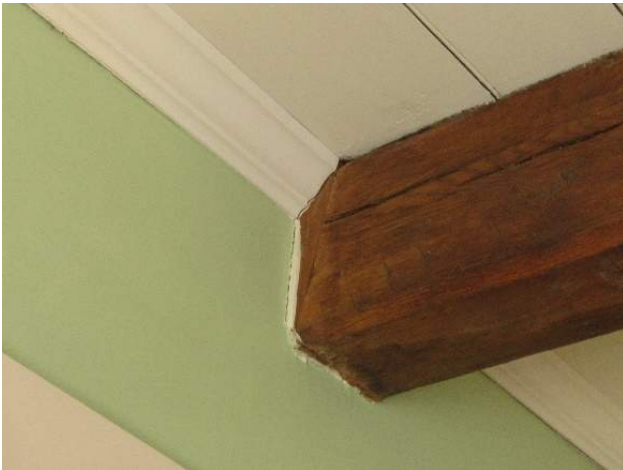
Figure 180. Exposed joist in Room 104 with fill at bearing end.  
(Source: RRJ, 2022)

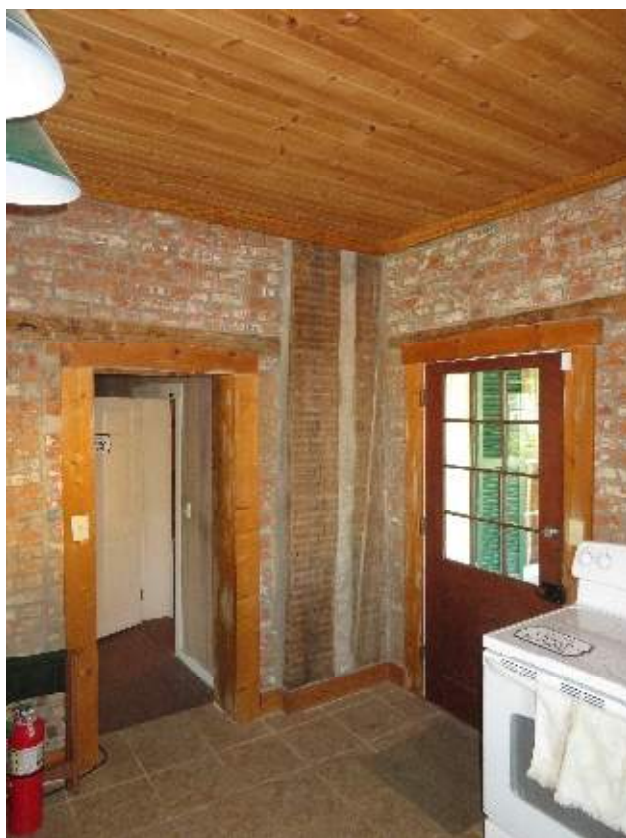
Figure 187. Two exposed vertical logs present within the first-floor kitchen. (Source: RRJ, 2022)

Where visible within the first-floor kitchen, the vertical log wall was observed to be in good condition (Figure 187). The visible surface of these logs would have been the exterior face of the log wall in its original configuration, before the infilling of gallery space to create the current kitchen area. A striping pattern visible at the surface of the logs, in addition to patterns of empty nail holes along the height of the vertical log, indicates the presence of a previous lath finish at this wall. The top plate and sill plate of the wall were not visible, nor could the composition of wall infill material be determined at this location. A relatively modern parge coating is present between the two vertical logs at present.

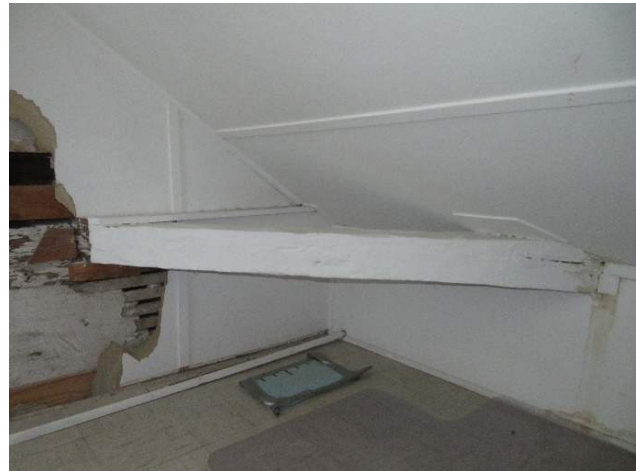
Top plate braces were observed to be in fair condition. Braces within rooms 208, 205, and 206 exhibited light checking, and evidence of water infiltration resulting in stained interior finishes was observed near brace connections within Rooms 208, 203, and 206. It is possible that over time, exposure of vertical log and brace members to water may hasten deterioration mechanisms such as fungal decay and/or pest damage.

Figure 188. Top Plate Brace at Northeast (Room 208). (Source: RRJ, 2022)

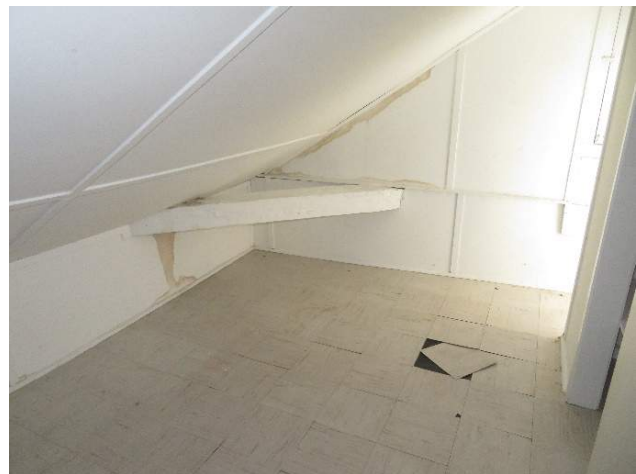
Figure 189. Top Plate Brace at Southeast (Room 203). (Source: RRJ, 2022).

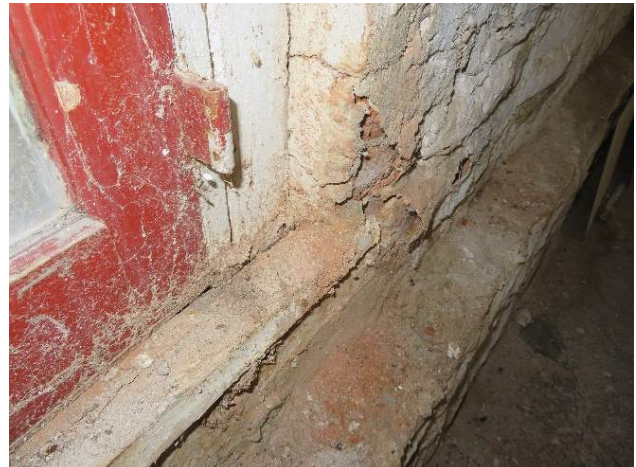
The basement walls are brick masonry with a plaster finish. The plaster finish has failed in most rooms, and severe brick deterioration was noted in many locations within all rooms. Moisture-related brick decay was noted at the perimeters of the foundation wall windows. A combination of exterior moisture infiltration and interior coatings has led to the disintegration of many window perimeter bricks. The south wall in Room 010 appeared to be finished in a cementitious parging.

Figure 190. Moisture related brick decay at basement window; typical along east wall. (Source: RRJ, 2022)

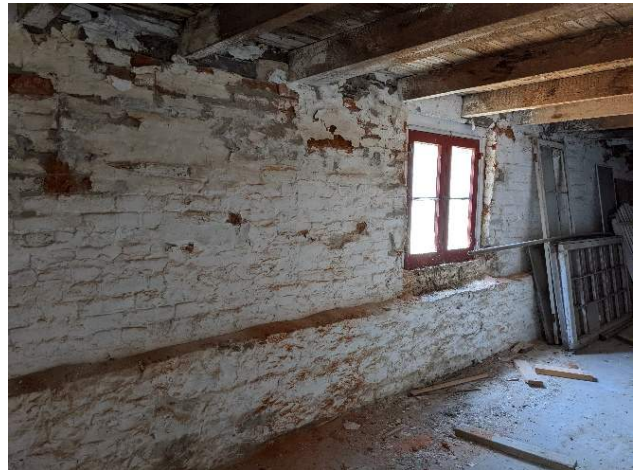
Figure 192. Failed plaster and brick decay at east wall of basement. (Source: RRJ, 2022)

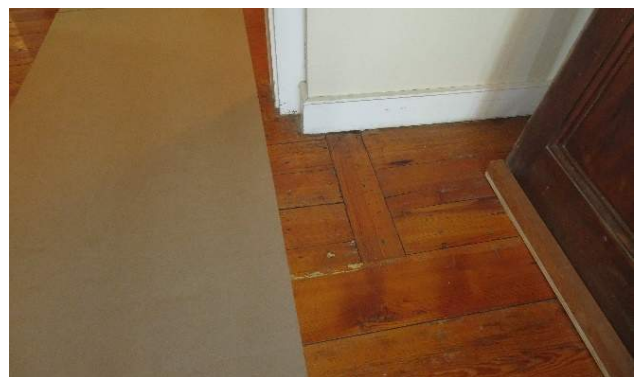
The existing floor is finished with tongue-and-groove wood planks of varying widths running north to south. Evidence of a former partition wall running east to west is present through the middle of the hall where smaller wood planks have been infilled in the flooring. The flooring is in good condition, but there is evidence of mild moisture damage near the baseboard at the south wall. Loose floor boards approximately 2-feet from the entry door cause a squeaking noise when walked on.

Figure 194. Evidence of former partition wall in Room 101 . (Source: RRJ, 2022).

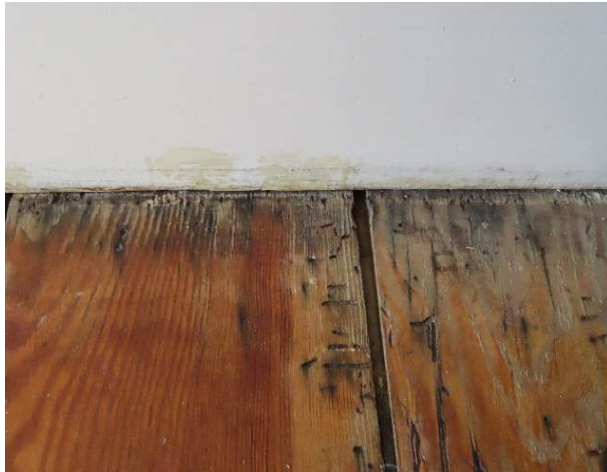
Figure 196. Mild moisture damage of flooring in Room 101. (Source: RRJ, 2022).

The room had six-inch baseboards that were notched 1/2-inch from the top and ogee style ceiling moulding. Simple moulding was present around the doorways with the top molding forming a slight pediment. All the moulding in the room was painted white. The mouldings are in good condition, but discolored, scuffed paint is present on the baseboards throughout the room. Peeling paint is present on the baseboard along the south wall above the moisture damaged flooring.

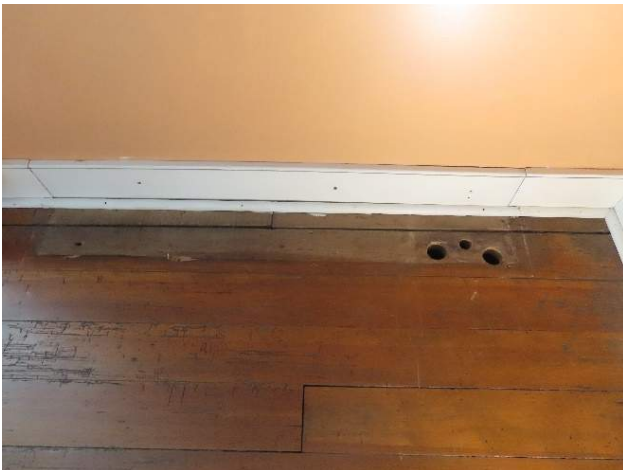
The existing flooring was tongue-and-groove wood planks of varying widths running north to south. The flooring is in good condition. Carpet mats were placed over typical walking paths to protect the wood flooring. Three small holes have been drilled into the flooring at the southeast corner of the room. These likely permitted piping from the basement to reach a radiator for heating the room.

Figure 201. Penetrations in flooring likely from previous radiator. (Source: RRJ, 2022).

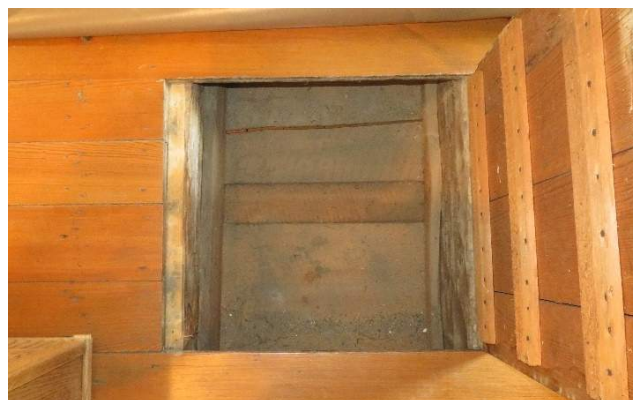
The existing flooring was tongue-and-groove wood planks of varying widths running north to south. The flooring is in good condition. Carpet mats were placed over typical walking paths to protect the wood flooring. Three small holes have been drilled into the flooring at the northwest corner of the room. These likely permitted piping from the basement to reach a radiator for heating the room. A small, concealed storage space was located below the floor planks in this room. Portions of the flooring were cut and anchored with hinges to provide access to the space.

Figure 205. Concealed storage space below floor planks in Room 104. (Source: RRJ, 2022).

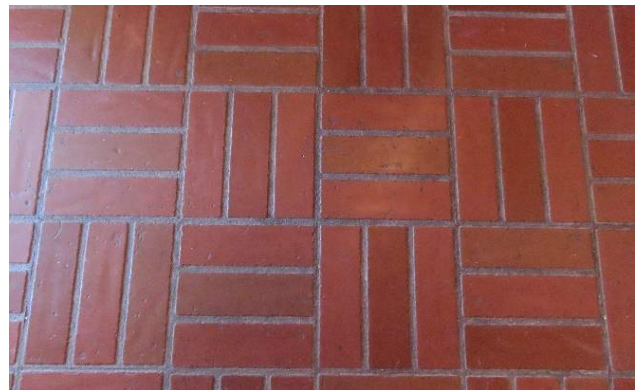
The existing flooring was red faux brick linoleum tile set in a basket weave pattern with grey grout (Figure 211).

Figure 211. Basketweave flooring pattern in Room 107. (Source: RRJ, 2022).

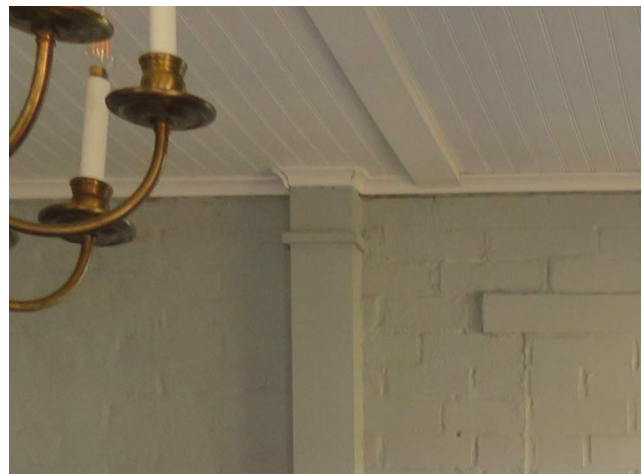
Figure 215. Room 108, looking north, showing detail of a portico column. The banding detail is the lower part of the column in the image below. (Source: RRJ, 2022)

Evidence of the 1880s portico can be seen on the north wall of the sunroom, where two of the original portico columns are partially intact (Figure 215). The

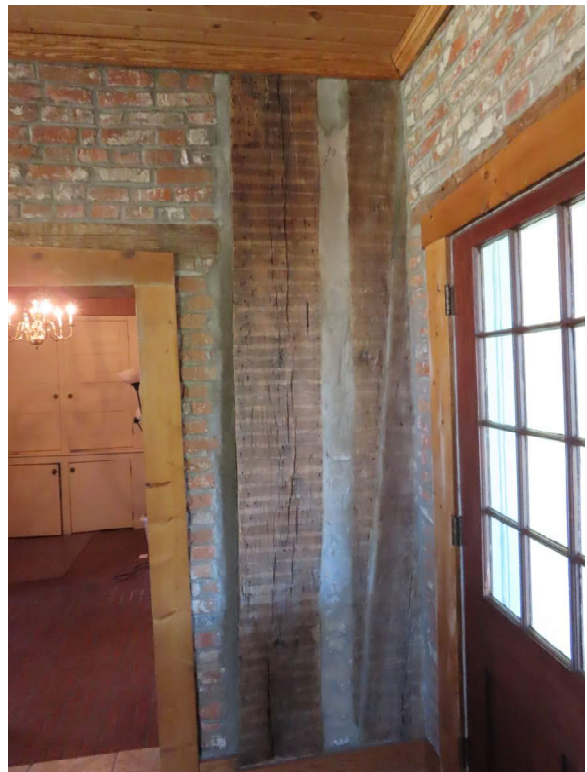
Figure 219. Exposed vertical logs in the southeast corner of the kitchen. (Source: RRJ, 2022).

At the southeast corner of the kitchen, where the c. 1862 structure intersects with the c. 1794 structure, there are two exposed vertical logs and infill parged with a cementitious coating. Evidence of removed wood lath is visible as ghosting on the logs. This is the only location on the first floor where the vertical logs are exposed.

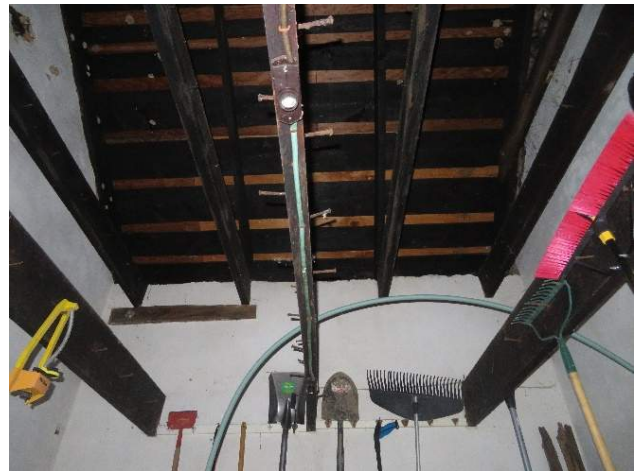
No ceiling finishes are present in this room, exposing wood rafters and ceiling joists.

Figure 220. Exposed roof structure within Room 110. (Source: RRJ, 2022)

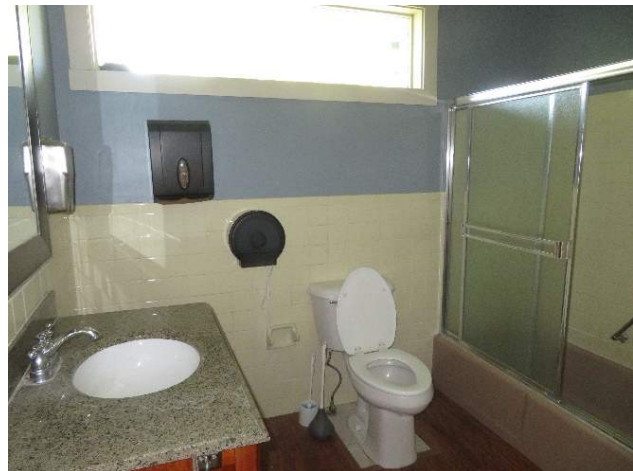
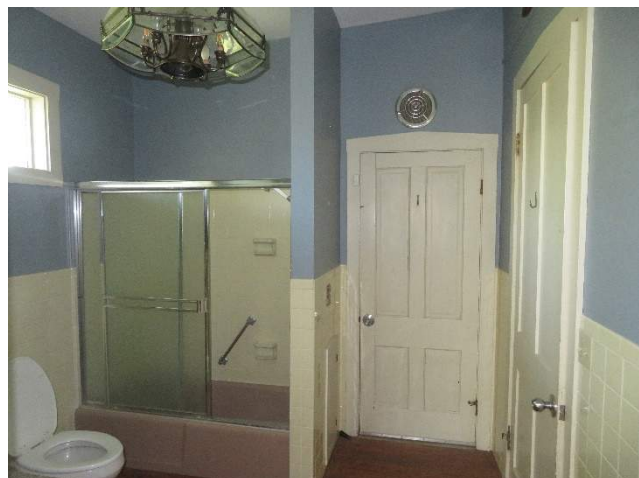
The walls in Room 112 have 49-inch-high tile wainscoting composed of 4x4-inch square field tiles and painted plaster walls for the upper portion of the walls. The field tiles are cream with grey speckles and are set in off-white grout. Bullnose 2x6-inch trim tiles are used to border the top of the wainscoting. Some of the tiles are cracked and grout is missing at isolated

locations. Evidence of the vertical log wall top plate may be visible though changes in interior over the door shared with room 104.

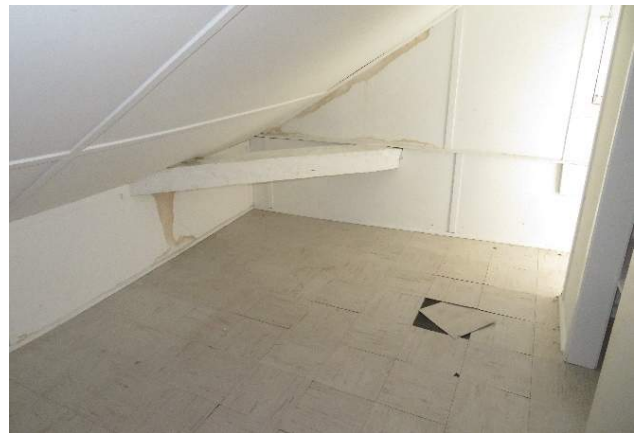
The existing flooring is 12x12-inch linoleum tile. The linoleum tiles are loose and cupping in several locations.

Figure 231. Debonded linoleum tile flooring in Room 203. (Source: RRJ, 2022)

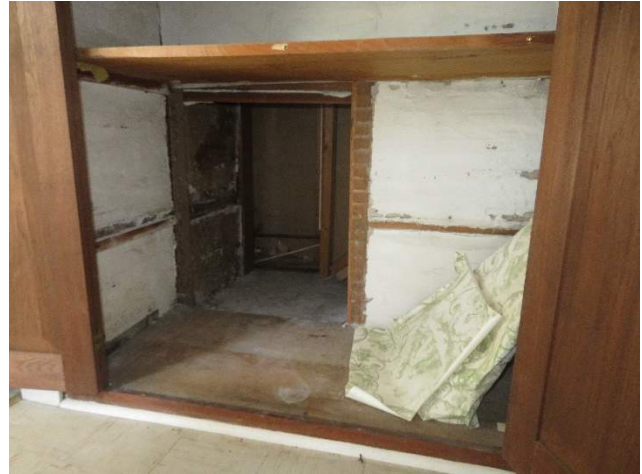
Within the built-in cabinet, a small, concealed storage space is present under the eave. The storage space has plaster walls finished with newspapers dating from 1857 to 1862.

Figure 234. Concealed space with newspapers applied to the walls. (Source: RRJ, 2022)

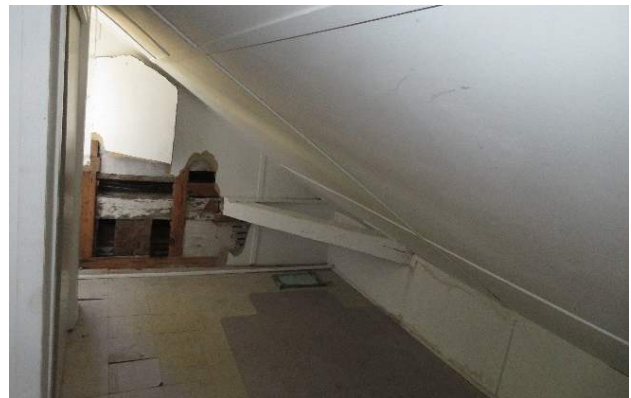
The existing flooring is 12x12-inch linoleum tile. The linoleum tiles are loose and cupping in several locations.

The walls in Room 208 are finished with painted wood paneling. The paneling is painted white. The finishes below the window have been removed exposing the timber framing. There are water stains from previous roof leaks near the timber brace in the northeast corner.

Figure 242. Overview of Room 208 facing north showing failed flooring and water staining. (Source: RRJ, 2022)

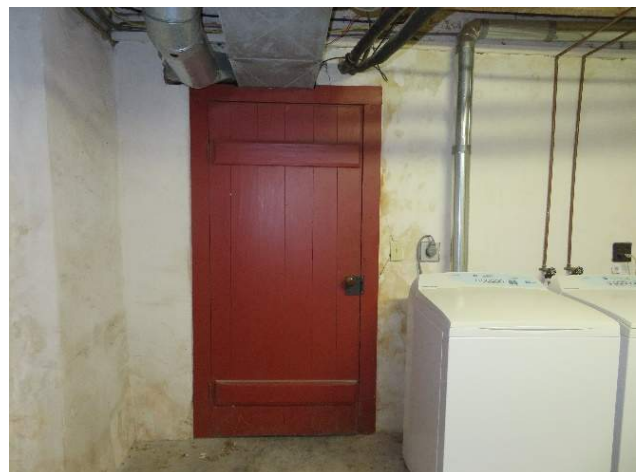
**D002** – Door D002 is a board and batten style door constructed with nails. The door and trim were painted red. A porcelain knob with an old latch was present. The door knob has a "mineral" swirly pattern indicating it could be from the 1880s. The door was operational, and the latch was functional. The door hardware was replaced at some unknown time and was in good condition. The butt hinges, wood and paint on the door were also in good condition.

Figure 244. Door D002 viewed from within Room 002. (Source: RRJ, 2022)

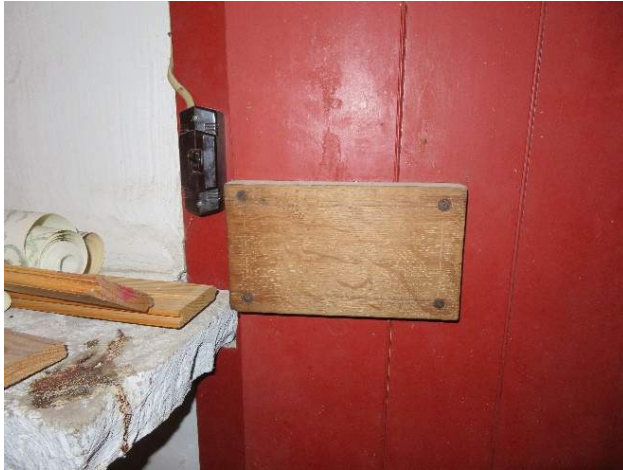
**D006** – D006 is a board and batten door constructed with narrow boards with a beaded detail. The door was painted red. A pull handle that appeared to be from the 1880s was present at the outside face of the door. A wood rim lock was present at the interior face. The door was attached to the frame with butt hinges. Overall, the door was in good condition.

Figure 248. Hardware at Door D006. (Source: RRJ, 2022)

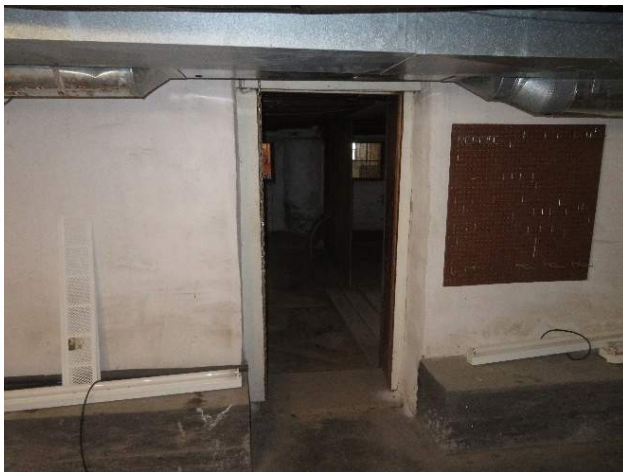
Figure 249. Door D009 has been removed since 1985 HABS documentation. (Source: RRJ, 2022)

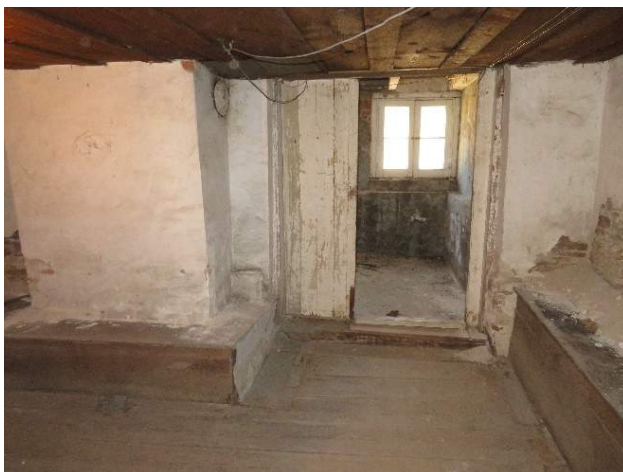
**D010** – No door was present at the D010 location. A door frame was present, and this location likely once contained a door to the original section of the house. The door has been removed since the 1985 HABS documentation.

Figure 250. Door D010 has been removed since 1985 HABS documentation. (Source: RRJ, 2022)

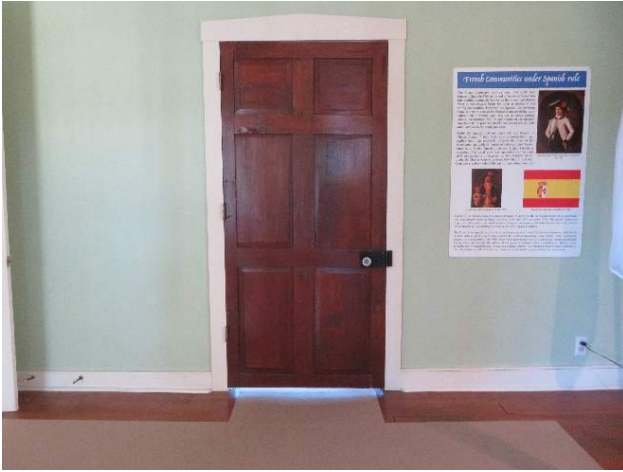
**D104B** – D104B is a stained wood six panel door with raised panels. The appearance of the two middle panels differed from the other panels, indicating that parts of the door may have been previously replaced. A crystal door knob and covered lock were present. Modern replacement brass butt hinges were present. The bottom of the door has been cut down several inches, but overall, the door is in good condition.

Figure 251. Door D104B seen from Room 104. (Source: RRJ, 2022)

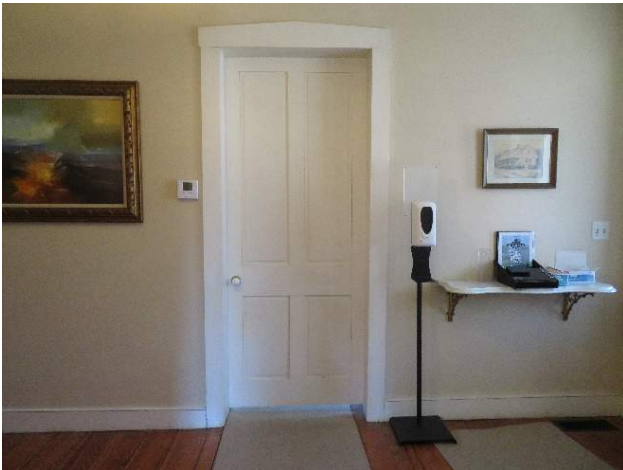
Figure 252. Door D105A seen from Room 101. (Source: RRJ, 2022)

**D105A** - D105A is a four-panel wood door with raised panels. Molding was present at the Room 105 side and unmolded panels were present on the hallway side. The door casing was painted white and had square edges with a pediment. A porcelain door knob and butt hinges, which appeared to be original to the door, were present. Slight separation of the wood at the joints was noted. Overall, the door was in good condition.

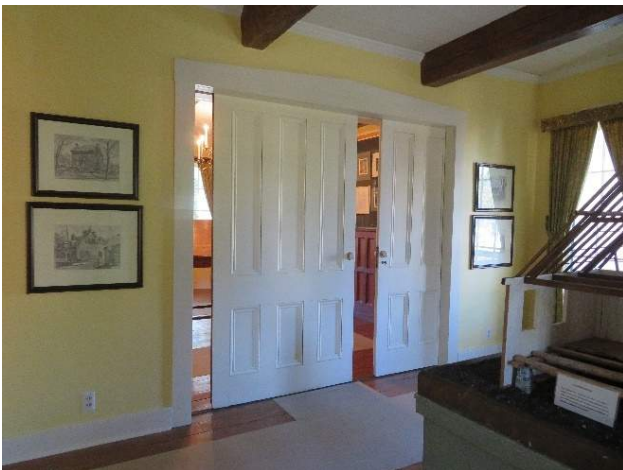
Figure 253. Semi-closed double pocket doors (D105B) seen from Room 105. (Source: RRJ, 2022)

**D105B** – D105B is a double sliding pocket door between Rooms 105 and 106. The pocket doors are fully operational. Floor tracks and porcelain knobs were present. Each door contained six recessed panels. A key was present in the lock. The pocket doors were in good condition.

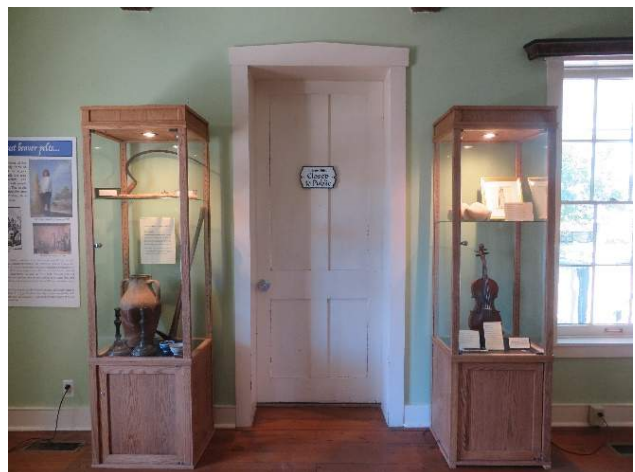
**D112A** – D112A provides access between Room 104 and the bathroom. This door was a four-panel white wood door. The panels were flat on both sides. A modern lockset and handle were present. Square-edge casing with a pediment head was present on both sides of the door. Butt hinges and a door stop were present. Some minor separation of the wood at the joints was noted, but overall, the door was in good condition.

Figure 256. Door 112A seen from Room 104. (Source: RRJ, 2022)

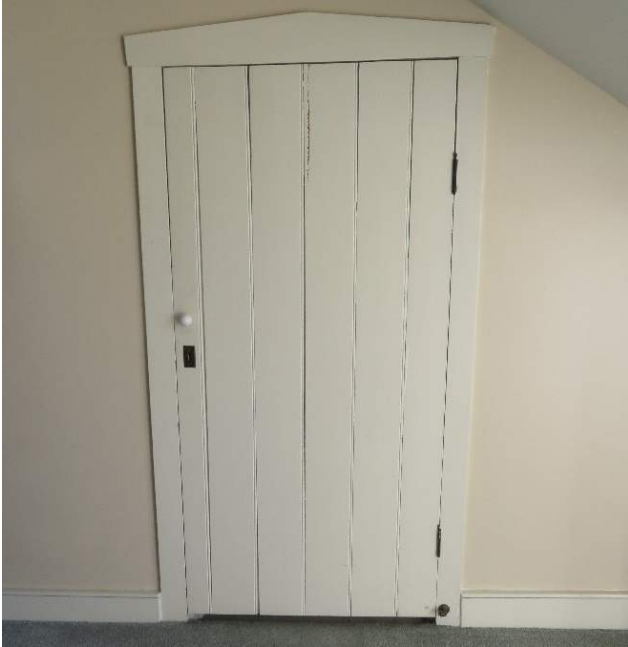
**D201** – D201 is a wood board and batten door that was assembled with flat head screws. The boards of the door were narrow planks of wood with a beaded edge. An exterior porcelain knob, brass key hole, and brass door stop were present. A straight edge casing with pediment head similar to most other doors in the house was present. The door is shorter than most due to the slope of the roof in this location. The door and latch were fully operation. Overall, the door was in good condition.

Figure 257. Door D201 seen from Room 201. (Source: RRJ, 2022)

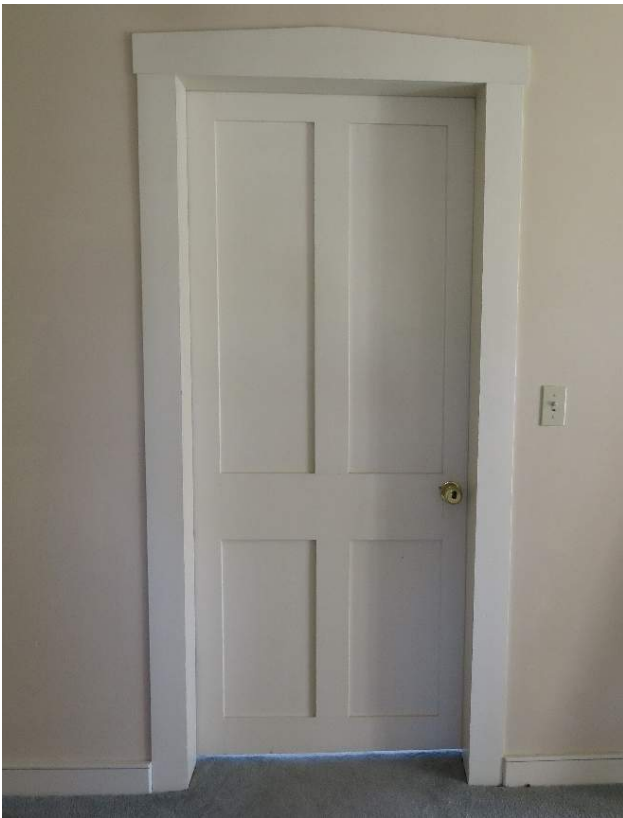
**D204A** – D204A was a white four-panel door with flat panels. Brass butt hinges and modern brass knobs and lockset were present. Typical casing was present. The door was fully operational and in good condition. Based on historical photographs in the Schram Collection at the Felix Vallé State Historic Site, the second-floor bedroom doors may have had glazed transoms which have since been removed, reducing the overall height of the door openings.

Figure 258. Door D204A seen from Room 201. (Source: RRJ, 2022)

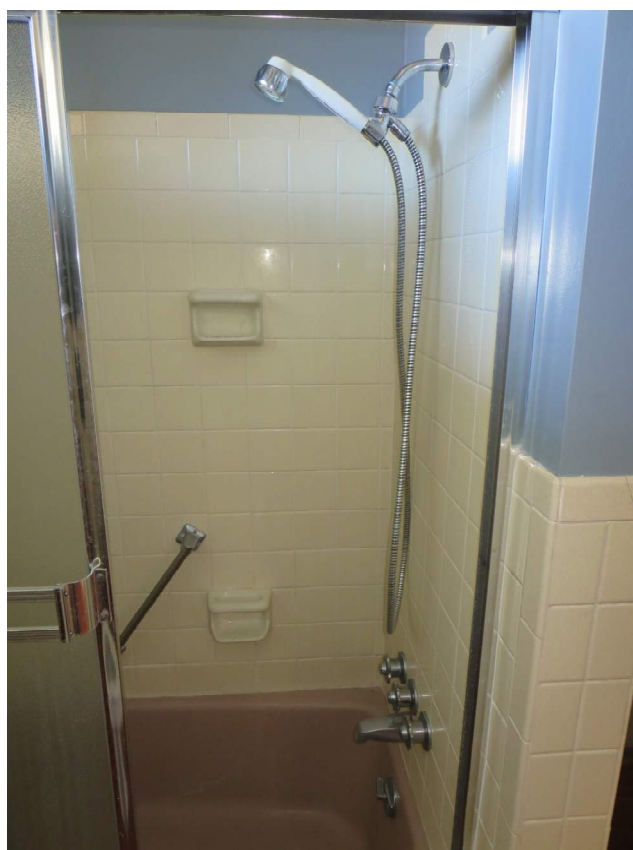
Showers exist on both the first level and second level restrooms. Showers have hand-held shower heads. Both showers do not meet accessibility requirements.

Figure 271. Existing shower at First level restroom. (Source: Alvine, 2022)

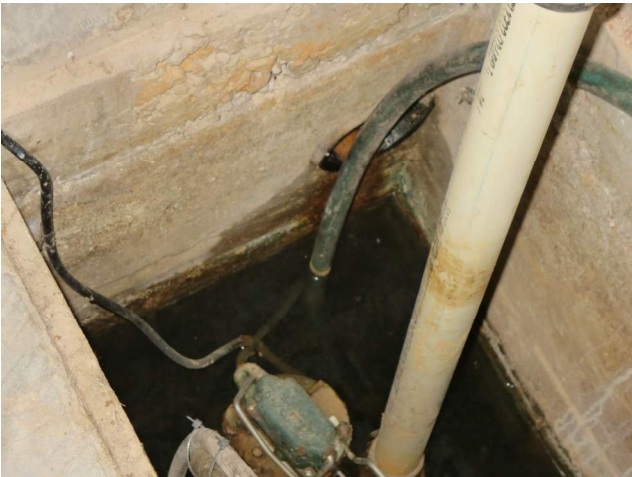
It appears that all of the floor drain piping is connected below the floor with the sanitary line running to the sump pit located adjacent to the washing machine. The drain line discharges into the pit near the southwest corner of the pit (the pipe with the green hose in front of it). The drain lines may need to be cleaned out to ensure their viability to continue to serve the house.

Figure 276. Existing below floor waste piping at the southwest corner of the sump pit where the waste pipe discharges into the pit (drain line with the green hose in front of it). (Source: Alvine, 2022).

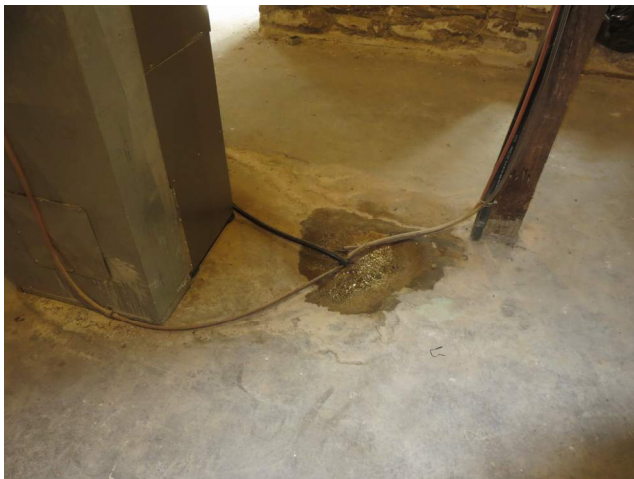
Figure 275. Existing floor drain in the center of the basement level adjacent to the furnace. The drain grate appears to be dirty and partially clogged with debris. (Source: Alvine, 2022).

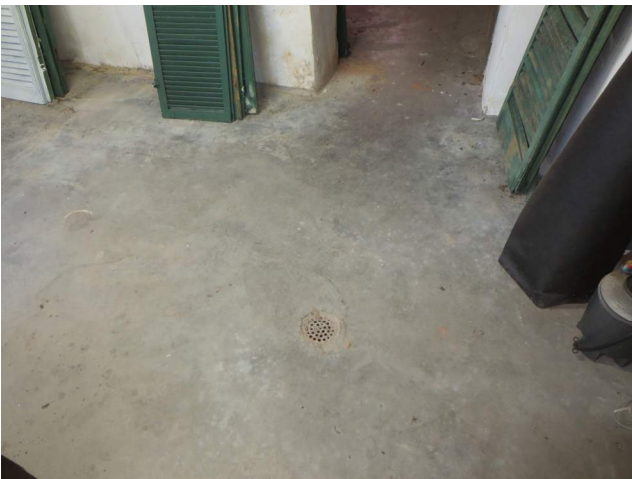
Figure 277. Existing floor drain in the far southwest room of the basement level. The drain grate appears to be dirty and partially clogged with debris. (Source: Alvine, 2022)

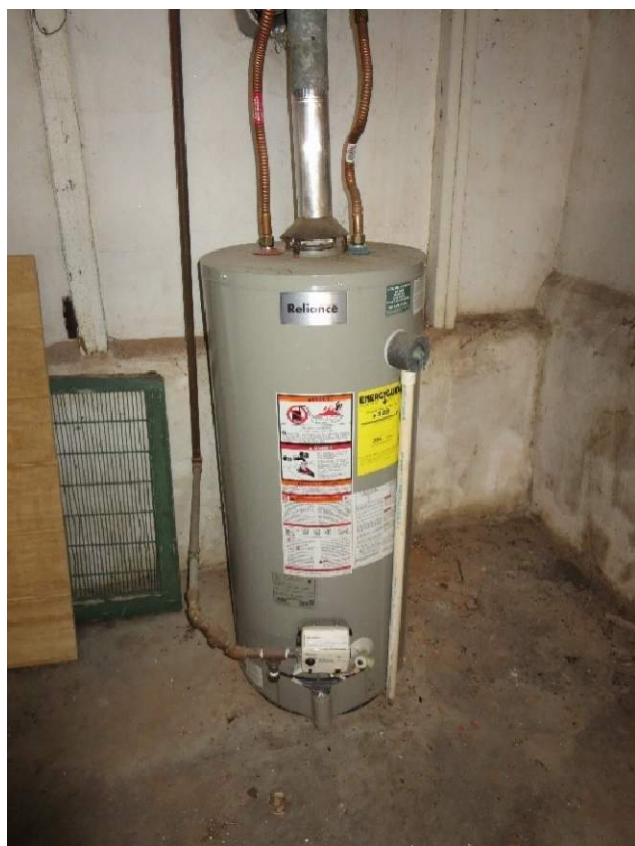
With the water heater being 10-years old, it appears to be in good condition with no signs of tank deterioration or leakage. Based on this assessment, it is estimated that it could continue to serve the house for another 10 years before it would be considered for replacement. Gas-fired water heaters have a 20-year life expectancy under normal use, so it has only reached half of its expected lifespan.

A single, Reliance model number 640GORS 300, gas-fired water heater is located at the basement level. The water heater is a 40-gallon storage size with a 36.33 gallons per hour (GPH) recovery capacity with a 35,500 Btuh gas input. The water heater is only 12-years old as it was manufactured in 2012.

Figure 282. Existing gas-fired water heater located at the basement level. (Source: Alvine, 2022)

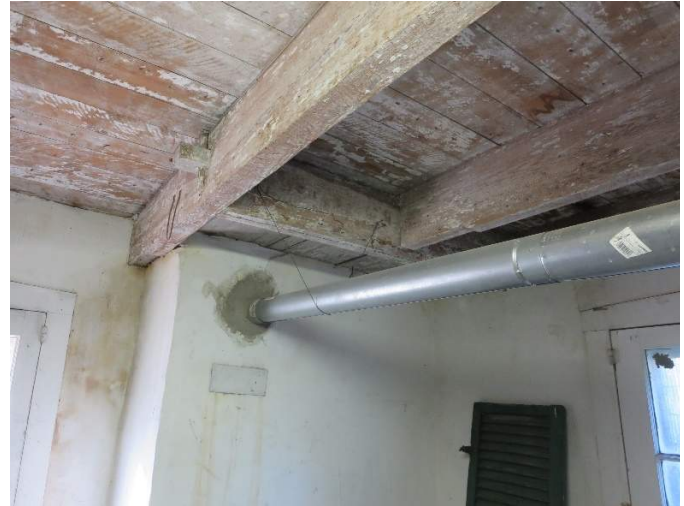
Figure 285. The water heater flue continues to the south where it connects to an existing chimney. (Source: Alvine, 2022)

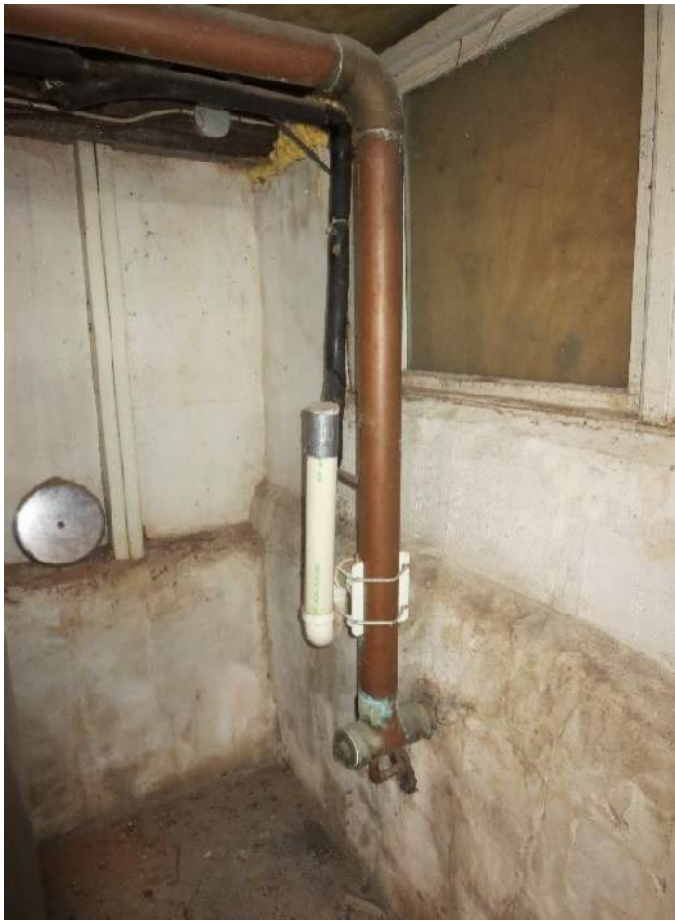
The house sanitary sewer lines are comprised of different piping materials. These include hub and spigot cast iron, copper DWV and polyvinyl chloride (PVC) piping. All of the sanitary sewer piping exits the house on the west side with piping exiting in multiple locations.

Figure 286. The main sanitary sewer piping exiting the building is copper DWV piping as indicated in the above photo. (Source: Alvine, 2022)

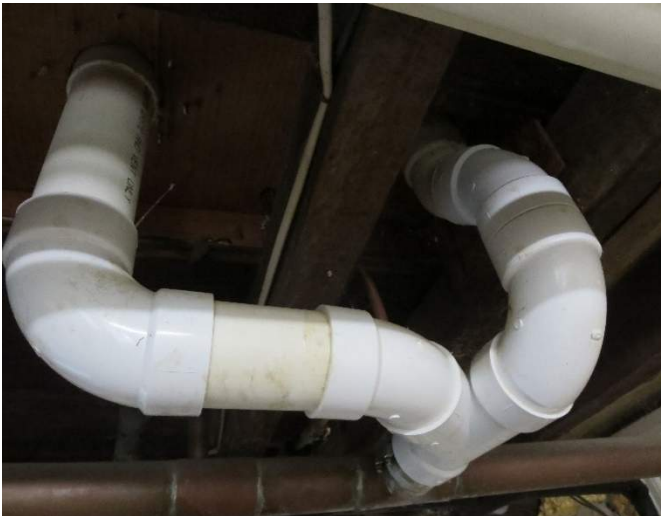
Figure 287. There are portions of the building which have PVC sanitary waste piping connected to the copper DWV piping as indicated in the above photo. (Source: Alvine, 2022)

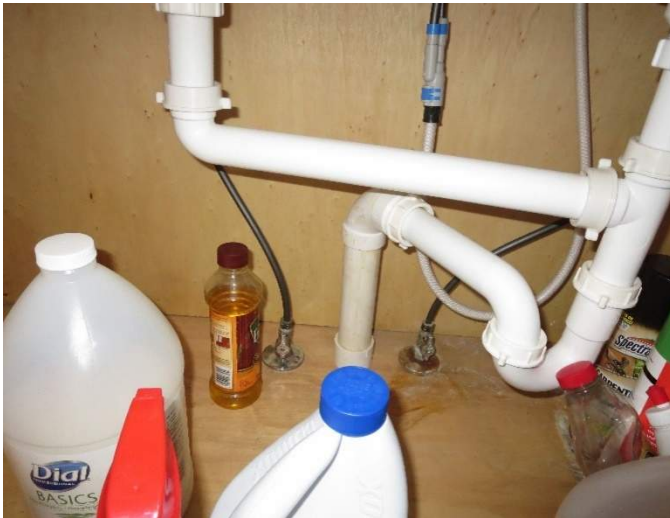
Figure 288. Existing sanitary waste piping below the kitchen sink is PVC. (Source: Alvine, 2022)

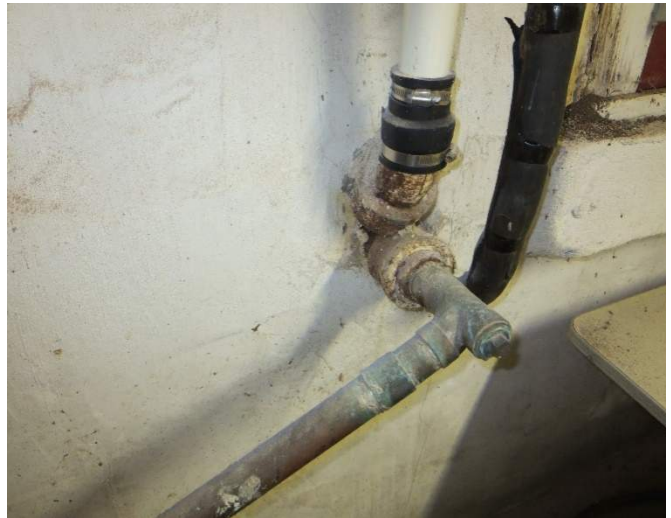
Figure 289. At the north end of the basement level there is a copper DWV sump pump discharge pipe and PVC waste piping (white pipe) which connect to hub and spigot cast iron pipe before exiting the house through the wall. (Source: Alvine, 2022)

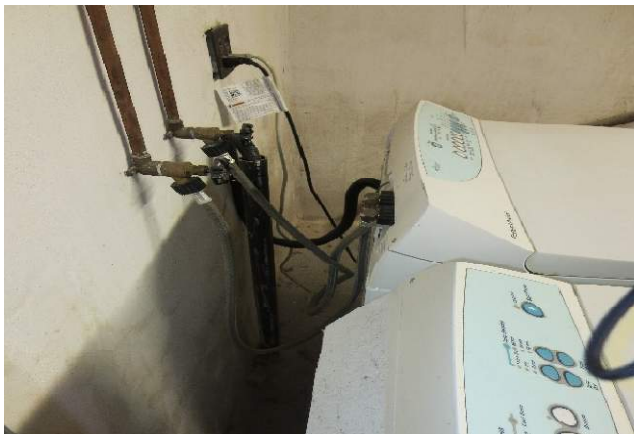
Figure 294. Existing washing machine waste piping discharging into a PVC standpipe behind the washing machine. (Source: Alvine, 2022)

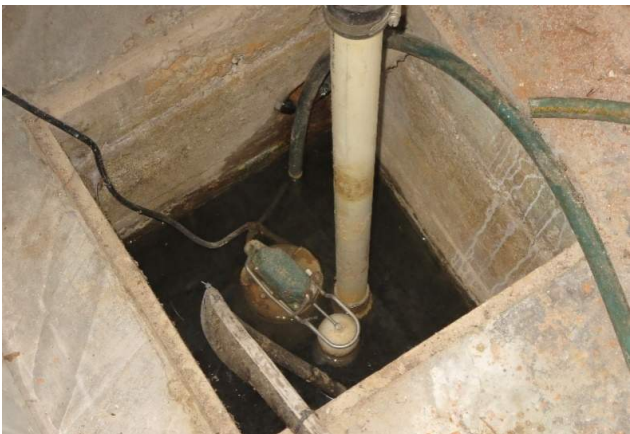
Figure 295. The PVC standpipe routes under the floor to a concrete pit where a sump pump is located. (Source: Alvine, 2022)

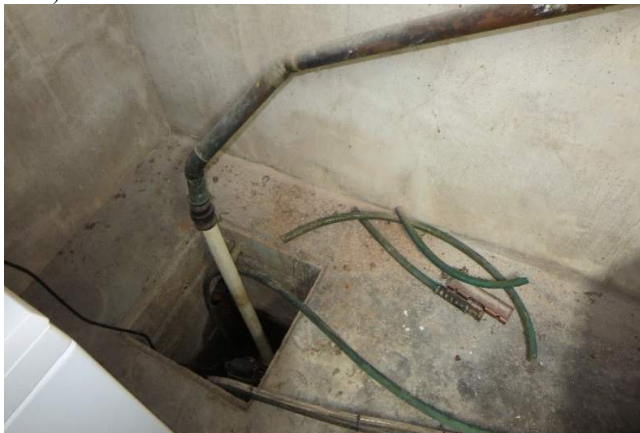
Figure 296. The sump pump has a PVC discharge pipe which is connected to copper DWV piping. (Source: Alvine, 2022)

waste water over to a cast iron pipe existing the house at the west wall. This pump should be cleaned and checked for operation to ensure reliability.

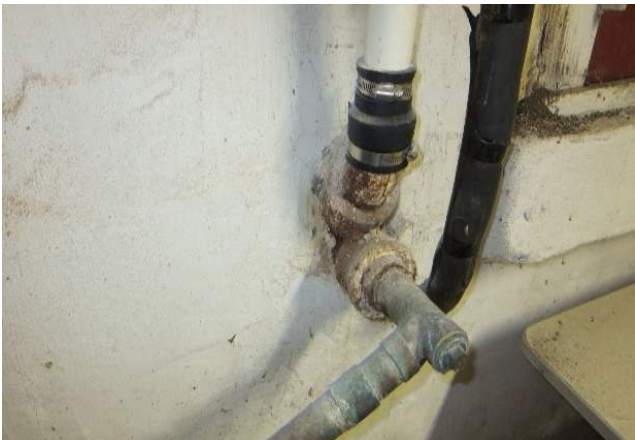
Figure 297. The existing copper DWV waste piping then connects to a cast iron hub and spigot drain line which exits the west wall of the basement level. (Source: Alvine, 2022)

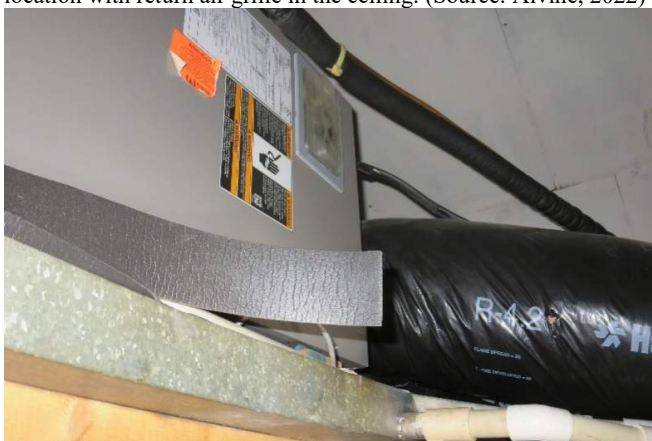
Figure 312. Existing Second level electric furnace with sheet metal pan below. Note the PVC drain line from the pan. (Source: Alvine, 2022)

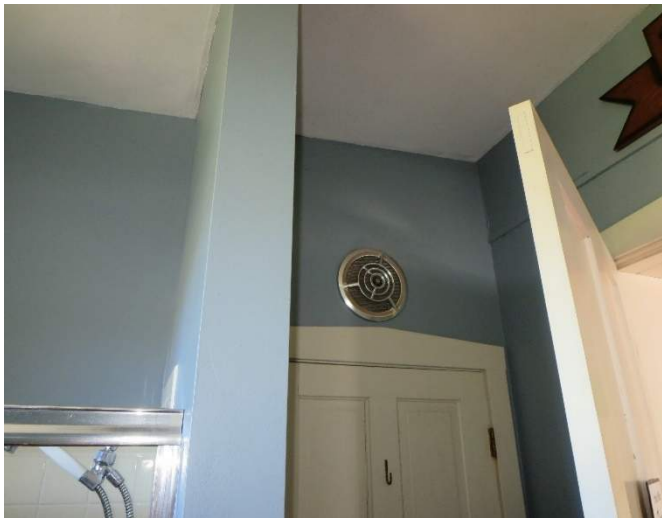
At the north wall of the interior first floor restroom, there is an old exhaust fan located in the wall above an existing exterior door to the west deck. It is unknown if this fan still operates and if it is ducted in the wall beyond the fan as there is no exhaust grille at the exterior side of the wall. Operation should be verified to make sure there are no issues regarding exhaust.

Figure 329. First level restroom wall exhaust fan. (Source: Alvine, 2022)

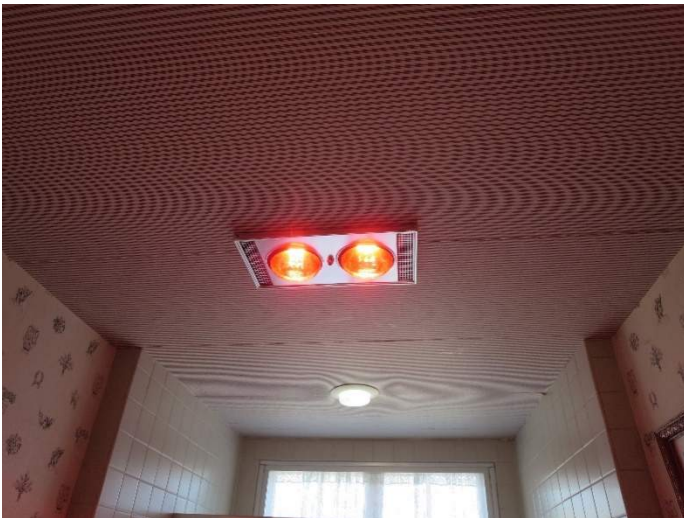
The restroom at the second level has a combination heat lamp / exhaust fan unit at the ceiling of the room. It is assumed that the exhaust fan operates as the heat lamp currently operates. Operation should be verified to make sure there are no issues regarding exhaust.

Figure 330. Second level restroom ceiling exhaust fan/heat lamp. (Source: Alvine, 2022)

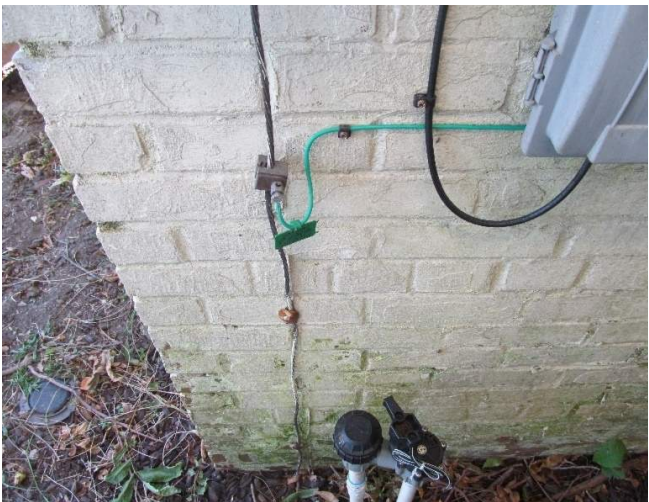
From the 200-amp meter socket, a bare #6 American Wire Gauge (A.W.G), copper grounding conductor is routed down to a driven ground rod. The grounding conductor is not installed in conduit.

Figure 341. Grounding from electrical meter socket and telephone cable termination box down to a ground rod. (Source: Alvine, 2022)

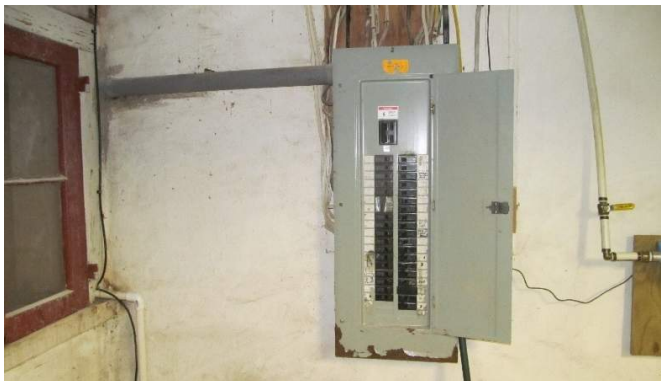
pole branch breakers. The branch breakers are manufactured by Challenger with a 10,000 A.I.C. rating. There are four blank spaces for future breakers. The exterior of the panel has rust on it.

Challenger electrical load centers were manufactured from 1973 through the 1990s. Challenger products are currently discontinued.

Figure 342. 240/120-volt, 200-amp load center in basement. (Source: Alvine, 2022)

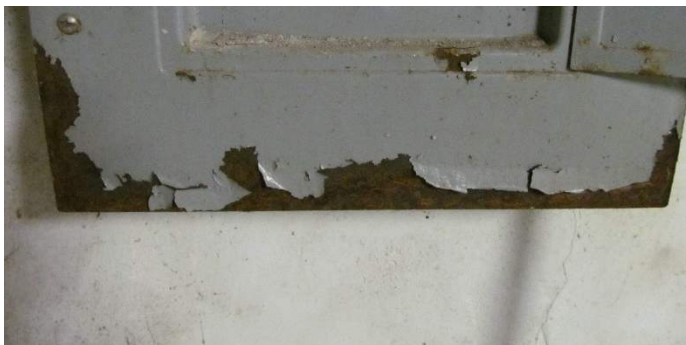
Figure 343. Rusting on load center. (Source: Alvine, 2022)
