# Jean Baptiste Vallé House

STE. GENEVIEVE NATIONAL HISTORICAL PARK  
STE. GENEVIEVE, MISSOURI

## Historic Structure Report

PMIS 311236  
OCTOBER 2024

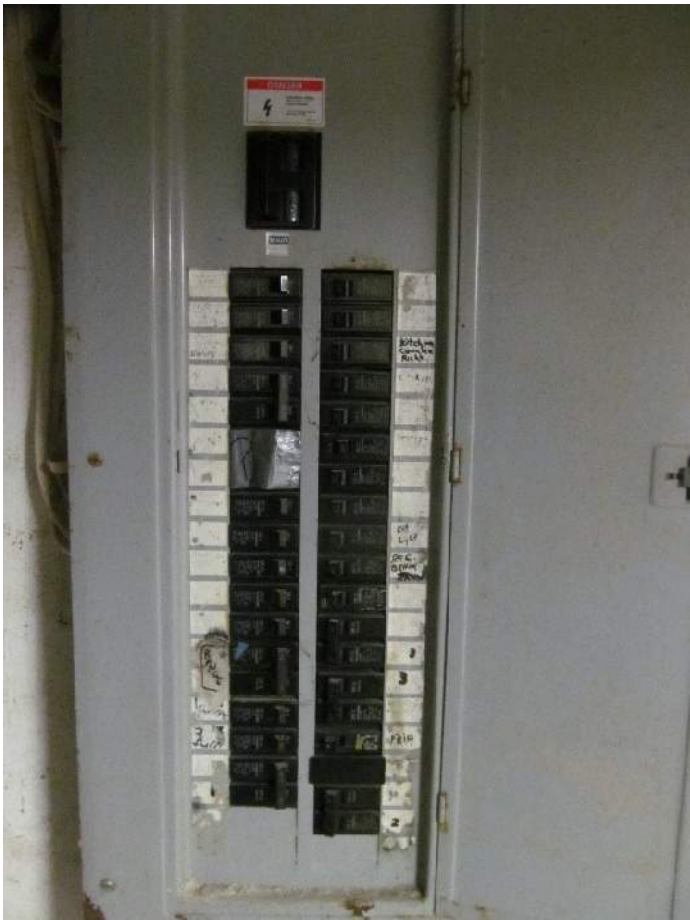
The circuit directory for the load center is marked next to each individual breaker. Some labels are difficult to read.

Figure 345. Circuit load marked next to each circuit breaker in load center. (Source: Alvine, 2022)

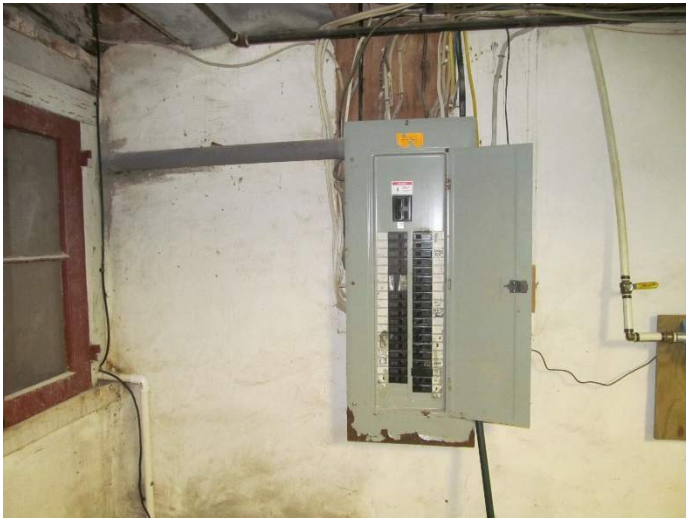
There is no visible grounding electrode connection from the electrical load center to a metallic water pipe or to a ground rod.

Figure 346. There is no visible grounding electrode connection visible from load center. (Source: Alvine, 2022)

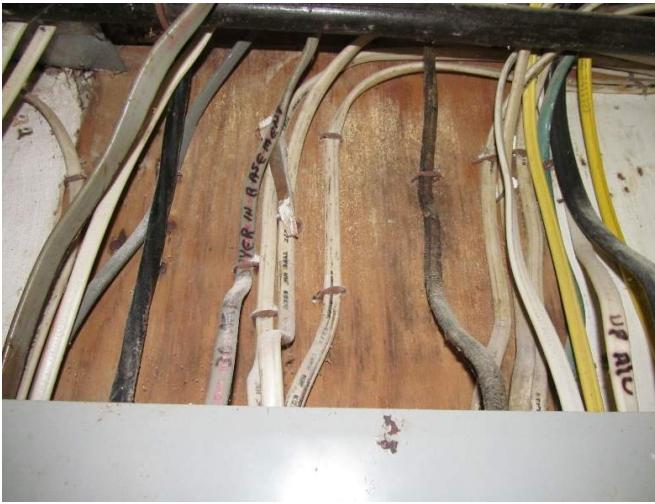
There was on short piece of cloth-covered NC cable that is older than 60 years that has two #14 A.W.G. phase and neutral conductors with no equipment grounding conductor. This cable was visible in the basement between the load center and a splice to a newer NM cable 10 feet away.

Figure 349. Non-metallic sheathed (NM) cable and cloth covered NC cable originating from top of load center. (Source: Alvine, 2022)

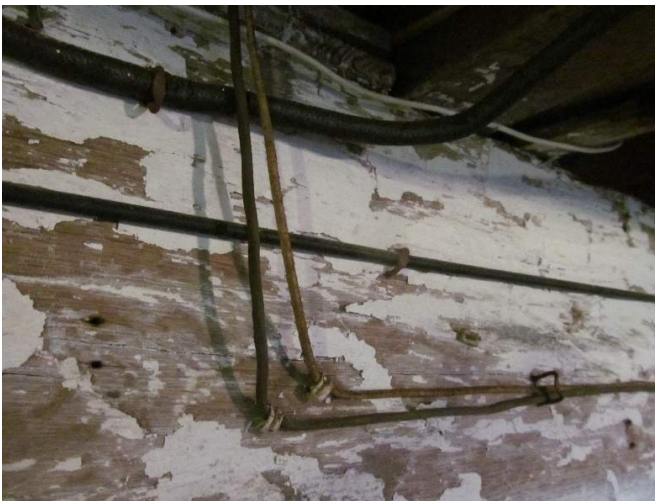
Figure 351. An older, cloth-covered cable in the basement. (Source: Alvine, 2022)

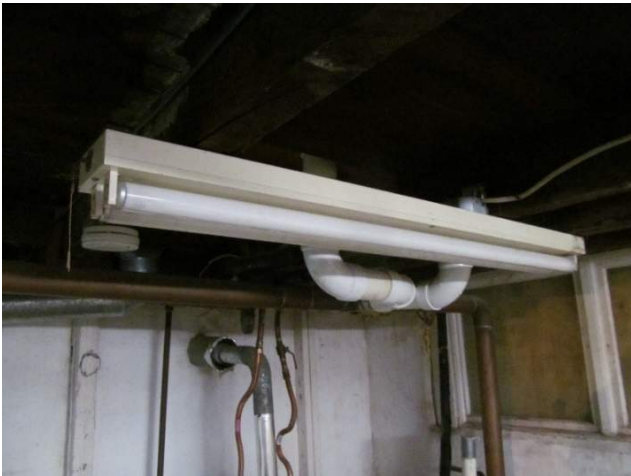
The lighting fixtures on the second floor and hall on the second floor are higher-end, incandescent-type. The lighting fixtures in the four closets are outdated, older, fluorescent type. The lighting fixtures in the bathroom are older, low-end, incandescent, residential type. The following rooms on the second floor have these types of lighting fixtures:

Figure 352. Fluorescent 4-ft. strip light in basement. (Source: Alvine, 2022)

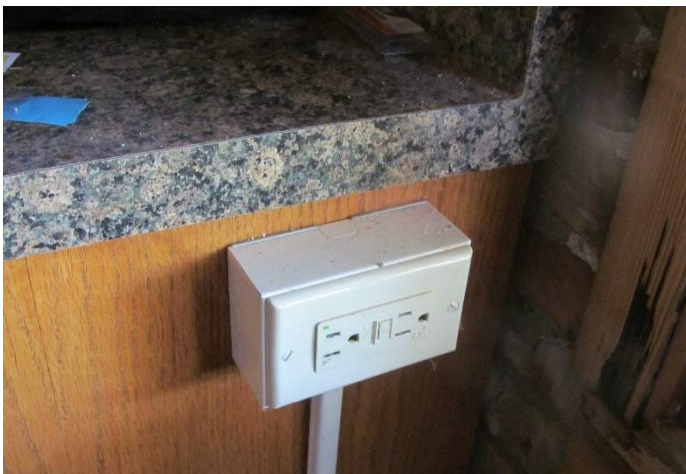
Figure 365. Double-duplex, non-grounded, 120-volt receptacle in north storage room in basement. (Source: Alvine, 2022)

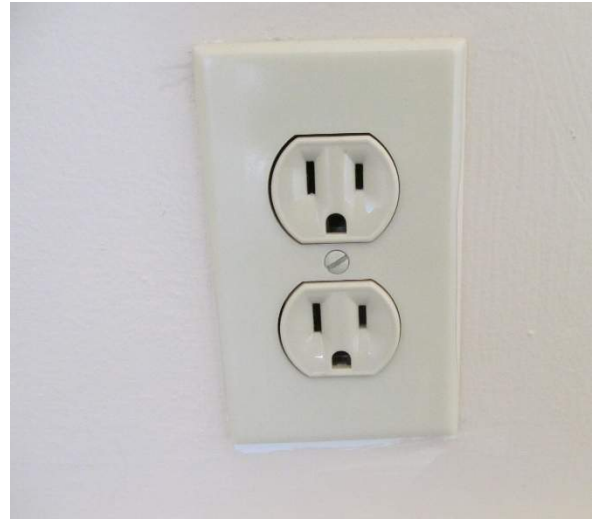
Figure 368. Double-duplex, non-grounding, 120-volt receptacle in the living room on first floor. (Source: Alvine, 2022)

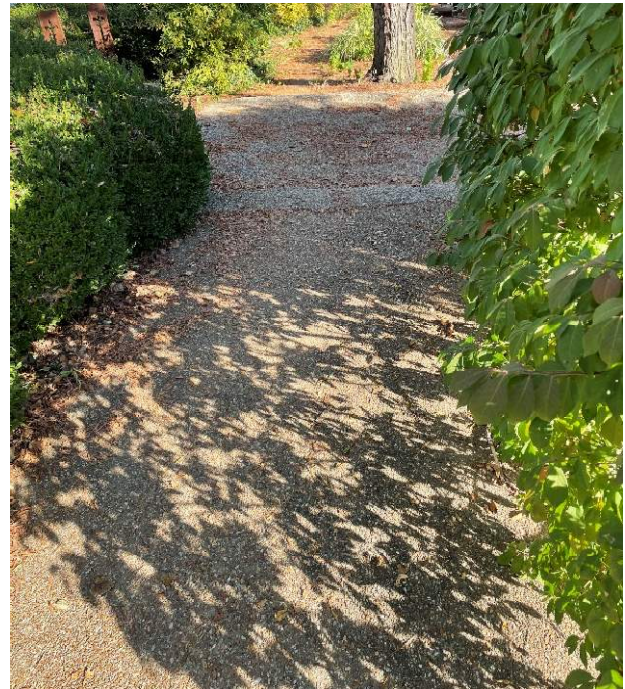
Figure 375. View of the existing ramp adjacent to the accessible parking space in the welcome center parking lot, which does not meet accessibility standards. The parking space striping was also not clear at the time this photograph was taken. (Source: LSHLA, 2022)

Within the parking area, there is a sign marking the location of a single accessible parking space. However, at the time field investigations were conducted on behalf of the HSR, the space was covered with leaves and the white painted lines delineating where to park and how to reach the adjacent walk were not visible.

A ramp extending from the striped margin of the accessible parking space to the walk leading to the welcome center also did not comply with ABAAS because it did not include at least 4 feet of a level landing to allow for someone in a wheelchair to navigate the turn from the ramp to meet the grade of an adjacent walk, which must be a minimum of 4 feet in width. These features are not in place to allow visitors to reach the sidewalk on Market Street (Figure 375 and Figure 376). Once visitors have reached the fully accessible welcome center plaza from the Market Street sidewalk, an accessible ramp is provided to the front door of the building, allowing for an accessible entrance.

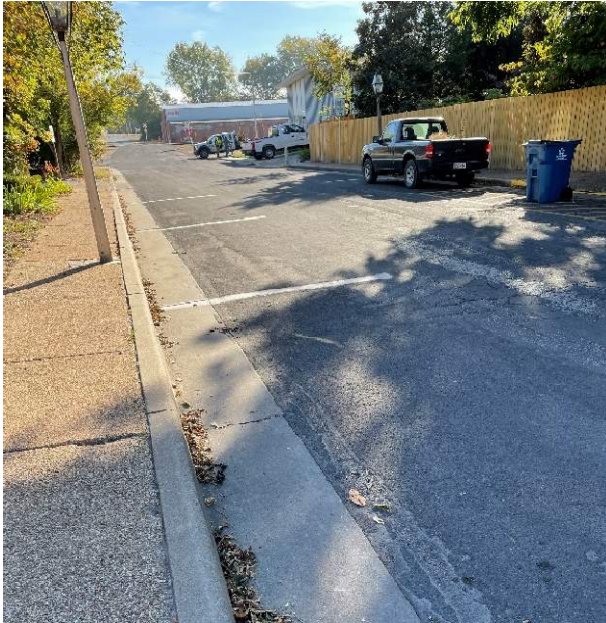
Figure 376. View to the connecting walkway that needs to be reached via an accessible ramp and level landing at grade. (Source: LSHLA, 2022).

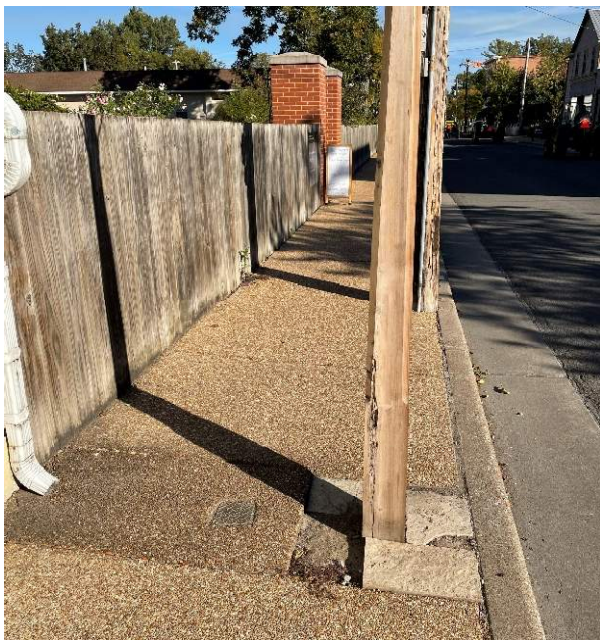
Figure 377. View of the sidewalk along Market Street that leads to the Ste. Genevieve Welcome Center and the Jean Baptiste Vallé House, with a lamp post limiting available space for wheelchair access. (Source: LSHLA, 2022)

Additional challenges to accessibility once visitors reach the sidewalk along Market Street, which provides access to the Jean Baptiste Vallé House, include the presence of power line poles and lamp posts set within the walk itself that reduce the clear passage space below the minimum requirement of 4 feet in width and render them impassable for a wheelchair (Figure 377 and Figure 378).

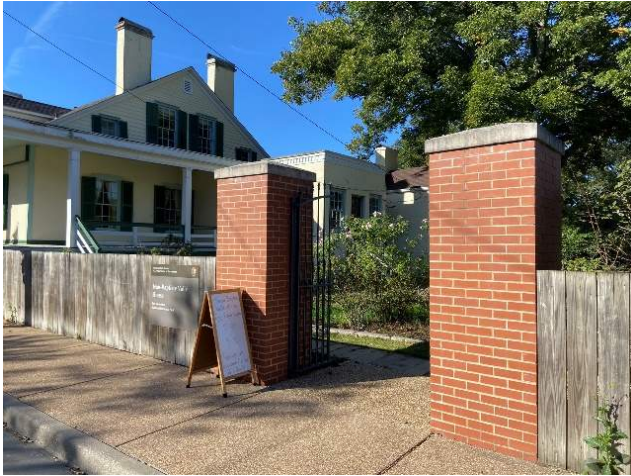
Figure 378. View along the sidewalk on South Main Street toward the brick piers that mark the entrance into the Jean Baptiste Vallé House property and features limiting accessibility that include a lamp post, power pole, and gutter. (Source: LSHLA, 2022).

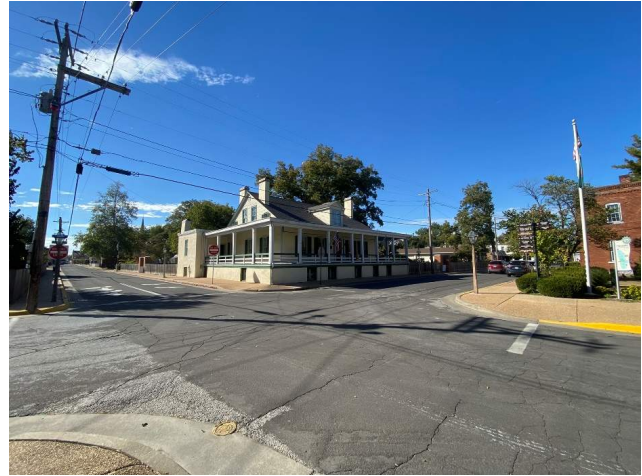
Figure 379. View toward the South Main Street entrance into the Jean Baptiste Vallé House property and the concrete landing that leads to a pathway within the parterre garden . (Source: LSHLA, 2022)

There are two entrances into the Jean Baptiste Vallé House property, one on the South Main Street sidewalk (Figure 381 and Figure 379) and the other on the Market Street sidewalk. Neither complies with ABAAS.

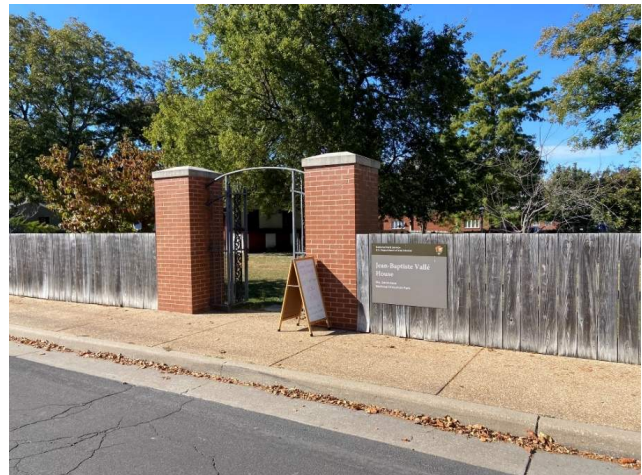
Curb cuts are another feature that can facilitate or interfere with accessibility within the landscape. Within the vicinity of the welcome center and the Jean Baptiste Vallé House there are several curb cuts near the intersection of Market and South Main Streets (Figure 380). These do not facilitate access to the Jean Baptiste Vallé House because while there is a curb cut that allows visitors to cross Market Street from the South Main Street sidewalk at the corner of the Jean Baptiste Vallé House property leading south, there is no curb cut on the opposite side of the street. There are also no curb cuts along the South Main Street sidewalk adjacent to the east façade of the house, including near the main visitor entrance into the property. Evaluation of the locations and accessibility of the existing curb cuts in the vicinity of the Market and South Main Street intersection and routes leading to the entrance into the Jean Baptiste Vallé House needs to be undertaken to ensure visitor safety, compliance with accessible design

Figure 380. View of the intersection of Market and South Main Streets where the curb cuts need evaluation in order to ensure accessible routes are available to visitors from the accessible parking space at the welcome center to the Jean Baptiste Vallé House entrance. (Source: LSHLA, 2022)

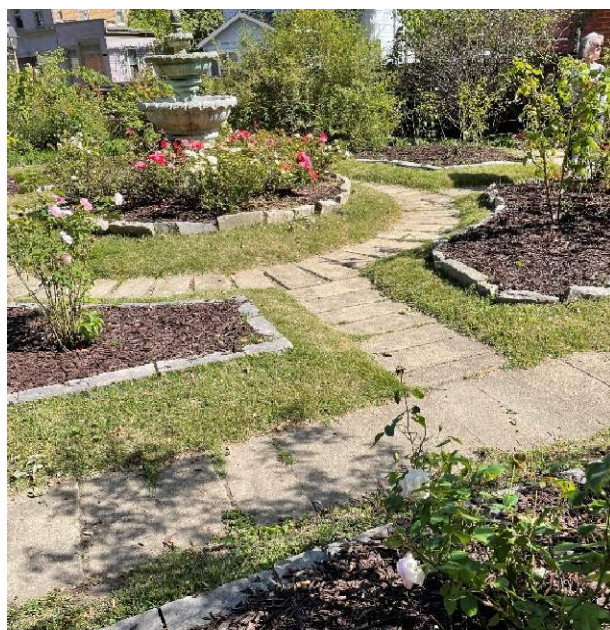
Figure 384. View of the intersection of the cut-stone walkways, their deteriorated condition, and the staircase leading to the west porch. The existing conditions interfere with an accessible route to the west entrance of the house. (Source: LSHLA, 2022)

Also, as the walk passes through the gate, the paving stone is raised 3 inches above grade, prohibiting accessible passage from the grape arbor to the landing at the west porch steps (Figure 384).

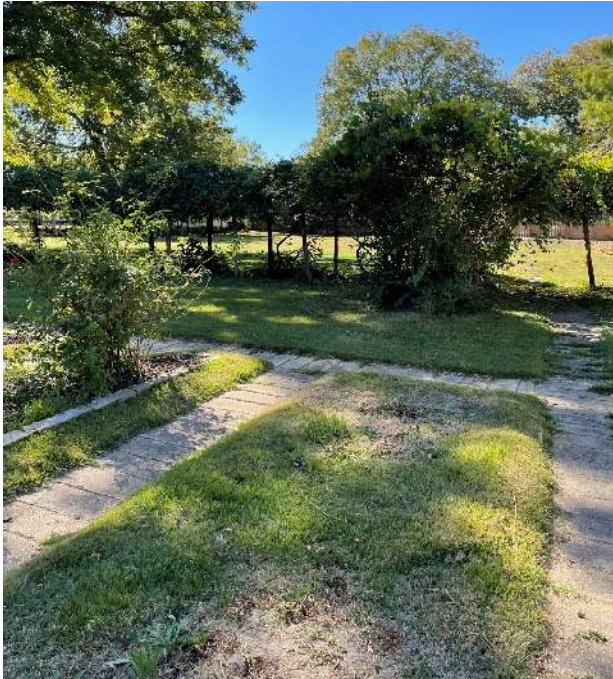
Figure 386. The pathway under the arbor (looking south) is paved with cut stones. It is overgrown with grass and groundcovers. The NPS has closed this path to visitors due to the condition of the arbor. (Source: LSHLA, 2022)

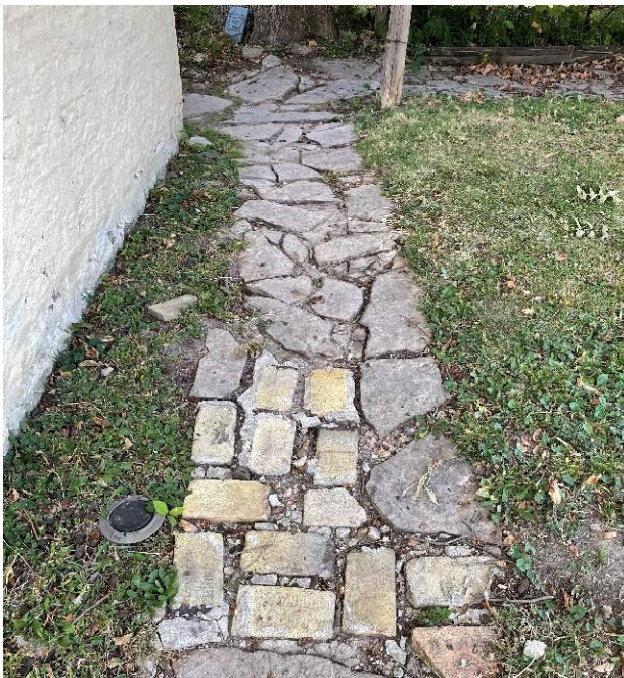
Figure 387. Concrete block pavers also extend into the landscape from the parterre garden and lead to the pathways that continue through the turf grass area west of the grape arbor. (Source: LSHLA, 2022)

The parterre garden pathways, as noted earlier, measure approximately 2 feet 6 inches in width, which is too narrow to meet accessibility standards (Figure 385 and Figure 387). Additionally, the paving material is often deteriorated, broken, or unevenly laid, which can present a trip hazard (Figure 388). Due to the poor condition of the grape arbor, visitors are not permitted to walk on the pathway leading beneath the wood structure (Figure 389).

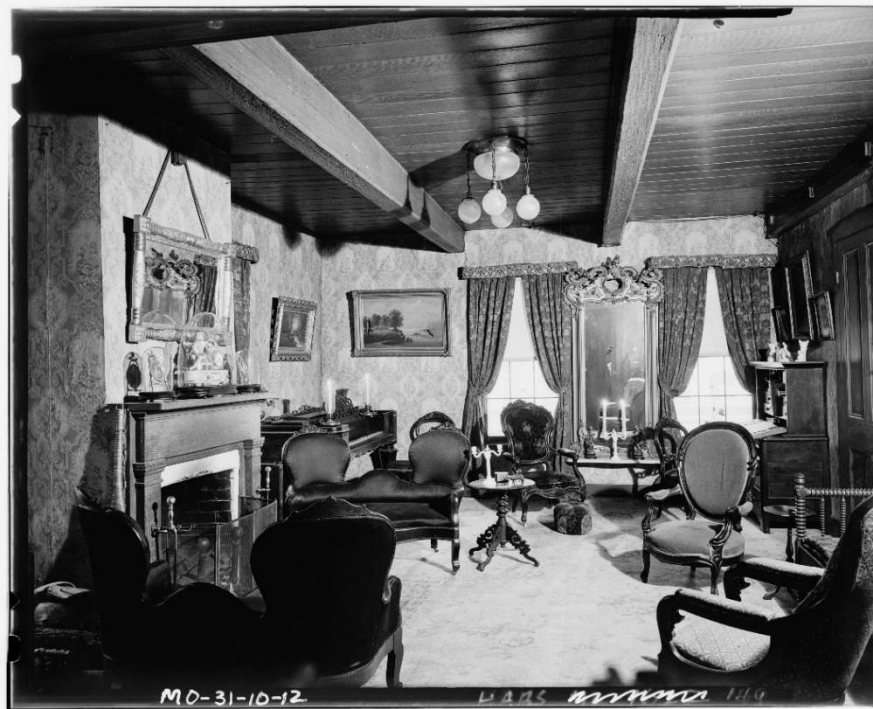
Figure 19. 1949, Room 105 looking east towards Main Street. Note the fireplace mantel at left is not the same mantel as is presently in place at the house. (Source: Historic American Buildings Survey, Library of Congress, Call no. HABS MO,97-SAIGEN,1-). <https://www.loc.gov/item/mo0360/>)

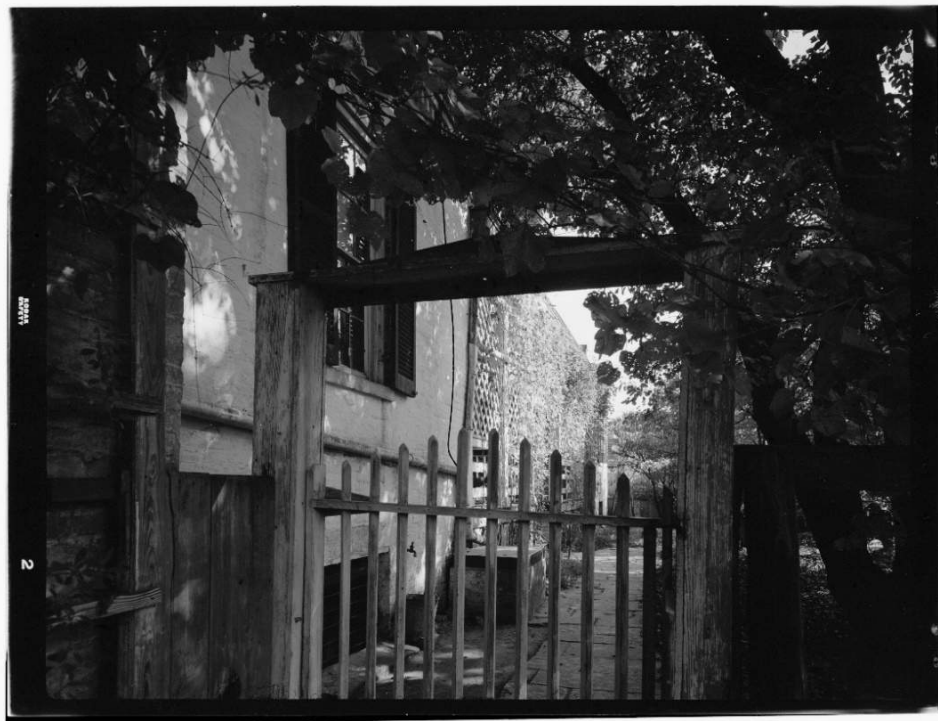
Figure 20. Undated (after 1934, possibly 1949), looking south towards Market Street along the west exterior wall. Note the vegetation growth on the west porch lattice. (Source: Historic American Buildings Survey, Library of Congress, Call no. HABS MO,97-SAIGEN,1-). <https://www.loc.gov/item/mo0360/>)

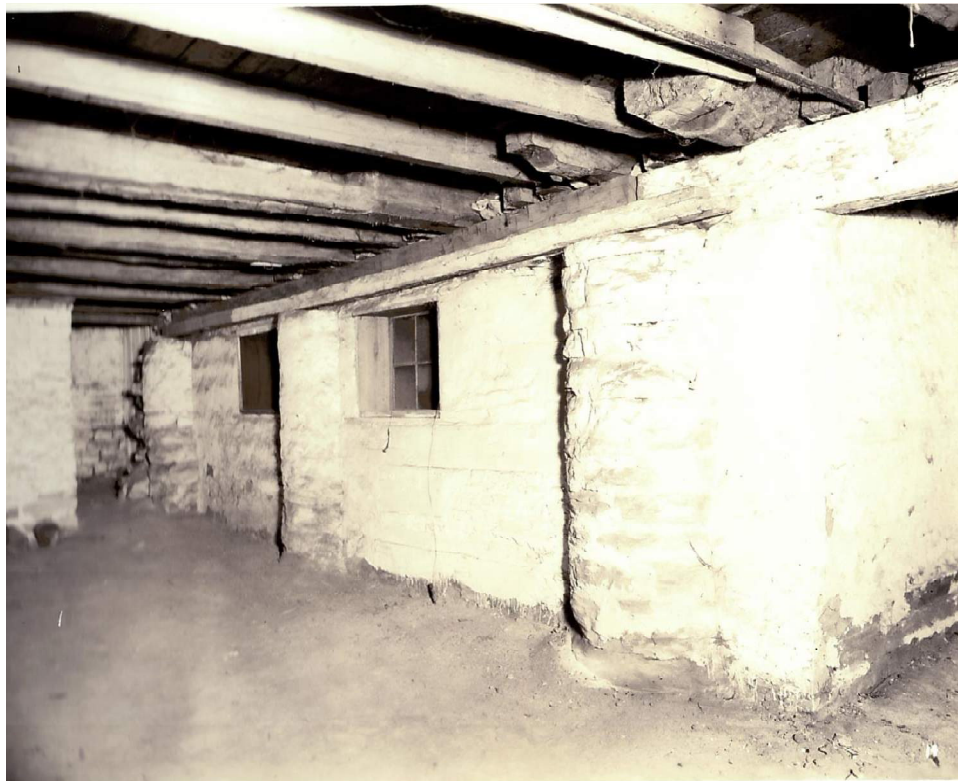
Figure 24. Undated (possibly before 1960s renovations), Room 011B, looking southwest, showing the three stone masonry piers and windows in the original foundation wall. (Source: Schram Collection, Felix Vallé State Historic Site)

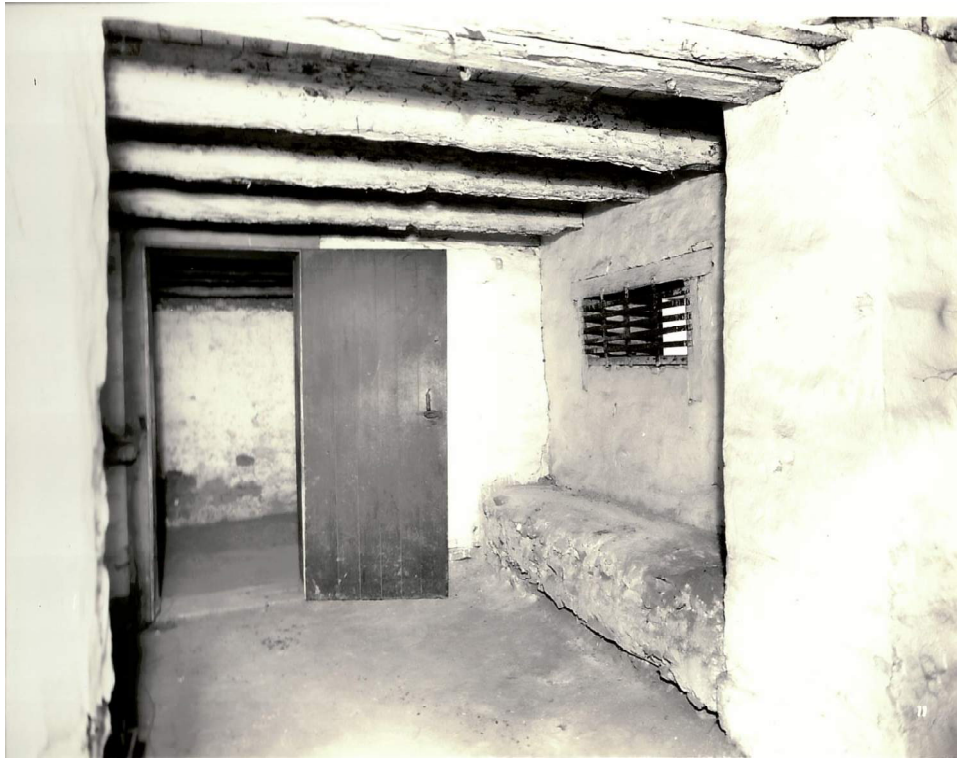
Figure 25. Undated (possibly before 1960s renovations), Room 001, looking north towards Door D002. Note the thickened stone masonry at the base of the foundation wall at right. (Source: Schram Collection, Felix Vallé State Historic Site)

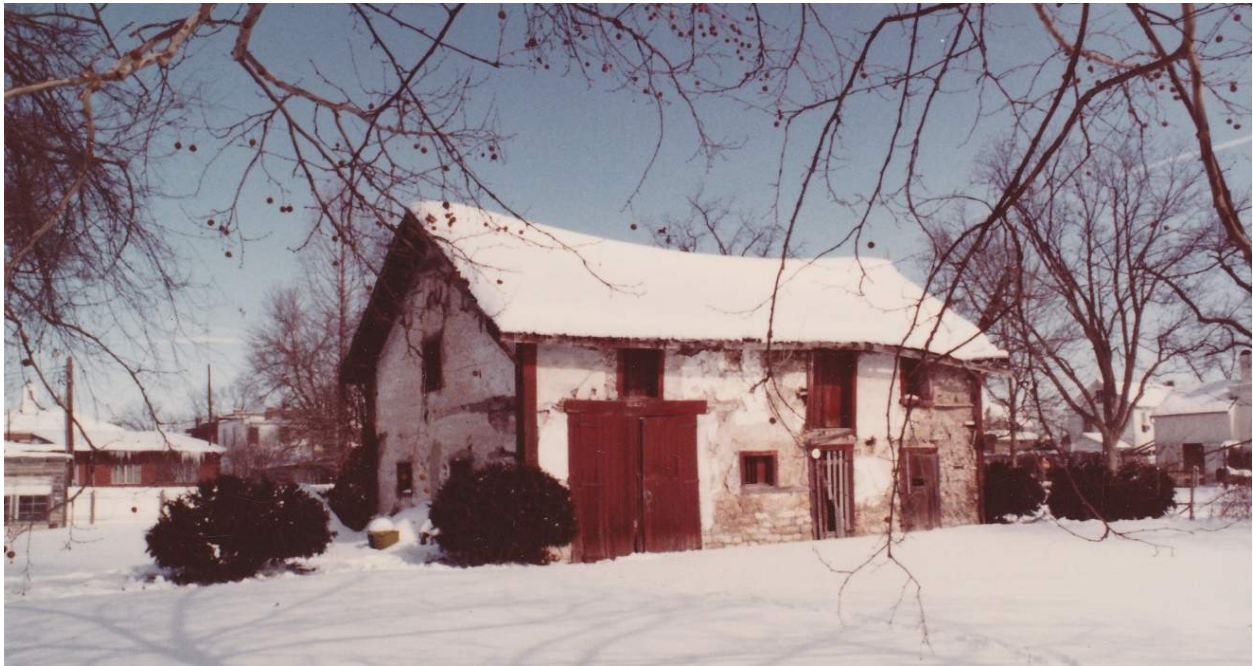
Figure 70. c. 1982, looking slightly northeast to the barn from Market Street, note the distress to the bar roof framing. (Source: Robert Mueller, private collection)

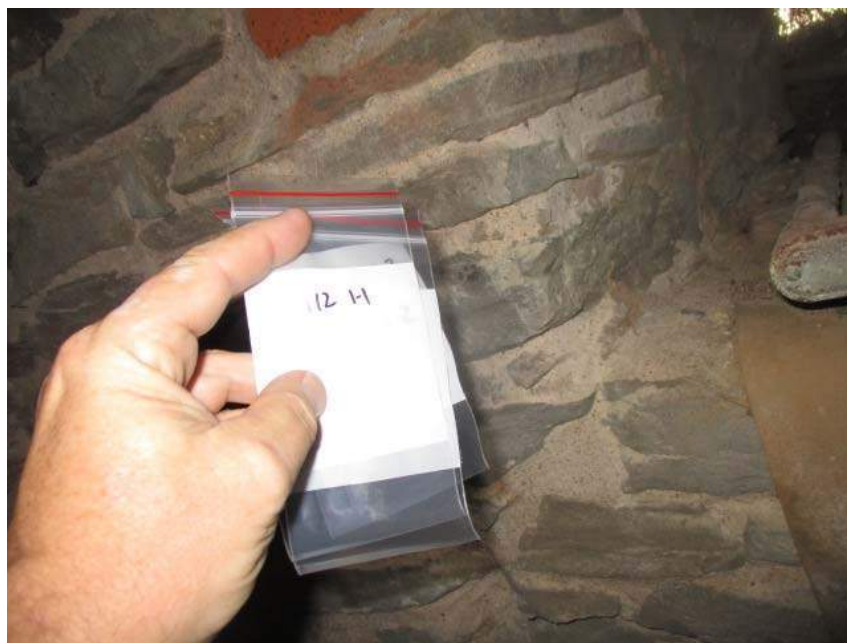
Photograph No. 3

View of HA-1

Non-ACM  
Stone mortar.

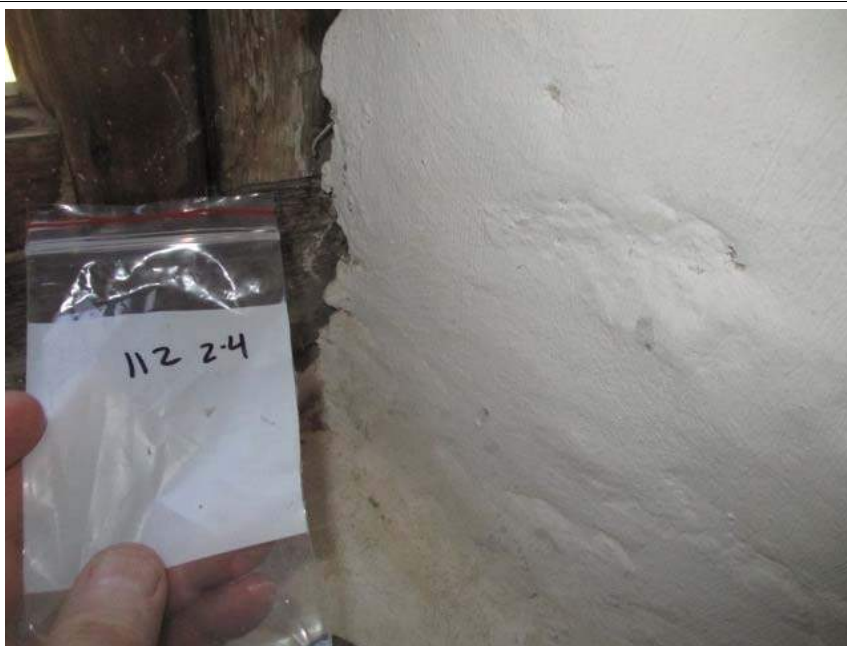
Photograph No. 4

View of HA-2

Non-ACM  
Kitchen mortar.

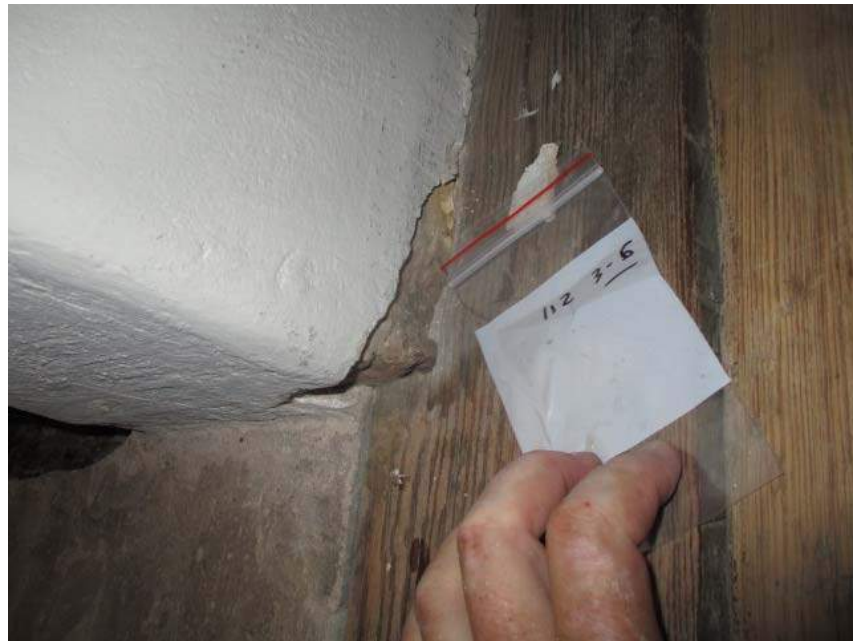
Photograph No. 5

View of HA-3

Non-ACM  
Plaster.

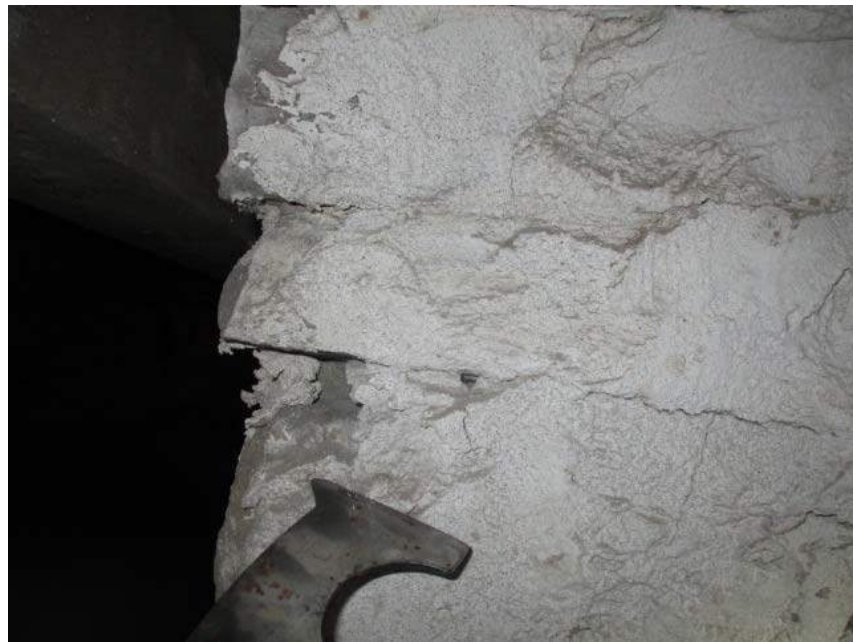
Photograph No. 6

View of HA-4

Non-ACM  
Surfacing in basement.

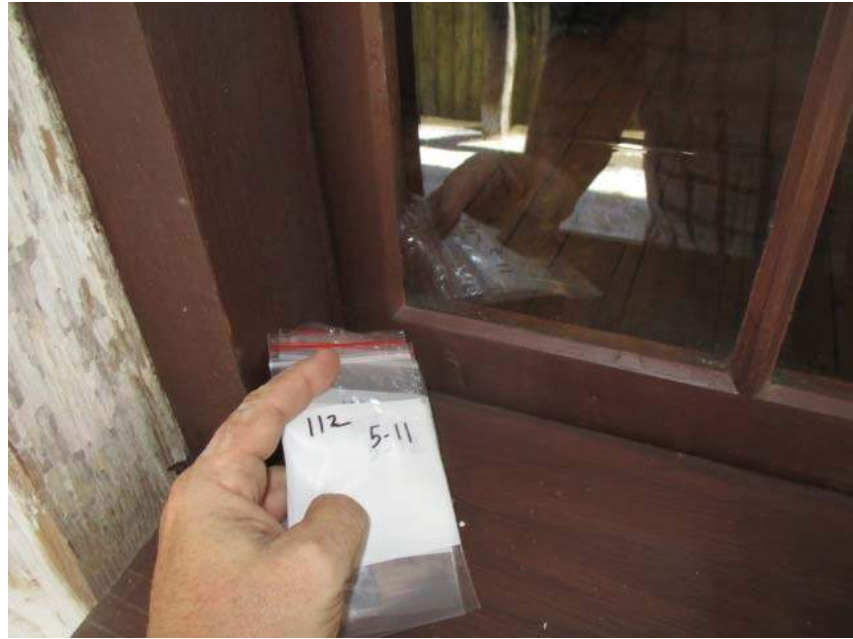
Photograph No. 7

View of HA-5

Non-ACM  
Window glazing.

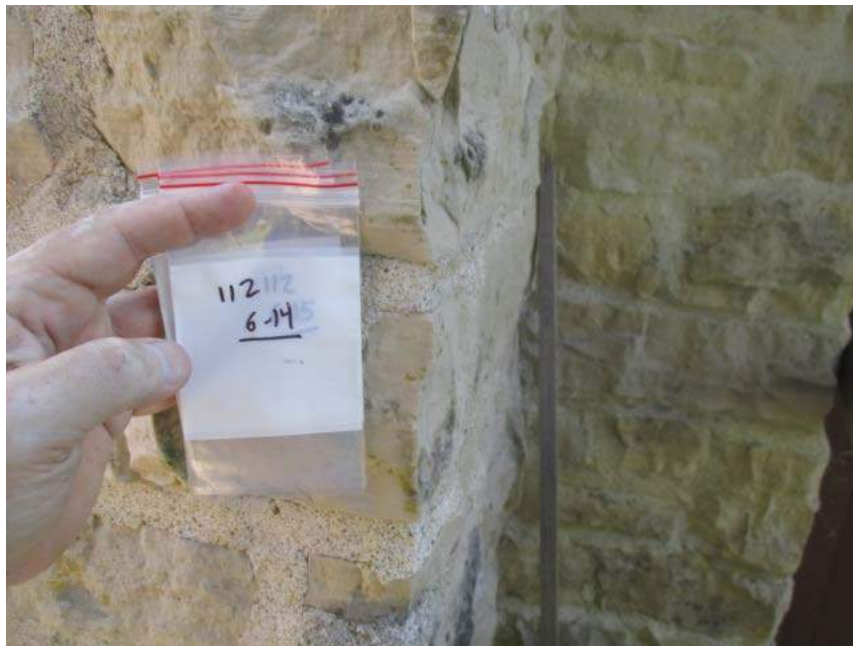
Photograph No. 8

View of HA-6

Non-ACM  
Stone cottage mortar.

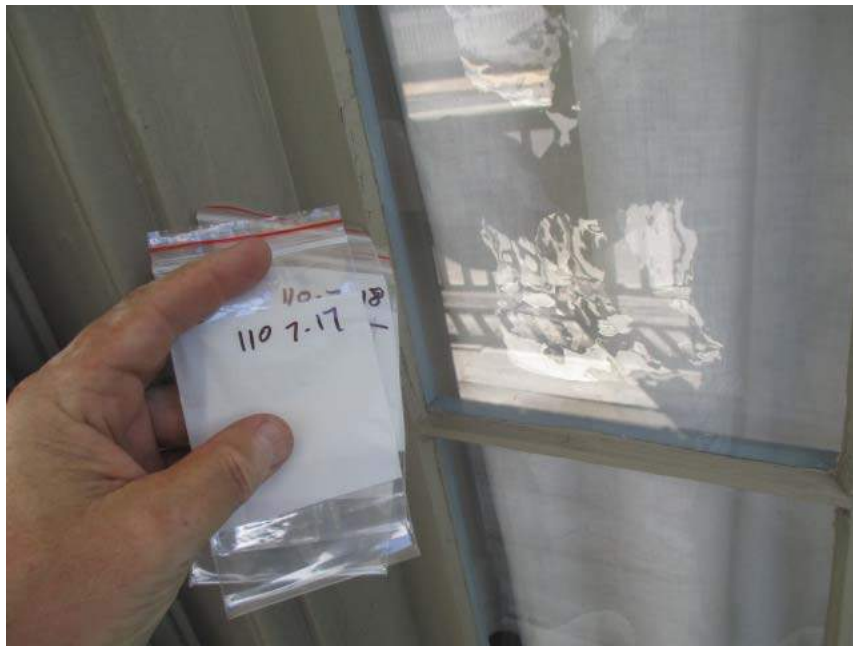
Photograph No. 10

View of HA-7

Non-ACM  
Window glazing.

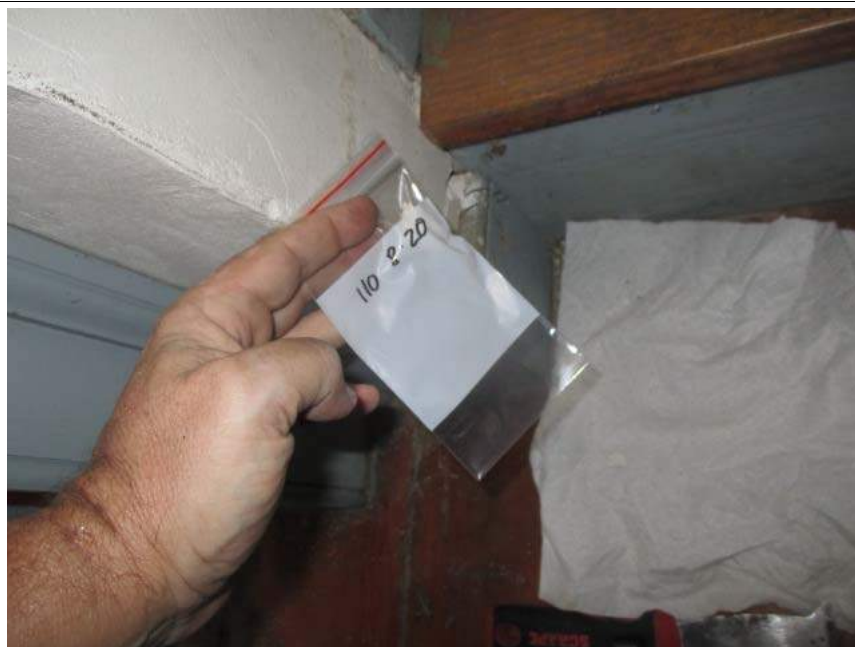
Photograph No. 11

View of HA-8

Non-ACM  
Plaster.

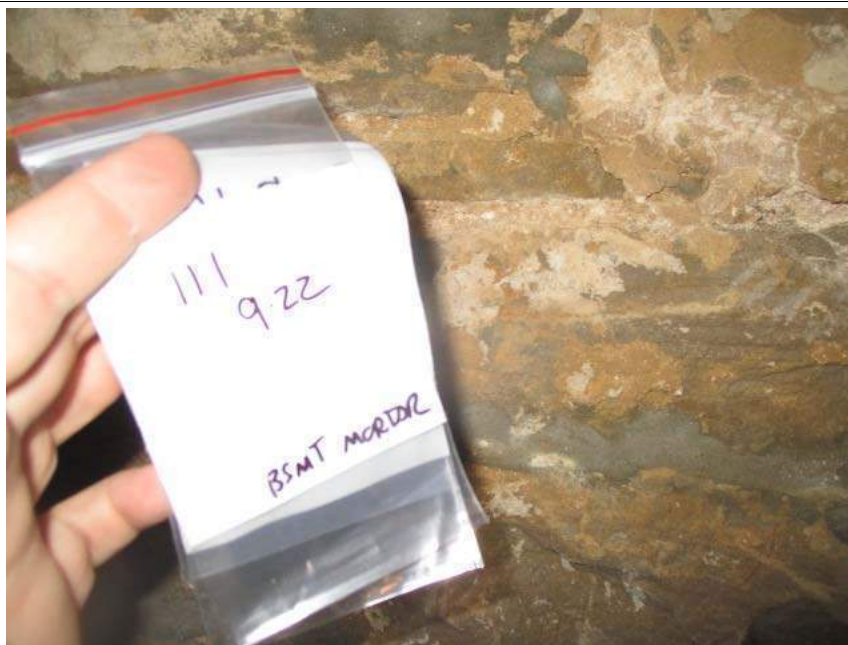
Photograph No. 13

View of HA-9

Non-ACM  
Basement mortar.

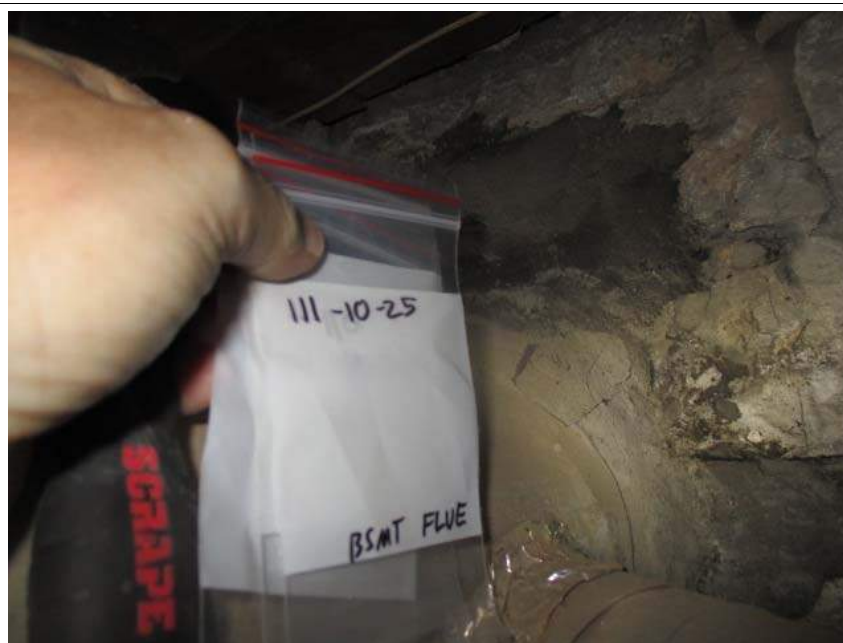
Photograph No. 15

View of HA-10

Non-ACM  
Mortar on flue.

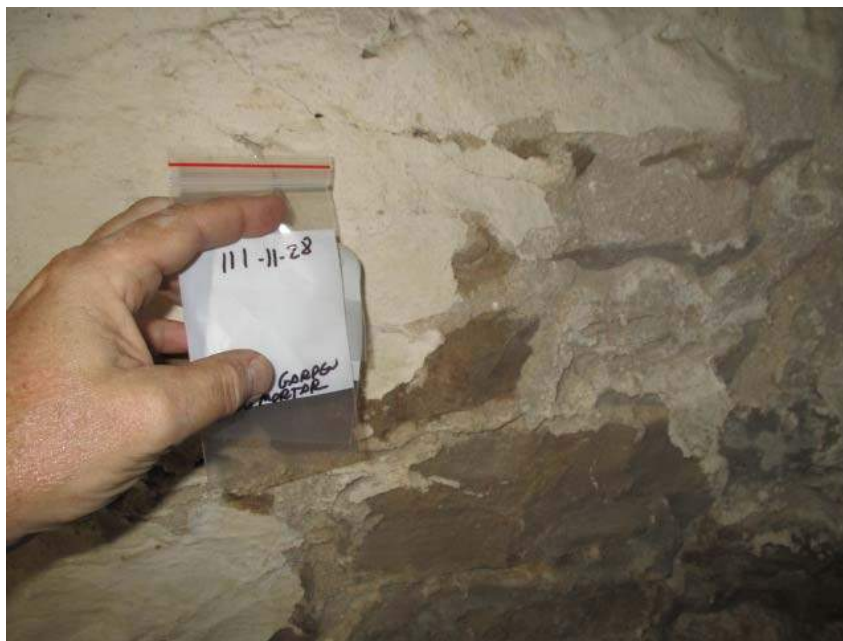
View of HA-11

Non-ACM  
Surfacing on basement  
garden walls.

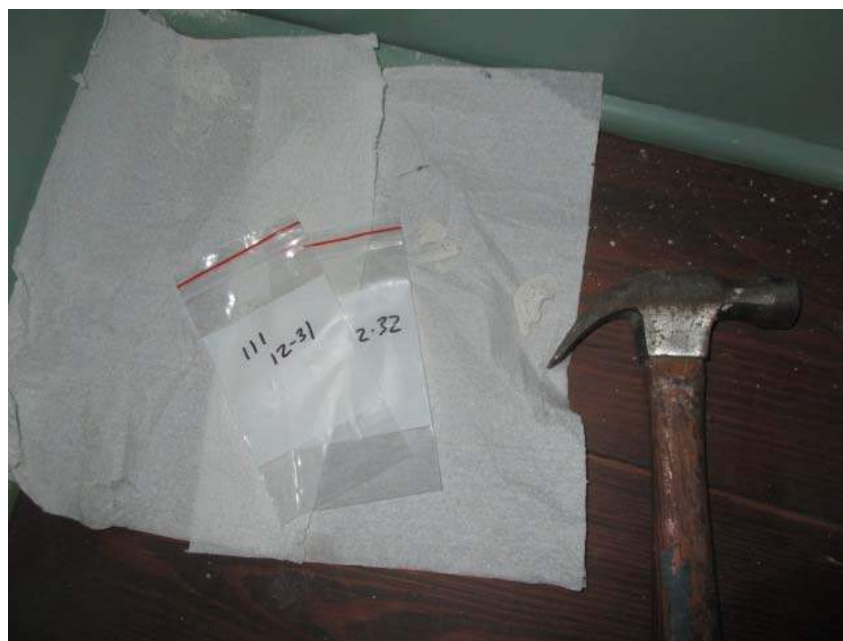
View of HA-12

Non-ACM  
Wall plaster.

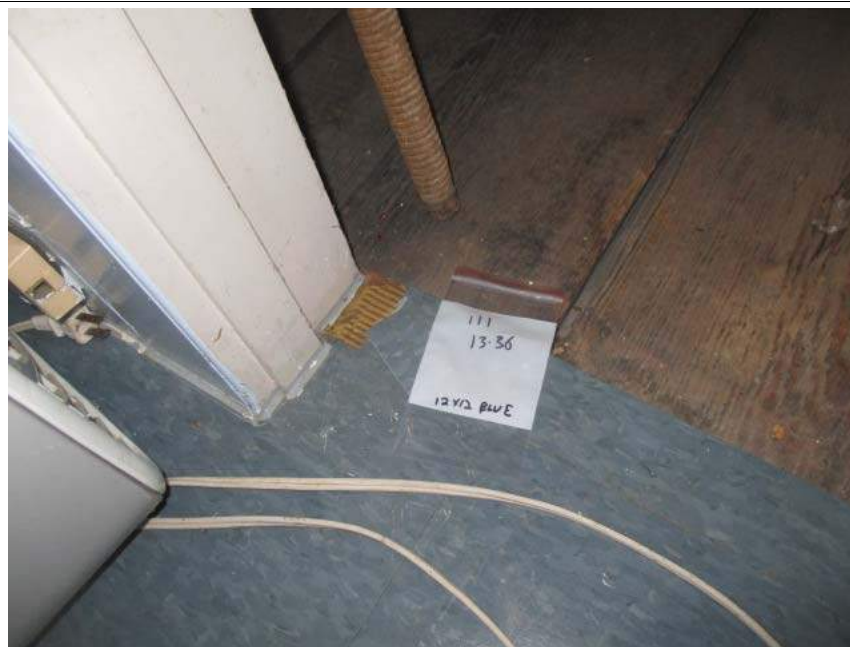
View of HA-13

Non-ACM  
12" x 12" Blue floor tile  
and brown mastic.

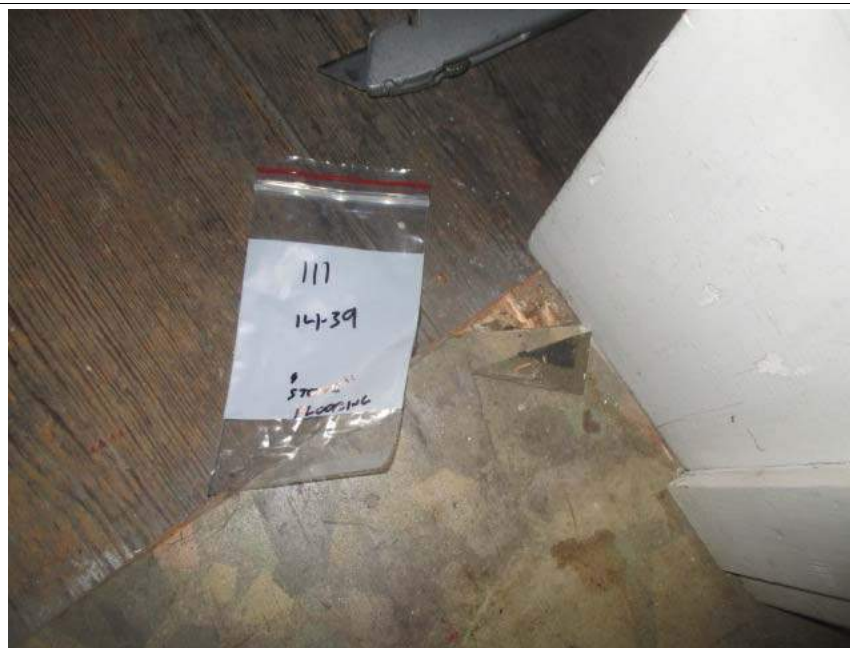
View of HA-14

Non-ACM  
"Stone" pattern sheet vinyl  
flooring and brown mastic.

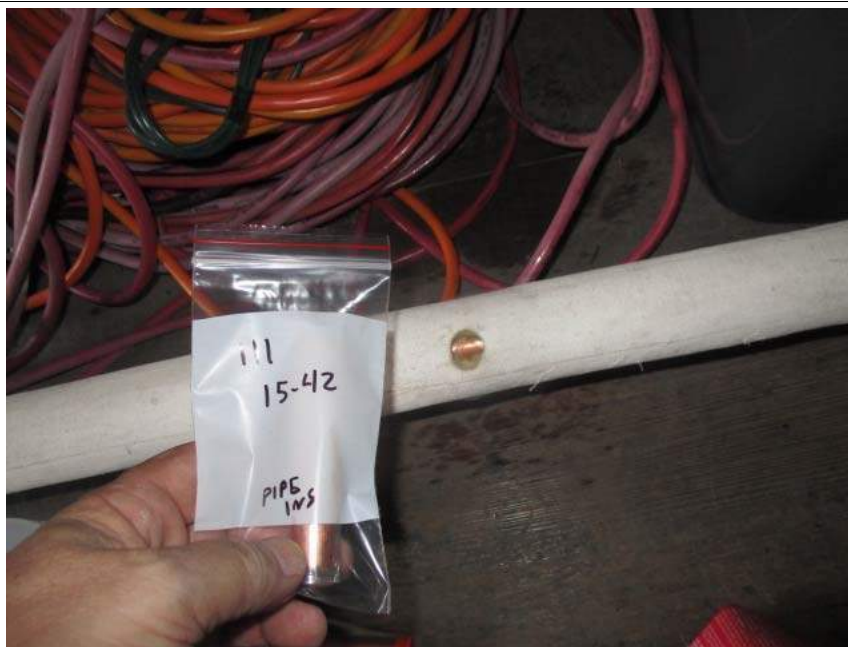
View of HA-15

Non-ACM  
Pipe insulation.

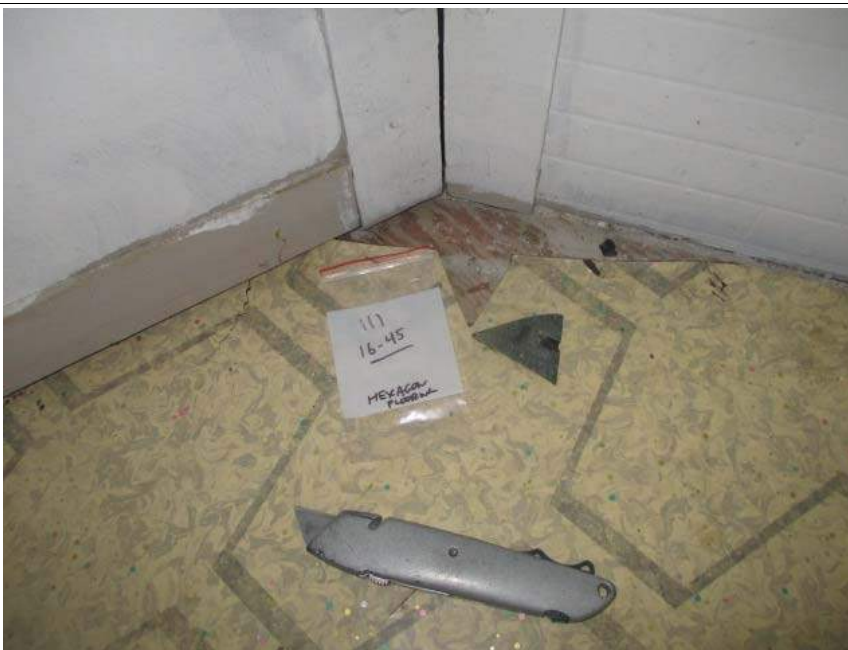
View of HA-16

“Hexagon” pattern sheet  
vinyl flooring.

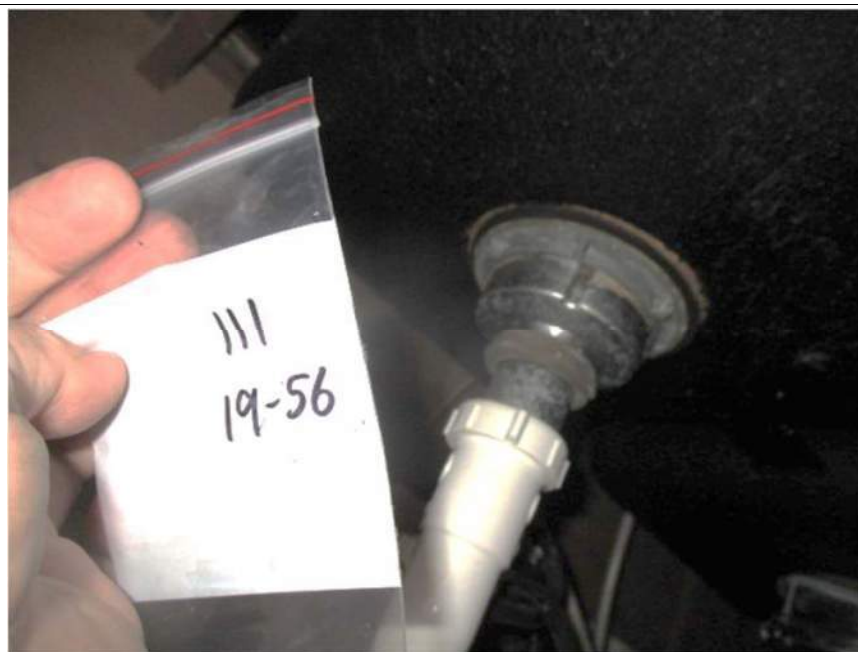
View of HA-19

ACM-Containing  
Black sink insulation.

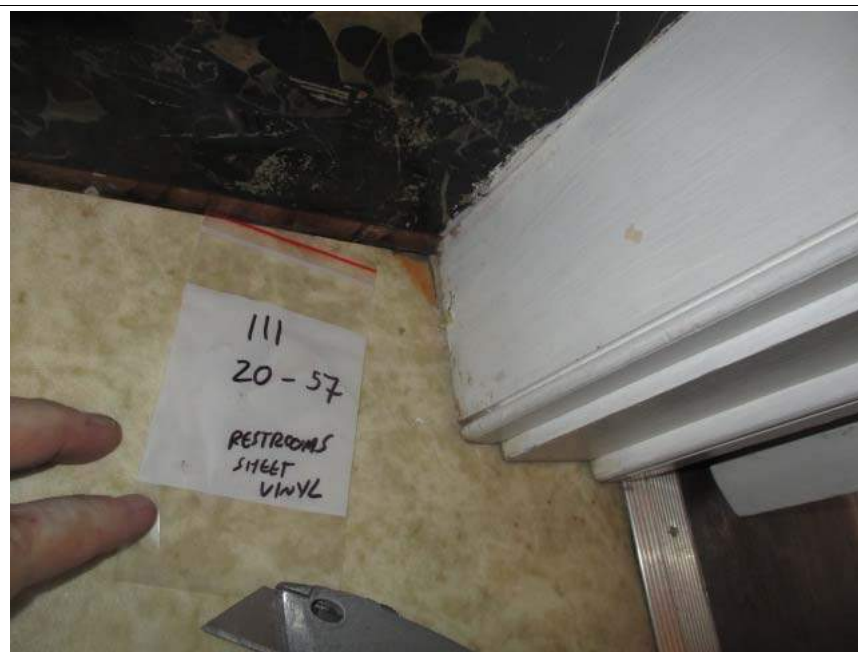
View of HA-20

Non-ACM  
Bathroom sheet vinyl  
flooring.

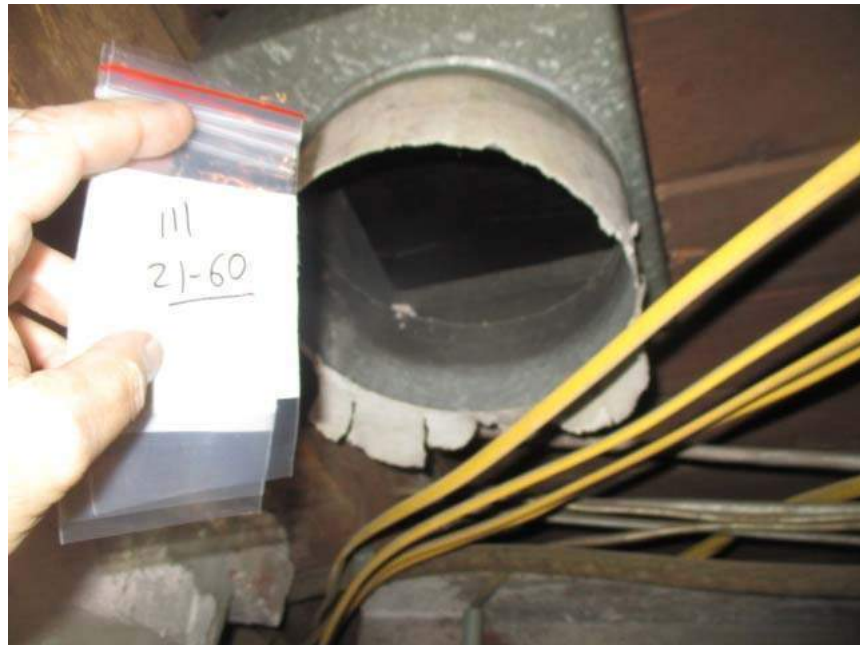
View of HA-21

ACM-Containing  
Duct wrap.

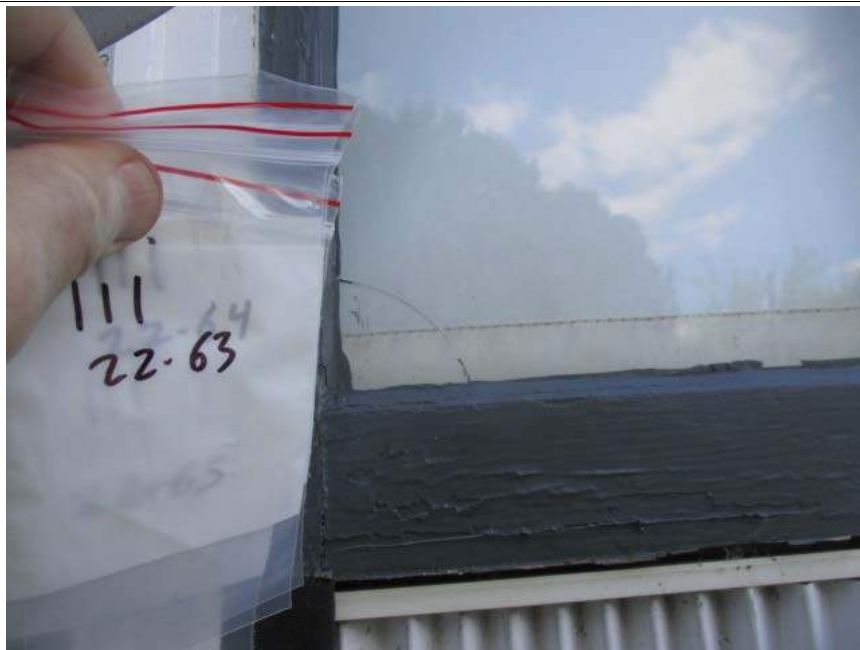
View of HA-22

Non-ACM  
Window glazing.
