# Jean Baptiste Vallé House

STE. GENEVIEVE NATIONAL HISTORICAL PARK  
STE. GENEVIEVE, MISSOURI

## Historic Structure Report

PMIS 311236  
OCTOBER 2024

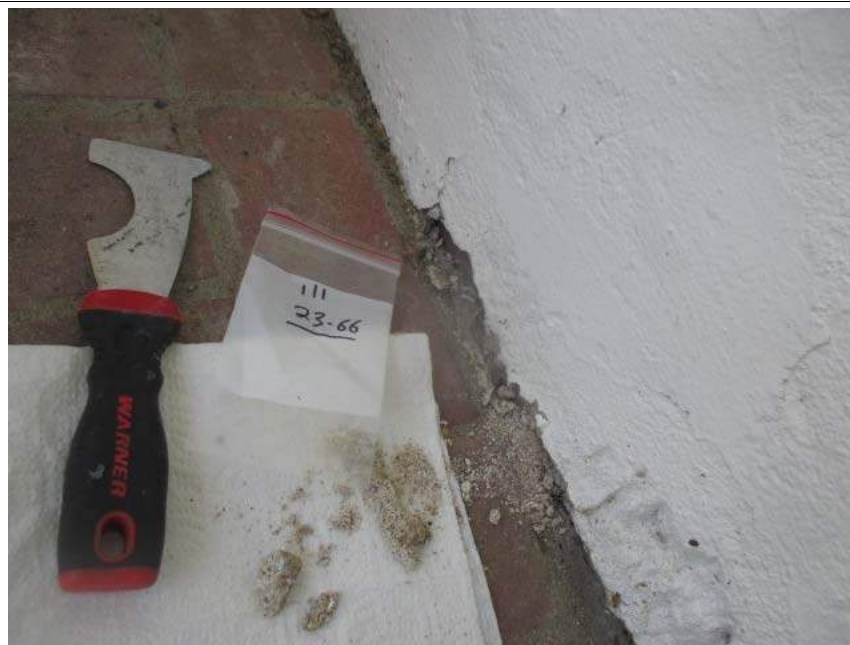
View of HA-23

Non-ACM  
Exterior surfacing.

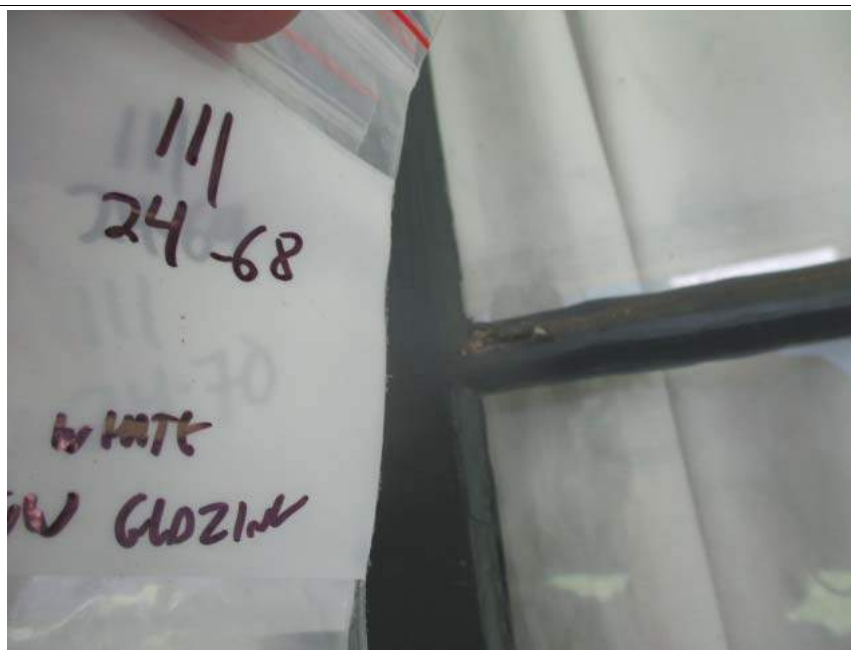
View of HA-24

Non-ACM  
Window glazing.

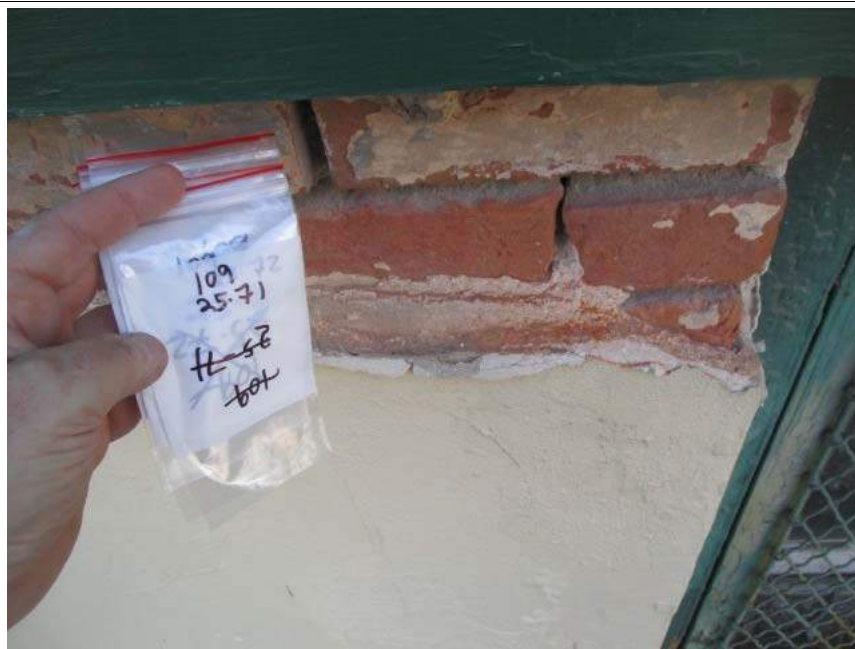
View of HA-25

Non-ACM  
Wall plaster.

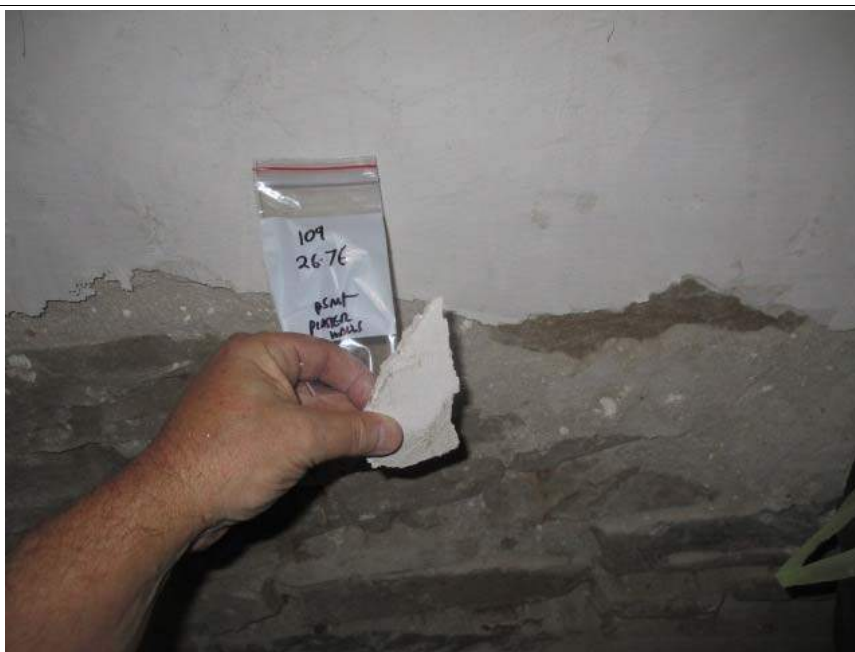
View of HA-26

Non-ACM  
Basement plaster walls.

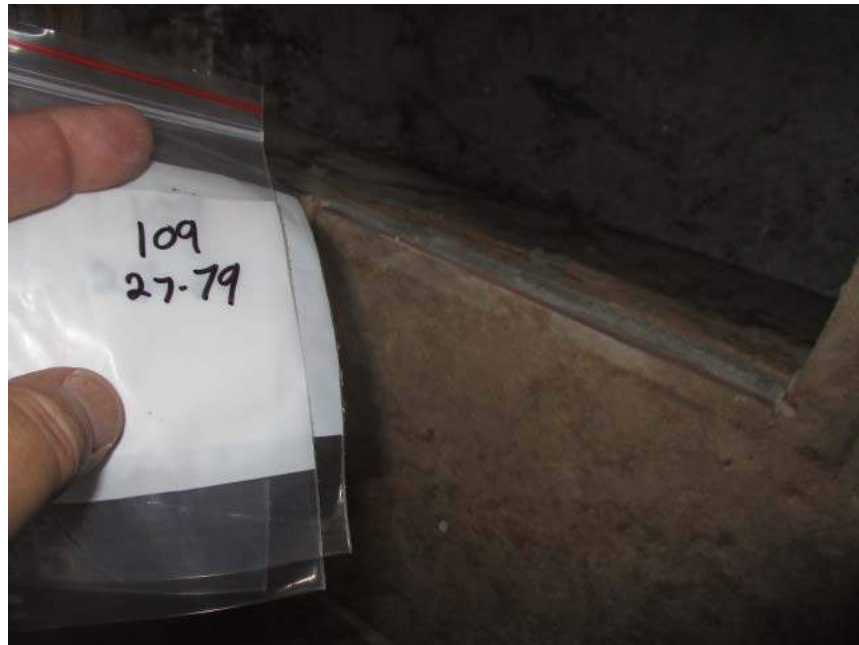
View of HA-27

Non-ACM  
Ceramic floor tile thinset.

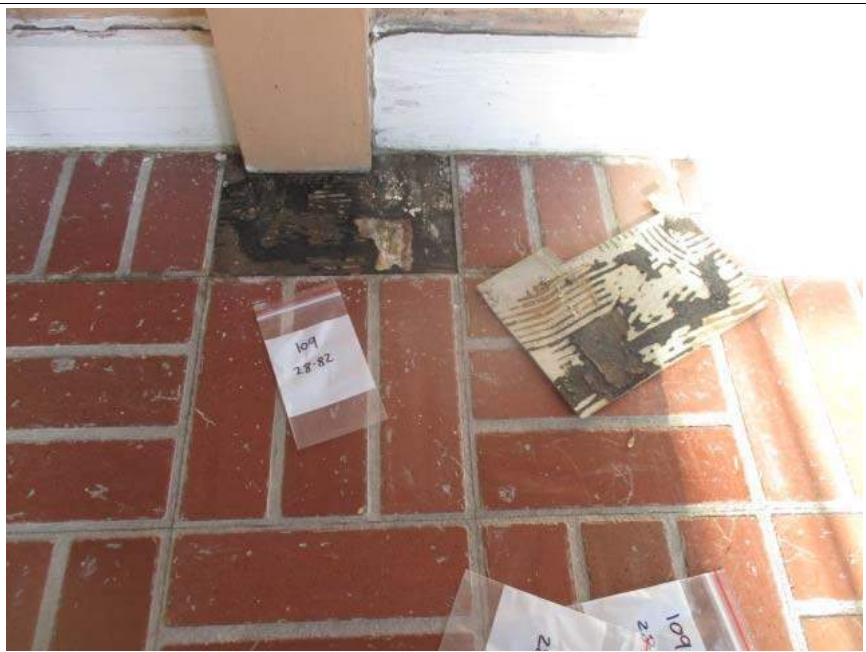
View of HA-28

Non-ACM  
Faux brick vinyl floor tile  
and  
Non-ACM (<1%)  
black mastic.

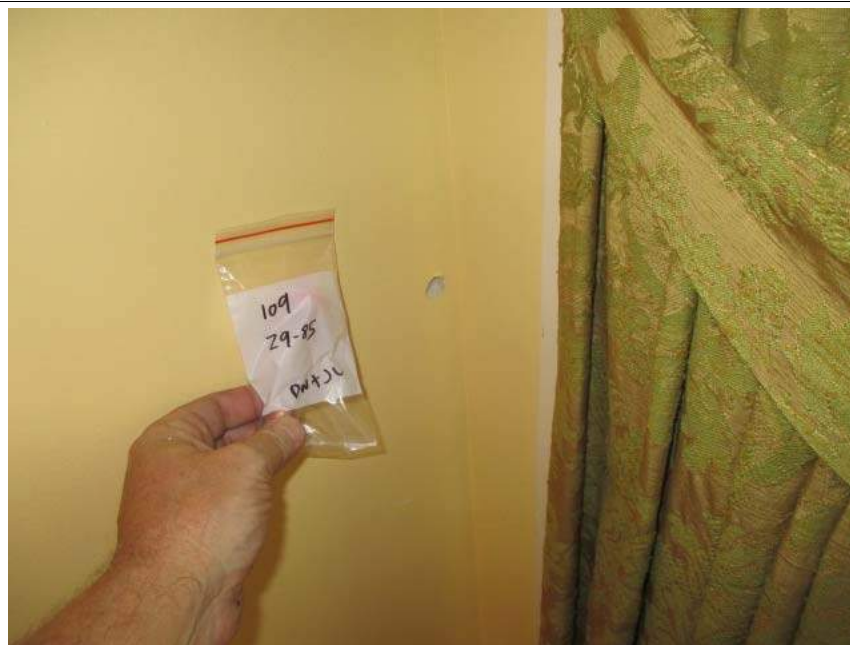
View of HA-29

Non-ACM  
Drywall and joint  
compound.

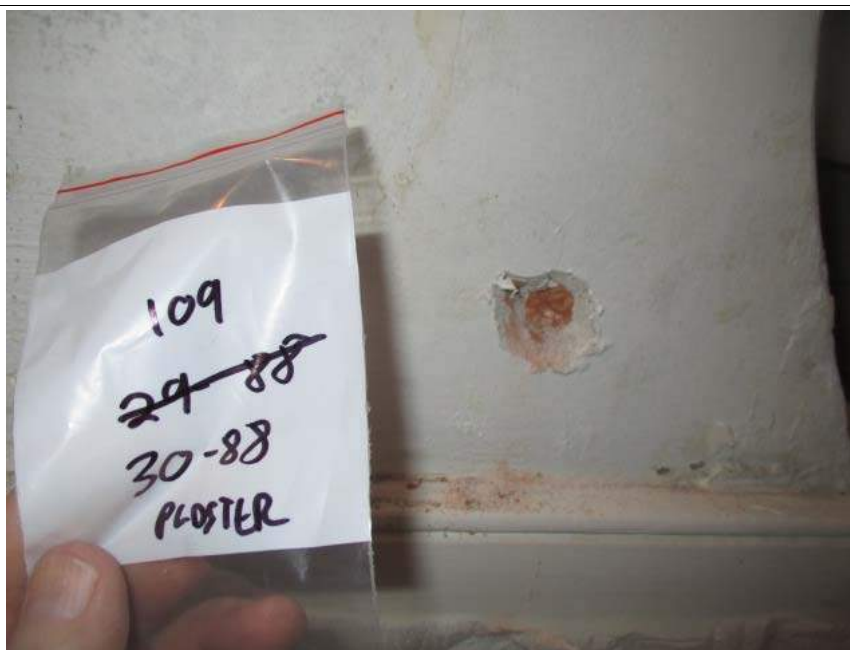
View of HA-30

Non-ACM  
Wall plaster and brick.

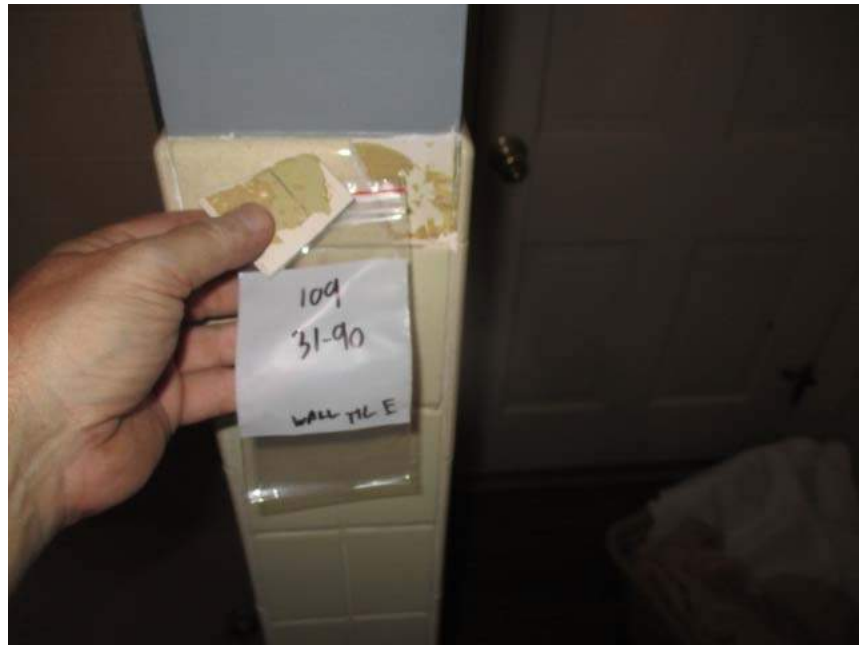
View of HA-31

Non-ACM  
Ceramic wall tile adhesive.

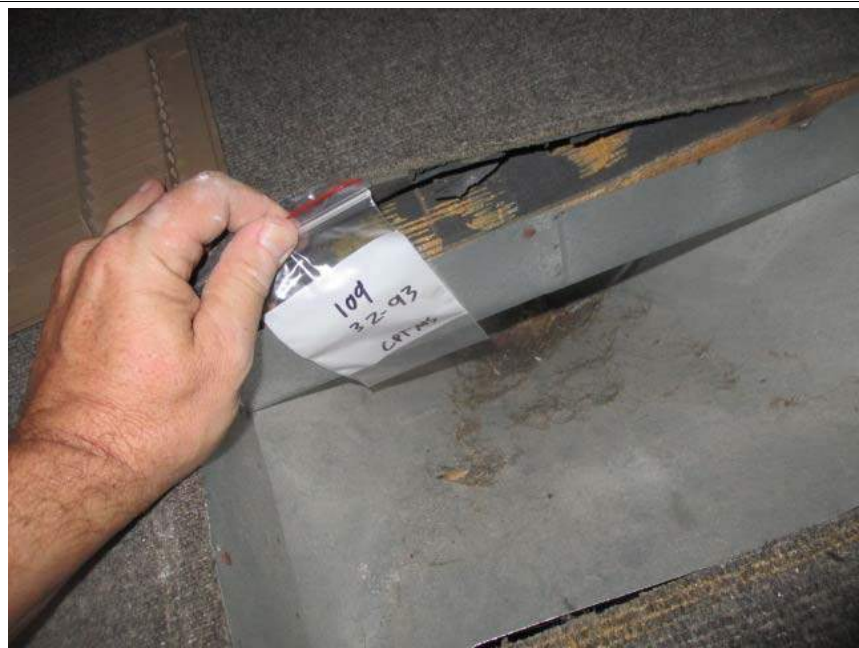
View of HA-32

Non-ACM  
Carpet adhesive.

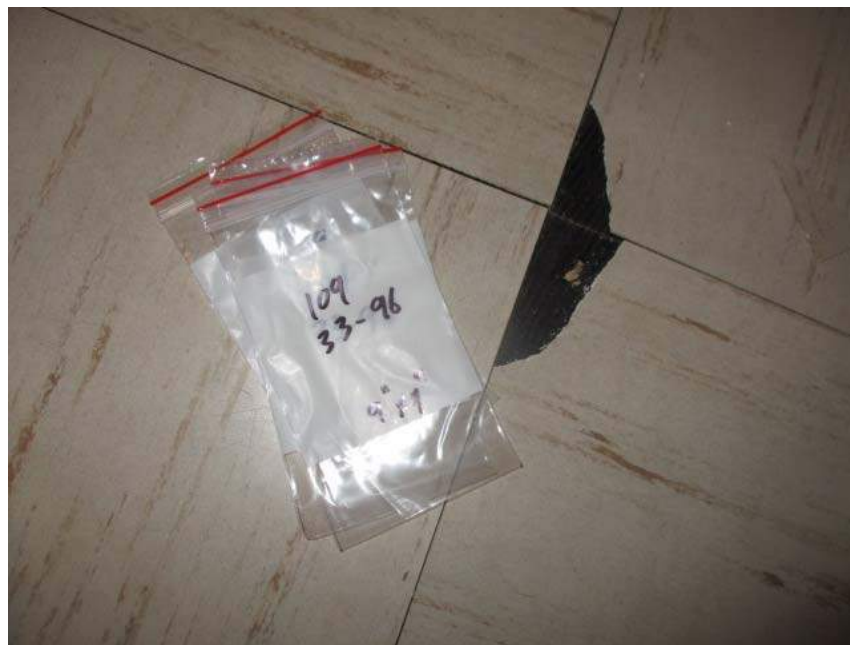
Non-ACM  
Black mastic.

Non-ACM  
Felt.

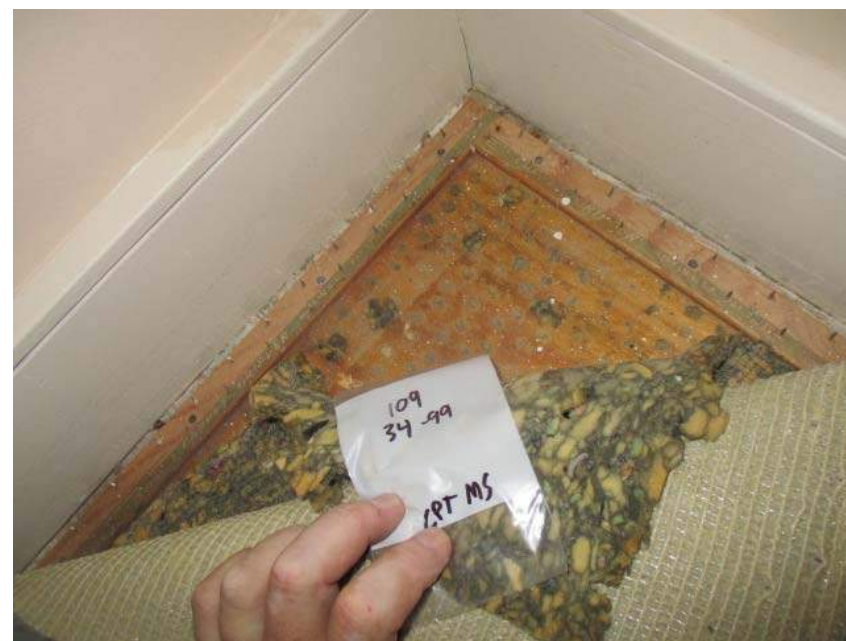
View of HA-34

Non-ACM  
Carpet adhesive.

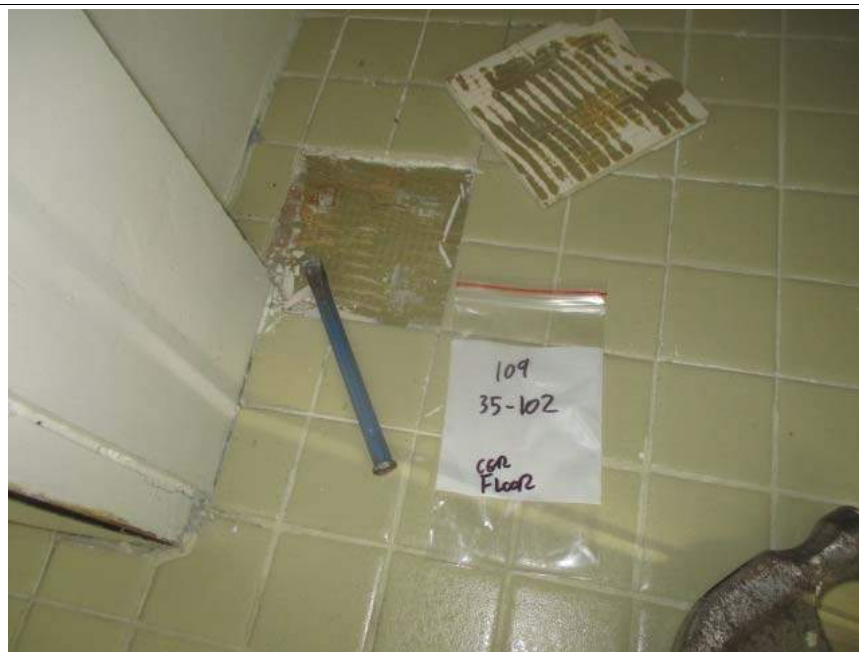
View of HA-35

Non-ACM  
Ceramic floor tile thinset.

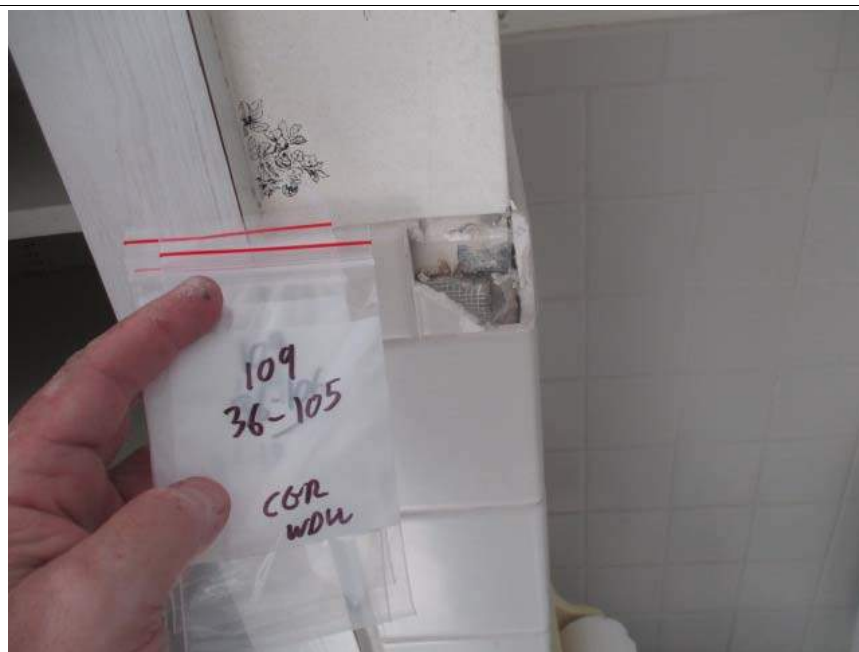
View of HA-36

Non-ACM  
Ceramic wall tile adhesive.

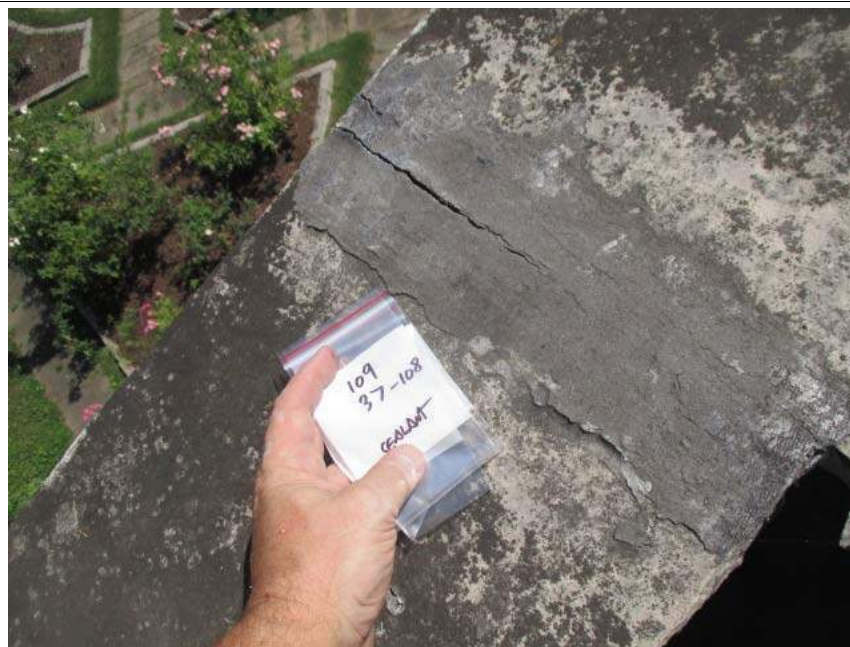
View of HA-37

ACM-Containing  
Roof capstone asphalt  
sealer.

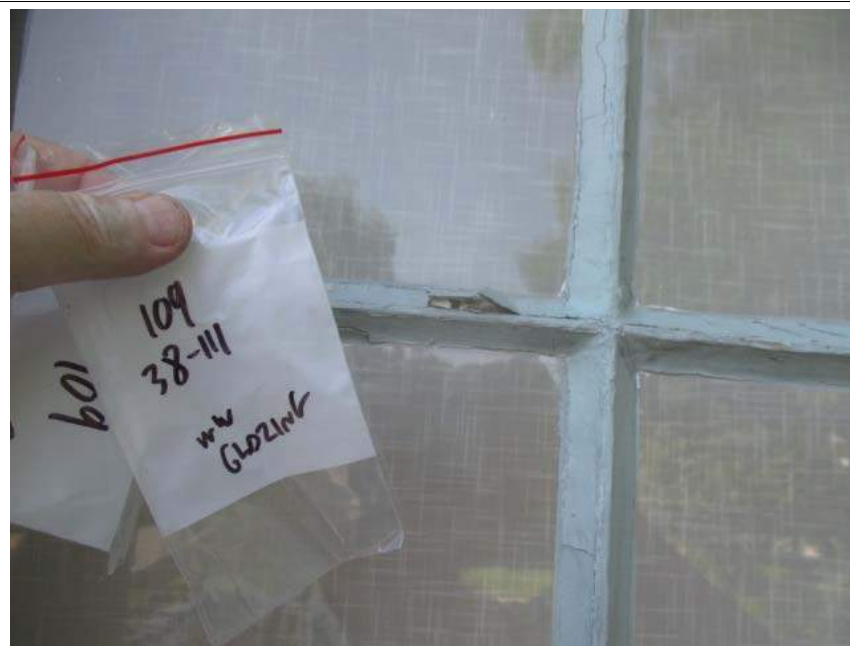
View of HA-38

Non-ACM  
Window glazing.

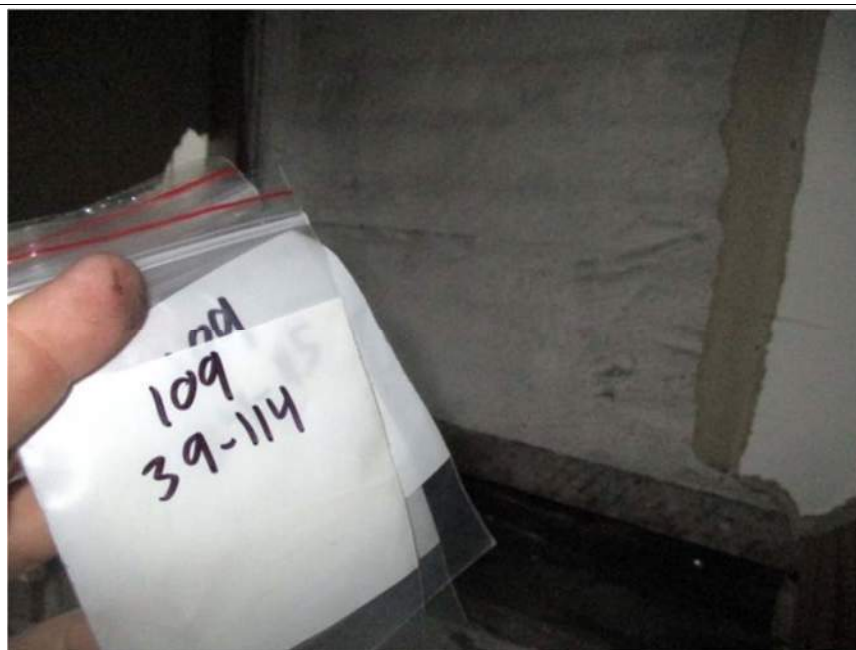
View of HA-39

Non-ACM  
Old exposed plaster.

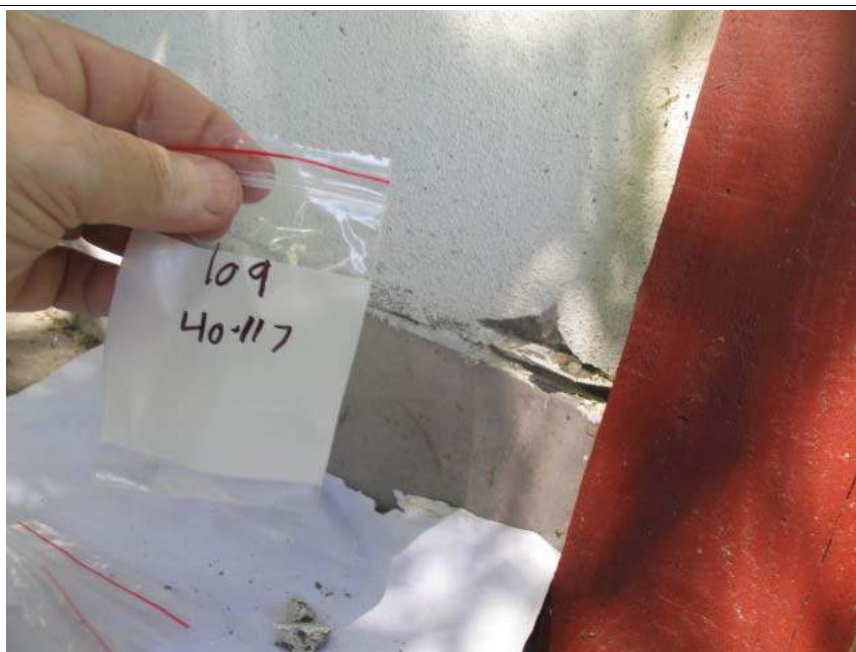
View of HA-40

Non-ACM  
Wall stucco.

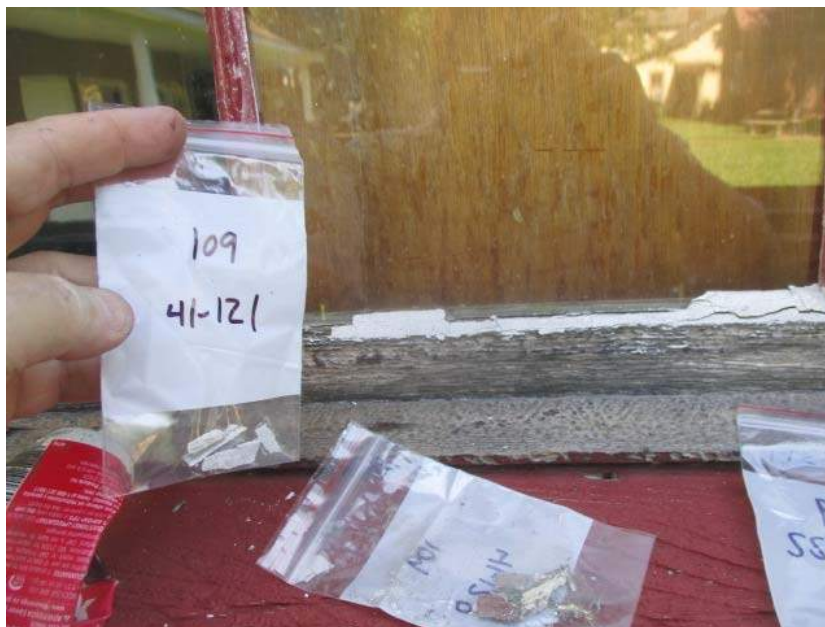
View of HA-41

Non-ACM  
Window glazing.

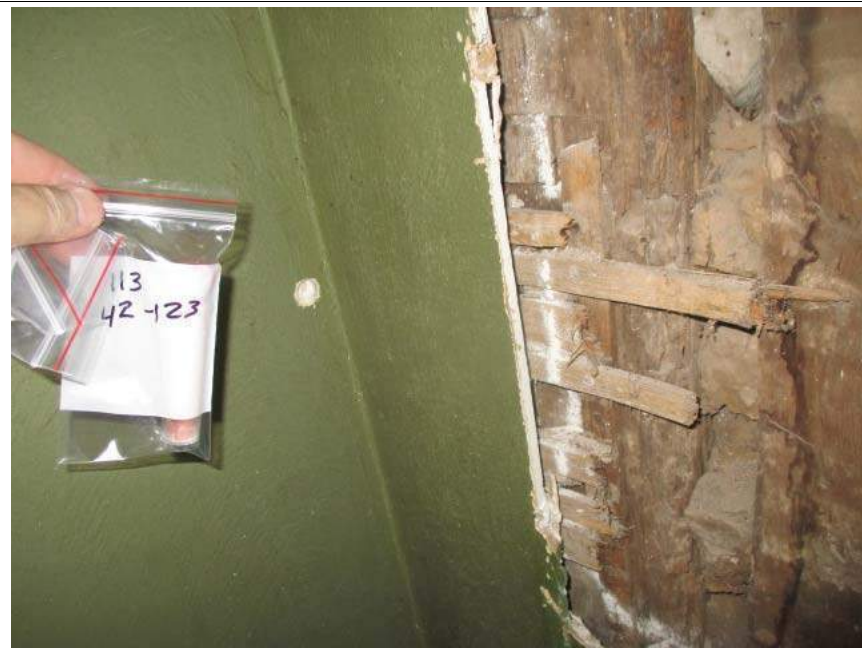
View of HA-42

Non-ACM  
Drywall and joint  
compound.

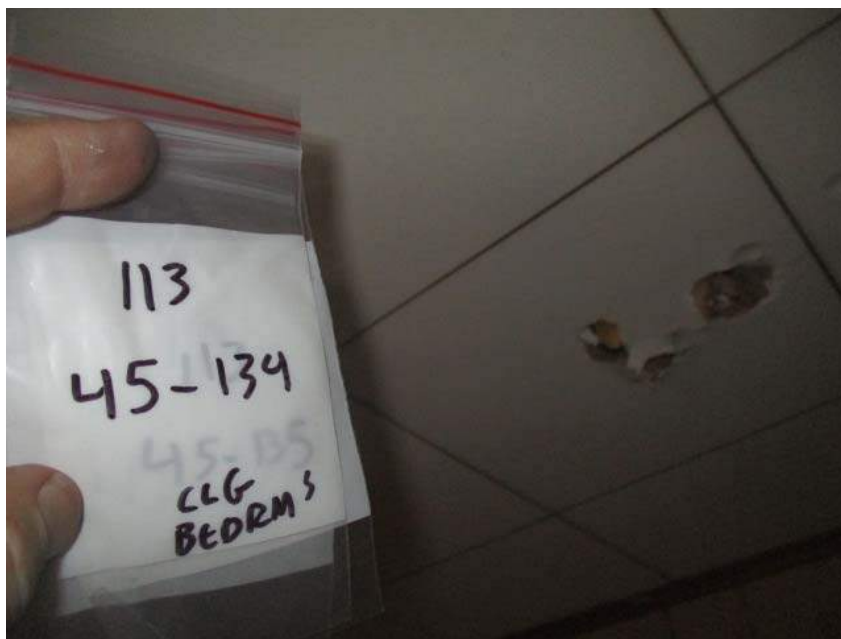
View of HA-45

Non-ACM  
Ceiling tile.

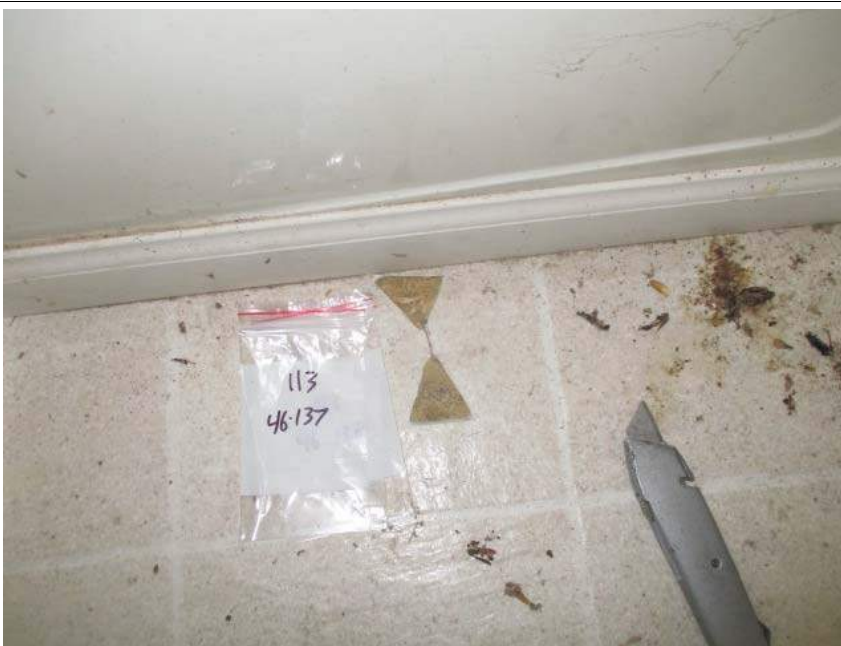
Photograph No. 55

View of HA-46

Non-ACM  
Bathroom sheet vinyl  
flooring.

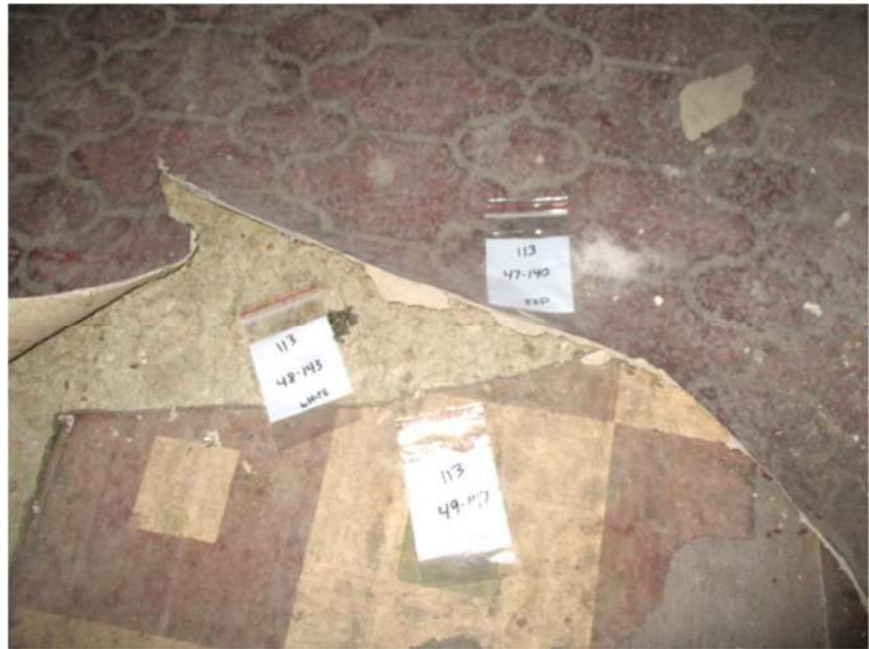
Photograph No. 56

View of HA-48  
Non-ACM  
White sheet vinyl flooring.

View HA-49  
Non-ACM  
“Squares” pattern sheet  
vinyl flooring.

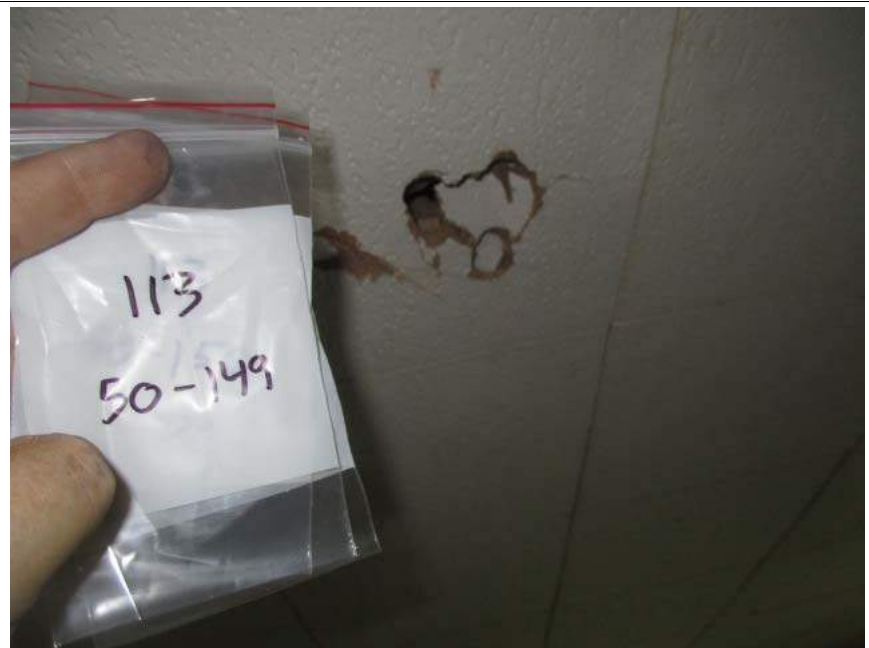
Photograph No. 57

View of HA-50

Non-ACM  
Ceiling tile.

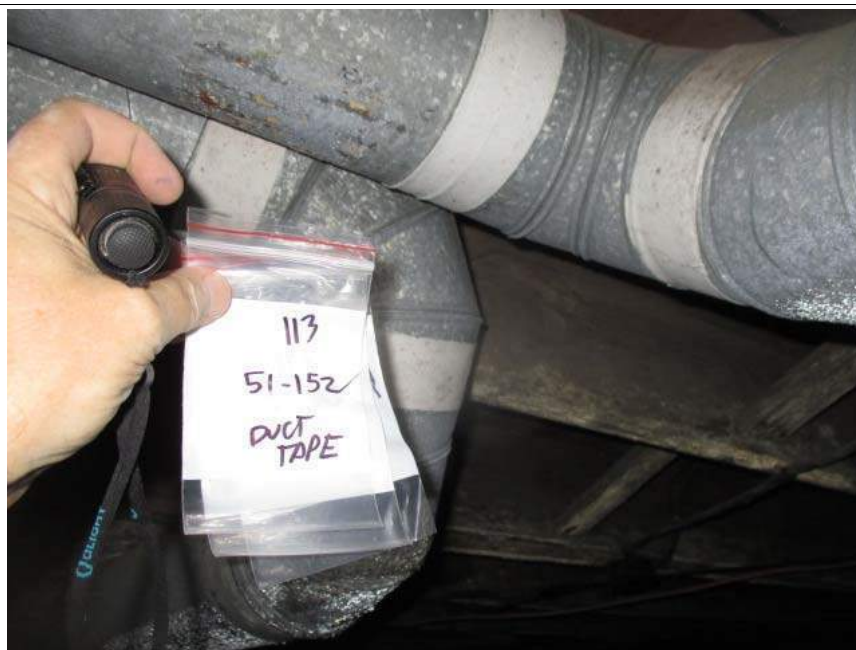
Photograph No. 58

View of HA-51

ACM-Containing  
Duct tape.

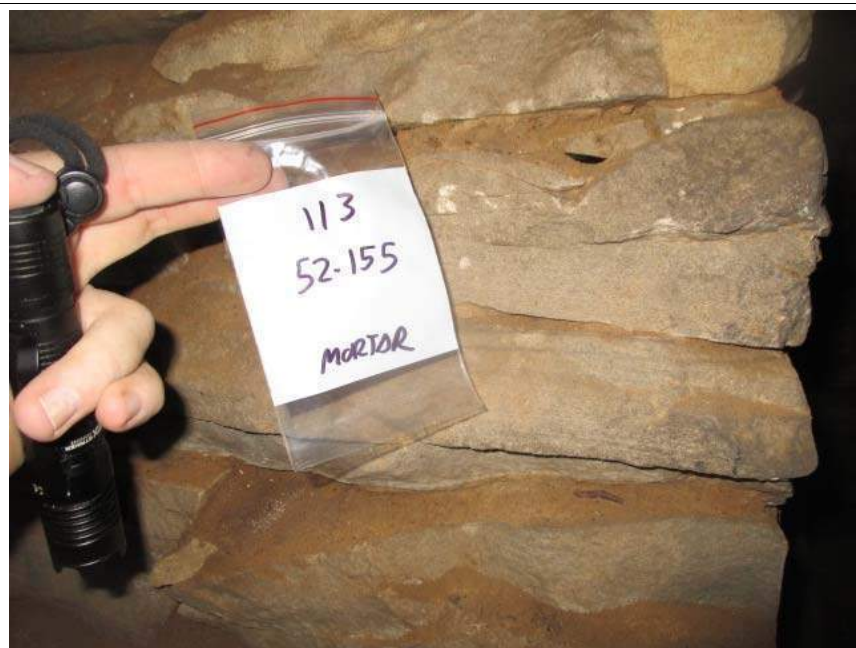
Photograph No. 59

View of HA-52

Non-ACM  
Stone mortar.

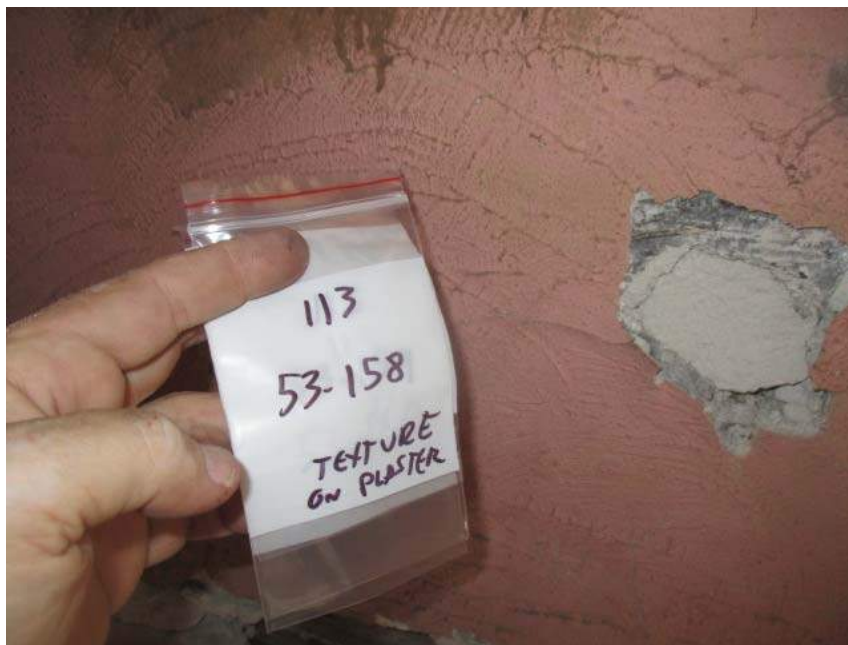
Photograph No. 60

View of HA-53

Non-ACM  
Texture on plaster.

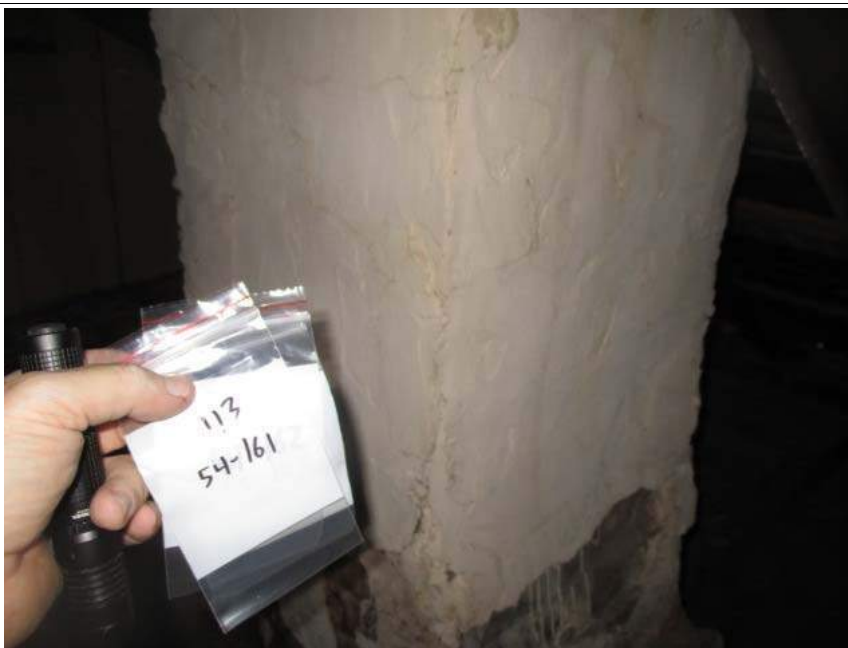
Photograph No. 61

View of HA-54

Non-ACM  
Surfacing on chimney.

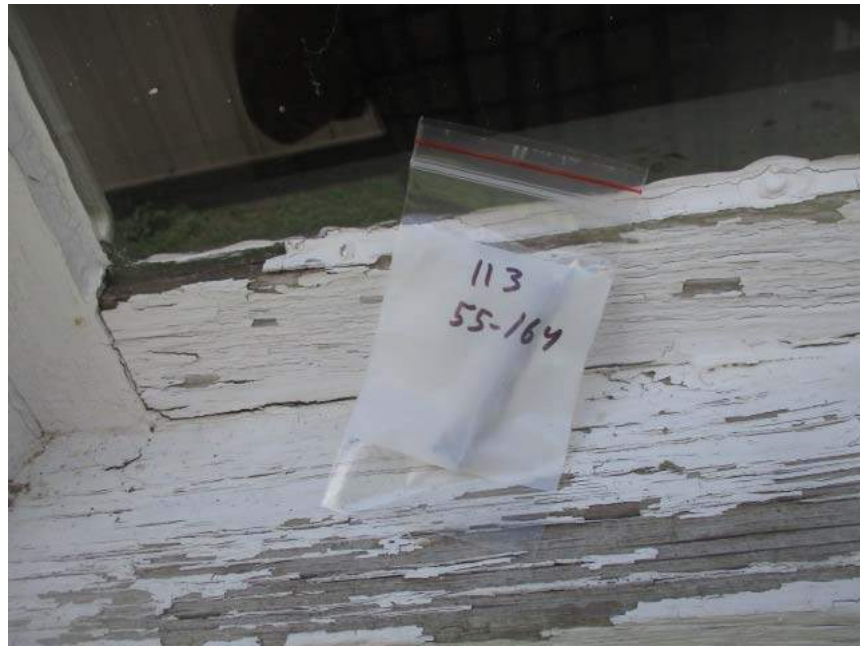
View of HA-55

Non-ACM  
Window glazing.

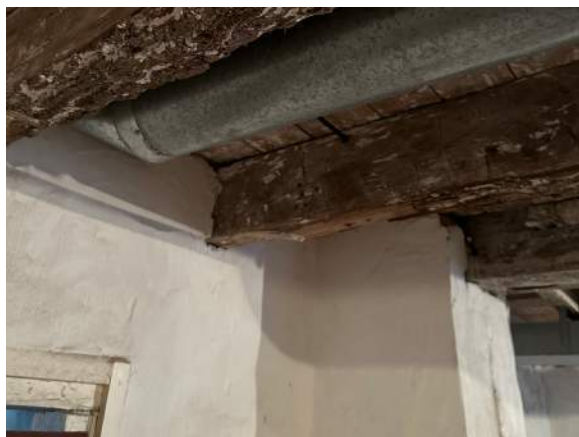
Figure 3. Sample 1. Room 6, beam, white oak.

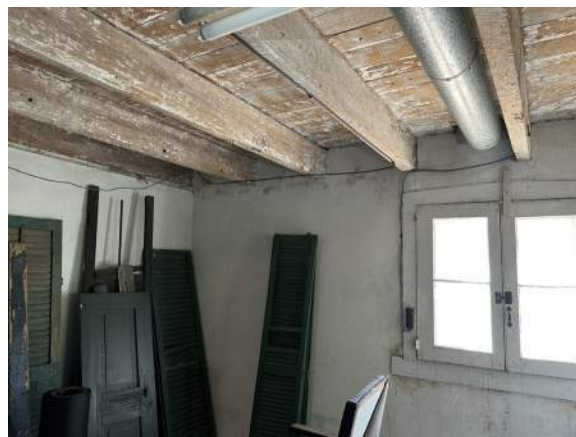
Figure 4. Sample 2. Room 4, joist, southern pine.

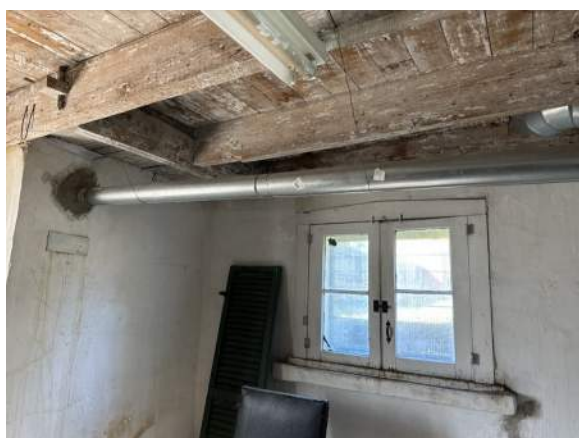
Figure 5. Sample 3. Room 4, joist, southern pine.

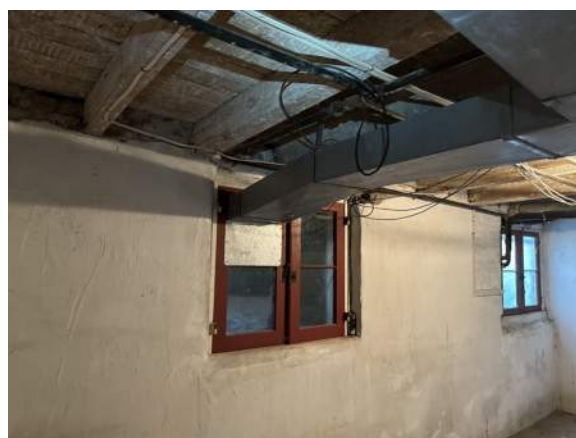
Figure 6. Sample 4. Room 7, beam, southern pine.

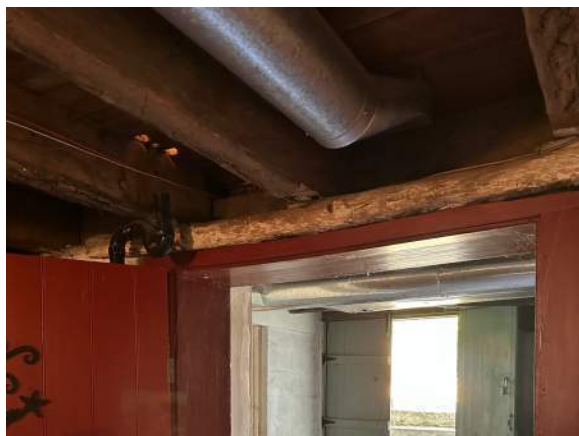
**Figure 7. Sample 5. Room 5, beam, red oak.**

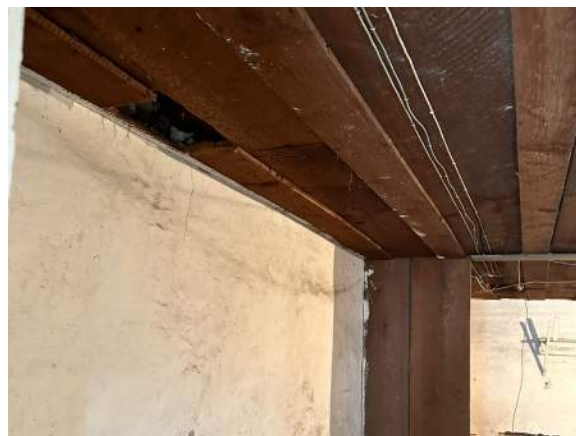
**Figure 8. Sample 6. Room 9, beam, white oak.**

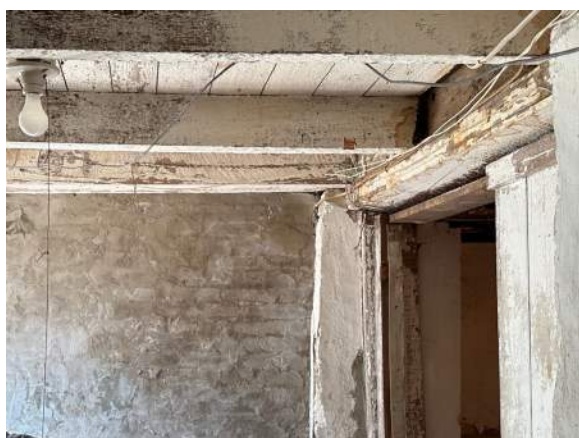
**Figure 9. Sample 7. Room 10, beam, southern pine.**

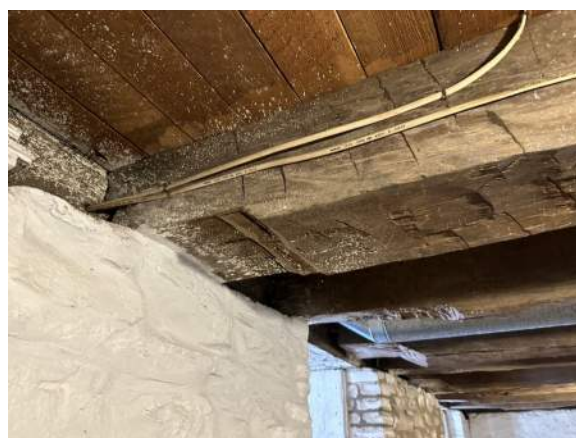
**Figure 10. Samples 8, 9, and 10. Beams in Rooms 11, 11A, and 11B, white oak.**

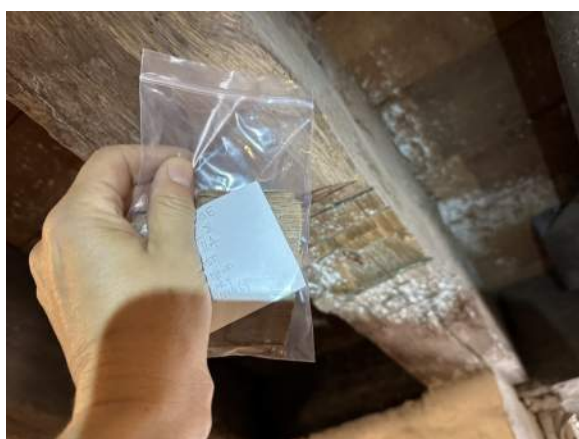
**Figure 11. Sample 8. Room 11A, beam, white oak.**

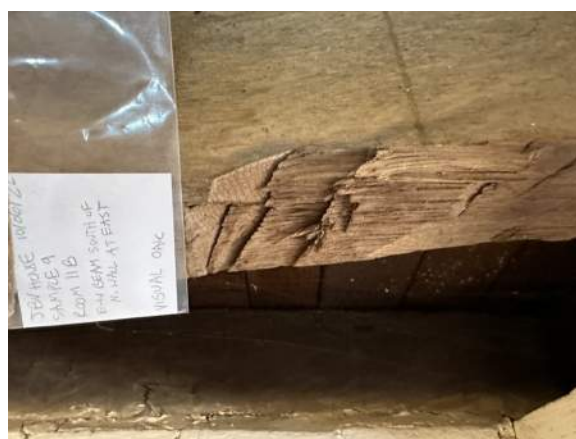
**Figure 12. Sample 9. Room 11B, beam, white oak.**

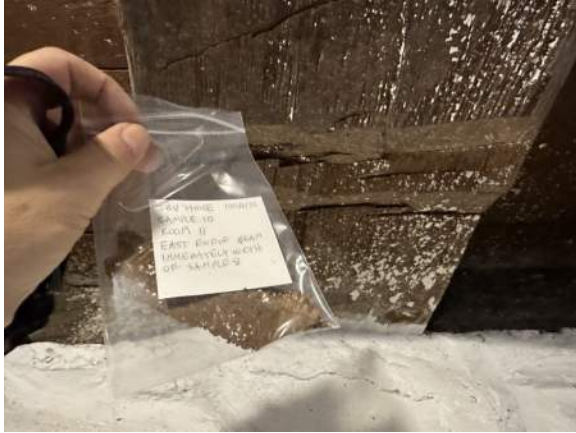
**Figure 13. Sample 10. Room 11, beam, white oak.**

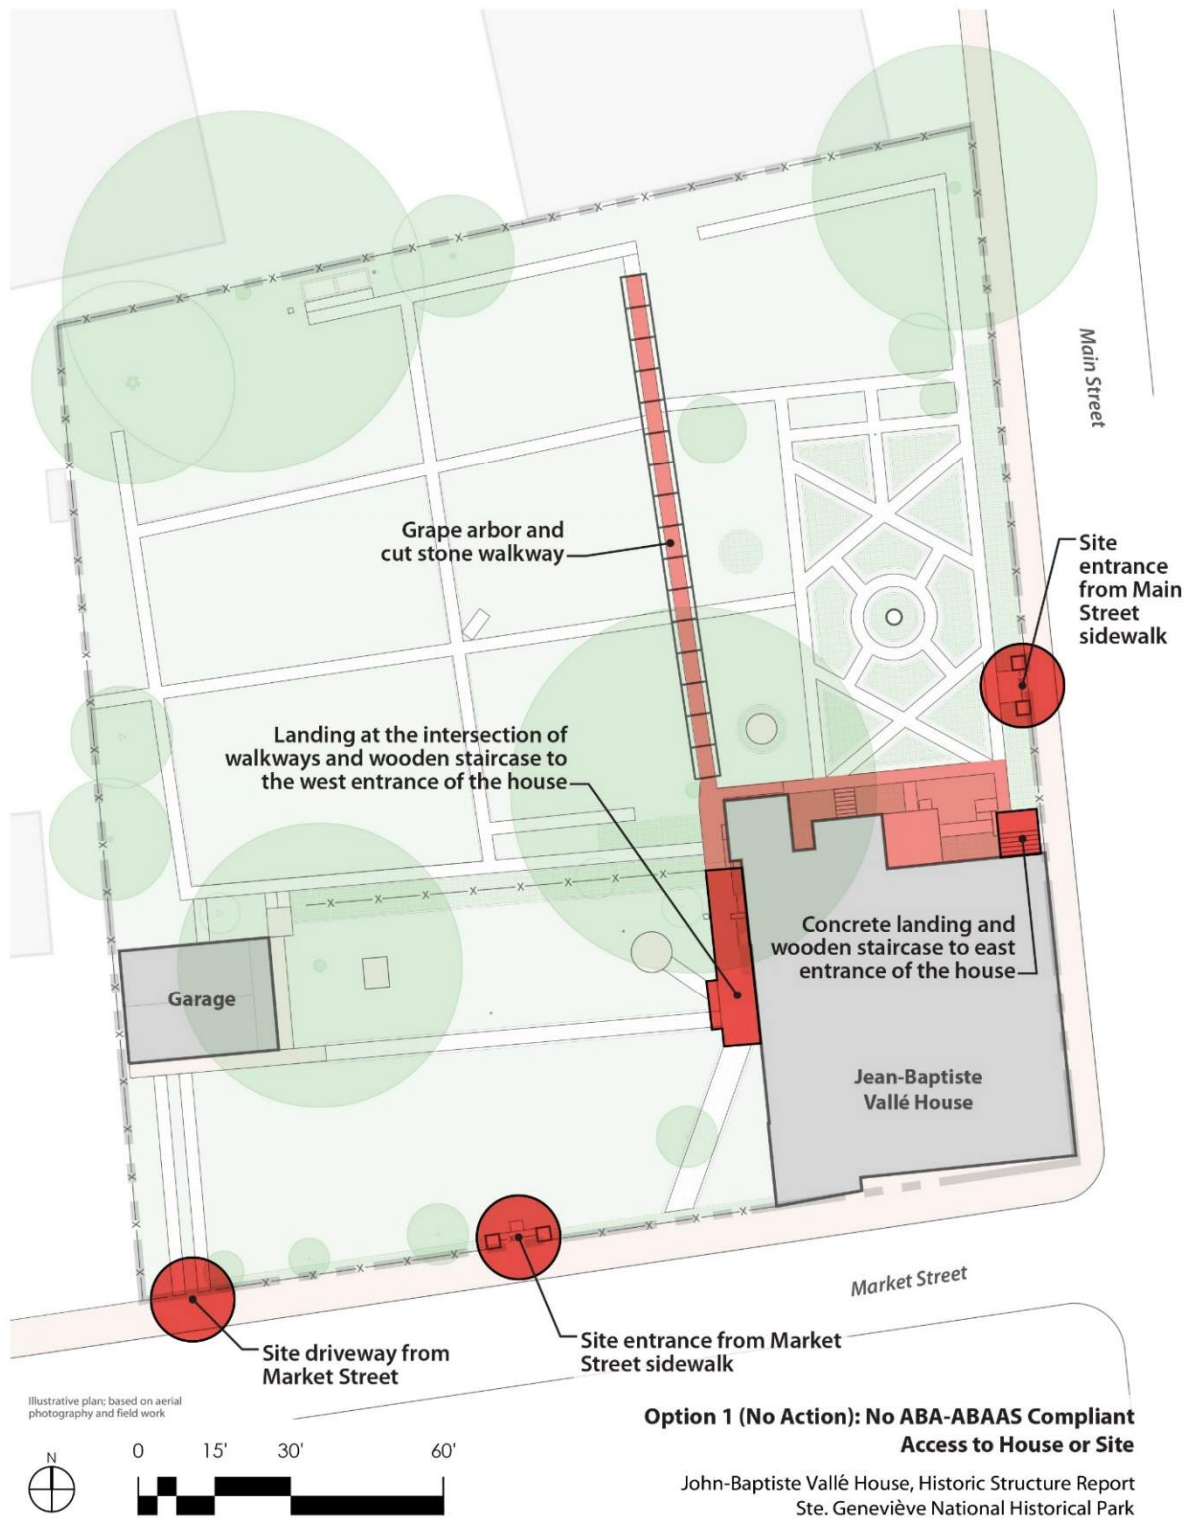
- The grape arbor is in poor condition and cannot be accessed by the public currently. Repairs are needed to the structure and the walkway.
- There are no accessible pathways along the public sidewalks from the Visitors Center parking lot or street parking to the historic site. Curb cuts, sidewalk widths, obstacles in the walkway, and walking surfaces are not compliant with ABAAS requirements.

Currently, the existing conditions do not respond to NPS goals or objectives for interpretation for the House and site and do not provide a barrier-free experience for visitors. Repairs and improvements to the problematic features listed above can be performed with little to no impact to the historic resource. As such, this option was not identified as the preferred treatment.

Figure 1. Treatment Option 1: Existing Conditions: No ABAAS Compliant Access to the Jean Baptiste Vallé House and Landscape. (Source: LSHLA)
