# historic structure report

FORT WOOD

Architectural Data Section

Statue of Liberty National Monument

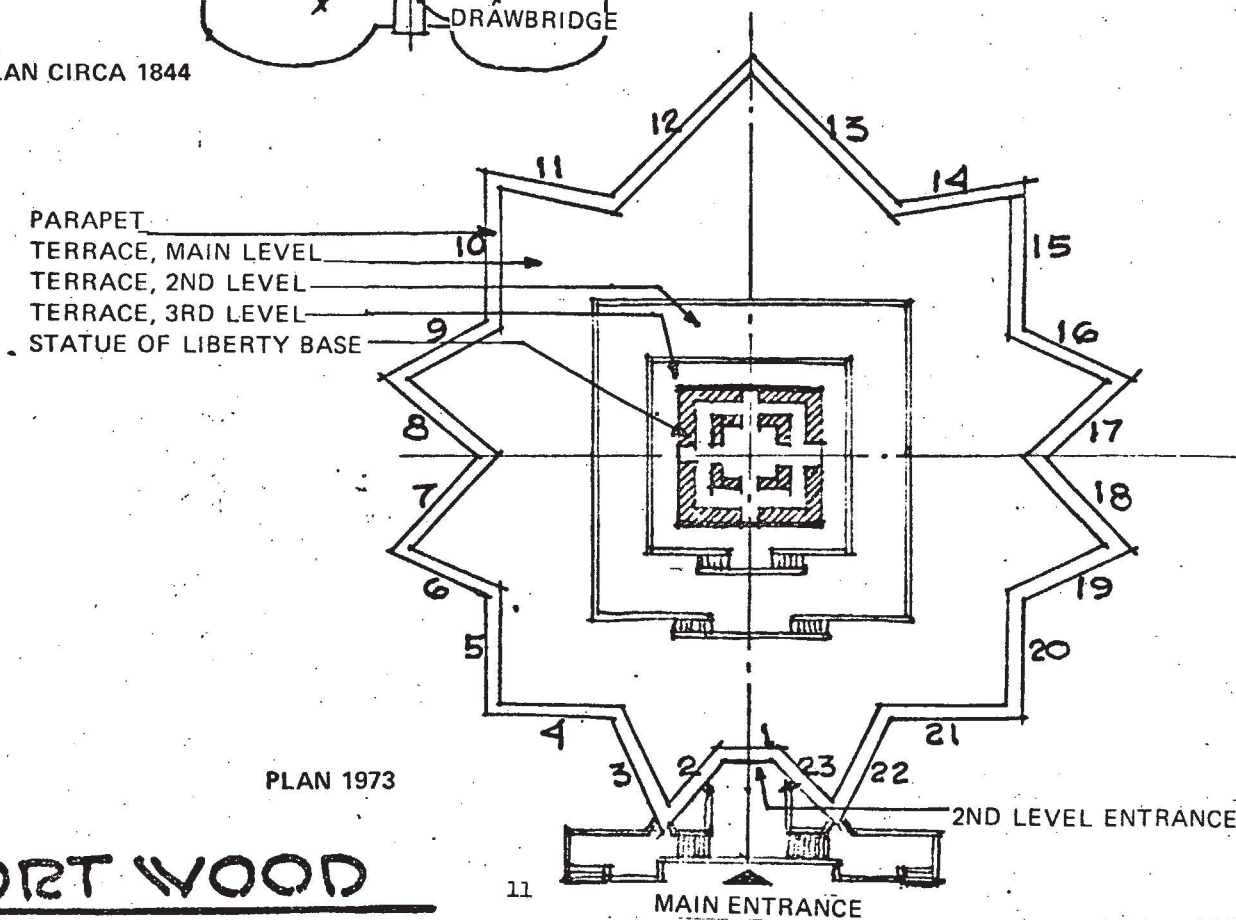
PLAN 1973

C-19 = PARAPET COPING - 19 JOINTS TO REPLACE (±8' Lin. Ft. each joint)

W - ±25 = WALL - ± 25 Lin. Ft. Joints to replace
