**PART II HISTORIC STRUCTURES REPORT**

# **Ansley Wilcox House N.H.S.**

**NOV. 1969**

**Office Of Archeology And Historic Preservation**

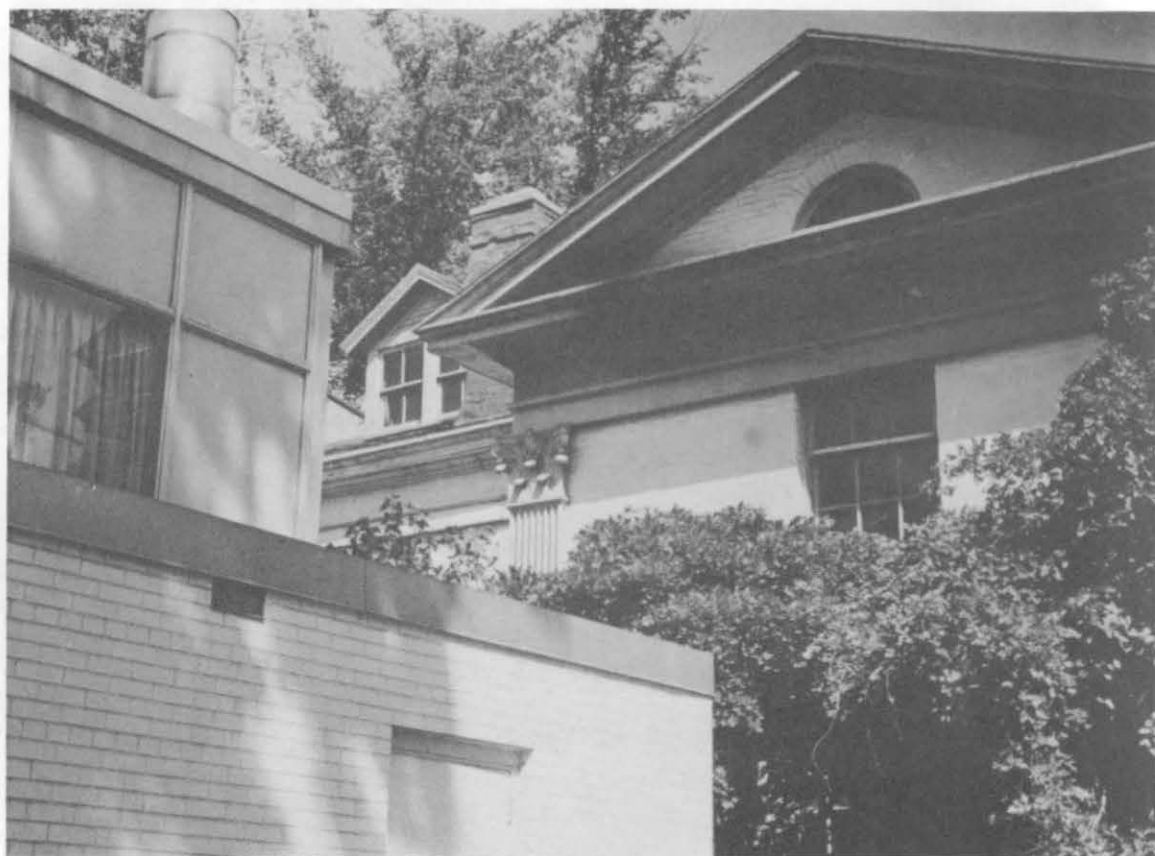
ILLUSTRATION NO. 8

The south wall of the Ansley Wilcox addition at the dining room. The wood terrace together with the scars over the doors and windows are the remains of a long terrace pavillion for outdoor restaurant dining.

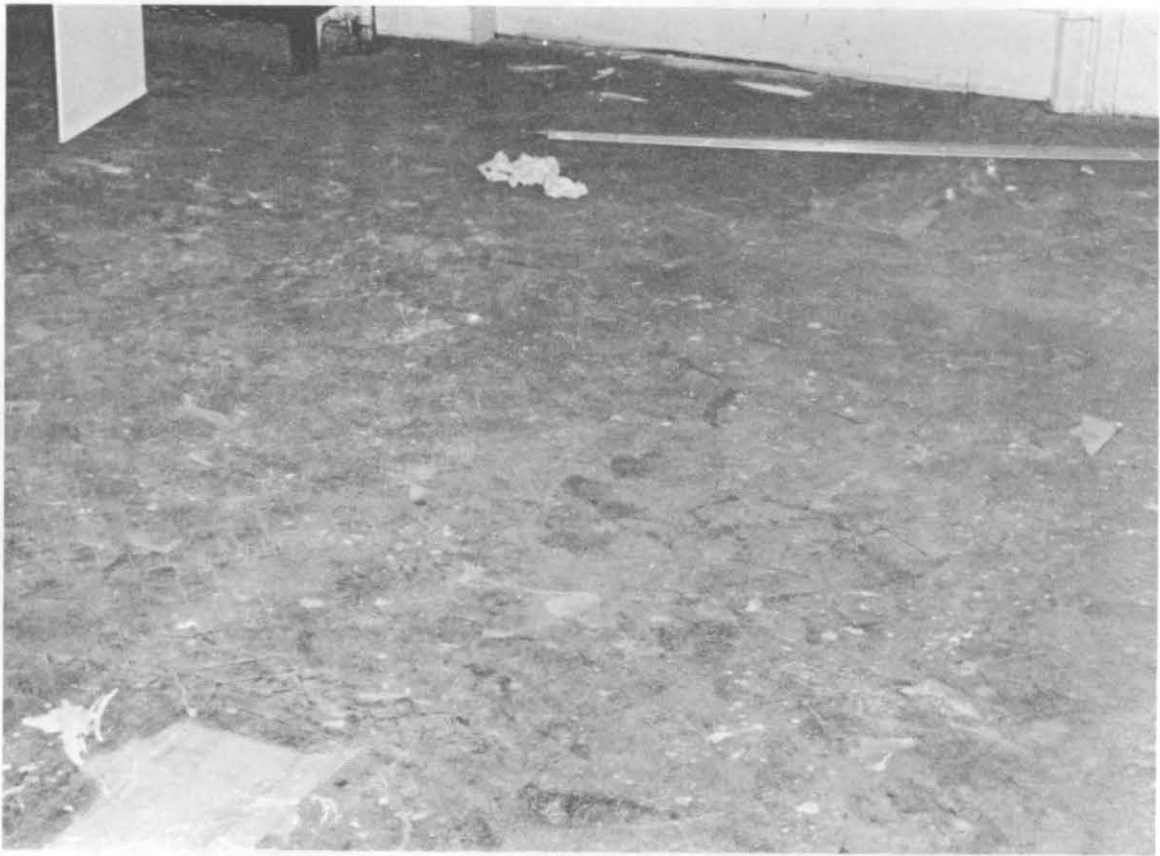
ILLUSTRATION NO. 30

The second floor of the 1838 section which has been converted into one large room by the removal of the hall and bedroom partitions. For the location of the original partitions, see the second floor plan for the conversion of the house into a restaurant.

The present plans for the restoration of the house do not include the restoration of the second floor partitions. Alteration of the area will depend upon the proposed use as rental office space.
