# Preservation/Restoration of Moton Field

## Phase II

Tuskegee Airmen  
National Historic Site  
Tuskegee, Alabama

*Historic Structure Report*  
Bath & Locker House

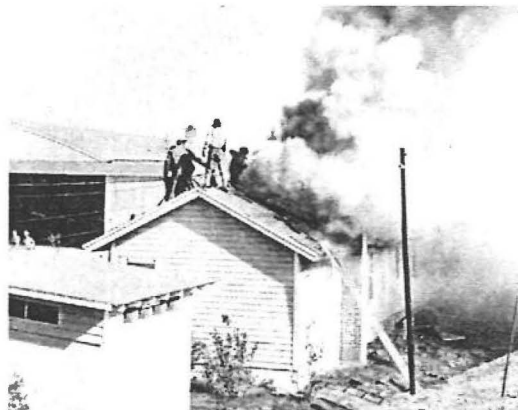
A fire occurred in the building sometime between May of 1943 and 1945. This date range is identified because a completed Hangar Number Two can be seen in the background of one of the pictures and the small addition to the rear of the first aid room has not yet been constructed. Photographs document efforts to extinguish the fire which resulted in the roof of the heater room being damaged to the point of collapse.<sup>36</sup> (See *Figures 3 and 4*.)

**Figure 3:** Fire in the women's locker room circa 1944. Historic Photograph Collection, Howard University.

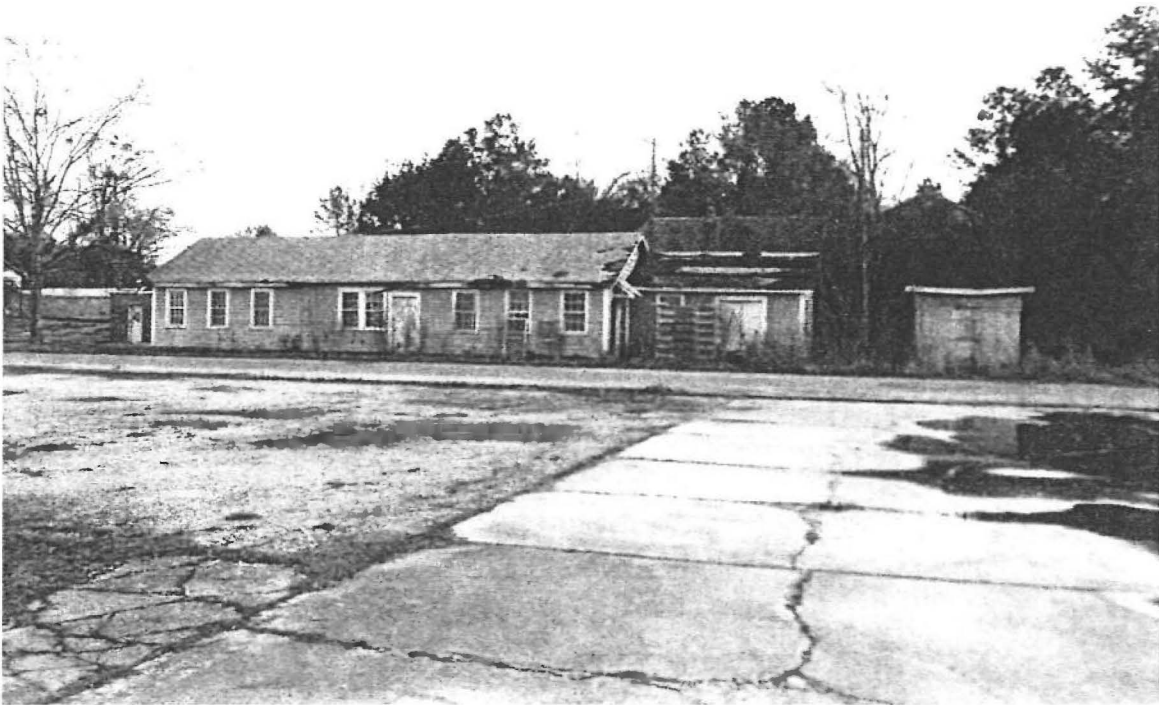
According to Ed Pryce, landscape architect and superintendent of grounds maintenance at Tuskegee Institute from 1955-1969, there was little money to maintain Moton Field during the 1950s and 1960s, and the airfield and its buildings deteriorated.<sup>37</sup> A photograph from the 1970s shows the building to be in fair condition.<sup>38</sup> (See *Figure 5*.)

**Figure 5:** North and west facades on June 14, 1977. Booker Conley's Files, Physical Plant, Tuskegee University.

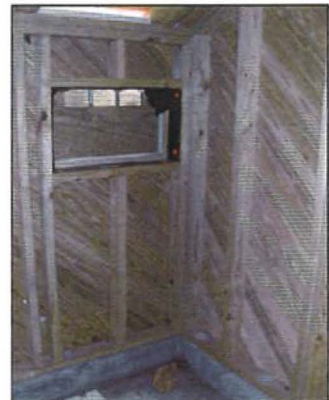
**Deficiency:** Replaced with wood sheathing  
No interior finish material present.

**Recommendation:** Utilize as restored.

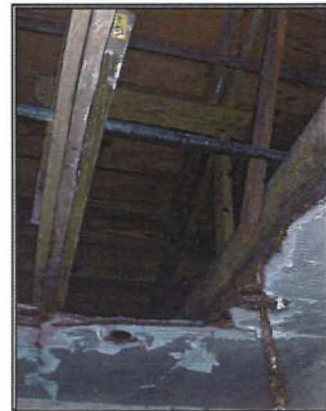
**Deficiency:** Missing portions of ceiling in facility.

**Recommendation:** Utilize as restored.

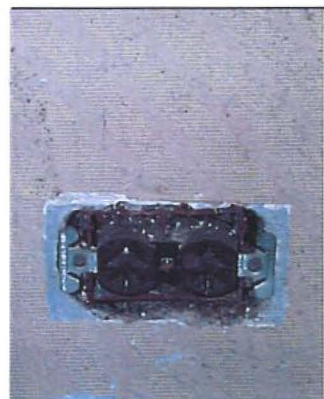
**Deficiency:** Coverplate is missing

**Recommendation:** Use to replicate device. Install  
new devices in existing locations throughout facility.

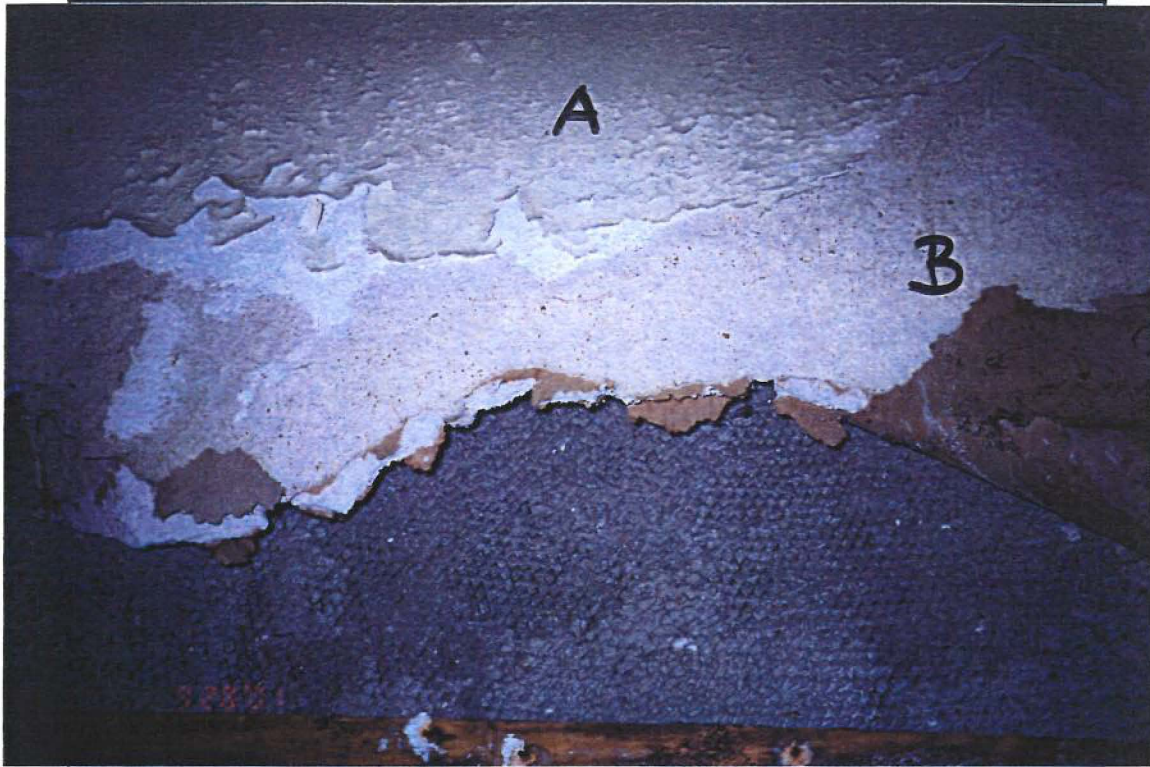
The plaster sample analyzed from the Bath and Locker House was a gypsum-based material (Photos 20 and 21 ). This is typical plaster material. The gypsum board sample was analyzed similar to the mortars. There was an indication that gypsum was present, but it was not quantified.

Photo 20. Bath and Locker House – Interior, Plaster (A) and gypsum board (B)

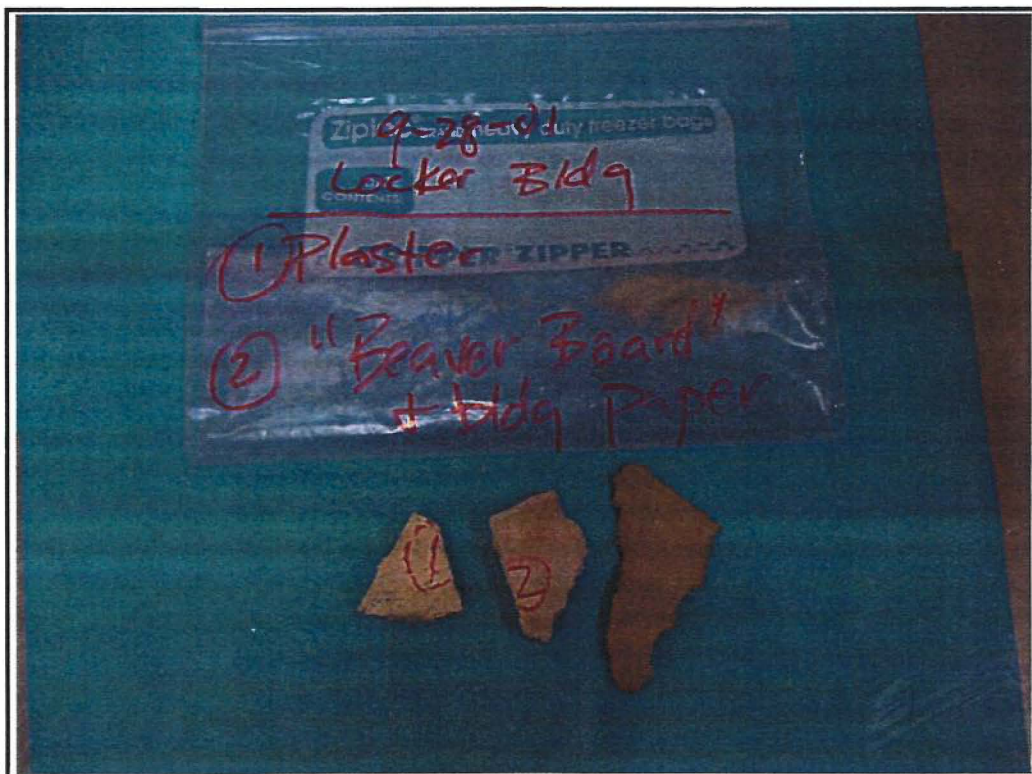
Photo 21. Bath and Locker House – Samples of Plaster (1) and gypsum board (2) with building paper (3)
