# Preservation/Restoration of Moton Field

## Phase II

Tuskegee Airmen  
National Historic Site  
Tuskegee, Alabama

*Historic Structure Report*  
Entrance Gate

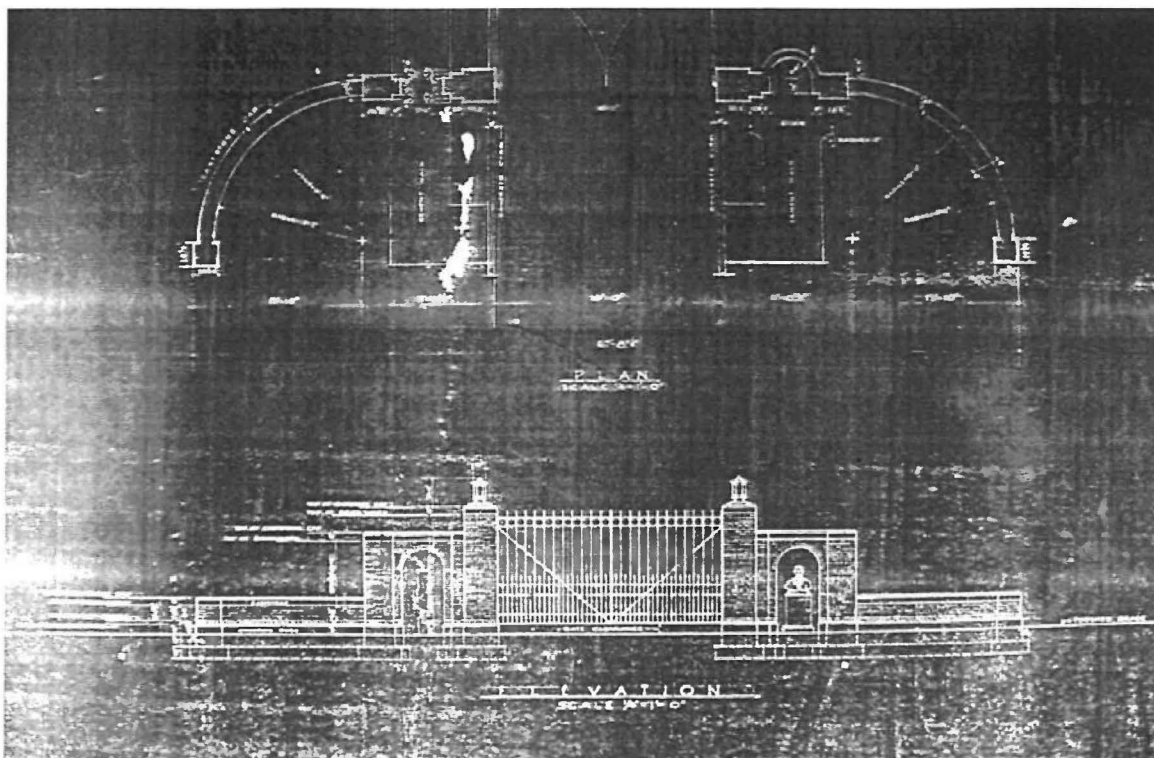
An undated war-era architectural drawing of the planned entrance gate attributed to Edward C. Miller, head of Tuskegee Institute's architecture department, shows that the surviving gate was built as drawn with a few minor exceptions. (See *Figure 1*.) The actual iron gates that were proposed were never installed.<sup>28</sup> According to Booker Conley, a simple chain was used instead to block vehicular access.<sup>29</sup> In addition, the proposed cement sidewalks on the west side of the gate to the niche and through the archway were never installed.

**Figure 1:** Undated plan and elevation for the Entrance Gate. The iron gates shown were never installed. Physical Plant, Tuskegee University.

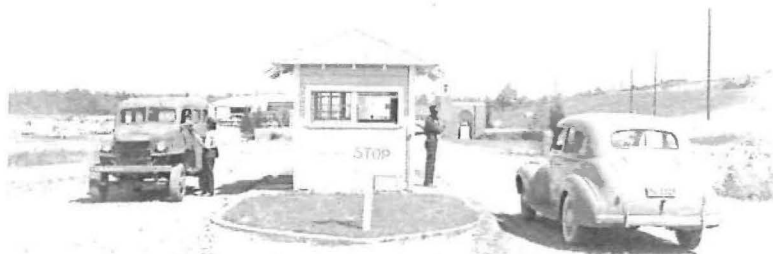
The Entrance Gate served as the main point of entry into Moton Field. By May 1944 a guard booth was located on the west side of the gate on a grassed island in the road to monitor vehicular traffic at the airfield.<sup>30</sup> (See *Figure 2*.)

**Figure 2:** 1944 photo of the Guard Booth showing the Entrance Gate in the background complete with lighting fixtures on gate piers and the bust of Robert Moton in the niche. Historic Photograph Collection, Howard University.

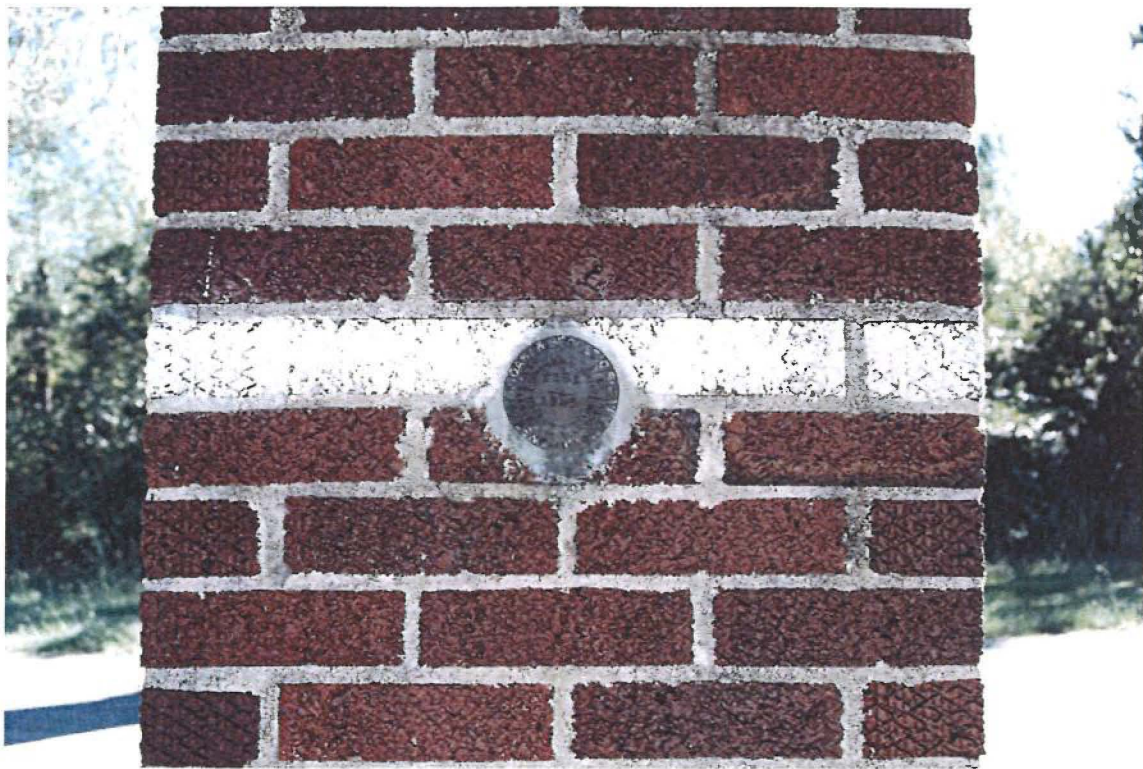
In 1945, a United States Coast and Geodetic Survey Bench Mark was installed on the north side of the archway on the North Wall. (See *Figure 3*.)

Figure 3: United States Coast and Geodetic Survey Bench Mark installed in 1945.

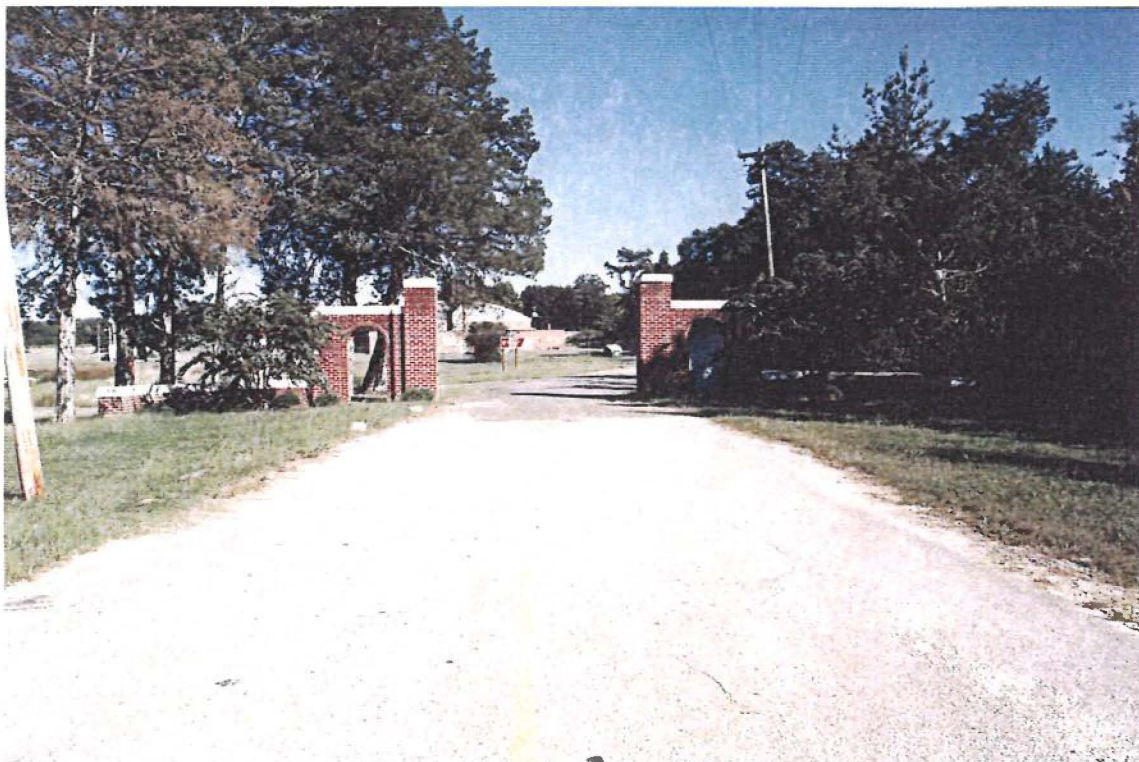
Figure 4: Entrance Gate as viewed from the west.

The Entrance Gate consists of two sections flanking the entrance road. (See *Figure 4*.) Each section contains a gate pier, a wing wall, and a seat wall. The seat walls extend away from the wing walls in a radial fashion. All portions of the gate are constructed of textured brick veneer laid in a running bond pattern with a soldier ground course. The brick is capped with cast stone sections that have been painted white.

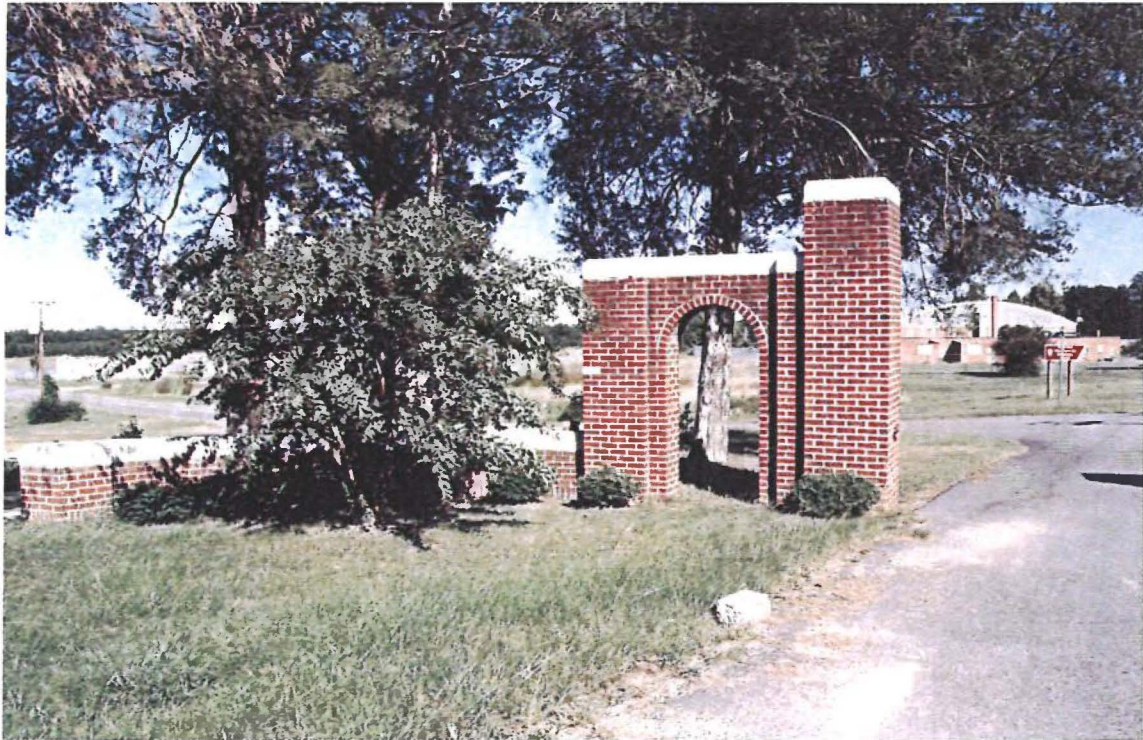
**Figure 5:** North Wall of Entrance Gate.

The North Wall contains an arched pedestrian entranceway in the wing wall. A United States Coast and Geodetic Survey Bench Mark dated 1945 is located on the north side of the archway. The row of bricks closest to the marker location on this side has been painted white. On the south side of the gate pier an iron ring with one remaining chain link attached has been cemented in the gate twelve courses from the ground. (See *Figure 6*.)

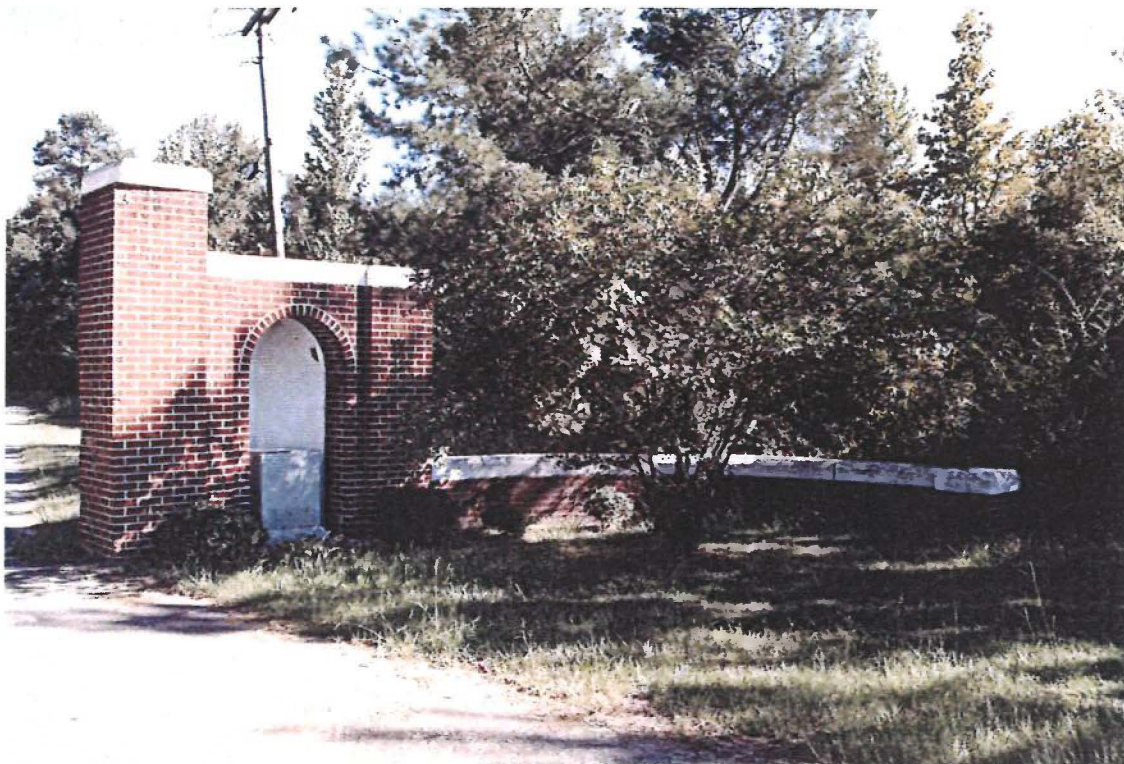
**Figure 7:** South Wall of Entrance Gate.

The south wing wall houses a niche that is of the same proportions as the arched entranceway in the North Wall. This niche contains a marble pedestal with the words *Robert Moton* etched in the front panel. A bust of Robert Moton, second president of Tuskegee Institute for whom the airfield was named, was formerly located on this base. (See *Figure 8*.) The bust has been missing for several years and it is not known whether it was removed for safekeeping or by vandals. The whereabouts of the bust is unknown at this time. During research for this project, inquiries about the bust's possible location were made with those interviewed about Moton Field as well as with Tuskegee University's Physical Plant and Archives. No one was able to provide the bust's current location. It is possible that the bust may be located among the Tuskegee University Archives' collections. The interior rear wall of the niche is finished with a thin layer of cement covered with several layers of paint. On the north side of the gate pier an iron ring with a padlock attached to it has been cemented into the gate twelve courses from the ground.

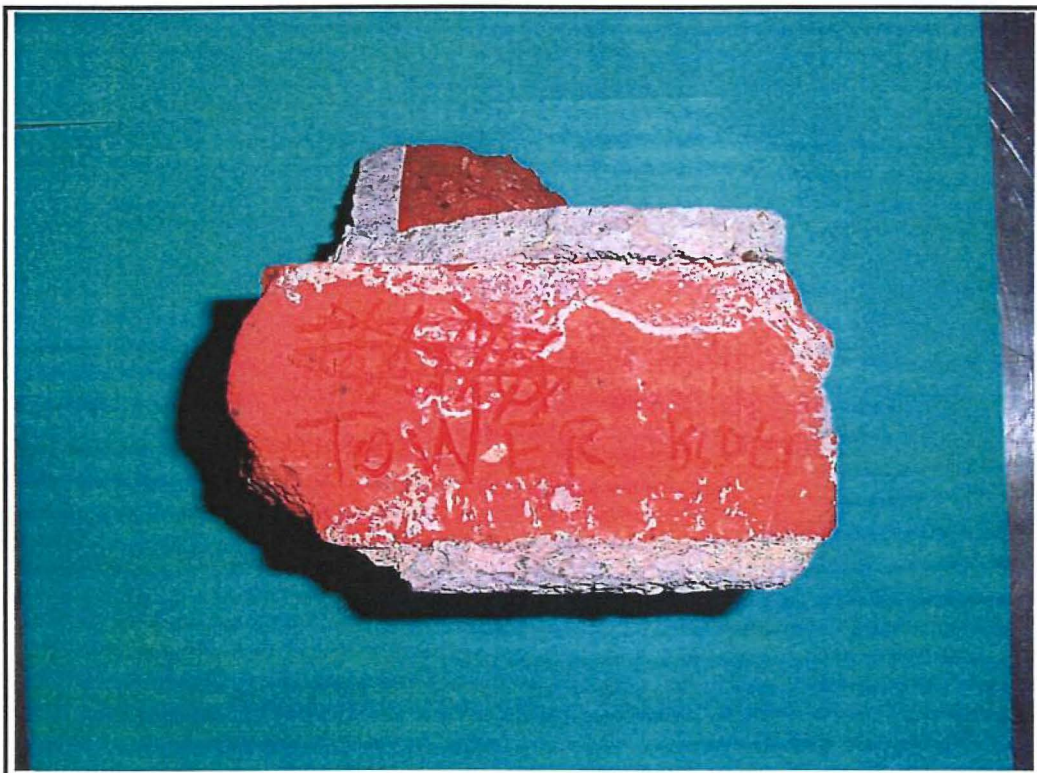
Photo 4. Brick/Mortar sample taken from exterior of Control Tower Building

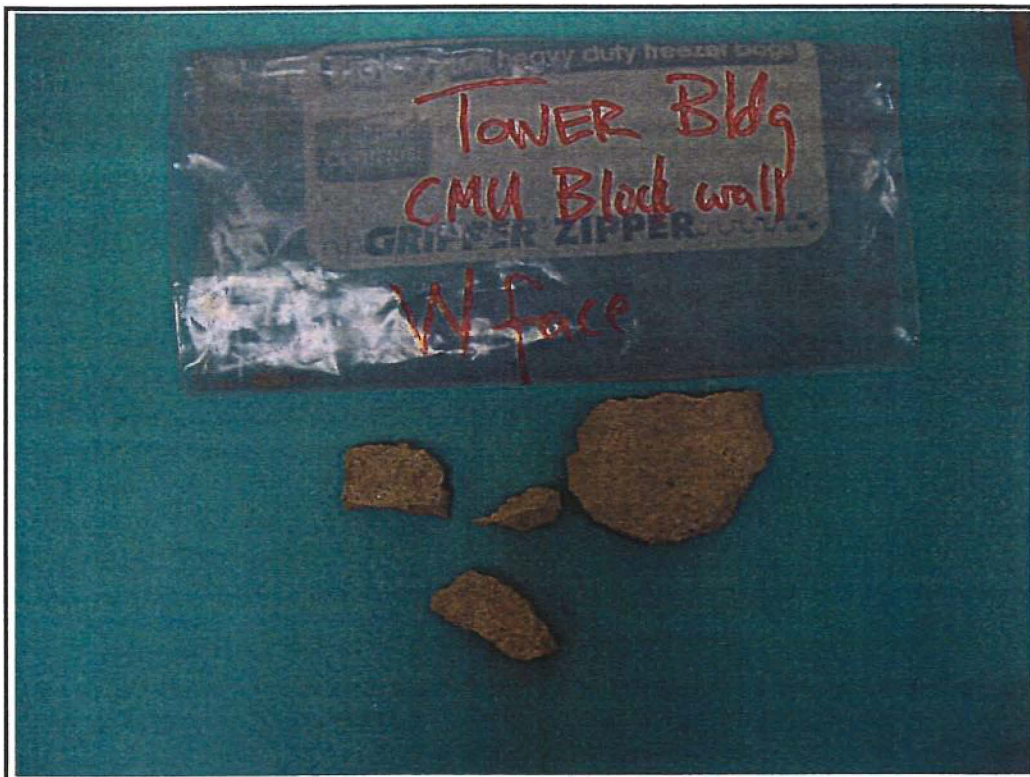
Photo 5. Mortar samples from Control Tower – exterior west face of building

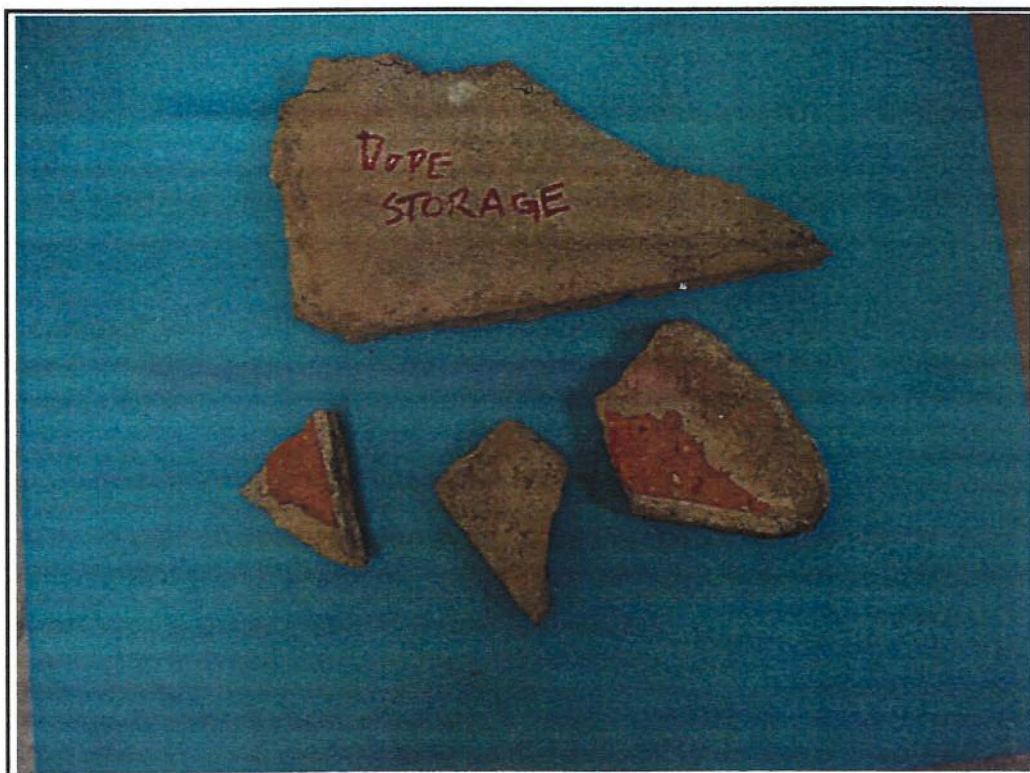
Photo 6. Mortar/Brick samples taken from interior of Dope Storage Shed

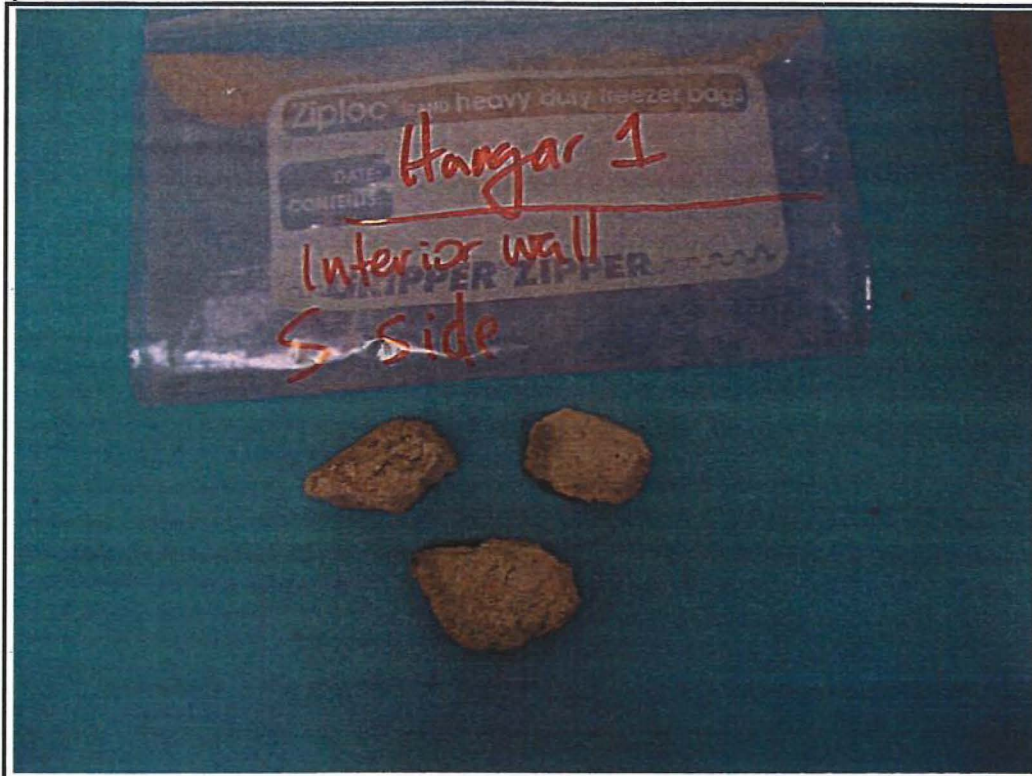
Softer mortar was observed in isolated areas of Hangar No. 1. The mortar appeared to have a higher lime content at some places than the other mortars observed. This determination was made by observation of the mortar color and the hardness of the mortar. The mortar inside Hangar No. 1 ranged from soft (easily scratched with a metal chisel) around the structural clay tile to medium hard around the brick. A section of the exterior south face of this building was re-constructed the summer of 2001. The white colored mortar with a brown surface smear coat was observed (Photo 12). The brown smear coat was applied for aesthetic reasons to match the new mortar to the existing one.

Photo 13. Hangar No. 1, Interior South Side– Mortar taken from brick

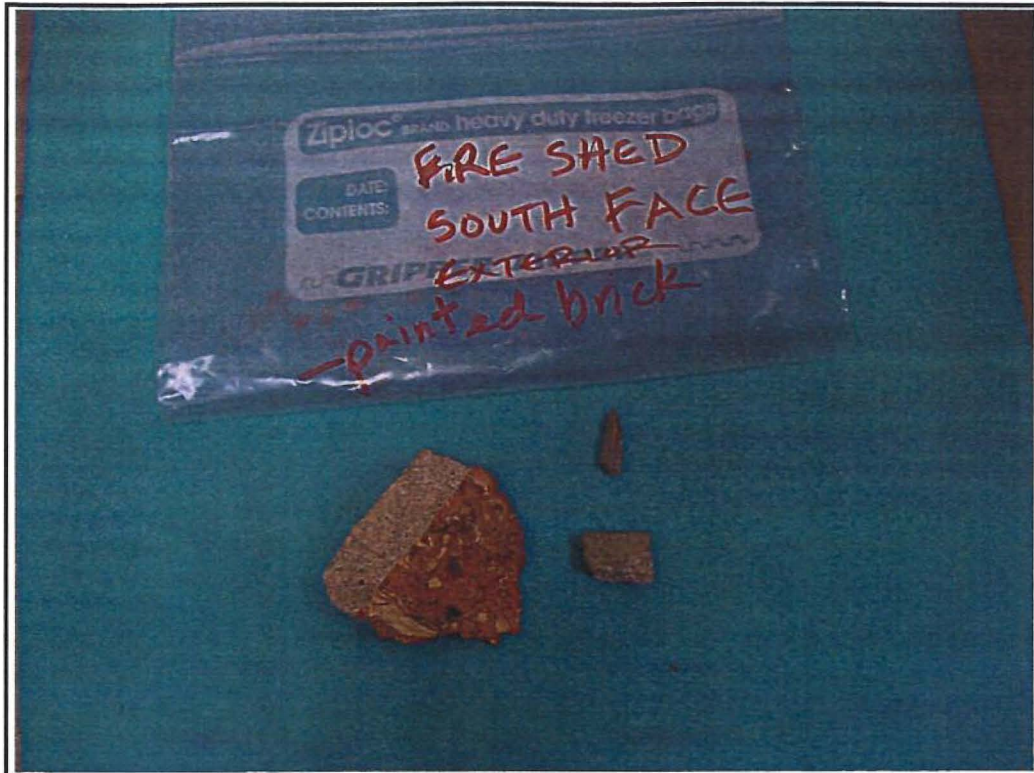
Photo 16. Fire Protection Shed – Mortar/brick samples from south face. Brick painted on side not shown.

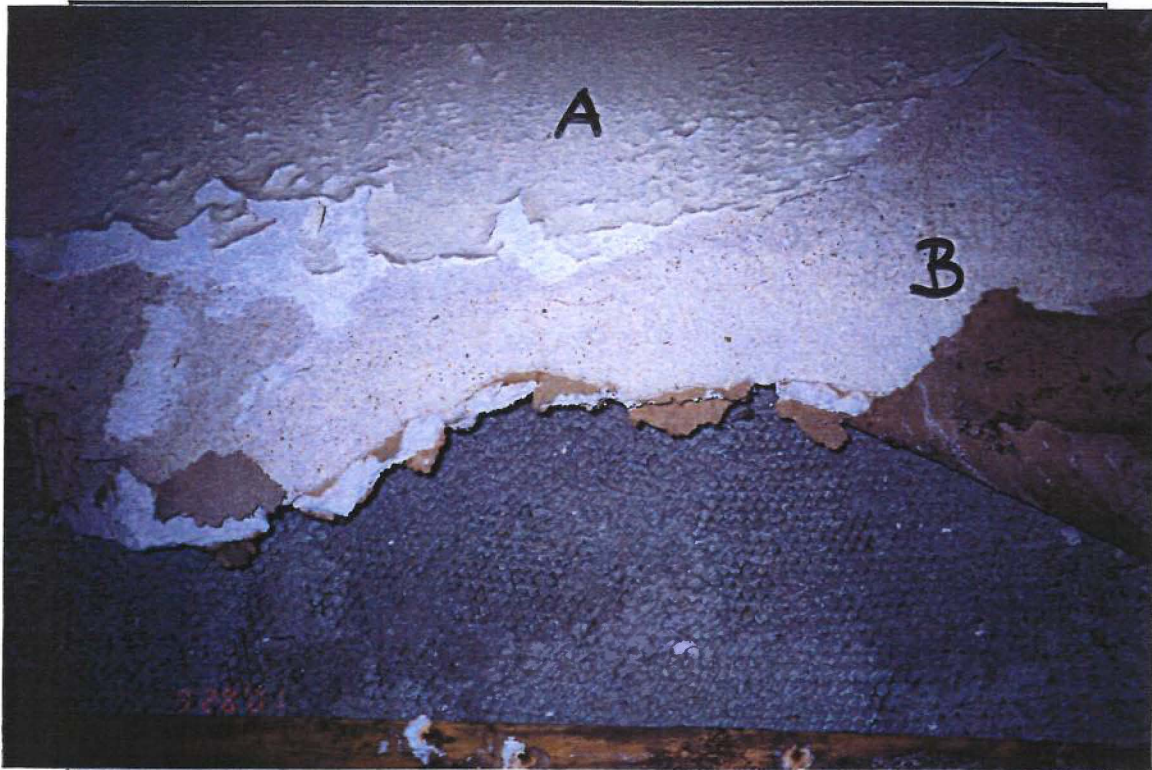
The plaster sample analyzed from the Bath and Locker House was a gypsum-based material (Photos 20 and 21 ). This is typical plaster material. The gypsum board sample was analyzed similar to the mortars. There was an indication that gypsum was present, but it was not quantified.

Photo 20. Bath and Locker House – Interior, Plaster (A) and gypsum board (B)

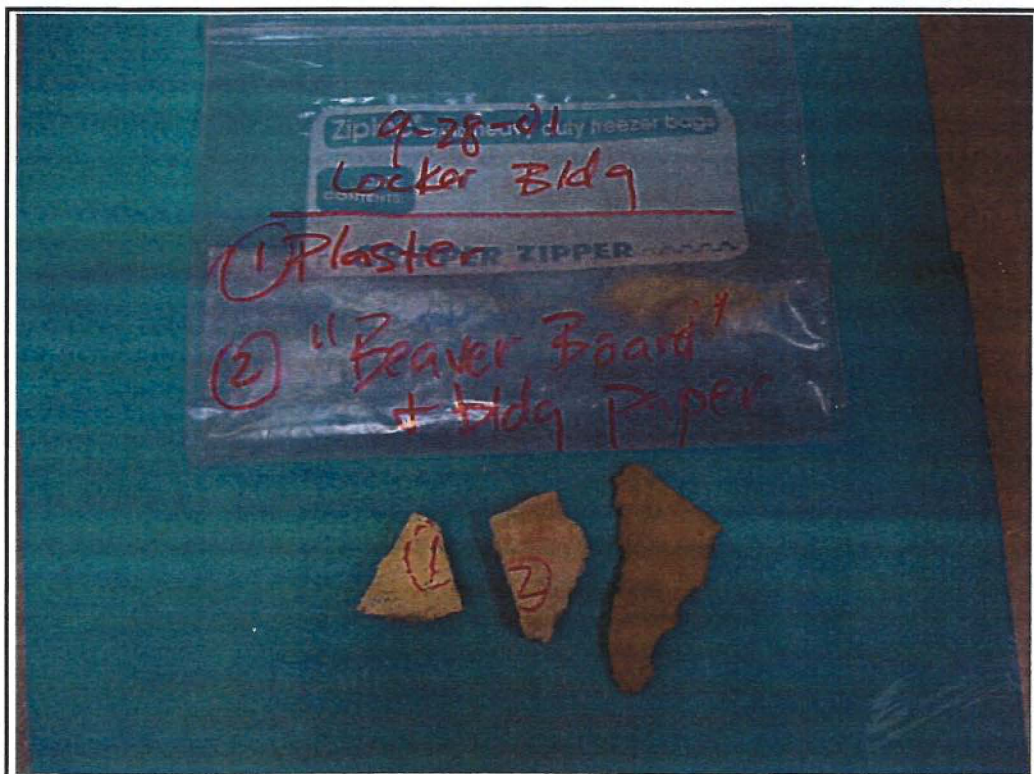
Photo 21. Bath and Locker House – Samples of Plaster (1) and gypsum board (2) with building paper (3)
