# Preservation/Restoration of Moton Field

## Phase II

Tuskegee Airmen  
National Historic Site  
Tuskegee, Alabama

*Historic Structure Report*  
Hangar Number One

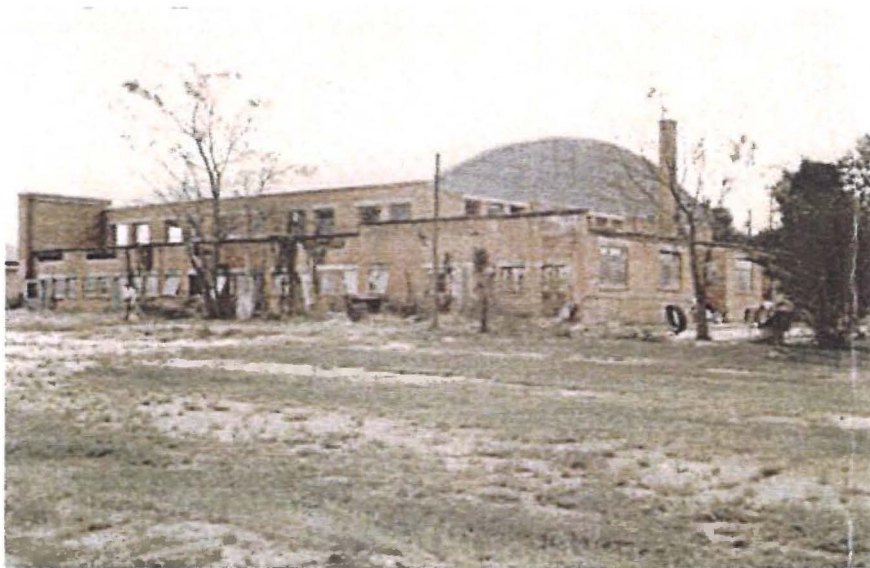
Photographs of Hangar Number One from the 1970s show a vacant and deteriorating building.<sup>38</sup> (See *Figure 12*.) The roofs of the rooms surrounding the hangar space appear to be largely gone by this time.

**Figure 12:** 1970s photo of Hangar Number One. Booker Conley's Files, Physical Plant, Tuskegee University.

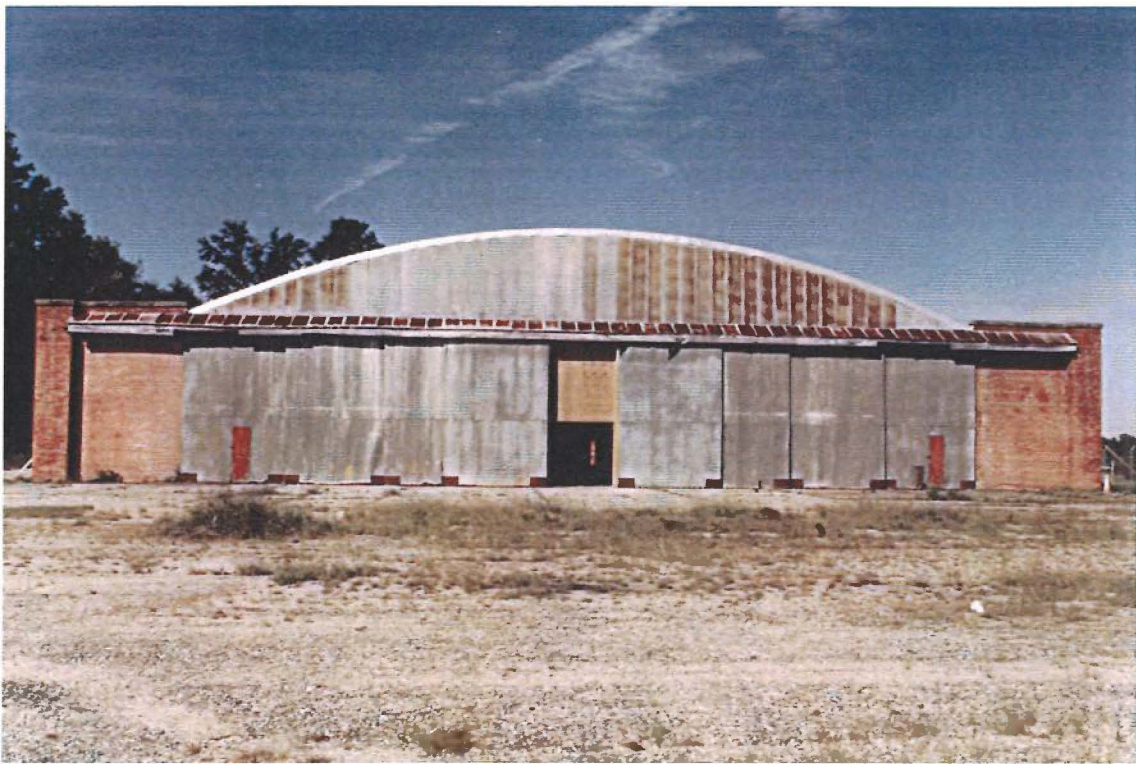
**Figure 14:** Existing east front facade.

The wood structure of the pent roof over the hangar doors on the front facade is in poor condition due to moisture decay. A number of the wood fascia boards are missing, and many of the remaining boards are warped. The corrugated metal is rusted but appears to be in fair condition.

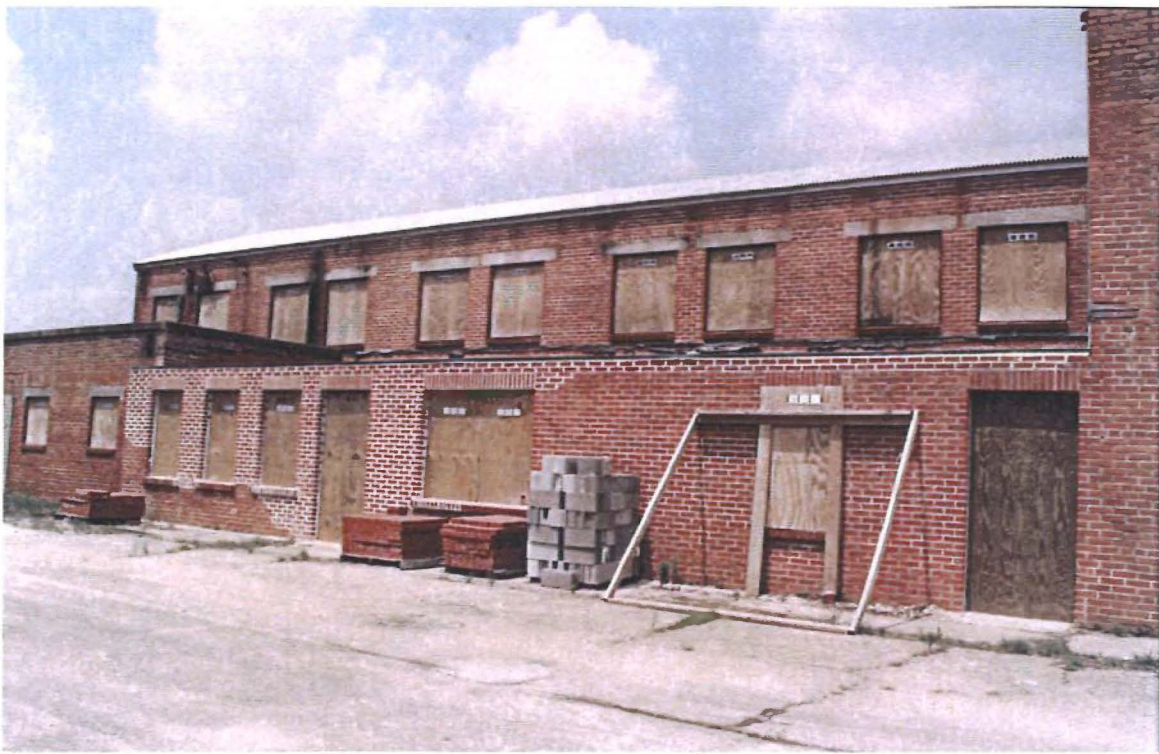
**Figure 16:** Existing south side facade showing rebuilt wall of lunch/tea room addition.

The exterior wall of the addition was largely reconstructed in the recent stabilization work. The 2x4-frame and brick-veneered wall was replaced, however, with a concrete block and brick-veneered wall, making the wall thicker than its original width. The reconstructed wall is approximately 11 inches thick as compared to the original wall thickness of approximately 9½ inches based on original architectural drawings of the lunch/tea room addition. (See *Figure 7*.) Portions of the original brick veneer remain on the wall's exterior.

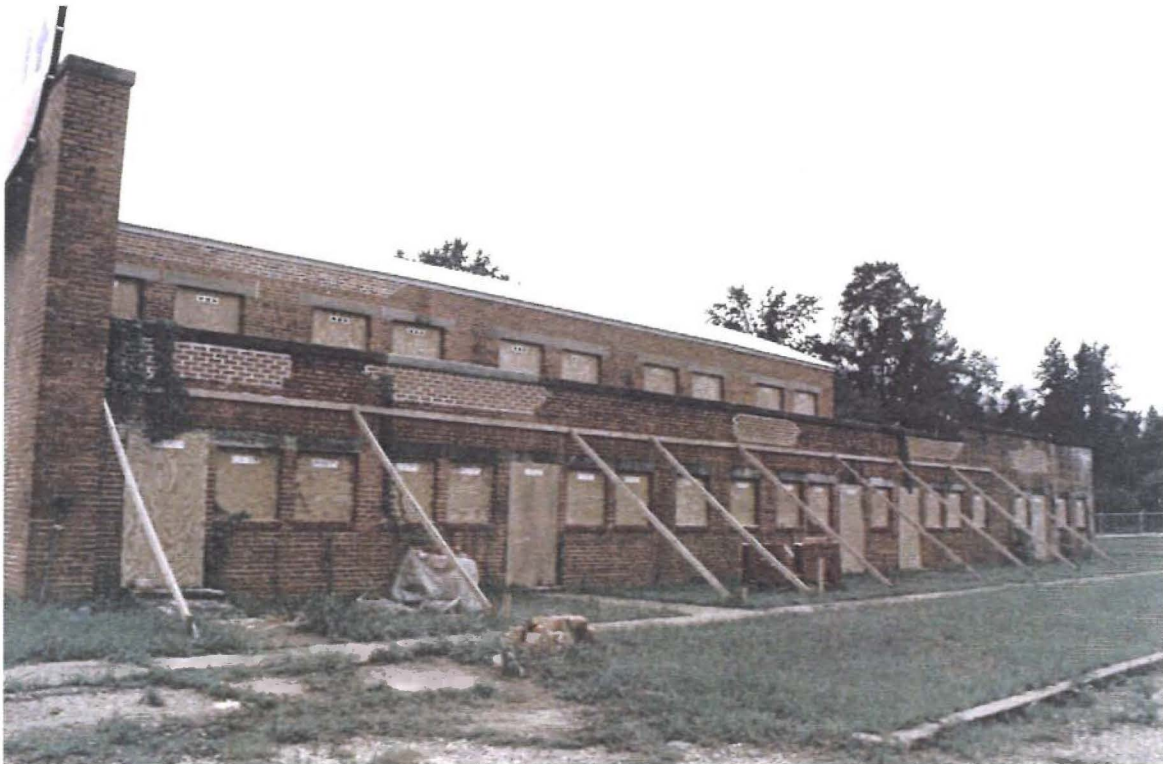
**Figure 17:** Existing north side facade with temporary shoring.

Several sections of brick were missing near the top of the exterior brick wall of the perimeter rooms on the north facade. The holes were infilled with new brick masonry. As in the south facade wall, the new brick masonry units are shorter in length than the original bricks, causing the vertical mortar joints to be wider than the original joints. Also, the new mortar is whiter in color and a brown-colored smear coat has been placed over it to disguise its white color. One portion of the concrete parapet cap that was missing was replaced in kind with new concrete. The entire north facade wall of the perimeter rooms has been braced from the exterior with temporary wood braces.

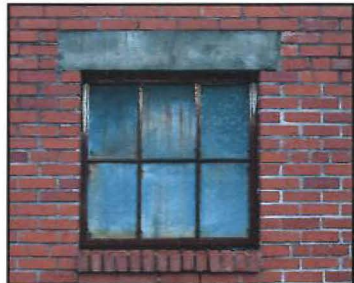
**Deficiency:** Window frames are rusted and contain broken glass

**Recommendation:** Remove vented plywood. Clean and repair existing frames. Replace sash, glass and other missing elements as necessary.

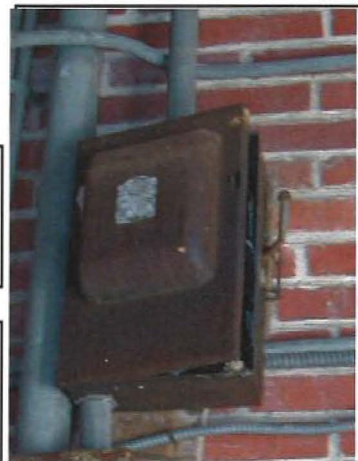
**Deficiency:** Wiring is lost.

**Recommendation:** Clean and repaint. For interpretive purposes only. Install new panels and switches for new electrical service requirements.

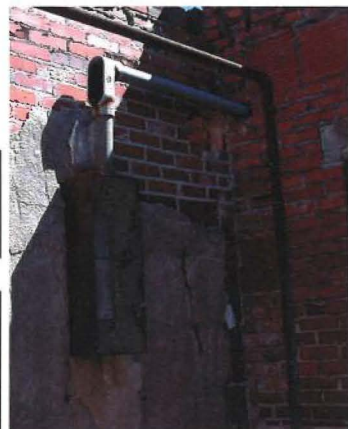
**Deficiency:** Door, wiring, conduit and internal components are lost.

**Recommendation:** Clean and repaint. For interpretive purposes only. Install new panels and switches for new electrical service requirements.

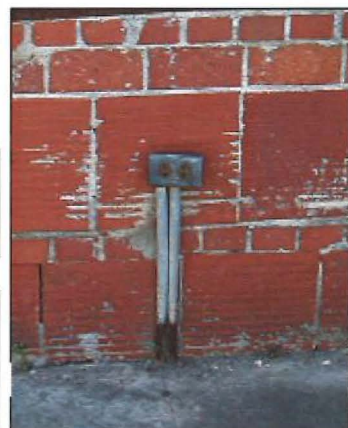
**Deficiency:** This receptacle is in tact, however, portions of the circuit wiring is no longer extant.

**Recommendation:** Remove and use to replicate new devices for use with new electrical service in facility. Locate new devices in existing locations.

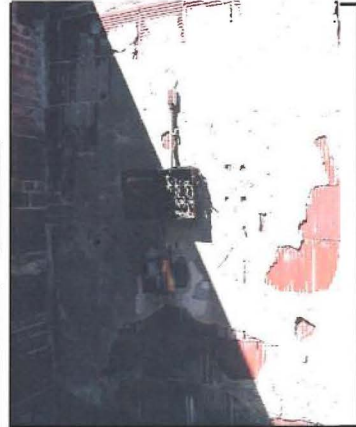
**Deficiency:** Cover missing from disconnect switch. Nature of equipment served is unknown.

**Recommendation:** Replicate cover, fix in place, and paint - for interpretive uses only. Install new panels for new electrical service requirements.

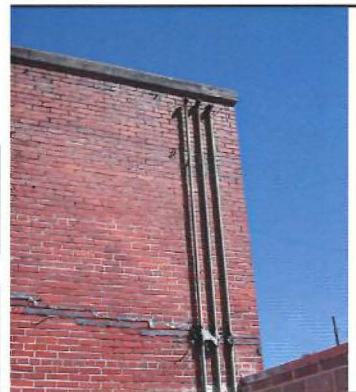
**Exterior****5835****Electrical Equipment****Feature Description:** Three conduit riser with weatherheads located at the east end of the supply room.  
The purpose of these conduits is unknown they go down the wall and disappear  
into the concrete slab floor.**Feature Notes:****Feature Condition:****Total Inventory:** 1**Historic Rating:****Priority:****Deficiency:** Electrical wiring is lost**Recommendation:** Leave as existing for interpretive purposes  
only.

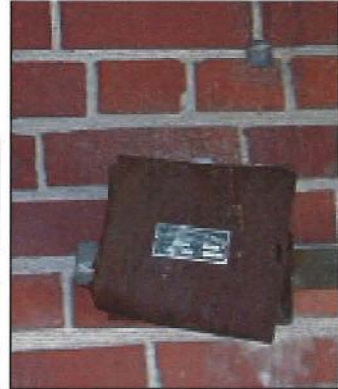
**Deficiency:** Cover is bent, conduit and wire are missing.

**Recommendation:** Clean, repair and repaint -leave in place for interpretive purposes only.

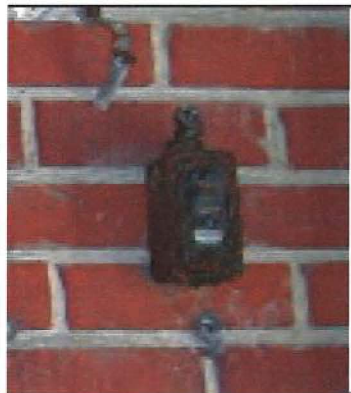
**Deficiency:** Conduit, wire and equipment served by switch are lost.

**Recommendation:** Clean, repair and repaint -leave in place for interpretive purposes only.

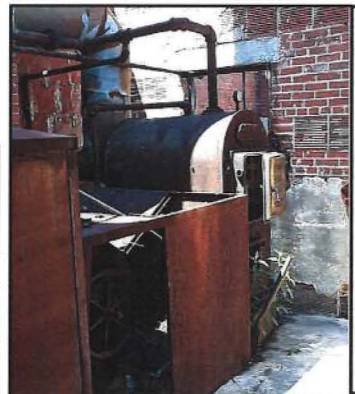
| <b>Deficiency:</b> | Disconnect switch that served this equipment is been lost. lying on top. |

| <b>Recommendation:</b> | Clean and repaint - leave in place for interpretive purposes only. |

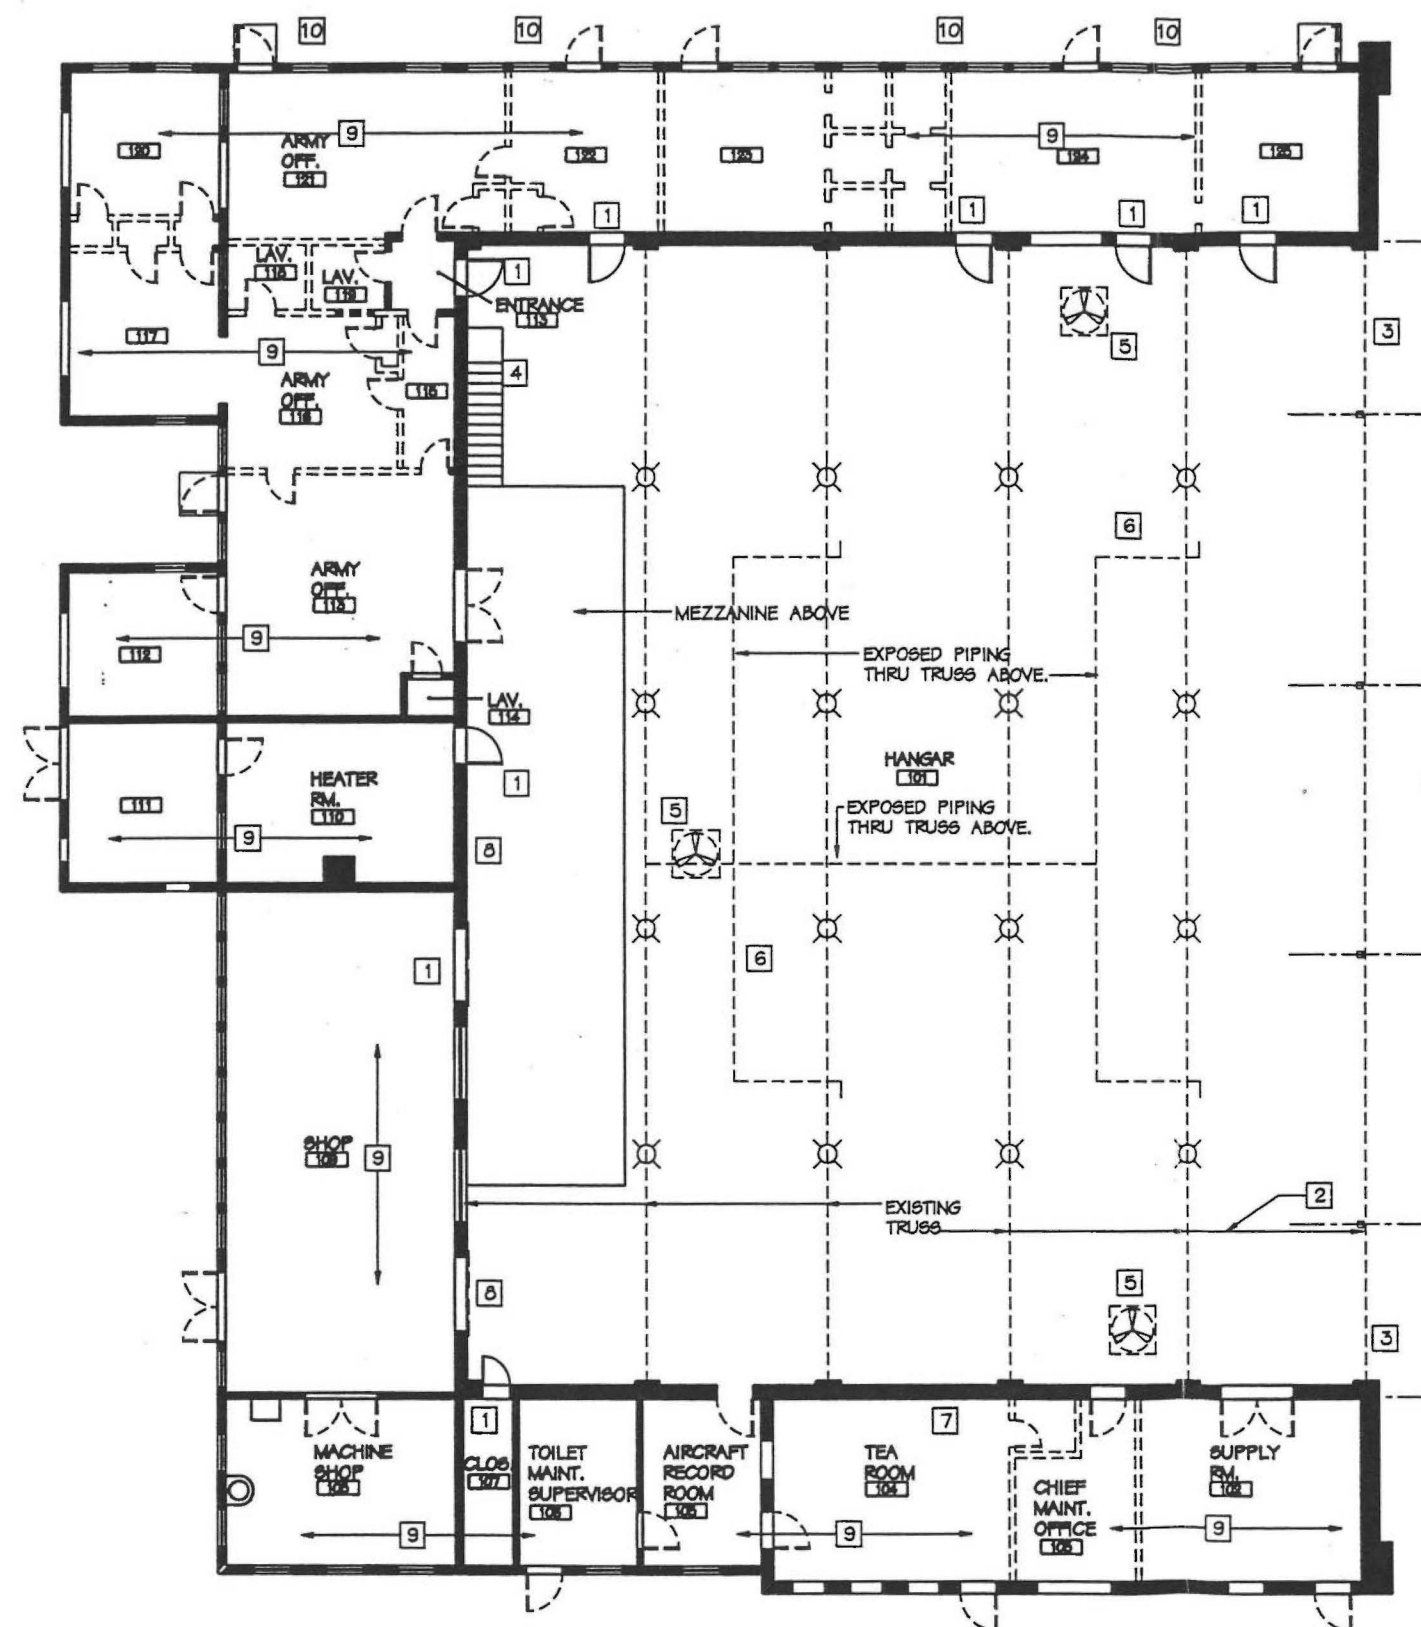
Figure 1

- KEY NOTES
- 1 DOOR DAMAGED
  - 2 TRUSS BROKEN/ DAMAGED WAS REPAIRED DURING STABILIZATION PHASE
  - 3 HANGAR DOORS DAMAGED, PANELS RUSTED
  - 4 SECTION OF STAIR MISSING.
  - 5 EXISTING CEILING FAN (DAMAGED)
  - 6 EXPOSED PIPING THRU TRUSS ABOVE
  - 7 EXISTING ROOF LEDGE ABOVE, BROKEN
  - 8 EXPOSED ELECTRICAL CONDUITS ALONG WALL
  - 9 ROOF MISSING
  - 10 SECTION OF WALL MISSING ABOVE (SEE SHEET A4A)- BRICK HAS BEEN ADDED DURING STABILIZATION PHASE.

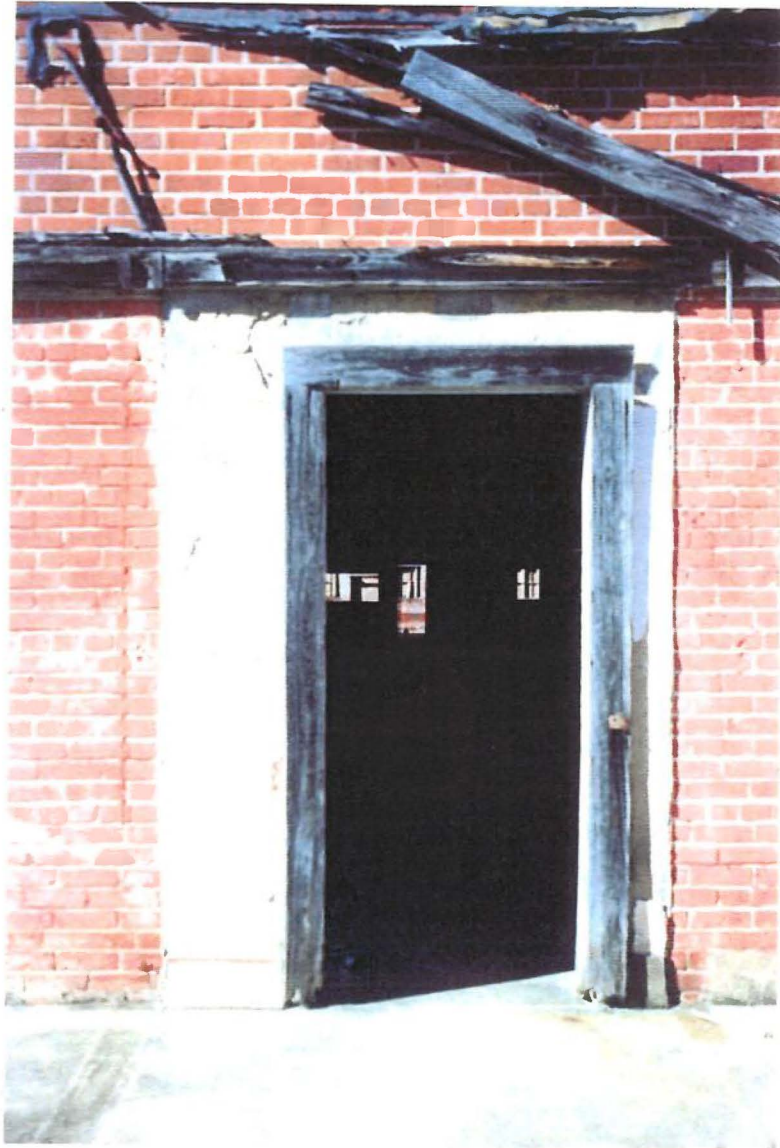
**Figure 3**

The deteriorated frame walls have been removed. Plaster remnants remain on the concrete door surrounds in Room 103. (See Figure 3)

Concrete lintel and door surround were covered with plaster. (See Figure 3) The wood door frame has been painted white, grays, blue green, and light blue. The frame sample sent to Frank Welsh showed at least two layers of white close to Sherwin Williams #1004 (See Sample 1) and a medium blue green color.

Room 103: plaster over concrete lintel and surround

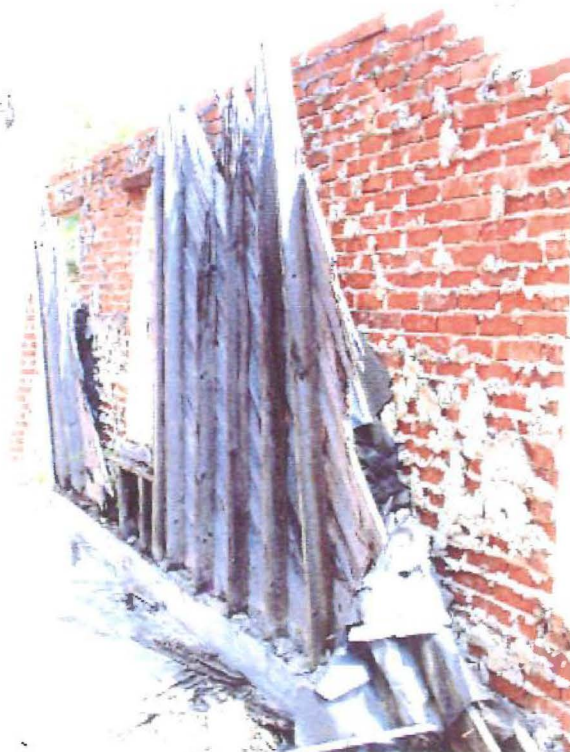
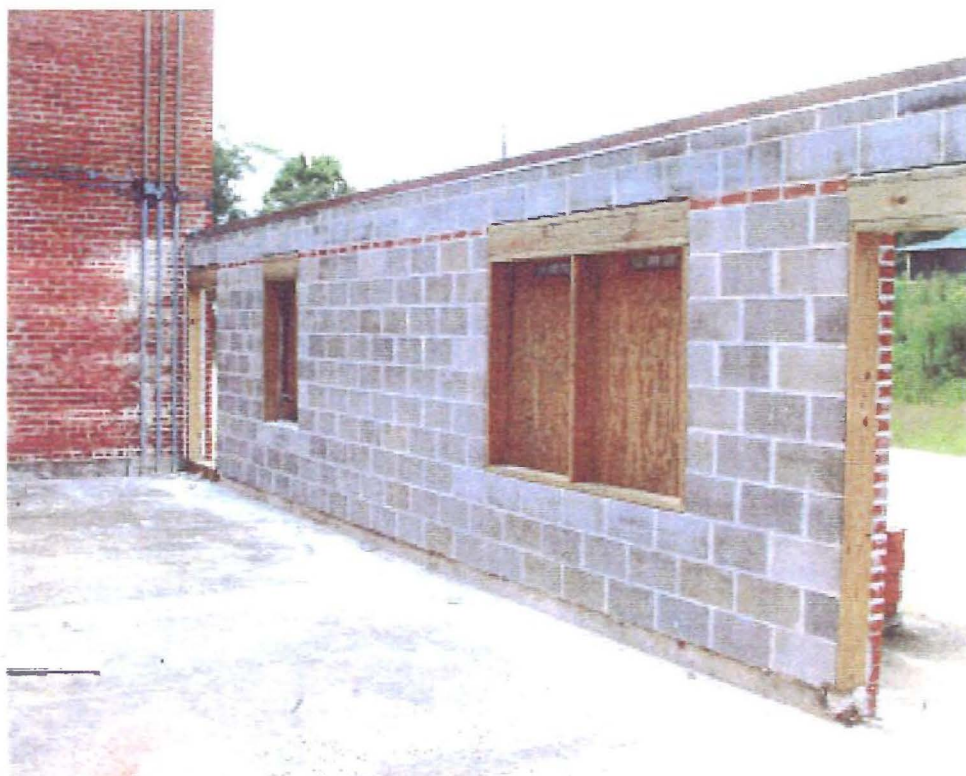
**Figure 4**  
NATIONAL PARK SERVICE  
MOTON FIELD HISTORIC STRUCTURES  
STABILIZATION STATUS JULY 2001  
BUILDING: HANGER ONE

Original frame walls have been removed. (See Figure 4) Final wall finish is rocky plaster.

BEFORE

PRESENT

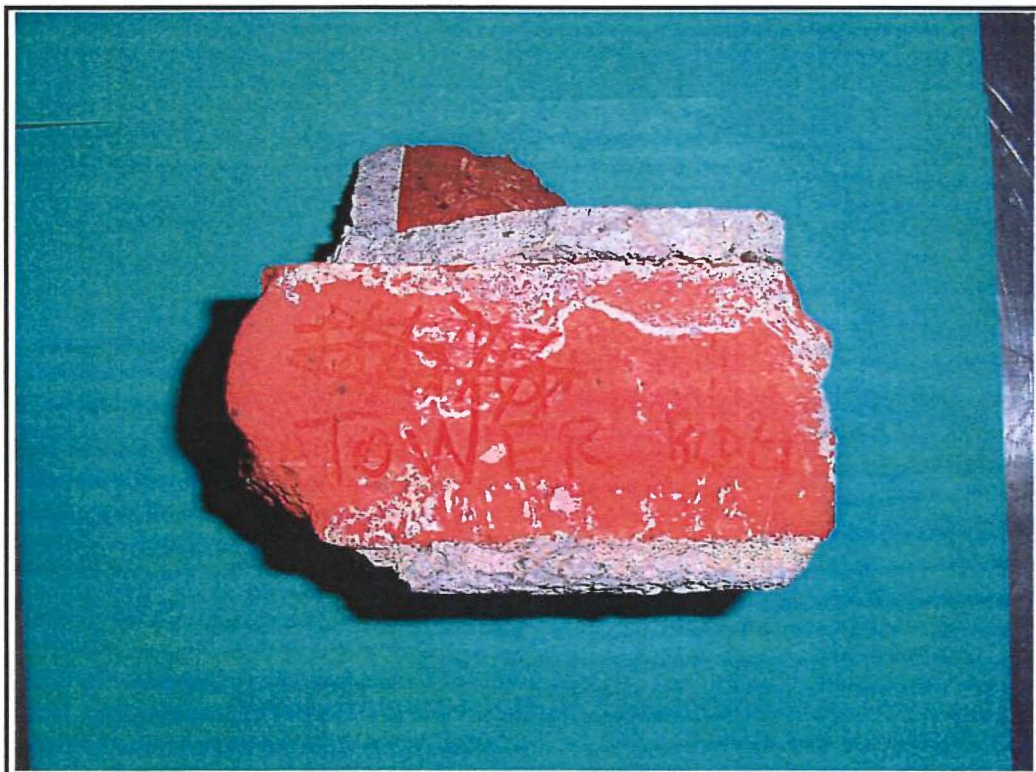
Photo 4. Brick/Mortar sample taken from exterior of Control Tower Building

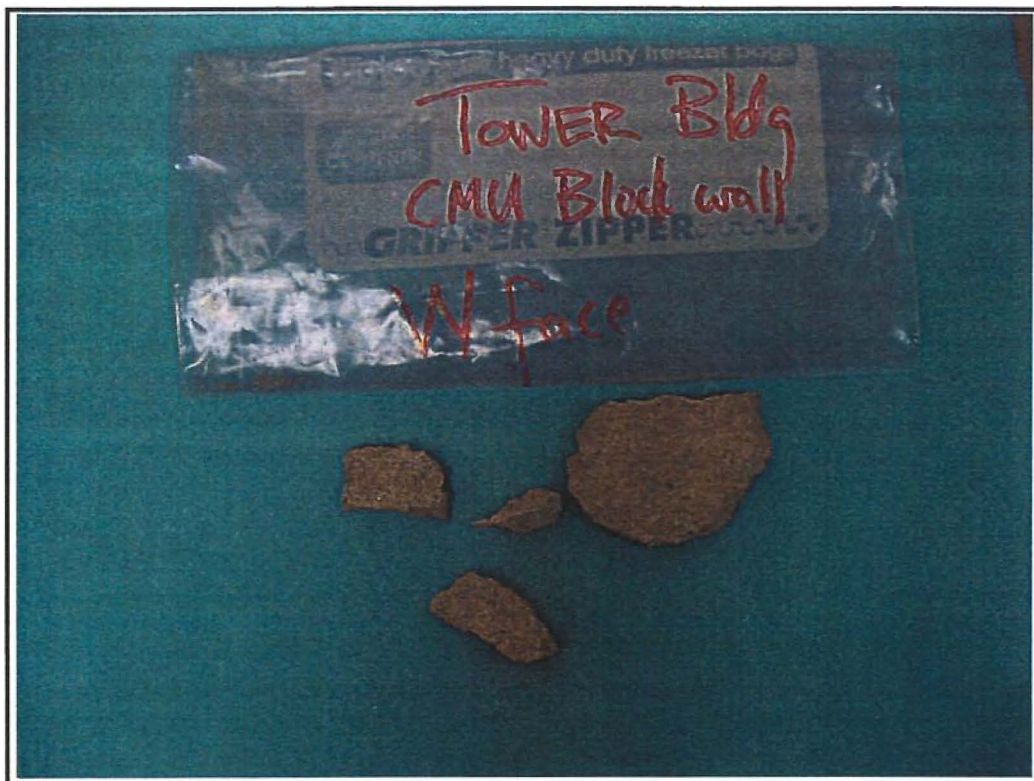
Photo 5. Mortar samples from Control Tower – exterior west face of building

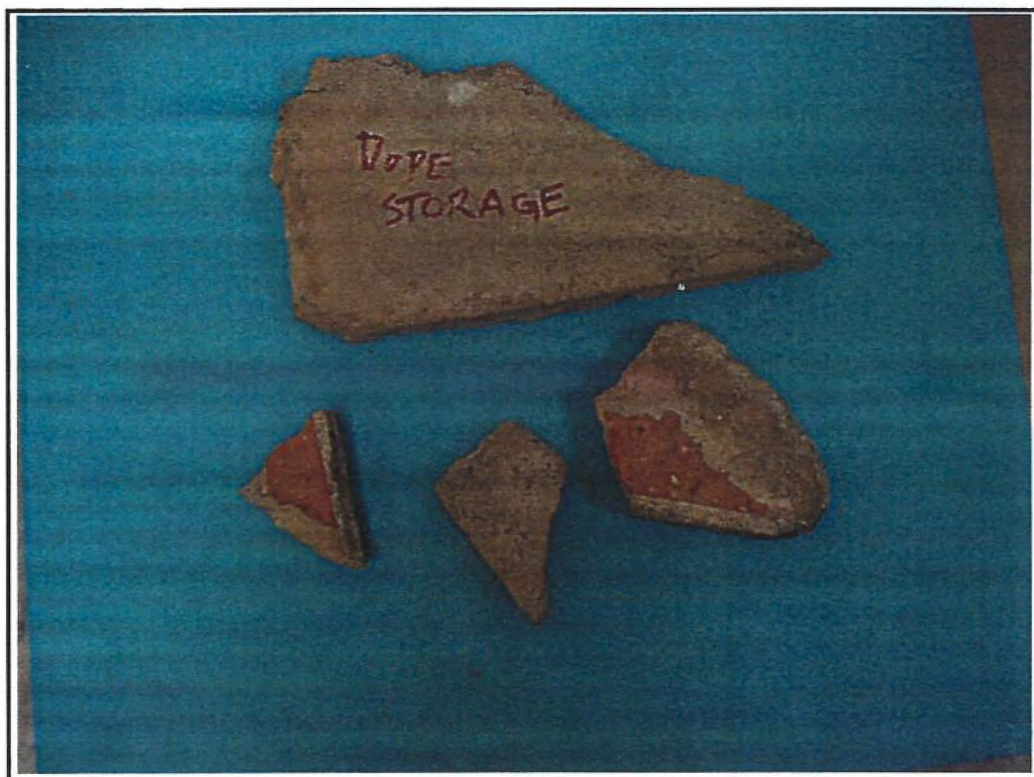
Photo 6. Mortar/Brick samples taken from interior of Dope Storage Shed

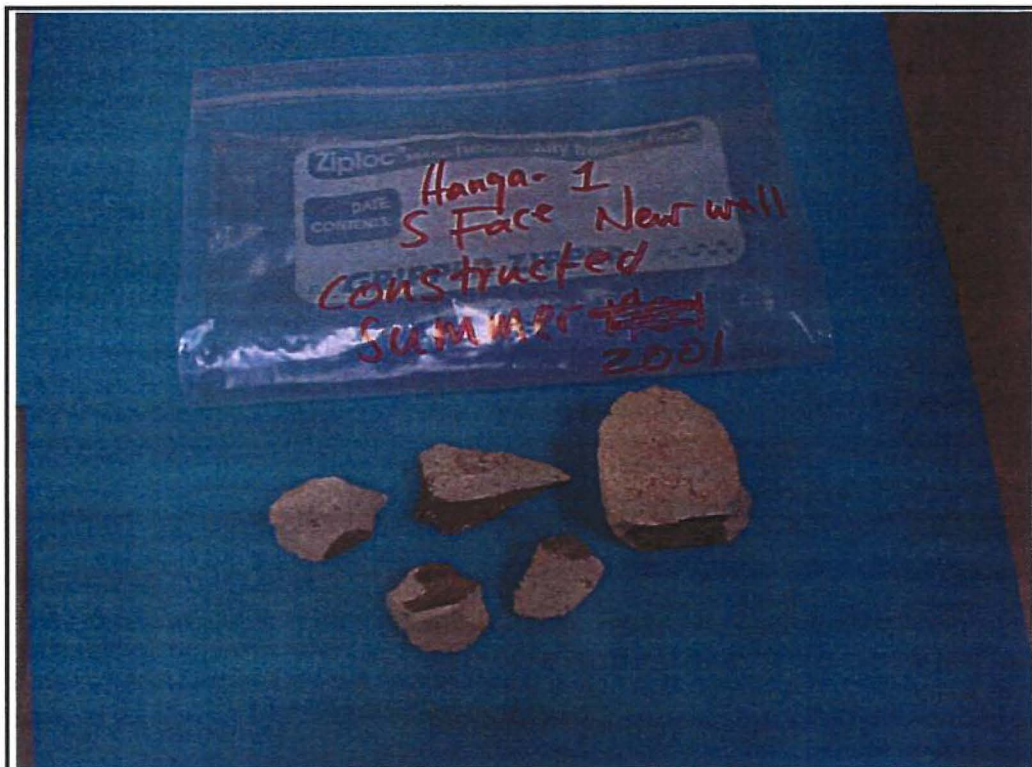
Softer mortar was observed in isolated areas of Hangar No. 1. The mortar appeared to have a higher lime content at some places than the other mortars observed. This determination was made by observation of the mortar color and the hardness of the mortar. The mortar inside Hangar No. 1 ranged from soft (easily scratched with a metal chisel) around the structural clay tile to medium hard around the brick. A section of the exterior south face of this building was re-constructed the summer of 2001. The white colored mortar with a brown surface smear coat was observed (Photo 12). The brown smear coat was applied for aesthetic reasons to match the new mortar to the existing one.

Photo 12. Hangar No. 1, Exterior South Face – Mortar samples taken from new construction. Note white mortar color (A) and brown smear coat (B) on tooled joint surface.

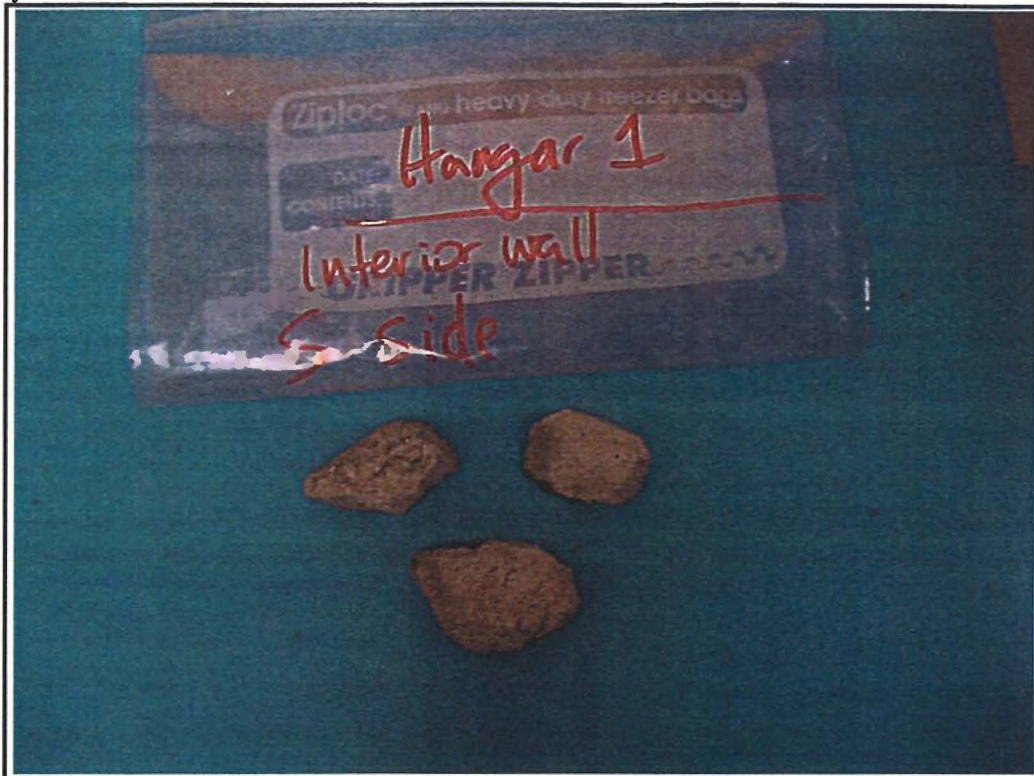
Photo 13. Hangar No. 1, Interior South Side– Mortar taken from brick

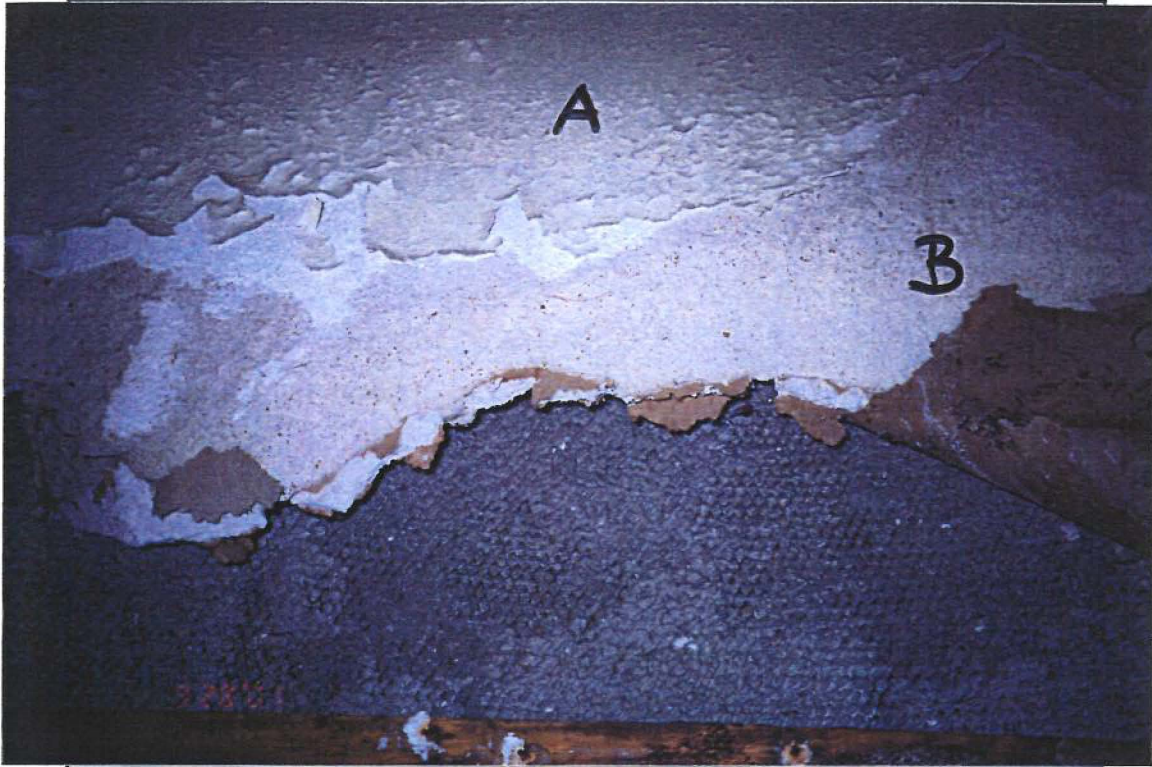
The plaster sample analyzed from the Bath and Locker House was a gypsum-based material (Photos 20 and 21 ). This is typical plaster material. The gypsum board sample was analyzed similar to the mortars. There was an indication that gypsum was present, but it was not quantified.

Photo 20. Bath and Locker House – Interior, Plaster (A) and gypsum board (B)

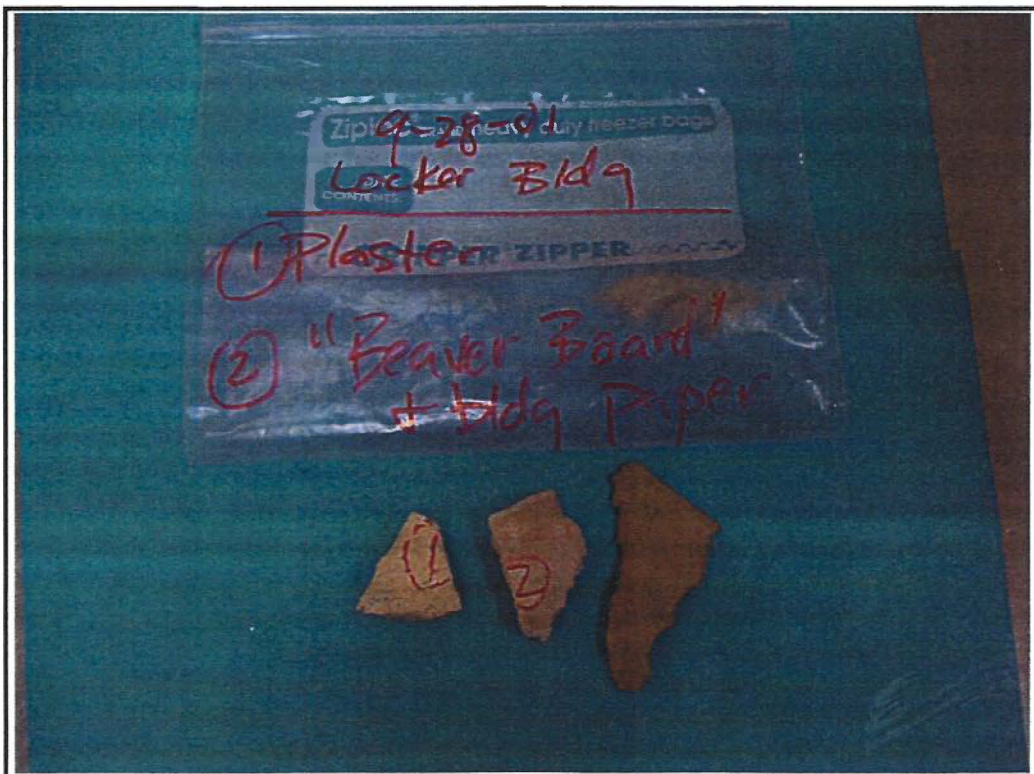
Photo 21. Bath and Locker House – Samples of Plaster (1) and gypsum board (2) with building paper (3)
