# Preservation/Restoration of Moton Field

Tuskegee Airmen  
National Historic Site  
Tuskegee, Alabama

*Historic Structure Report*  
Warehouse/Vehicle Storage Building

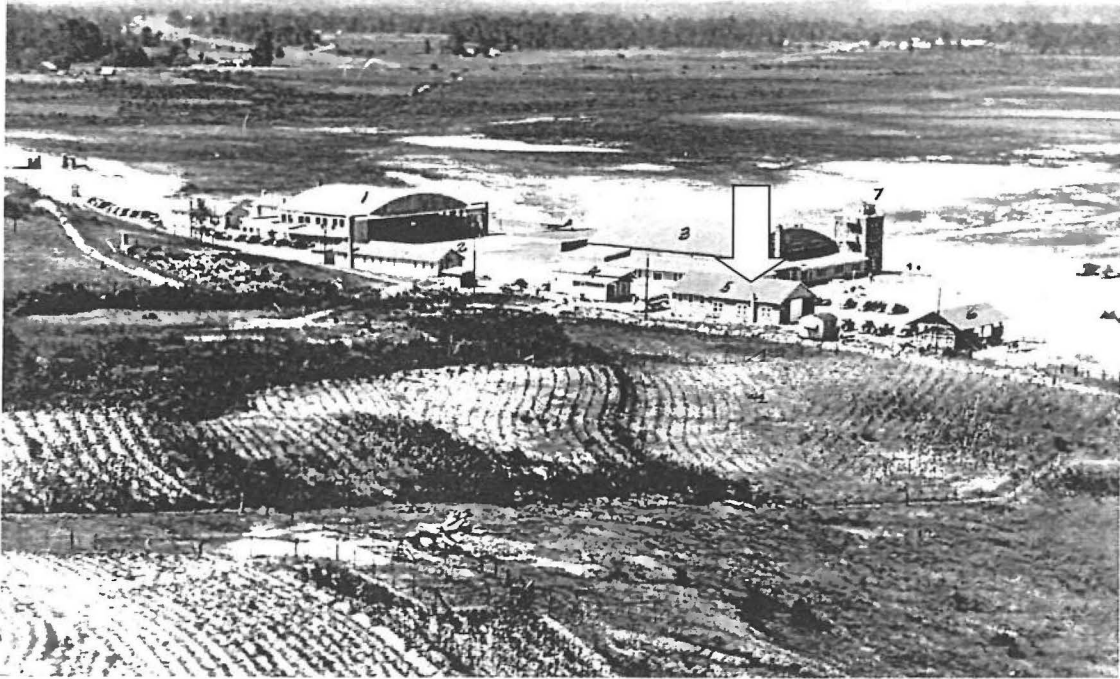
The Warehouse/Vehicle Storage Building was built during Phase Two of the war-era construction at Moton Field. This building was constructed to house both large and small shipments of supplies other than airplane supplies.<sup>27</sup> The concrete block building is located at the east end of the building complex, southeast of the former site of Hangar Number Two. (See *Figure 1*.) Construction was completed by March of 1943.

Figure 1: Aerial photograph of Moton Field circa Fall 1944 with the Warehouse/Vehicle Storage Building labeled number 5. Historic Photograph Collection, Howard University.

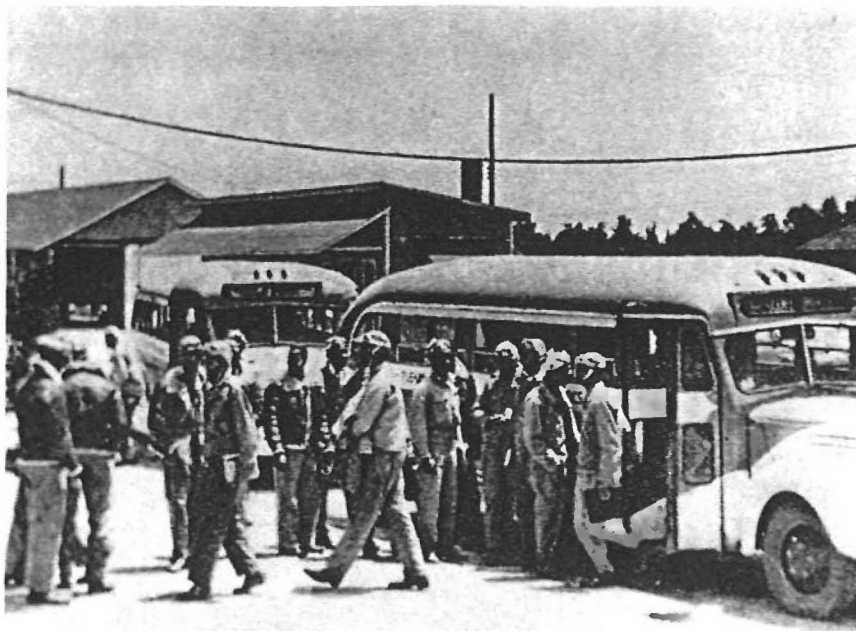
These openings were closed with large doors that slid horizontally along the side of the building.<sup>29</sup> (See *Figure 2*.)

**Figure 2:** Warehouse/Vehicle Storage Building in the background at the left with a vehicle parked in the storage bay. AFHRA, Maxwell AFB.

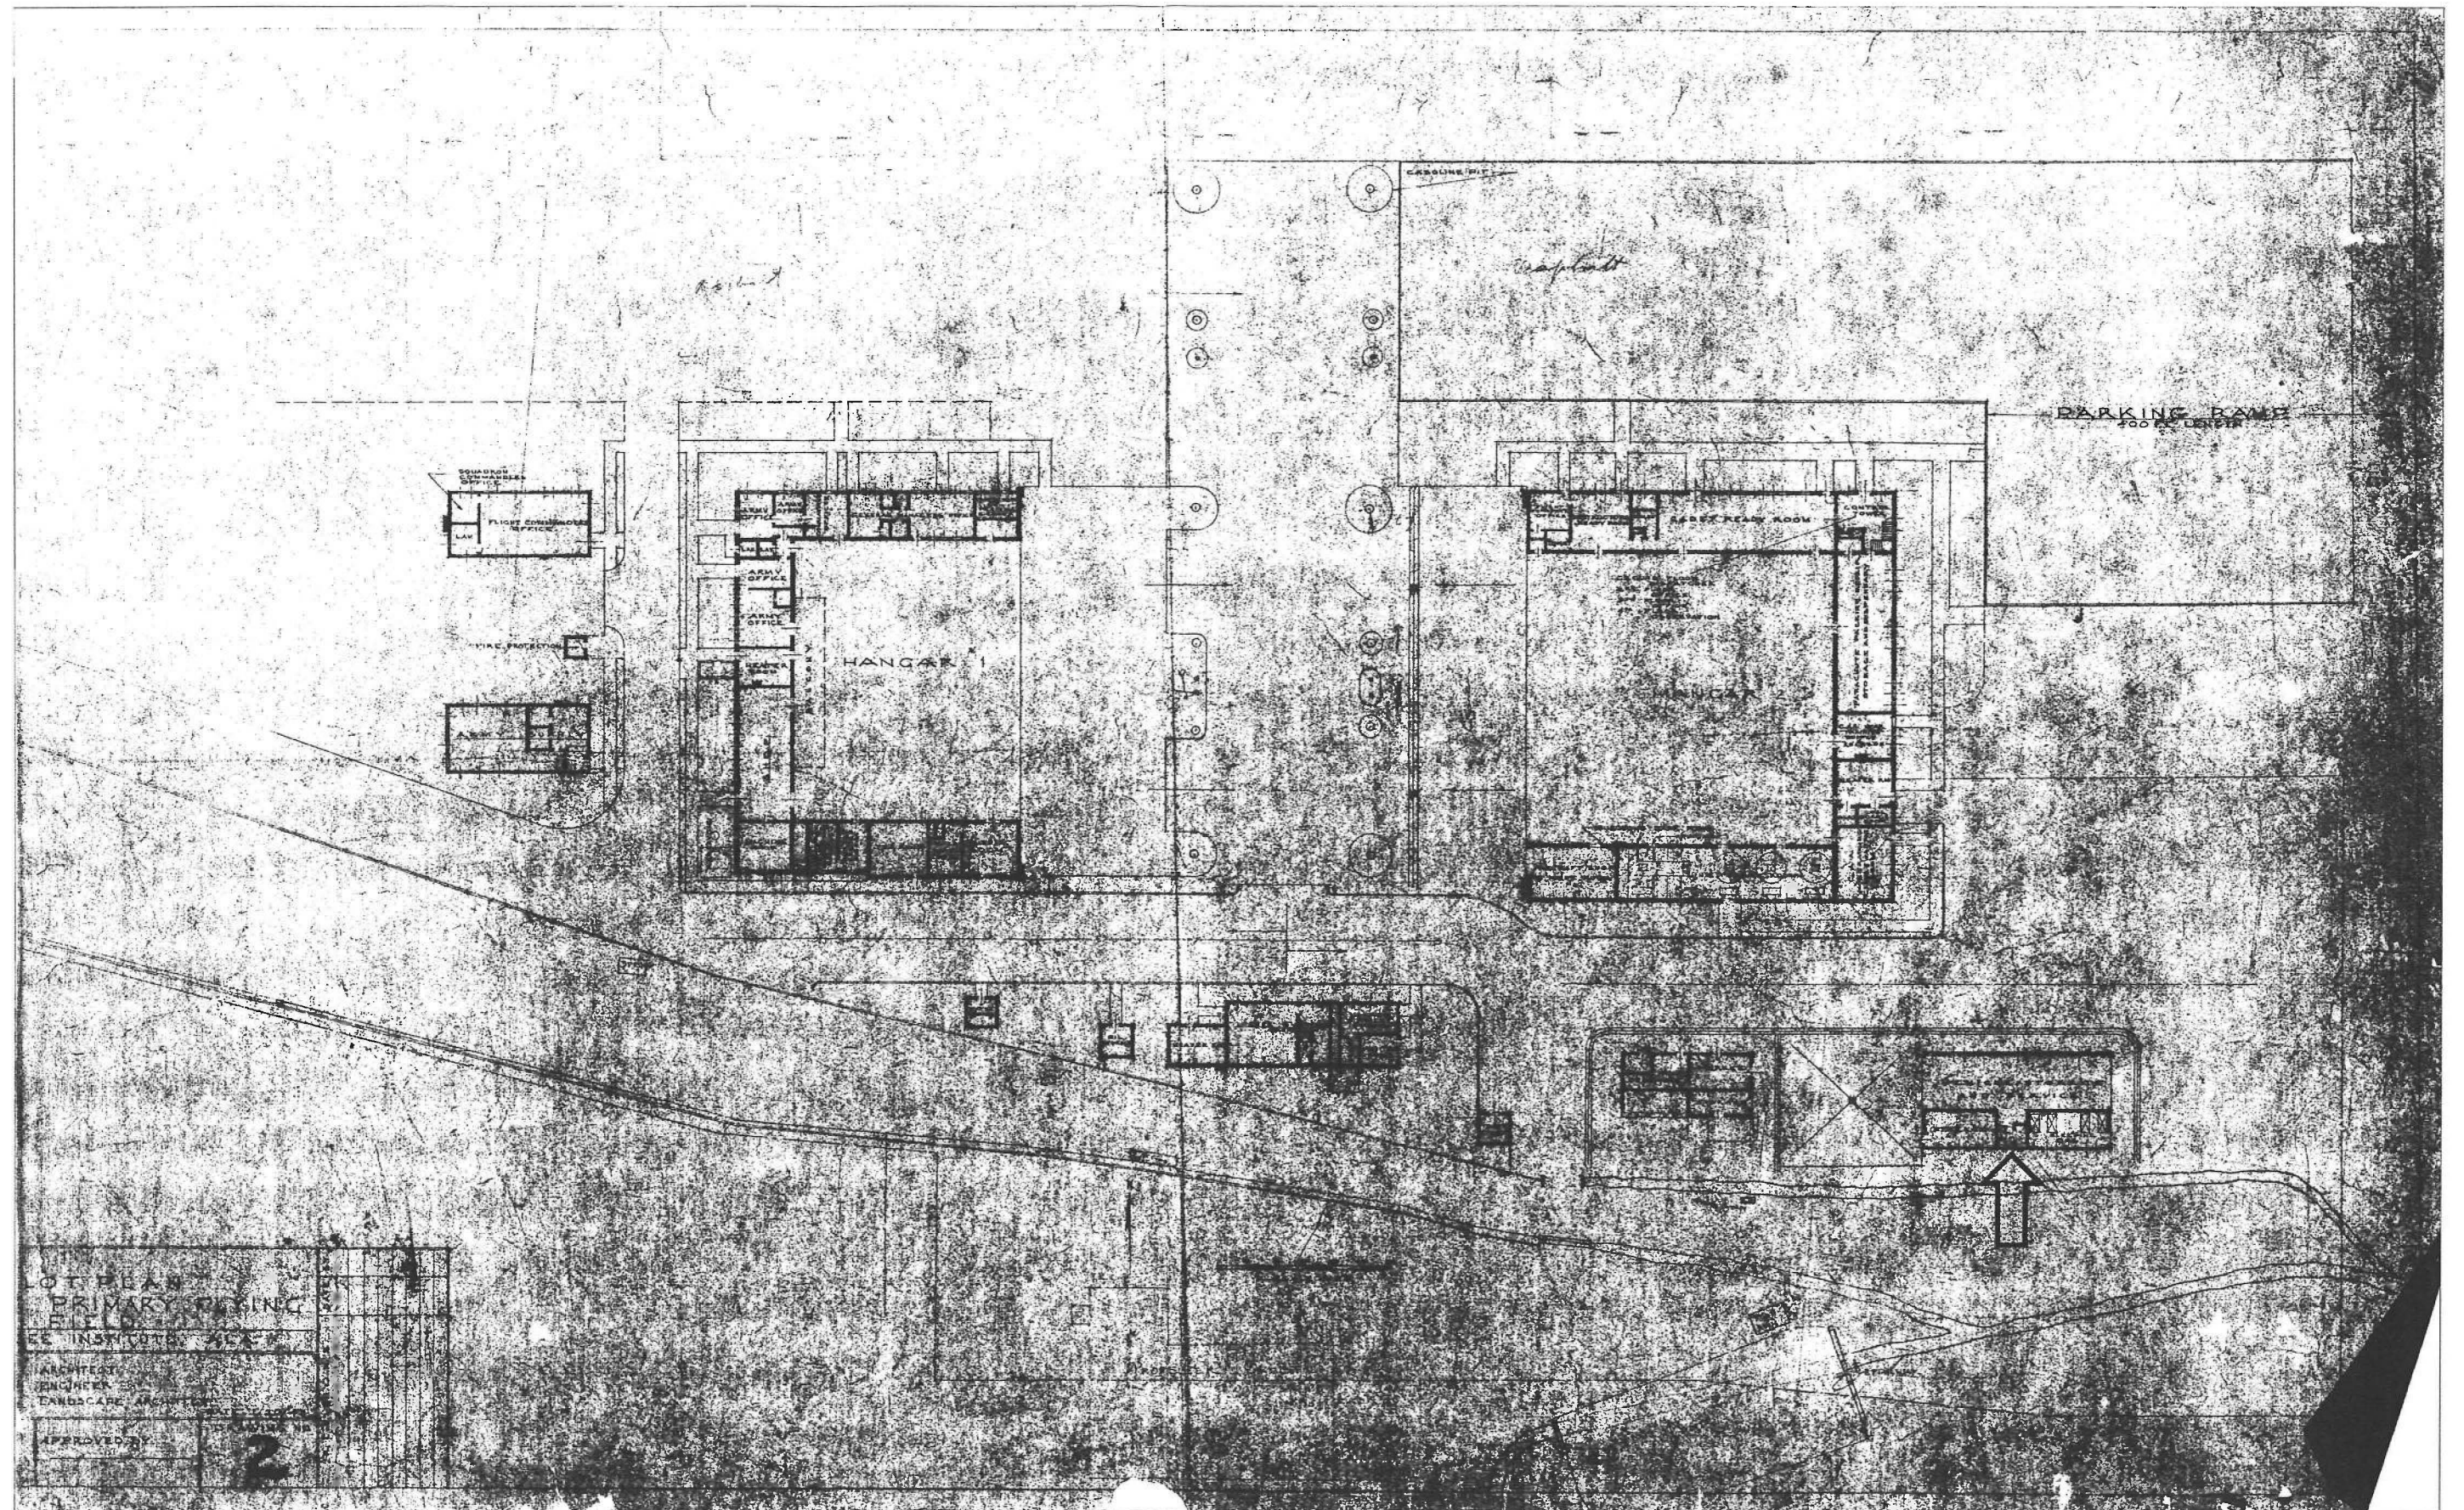
A January 1943 plot plan for the field labels the rooms within this building, but does not give the building a name.<sup>30</sup> (See *Figure 3*.) The largest portion of the building was devoted to vehicle storage and service and was a large open area located on the north side and running the length of the building. Along the south wall there was a room for storage and a room labeled sleeping quarters. A centrally located toilet and shower area separated these two larger rooms. According to G. L. Washington, this building was used for storing shipments of supplies that were unrelated to airplane maintenance. A clerk maintained inventory and was responsible for placing orders when the supplies reached a certain minimum.<sup>31</sup>

**Figure 3:** January 1943 site plan that shows the Warehouse/Vehicle Storage Building at the east end of the building complex. Physical Plant, Tuskegee University.

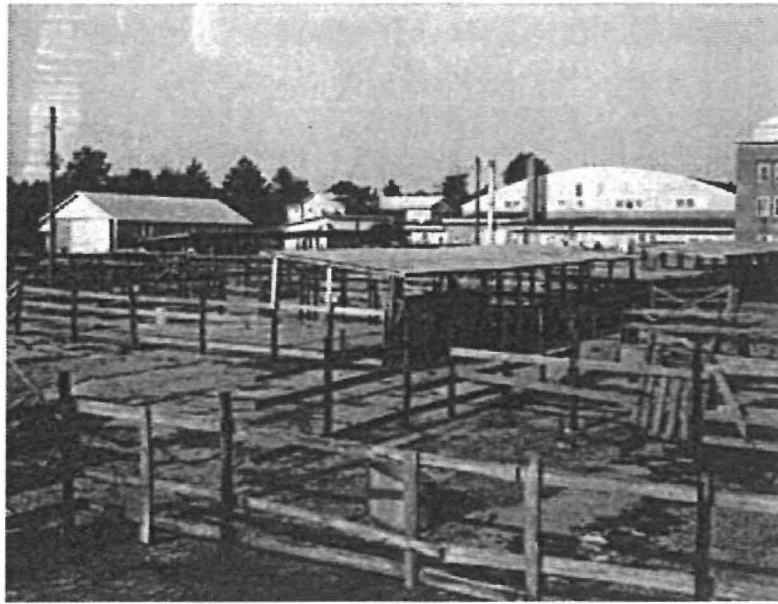
**Figure 4:** Early 1970s view looking west at the rear of Hangar Number Two. The Warehouse/Vehicle Storage Building, at the left of the photograph, has not yet been renovated by the Veterinary School. Booker Conley's Files, Physical Plant, Tuskegee University.

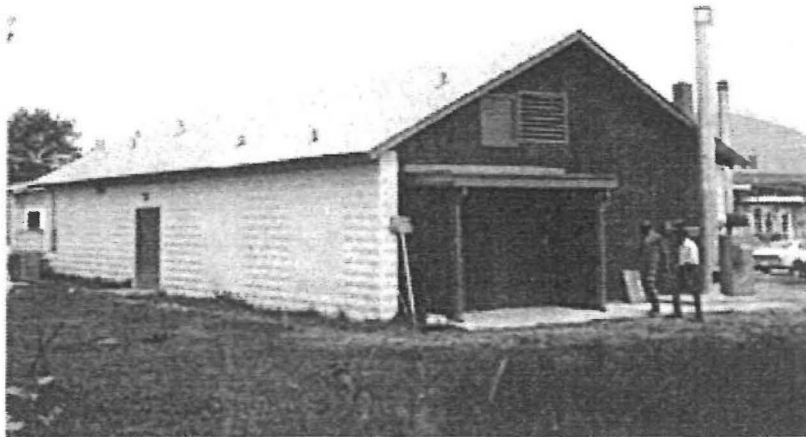
Booker Conley photographed the Warehouse/Vehicle Storage Building in 1975 shortly after this renovation had been completed. (See *Figure 5*.) He referred to the building as “Old Garage.” The original exterior textured concrete block and infilled window and door openings had been painted white by this time.<sup>37</sup>

**Figure 5:** The Warehouse/Vehicle Storage Building as it looked shortly after the Veterinary School's renovation. Booker Conley's Files, Physical Plant, Tuskegee University.

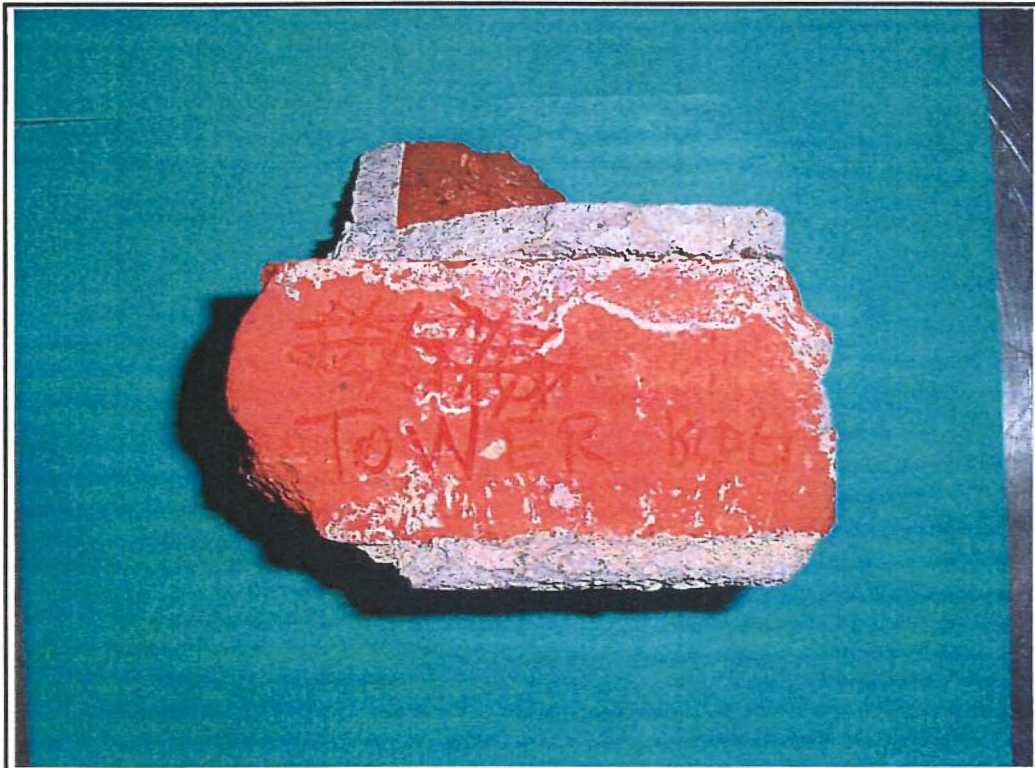
Photo 4. Brick/Mortar sample taken from exterior of Control Tower Building

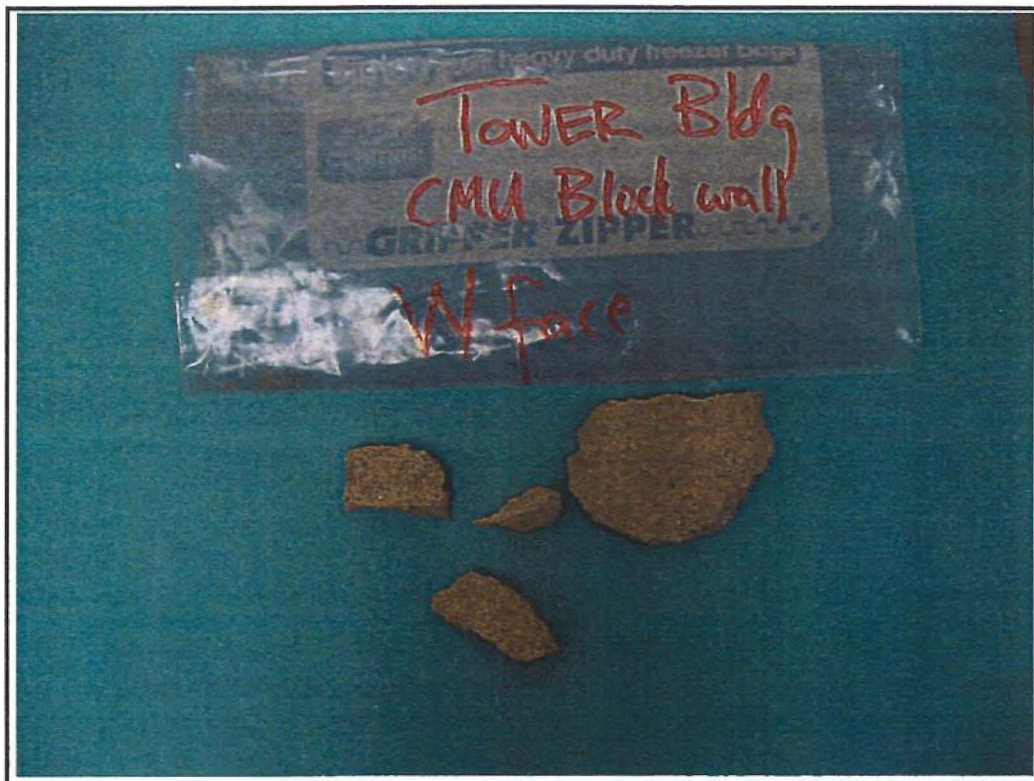
Photo 5. Mortar samples from Control Tower – exterior west face of building

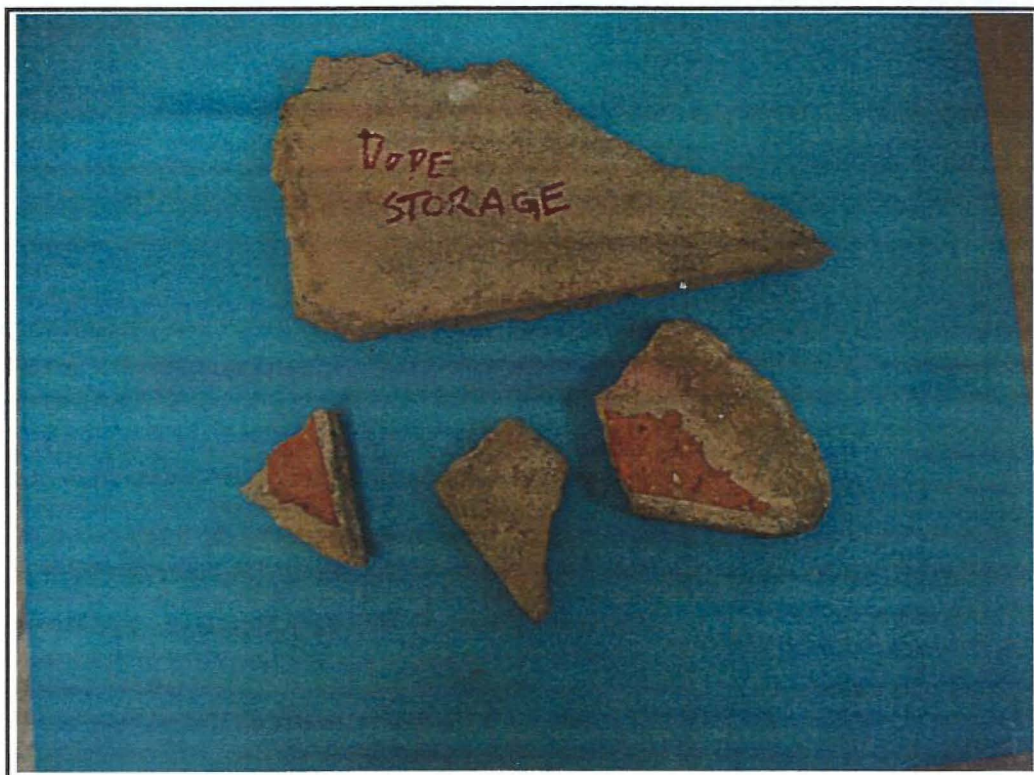
Photo 6. Mortar/Brick samples taken from interior of Dope Storage Shed

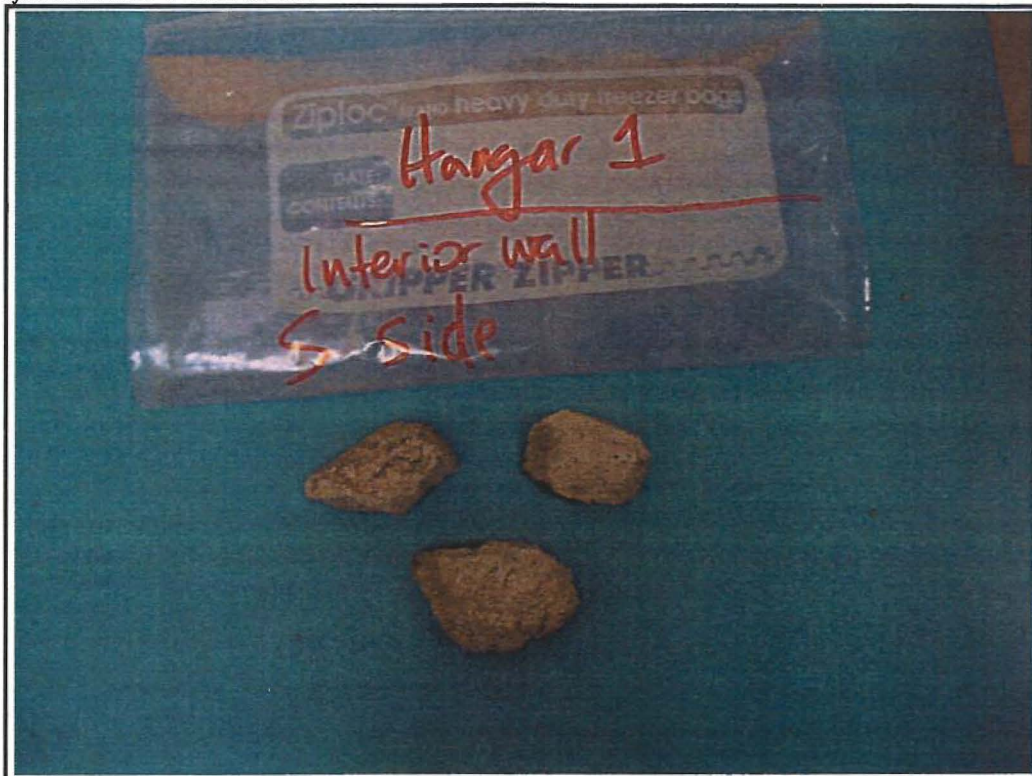
Softer mortar was observed in isolated areas of Hangar No. 1. The mortar appeared to have a higher lime content at some places than the other mortars observed. This determination was made by observation of the mortar color and the hardness of the mortar. The mortar inside Hangar No. 1 ranged from soft (easily scratched with a metal chisel) around the structural clay tile to medium hard around the brick. A section of the exterior south face of this building was re-constructed the summer of 2001. The white colored mortar with a brown surface smear coat was observed (Photo 12). The brown smear coat was applied for aesthetic reasons to match the new mortar to the existing one.

Photo 13. Hangar No. 1, Interior South Side– Mortar taken from brick

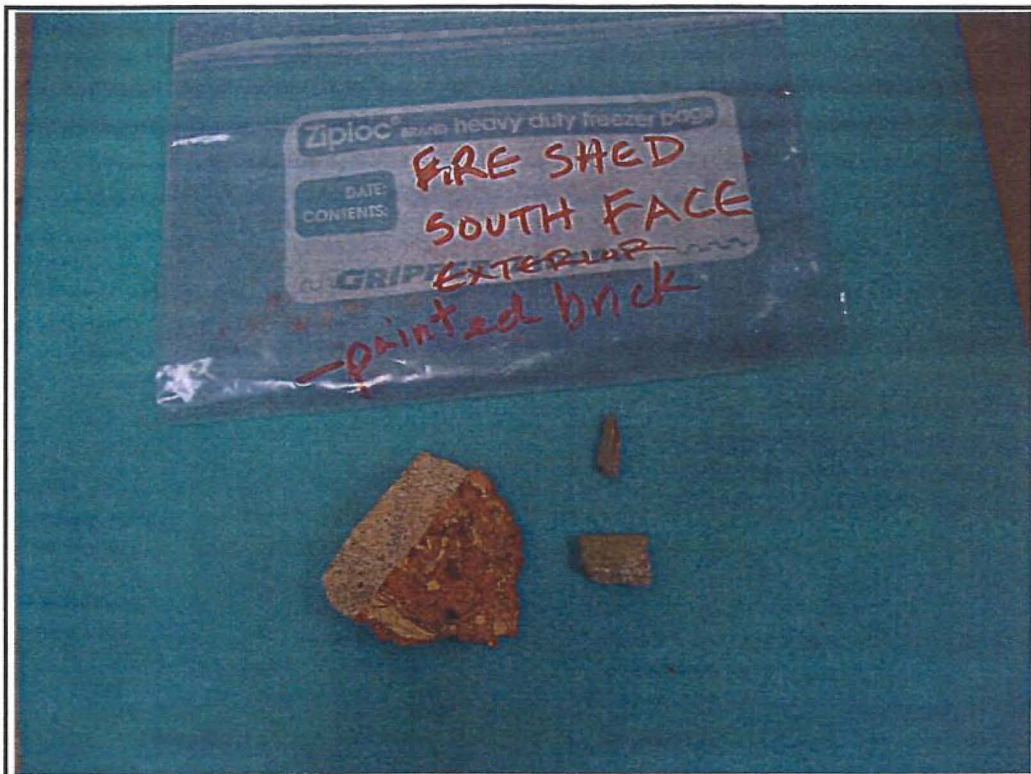
Photo 16. Fire Protection Shed – Mortar/brick samples from south face. Brick painted on side not shown.

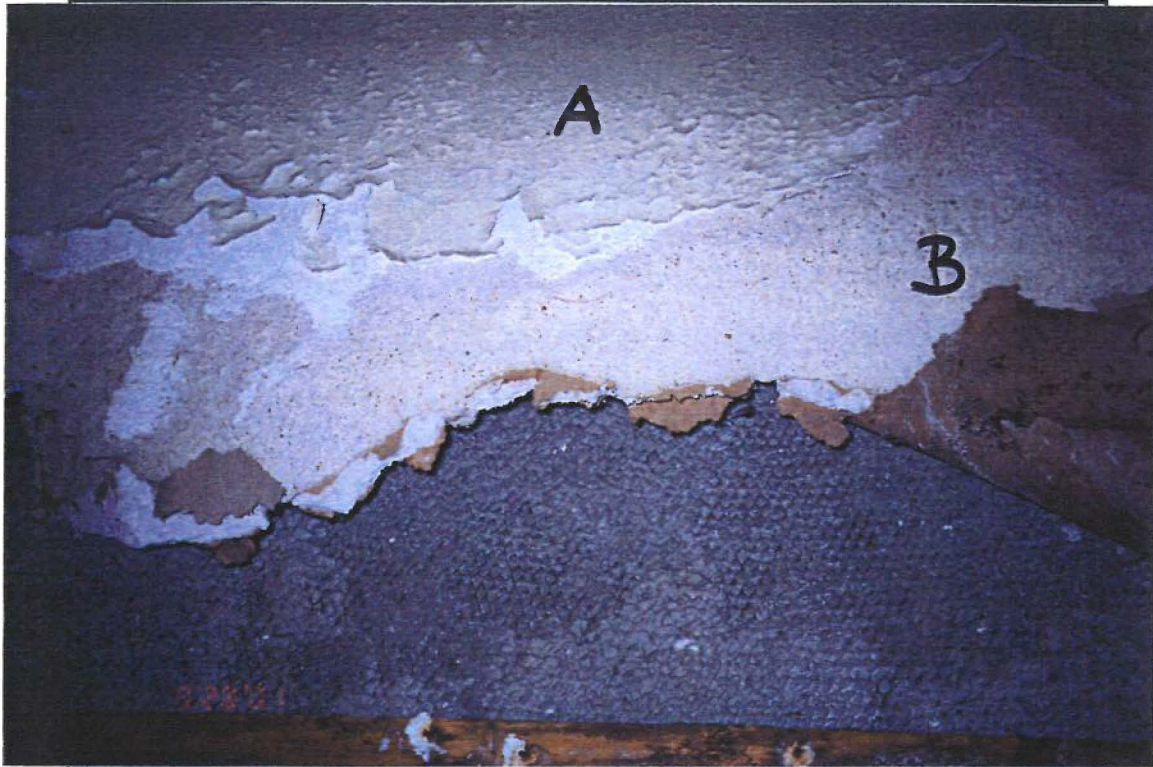
The plaster sample analyzed from the Bath and Locker House was a gypsum-based material (Photos 20 and 21 ). This is typical plaster material. The gypsum board sample was analyzed similar to the mortars. There was an indication that gypsum was present, but it was not quantified.

Photo 20. Bath and Locker House – Interior, Plaster (A) and gypsum board (B)

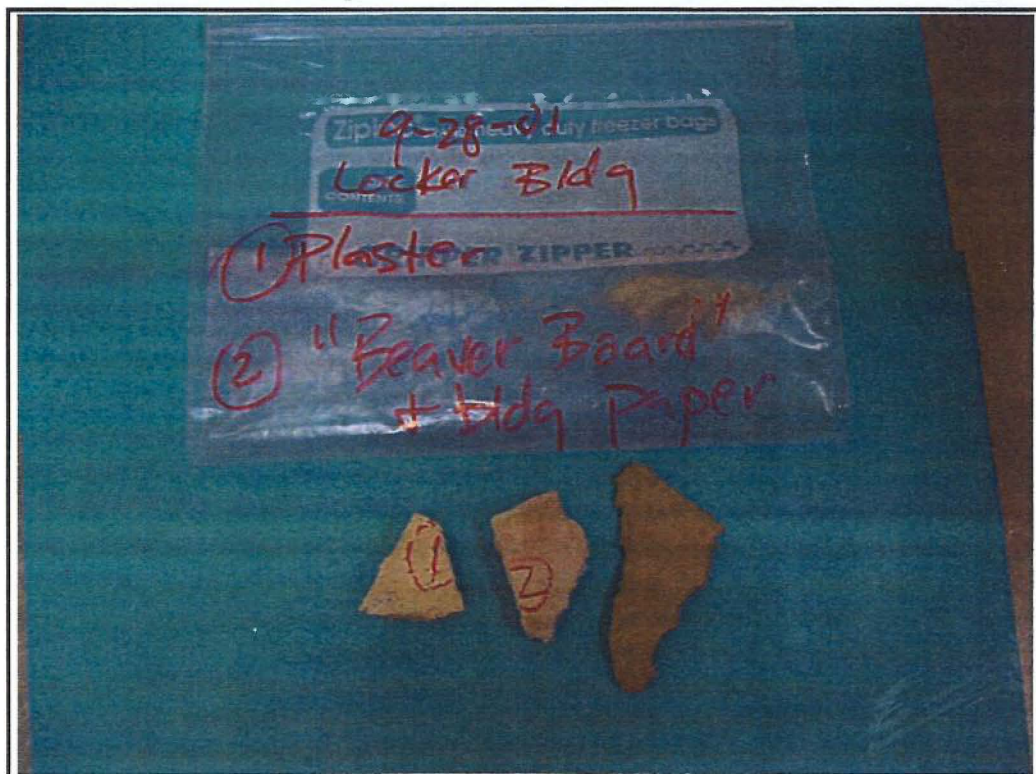
Photo 21. Bath and Locker House – Samples of Plaster (1) and gypsum board (2) with building paper (3)
