# Historic Structure Report

# The Oaks

## Tuskegee Institute National Historic Site

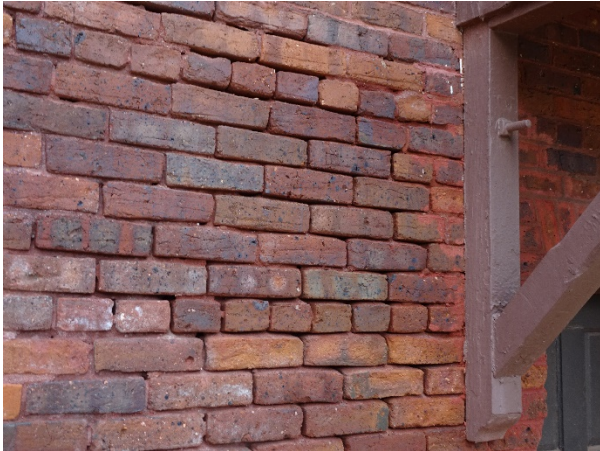
- Open, eroded, and deteriorated mortar joints were observed at the field of the wall and at chimneys (Figure 82 and Figure 83). Eroded mortar joints were typically recessed 1/2 inch beyond the face of the brick. The erosion was most pronounced near entrances and at corners of the building adjacent to the downspouts. Evidence of previous localized repointing was observed. At both the field of the wall and chimneys, the repointing mortar was typically red in color and was struck flush with the brick (Figure 84).

**FIGURE 82.** Eroded mortar joints at the field of the wall.

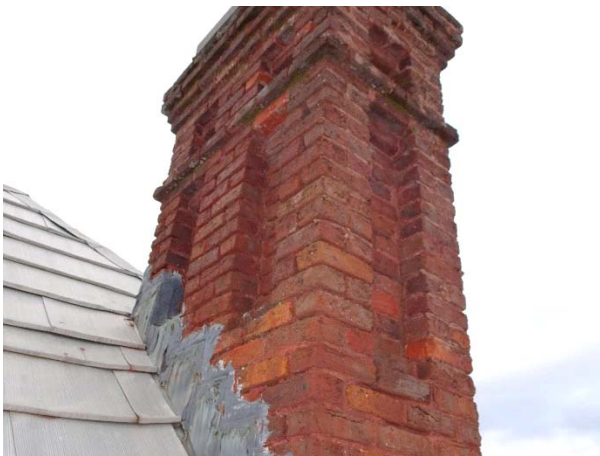
**FIGURE 83.** Deteriorated mortar joints and evidence of previous repointing efforts visible at the chimney.

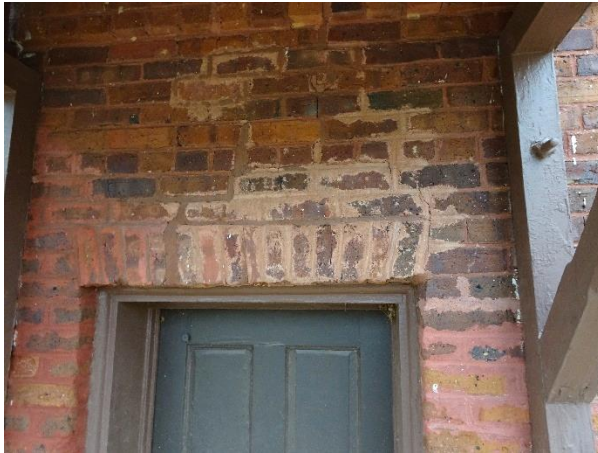
- Cracked and open mortar joints were observed above the door opening at the east end of the south elevation (Figure 87). The opening has a flat arch brick opening. Some mortar joints between the flat arch brick are cracked and many appear to have been recently repaired. The cracked joints extend in a stepped pattern approximately five courses above the opening.

**FIGURE 87.** Cracking and open mortar joints above flat arch opening.

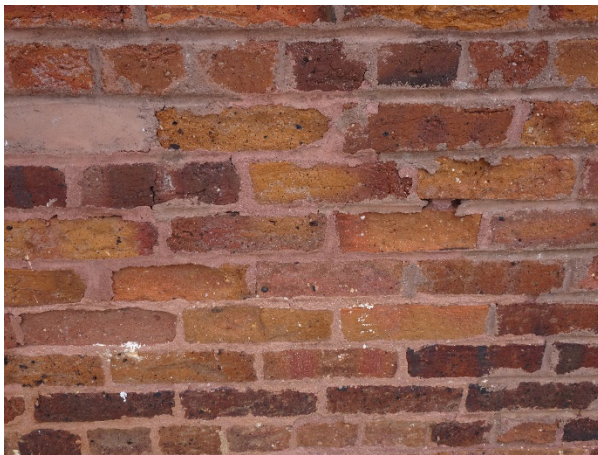
- Spalled brick was located at the field of the wall as well as at corners and along edges of building features (Figure 88). Spalling was most pronounced at the first-floor level at the east end of the south elevation. The spalling consisted of full-face spalling of the fired face of multiple brick units. Spalling was also observed at corners and edges of the building, specifically at door openings and chimneys.

**FIGURE 88.** Face spalling of brick.

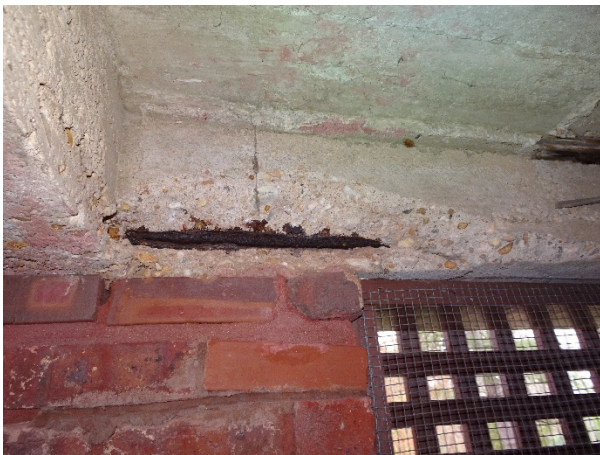
- Cracked and spalled concrete was observed at the edge of the concrete bond beam below the concrete porch slab (Figure 92). The cracking extended horizontally, approximately 3 inches above the bottom edge of the bond beam. At spalled areas, the reinforcing bar was exposed and observed to be corroded. The reinforcing bar was noted as having a cover of corrosion of approximately 1 inch (Figure 93 and Figure 94). Previous patch repairs had been performed at some concrete spalls but appear to have failed. Moisture staining was also visible and appeared to originate from the bed joint below the concrete porch slab (Figure 95).

**FIGURE 92.** Spalled concrete bond beam at porch wall.

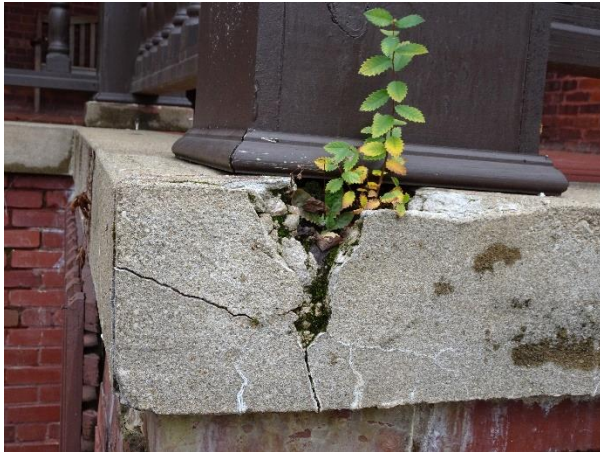
- Cracked and spalled concrete was observed at some corner locations at the northwest corner of the porch slab. The concrete slab had vertical cracks that extended through the concrete. There was biological growth associated with some of the spalled areas (Figure 96). In addition to larger spalls, there were finer cracks that exhibited efflorescence, staining, and other indications of moisture-related distress. The distress was located above areas where brick distress was observed.

**FIGURE 96.** Spalling and cracking of concrete at northwest corner of porch.

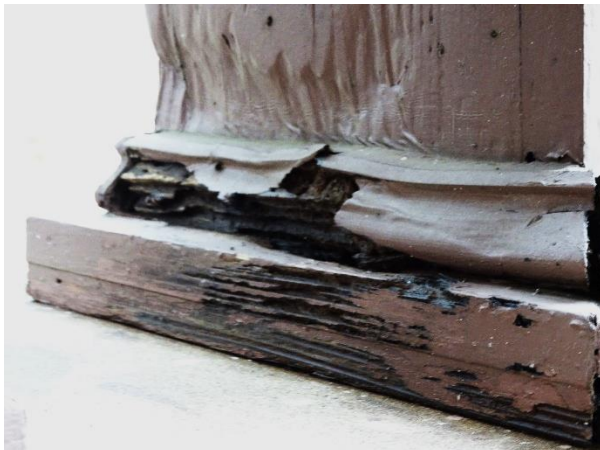
- Deteriorated wood was observed at the base and at the cladding of approximately half of the wood porch columns (Figure 97). The wood at the columns was friable. At some locations, previous repairs had been performed with wood dutchman.

**FIGURE 97.** Deteriorated wood at base of columns.

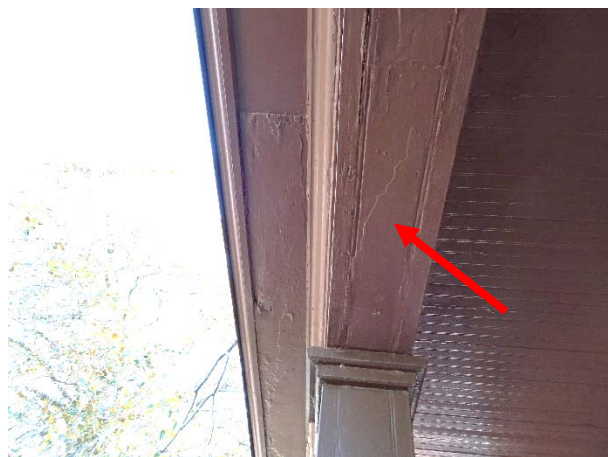
**FIGURE 102.** Previous paint coatings at wood porch members were not completely removed prior to repainting.

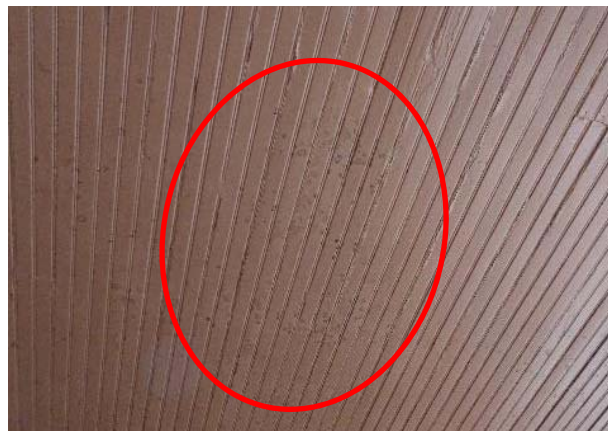
**FIGURE 103.** Dark spots of biological growth on face of ceiling boards at porch.

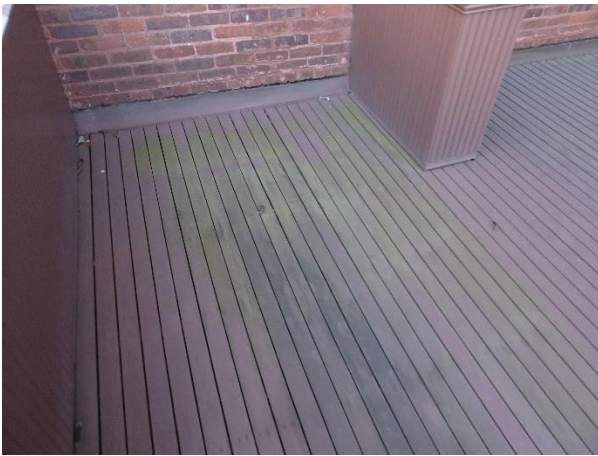
**FIGURE 104.** Biological growth at second-floor balcony deck.

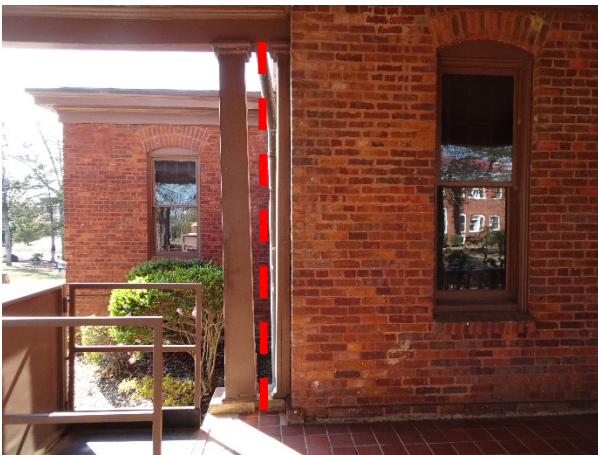
- Blistered and peeling paint was observed at wood porch columns. At many locations, the paint is blistered and debonded from the wood substrate (Figure 101). The underlying wood appeared to be deteriorated when probed. Throughout the porch, there is evidence of previous paint coatings that were not completely removed and remain in place (Figure 102).
- Biological growth was observed at the underside of the bead board porch ceiling (Figure 103). The growth consisted of dark-colored spots on the wood. Biological growth was also observed at the floor boards on the second floor balcony deck (Figure 104).
- One of the wood porch columns at the east end of the porch is displaced (Figure 105). The base of the column has been shifted approximately 1 inch to the northwest and is no longer centered on its concrete base.

**FIGURE 105.** Tilted and displaced porch column.

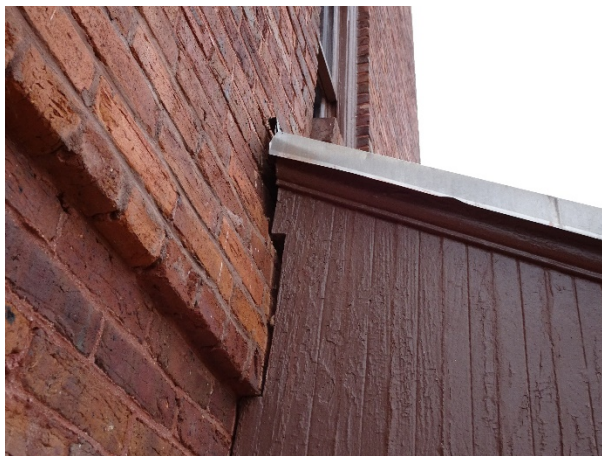
- Missing wood cladding boards were observed at the south porch enclose (Figure 106). The missing tongue-and-groove boards were located adjacent to a downspout. The remaining wood members exhibit some indications of moisture-related distress.
- A cracked recessed wood panel was observed at one door leaf (Figure 107). The hairline crack extends vertically through the panel.
- Peeling paint was observed at all window and door openings (Figure 108). At some locations, the peeling paint had been removed and the underlying wood is exposed to view.
- A gap was observed between the wood-framed shed roof awning over the south entrance and the brick masonry wall (Figure 109). The gap was located at the top of the roof framing and

**FIGURE 109.** Displaced roof framing over south entrance.

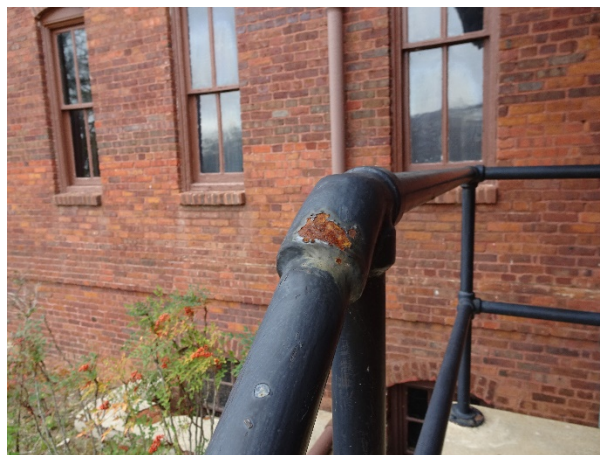
- Mild surface corrosion was observed at the handrail at the south entrance to the east wing (Figure 111). The paint at the handrail has peeled and the exposed metal handrail has surface corrosion.
- Peeling paint was observed at the sheet-metal roof flashing and copings and pressed metal siding (Figure 112 and Figure 113). At the sheet-metal copings, the paint peeled away and

**FIGURE 111.** Surface corrosion and paint loss at metal handrail.

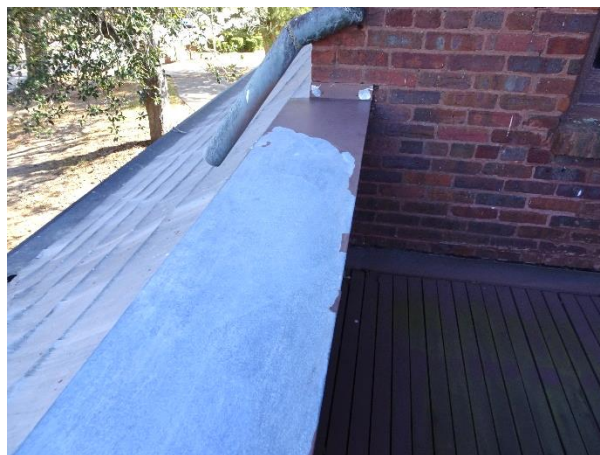
**FIGURE 112.** Peeling paint at the sheet-metal flashing at second-floor balcony.

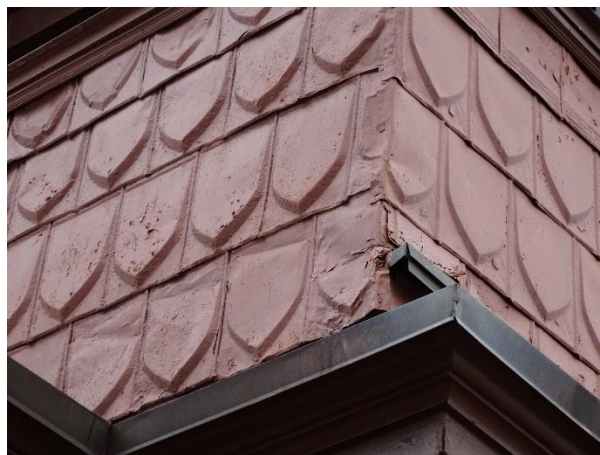
the sheet metal was exposed. At pressed metal cladding, the peeling paint was cracking and flaking. Where the paint had been removed, a previous layer of paint was exposed to view.

**FIGURE 113.** Peeling paint at the pressed sheet-metal cladding.

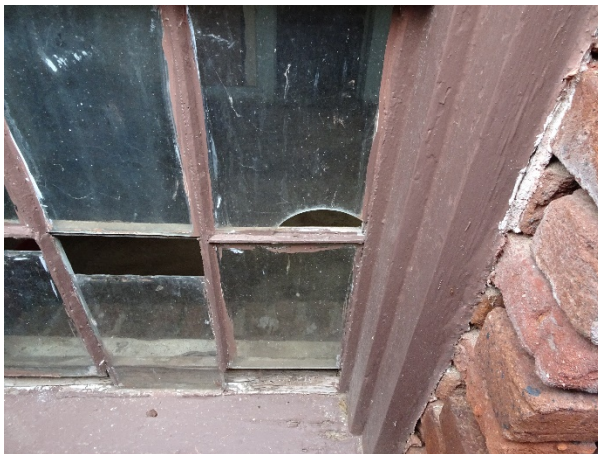
- Missing screen stops were observed at one first-floor screen door on the southwest porch. The anchorage for the screen was exposed to view.
- Broken and loose glass units were observed at a few window units (Figure 114). The distress was most pronounced at the three basement window units on the east elevation. At these locations, many of the wood muntins are deteriorated, and the glazing putty has been removed. Many of the glass units are loose, displaced, or cracked. Cracked glass was also observed at two first-floor windows.

**FIGURE 114.** Broken and displaced glass at basement windows.

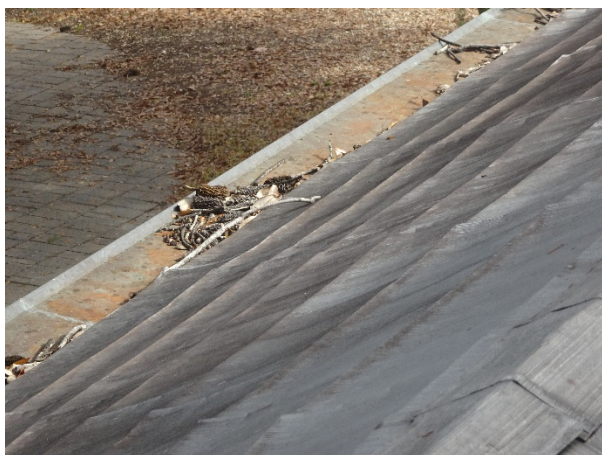
- Clogged, damaged, and backed-up downspouts were observed at many roof locations (Figure 117). Many of the downspouts are damaged or have evidence of being clogged. Some of the gutters also exhibited large amounts of debris (Figure 118). At one location, the gutter near the downspout was overfilled with water and flowing onto the adjacent cornice ledge (Figure 119). There were small branches in the gutter. The sheet-metal roof cladding adjacent to the gutter has deformed and separated from the gutter liner and flashing (Figure 120).

**FIGURE 118.** Debris and organic matter at gutter.

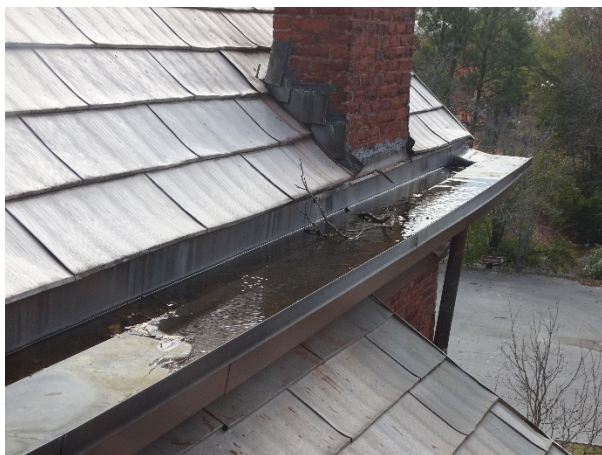
**FIGURE 119.** Gutter overflowing with water. Note branches in the gutter.

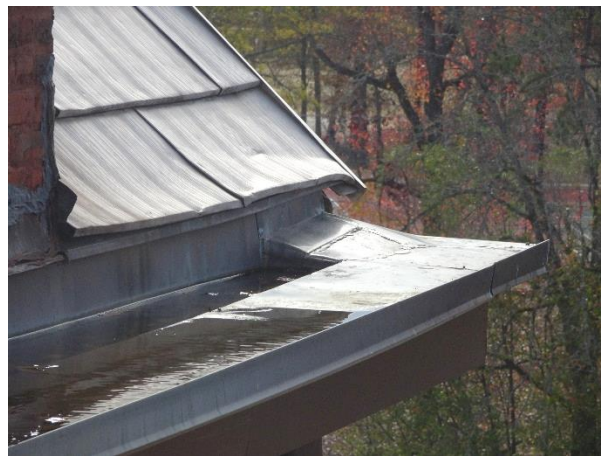
**FIGURE 120.** Deformed and damaged roofing adjacent to overflowing gutter.

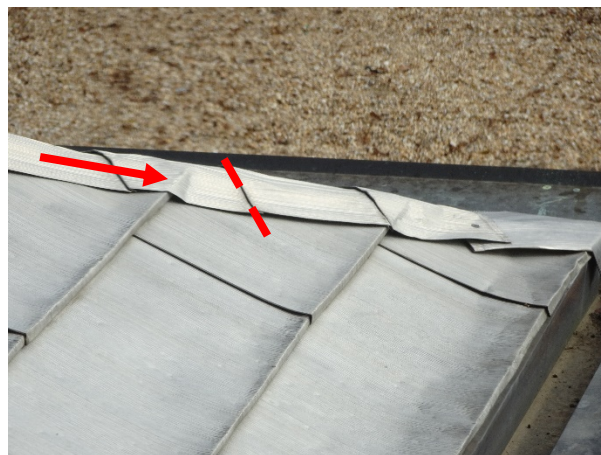
- Reverse lapped shingles were observed at the gable roof over the north porch and the east wing (Figure 121). The shingles at the ridges are lapped in the opposite direction as the flow of water. Water at these locations has the potential to infiltrate the roof system at the reverse lap of the shingles.
- Gaps were observed between the gutter liner and the sheet-metal roof cladding at the porch (Figure 122). Where observed, the gutter liner appeared to have been deformed and was outboard of the bent edge of the sheet-metal roof cladding. There was a 1/8-inch-wide gap along the flashing to the roof cladding interface.

**FIGURE 121.** Roof ridge with reverse-lapped shingles. Arrow shows desired direction of water flow away from building. The seams between the panels (dashed line) would allow water to enter the seam.

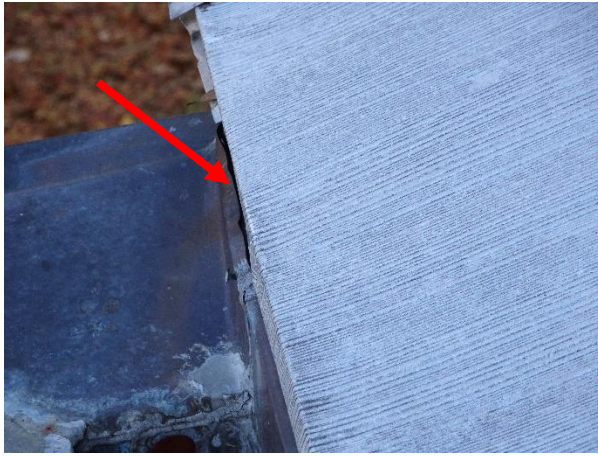
**FIGURE 122.** Gap between the copper flashing and the roof cladding.

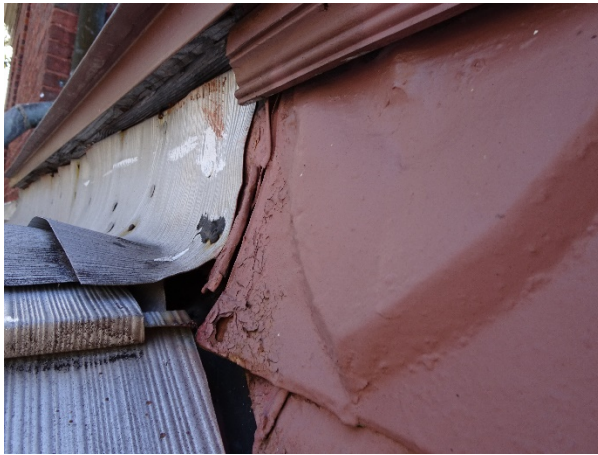
**FIGURE 123.** Gap at interface between the sheet-metal roof and wall cladding.

- A large open joint was observed at the roof to wall interface (Figure 123). The gap between the roof materials was approximately 1 inch wide. The large opening is a potential source of water infiltration. Further investigation is required to determine the condition of underlying flashing, if present.
- Deformed and damaged sheet-metal shingles were observed at a few areas of the roof, including near gutters and at the field of the main building roof (Figure 124 and Figure 125). Damaged shingles at the low end of the roof slope, adjacent to gutters and downspout outlets, were warped and curled and had become displaced from the supporting edge cleat. At the field of roof, the deterioration consisted of warping and buckling of sheet metal along the bottom edge of the shingles.

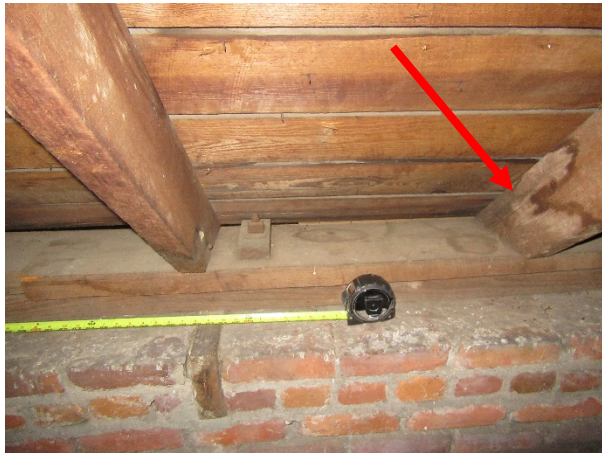
at the bottom of rafters adjacent to the southwest chimney (Figure 127). The staining does not appear to be active.

**FIGURE 127.** Moisture staining at roof rafters.

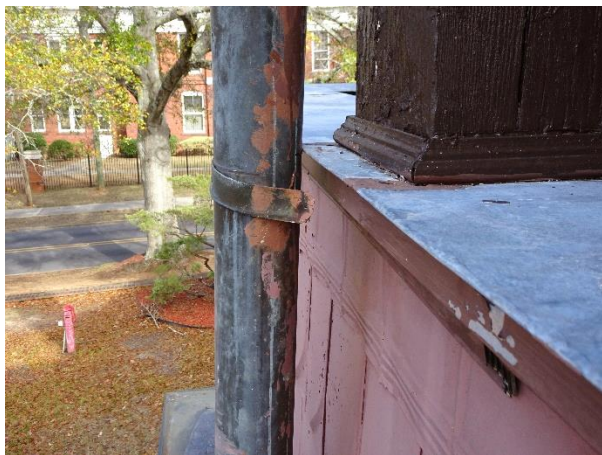
- Loose and detached copper straps were observed at some of the downspouts (Figure 128). The failure consisted of the fastener head slipping through the anchor hole in the strap. The downspout pushed out approximately 2 inches from the building.
- Deteriorated sealant at roof flashing was observed (Figure 129). The flashing at the joint between the roof flashing and the brick masonry wall is deteriorated. It appears that sealant repairs were installed over previously existing failed sealant.

**FIGURE 128.** Damaged and dislodged downspout strap.

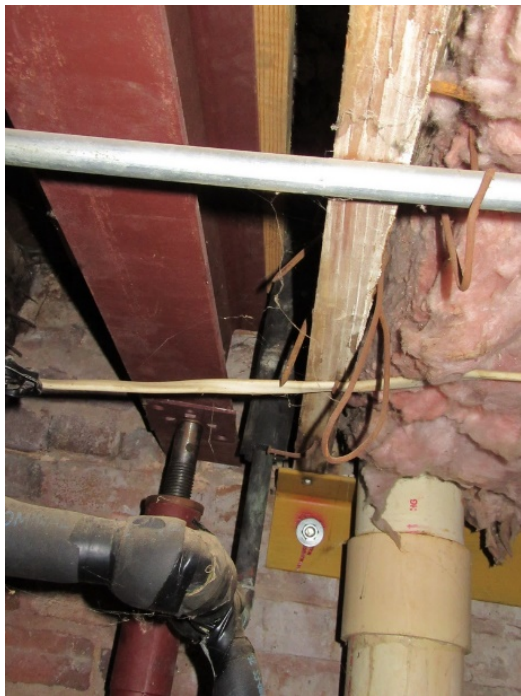
**FIGURE 133.** Detail of shoring at basement.

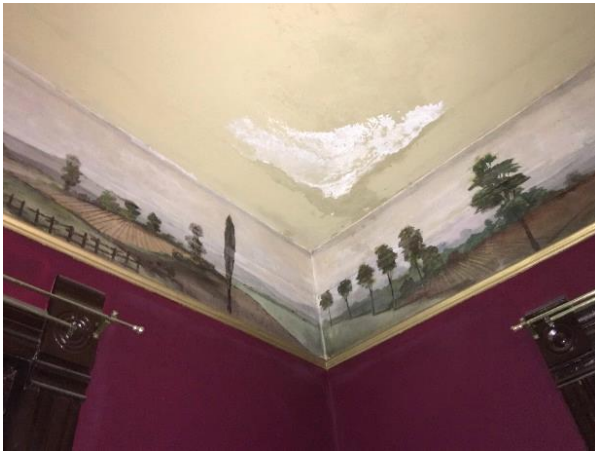
Horizontal planes of plaster walls are interrupted by individual and groups of wooden windows of varying sizes with distinctly vertical proportions. Windows are almost always positioned in the center of a wall which reinforces the strict interior symmetry of the room, a design principle of the Queen Anne style and a character-defining feature of the house. Wall planes are divided vertically by a traditional picture rail that runs around the rooms approximately 12 inches below the ceiling (Figure 136). Above the picture rail, frieze murals were painted by E.W. Borman around 1908. Frieze murals are a unique decorative feature of the parlor, study, dining room, and dining room extension (Figure 137 and Figure 138). There is water damage to the mural in the dining room extension because of roof and flashing leaks (Figure 139).

**FIGURE 139.** Water damage at ceiling.

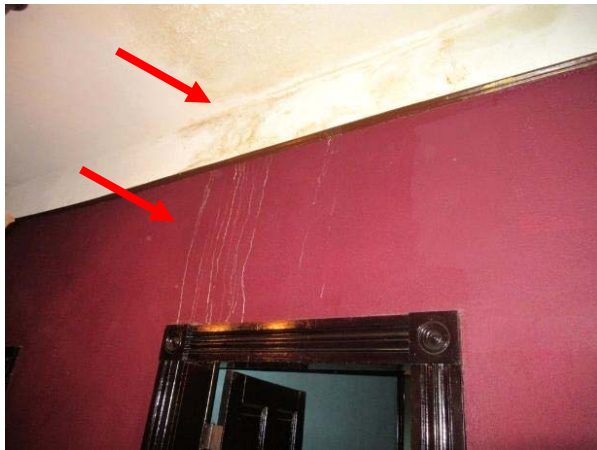
**Walls and Ceilings.** Exterior walls are load-bearing brick masonry and finished with plaster on the interior. Settlement, structural deficiencies, and roof and gutter leaks caused visible damage to plaster. Although major and minor plaster repairs were included in the 1979, 1999, and 2007 rehabilitation and repair projects, plaster damage remains on the second floor. Much of it is minor and less prevalent than it is on the first floor, but there are locations where the damage is serious, because it compromises the integrity of the plaster and adversely affects its appearance (Figure 170).

**FIGURE 170.** Plaster damage from water in second-floor front hall.

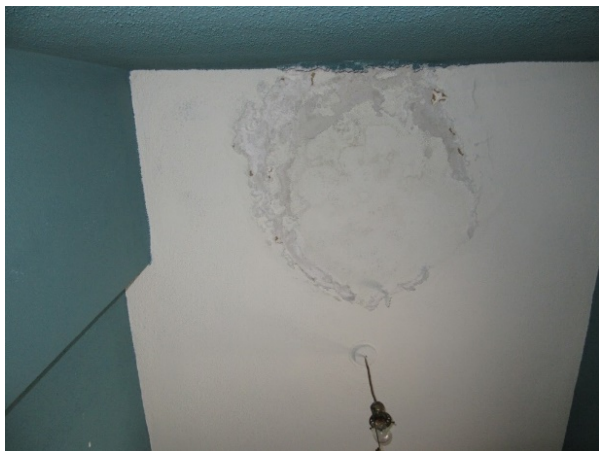
The 10-foot-8-inch-high ceilings are composed of plaster applied over wood lath. Second-floor plaster ceilings have evidence of water damage, discoloration, and degradation mostly because of roof and gutter leaks (Figure 177 and Figure 178), but generally, they are in good condition. One inconsistency is the narrow-board wooden ceiling in the den that dates to the period between 1910 and 1915, when the second story was added to the

**FIGURE 178.** Plaster damage at ceiling of Portia's shower room.

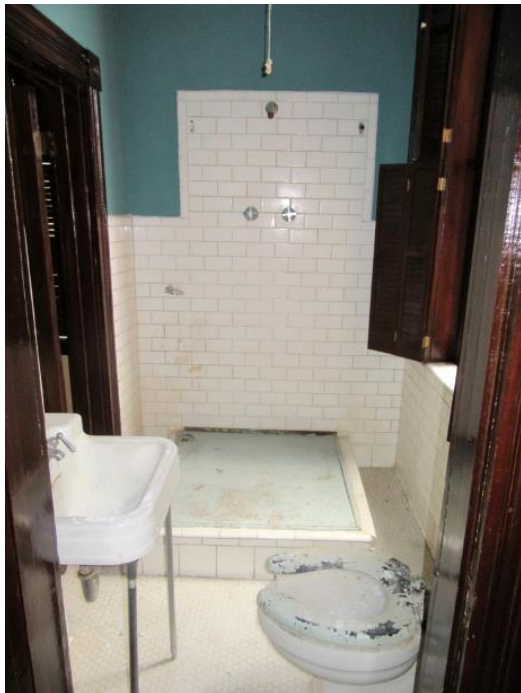
**Portia's Shower Room.** Shared by Portia and Margaret Washington, this small bathroom possessed doors that opened into each of their adjoining bedrooms. Because it did not have a bathtub, the room was referred to as a shower room. A tile curb surrounds the shower area and the white tile wainscot on all four walls rises to approximately 6 feet 6 inches on the north wall at the shower area where the shower head and controls are. Two metal brackets for a U-shaped, shower curtain rod are attached to the tile, but the rod is missing (Figure 185). White plumbing

**FIGURE 185.** Overall view at Portia's shower.

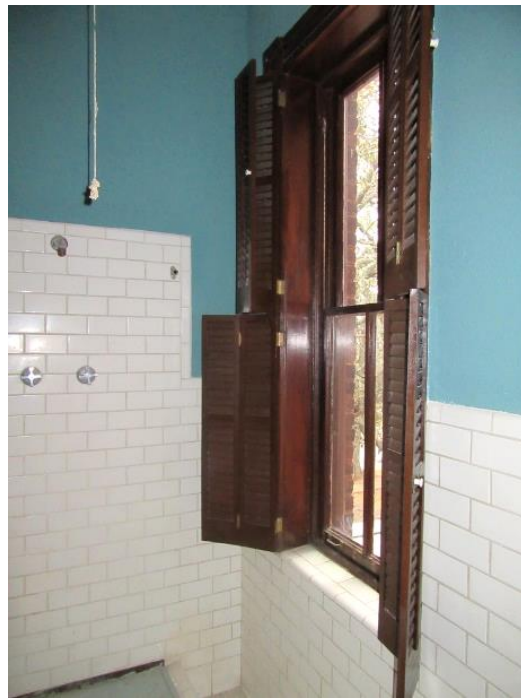
fixtures include a toilet with a flush valve and a pedestal sink. Fittings are chrome. None of the fixtures are functional. The floor is made of one-inch, octagonal, white mosaic tiles. A single, suspended light fixture is mounted in the center of the ceiling, and natural light comes from a window in the east wall (Figure 186). There is obvious plaster damage on the ceiling from a gutter or roof leak.

**FIGURE 186.** Detail of window in Portia's shower room.

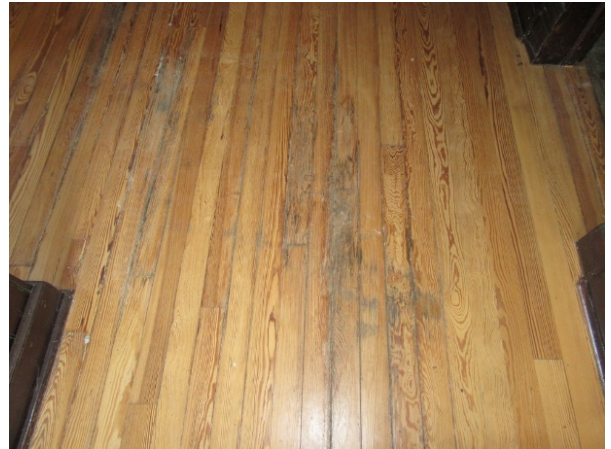
**Floors.** Existing original wood-strip flooring runs north-south in the hall and in the north bedroom (Figure 197). It runs east-west in the east and west

**FIGURE 197.** Third-floor hall – discoloration from moisture on wood-strip flooring.

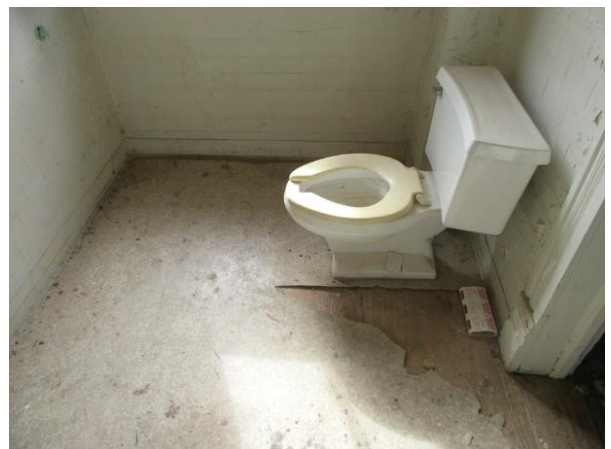
bedrooms and the trunk room (Figure 198). The bathroom floor is deteriorated sheet vinyl that is in very poor condition (Figure 199).

**FIGURE 199.** Floor in third floor bathroom.

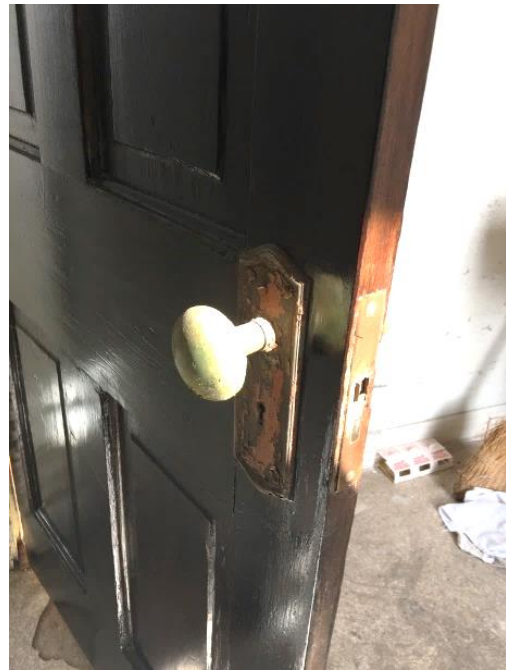
the attic door in the west wall is a large, dark water stain which is indicative of plaster damage. The bathroom door needs repairs and refinishing, and the hardware is tarnished, corroded, and not functional (Figure 214). The window and shutters are also in poor condition and are inoperable.

**FIGURE 214.** Door and hardware at bathroom.

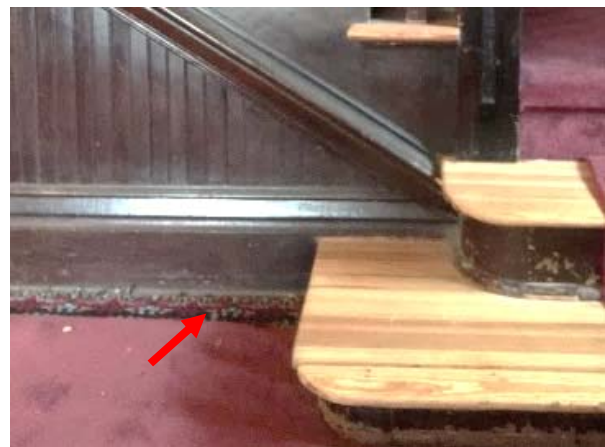
- As noted above, the plethora of woodwork and wood trim is in good condition except for the effects of prolonged wear-and-tear. The dark brown finish is scratched, chipped, and worn, and the varnish has lost its sheen. This is more of a concern about appearance than the durability of most wooden elements. Baseboards, handrails, chair rails, and stairs are particularly susceptible (Figure 215).
- Mantels should be considered important features of the house. They are in excellent condition.

**FIGURE 215.** Common damage to woodwork and trim.

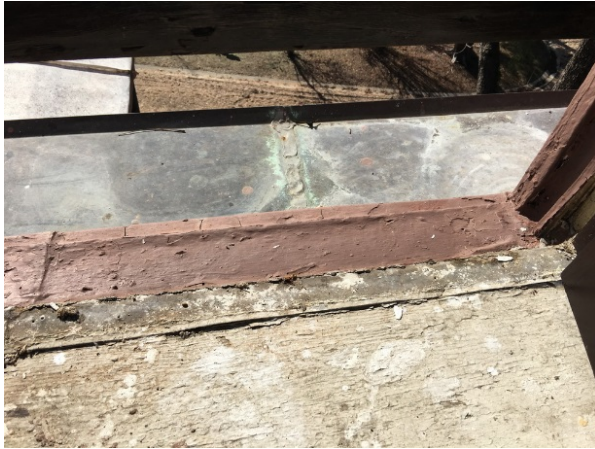
- Paint and varnish on window sash and sills is peeling and delaminating, and exposing the wood components to deterioration (Figure 216 and Figure 217).
- Wood shutters are in serviceable condition. Missing or broken hardware and knobs are preventing normal operation.

**FIGURE 216.** Third-floor bathroom – severely deteriorated window and wood sill.

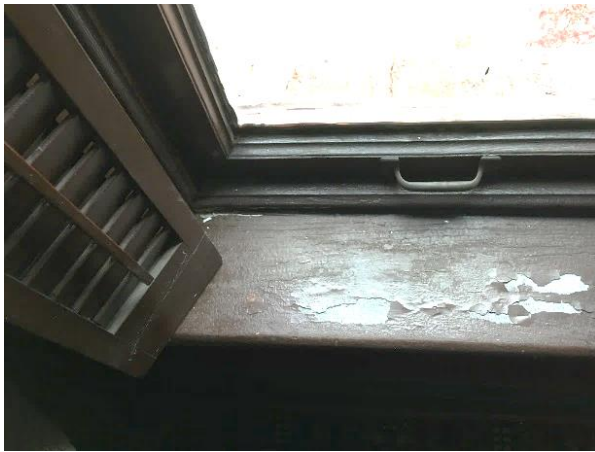
**FIGURE 217.** Dining room extension – blistering and peeling paint on the window sill.

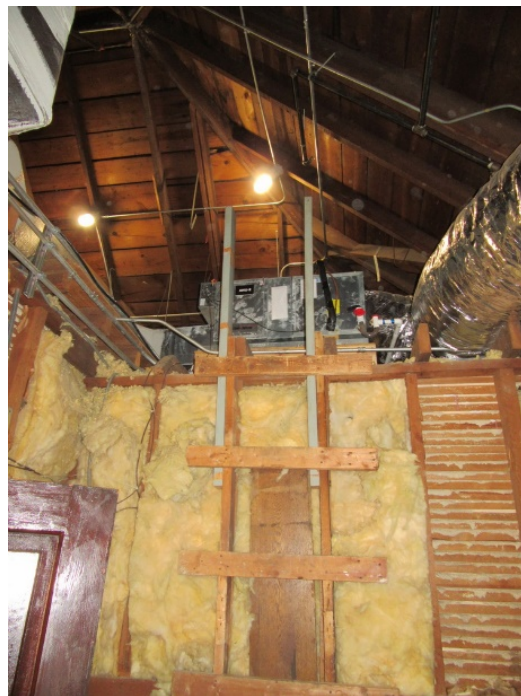
**Figure 219.** Air-handling unit in the attic.

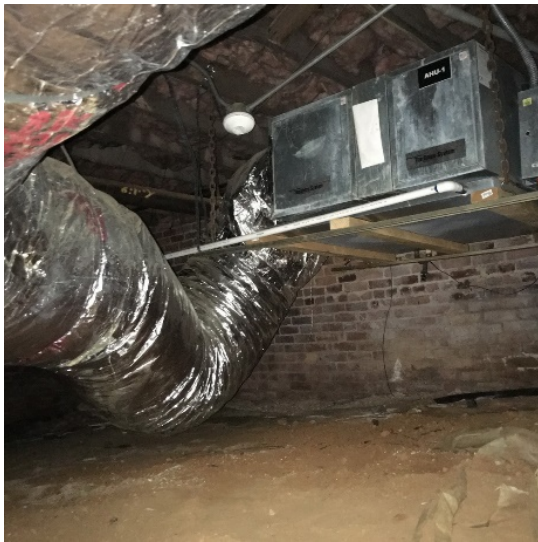
**FIGURE 220.** Air-handling unit in crawl space.

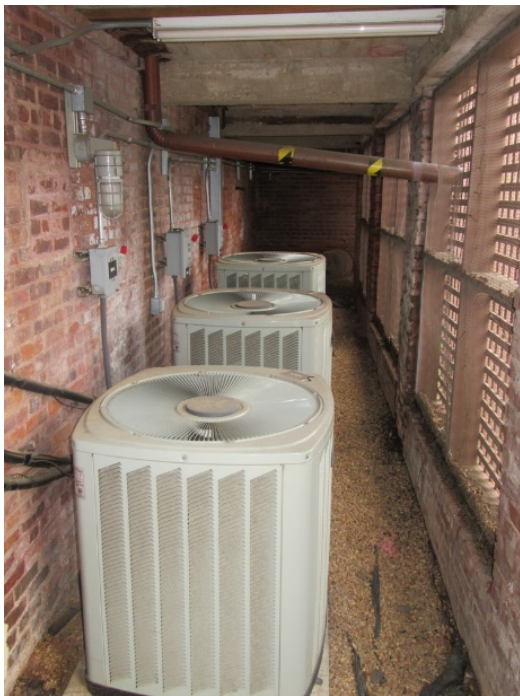
**FIGURE 221.** Condensing units at porch crawl space.

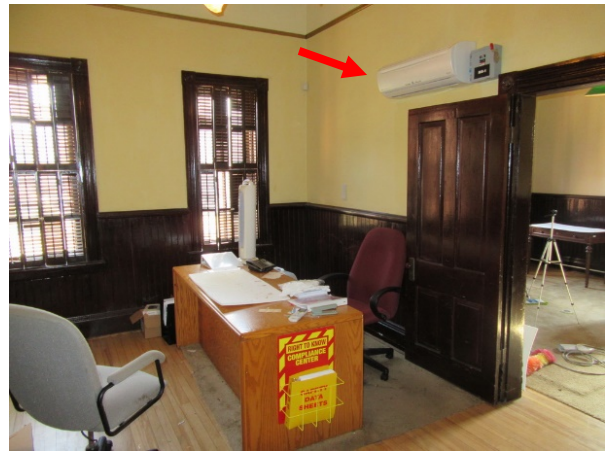
**FIGURE 222.** Wall-mounted VRF unit in the breakfast room.

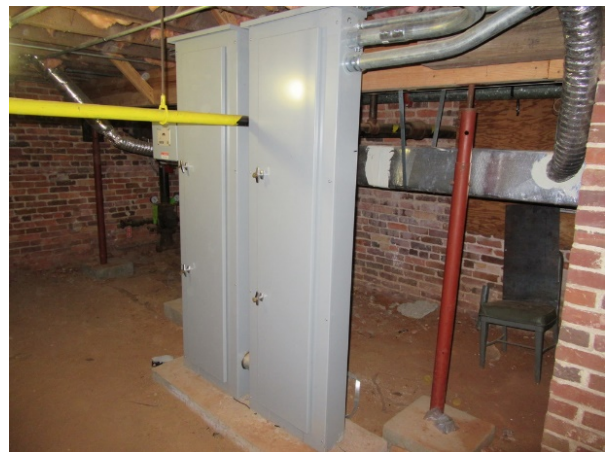
**FIGURE 223.** Electrical panels in the crawl space.

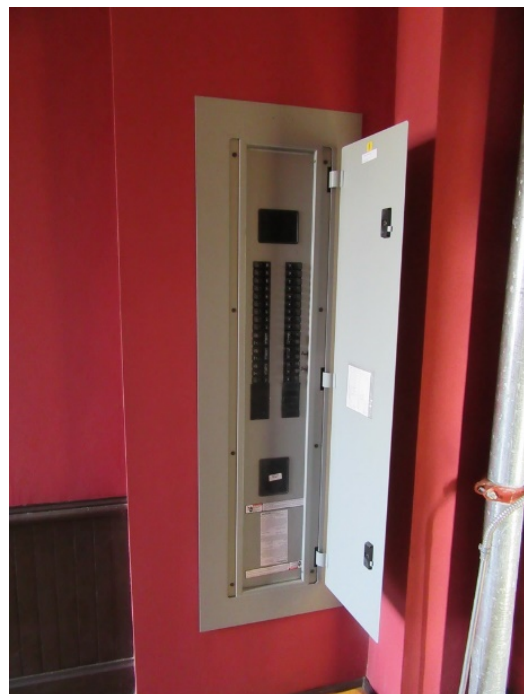
**FIGURE 224.** Electrical sub-panel at west bedroom.

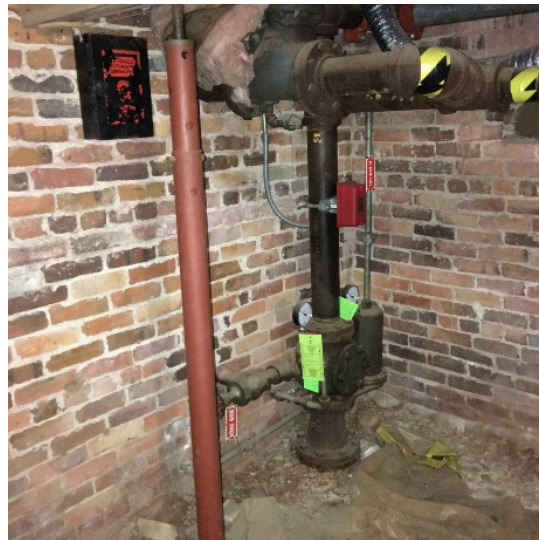
**FIGURE 226.** Fire sprinkler standpipe in basement.

- The fire alarm and fire-suppression (sprinkler) systems were upgraded in 2007 and should be inspected and tested periodically for proper operation and compliance with current life safety codes.
- A few inoperable smoke and fire sensors were observed in the crawl space.

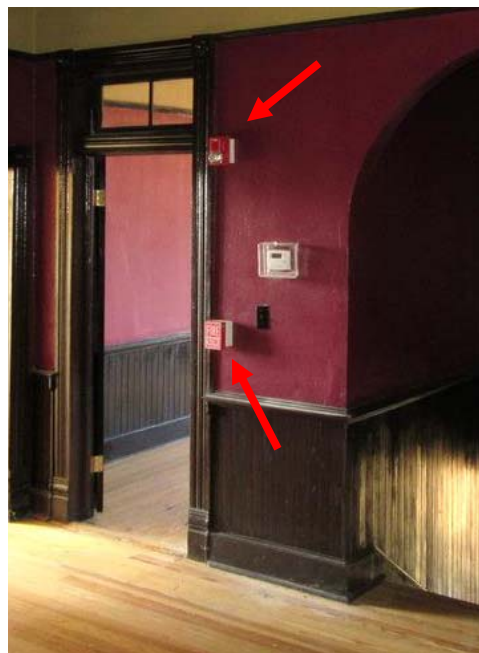
**FIGURE 227.** Typical alarm pull-station (bottom) and strobe (top).

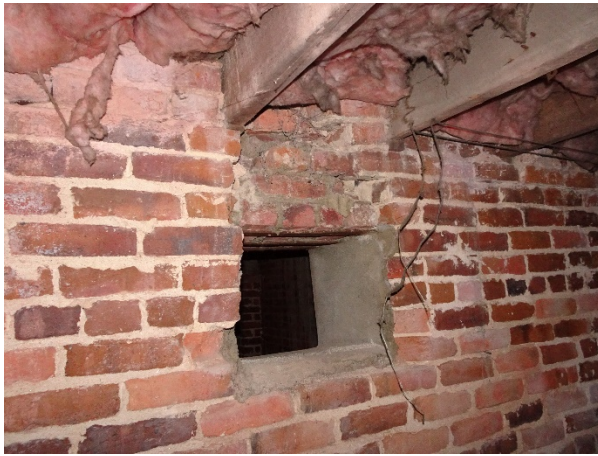
basement / crawl space is a network of interior load-bearing masonry walls arranged perpendicular to each other that define eight separate rooms. The interior load-bearing walls are approximately 16 inches thick. The walls have joist pockets that support the wood floor framing (Figure 228).

**FIGURE 228.** Load-bearing masonry wall at interior of basement / crawl space.

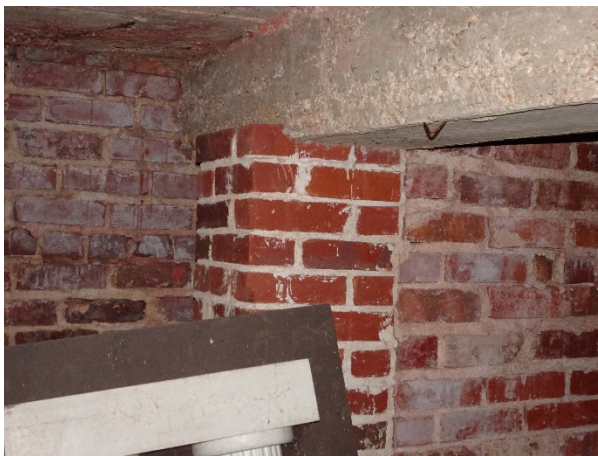
A second brick masonry wall wraps around the north, west, and south elevations of the building and supports the concrete floor slab for the main wrap-around porch. The masonry wall for the porch foundation is approximately 8 inches thick and has brick masonry piers, each measuring 12 inches square, which support concrete beams, measuring 10 inches wide and 9 inches deep, cast into the concrete floor slab (Figure 229).

**FIGURE 229.** Brick support pier and concrete beam at porch foundation.

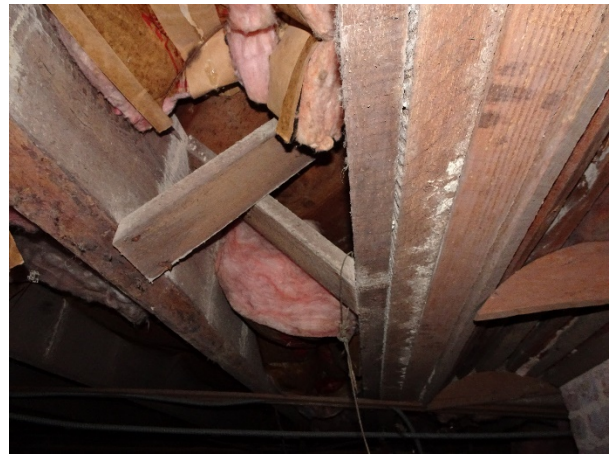
**FIGURE 230.** View of first-floor framing. Note bridging and insulation at joist pocket.

The first-floor framing consists of 2x12 joists spaced 18 inches on center (Figure 230). The joists have wood bridging at the midspan and support a 1-inch-thick subfloor. Fiberglass batt insulation has been installed at the joist pockets. At the crawl space wall that separates the dining room from the rest of the building, there are two steel columns. The columns are 7-1/2 inches in diameter and rest on a steel plate measuring 14 inches square and 1 inch thick. The columns appear to support an encased beam that spans the first-floor opening to the dining room.

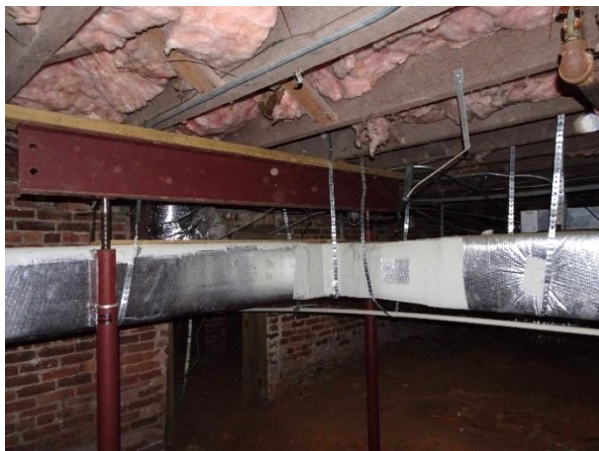
Non-original supplemental framing is at two of the crawl space rooms at the southwest corner of the building. The supplemental framing is located below a first-floor bathroom and the main stair. It consists of steel I-beams that span perpendicular to the joists (Figure 231). The beams are supported by steel jacks. Some of the joists are sistered with new wood members.

**FIGURE 231.** Supplemental non-original framing at southwest corner of the crawl space.

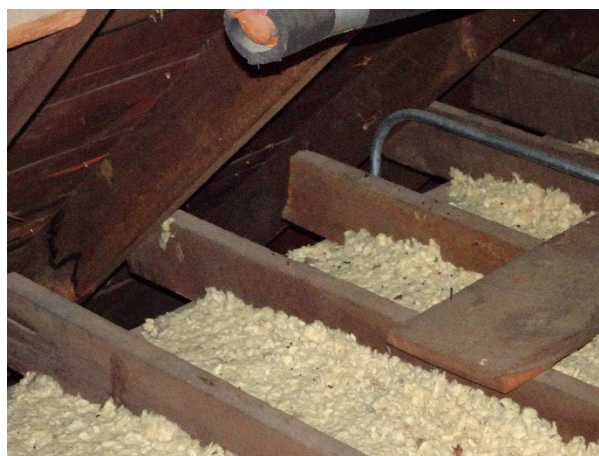
The roof is wood framed and includes both occupied finish space and unfinished attic space. The ceiling above the occupied space is constructed of 2x6 ceiling joists spaced 13 inches on center (Figure 232).

**FIGURE 232.** Ceiling joists as viewed from the attic.

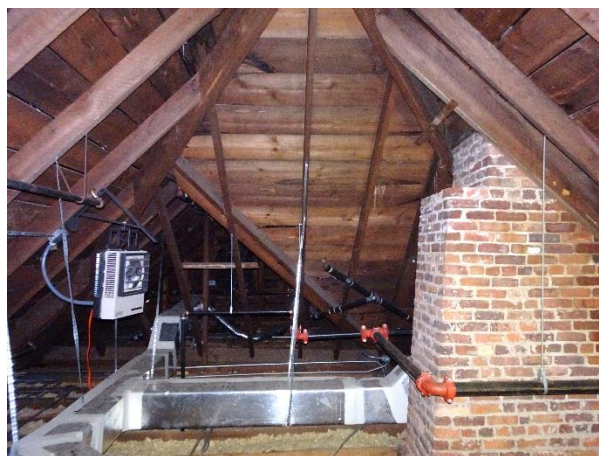
The main roof has a 45-degree slope and is constructed of 2x6 rafters spaced 30 inches on center (Figure 233). The hips and valleys of the roof have doubled 2x6 rafters consisting of many smaller length rafters scabbed together to form one longer rafter. The makeshift rafters have staggered joints. The ridge beam of the roofs is a 1x8. The roof has 1x12 wood sheathing, although lower portions of the roof have narrower sheathing boards. At the center of the roof, where the main gable and cross gables intersect, there is

**FIGURE 233.** Overview of main roof structure.

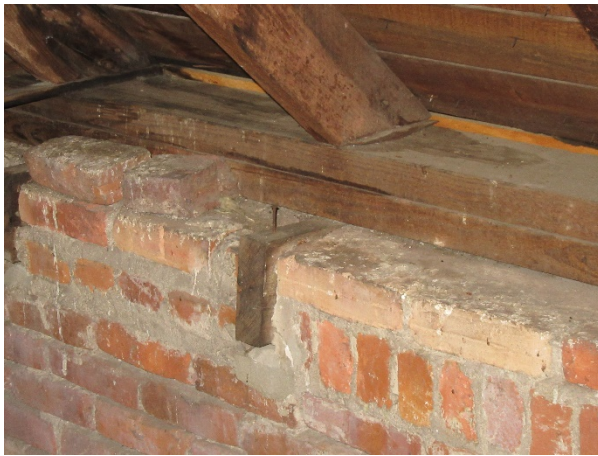
Along the edge of the roof are 2x6 wood kickers, spaced 42 inches on center. The kickers are set in pockets in the masonry wall and support the wood-framed projecting cornice and gutter system (Figure 234).

**FIGURE 234.** Typical wood kicker found in the attic of the south wing.

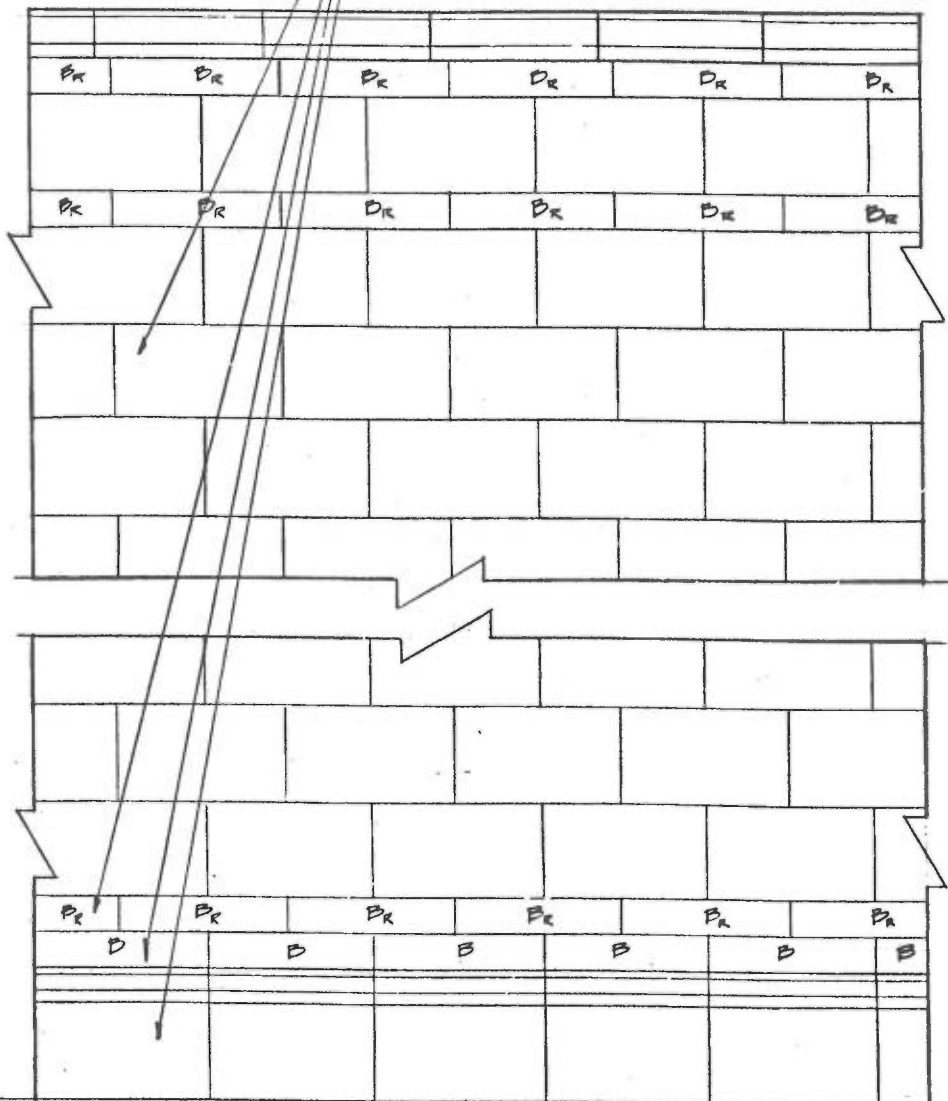
BATHROOM 212 CERAMIC WALL TILE  
 SCALE: 3" = 1'-0"

REPLACED 15 WHITE TILES  
 REPLACED 6 BROWN TILES  
 REPLACED 7 BLUE TILES  
 REPLACED 5 BASE TILES

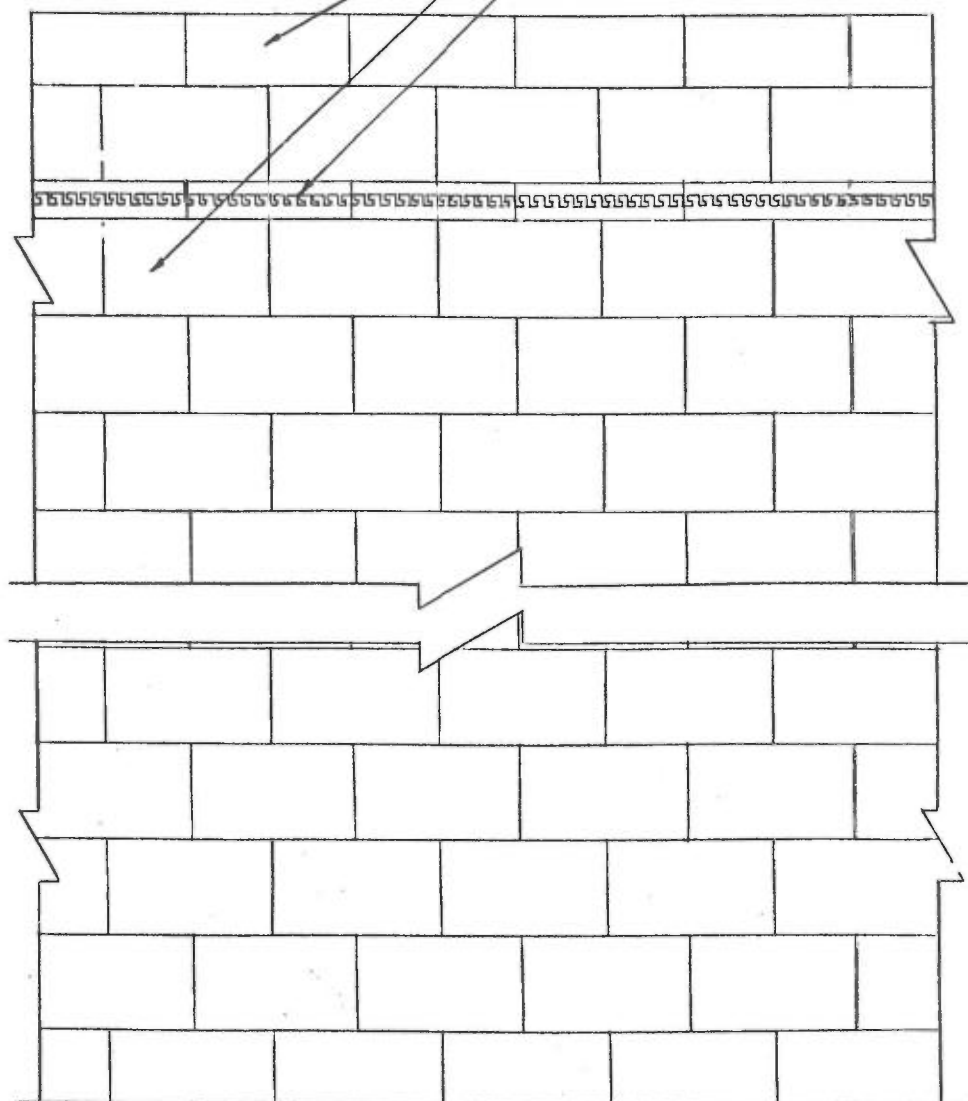
BATHROOM 110 CERAMIC WALL TILE  
 SCALE: 3" = 1'-0"

REPLACED 17 TILES  
 REPLACED 12 TILES  
 GOLD TRIM
