# Historic Structure Report

# The Oaks

## Tuskegee Institute National Historic Site

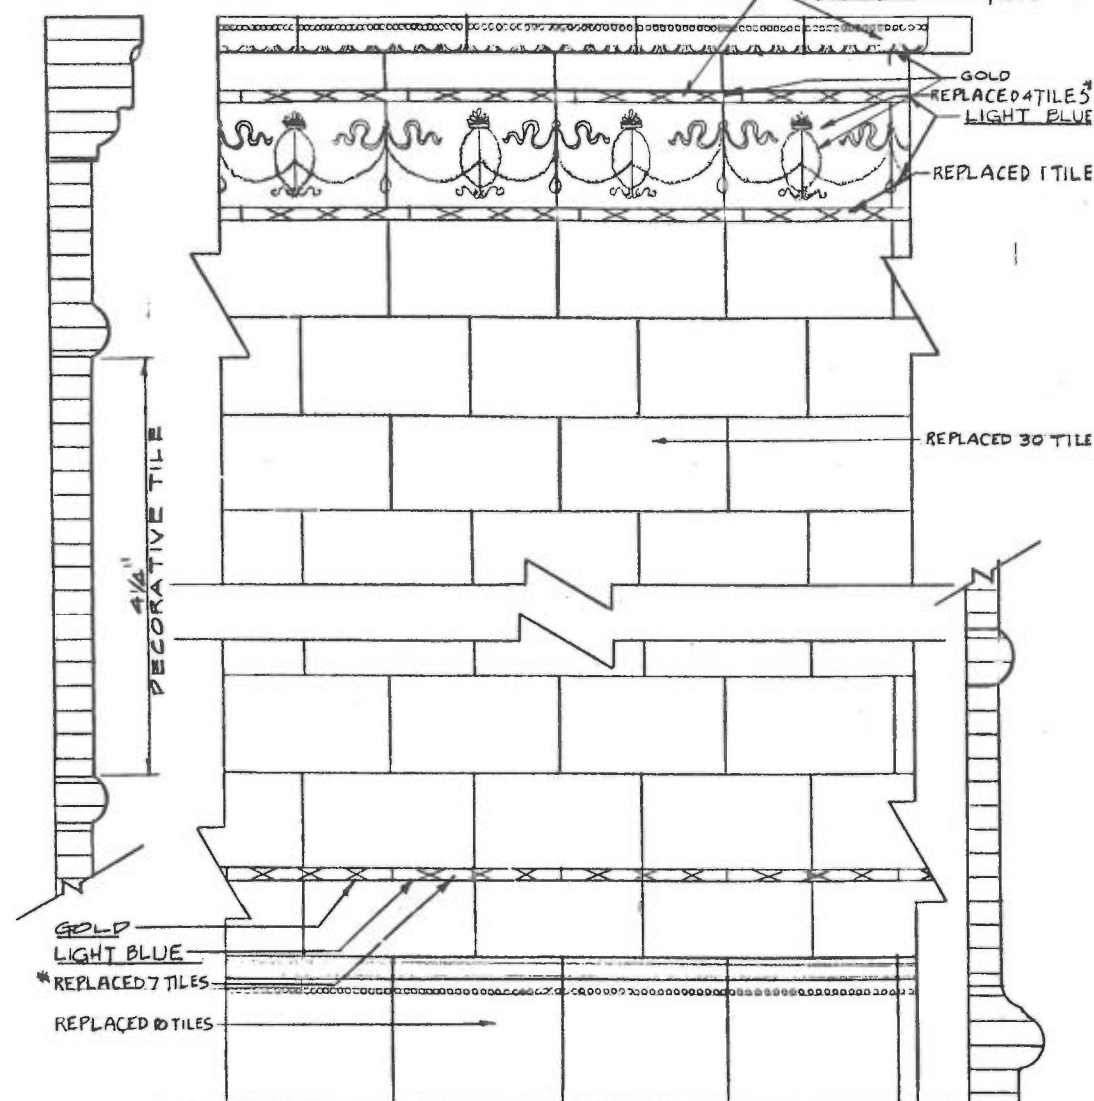
BATHROOM 210 CERAMIC WALL TILE  
 SCALE: 3" = 1'-0"

REPLACED APPROX. 100 GREY TILES  
 REPLACED APPROX. 200 WHITE TILES

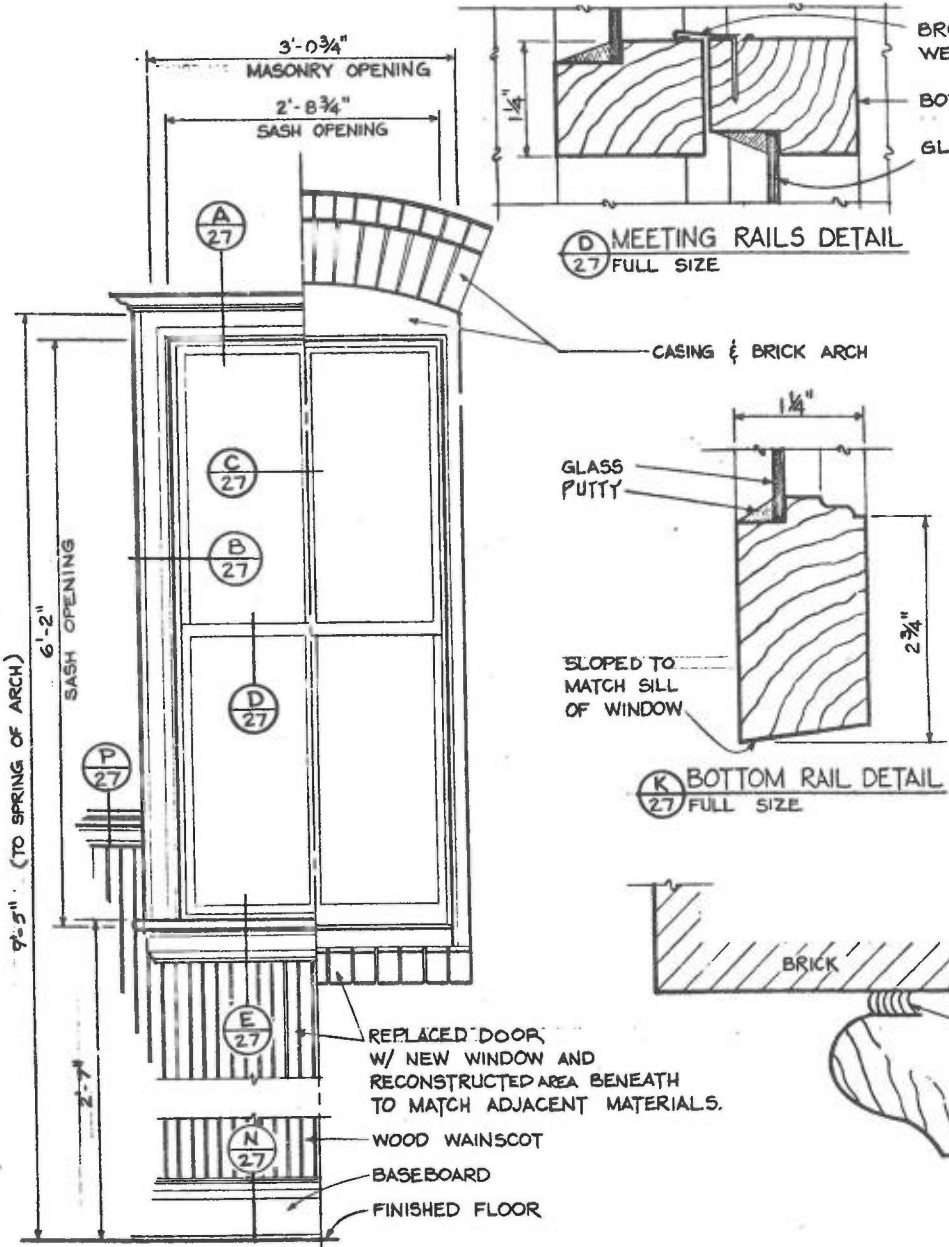
WINDOW 17C - ELEVATION  
SCALE 1"=1'-0"

- WINDOW No 1/C - REPLACED I.S. SASH GUIDE
- WINDOW No 17/C - REPLACED MEETING RAIL @ TOP SASH
- WINDOW No 18/C - REPAIRED MEETING RAIL @ TOP SASH
- WINDOW No 19/C - REPAIRED MEETING RAIL @ TOP SASH

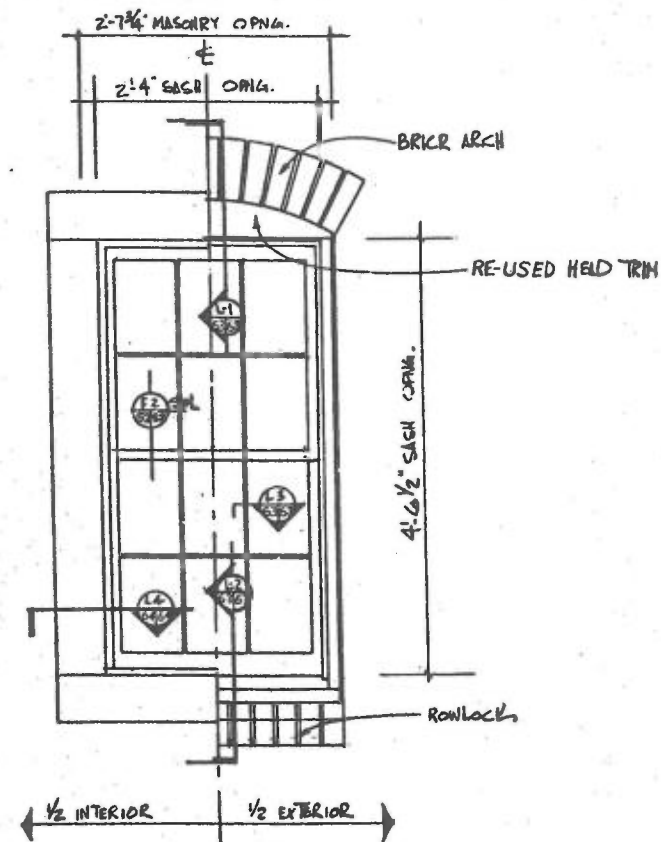
ELEVATION - WINDOW No 1/A

NOTE: ALL DIMENSIONS & DETAILS @ THIS WINDOW WERE JOB VERIFIED
