## Of Adobe, Lime, and Cement: The Preservation History of the San José de Tumacácori Mission Church (Part II - Structures)

### Introduction

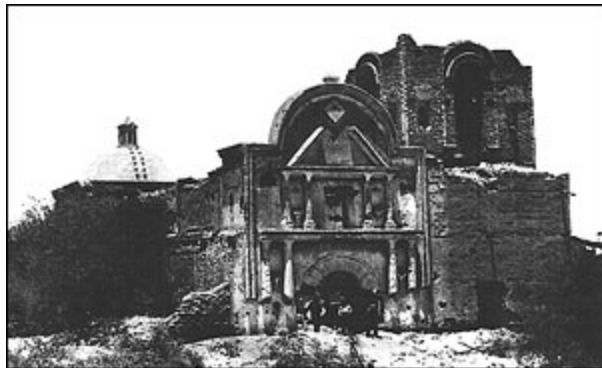
Mission church in 1889. This photo was used by Pinkley (1921) as a reference for the reconstruction of the façade pediment. Photo taken by George Roskrue.

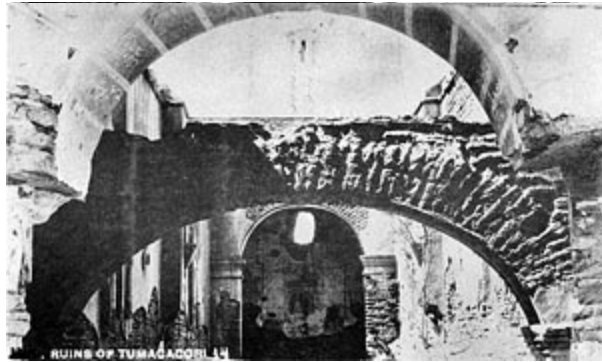
Photos of the church interior taken before 1893 show an intact choir loft. Based on available evidence, the choir loft fell sometime between 1892 and 1907. By circa 1905, the choir loft was no longer intact. Clemensen believes the choir loft fell in 1906.<sup>7</sup> Tomas Alegria thought the choir loft collapsed in 1901, when the Montez family living at the mission hung a swing for their son from the arch.<sup>8</sup> However, geologist William Blake visited the mission in 1905 and 1907, and notes from his 1907 visit suggest that the choir loft fell sometime between 1905 and 1907; presumably due to the combined impact of the 1887 earthquake and its use as a swing support.<sup>9</sup>

**Close up of the choir loft ca. 1890.**
