Vanderbilt Mansion National Historic Site  
Hyde Park, New York

## **Vanderbilt Mansion National Historic Site Historic Structure Report**

Volume I: Executive Summary, History, and Record of Treatment  
October 2018

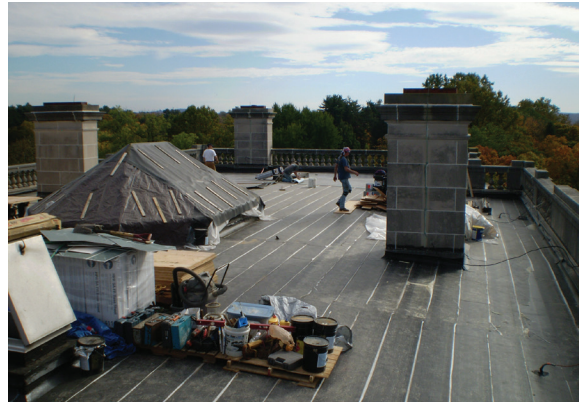
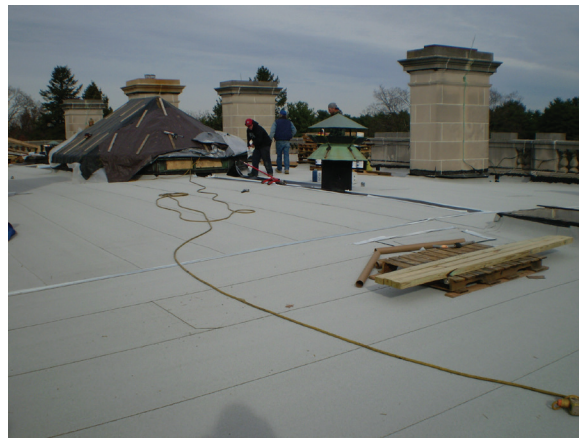
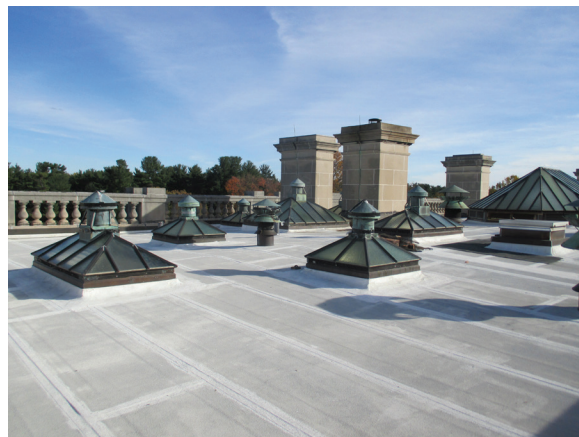
Figure 14. Base sheet installation looking northeast (upper image); cap sheet installation (center image); and the roof in 2017. PBS&J 2009, JGWA 2017.

The roofing system installed was the Garland Company's StressPly SA FR Mineral, a self-adhering, fire-resistant, dual fiberglass reinforced, modified bitumen membrane, with White Knight (a liquid waterproofing membrane). The system included self-adhering base sheet underlayments and the surface membrane (see Figure 14).

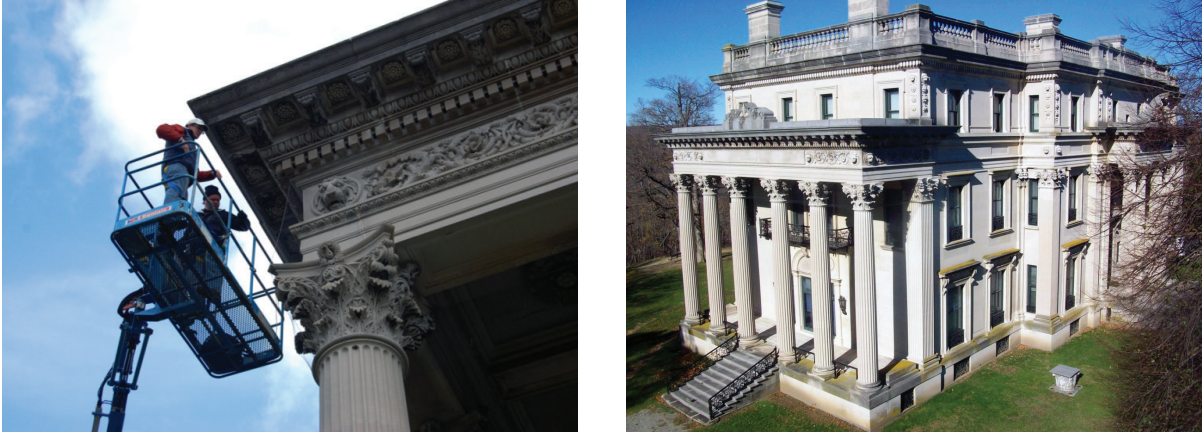
Figure 19. The entire exterior was surveyed in the fall of 2010, using a sixty-five foot lift.

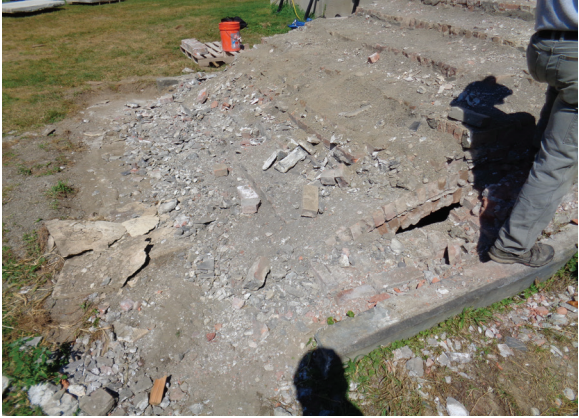
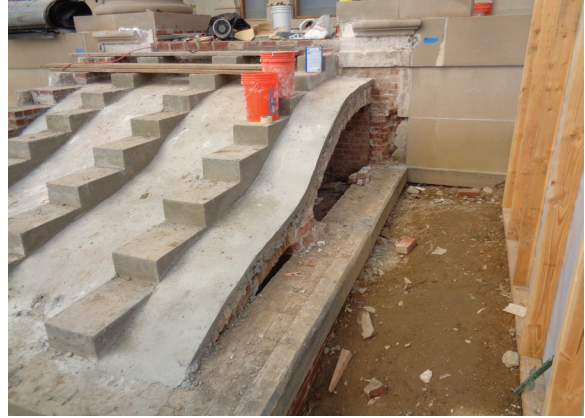
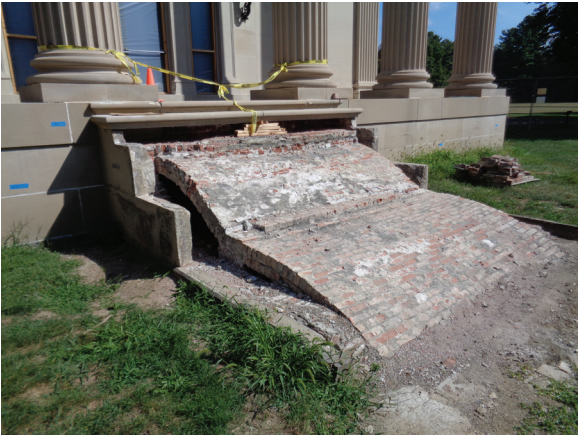
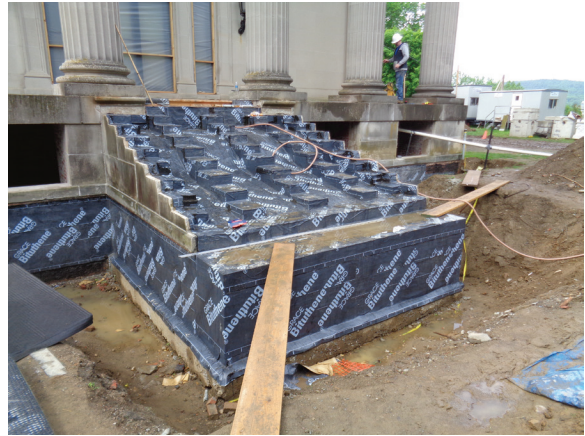
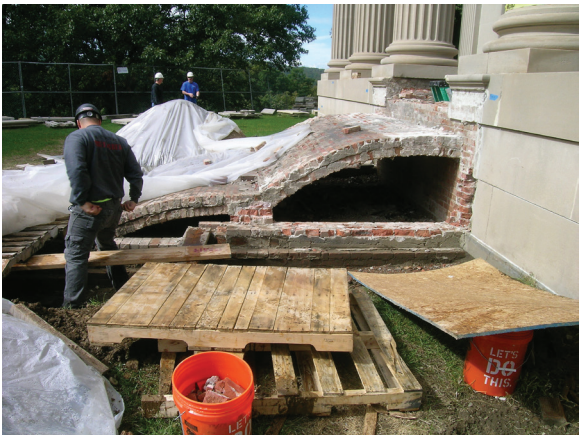
**Figure 28. Portico steps:** (Upper left) The south portico steps after the stone steps were removed. The steps were set on a brick fill that covered the shallow brick supporting arch. (Center image) The fill removed from the supporting arch. (Lower left) The supporting arch after the cheek walls were removed. (Upper right) New lightweight stepped concrete slab. The slab allows water to drain through the structure. (Lower right) The steps and cheek walls during reinstallation. Note the waterproofing installed over the new concrete slab. JGWA, 2015.

The steps at all four porticos were displaced. Three options, like those for the portico floors, were proposed for repair; and, as at the floors, the option for a new lightweight concrete structure was chosen (see Figure 27). At the north, south, and east porticos, the contractor removed the steps and cheek walls, revealing brick fill covering shallow brick jack vaults. The fill was cleared away and lightweight concrete stepping installed to support the steps; this concrete base was designed to allow water to drain out of the stair. A waterproof lining was installed on the stepping, and the stone treads were then reset on a setting bed and cleaned (see Figure 28 and Figure 29).

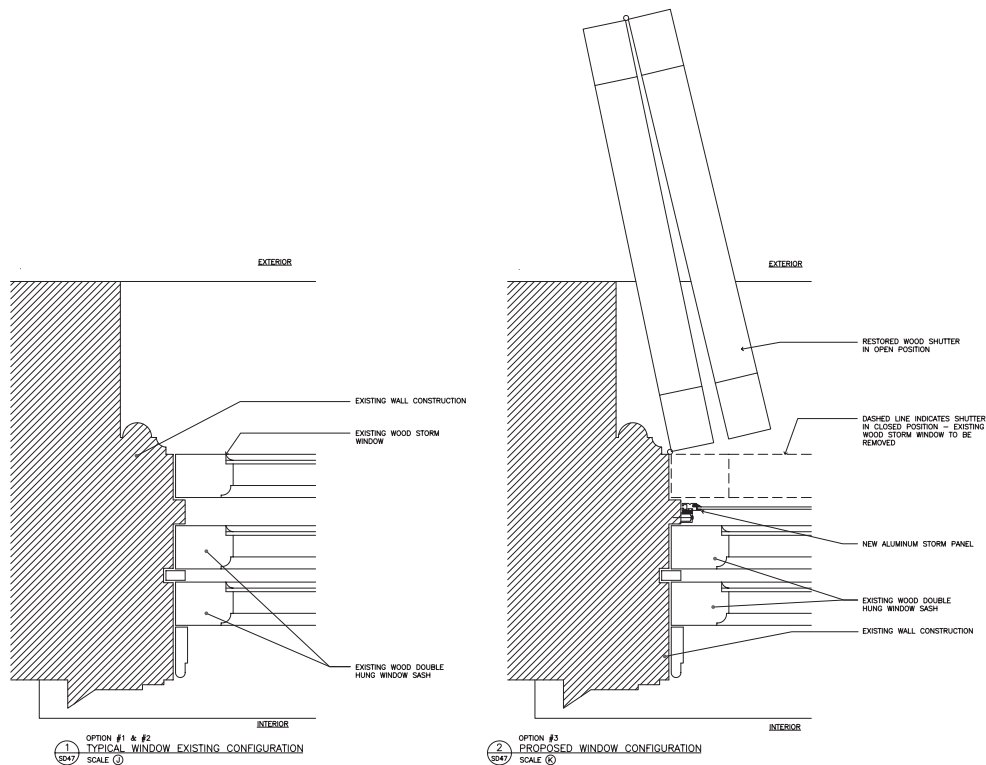
**Figure 30. Detail of window and storm window installation. JGWA, 2010.**

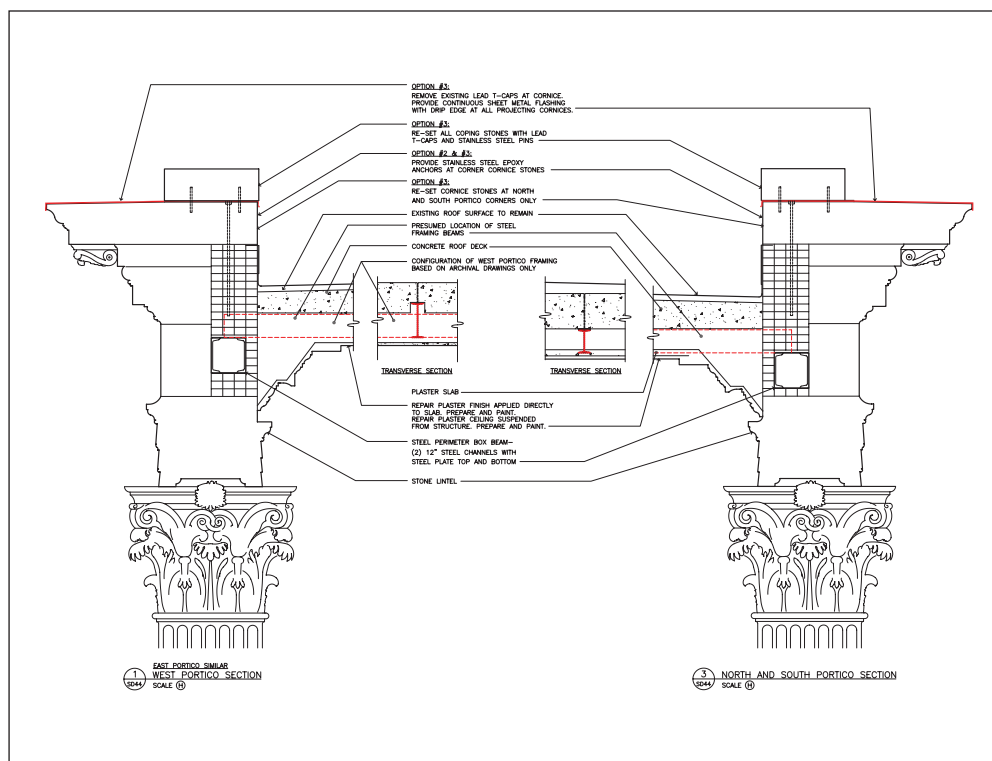
Figure 31. Detail showing the plan for resetting the north and south portico corner stones using Lewis pins. JGWA.

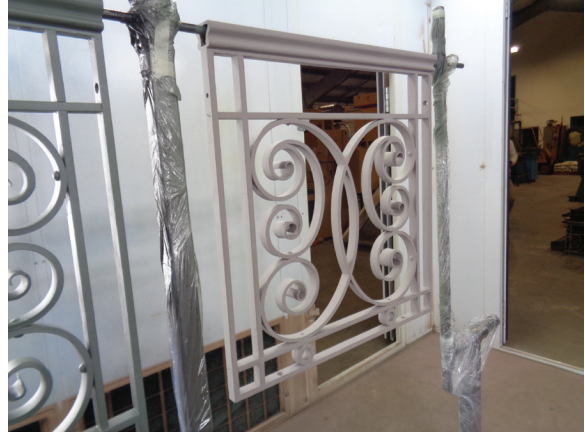
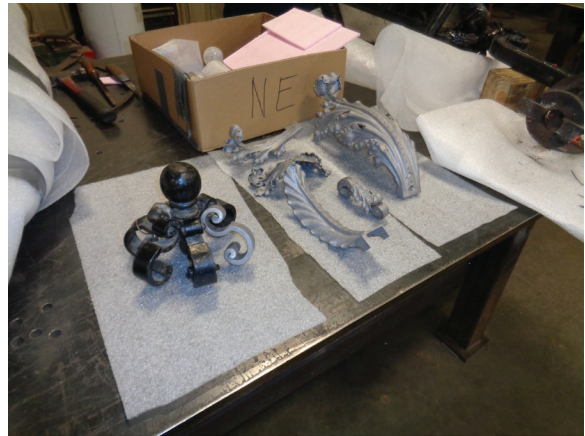
**Figure 38.** Window grilles (upper image) and historic lanterns from the north and south portico (lower image) were removed to the Keicher Metal Arts shop for restoration. JGWA, 2017.

The four historic lanterns from the north and south porticos were removed to Keicher Metal Arts' studio. The artisans took each lantern apart, stripping the individual pieces, refinishing them, and then reassembling the lanterns (see Figure 38). The fixtures were re-wired, re-lamped, and then reinstalled.

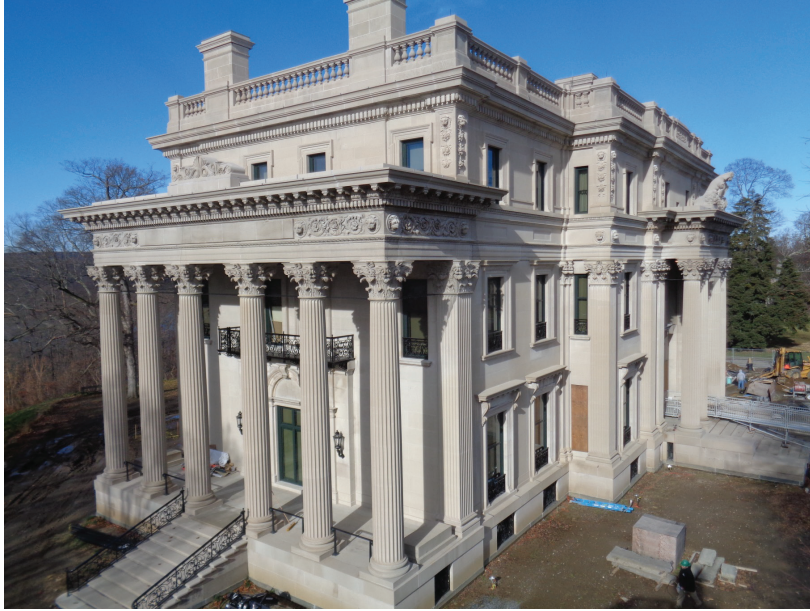
**Figure 39.** The mansion from the southeast during restoration. The windows were removed from the mansion for restoration and temporarily replaced with plywood coverings; one of those coverings is visible in the south window opening of the Den. JGWA, 2017.
