## **Vanderbilt Mansion National Historic Site Historic Structure Report**

Volume VIII: Appendix G - Record of Treatment Documents  
Complete the Exterior Restoration of the Vanderbilt Mansion: PMIS 152373  
October 2018

COMPLETE THE EXTERIOR RESTORATION  
OF THE VANDERBILT MANSION  
PMIS 152373

**JOHN G. WAITE ASSOCIATES, ARCHITECTS**

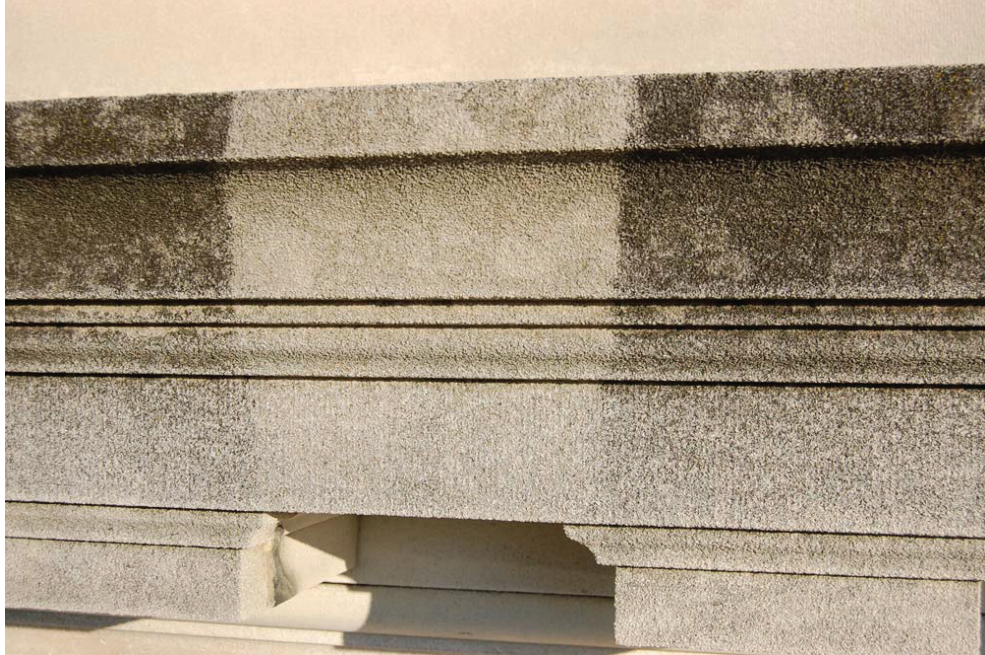
Masonry cleaning test were performed December 2010 in several locations. The preliminary report is attached. Follow up testing will be completed in April 2010. A large portion of the staining on the building is attributable to biological growth.

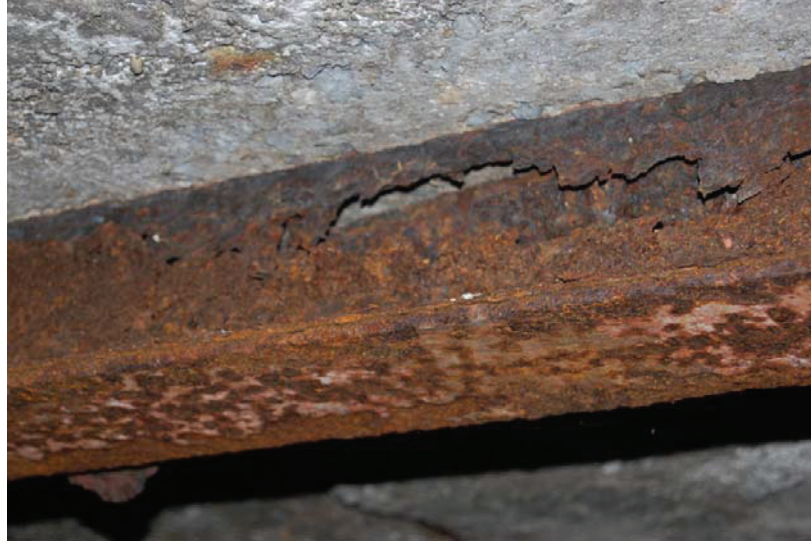
A comprehensive visual inspection of exposed steel at the west portico indicates nearly all steel framing and reinforcing is not salvageable for continued use. No laboratory testing is recommended.

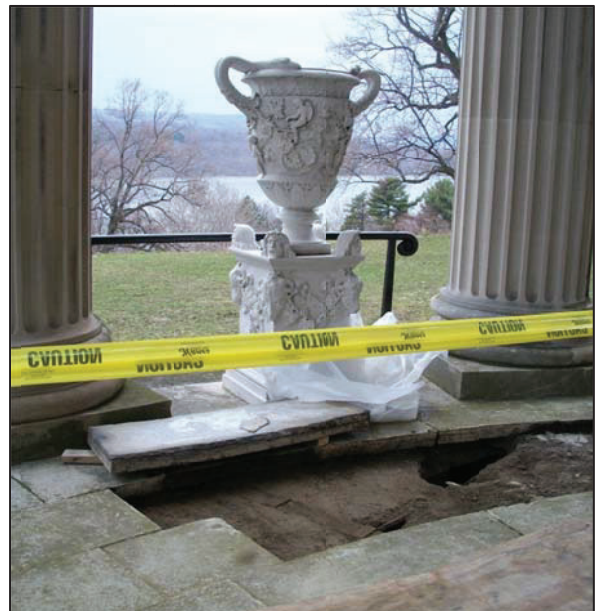
Photo 2 – Probe Below West Portico Pavers

A probe was taken at the west portico by removing the paving stones and demolishing a small section of the concrete slab (Photo 2). Based on measurements taken at the probe; the portico assembly includes 3 inch stone pavers, a 2 inch sand setting bed and a 4 inch one-way concrete slab. The slab is supported by steel wide flange beams which range in depth from 9 to 12 inches. The top flange is embedded in the concrete slab. At the probe location the steel beam was 9 inches deep, with a flange 4-1/2 inches wide x 3/8 inch thick.

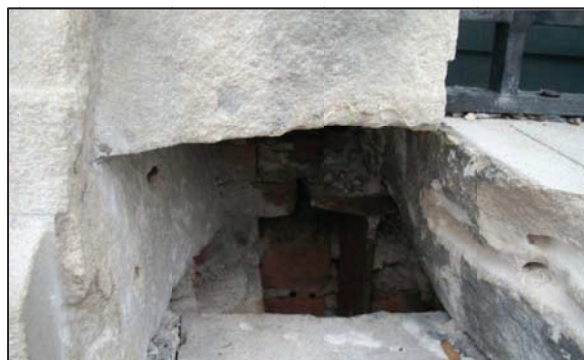
Photo 4 – Probe at Window Sill

A probe was made below a first floor window on the west façade. In this area, significant cracking was observed in the stone veneer and the intent of the probe was to identify potential causes of this cracking. The stone and brick masonry was removed the end of a steel wide flange floor beam bearing on the brick masonry wall (Photo 4).

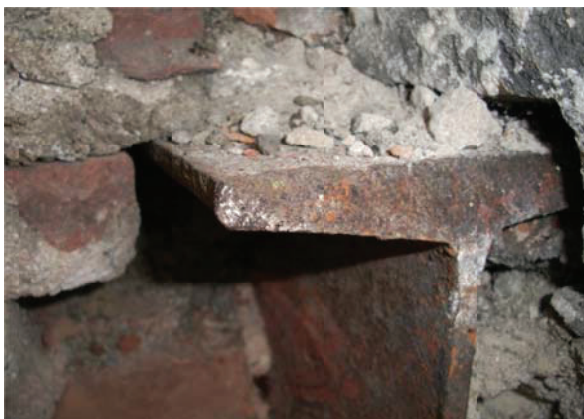
Photo 5 – Steel Framing Exposed at Window Sill Probe

The steel section is set back approximately 5 inches from the interior face of the lower stone. Field measurements show the section is 5 inches wide x 12-1/2 inches deep. The flange thickness is tapered from 3/8 inch at the edge to 3/4 inch at the web, while the web is 3/8 inch thick (Photo 5). Bricks are packed tightly around the steel section. The section was in surprisingly good condition given its proximity to the building envelope and is not the cause of the cracking in the stone veneer.

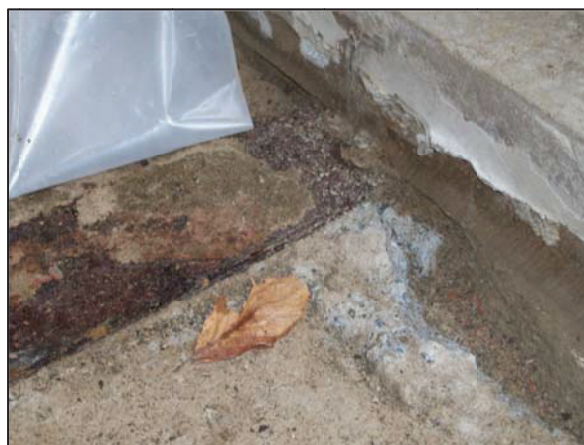
Photo 11 – Probe at East Portico Floor

At the east portico several paving stones were removed to reveal the portico slab. The structural slab at the probe is supported on the bottom flange of steel wide flanges. Above the structural slab there is a topping slab flush with the top flange of the steel beam. Portions of the topping slab include brick infill, which when removed revealed the structural slab below (Photo 11). The total assembly is approximately 14 inches thick, with 3 inch paving stones on a one inch setting bed of sand, above a 10 inch slab. It is believed that the slab consists of a 4-1/2 inch structural one-way slab, below a sloped topping slab that is at a minimum 5-1/2 inches. Steel beams with a depth of 10 inches run in the east-west direction. Overall the slab is in good condition, but the exposed top flange of steel show signs of corrosion.

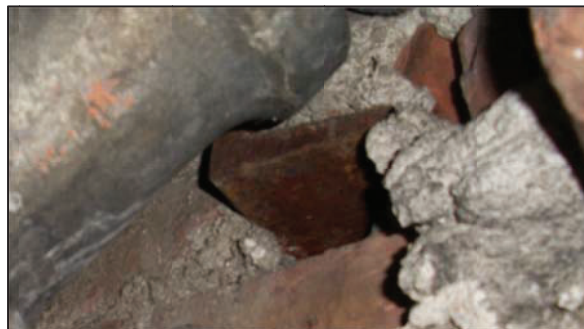
Photo 18 – Steel Section Embedded in Masonry

At the upper floor level a probe was opened to reveal the framing at the interface between the east portico and the main building. The opening at the base of the wall shows a 2-3/4 inch gap between the face of plaster and the face of brick. Embedded in the brick masonry are two steel wide flange sections. Although only the top half of the sections was exposed, much of the geometry could still be documented (Photo 15). Based on site observations it is believed that the portico framing perpendicular to the wall is hung off of and supported by the two wide flange beams. The sections are each 7 inches wide with a 3/4 inch thick web and a flange tapered from 5/8 to 3/4 inch.

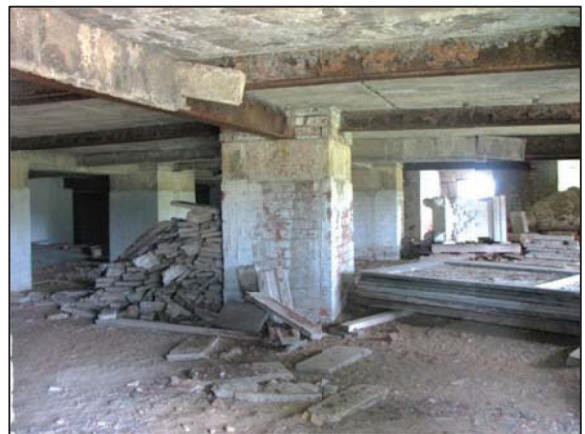
**Figure 2:** Framing in Crawlspace Below West Portico

In general, the portico floor framing consists of steel beams supporting a concrete slab. At the west portico a 4 inch structural slab is supported from the top flange of the beams (Figure 2). At the north, south and east porticos the slab is approximately 9 inches thick with a 5 inch topping slab above a 4 inch structural slab (Figure 3). The structural slabs are reinforced with a proprietary system from the Columbian Reinforcing Company (Figure 4). Above the slabs there is a one inch setting bed and 3 inch thick stone pavers (Figure 7).

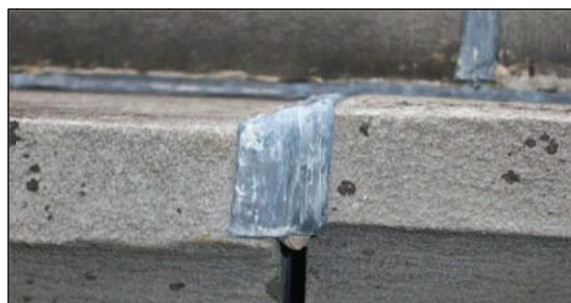
Several of the corner cornice stones at both the north and south porticos have been displaced and are rotating away from their ledge support (Figure 10 & 11). If a cornice stone were to ever fail and fall off of its support, it would present a serious life safety hazard.

Figure 11: Rotation and Displacement at Cornice Joint

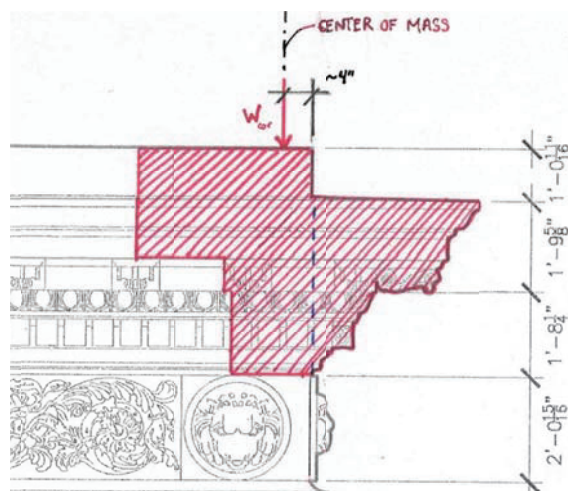
With that being said, the center of mass of the cornice assembly was only a few inches from the edge of its bearing support (Figure 12). The continued lateral displacement and rotation of the stone would lead to a shift in that center of mass and potentially an unstable condition. Until there is conclusive evidence otherwise, it must be assumed that there are no anchors and therefore it becomes even more imperative that the freeze-thaw

Figure 12: Corner Cornice Stone Center of Mass

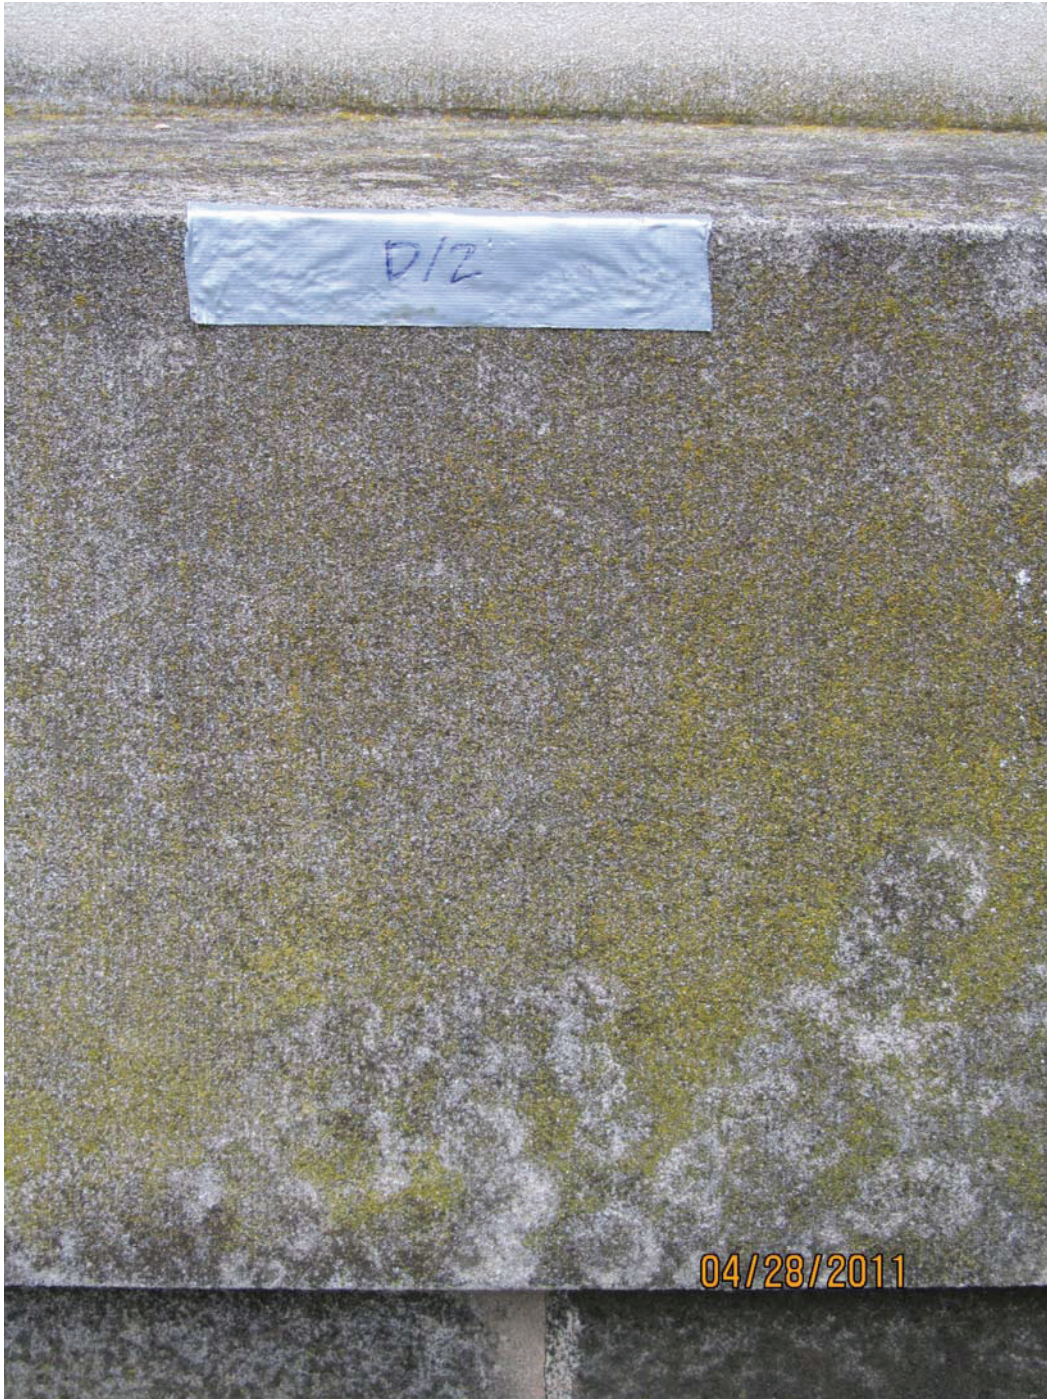
Test area #1, biological growth before cleaning with D/2

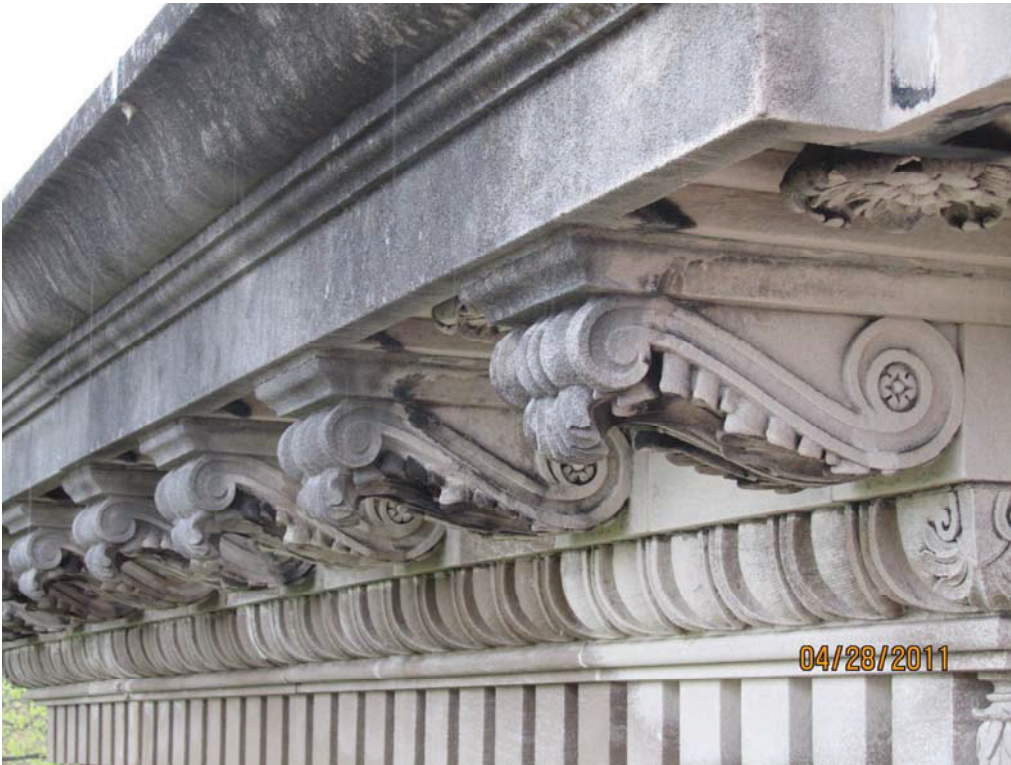
Test area #4, cornice conditions before cleaning

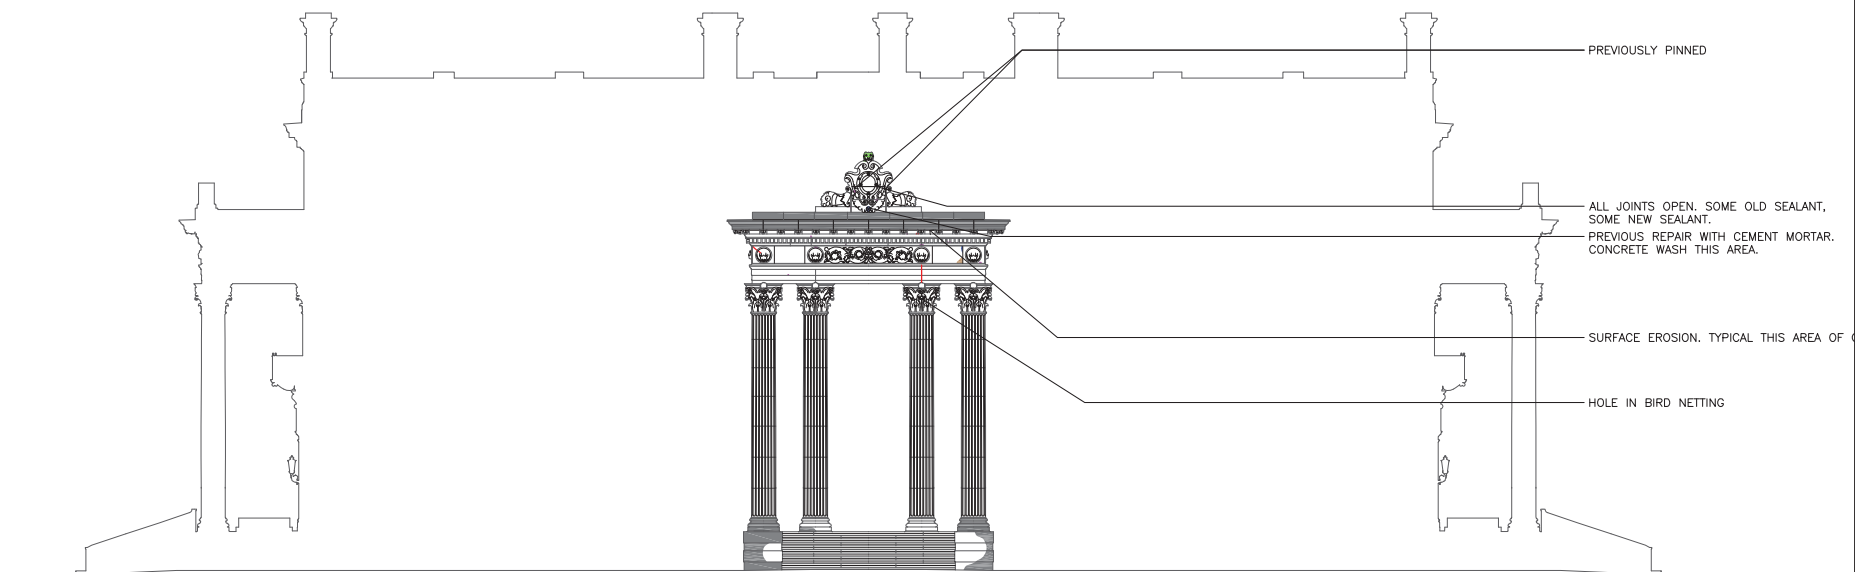
1 EAST PORTICO ELEVATION  
PD20 SCALE (B)

STONE BROKEN

DUE TO HARD MORTAR,  
MULTIPLE CRACKS AT TOP EDGE

MINOR RUST STAINING

UV FILM FAILING

CRACK AT SASH

LOOSE SCREEN

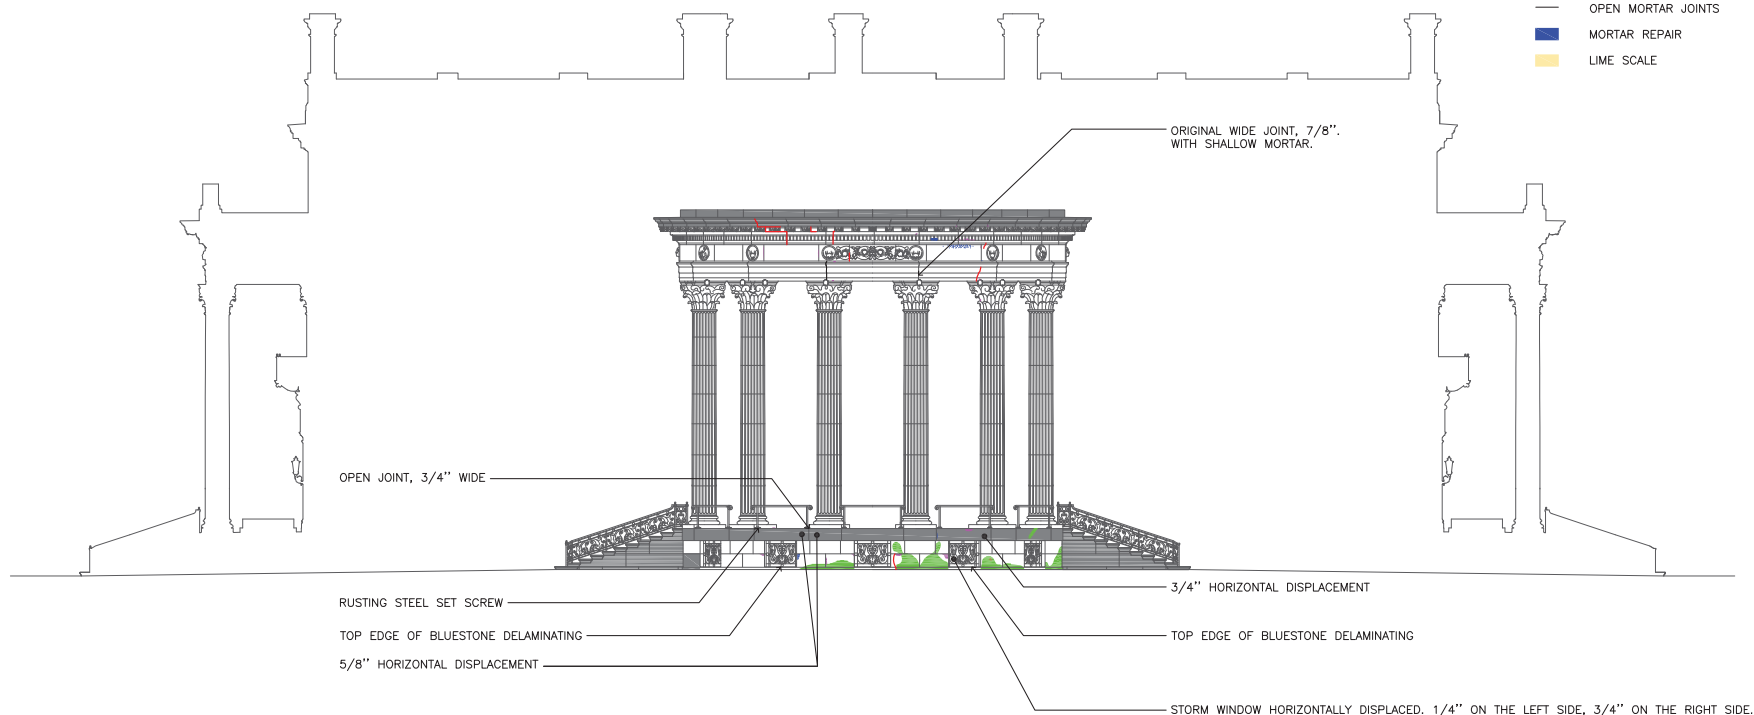
1 WEST PORTICO ELEVATION  
PD24 SCALE (B)

WOOD ROTTEN, DUTCHMAN REPAIR NEEDED

GLAZING PUTTY FAILING

CRACKED GLAZING PUTTY  
AND MINOR PAINT FAILURE

RUST STAINING ON TOP OF SILL  
FROM PREVIOUS AIR CONDITIONER

UV FILM FAILING, TYP.

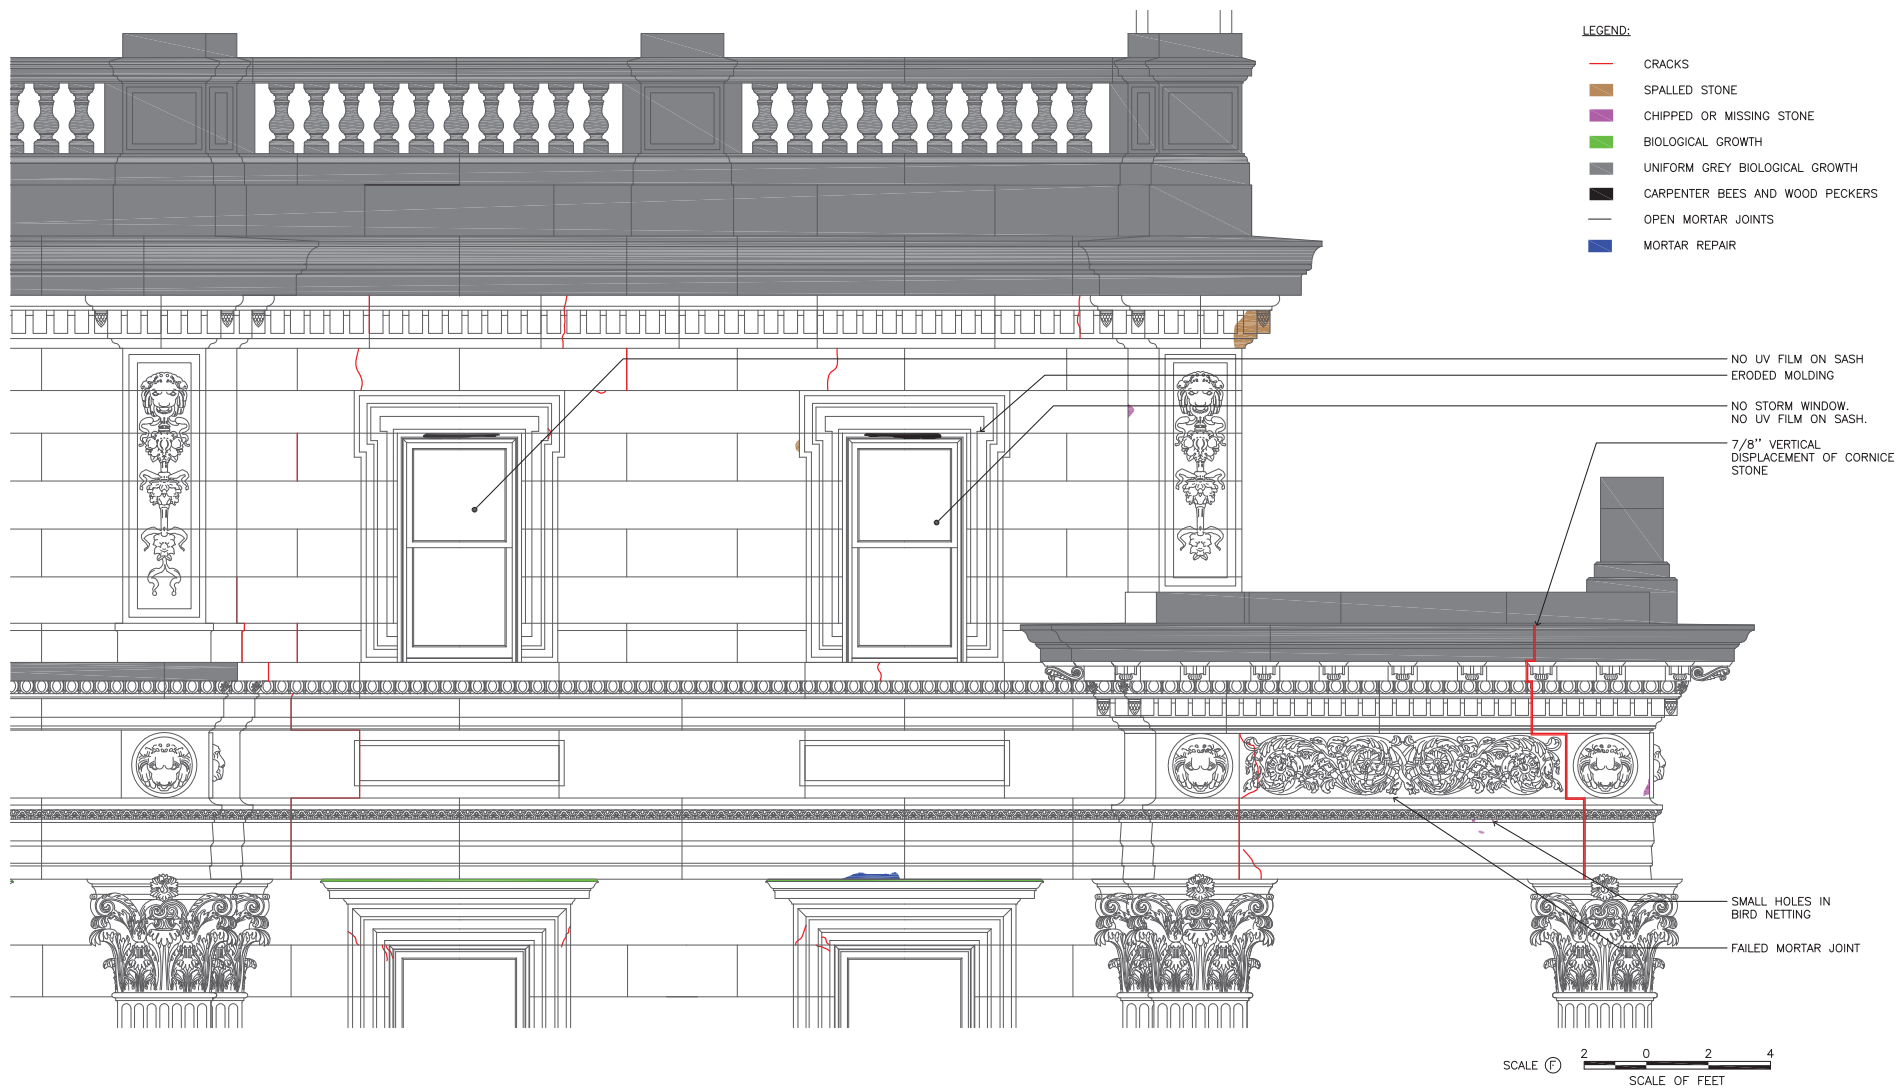
1 TYPICAL LARGE SCALE CONDITIONS NOTES - THIRD FLOOR EAST ELEVATION  
PD30 SCALE (F)

TYPICAL WINDOW THIS SIDE OF THIRD FLOOR: PEELING PAINT.  
PARTIAL GLAZING FAILURE. NO EXTERIOR STORMS, ONLY INTERIOR STORMS.  
PAINT ON SILLS PEELED, NEED DUTCHMAN REPAIR FOR  
THE FIRST 2" MIN. MEETING RAILS UNEVEN.  
JAMBS UNPAINTED AND CHECKED. PARTING STOPS ROTTEN.
