**Vanderbilt Mansion National Historic Site  
Conservation of Interior Stonework  
May-June 2005**

## Conservation of Interior Stonework 2005

### Conservation Assessment and Treatment Reports

# **Vanderbilt Mansion National Historic Site Interior Architectural Stone Conservation Needs Assessment**

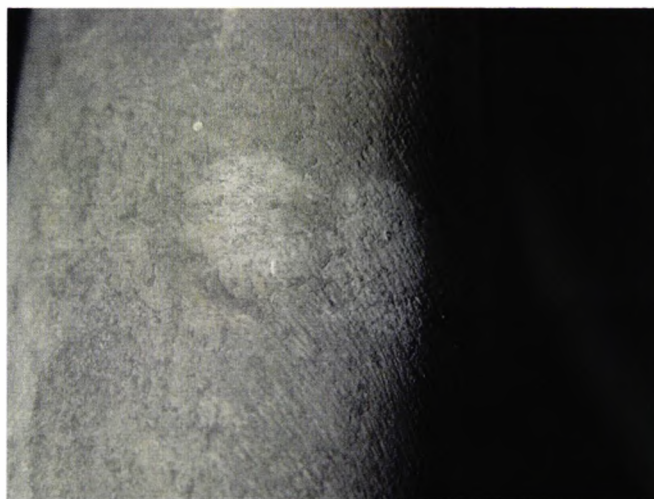
Cleaning tests were conducted on the caryatids and various areas of the entablature. A vinyl eraser did little to remove soot deposits, as did pure spring water, acetone, and ethanol. Saliva removed some soot, but a 3% ammonium citrate/water solution was most successful, exposing white marble below, especially as dwell time was increased. Ultra Violet light examination exposed areas of infills, toning, and joins on the caryatids.

**Detail of soot accumulation and cleaning test areas, water first, then 3% ammonium citrate, on proper left caryatid left arm.**

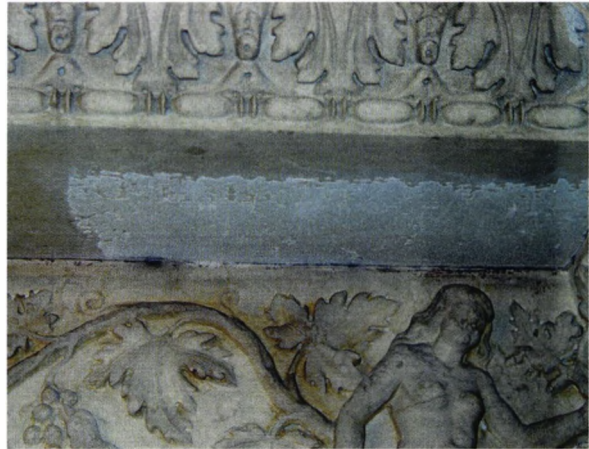
**White, powdery accretions on underside of mantel.**

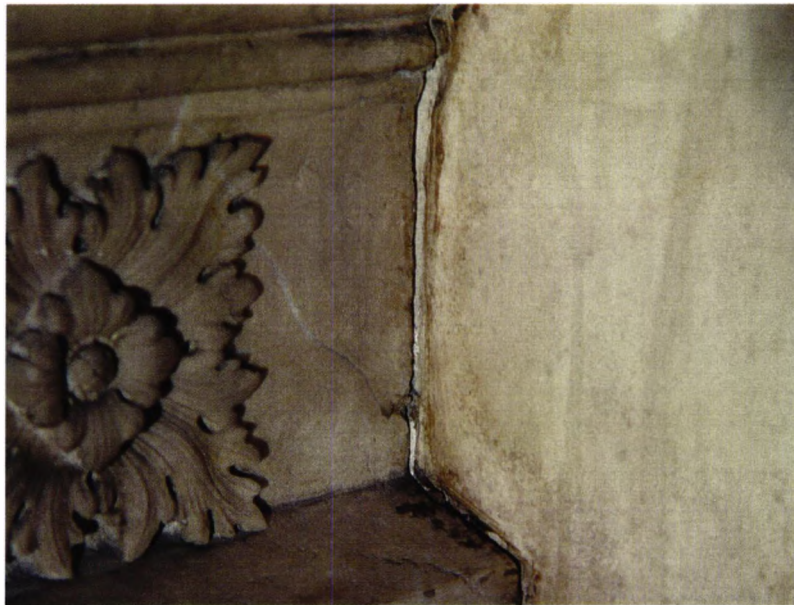
**Figure 11. Accumulated brown toning is apparent in the gaps between the flat marble panels and the fireplace surround.**

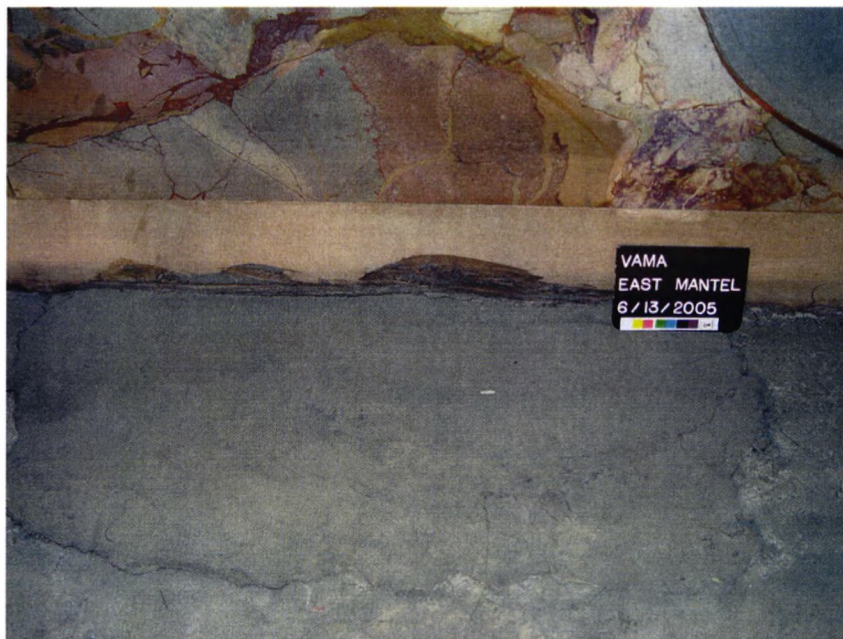
On the northeast side of the dining room of the Vanderbilt Mansion is a marble and plaster fireplace mantel (Figure 1). The Historic Resource Study Draft states that the mantel was acquired by Stanford White of the architecture firm McKim, Mead and White, NYC (Albee, Peggy A., Molly Berger, Elliot Foulds, Nina Gray, and Pamela Herrick. *Historic Resource Study for Vanderbilt Mansion National Historic Site*. DRAFT. Boston, MA: U.S. Department of the Interior, National Park Service, Northeast Museum Services Division, 2000). He purchased the mantel from either Bardini in Florence or Heilbronner in Paris (HRS Draft, Ch. 3, p. 17). The mantel consists of two top panels of brecciated grey and red/orange marble. These panels have a central grey marble shield flanked by two plaster medallions; a figure of a crab representing the astrological symbol of Cancer on the proper right, and a ram representing the astrological symbol of Aries on the proper left. On the vertical plane, where the mantel extends from the wall above the frieze panels, is a relatively shallow layer of roughly applied plaster over metal mesh (Figure 2).

**Figure 2. The top of the fascia and frieze panel consists of plaster/cement over metal mesh.**

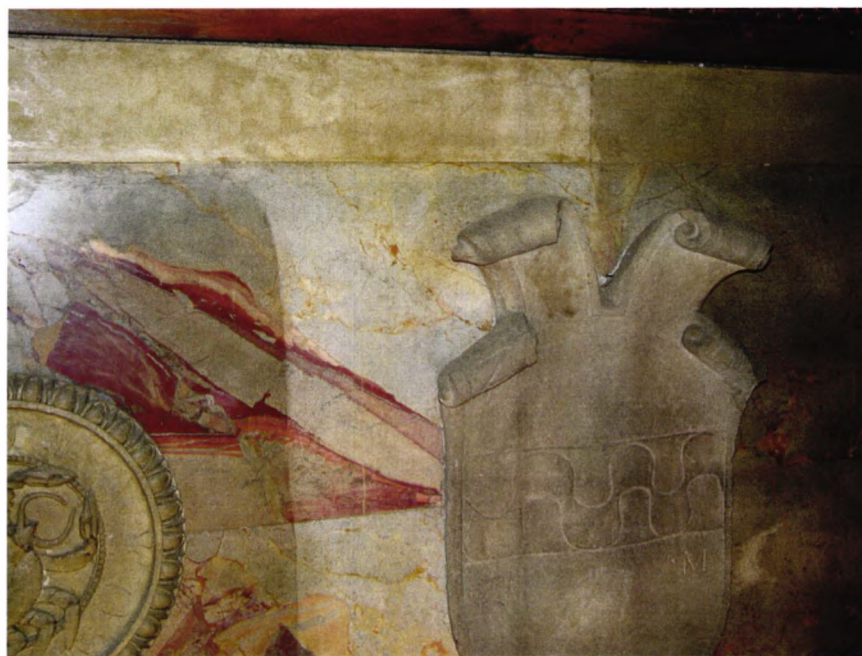
**Top Panel:** This area has the heaviest soot accumulation of the entire mantel piece (Figure 5). The plaster medallions have a light brown coating that fluoresces a light green/blue color under ultraviolet light, possibly indicating hide glue. These have suffered surface losses to the toned coating from soot

**Figure 5. Detail of soot on top panel partially cleaned.**

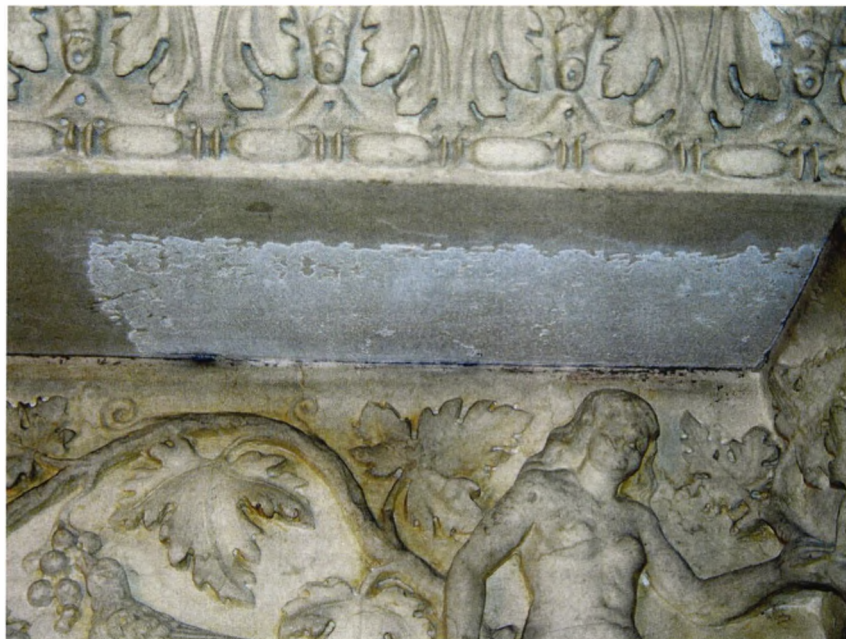
**Fireplace Surround:** The proper left side of the surround has heavy, oily soot accumulation while the proper right side has somewhat less. There are two areas of regularly shaped, rectangular patches of white, powdery accretions on the underside of the mantelpiece (Figure 11). It is unclear if these are due to previous testing or are natural carbonate accretions from the marble.

**Figure 11. White, powdery accretion on the underside of the mantelpiece.**

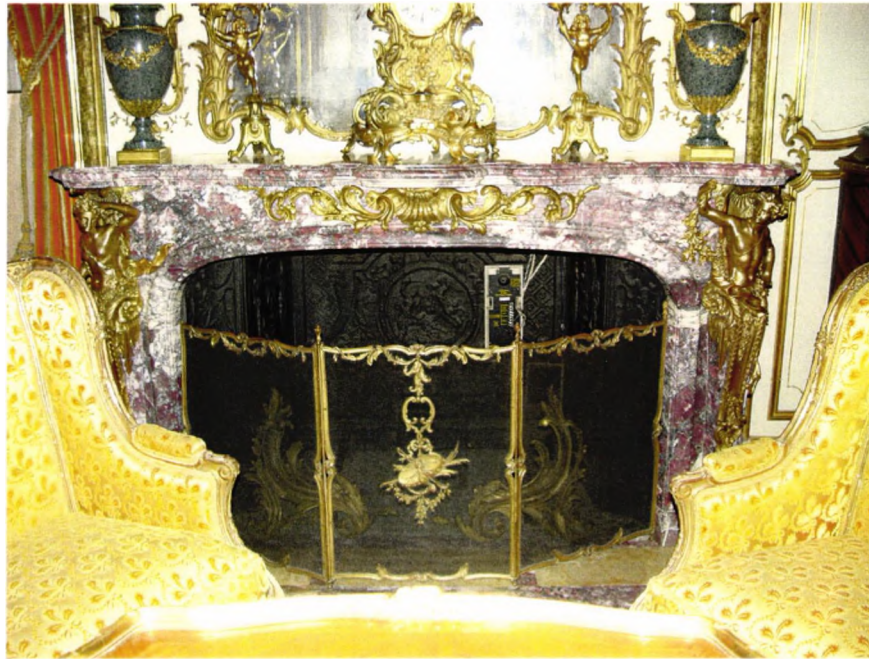
**The fireplace mantel before treatment.**

- The fireplace mantel was cleaned by wiping with cotton pads slightly dampened with spring water. Care was taken to avoid the bronze elements of the mantel.

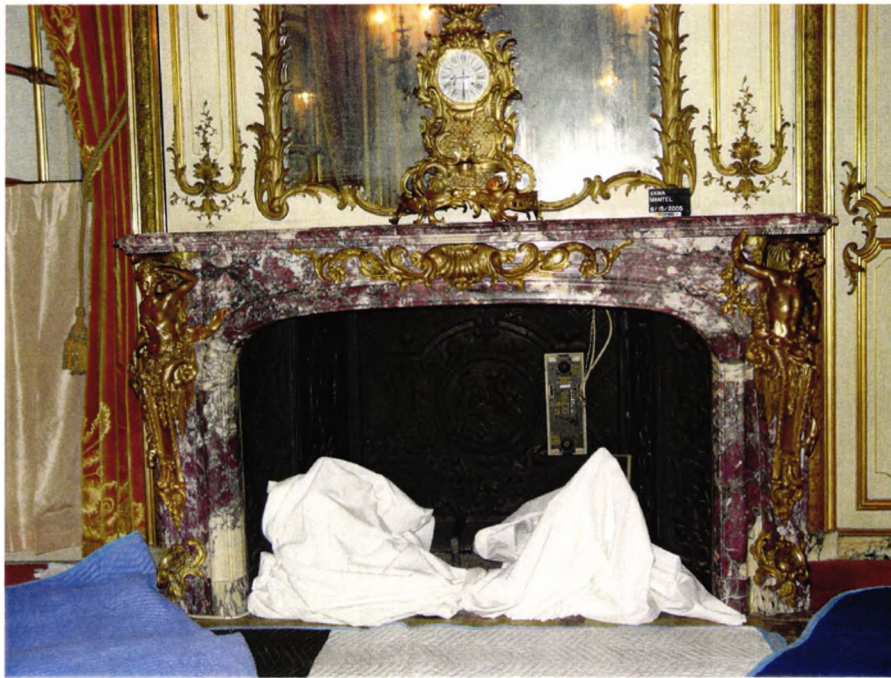
**The fireplace mantel after treatment.**

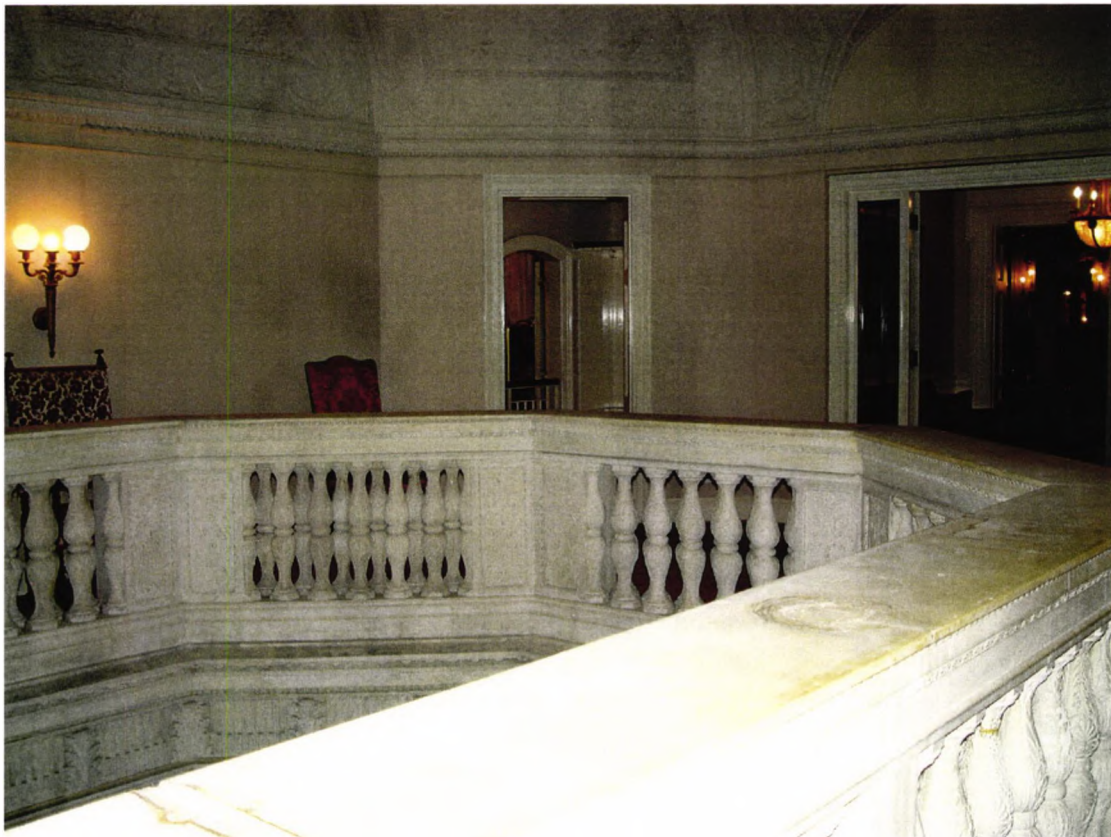
**The balustrade after treatment.**

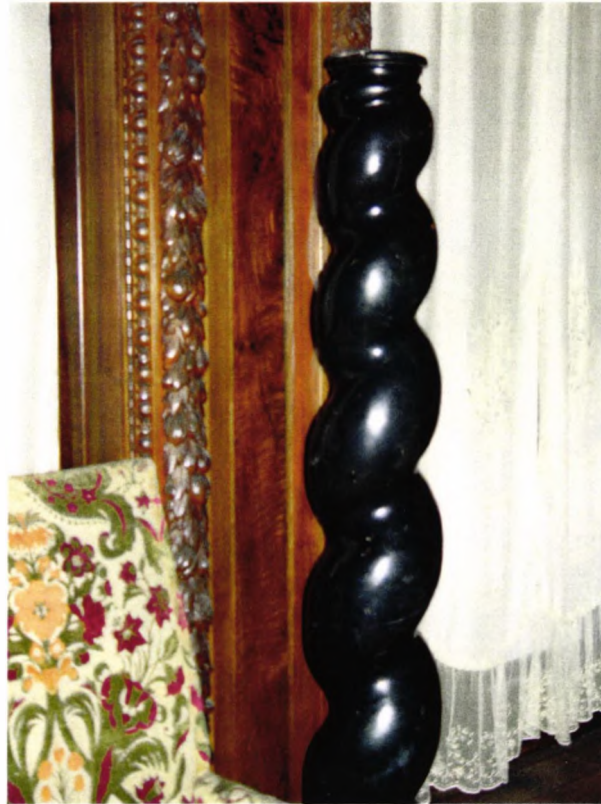
**Before treatment: the column without the capital.**

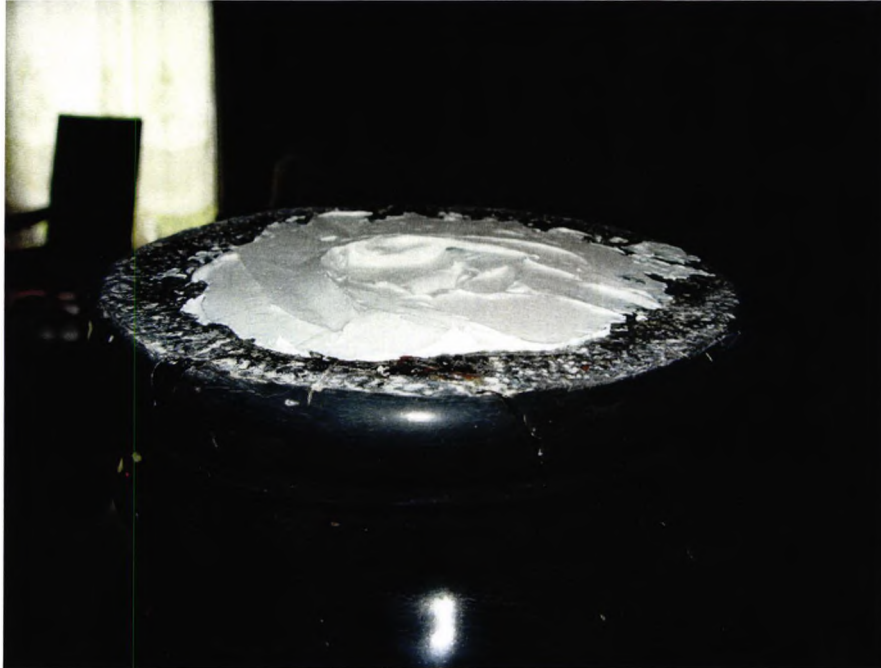
**Pre-mixed tile grout applied to surface and filling hole of column.**
