# Whiskeytown Visitor Center VOLUME 1

HISTORIC STRUCTURE REPORT | AUGUST 2022

Siegel & Strain Architects  
architecture + history, llc

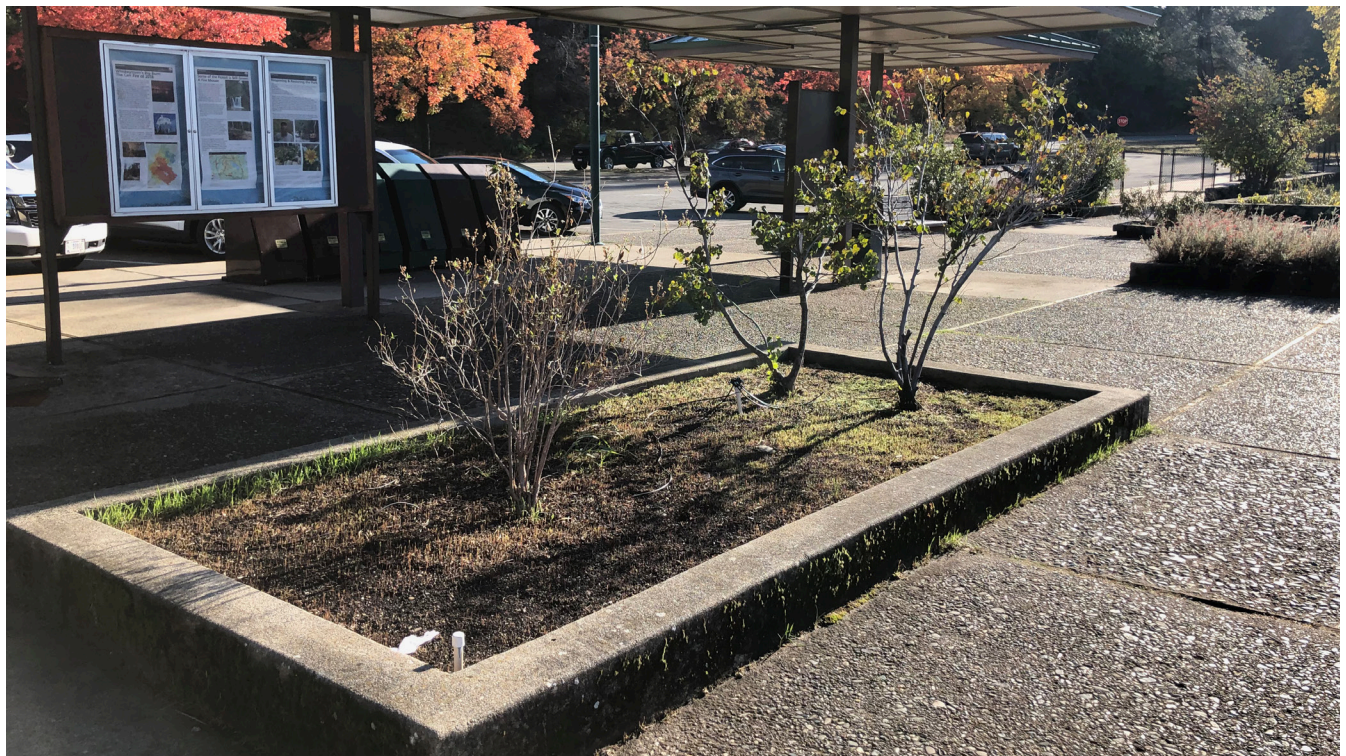
Figure 11  
The aggregate paving panels and planters at the promenade, looking southwest.

A wood sign for Whiskeytown Lake, several NPS interpretive panels, and a telescope stand along the retaining wall (Figure 9). A free-standing c.2005 solar panel array is located northwest of the Visitor Center (Figure 10). The promenade is approximately 64' wide at the north end, but progressively steps in until it measures 16' at the south end. The promenade features 8' x 8' aggregate concrete paving squares separated by 2x4 redwood dividers creating a checkerboard-like pattern interspersed with planting beds (Figure 11).

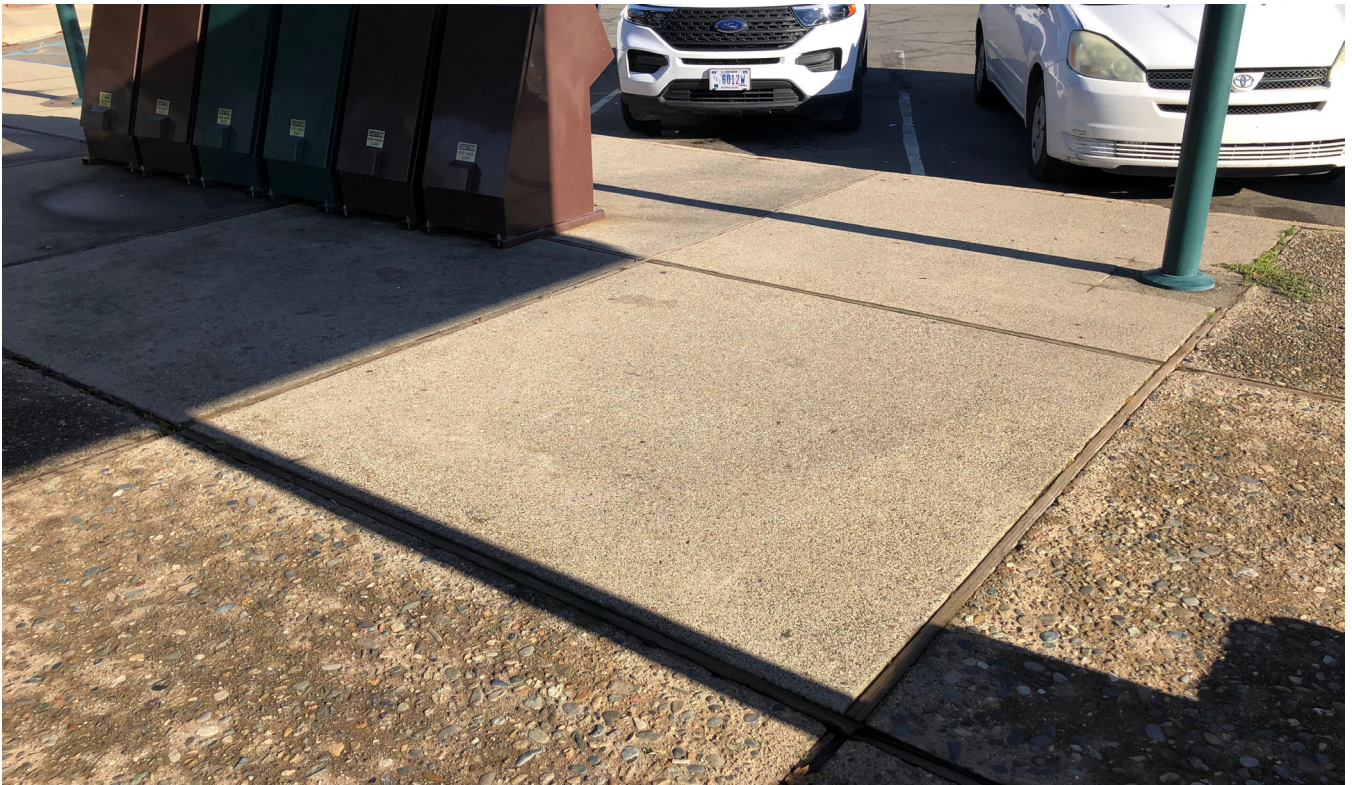
Figure 12  
Example of the replacement paving at the promenade which does have the same aggregate quality as the original.

Some areas of the original checkerboard pavers have been replaced with poured, smooth concrete paving in 1998 (Figure 12). The south end paving was replaced with integrally-colored, smooth concrete in 2014 (Figure 13).

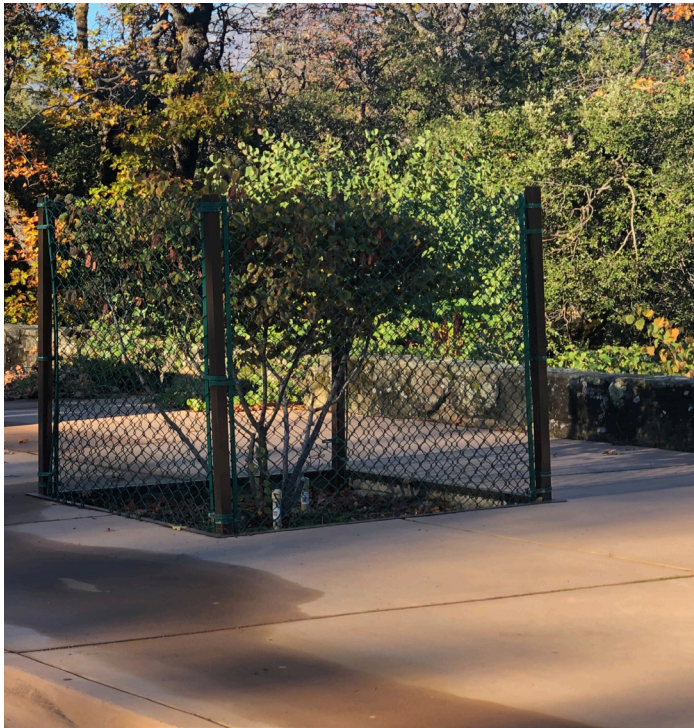
Figure 18  
Recently planted trees with fences and the newer integrally-colored concrete at the south end of the promenade, looking south.

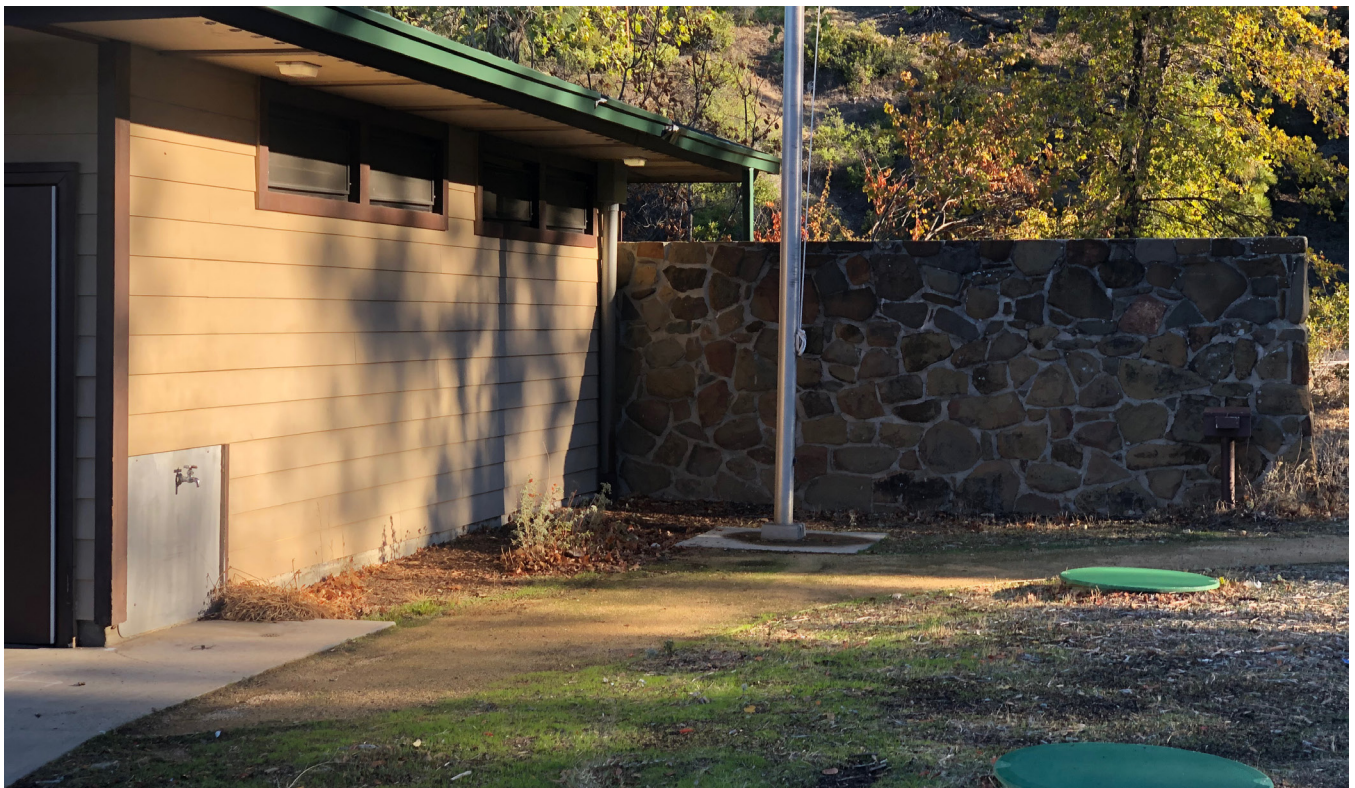
Figure 39  
East façade of the Comfort Station, looking north.

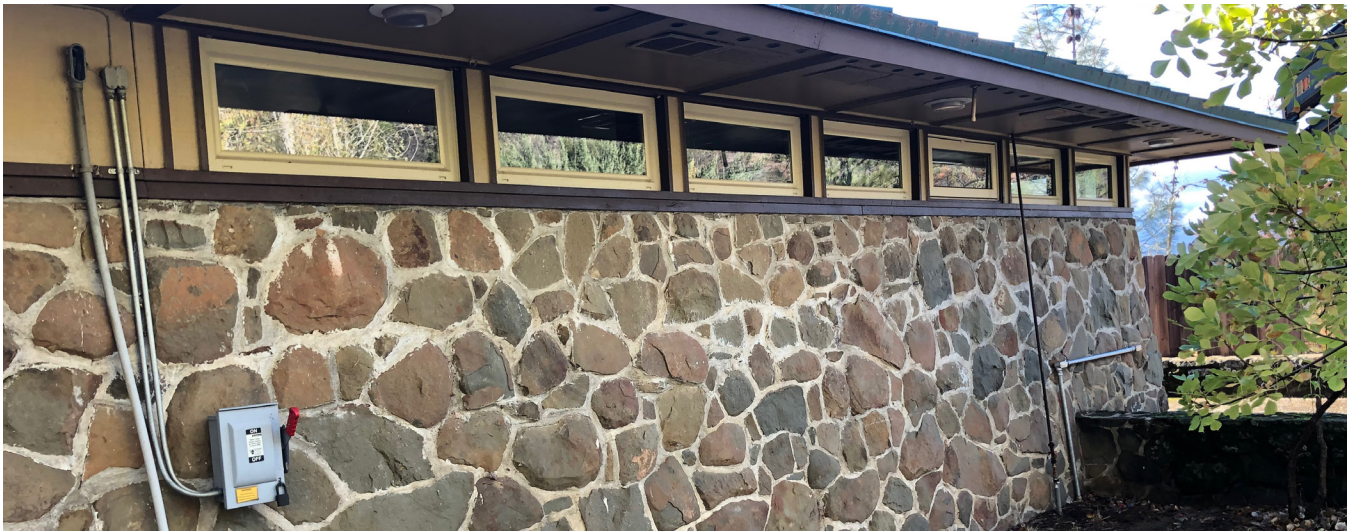
Figure 40  
North façade ribbon of clerestory windows above the solid masonry wall, looking west. There are some surface mounted conduits and utility boxes at this wall.

The north façade features a slightly battered, mortared rubble masonry wall and a ribbon of operable, hopper style clerestory windows (Figure 40). In its original configuration, the masonry wall continued 27' beyond the Visitor Center to form a 6'-10" high masonry site wall (Figure 41). In 1984, the wall extension was incorporated into the Comfort Station Addition and further extended to continue beyond the Comfort Station (Figure 42). The ribbon of clerestory windows brings natural light into both the Visitor Center and Comfort Station interiors. At the Visitor Center, the clerestory windows are continuous (Figure 43). At the Comfort Station, the windows correspond to the interior spaces with simple wood wall finish between them. (Figure 44).

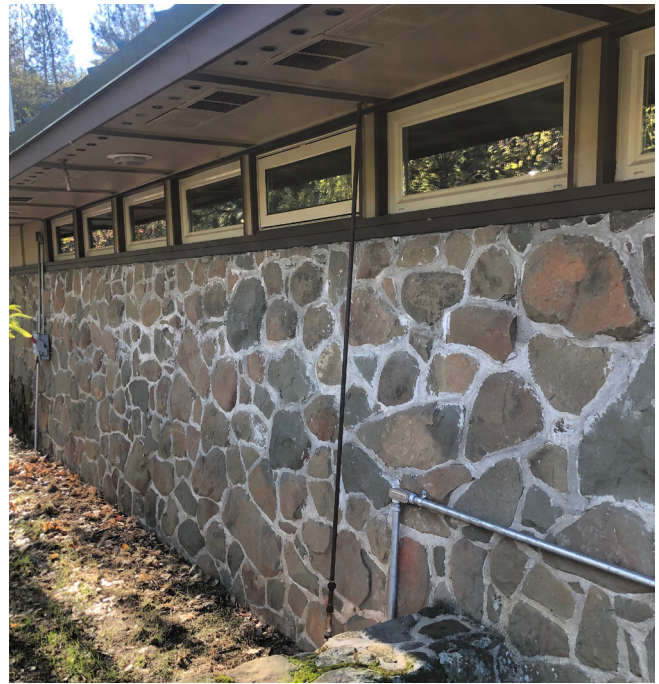
**Figure 43**  
The ribbon of clerestory windows at the north façade of the original Visitor Center, looking southeast.

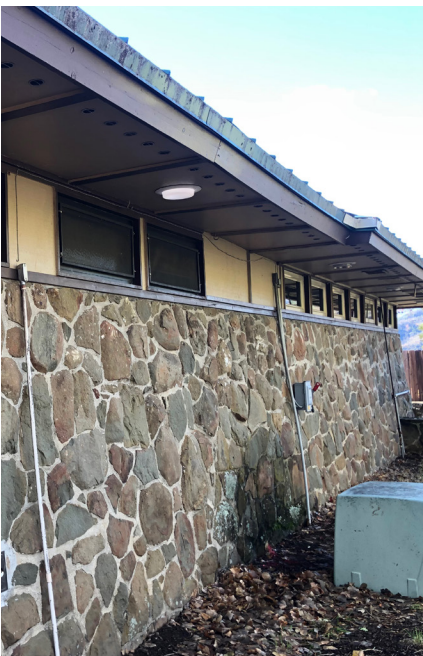
**Figure 44**  
North facade of Comfort Station addition showing clerestory windows with wood wall panels between and with screens. There are no screens in the clerestory windows in the original Visitor Center, looking west.

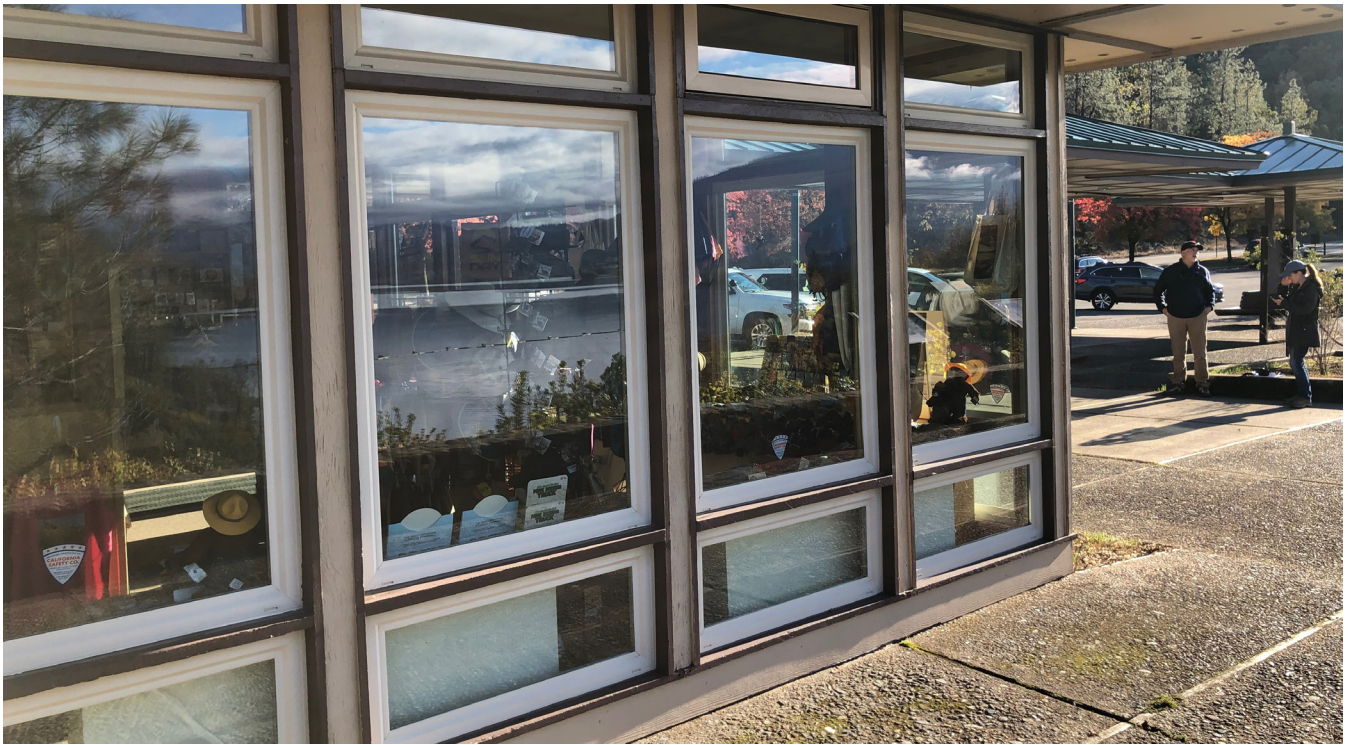
Figure 45  
South end of the west façade, showing glazed window wall. The central two bays originally included two entry doors with a post between.

The west façade of the Visitor Center faces Whiskeytown Lake. At the south end there are four tall fixed pane, wood framed picture windows with operable hopper style windows above and below (Figure 45). The original 1965 design included a pair of entry doors centered within these four bays, but these doors are no longer extant – or it is not known when they were removed, except it appears to have been before 1984 (Figure 46). The original design, which included a pair of entry doors at both the west and south façades, allowed visitor circulation to flow through the Visitor Center from the primary entry at the south façade to a separate exit at the west façade.

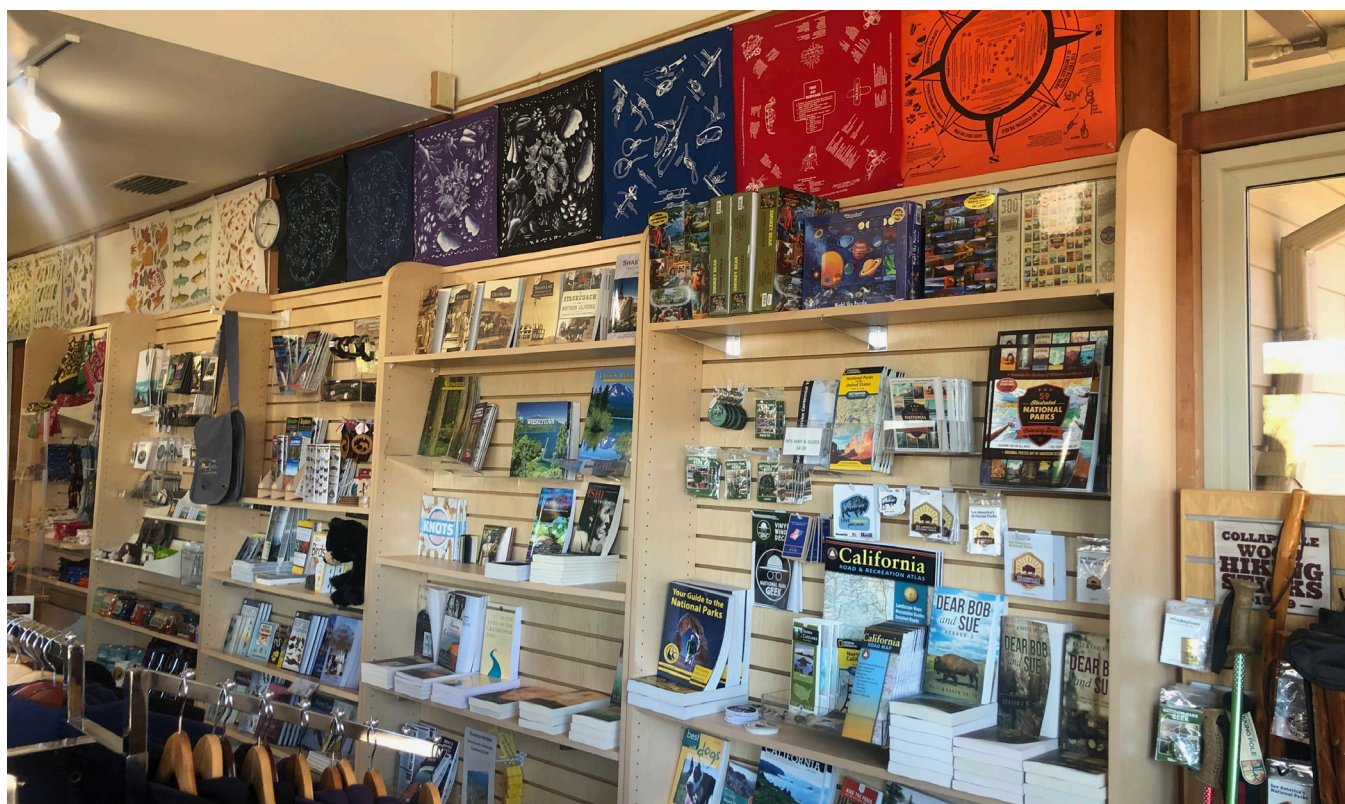
Figure 61  
The original clerestory windows may exist behind the wall board paneling at the east wall.

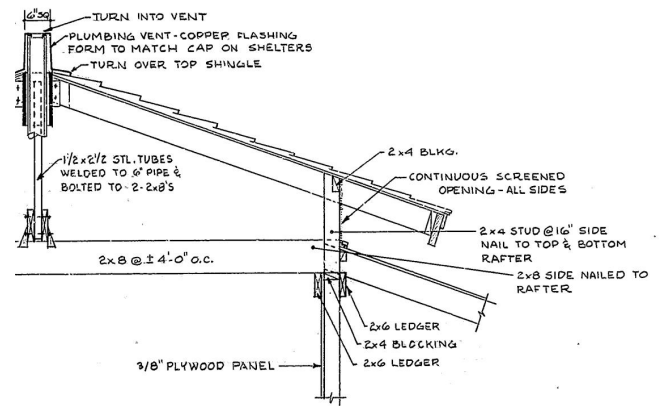
Figure 18  
The 1965 As Constructed Drawings of the Visitor Center detail the vented portion of attic between the lower and upper hipped roof structures. Source: NPS eTIC Drawing #RA-WHI 3018 E. Sheet 8 of 13.

- A downspout, at the south façade of the 1984 Comfort Station, outpours directly onto pavement.
- Organic debris buildup accumulates at valley areas of the roof (Figure 17).
- The area of exposed wall at the attic between the lower and upper pyramidal hipped roofs of the original Comfort Station employs metal screening on all four sides to provide natural ventilation (Figure 18). The screening is in poor condition.

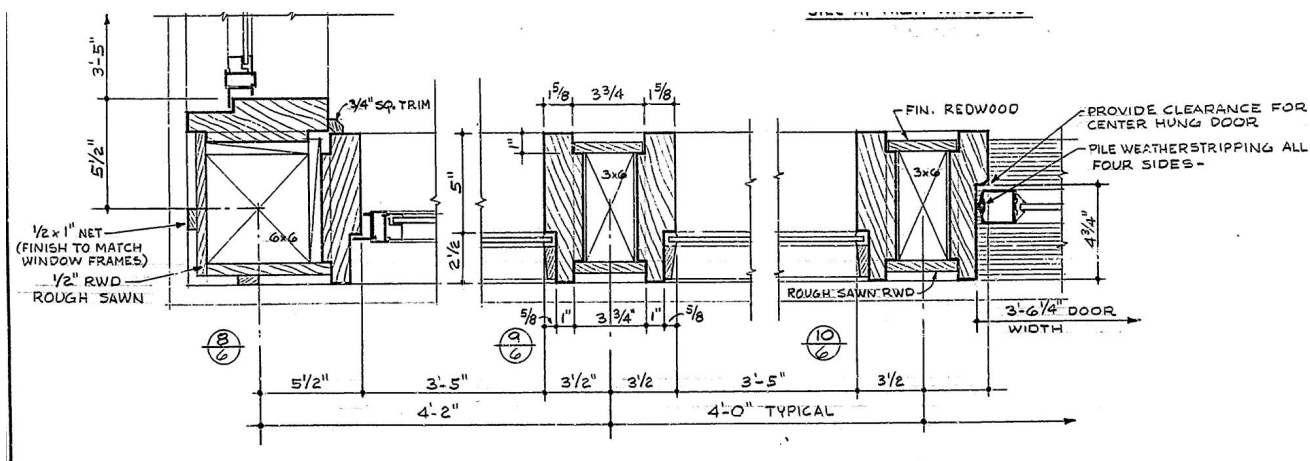
Figure 22

- The original expansive window walls (comprised a central, fixed pane, wood framed picture window with inward-projecting, medium-bronze anodized aluminum, single-pane, hopper windows above and below, as well as the Kawneer medium bronze, anodized aluminum hopper clerestory windows above the rubble wall, were replaced with light tan vinyl windows in 2009. The replacement vinyl windows at the south and west façades receive harsh sunlight and show some signs of deterioration, but these replacement windows are generally in good condition.
- Some redwood mullions and trim elements are deteriorated showing cracked and missing paint coatings (Figures 22 and 23). The redwood mullions and trim were not originally painted, but stained.

Structural posts within the window walls are framed out with redwood mullions and trim, as shown in this detail from the As Constructed Visitor Center drawings. Source: NPS eTIC Drawing #RA-WHI 3018 E. Sheet 6 of 13.
