# President William Jefferson Clinton Birthplace Home

## Cultural Landscape Report

## **Cultural Landscape Report Environmental Assessment**

April 2014

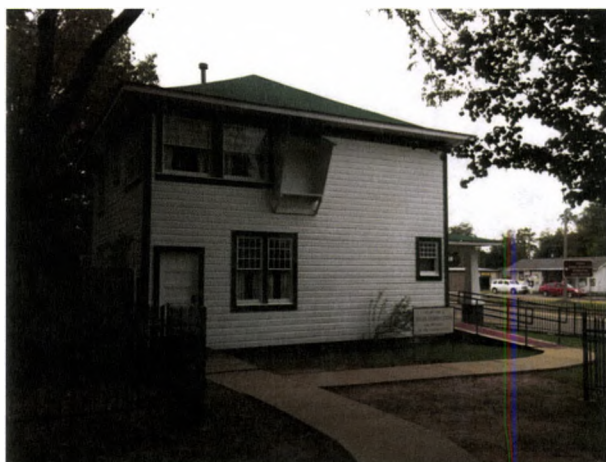
**FIGURE 65.** Looking south, at the north wall and north side yard of the Cassidy House viewed from the memorial garden area. Note bare earth to the right of the concrete walk. Photograph by Oculus, October 16, 2012.

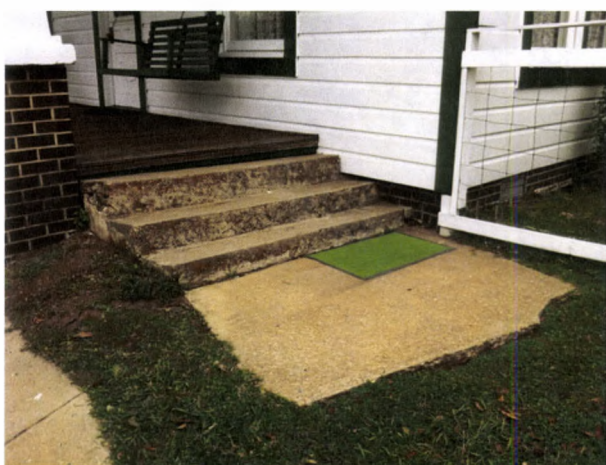
**FIGURE 66.** View northeast of the south end of the Cassidy House porch with concrete steps and pad. The white-painted wood and boxwire fence is intended to simulate the fence visible in historic photographs. Photograph by Oculus, October 16, 2012.

**Concrete Steps at South End of Front Porch.** These steps show evidence of decay, multiple repairs, and biological growth (refer to Figure 66). The lengthwise slope of these steps differs from the porch surface. The concrete

surface is spalling, there are numerous cracks, and the treads are uneven. Consequently, the condition of these steps is poor.

**Concrete Pad below Steps at South End of Front Porch.** One corner of the pad is chipped (refer to Figure 66). Given that the slab is undermined with an uneven surface and spalling is evident, the condition is fair.

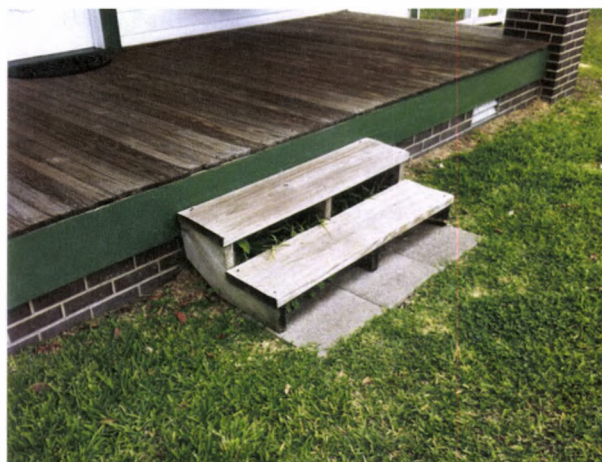
**FIGURE 67.** Looking toward the southeast, at the wooden steps at the front of the Cassidy House porch. Photograph by Oculus, October 16, 2012.

**Wood Steps at Front Porch.** These steps are constructed of wood with a concrete masonry unit pad foundation (refer to Figure 67). The steps rock in place and lack handrails; therefore, the condition of these steps is fair.

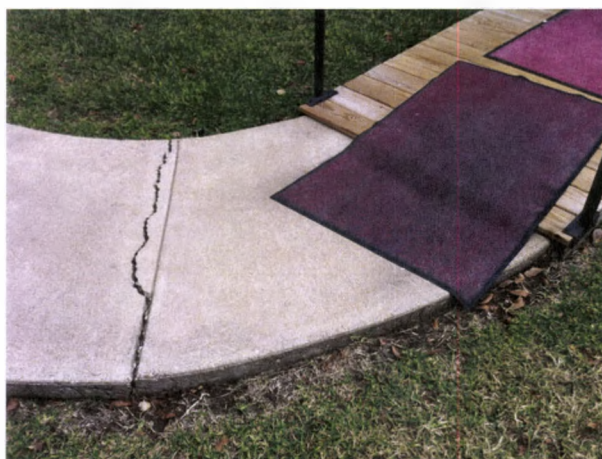
**Concrete Walkways.** The concrete walks are broom-finished and four feet wide. Cracking, subsidence, and unevenness of abutting surfaces were observed (Figure 68 and Figure 69). The lowered soil surface conditions along the walks present trip and falling hazards. Adjacent to the walkway are several bare patches, areas of erosion, and remnants of asphalt paving (Figure 70). The condition of the walkways is fair.

**FIGURE 68.** View southeast of the concrete walk as it approaches the wood ramp to the Cassidy House front porch. The walk is slightly raised and exhibits cracking. Photograph by Oculus, October 16, 2012.

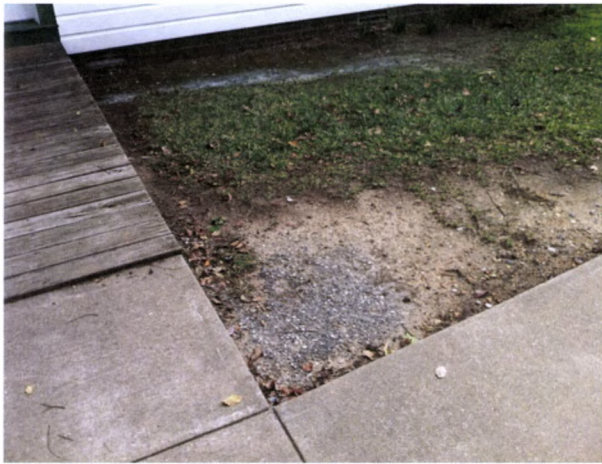
**FIGURE 70.** Looking south toward the Cassidy House the concrete walk provides access to a ramp leading to the side door. Photograph by Oculus, October 16, 2012.

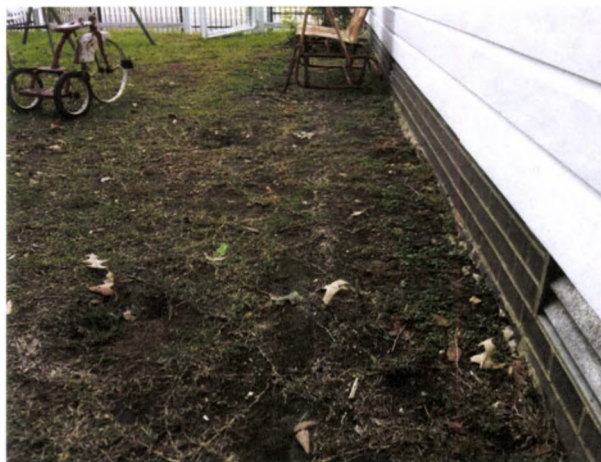
There is very little change in elevation at the building site. The yard areas are nearly level and tend to drain poorly. Eroded areas and bare patches within lawn areas indicate possible poor drainage (Figure 73). Immediately north of West Division Street, South Hervey Street passes under a railroad that lies slightly above the elevation of the national historic site. The South Hervey Street grade change required to facilitate access under the railroad bridge begins roughly at the south edge of the national historic site property. A concrete retaining wall runs parallel to the west wall of the Cassidy House, approximately ten feet from the front porch. The slope of South Hervey Street results in a drop in grade from the front yard at the porch to the sidewalk and street below (Figure 74). The Cassidy House area lies at approximately the same elevation as the remainder of the national historic site but sits several feet above South Hervey Street. Owing to drainage problems at the building line the condition of the grade of the yards is fair. The grades associated with the retaining wall are fair owing to drainage problems causing soil erosion and undermining of the concrete drainage flumes.

**FIGURE 73.** Looking west at the ground surface of the south play yard adjacent to the south wall of the Cassidy House. Note bare soil patches and moss indicating poor drainage. Photograph by Oculus, October 16, 2012.

**Lawn Areas.** The grass lawn areas exhibit bare patches and erosion in places (refer to Figure 73). The lawn is generally in good condition, but the areas of poor drainage near the building foundation and more densely shaded areas at the rear of the house are in poor condition.

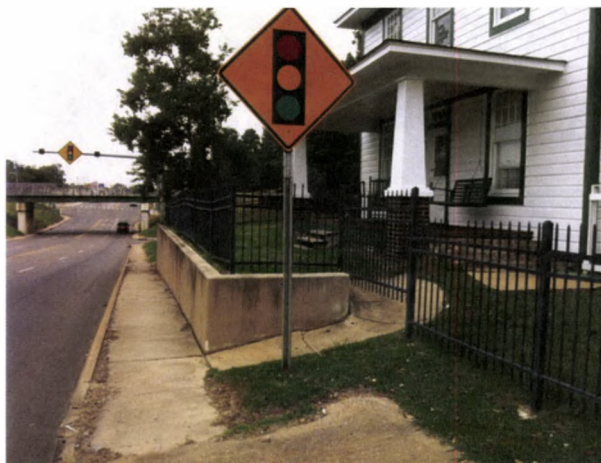
**FIGURE 74.** Looking north along South Hervey Street. Photograph by Oculus, October 16, 2012.

**South Concrete Drainage Flume.** The flume (refer to Figure 74) directs water from the front yard to the street/sidewalk. It is located at the south end of the concrete retaining wall. The condition of this feature is fair owing to cracking and settlement. Portions of the flume may be located outside of the national historic site boundary.

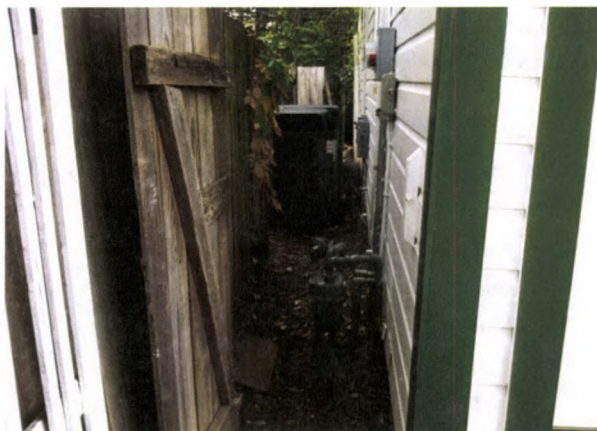
**FIGURE 86.** Looking south, the rear yard is a narrow space between the east wall of the Cassidy House and the west boundary of the Vincent Foster property. This area contains utilities and HVAC equipment. Photograph by Oculus, October 16, 2012.

**Wood Gate to Rear Yard.** This wood board gate is approximately 6 feet tall and screens and provides access to the rear utility yard (refer to Figure 86). It is connected to the wood board fence associated with the adjoining Vincent Foster House property and to the northeast corner of the Cassidy House. Planks are 1x6 boards. The condition of the gate is fair owing to the gate not swinging properly and being out of plumb.

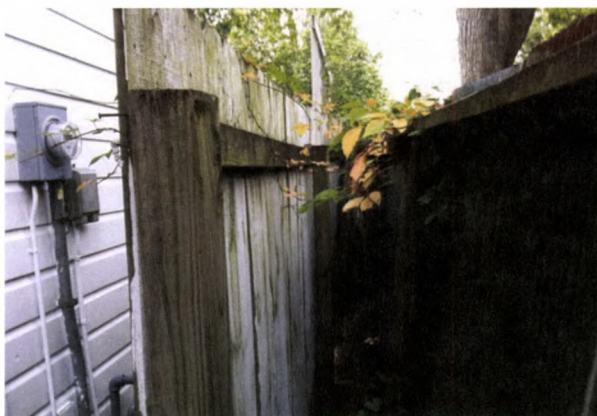
**FIGURE 87.** The space between the Cassidy House and the Vincent Foster House property contains fences of several eras. The corrugated metal "tin roof" fence is noted on a 1996 survey. This view is toward the north. Photograph by Oculus, October 16, 2012.

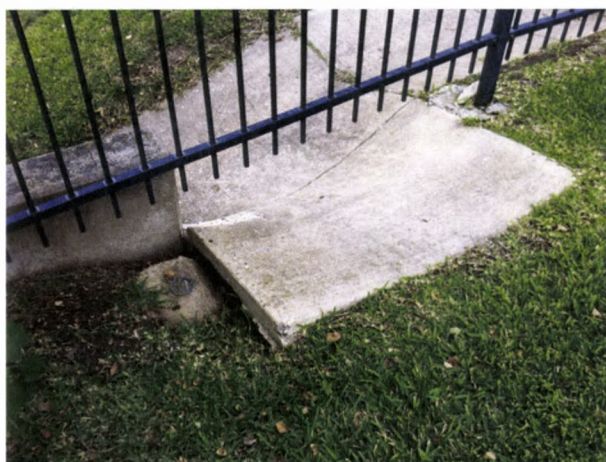
**FIGURE 98.** View northeast of the top of a concrete flume in the corner of the Cassidy House front yard. Note the remnant concrete base that once supported a metal pipe guardrail adjacent to the back of the concrete retaining wall. Also, note the flume is undermined. Photograph by Oculus, October 16, 2012.

**Remnant Concrete Chain Link Fence Post Bases.** Concrete bases and embedded pipes run along the top of the concrete retaining wall (refer to Figure 98). At some point in the past a metal pipe guardrail or chain link and metal post fence was located at the top of the retaining wall, likely for fall protection. This fencing was removed at the time the Cassidy House was restored by the Clinton Birthplace Foundation. As remnant features they are in poor condition.

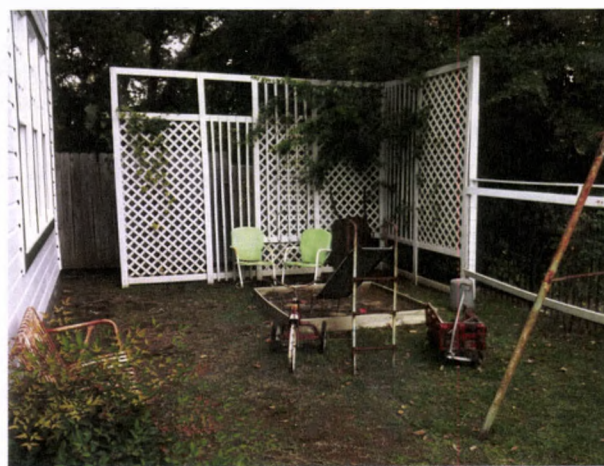
**FIGURE 100.** Play equipment, fence, and lattice screen viewed from inside the play yard looking east. Photograph by Oculus, October 16, 2012.

White-painted 4x4 wood posts support a combination of diagonal 4-inch-on-center lattice and vertical strips. The lattice functions to screen the play yard from the deteriorated wood fence associated with the Vincent Foster House property beyond. This screen is in poor condition owing to failed supports and fasteners (refer to Figure 100).

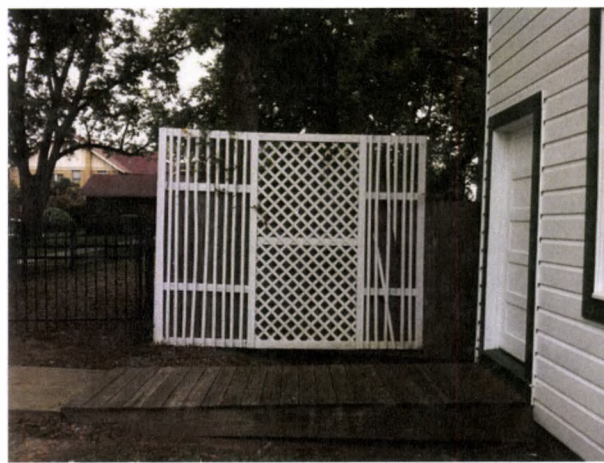
**FIGURE 101.** Looking east along the north wall of the Cassidy House. The lattice structure is attached to a wood board fence that edges the Vincent Foster House property. The comfort station is visible in the background. Photograph by Oculus, October 16, 2012.

**North Side Yard Wood Lattice Screen.** There is a second lattice screen at the rear of the north side yard (refer to Figure 101). It is similarly constructed to the first and is about 62 inches in height. It serves a similar purpose to the lattice located at the rear of the play yard. This screen is in poor condition owing to failed supports and fasteners (refer to Figure 100).

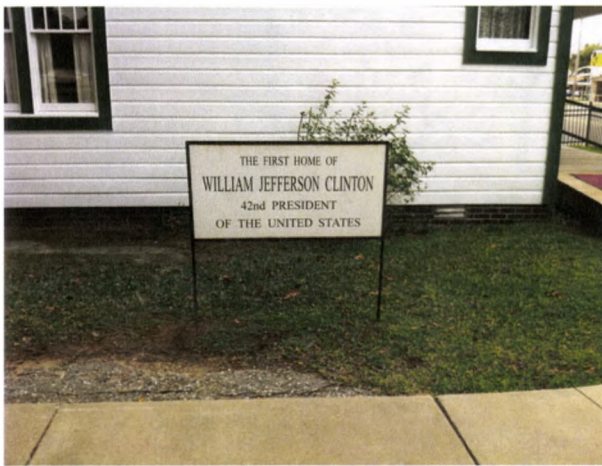
**FIGURE 107.** View south of a metal sign near the north wall of the Cassidy House. Photograph by Oculus, October 16, 2012.

**Sign.** Facing the concrete walk that functions as the main public entryway to the Cassidy House is a sign reading “THE FIRST HOME OF WILLIAM JEFFERSON CLINTON 42ND PRESIDENT OF THE UNITED STATES.” The sign is in good condition (refer to Figure 107).

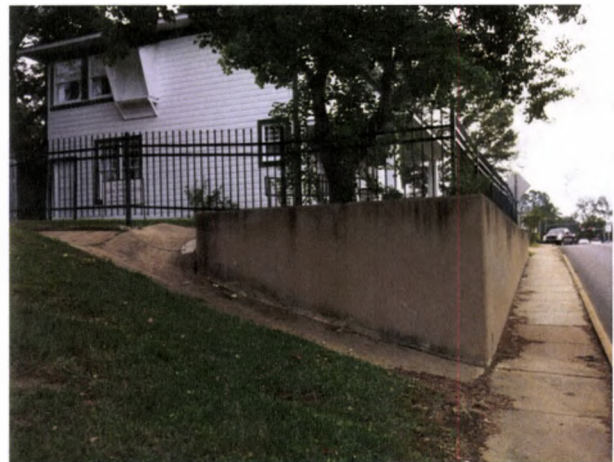
**North Concrete Drainage Flume.** Located at the north end of the concrete retaining wall is a second flume (Figure 108 and Figure 109) also directing water from the front yard and former alley to the street/sidewalk. The condition of this feature is fair owing to crack and settlement. Portions of the flume may be located outside of the national historic site boundary.

**FIGURE 108.** View south, of the north concrete drainage flume. Photograph by Oculus, October 16, 2012.

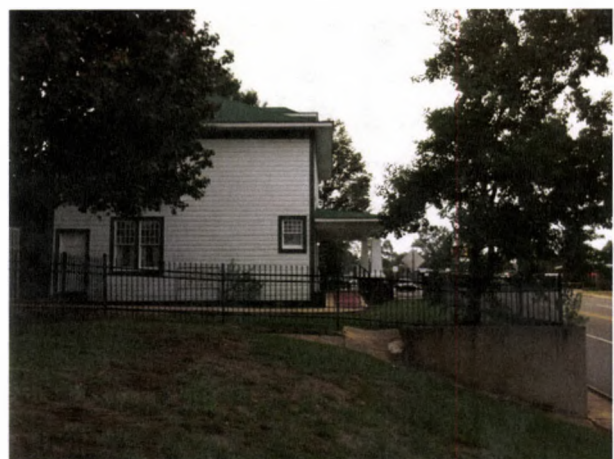
**FIGURE 109.** View from the slope just outside the memorial garden looking south. The north concrete drainage flume runs along the retaining wall. Photograph by Oculus, October 16, 2012.

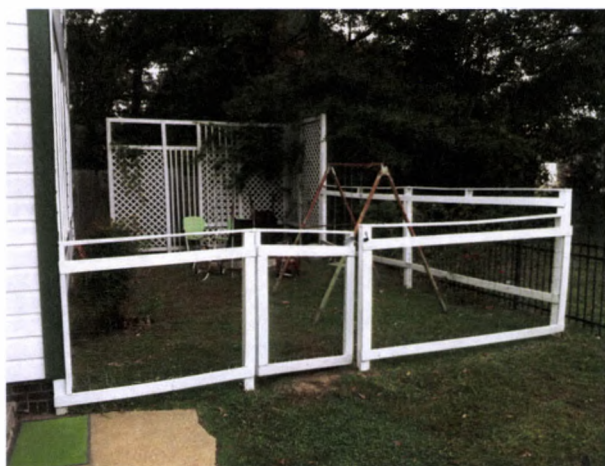
**Painted-Wood and Boxwire Fence.** The fence surrounding the play yard is made of white painted wood and boxwire mesh (Figure 110). Lumber is a combination of 1x- and 2x- stock. Wire mesh spacing is approximately 6 inches by 6 inches at the top rail with vertical spacing decreasing toward the bottom rail. The height is approximately 50 inches. Set into the play yard fence and similarly constructed, this gate is 40 inches wide and 50 inches in height. It is malfunctioning, and the frame is sagging. The condition of the fencing is fair owing to the poor construction and nearly inoperable gate.

**FIGURE 110.** View of the fence surrounding the play yard looking southeast. Photograph by Oculus, October 16, 2012.

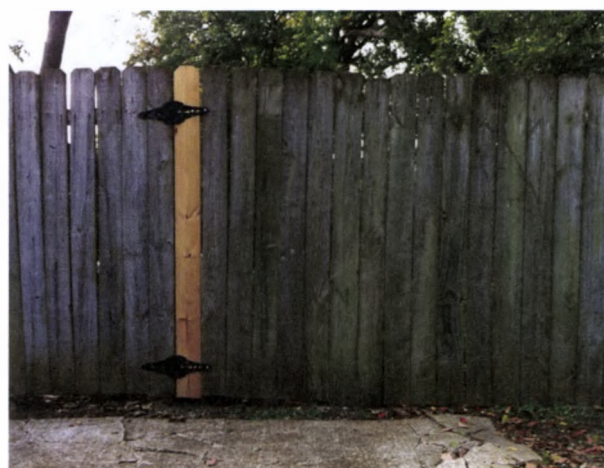
**Wood Board Screen Fence.** This fence runs around the rear and side yards of the Vincent Foster House property (Figure 111). Boards are set vertically with approximately 3/8-inch spaces between boards. Each board is a nominal 1x6, 72 inches in height, with chamfered tops. Some boards are weathered; a few appear to be recently installed. The condition of the fence is generally good. The fencing runs along the Vincent Foster House property line at the rear of the Cassidy House. NPS staff could not verify ownership of the fencing at the time of fieldwork.

**FIGURE 111.** View of the fence that runs around the rear and side of the Vincent Foster Property. Photograph by Oculus, October 16, 2012.

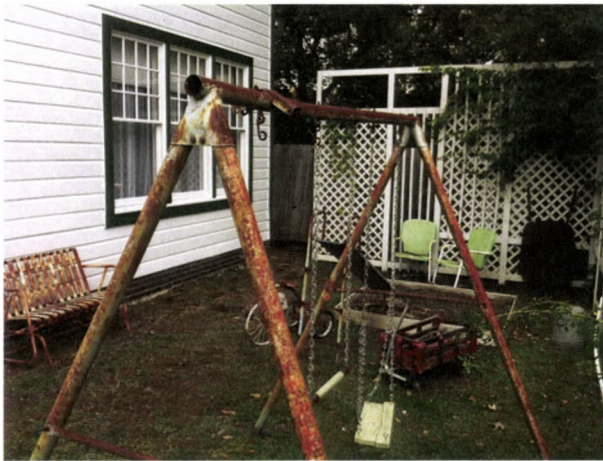
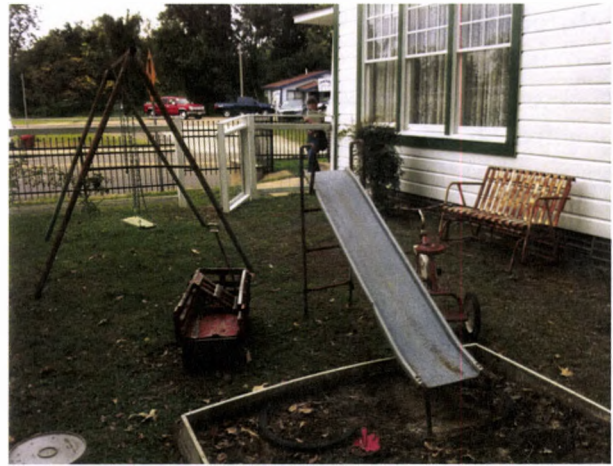
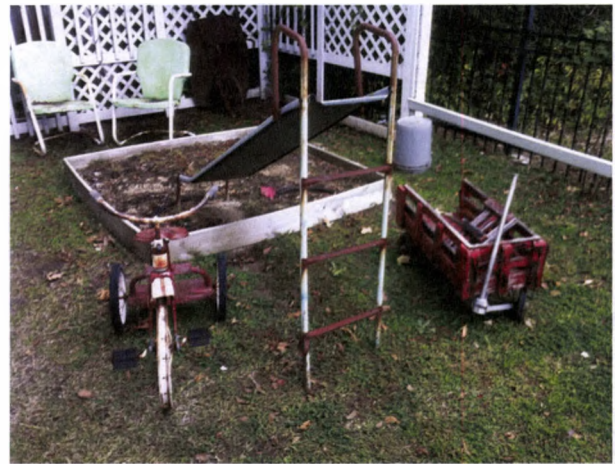
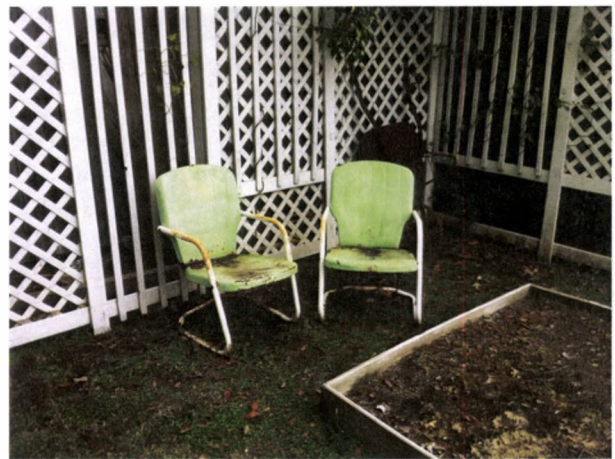
**Site Furnishings.** Several items that support interpretation are located within the play yard including a swing set fabricated of metal pipe or tube, a metal play slide, a sandbox, a metal glider, painted metal chairs, a metal toy wagon, a metal wheelbarrow, and a metal tricycle (Figure 112 through Figure 115, and refer to Figure 104 through Figure 106). All of these features date to the mid-twentieth century and are in fair to poor condition owing to their age and exposure to weather.

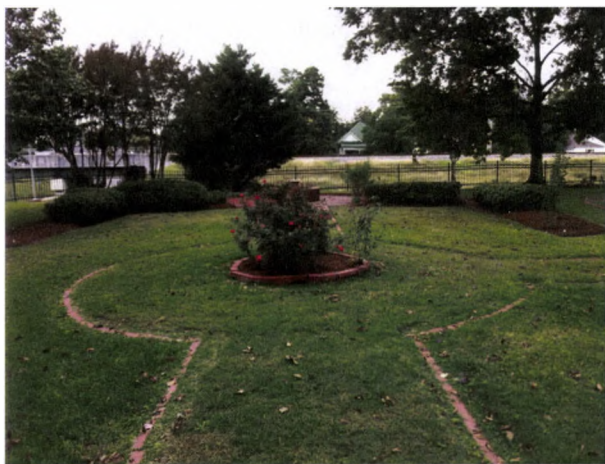
**FIGURE 116.** View of the north portion of the memorial garden looking north. The railroad is visible in the background. Photograph by Oculus, October 16, 2012.

**Central Axial Path.** This path is defined by a border of wire-cut red bricks set flush with the ground (refer to Figure 116). The surface of the path is crushed stone. The paved area and edging are in poor condition owing to extensive coverage of grass and weeds. The brick edging appears to be installed improperly resulting in an uneven appearance.

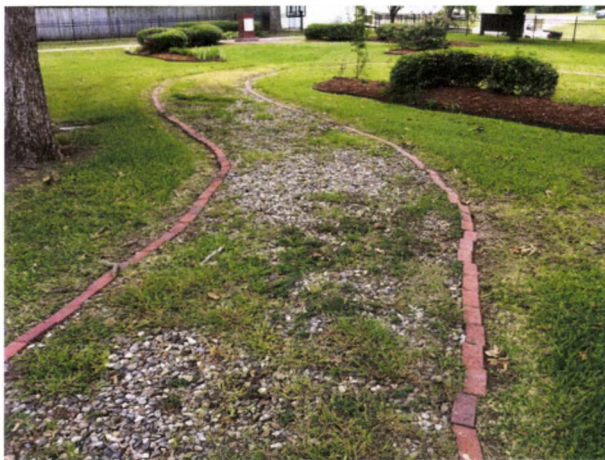
**FIGURE 117.** View southwest, along the path leading from the visitor center to the center of the memorial garden. Photograph by Oculus, October 16, 2012.

**Secondary Path (to visitor center).** The secondary path emerges orthogonally from the memorial garden. The path has a crushed stone surface and is edged with wire-cut bricks measuring 7-5/8 by 3-5/8 by 2-1/4 inches (Figure 126 and refer to Figure 117). The paved path and edging are in poor condition owing to extensive coverage of grass and weeds. The brick edging appears to be installed improperly resulting in an uneven appearance.

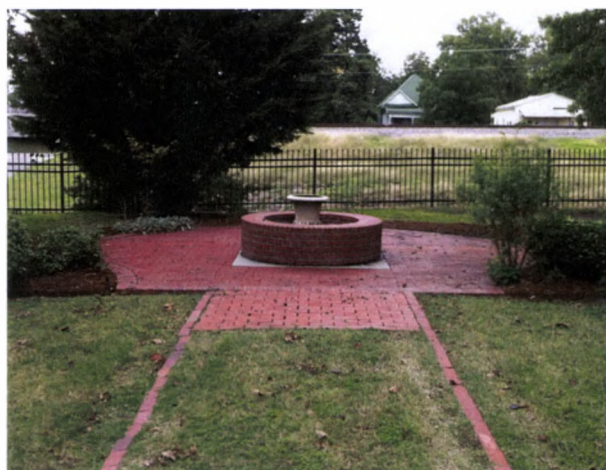
**North Brick Terrace.** This terrace is semi-circular in shape with quarter-circle “notches” at either end of the straight edge and a rectangular brick extension toward the south (Figure 119). The terrace and its extension, which coincides with the central axial path, are composed of three types of paving brick. All are red in color. Two types of dry-laid molded brick each with beveled edges are embossed with names of donors. Lettering in both cases is sans-serif with one typeface of all capital letters and the other with only the first letters of names capitalized. Notable names include Roger Clinton and Vincent Foster (Figure 120 and Figure 121). Separating the two types and forming a border surrounding the terrace is a row of mortared, wire-cut bricks (Figure 122). There is a concrete pad within this terrace on which is installed a circular brick structure (Figure 123). A semi-circular portion of the terrace to the north of the concrete pad is surfaced with dry-laid wire-cut bricks (Figure 124). The brick terrace is in fair condition owing to lippage (an offset in level between adjacent pavers), settlement, and poor drainage.

**FIGURE 119.** Looking north toward the north brick terrace. Photograph by Oculus, October 16, 2012.

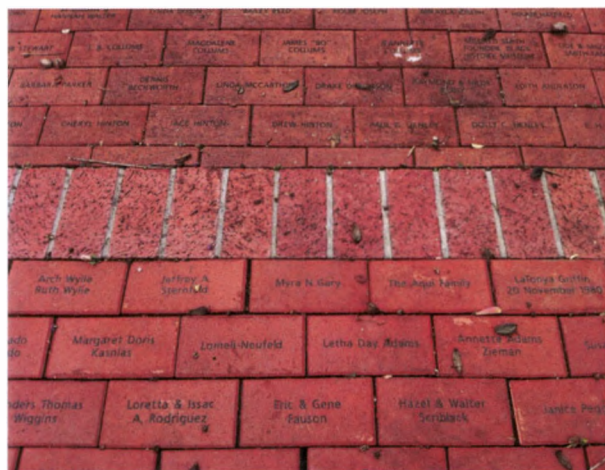
**FIGURE 122.** Detail of the north brick terrace, showing different types of brick. This view is facing north. Photograph by Oculus, October 16, 2012.

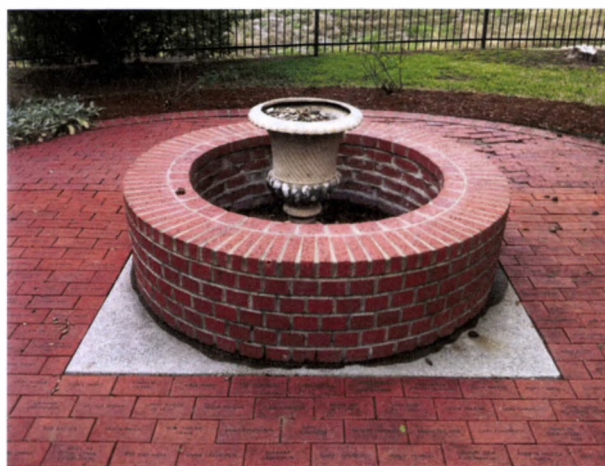
**FIGURE 123.** The circular brick structure with glass-fiber reinforced concrete (GFRC) vase looking north. Photograph by Oculus, October 16, 2012.

**Brick Planter Structure.** This structure installed on a square concrete pad set within the brick surface of the north terrace is a 69-inch diameter, 17-inch tall circle of running bond brick placed with header side facing outward (refer to Figure 123). The interior is the same brick, applied with stretcher side facing outward with mortared joints (Figure 154). There is a cap of the same brick placed radially with soldier side facing upward. Inside sits a vase approximately 28 inches in height and 21 inches in diameter (Figure 155). A length of galvanized metal channel stock protrudes vertically from the floor inside the structure to which is attached an electrical receptacle (Figure 156 and refer to Figure 154). The brick structure is in good condition.

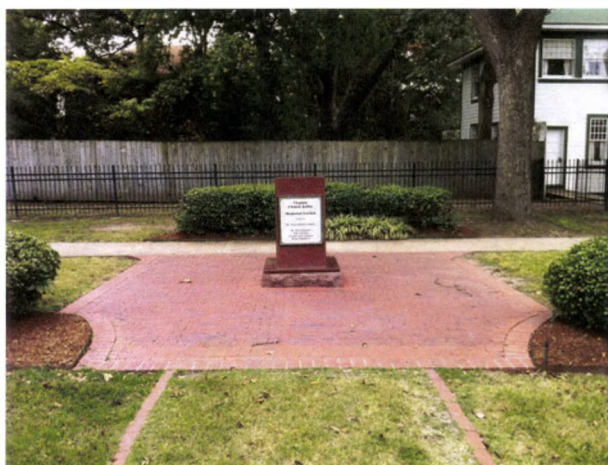
**South Brick Terrace.** The south terrace (Figure 125) is rectangular in shape, and has quarter circle “notches” symmetrical to the north terrace. Where the terrace abuts the concrete walkway there are two small brick triangles. This terrace is primarily composed of dry-laid red wire-cut bricks most of which have been embossed with the names of donors. Many of the bricks along the edges and in the vicinity of the granite monument are of a lighter red color. The brick terrace is in fair condition owing to settlement and poor drainage. In addition, bare ground adjacent to the terrace may indicate possible wear from foot traffic and/or poor drainage in these areas.

**FIGURE 125.** View of the south brick terrace looking south. Photograph by Oculus, October 16, 2012.

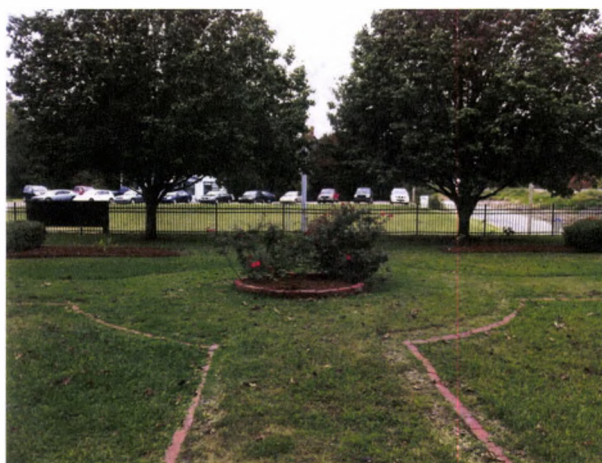
**FIGURE 126.** The central rose bed, looking west toward South Hervey Street. The path in the foreground leads to the visitor center. Photograph by Oculus, October 16, 2012.

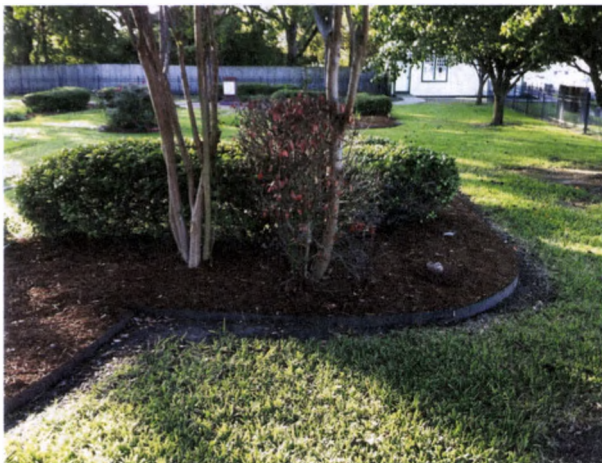
In addition to two brick terraces and a pathway several planting beds have been installed. These are bordered by green-painted steel edging and surfaced with shredded wood mulch, and are slightly raised above the level of the lawn that comprises the greater part of this area (Figure 128). The garden area appears to drain well though some evidence of ponding was visible.

**FIGURE 128.** View south showing crape myrtles and possible volunteer shrub in the west part of the north planting beds. Photograph by Oculus, October 16, 2012.

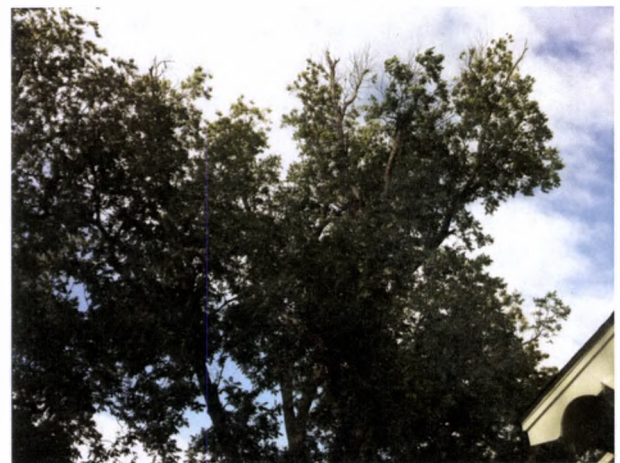
**Pecan Tree No. 3 (*Carya illinoensis*).** This pecan is one of three of similar age and size on the national historic site property (Figure 129). The condition of the tree appears to be fair owing to die-back evident in numerous upper branches. See the tree condition assessment in Appendix F.

**FIGURE 129.** Looking north and up at the crown of the pecan tree at the west side of the visitor center. Photograph by Oculus, October 16, 2012.

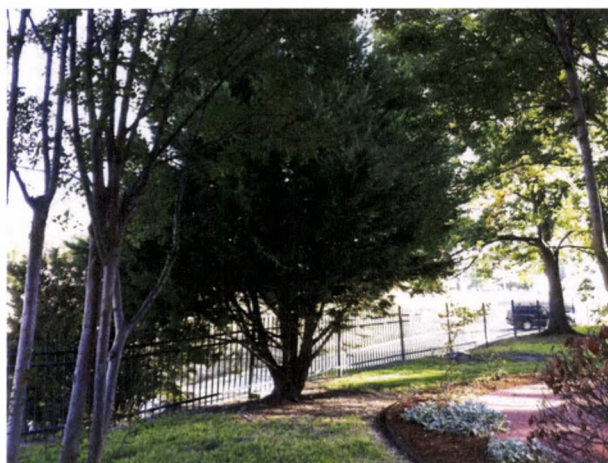
**Evergreen Tree (genus and species not identified).** The trunk of this tree is approximately eighteen inches in diameter with multiple branches emerging a few inches above the ground. Foliage begins about 4 feet from the ground creating a broadly pyramidal form (Figure 130). The condition of this tree is good.

**FIGURE 130.** Looking northeast, toward the cedar tree at the perimeter of the memorial garden. Photograph by Oculus, October 16, 2012.

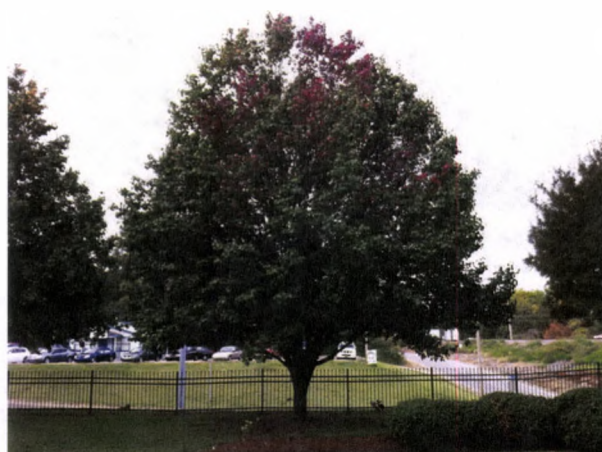
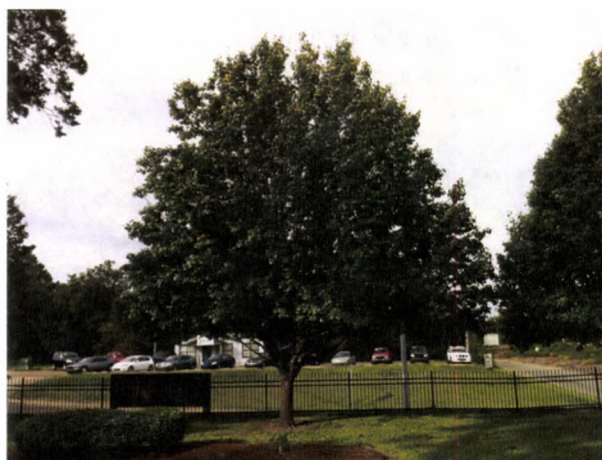
**Bradford pear trees (3) (*Pyrus calleryana* 'Bradford').** Each tree is pyramidal/elliptical in form: flat and broad at the base tapering to a round top-of-crown (Figure 131 and Figure 132). All have fairly even crowns and are approximately 20 feet in height. The condition of these trees is good. However, Bradford pears are subject to damage caused by high winds and snow and ice loads. In addition, while they are not listed as an invasive species in Arkansas they are known to have escaped cultivation and may present ecological problems due to the displacement of native species.<sup>70</sup>

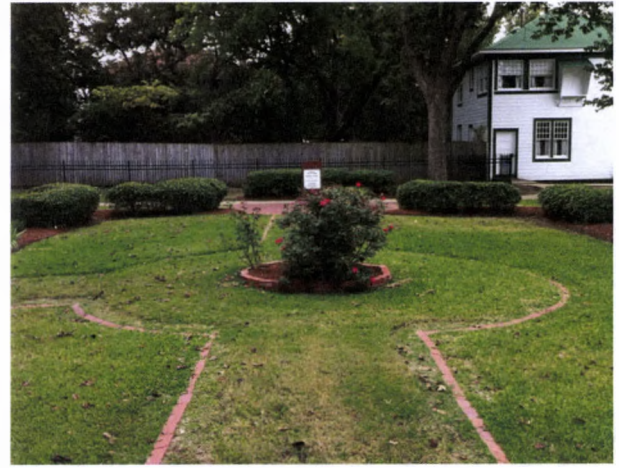
**Central Rose Bed (*Rosa* spp.).** Of the roses in bloom in this bed during the October fieldwork all are of a bluish-red cast similar to those found on other sections of the property (Figure 135). The condition of the various roses is fair owing to the sparse and leggy branching habits.

**FIGURE 135.** View of the south portion of the memorial garden looking south. Photograph by Oculus, October 16, 2012.

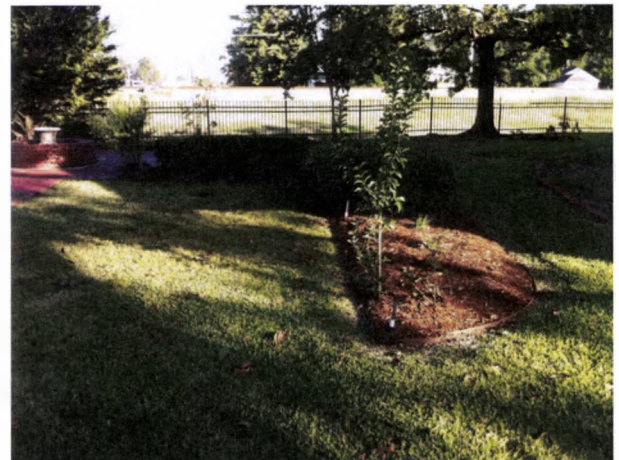
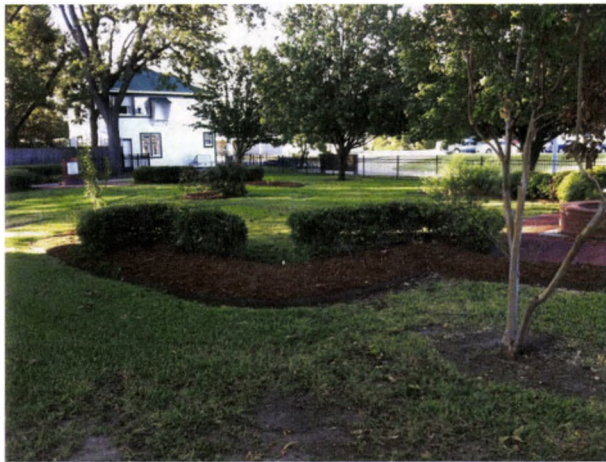
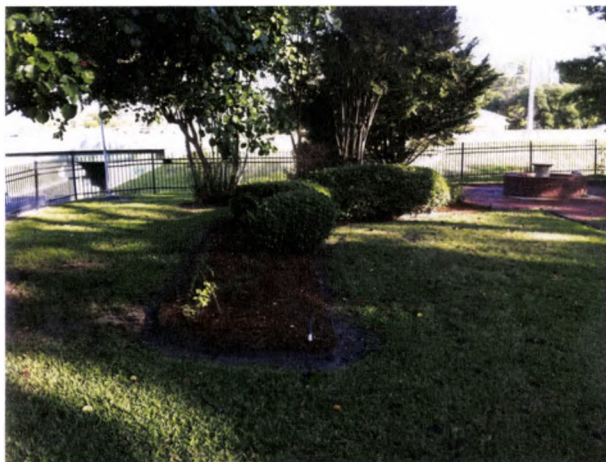
**North Lawn Planting Beds.** These beds are situated in the northwest and northeast corners of the garden forming part of the enclosure of the rectangular lawn (Figure 136, Figure 137, Figure 138, and refer to Figure 128). Edging is of 1/8-inch thick green-painted steel. Plantings in evidence during October included sheared shrubs (possibly *Photinia × fraseri*); lamb's ears (*Stachys* sp.); an unknown shrub (possibly a volunteer); bulbs (possibly spider lily, *Lycoris* sp.); roses of unknown variety; and lantana. There are several small-diameter stumps cut close to the ground. According to the NPS these stumps are the result of the removal of dead shrubs that were part of the initial phase of garden construction. Other than the remaining stumps the plants within the planting bed are in good condition.

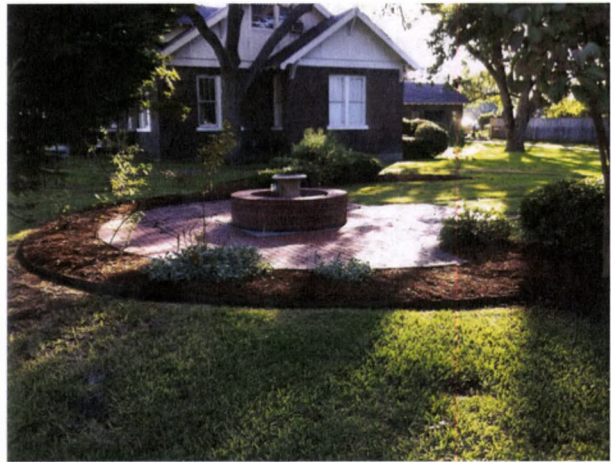
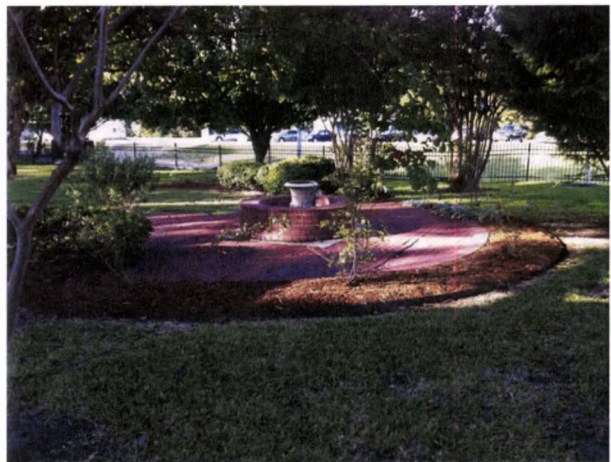
**North Terrace Planting Bed.** This bed is also edged with 1/8-inch thick green-painted steel where it abuts the lawn area (Figure 139 and Figure 140). It contains small compact evergreen shrubs, scattered unidentified roses, a volunteer hackberry (*Celtis occidentalis*), lamb's ears (*Stachys* sp.), and lantana. The condition of the planting bed is good.

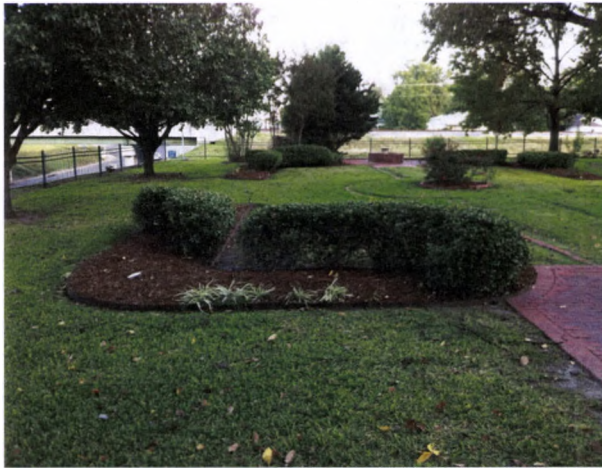
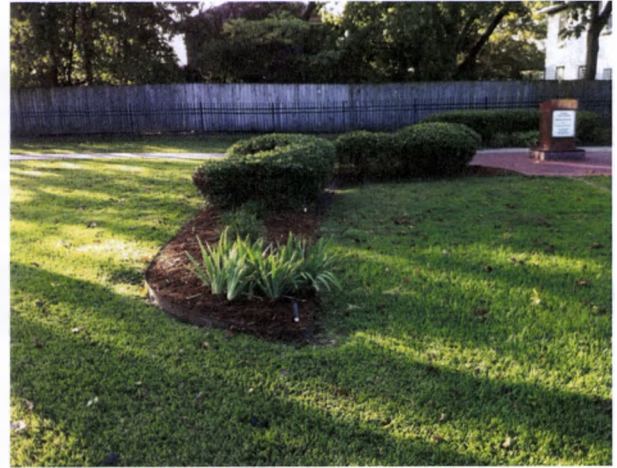
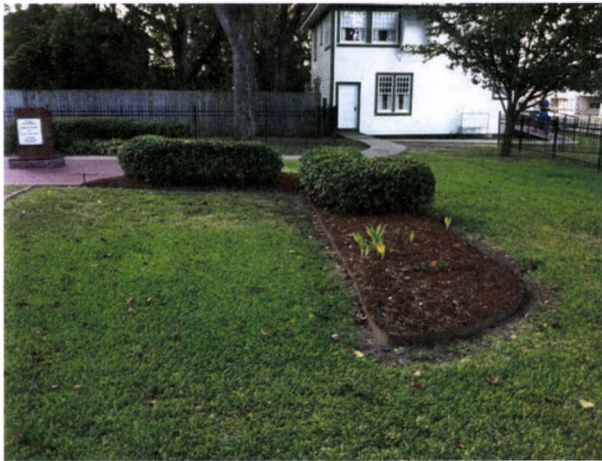
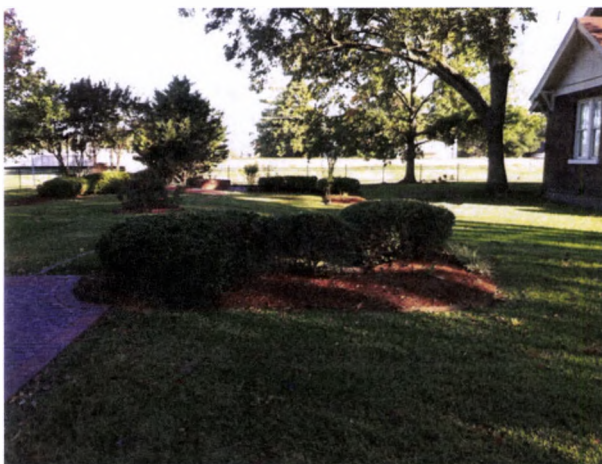
**South Lawn Planting Bed.** Symmetrical to the north lawn terrace planting bed it is likewise bordered with 1/8-inch thick green steel edging (Figure 141, Figure 142, Figure 143, and Figure 144). Shrubs are low and sheared. This bed also contains variegated Liriope and bulbs which may be spider lily or Stella D'Oro lily and iris. The condition of the planting bed is good.

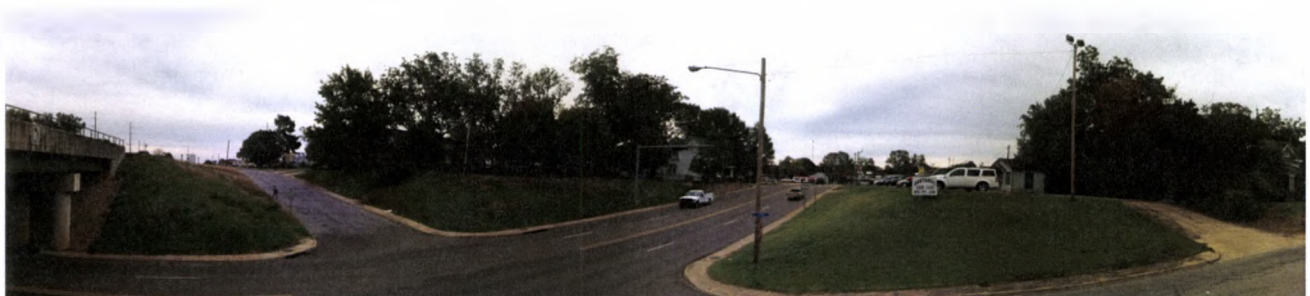
From West Division and South Hervey streets the most visible elements of the memorial garden area are the metal perimeter fence and the larger trees. Below these are steeply graded embankments planted with grass and showing evidence of significant erosion (Figure 149). Approaching from the parking lot at Second and Pine streets the garden is situated beyond the visitor center and to the right of the Cassidy House. It is viewed through mature pecan trees. Lightly screened by the larger trees of the garden, the auto sales lot, railroad, and railroad bridge are nevertheless quite

**FIGURE 149.** Panoramic view east to south, from the corner of South Hervey and West Division Streets, toward the NPS property. Photograph by Oculus, October 16, 2012.

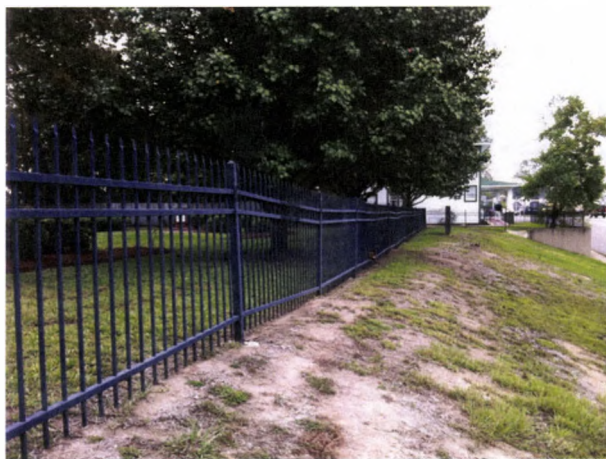
This is the same metal fence described in the Cassidy House landscape (Figure 150). Its alignment corresponds roughly to the national historic site property boundary. The picket fencing is in good condition.

**FIGURE 150.** View south showing erosion on the bank just outside the metal perimeter fence. Photograph by Oculus, October 16, 2012.

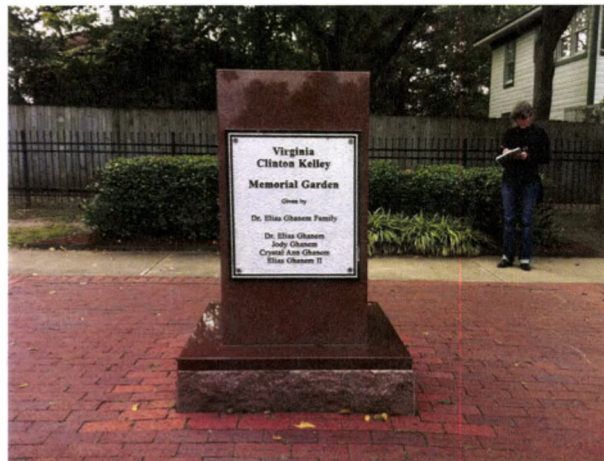
**FIGURE 151.** Looking south at the granite monument. Photograph by Oculus, October 16, 2012.

**Granite Monument.** A red granite monument with a podium-like shape occupies the south brick terrace at the south entry to the memorial garden (Figure 151). See Appendix C for a description of

the monument inscriptions. The base is approximately 36 inches wide by 36 inches deep by 9 inches tall, with rusticated sides and a polished top. The vertical element is approximately 42 inches tall at the highest point, 24 inches square and centered on the base. It has polished surfaces each with an inscription (Figure 152). The monument is in good condition.

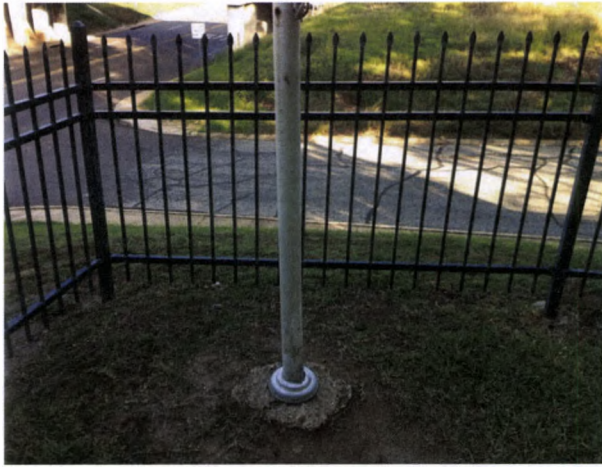
**FIGURE 153.** Flagpole in the northwest corner of the memorial garden. Photograph by Oculus, October 16, 2012.

**Flagpole.** In the northwest corner of the property visible from South Hervey and West Division Streets is a flagpole carrying the flag of the United States (Figure 153). It is fabricated of metal and carries a plaque identifying it as having been manufactured by Park-O-Meter. The condition of the flagpole is good though a headless screw protrudes near chest height representing a possible impaling hazard.

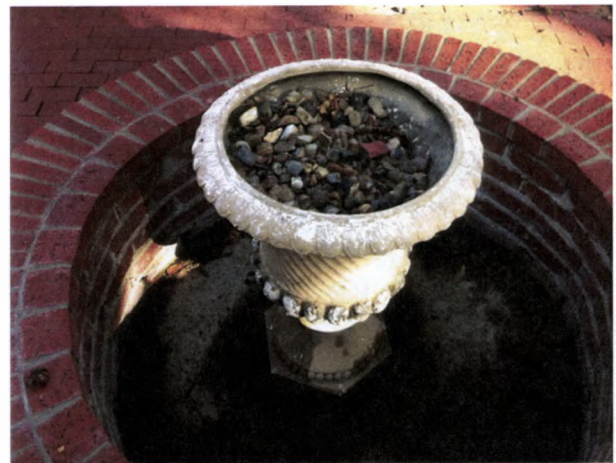
**FIGURE 155.** Looking north and down into the vase within the circular brick structure. Photograph by Oculus, October 16, 2012.

**Vase.** The vase appears to be cast glass fiber reinforced concrete. The condition of the vase is poor. It exhibits deterioration in the form of cracking, chipping, discoloration, apparent surface pitting, and biological growth. At the time of the visit it contained gravel (refer to Figure 155).

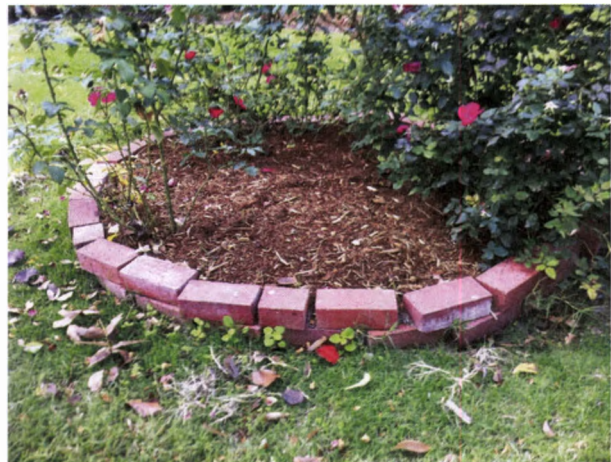
**FIGURE 157.** Looking west at a detail of the central rose bed with brick edging. Photograph by Oculus, October 16, 2012.

**Central Brick Planter.** This feature is a circular slightly raised and symmetrically situated planting bed in the center of the memorial garden along the central axial path (Figure 157). Construction is of dry stacked red brick. The condition of the planter structure is poor. Bricks are unevenly stacked without mortar joints and are unstable.

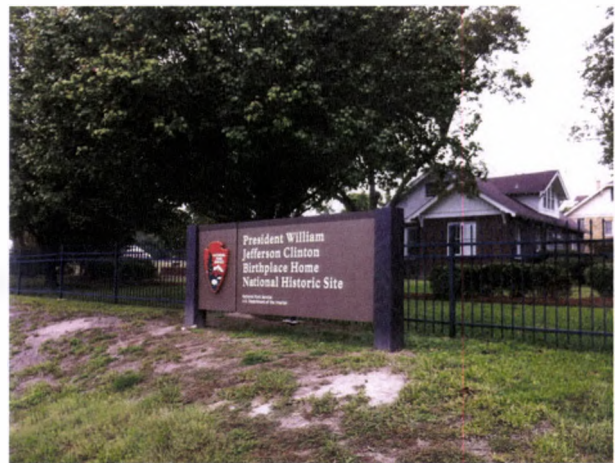
**FIGURE 158.** View southeast of an NPS identity sign that sits atop the bank at the western perimeter of the property. Photograph by Oculus, October 16, 2012.

**National Historic Site Identity Sign.** This sign is located just outside the perimeter fence facing South Hervey Street (Figure 158). It is constructed of a plywood-sheathed 2x4 frame attached to rough-sawn square timber posts. The sign face includes a raised NPS arrowhead logo to the left. To the right it reads: “President William Jefferson Clinton Birthplace Home National Historic Site” and in smaller letters at the bottom: “National Park Service, U.S. Department of the Interior.” The sign is in good condition.

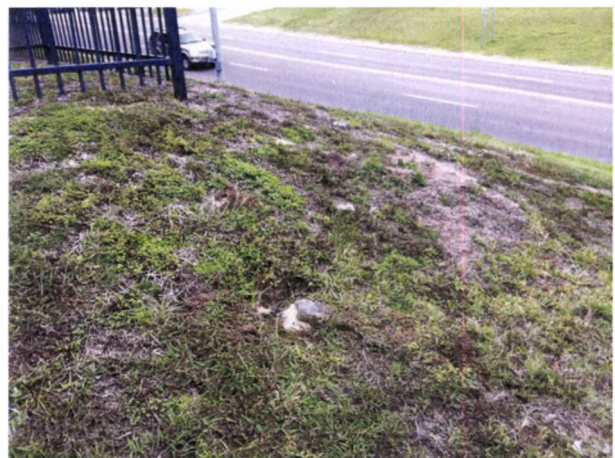
**FIGURE 159.** Looking southwest, across the bank at the corner of the NPS property. Photograph by Oculus, October 16, 2012.

**Former Sign Posts.** At the top of the embankment just outside the northwest corner of the metal perimeter fence is a pair of 4x4 posts set into the ground. The posts were cut close to the ground (Figure 159). Given that the posts and bases are remnant features they are in poor condition.

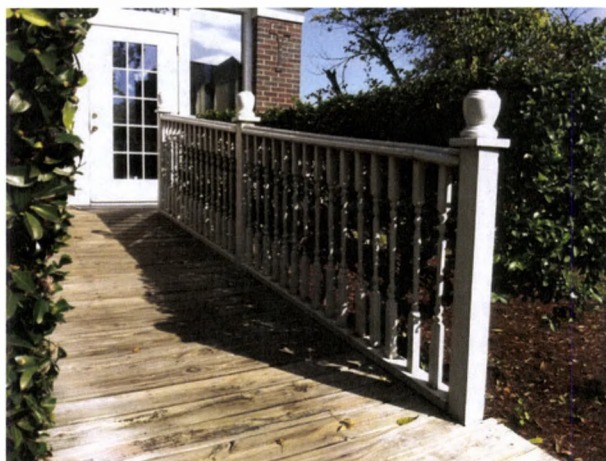
**FIGURE 163.** View north, of the ramp attached to the deck at the rear of the visitor center. Photograph by Oculus, October 16, 2012.

**Deck at Rear of Visitor Center.** The structure of this deck is of 2x6 joists and 4x4 wood posts. The decking is also wood of 5/4-inch by 6-inch planks. Visible wood members are painted or stained grey but worn through to bare wood in some areas. A set of wood steps, similarly constructed, leads to the visitor center driveway to the east. A wood ramp, also of similar construction, leads to the concrete walk fronting the comfort station to the south (Figure 163). The guardrail of the deck is constructed of wood 4x4 posts with decorative caps, wood 2x4 top rails, and decorative turned wood balusters. The guardrail is painted or stained light gray. The condition of the wood deck, steps, and guardrail is fair owing to the poor condition of the guardrail. The connections and fasteners of the guardrail members are loose in some locations.

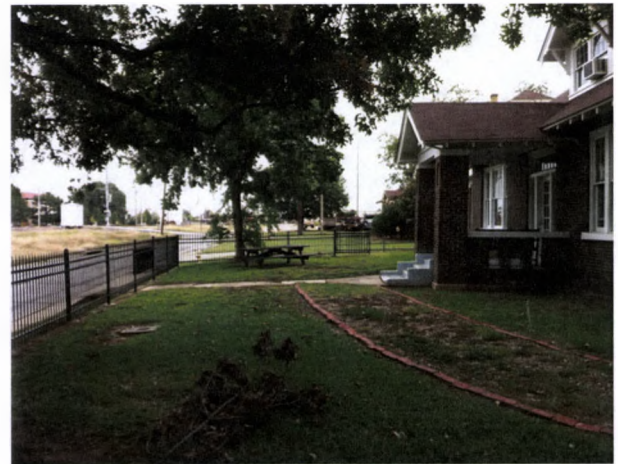
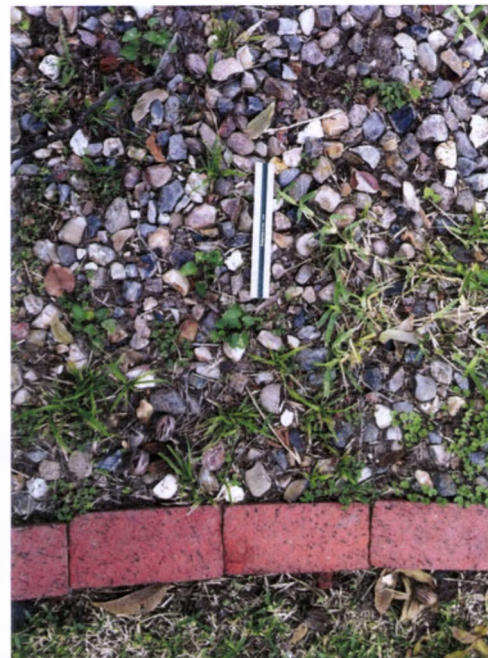
This path leads from the central rose bed planter in the memorial garden eastward toward the visitor center. From the garden the path curves northeast then east again to connect with the concrete walk that leads to the front porch of the visitor center (Figure 169 and Figure 170). The path is edged with brick and has a crushed stone surface. The pathway is in fair condition owing to grass and weeds throughout the walk and to brick edging that is loose in places presenting a trip hazard.

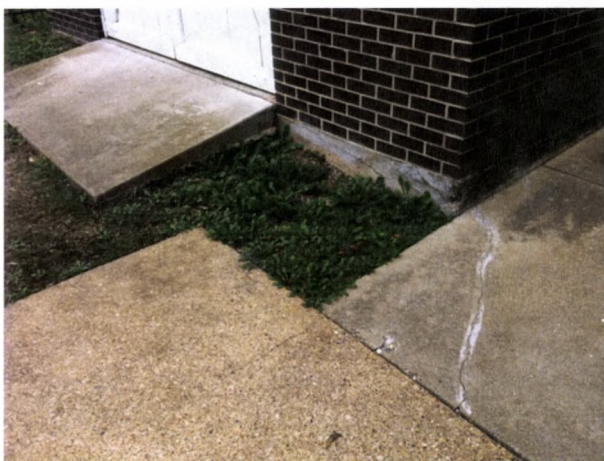
**FIGURE 171.** A concrete ramp provides access to an equipment and supply storage room at the north end of the comfort station building. This view is toward the southeast. Photograph by Oculus, October 16, 2012

**Concrete Ramp.** A small concrete ramp leads into the equipment and supply storage area via a garage door (Figure 171). The condition of the ramp is fair owing to erosion of soil or crushed stone paving resulting in the undermining of the slab.
