# President William Jefferson Clinton Birthplace Home

## Cultural Landscape Report

## **Cultural Landscape Report Environmental Assessment**

April 2014

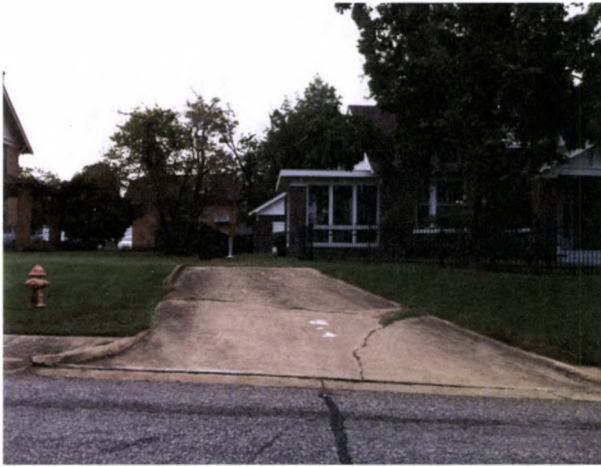
**FIGURE 174.** Looking south at the concrete apron at the entrance to the visitor center driveway as it connects to West Division Street. Photograph by Oculus, October 16, 2012.

**Concrete Driveway Apron.** A concrete apron connects the driveway to West Division Street (Figure 174 and Figure 175). The concrete pavement is edged along a portion of the east side with a yellow-painted curb (Figure 176). The apron is in fair condition owing to large cracks in the concrete resulting in lippage and soil- and grassed-filled crack openings.

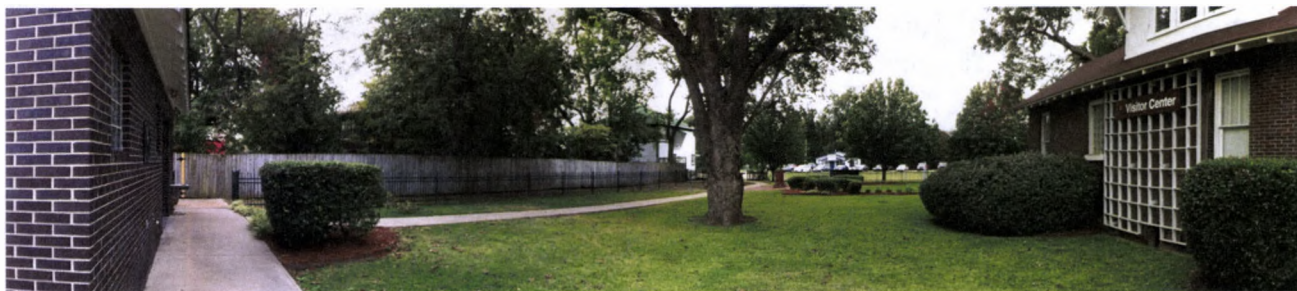
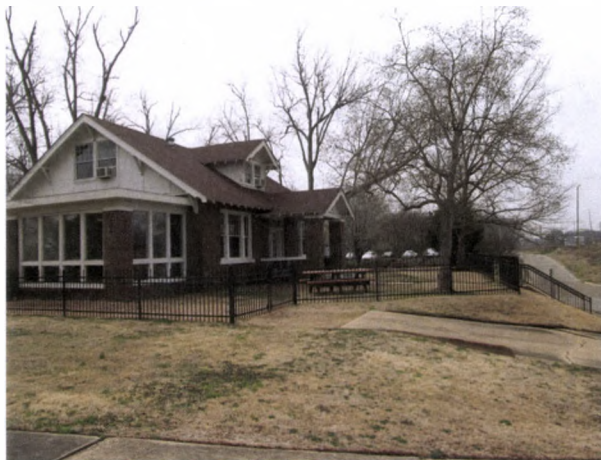
**Building Site, Visitor Center.** As with the Cassidy House there is little variation in elevation of the topography across the site (Figure 180 and Figure 181). The condition of the building environment grades is poor. The NPS reports that water drains into the crawlspace entrance at the back of the visitor center during and after rain events. Visual inspection of the grades at the building line indicates a lack of positive drainage away from the building. This condition may be the result of soil settlement.

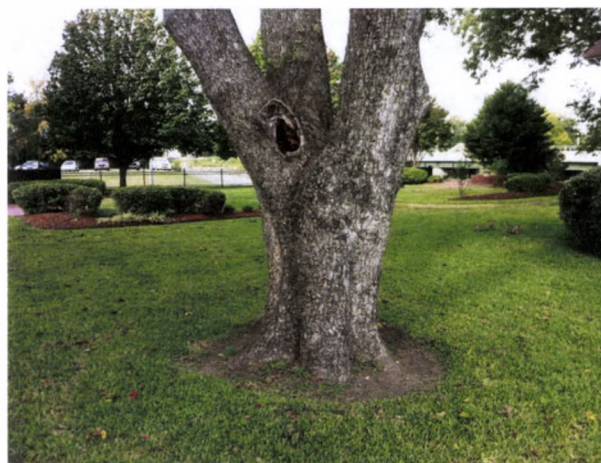
**FIGURE 182.** The base of the pecan tree located in the rear yard of the visitor center. The memorial garden is in the background. Photograph by Oculus, October 16, 2012.

**Pecan Tree No. 1 (*Carya illinoensis*).** This tree is located south of the visitor center in the lawn bounded by the visitor center and the comfort station. The condition of this tree appears to be fair. See Appendix F for a more detailed condition assessment of this tree. At least one major branch is hollow (refer to Figure 180 and Figure 182). Die-back is evident in numerous upper branches.

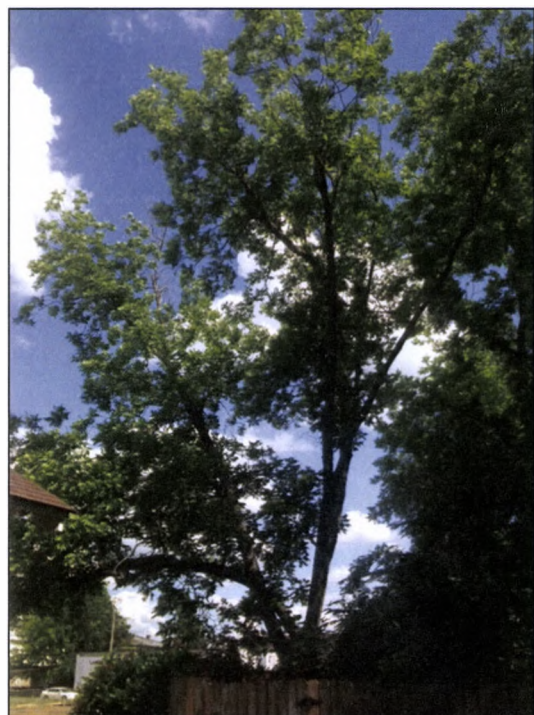
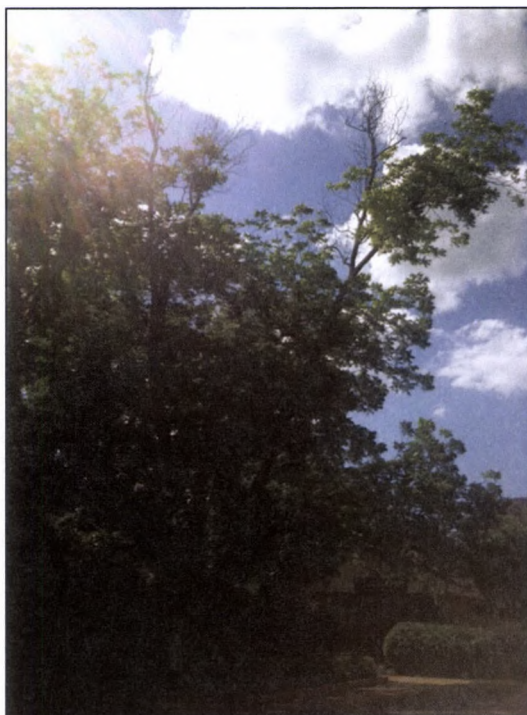
***Tree No. 4***

**Tree No. 4.** The large pecan has an overall well balanced canopy. The foliage has a normal, healthy appearance. There are several large branches in the center of the canopy. The tree is located in a raised landscape bed, and the grade around the tree is at least 5 inches above the tree's natural grade. This most likely is contributing the branch mortality and will continue to affect the health of the tree. There is an open cavity at the base of the tree with extensive decay into the trunk of the tree. The strength loss was calculated using the following formula:
